BAFFINLAND IRON MINES CORPORATION

MARY RIVER PROJECT

Construction Summary Report

Km106 Run of Mine Stockpile & Sedimentation Pond

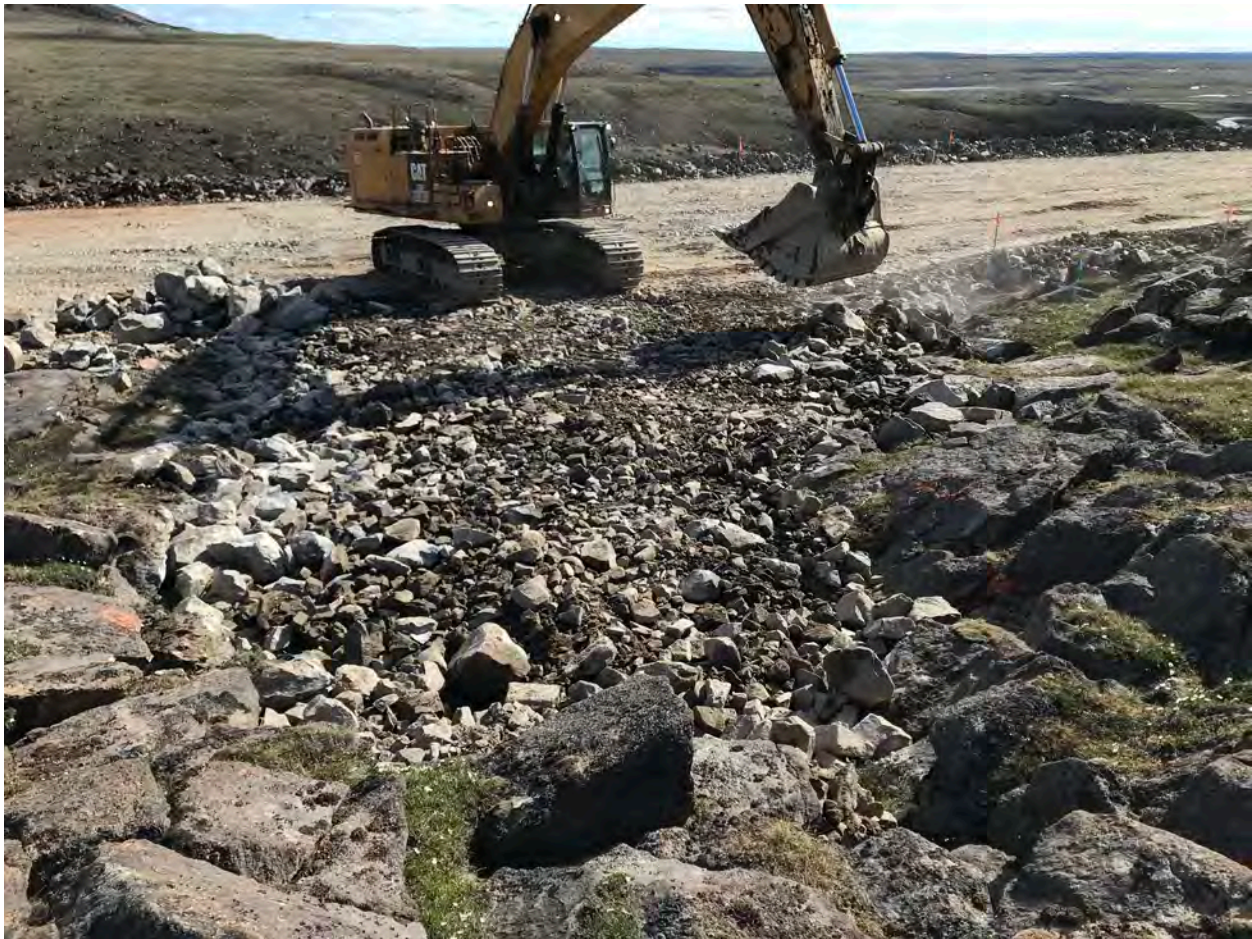
Filling in a Crevice with ROQ and 150mm minus – 7Jul20

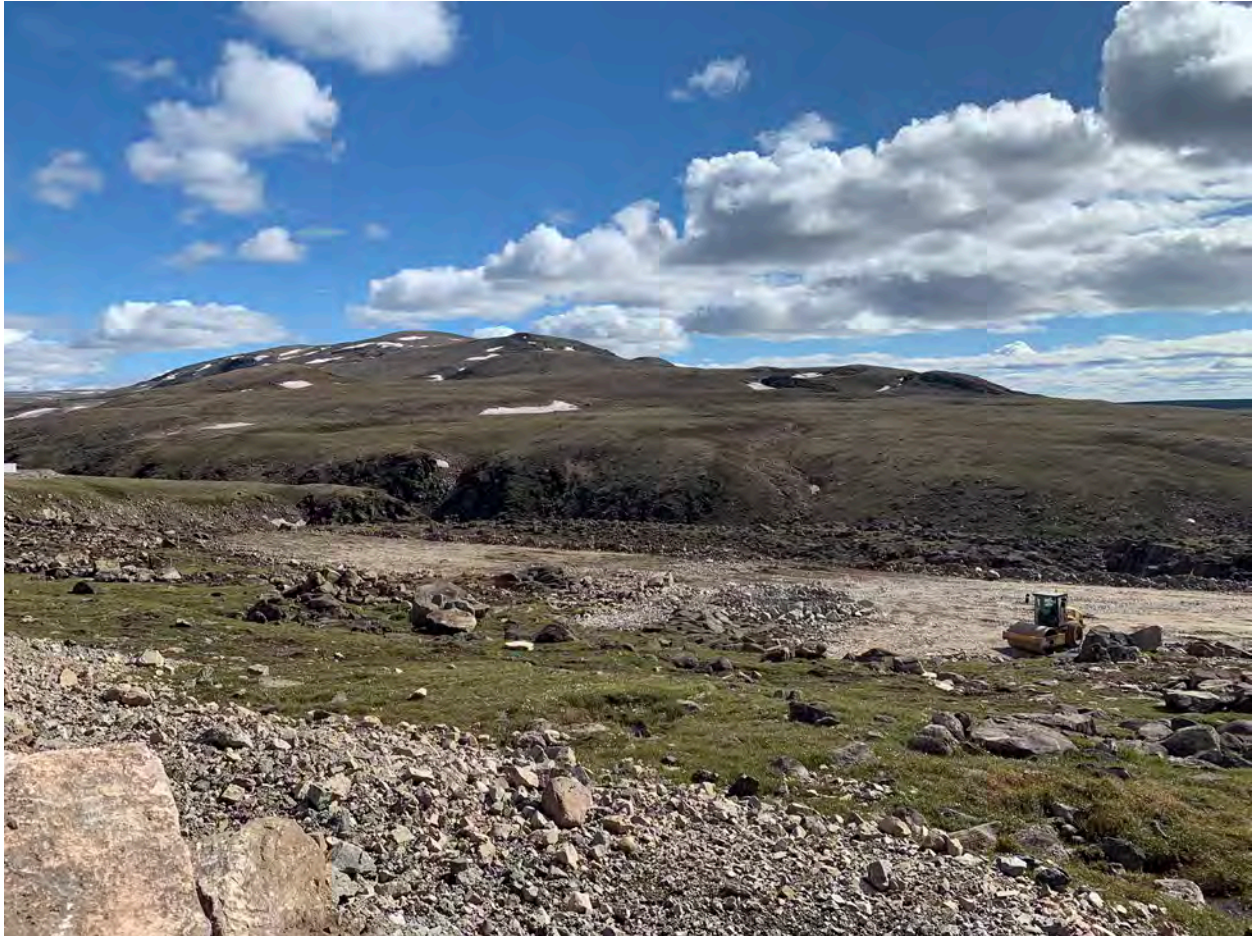
Placing 150mm minus material in Existing Crevices - 8Jul20

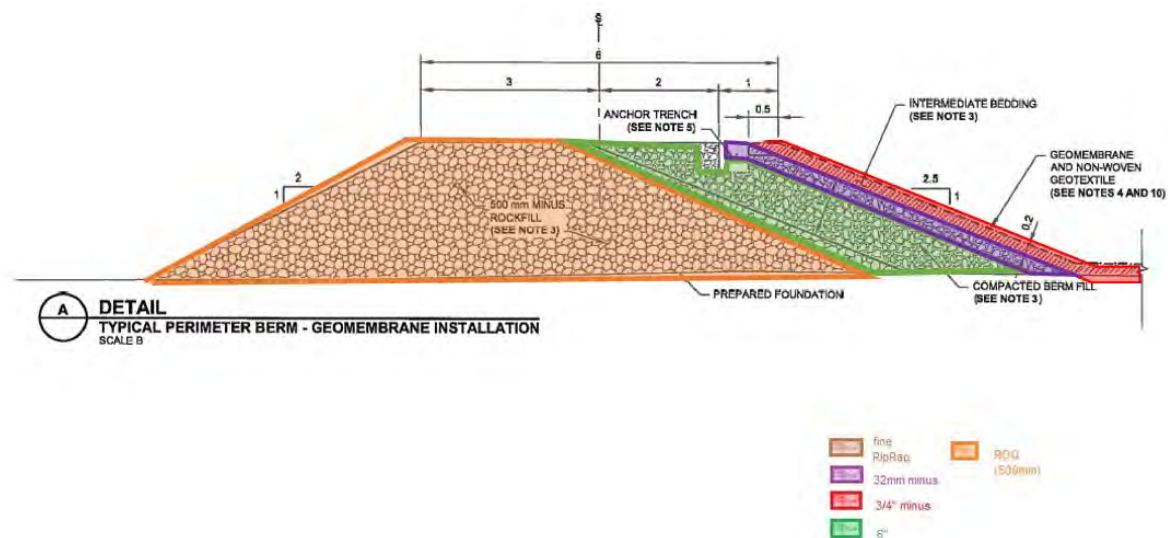
Figure 1: Intermediate Bedding Modification

The KP Consulting original IFC drawings specified and showed in the drawings, the intermediate bedding layer of 32mm minus material, geotextile fabric, and liner. Allan Knowlton, P.Eng., discussed changing the upper intermediate layer to $\frac{3}{4}$ " minus aggregate material in order to provide more protection to the liner from the intermediate layer, as crushed 32mm minus can be very angular, and the larger angular aggregate size may compromise the liner over time. KP Consulting agreed to the change with the exception of keeping the 32mm minus layer over the 150 mm minus layer to ensure aggregate differential size filter compatibility. See below agreed modification in Figure 1.

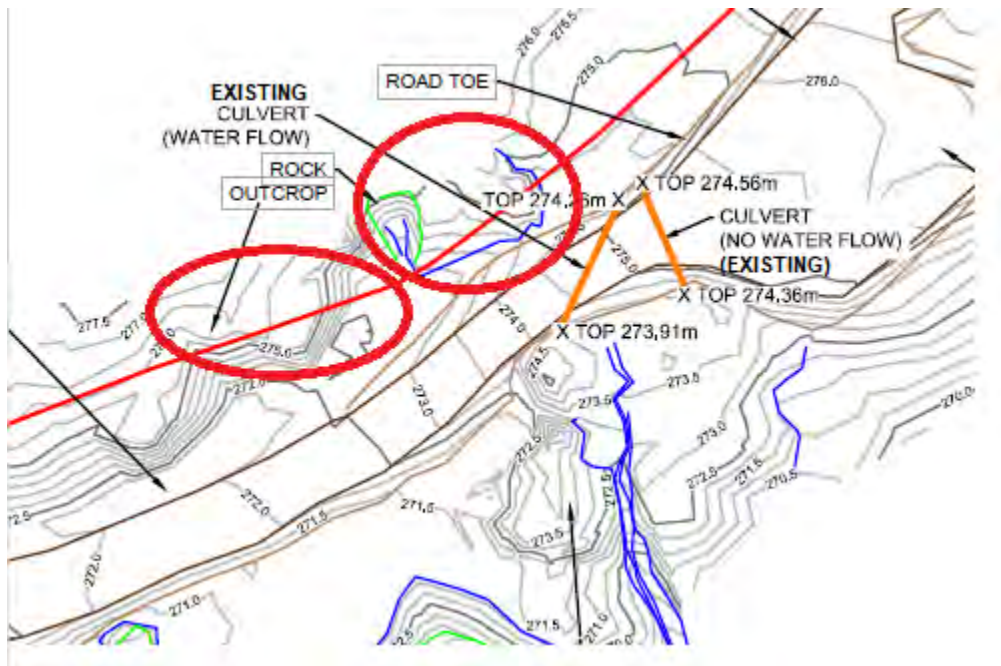
Figure 2: Rock Outcrop and Low Lying Area at East Stockpile Diversion Berm

The east stockpile perimeter diversion berm per the IFC was located along a path that intersected a rock outcropping not identified in the IFC drawings. This created a situation where the diversion berm water flow path was lower than the pond inlet elevation and would trap water. KP Consulting was requested to shift the entire berm northward 10 meters to clear the outcropping. KP agreed to the new positioning, work proceeded and documented in the as-built drawing. See below Figure 2 and Appendix C.2 for berm location modifications.

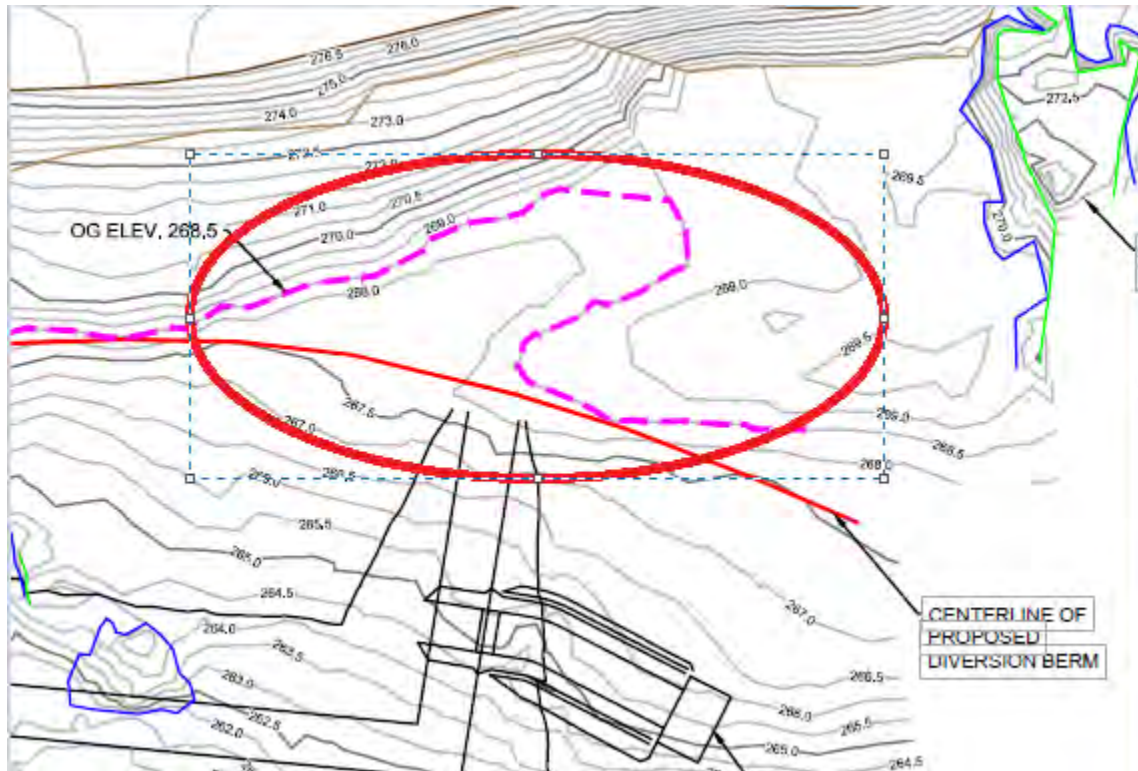
Figure3: Location of Existing Depression

Another low lying area not identified on the IFC drawings was located at the end of the pond berm at the northeast corner of the pond. An existing low depression, surrounded by a rock outcrop and blocked by the future north pond diversion berm presented an issue which would trap water. The agreed solution with KP Consulting was to fill the depression, excavate a swale to the south east of the depression, install geotextile fabric, and fine rap along the swale. This would direct the water around the pond and spillway. See below Figure 3.

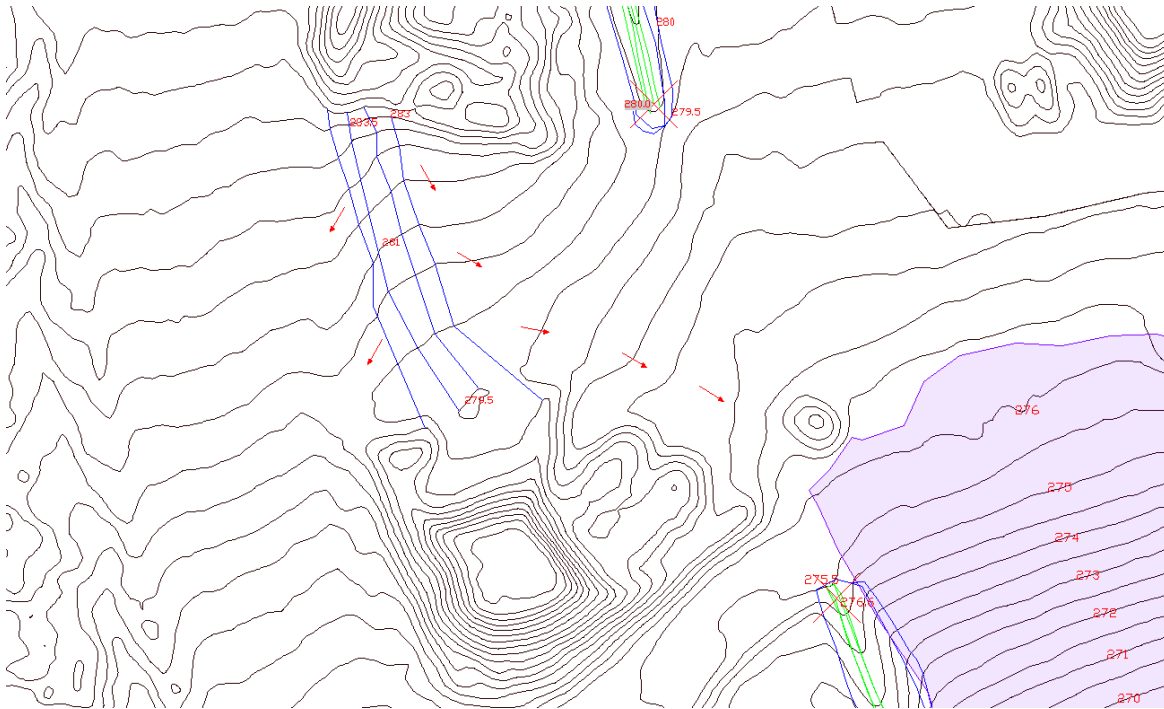
Figure4: Access Road Entry Berm and Swale Water Management Measures

Due to Mine Operations requiring access to the lower portion of the stockpile to load the stockpiled material at future times and existence of an existing access road to the explosive magazine which was not accounted for in the design the berm was not installed in this area. To ensure runoff water from the haul road did not migrate into the stockpile area, and to ensure the stockpile water did not leave the area without reporting to the pond, a wider berm in conjunction with a swale was designed to control the water as shown below in Figure 4 and Appendix C.2. The upper access road will be in continual development as the stockpile grows in size and extends out from the haul road to eventually complete as per the KP Consultant design.

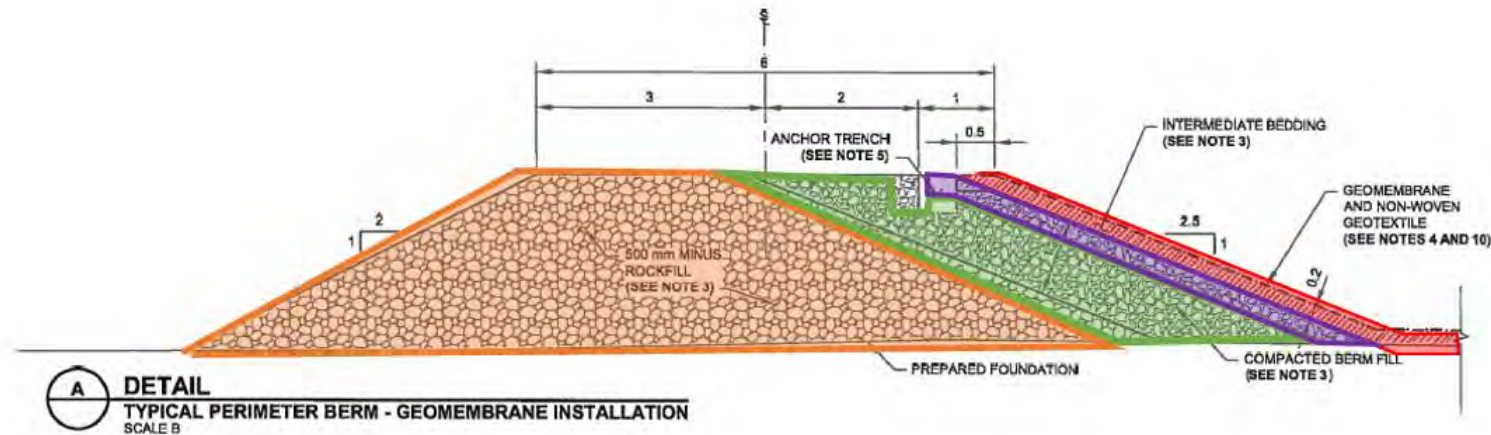
Hi Allan,
I understand that you want to use ¾ in material to better protect the liner. This is a good idea, however I have the following comments and recommendations:

- **Perimeter Berm** – I recommend that the ¾ in minus material be added as a new zone on the upstream slope, and that both the 6 inch minus and 32 mm minus material be placed as planned (see sketch below). The new zone of ¾ inch minus material should be 0.2 m thick and you can reduce the width of the 500 mm minus rockfill zone by 0.2 m to accommodate this new zone without compromising capacity in the pond. In my experience, replacing the 32 mm minus material with ¾ minus material directly adjacent to the 6 in minus material could result in loss of the ¾ in minus material into the voids of the larger 6 in minus material. If this were to happen, the liner could be damaged due to the development of underlying voids, or more susceptible to puncture from exposure to the 6 inch minus material. My recommendation is based on experience and rules of thumb - if you are able to provide gradations for the different materials, then I could confirm the filter compatibility between the ¾ in minus and 6 in minus material and verify if the 32 mm minus material could be eliminated without compromising the liner.
