4.0 MILNE INLET

4.01 General

The containment facilities that we have been doing inspections on for the last 6 years are now rapidly changing in function with the construction underway at the Milne Inlet site.

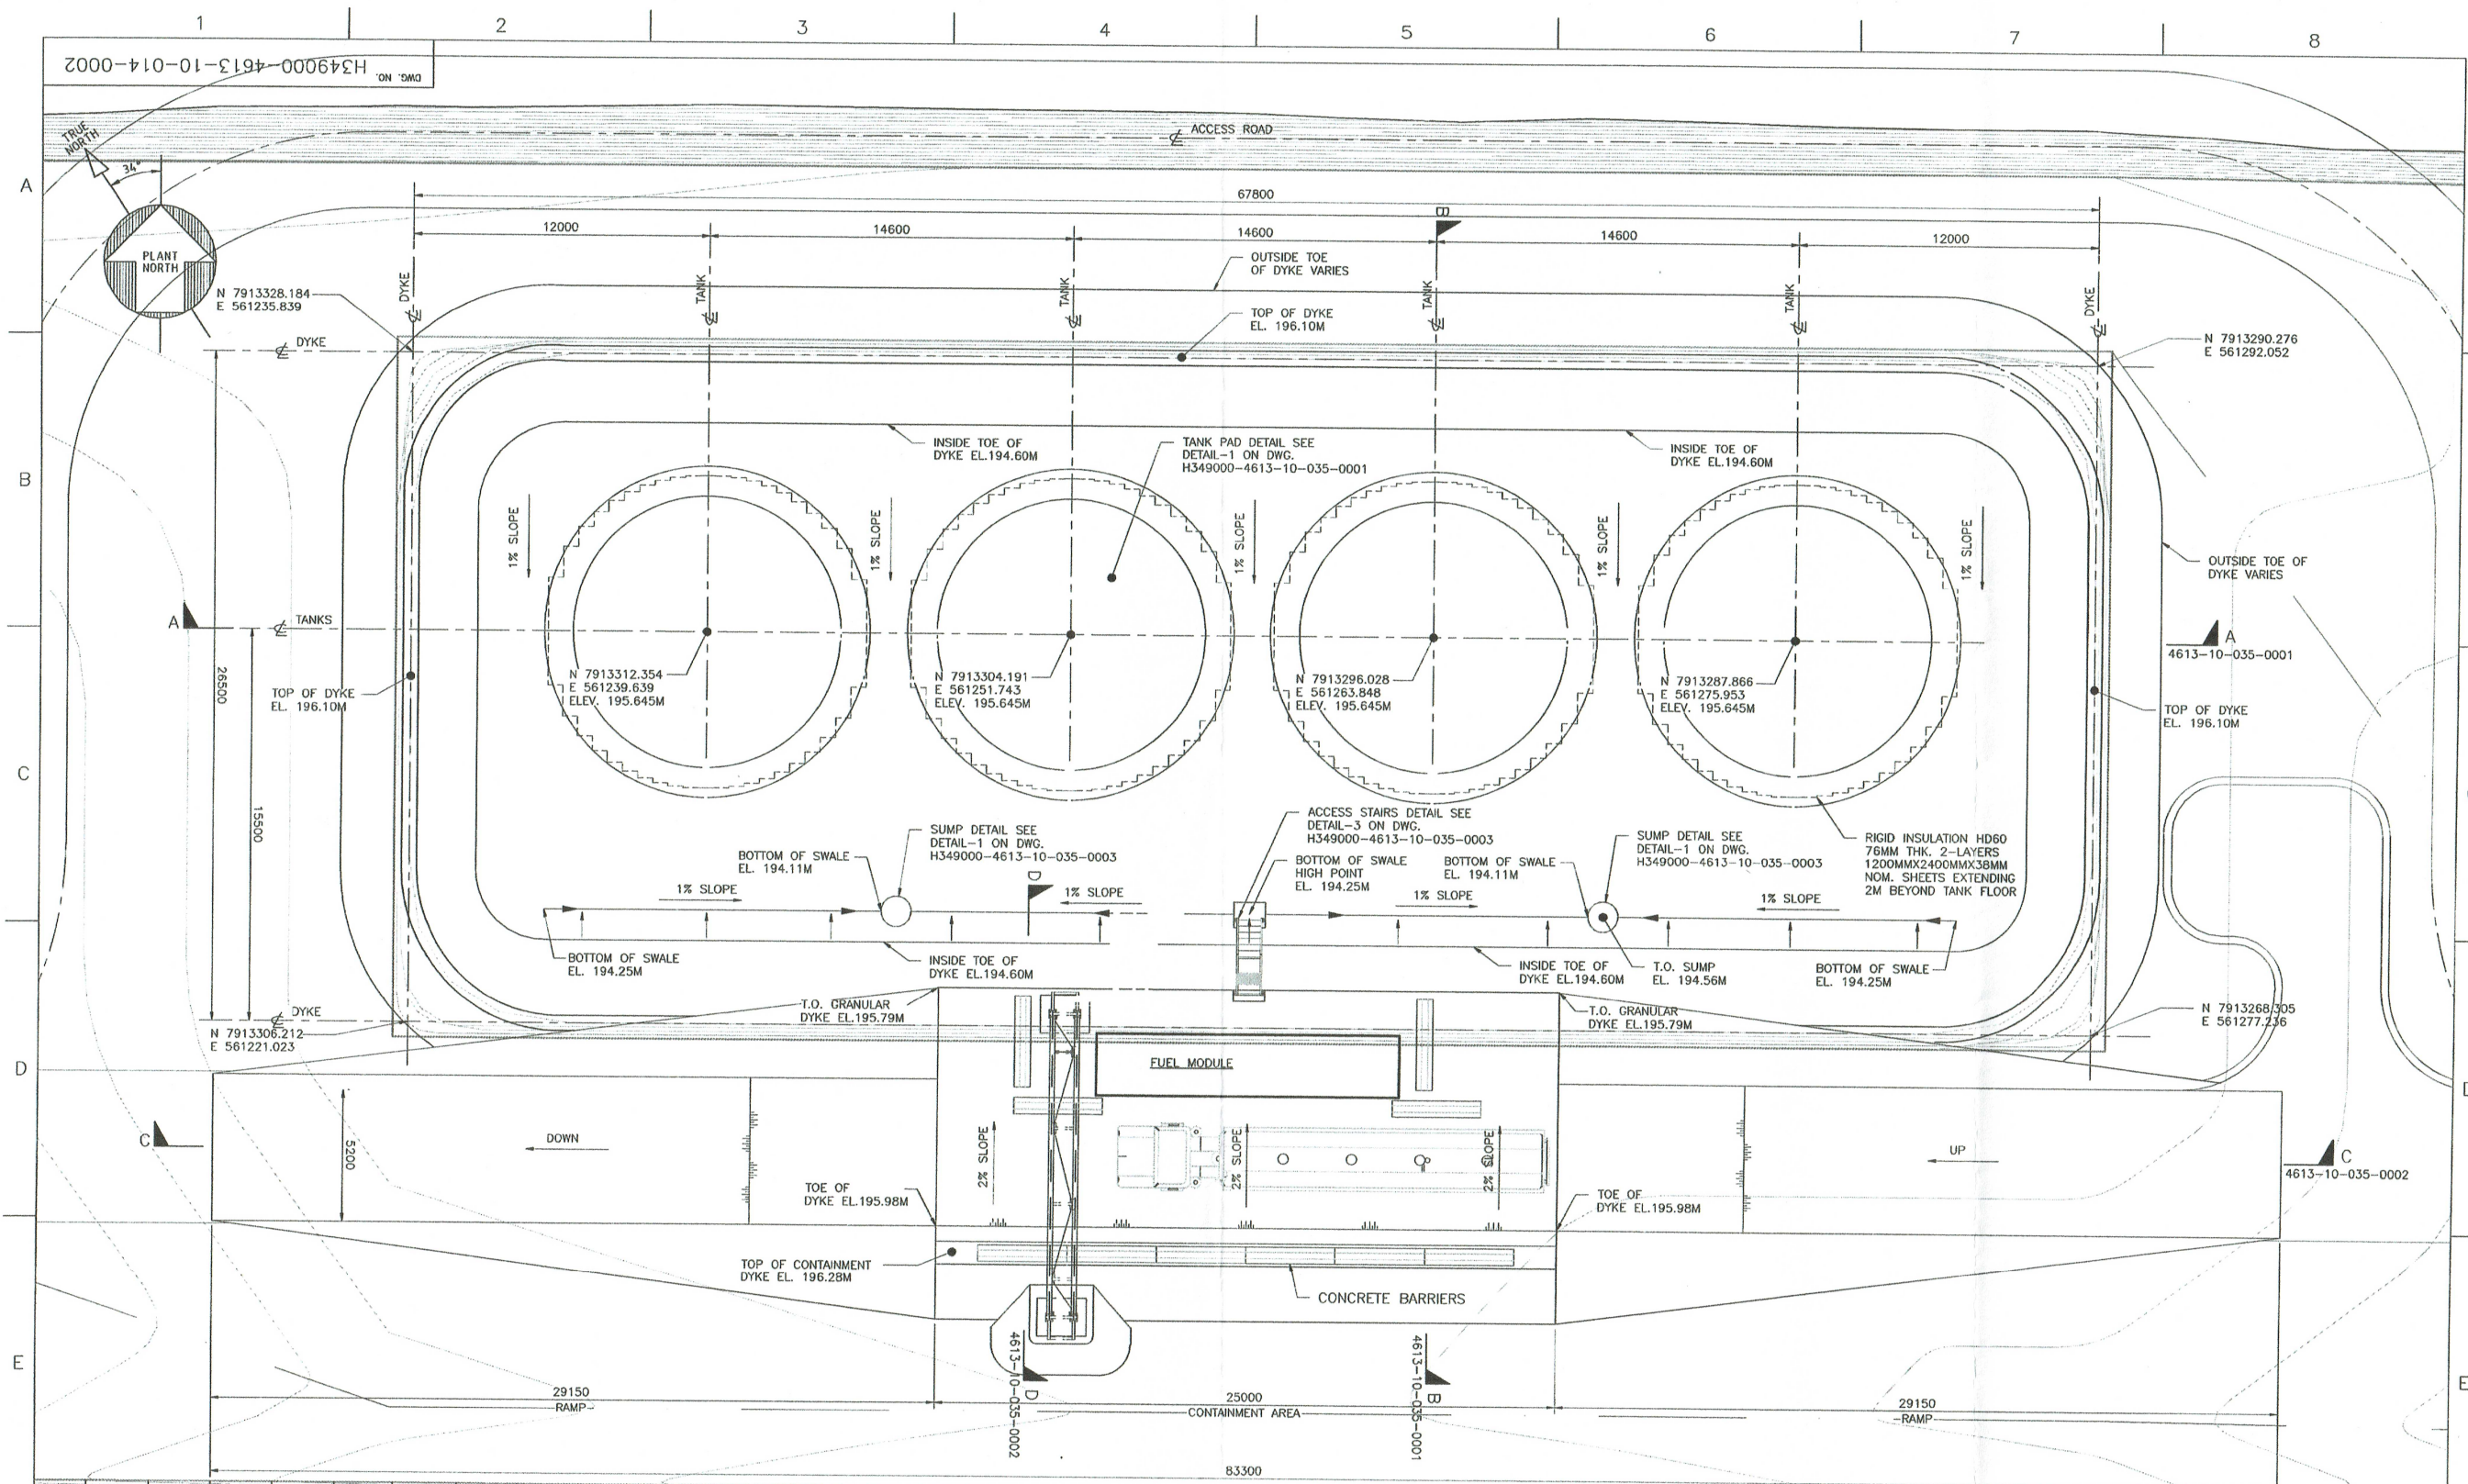
At the time of our last inspection in 2013, the containment structure had been put in place for the entire tank farm but not all tanks were in place.

Since that time, all fuel tanks have been constructed.

There existed in place, a temporary ramp at the north west corner of the containment structure to facilitate the construction of the last tank and entry of crane(s) into the containment structure at the time of our August review.

This temporary ramp did not affect the integrity of the containment structure nor infringe upon the required capacity of the structure. The reamp had been removed by the time of our September review.

We noted no sign of weakness in any of the structure construction.

At both inspections we noted minor water ponding at the low end of the containment confirming the integrity of the liner.

We have no recommendation for this structure.
