4.13 Sediment Pond West

4.14 Quarry

Milne Inlet August Inspections

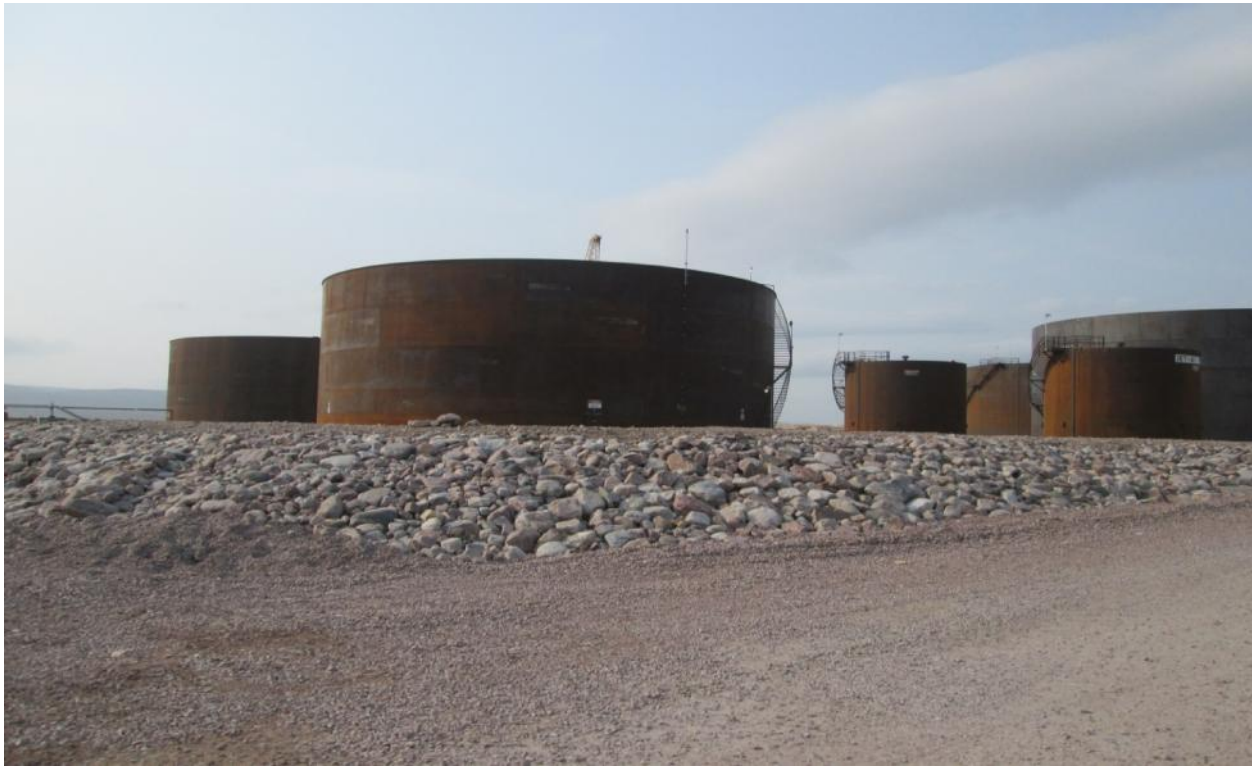
Photo taken from the south east corner of the steel storage tank containment outside the containment looking north west.

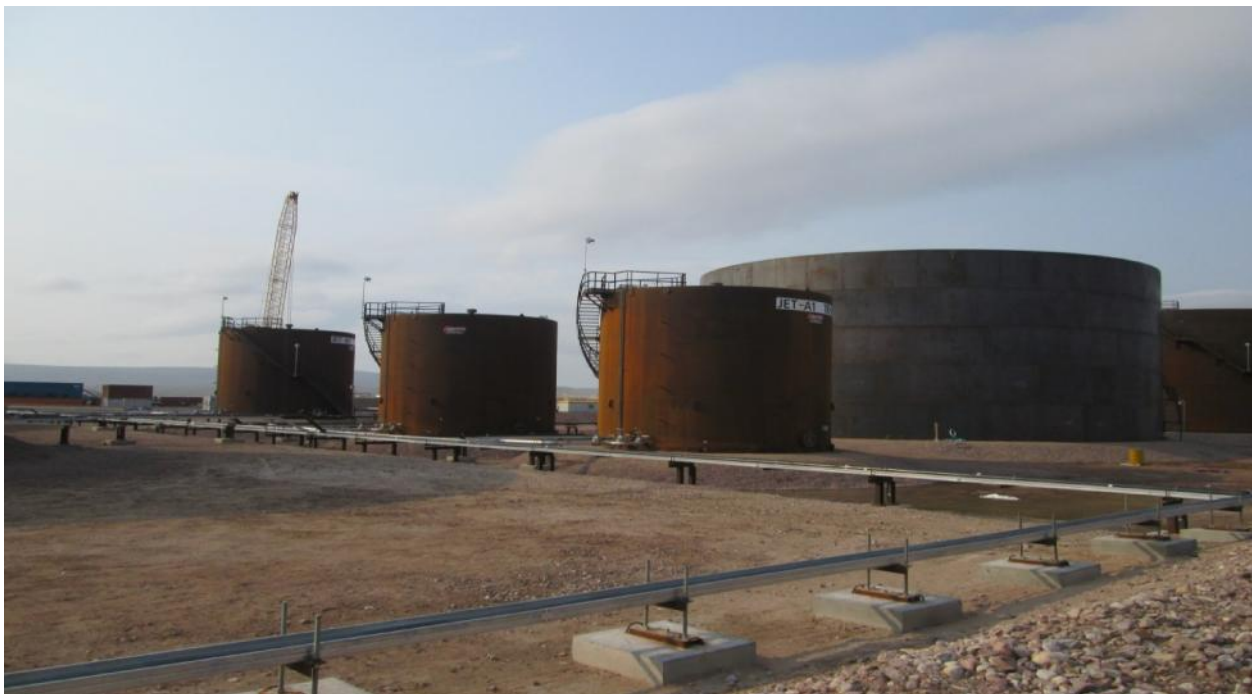
Photo taken from atop the containment dyke looking west into the containment.

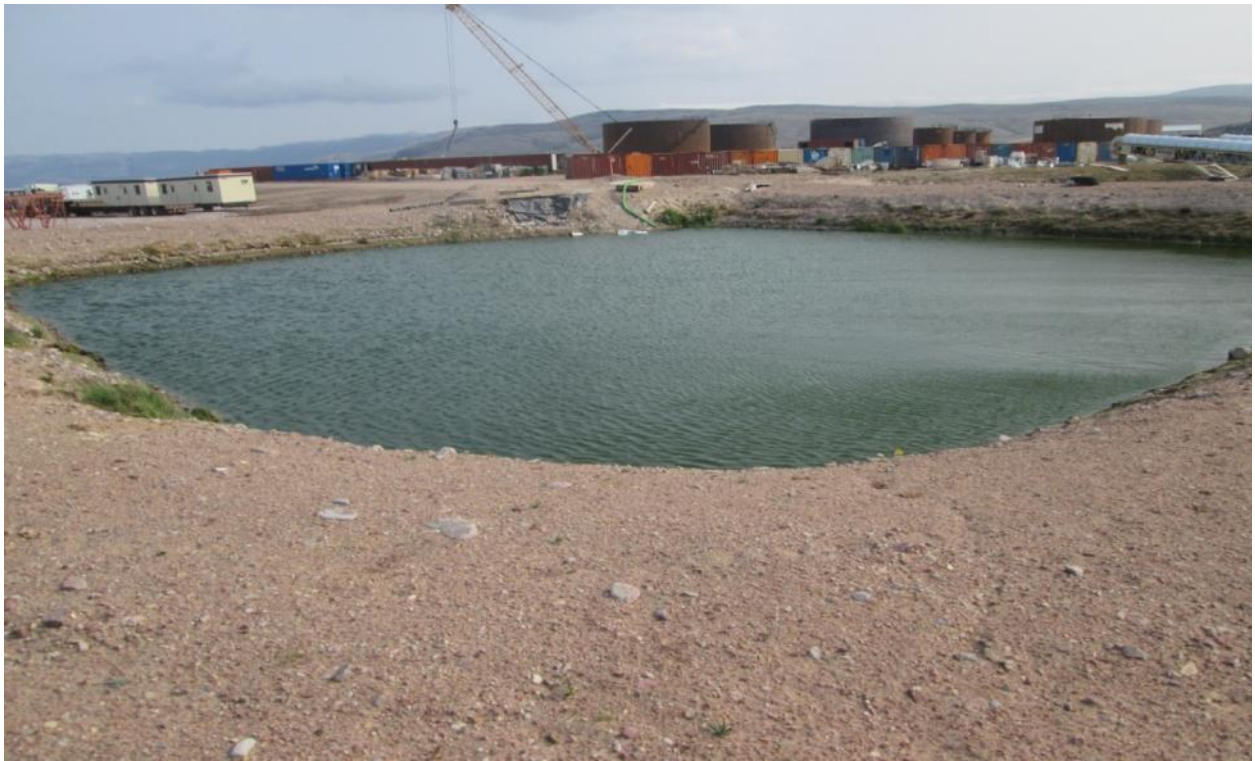
Photo taken from atop the soon to be decommissioned PWSP looking south.

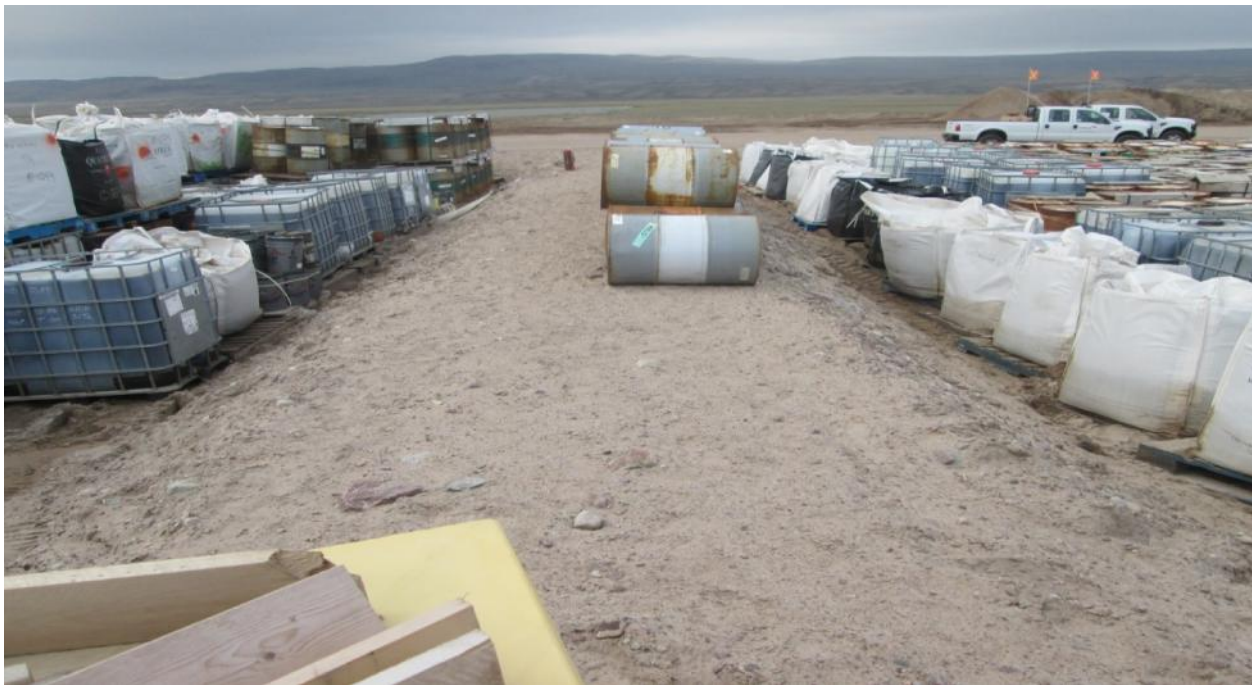
Photo taken of central dyke in barrel fuel storage looking west.

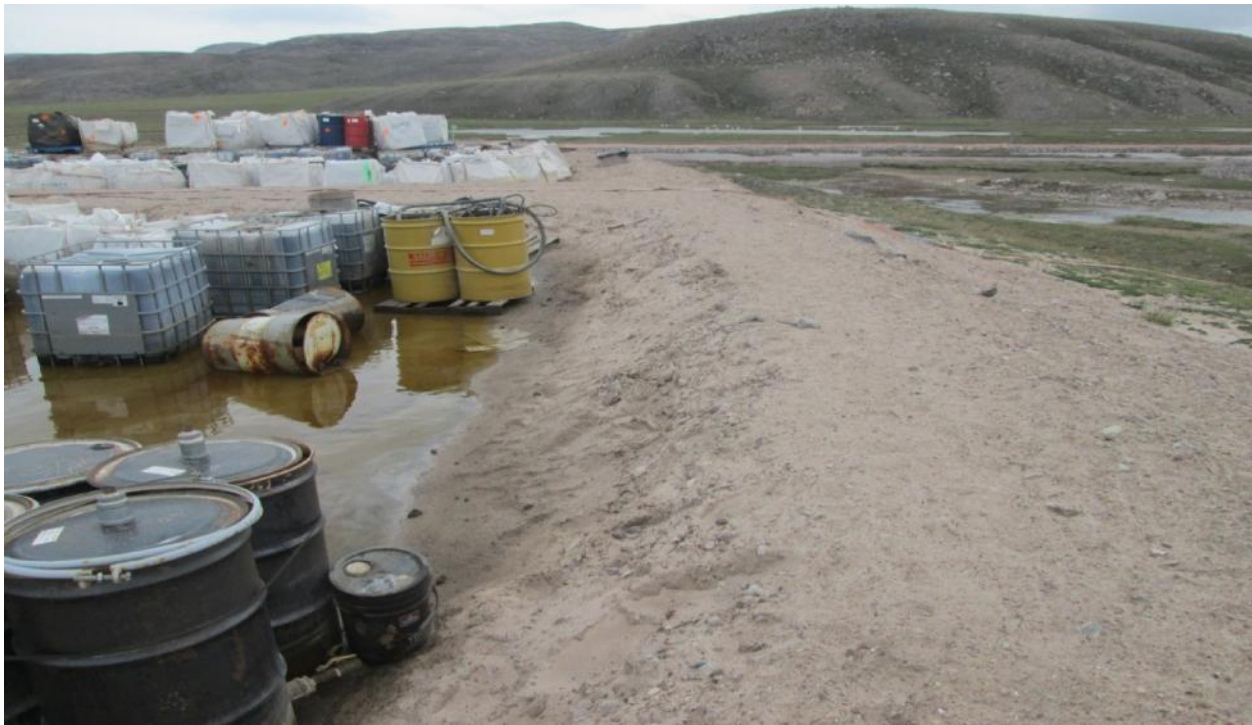
Photos taken along rear dyke at hazardous waste storage area. Note water contained within dyke.

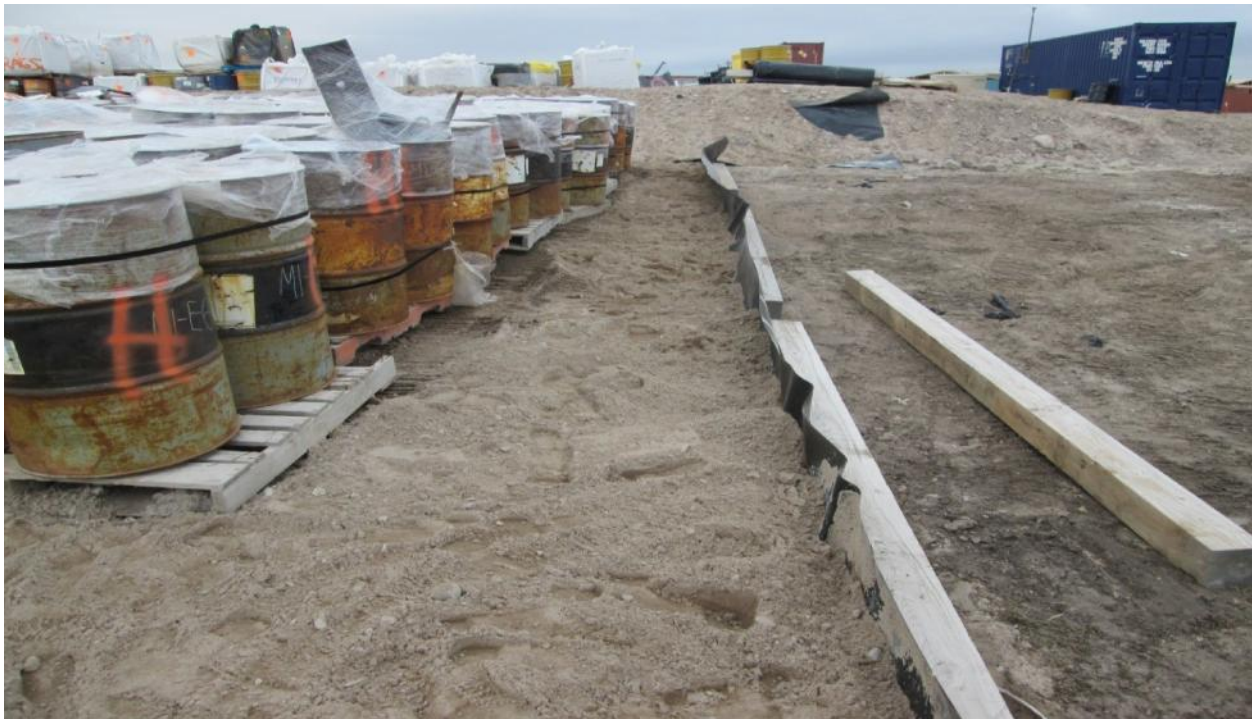
Photo shows temporary curbed area for hazardous waste awaiting immediate shipment.
