BAFFINLAND IRON MINES CORPORATION

ANNUAL GEOTECHNICAL INSPECTIONS

MARY RIVER PROJECT

JULY/AUGUST 2015

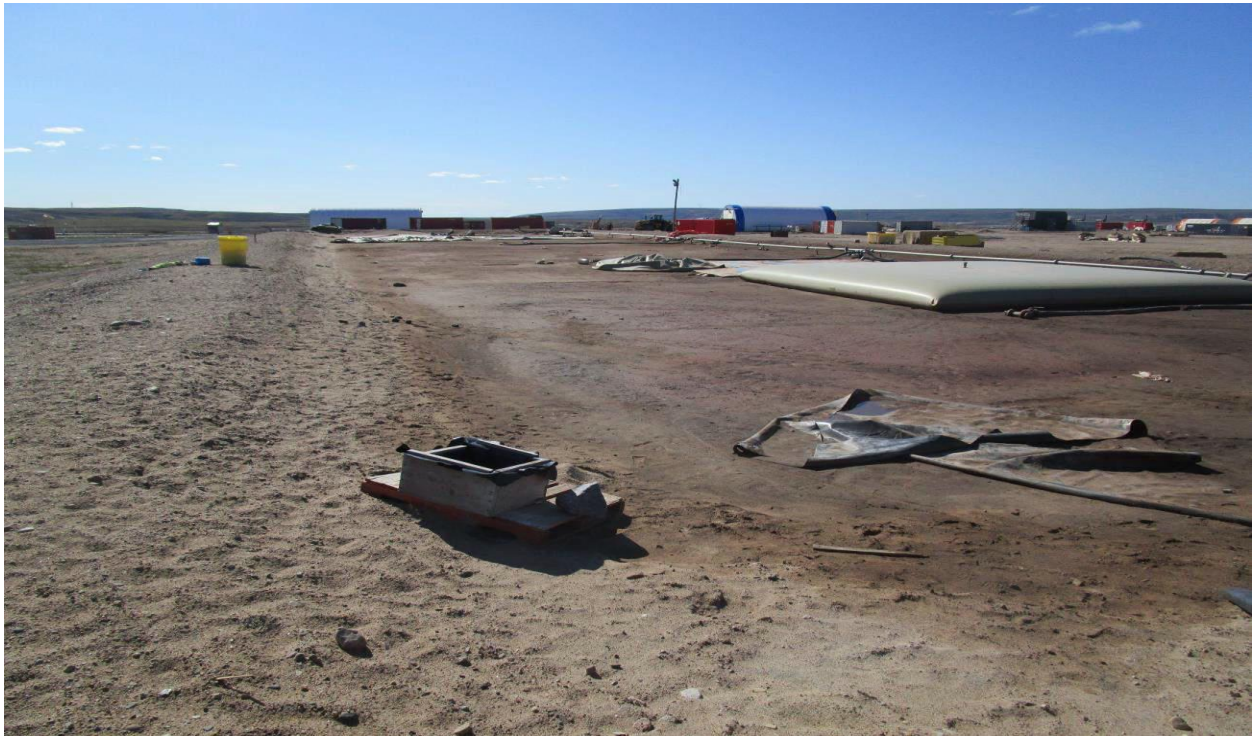
The Bulk Fuel Storage Facility still exists but it is no longer utilized as a bulk fuel storage facility. There is only a single bladder in the facility being utilized although there are a number of empty bladders still in place.

The one bladder within the containment that is full at this time contains contaminated water (water/oil mixture).

At the time of this initial review, water had not been removed for a period from within the containment and water was ponding above the level of the gravel within the bottom of the containment. There is still considerable factor of safety against failure of the one bladder within the dykes with the water level as it exists.

The structure was visually inspected for any signs of cracking or subsidence. There was no indication of any settlement, seepage, or cracking in the soil structures that formed the dykes. As well, there was no indication of seepage at the base of the structure around the exterior.

At the load-out end of the facility there was water ponding at the low point.

The presence of water within the structure and at the load-out area is an indication of the integrity of the liner.

Bulk Fuel Storage Facility showing one former fuel bladder in use.

We have no recommendations with respect to this containment structure as it awaits decommissioning.

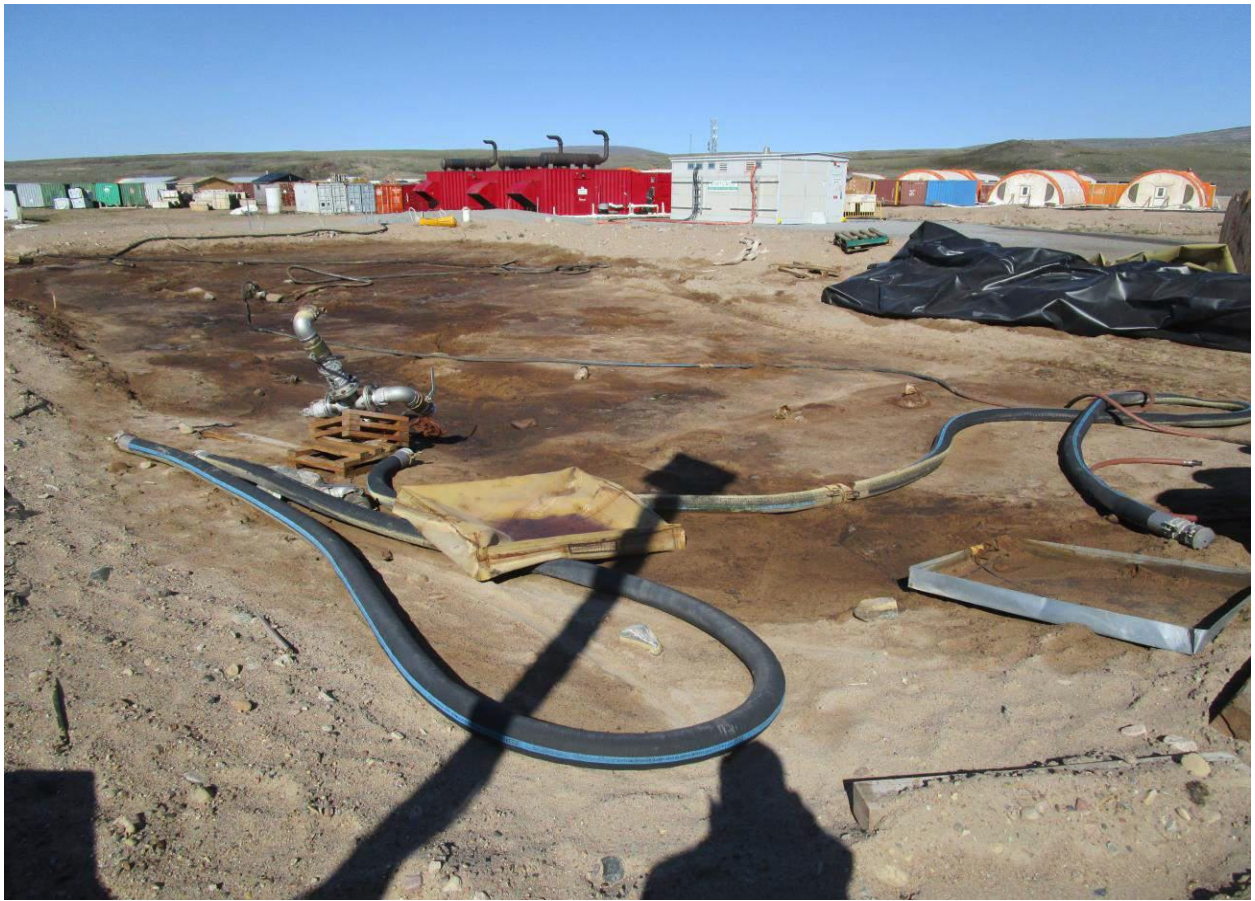
This particular containment structure is currently being decommissioned. The fuel bladder that was contained within the dyke has been emptied and the fuel bladder is rolled up awaiting removal on the east dyke.

The granular fill over the geotextile and liner shall require landfarming with the material from the bulk fuel storage facility.

There is no indication that the liner is compromised and decommissioning should proceed when the granular cover is either moved to a land farm or other containment.

Generator Fuel Containment in process of decommissioning.

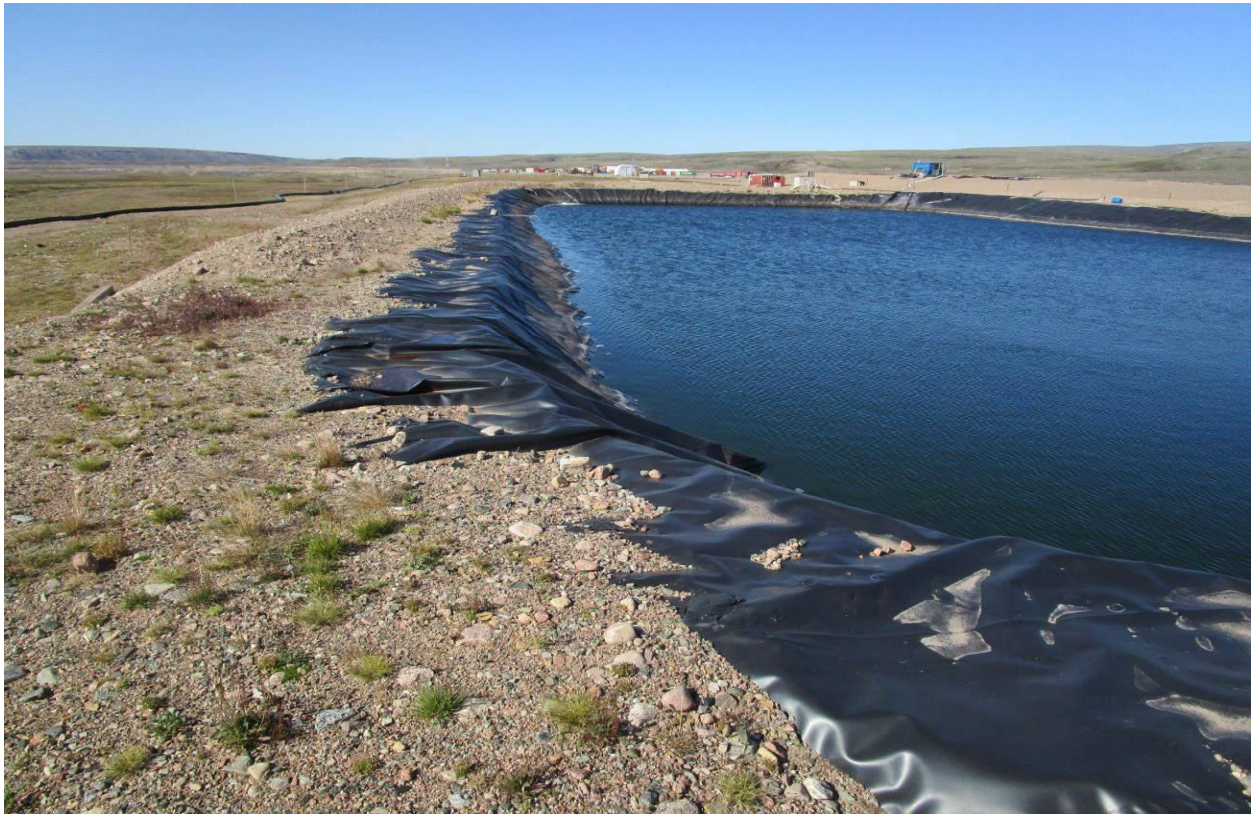
At the time of our visit there was approximately fifty percent of capacity to accommodate further sewage and the structure readily conforms to its design intent.

Our review of this area around the pond at the base of the slopes showed no sign of seepage and hence we conclude that the liner has been effective in containing sewage and there are no tears or ruptures in the membrane, excepting some minor tears from past activity at the top of the dyke well above the allowable effluent level in the structure in the horizontal portion of the membrane.

Many of the tears that had occurred in the liner on the top of the dyke have been patched during the period between reviews in 2008 and 2009 and are holding well. As well, there are no signs of weather related deterioration of the liner where it is exposed.

Monitoring points have been set up on the top of the dyke and have been monitored since 2009. Settlements have occurred since that time. These settlements have not led to any stress cracks in the structure. These small settlements are an indication of consolidation in the berm structures and the active layer beneath the dyke and are not considered to be of any concern.

Polishing/Waste Stabilization Pond #1.

We have no recommendations with respect to this containment facility.

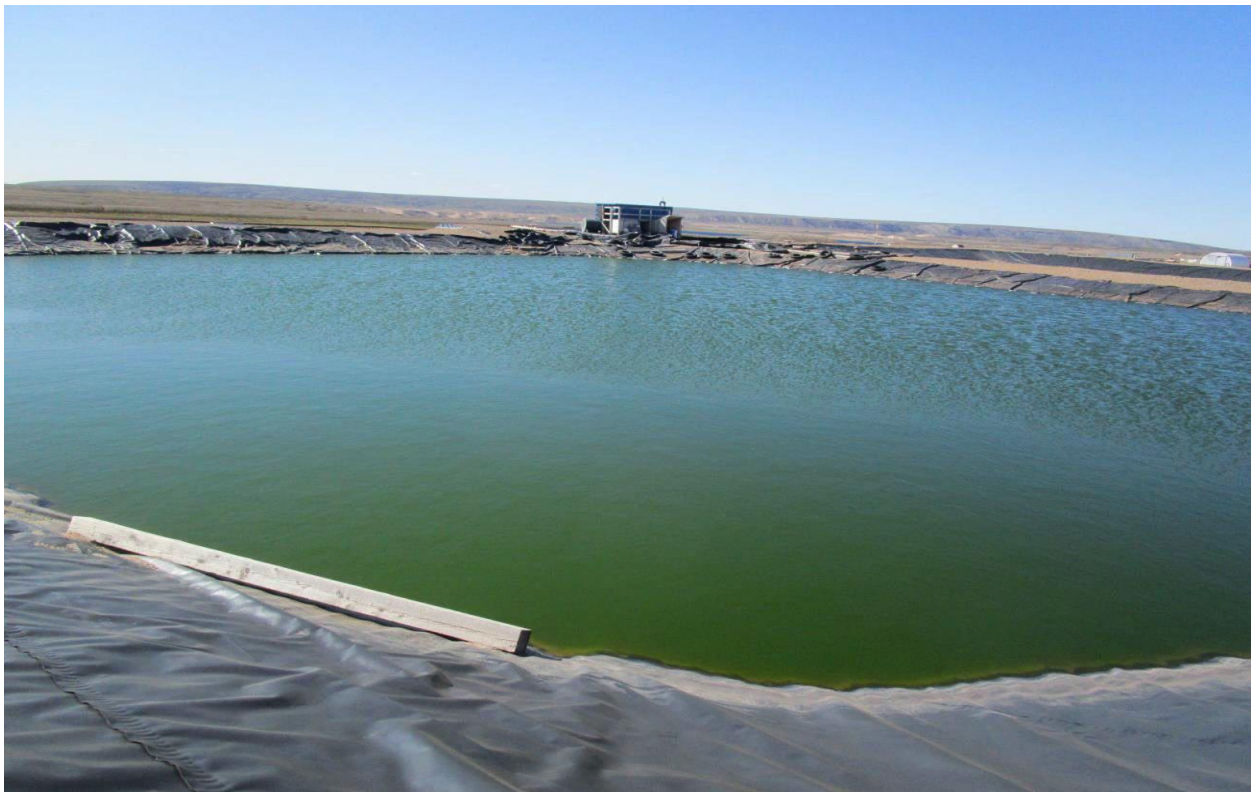
At the time of our visit there was considerable freeboard to accommodate further sewage and the structure readily conforms to its design intent. There was fifty-percent remaining capacity in one cell and the second cell was almost empty at the time of our inspection.

Our review of the area around the pond at the base of the slopes showed no sign of seepage and hence we conclude that the liner has been effective in containing the sewage and there are no tears or ruptures in the membrane.

Polishing/Waste Stabilization Pond #2.

We have no recommendations with respect to this containment facility.

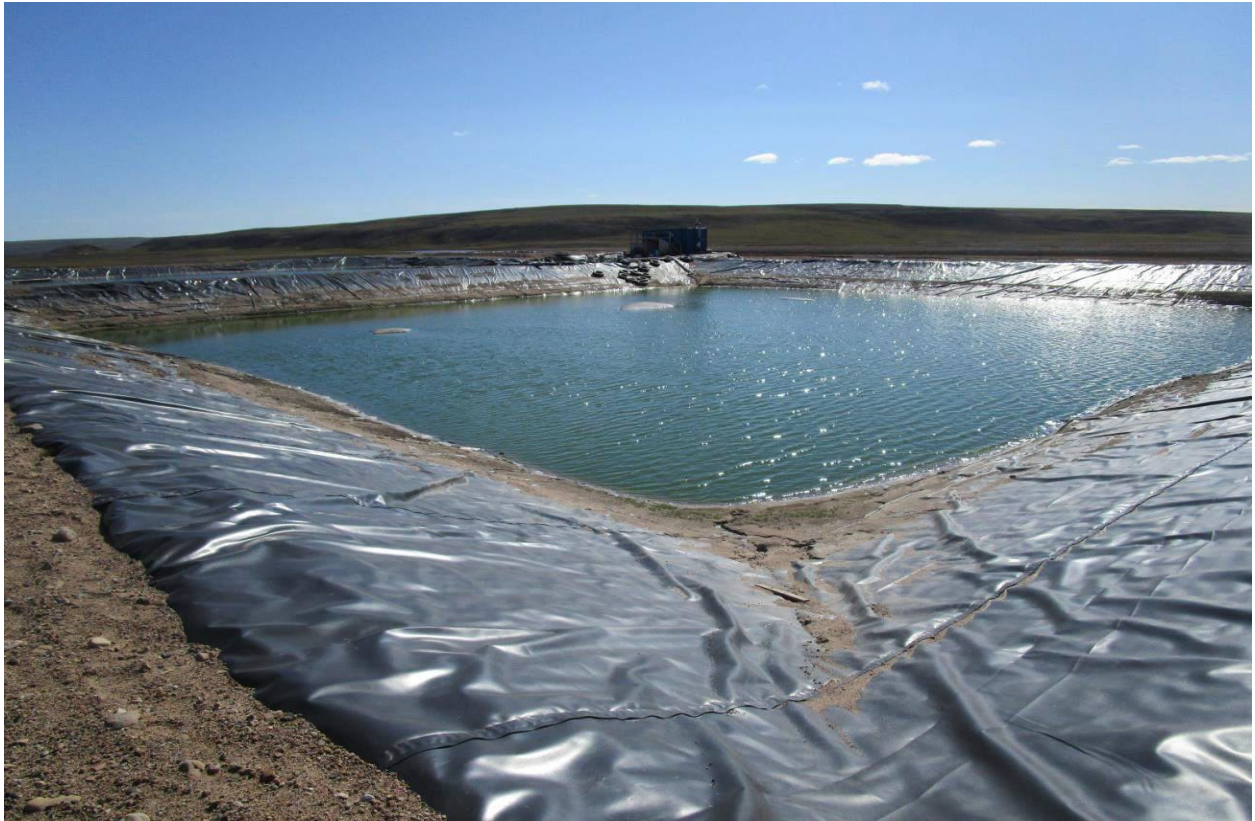
Longitudinal cracking which appeared in the dykes of PWSP #3 due to the melt of permafrost wedges in 2009 has not reoccurred and we consider this structure to be stable in its present condition.

Monitoring points have been set upon the top of the dyke and have been monitored since 2009. Settlements have occurred since that time. These settlements have not led to any stress cracks in the structure. Monitoring was discontinued over the last year.

There appears to be no sign of erosion of the dykes and plants are continuing to seed themselves on the dykes. This growth is minimal, however.

Polishing/Waste Stabilization Pond #3.

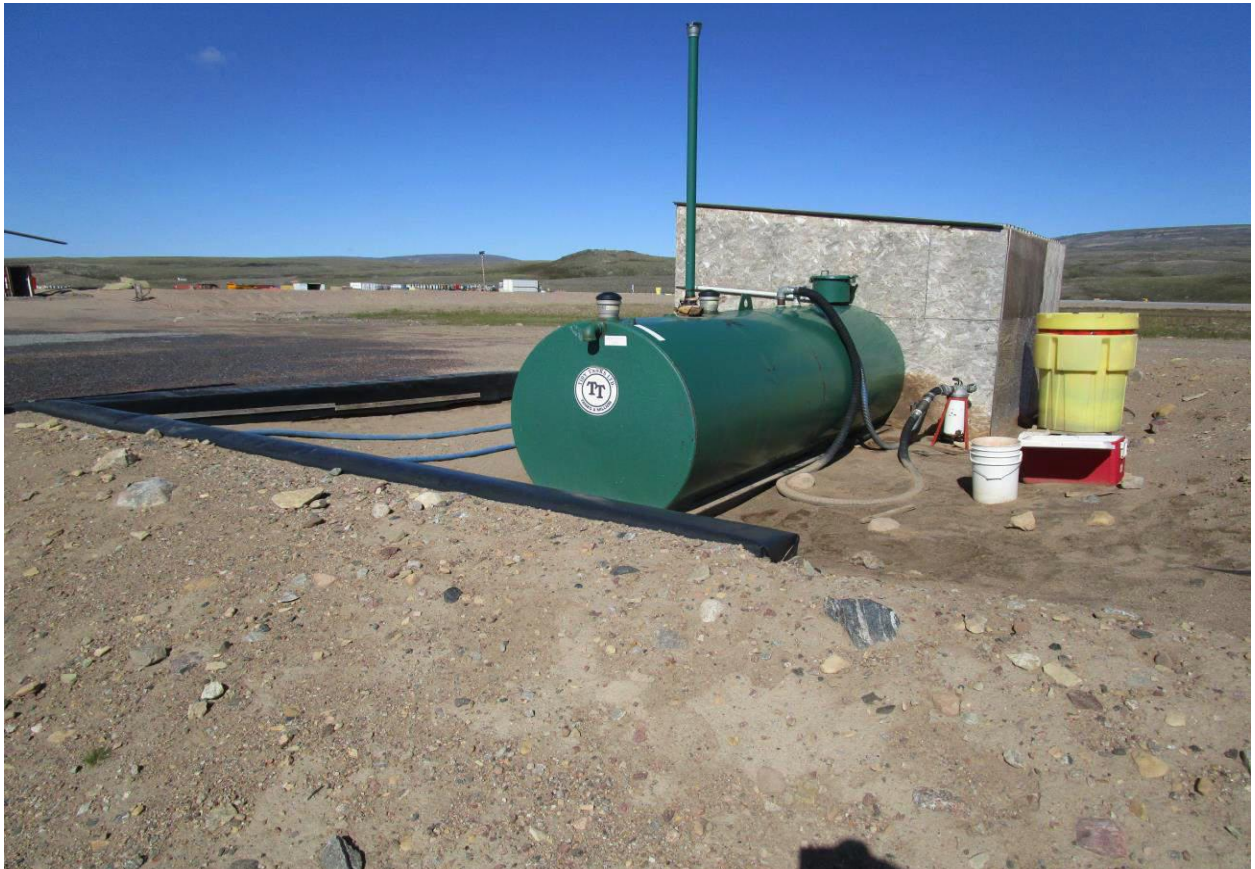
Our review of the area around the pond at the base of the slopes showed no sign of seepage. There is wet sand in the bottom of the containment indicating the integrity of the liner with the weather recently experienced.

A review of the exterior and the top of the berms showed no sign of cracking or settlement which would indicate stress within the structure.

The structure is considered to be stable in its present condition.

Helicopter Fuel Cell Containment.

We have no recommendations with respect to this structure.

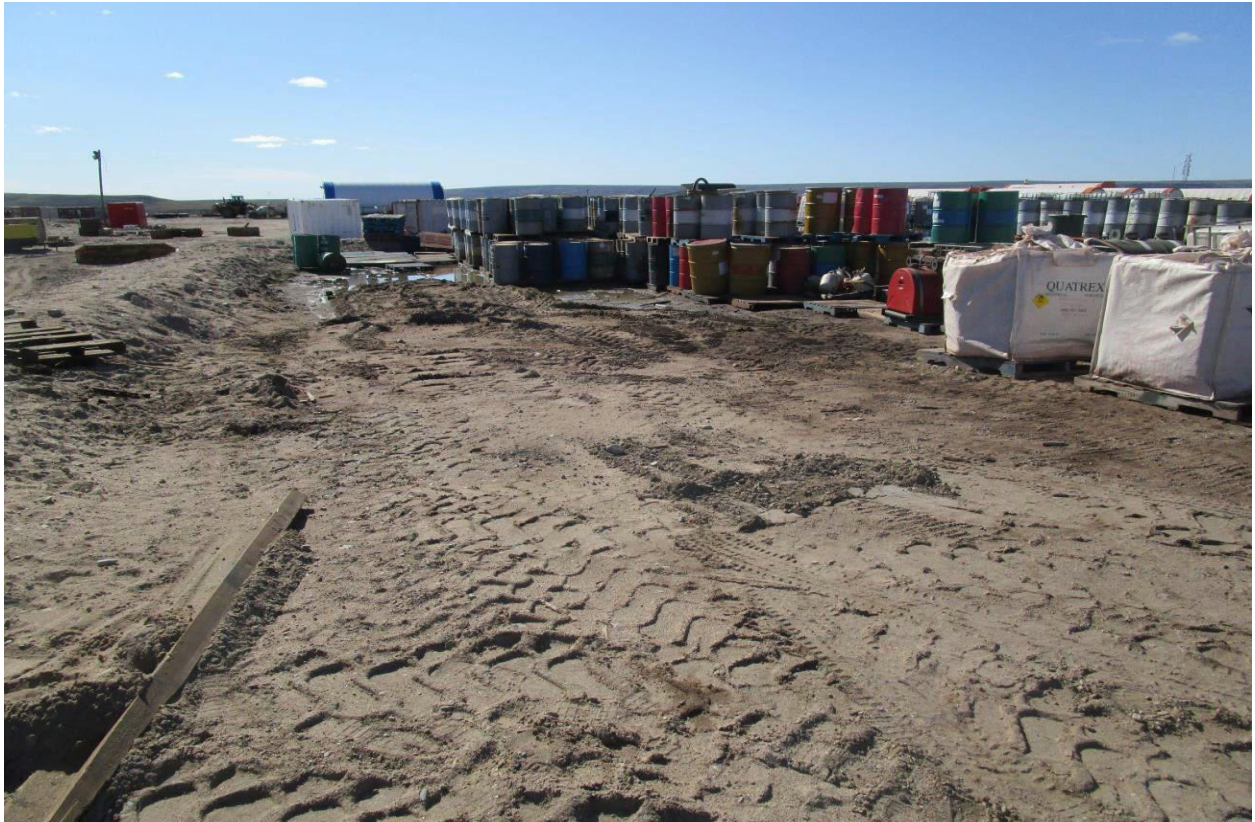
Our review of the area around this containment structure showed no sign of seepage. This shows that there is reasonably little chance of tearing or rupture of the membrane having taken place.

A review of the exterior and top of the dyke showed no sign of cracking or settlement which would indicate stresses within the structure.

The structure is considered to be stable in its present condition.

Barrel Fuel Containment. (Now MS-HWB-4)

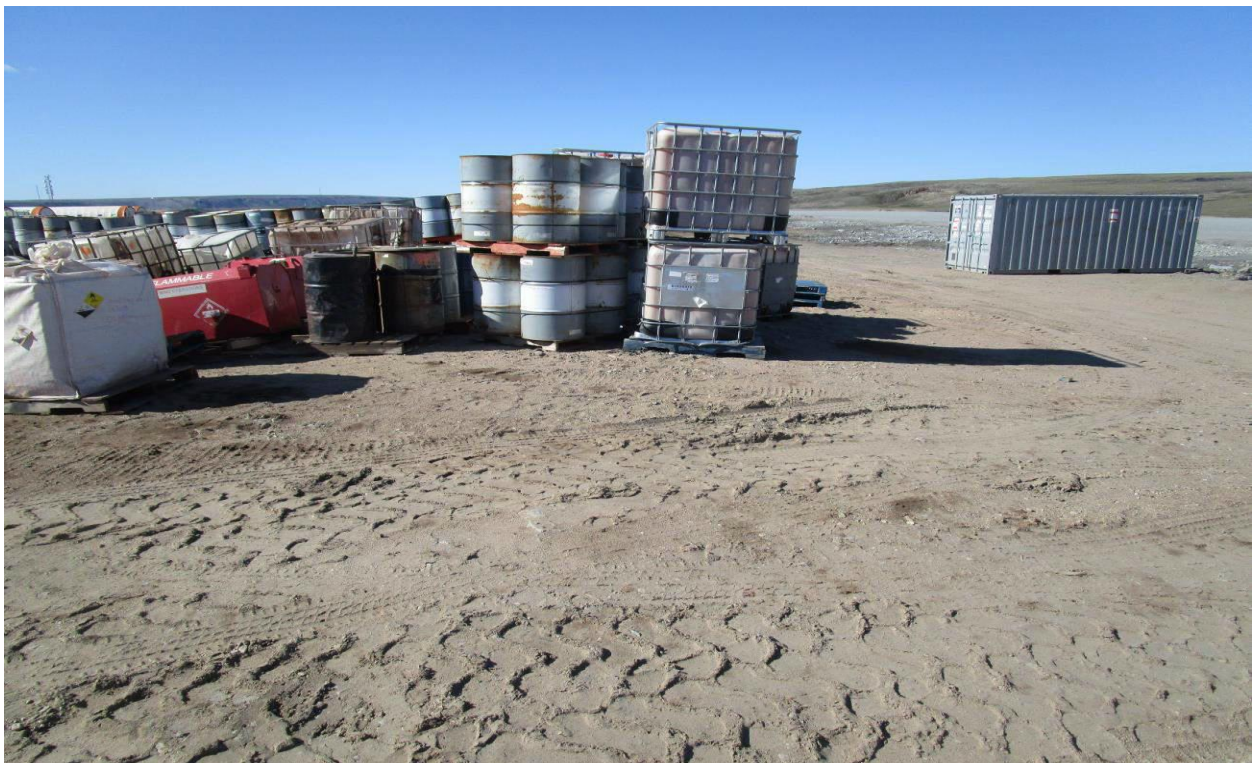
There are currently contained closed barrels and cubes which are sitting at the entries that are not over the lined area. We assume this is a temporary situation.

Barrel Fuel Containment – Containers outside of cell. (Now MS-HWB-4)

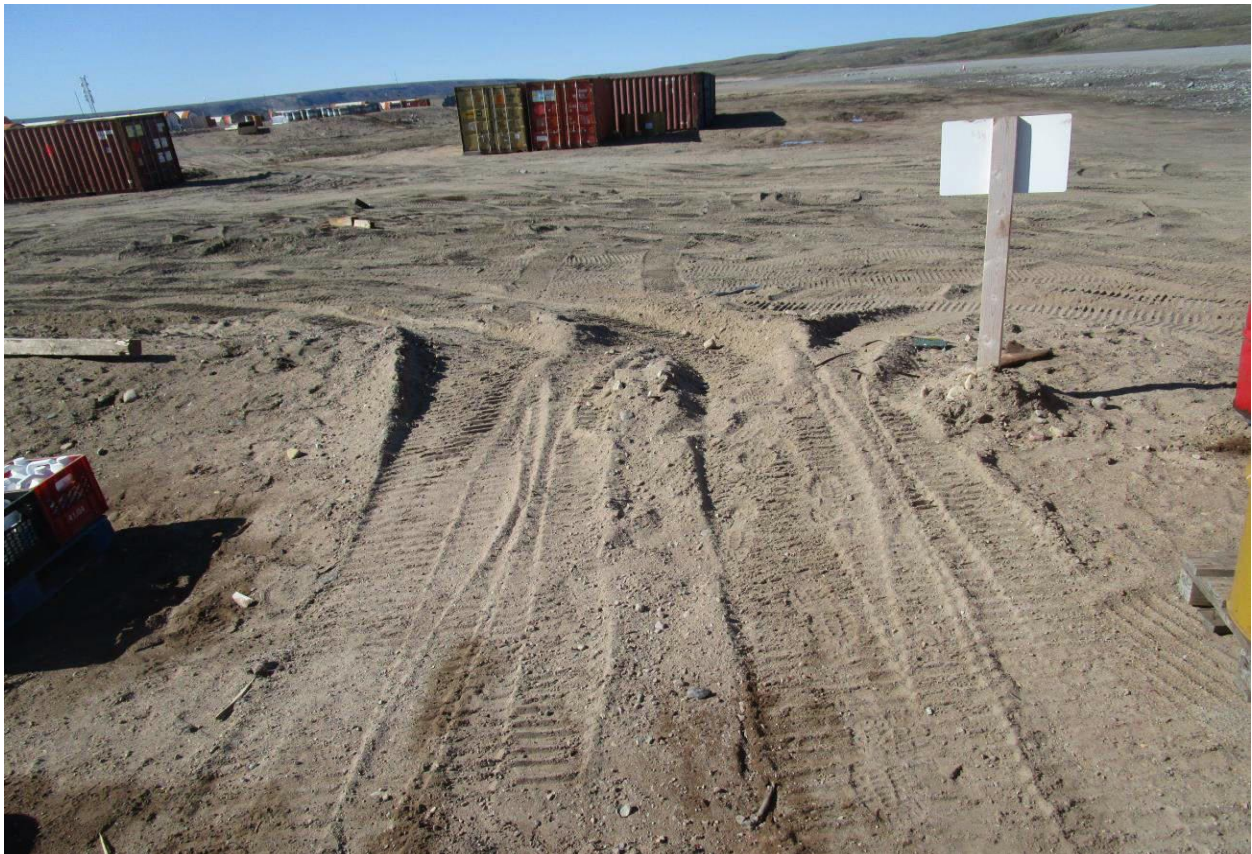
Barrel Fuel Containment – Shows travel over side dyke of cell. (Now MP-HWB-3)

The north dyke in the north cell has had a track fork lift travel over the berm at the east end. We recommend signage to prevent this before damage occurs to the liner.

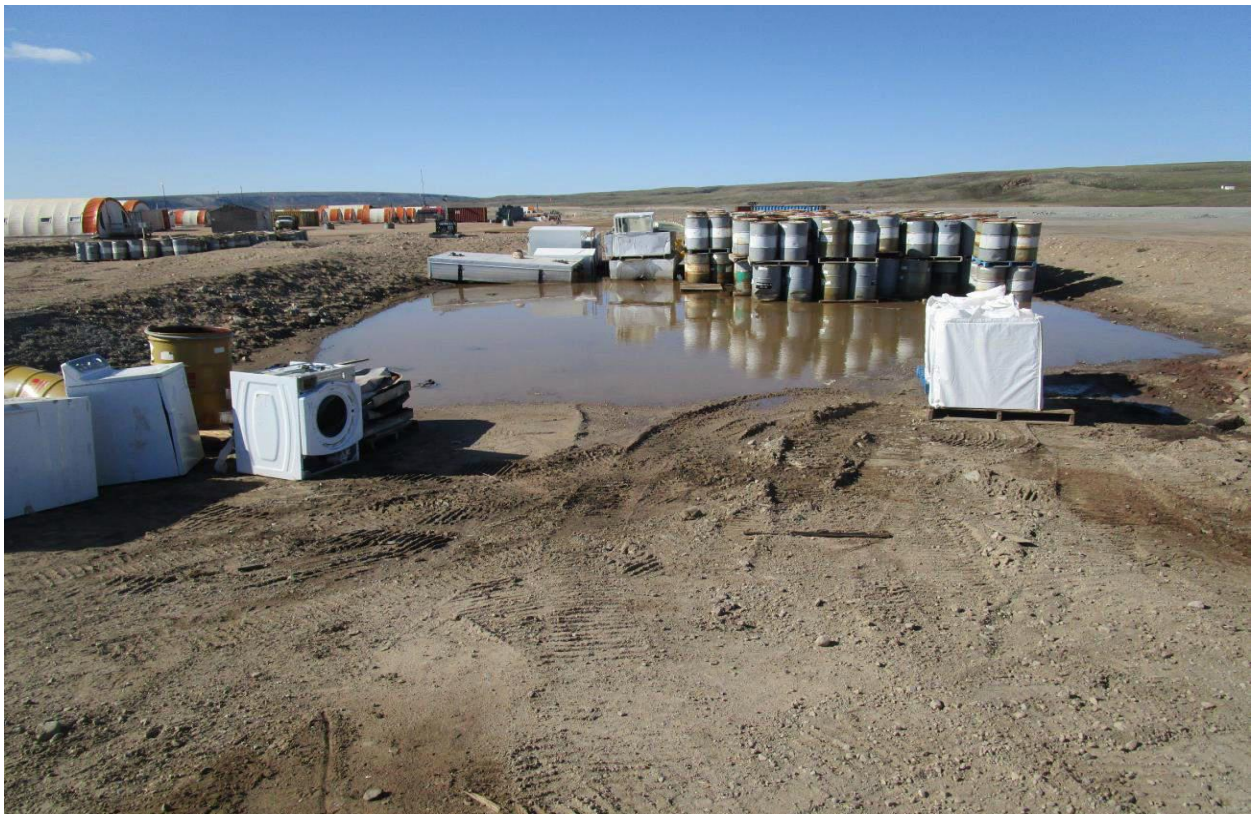
Our review of the area around this cell at the base of the slopes, showed no sign of seepage. There is water ponding in this structure.

The structure appears to be stable in its present condition. The water confirms the integrity of the liner.

Hazardous Waste Containment. (Now MS-HWB-2)

There are no recommendations at this time.

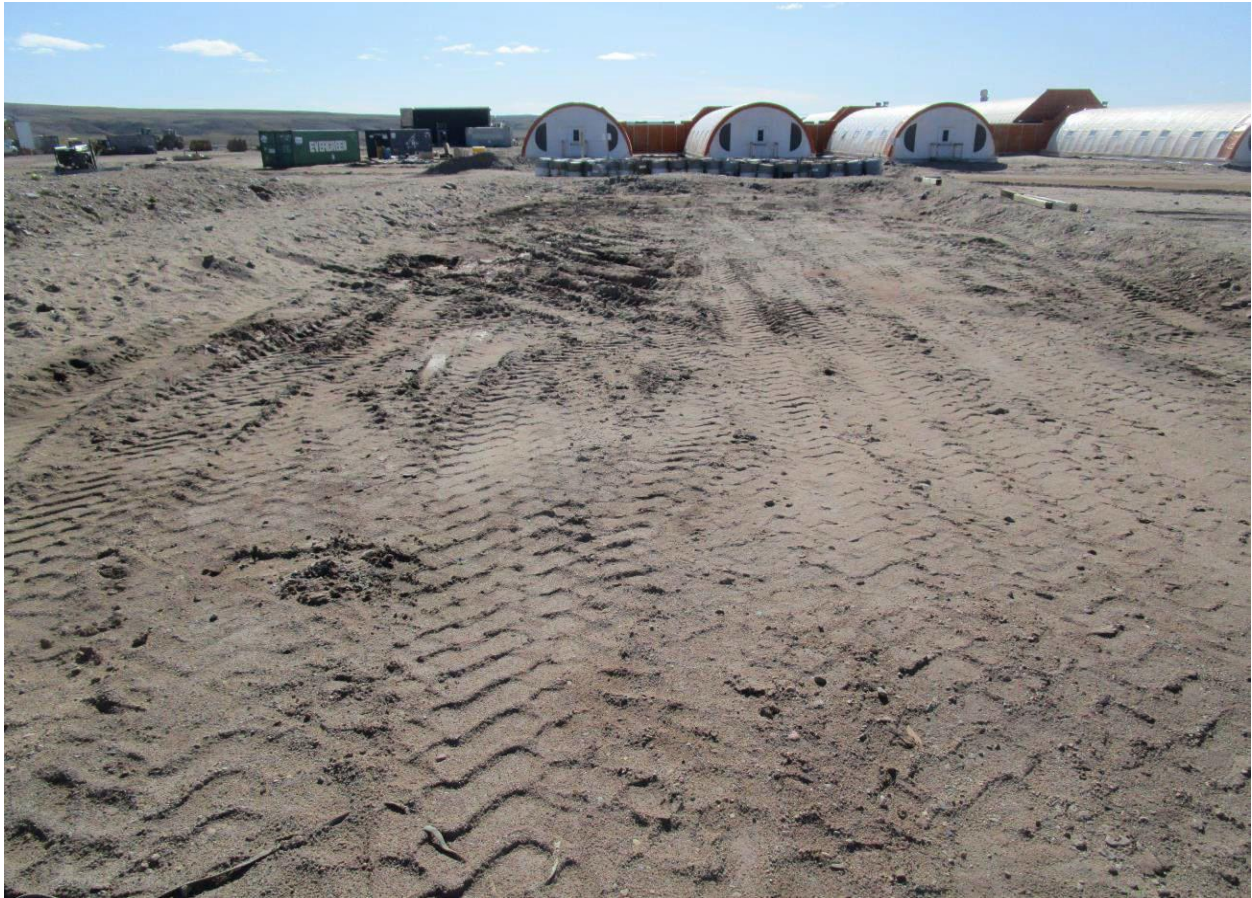
Last year there was concern for the integrity of this cell as the cell was dry and the geotextile was exposed from heavy traffic during our initial inspection. During our second inspection, the cell was holding a small amount of water confirming the integrity of the liner.

The cell is dry this year raising concerns anew on the integrity of the liner.

Enviro Tank Storage – No longer in use. (Now MS-HWB-1)

We recommend that the geotextile over the liner be checked and the granular cover be made good prior to continuing use of this cell as a wash down cell this season.

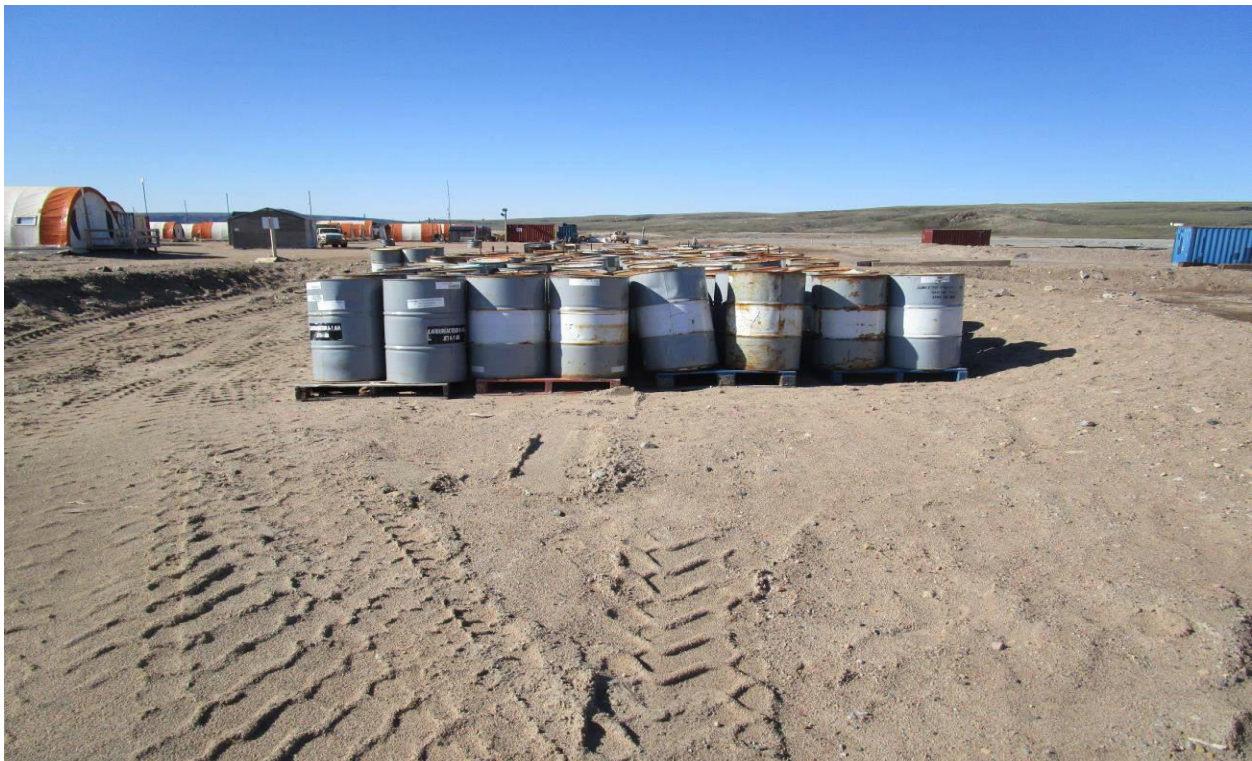
Our review of the exterior at the base of the dyke showed no sign of seepage. This shows that there is reasonably little chance of tearing or rupture of the membrane having taken place.

A review of the exterior and the top of the dyke showed no sign of cracking or settlement which would indicate stresses with the structure.

There is water contained within the cell confirming the integrity of the liner.

The structure is considered to be stable in its present condition.

Stove Oil Storage. (Now MS-HWB-5)

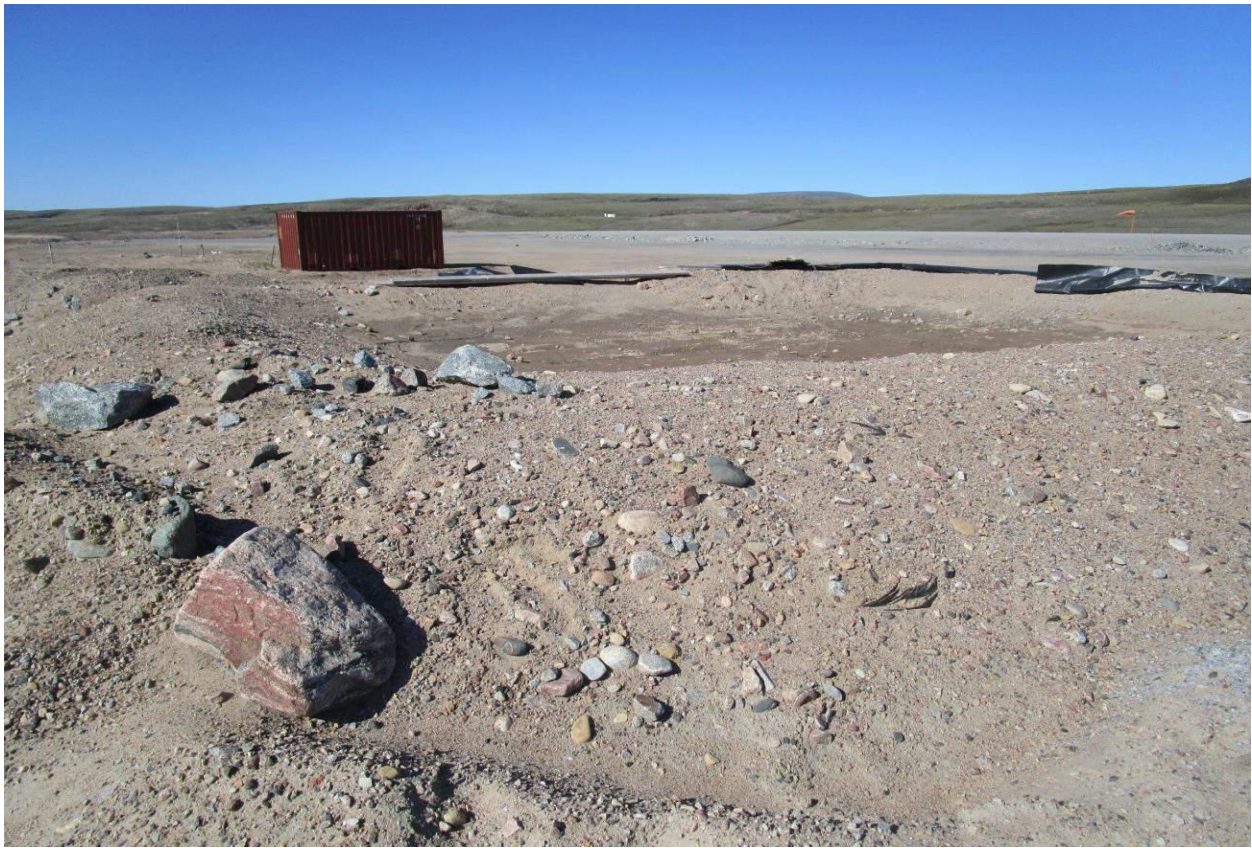
The construction appears proper and the structure is in good condition.

Minor water ponding confirms the integrity of the liner.

At this time the jet fuel tank and pump have been removed and the cell is empty.

Jet Fuel and Pumping Containment – Now empty.

There are no recommendations at this time.

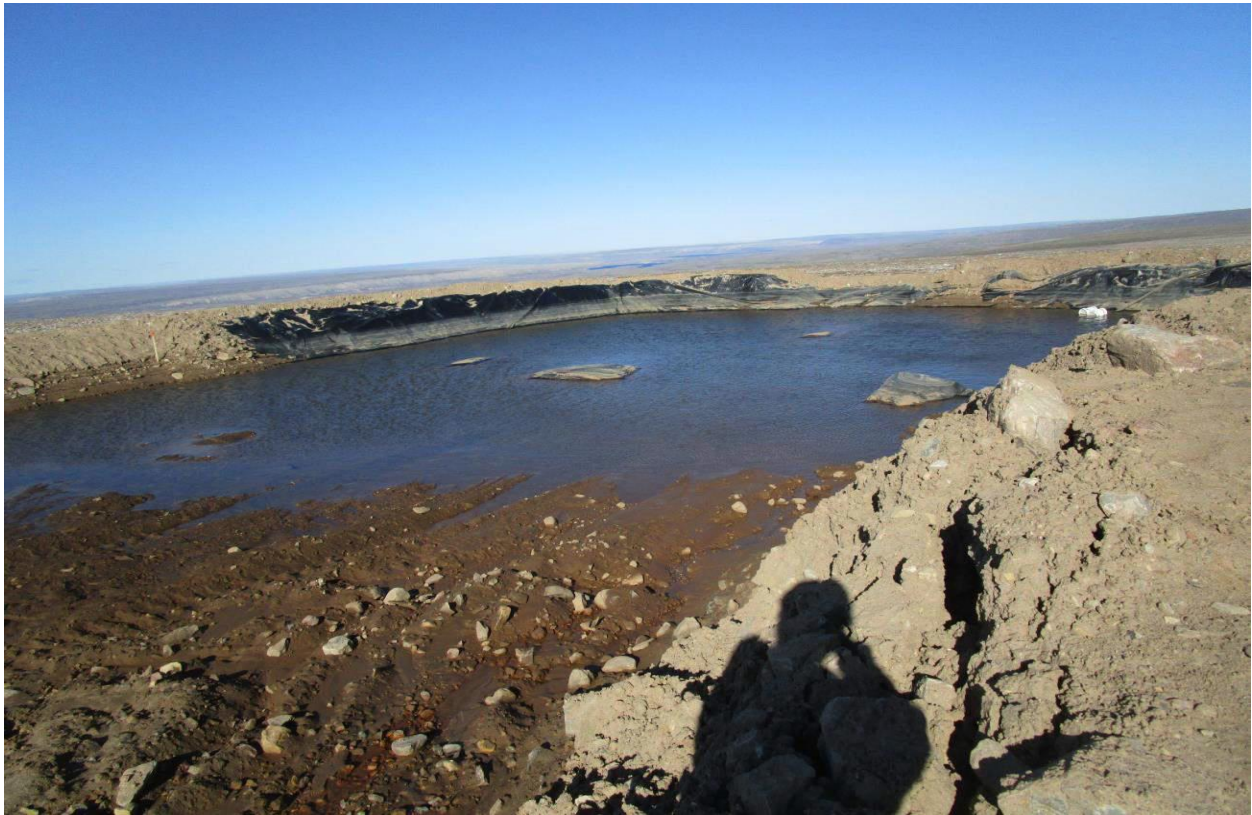
This structure is just in the process of being completed and put into operation. It shall be fully reported on during the next review at the end of September.

Waste Stockpile Drainage Containment.

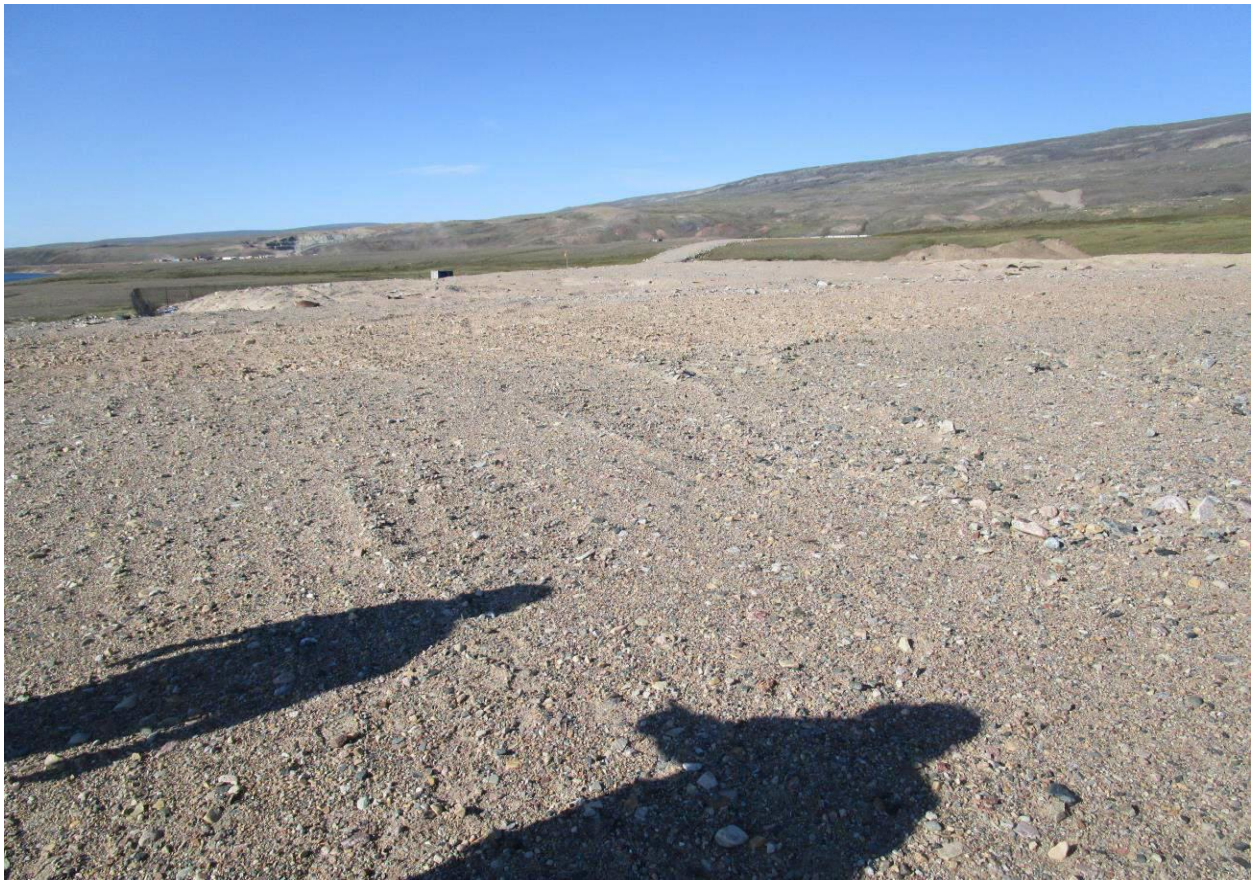
Berms appear stable and no erosion appears to have taken place on the back and both sides of the site. Solid waste was being placed at the front edge of the site and was awaiting salvage of wood and lumber prior to the placing of cover at the time of our site review. There is also separation of metals from other waste taking place.

The current footprint as established by the existing covered material and the “blow control” fence at the front of the immediate site is full and the site footprint shall have to be expanded within the plans and guidelines set out for this solid waste disposal site.

Solid Waste Disposal – Top of cover.

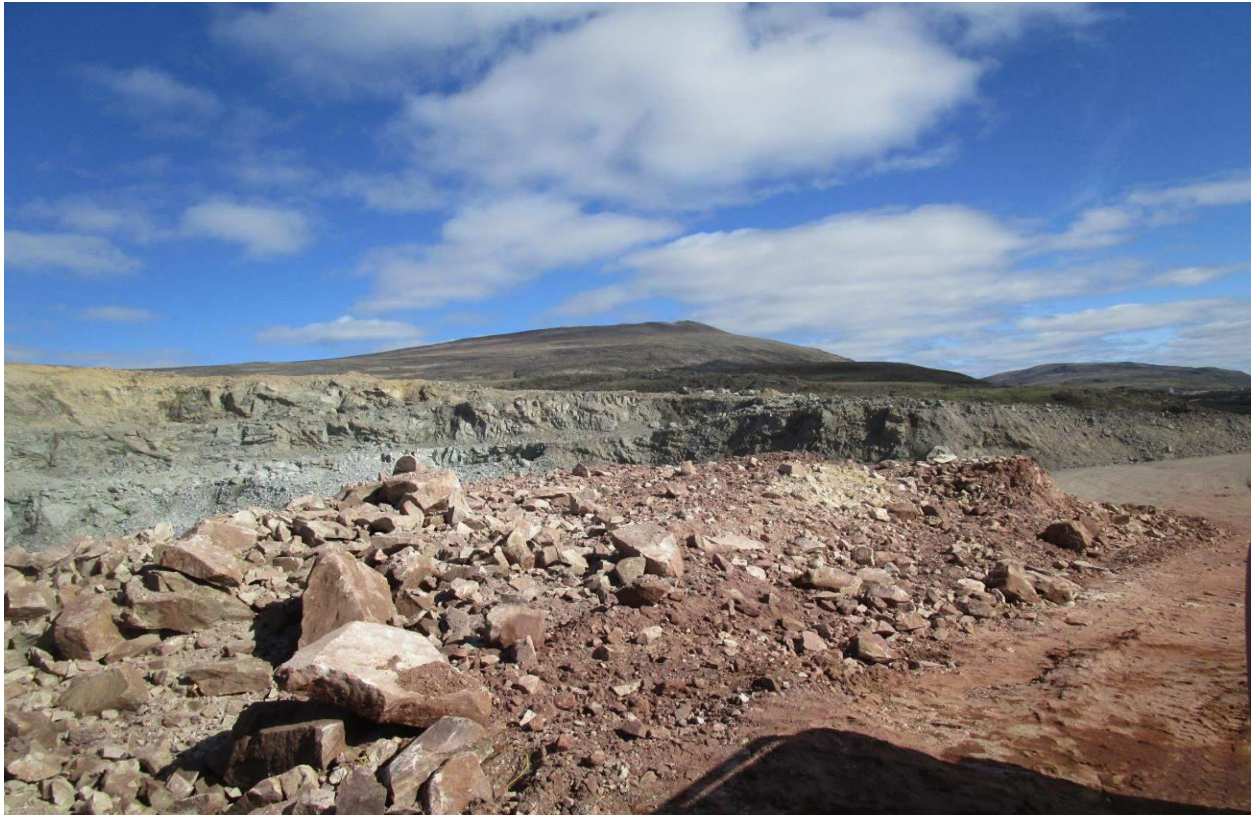
The quarry has well defined benches. The quarry faces at the benches shall be cleaned and berms placed at the edges of the bench to control the movement of weather induced loose in the long term.

Currently overburden from the top surface is being cleaned and pushed as thawing permits, to serve as long term protection against moving aggregate and the establishment of long term stability.

There are a number of cobbles and larger boulders at the upper edge however that appear to act as a hazard at this time.

Mary River Quarry.

The quarry shall be closed in a manner as set out to maintain long term stability.

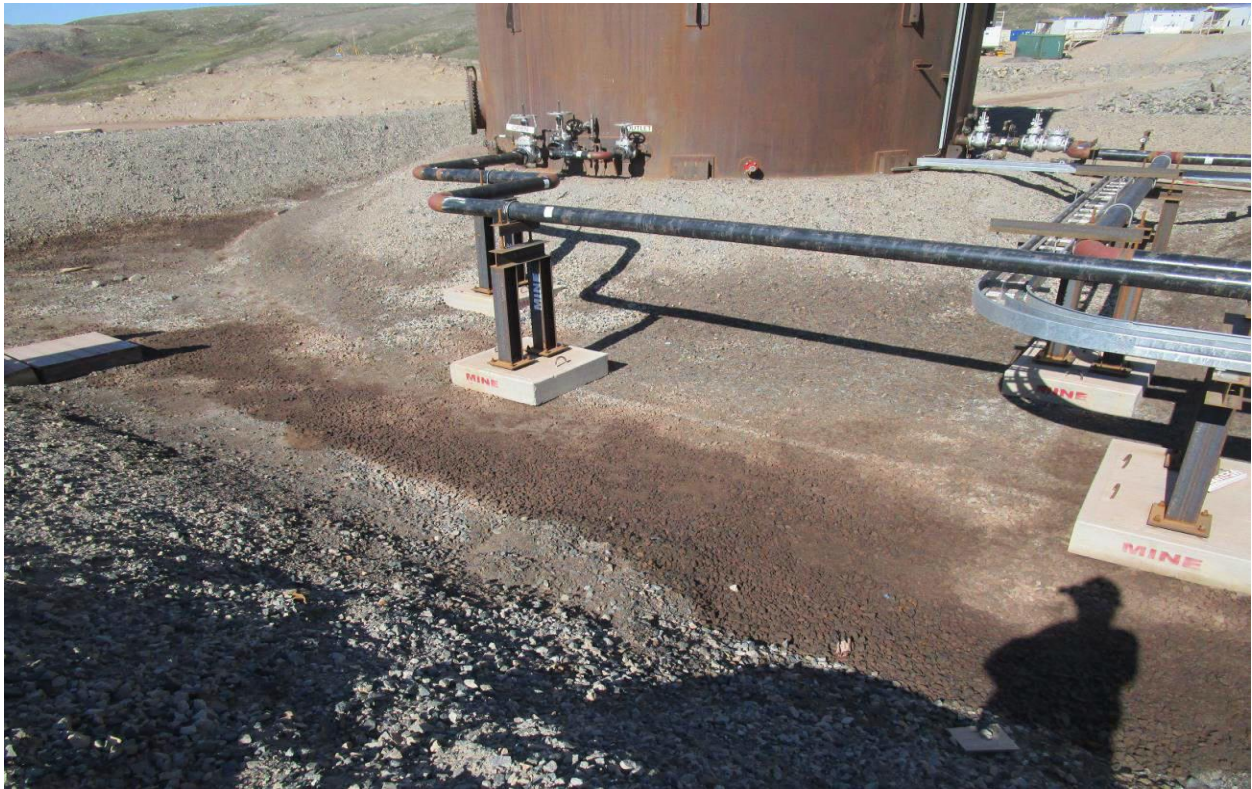
All work appears to be complete excepting the installation of the sump pits that are on site awaiting installation and which shall be utilized to facilitate the removal of water that collects from precipitation. There is water ponding in the bottom of the containment confirming the integrity of the liner.

All work appears to have been completed in accordance with drawings and we have no concerns with the stability of this containment structure.

Mary River Steel Tank Containment.

We recommend that at least one sump be installed as per the drawings prepared for this facility.
