4.0 MILNE INLET

4.01 General

Milne Inlet Photos

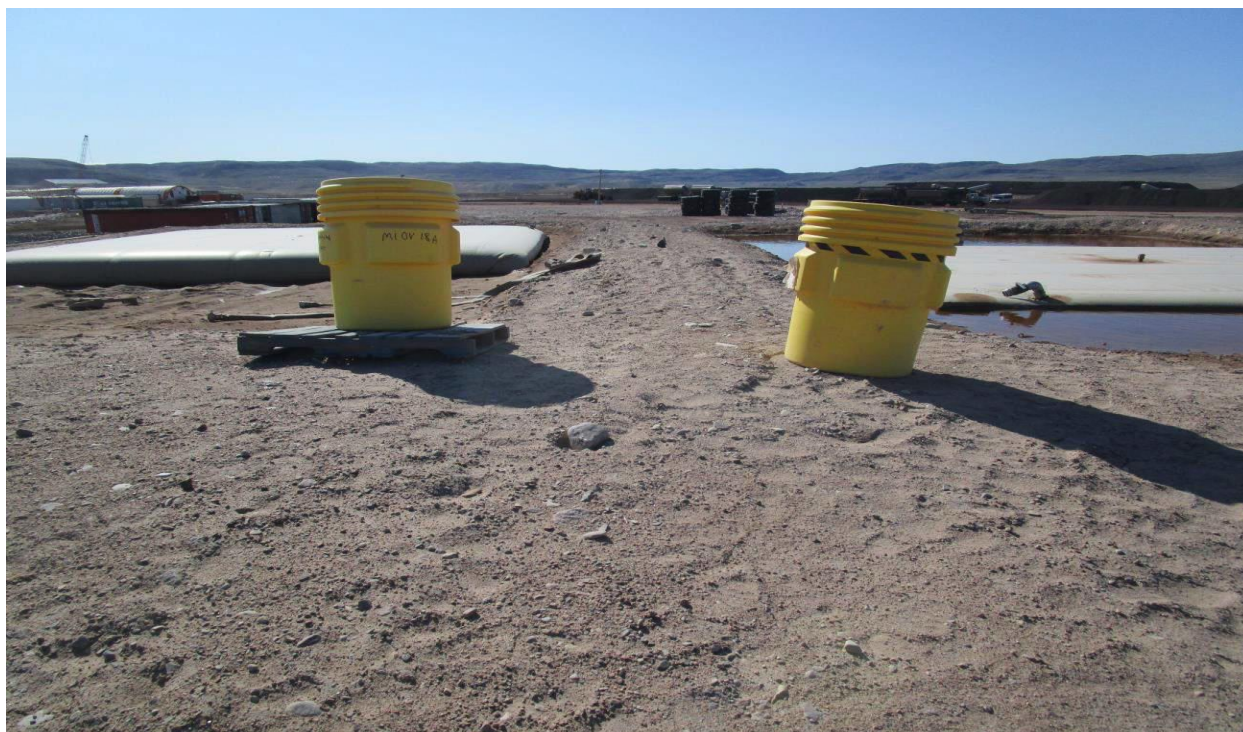
Hazardous Storage Containment. (Now MP-HWB-3)

This particular structure has been constructed as a two-cell structure.

There is water ponding in both cells of the original structure confirming the integrity of the liner at this time.

Our review of the area around the dykes, at the base of the slopes, showed no sign of seepage. The structure is considered stable.

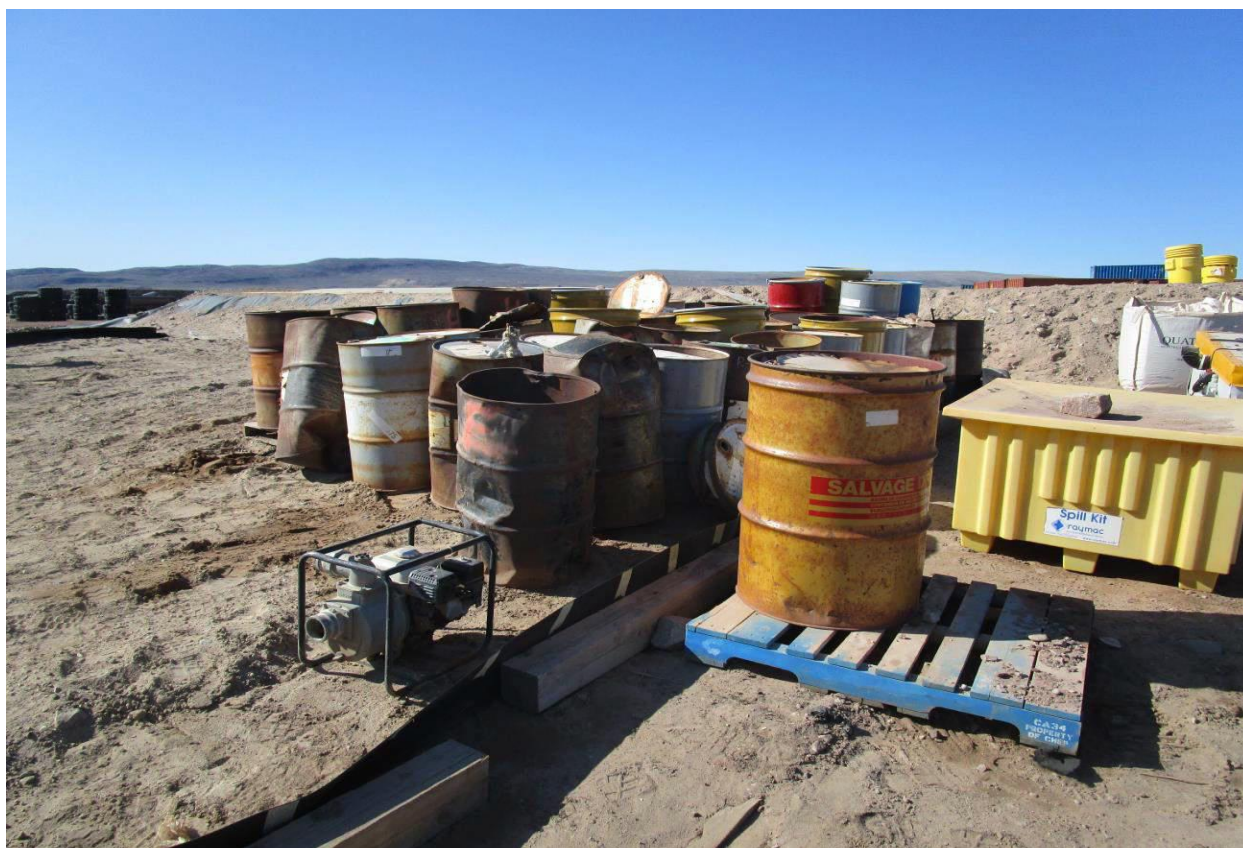
Temporary Hazardous Storage. (Now MP-HWB-5)

Due to an excess of hazardous waste in the two-cells, a third temporary cell has been constructed for the very short term until the ship picks up the hazardous waste at the end of the summer season.

The third cell is constructed with a one piece liner and wood timber curb for this very short term and is contiguous with the south side of the structure.

This cell actually stores hazardous waste in containers, barrel fuel, and lubricant cubes and does not have the integrity to resist a large spill. There are now bladders with contaminated water in each cell. A new hazardous waste storage facility has now been constructed near the loadout area for storing hazardous waste to be shipped out.

We recommend that the use of the temporary third cell, recently constructed, be discontinued when possible.

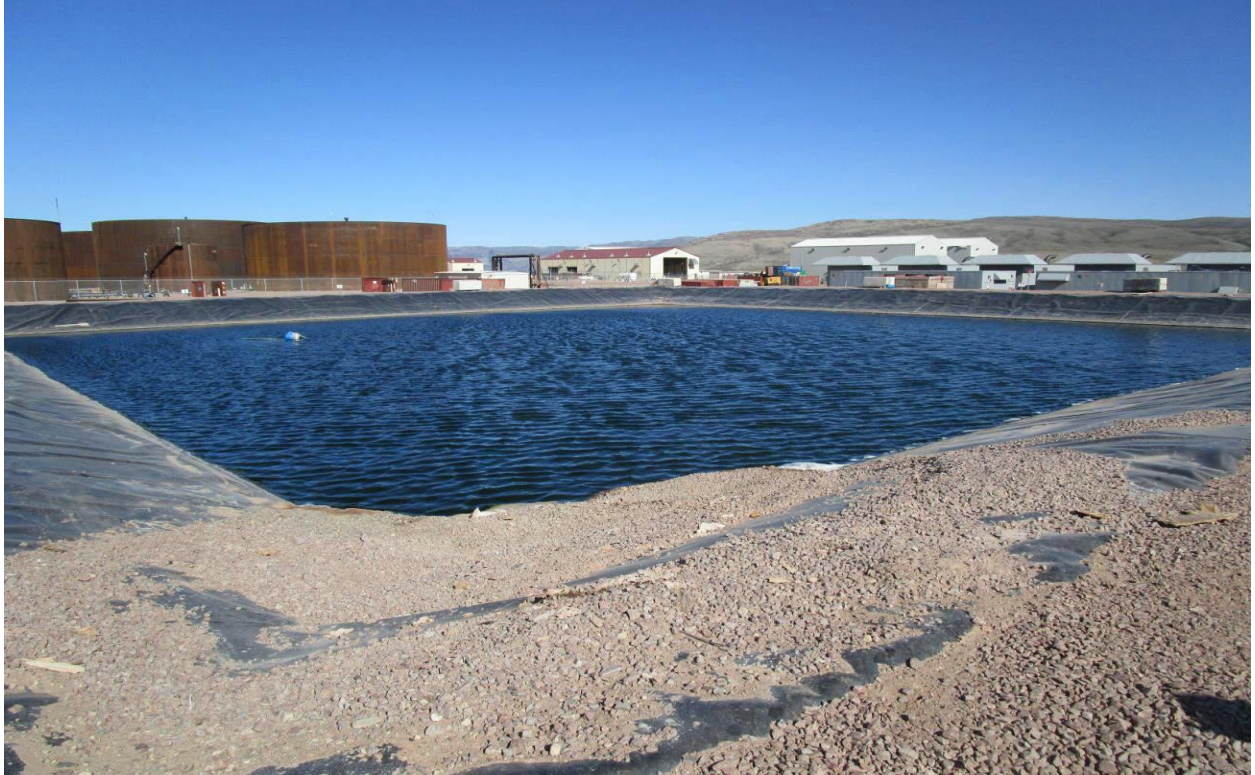
Polishing/Waste Stabilization Pond.

This containment facility has been decommissioned since our last inspection.

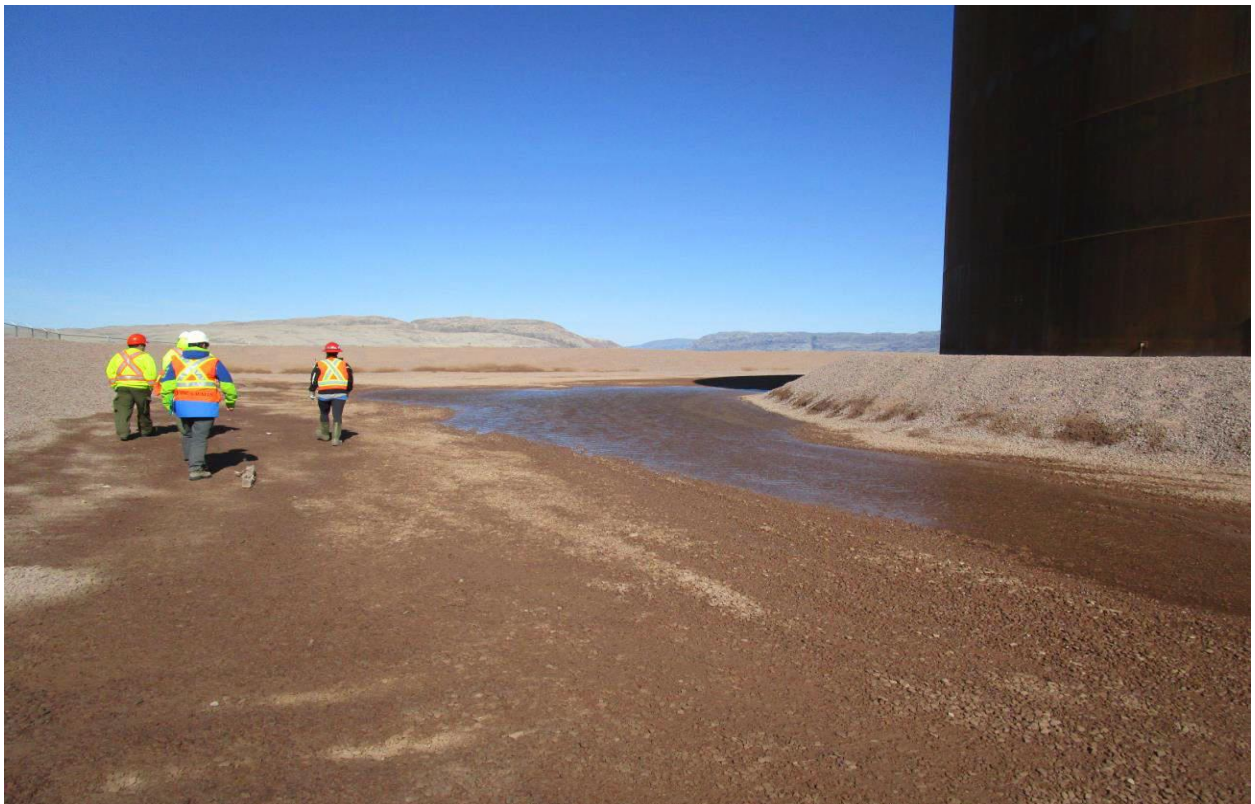
Fuel Tank Farm Containment.

We note that the sump placed in the containment is located at the high end of the containment. There is water ponding in the low end of the containment.

At our inspection we noted minor water ponding at the low end of the containment confirming the integrity of the liner.

We recommend that the sump be relocated to the low point at the north end of the containment or an addition sump installed.

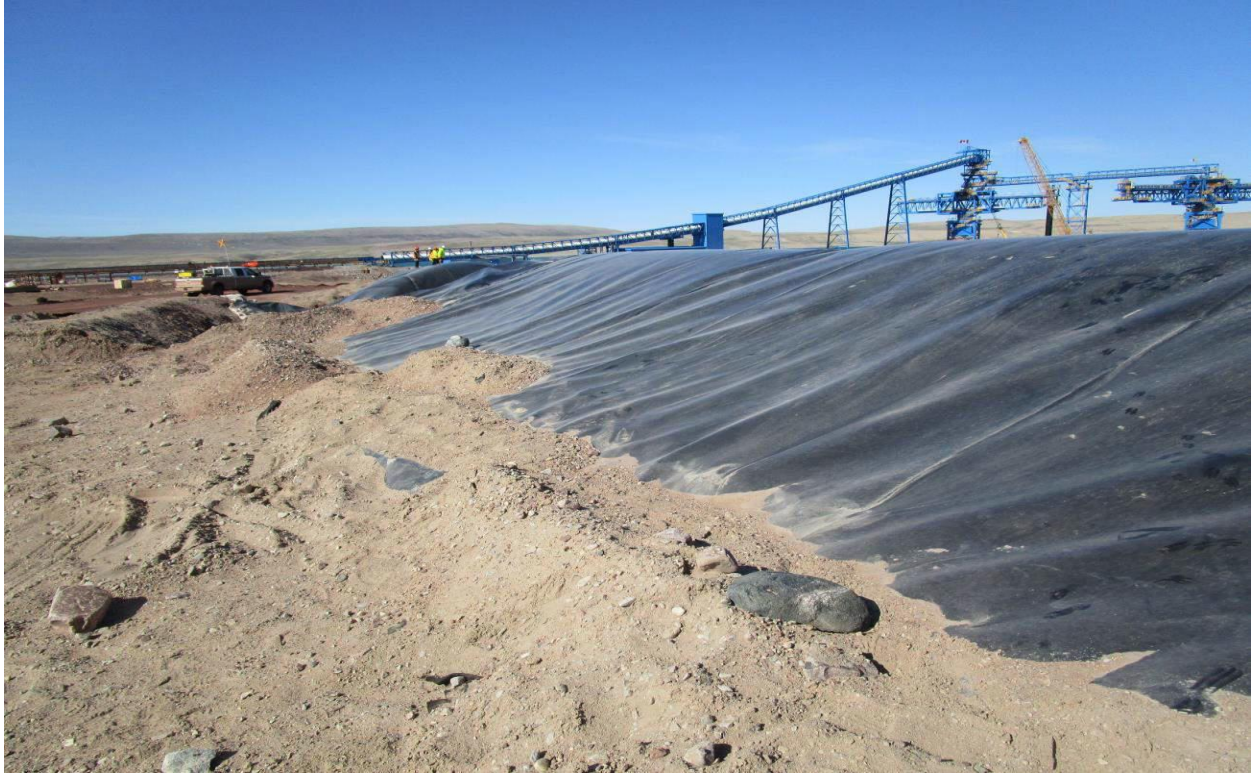
There has been no cover placed over the liner to this point and rip rap has not yet been placed in the outlet weir.

We have concerns over the stability of the liner and recommend more soil ballast on the south edge and possibly tire ballast over the liner which appears subject to wind damage. This shall provide a function for used tires.

East Settling Pond – Add ballast this area.

We recommend review of the use of a ballast (possibly tires) on the exposed liner at the dyke to prevent wind uplift.

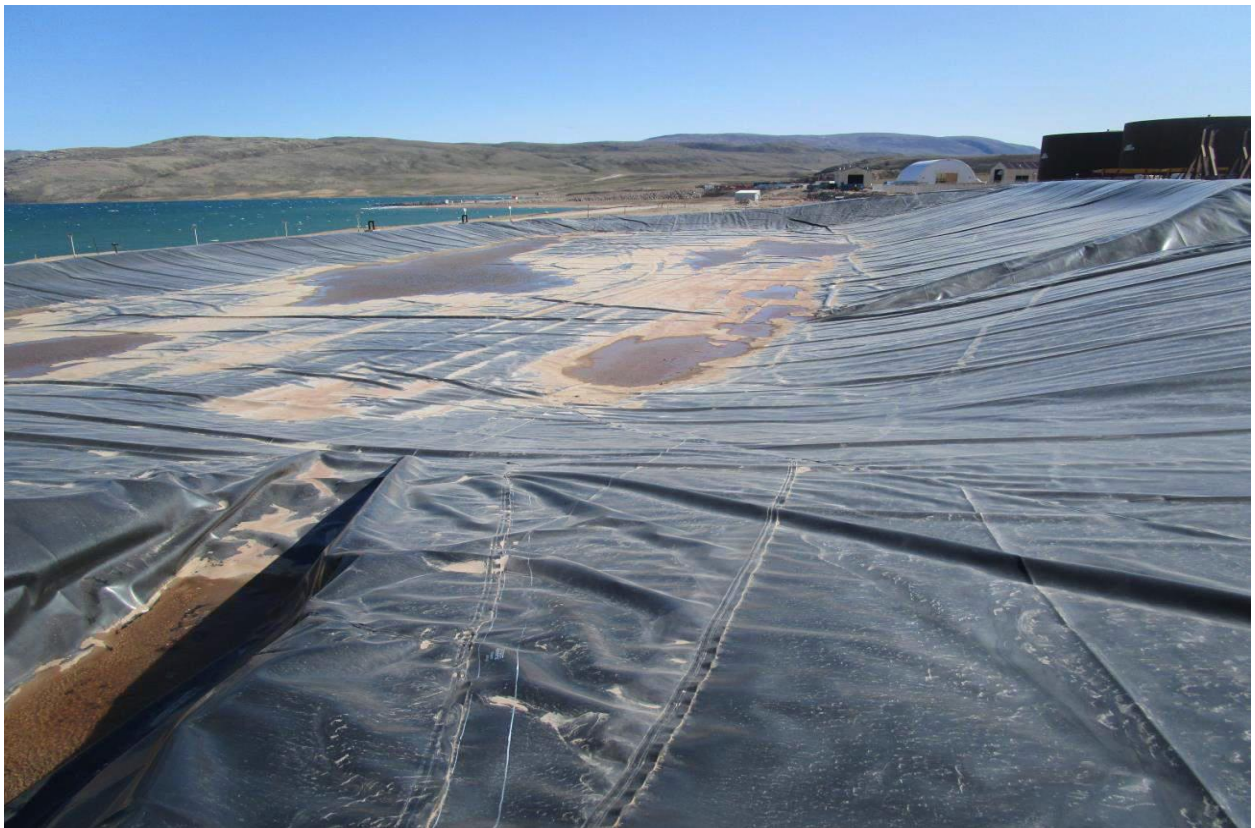
East Settling Pond.

The construction of this sedimentation pond for drainage from the east side of the site is complete. The basin is shaped and the liner has been installed throughout the basin from inlet to the berms on the north side of the basin.

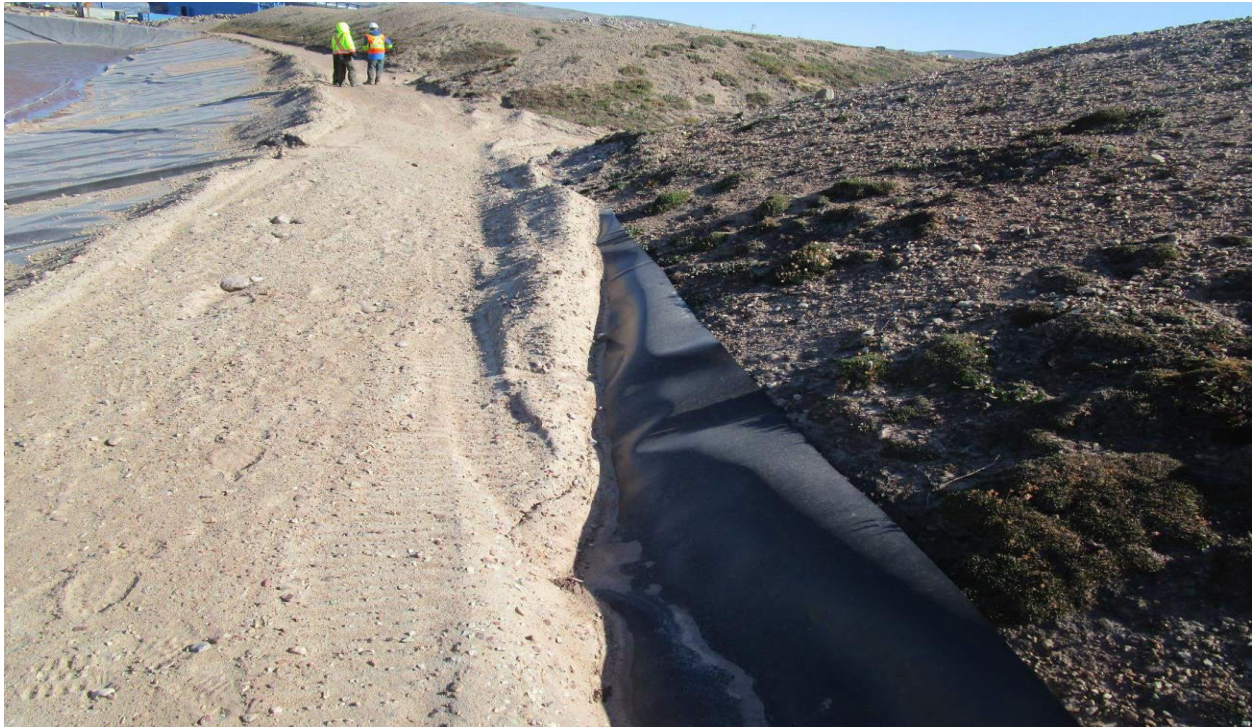
The construction of this sedimentation pond for drainage from the west side of the site is nearing completion except for the west end on the south side where the liner must be “tucked” in.

We have some concern over the stability of the liner on this pond as we have with the east pond and further recommend that used tire ballast be considered.

West Settling Pond – “Tuck-in” liner this location.

Complete construction at the south side, west end, by “tucking” the edge of the liner under the soil.

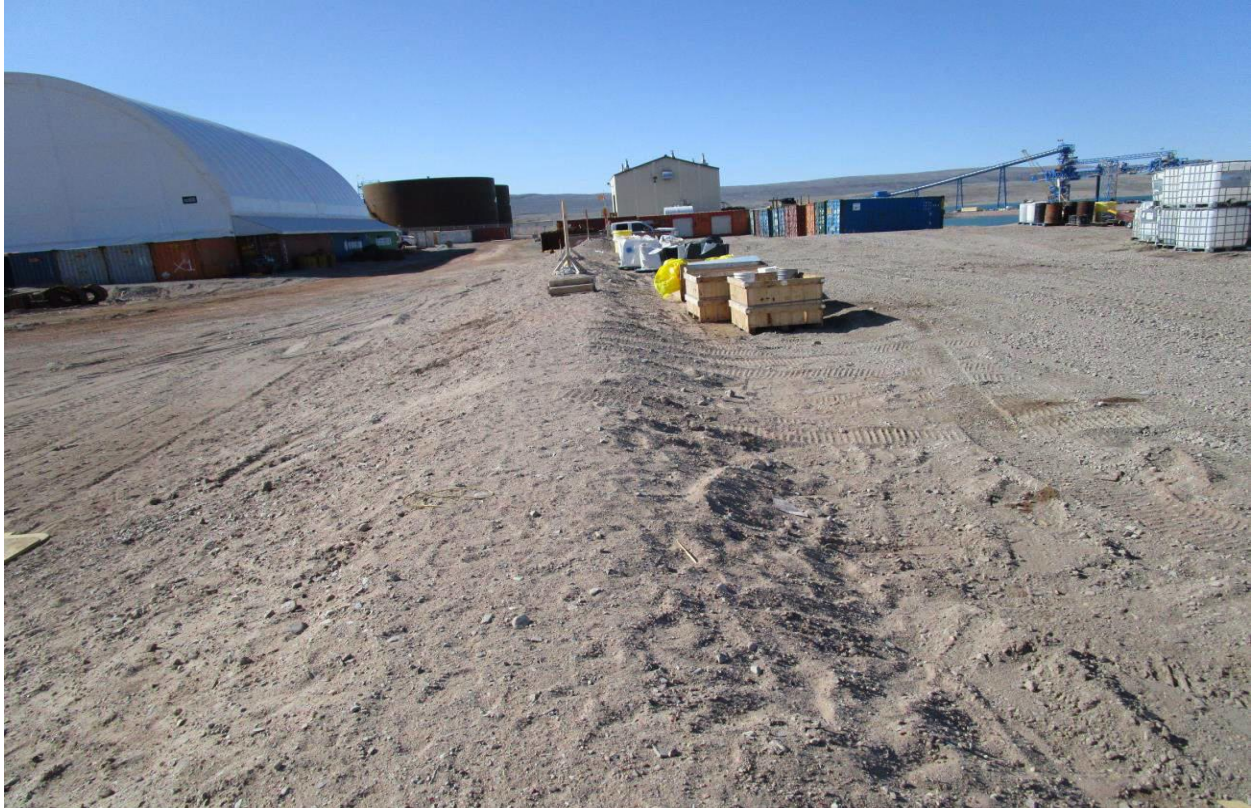
Load-out Area Hazardous Waste Containment. (Now MP-HwB-1)

This area has been constructed near the loading dock to facilitate assembly of hazardous materials for shipment out. It appears that some material from the temporary hazardous storage containment have now been assembled here.

It appears that travel has taken place over the north dyke in the placing of containers. It does not appear that the liner has been damaged.

We recommend that action be taken to prevent travel over the berms before liner damage takes place.

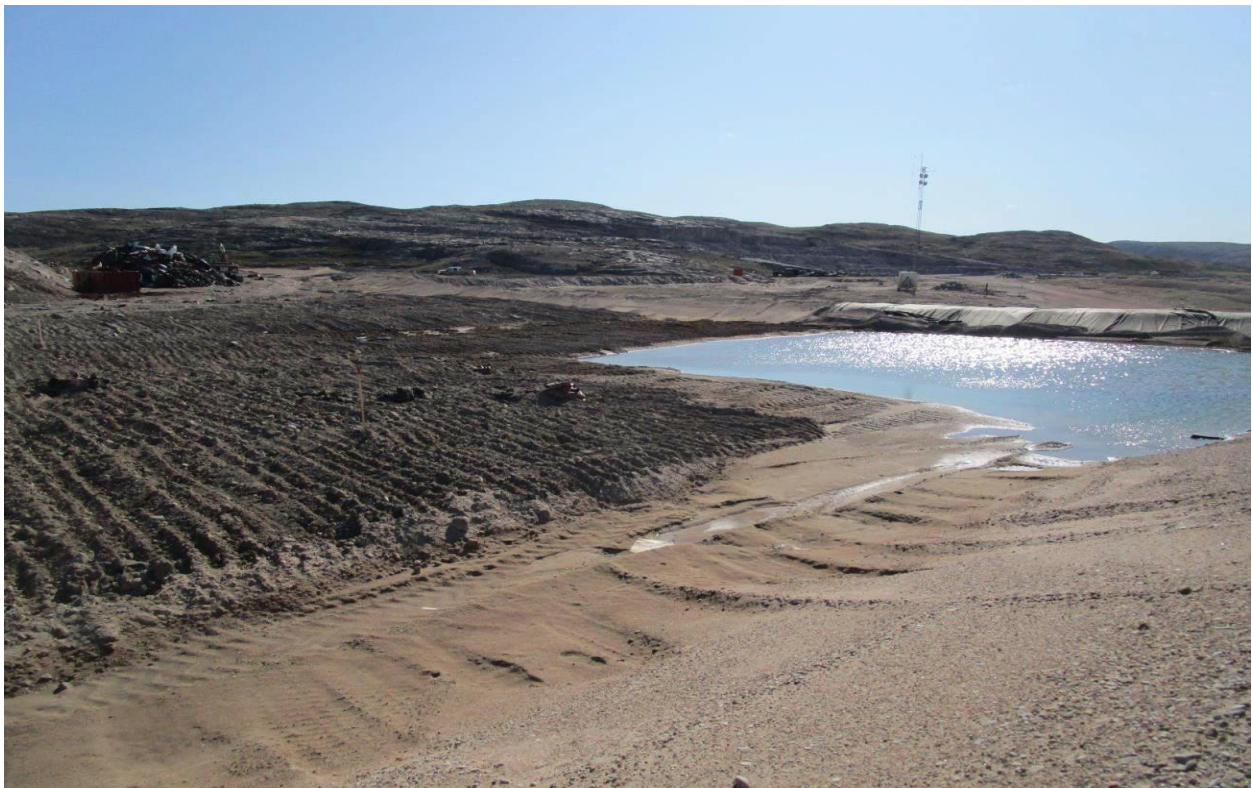
Land Farm Containment.

The landfarm containment is complete except for soil cover in the area of the sump.

The structure appears stable as constructed.

We recommend that the remaining dyke structure without protective cover over it be covered as per the design drawings, if any activity is expected in this area.

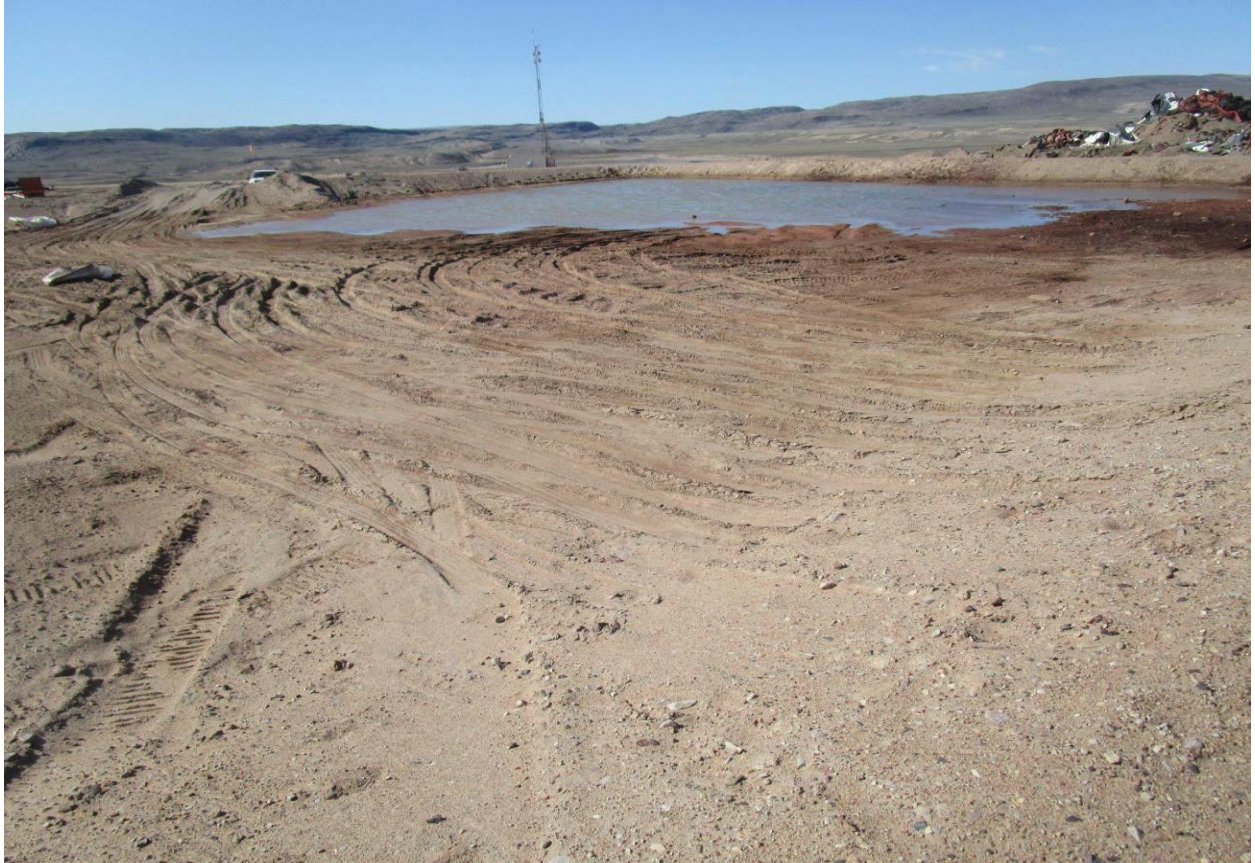
Contaminated Snow Melt Containment.

The construction of the contaminated snow containment structure is contiguous with the east end of the landfarm.

The snow containment facility has a containment volume of 929 m³ based on estimates of snow volume provided by the owner and only a small percentage of the capacity is utilized.

The structure appears stable as constructed.
