# BAFFINLAND IRON MINES CORPORATION

ANNUAL GEOTECHNICAL INSPECTIONS

MARY RIVER PROJECT

SECOND INSPECTION OF TWO

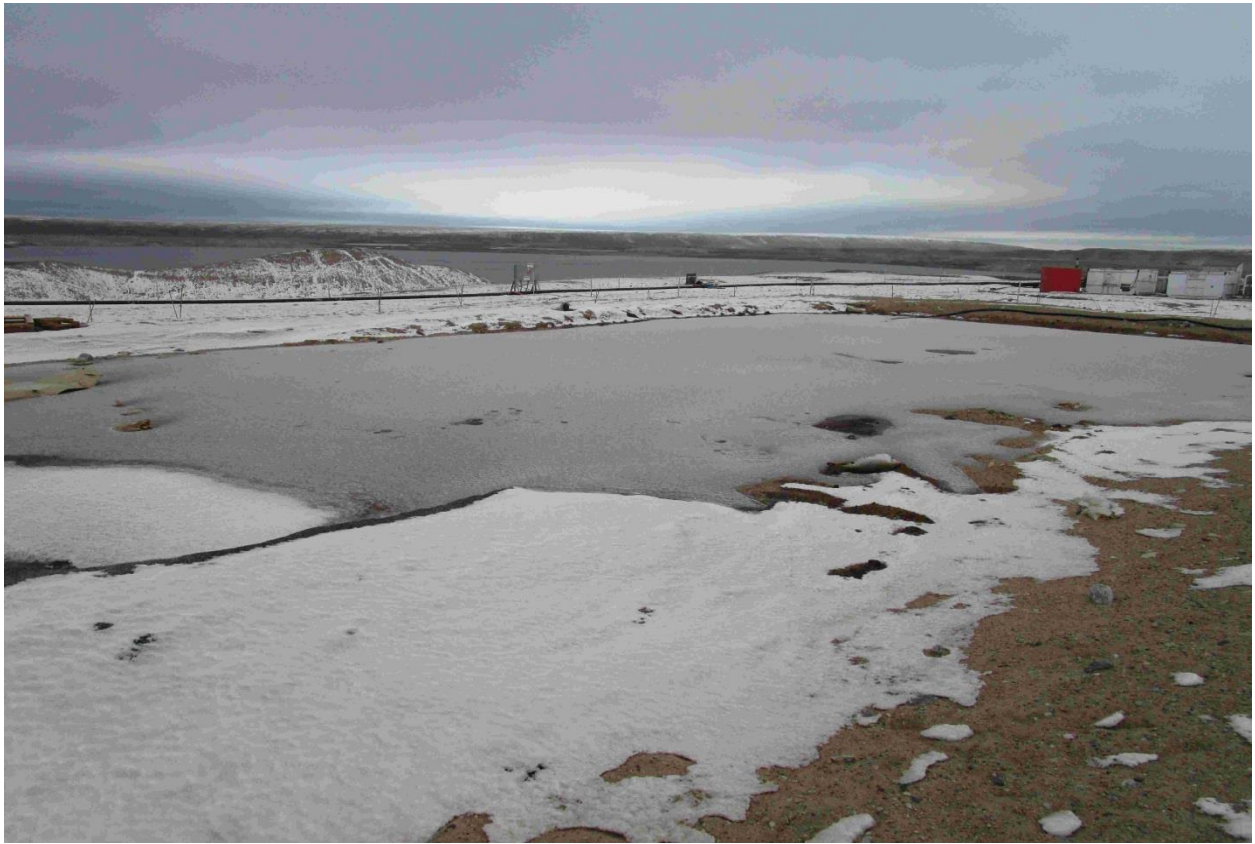
Generator Fuel Storage Containment

This particular containment structure is currently being decommissioned. The fuel bladder that was contained within the dyke has been removed.

There is no indication that the liner is compromised and decommissioning should proceed when the granular cover is either moved to a land farm or other containment. There is water ponding within the structure.

The granular fill over the geotextile and liner shall require landfarming with the material from the bulk fuel storage facility.

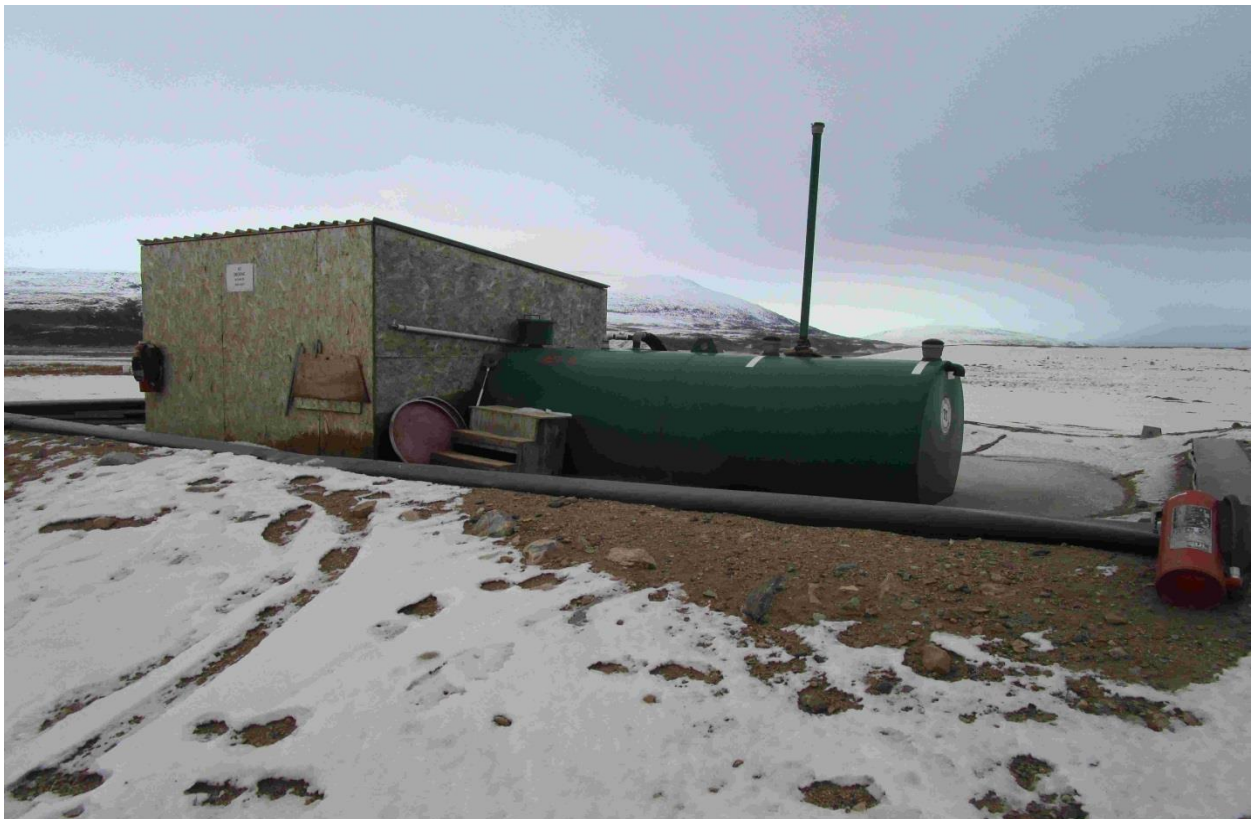
Helicopter Fuel Tank Containment

Our review of the area around the pond at the base of the slopes showed no sign of seepage. There is water in the bottom of the containment indicating the integrity of the liner.

A review of the exterior and the top of the berms showed no sign of cracking or settlement which would indicate stress within the structure.

The structure is considered to be stable in its present condition.

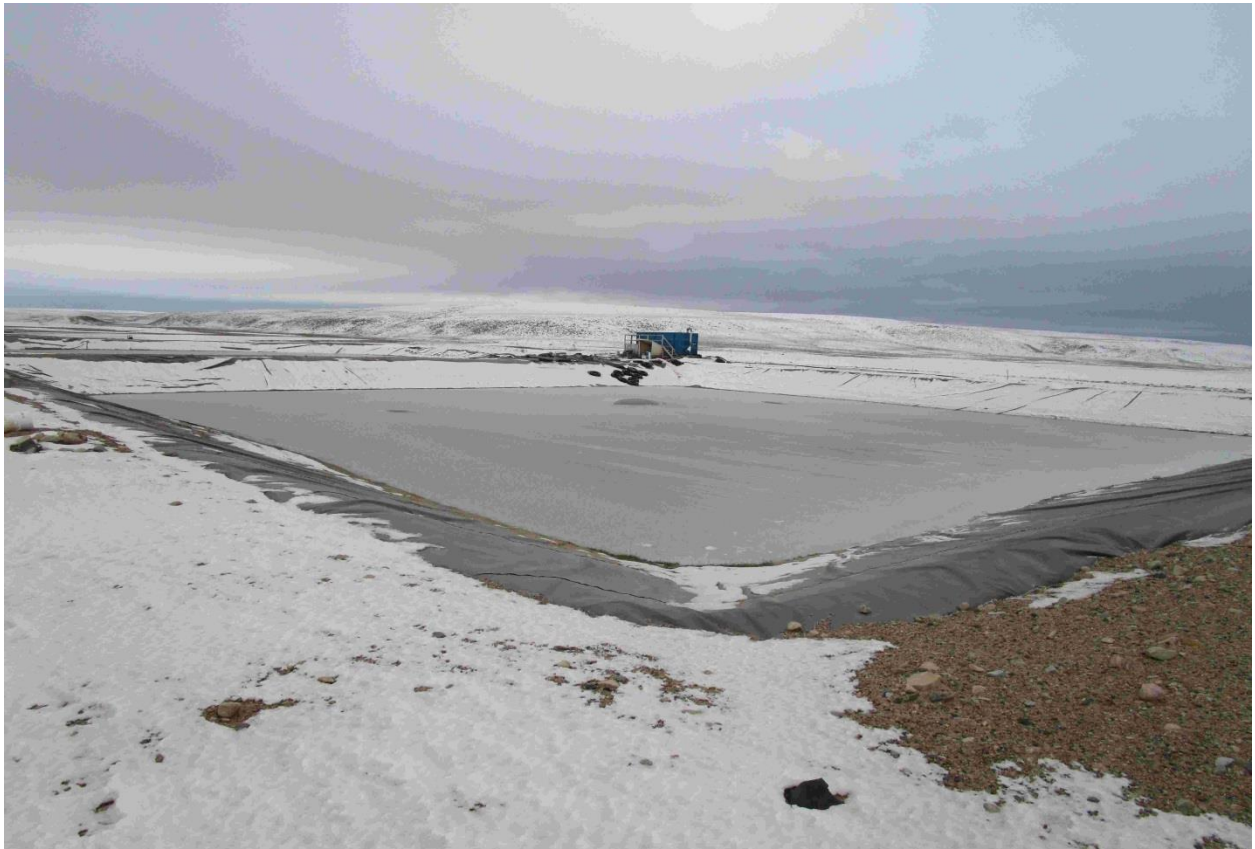
PWSP #2

Our review of the area around the pond at the base of the slopes showed no sign of seepage and hence we conclude that the liner has been effective in containing the sewage and there are no tears or ruptures in the membrane.

There are three small bubbles formed by air trapped under the enviroliner that were present in the first review that are probably the result of wrinkles in the liner that should disappear if further liquid is added to the cell.

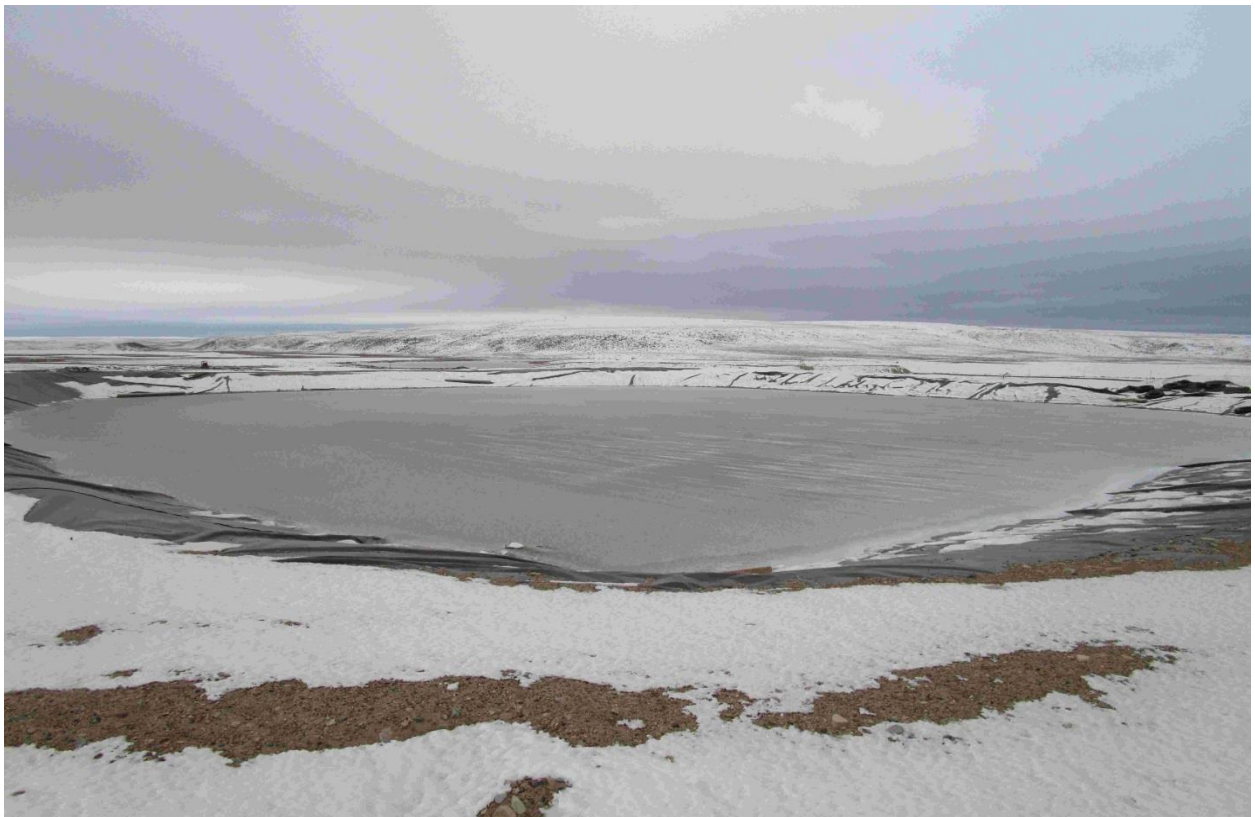
Longitudinal cracking which appeared in the dykes of PWSP #3 due to the melt of permafrost wedges in 2009 has not reoccurred and we consider this structure to be stable in its present condition.

Monitoring points have been set upon the top of the dyke and have been monitored since 2009. Settlements have occurred since that time. These settlements have not led to any stress cracks in the structure. Monitoring was discontinued last year.

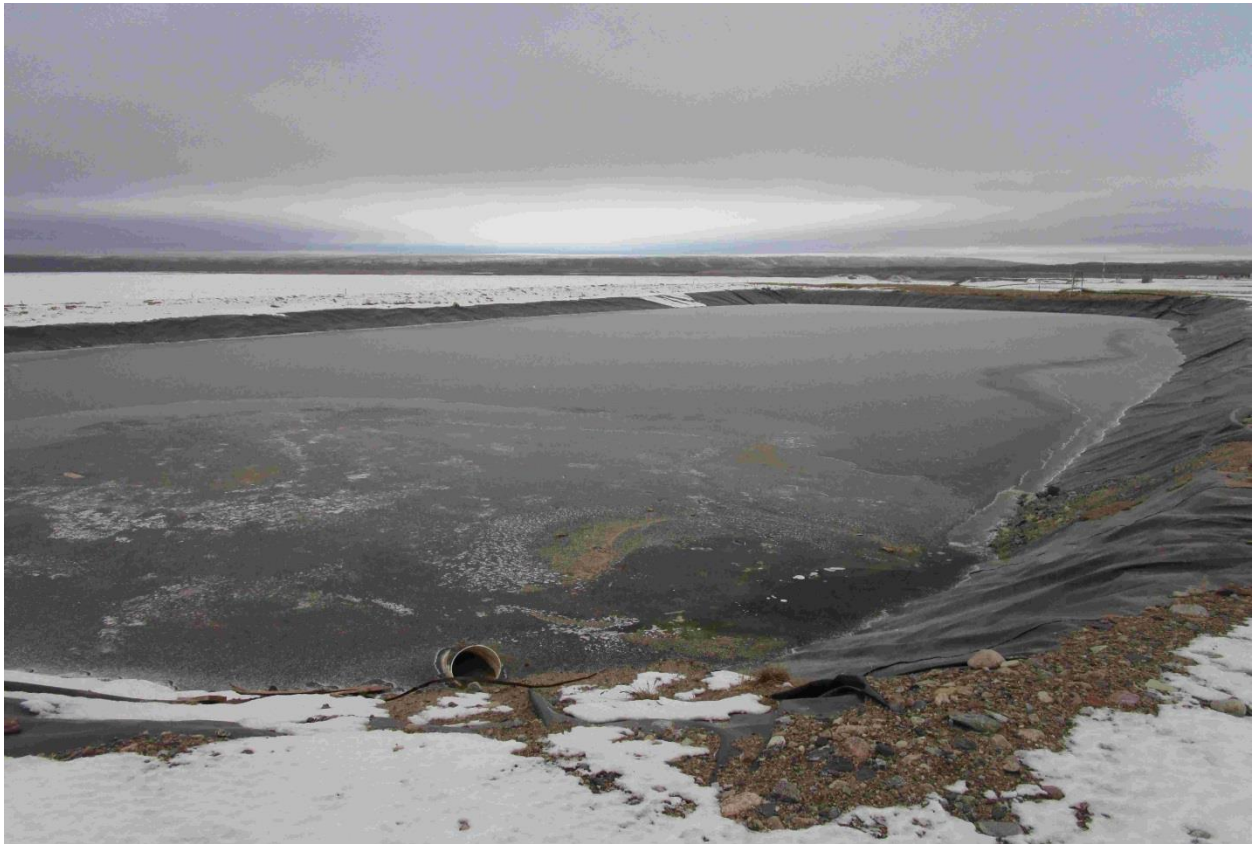
PWSP #1

Our review of this area around the pond at the base of the slopes showed no sign of seepage and hence we conclude that the liner has been effective in containing sewage and there are no tears or ruptures in

the membrane, excepting some minor tears from past activity at the top of the dyke well above the allowable effluent level in the structure in the horizontal portion of the membrane.

A review of the top of the dyke showed no indication of cracking or settlement which would indicate stresses within the structure.

Many of the tears that had occurred in the liner on the top of the dyke have been patched during the period between reviews in 2008 and 2009 and are holding well. As well, there are no signs of weather related deterioration of the liner where it is exposed.

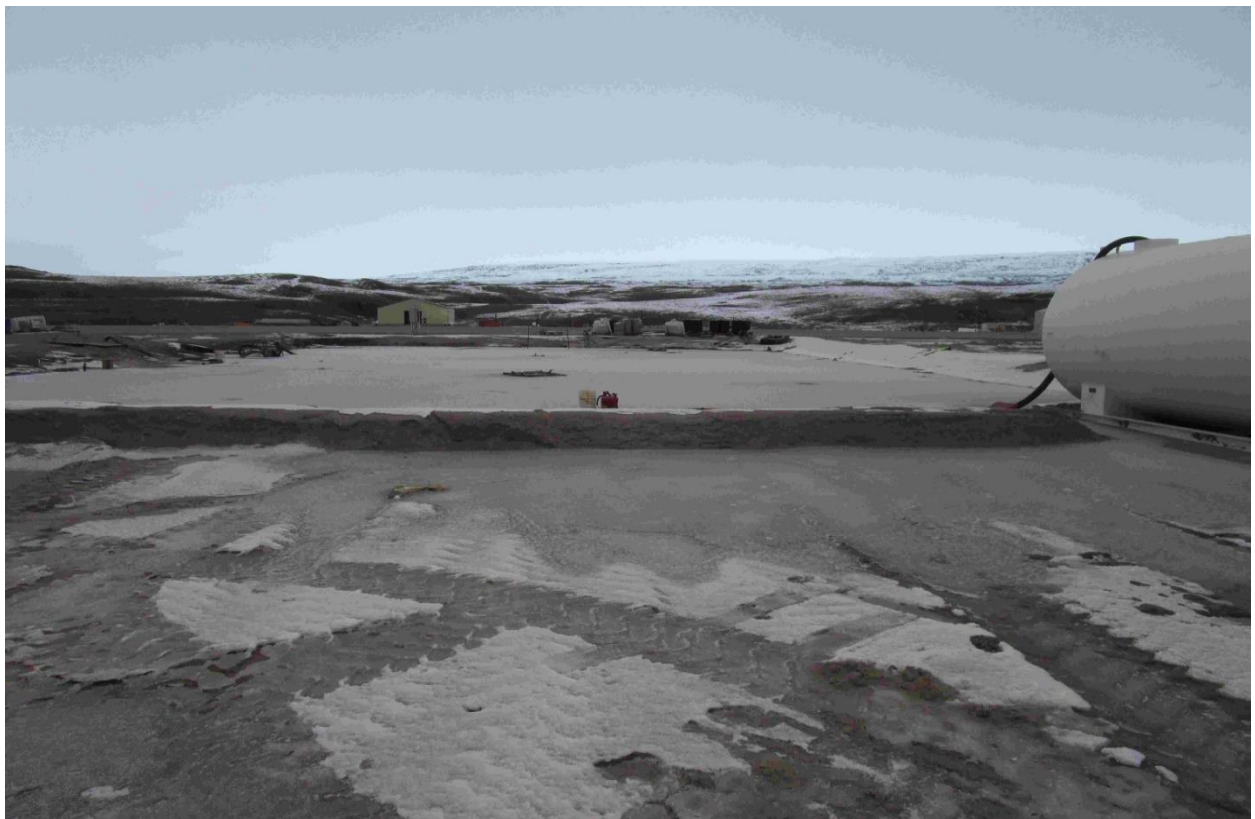
The Bulk Fuel Storage Facility still exists but it is no longer utilized as a bulk fuel storage facility. There are a number of full fuel barrels and lubricant cubes now stored within the berms, as well as a large fuel tank.

The granular cover over the geotextile and liner is still in place within the containment structure awaiting land farming and a fair amount of water at one end awaiting treatment.

At the time of this initial review, water had not been removed for a period from within the containment and water was ponding above the level of the gravel within the bottom of the containment at the north of the facility.

At the load-out end of the facility there was water ponding within the dykes.

The soil structure is considered stable in the present condition and is in conformance with the design basis for the facility.

We have no recommendations with respect to this containment structure as it awaits decommissioning.

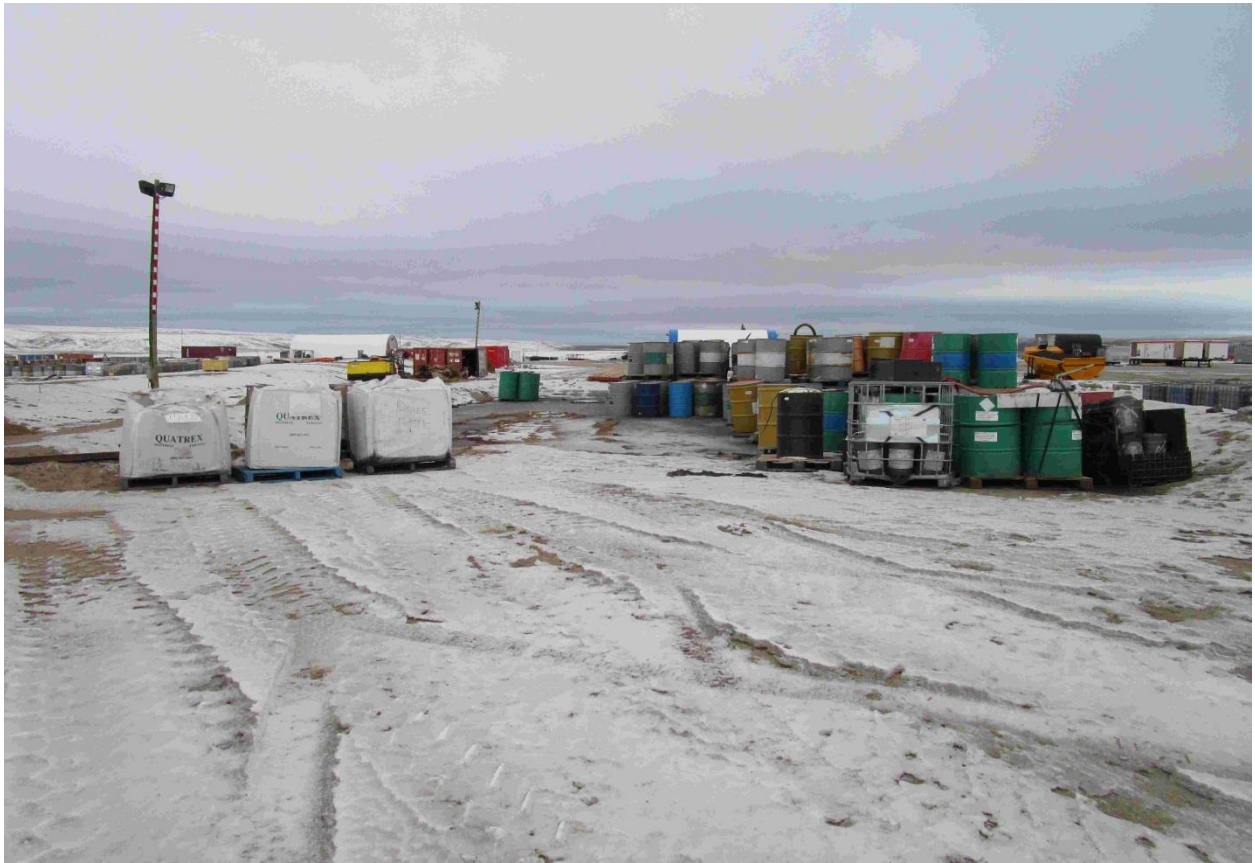
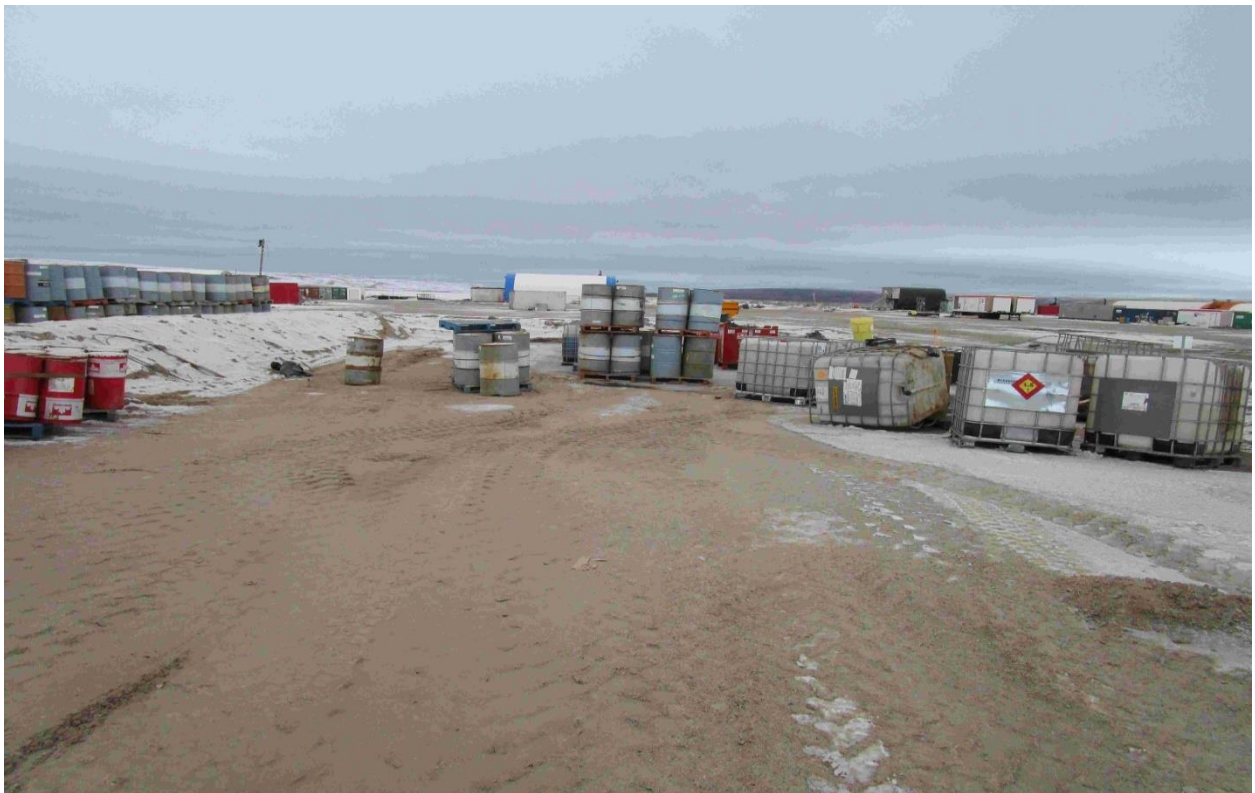
This particular structure which we called “Barrel Fuel Containment” in our previous inspection reports is a two-cell structure which is currently used to accommodate cubes of lubricant and barrels in the east cell and cubes of lubricant and antifreeze in the west cell.

Our review of the area around this containment structure showed no sign of seepage. This shows that there is reasonably little chance of tearing or rupture of the membrane having taken place.

A review of the exterior and top of the dyke showed no sign of cracking or settlement which would indicate stresses within the structure.

The structure is considered to be stable in its present condition.

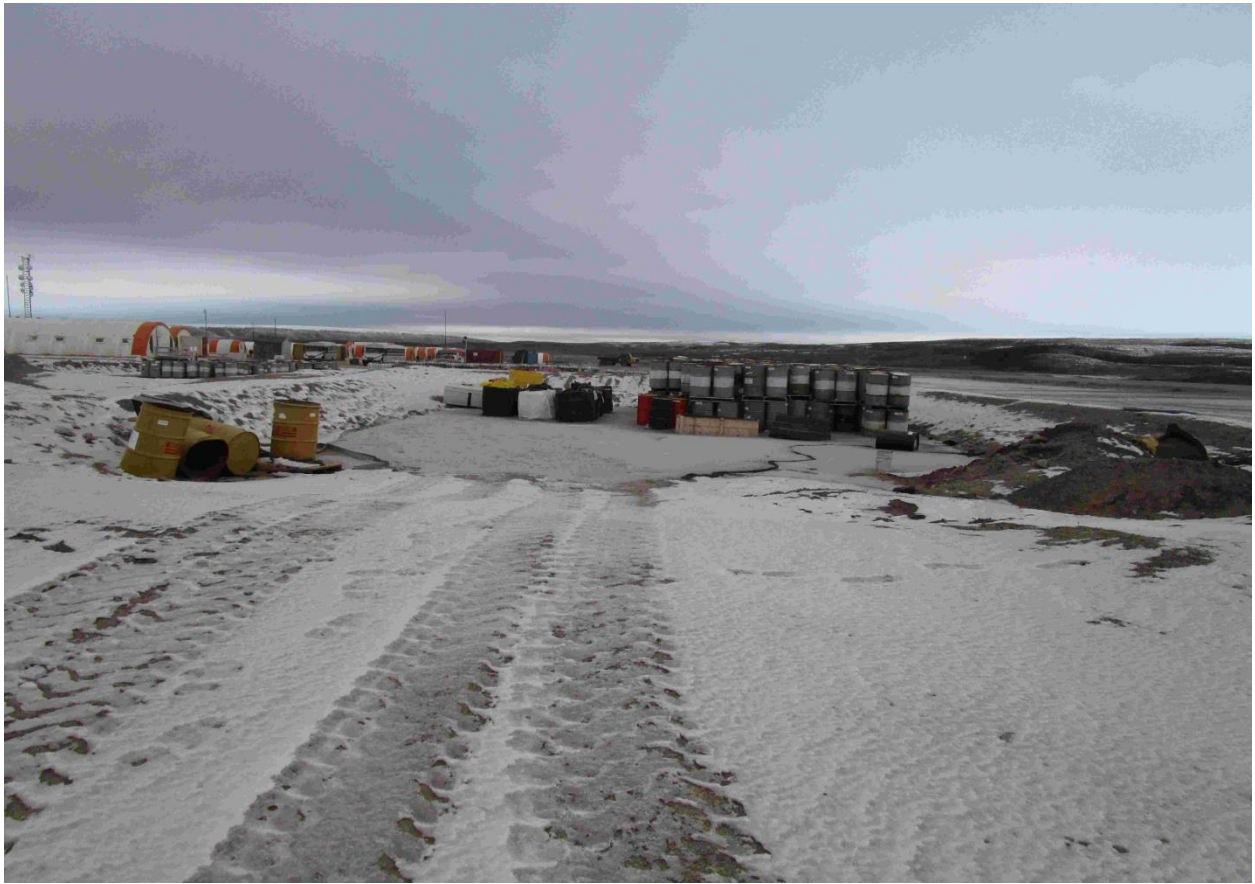
Hazardous Waste Containment MS-HWB-2

This structure contains barrels and bags of hazardous waste.

Our review of the area around this cell at the base of the slopes, showed no sign of seepage. There is water ponding in this structure.

The structure appears to be stable in its present condition. The water confirms the integrity of the liner.

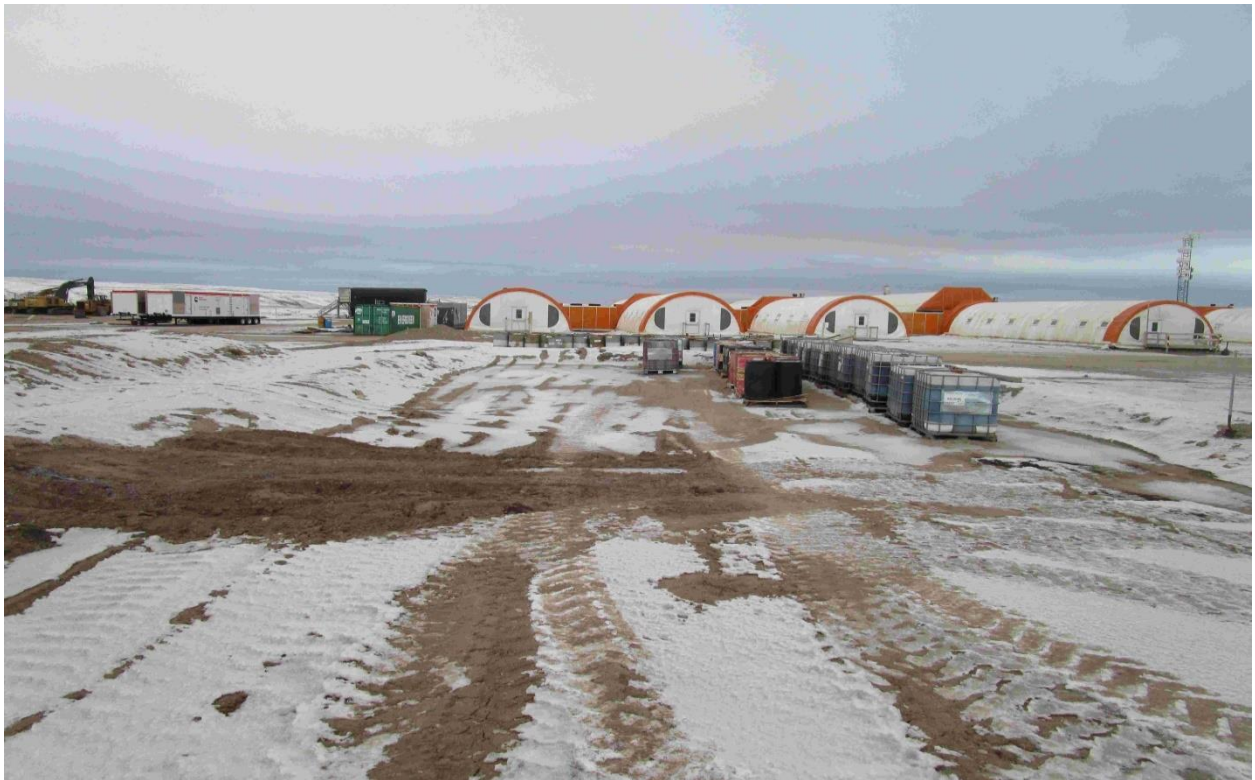
Enviro Tank Containment MS-HWB-1

Last year there was concern for the integrity of this cell as the cell was dry and the geotextile was exposed from heavy traffic during our initial inspection. During our second inspection, the cell was holding a small amount of water confirming limited integrity of the liner.

The cell is dry this year at both of the 2015 inspections raising concerns anew on the integrity of the liner.

We recommend that the geotextile over the liner be checked and the granular cover be made good prior to continuing use of this cell

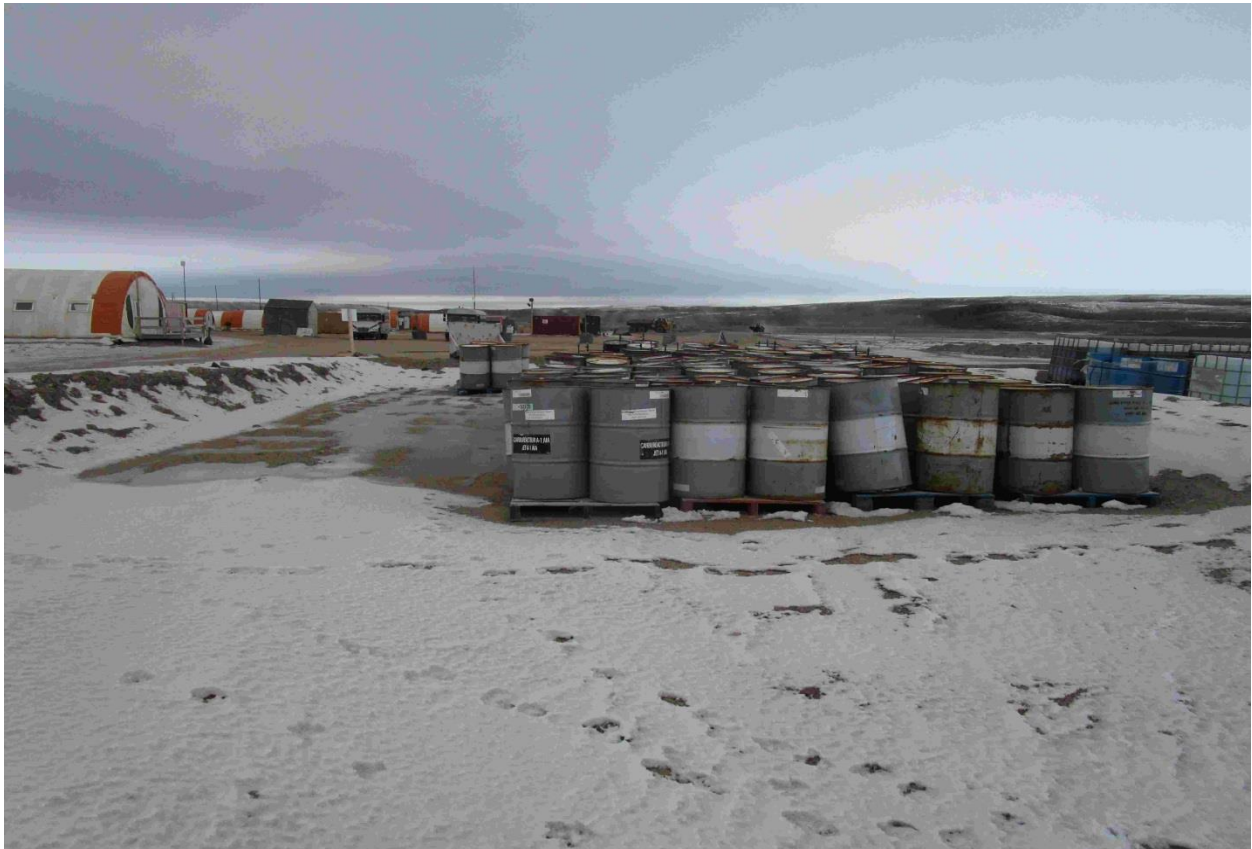
Stove Oil Storage MS-HWB-5

The structure again contains barrels of stove oil and some Jet "A" fuel.

Our review of the exterior at the base of the dyke showed no sign of seepage. This shows that there is reasonably little chance of tearing or rupture of the membrane having taken place.

A review of the exterior and the top of the dyke showed no sign of cracking or settlement which would indicate stresses with the structure.

There is water contained within the cell confirming the integrity of the liner.

The structure is considered to be stable in its present condition.

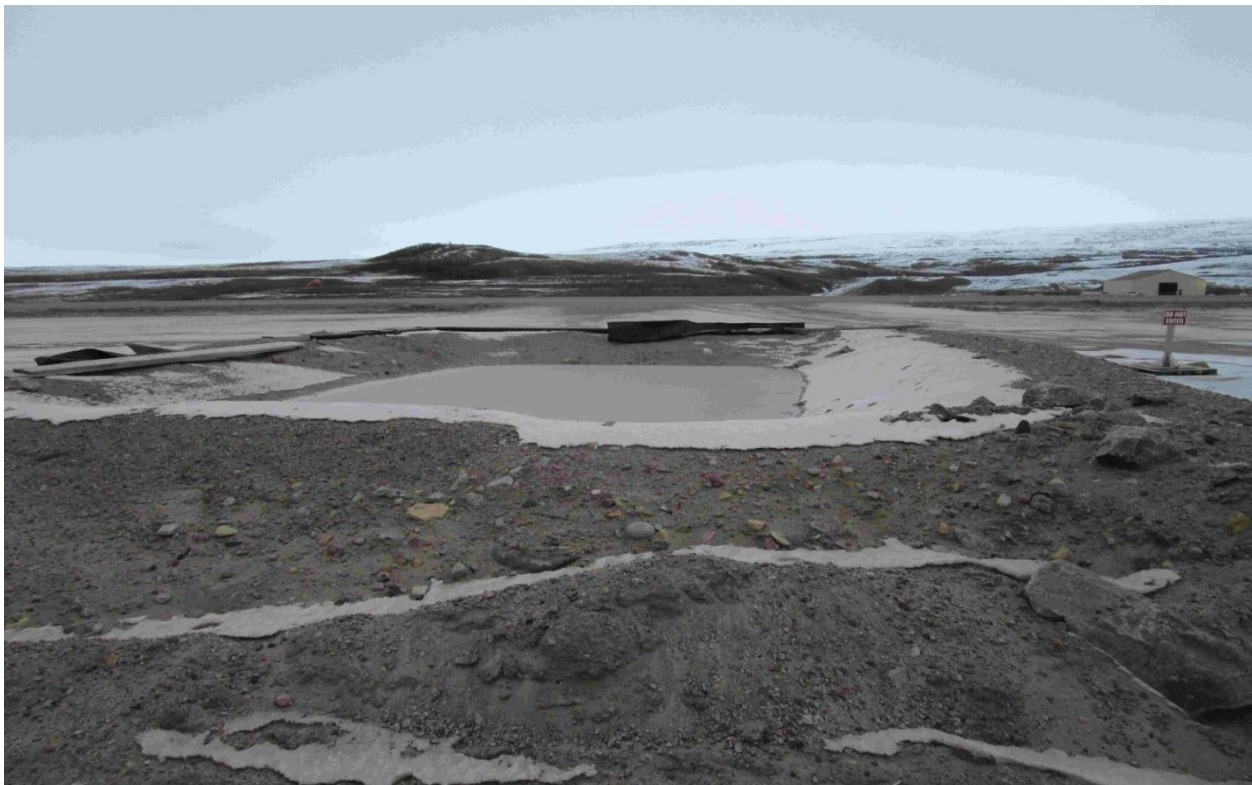
Jet "A" Fuel Containment from 2014

The construction appears proper and the structure is in good condition.

Minor water ponding confirms the integrity of the liner.

At this time as in our earlier inspection report this year, the jet fuel tank and pump have been removed and the cell is empty.

Our review of the area around the cell at the base of the slopes showed no sign of seepage and water is ponding within the cell.

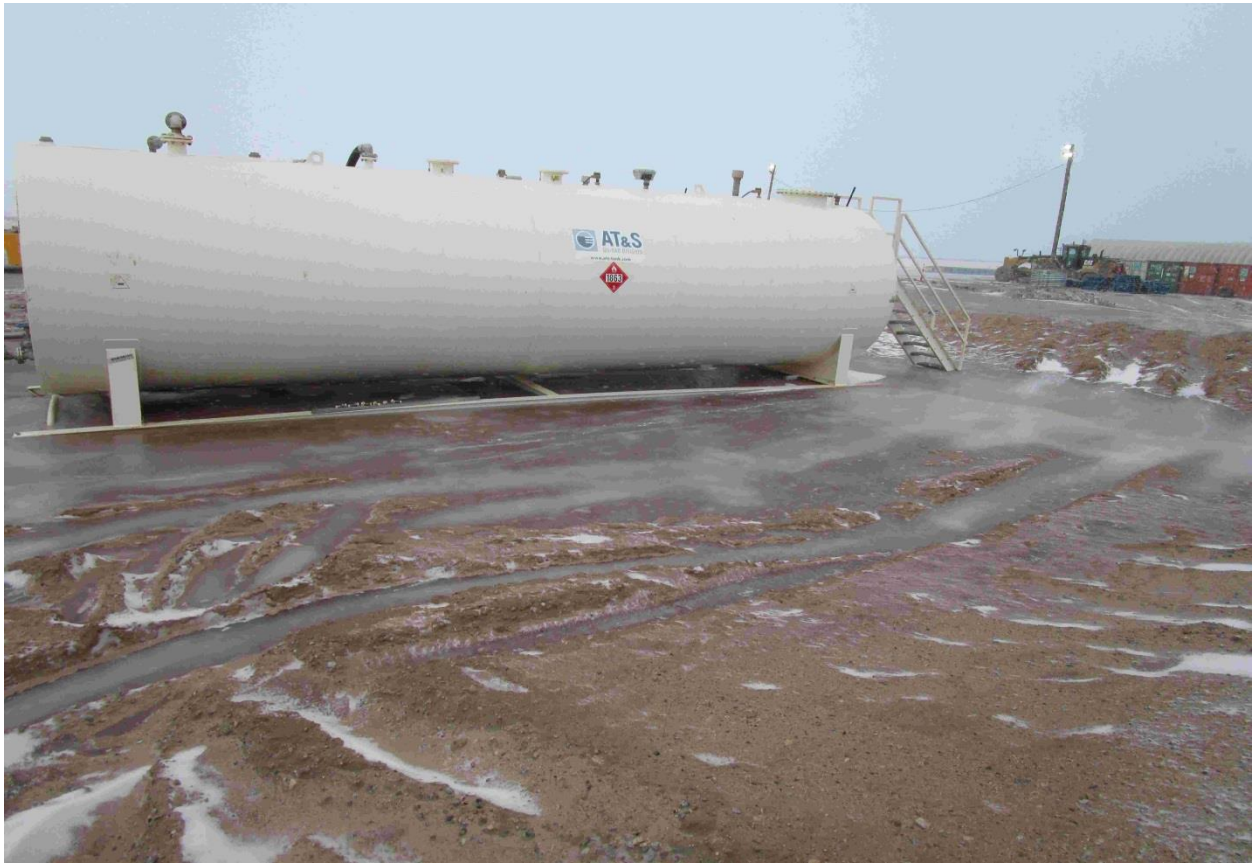
Jet "A" Fuelling Containment

This cell now contains two double walled tanks and is located north of the air terminal buildings.

The cell was constructed using a one piece enviroliner with geotextile and was constructed in accordance with standardized drawings prepared in the past for such construction by our office.

There is water ponding in the bottom of the cell confirming the integrity of the liner.

There were no signs of cracking of the dykes.

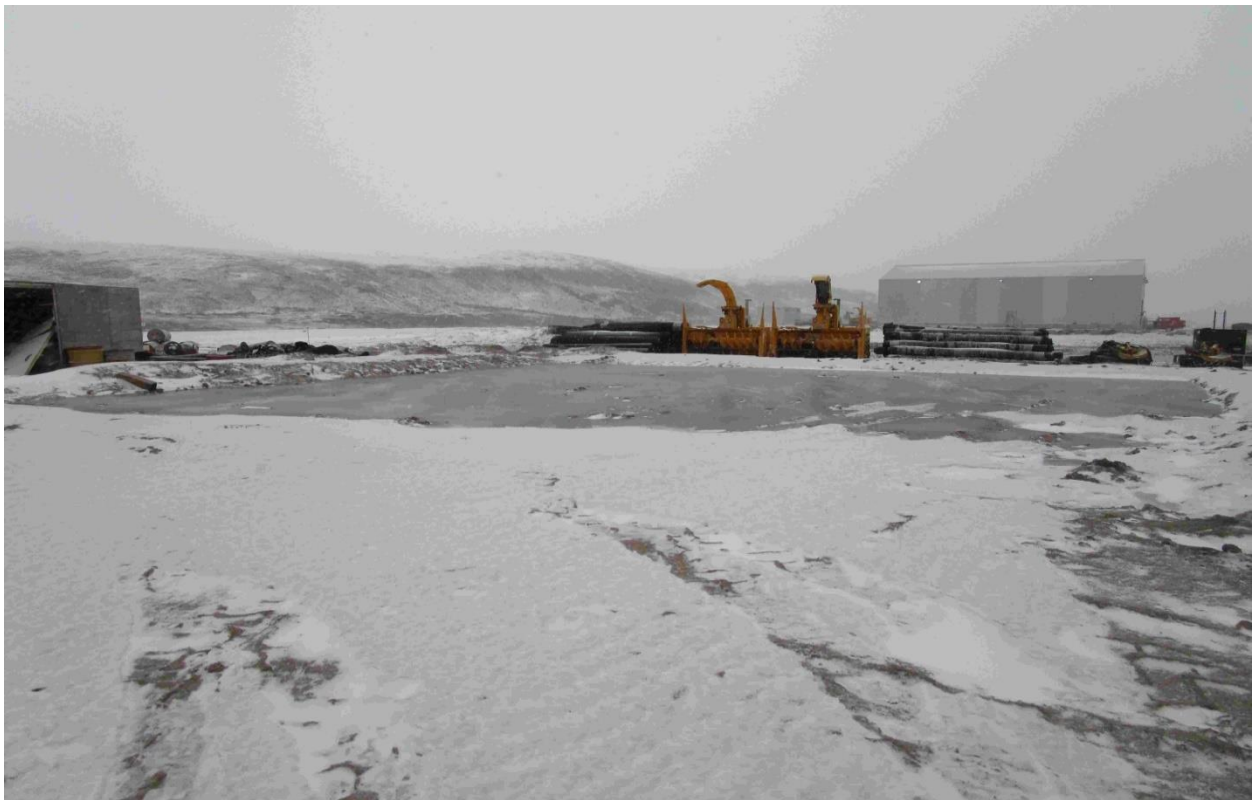
Hazardous Waste Containment MS-HWB-6

It is located near the incinerator and is utilized to store barrels of ash from the incinerator. It is, however, empty at this time.

There is water ponding in the bottom of the cell confirming the integrity of the liner.

There were no signs of cracking of the dykes or seepage around the exterior of the dykes.

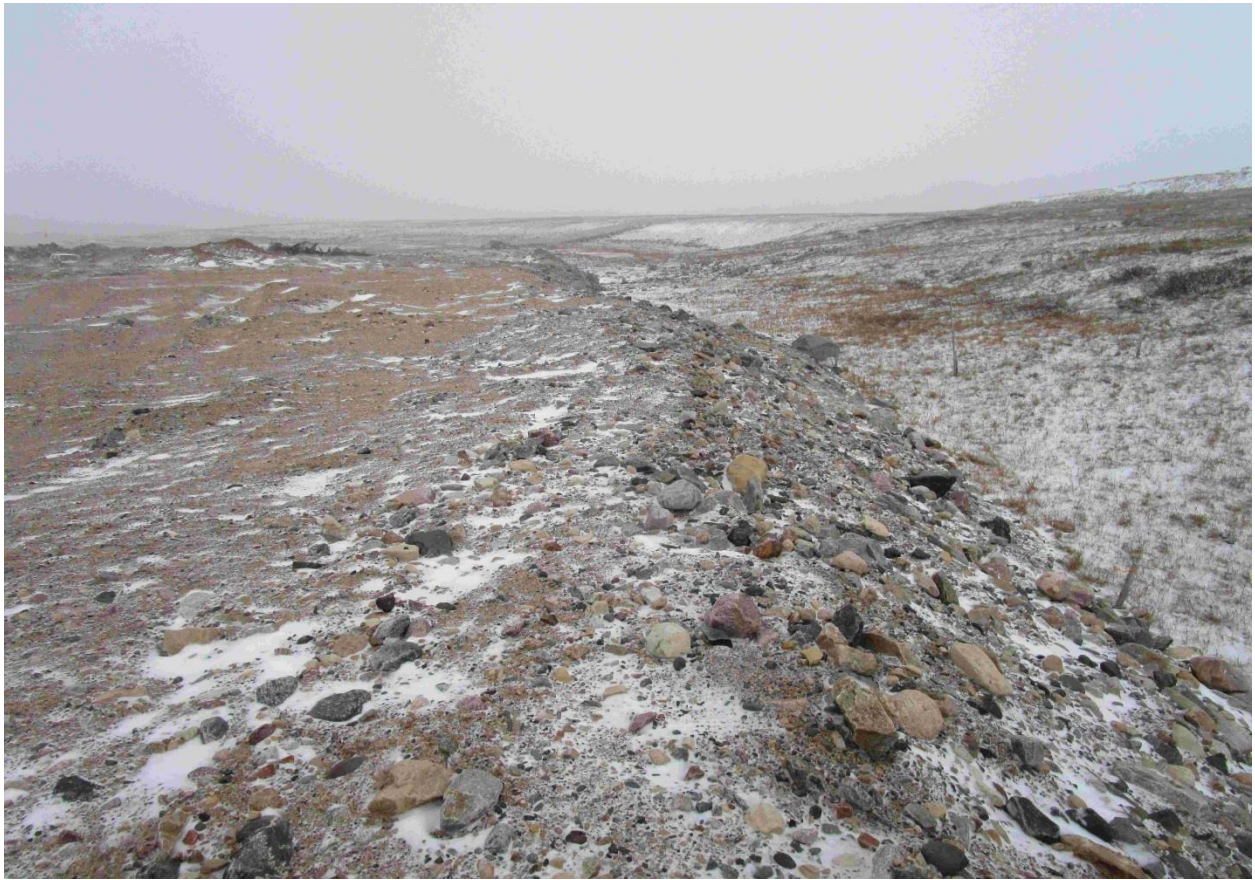
Edge and Top of Solid Waste Disposal Site

Berms appear stable and no erosion appears to have taken place on the back and both sides of the site. Solid waste was being placed at the front edge of the site and was awaiting salvage of wood and lumber

prior to the placing of cover at the time of our site review. There is also separation of metals taking place.

The current footprint as established by the existing covered material and the “blow control” fence at the front of the immediate site has now reached capacity. It is our understanding that the footprint of the facility and blow fence shall be expanded in the near future in accordance with plans and guidelines set out for this solid waste disposal site.

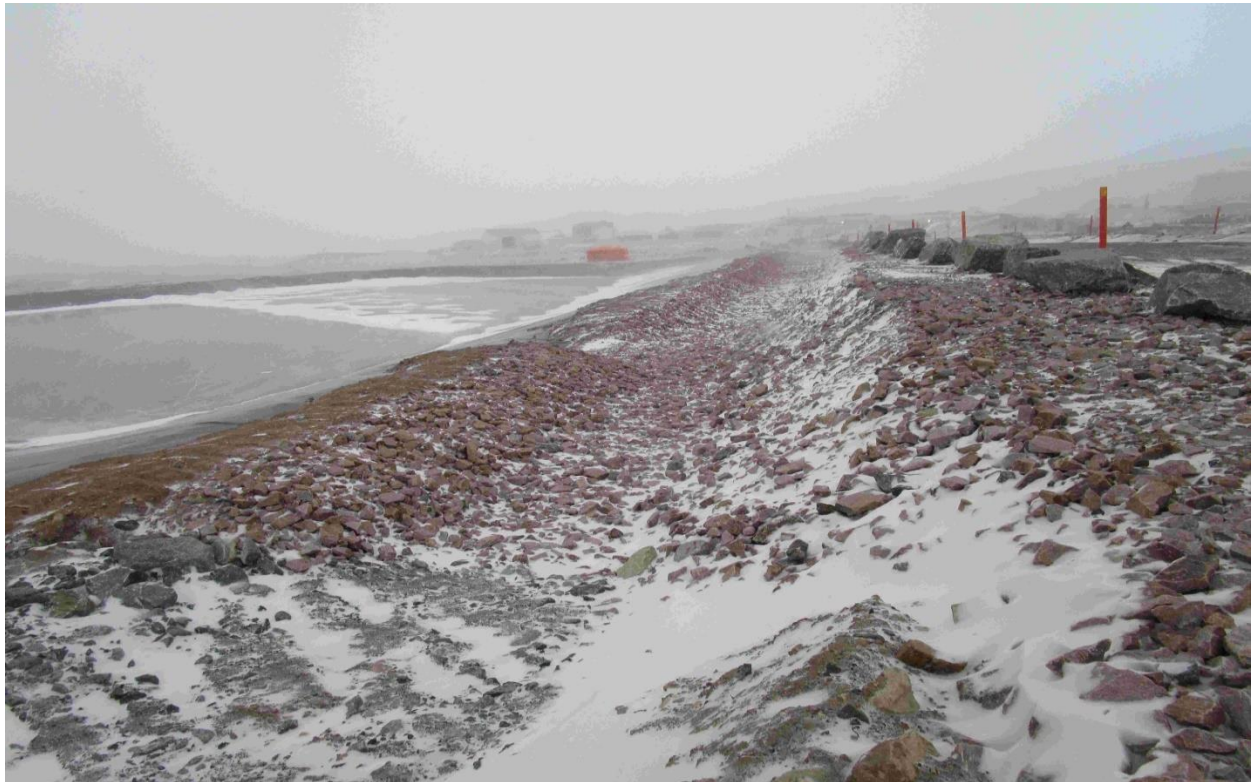
Crusher Pad Drainage Pond and Swale

The ditch at the entry to the recessed inlet on the east and west side of the containment is now complete and the facility has now been completed.

The structure has been completed in accordance with drawings included in our last report in a most satisfactory manner.

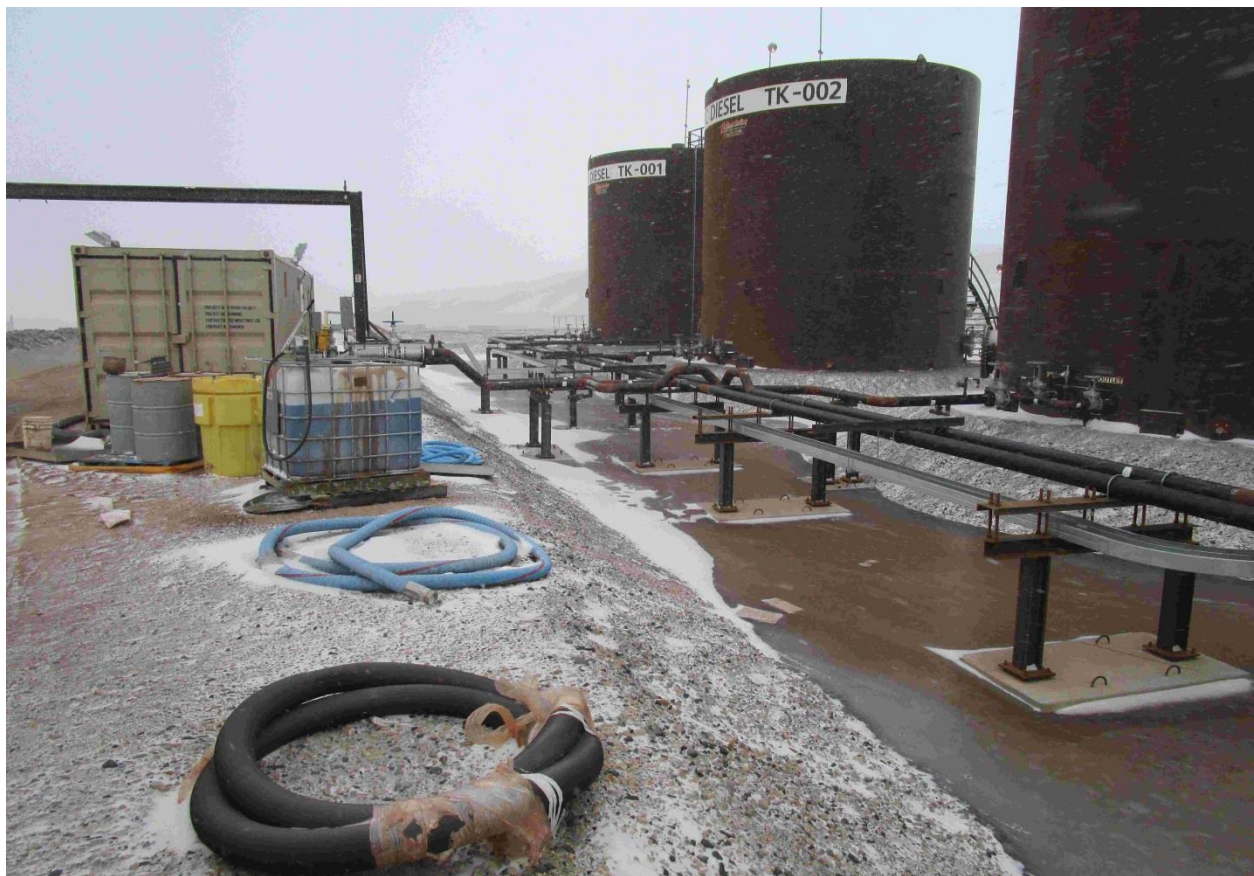
Mary River Tank Farm Containment

All work appears to be complete excepting the installation of the sump pits that are on site awaiting installation and which shall be utilized to facilitate the removal of water that collects from precipitation.

There is water ponding in the bottom of the containment confirming the integrity of the liner. This ponding of water is now well above the cover on the bottom of the containment.

All work appears to have been completed in accordance with drawings and we have no concerns with the stability of this containment structure.

We recommend that at least one sump be installed as per the drawings prepared for this facility and that when weather permits, removal of water within the containment.

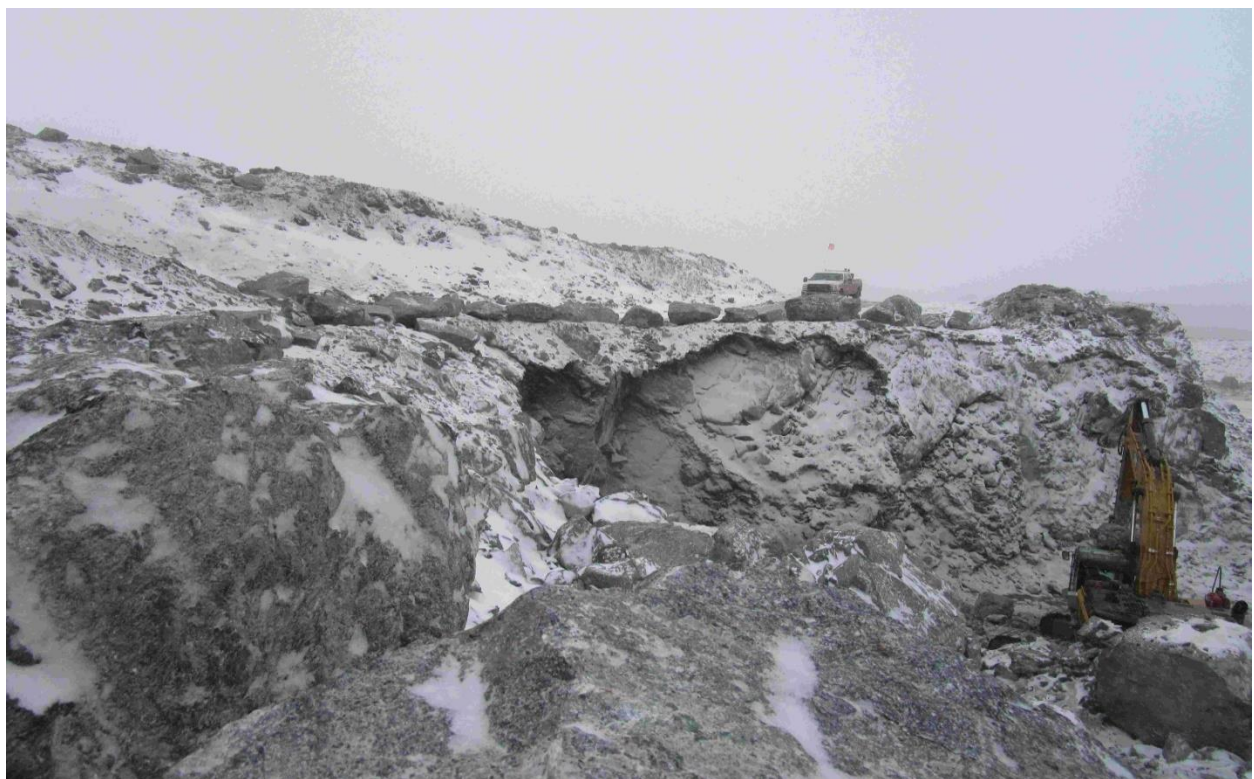
Mary River Quarry Bench Undermining

The current work site is undermining the road on the bench above it (see photo). However, it is recognized that the road area referred to is restricted access. The quarry is active, and the area of instability will soon be removed as part of ongoing quarry development.

The current work site is undermining road on the bench above it. (see photo)

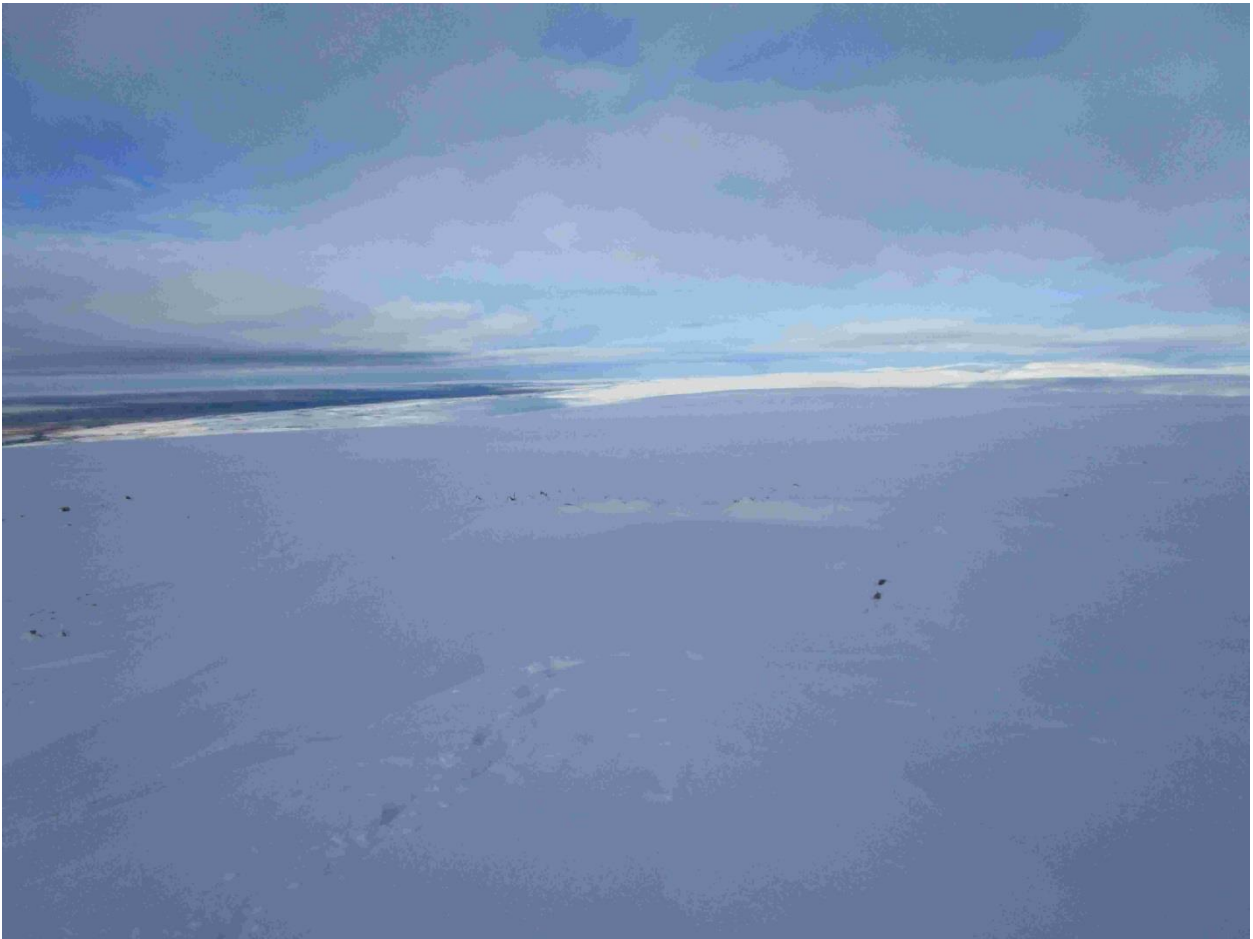
Waste Rock Containment  
(Verified via Aerial Photography)

This pond is a collection pond wherein the front end of the pond is not lined with an eviroliner and only the end dykes are.

As there was snow windswept across this area at the time of our inspection, it was reviewed from aerial photography done prior to the snow.

The area appears stable at this time.
