Mary River Drawing

4.0 MILNE INLET

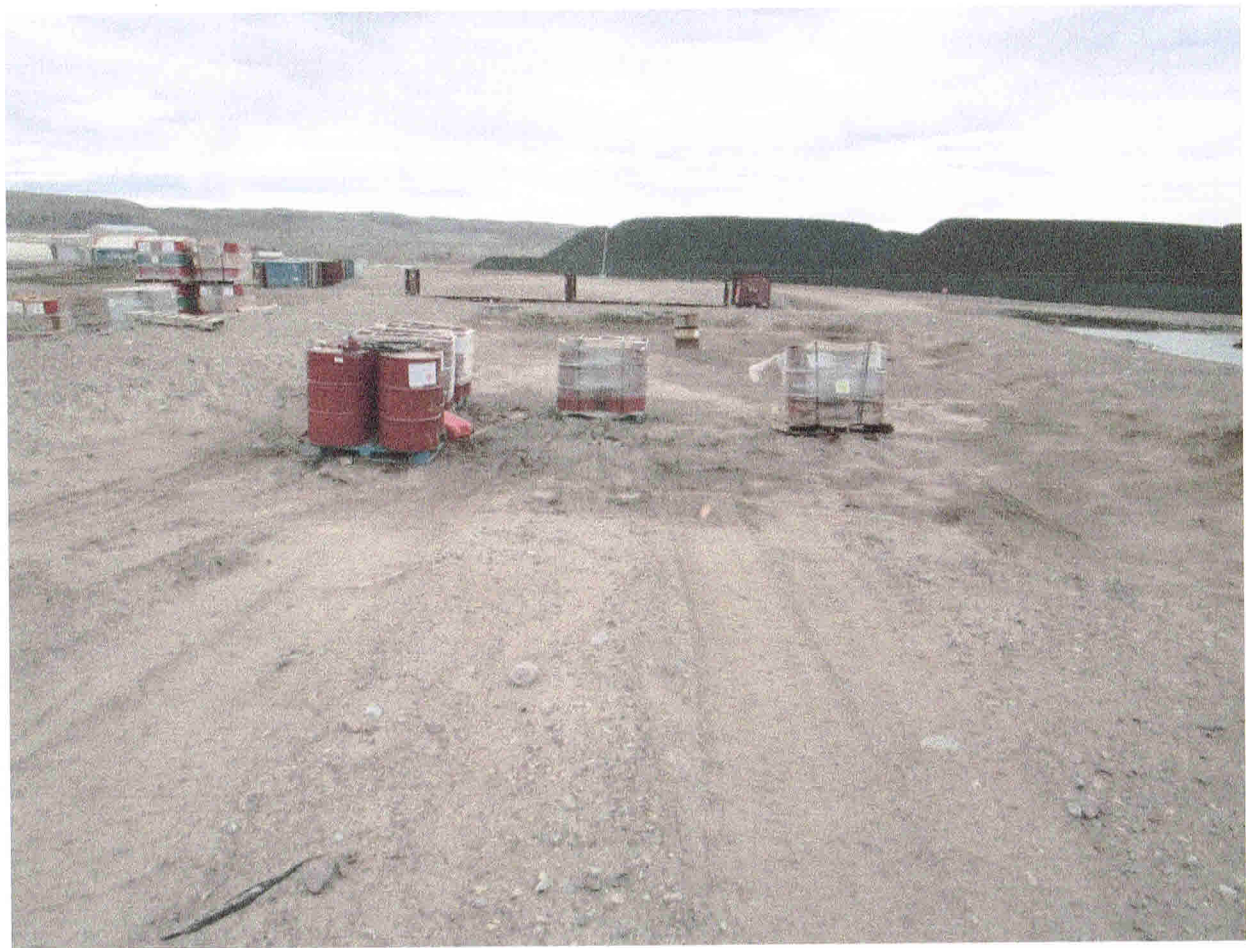
Hazardous Waste Storage MP-HWB-3

This particular structure has been constructed as a two-cell structure and is now only used to store a few items.

There is no water ponding in both cells of the original structure. We are advised that water has been pumped from these structures and sand in the structures is wet.

Our review of the area around the dykes, at the base of the slopes, showed no sign of seepage. The structure is considered stable.

We have no recommendations with respect to the use of these two cells at this time. Prior to our inspection in September, we request that water not be pumped from the structures.

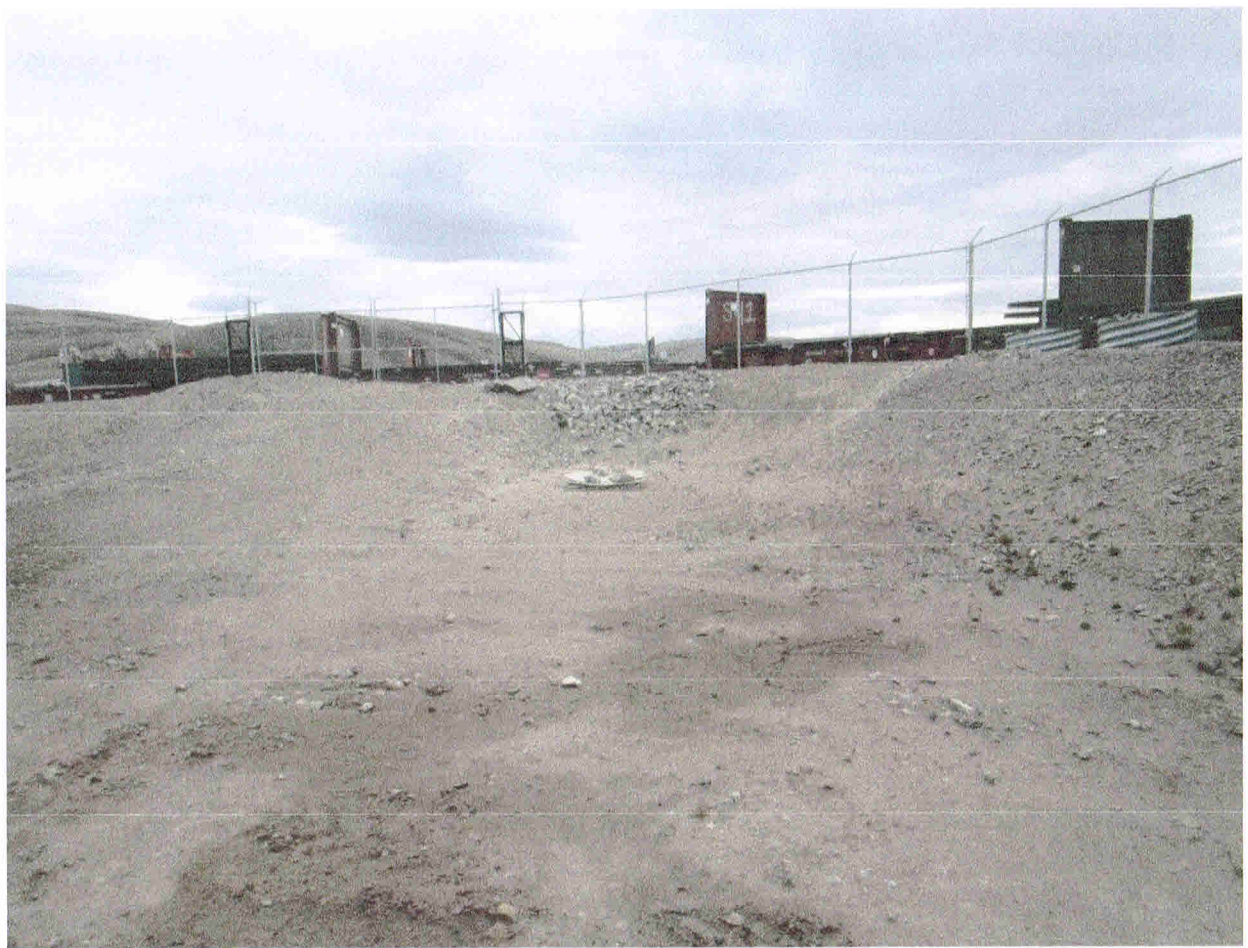
Fuel Tank Farm

Since both 2012 and 2013 the fuel tank farm has been expanded considerably with the addition of a number of new tanks. No tanks have been added since last season but there is room to place additional tanks.

We note that the sump placed in the containment is still located at the high end of the containment. There is water ponding in the low end of the containment.

We have minor water ponding at the low end of the containment confirming the integrity of the liner.

We recommend that a sump be considered at to the low point at the north end of the containment, to better facilitate the removal of water to minimize the treatment of water should a minor spill occur within the containment.

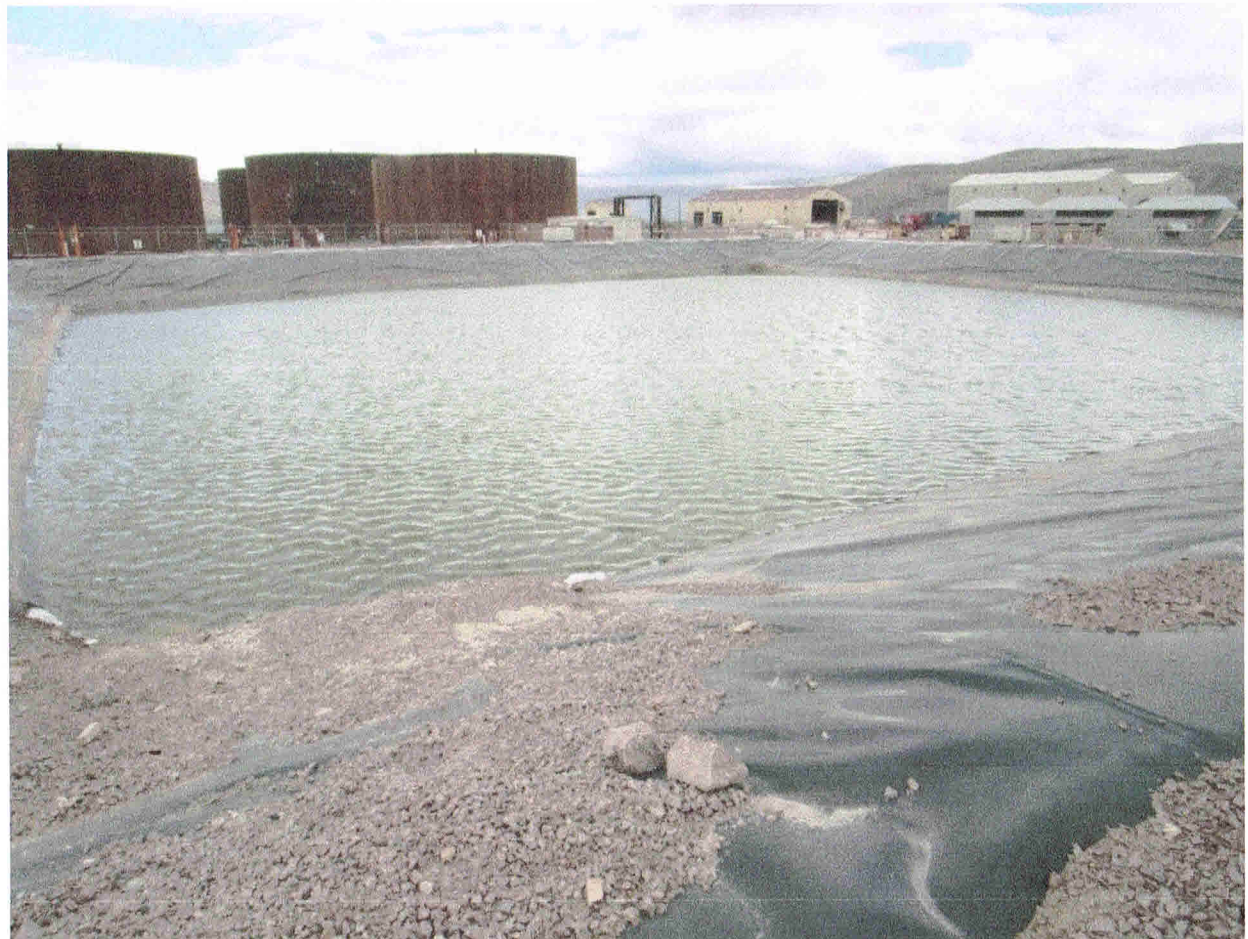
New Sewage Effluent Pond

The containment pond was operating at approximately sixty-percent of capacity at the time of our inspection.

We noted no sign of weakness in any of the construction.

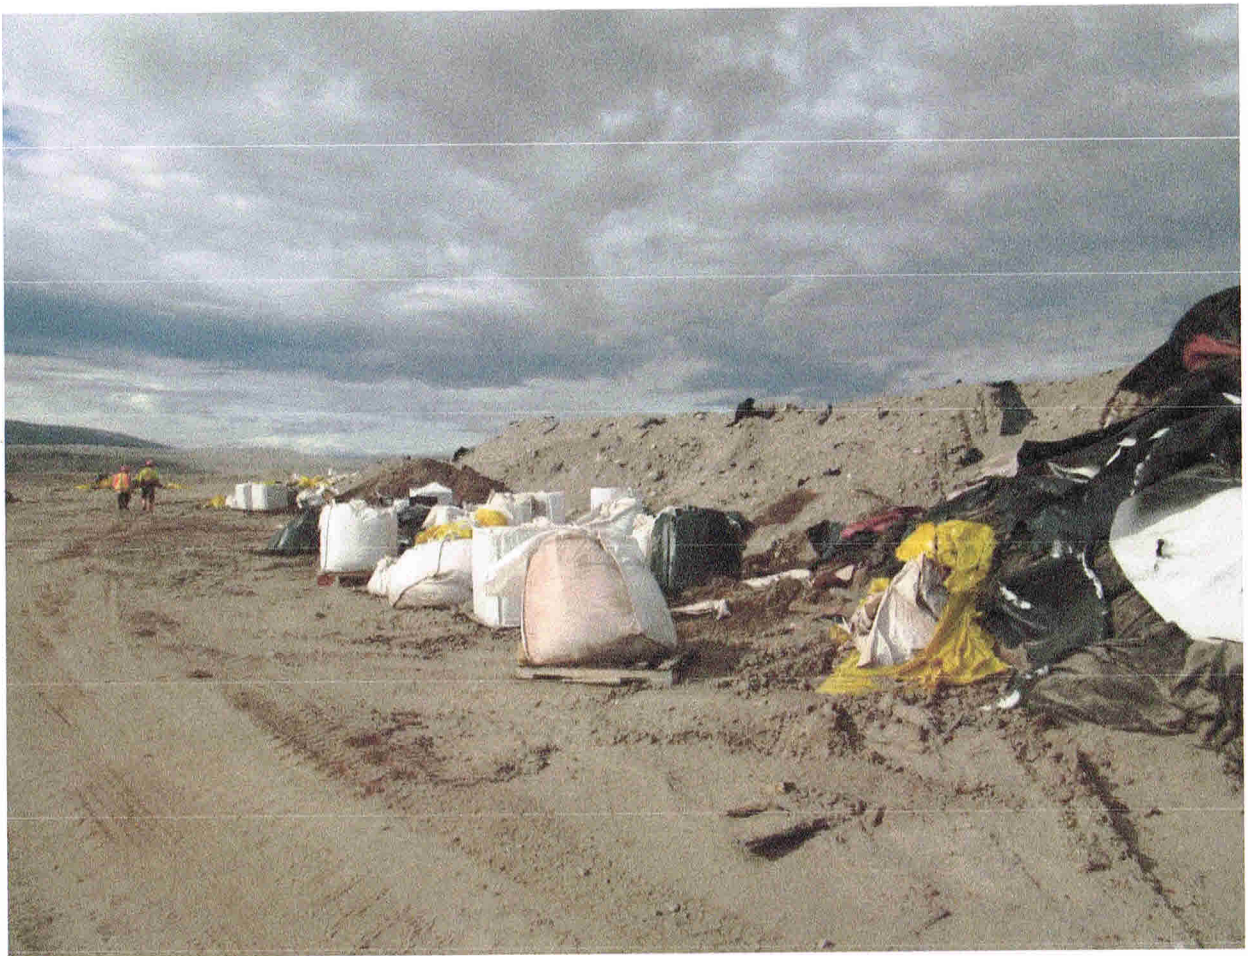
Land Farm

The landfarm containment is complete except for soil cover on the dykes in the area of the sump.

There is considerable contaminated waste in the landfarm in addition to contaminated soil. No landfarming of treated contaminated soil has taken place.

The structure appears stable as constructed.

We recommend that the remaining dyke structure, without protective cover over it, be covered as per the design drawings. This, however, is not an absolute requirement.

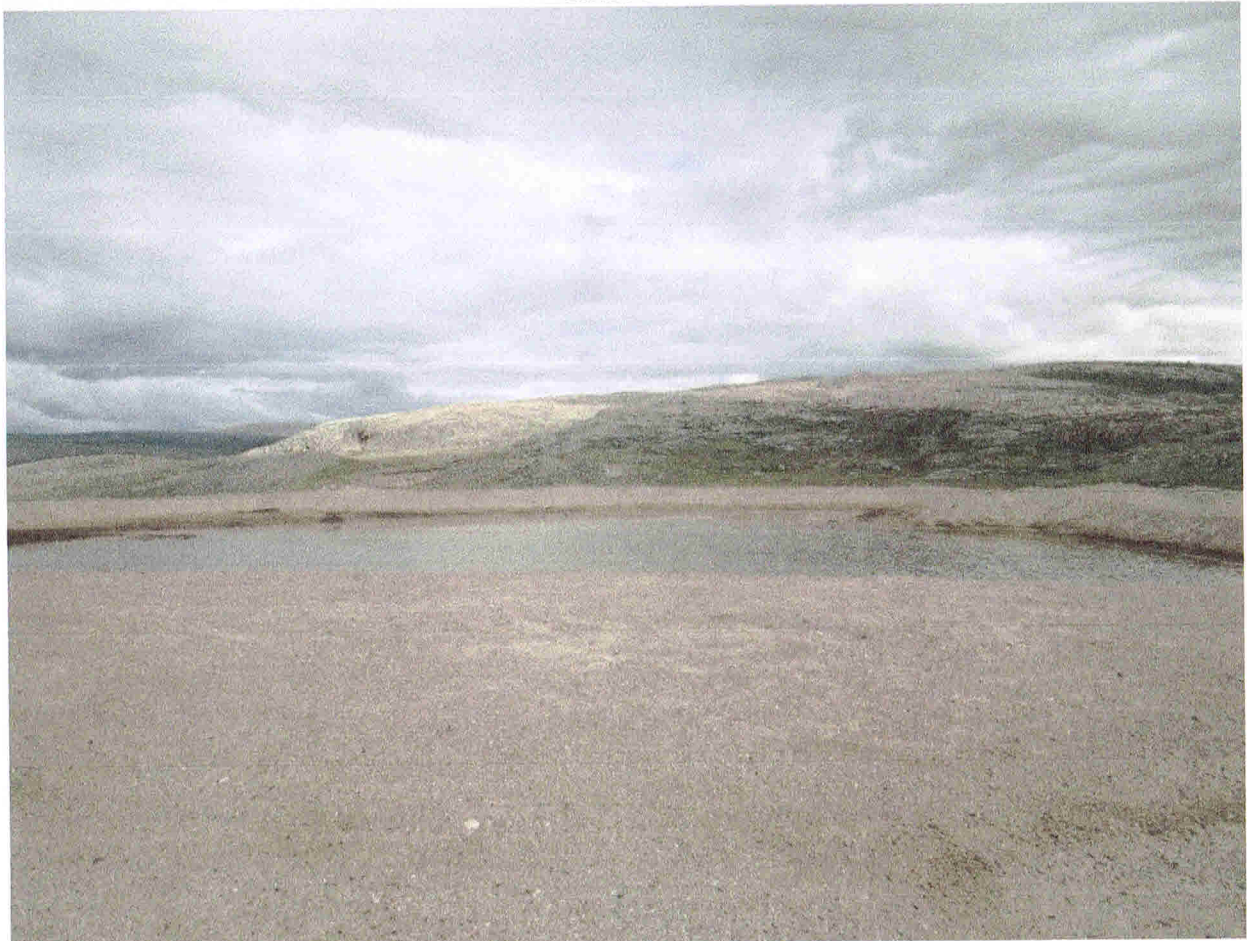
Contaminated Snow Containment

The snow containment facility has a containment volume of 929 m³ based on estimates of snow volume provided by the owner and only a small percentage of the capacity is utilized.

The structure appears stable as constructed.

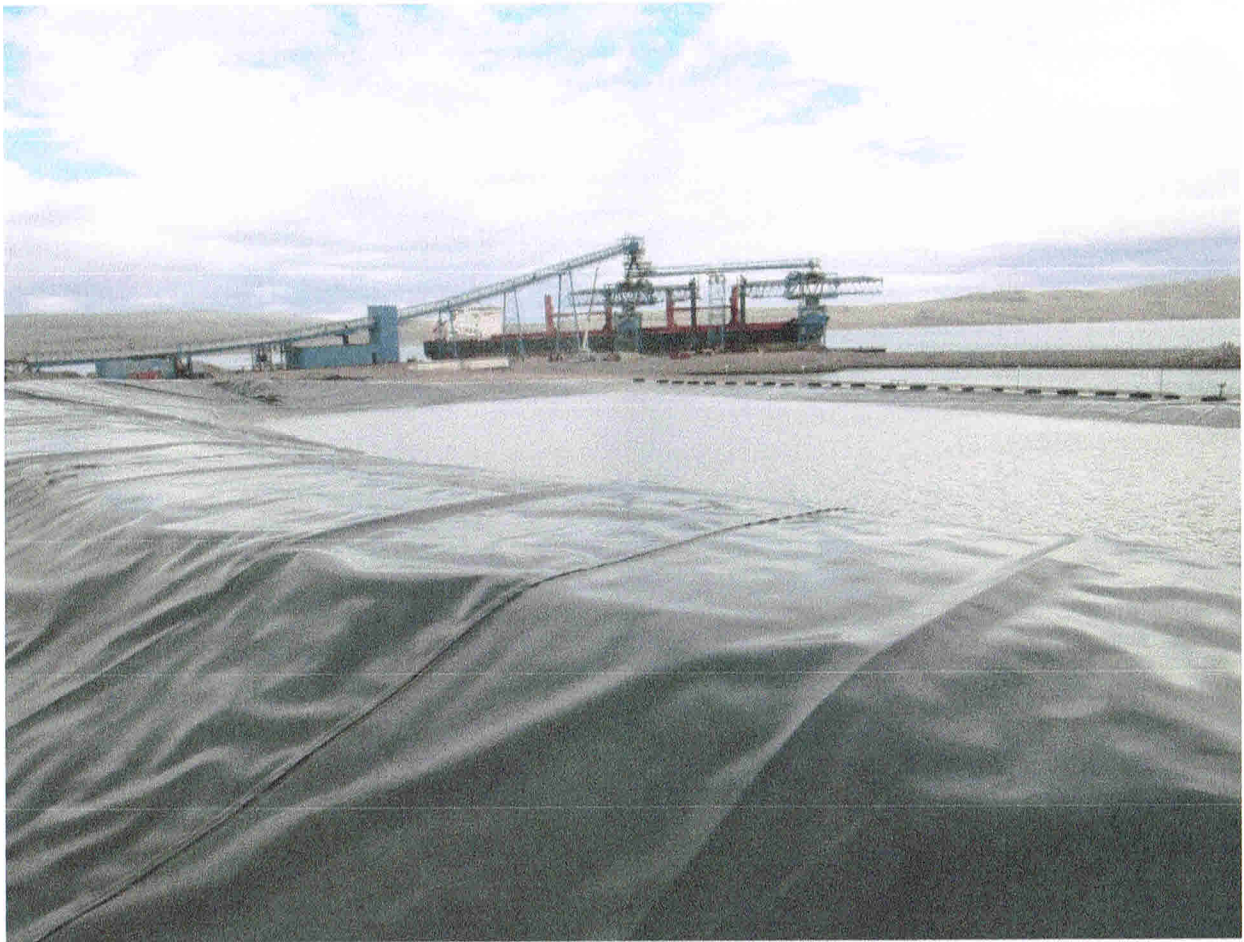
Sediment Pond East

There has been no cover placed over the liner to this point and rip rap has not yet been placed in the outlet weir.

The liner at the inlet has tears and punctures and water can leak out under the liner at this time.

We still have concerns over the stability of the liner and recommend possibly tire ballast over the liner which appears possibly subject to wind damage. This shall provide a function for used tires.

We recommend review of the use of a ballast (possibly tires) on the exposed liner at the dyke to prevent wind uplift.

We further recommend the re-installation of the liner at the inlet.

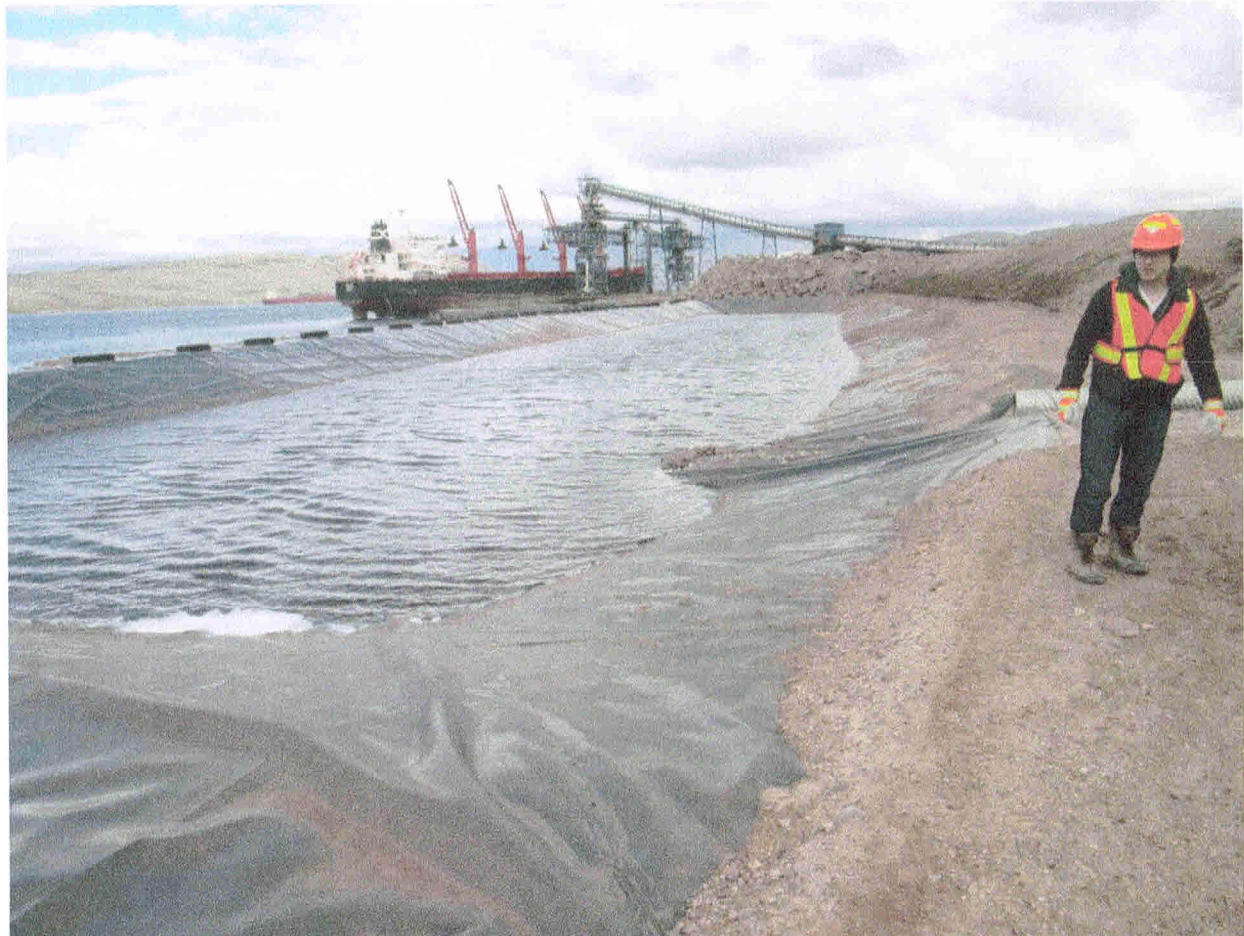
Sediment Pond West

The construction of this sedimentation pond for drainage from the west side of the site is nearing completion except for the west end on the south side where the liner must be "tucked" in as set out in our report last year.

As well, the inlet culvert construction is allowing water to be conducted under the liner and must be repaired.

We have some concern over the stability of the liner on this pond as we have with the east pond and recommend the further use of tire ballast on the liner.

Complete construction at the inlet structure to ensure contaminated water flows into the containment and not under it.

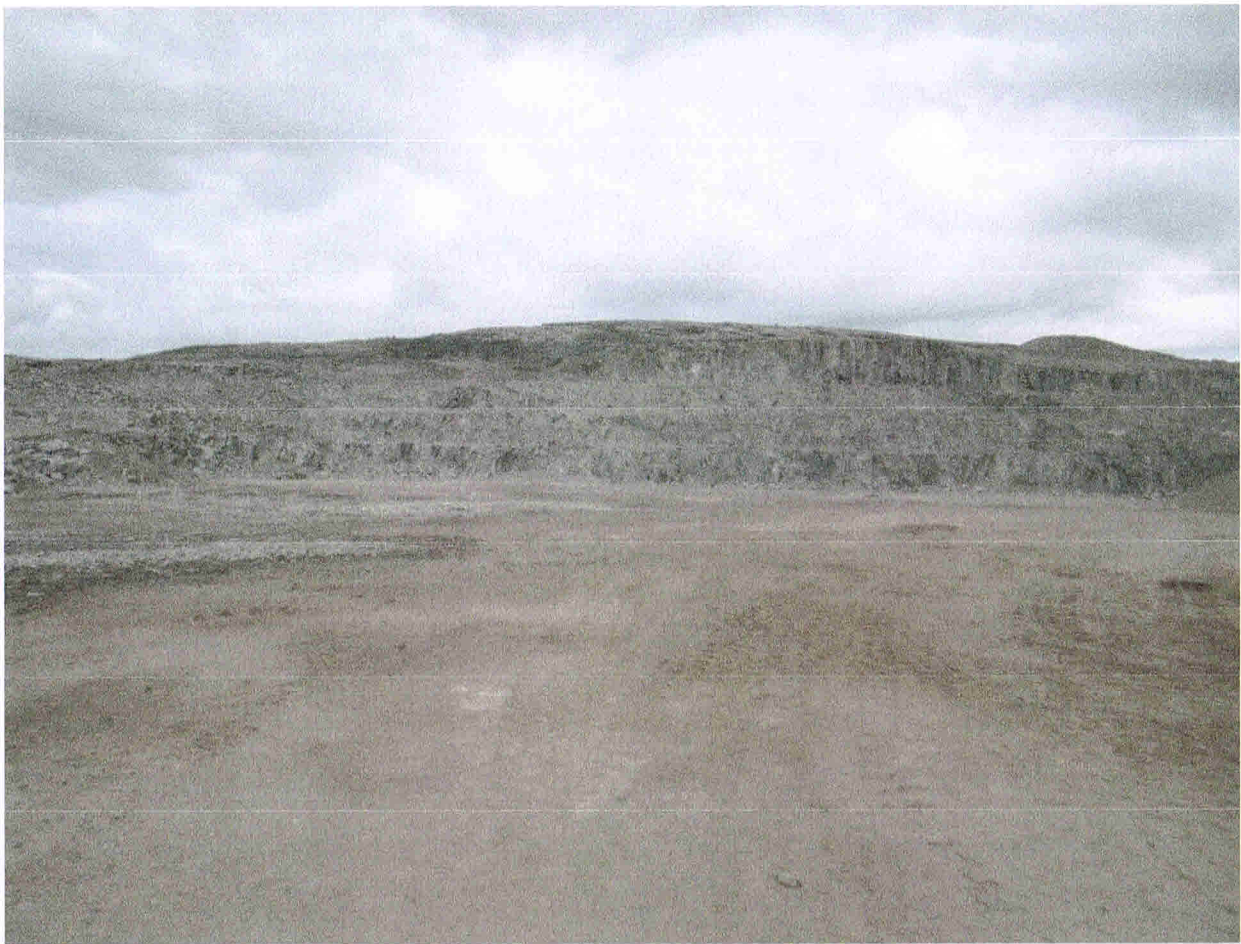
Quarry

The quarry was inactive at the time of our review and most blasted rock had been removed from the quarry site.

Rock faces appear stable.

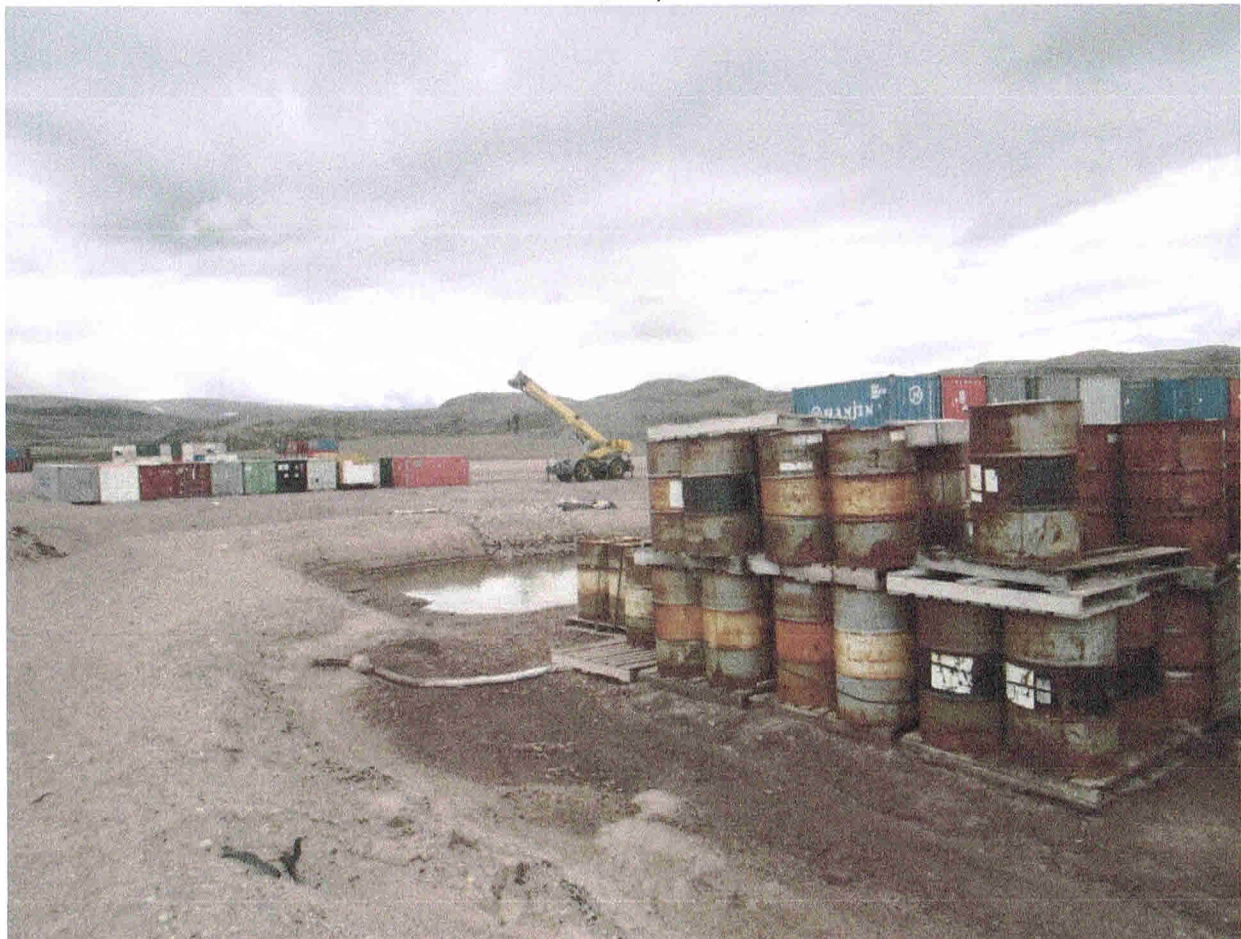
Loading Area Contaminated Storage MP-HWB-1

This area has been constructed near the loading dock to facilitate assembly of hazardous materials for shipment out. It appears that all material from the temporary hazardous storage containment have now been assembled here.

Construction appears stable.

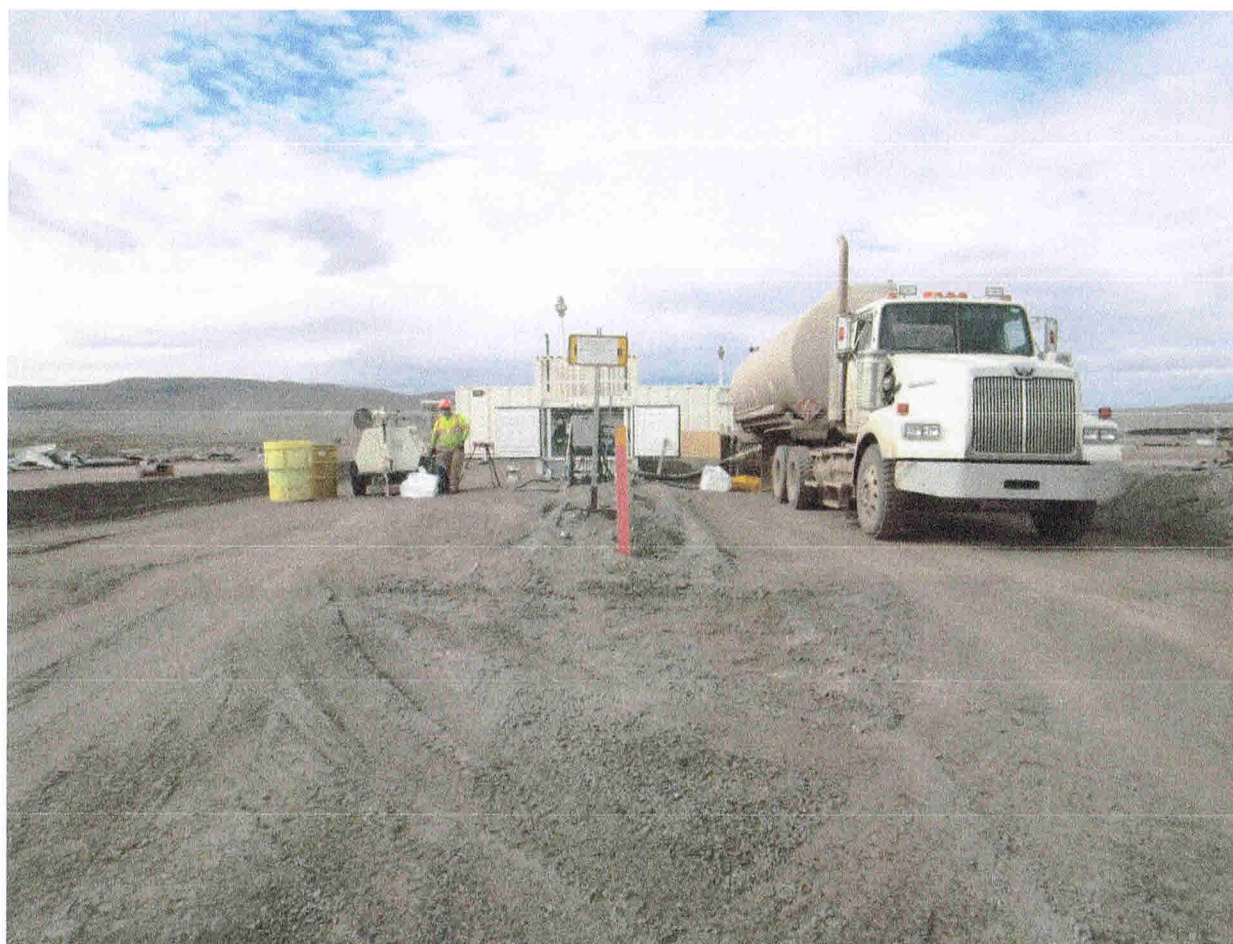
Fuelling Facility Containment

A new fueling facility for the fueling of B trains is under construction utilizing design drawings prepared by our office.

Work conforms to the design drawing.
