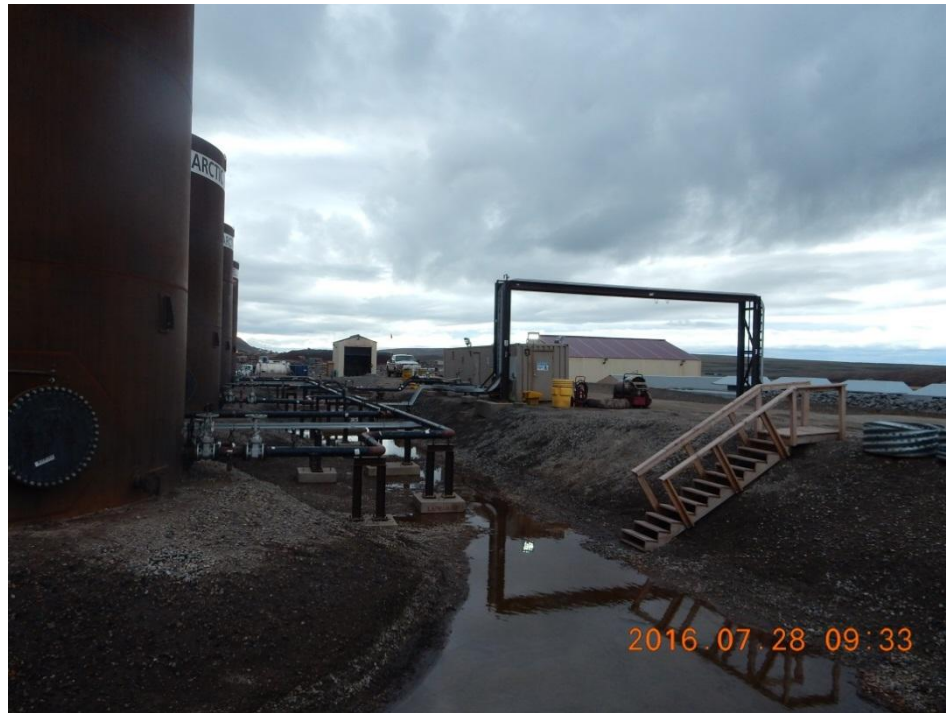
Photo 1: Bulk Fuel Storage Tank Farm Mine Site - Secondary Containment Dike

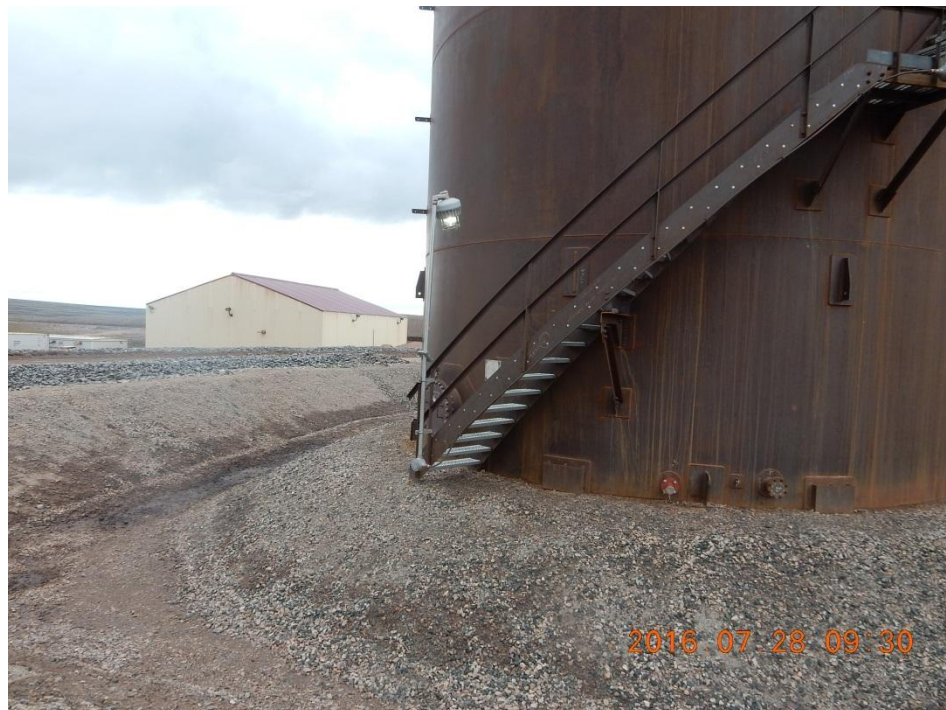
Photo 2: Typical Conditions of the Secondary Containment Base and the Dike

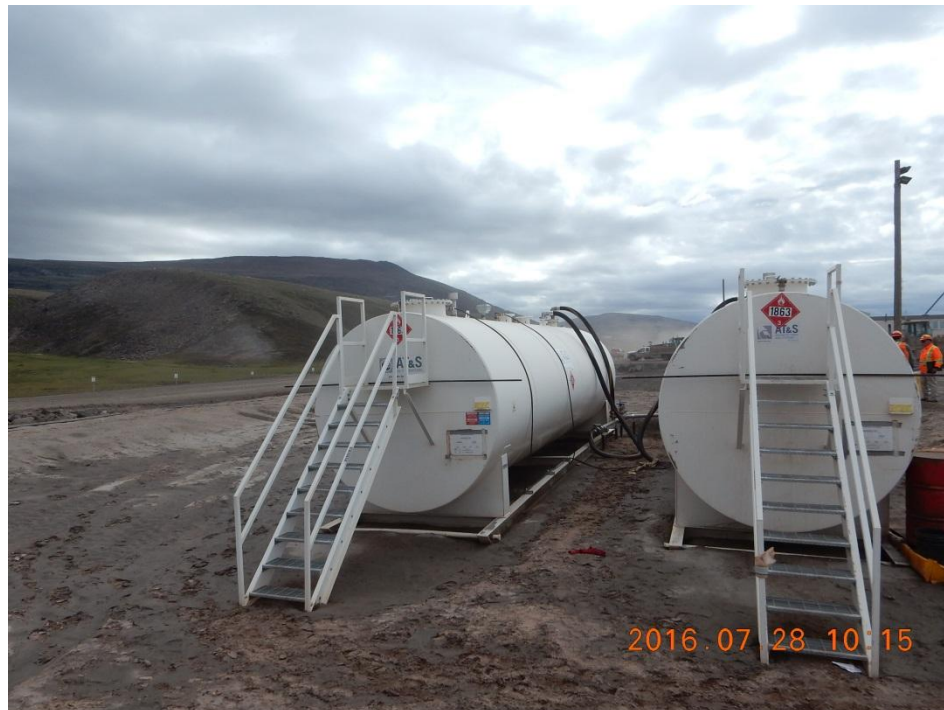
Photo 3: Mine Site Jet Fuel Storage Tank Farm Secondary Containment

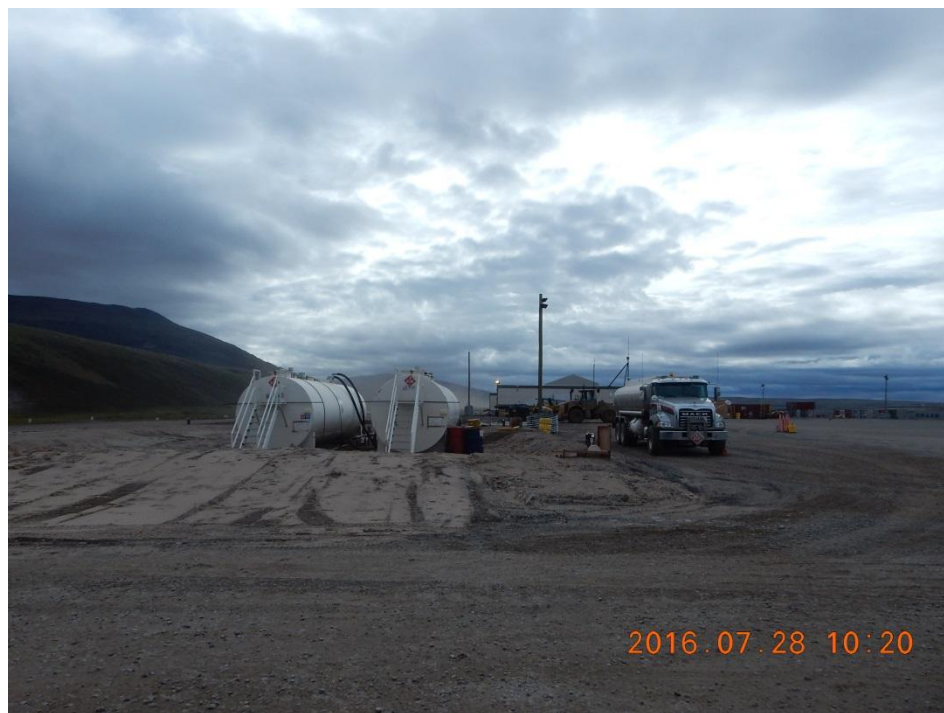
Photo 4: Typical Conditions in the Immediate Vicinity of Secondary Containment at Jet Fuel Tanks

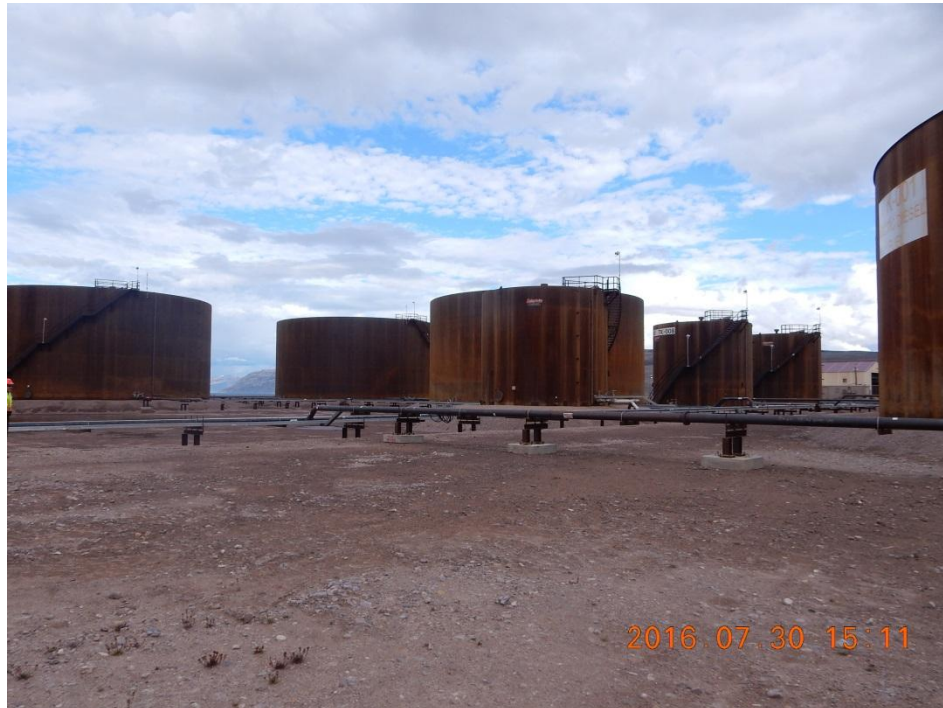
Photo 5: Bulk Fuel Storage Tank Farm at Port Site - Secondary Containment

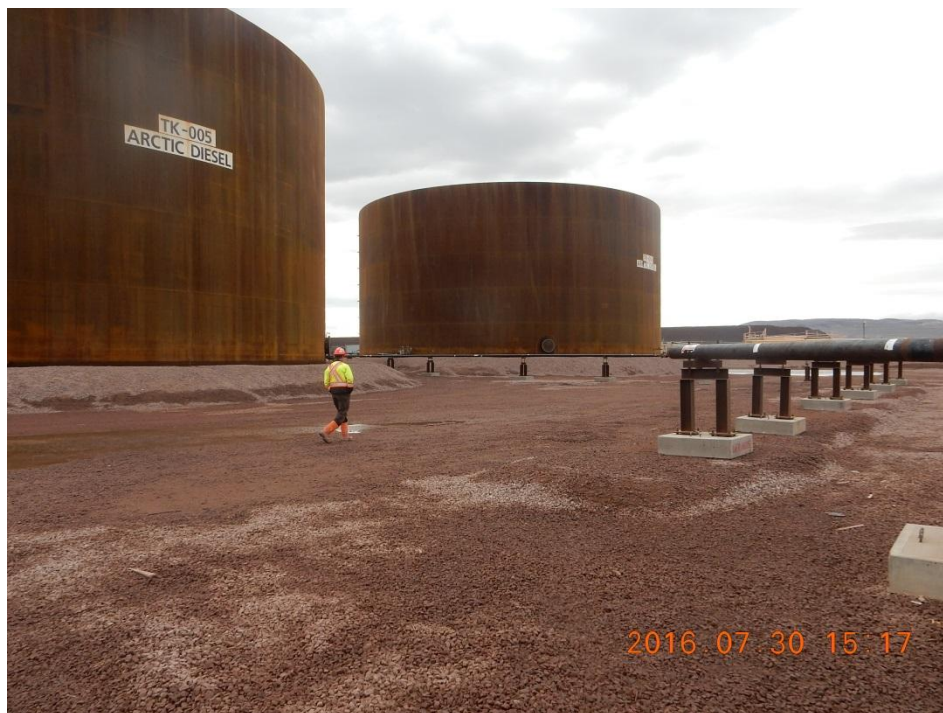
Photo 6: Typical Conditions at the Secondary Containment Base

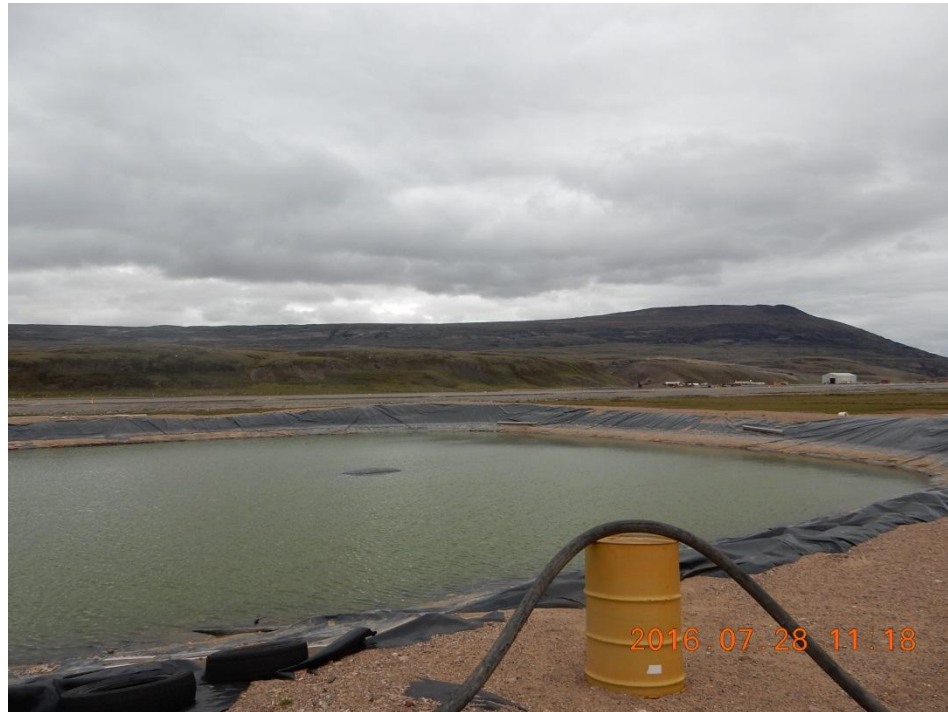
Photo 8: PWSP Pond 3 – Basin and Its Dikes

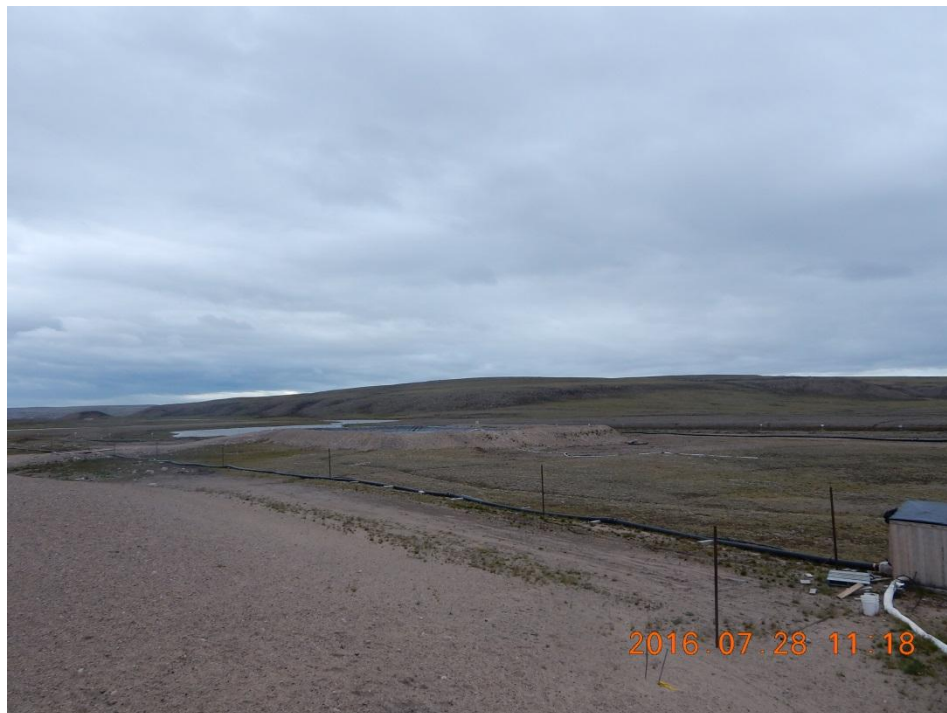
Photo 9: PWSP Pond 3 - Typical Conditions of the Dike, its Outside Slope and Vicinity

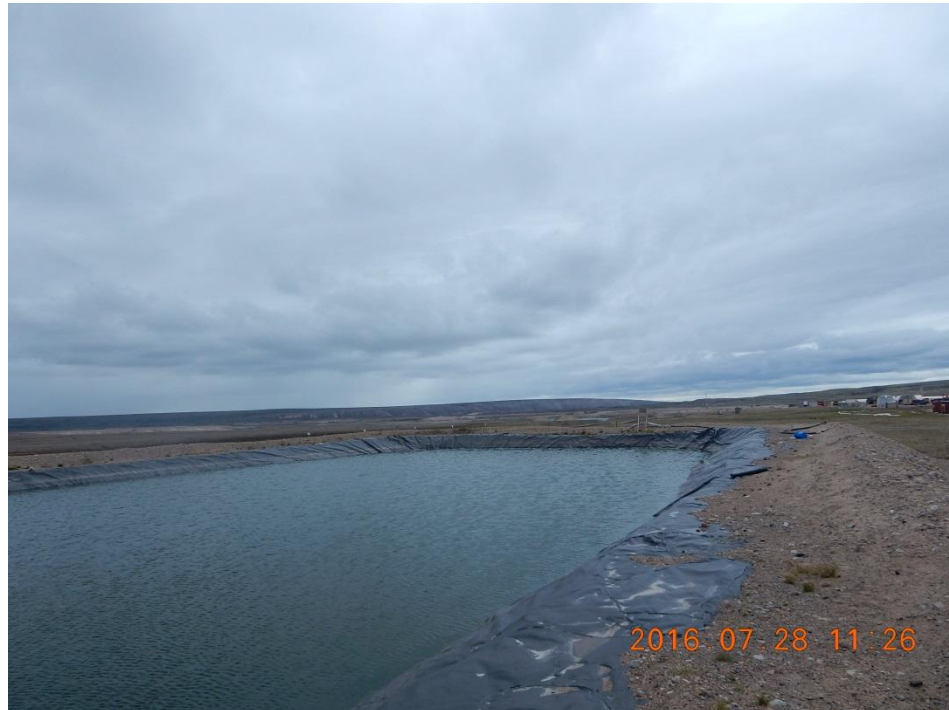
Photo 10: A View of PWSP Pond 2 (Facing North) and a View of its East Dike

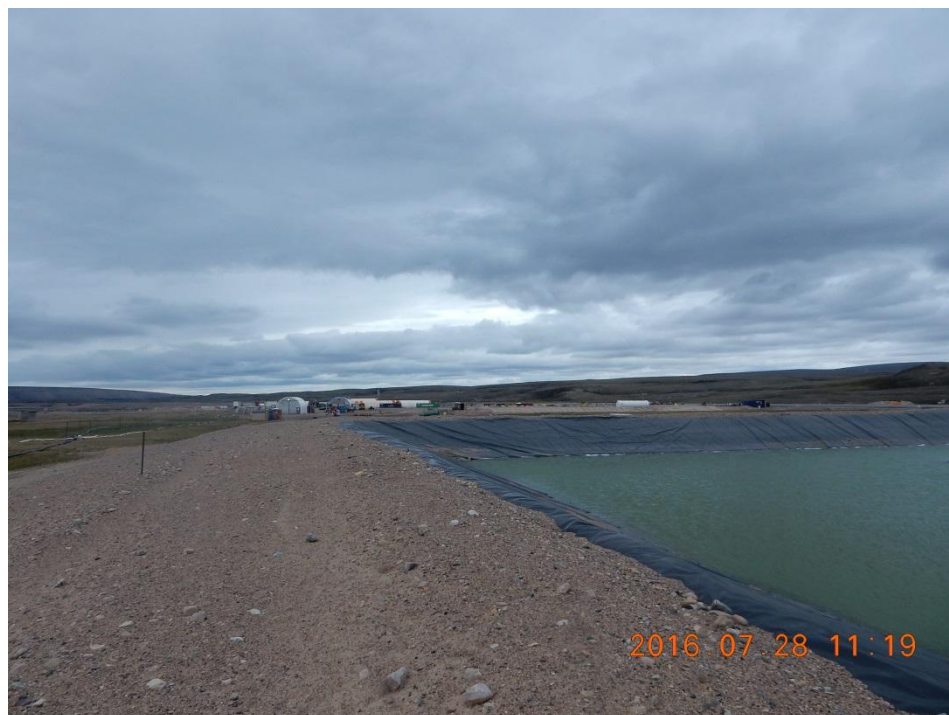
Photo 11: PWSP Pond 2 – a View of its West Dike and Vicinity

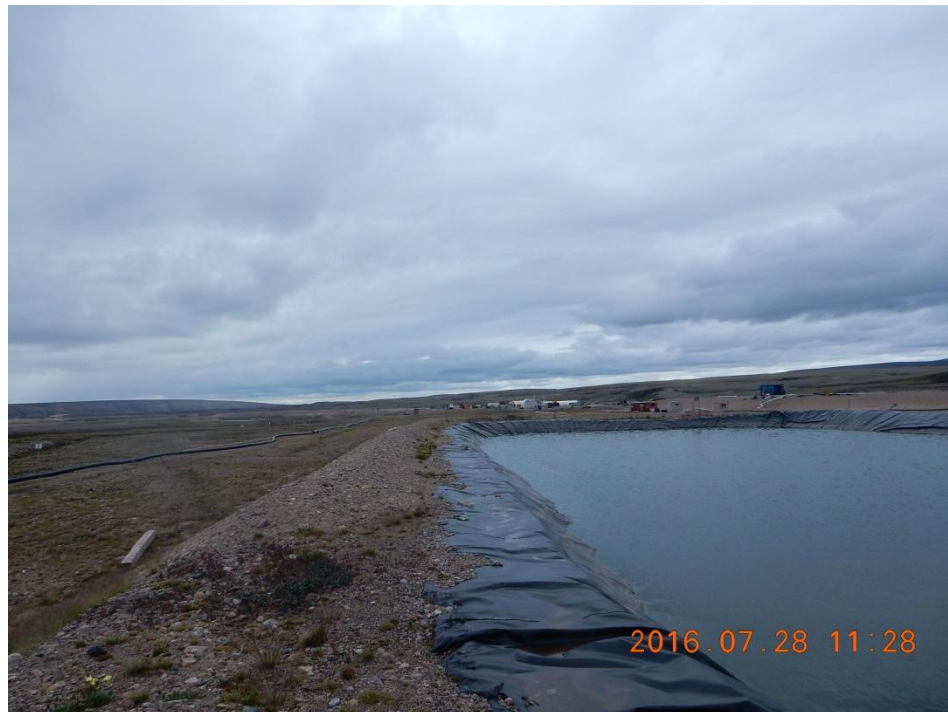
Photo 12: A View of PWSP Pond 1 (Facing North) and a View of its West Dike

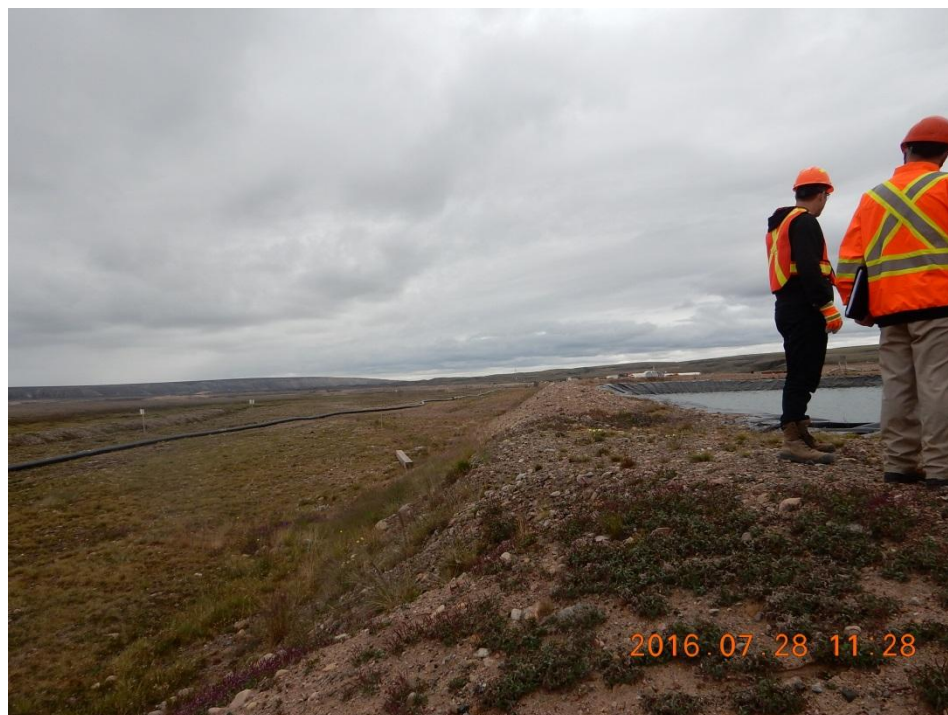
Photo 13: PWSP Pond 1 – Further close-up view of its West Dike and Vicinity

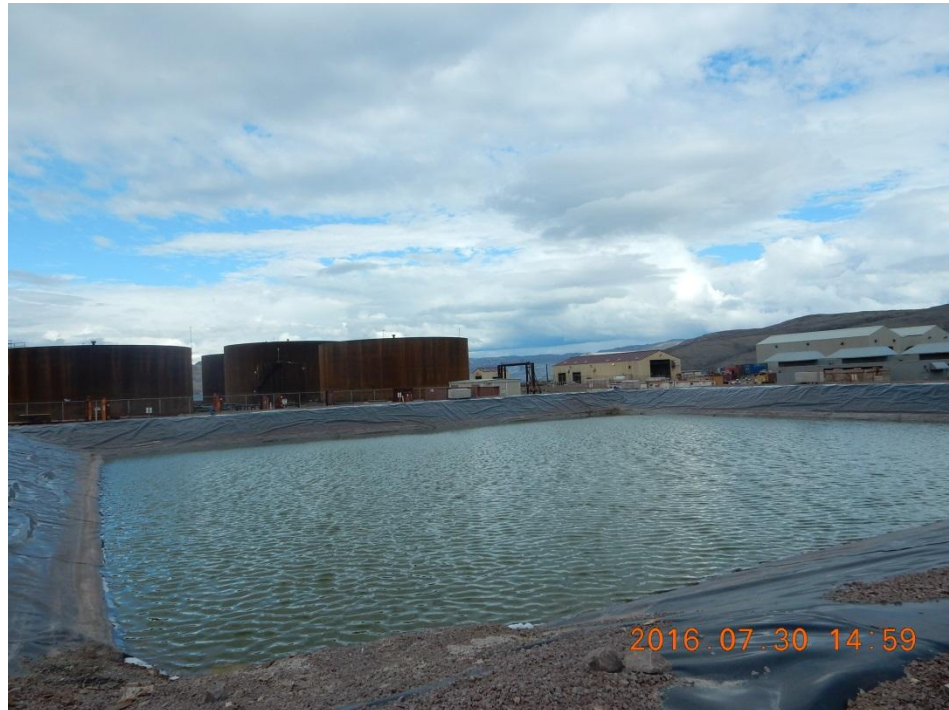
Photo 14: A View of PWSP Pond at Port Site

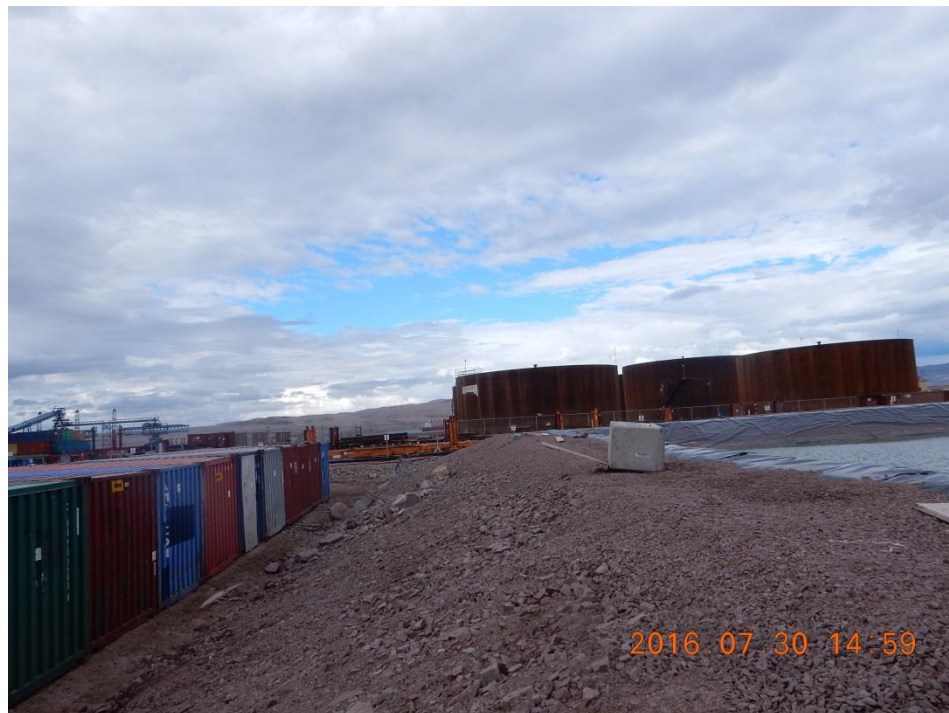
Photo 15: Port Site PWSP Pond – Further close-up view of its Dike and Vicinity

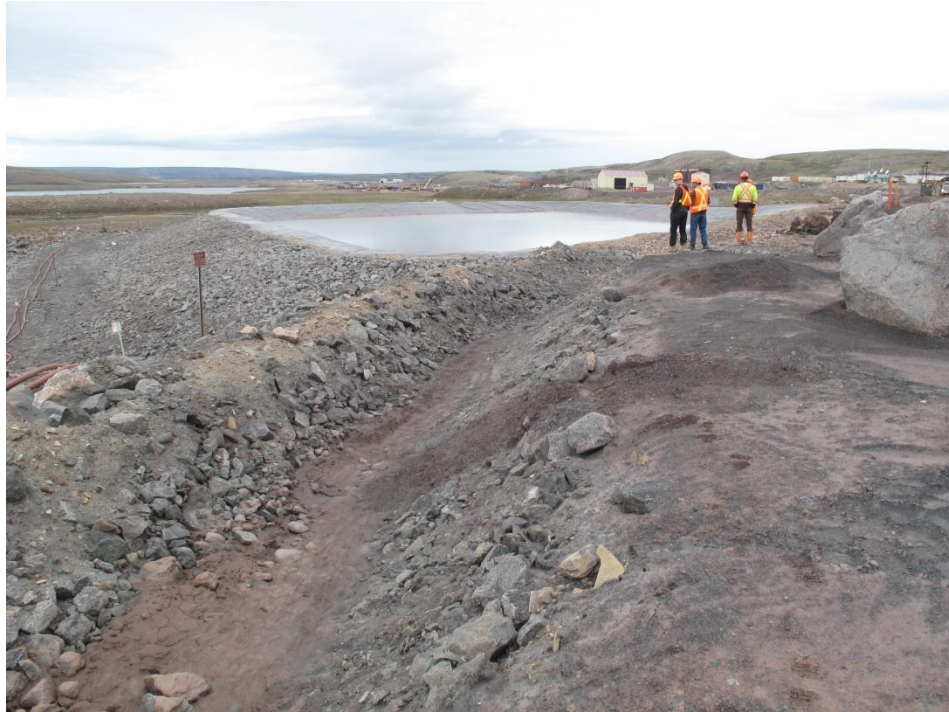
Photo 16: A View of Sedimentation Pond Crusher Pad Area at Mine Site

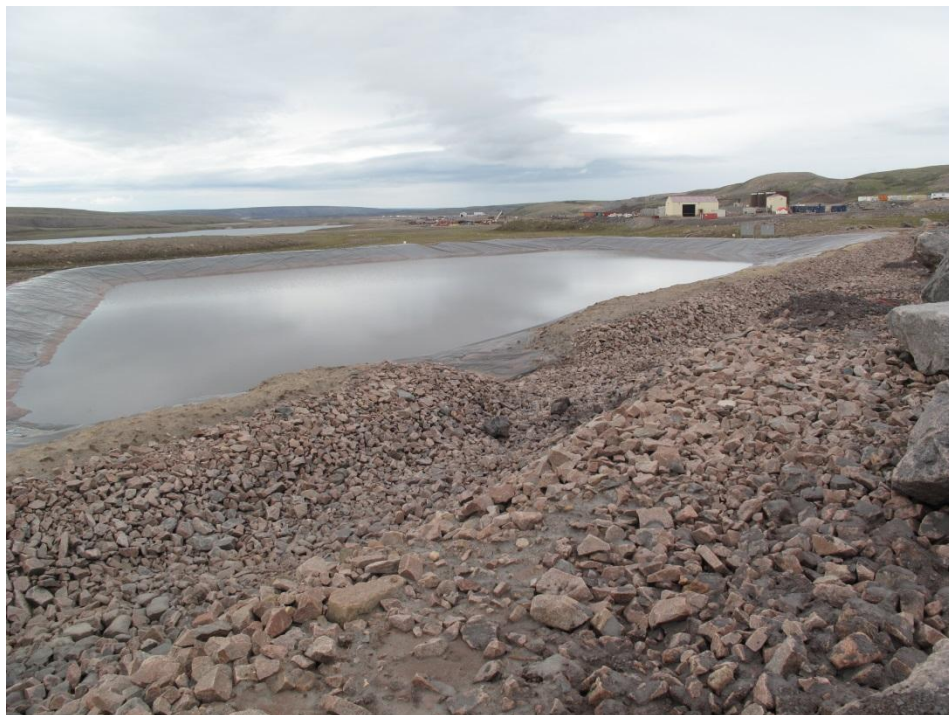
Photo 17: A Close-up View of Inlet - Sedimentation Pond Crusher Pad Area at Mine Site

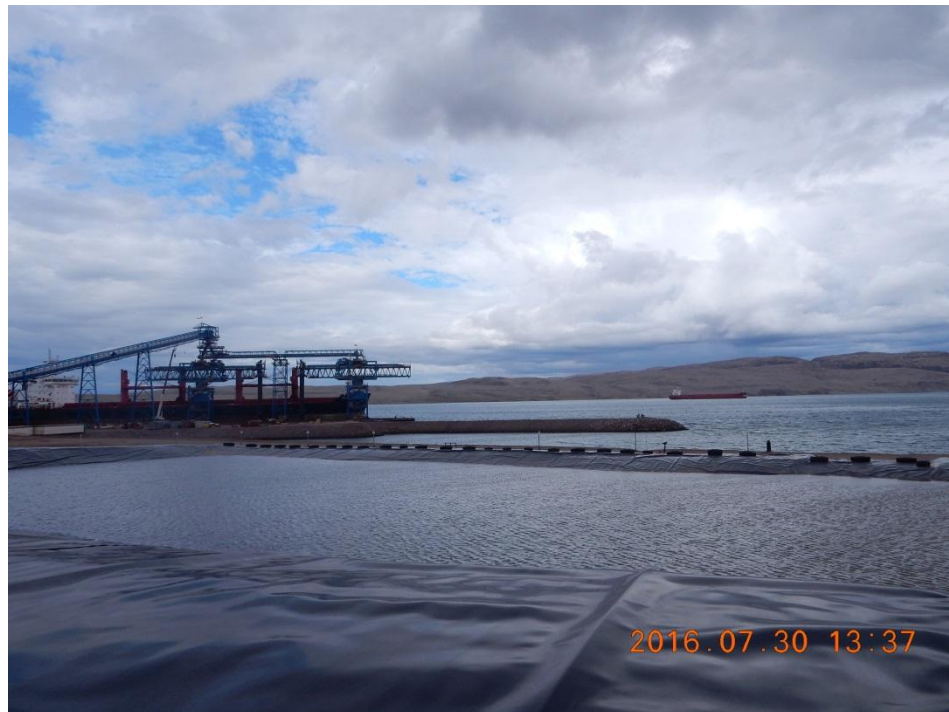
Photo 18: A View of Sedimentation Pond (East) Port Area

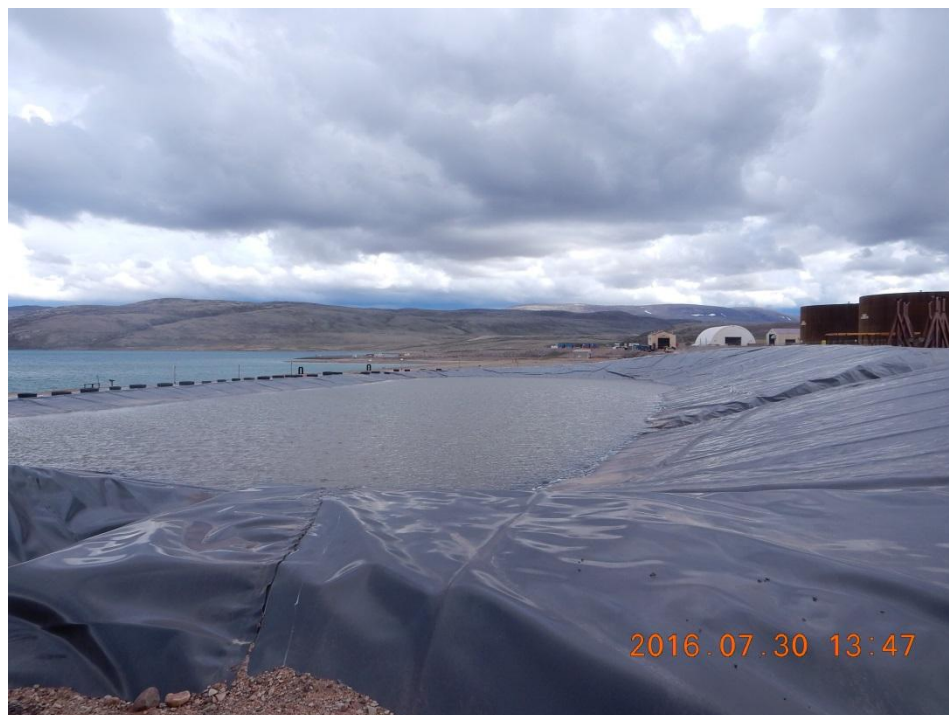
Photo 19: Multiple Inlets and an Emergency Spillway - Sedimentation Pond (East) Port Area

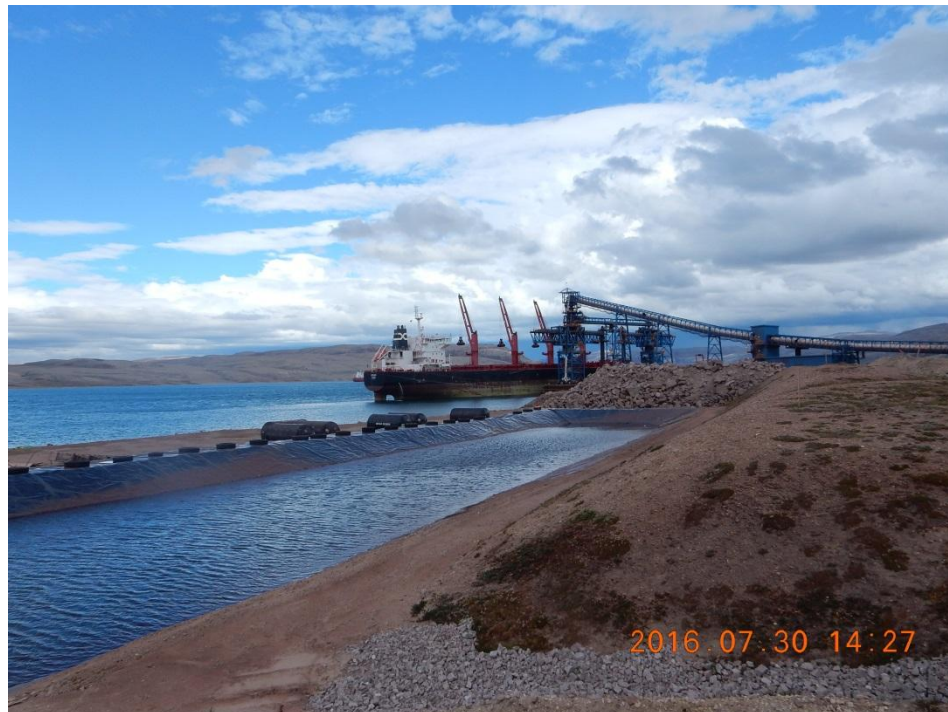
Photo 20: A View of Sedimentation Pond (West) Port Area

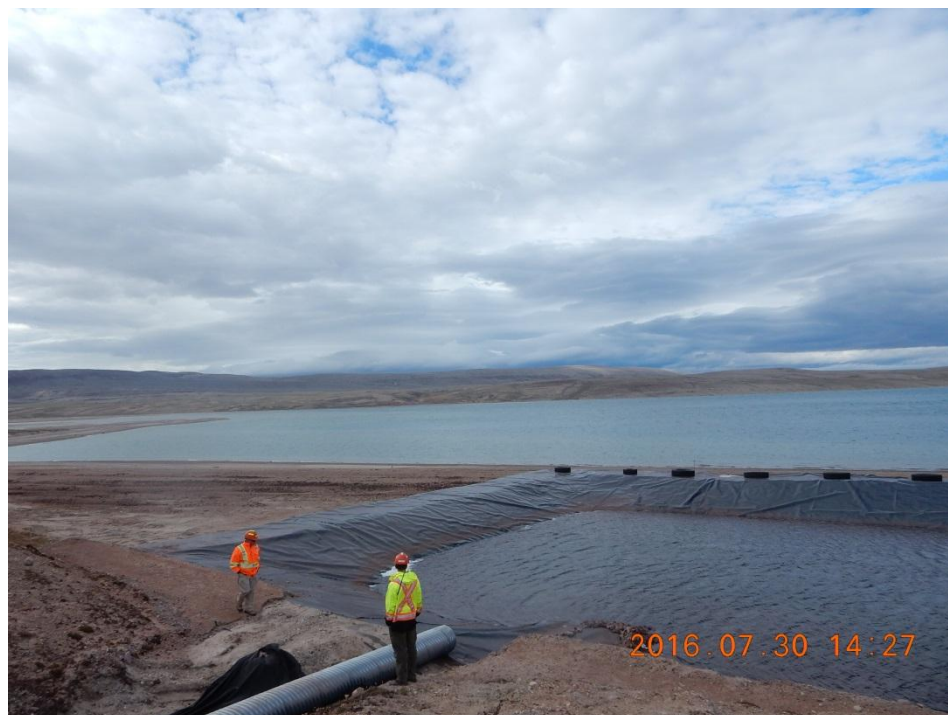
Photo 21: A close-up of Inlet to Sedimentation Pond (West) Port Area

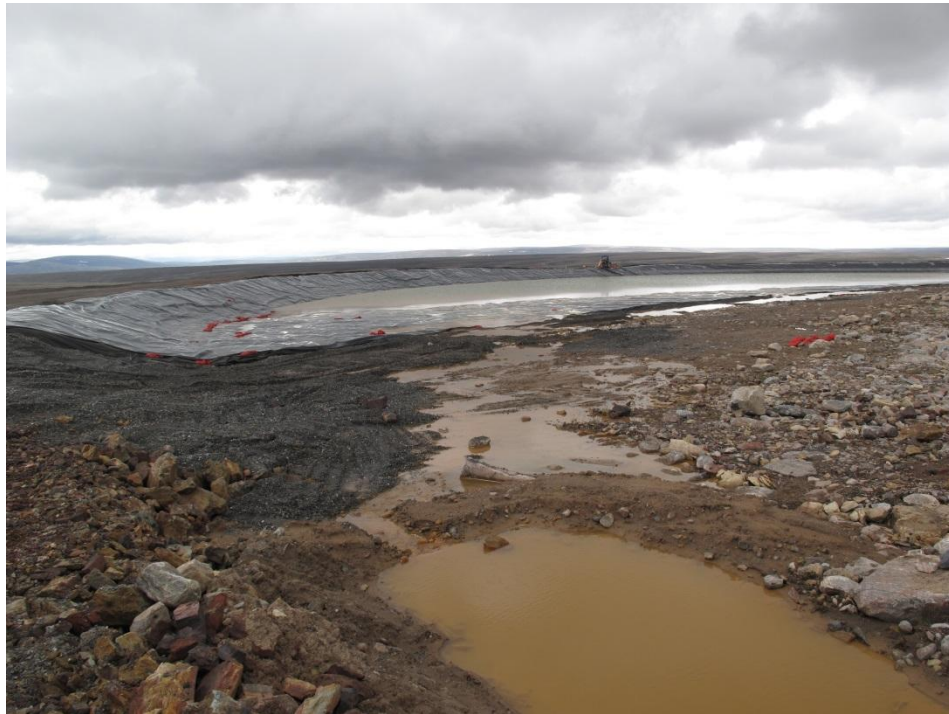
Photo 22: Mine Waste Rock Settling Pond

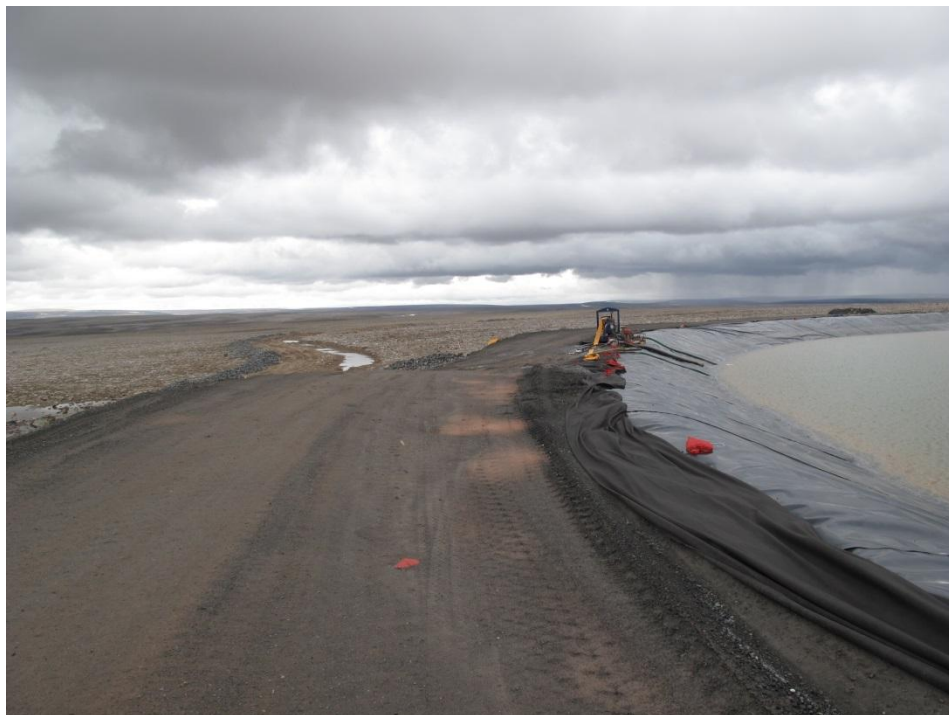
Photo 23: Mine Waste Rock Settling Pond – Dike and Pumping System for Discharge

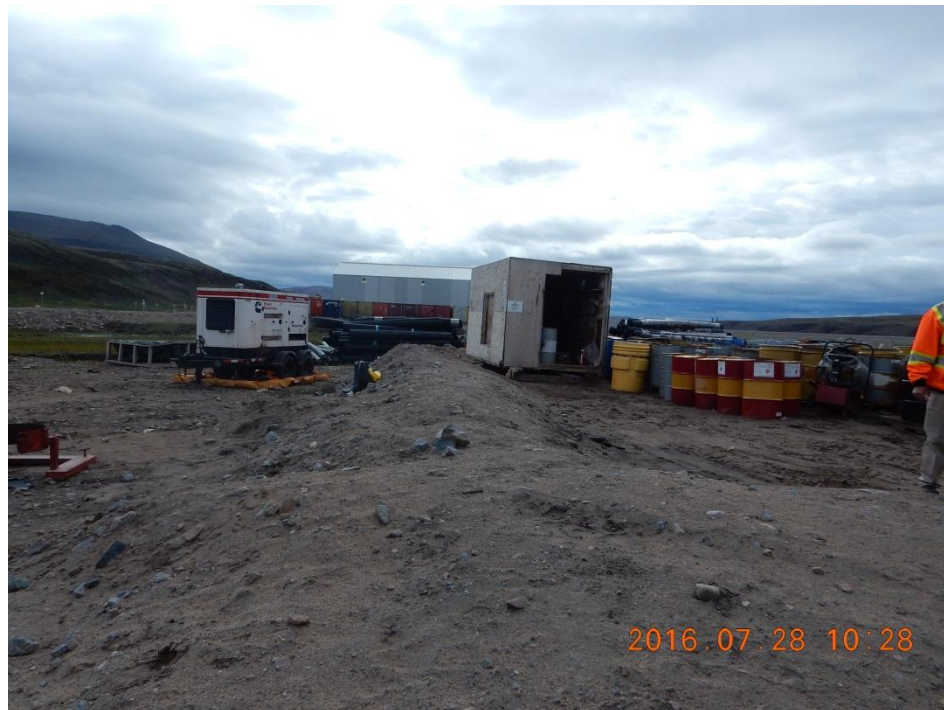
Photo 24: Mine Site Hazardous Waste Storage – its Contents and Dike

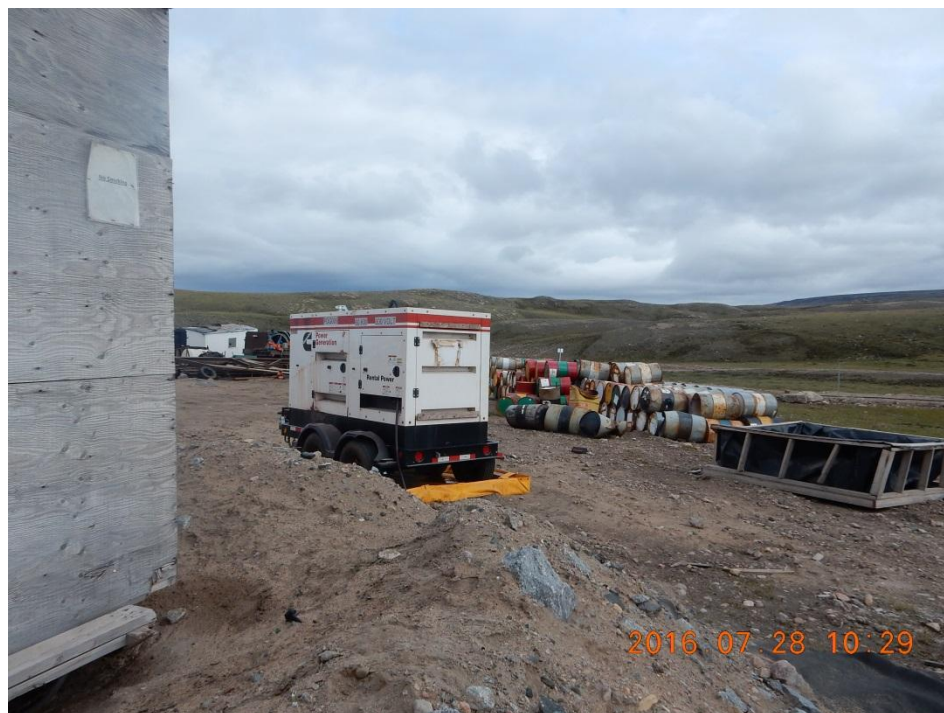
Photo 25: Mine Site Hazardous Waste Storage – its Dike and Vicinity

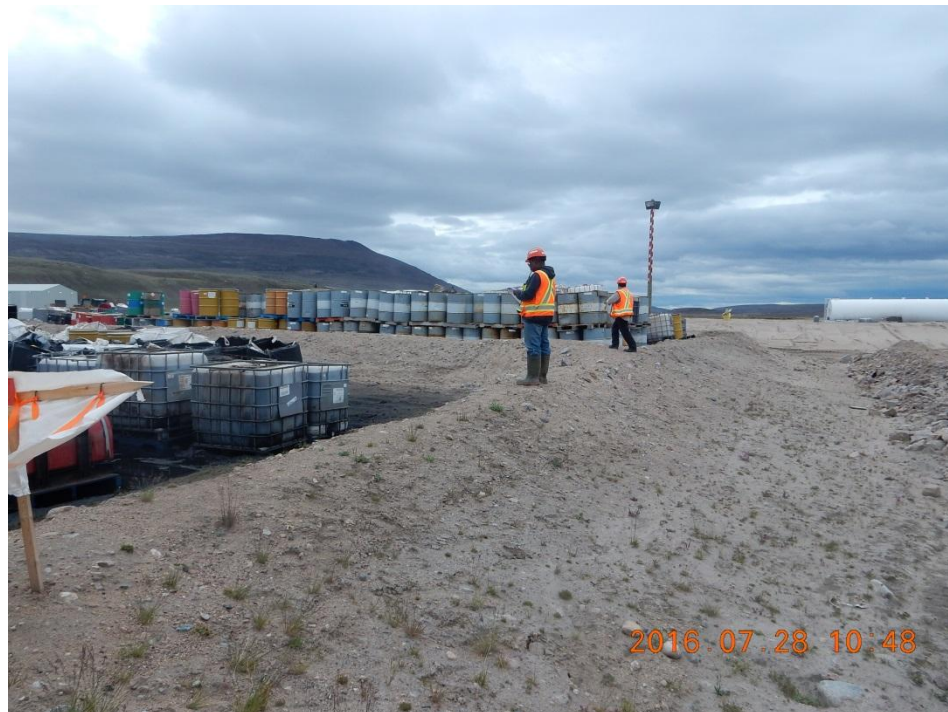
Photo 26: Mine Site Environmental Storage – General View of its Dike and Vicinity

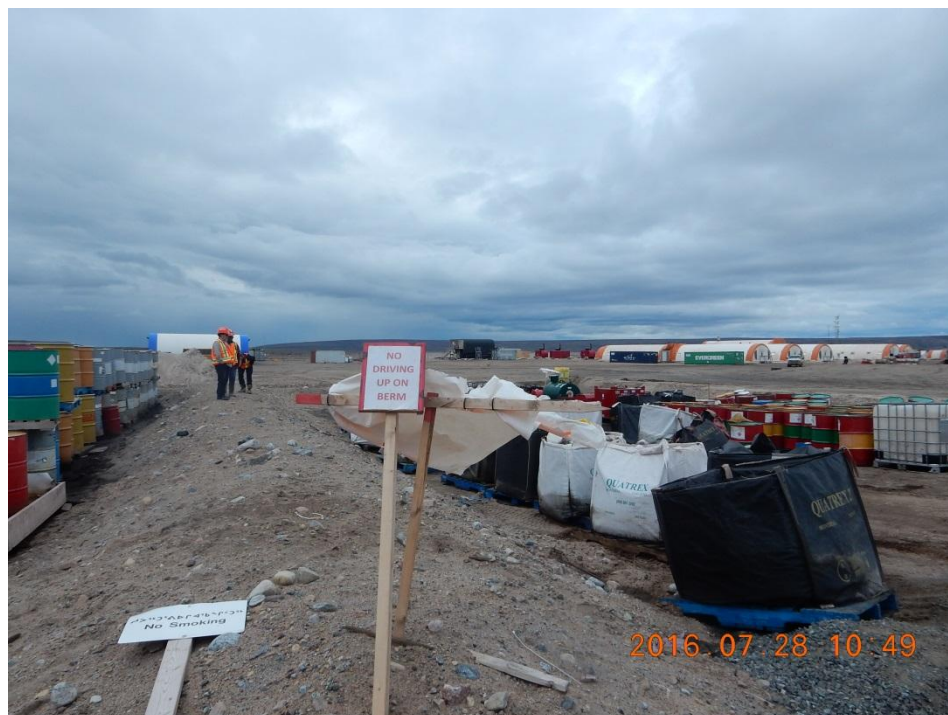
Photo 27: Mine Site Environmental Storage – its Dike Details

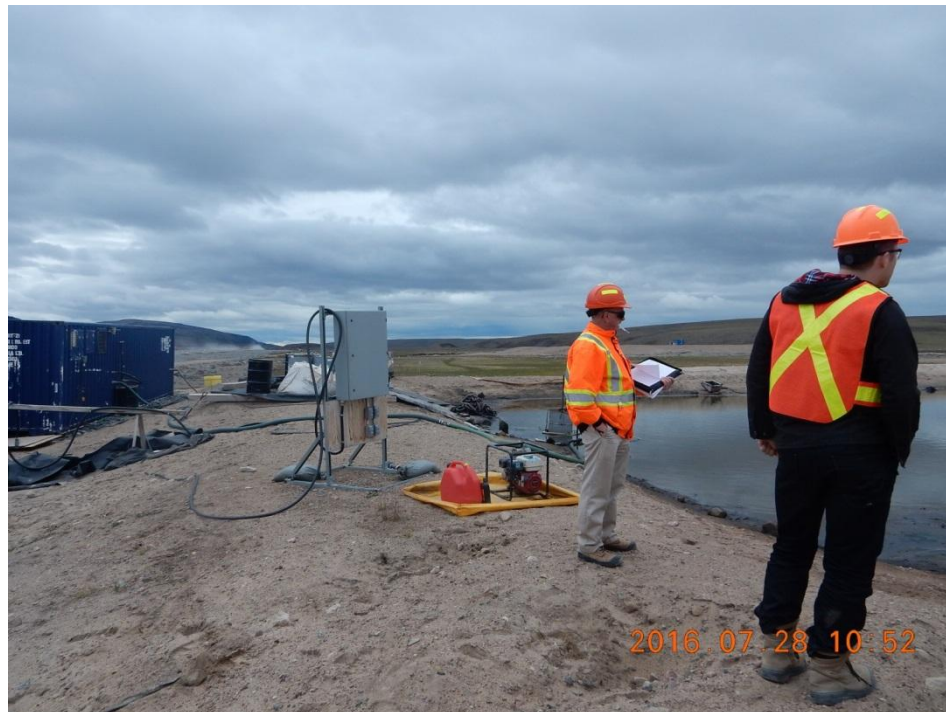
Photo 28: Environmental Storage Containment at Mine Site – Oily Water and Treatment Plant

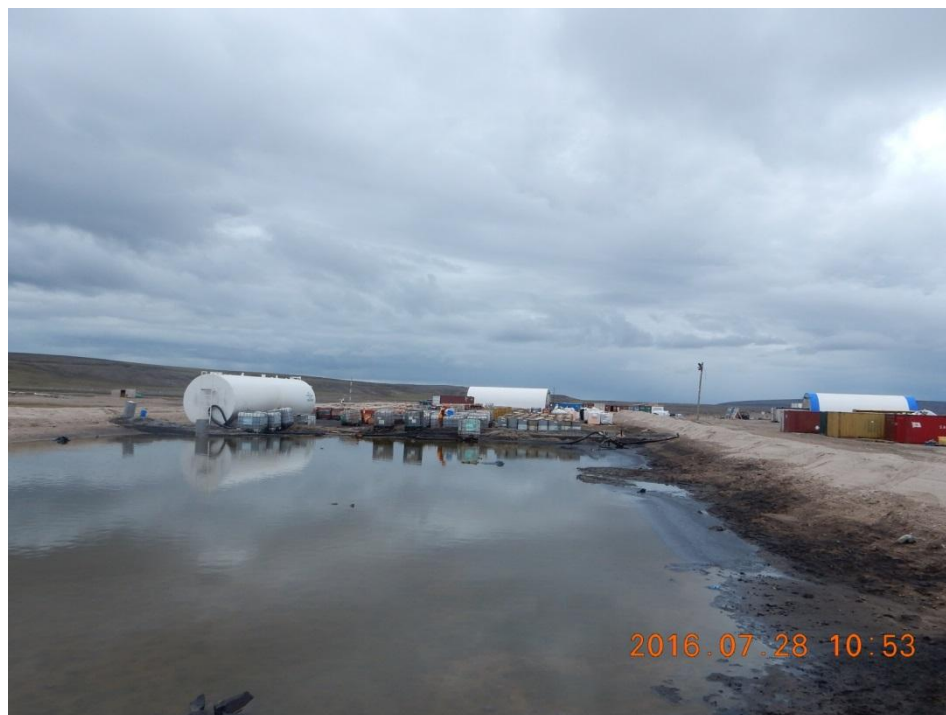
Photo 29: Environmental Containment at Mine Site – its Dike and Contents

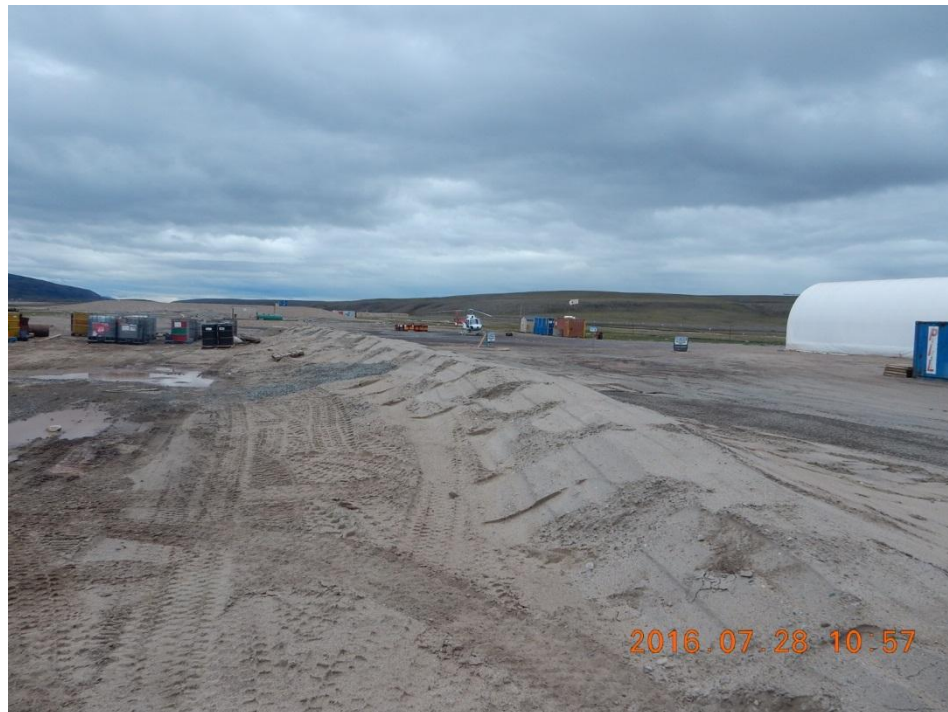
Photo 30: Mine Site – Environmental Storage Containment - its Dike and Vicinity

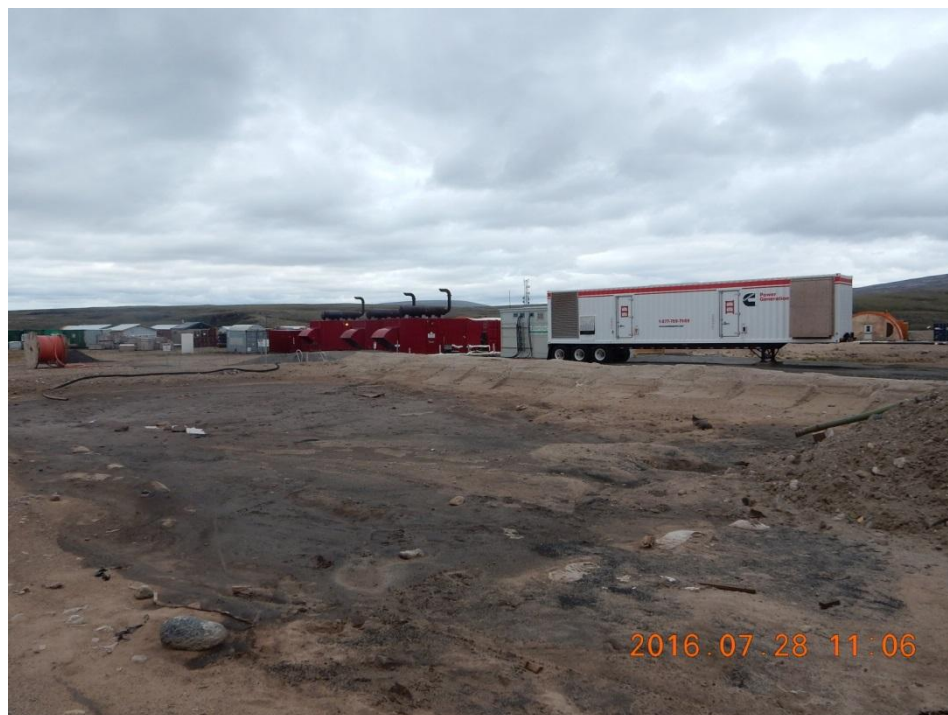
Photo 31: Mine Site – Environmental Storage Containment Dike (Generator Overflow)

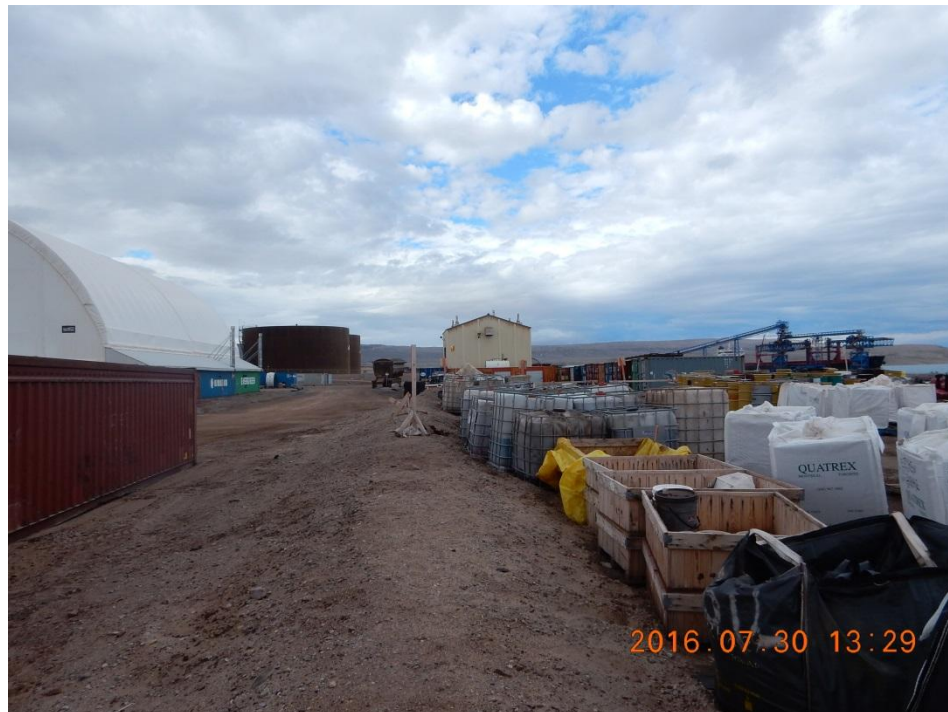
Photo 32: Port Area – Harzardous Waste Containment

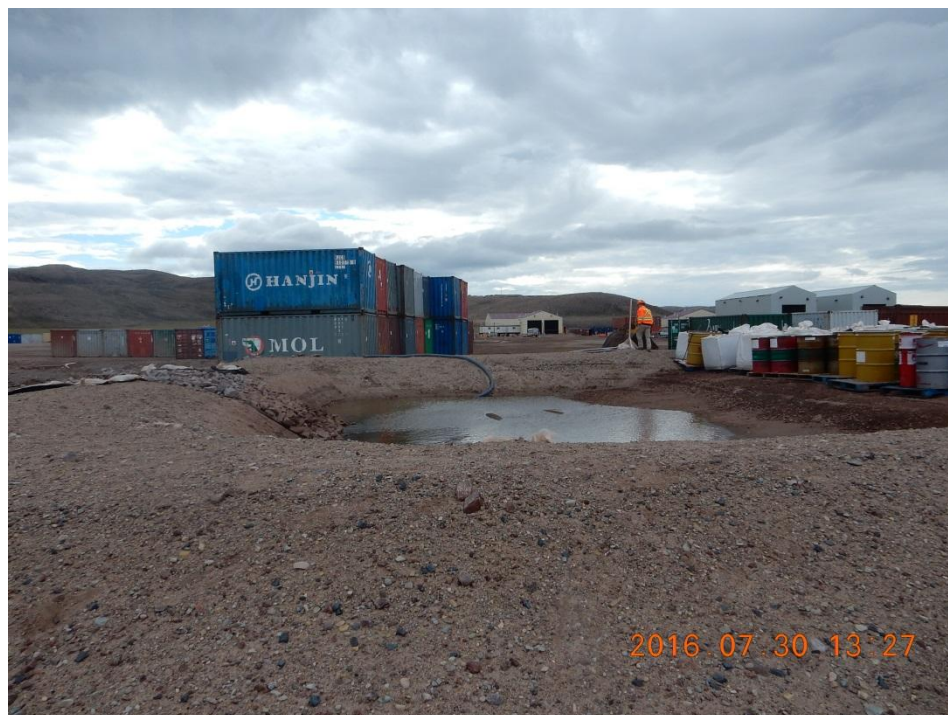
Photo 33: Port Area – Harzardous Waste Containment/ Associated Collection Pond

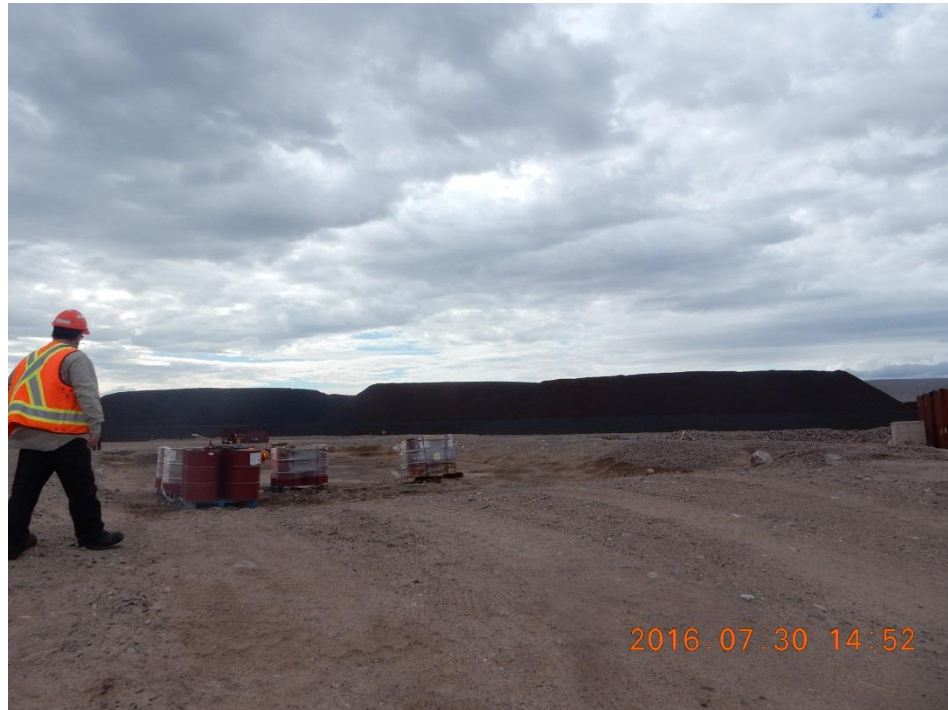
Photo 34: Port Area – Environmental Storage Containment – its Dike and Access Details
