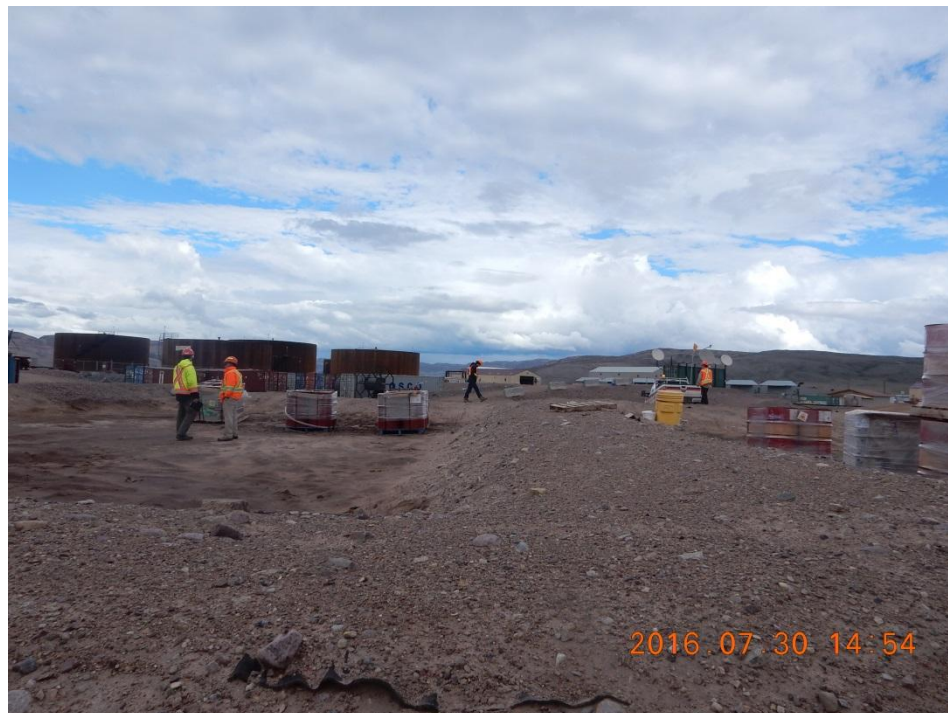
Photo 35: Port Area – Environmental Storage Containment

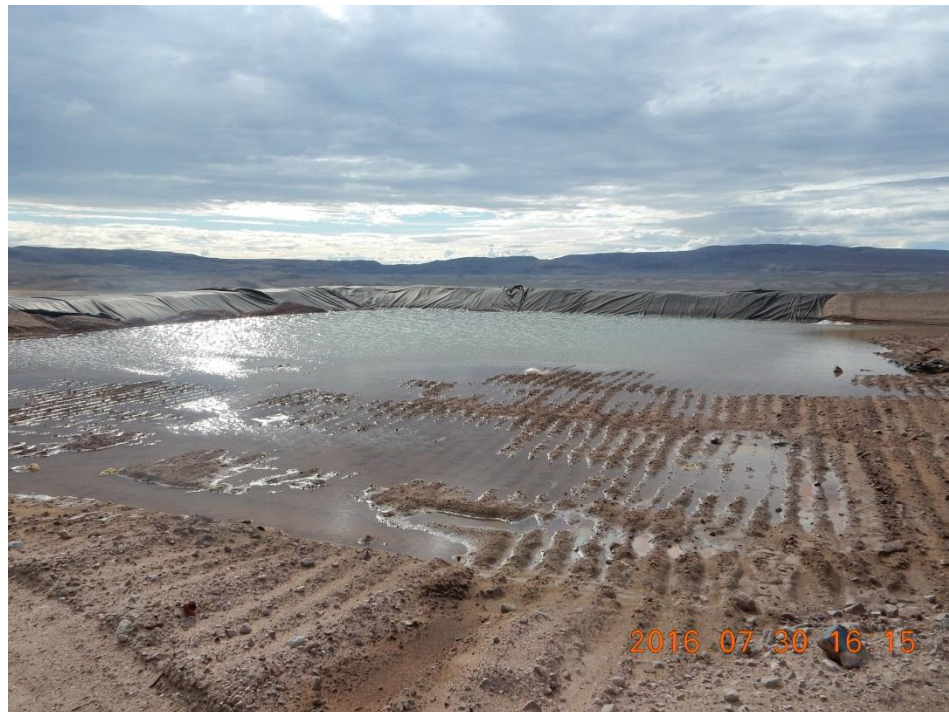
Photo 36: Port Area – Land Farm (Water Collection at the Lowest Level)

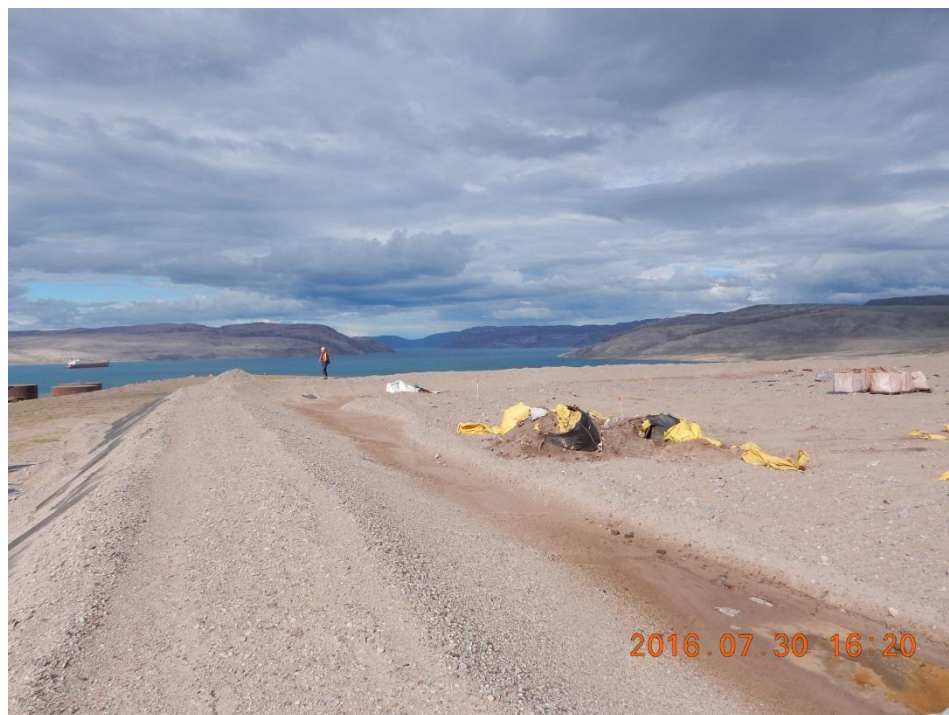
Photo 37: Port Area – Land Farm Dike Details and Contents

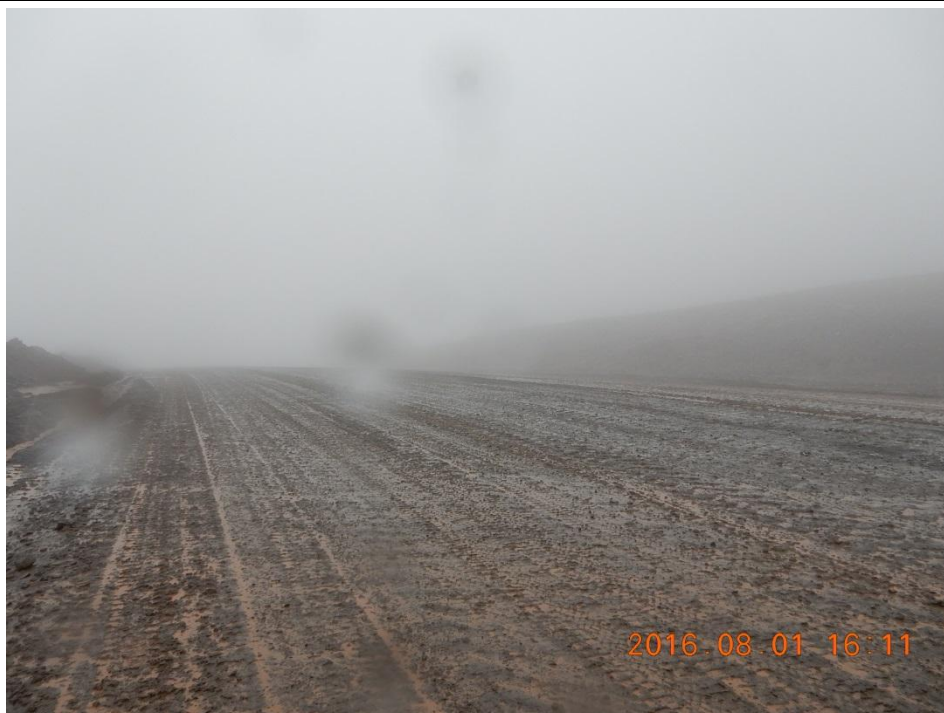
Photo 38: Mine Haul Road – During Rainfall Event

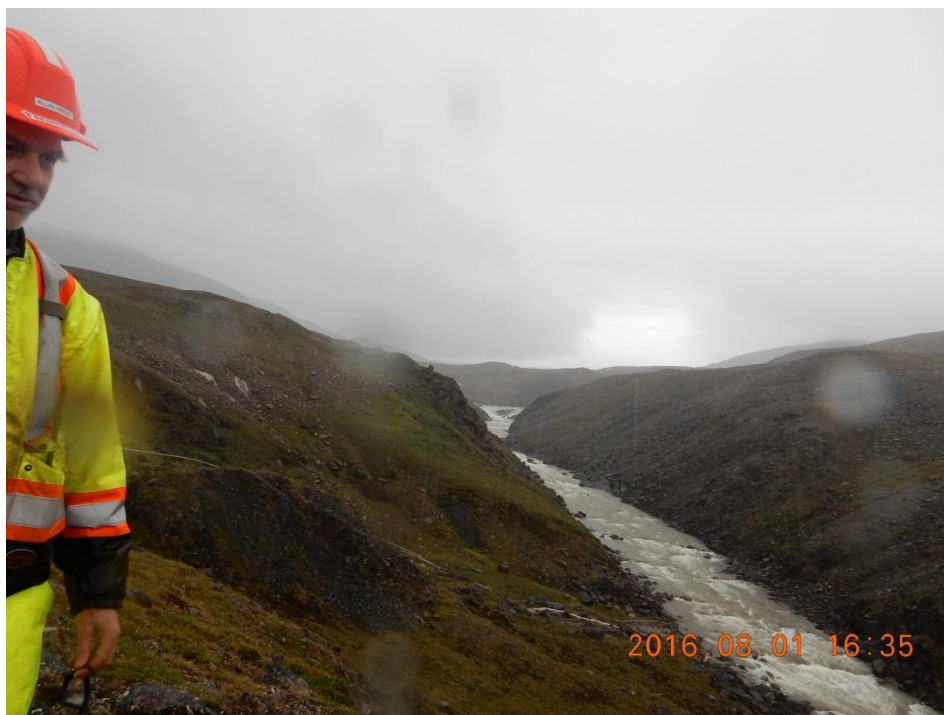
Photo 39: Mine Haul Road - Larger Drainage Area Reporting to a Tributary to Mary River

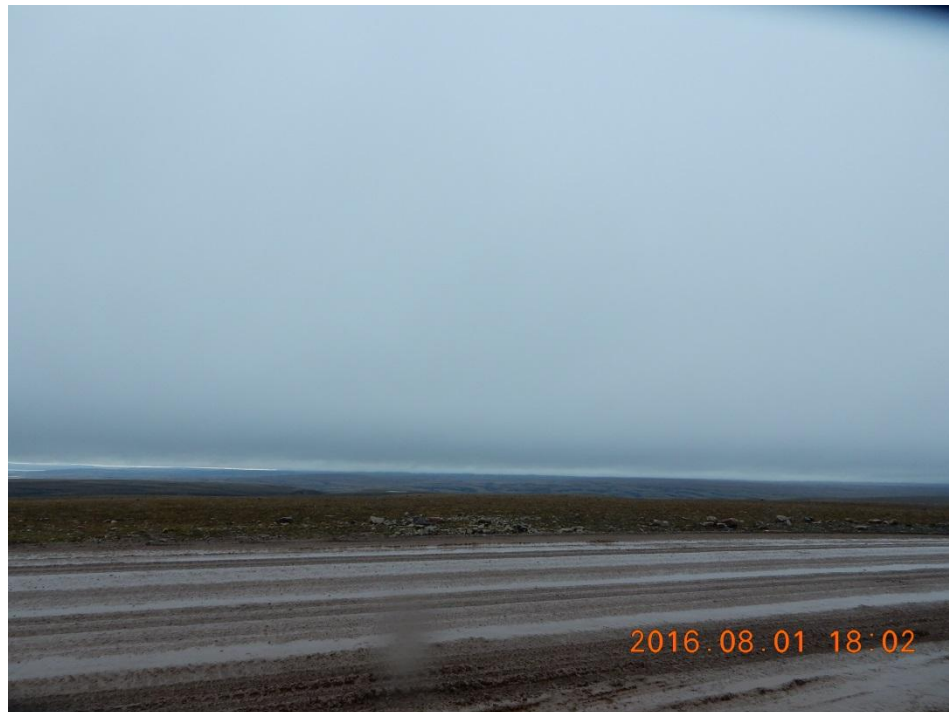
Photo 40: Tote Road – During Rainfall Event

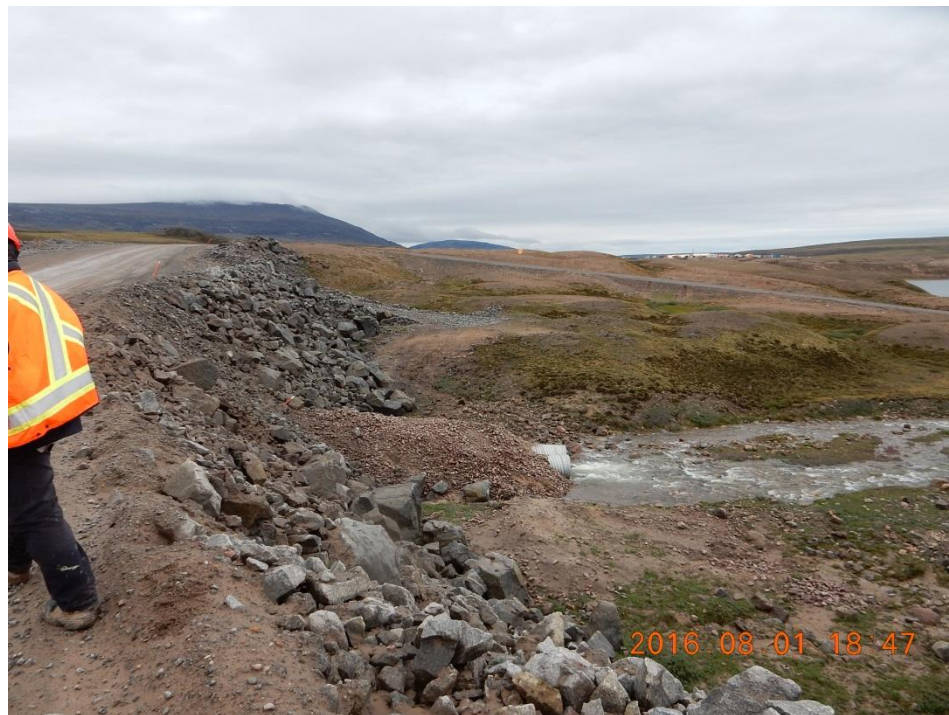
Photo 41: Tote Road Typical Drainage Crossing Culvert – During Rainfall Event

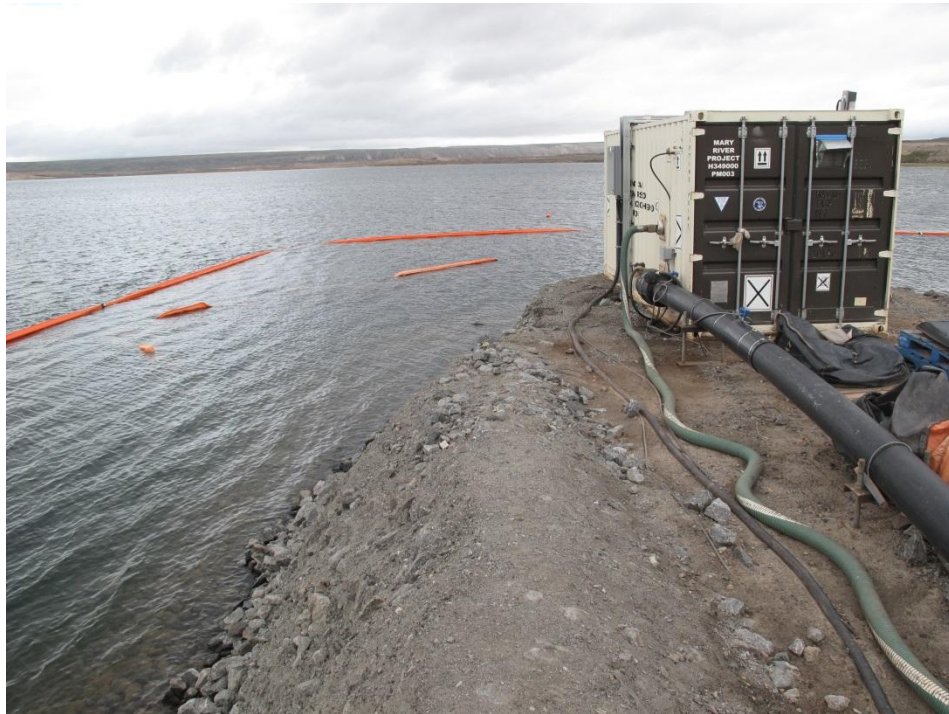
Photo 42: Raw Water Intake Jetty Head Requires Upgrade for Wave/Erosion Protection

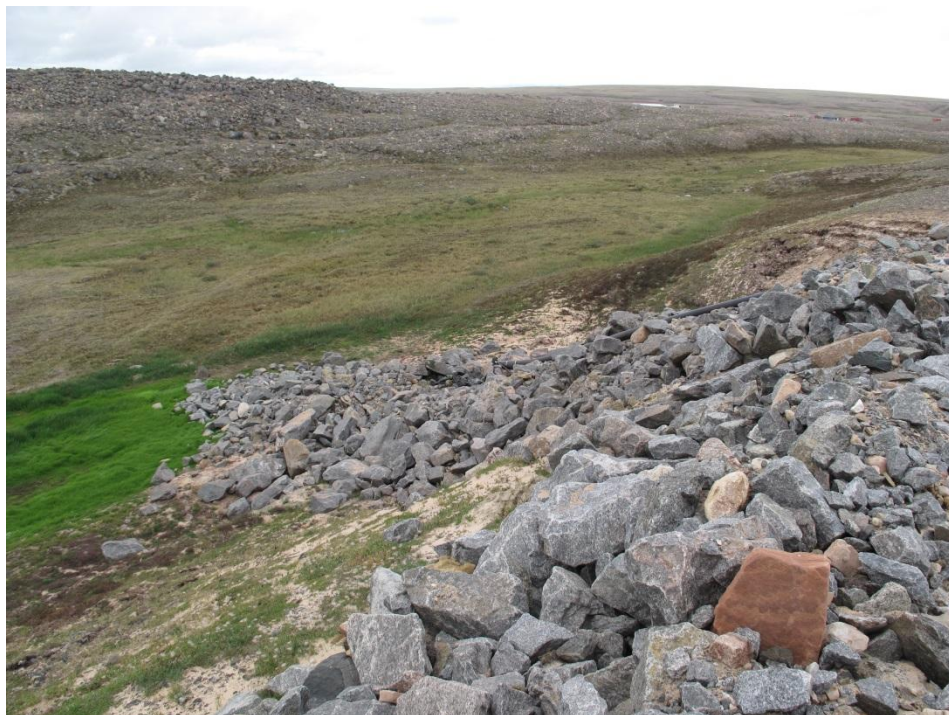
Photo 43: Sewage Outfall – Ground Sloughing on the Right Side

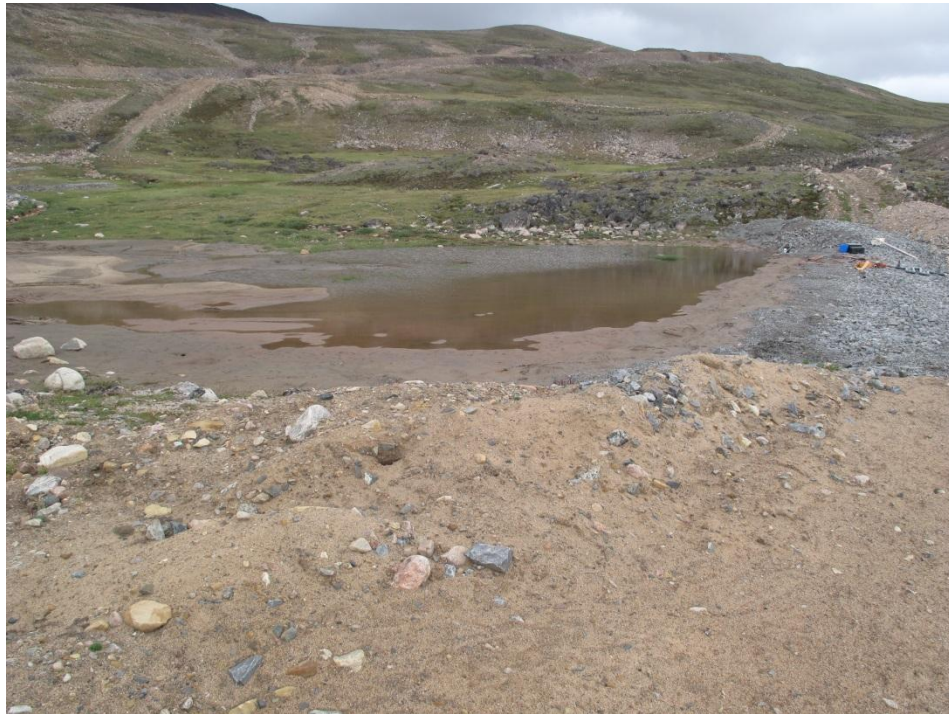
Photo 44: Magazine Off Road Settling Pond (Mine Hill Disturbed Area) – Before Rainfall Event

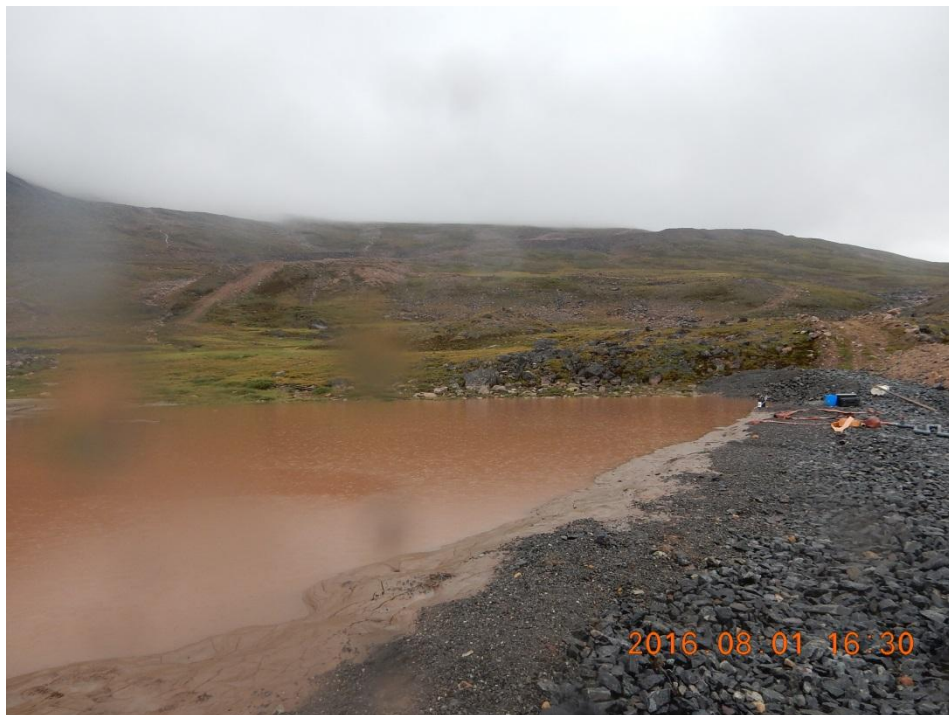
Photo 45: Magazine Off Road Settling Pond (Mine Hill Disturbed Area) – During Rainfall Event
