## **4.0 MILNE INLET**

### **4.01 General**

There are still changes taking place at Milne Inlet, since our last inspection in July/August of this year.

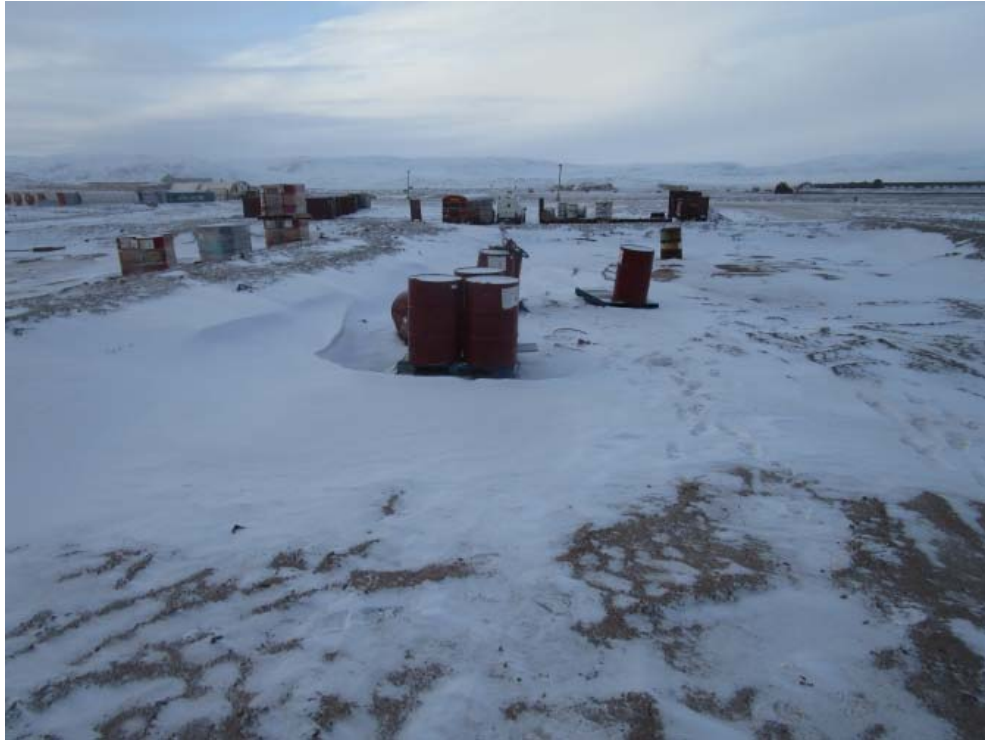
Hazardous Waste Storage MP-HWB-4

There is no water ponding in both cells of the original structure. We are advised that water has been pumped from these structures and sand in the structures contains ice.

Our review of the area around the dykes, at the base of the slopes, showed no sign of seepage. The structure is considered stable.

We have no recommendations with respect to the use of these two cells at this time. Prior to our inspection in September, we request that water not be pumped from the structures.

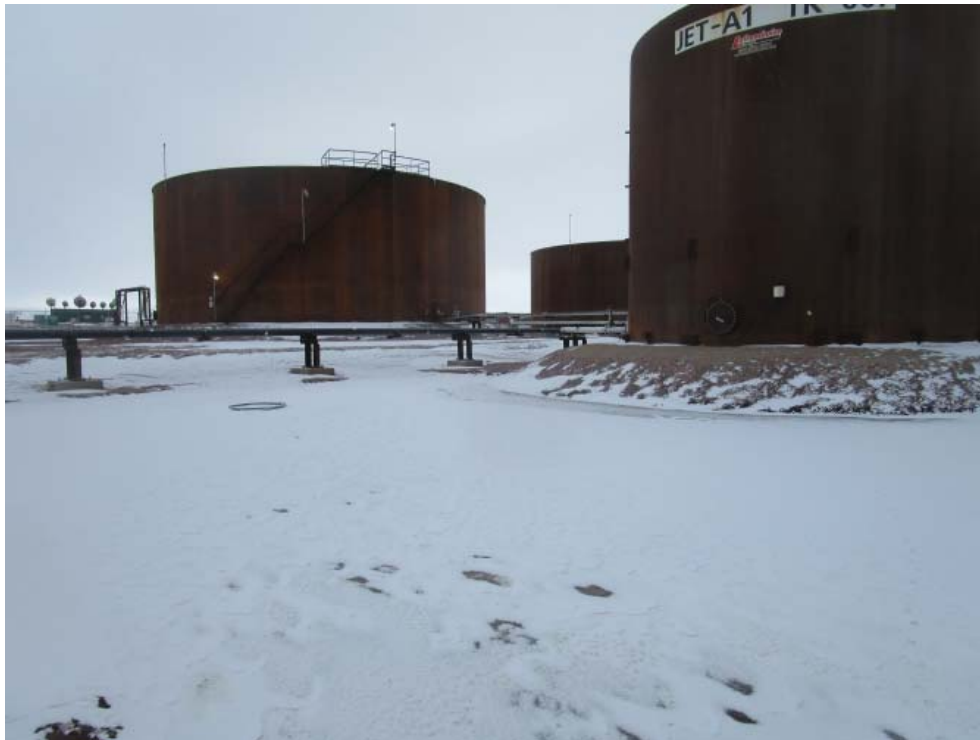
Fuel Tank Farm

During the last day of our earlier inspections, a major fuel oil spill took place. The berm around the containment effectively contained the spill. The sumps had not been installed at the time of the spill. These sumps have been installed.

We have minor water ponding at the low end of the containment confirming the integrity of the liner. This ponding is now in the form of ice in the bottom of the containment.

We have no recommendations with respect to the containment at this time.

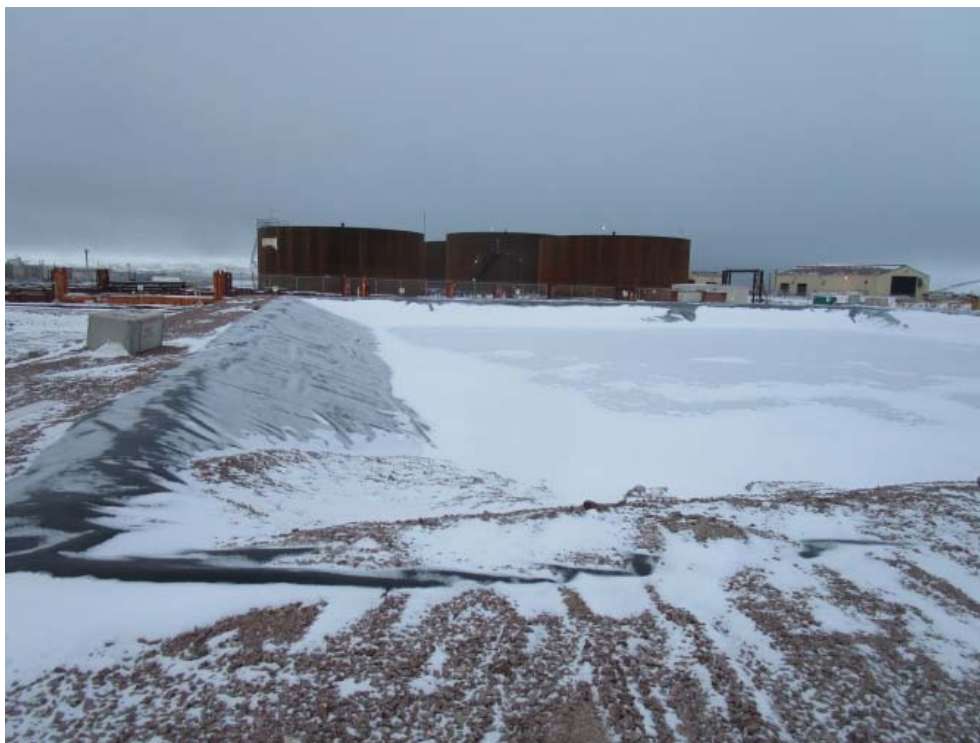
Milne Inlet Sewage Effluent Pond (PWSP)

The containment pond was operating at approximately sixty-percent of capacity at the time of our inspection.

We noted no sign of weakness in any of the construction.

We have no recommendations with respect to the use of this structure having no negative comments on the construction of this structure.

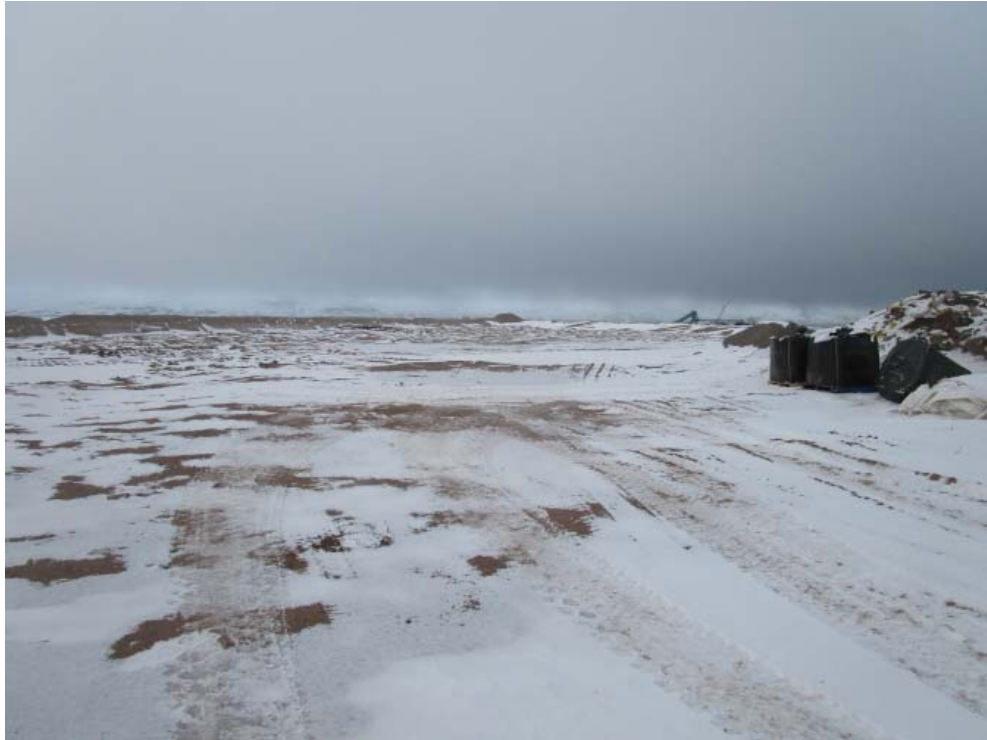
Land Farm Containment

The landfarm containment is complete except for soil cover on the dykes in the area of the sump.

At the time of our inspection the landfarm was in operation and some sorting of contaminated materials had taken place. Since our last inspection, there is still minor sorting to take place including the removal of some waste and contaminated waste.

There is still some contaminated waste in the landfarm in addition to contaminated soil. No landfarming of treated contaminated soil has taken place.

The structure appears stable as constructed.

We recommend that the remaining dyke structure, without protective cover over it, be covered as per the design drawings. This, however, is not an absolute requirement.

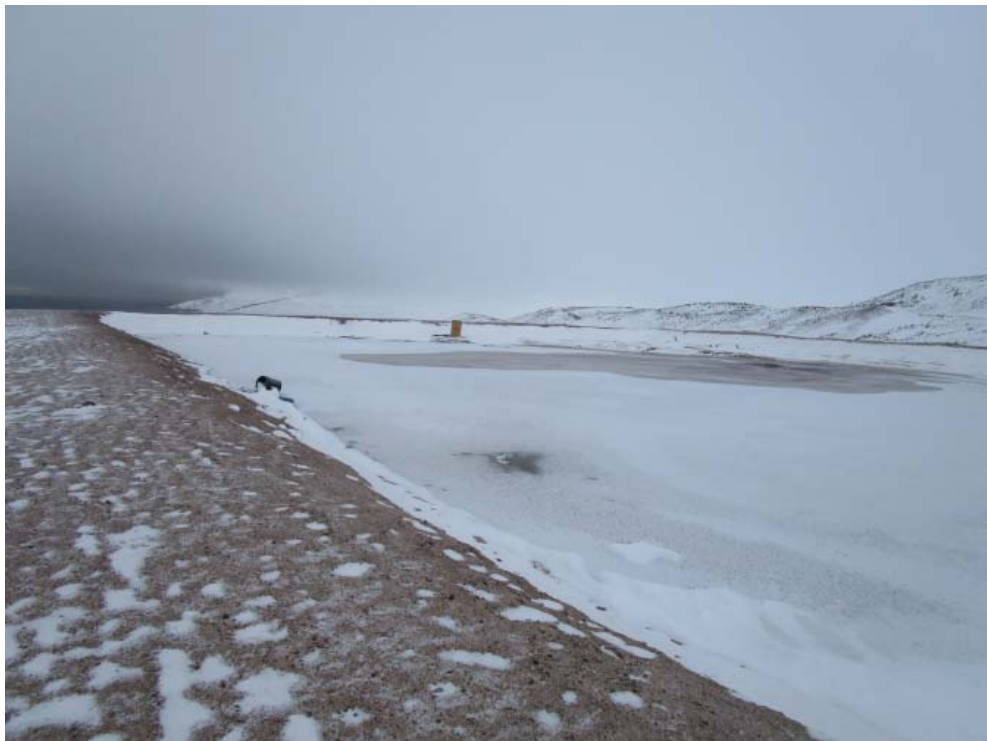
Contaminated Snow Containment

The snow containment facility has a containment volume of 929 m<sup>3</sup> based on estimates of snow volume provided by the owner and only a small percentage of the capacity is utilized.

The structure appears stable as constructed.

We have no recommendations with respect to this construction at this time. The structure appears as it did in our July/August review.

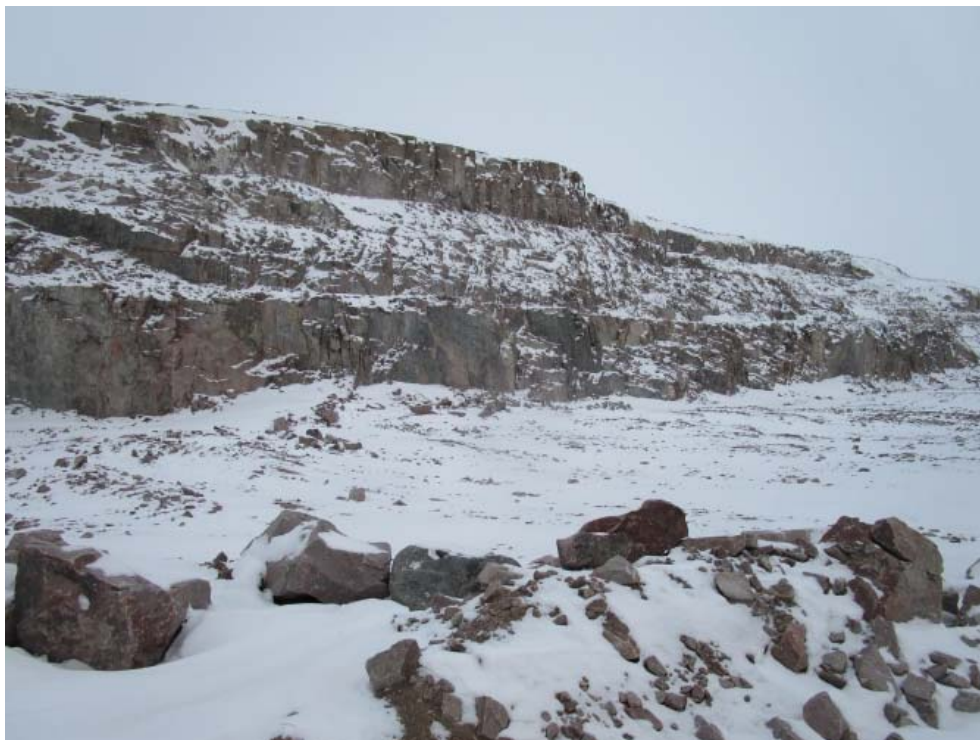
Milne Inlet Quarry

The quarry was inactive at the time of our review and most blasted rock had been removed from the quarry site.

Rock faces appear stable.

We have no recommendations to be made with respect to the quarry.

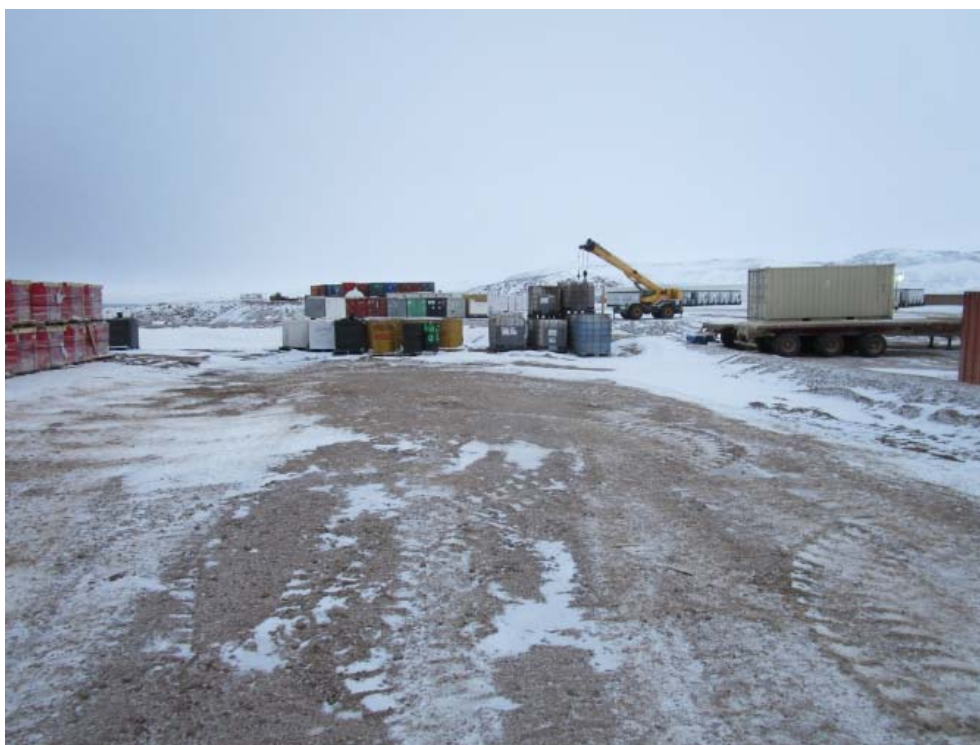
Loading Area Contaminated Storage MP-HWB-1

Most hazardous waste has now been removed from the containment and shipped out.

Construction appears stable.

We have no recommendations with respect to this structure.

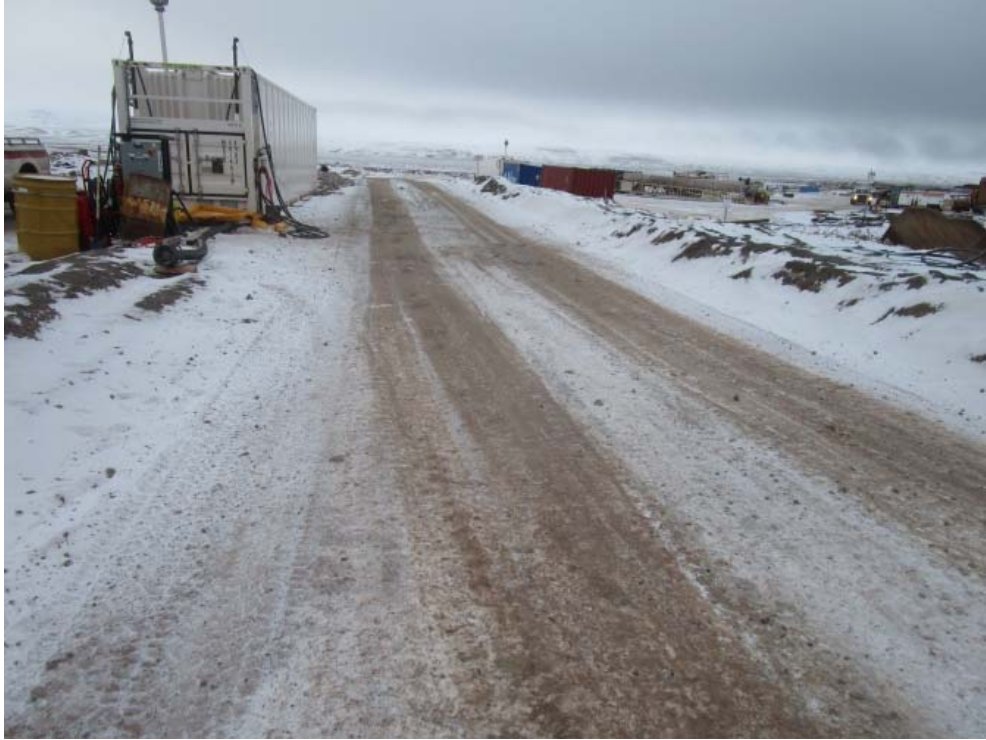
Fuelling Facility Containment

A new fueling facility for the fueling of B trains is completed utilizing design drawings prepared by our office.

Work conforms to the design drawing.

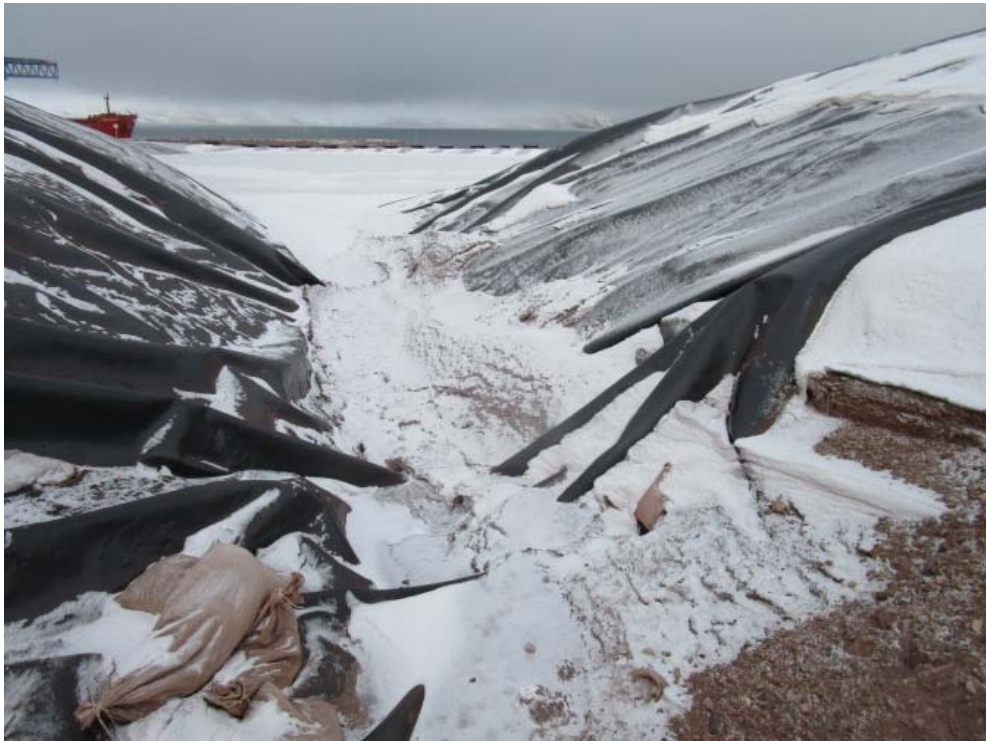
East Drainage Pond

There has been no cover placed over the liner to this point and rip rap has not yet been placed in the outlet weir.

The tears and punctures that were present at the time of our July/August review have yet to be repaired.

We still have concerns over the stability of the liner and recommend possibly tire ballast over the liner which appears possibly subject to wind damage. This shall provide a function for used tires.

We recommend review of the use of a ballast (possibly tires) on the exposed liner at the dyke to prevent wind uplift.
