BAFFINLAND IRON MINES CORPORATION

ANNUAL GEOTECHNICAL INSPECTIONS

MARY RIVER PROJECT

SECOND INSPECTION OF TWO

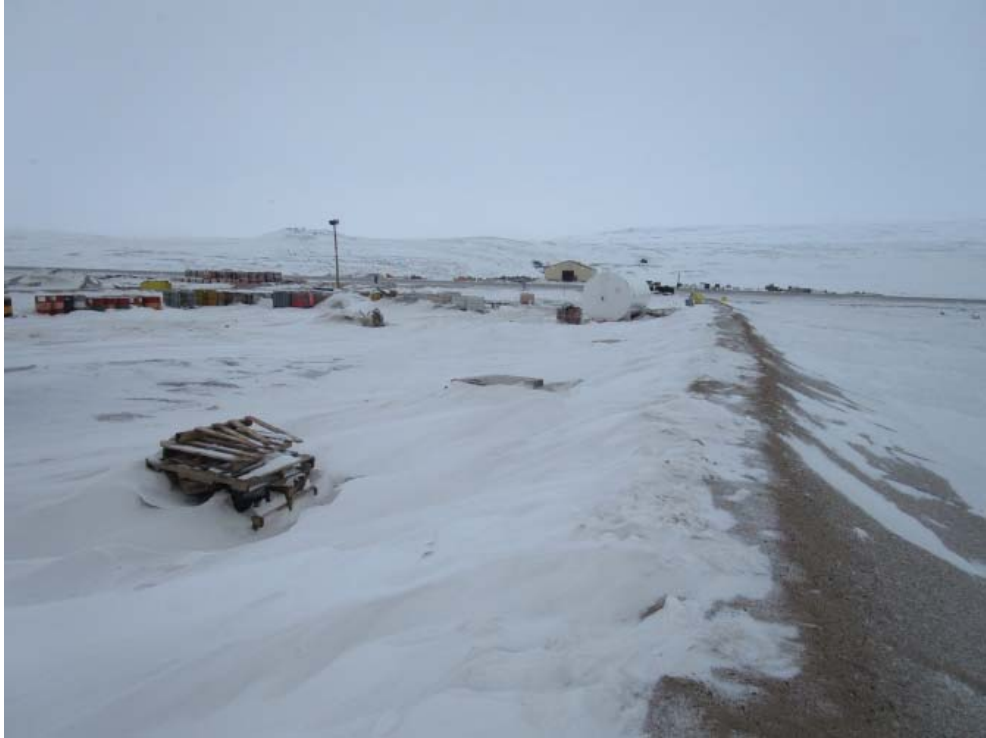
The Bulk Fuel Storage Facility still exists but it is no longer utilized as a bulk fuel storage facility. There are a number of full fuel barrels and lubricant cubes now stored within the berms, as well as a large fuel tank.

The granular cover over the geotextile and liner is still in place within the containment structure awaiting land farming. There is water that is contained within the dykes at one end awaiting treatment.

At the time of this initial review, water had not been removed for a period from within the containment and water was ponding above the level of the gravel within the bottom of the containment at the north end of the facility. This water was frozen in place as ice.

The soil structure is considered stable in the present condition and is in conformance with the design basis for the facility.

The presence of water within the structure and at the load-out area is an indication of the integrity of the liner.

We have no recommendations with respect to this containment structure as it awaits decommissioning.

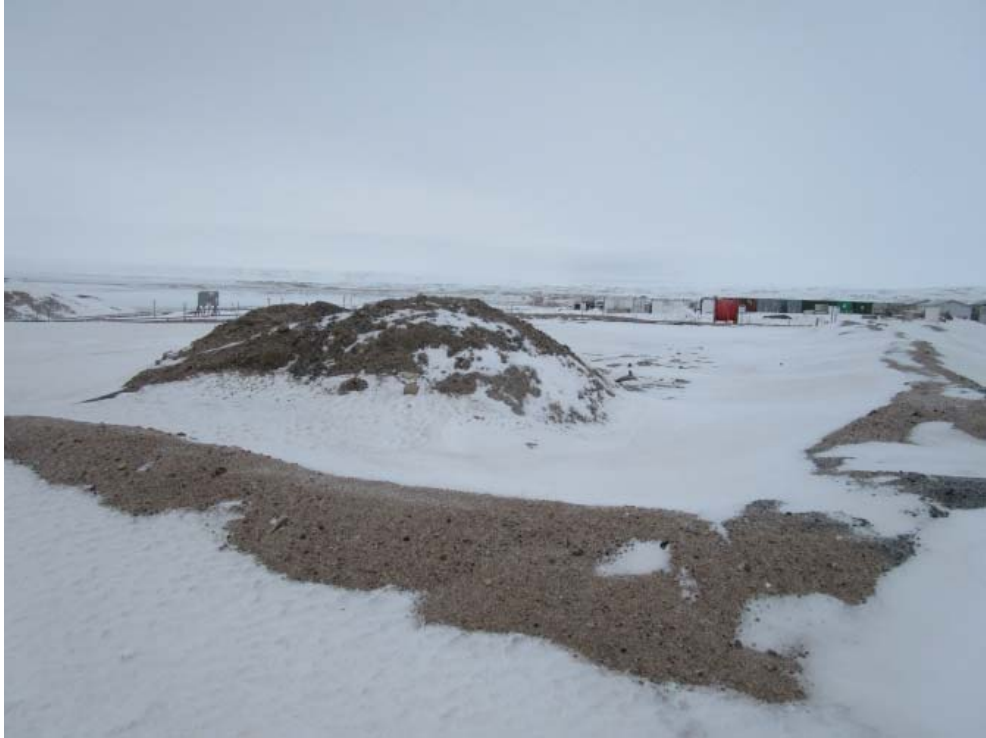
Generator Fuel Storage Containment

This particular containment structure is currently being decommissioned. The fuel bladder that was contained within the dyke has been removed.

There is no indication that the liner is compromised and decommissioning should proceed when the granular cover is either moved to a land farm or other containment. There is ice within the structure.

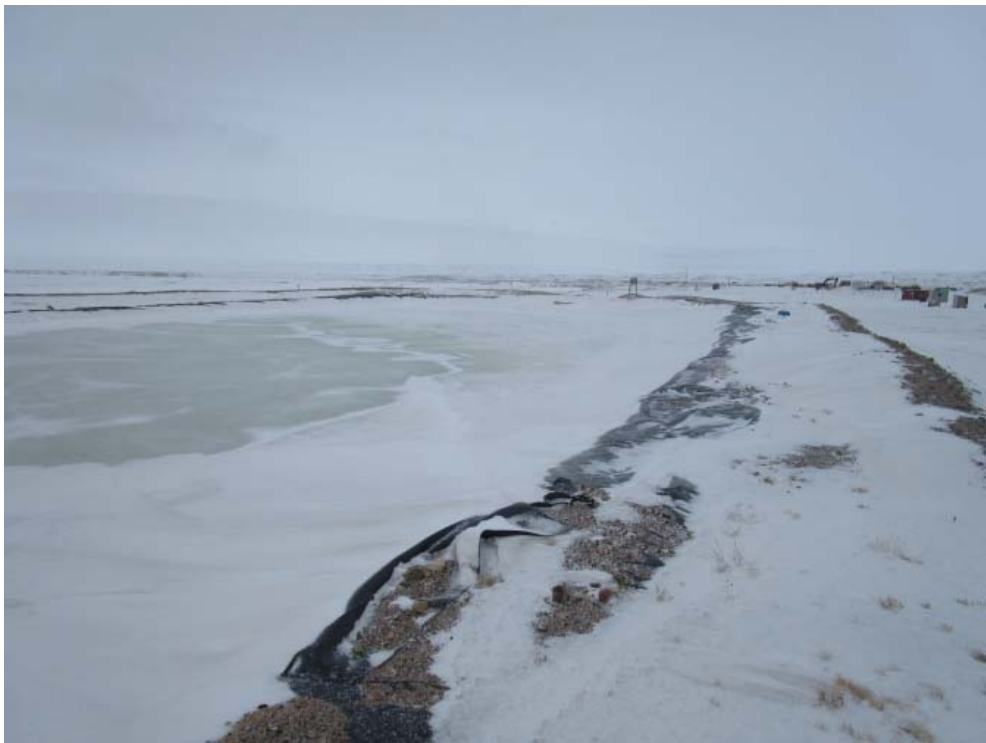
PWSP #1

At the time of our visit there was approximately fifty percent of capacity to accommodate further sewage and the structure readily conforms to its design intent.

Our review of this area around the pond at the base of the slopes showed no sign of seepage and hence we conclude that the liner has been effective in containing sewage and there are no tears or ruptures in the membrane, excepting some minor tears from past activity at the top of the dyke well above the allowable effluent level in the structure in the horizontal portion of the membrane.

A review of the top of the dyke showed no indication of cracking or settlement which would indicate stresses within the structure.

Many of the tears that had occurred in the liner on the top of the dyke have been patched during the period between reviews in 2008 and 2009 and are holding well. As well, there are no signs of weather related deterioration of the liner where it is exposed.

We have no recommendations with respect to this containment facility.

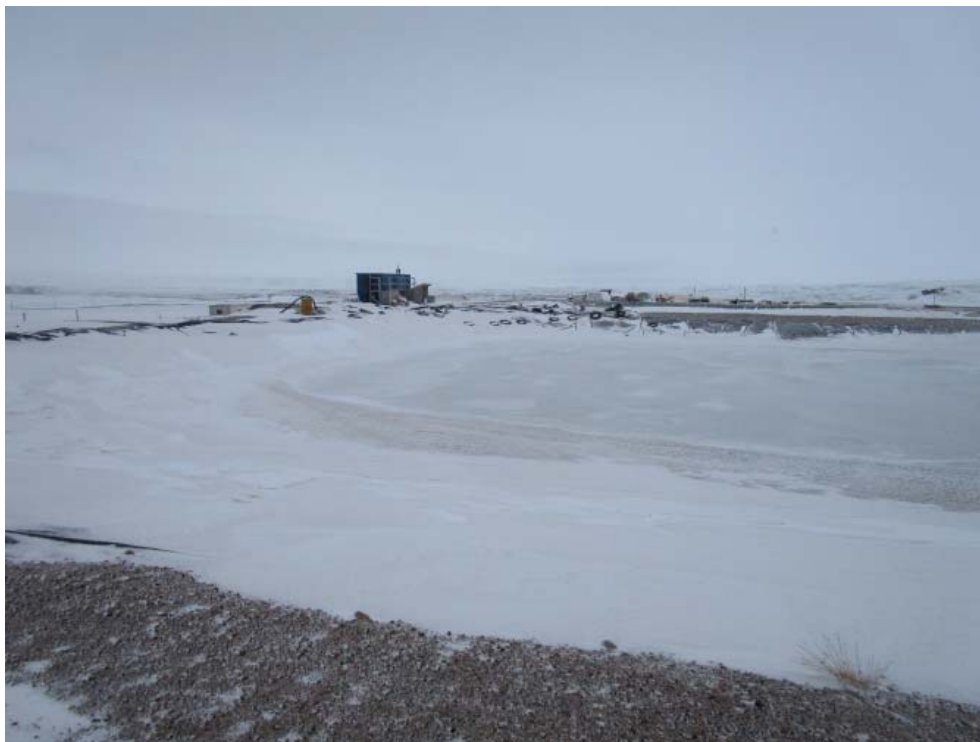
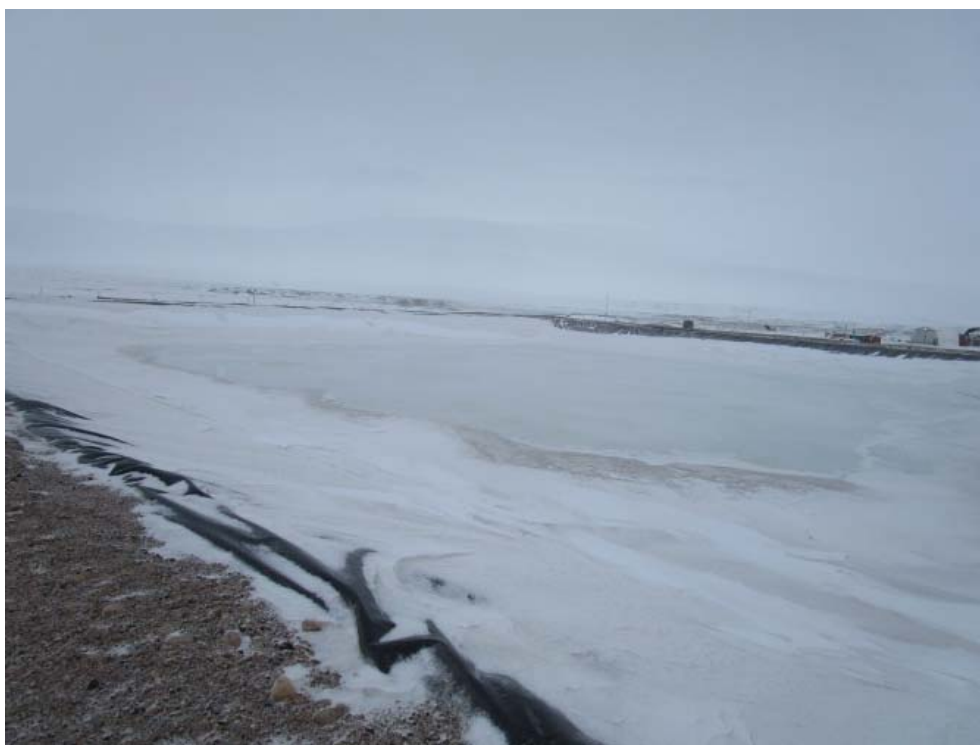
At the time of our visit there was considerable freeboard to accommodate further sewage and the structure readily conforms to its design intent. Both cells were almost empty and contained less than one foot of liquid as an ice covered liquid which was the capacity allowed for sludge in the original design.

we conclude that the liner has been effective in containing the sewage and there are no tears or ruptures in the membrane.

Longitudinal cracking which appeared in the dykes of PWSP #3 due to the melt of permafrost wedges in 2009 has not reoccurred and we consider this structure to be stable in its present condition.

Monitoring points have been set upon the top of the dyke and have been monitored since 2009. Settlements have occurred since that time. These settlements have not led to any stress cracks in the structure. Monitoring was discontinued last year.

There appears to be no sign of erosion of the dykes and plants are continuing to seed themselves on the dykes. This growth is minimal, however.

We have no recommendations with respect to this containment facility.

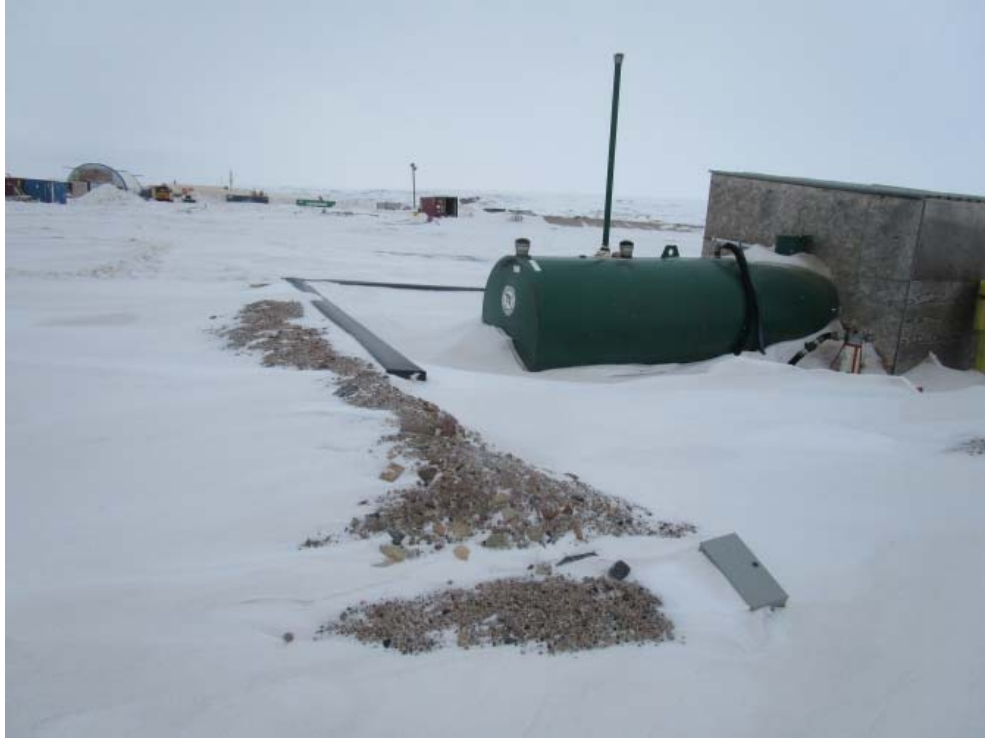
Helicopter Fuel Tank Containment

The structure currently conforms to its design intent.

Our review of the area around the pond at the base of the slopes showed no sign of seepage.

A review of the exterior and the top of the berms showed no sign of cracking or settlement which would indicate stress within the structure.

The structure is considered to be stable in its present condition.

We have no recommendations with respect to this structure.

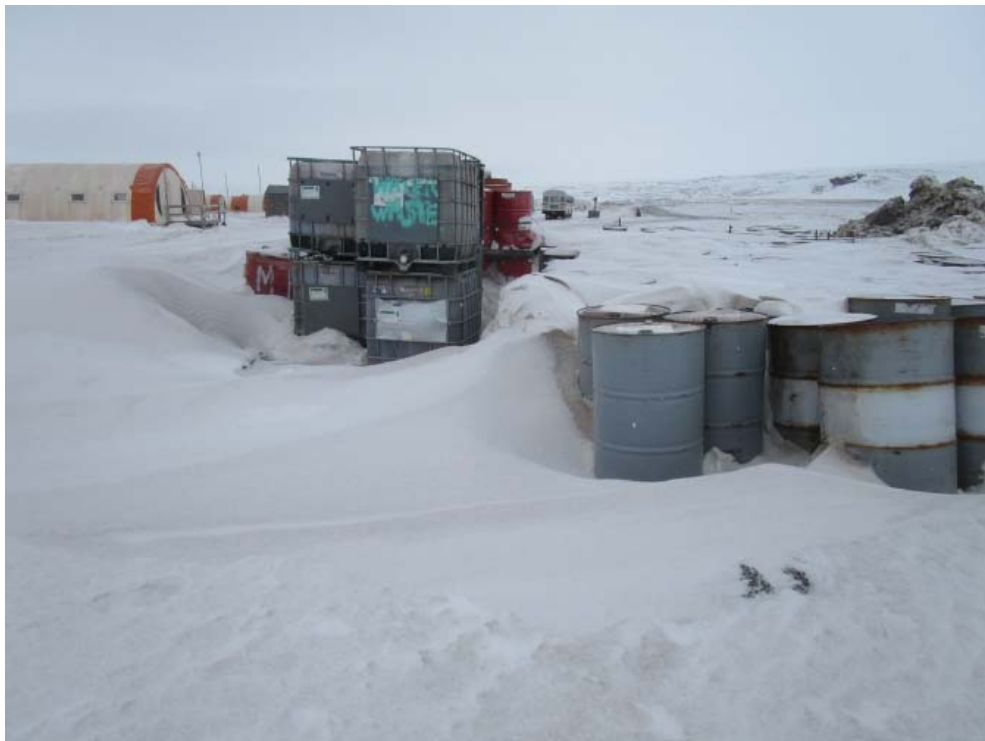
Stove Oil Storage MS-HWB-1

Our review of the exterior at the base of the dyke showed no sign of seepage. This shows that there is reasonably little chance of tearing or rupture of the membrane having taken place.

A review of the exterior and the top of the dyke showed no sign of cracking or settlement which would indicate stresses with the structure.

There is ice contained within the cell confirming the integrity of the liner.

The structure is considered to be stable in its present condition.

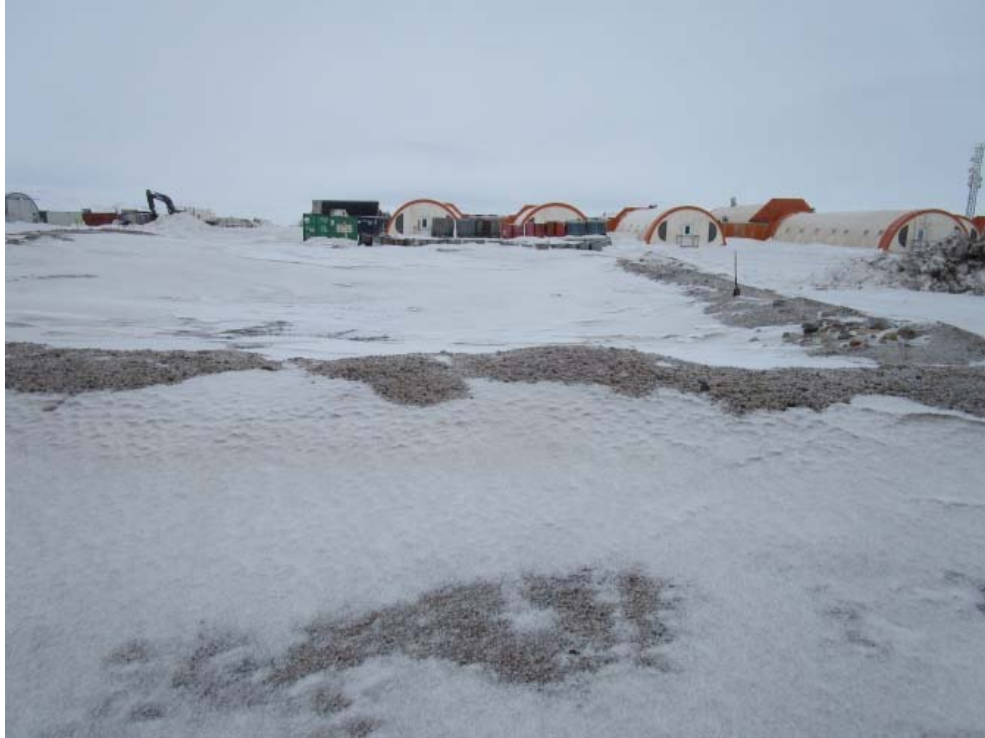
Enviro Tank Storage MS-HWB-5

Last year there was concern for the integrity of this cell as the cell was dry and the geotextile was

exposed from heavy traffic during our initial inspection. During our second inspection, the cell was holding a small amount of water confirming limited integrity of the liner.

The cell is dry this year at both of the 2015 inspections raising concerns anew on the integrity of the liner.

We recommend that the geotextile over the liner be checked and the granular cover be made good prior to continuing use of this cell

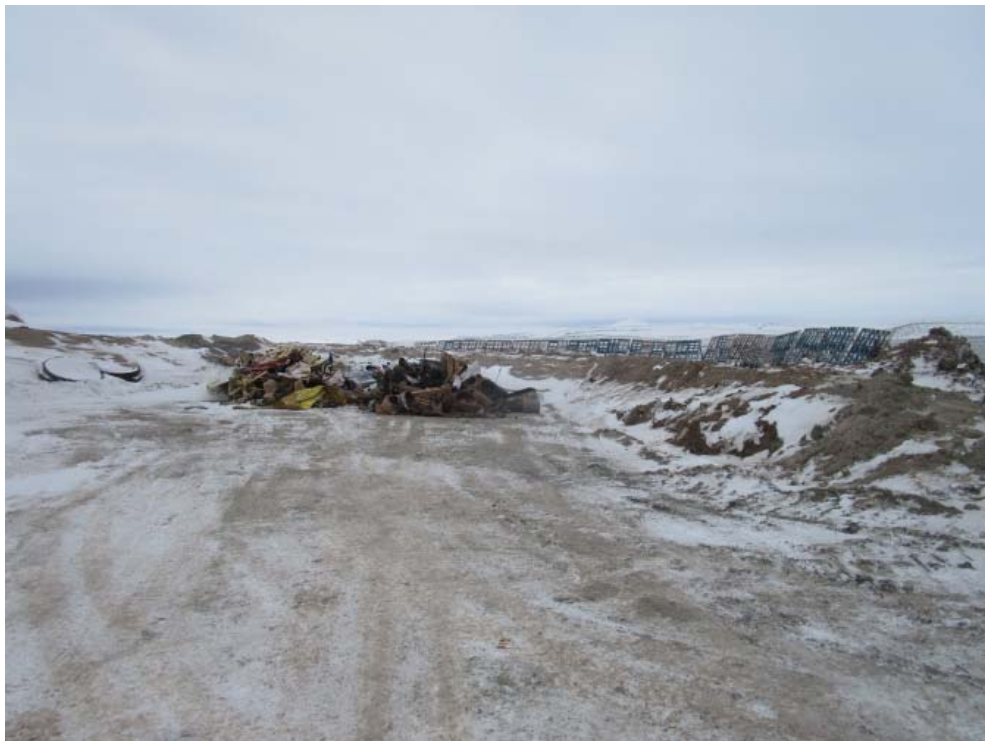
Solid Waste Disposal Site

The solid waste disposal site is currently entering the second phase of its construction. The first lift of solid waste has been placed and covered fully and appears to be doing exactly what it was proposed to do at the design stage. Since our last inspection in July/August the first lift has been expanded.

Work is currently continuing on building a berm on three sides of the disposal site at a level above the existing lift in advance of placing another lift. The berm is being constructed as per the berm on the first level that served well over the past several years,

The blow fence has not been reinstalled yet. In the meantime, solid waste has been covered as it is installed and may be continued to be done to control "blow".

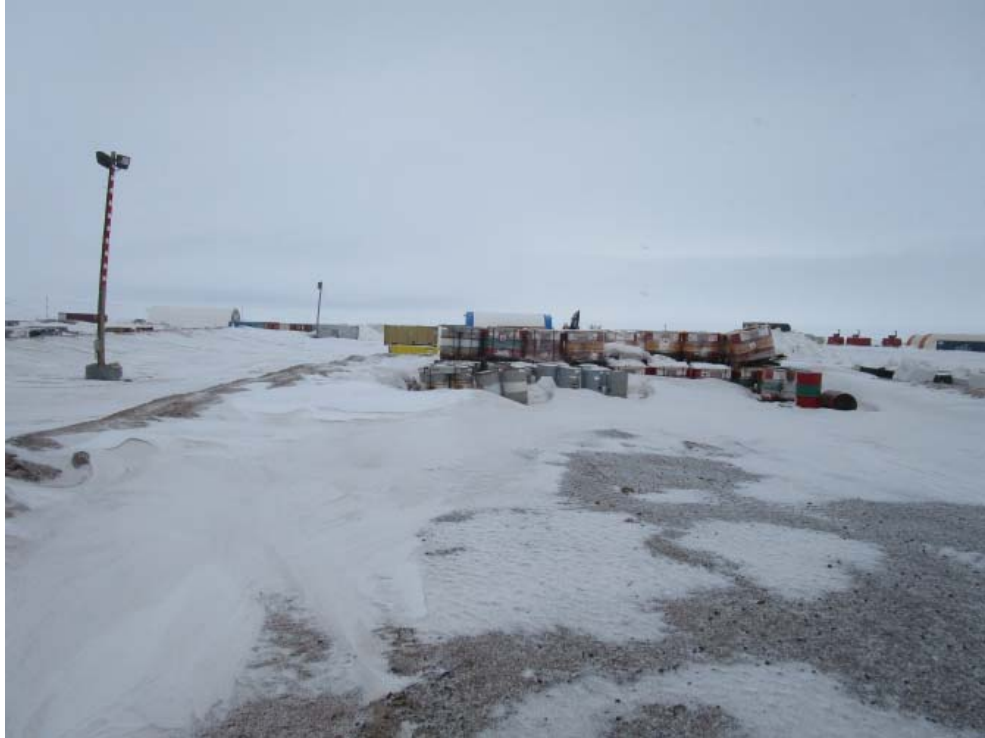
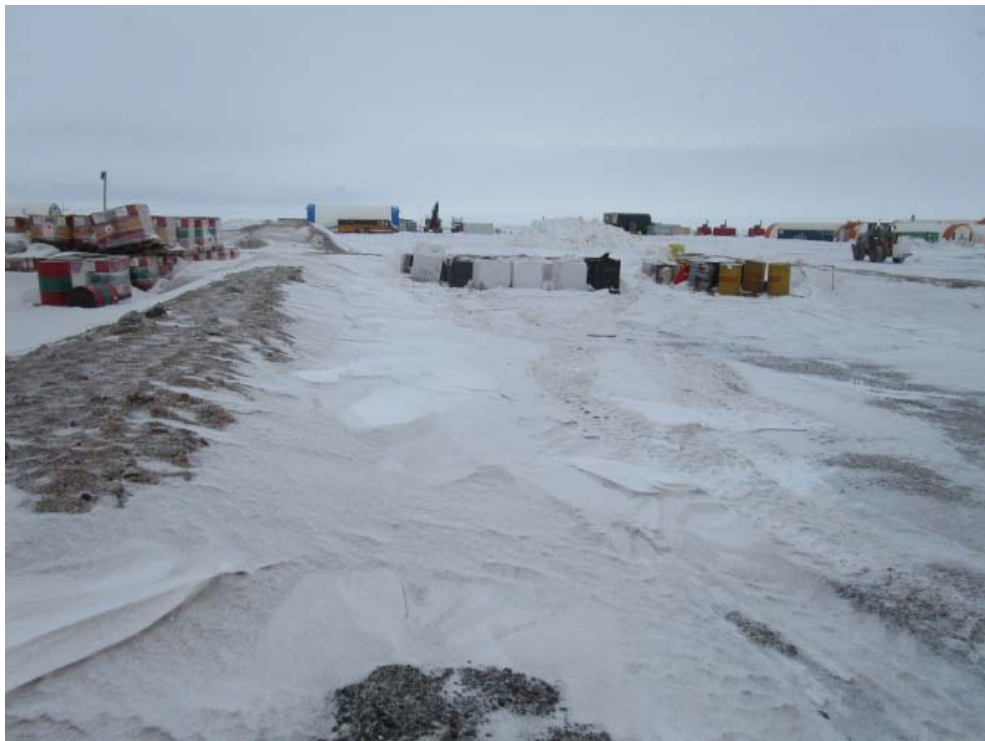
Our review of the area around this containment structure showed no sign of seepage. There is water ponding in this structure as evidenced by the ice in the cell.

A review of the exterior and top of the dyke showed no sign of cracking or settlement which would indicate stresses within the structure.

The structure is considered to be stable in its present condition. The ice confirms the integrity of the liner.

We have no recommendations at this time.

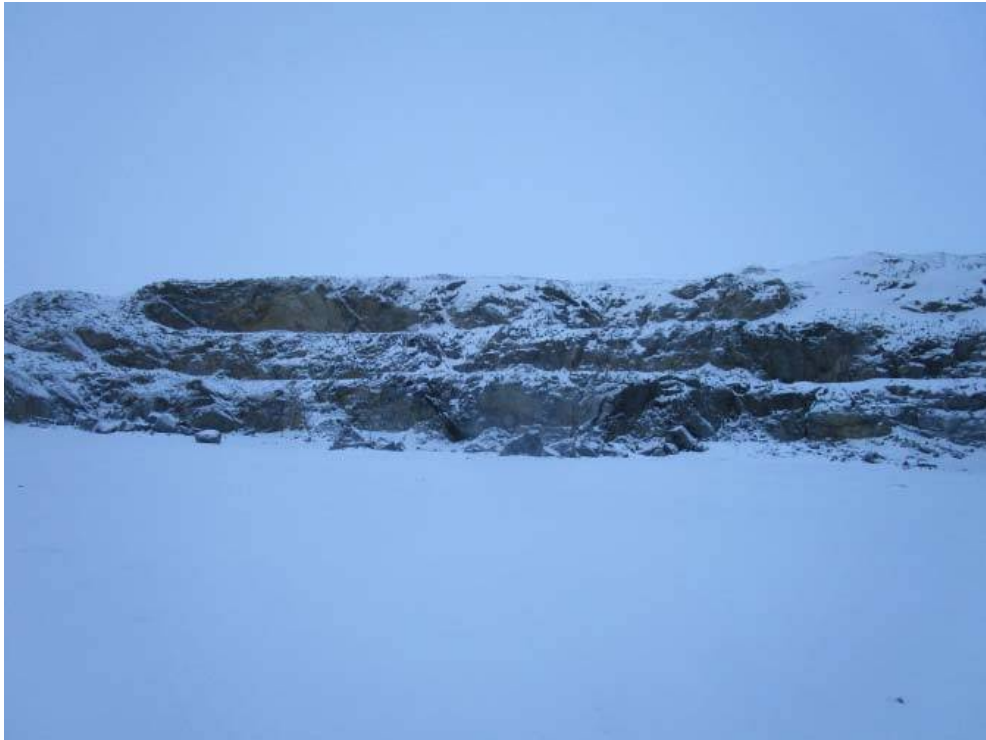
Mary River Quarry

The quarry has well defined benches. The quarry faces at the benches appear clean.

The area where the road was undermined in September 2015 has undergone further quarrying and the access road is gone. This area is a fractured zone and subject to subsidence as we noted while on site.

Care must be taken while quarrying in the unstable fractured zone.

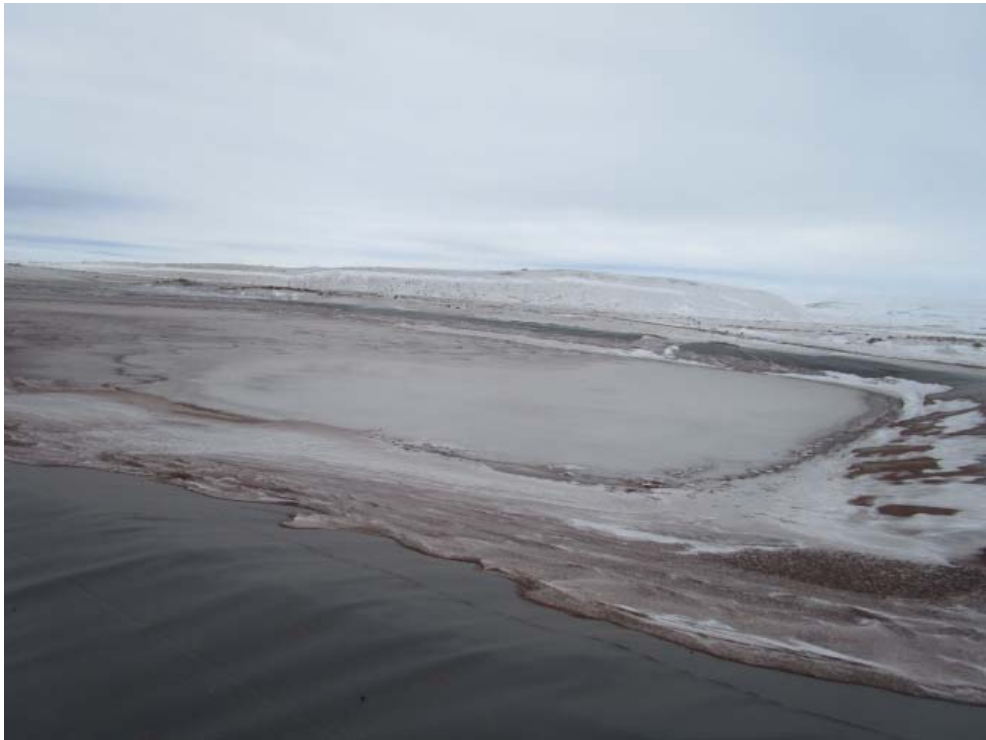
Crusher Pad Drainage Containment

Although there was no moisture flowing to the catchment pond, it is evident that the ditches in place and the containment pond are operating as intended.

The structure has been completed in accordance with drawings included in our last report in a most satisfactory manner.

We have no recommendations with respect to this containment structure.

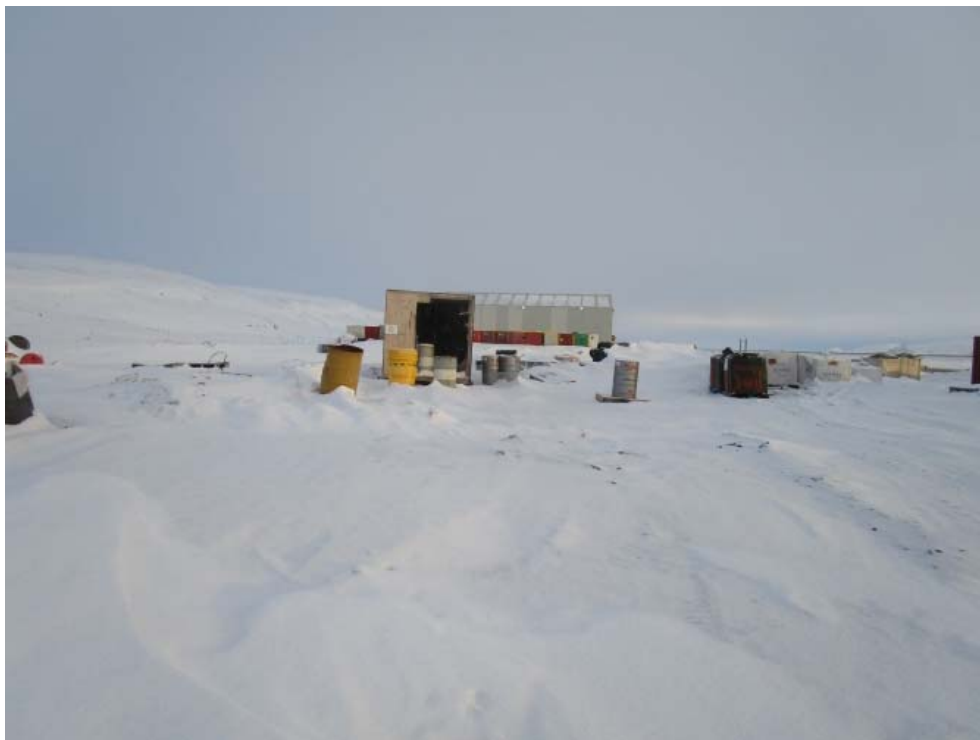
Hazardous Waste Containment MS-HWB-6

There is water ponding in the bottom of the cell confirming the integrity of the liner. This water is currently in the form of ice.

There were no signs of cracking of the dykes or seepage around the exterior of the dykes.

We have no recommendations with respect to this structure at this time..

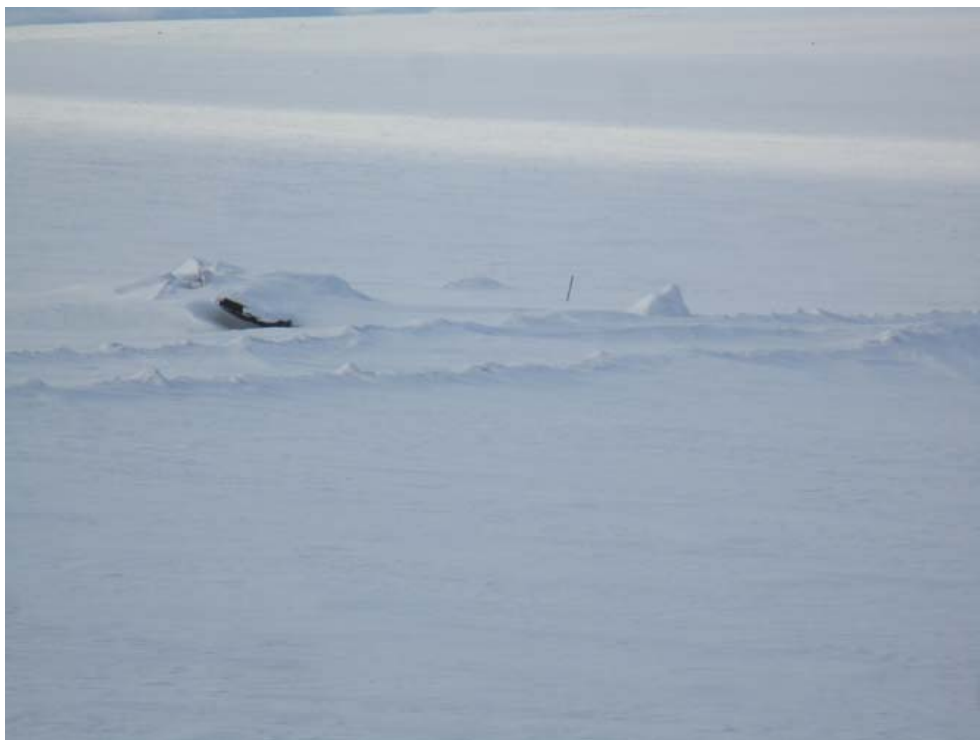
Waste Pile Drainage Containment

The dyke appears stable at this time.

This particular structure has now been completed. The structure is in place with only minor trimming required on the inlet side. The outfall hose to pump the supernatant water over to the Mary River watershed is in place with the pump in place on the dyke.

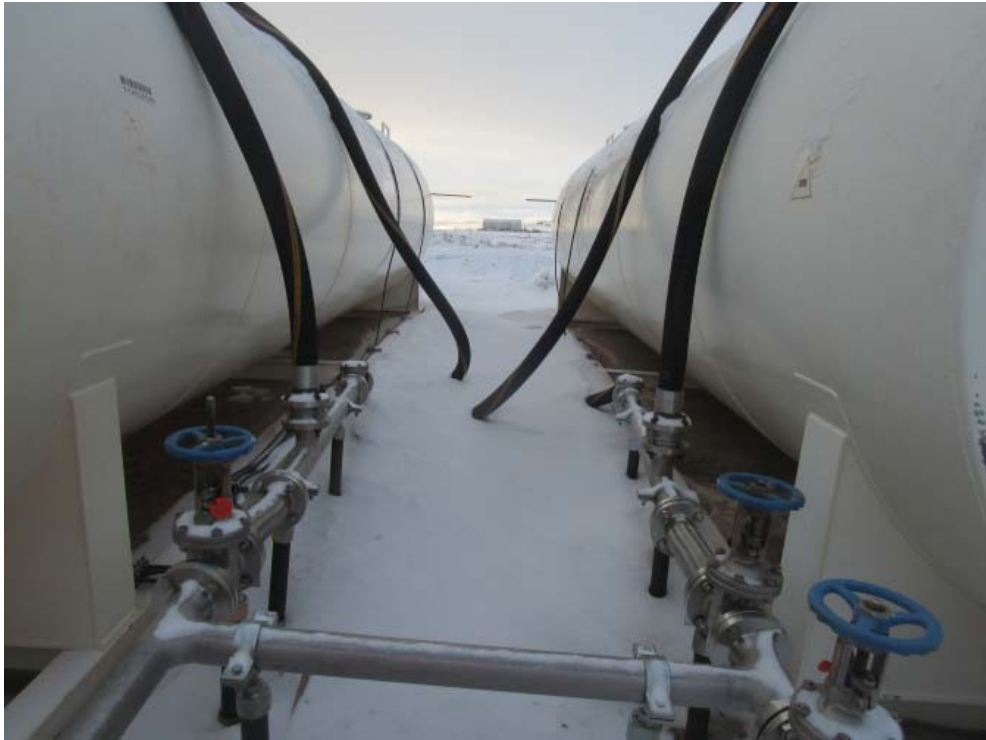
Jet "A" Fuel Containment

There is water ponding in the form of ice in the bottom of the cell confirming the integrity of the liner.

There were no signs of cracking of the dykes. A granular ramp has been constructed over the dyke to facilitate access for snow removal.

We have no recommendations with respect to this structure.
