RE: Submission of 2018 Geotechnical Inspection Report No. 1 (Jul/Aug. 2018)

BAFFINLAND IRON MINES CORPORATION

ANNUAL GEOTECHNICAL INSPECTIONS

MARY RIVER PROJECT

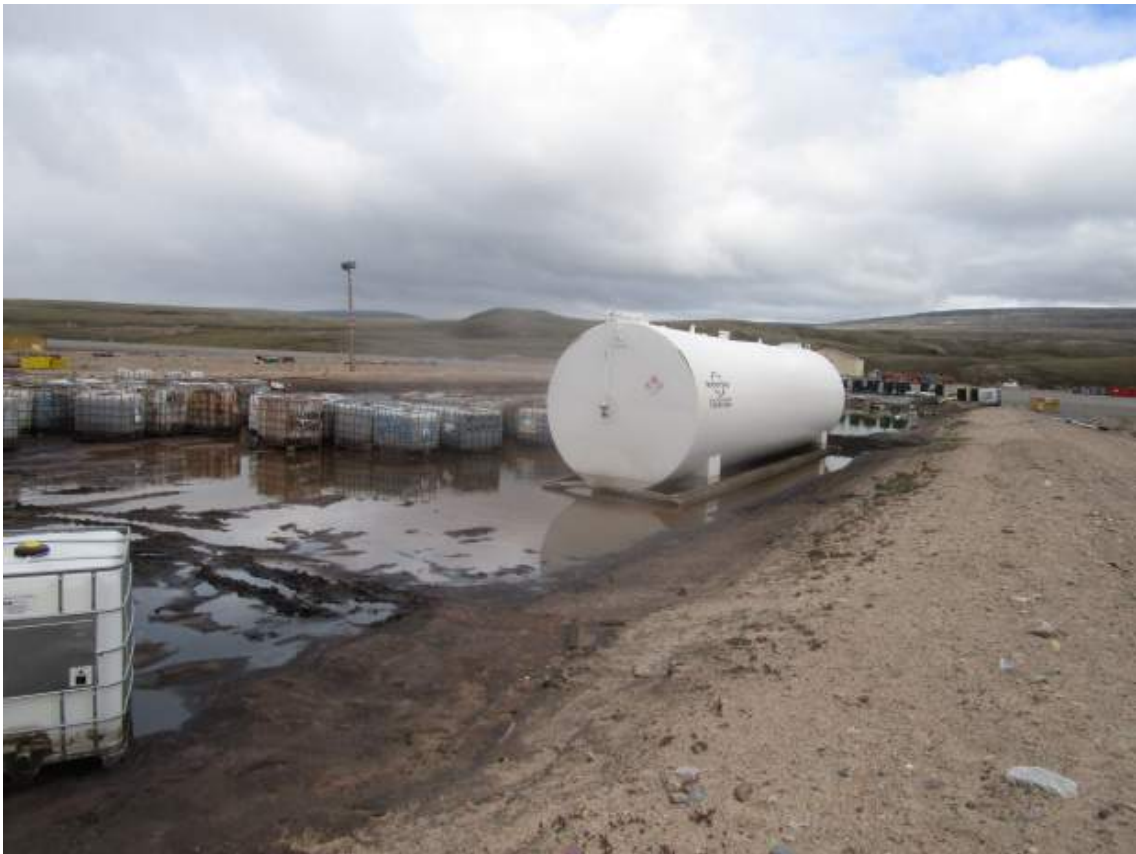
1. Bulk Fuel Storage Facility.

The soil structure is considered stable in the present condition and is in conformance with the design basis for the facility.

Baffinland Action: The liner of this storage facility was repaired in August 2018. This repair will be monitored in further inspections to confirm integrity.

We have no recommendations with respect to this containment structure other than to repair the puncture in the liner.

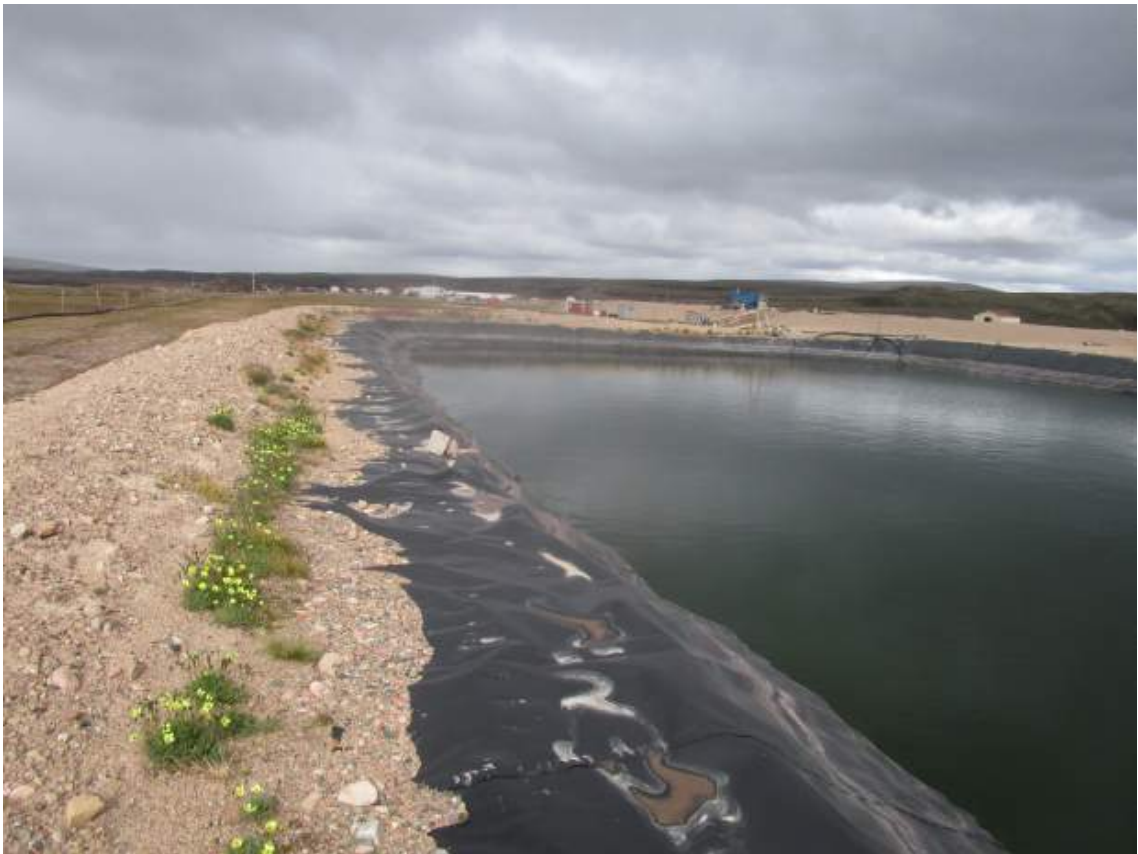
3. PWSP #1

Our review of this area around the pond at the base of the slopes showed no sign of seepage and hence we conclude that the liner has been effective in containing sewage and there are no tears or ruptures in the membrane, excepting some minor tears from past activity at the top of the dyke well above the allowable effluent level in the structure in the horizontal portion of the membrane.

A review of the top of the dyke showed no indication of cracking or settlement which would indicate stresses within the structure.

Many of the tears that had occurred in the liner on the top of the dyke have been patched during the period between reviews in 2008 and 2009 and are holding well. As well, there are no signs of weather related deterioration of the liner where it is exposed.

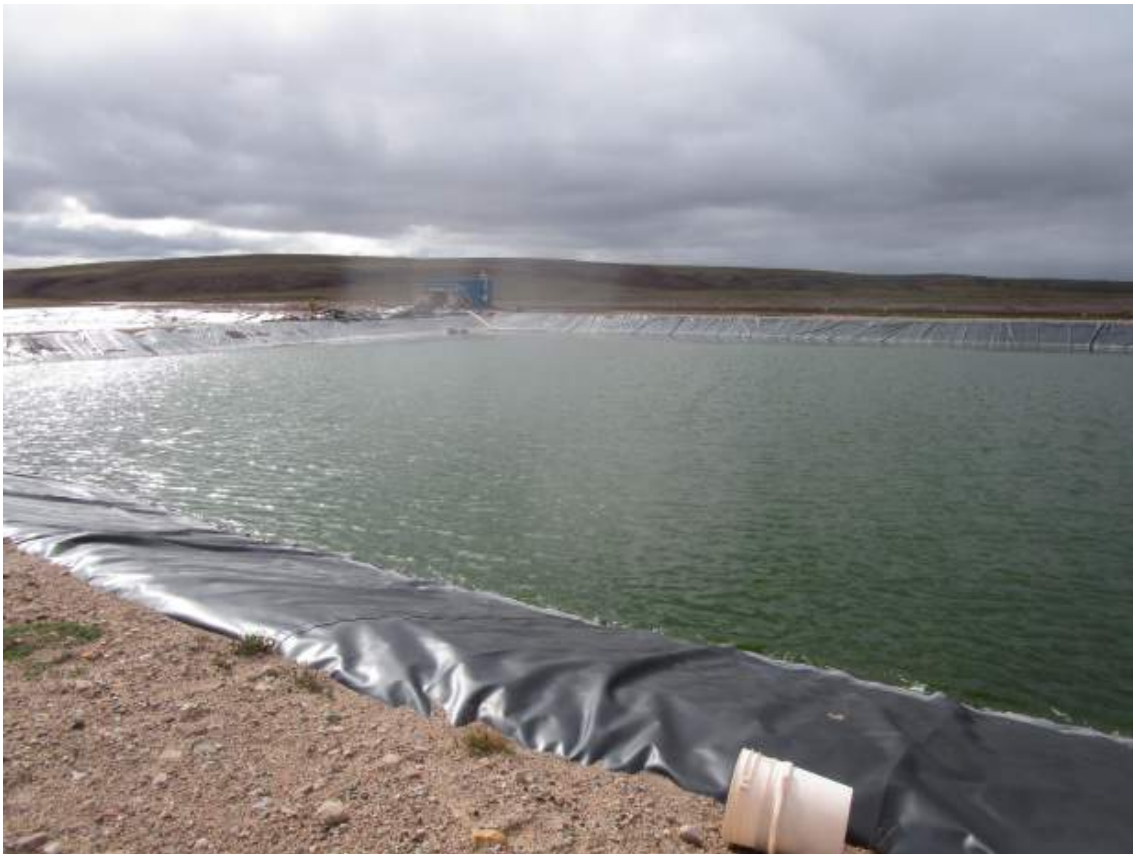
5. PWSP #3

Longitudinal cracking which appeared in the dykes of PWSP #3 due to the melt of permafrost wedges in 2009 has not reoccurred and we consider this structure to be stable in its present condition.

Monitoring points have been set upon the top of the dyke and have been monitored since 2009. Settlements have occurred since that time. These settlements have not led to any stress cracks in the structure. Monitoring was discontinued three years ago.

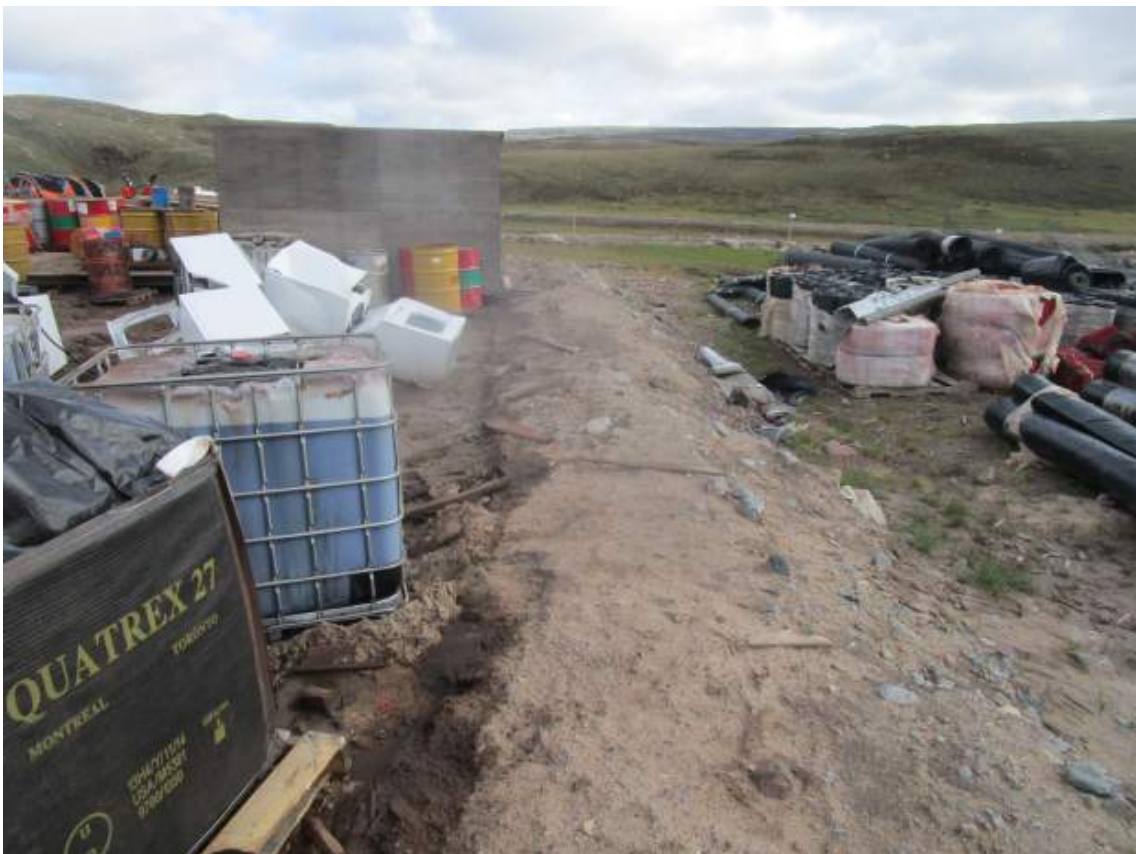
18. Hazardous Waste Containment (MS-HWB-6)

There is water ponding in the bottom of the cell confirming the integrity of the liner. There are tears in the enviroliner noted with 3 in the west side and one in the south east corner. All waste is in barrels or totes and is contained.

There were no signs of cracking of the dykes or seepage around the exterior of the dykes.

Baffinland Action: Baffinland has repaired the enviroliner at this facility and will monitor the status in the future.

We have no recommendations with respect to this structure other than making repairs to the damaged enviroliner. There are four tears in the side of the liner that should be repaired if use is to continue as we understand it shall. The side dykes should be also built up to keep traffic off them.

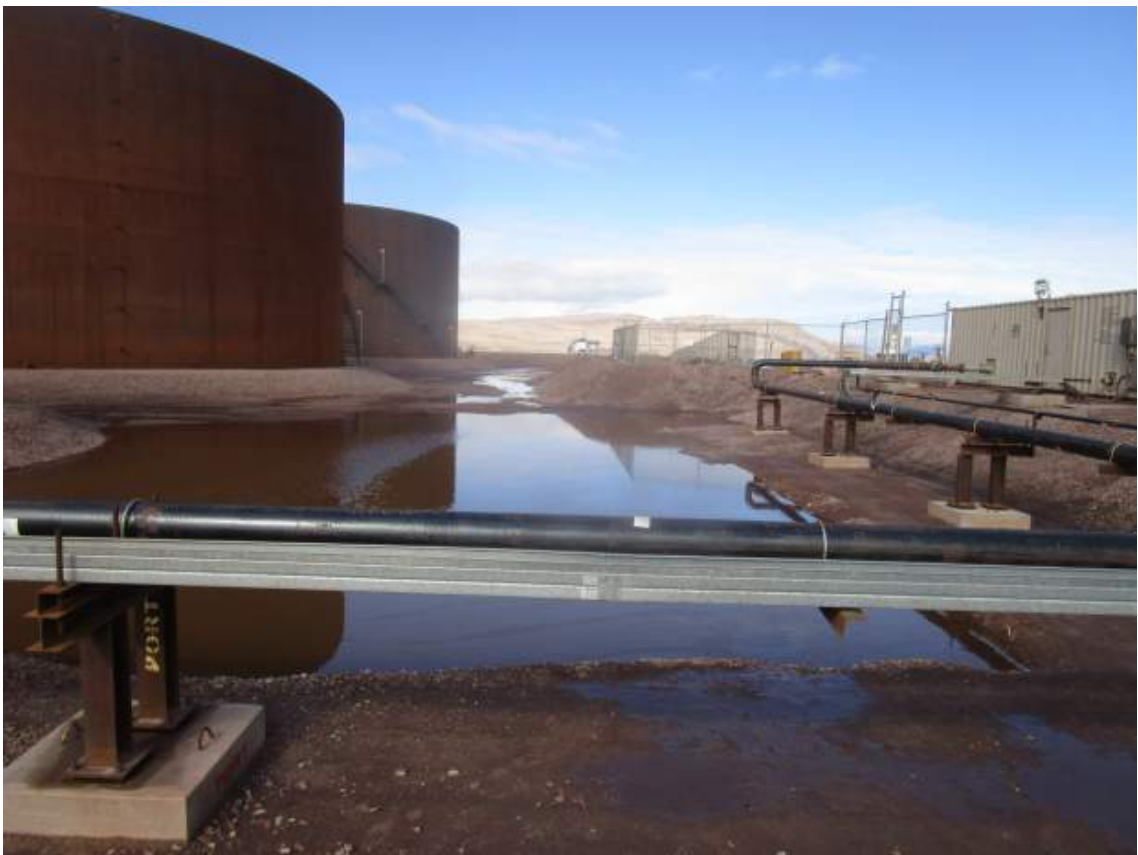
2. Port Site Fuel Tank Farm

All containment dykes are in excellent condition and there are no signs of weakness.

We have no recommendations with respect to the containment at this time other than to make sumps at the north end operational, to readily facilitate water removal.

Baffinland Action: Baffinland will review sumps in the north end of the tank farm and evaluate if further excavation is required.

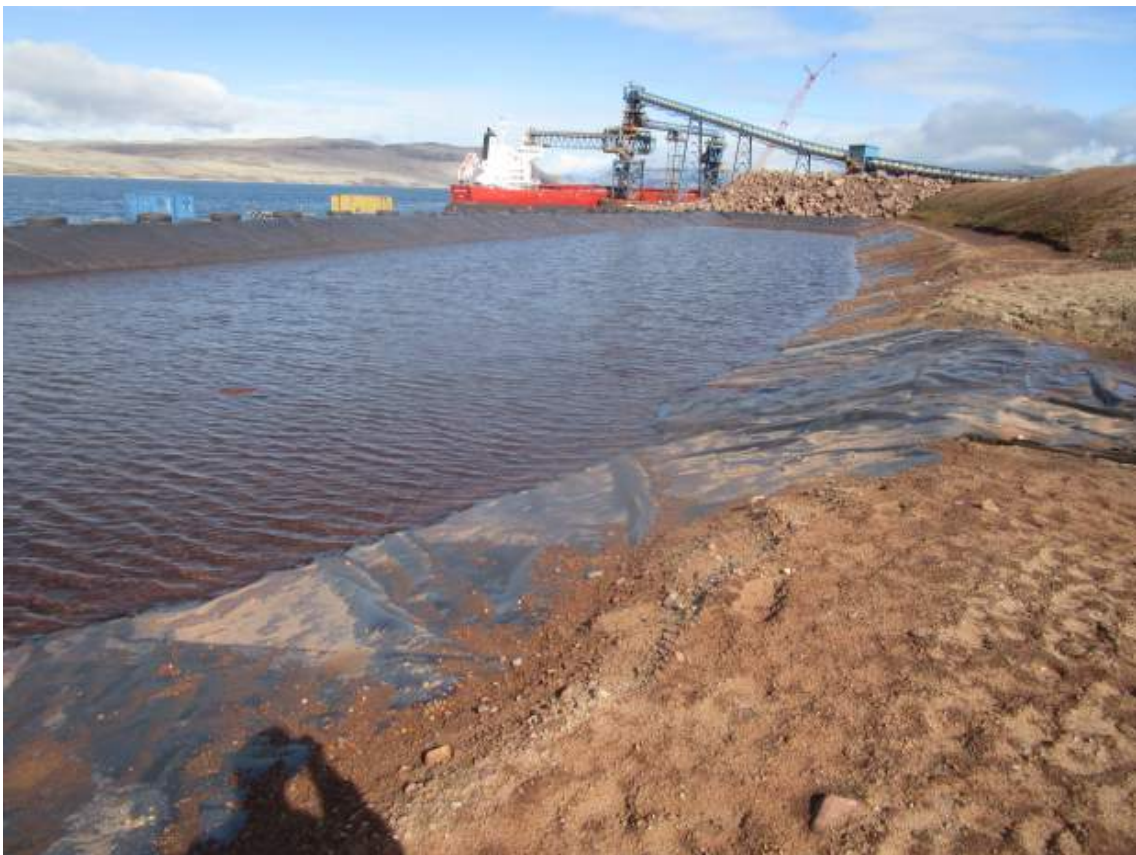
6. Sediment Pond West

We have some concern over the stability of the liner on this pond as we have with the east pond and further recommend that used tire ballast be further considered.

Baffinland Action: Baffinland will review ballast currently used on the exposed liner and place additional used tire ballast, as required.

We have no concerns other than that of possible wind damage to the liner and recommend the use of tires as ballast.

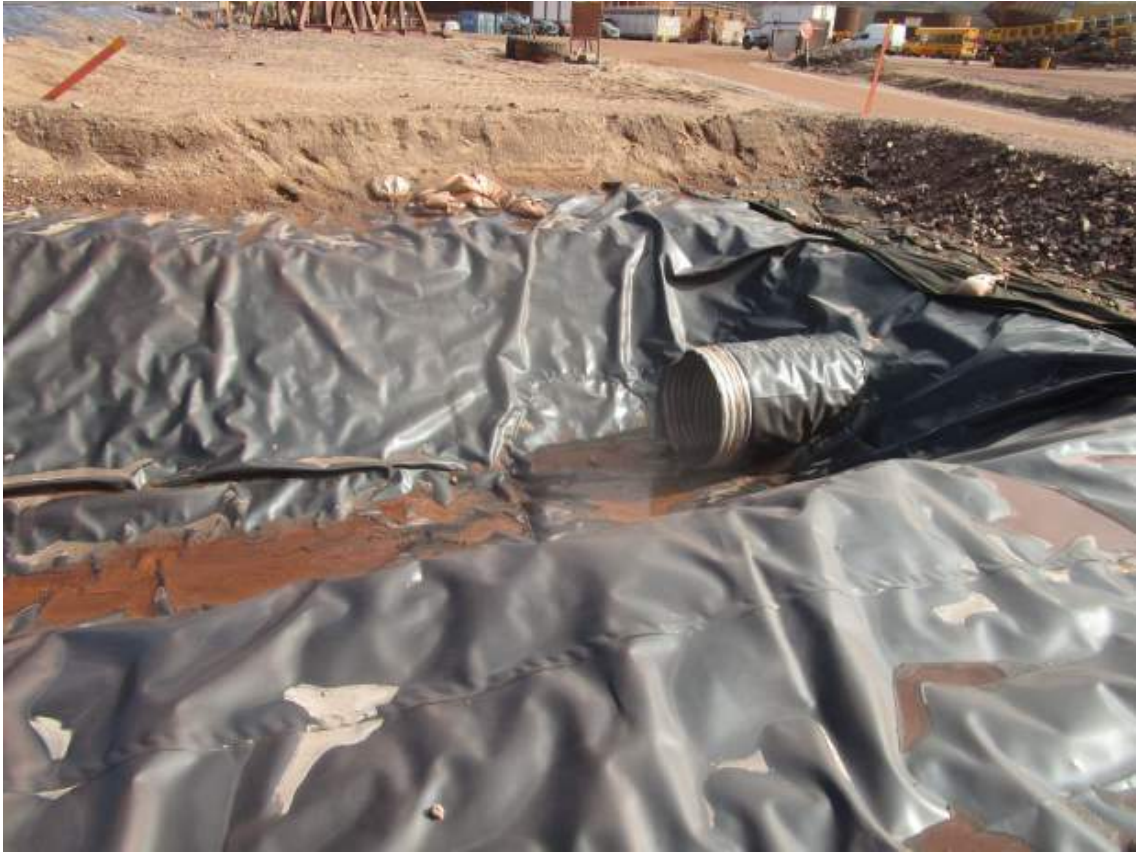
7. Sediment Pond East

The two inlets to the pond have recently been upgraded and the enviroliner repaired at these locations. It is performing well, particularly at the culvert entrance.

We have concerns over the stability of the liner on this pond and recommend possibly further tire ballast over the liner which appears possibly subject to wind damage. This shall provide a function for used tires

Baffinland Action: Baffinland will review ballast currently used on the exposed liner and place additional used tire ballast, as required.

We further recommend review of the use of a ballast (possibly tires) on the exposed liner at the dyke to prevent wind uplift. I do note that there is no deterioration of the exposed liner.

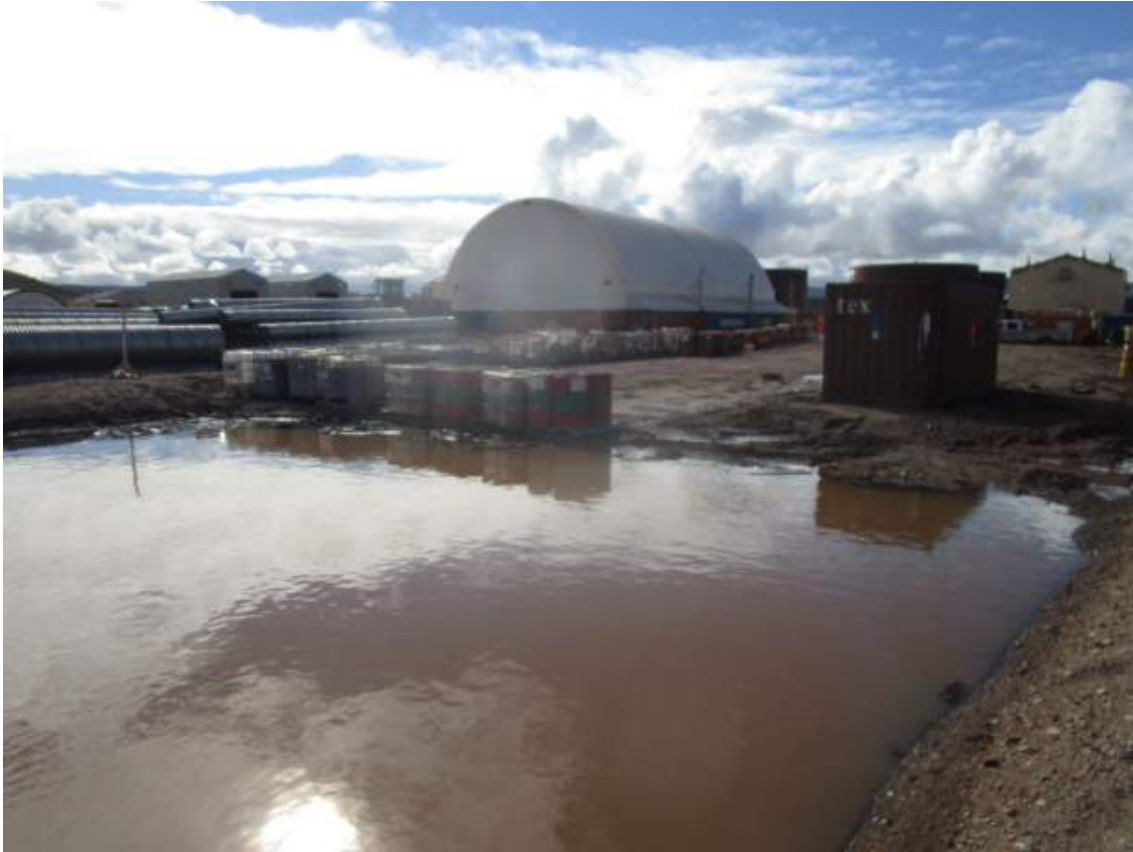
9. Loading Area Contaminated Storage (MP-HWB-1)

Construction appears stable. However there is one exposed tear in the liner at the dyke that requires repair. This was noted last year and awaits repair. This tear is where travel took place over the berm on the north side of the structure.

Baffinland Action: Baffinland will repair the torn liner by the end June 2019. In the meantime, stormwater and snowmelt in the berm will not be allowed to reach the height of the tear.

We have no recommendations with respect to this structure other than the liner repair.
