RE: Submission of 2018 Geotechnical Inspection Report No. 2 (Oct. 2018)

SECOND INSPECTION OF TWO

October 2018

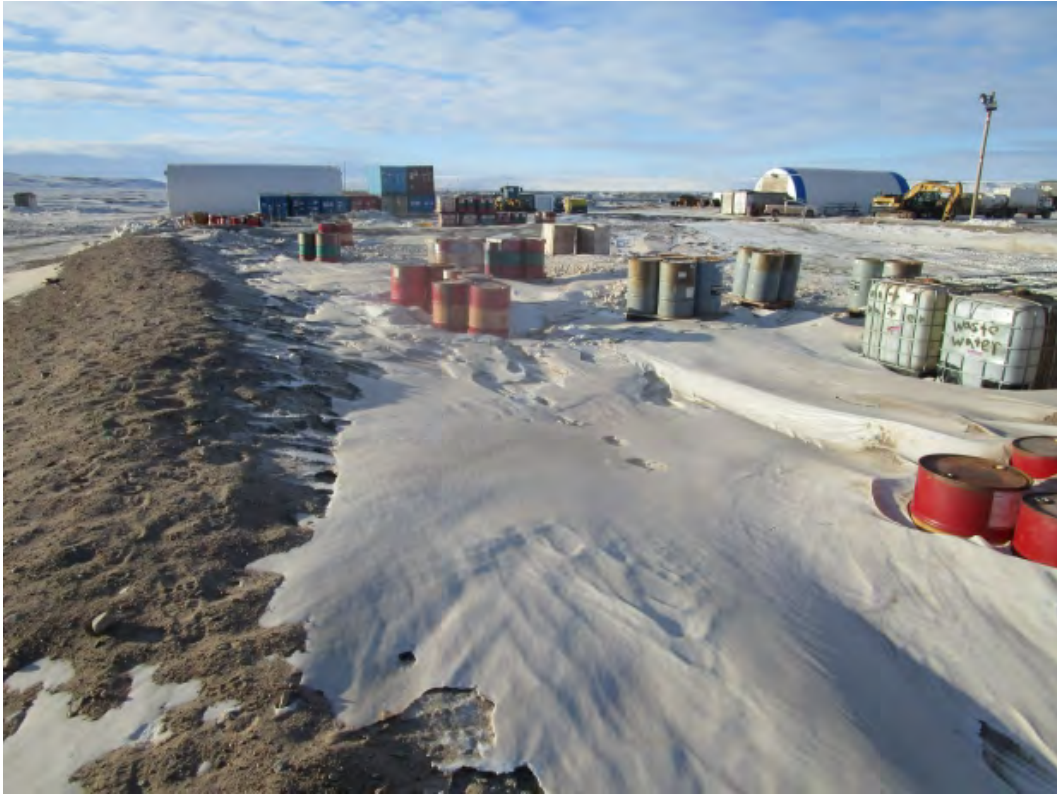
There is one area along the interior of the west dyke where the liner integrity had been compromised by a loader operator that has punctured the membrane. The puncture appears to have been repaired and covered.

We have no recommendations with respect to this containment structure other than to confirm the puncture was repaired and then covered.

A. Bulk Fuel Storage Facility

We have no recommendations with respect to this containment structure other than to confirm repair of the puncture in the liner on the west berm of the structure.

Baffinland Action: The liner of this storage facility was repaired in August 2018. This repair will be monitored in further inspections to confirm integrity.

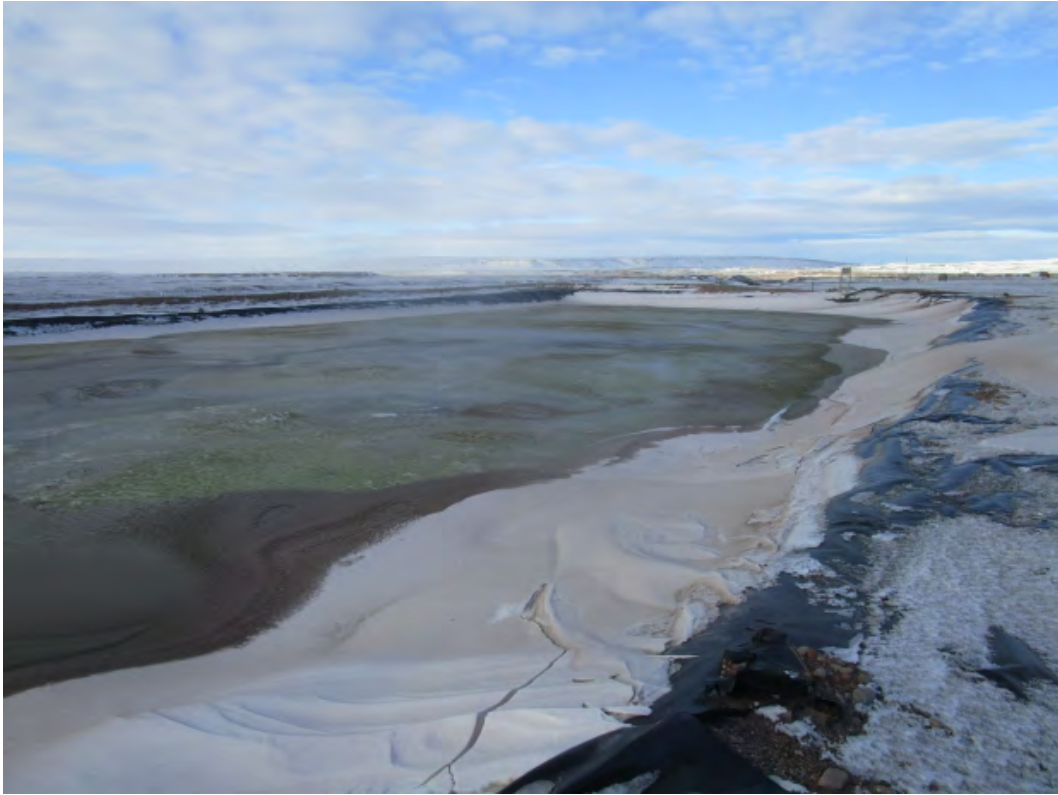
Our review of this area around the pond at the base of the slopes showed no sign of seepage; hence, we conclude that the liner has been effective in containing sewage. There are no tears or ruptures in the membrane, excepting some minor tears from past activity at the top of the dyke well above the allowable effluent level in the structure in the horizontal portion of the membrane. Travel with small machinery in the past has caused many punctures and small tears in the top of the dyke.

The damage to the liner at the top of the dyke at the area where trucks dump into the cell should be repaired.

C. PWSP #1 – Repair Liner at Unloading Area

The damage to the liner at the top of the dyke at the area where trucks dump into the cell should be repaired.

Baffinland Action: The small tears on the top of the berm walls where vacuum truck offload will be repaired by Jul 2019.

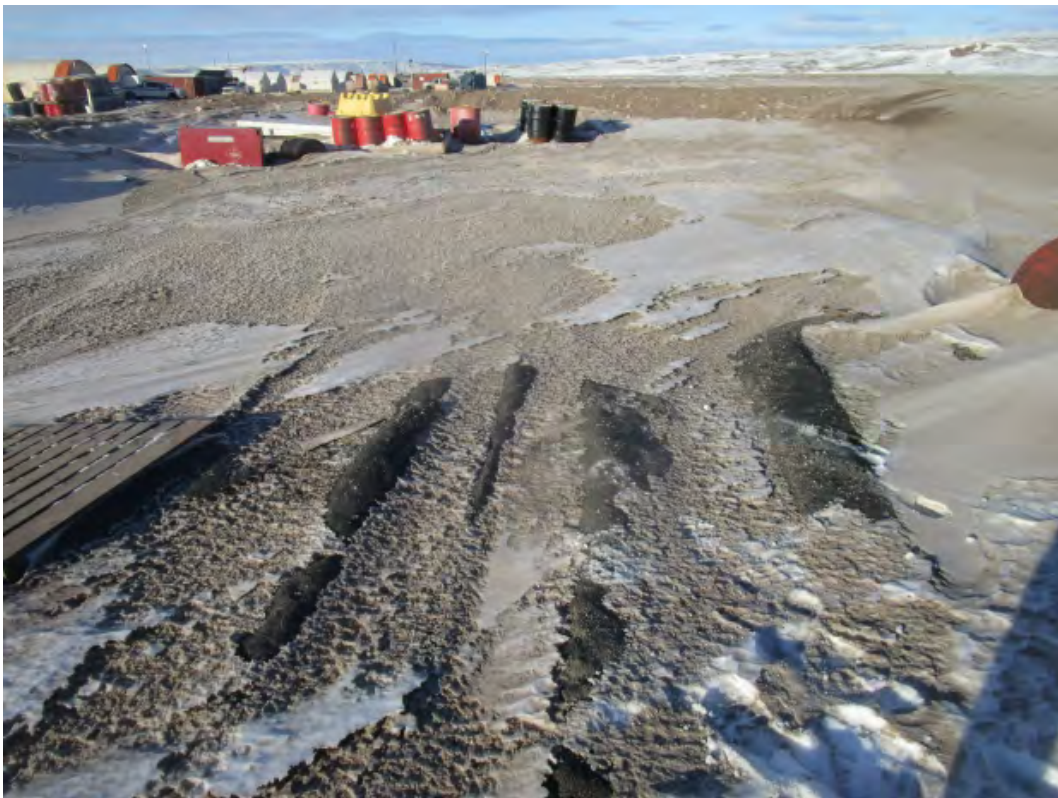
There is an area at the front of the cell where traffic has exposed the liner. This liner is to be covered.

H. MS-HWB-2 – Hazardous Waste Storage – Exposed Liner

Baffinland Action: Aggregate will be used to cover the exposed area as soon as conditions and snow cover allow.

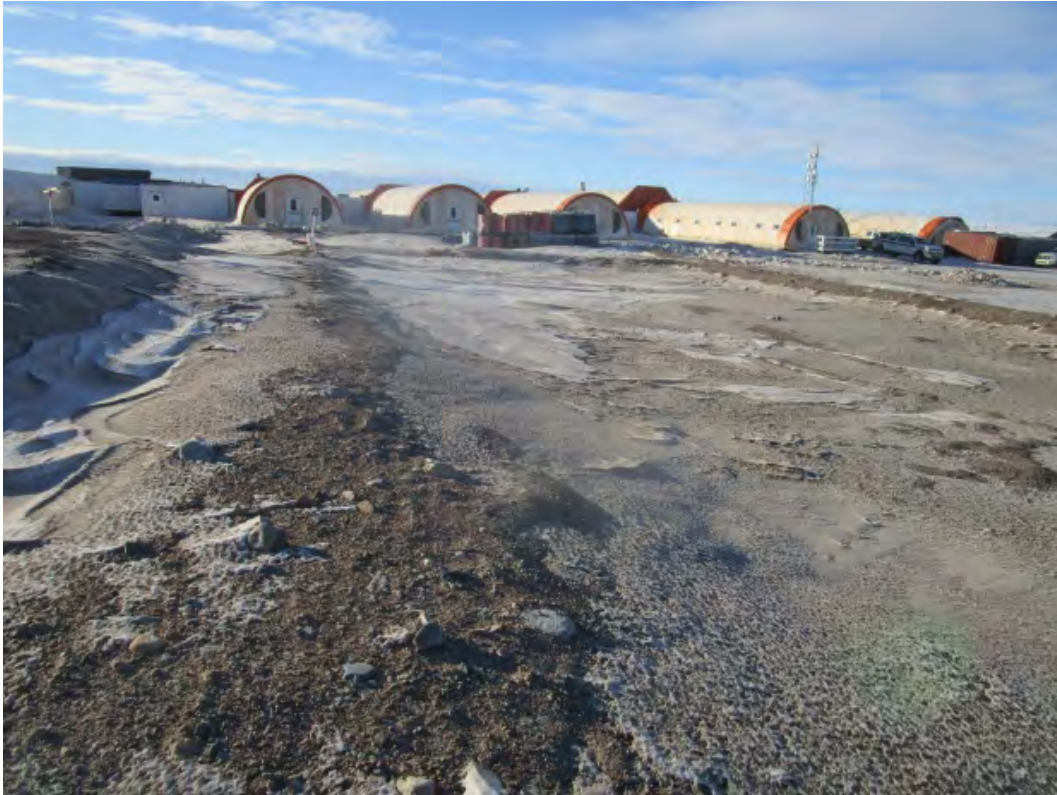
We recommend that the geotextile over the liner be checked and the granular cover be made good prior to continuing use of this cell. Alternatively, as the cell has not been utilized for over a year, it could be removed.

I. MS-HWB-5 – Envirotank Storage

We recommend that the geotextile over the liner be checked and the granular cover be reapplied prior to continuing use of this cell.

Baffinland Action: The cell is currently not being used and has been left empty. The Site Services Department are aware that this area shall not be used for the storage of Hazardous waste or substances until it has been repaired. Alternatively, this facility may be decommissioned.

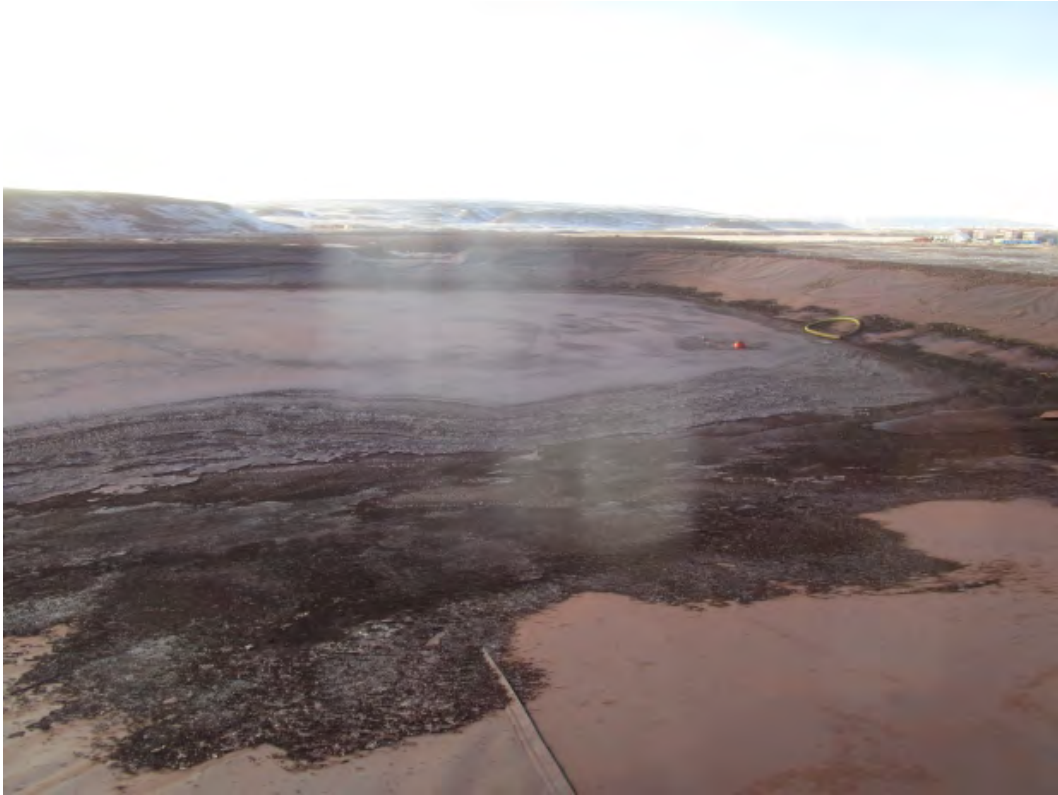
We recommend that the ore on the pad be placed to suit the design with an 3m buffer between the ditch and the ore. This shall require the relocation some ore. Ditches were snow filled and could not be reviewed fully.

O. Crusher Pad Drainage Containment (MS-06)

We recommend that the ore on the pad be placed to suit the design with a 3m buffer between the ditch and the ore. This shall require the relocation of stockpiles. Ditches were snow filled and could not be reviewed fully.

Baffinland Action: As in 2018, Baffinland will continue to perform ongoing design maintenance of drainage ditches in 2019. Baffinland recognizes the original 2013 Hatch design stating a 3m setback of material from the ditching perimeter and material accessible by heavy equipment has been setback 3m, however, the stockpile design results in certain areas being difficult to access. Baffinland is developing a progressive strategy to address this issue and will work towards addressing this setback in the 2019 season. As an interim supplementary measure to ensure fines do not slough into the ditching structures, strategically spaced out oversize rock barriers have been placed.

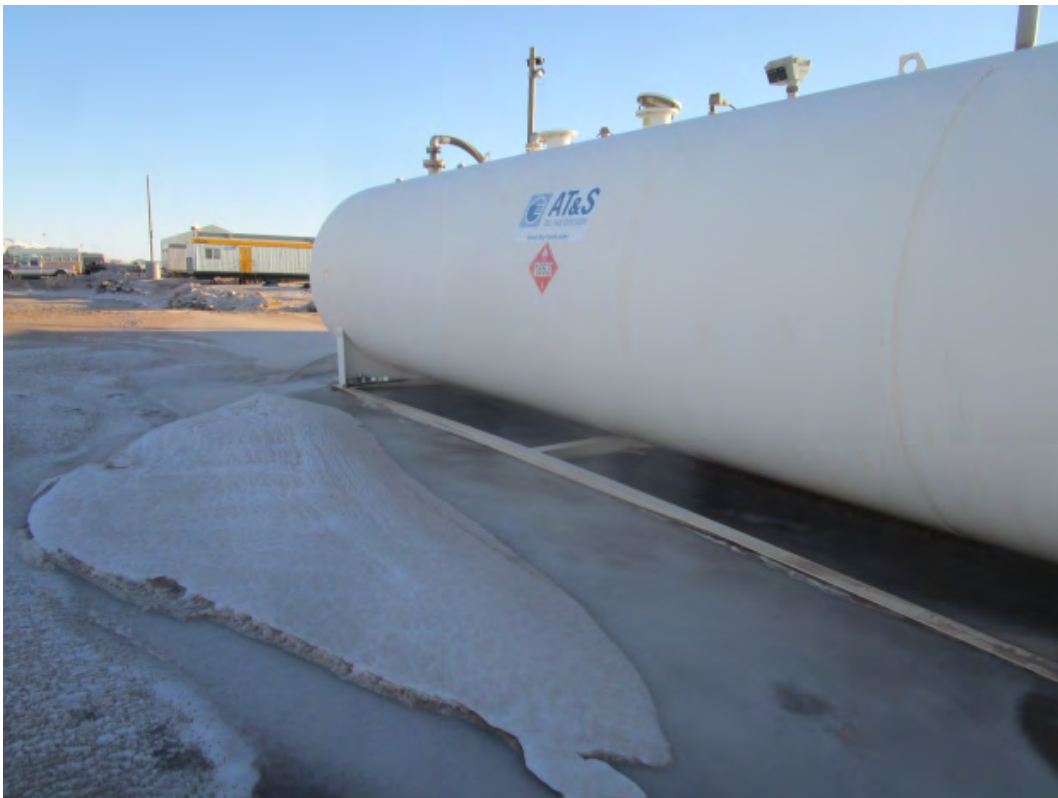
There is one small area of exposed liner on the west dyke of this containment. This exposed liner should be covered with material.

R. Jet 'A' Fuel Containment

Baffinland Action: The liner will be covered with material as soon as snow conditions allow.

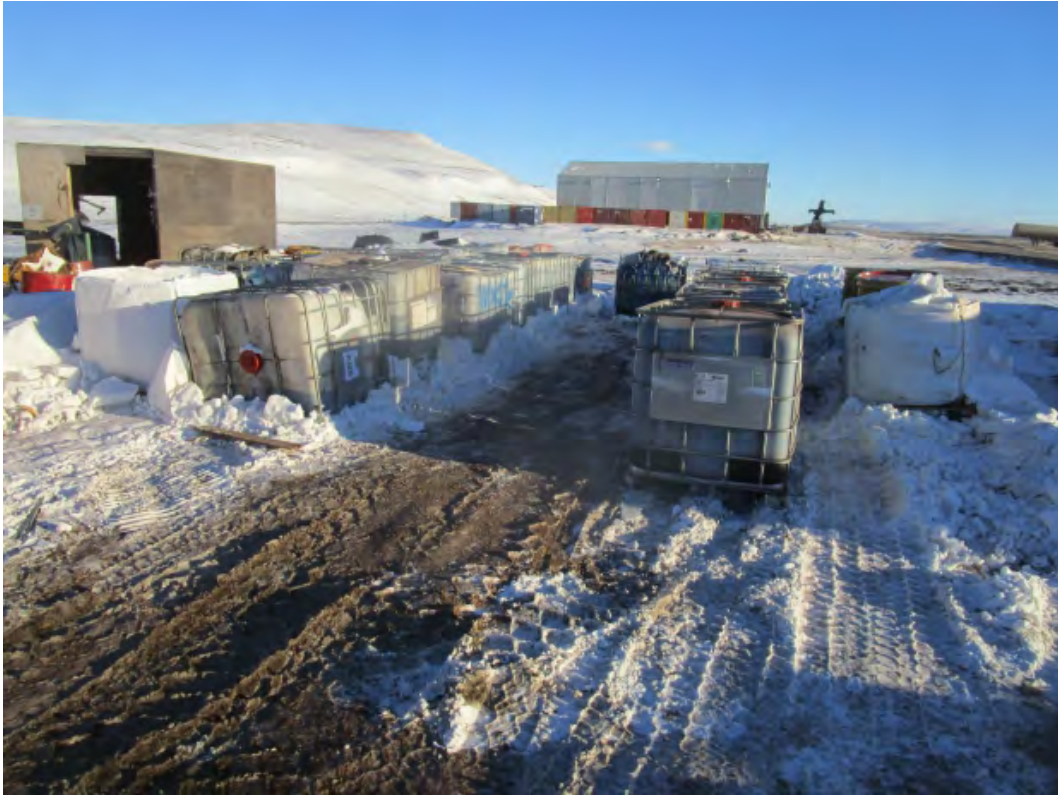
There is ice and water ponding in the bottom of the cell confirming the integrity of the liner. There are tears in the enviroliner noted with three in the west side and one in the south east corner. All waste is in barrels or totes and is contained. The tear in the liner in the south east corner has been repaired but not covered. Other tears have not been repaired and are slightly above the bottom of the containment.

We have no recommendations with respect to this structure other than making repairs to the damaged enviroliner in three locations. The side dykes should be also built up to keep traffic off them and material stored outside of the dykes should be relocated to within the dykes.

S. MS-HWB-6 – Hazardous Waste Containment

We recommend making repairs to the damaged liner in three damaged locations. The side dykes should be also built up to keep traffic off them and material stored outside of the dykes should be relocated to within the dykes.

Baffinland Action: Baffinland repaired one of the small liner tears in August 2018 and will repair the remaining by July 2019. The tears are located on the berms and are above freeboard levels at this facility.

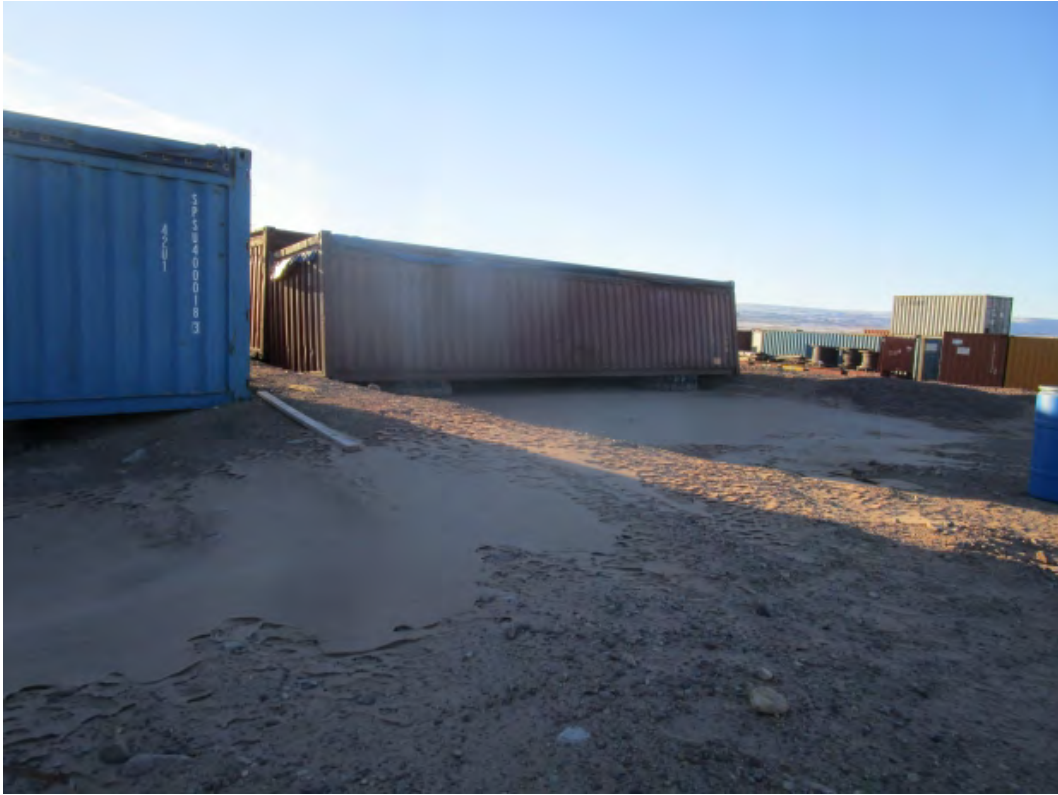
We have no recommendations with respect to the use of these two cells at this time except for repair to the liner in MP-HWB-3 directly in front of the container stored within the cell.

1. Hazardous Waste Storage (MP-HWB-3 and MP-HWB-4)

We recommend to repair the liner in MP-HWB-3 directly in front of the container stored within the cell.

Baffinland Action: Baffinland will make repairs the minor tear by July 2019 which is above freeboard levels.

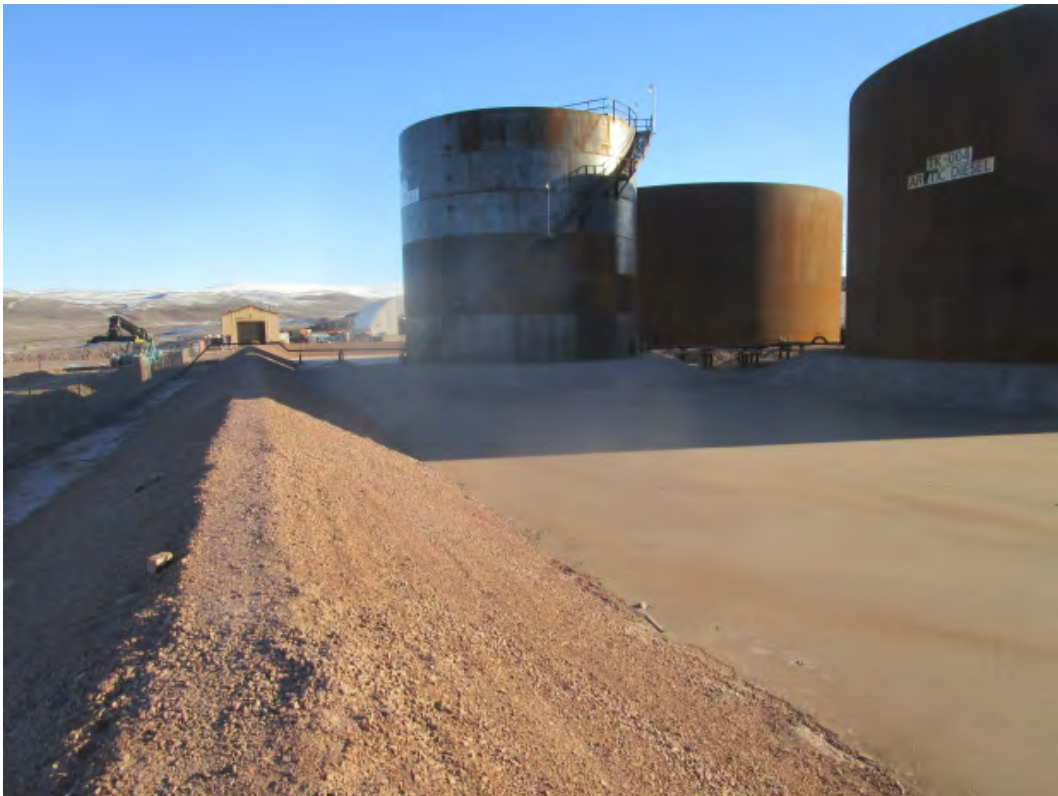
All containment dykes are in excellent condition and there is no sign of weakness except for the top of the dyke midway on the east side where a dozer has turned around on top of the dyke.

We have no recommendations with respect to the containment at this time other than to trim the top of the east dyke.

2. Port Site Fuel Tank Farm

We have no recommendations with respect to the containment at this time other than to level/trim the top of the east dyke.

Baffinland Action: Baffinland will perform berm maintenance to level the east dyke by July 2019.

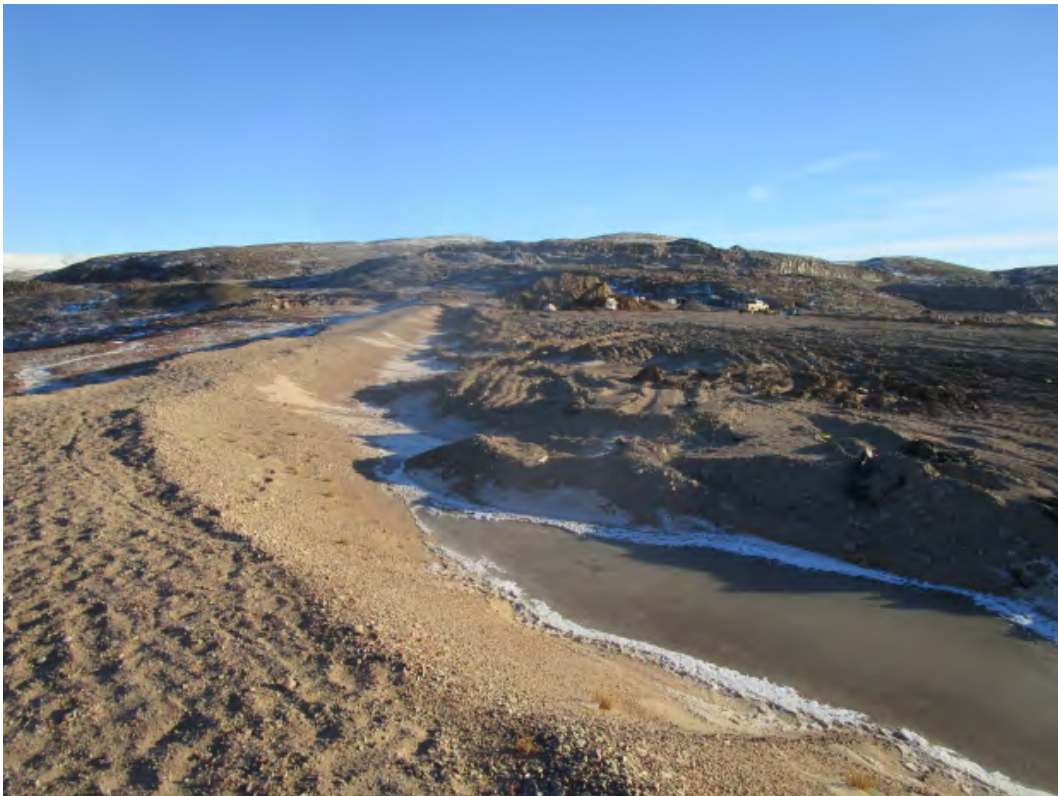
We recommend that as a minimum, the exterior side of the dyke be covered with gravel/soil to at least half way up from the bottom of the dyke at the area around the sump.

4. Land Farm Containment

We recommend that as a minimum, the exterior side of the dyke be covered with gravel/soil to at least half way up from the bottom of the dyke at the area around the sump.

Baffinland Action: Baffinland will cover the exposed section of the Landfarm sump by July 2019.

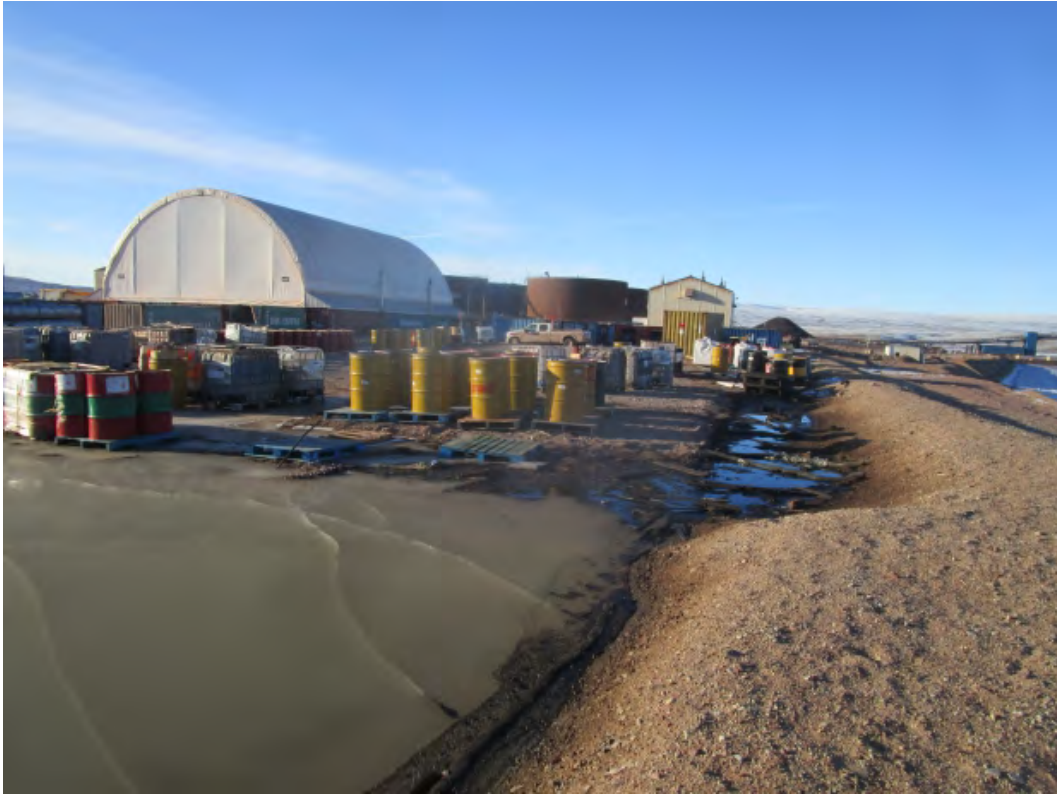
Construction appears stable. However, there is one exposed tear in the liner at the dyke that requires repair. This was noted last year and awaits repair. This tear is where travel took place over the berm on the north side of the structure.

We have no recommendations with respect to this structure other than the liner repair.

9. Loading Area Contaminated Storage (MP-HWB-1)

We have no recommendations with respect to this structure other than to repair the tear on the North Side of the structure.

Baffinland Action: Baffinland will repair the torn liner by July 2019. In the meantime, stormwater and snowmelt in the berm will not be allowed to reach the height of the tear.

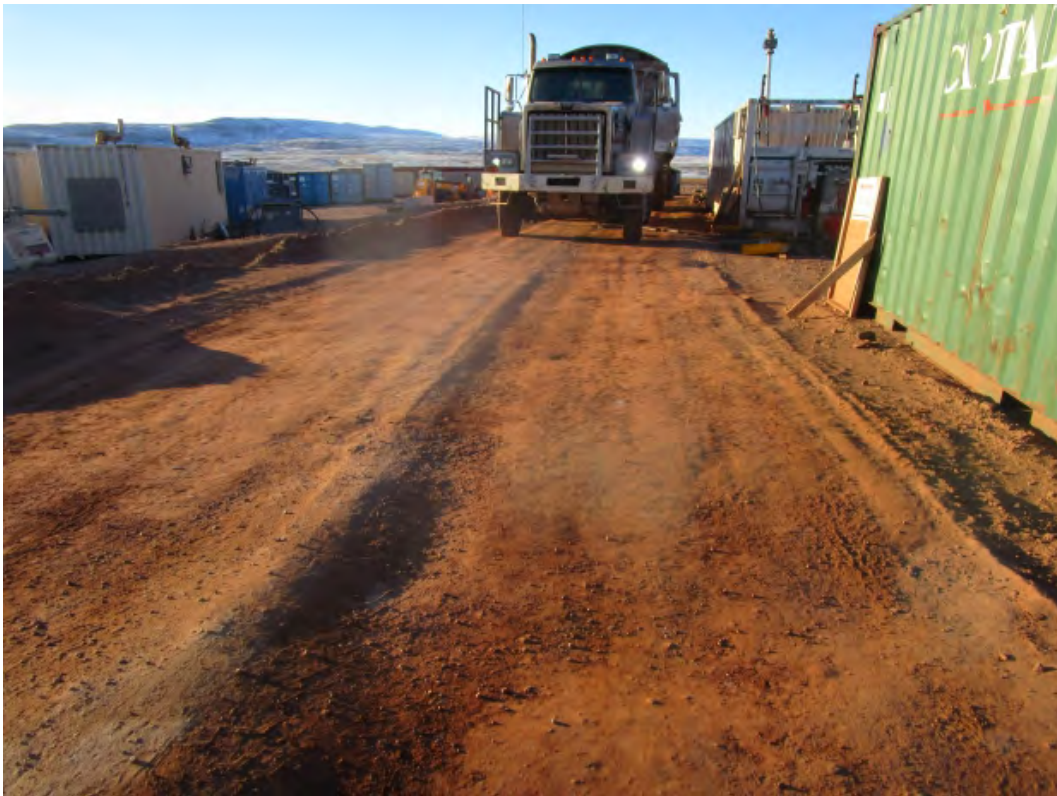
We recommend that 4" to 6" this "mud" and gravel be removed without disturbing the gravel layer over the liner at the base of the structure or the liner in both sides of the fuel tank. It is understood that some work is currently in progress.

10. Fueling Facility Containment

We recommend that 4" to 6" of "mud" be removed without disturbing the gravel layer over the liner at the base and sides of the fuel tank.
