RE: Submission of 2019 Geotechnical Inspection Report No. 1 (July 2019)

Project #: TC190307

Annual Geotechnical Inspections – 2019 Report 1. Mary River Iron Mine Complex – Nunavut

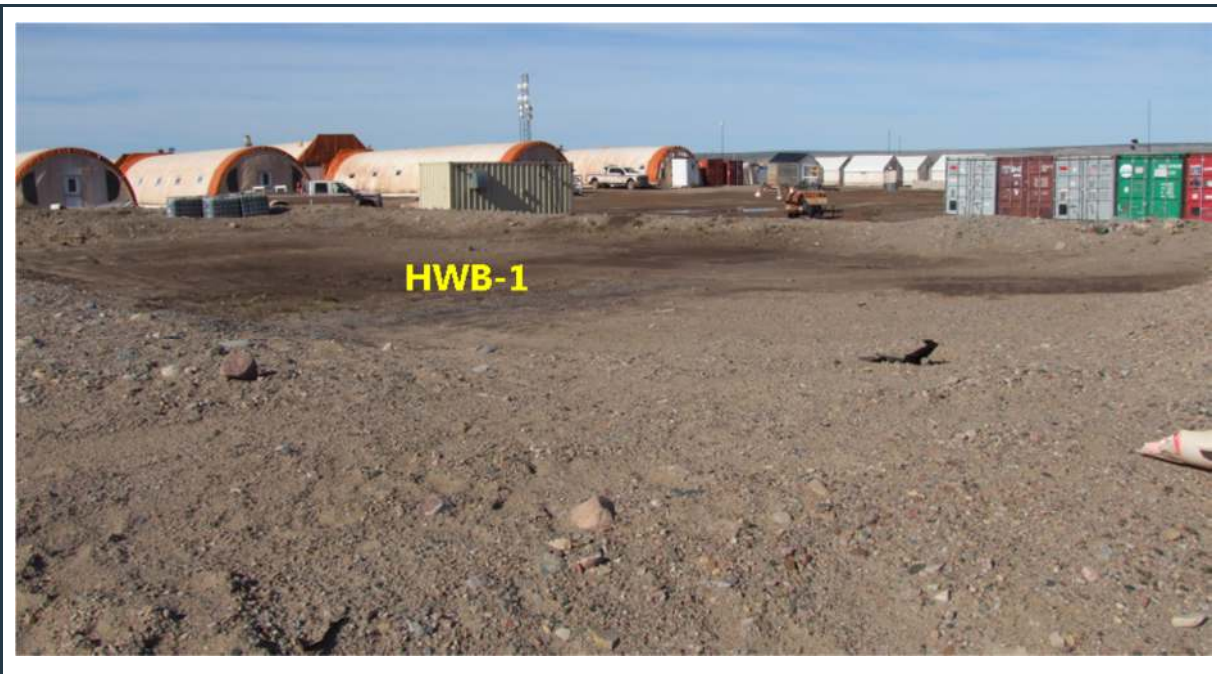
This cell is currently empty, as shown in Figure 11. Based on personal communication with William Bowden at the time of the site visit, concerns have been raised recently to suspected liner damage within this cell, and consequently no material is stored in the cell. The fact that no ponding water was visible within the cell during the inspection, may confirm this assumption. It may be advisable to rebuild the perimeter berm around the cell, followed by the installation of a new geomembrane liner with sand cover. Once the cell would be reconstructed, all materials from HWB-6 could be transferred into an upgraded HWB-1 cell, and the HWB-6 cell could be decommissioned. The reason for this suggestion will be explained within the section of HWB-6, in page 10.

Figure 11: View of HWB-1 – Currently this cell is empty

Baffinland Action: The cell is currently not being used and has been left empty. Baffinland shall not use this facility for the storage of hazardous waste or substances until it has been repaired. Alternatively, this facility may be decommissioned.

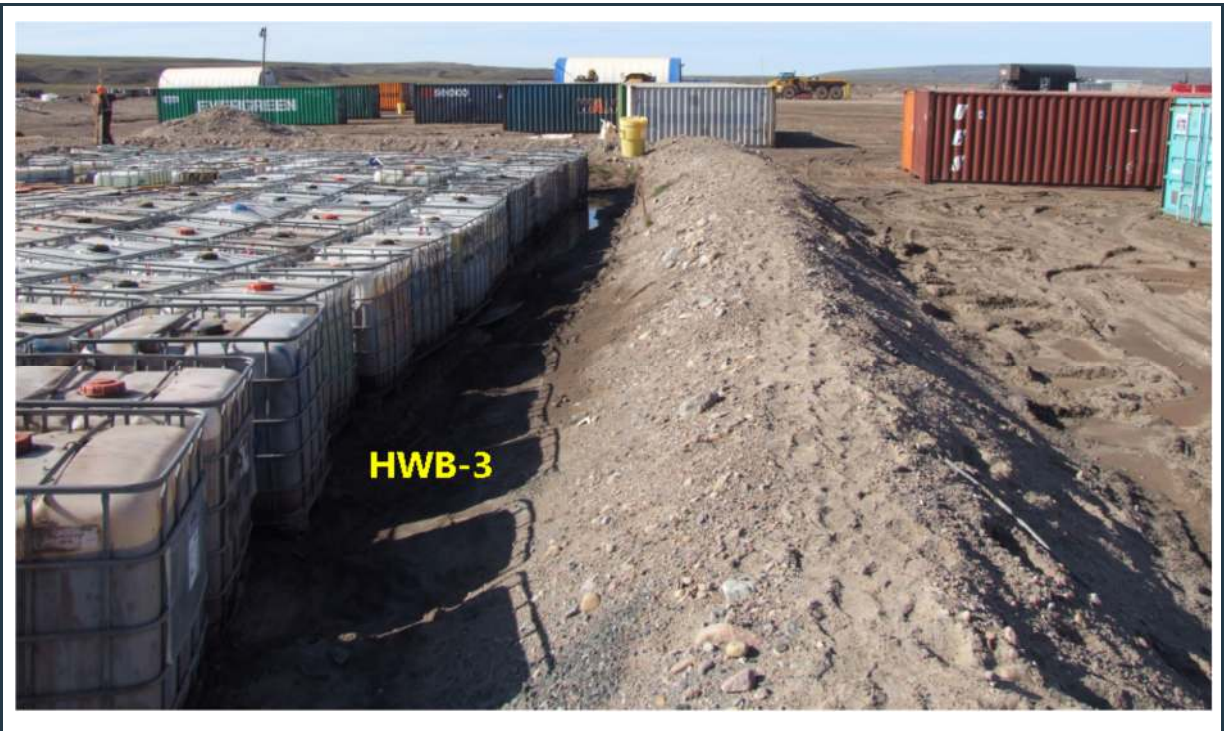
Figure 13: View of HWB-3

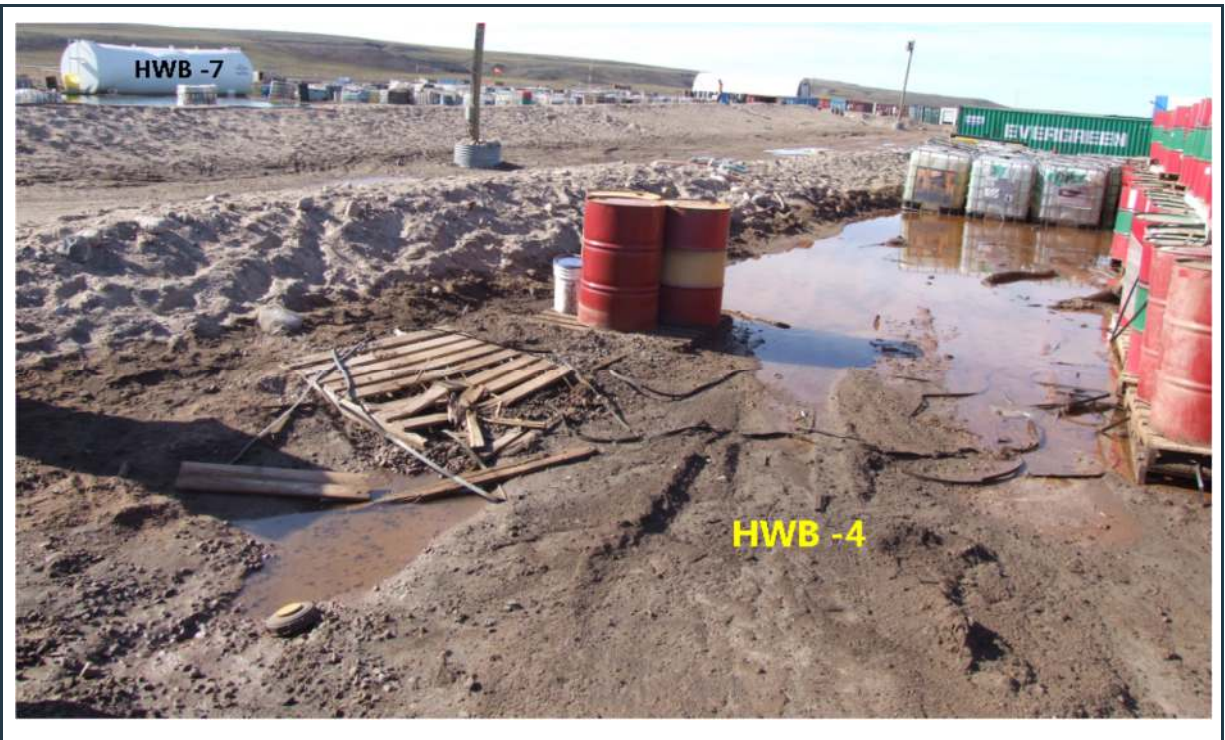
The photographs of the cells attest stable berm condition, and good liner performance (e.g., ponded water in Figure 14). However, it is also shown on the images that foot traffic had caused disturbance on the slopes of the berms and that should be avoided. Furthermore, access points into the cells should be limited and foot traffic on the berms, particularly on their slopes, should be minimized. Furthermore, damaged wood pallets (shown in Figure 14) with nails sticking out of them, should be stored in a designated area, in order to minimize the possibility of liner damage by the nails.

Figure 14: View of HWB-4

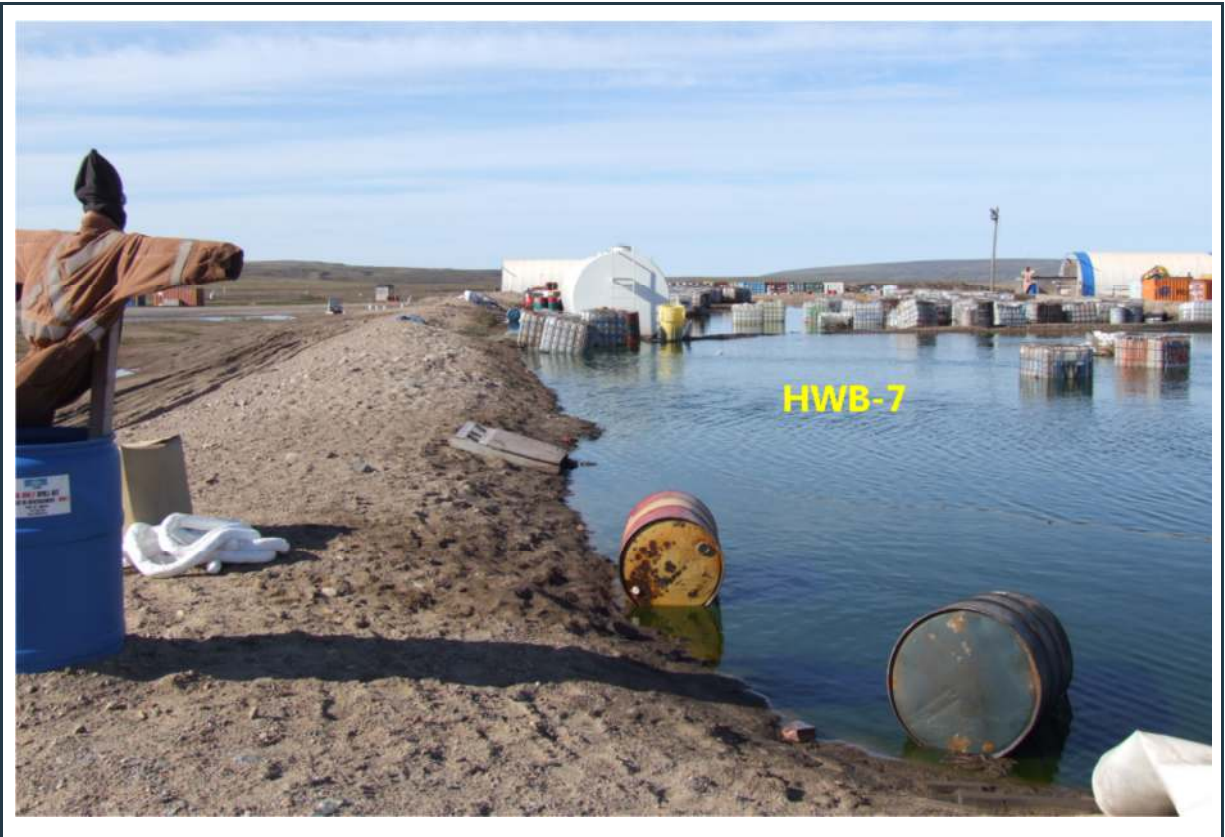
Minor damages to the geotextile (covering the liner) were noted at a few locations on the crest and downstream slope of the berm.

Minor damages to the geotextile (covering the liner) were noted at a few locations on the crest and downstream slope of the berm. It is recommended that the geotextile and soil cover be reinstated at those locations, in order to prevent potential damage to the liner in the future. As part of such maintenance program, regrading of slopes affected by foot traffic disturbance is recommended.

Figure 18: View of HWB-7

Baffinland Action: Baffinland commits to reinstating geotextile and soil cover in the specified areas in order to prevent potential damage to the liner in the future.

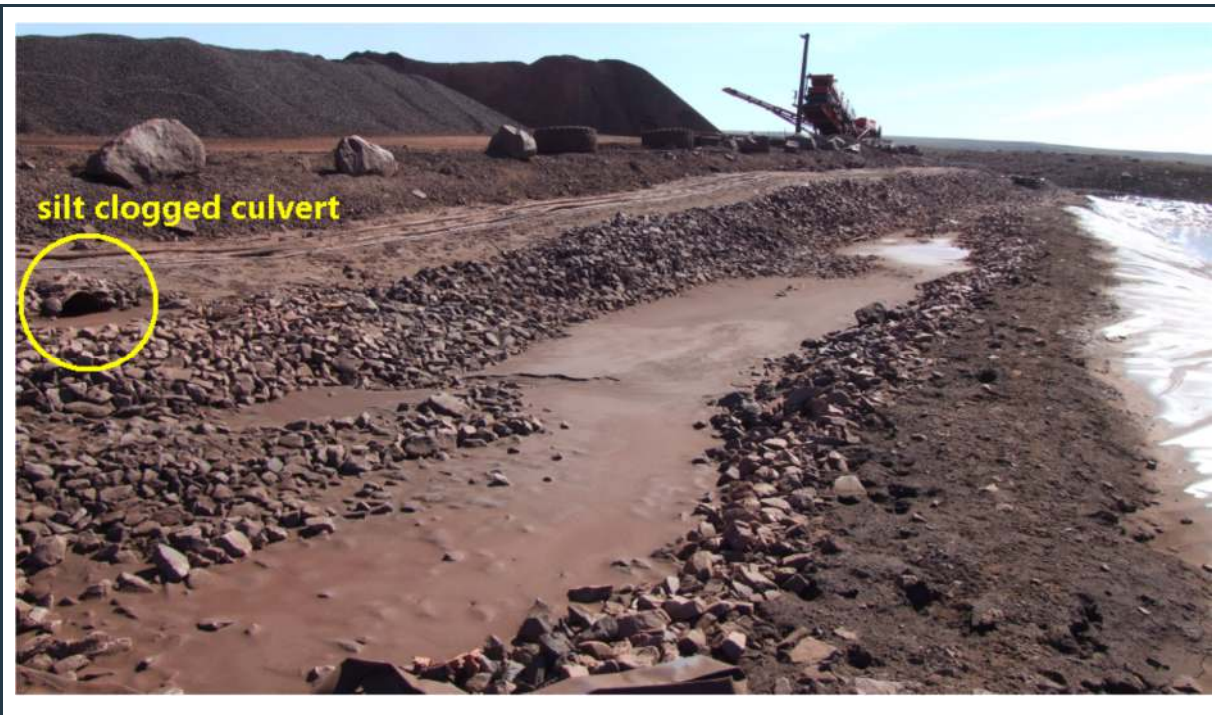
The side slopes of the water collection ditches were observed to be stable (Figures 21, 22 and 23). As with any other run-off collection ditches, the silt sized soil particles are accumulated at the base of the ditches (siltation), wherever the effluent flow velocity decreases. This is evident in Figures 21, 22 and 23. The siltation tends to reduce the design wet section of the ditches (flow capacity). The observed silt accumulation does not warrant maintenance measures at this time. However, this should be regularly monitored by mine personnel and any significant reductions in the flow capacity of the ditch should trigger maintenance measures by means of silt removal.

Figure 22: Surface water collection ditch with clogged culvert

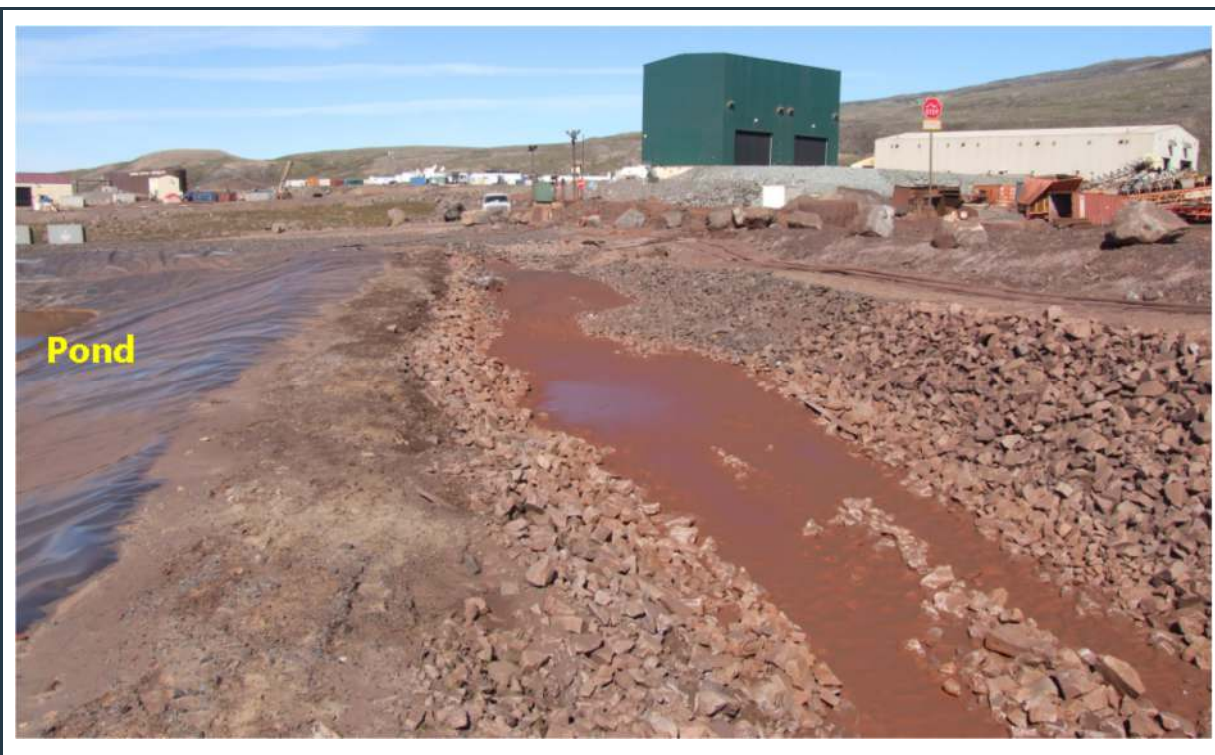
Figure 23: MS-06 surface water collection pond and side-ditch

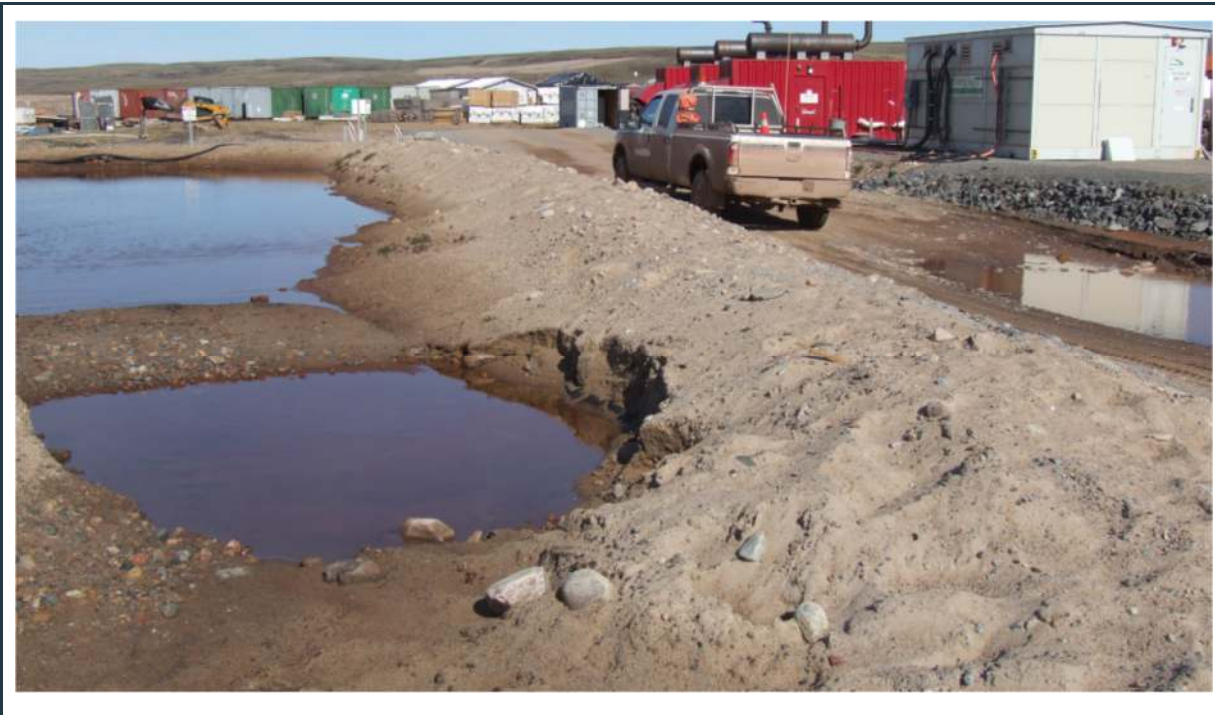
Figure 30: View of minor slope problem at the south-east corner of the berm at the Genset pond

Baffinland Action: Baffinland commits to bringing granular fill to this location to re-fill the slope and regrade the area. In addition to the repair work on the slope, the southern, lower section of the berm will be reconstructed to its original geometry.

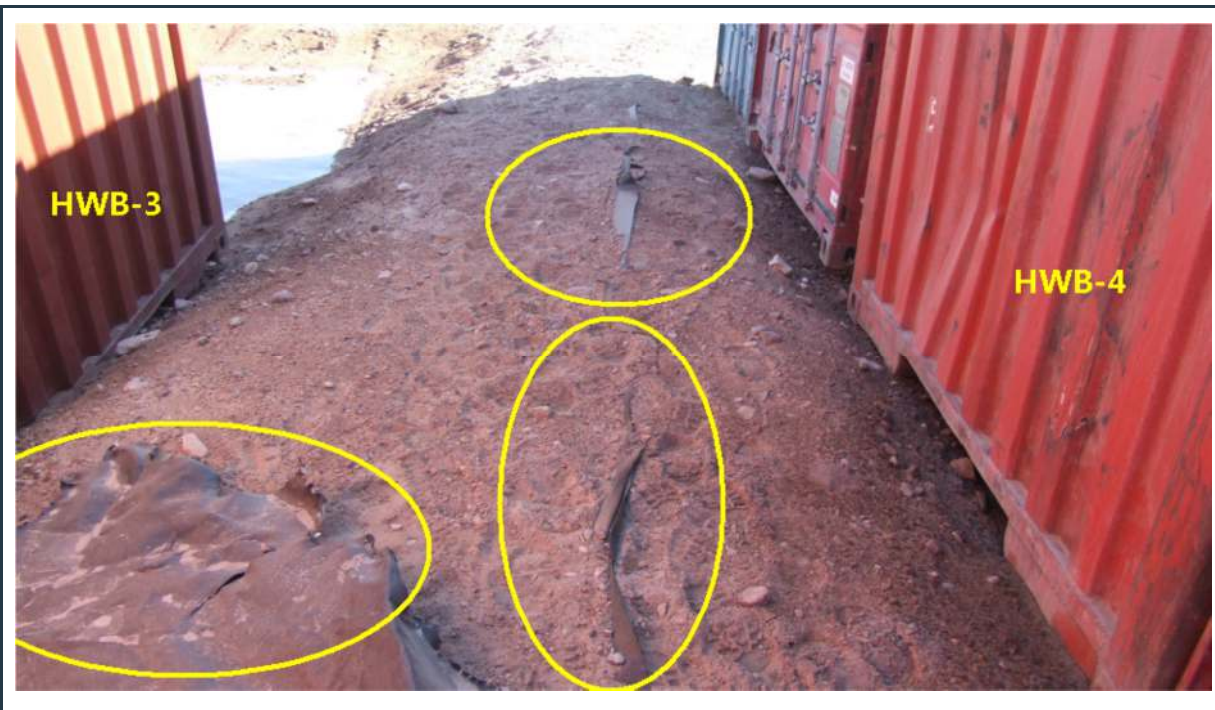
Ripped geotextile and exposed liner were noted at a few locations at higher elevations along the berm.

Figure 47: Exposed liner between the HWB 3 and HWB-4 ponds

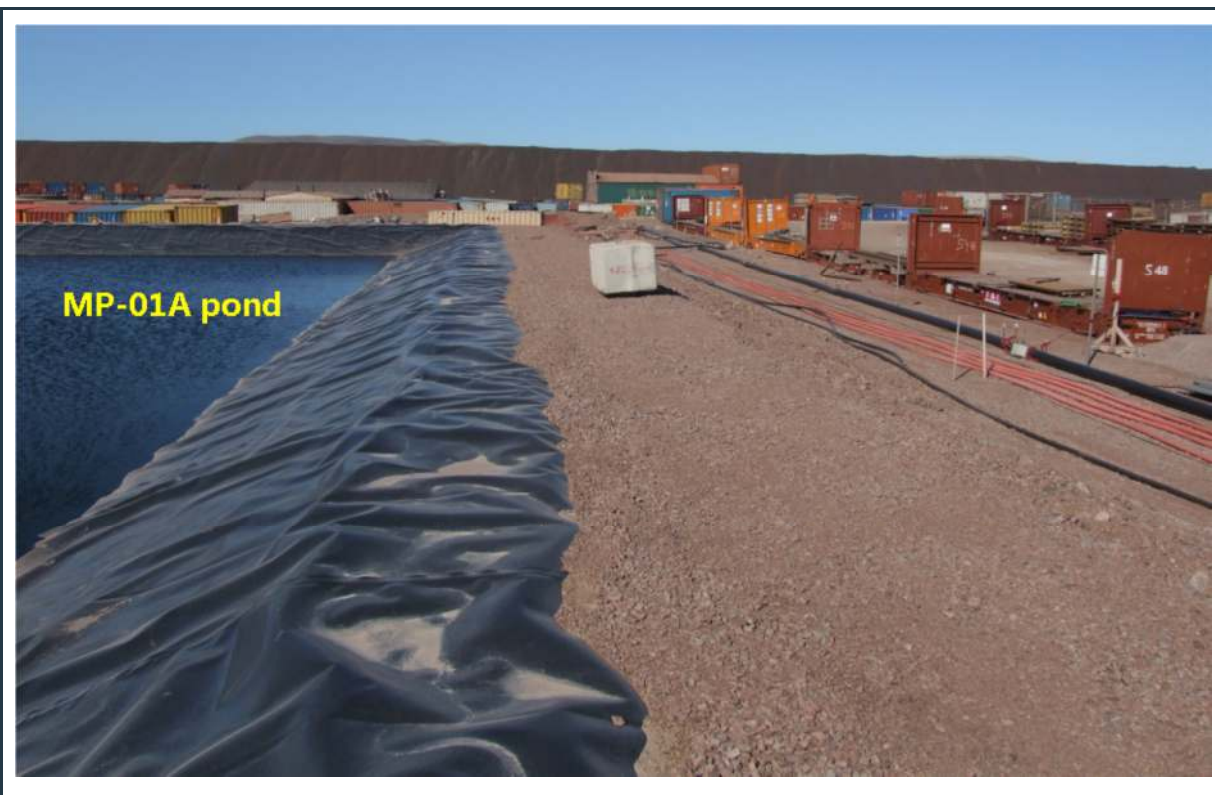
Figure 49: Berm in excellent condition with stable slopes around the MP-01A pond

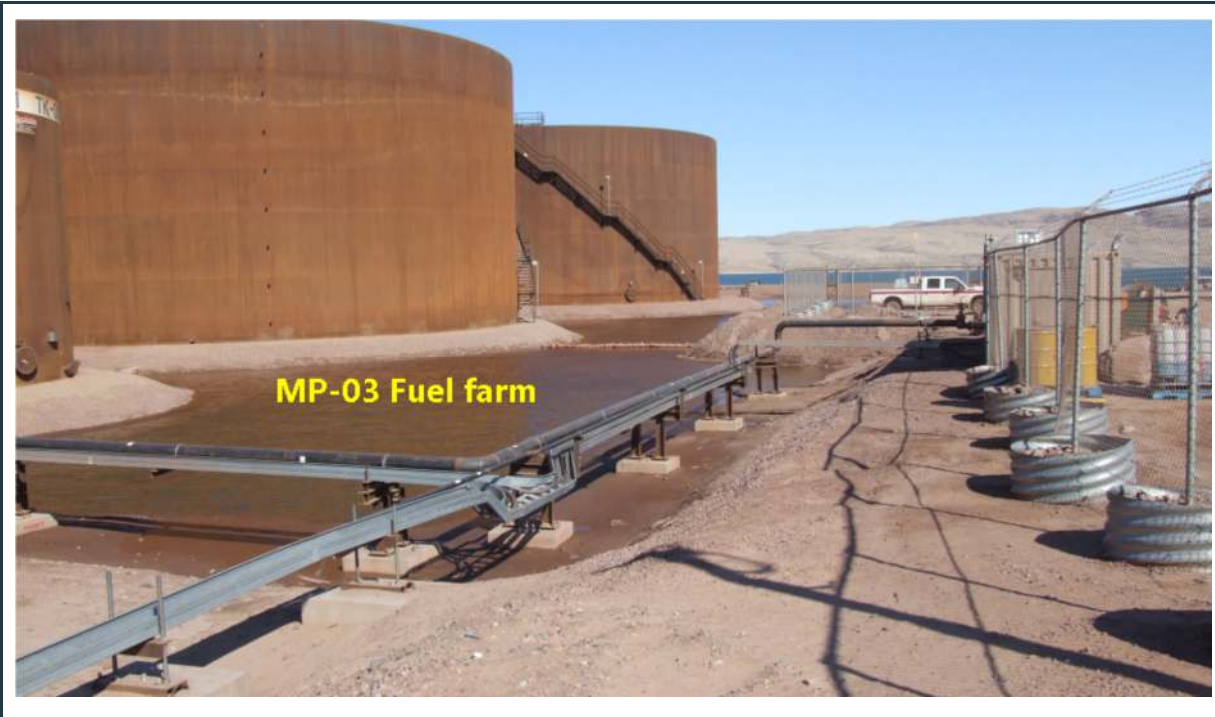
Figure 50: View of stable, well maintained berms around the MP-03 fuel tank farm

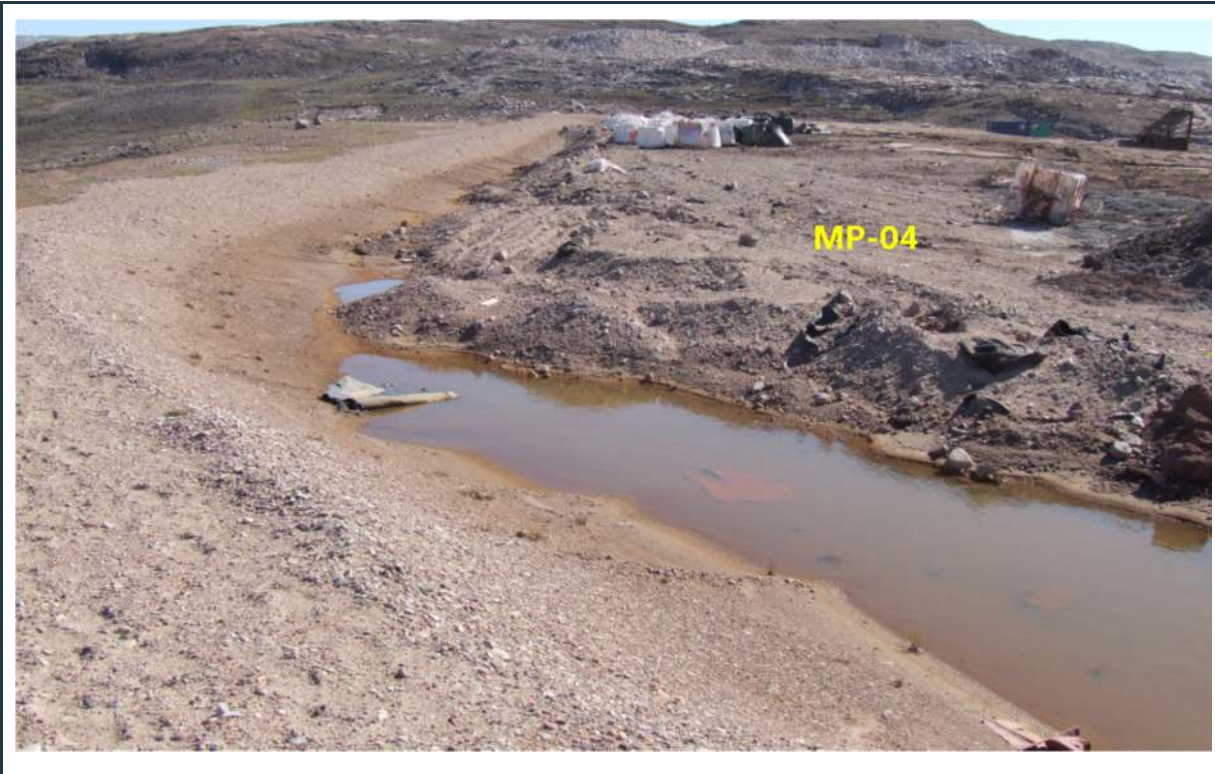
Figure 52: View of the waste and the stable berm at the MP-04 landfarm

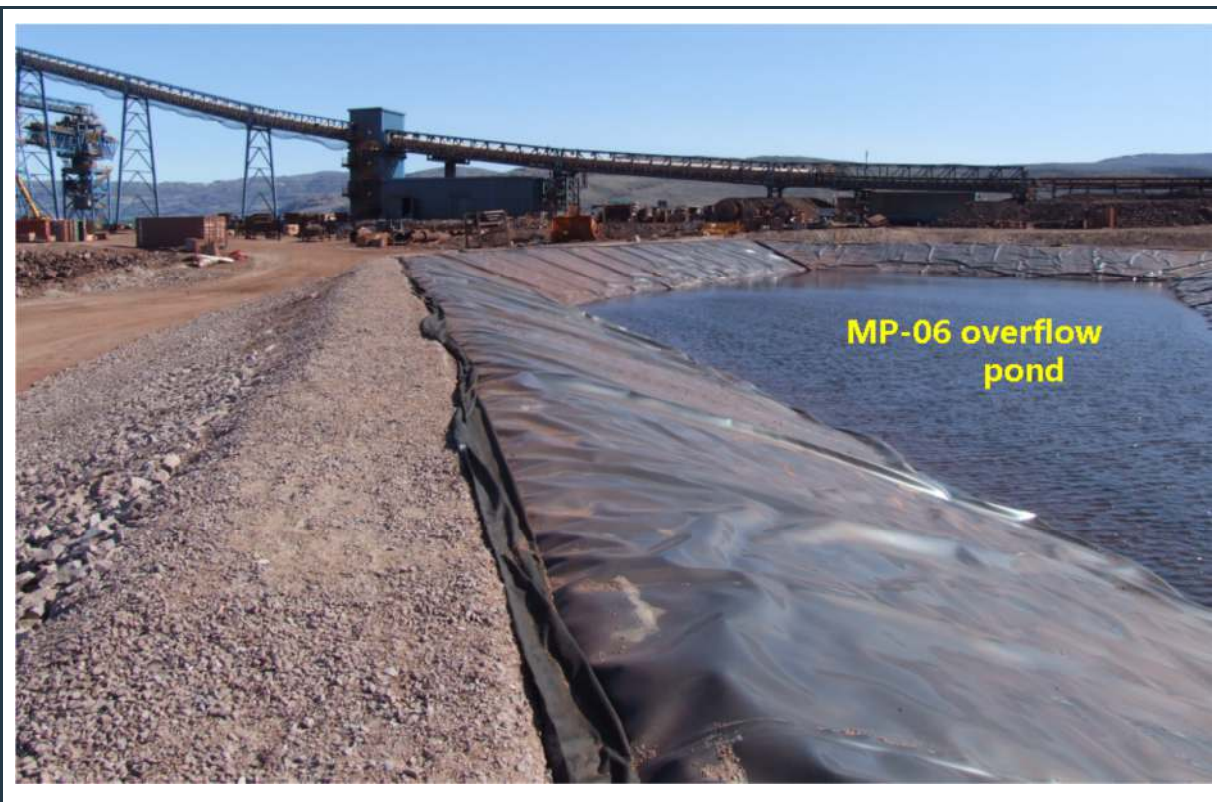
Figure 59: View of the MP-06 overflow pond with stable berm in excellent condition

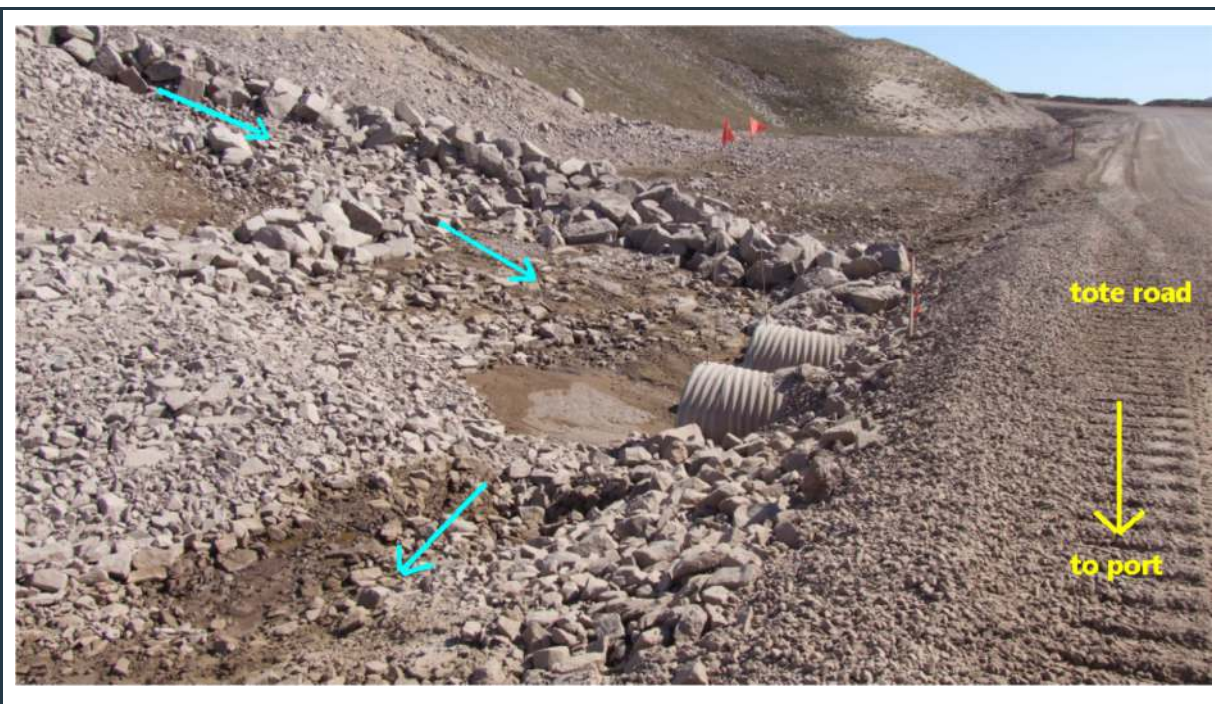
Figure 69: Surface water bypassing the two culverts installed under the tote road

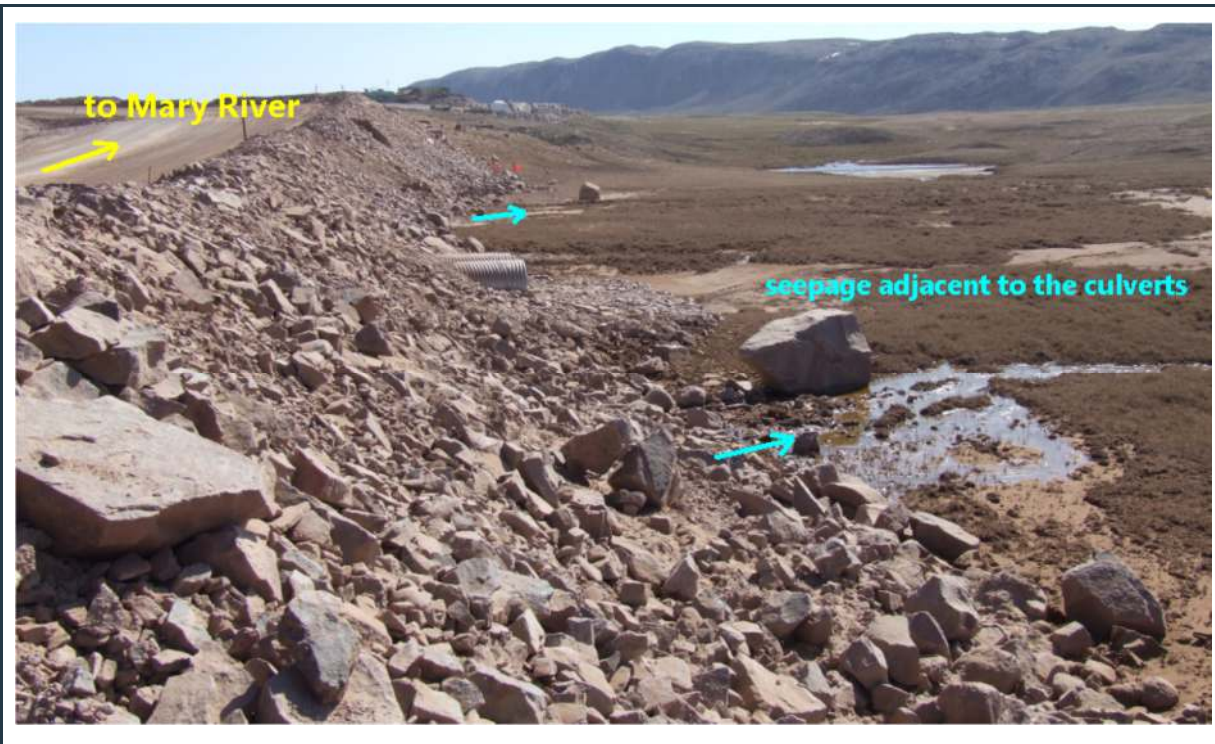
Figure 70: Water seepage through the road embankment adjacent to the tote road culverts

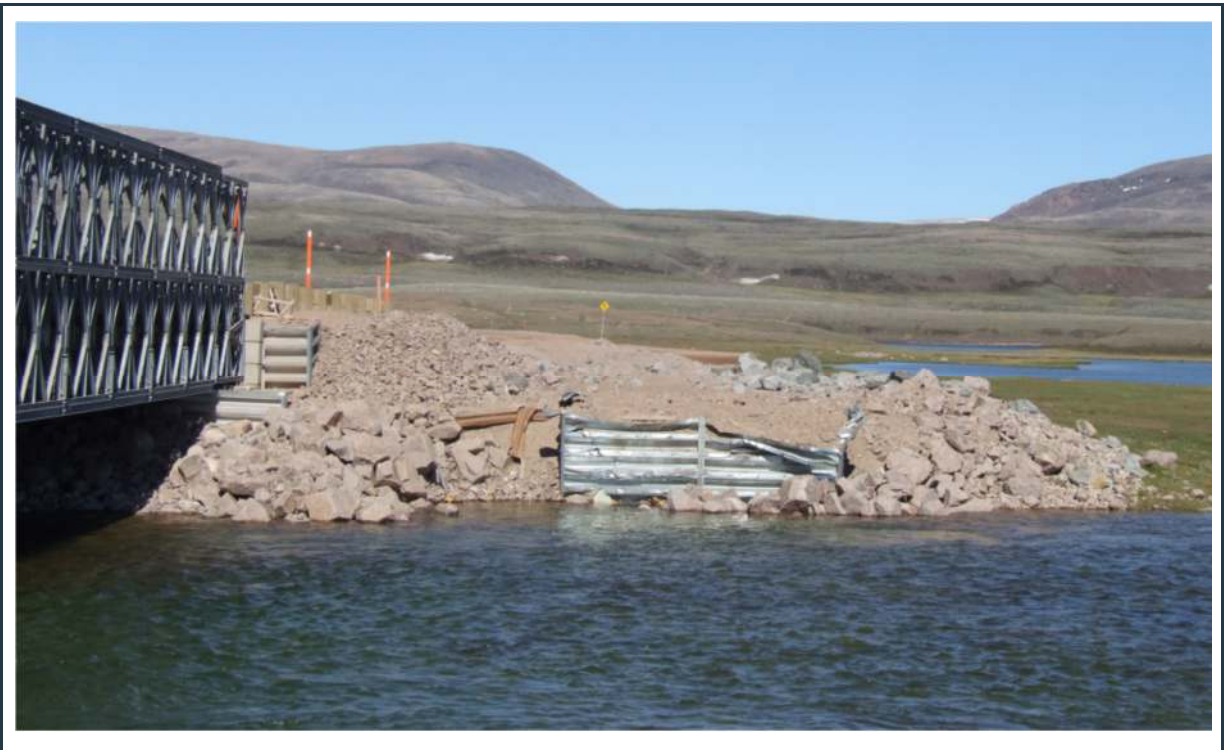
There are two historic abutments, located immediately adjacent to the “new” ones. The metal front and wing walls of both “old” abutments have suffered damages in the past, particularly the south abutment.

Figure 75: The "old" north-east abutment at bridge 17

Baffinland Action: To maintain the stability of the currently used bridge abutments, Baffinland will keep the two old abutments in place since they provide support to the adjacent new structures. Baffinland will schedule repairs to the damaged sections of the abutments identified during the inspection. Additional rip-rap on the regraded granular fill slopes will also be placed to prevent erosion.

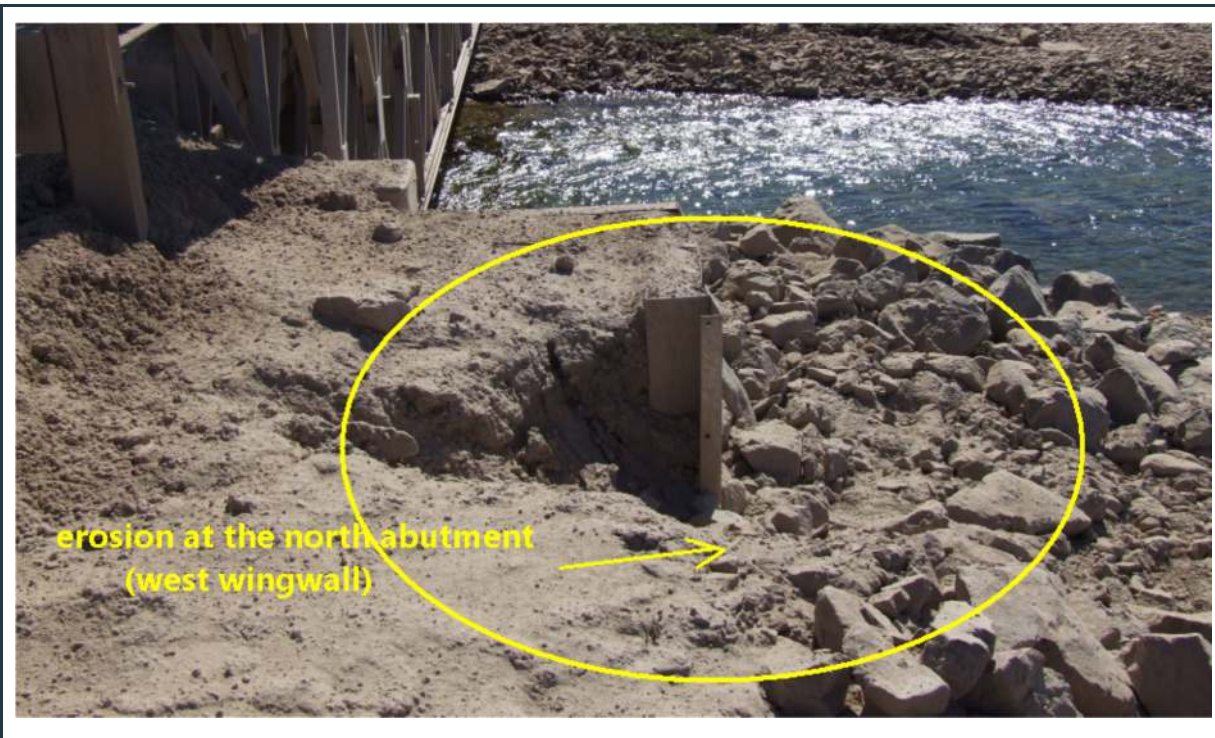
Figure 78: Minor erosion at the north-west wingwall at bridge 63

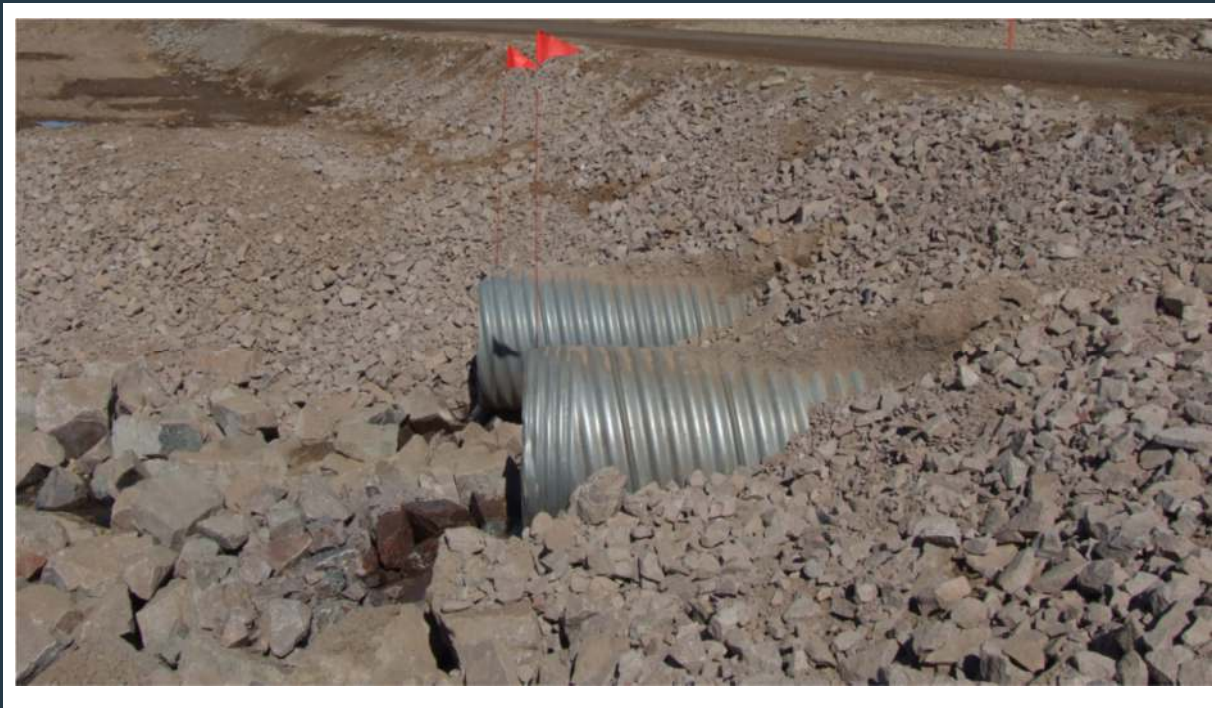
Figure 88: View of culvert(s) 094 (outlet) in excellent conditions

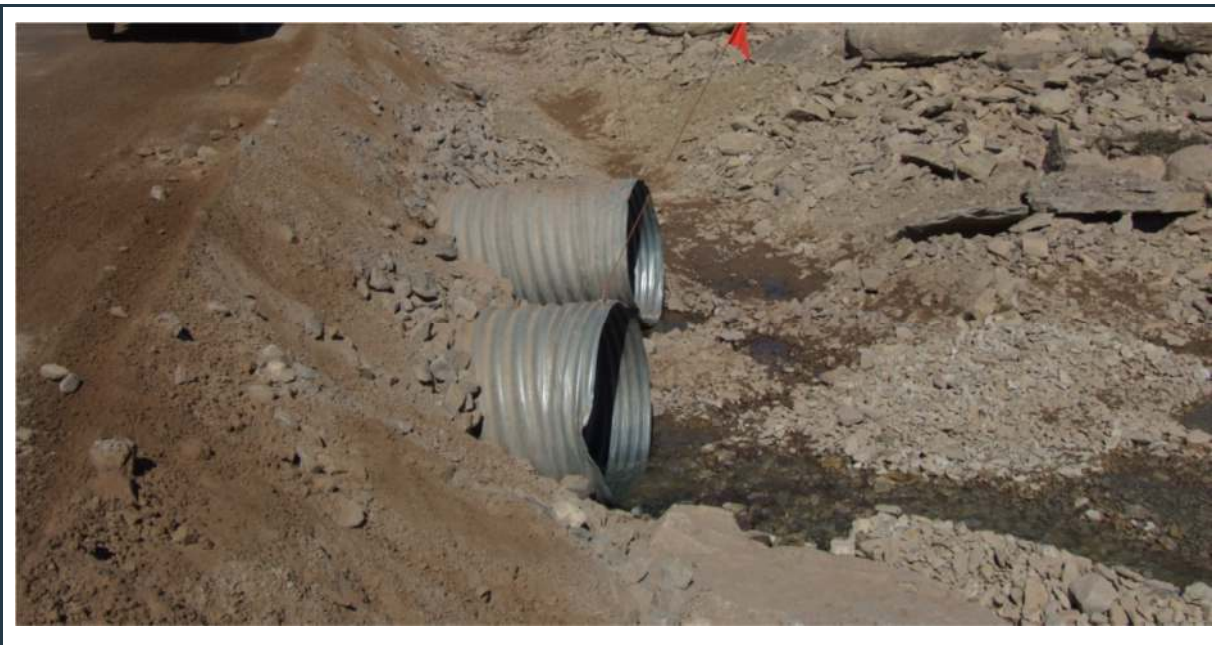
Figure 89: View of culvert(s) 094 (inlet) in excellent conditions

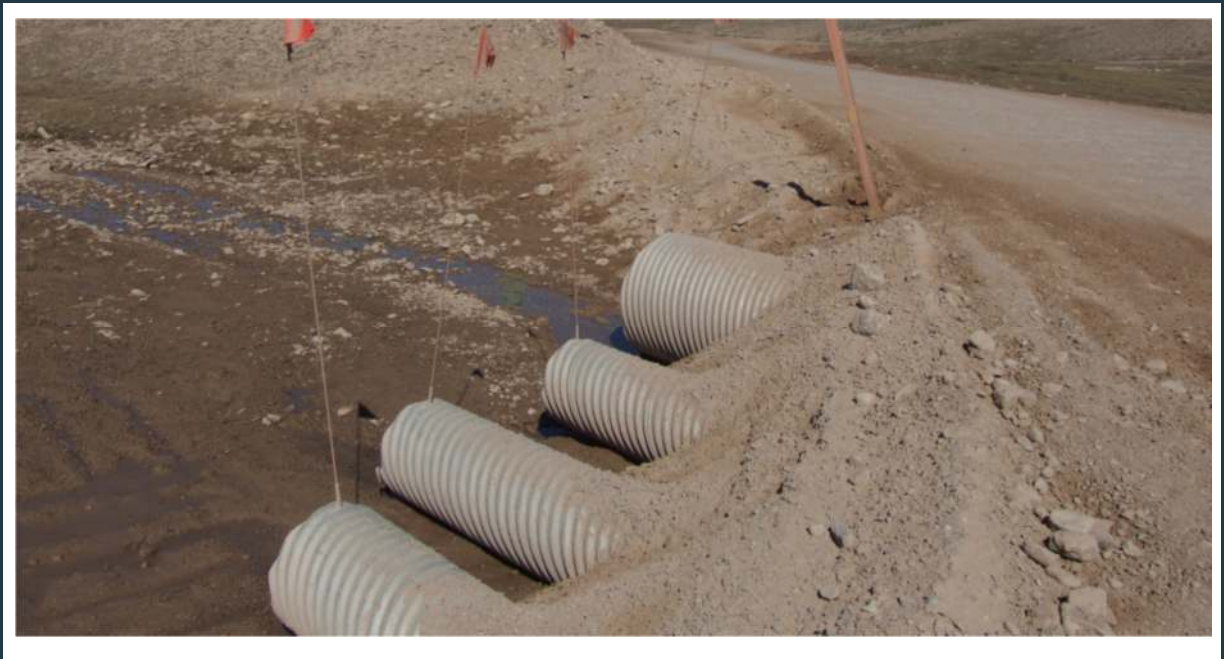
Figure 90: View of culvert(s) 102 (outlet) in excellent conditions

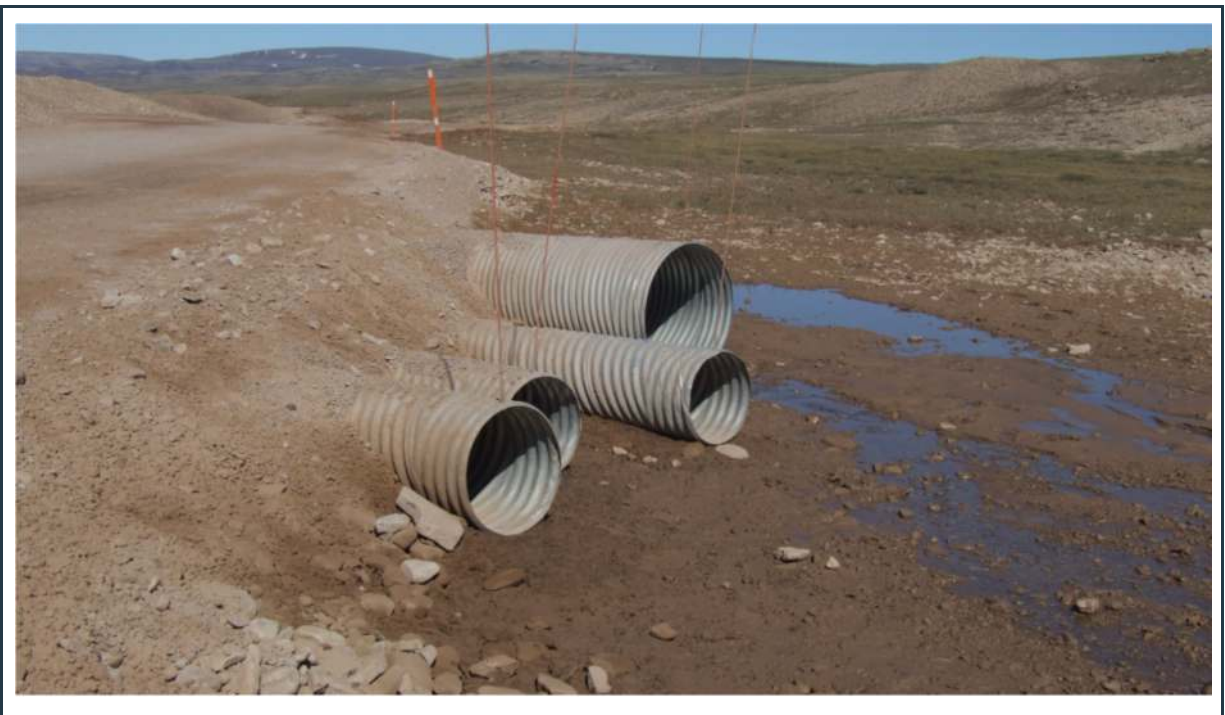
Figure 91: View of culvert(s) 102 (inlet) in excellent conditions

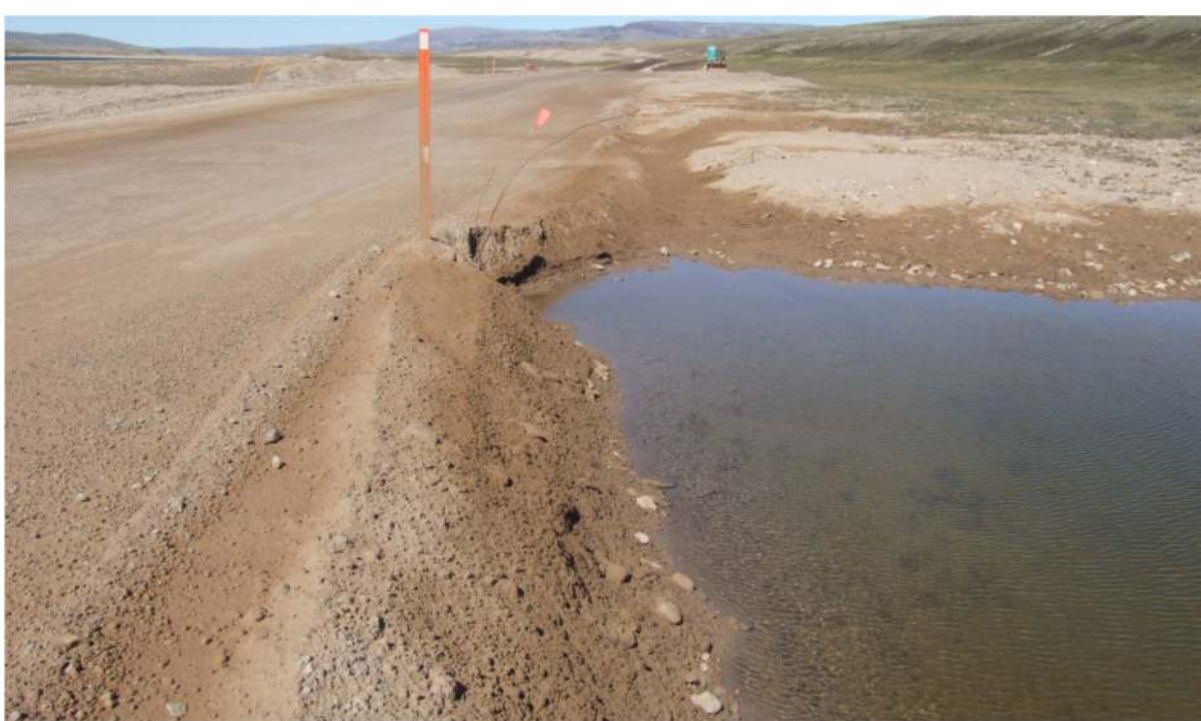
Figure 93: View of culvert 107 (inlet). Extension of the culvert is required.

Baffinland Action: Baffinland commits to further inspecting this culvert and will determine if replacement with a longer, larger pipe is required.

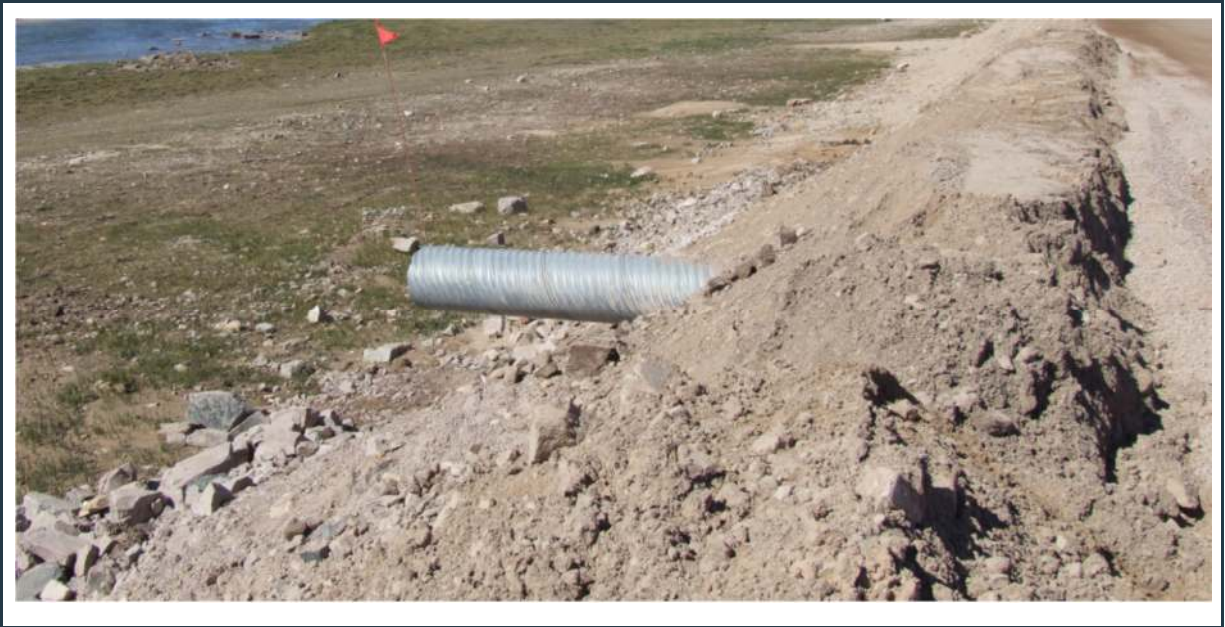
Figure 94: View of culvert 110A (outlet) in good condition

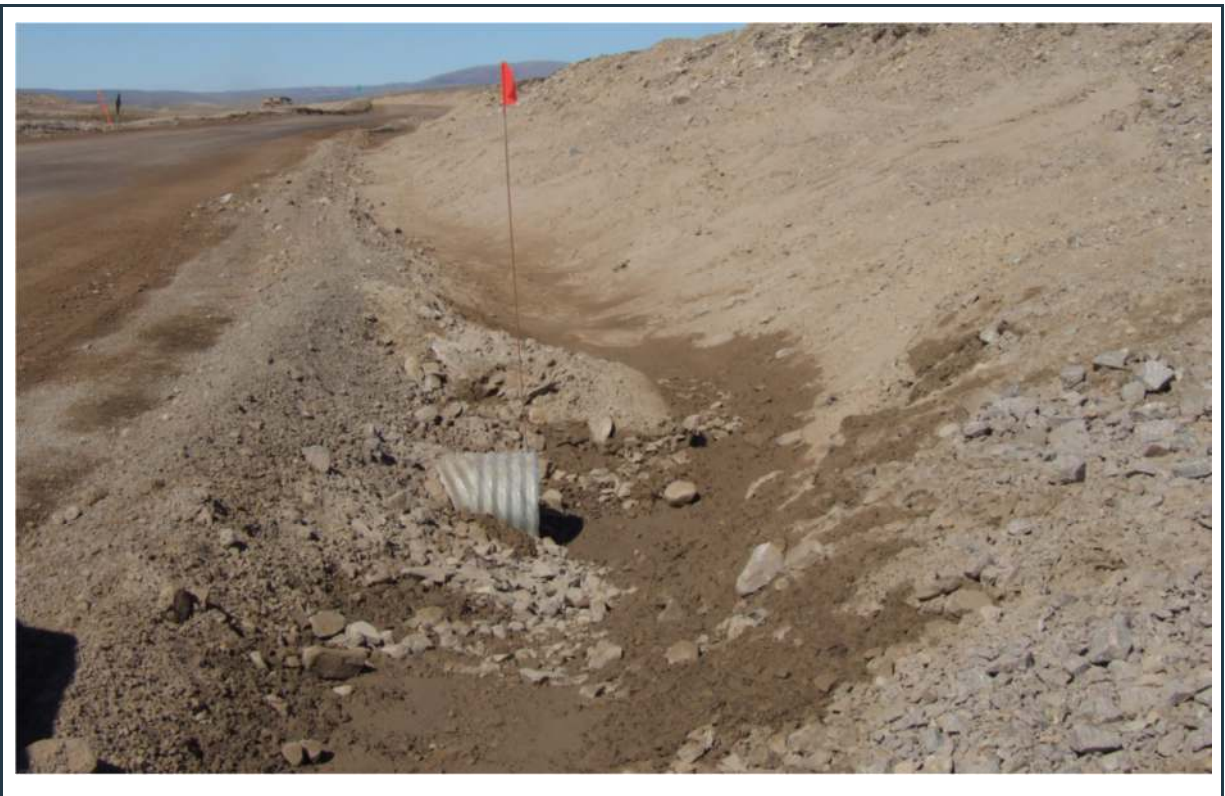
Figure 95: View of culvert 110A (inlet) in good condition

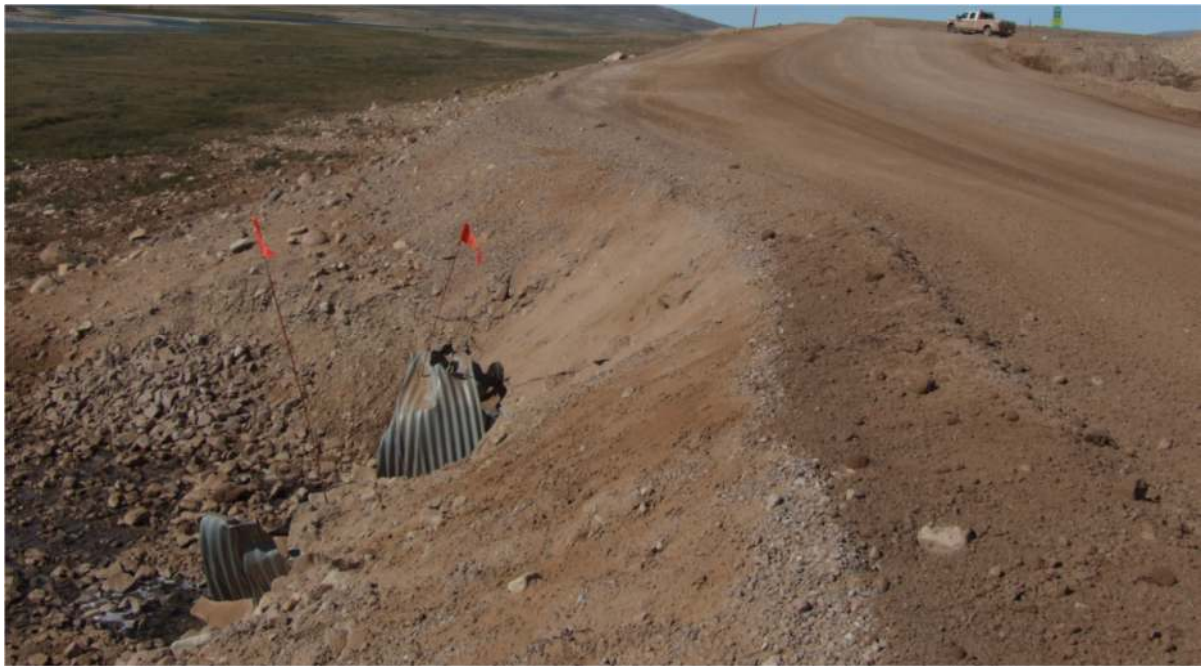
Both ends of this double-barrel culvert are damaged and too short, particularly at the outlet end.

Figure 100: View of culvert(s) 114D (somewhat damaged outlet). Repair and extension is required.

Baffinland Action: Baffinland commits to further inspecting this culvert to determine if replacement with a longer, larger pipe is required. If replaced, both pipes will be repaired and extended. Once the pipes are repaired and extended, the road embankment may be widened.
