RE: Submission of 2019 Geotechnical Inspection Report No. 1 (July 2019)

Project #: TC190307

Annual Geotechnical Inspections – 2019 Report 1. Mary River Iron Mine Complex – Nunavut

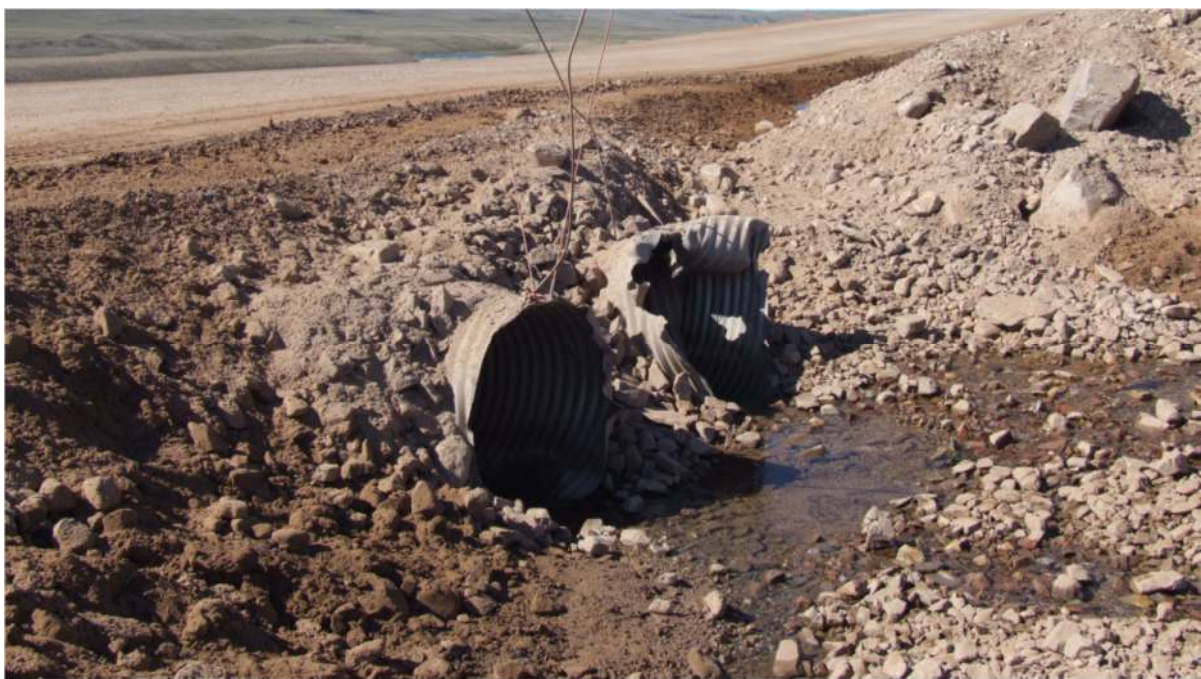
Both ends of this double-barrel culvert are damaged and too short, particularly at the outlet end.

Figure 101: View of culvert(s) 114D (somewhat damaged inlet). Repair is required.

Baffinland Action: Baffinland commits to further inspecting this culvert to determine if replacement with a longer, larger pipe is required. If replaced, both pipes will be repaired and extended. Once the pipes are repaired and extended, the road embankment may be widened.
