RE: Submission of 2019 Geotechnical Inspection Report No. 2 (September 2019)

November 22, 2019
Project #: TC190307

Annual Geotechnical Inspections – 2019 Report 2. Mary River Iron Mine – Nunavut

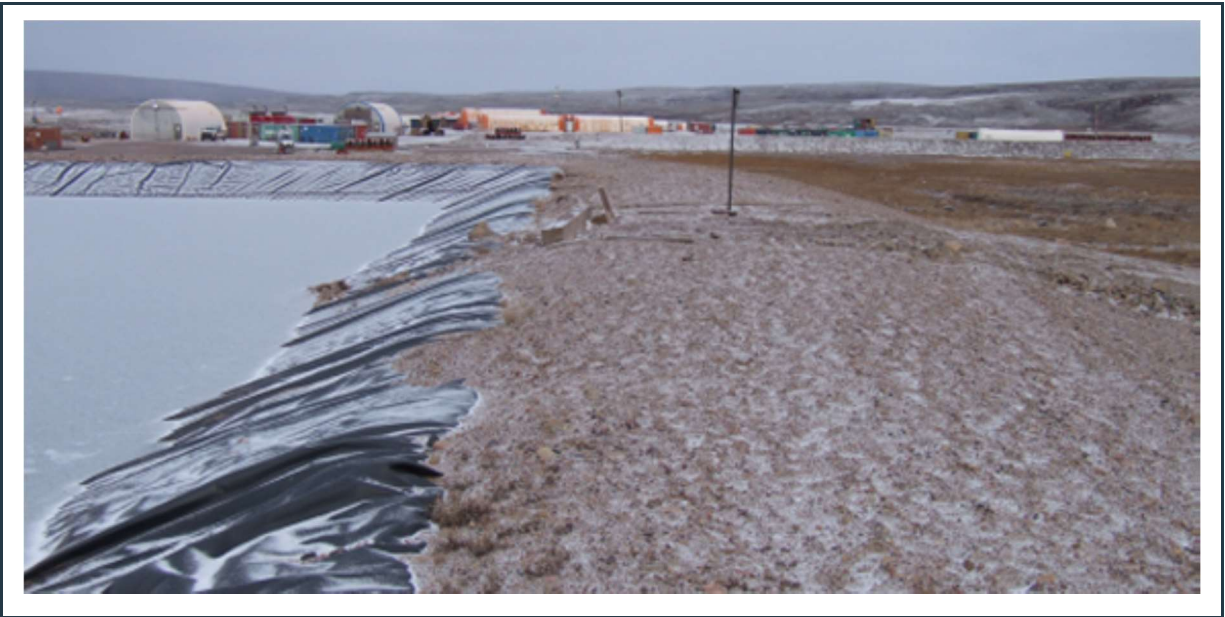
This assumption is further supported by the fact that there are no indications of differential settlements, sinkholes, sloughing, etc. at the perimeter berms. Previously, some minor truck-tire related damages (e.g., depression on the crest's surface and related densification) were observed at the top of the berms; however, most of these depressions have recently been backfilled by using sand and gravel, as shown in Figures 5 and 6.

Figure 6: PWS pond #2 – View of the berm and frozen water in the pond.

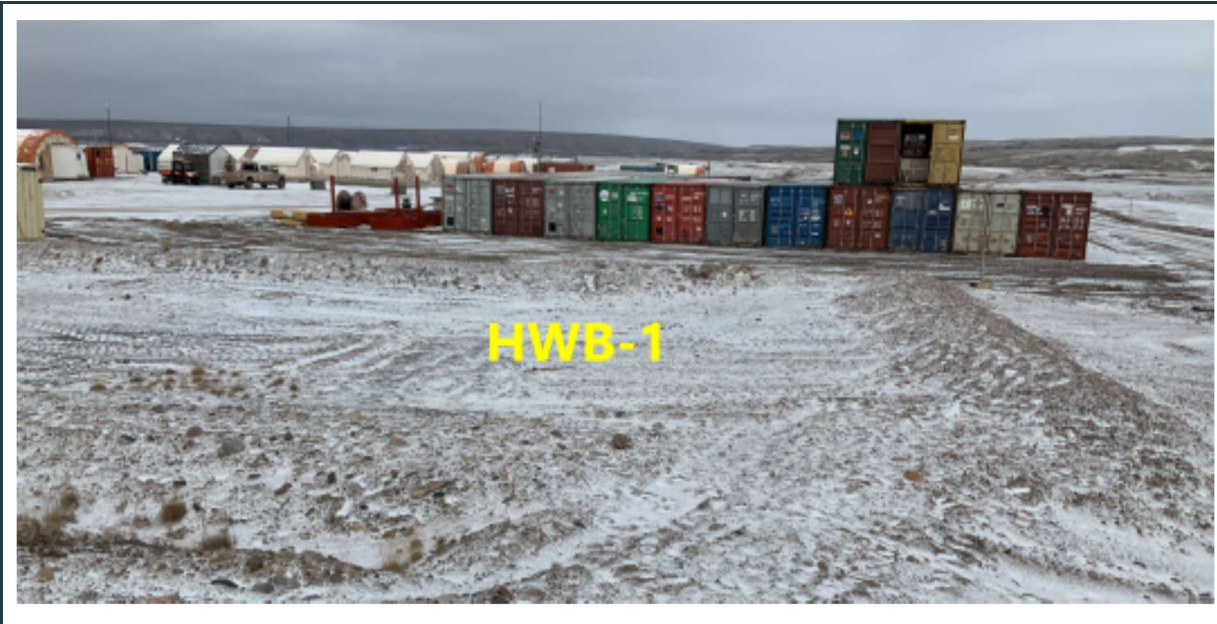
This cell is currently empty, with no water or ice visible within the cell (Figure 9). Based on information obtained during the June 27 to July 2, 2019 visit, it is understood that potential liner damage was suspected here, and consequently no material is stored in the cell.

Figure 9: View of HWB-1 – Currently this cell is empty.

Note that due to potential liner damage, Mine Site HWB-1 is currently not used and has been left empty. This facility will not be used for the storage of hazardous waste or substances until it has been repaired. Alternatively, this facility may be decommissioned.

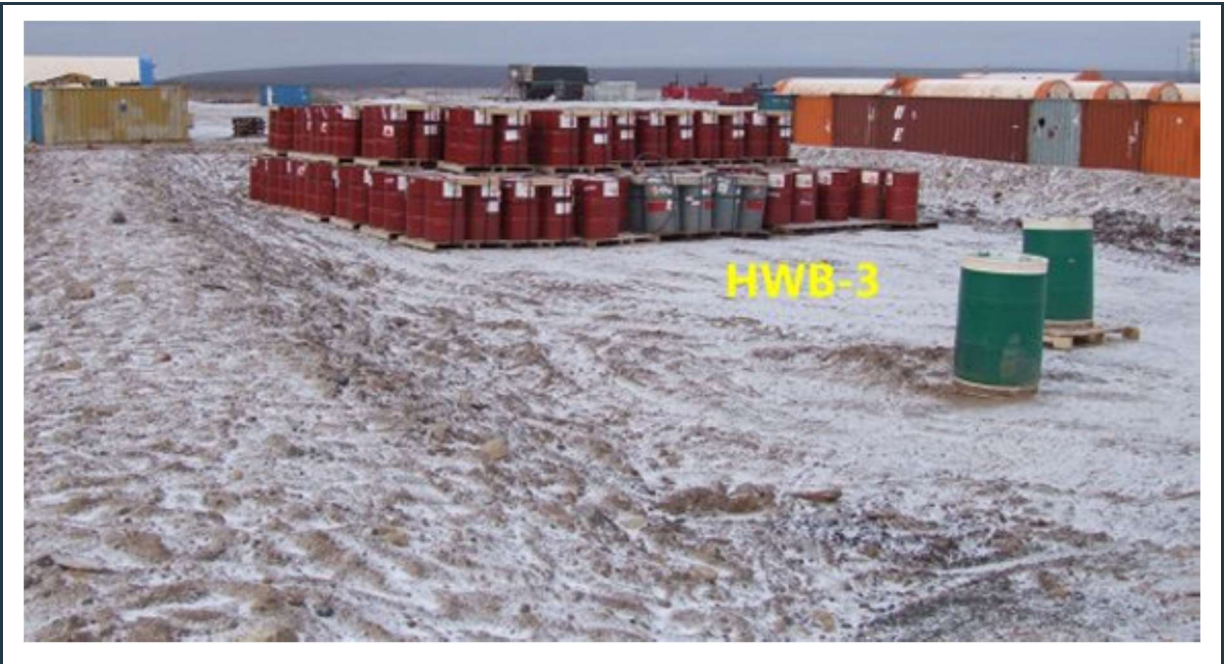
These cells are located side-by side and were called, in previous reports, "Fuel Containment" cells. As shown in Figures 11 and 12, there are only fuel barrels visible now in these two cells, stored on wooden pallets. The berms are stable and there is no visible liner damage in these cells. As recommended in the August 31, 2019 report, all damaged wood pallets and other debris have been removed from the cells to prevent potential damage to the liners.

Figure 11: View of HWB-3, with fuel barrels stored on wooden pallets.

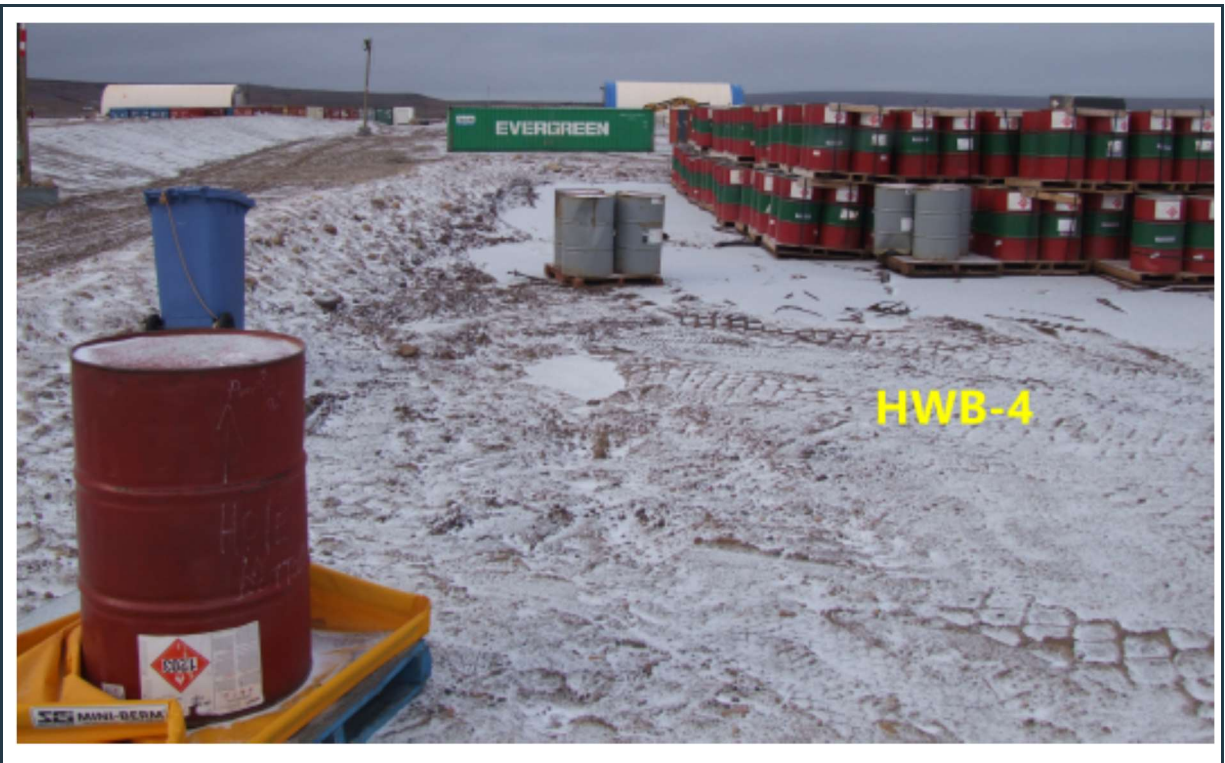
Figure 12: View of HWB-4, with fuel barrels stored on wooden pallets.

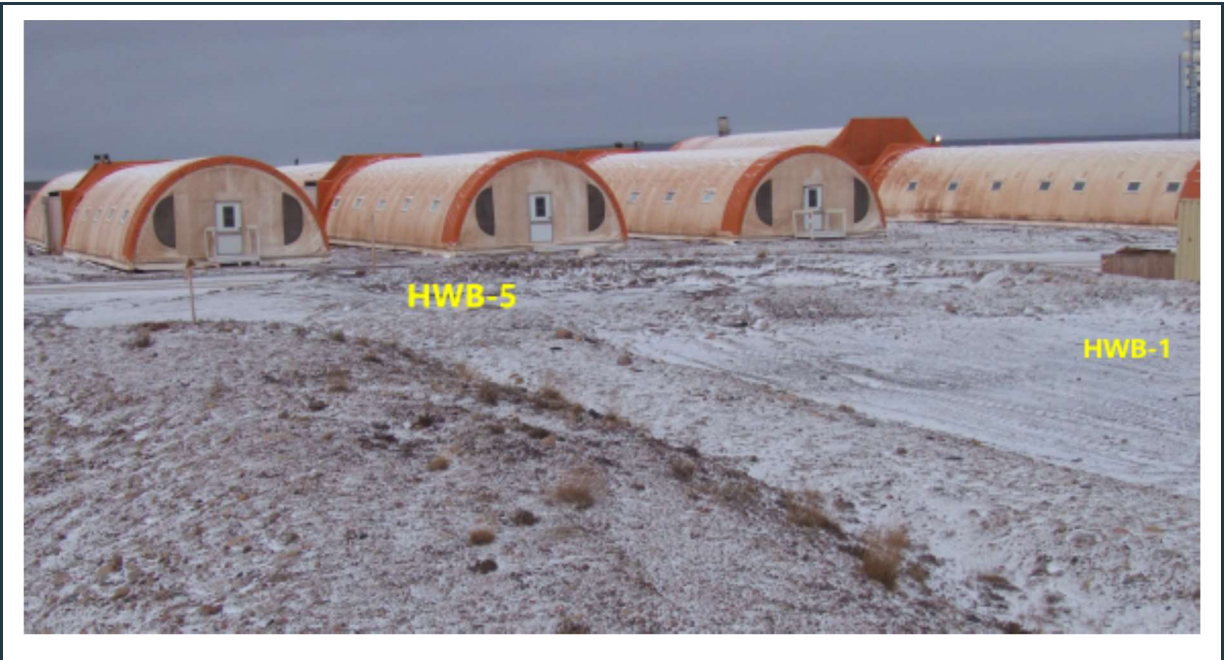
As shown in Figure 13, this cell is currently empty. The few totes of lubricants that were visible during the June 27 to July 2, 2019 inspection, have been removed from the cell. As pointed out in the earlier report, the berms around the cell appear to be stable and there is no visible liner damage.

Figure 13: View of HWB-5, located immediately adjacent to HWB-1. Both cells are currently empty.

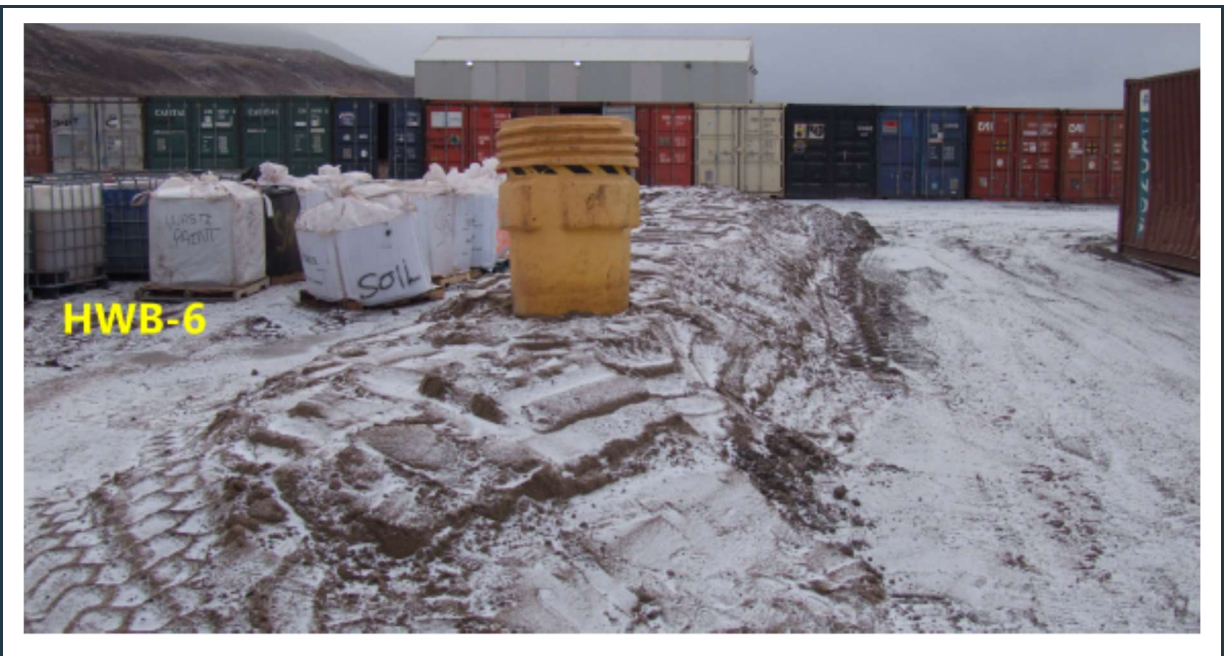
It was highlighted in the August 31, 2019 report that the HWB-6 cell was in poor condition. The berms showed extensive damage by truck and foot traffic, particularly at the northern section of the berm. Cracking and tearing of the liner were also visible at several locations on the upstream face and crest of the berm during the June 27 to July 2 inspection.

Following our recommendations, an extensive clean-up, repair and construction program was implemented at this cell. Reportedly, based on verbal information from William Bowden, Environmental Superintendent at the site, the damaged liner areas was patched and granular soil was brought to the site to cover the liner and improve the berm's profile. As specified in the August 31, 2019 report, a single ramped access point has also been provided to the cell, as shown in Figure 15. The images in Figures 14 and 15 indicate that the earthwork (fill placement on the crest and slopes of the berm) was undertaken using construction equipment (e.g., dozer and backhoe). Additional manual fine grading of the rough fill

surface will be completed during the spring, 2020. A few boulders have also been noted at the northern corner of the cell within the berm's profile. These boulders are prone to ice jacking and should be therefore removed and replaced by granular fill.

Figure 14: View of the HWB-6 cell, with additional fill placed recently on the berm.

Baffinland Action: Remove and replace the boulders at the northern corners with granular fill to ensure continued liner integrity in spring 2020.

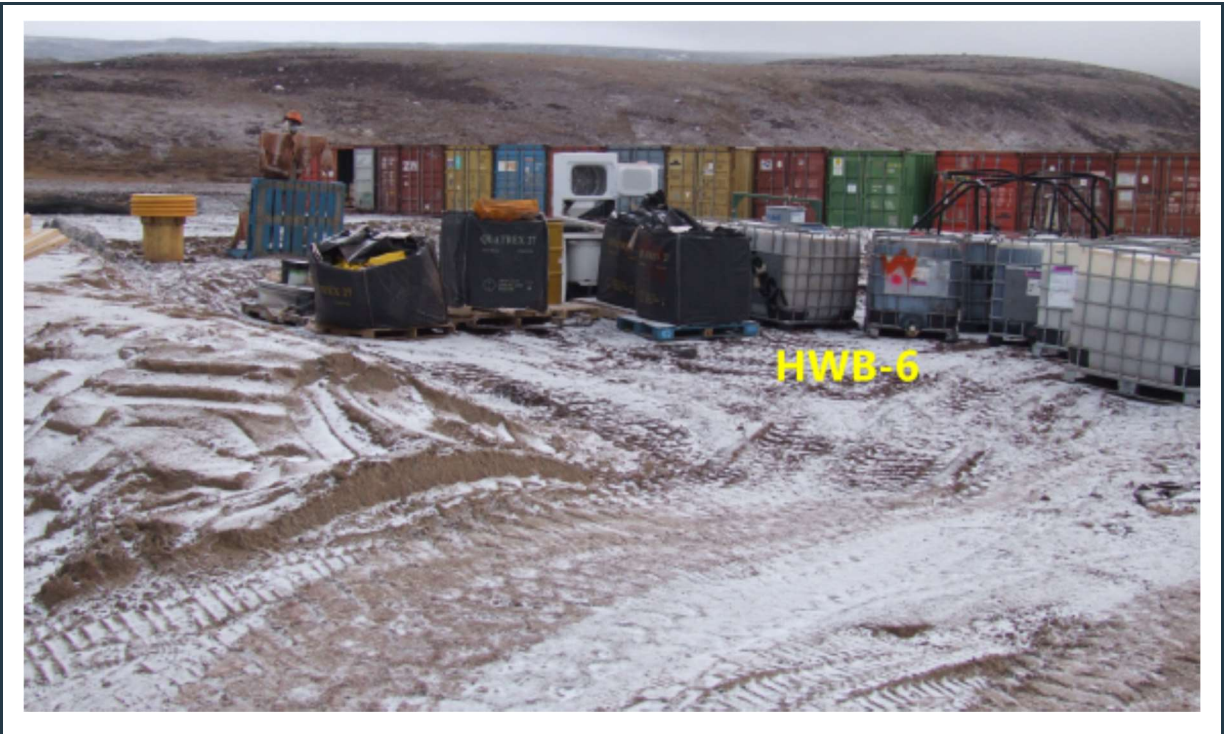
Figure 15: View of HWB-6, with recently completed access ramp through the raised berm.

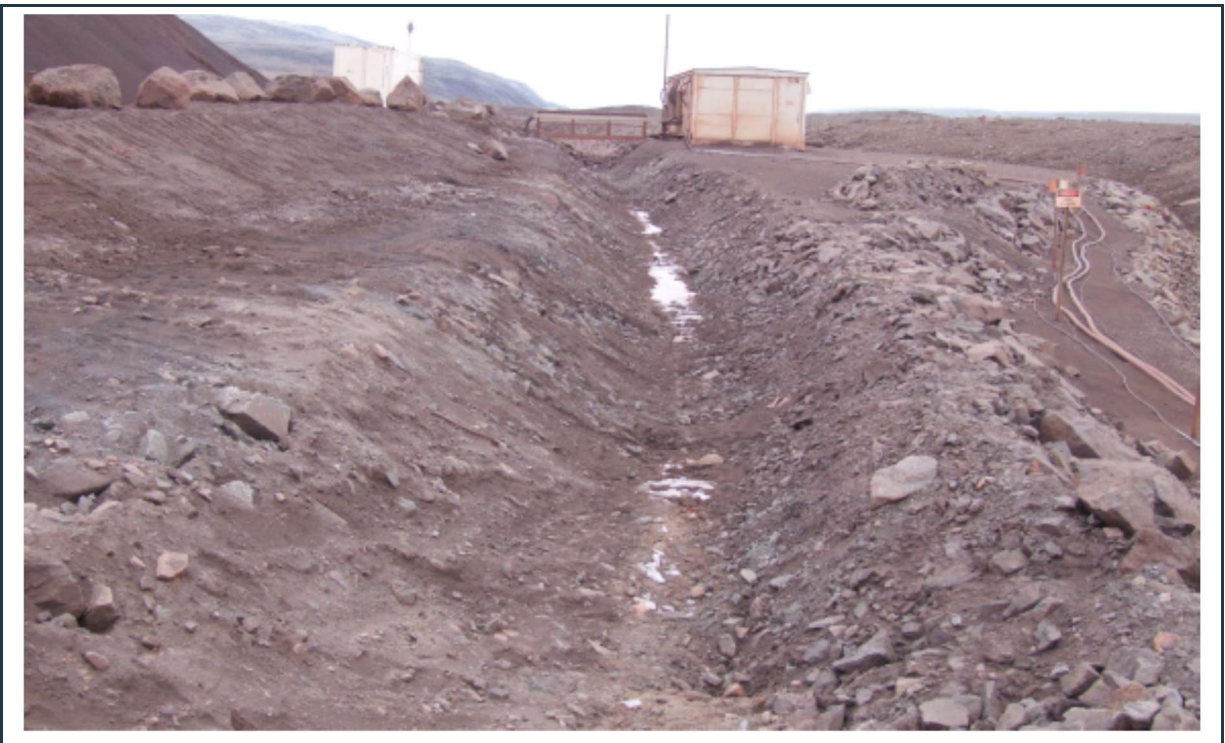
The side slopes of the water collection ditches were observed to be stable, as shown in Figure 18. The corrugated steel culvert, conveying the collected surface run-off from the crusher area to the pond (located beneath the tote road), was almost fully clogged with silt during the June 27 to July 2, 2019 visit. That culvert has been cleaned, providing uninterrupted flow of surface water toward the pond (Figure 19).

Figure 18: Surface water collection ditch around the crusher plant.

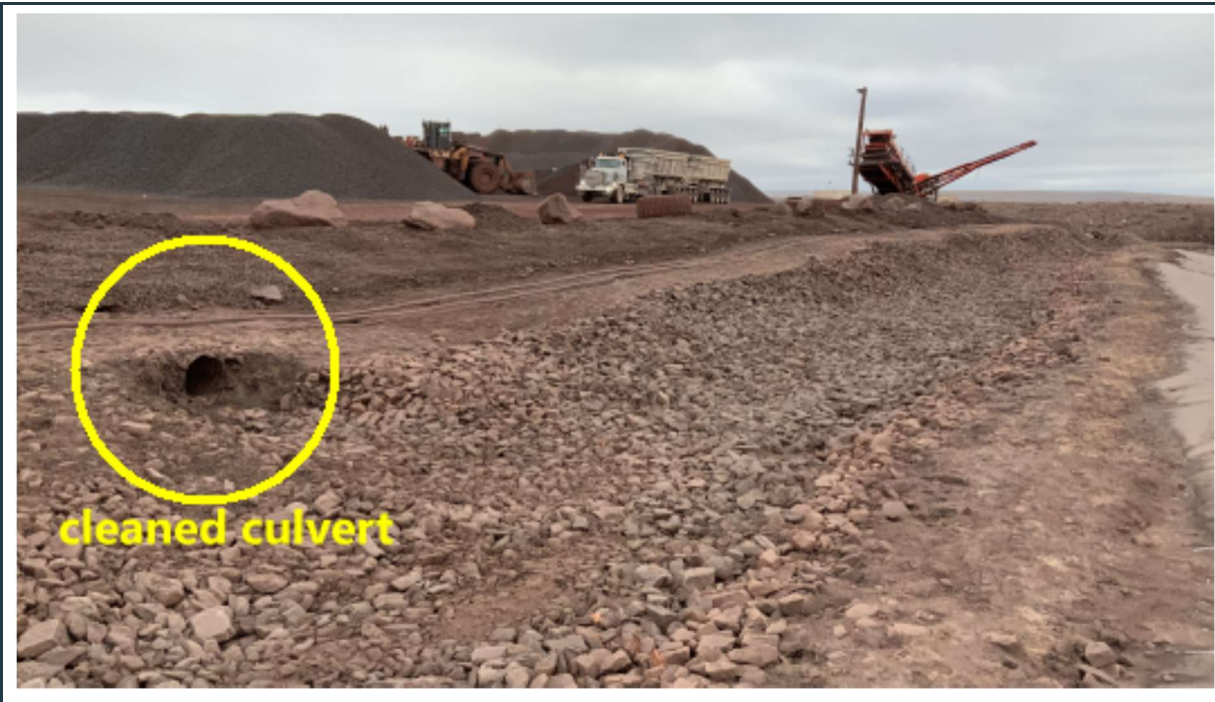
Figure 19: Surface water collection ditch, with recently cleaned culvert.

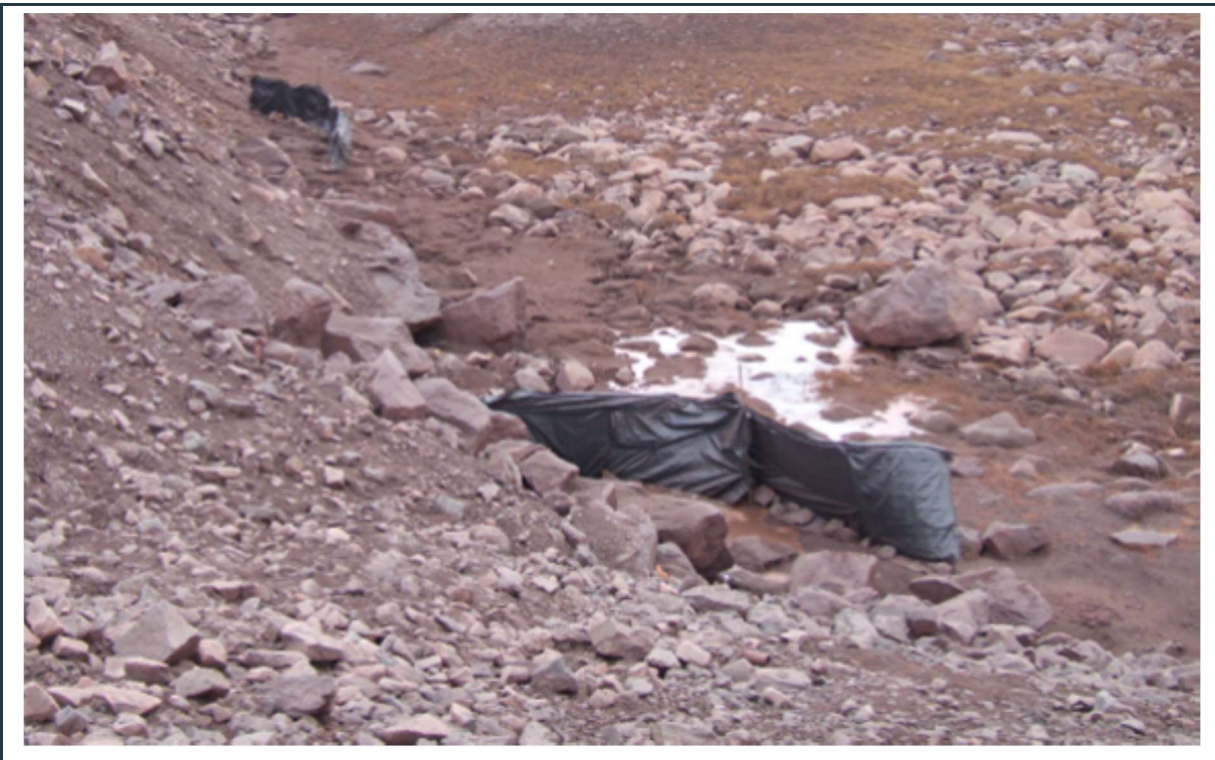
Minor water seepage was observed as ice mount at the toe of the embankment where the crusher pad ditch embankment fill meets the tundra, as shown in Figure 20.

Figure 20: Minor water seepage as ice mount at the toe of the embankment where the crusher pad ditch embankment fill meets the tundra.

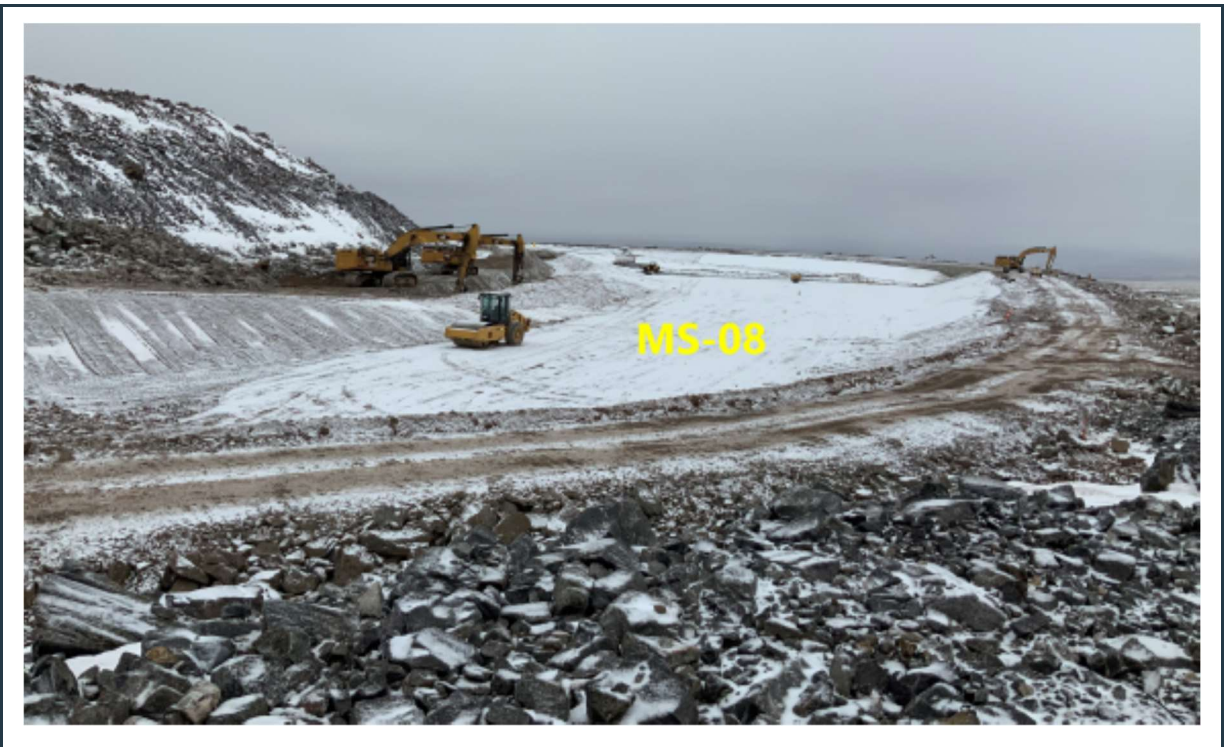
complete reconstruction of the MS-08 pond and replacement of the “old” crescent-shaped semicircular berm with new perimeter berms. The pond was being lined at the time of the current inspection, as shown in Figures 24 and 25. As noted during the inspection, the liner is properly anchored into the berm crest around the pond and extends beyond the active zone into to the permafrost, to prevent under-drainage.

Figure 24: Construction of the new MS-08 pond, immediately adjacent to the waste rock dump.

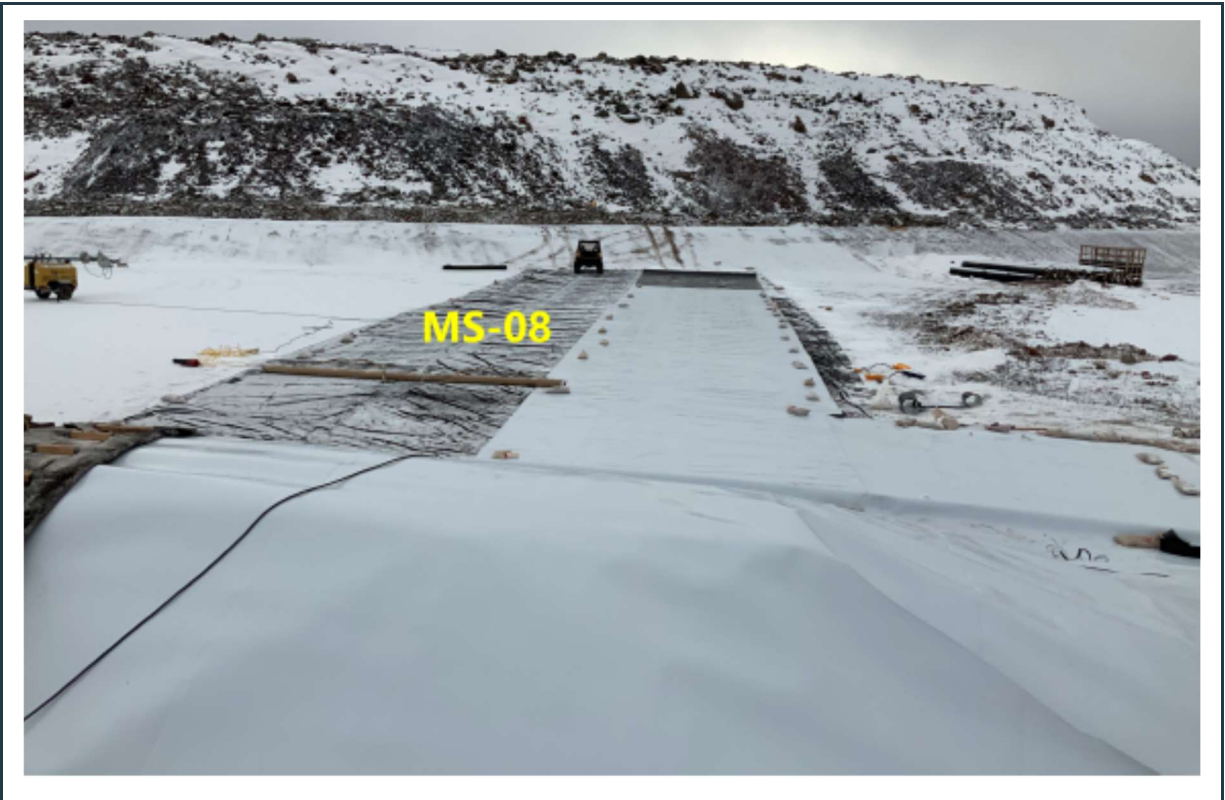
Figure 25: Liner installation in the new MS-08 pond, currently under reconstruction.

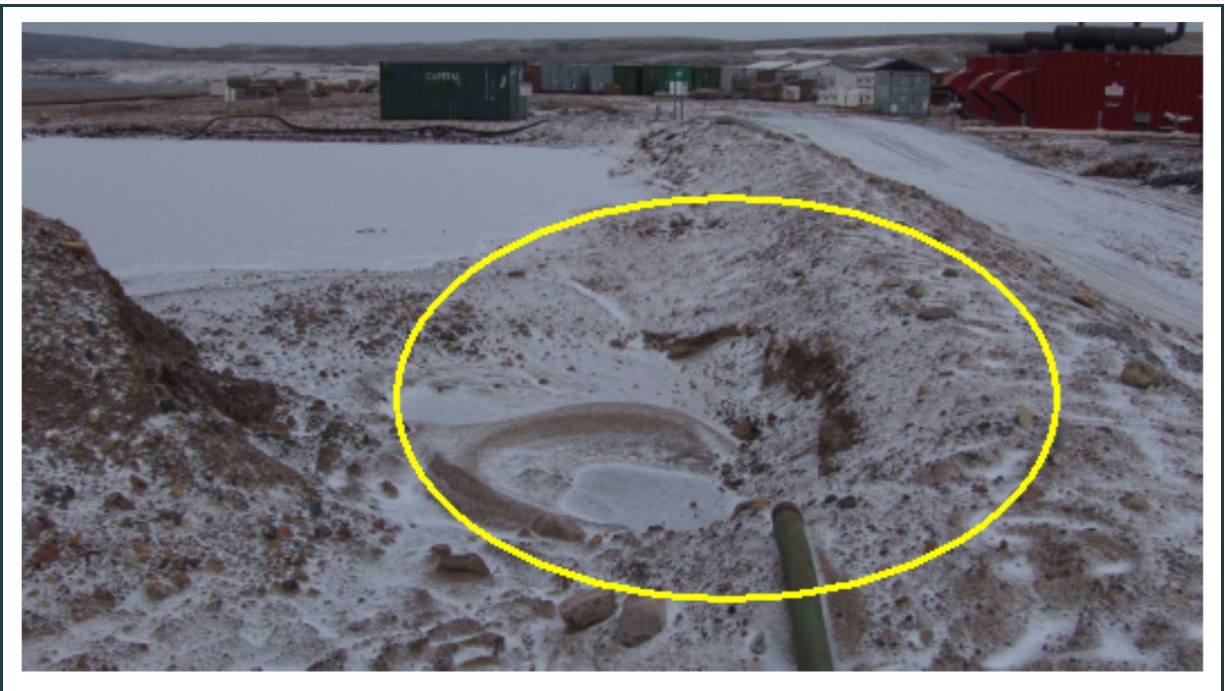
The generator fuel berm contained water with frozen surface during the inspection, covered with some snow. According to information provided by William Bowden, Environmental Superintendent at the site, this cell historically contained a fuel bladder for the gensets at the weatherhaven complex. The pond is located adjacent to the power generators, south-west of the hazardous waste cells (Figure 1). As shown in Figures 27 and 28, the perimeter berm around the pond generally comprises granular materials and the pond is lined. Disturbance by foot-traffic along most of the berm’s crest with some visible sloughing of the upstream side of the berm at the south-east corner of the pond has remained the same since the preceding (June 27 to July 2, 2019) inspection (see Figure 28).

The berm did not exhibit any signs of instability and exposed sections of the liner were observed to be intact. Also, no seepage from the pond was noted on the berm’s downstream slope at the time of the inspection.

Figure 28: View of minor slope problem at the south-east corner of the generator berm.

Baffinland Action: Re-fill the slope with granular fill and re-grade the area. In addition to the repair work on the slope, the southern, lower section of the berm will be reconstructed to its original geometry prior to July 2020.

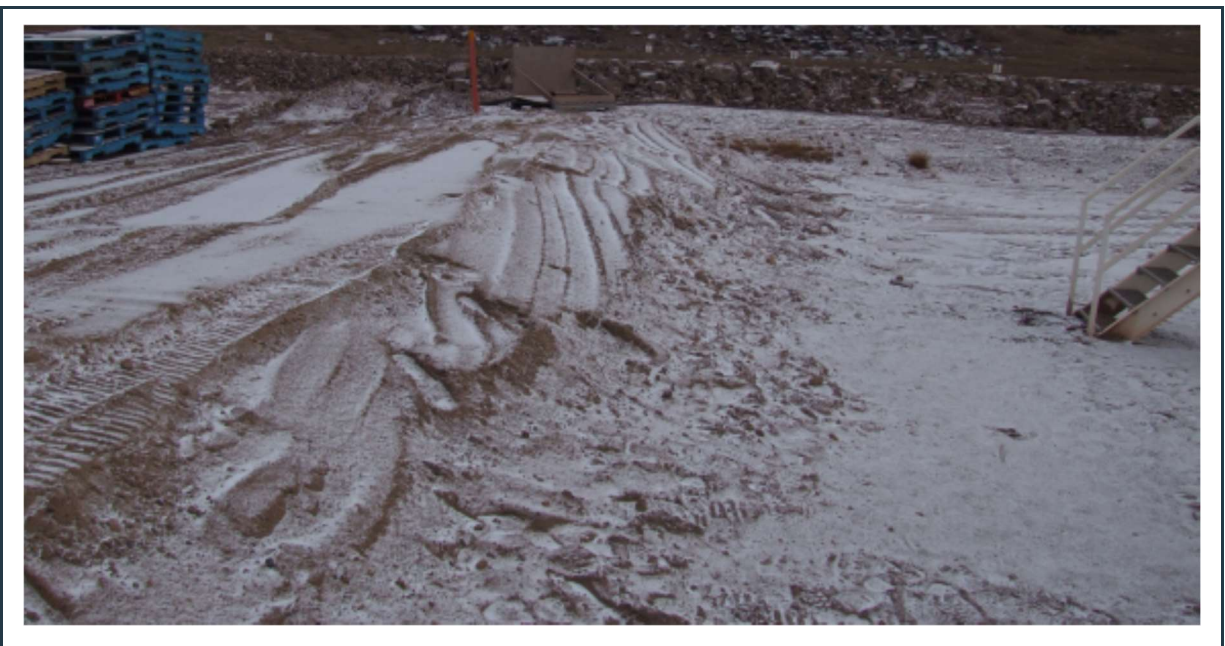
facility, constructed by using crushed rock fill. The geotextile fabric (liner cover) was exposed at a few locations along the berm's crest during the June 27 to July 2, 2019 inspection. Completion of maintenance work carried out prior to the subject inspection included placement of roughly graded soil cover, composed of sand and gravel, as shown in Figures 29 and 30. Additional fine grading (manual) is recommended on the berms following the next spring.

Figure 30: Recently placed granular fill on the berm's crest, to protect the previously exposed liner.

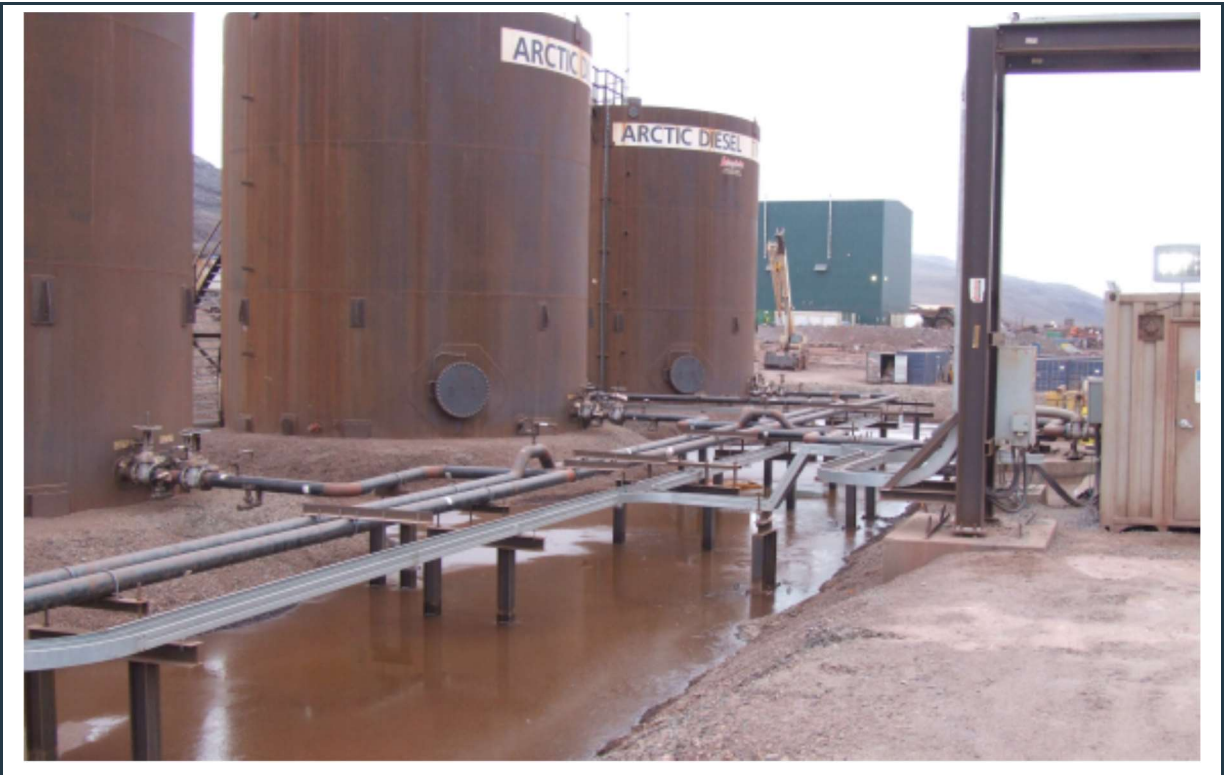
The berms around the diesel fuel storage are in excellent condition (see Figure 31), and they are well maintained year-round. The contained clean water from precipitation within the cell is an indication of the proper liner system functionality (i.e., no seepage from the cell is visible and the liner is well protected by granular fill throughout the facility).

Figure 31: View of the MS-03 diesel fuel storage with frozen water surface.

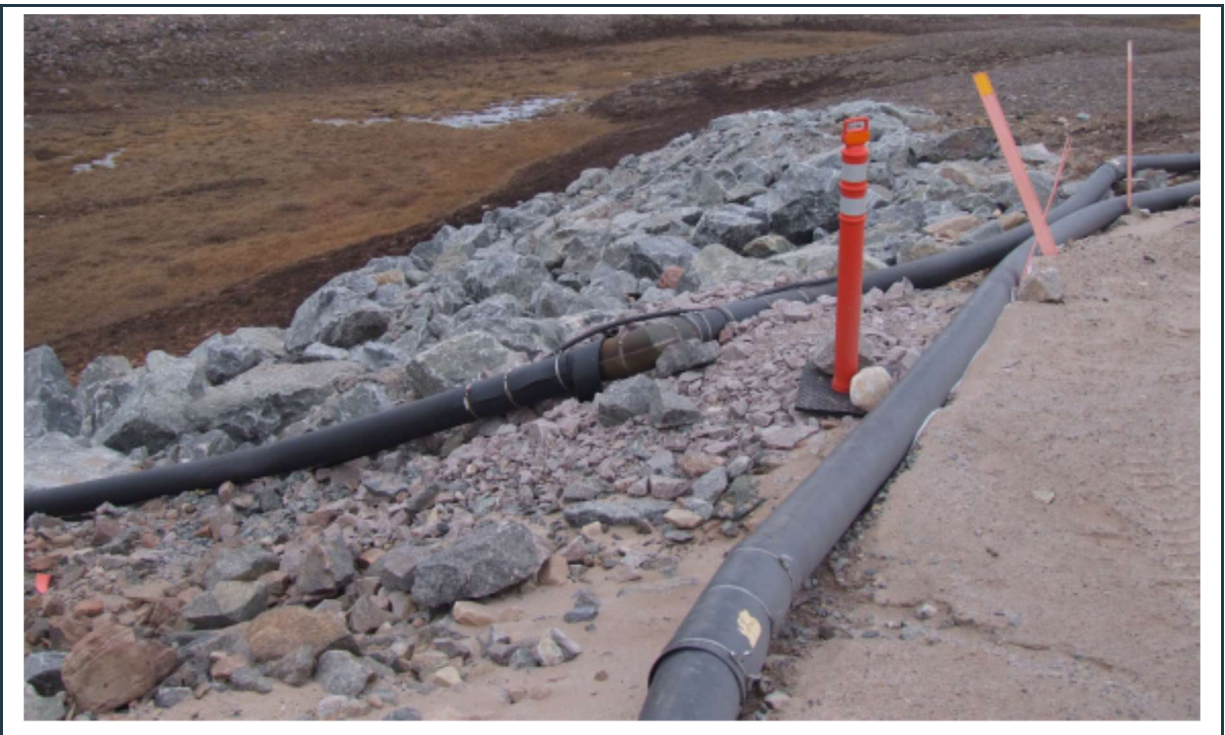
Figure 38: Recently stabilized slope erosion adjacent to the water (effluent) discharge site.

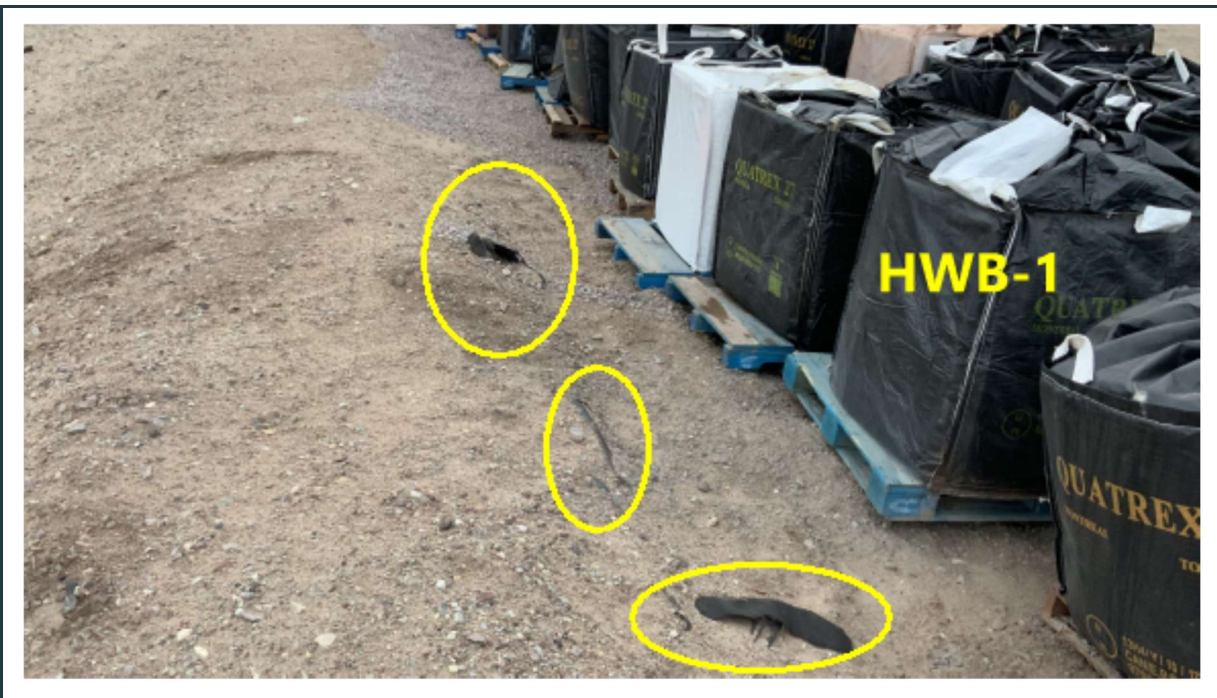
Figure 40: Ripped geotextile and exposed liner at the stable northern berm of the HWB-1 cell.

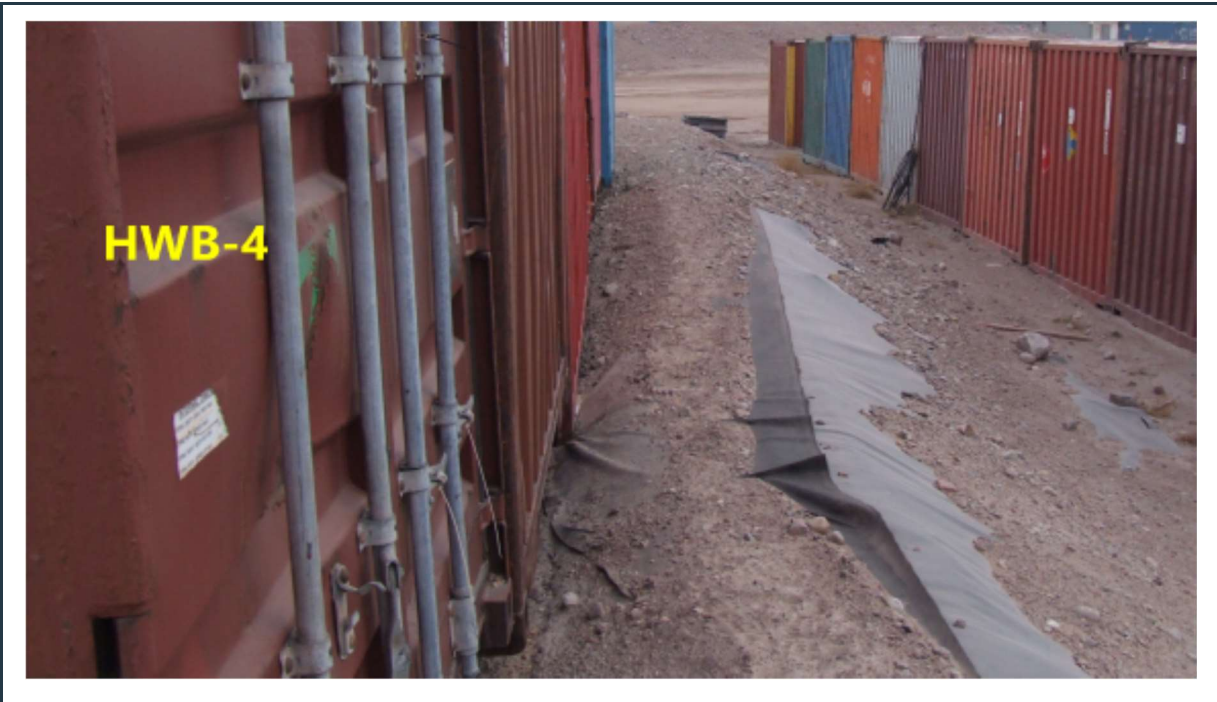
Figure 43: Perimeter berm at the HWB-4 cell, with exposed geotextile and liner.

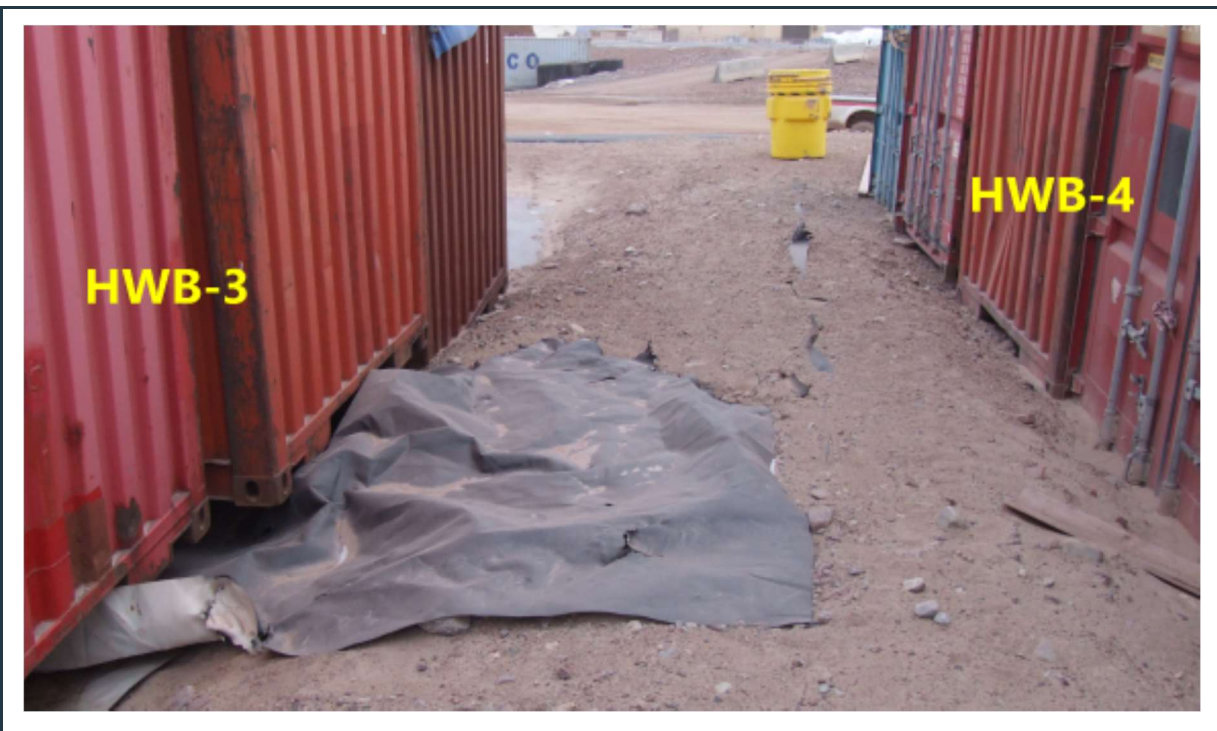
Figure 44: Exposed liners between the HWB-3 and HWB-4 cells.

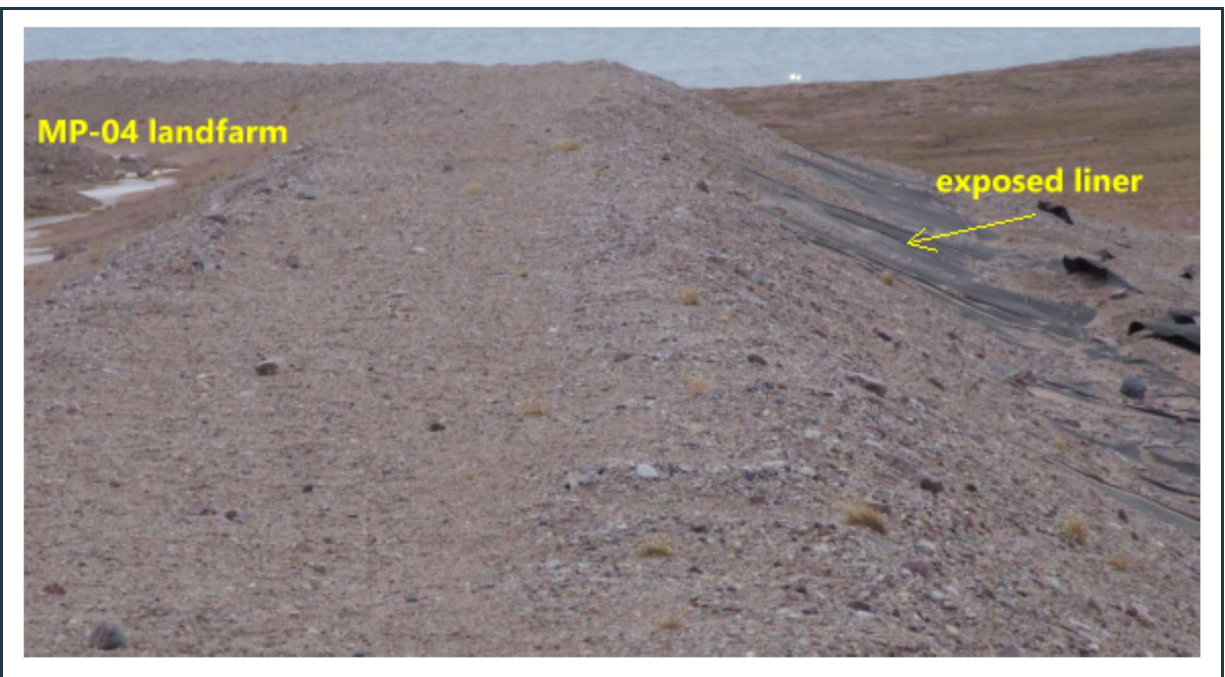
Exposed liner was visible on the downstream slope of sections of the MP-04 berm, particularly along the north berm, as previously noted during the first 2019 inspection.

Figure 48: Stable berm at the MP-04 landfarm, with exposed liner on the downstream slope.

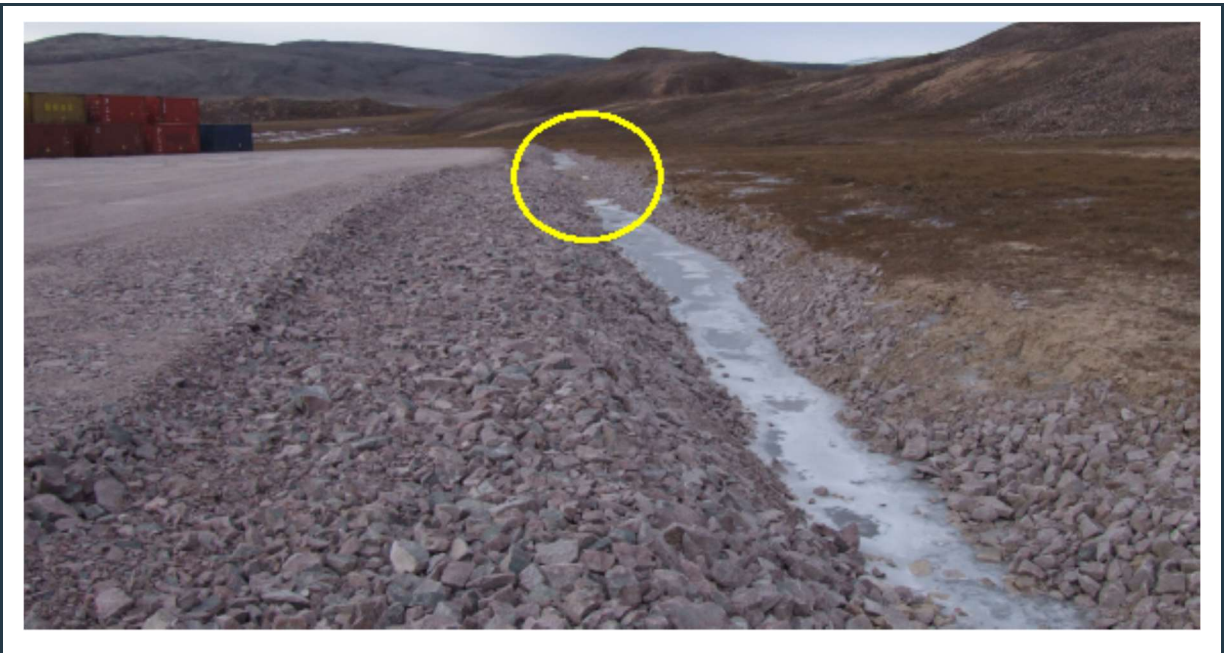
Ditch side slope failure was observed at the LP2 drainage ditch.

Figure 53: View of the LP2 surface water collection ditch – still under construction.

Baffinland Action: Repair LP2 drainage ditch slope deterioration prior to spring freshet and continue to monitor surface water collection ditches.

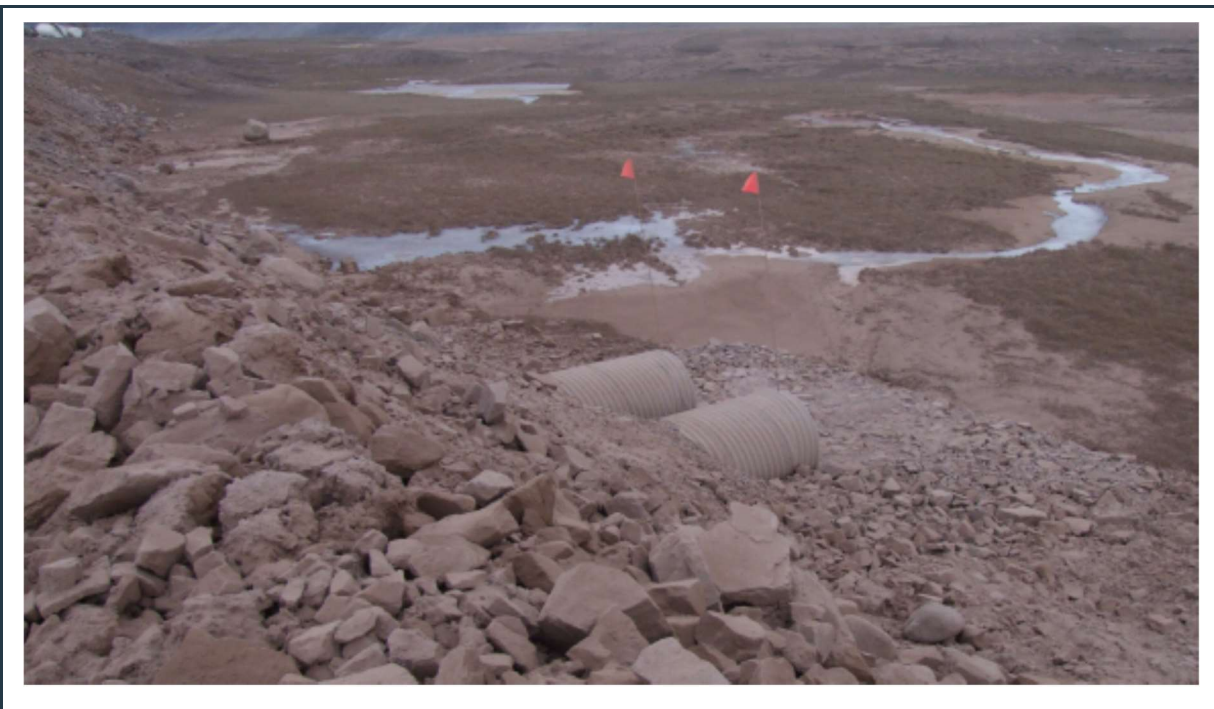
Figure 59: Water seepage through and beneath the road embankment near the tote road culverts.
