**RE: 2019 Inspection of the Milne Inlet Tote Road & Associated Borrow Sources  
Mary River Project, Type A Water Licence 2AM-MRY1325**

**2019 Inspection of the Milne Inlet Tote Road and Associated Borrow Sources**

DECEMBER 19, 2019  
ISSUED FOR USE  
FILE: ENG.EARC03171-01

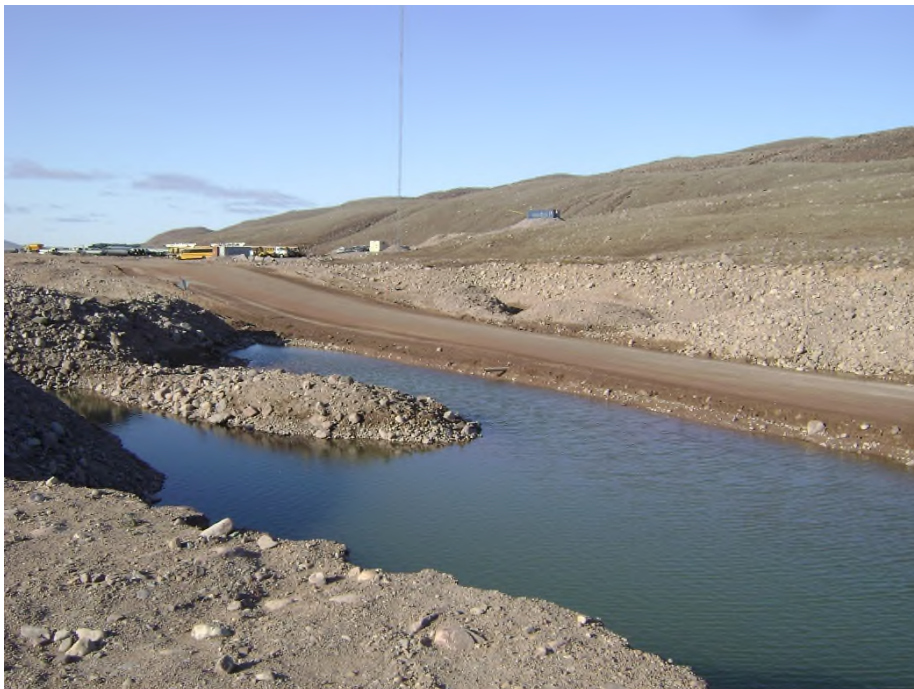
- Tote Road KM 7.2 – Borrow source has fill placed. The grade of the road appears to be near the original ground with water ponding encroaching on the road, possibly due to degradation of permafrost.

**Photo 7 (2531):**  
Pit at KM 7.2 with water on both sides of the new road alignment and extensive thaw of massive and wedge ice.

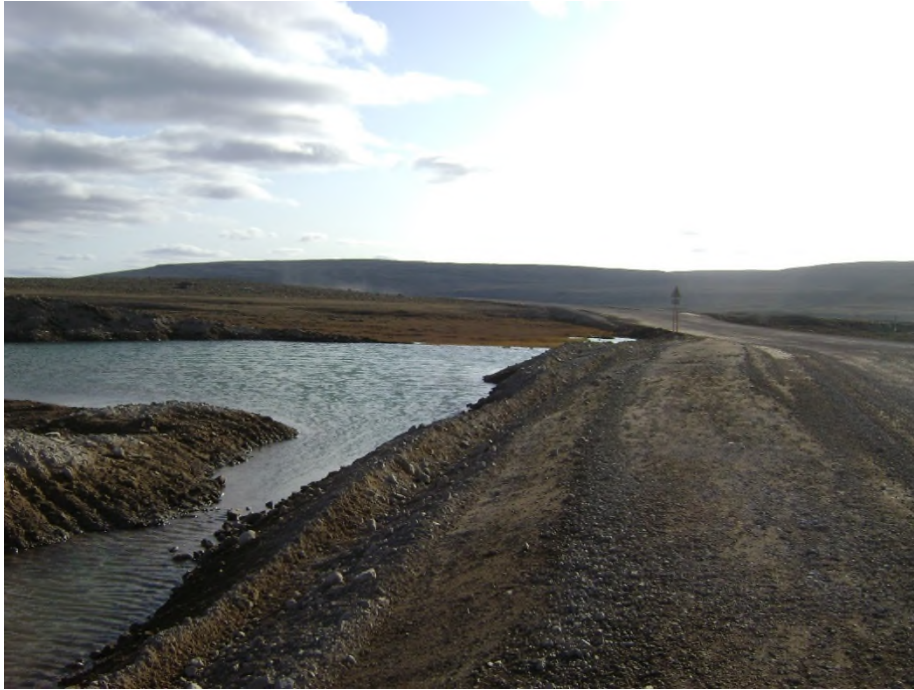
**Photo 18 (2693):**

Pit at KM 56.8 (Figure 8), the left side of the new road has steeper side slopes particularly where it narrows at the culvert inlet (close to the KM marker). This increases the potential for instability. The water needs to be pushed back from the toe of the slope by constructing berms on this side of the road (see Photo 17).

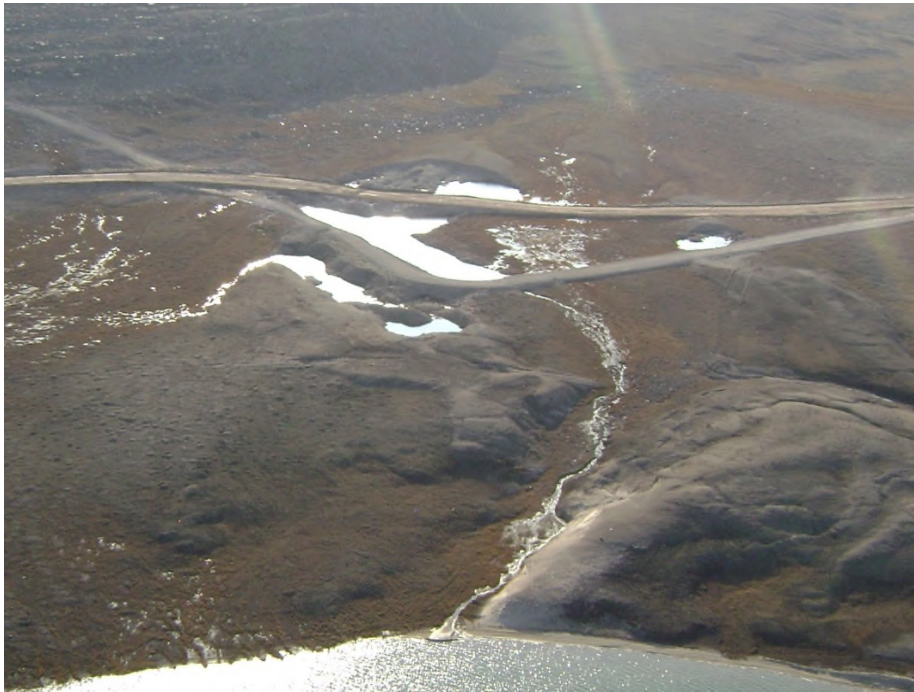
**Photo 19 (2592):**

Pit at KM 56.8 (Figure 8), drainage at this location is clearly shown in this photo. The culvert under the old road (near the hairpin corner) is currently being relied upon to keep water levels low around the new road.

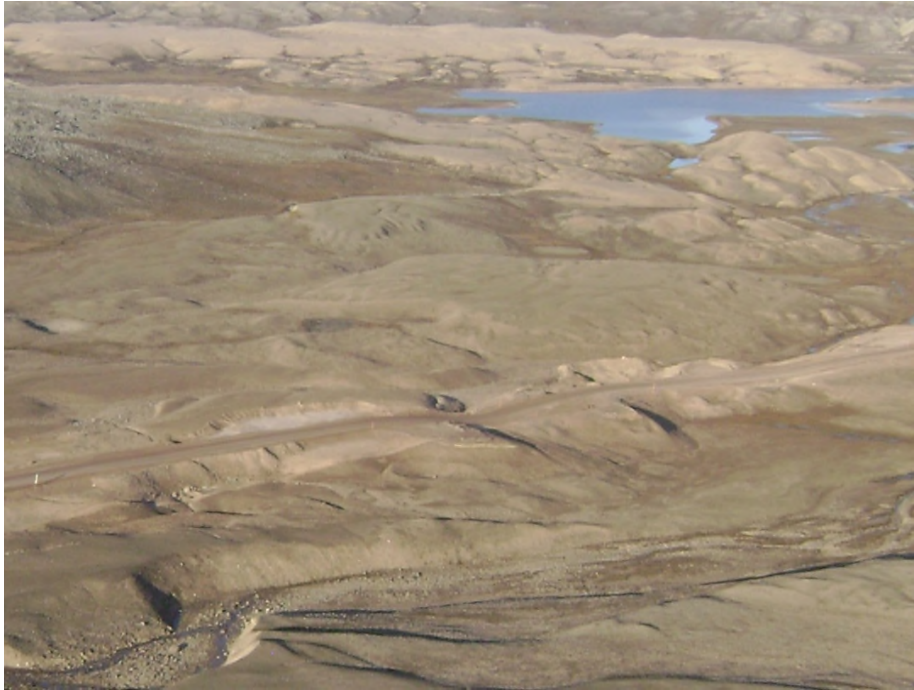
**Photo 20 (2558):**

Pits at KM 63 to 63.8 (Figure 9), continued thaw of ice-rich material threatens road stability at this location.

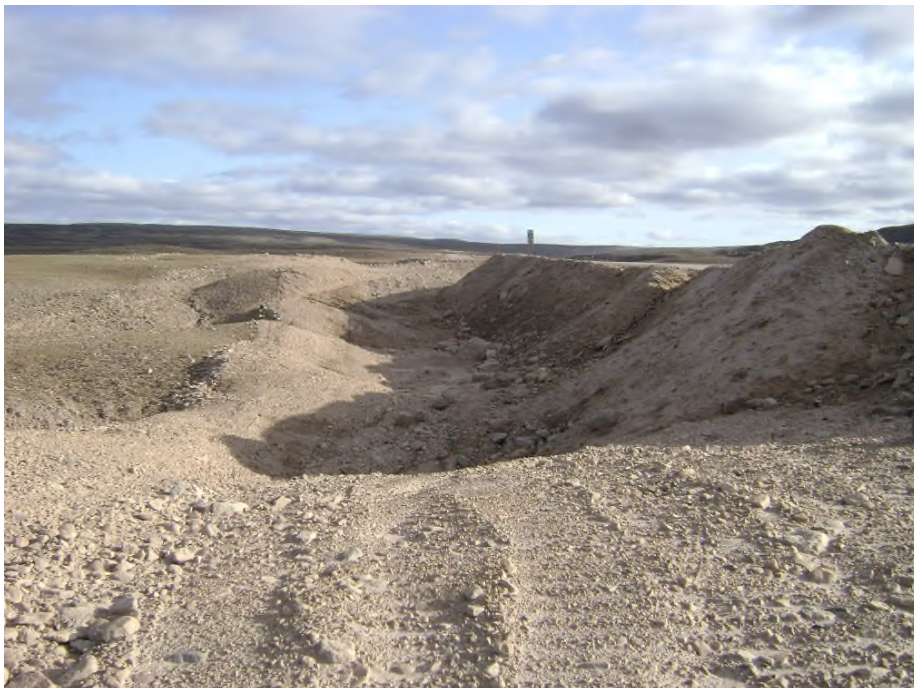
**Photo 21 (2657):**

Pit at KM 63.8 (Figure 9), continued thaw of ice-rich material beside the realigned road leading to steep side slope and instability of the embankment. Side slopes need to be significantly flattened to provide better thermal protection and stability.

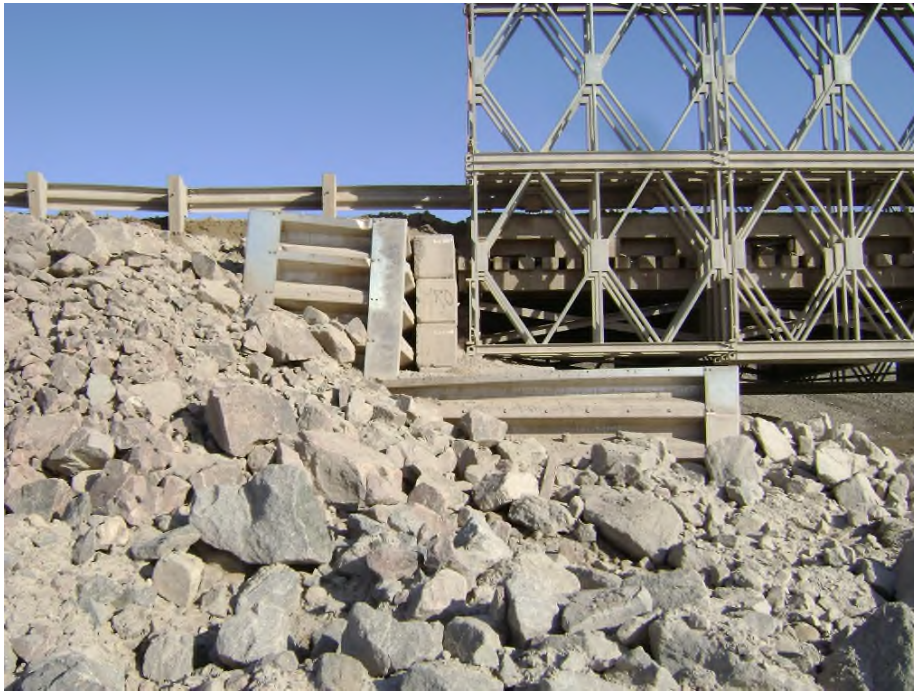
**Photo 30 (2683):**  
KM 63 Bridge, north abutment. Note tilting of upper bin wall.

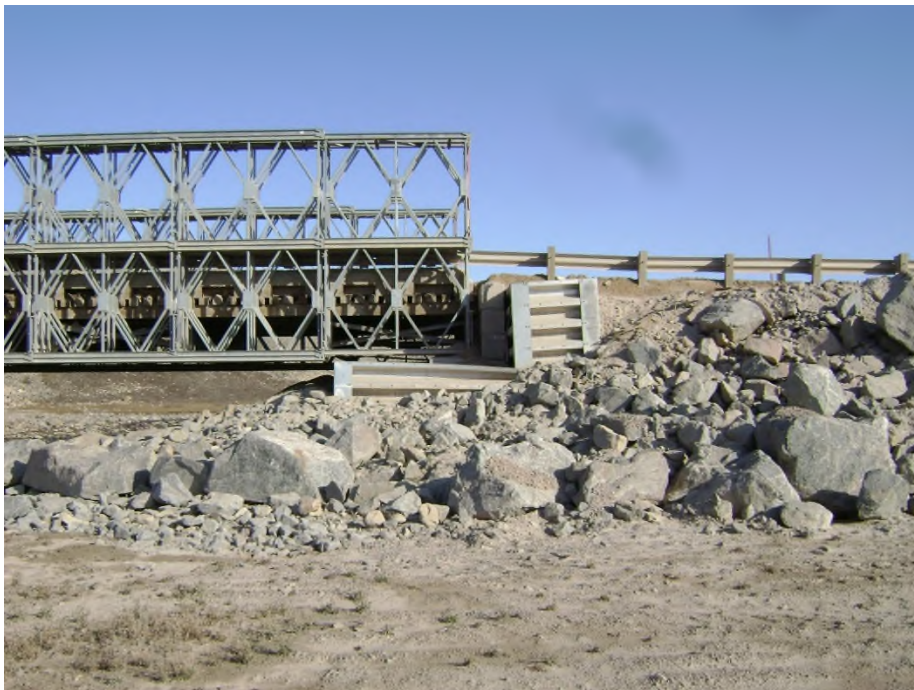
**Photo 31 (2708):**  
KM 64 Bridge, south abutment. Note tilting of upper bin wall.
