**Mary River Tote Road Quarry Reclamation  
Mary River, Baffin Island**

**PLAN PHOTO LOCATIONS  
SHEET 13 OF 13**

PROJECT NO. ENG.EARC03171-01	DWN BR/EP	CKD KJ	REV 0
OFFICE EDM	DATE December 2019

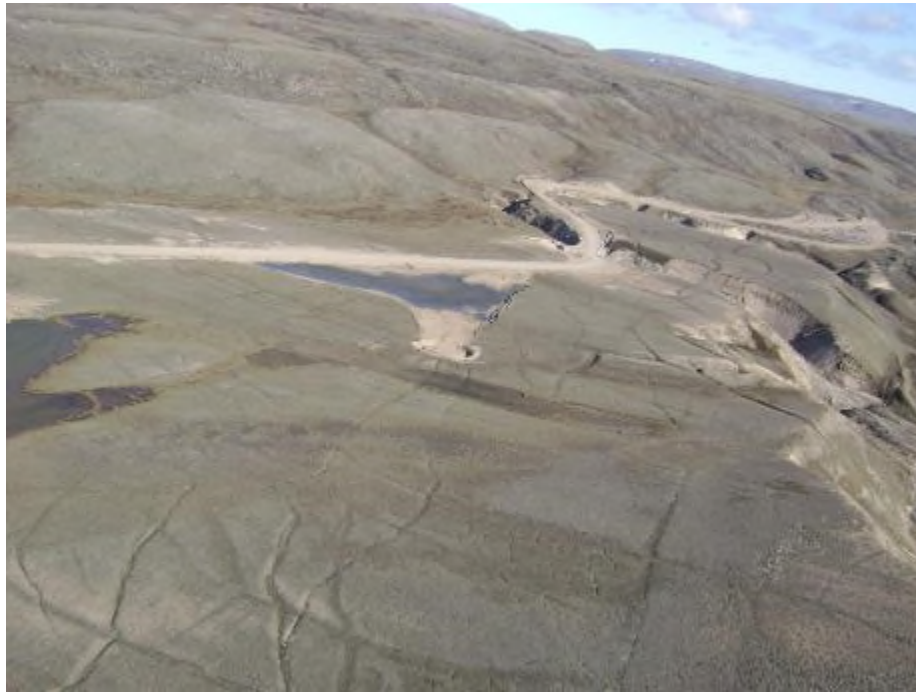
**Photo 1 (2014 Photo 1612):**

Priority C pit at KM 6.6 (Figure 1) lies on a gravel terrace with well-established ice wedge polygons. Removal of material from the active layer in the pit has initiated thaw and ponding but it has not changed since 2009 and remarkably is not currently impacting the embankment.

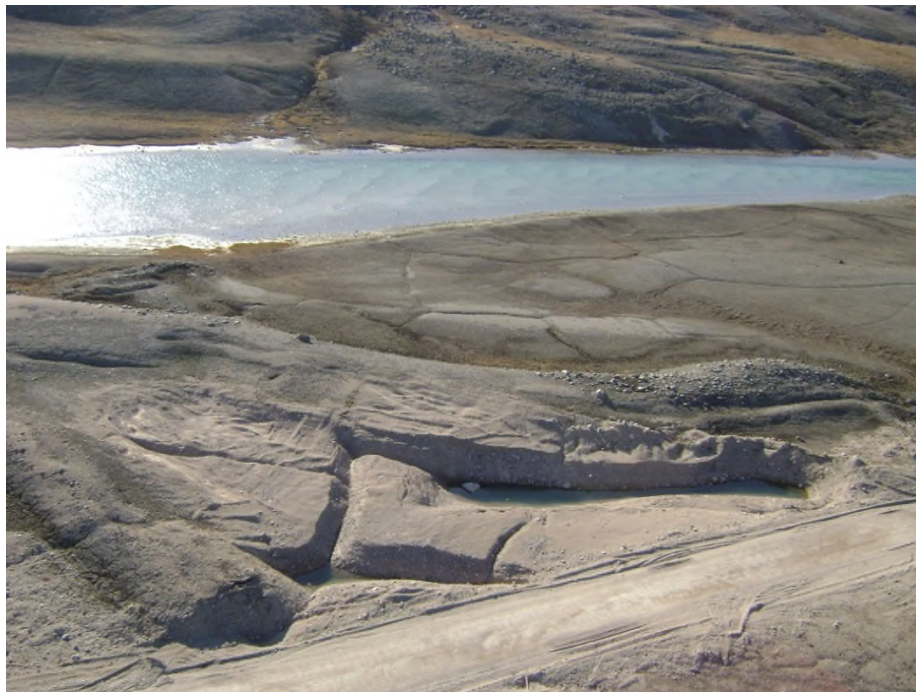
**Photo 2 (2014 Photo 1585):**

Pit at KM 20.7 (Figure 2), linear sinkholes from ice wedge melt out, see also Photo 3.

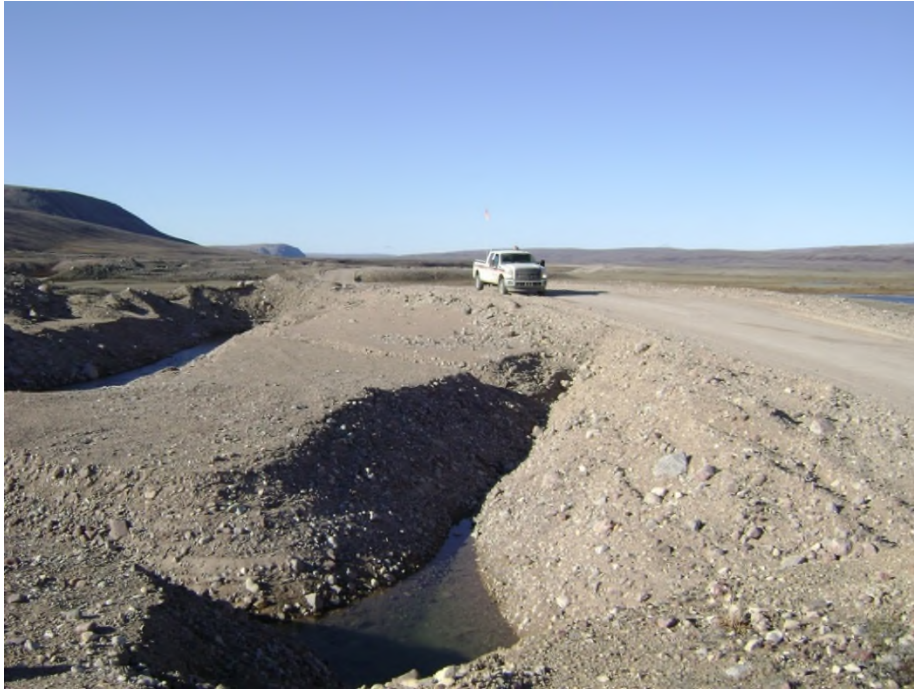
**Photo 3 (2014 Photo 1697):**

Pit at KM 20.7 (Figure 3) is threatening the stability of the road embankment as thermal erosion from water is occurring through the ice wedges exposed in the adjacent pit.

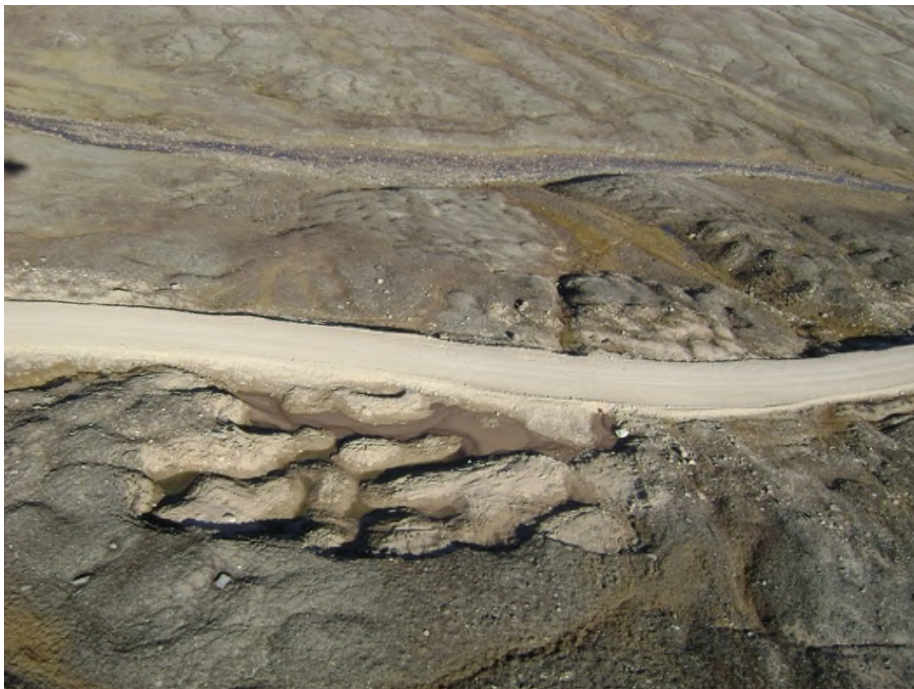
**Photo 4 (2014 Photo 1645):**

Pit at KM 71.6 (Figure 10), typical settlement from thaw of segregated ice common in finer-grained lacustrine soils.

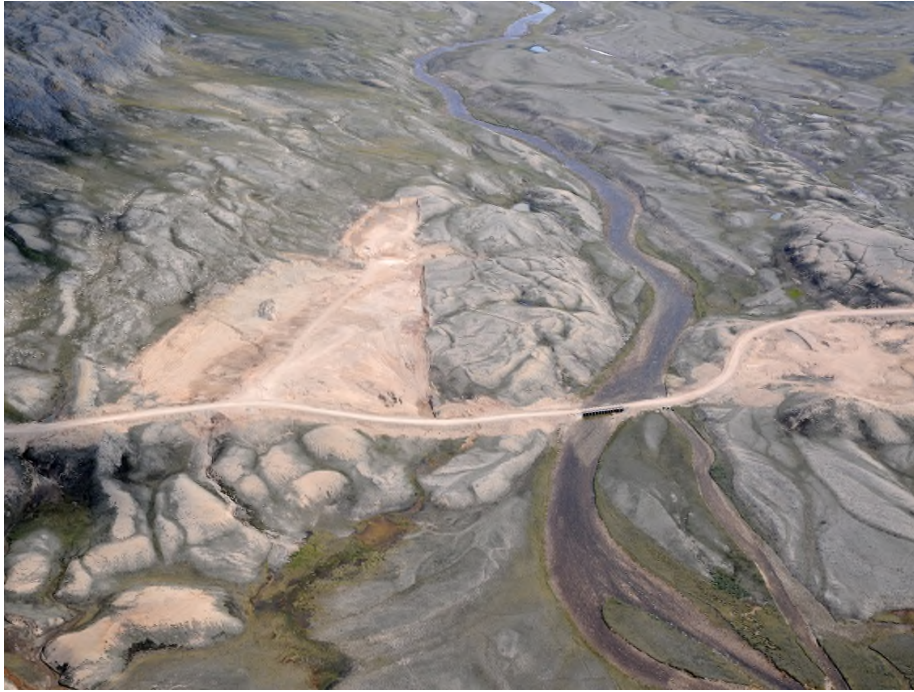
**Photo 5 (DWH 2009 Photo 593):**  
Pit at KM 61.7 (Figure 8) in 2009, compare to Photo 5A.

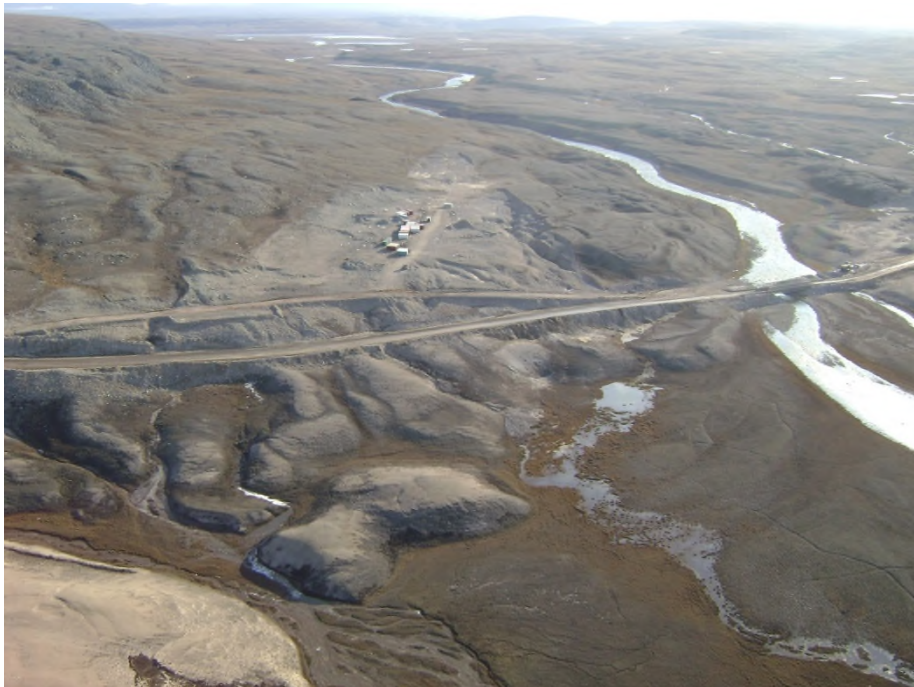
**Photo 5A (2593):**  
Pit at KM 61.7 (Figure 8), in 2019, note extensive settlement in southern portion (right side) of the developed pit indicative of the presence of massive ice in portions of this deposit. Note road realignment to improve grade.

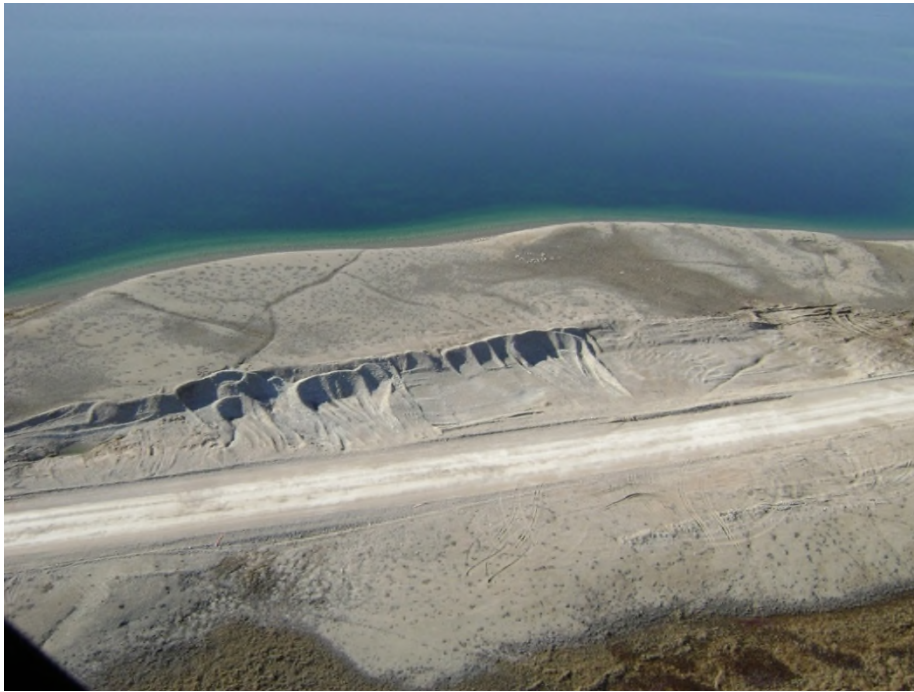
**Photo 6 (2014 Photo 1576):**

Pit at KM 32.4 (Figures 4 and 5), typical Priority C pit in thaw stable soils that only requires regrading.

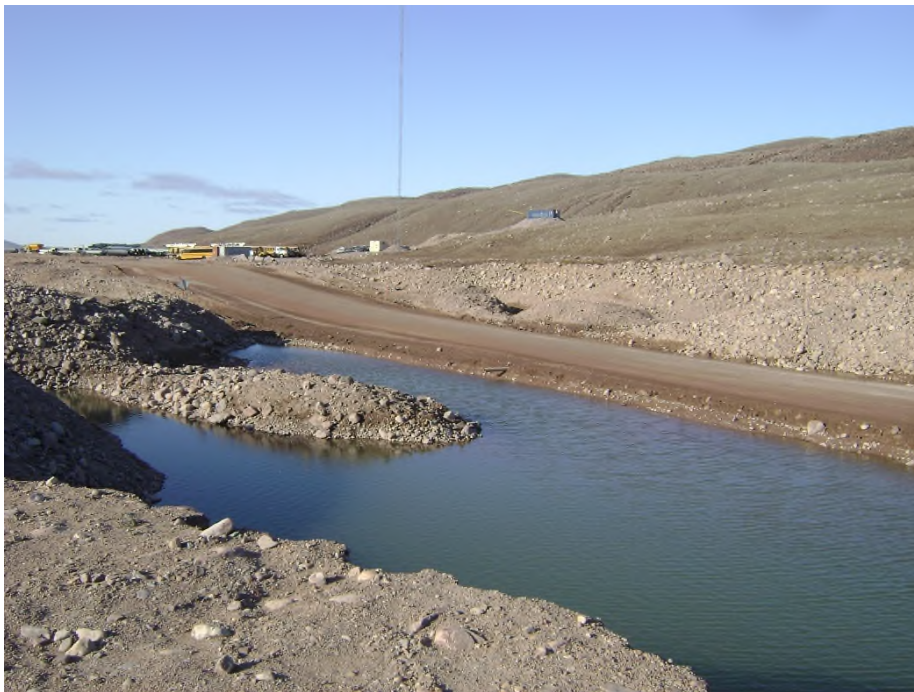
**Photo 7 (2531):**

Pit at KM 7.2 with water on both sides of the new road alignment and extensive thaw of massive and wedge ice.

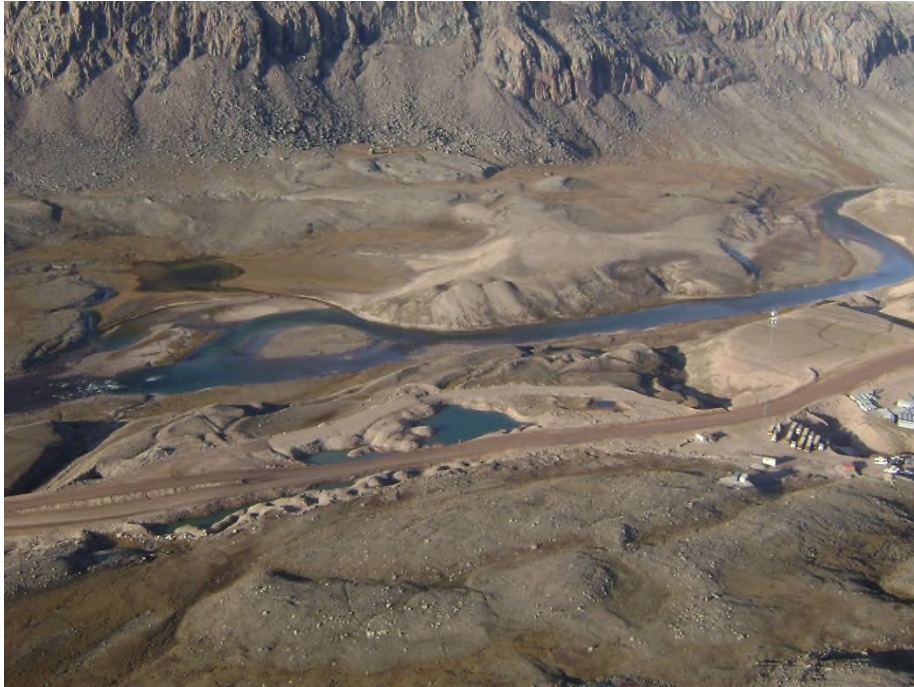
**Photo 8 (2578):**

Pit at KM 7.2 – Note extensive thaw ponds on the west (right) side of the road. The road has been significantly realigned since 2014 and thaw has progressed dramatically since then. Road is likely founded on permafrost that contains massive ice thereby raising concern that thaw due to the ponded water could lead to failure.

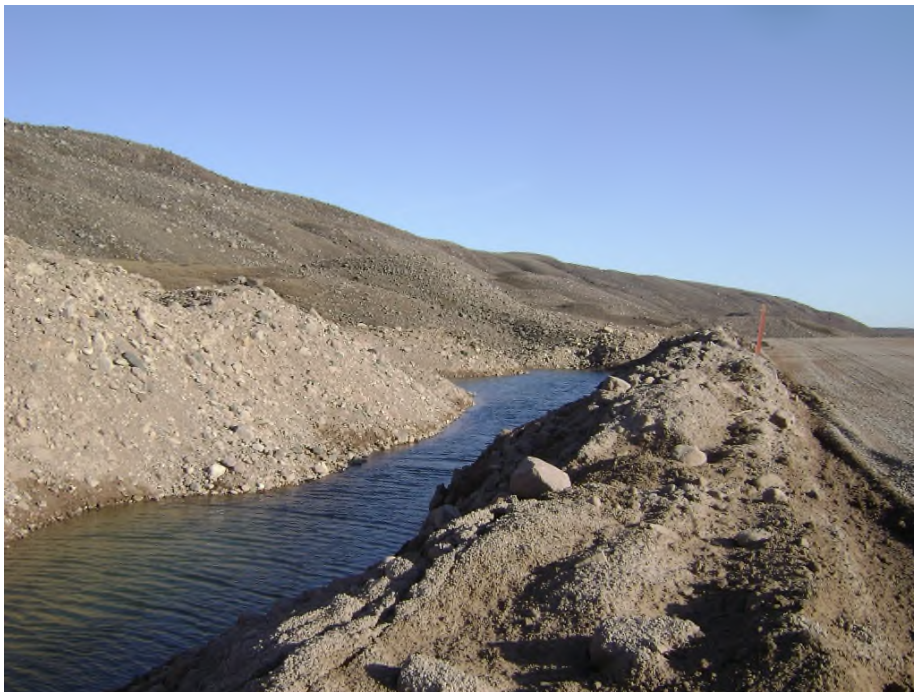
**Photo 9 (2536):**

Pit at KM 7.9 showing extensive settlement and ponding that is leading to embankment instability.

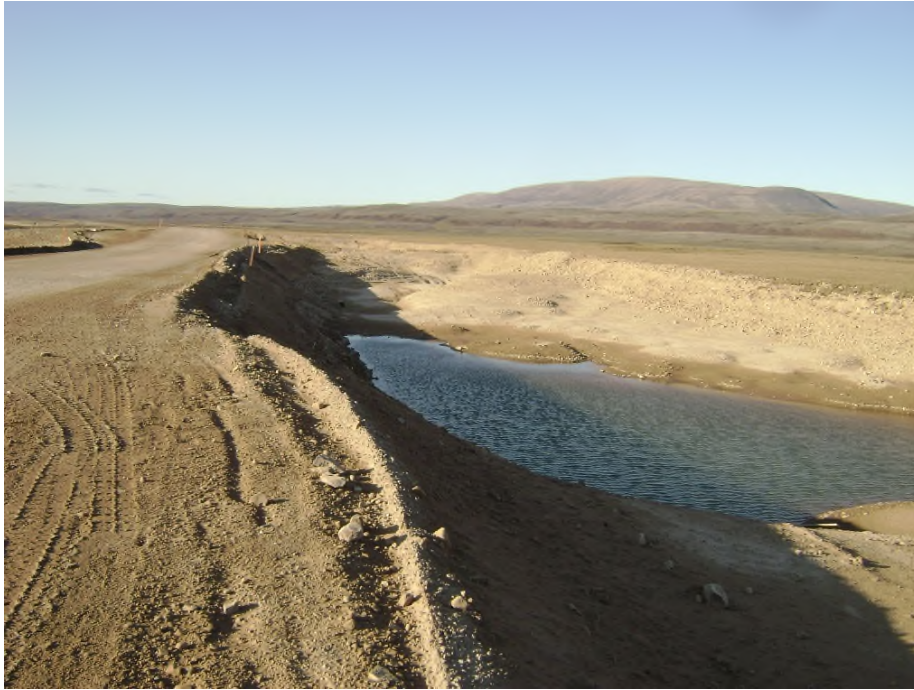
**Photo 10 (2540):**

Pit at KM 19.8 (Figure 4), pit is deepening due to continued thaw of ice-rich ground. Side slopes are very steep and there is considerable cracking on the shoulder and side slopes indicating that thaw is progressing under the road embankment. See Photo 11 for an aerial view of this pit.

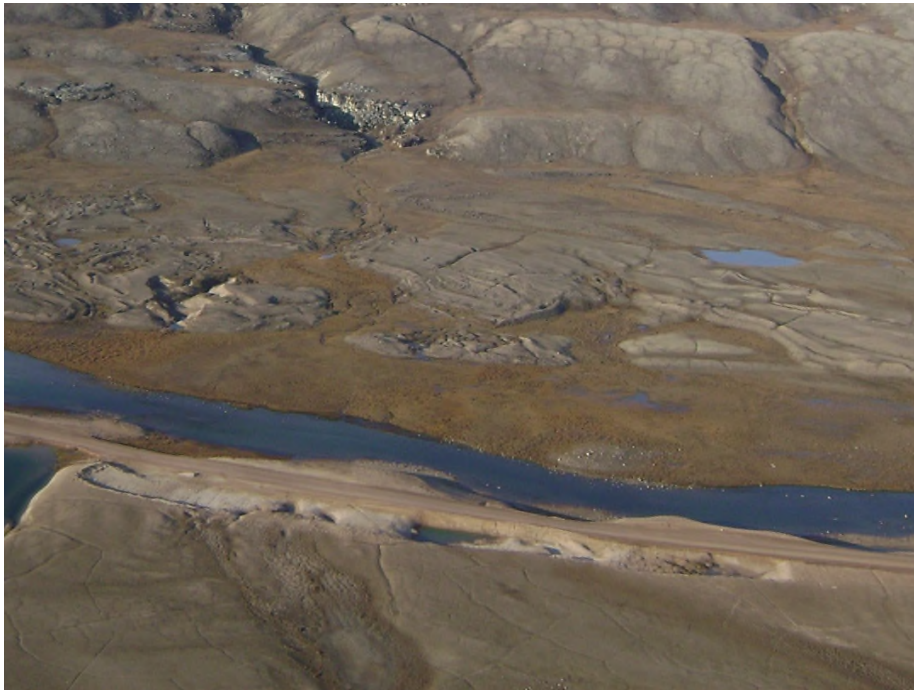
**Photo 11 (2571):**

Pit at KM 19.8 (Figure 3), note ponded water resulting from thaw of ice-rich material and over-steepened side slopes where water is ponding.

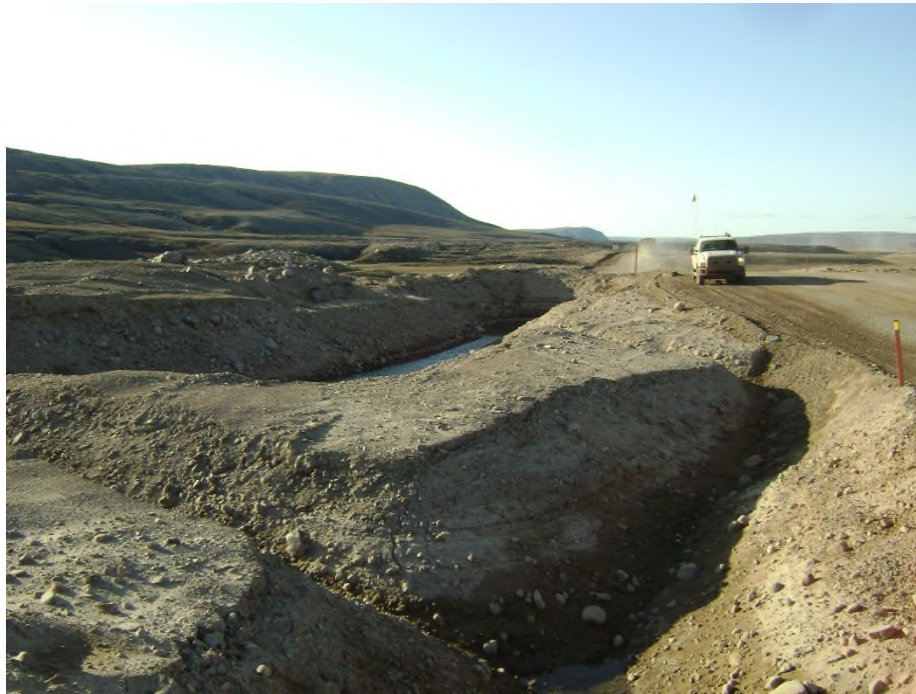
**Photo 12 (2544):**

Pit at KM 20.7 (Figure 3), continued melt out of wedge ice since 2009, embankment side slope is at angle of repose and there is substantial cracking on the side slope. There is evidence that the wedge ice that extends under the road is thawing because there are dips on the road surface. See also Photo 3 for comparison to 2014 condition.

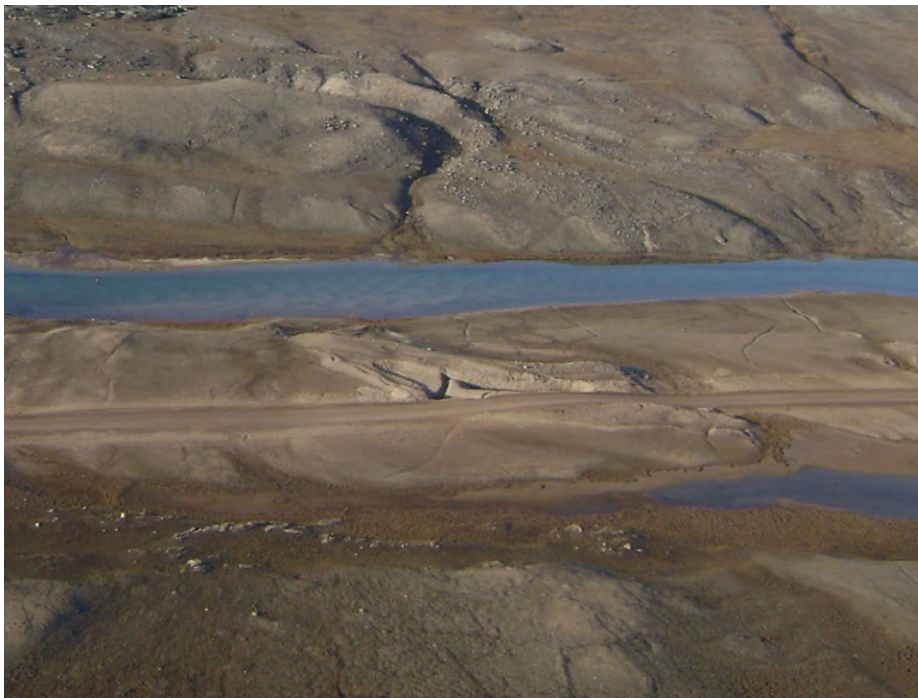
**Photo 13 (2571):**

Pit at KM 20.7 (Figure 3), see Photo 13 for closeup of this pit.

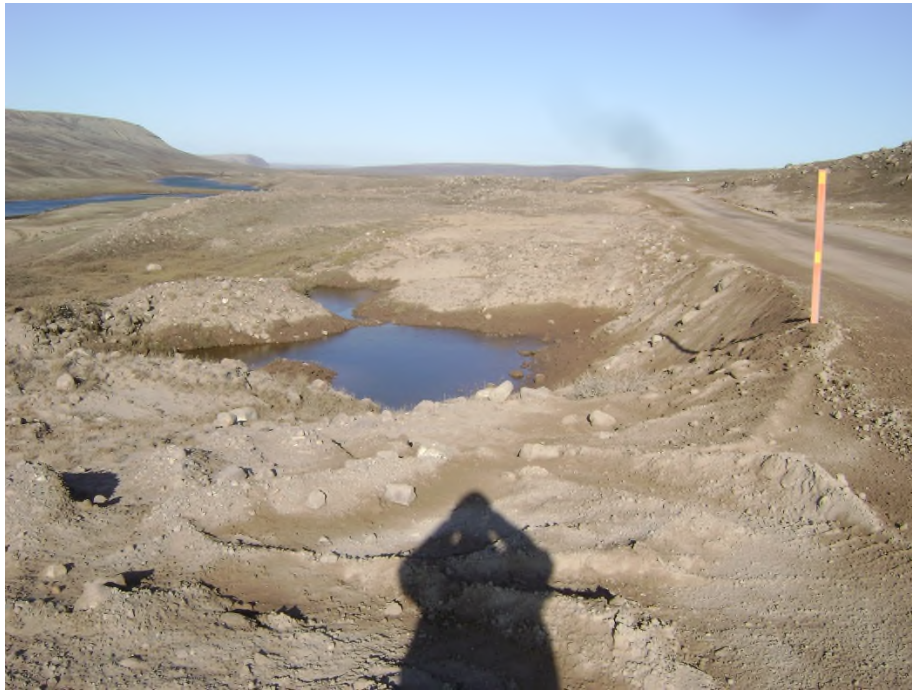
**Photo 14 (2693):**

Pit at KM 21.9 (Figure 3), continued thaw of ice-rich material exacerbated by the ponding leading to steep side slope and instability of the embankment.

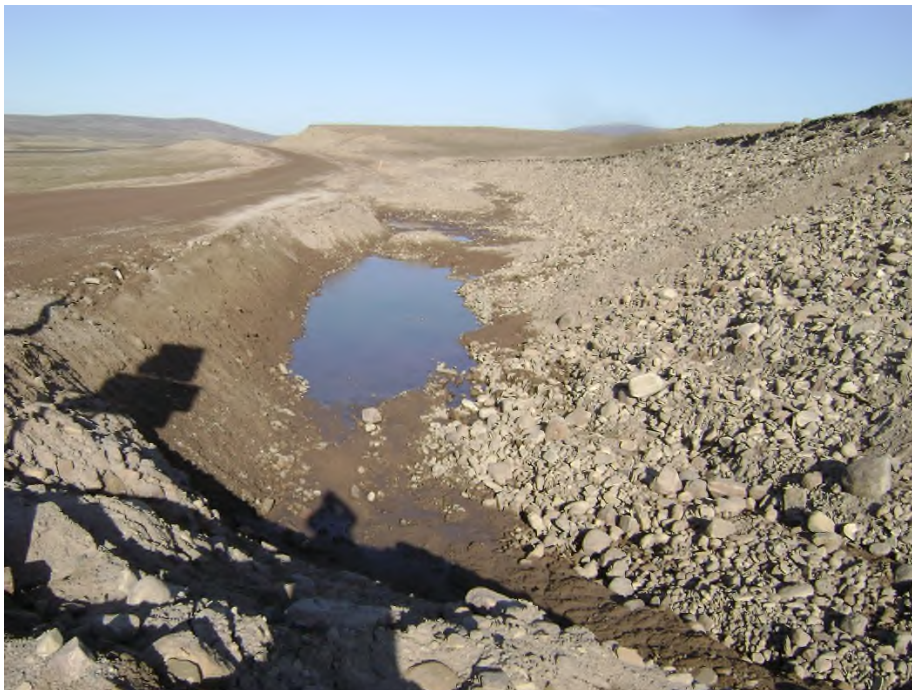
**Photo 15 (2693):**

Pit at KM 29.1 (Figure 4), continued thaw of ice-rich material exacerbated by the ponding leading to steep side slope and instability of the embankment. See also Photo 16. The central portion of this pit had been backfilled since 2014 dramatically improving embankment stability.

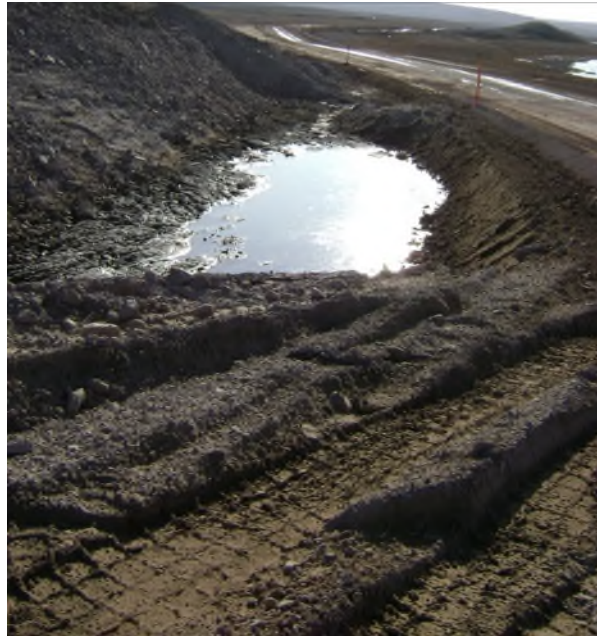
**Photo 16 (2695):**

Pit at KM 29.1 (Figure 4), continued thaw of ice-rich material exacerbated by the ponding leading to steep side slope and instability of the embankment. The central portion of this pit had been backfilled (bottom of the photo) since 2014 dramatically improving embankment stability.

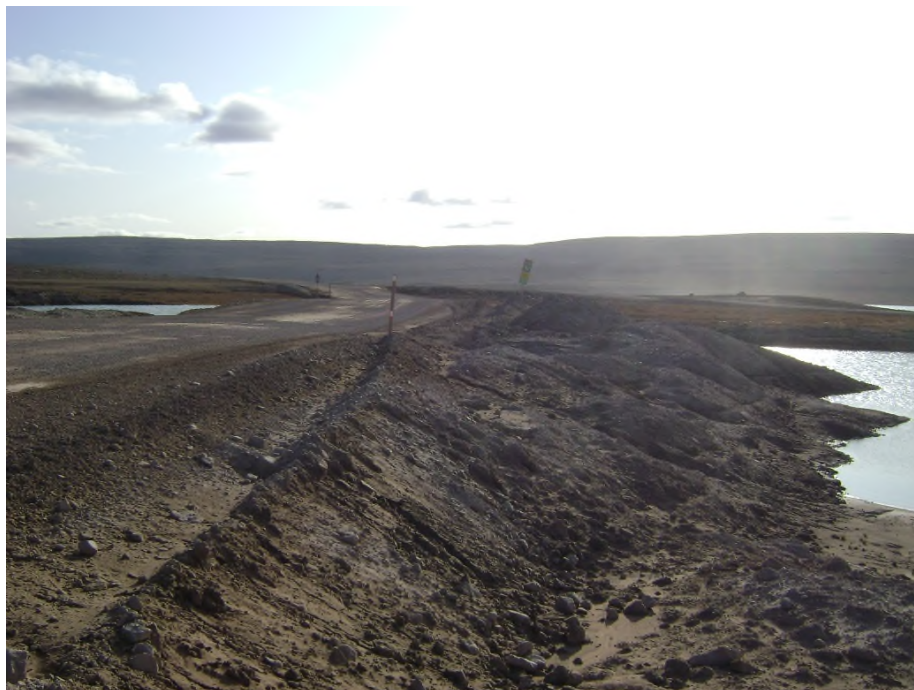
**Photo 17 (2670):**

Pit at KM 56.8 (Figure 8), berms along this (right) side of the new road effectively push water away from the embankment providing thermal protection to the embankment foundation soils and enhancing stability.

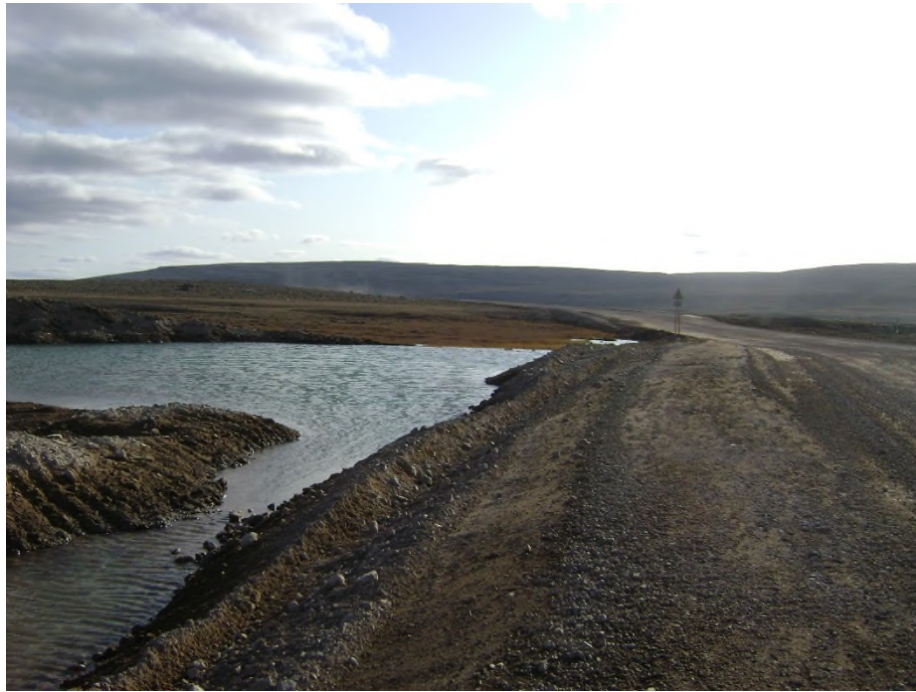
**Photo 18 (2693):**

Pit at KM 56.8 (Figure 8), the left side of the new road has steeper side slopes particularly where it narrows at the culvert inlet (close to the KM marker). This increases the potential for instability. The water needs to be pushed back from the toe of the slope by constructing berms on this side of the road (see Photo 17).

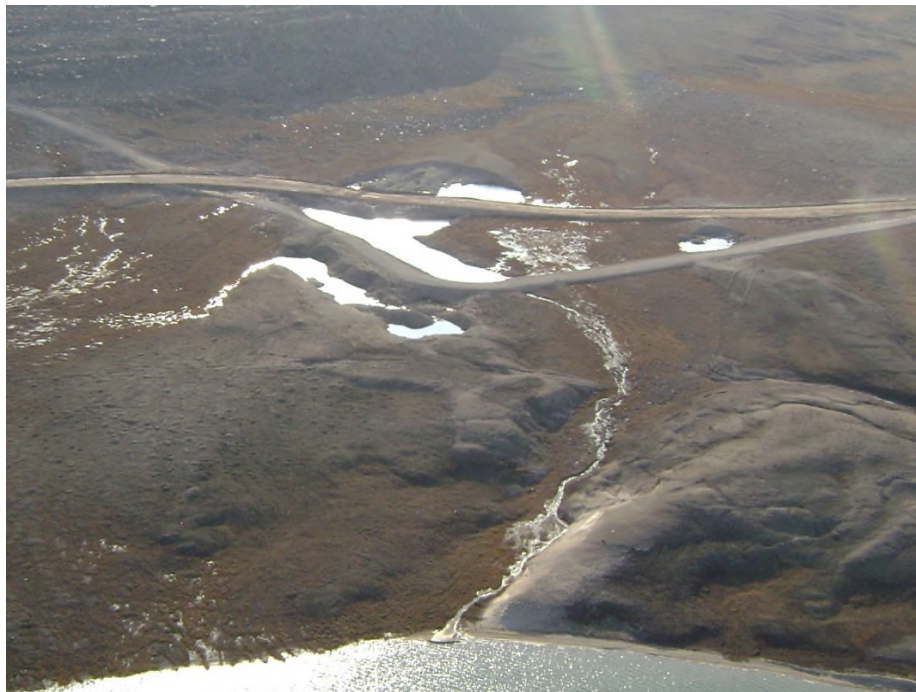
**Photo 19 (2592):**

Pit at KM 56.8 (Figure 8), drainage at this location is clearly shown in this photo. The culvert under the old road (near the hairpin corner) is currently being relied upon to keep water levels low around the new road.
