**Attachment 2**

**Execution Plan for Tote Road Remedial Action**

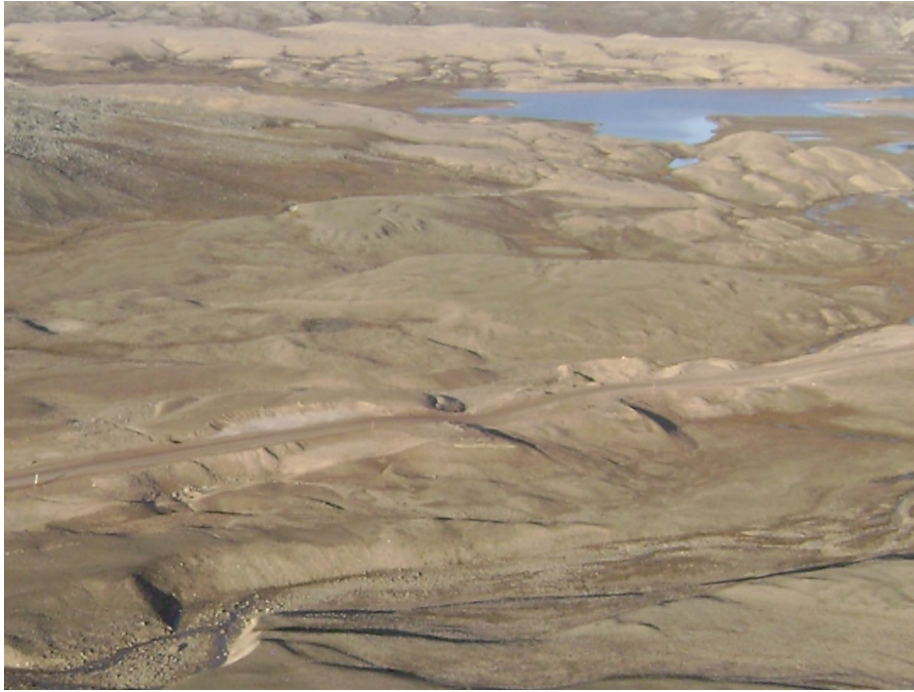
**Photo 20 (2558):**

Pits at KM 63 to 63.8 (Figure 9), continued thaw of ice-rich material threatens road stability at this location.

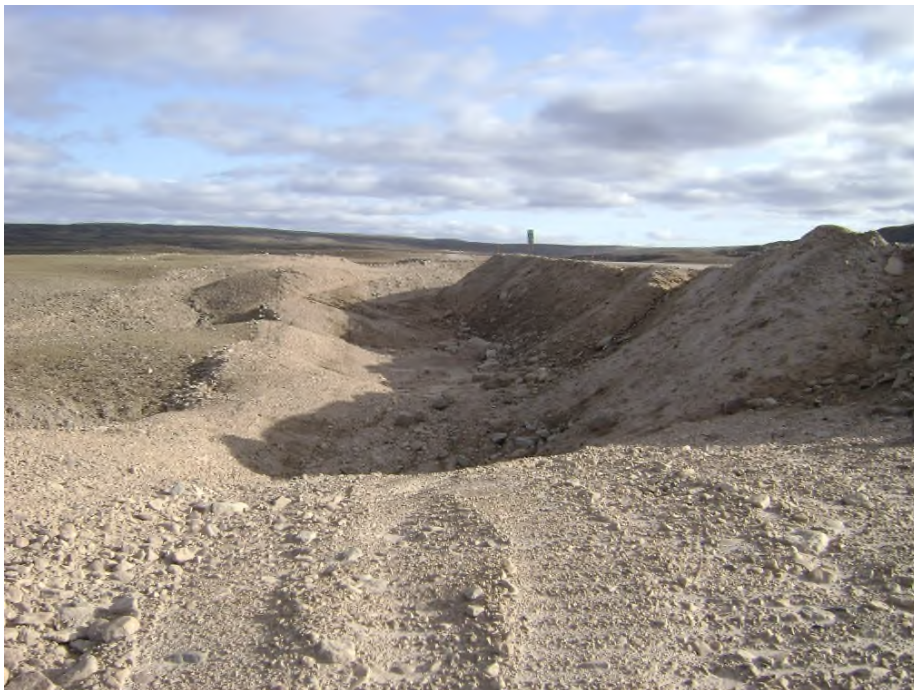
**Photo 21 (2657):**

Pit at KM 63.8 (Figure 9), continued thaw of ice-rich material beside the realigned road leading to steep side slope and instability of the embankment. Side slopes need to be significantly flattened to provide better thermal protection and stability.

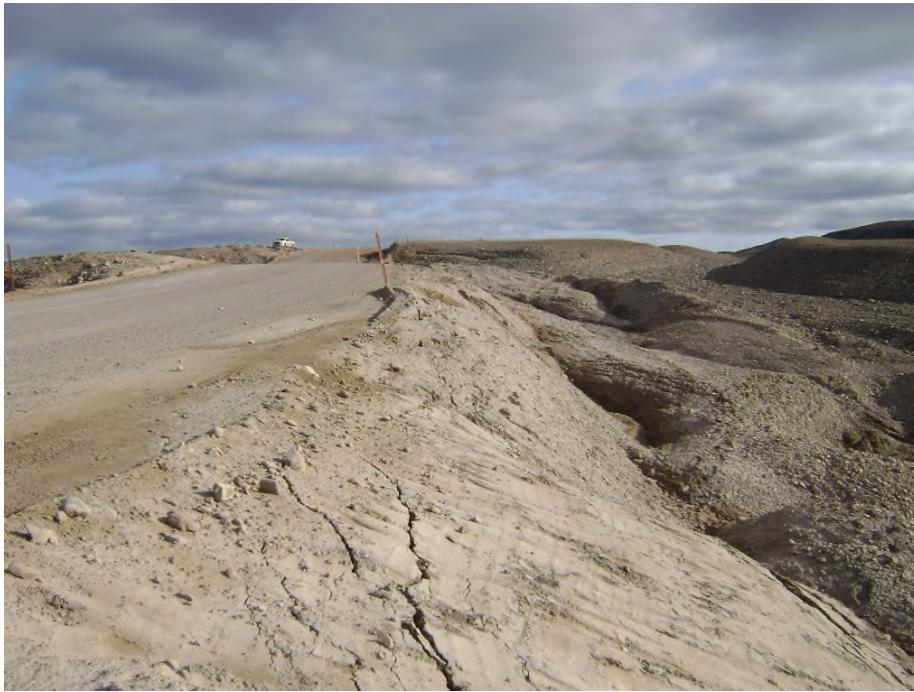
**Photo 22 (2662):**

Pits at KM 63 to 63.4 (Figure 9), continued thaw of ice-rich material beside the realigned road leading to steep side slope and instability of the embankment. Side slopes need to be significantly flattened to provide better thermal protection and stability.

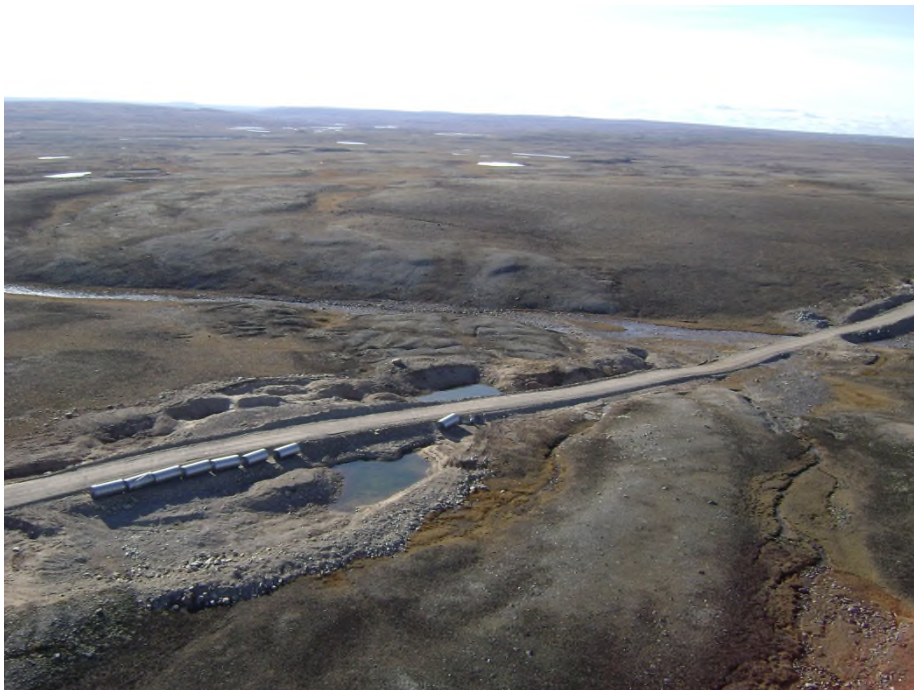
**Photo 23 (2014 Photo):**

Pit at KM 72.4 (Figure 10), extensive thaw settlement of very ice-rich soils in the borrow pits on both sides.

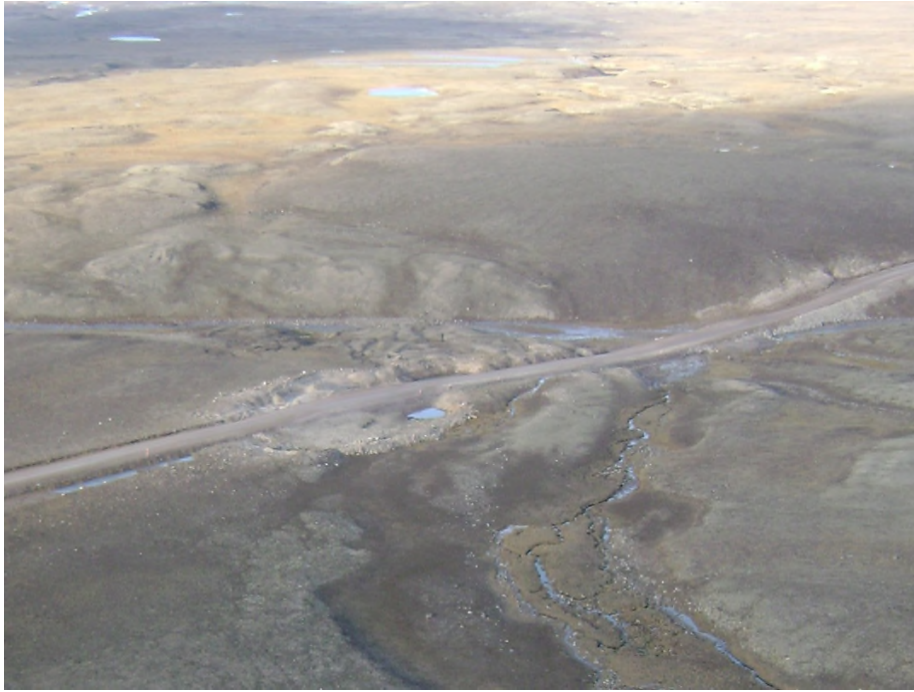
**Photo 24 (2555):**

Pit at KM 72.4 (Figure 10), compare to Photo 24. Thaw settlement is ongoing. Road was rebuilt after a failure occurred at the location of the pond on the left side of the road. Erosion channel from the left side is now more visible. When the water rises in the thaw settlement areas on the right side of the road it flows out and down to the creek and may be a source of sediment.

89.3	A				Q2/Q3 2020	Planned in coordination with km 89.8 works
22	72.4	A++++	2653	2555	QIA - noted issues at KM 72.3 and the uphill (left) borrow pit appears to be a source of sediment. Continued settlement and slope instability, and road maintenance noted that the left side of the road collapsed into the pond on left side earlier this year. Further work is needed as soon as possible to curtail further thawing and potential road collapse (see Section 4.0 for suggested repair). Filling in the pits will lessen the potential for sediment release if some check dams and armouring (rip rap) is also applied to the left of the road below the borrow pit.	Q3 2020	Sourcing materials from KM76 old road alignments, KM74 old road alignments - complete decommissioning and reclaim of these old road segments.
29	63.7	A++++	2657, 2658, 2659, 2660, 2661, 2662, 2663, 2664	2558, 2559, 2560, 2595,2596	This series of pits has gotten worse, recommendations from 2014 remain appropriate. See Section 4.0 in the report for additional details.	Q3/Q4 2020	Area to be properly assessed, but preliminary plans are to level areas and pull material from slopes back into pits, create even terrain that will not trap water.

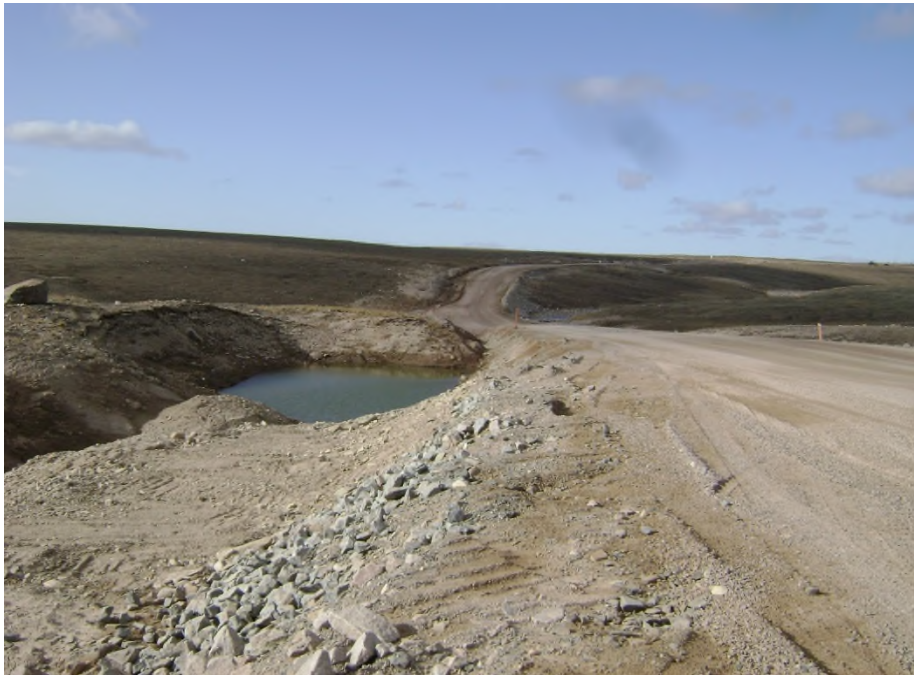
**Photo 25 (2555):**

Pit at KM 72.4 (Figure 10), photo shows right side borrow pit with very deep ponding due to thaw. Embankment shows signs of instability due to very steep slopes. Outlet for ponded water can be seen and is probably the source of sediments noted by the QIA.

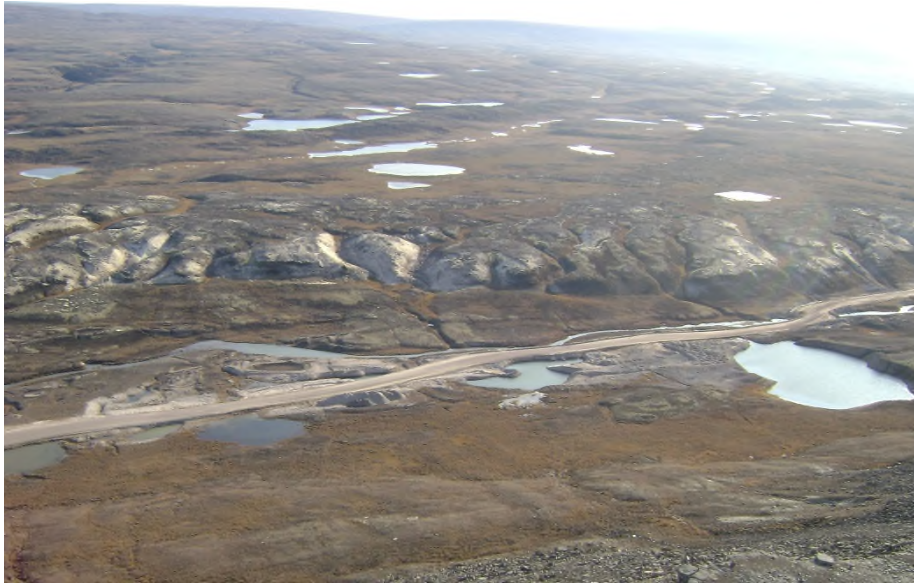
**Photo 26 (2597):**

Pit at KM 89.8 (Figure 12), photo shows borrow pit on the right side with very deep ponding due to thaw (centre of photo). Larger pond on the right is a natural thermokarst pond that existed before the road was constructed and is typical of the ponds that form due to thaw of massive ice bodies. This was likely also the case at the borrow pit location where the removal of the active layer initiated thaw of massive ice.

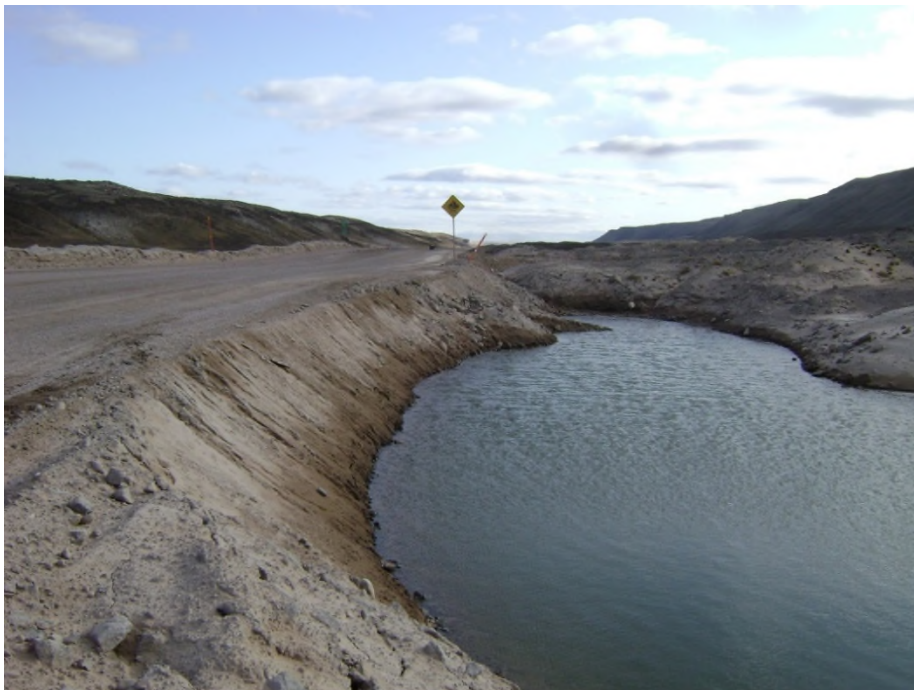
**Photo 27 (2656):**

Pit at KM 89.8 (Figure 12), photo shows right side borrow pit with very deep ponding due to thaw. Embankment shows signs of instability due to very steep slopes and ongoing thaw.

Site WP No. 2009	Km Post	Priority	Ground Photos	Aerial Oblique Photos	2019 Comments	Proposed Timeline for Execution	Notes for Execution
14	89.8	A++++	2655, 2656	2597	QIA -Noted road stability issues. Instability is very evident, water is very deep and the embankment side slope on the right side of the road is very steep and shows cracking on the shoulder and side slope. Stabilization should be undertaken as soon as possible (see Section 4.0)	Q2/Q3 2020	Materials stockpiled within 100 meters from erosion stabilization work completed at km 90 area in 2017

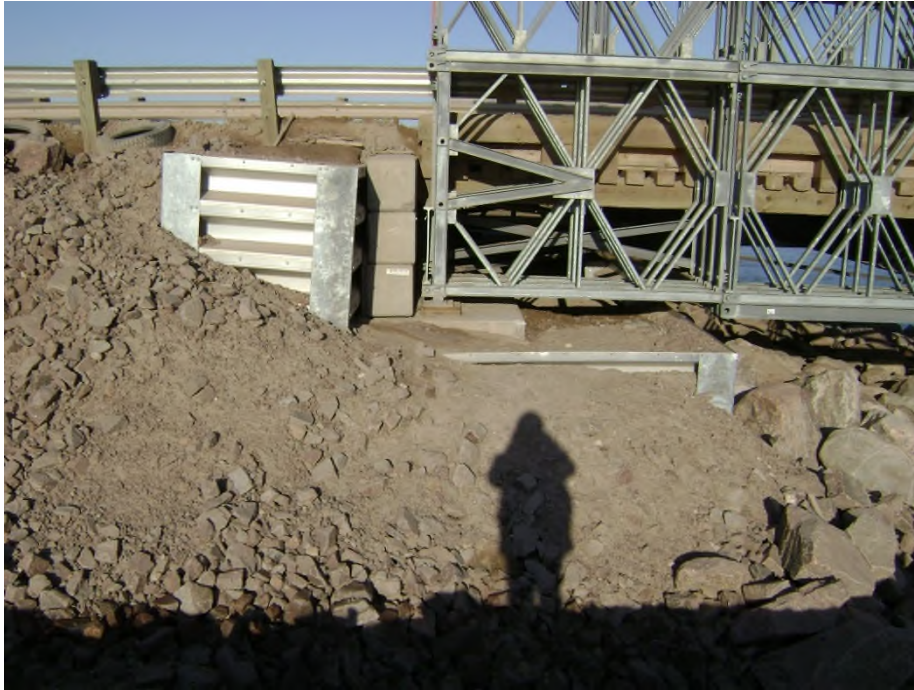
**Photo 28 (2678):**  
KM 17 Bridge, west abutment. Note tilting of upper bin wall.

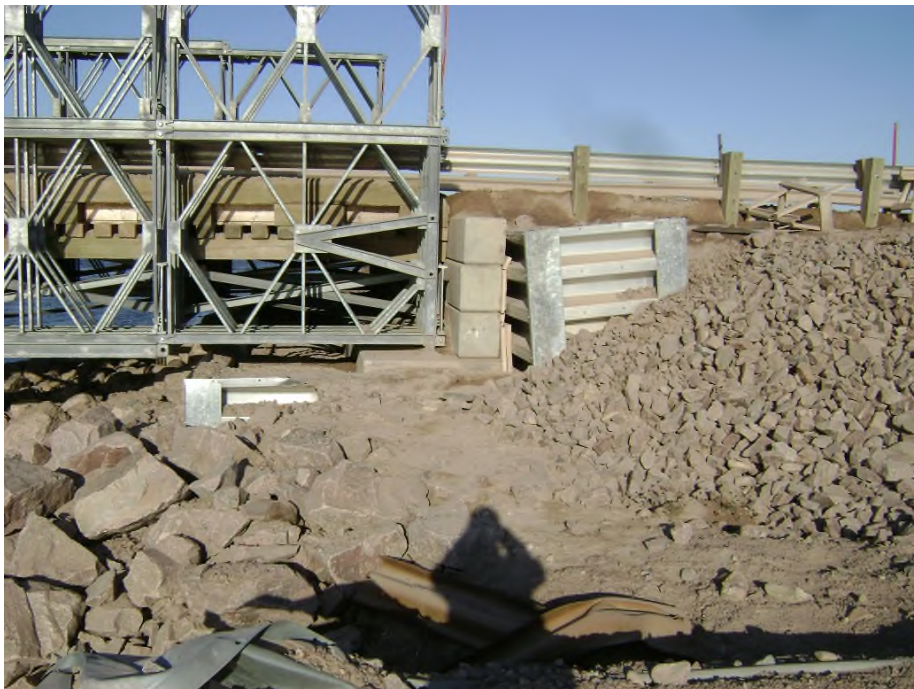
**Photo 29 (2683):**  
KM 17 Bridge, east abutment. Note tilting of upper bin wall.

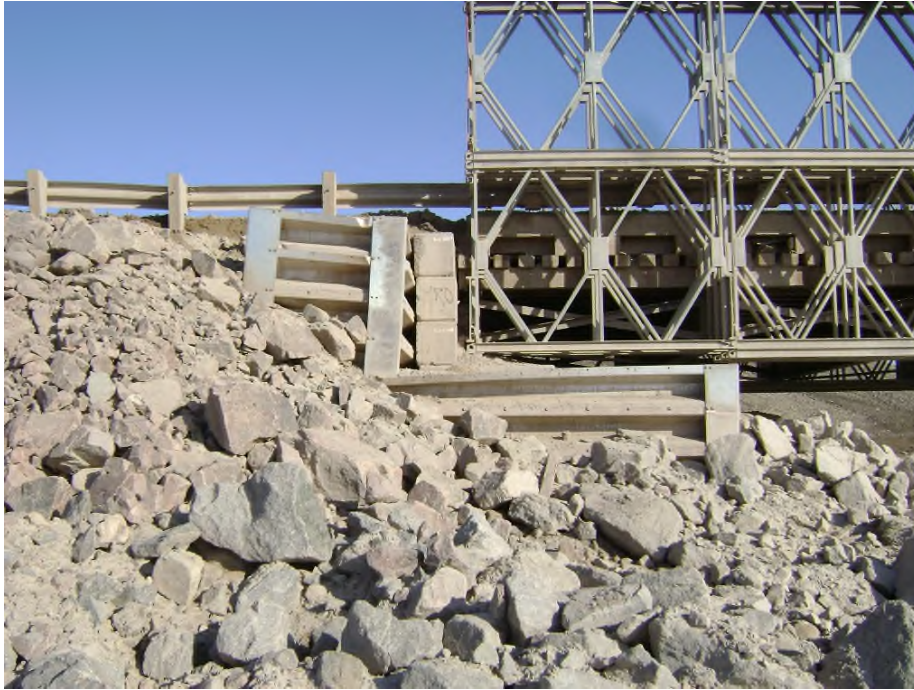
**Photo 30 (2683):**  
KM 63 Bridge, north abutment. Note tilting of upper bin wall.

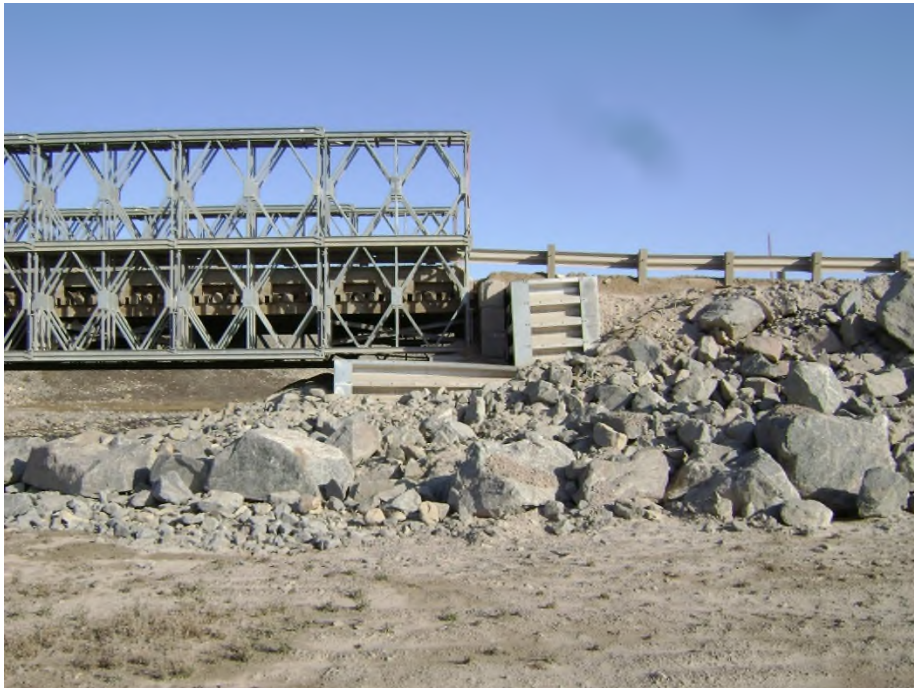
**Photo 31 (2708):**  
KM 64 Bridge, south abutment. Note tilting of upper bin wall.

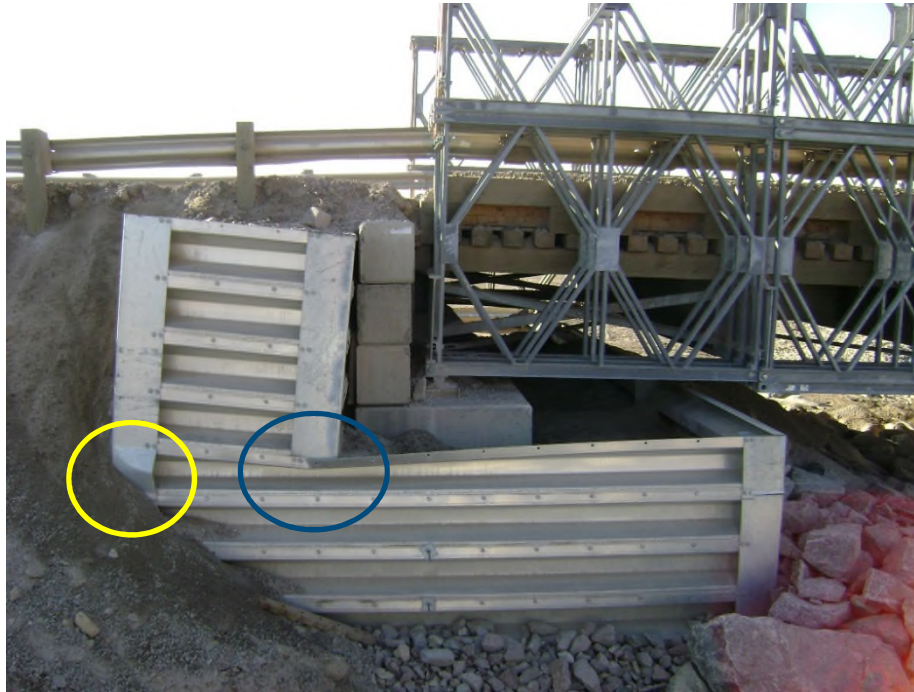
**Photo 32 (2712):**

KM 64 Bridge, south abutment. Note tilting of upper bin wall, buckling of back bin wall corner post (yellow) and bending of upper plate in the lower bin wall (blue).

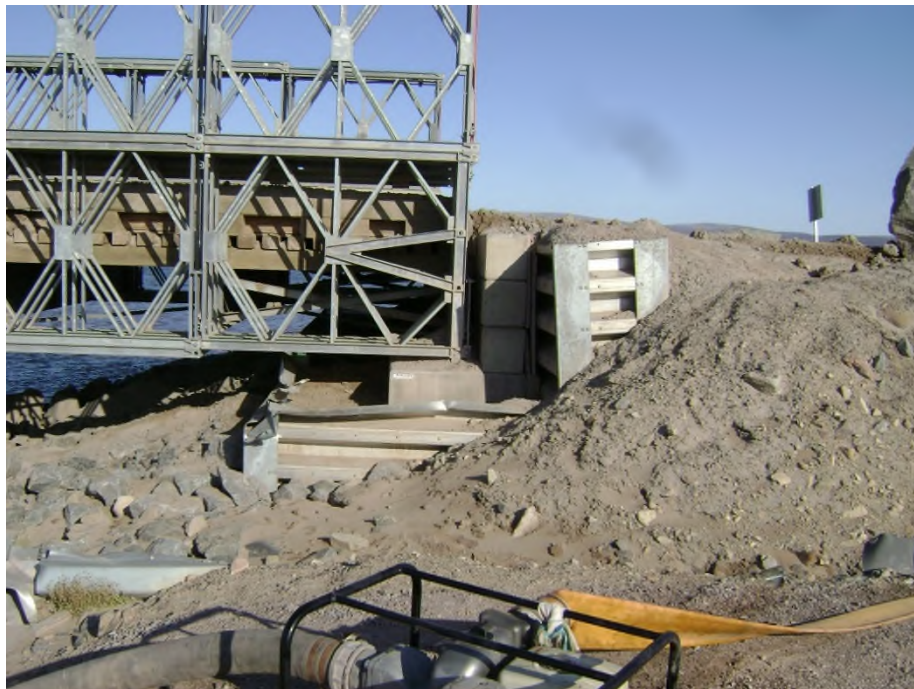
**Photo 33 (2715):**

KM 80 Bridge, south abutment. Note tilting of upper bin wall.

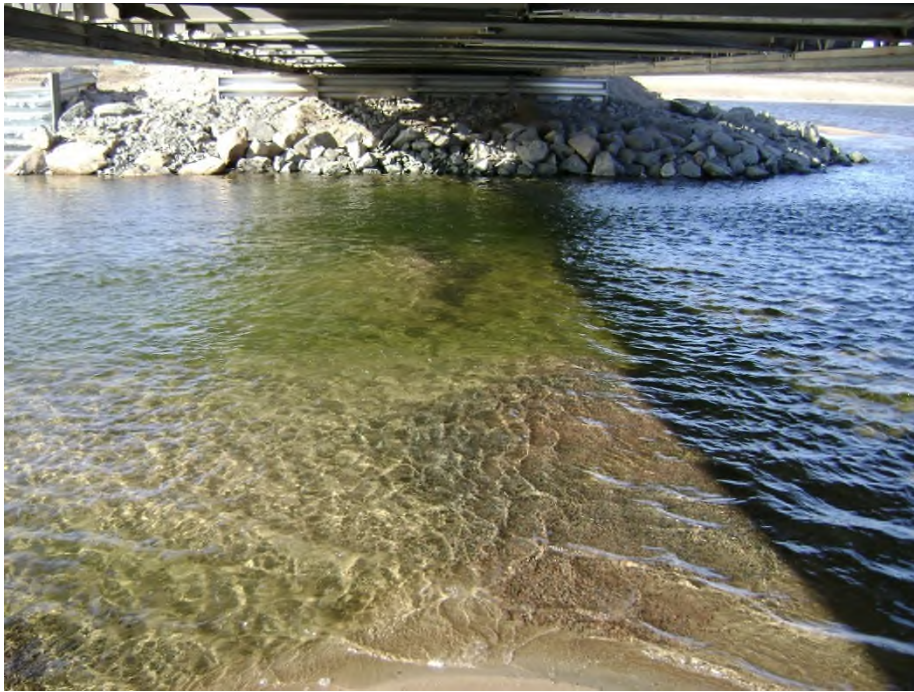
**Photo 34 (2718):**  
KM 80 Bridge, road surfacing gravel that has fallen through the centerline joint in the bridge deck and is visible in the river.

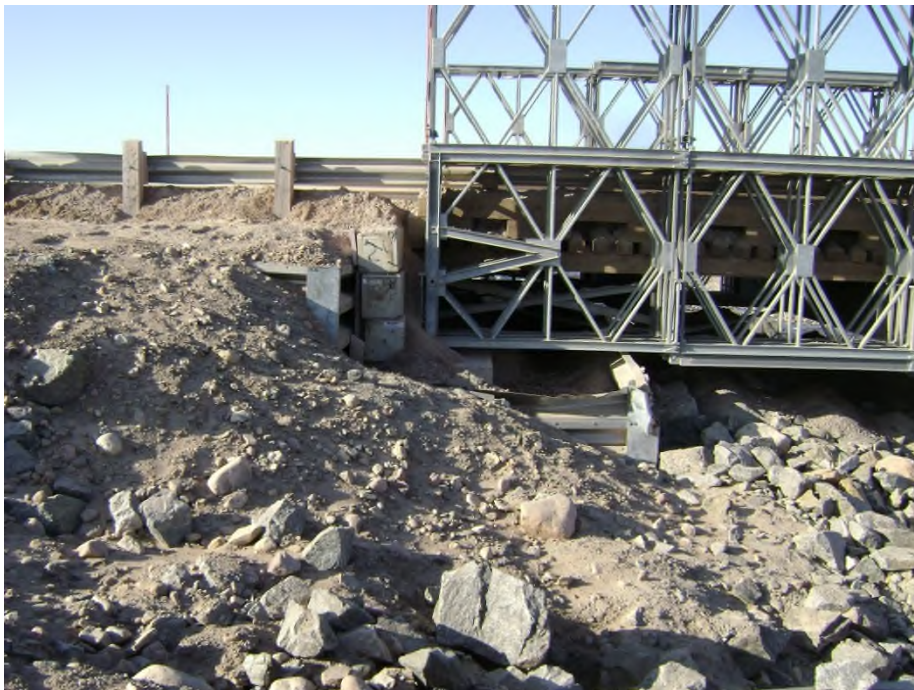
**Photo 35 (2719):**  
KM 97 Bridge, north abutment. Shorter upper bin wall has not tilted as much as other bridges. Lower chord of the bridge truss appears to be in contact with the lower bin wall.

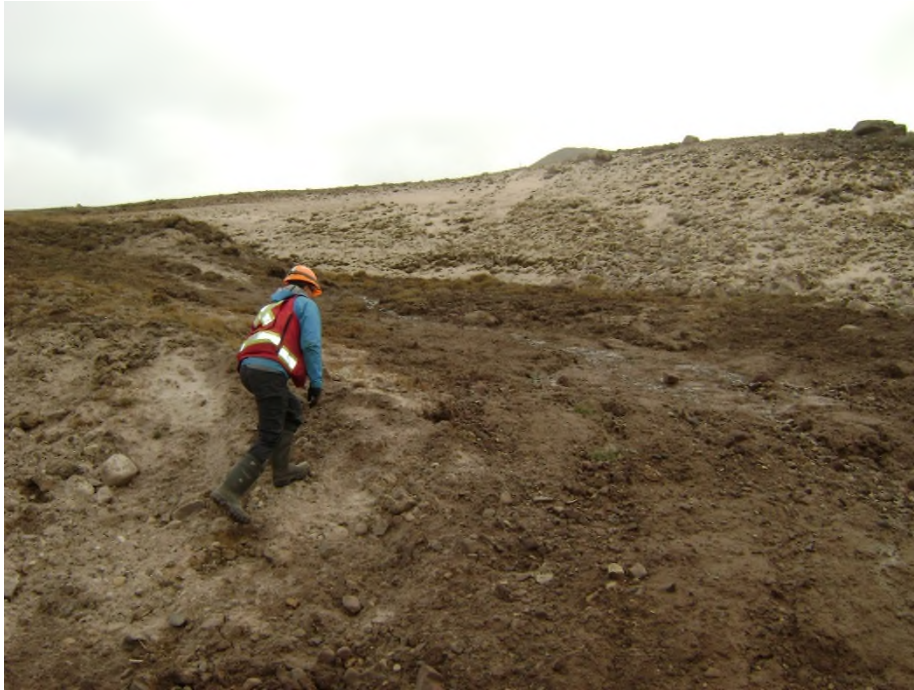
**Photo 36 (2523):**  
KM 2.5 slope instability and mud slide adjacent to the Tote Road.

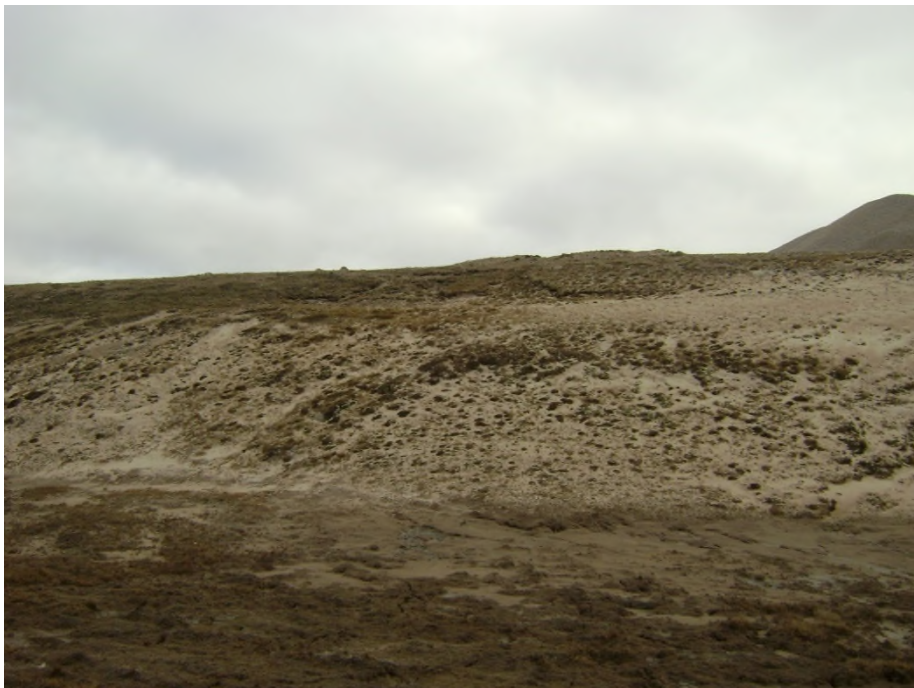
**Photo 37 (2524):**  
KM 2.5 slope instability and mud slide adjacent to the Tote Road. Photo on terrace above the road, note evidence of a small instability near the top of the slope and thawed surficial materials on the terrace.

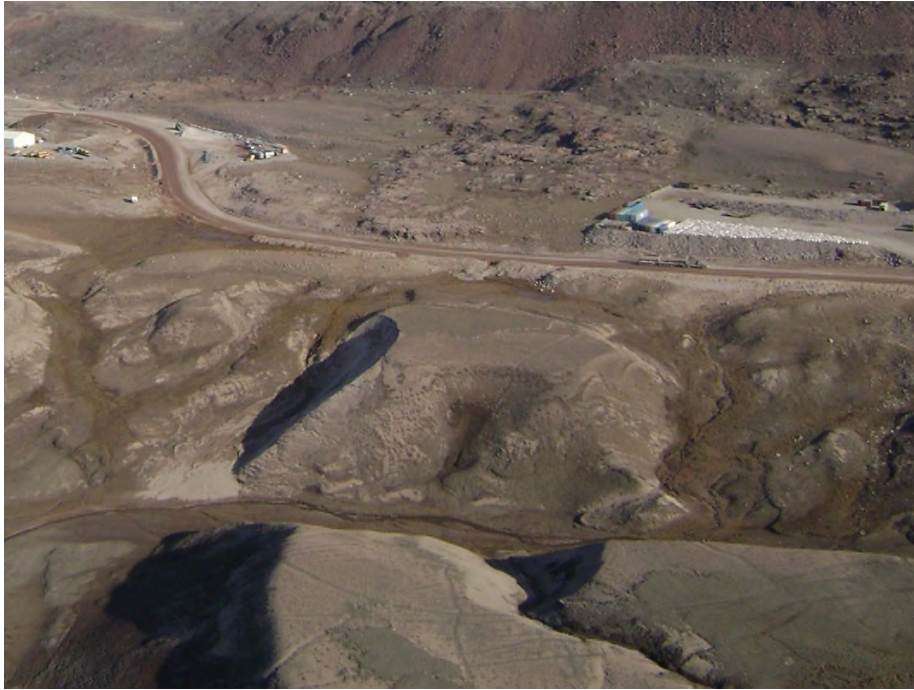
**Photo 38 (2526):**

KM 4.0 erosion location. Erosion is seen on the north (left in the photo) side of terrace (see also photo 39) with a large sedimentation fan near the creek, a wet area on the terrace below the road (see Photo 40) and secondary erosion feature (see Photo 41 on the south (right in the photo) side of the terrace).

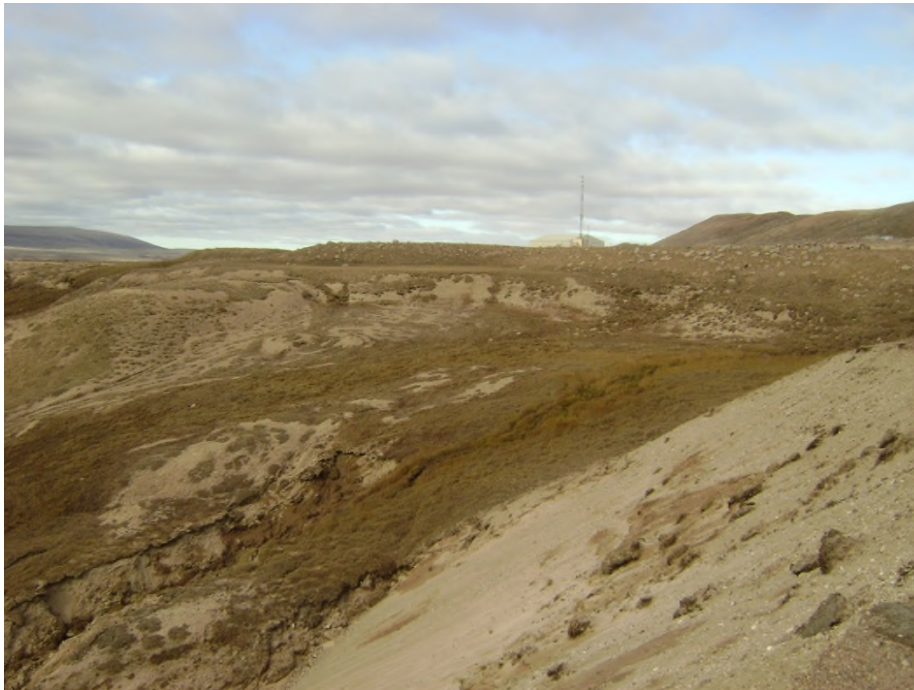
**Photo 39 (2528):**

KM 4.0 erosion location immediately below the culvert on the north side of the terrace.

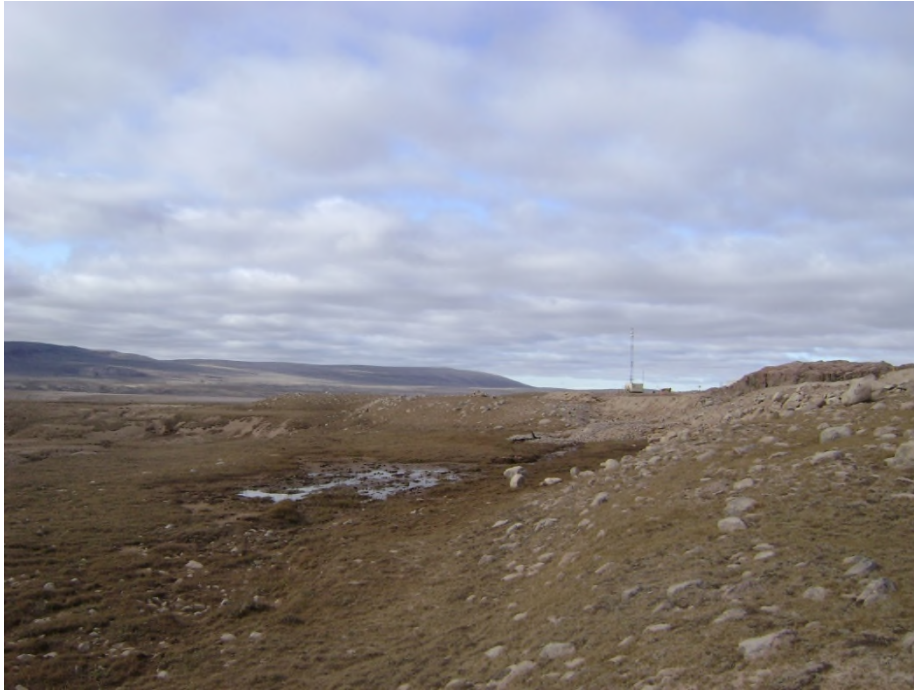
**Photo 40 (2526):**

KM 4.0 erosion location. Photo shows wet area below the road on the top of the terrace.

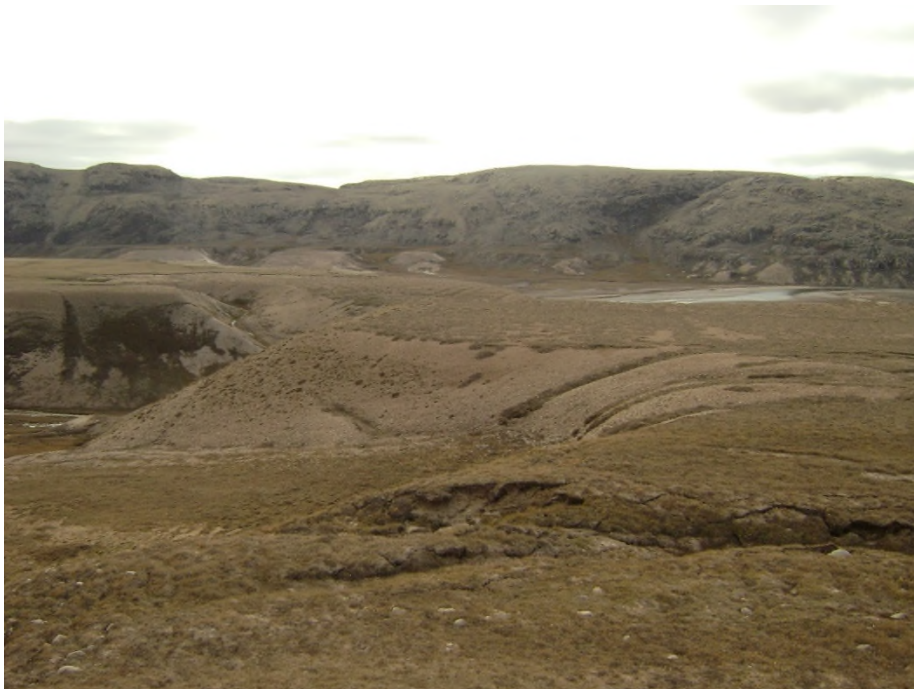
**Photo 41 (2527):**

KM 4.0 erosion location. Photo shows erosion at the edge of the south side of the terrace.

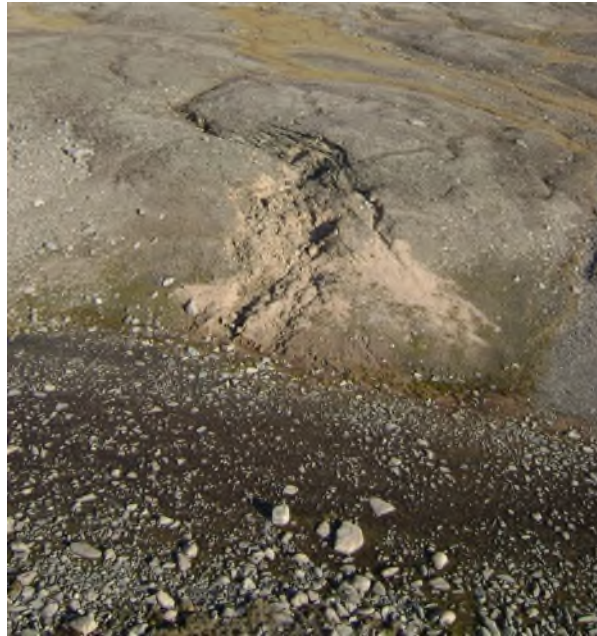
**Photo 42 (2728):**

Natural instability/erosion feature south of the Tote Road near KM 71. Surface water erosion leading to thaw and sediment release.

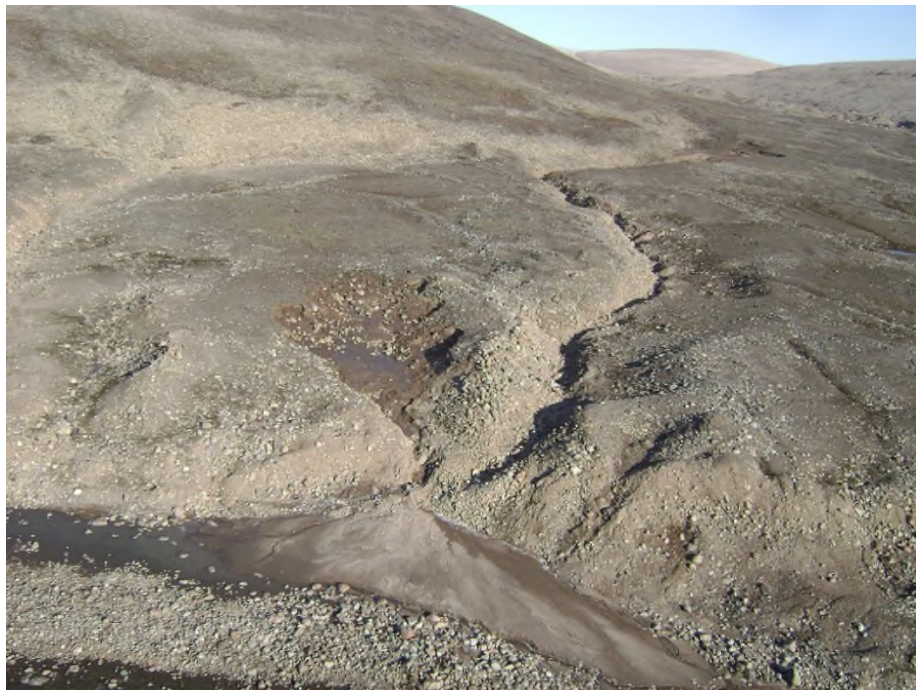
**Photo 43 (2721):**

Natural instability feature (active layer detachment side) on the headwaters of the Mary River 16 km east-northeast of the mine.

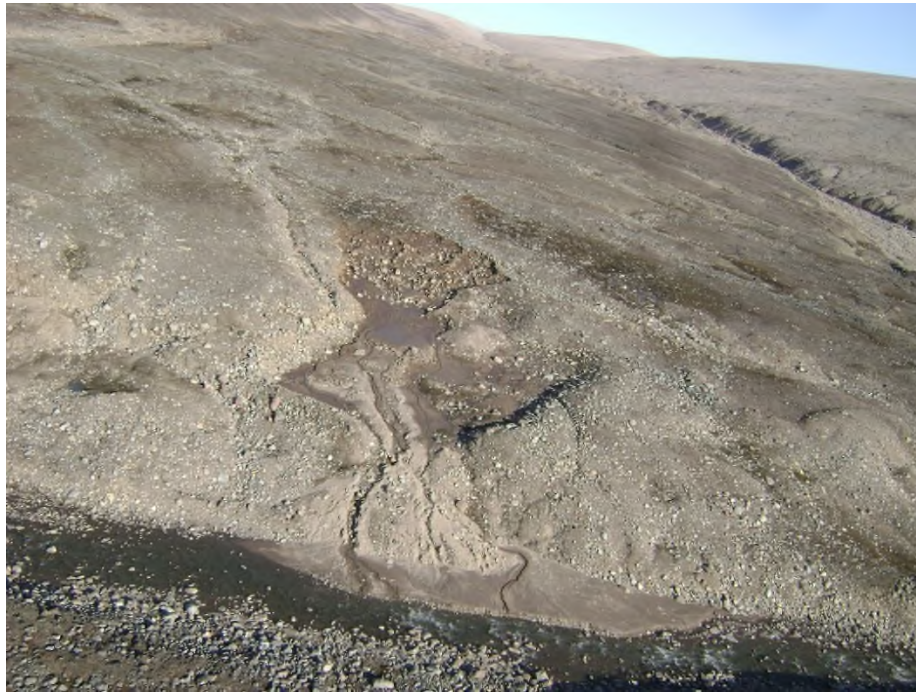
**Photo 44 (2722):**

Another natural instability feature (active layer detachment side) on the headwaters of the Mary River 16 km east-northeast of the mine. Note sedimentation into the river that lead to turbidity being observed in the river near the mine

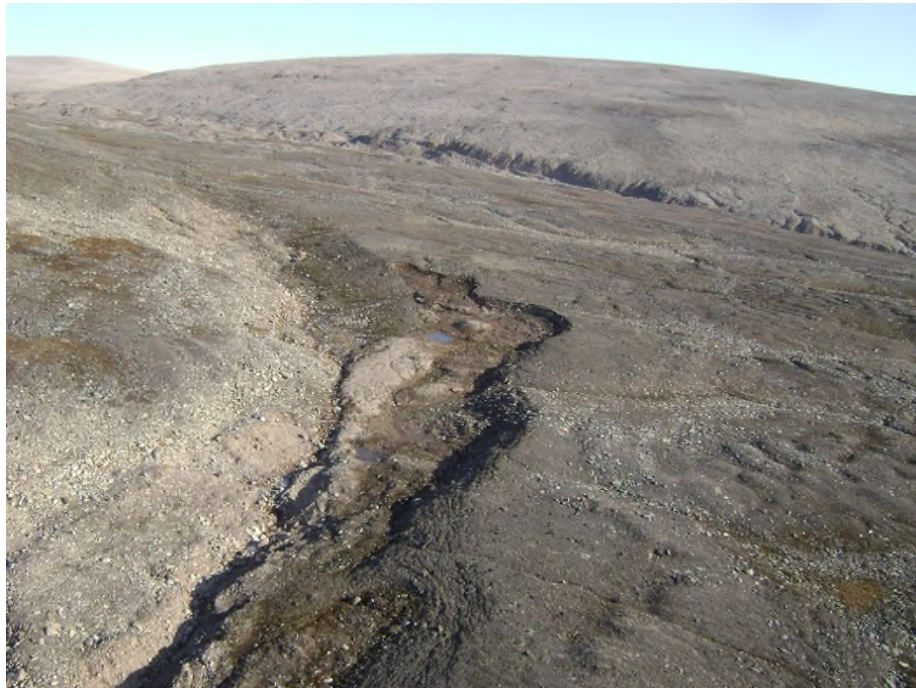
**Photo 45 (2724):**

More natural instability features (active layer detachment sides) uphill from the location shown in Photo 44 on the headwaters of the Mary River 16 km east-northeast of the mine.

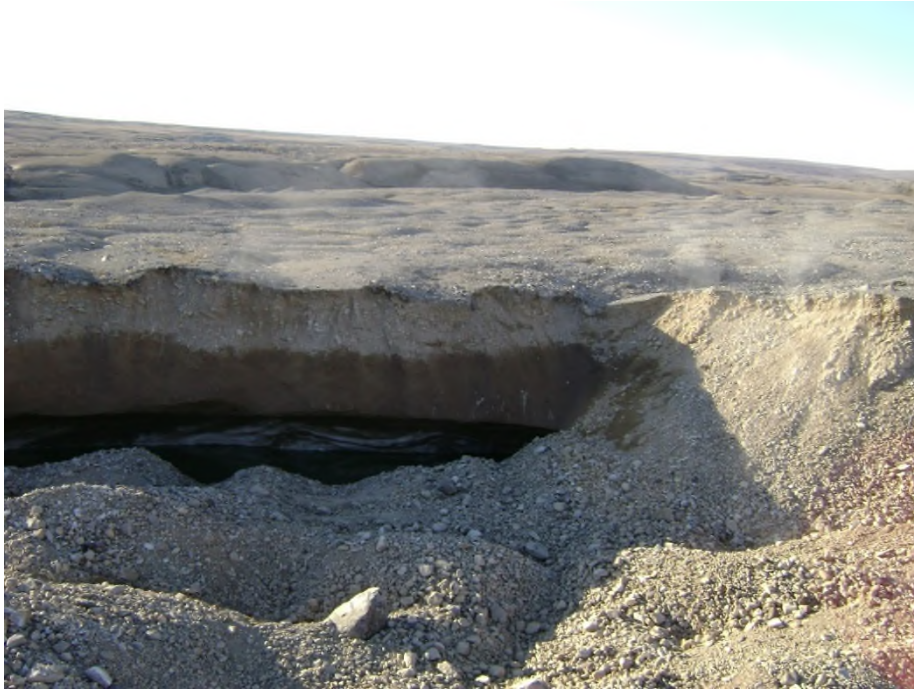
**Photo 46 (2014 photo):**

Photo of a natural collapse feature in undisturbed terrain. The photo clearly shows the active layer (light colour silty granular material), overlying frozen (darker material), overlying a massive ice body. Natural material over the ice is approximately 3.0 m thick. See Photo 48 taken in 2019 at the same location.

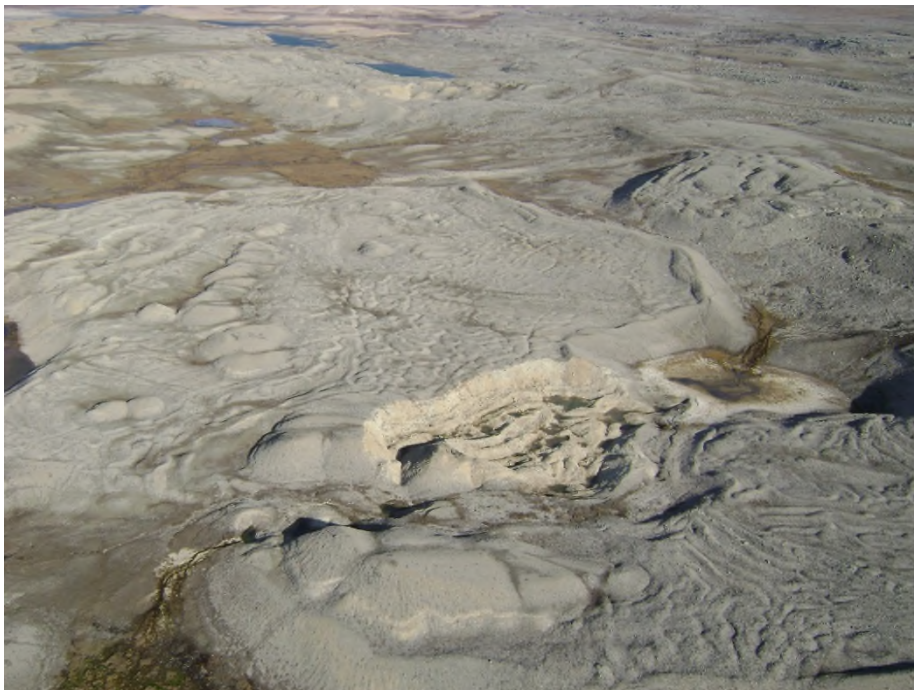
**Photo 47 (2638):**

2019 Aerial photo of the natural collapse feature shown in Photo 46. The size of the collapse feature has increased dramatically with extensive meltout of the massive ice. What can be learned from the photo is that terrain with this type of surface expression ("gummie worm") is likely indicative of deposits of massive ice. This type of terrain is particularly prevalent in the area where the railway deviates to the south of the Tote Road.

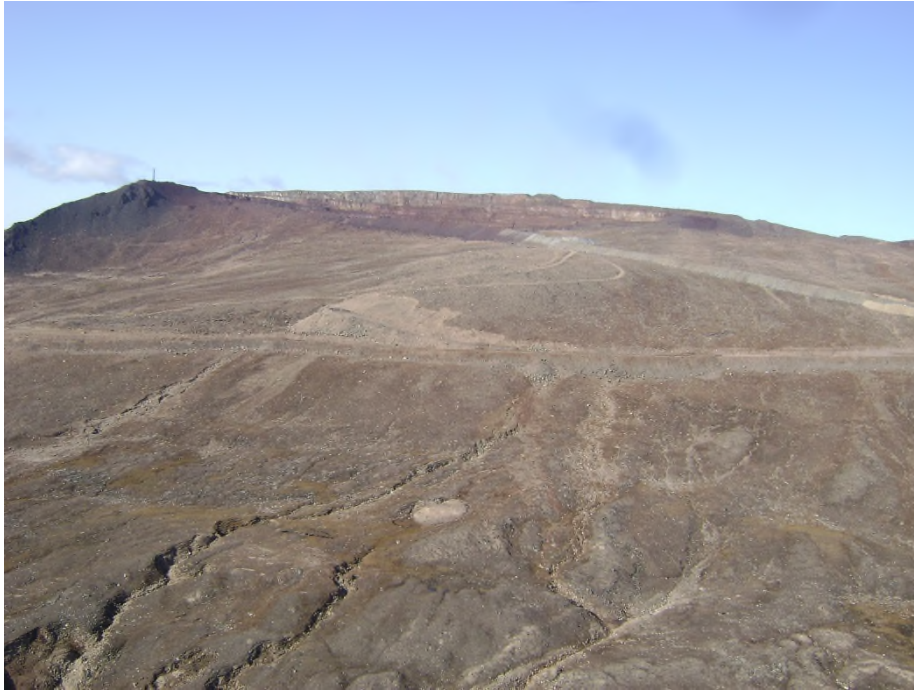
**Photo 48 (2650):**  
Erosion channels downslope of the main mine haul road from the open pit.

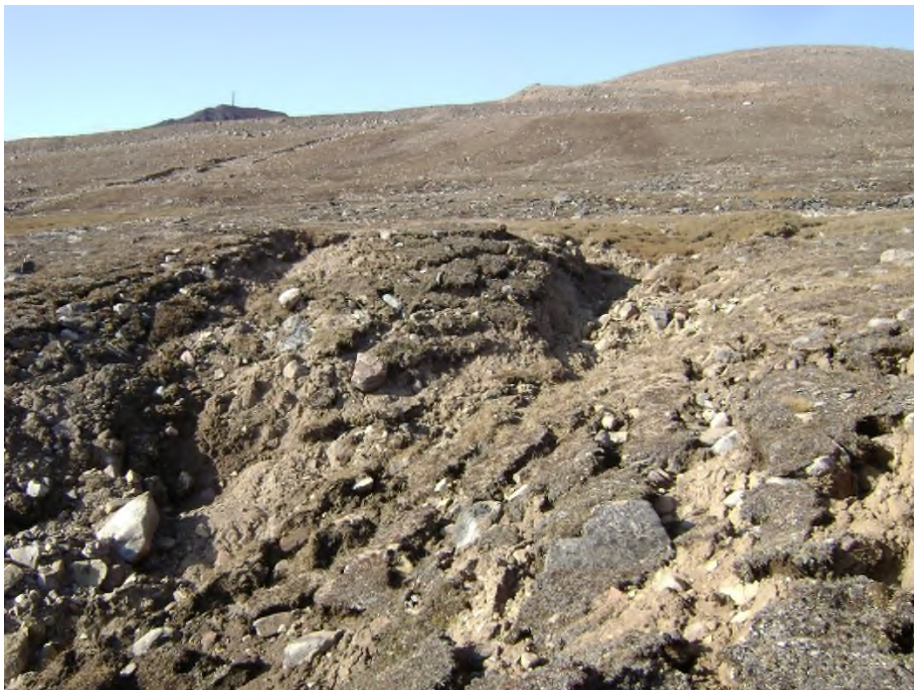
**Photo 49 (2652):**  
Close-up of some of the erosion channels downslope of the main mine haul road from the open pit.

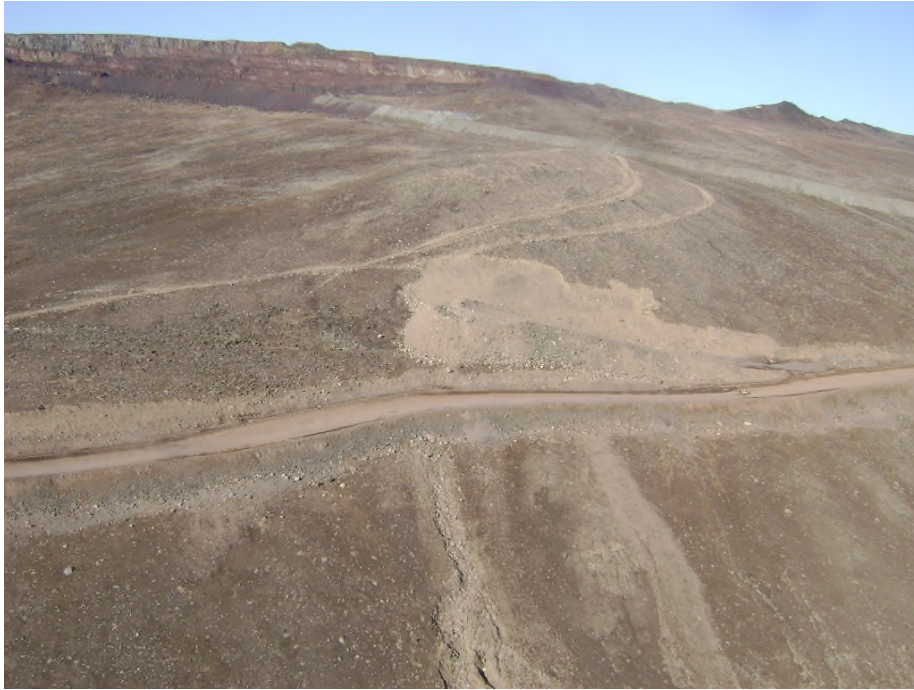
**Photo 50 (2643):**

Additional erosion channels downslope of the main mine haul road from the open pit.

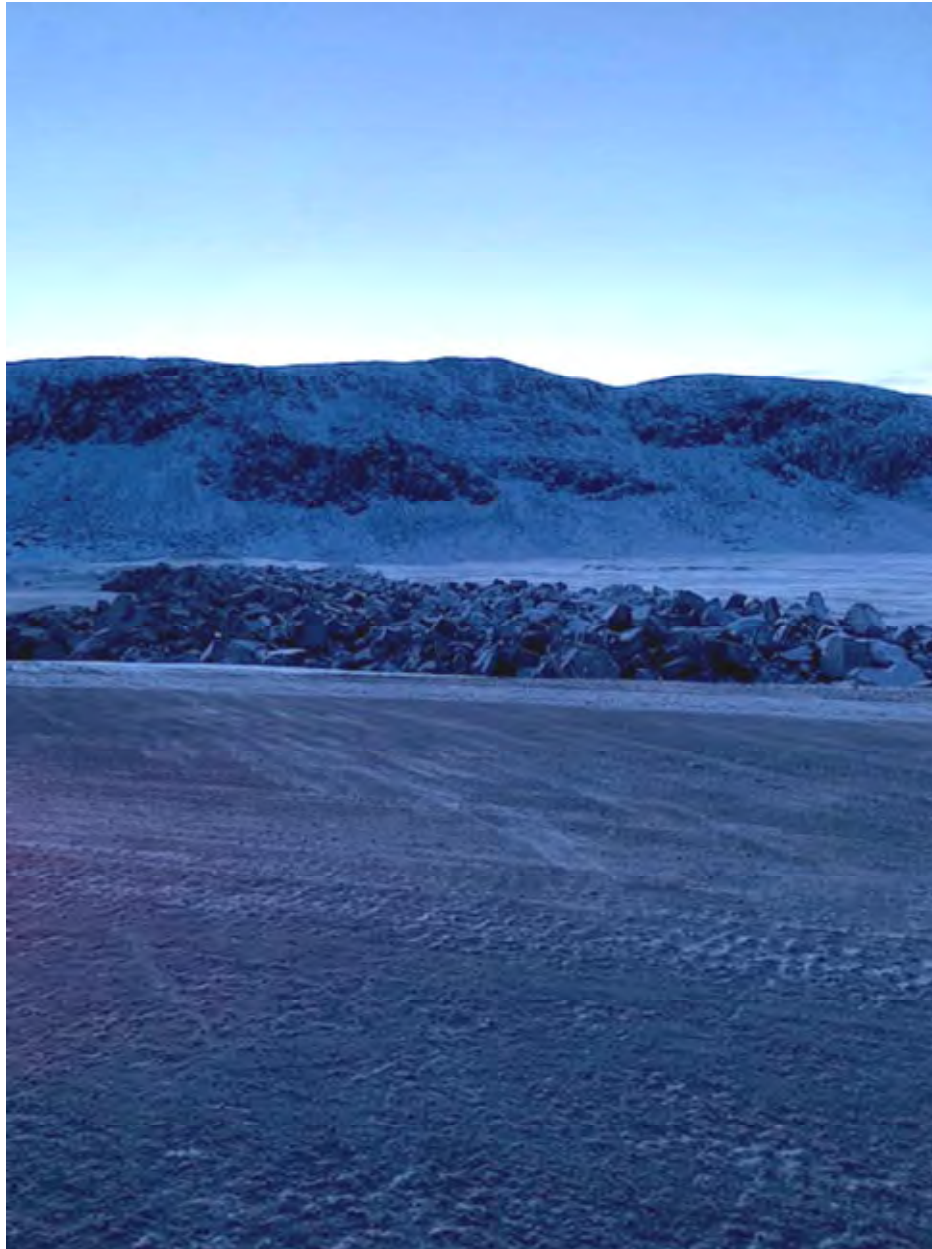
**Figure 1 – Bulk filling with run of quarry (ROQ) material, placed at KM7.2 Borrow**

Site WP No. 2009	Km Post	Priority	Ground Photos	Aerial Oblique Photos	2019 Comments	Proposed Timeline for Execution	Notes for Execution
83A	7.2	A++++	2531, 2535, 2536, 2537, 2538	2578, 2584	QIA noted that the road was surrounded by water at nearly the elevation of the road and noted that there appeared to be degradation of permafrost. Indeed, ongoing permafrost degradation is ongoing in the pit. The road appears much less stable in 2019 and the water levels have risen in the pits, leading to road instability due to thaw. This pit needs to be filled on both sides of the road after removing as much water as possible. Filling the pits a regrading will hopefully lead to aggradation of permafrost and enhance the stability of the road much worse. See Section 4.0 for further discussion.	Q4 2019	Bulk fill commenced late November 2019 with ROQ from Q1 quarry, continued work to completion to be done in Q2/Q3 2020 due to inavailability of finer materials being frozen and inaccessible. Estimated 15,000 m3 of overburden material required.
