Baffinland Iron Mines Corporation

Project #: TC190307

Annual Geotechnical Inspections – 2020 Report 1.

APPENDIX "A" - Mary River Mine Complex - Photographs

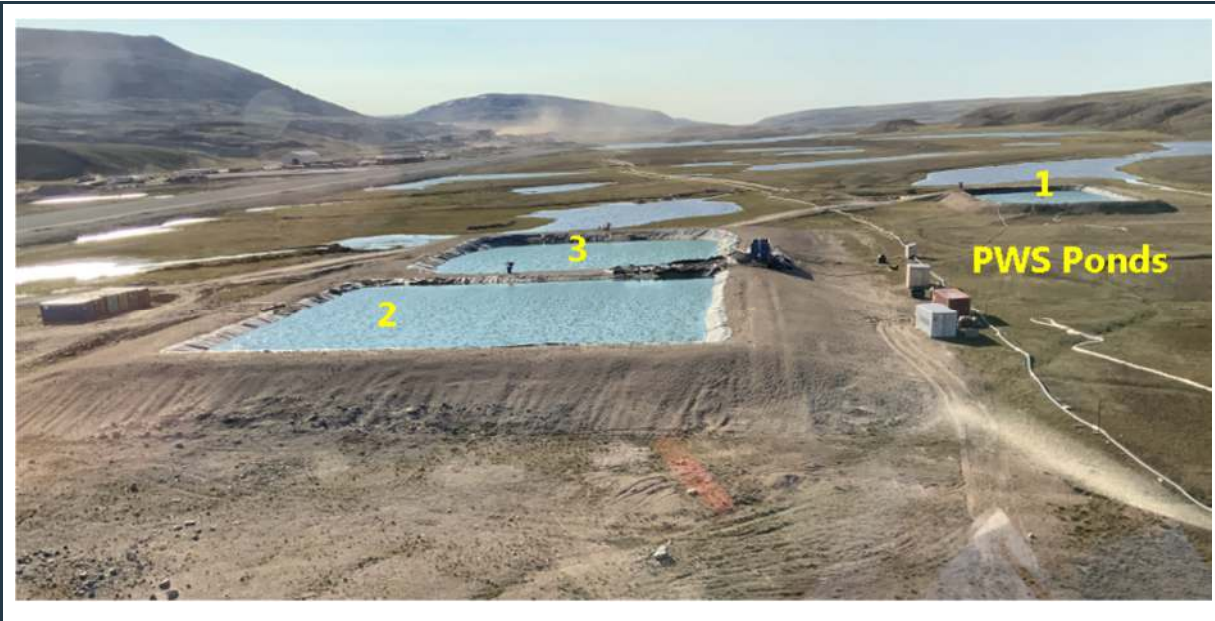
Figure 7: Aerial view of the three PWS ponds (this photo was taken in 2019)

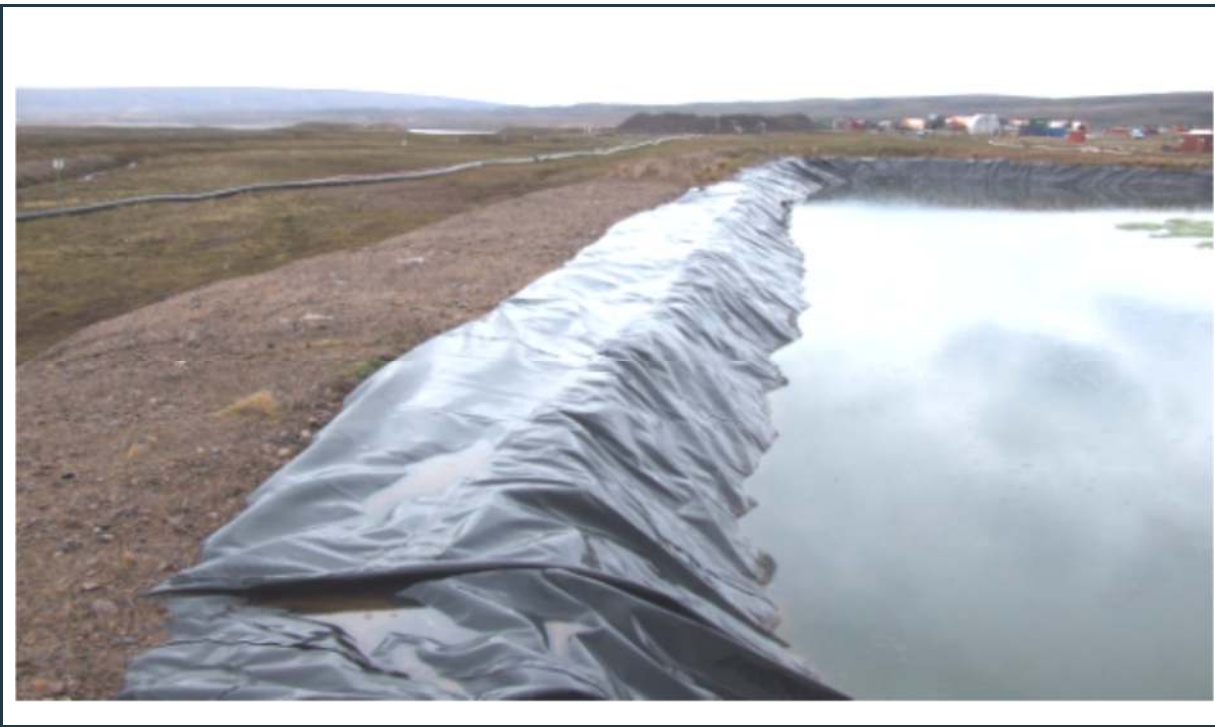
Figure 8: PWS pond #1. Well maintained perimeter berm and liner (note some floating ice in the pond).

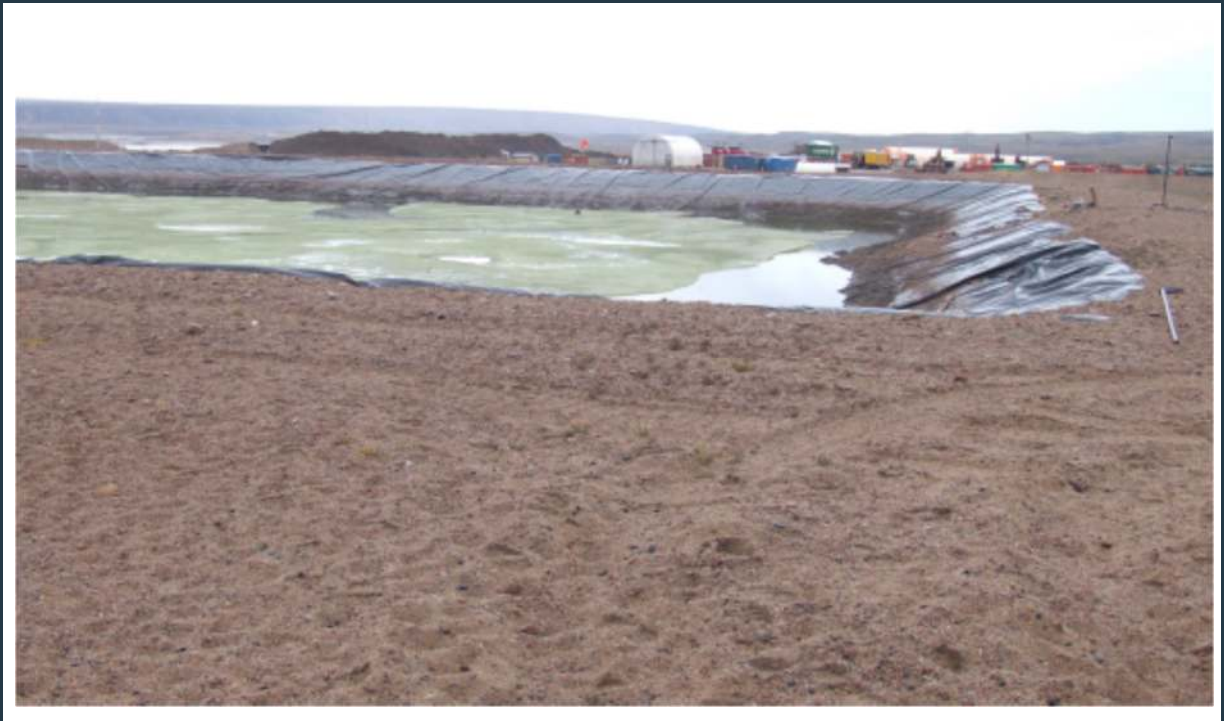
Figure 9: PWS pond #2 – Berm and liner in good condition. The water was recently lowered, and ice still visible in the pond.

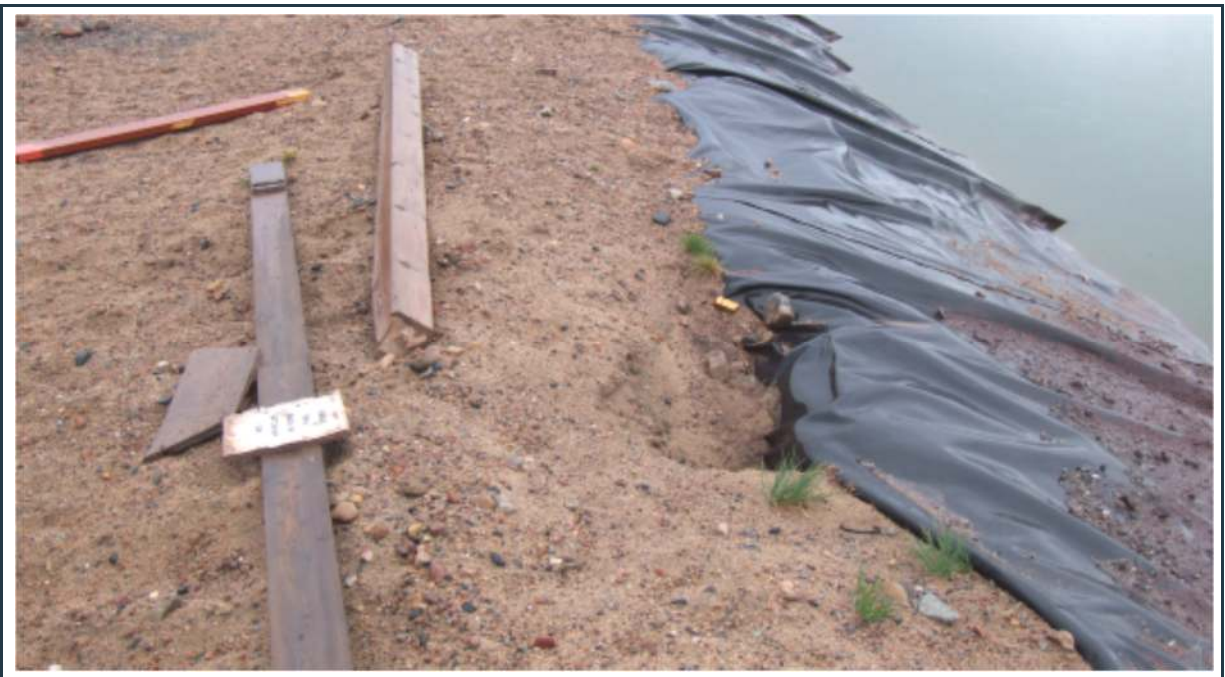
Figure 10: PWS pond #3 – Timber/lumber debris visible on the crest. Note the loss of some finer berm material (sand) into the voids of rock fill. The "sinkhole" should be filled and the debris removed.

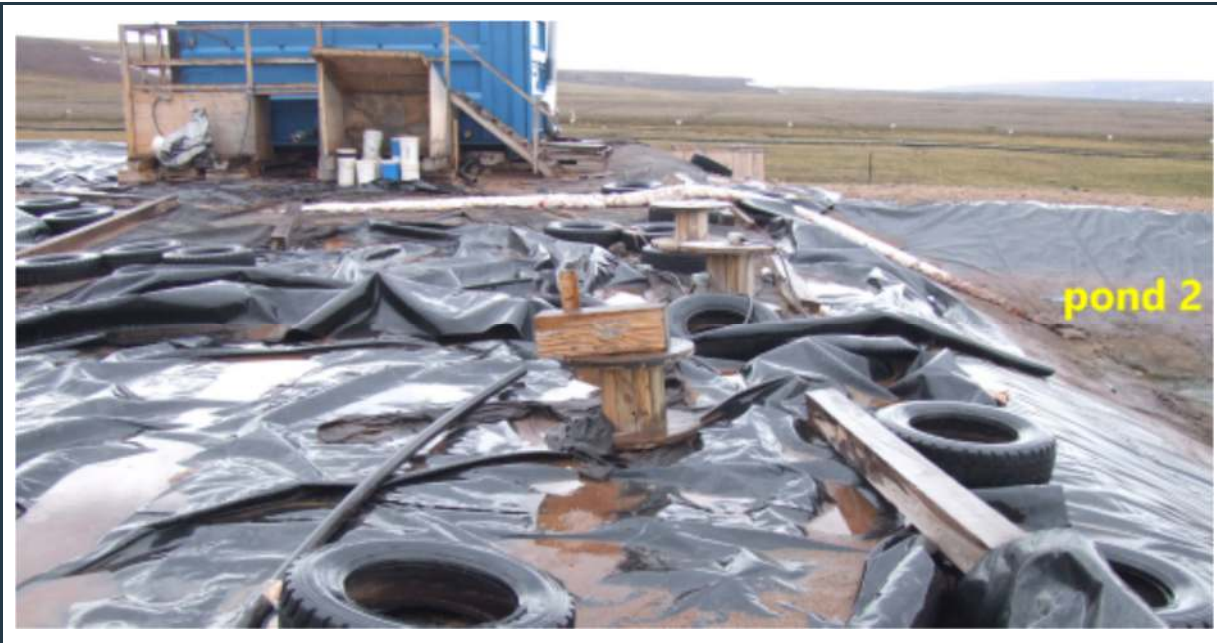
Figure 11: PWSP #2 and #3 – Untidy conditions at the water discharge point between ponds #2 and #3.

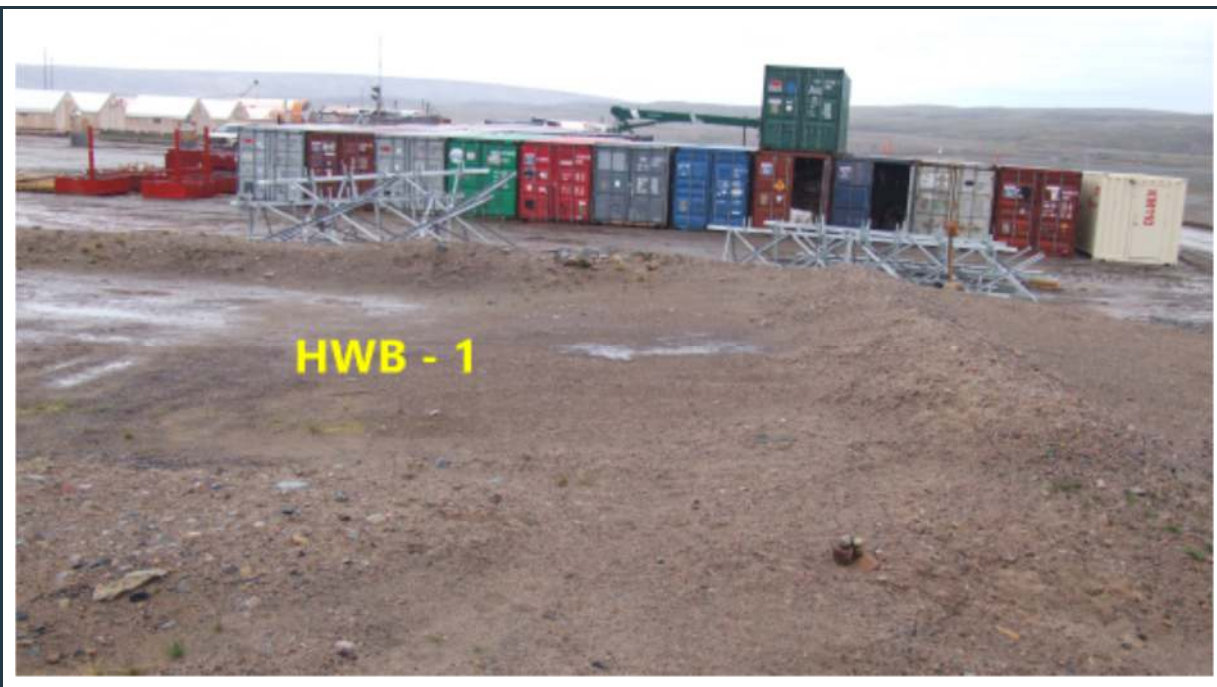
Figure 12: View of HWB-1 – Currently this cell is empty.

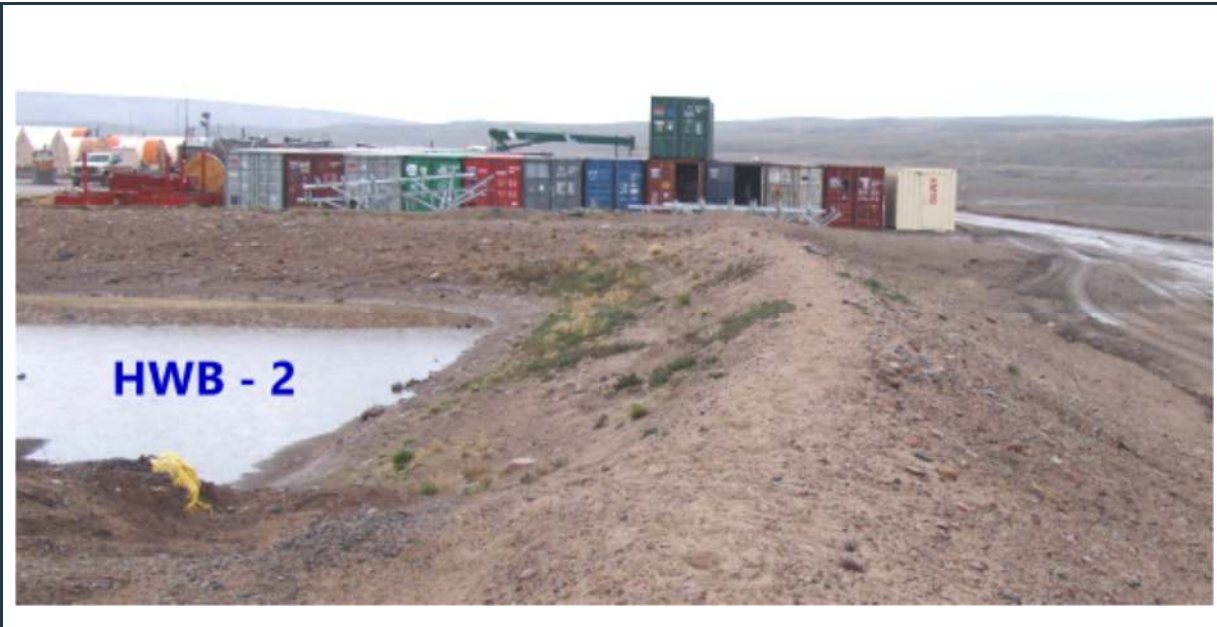
Figure 13: View of the stable berm at HWB-2. Other than some plastic, the cell is currently empty.

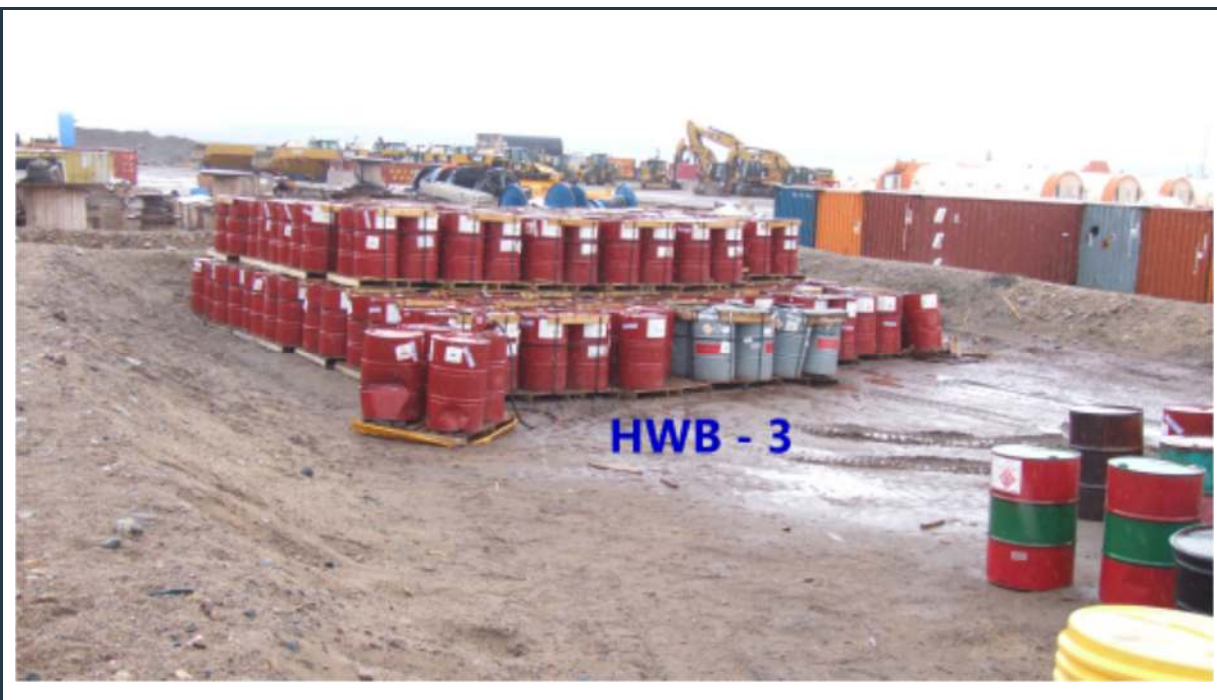
Figure 14: View of stable berms and the stored fuel barrels in HWB-3.

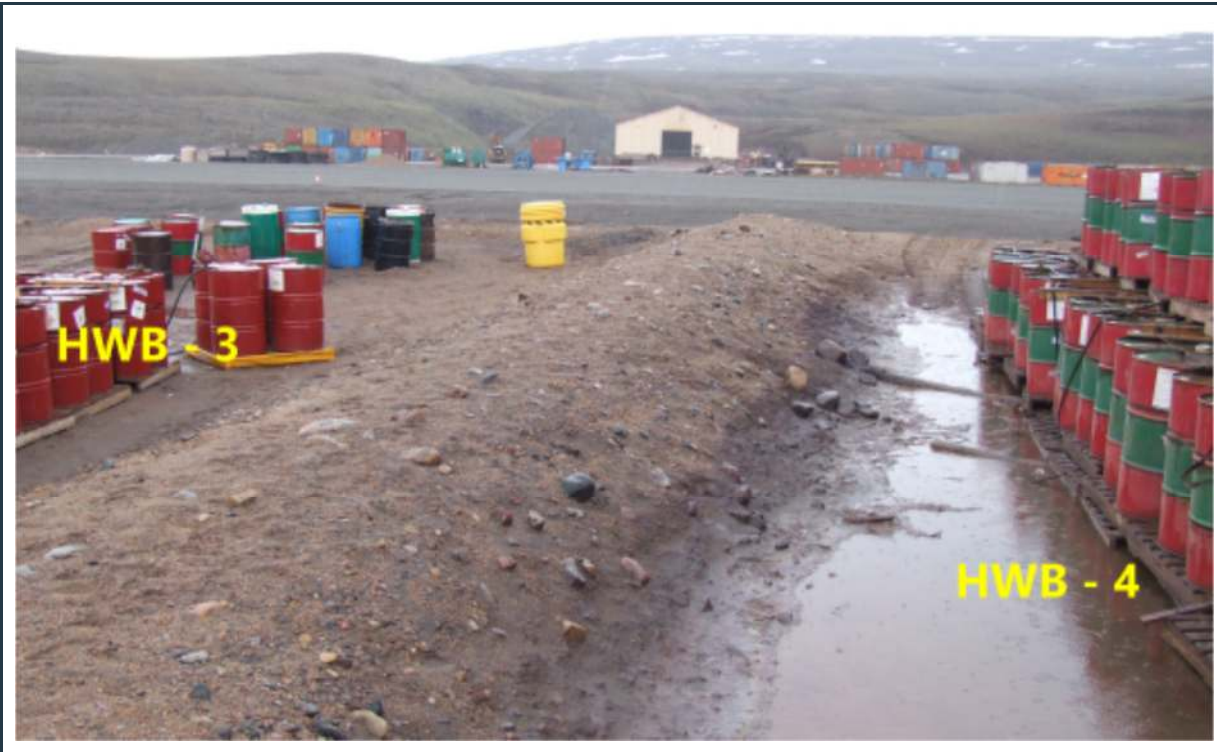
Figure 15: View of HWB-4 next to HWB-3, with jetfuel barrels stored on wooden pallets.

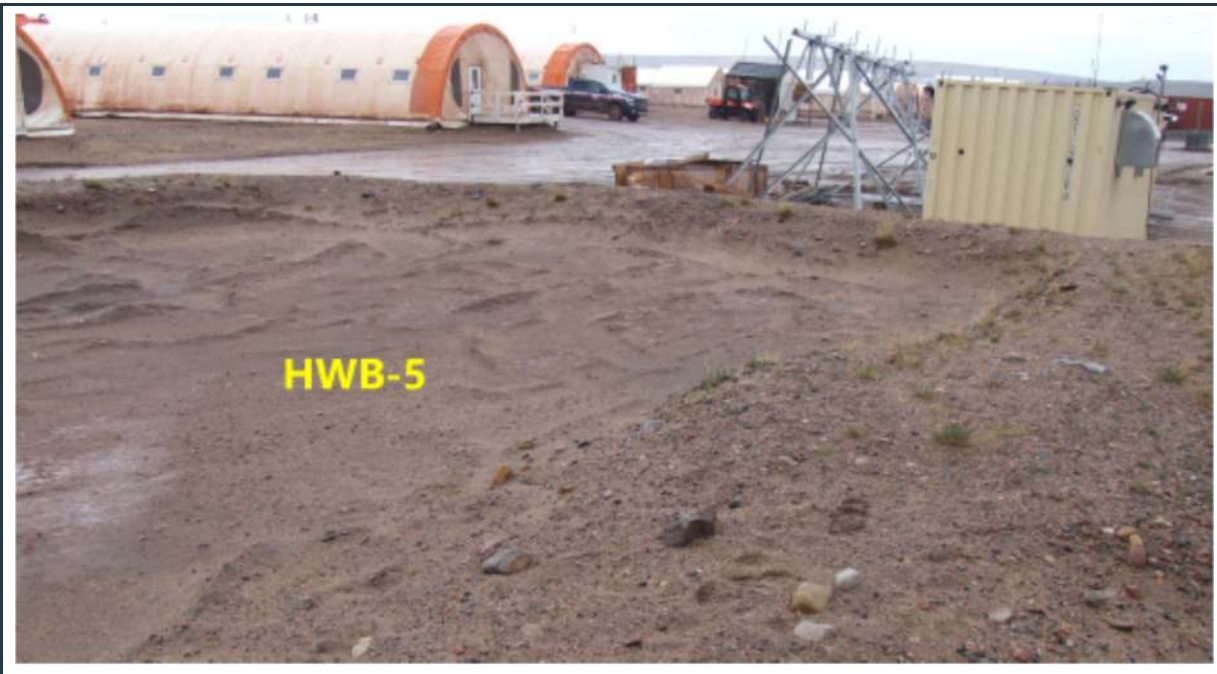
Figure 16: View of the HWB-5 cell, currently empty.

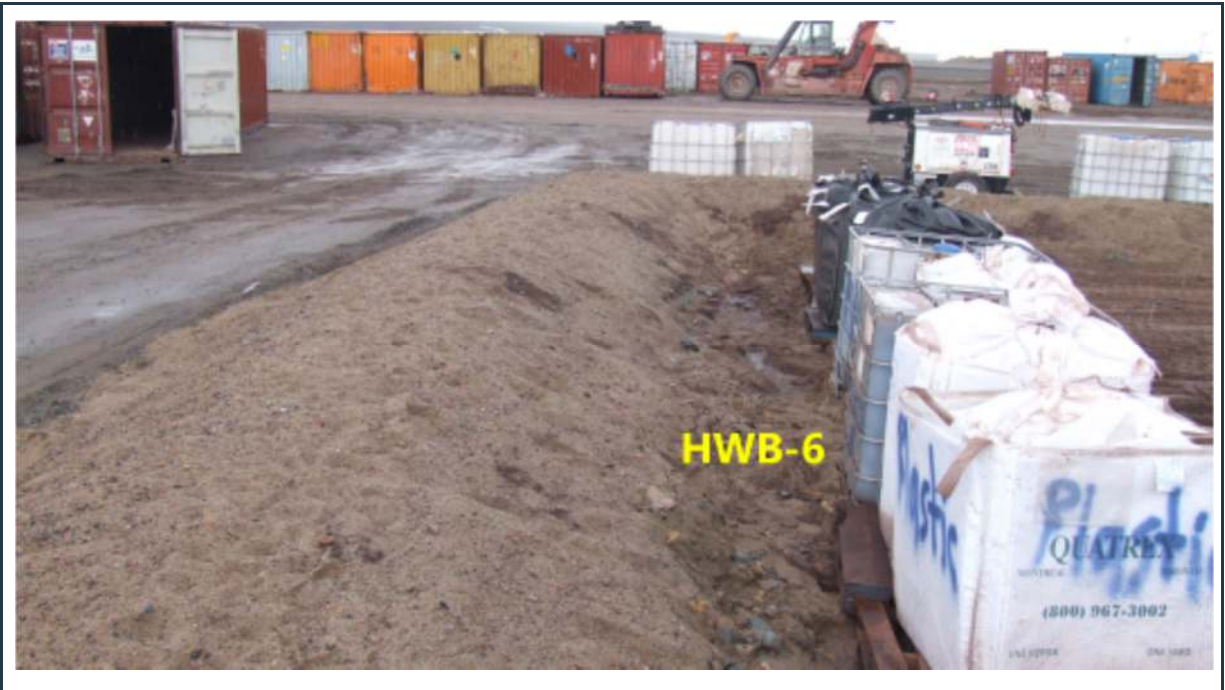
Figure 17: View of the recently upgraded stable berm around HWB-6.

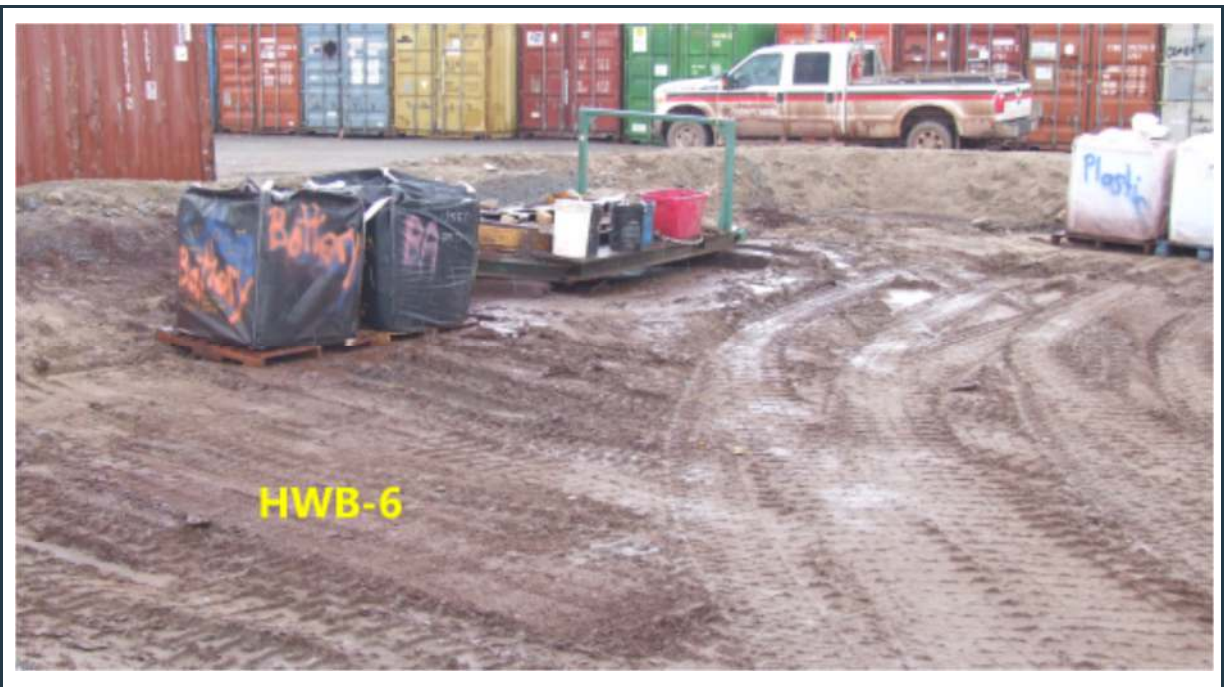
Figure 18: View of HWB-6. Note the well maintained "floor" (protecting the liner) within the cell.

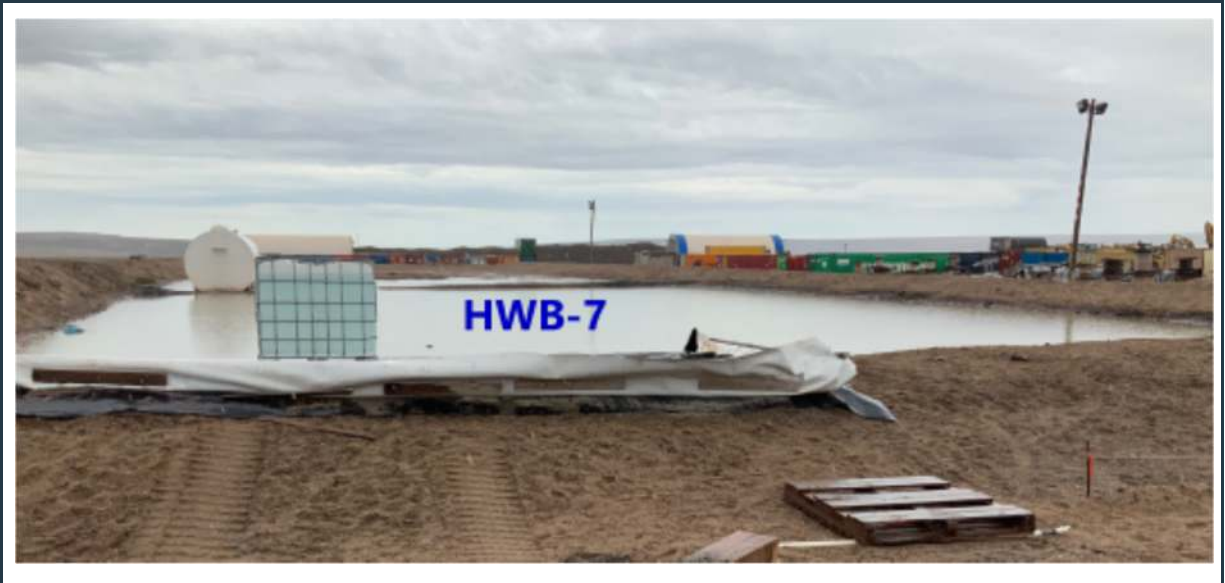
Figure 19: View of the large HWB-7, with only one fuel tank stored in this cell.

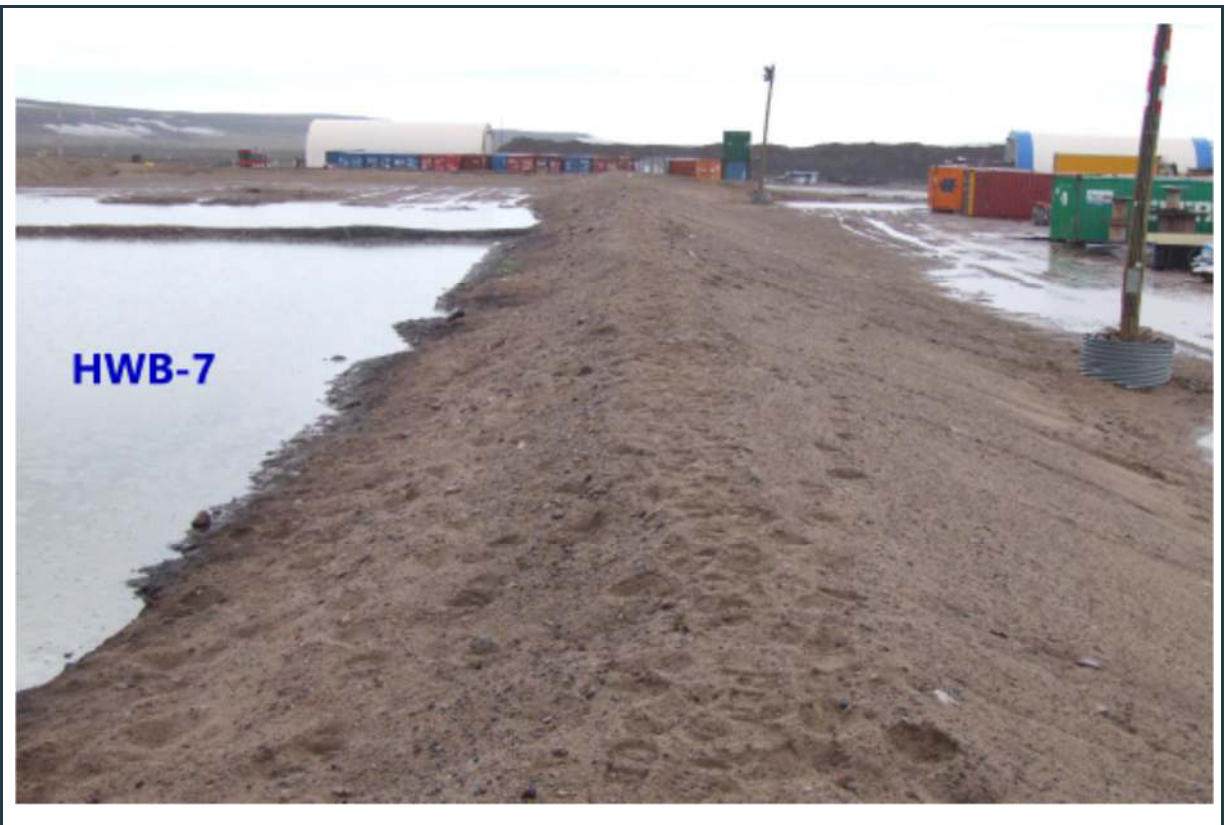
Figure 20: View of the stable berm around the HWB-7 cell.

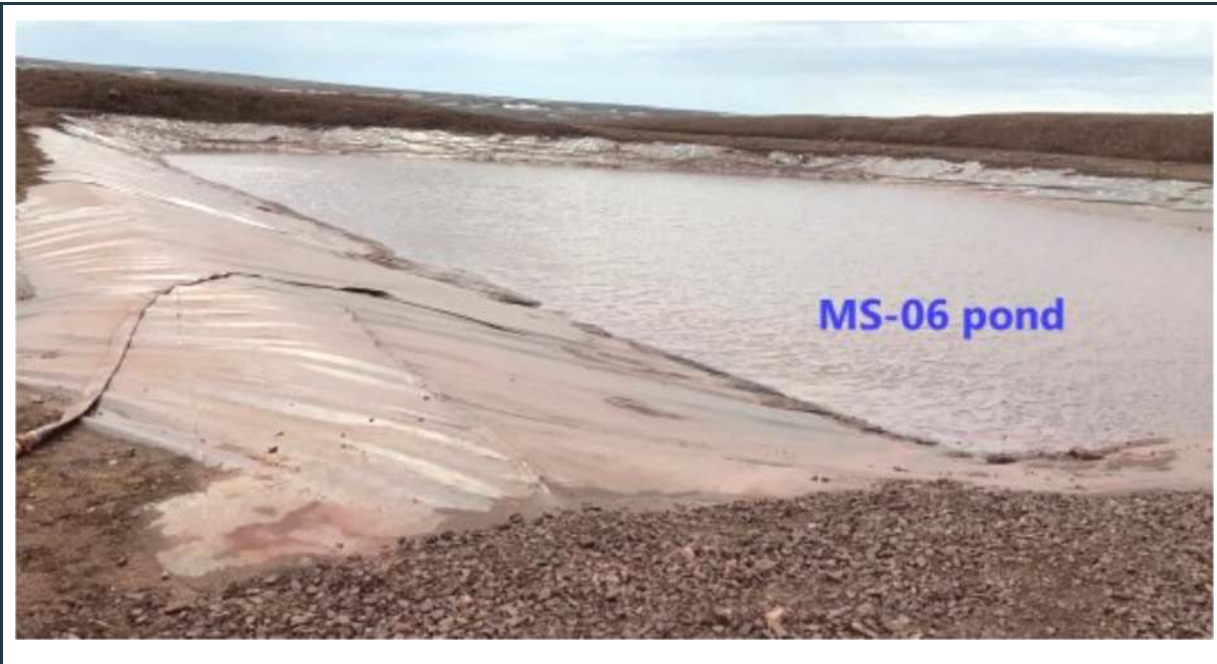
Figure 21: MS-06 surface-water collection pond with stable berms and intact liner.

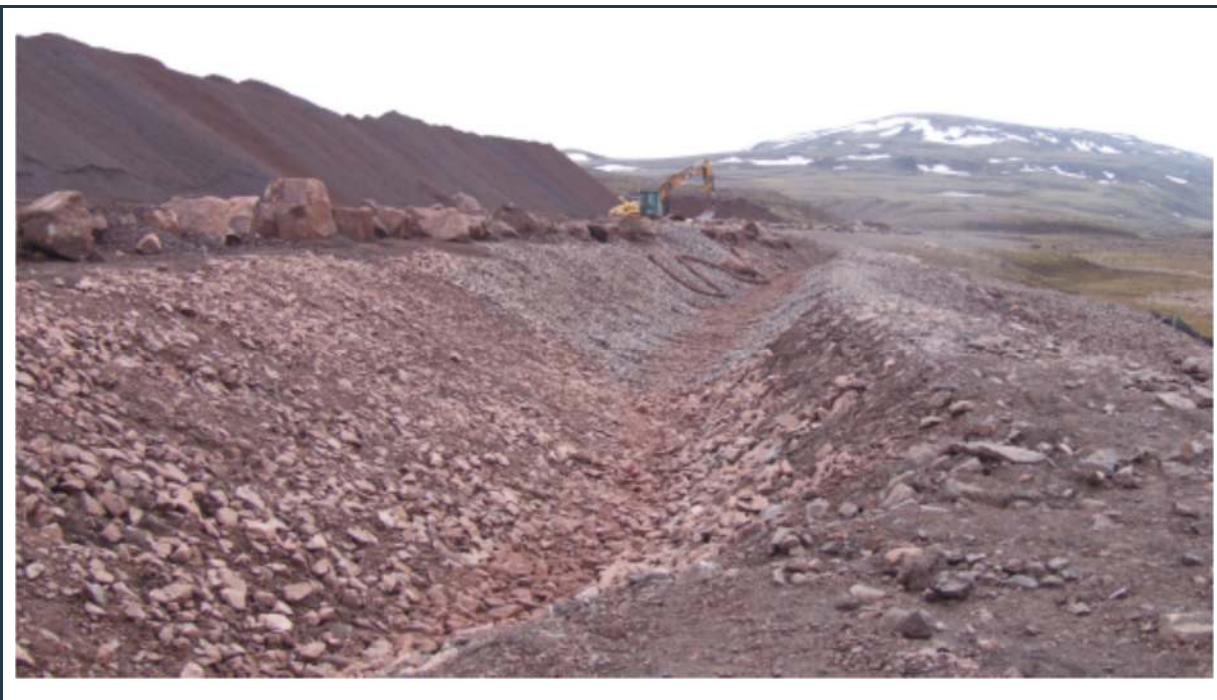
Figure 22: Well maintained surface-water collection ditch around the crusher plant, leading to MS-06.

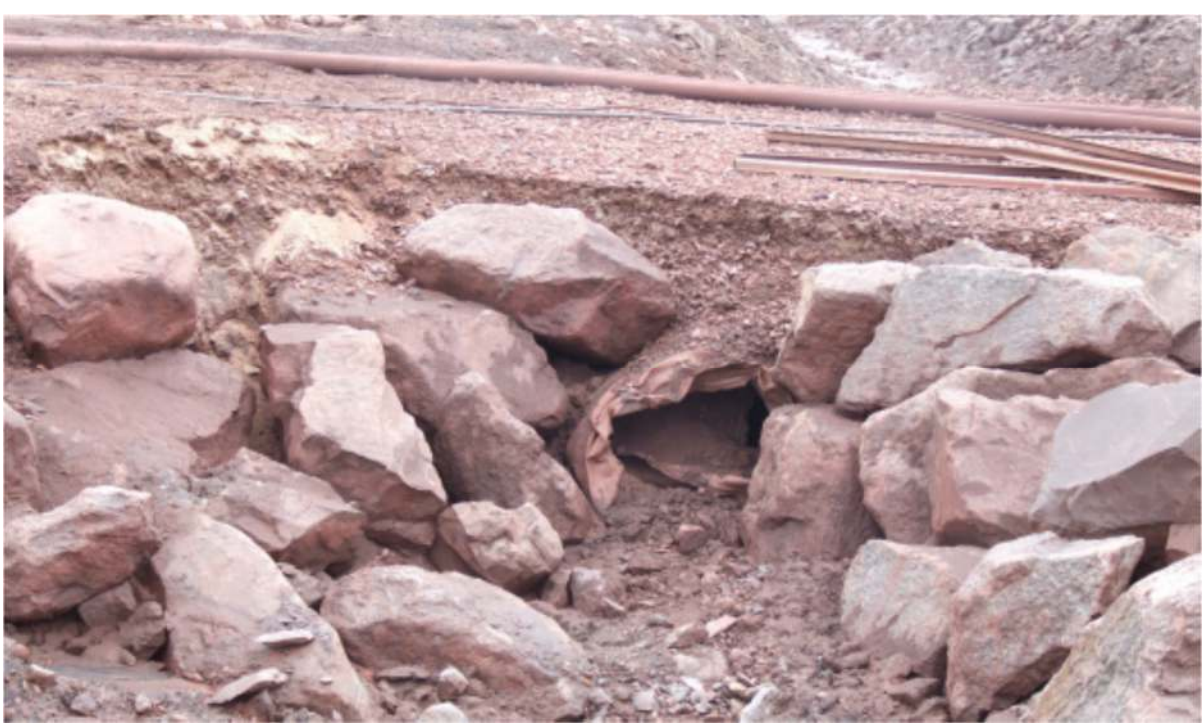
Figure 23: Damaged and clogged (silted) culvert in the ditch shown in Figure 22, near the MS-06 pond.

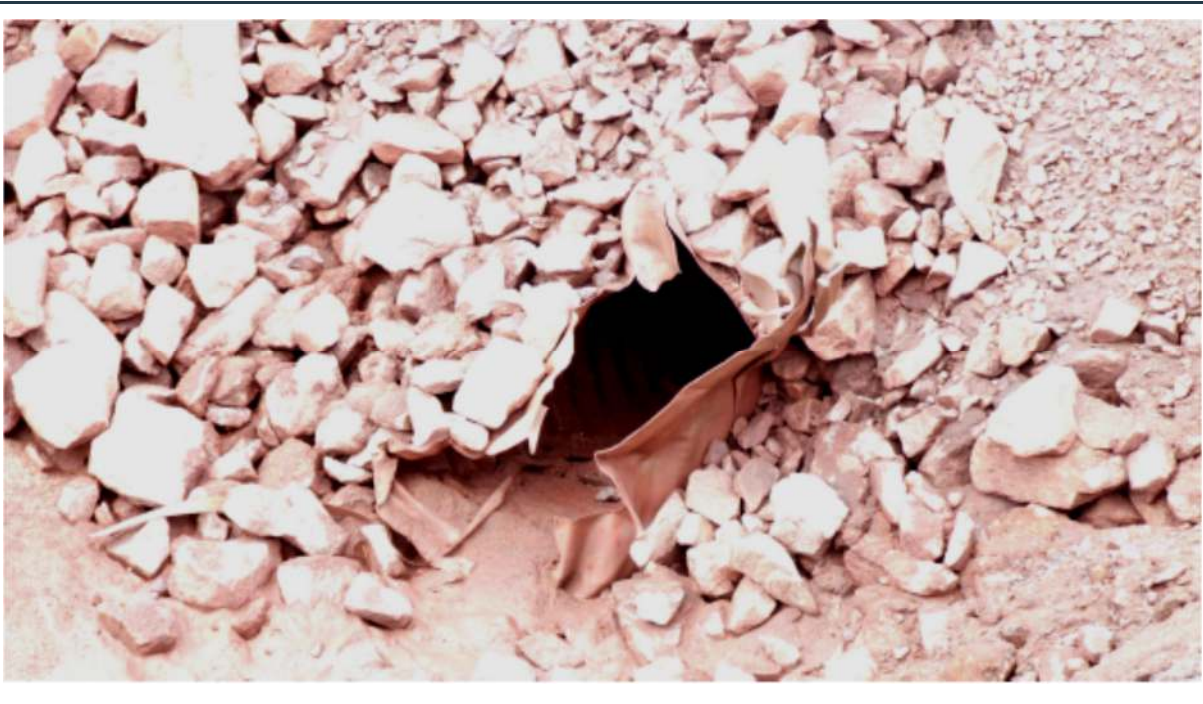
Figure 24: The other end (inlet) of the culvert shown in Figure 23.

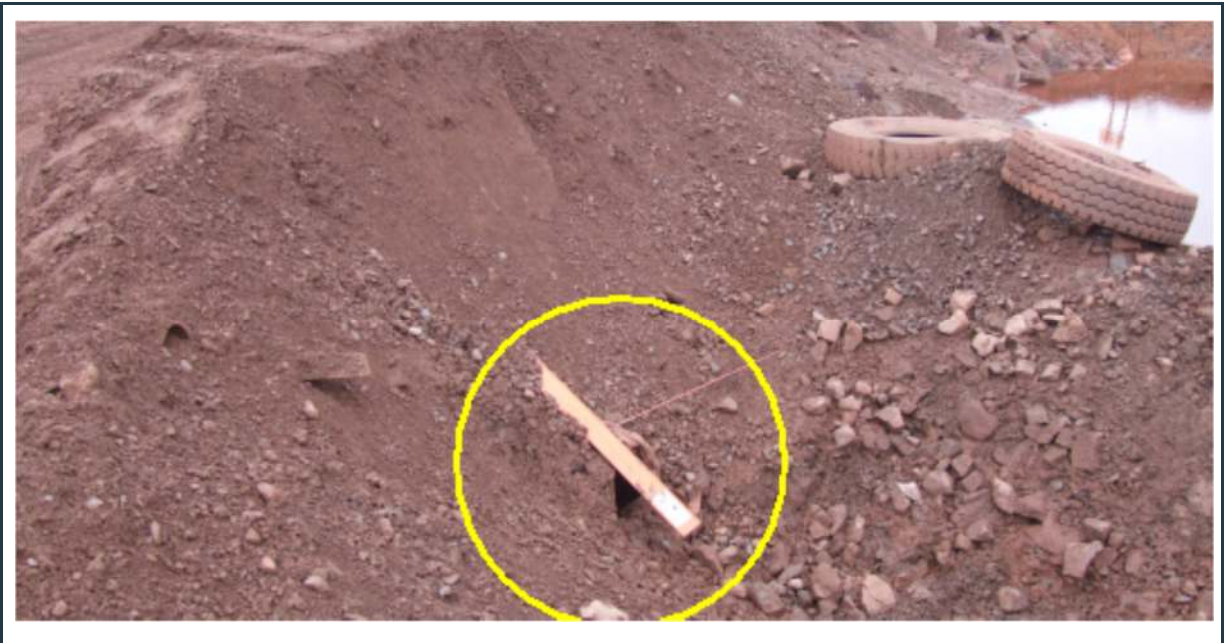
Figure 25: Partially clogged inlet of a culvert, located under the access road next to the truck weighing scale. It drains surface-water from the crusher area to the MS-06 pond.

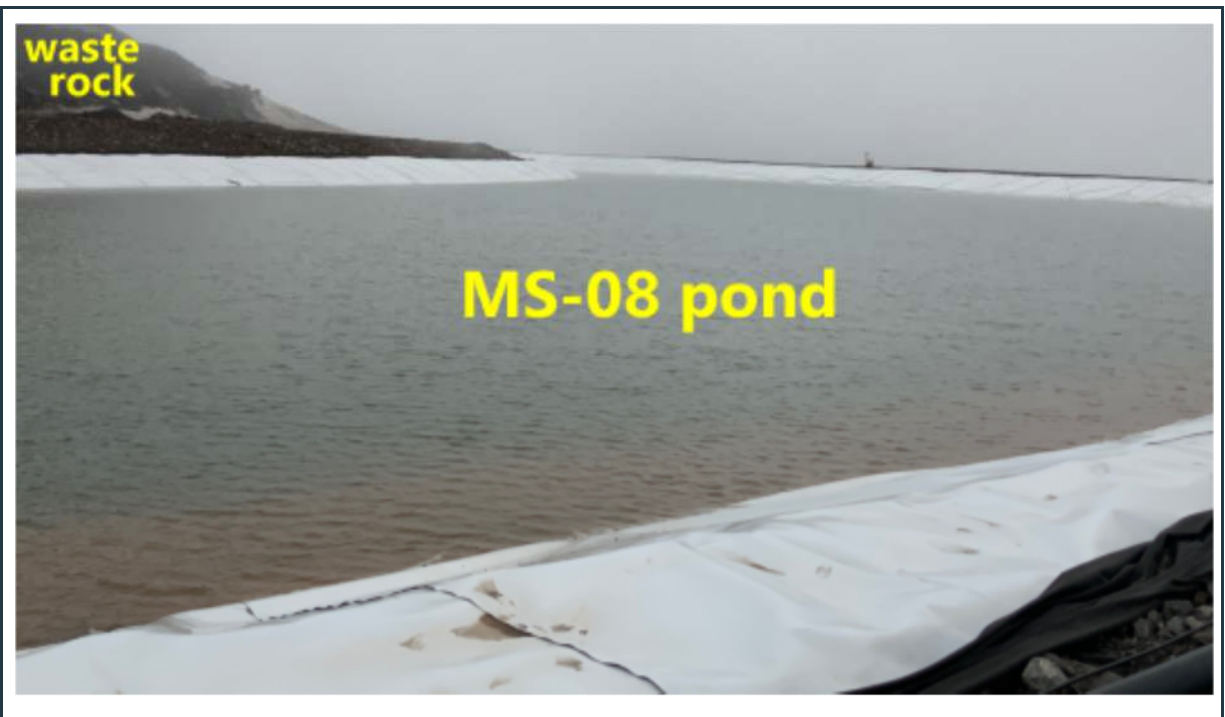
Figure 26: View of the recently completed enlarged MS-08 pond, downstream of the waste rock facility

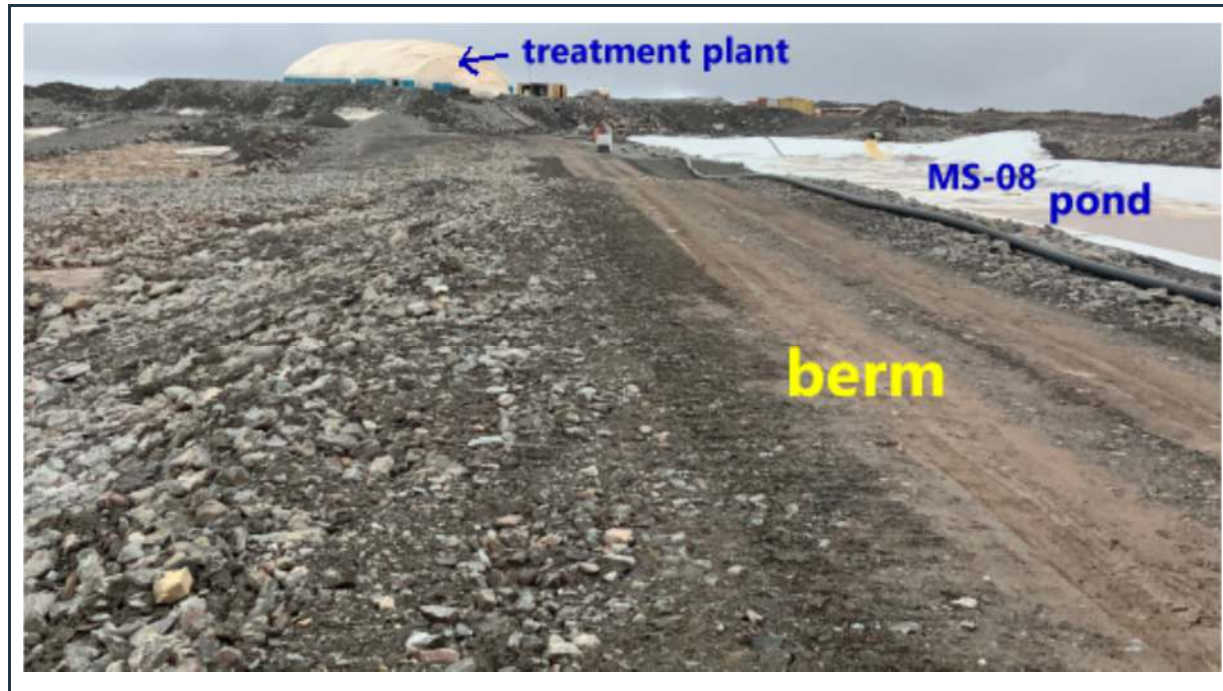
Figure 27: View of the new, robust berm with shallow side-slopes around the MS-08 pond

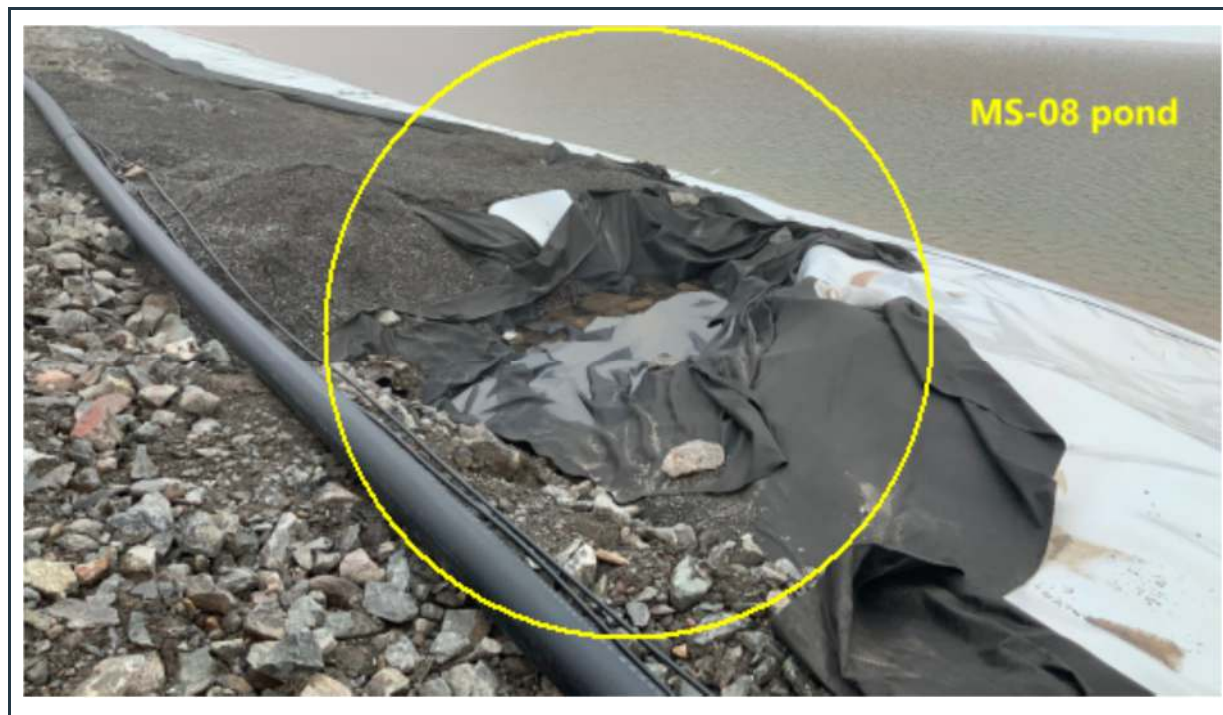
Figure 28: Area of minor fine-soil migration into the underlying rock fill at the northern section of the berm. The geotextile should be rearranged and the hole filled with fine crushed aggregate.

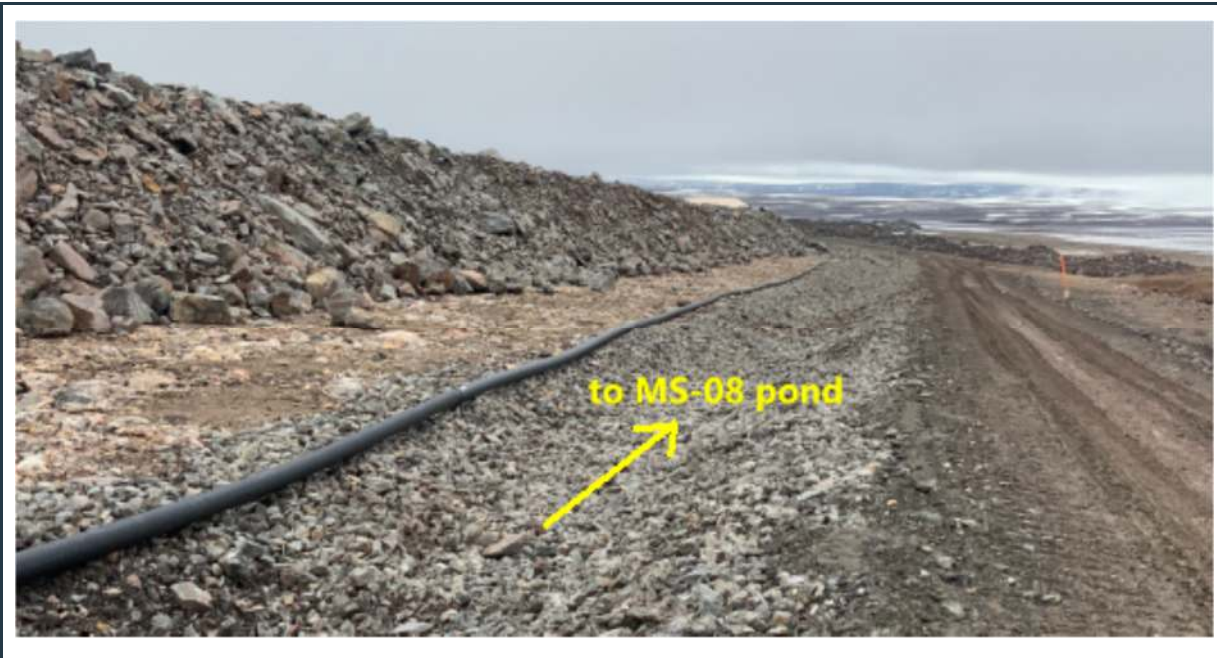
Figure 29: Well-maintained drainage ditch along the east side of the waste rock facility

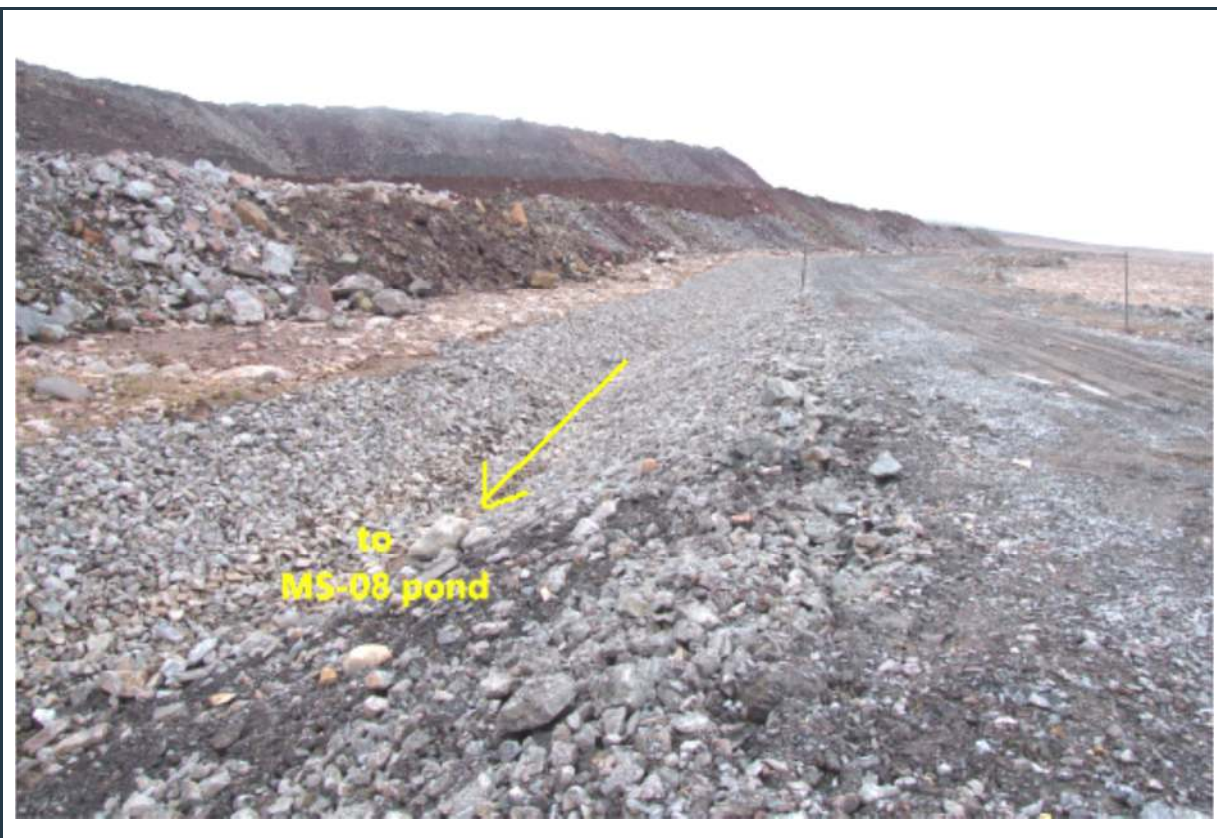
Figure 30: Well-maintained drainage ditch along the west side of the waste rock dump

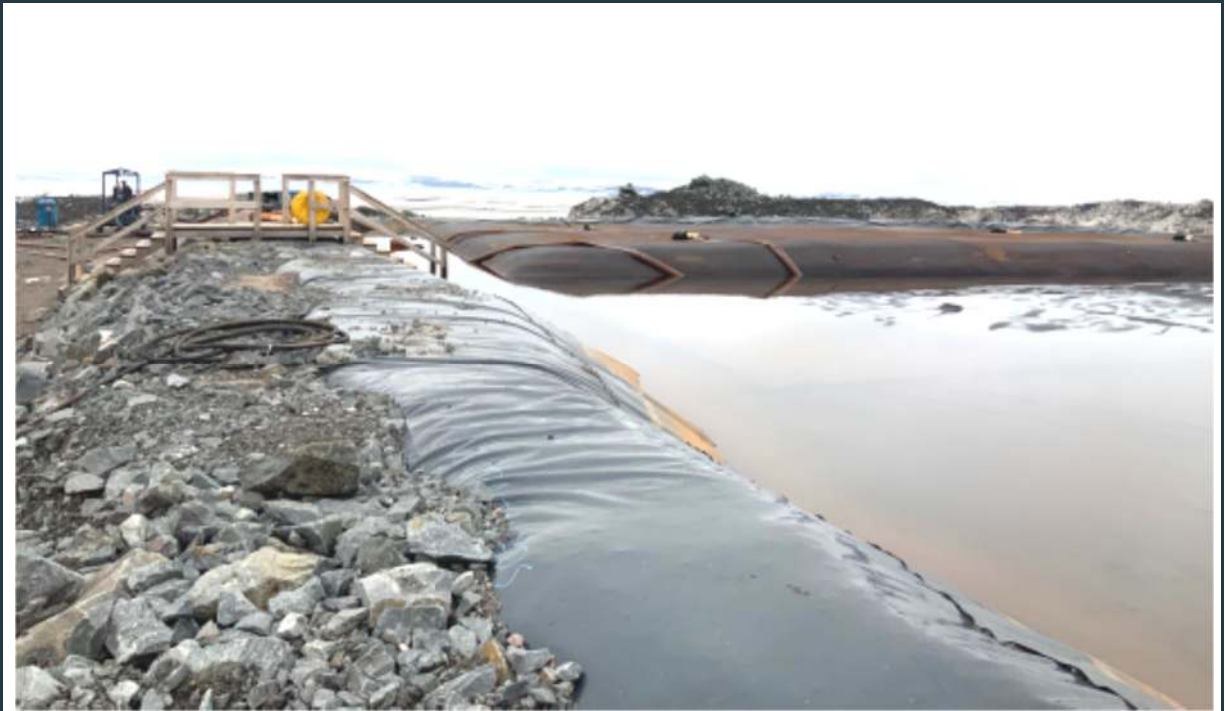
Figure 31: Water treatment pond adjacent to the waste rock dump and MS-08

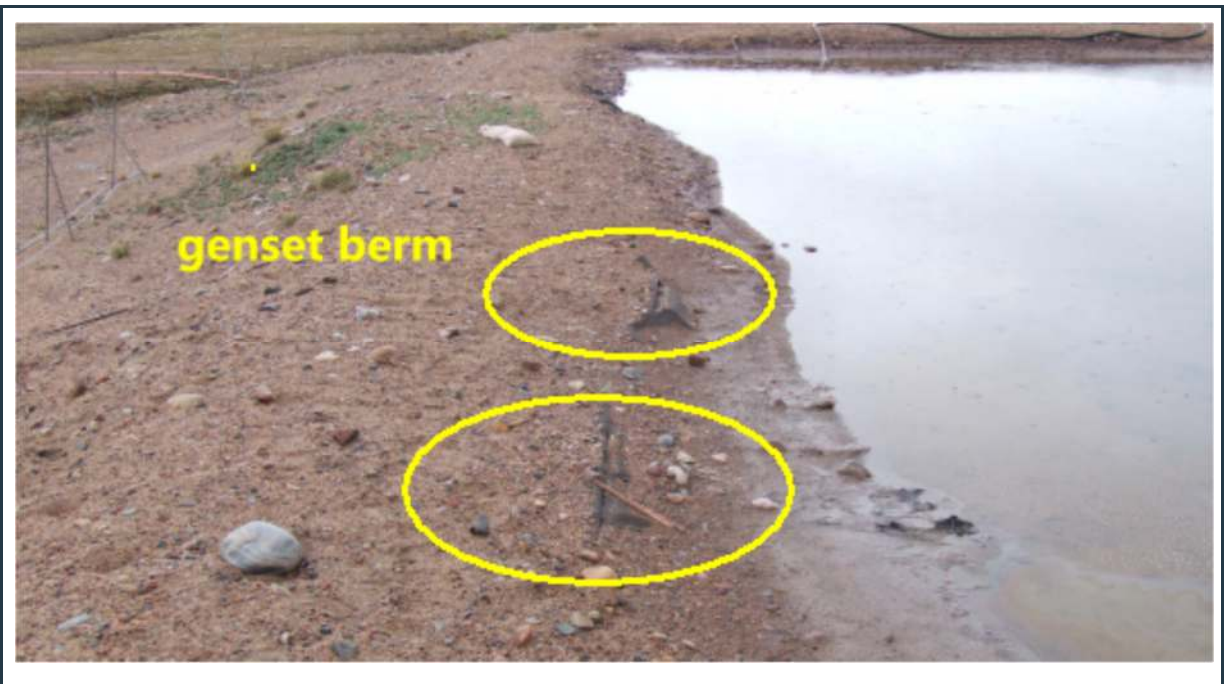
Figure 32: View of the berm near the generator, with exposed geotextile and liner at a few locations.
