Baffinland Iron Mines Corporation

Project #: TC190307

Annual Geotechnical Inspections – 2020 Report 1.

APPENDIX "A" - Mary River Mine Complex - Photographs

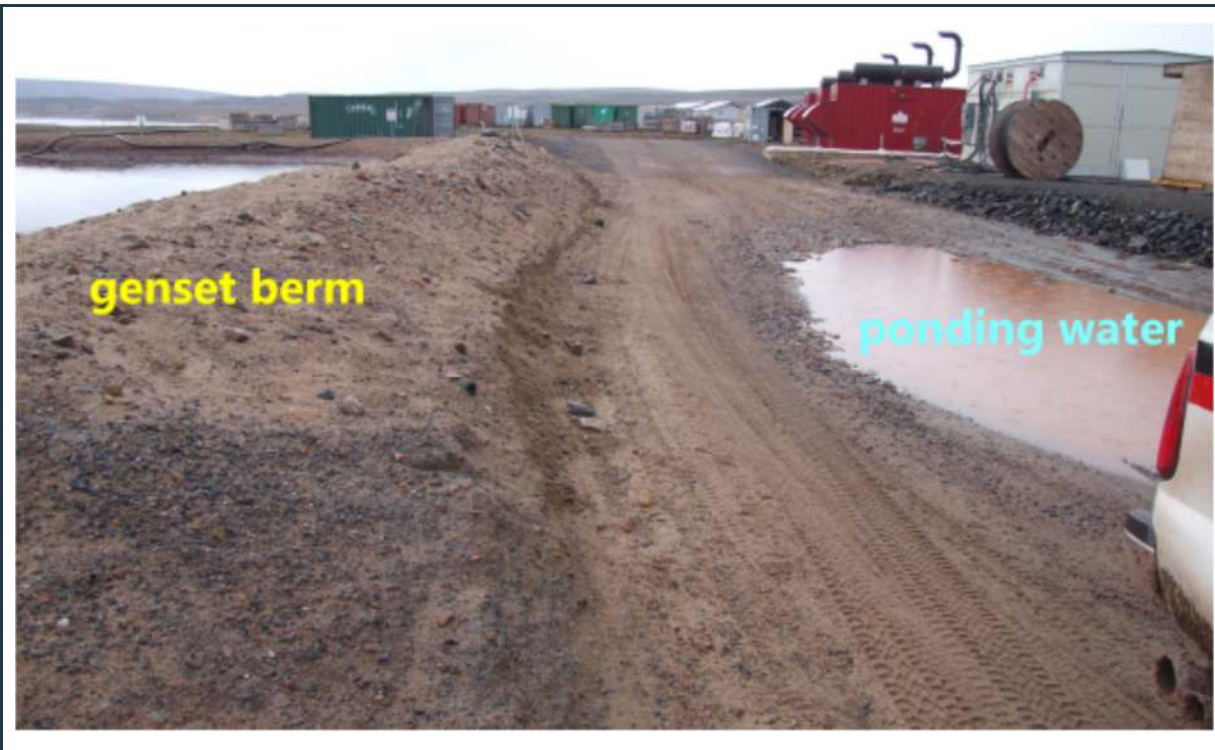
Figure 33: View of slope deterioration at a section of the berm near the generators. Trucks bypassing ponding surface water on the road are “cutting” into the toe of the berm.

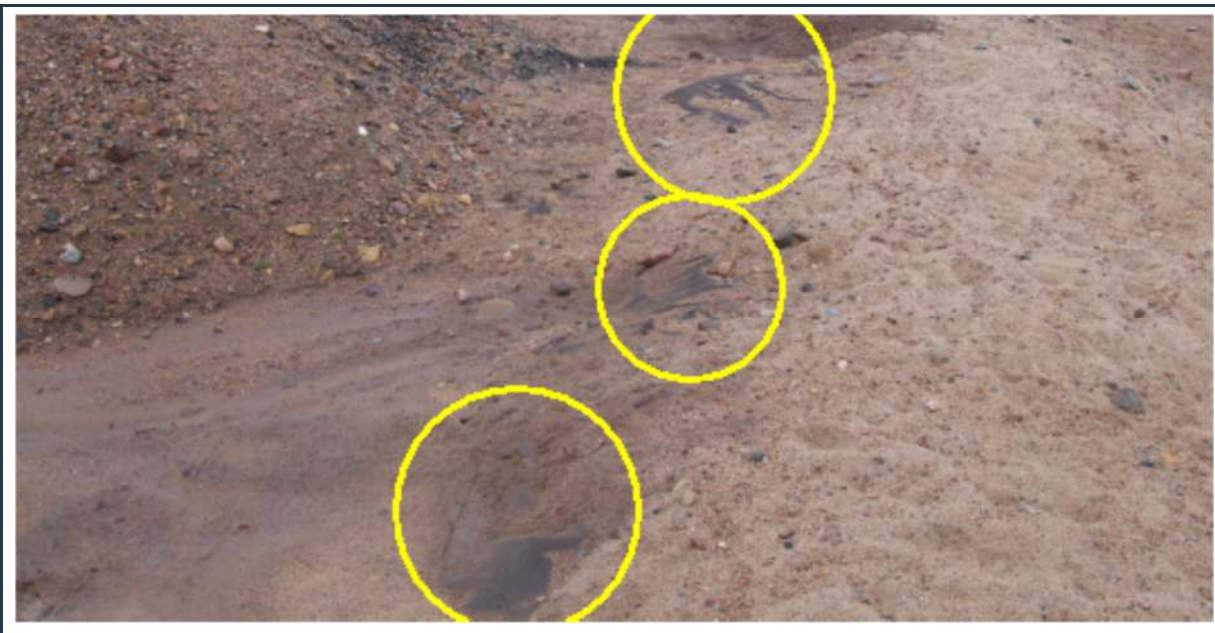
Figure 34: View of the south-east berm that needs to be repaired (raised and regraded). Note the exposed geotextile and liner that shall be covered with sand/gravel during berm rehabilitation.

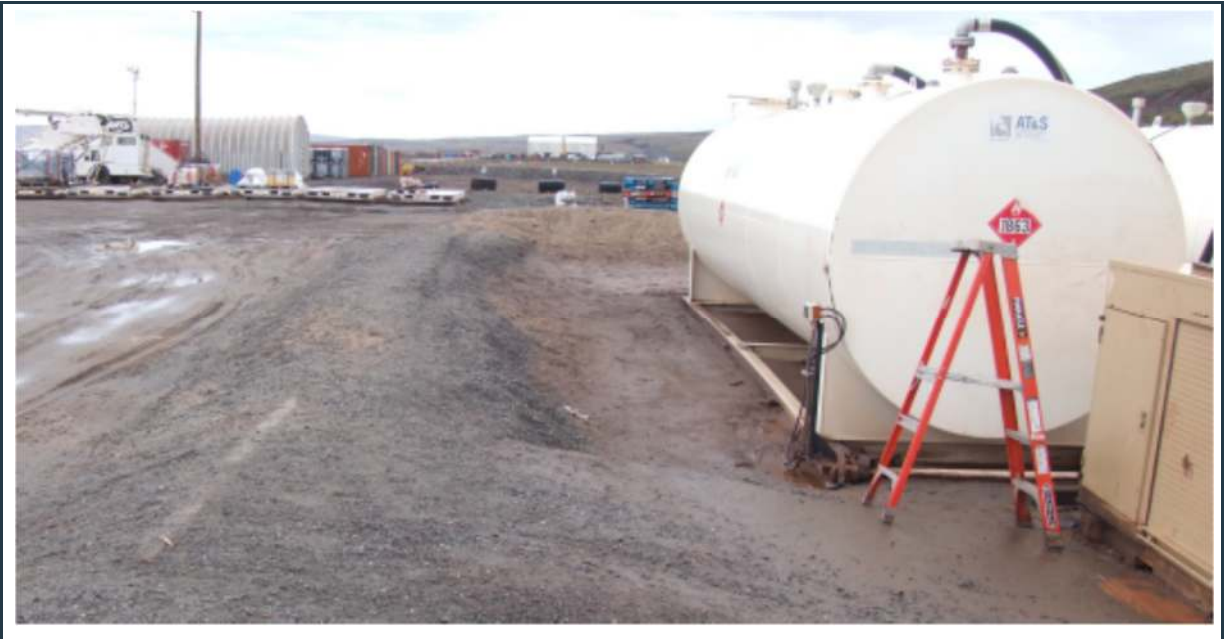
Figure 35: View of the well-maintained berm at the jetfuel storage cell.

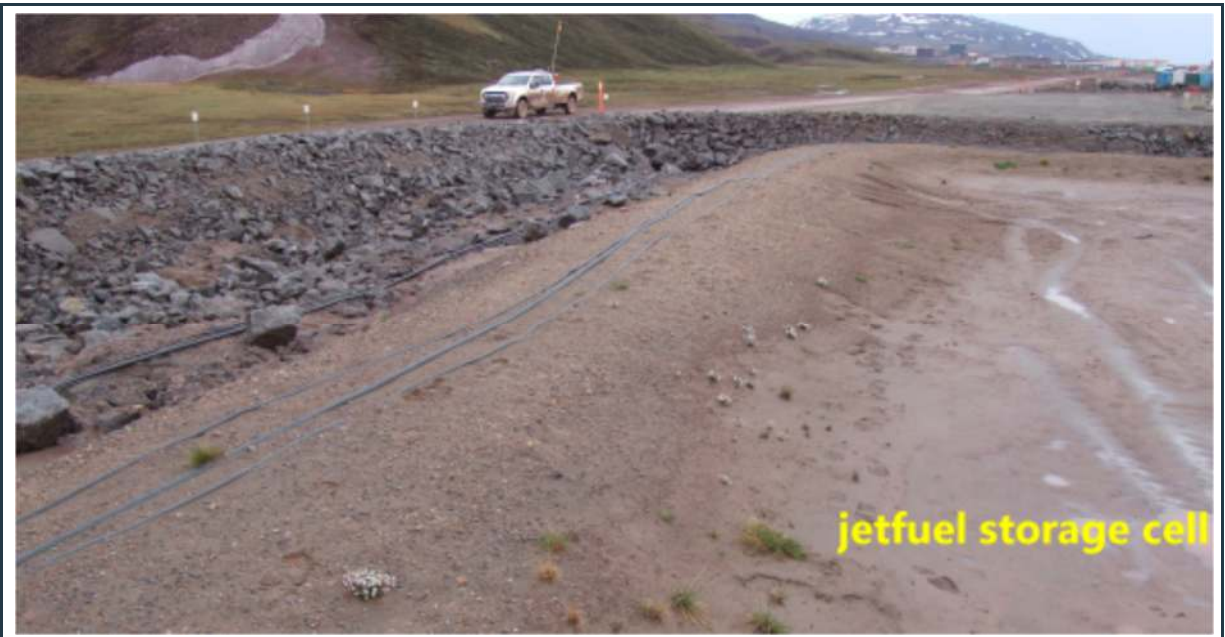
Figure 36: View of the jetfuel farm's double berm system (note the additional crushed rock berm between the cell's perimeter berm and the tote road/parking lot).

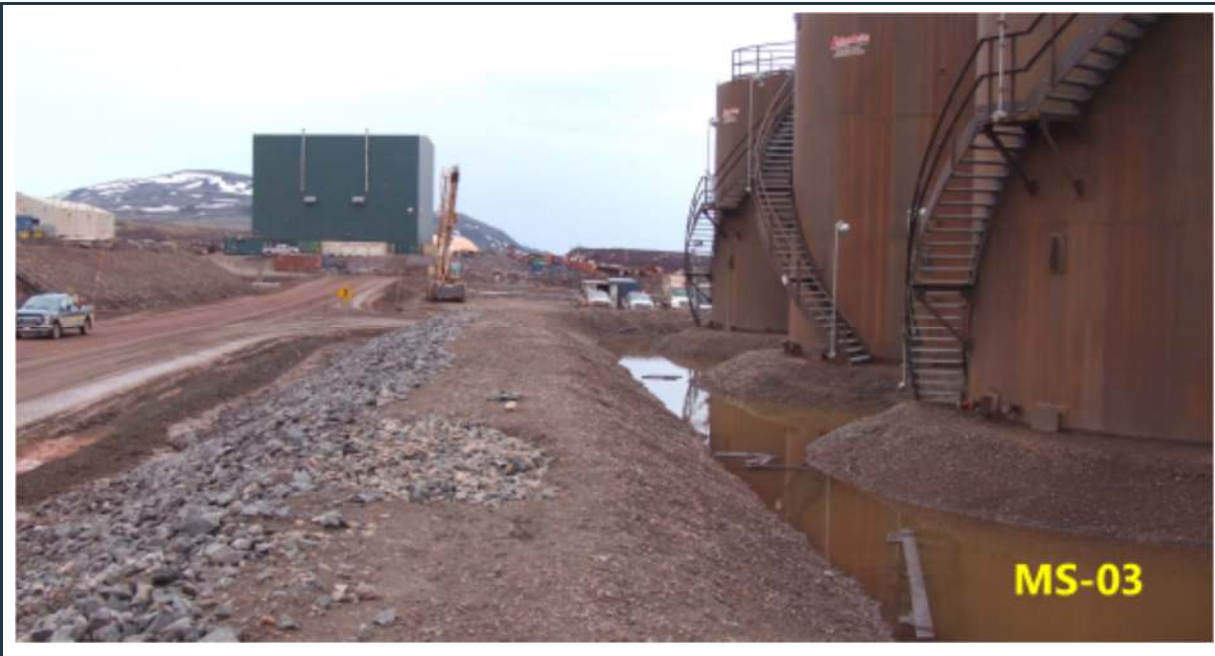
Figure 37: View of the MS-03 diesel fuel tank farm. Note some floating debris that should be removed.

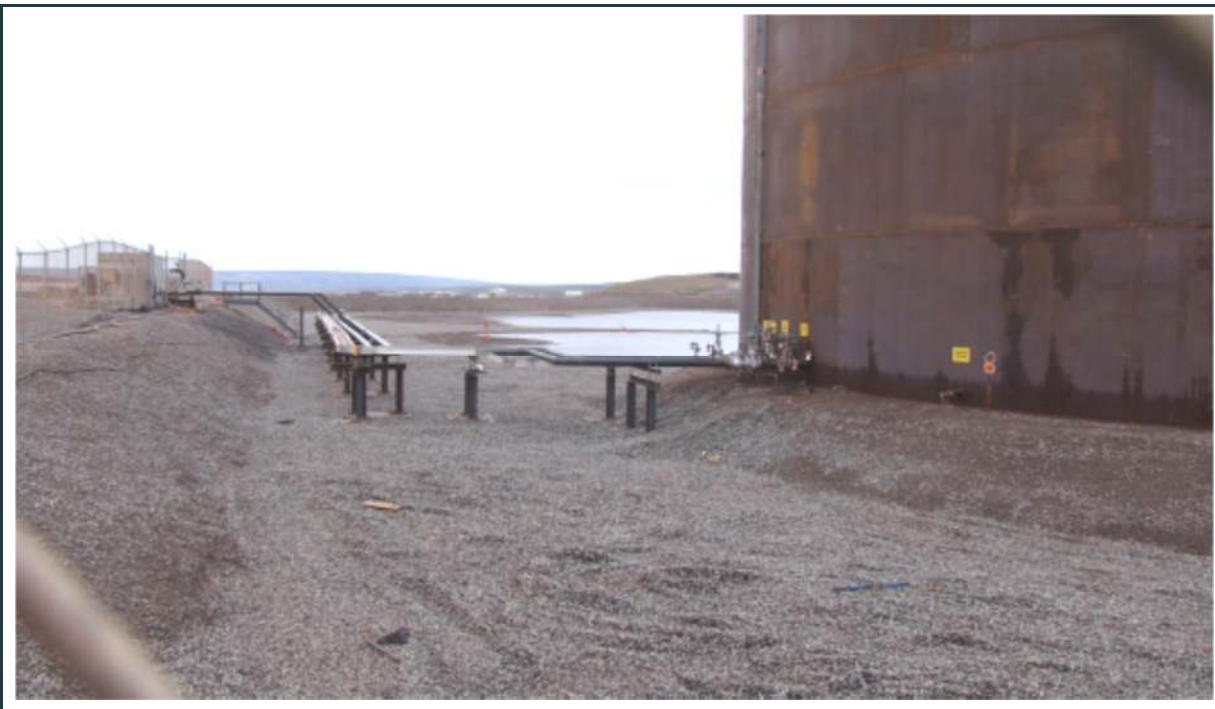
Figure 38: View of the recently completed fuel tank farm with well-constructed stable perimeter berms.

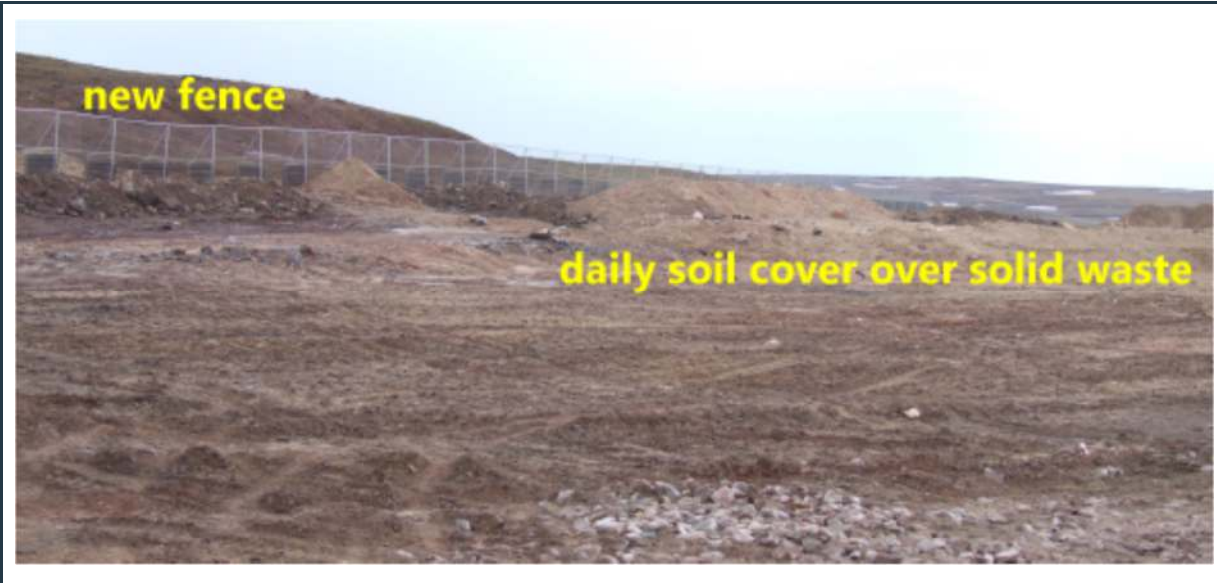
Figure 39: Solid waste landfill facility (note the recently installed perimeter fence).

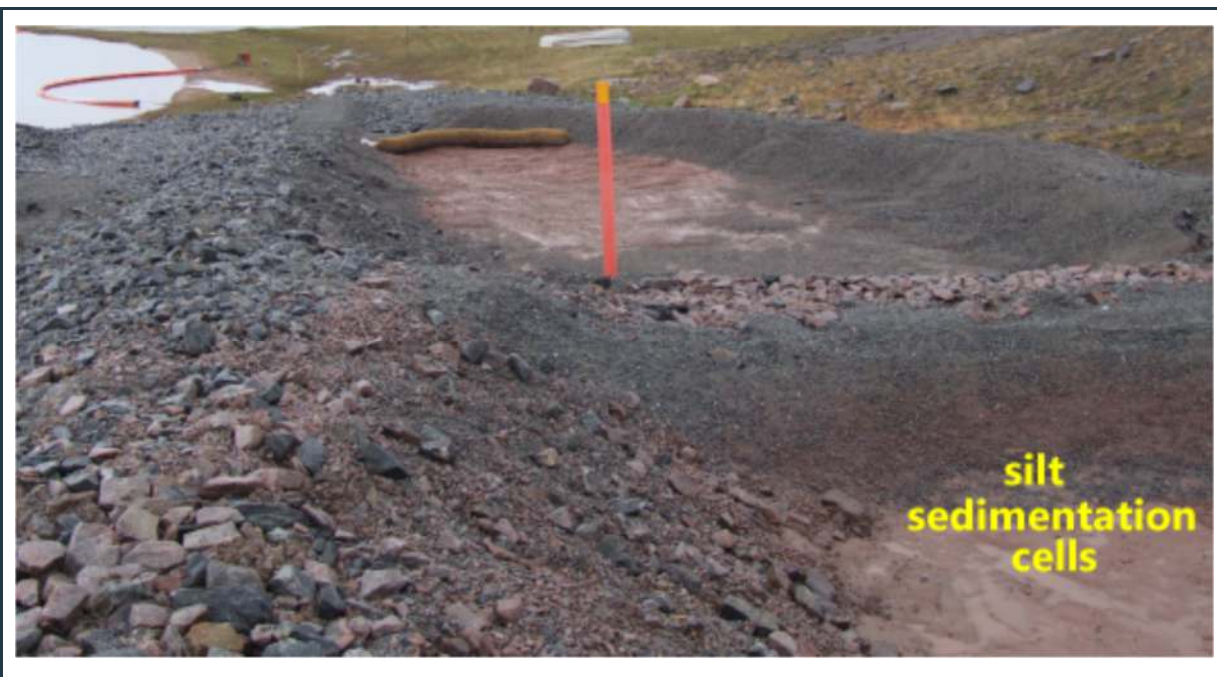
Figure 40: CLSP check dams and berms, forming efficient silt sedimentation cells

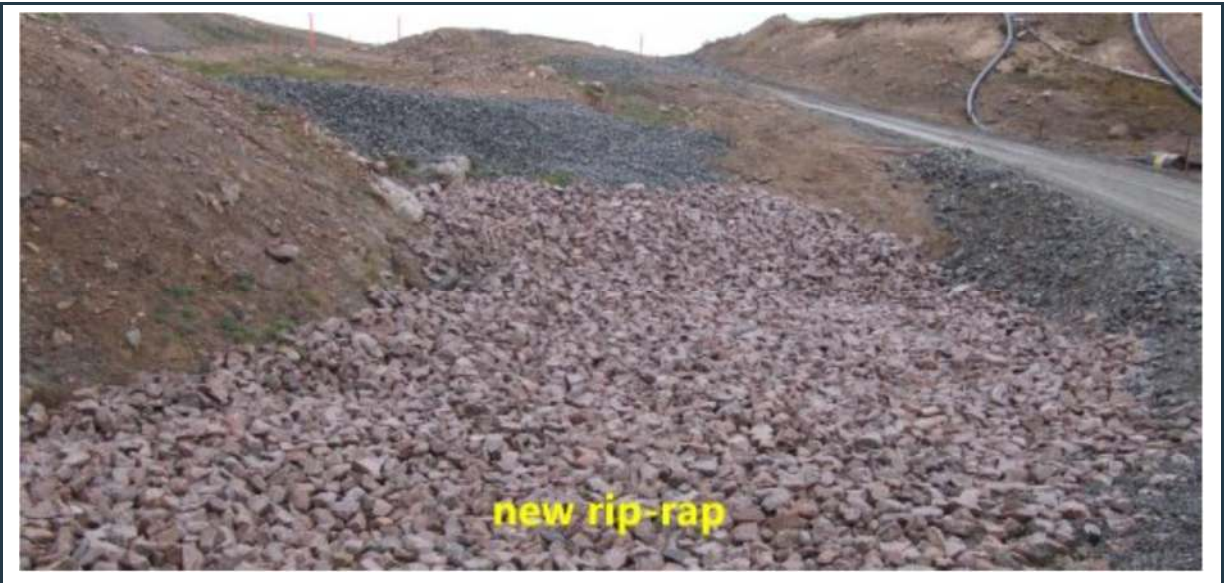
Figure 41: Recently placed rip-rap in one of the cells to prevent erosion of the channel floor at the critical vertical drop in elevation along the chain of sedimentation cells.

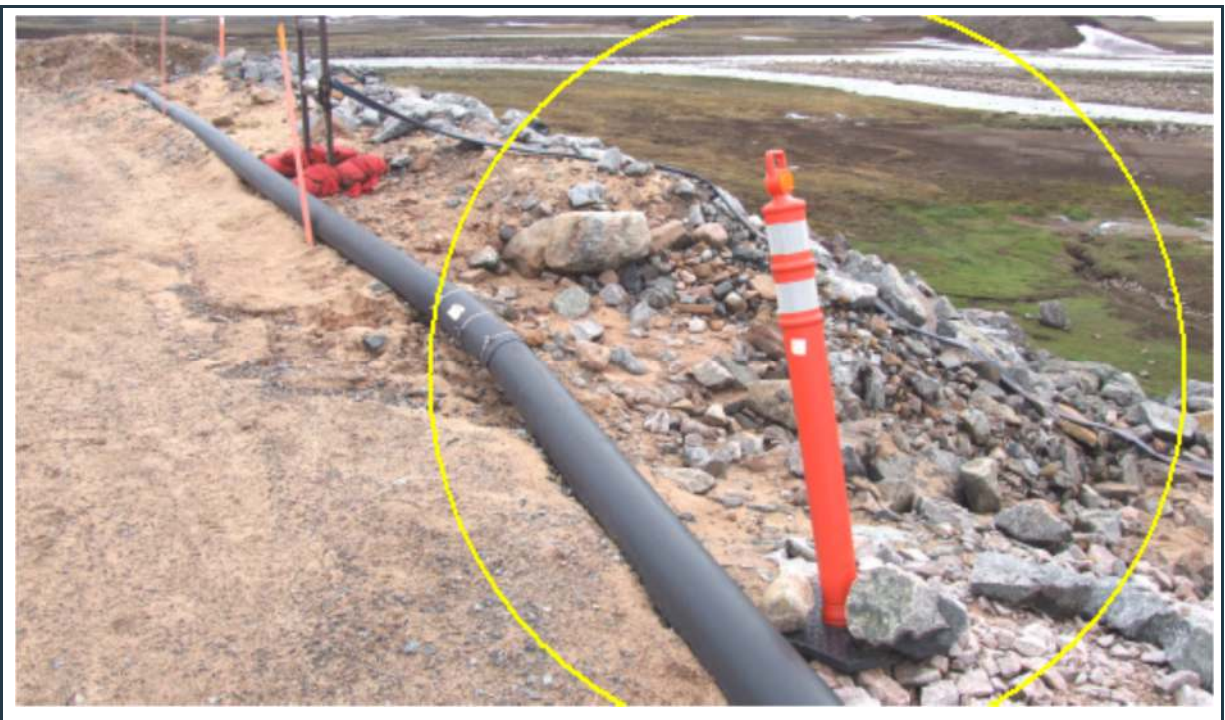
Figure 42: Minor crest/slope erosion (cobbles and boulders rolling down the slope) at the water discharge area. Placement of rock fill is required here to improve slope integrity and prevent erosion.

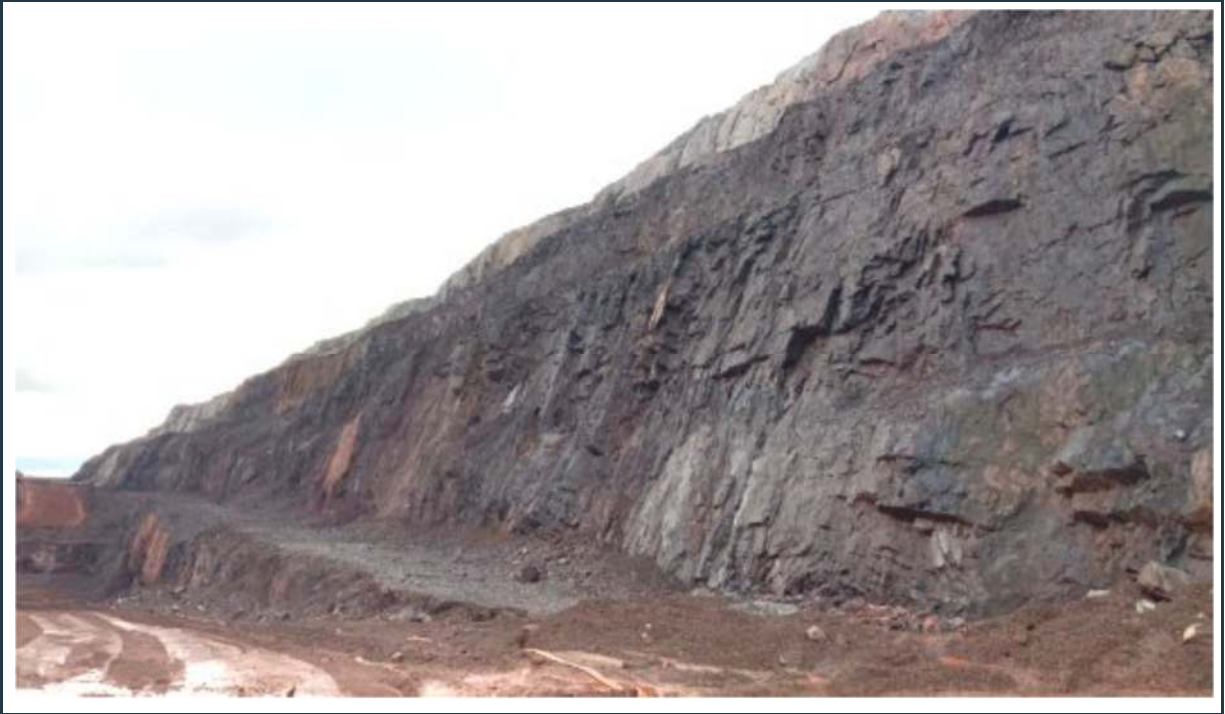
Figure 43: Stable pit-wall in the area of deposit-1.

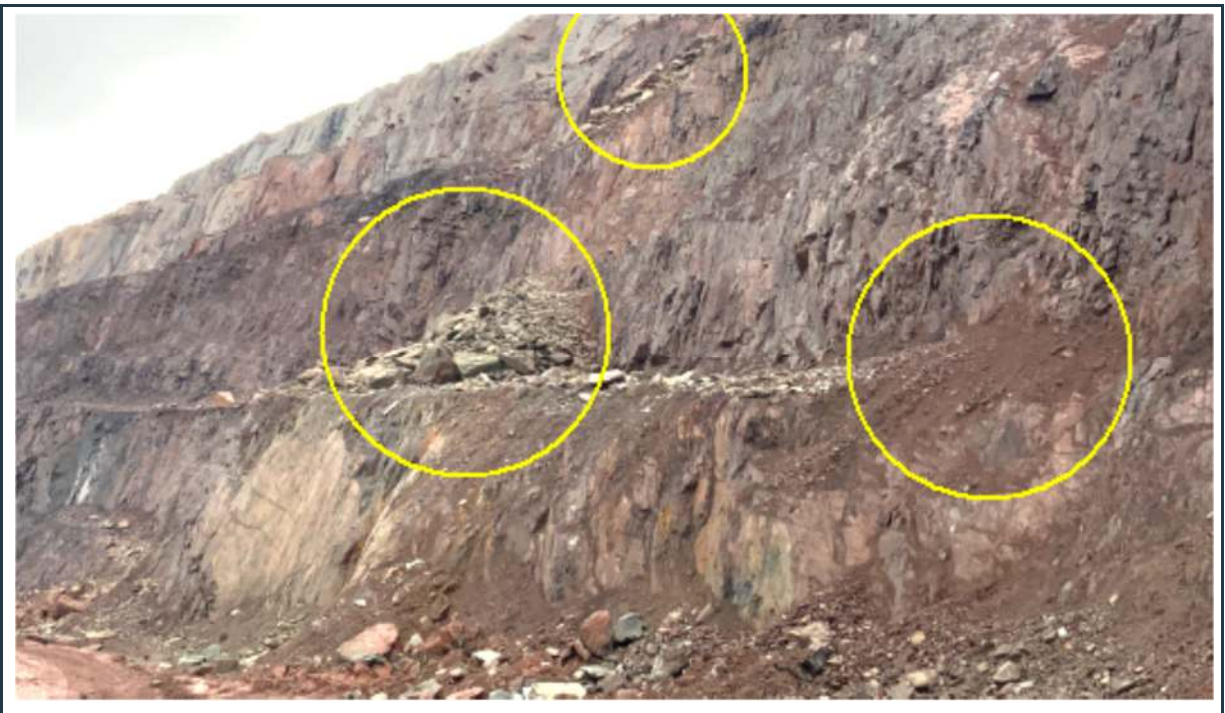
Figure 44: Minor weathering and pit-wall erosion in the area of deposit-1.

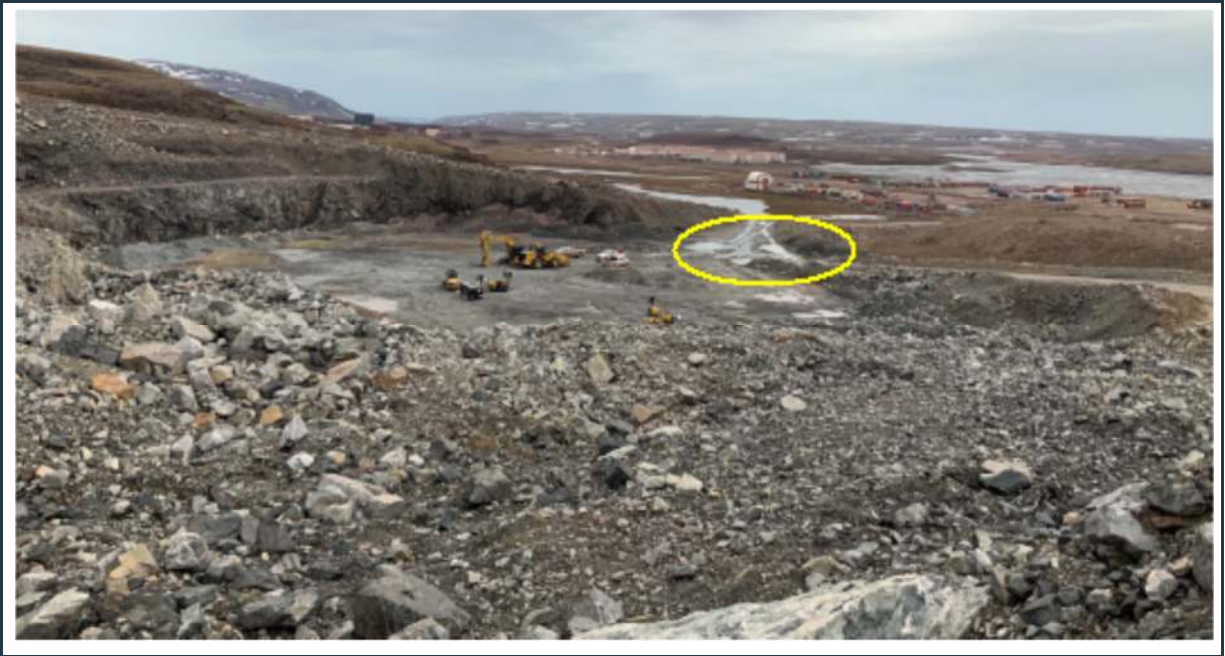
Figure 45: View of QMR2 quarry with area that requires surface water control (yellow circle).

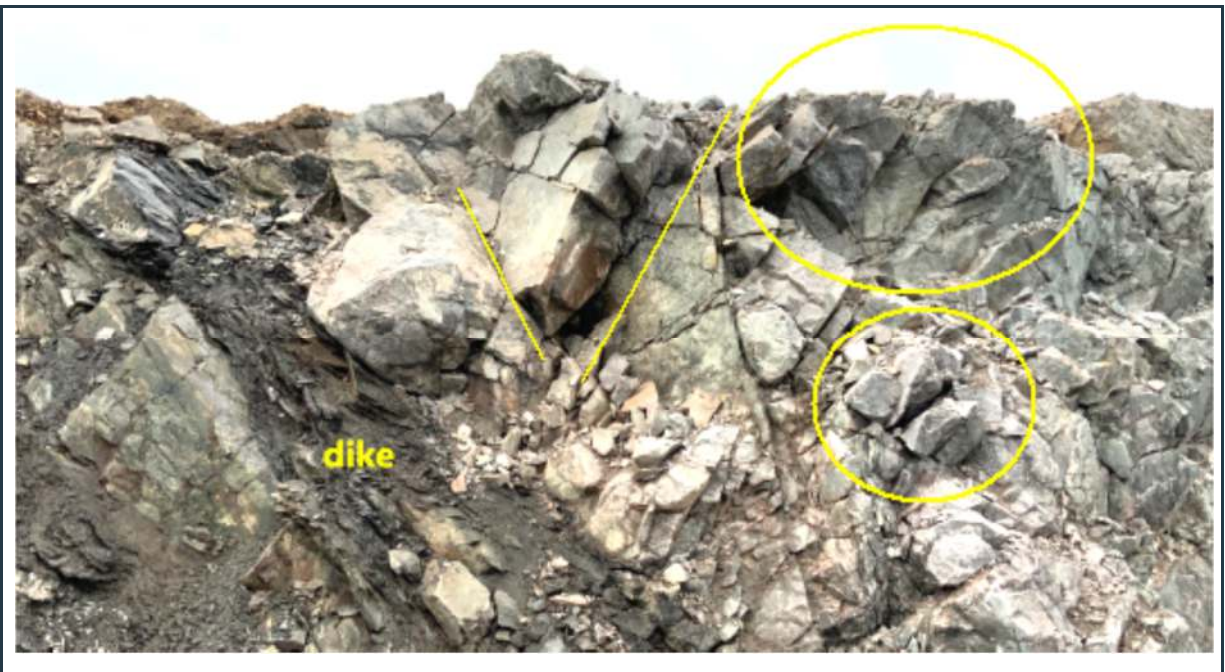
Figure 46: Potential hazards at one of the highwalls (weak dike, loose boulders and sliding wedge).

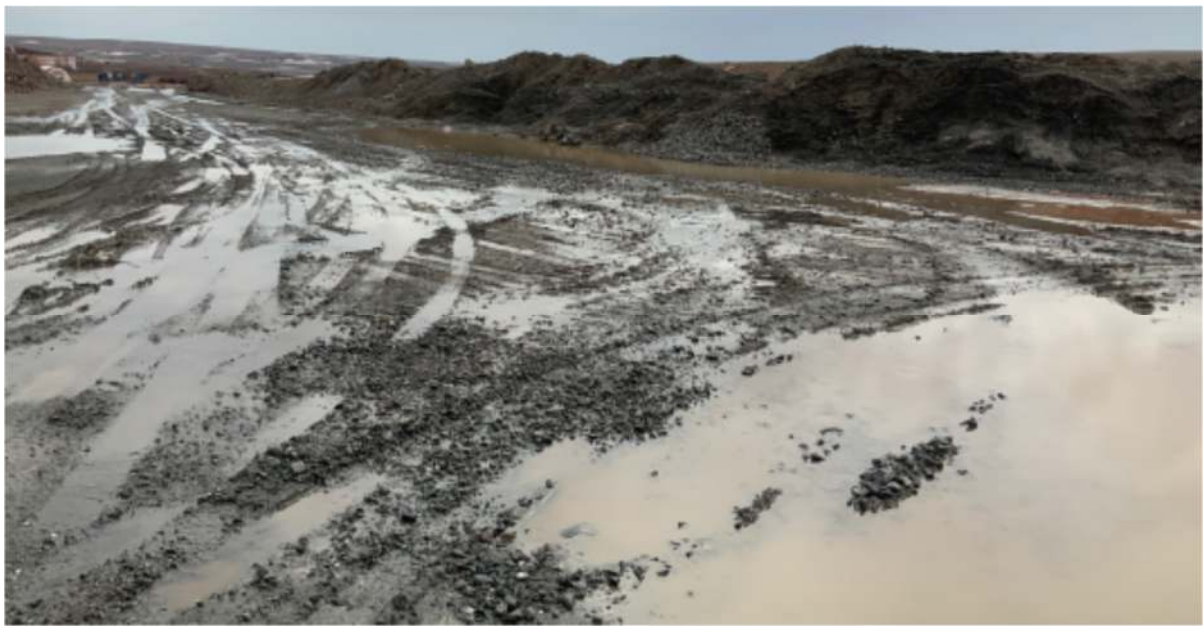
Figure 47: Area that requires improved surface water control at the main level of QMR2 quarry.

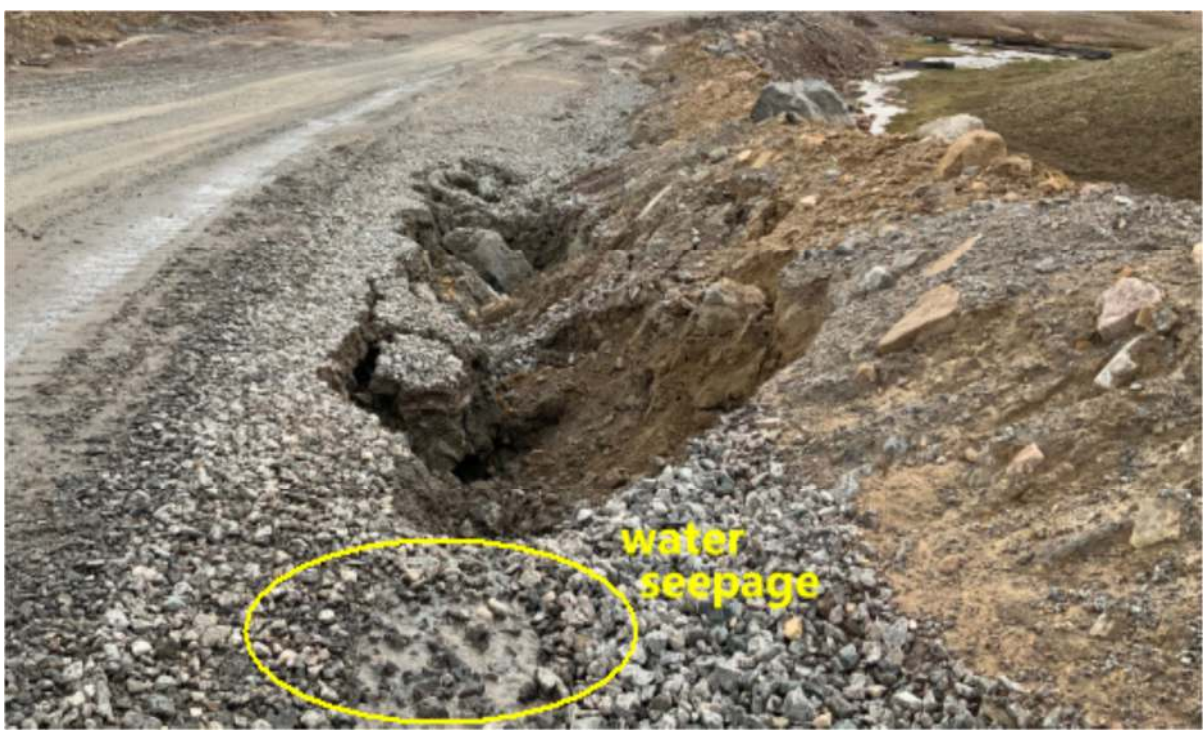
Figure 48: Surface water flowing from the quarry area along the road resulted in a failure of the edge of the access road leading to the quarry. Immediate repair was requested to prevent accidents.

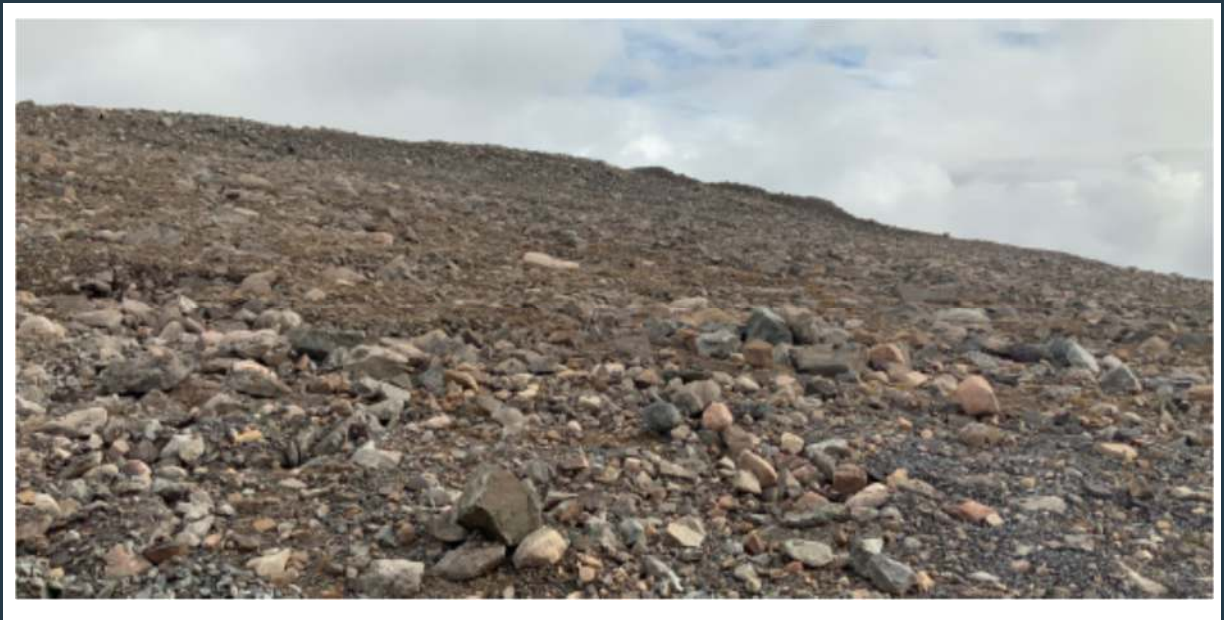
Figure 49: View of the northern slope of the future D1Q1 quarry.

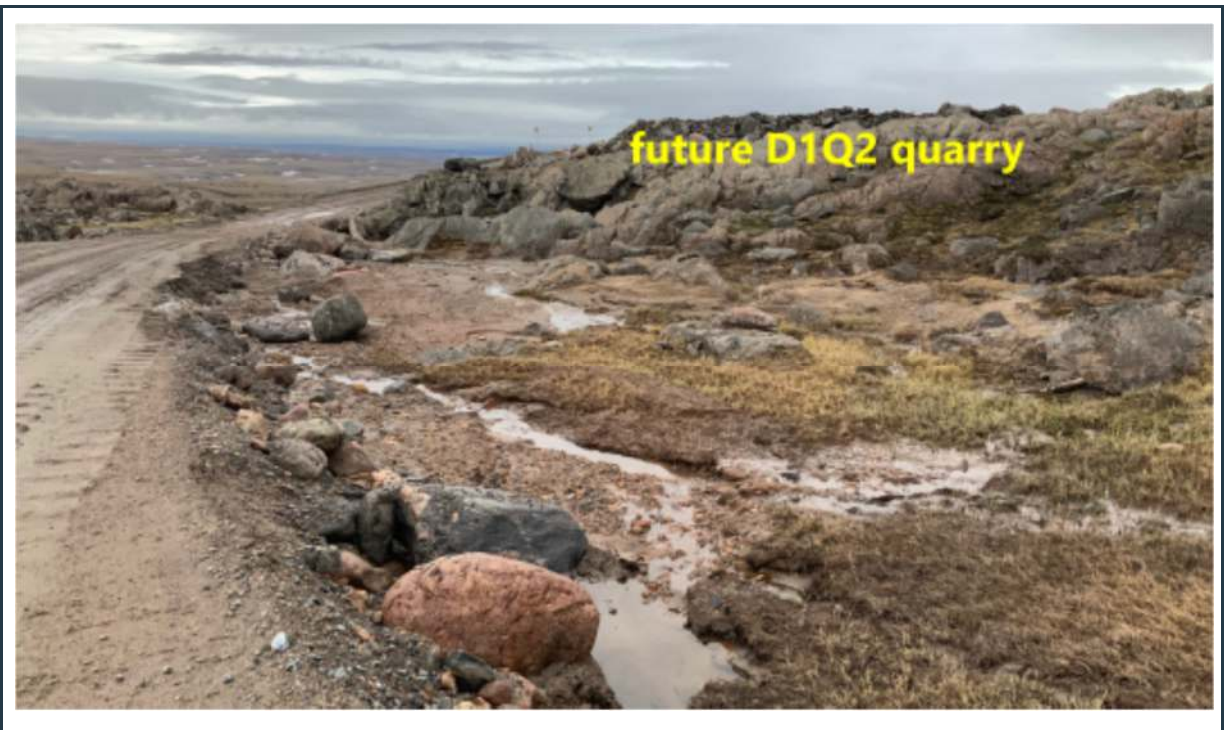
Figure 50: View of the southern section of the future D1Q2 quarry.

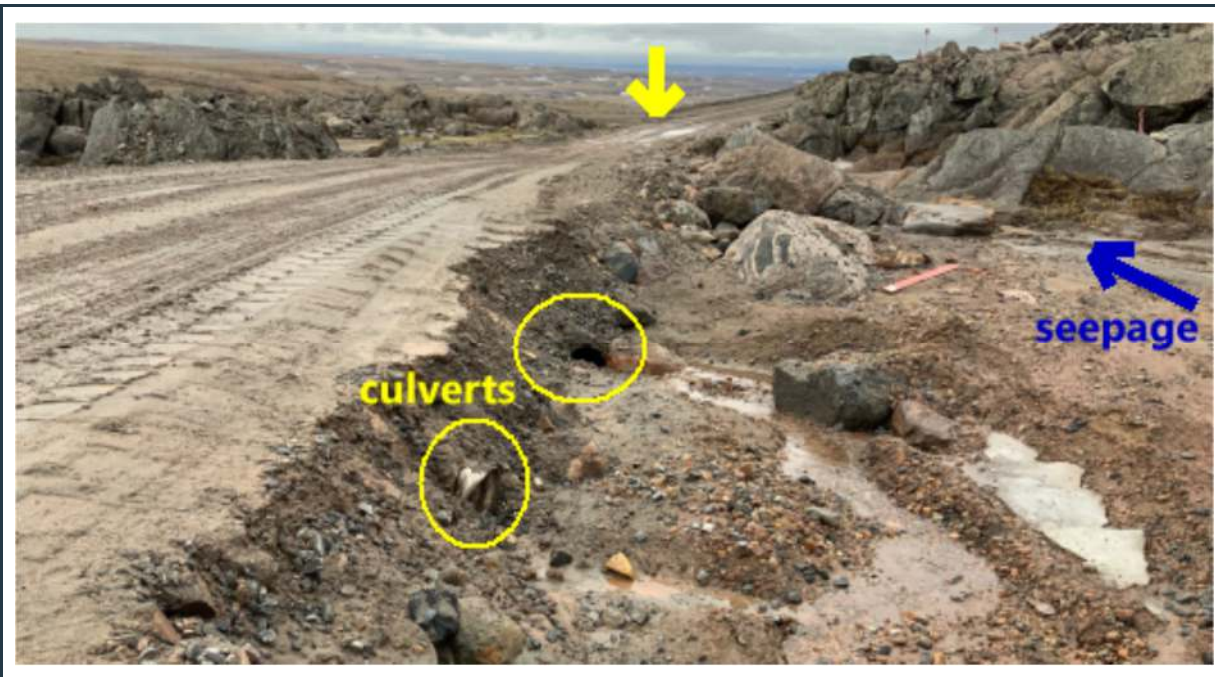
Figure 51: Existing culverts installed at the wrong place (yellow circles). New culvert required at the yellow arrow to prevent serious road problems in the future. Blue arrow indicates below grade seepage.

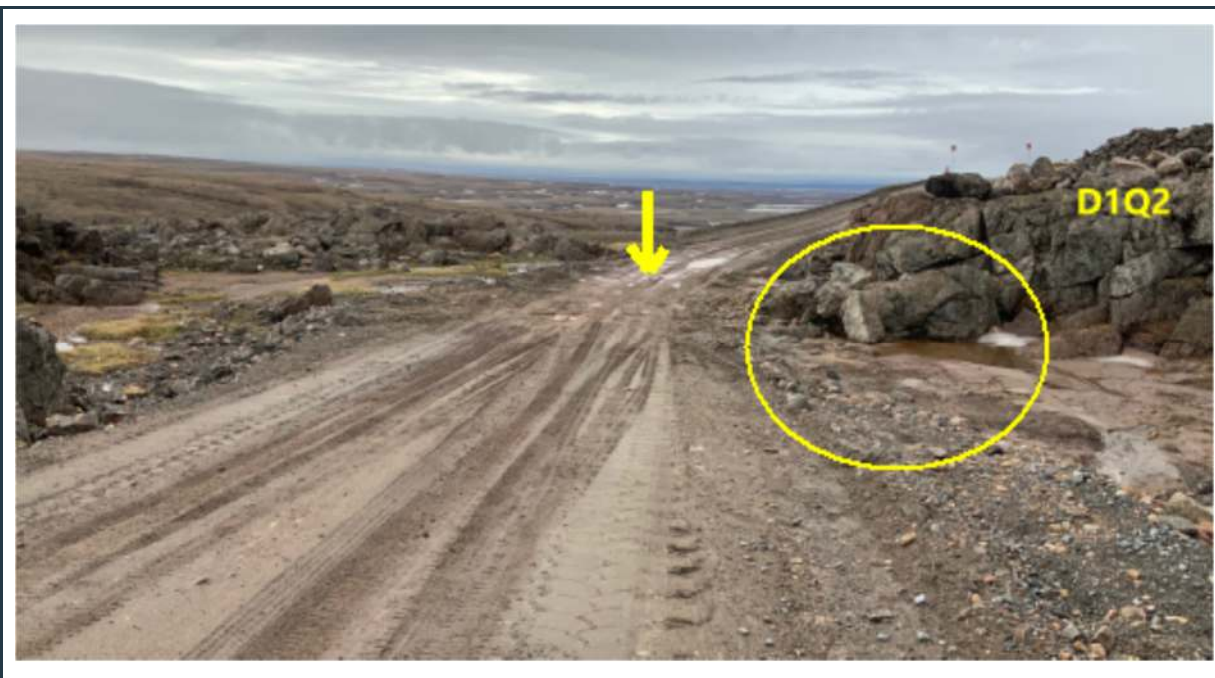
Figure 52: Ponding water at the edge of the future D1Q2 quarry. Culvert is required at the low point of the road and the road grade should be raised in the area above the culvert.
