## **Baffinland Iron Mines Corporation**

**Project #: TC190307**

### **Annual Geotechnical Inspections – 2020 Report 1.**

### **APPENDIX “B” – Milne Inlet Port Site - Photographs**

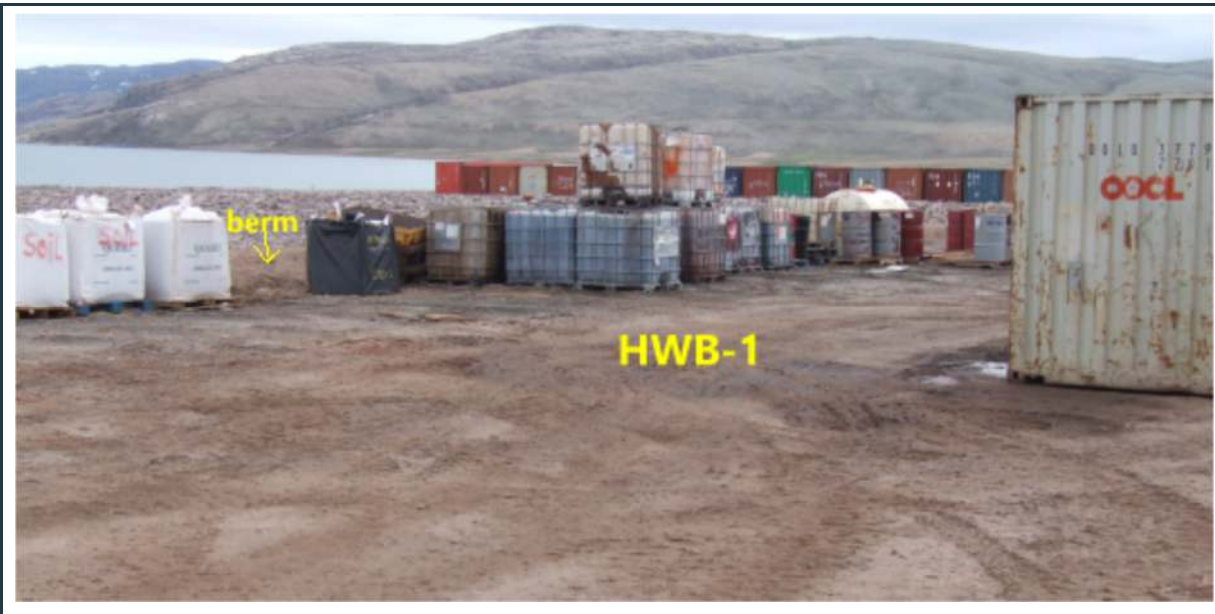
Figure 53: View of the well organized interior of the HWB-1 cell.

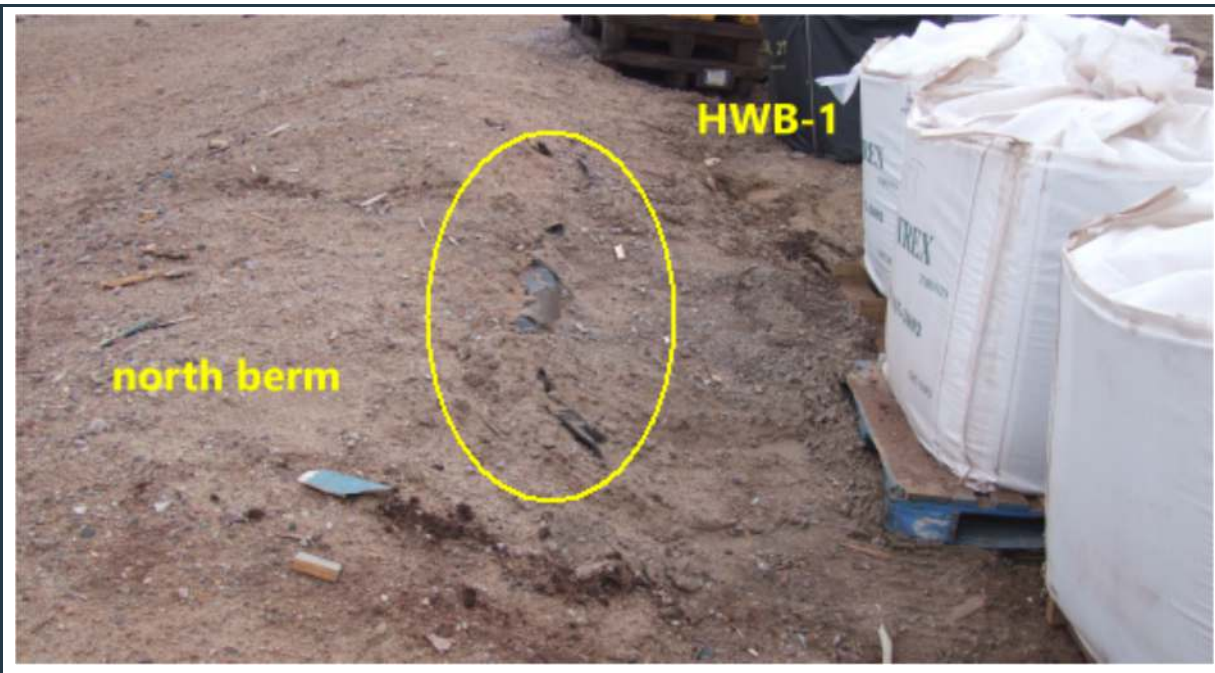
Figure 54: Ripped geotextile and exposed liner at a small area of the north berm of HWB-1 cell.

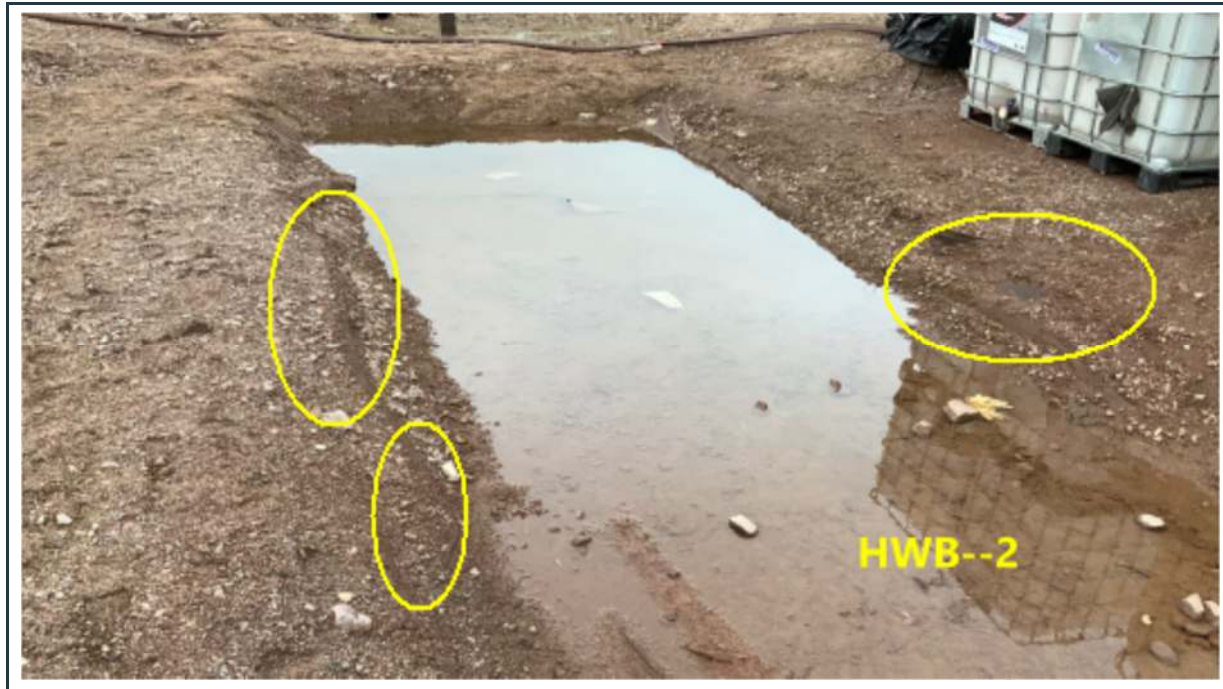
Figure 55: Ponding water in the empty HWB-2 cell with locally exposed geotextile and liner. Empty containers stored immediately adjacent to the cell.

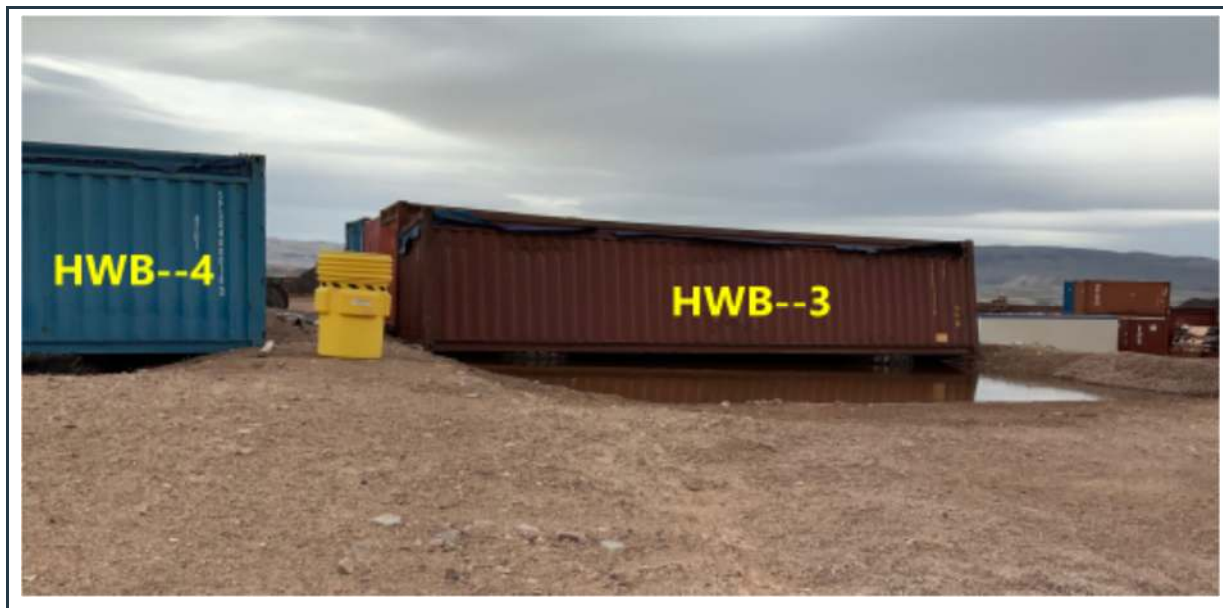
Figure 56: View of the HWB-3 and HWB-4 twin cells, containing solid waste in shipping containers.

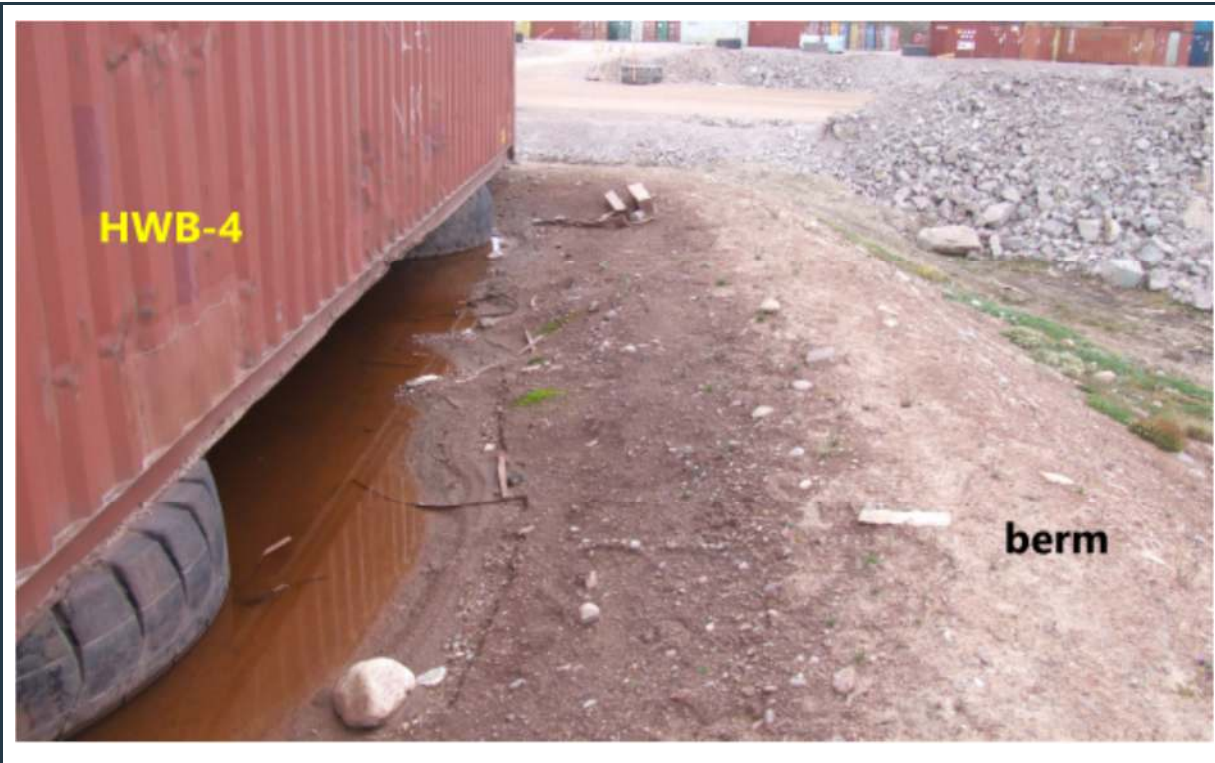
Figure 57: Stable berm around, and ponding water within the HWB-4 cell.

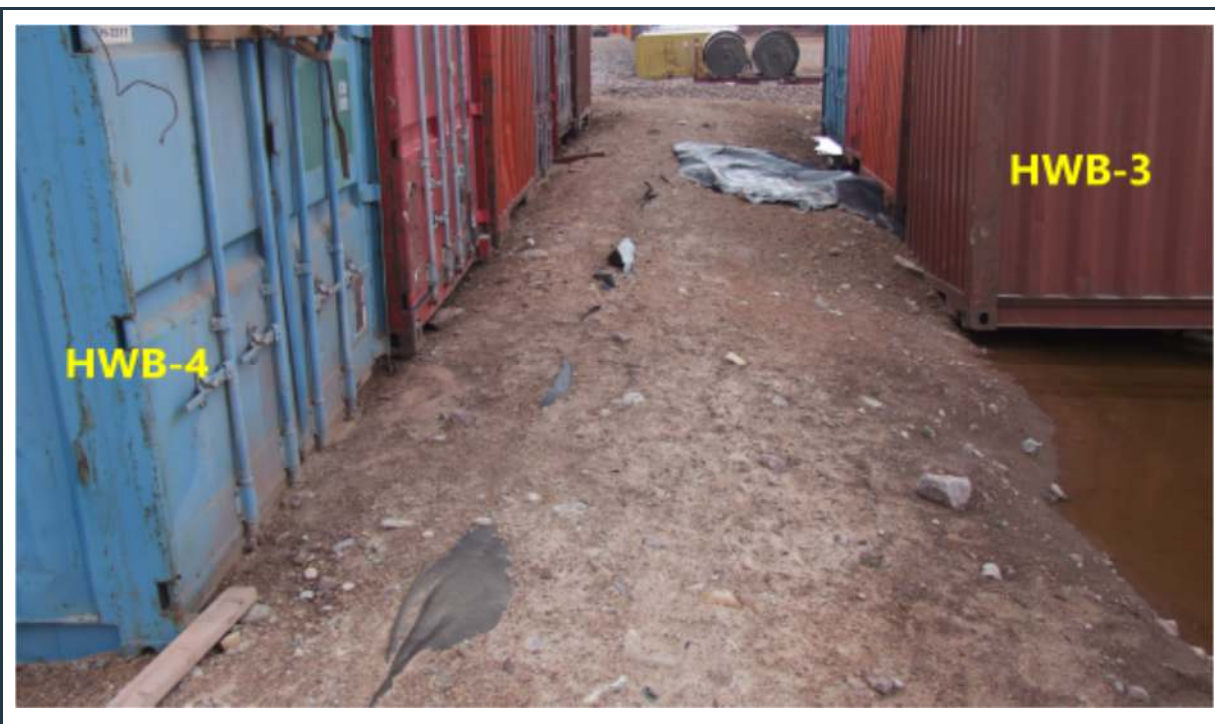
Figure 58: Exposed geotextile and liner on the internal berm between the HWB-3 and HWB-4 cells.

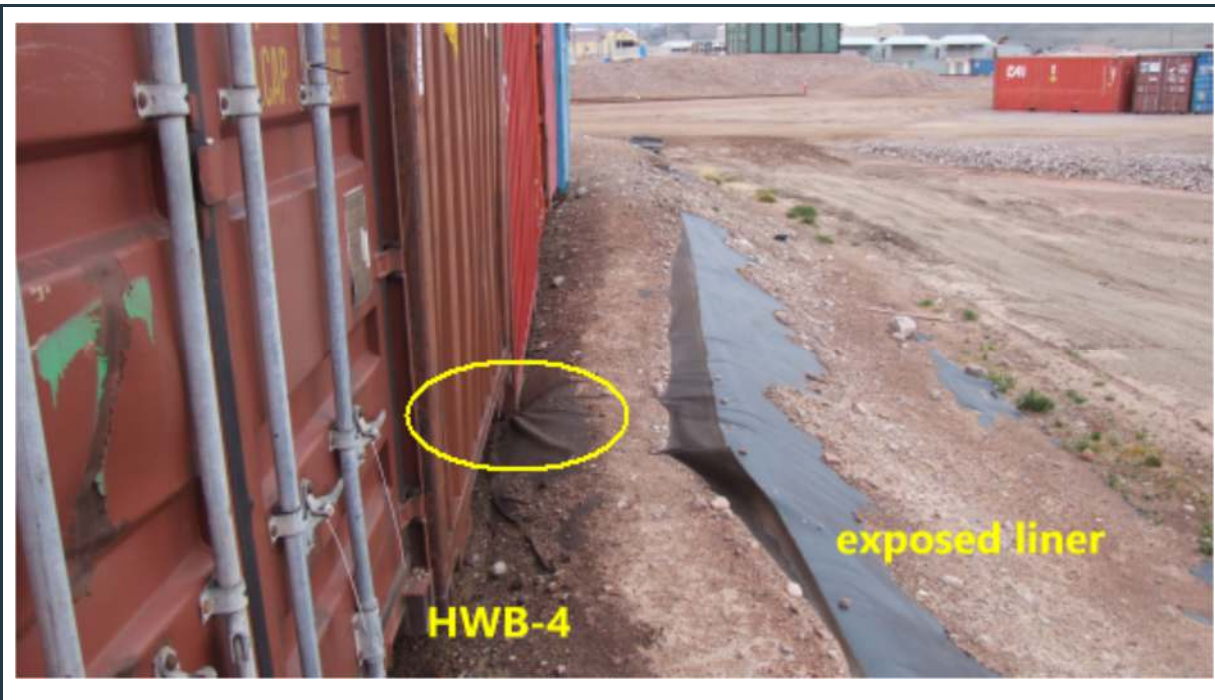
Figure 59: Exposed geotextile and liner at the HWB-4 cell, with location of potential damage to liner.

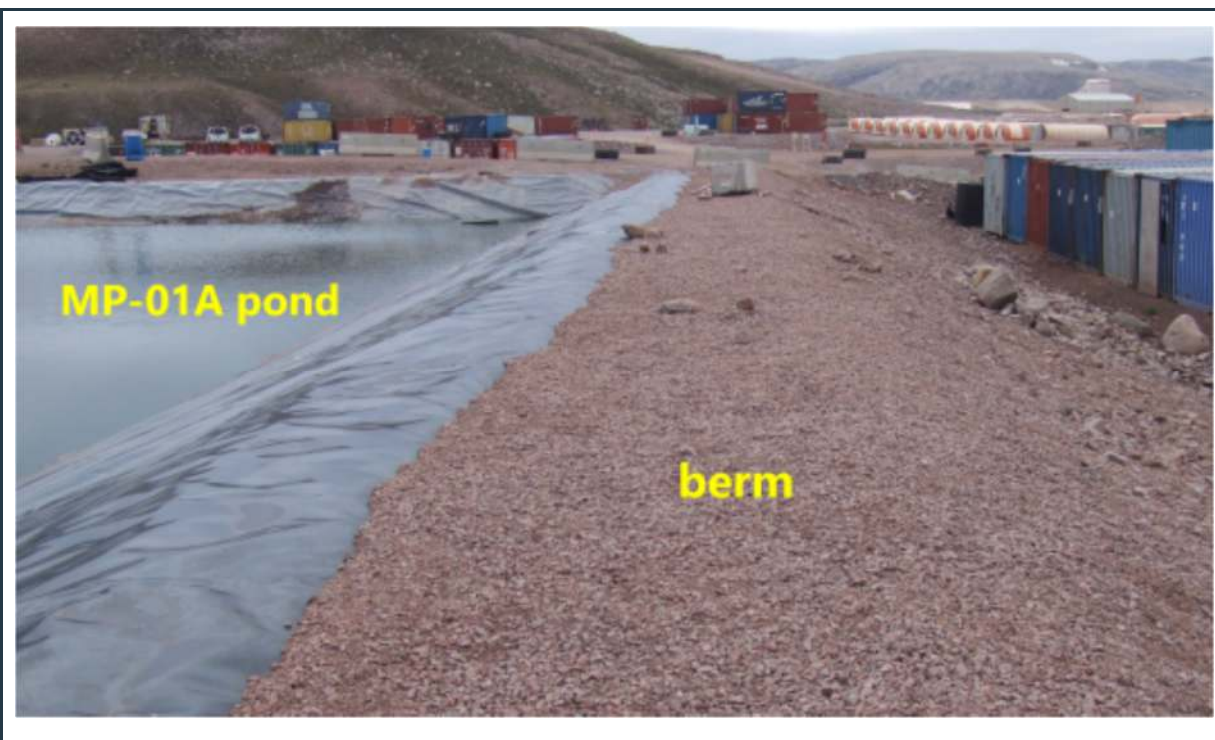
Figure 60: Berms in excellent condition with stable slopes around the MP-01A pond.

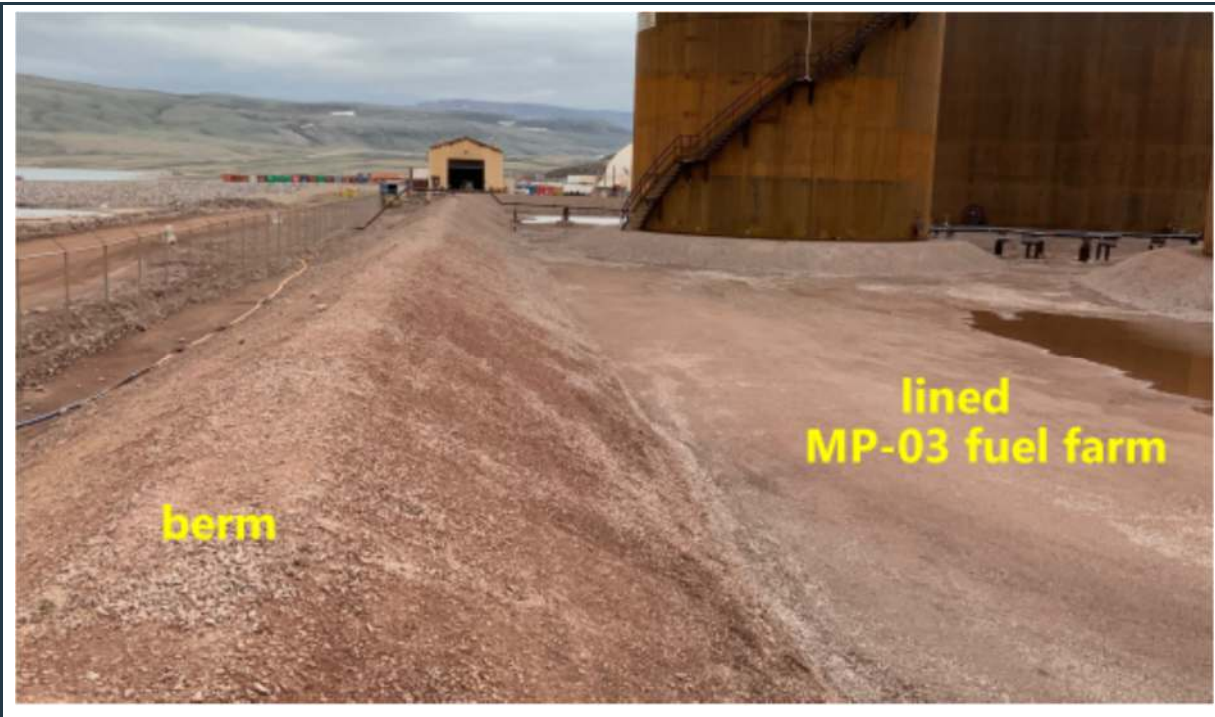
Figure 61: View of stable, well maintained berms around the MP-03 fuel tank farm.

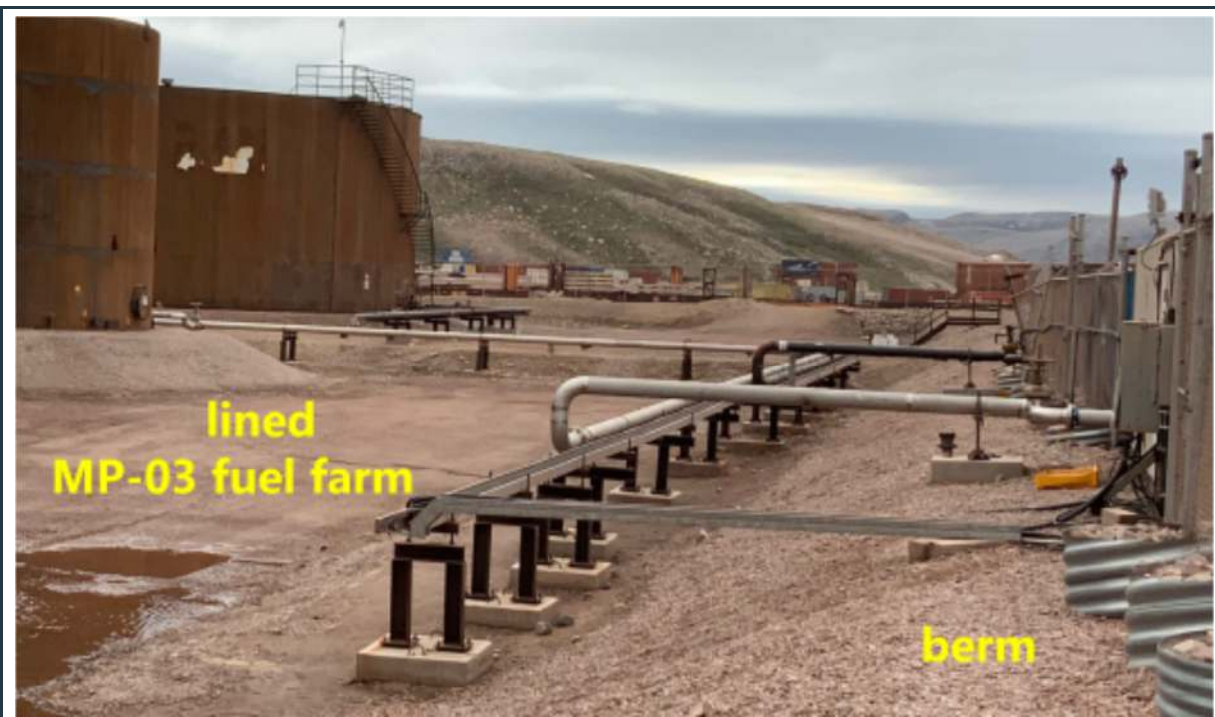
Figure 62: View of stable, well maintained berms around the MP-03 fuel tank farm.

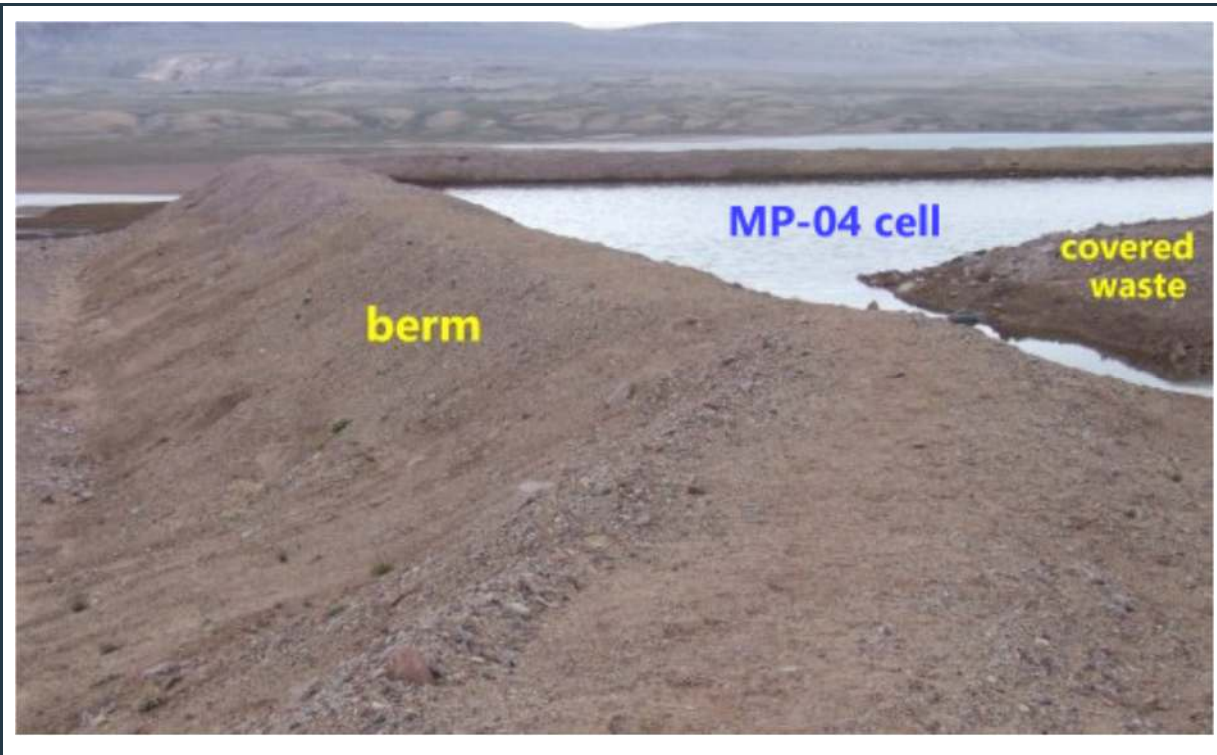
Figure 63: View of stable berm at the MP-04 landfarm, with covered waste within the cell.

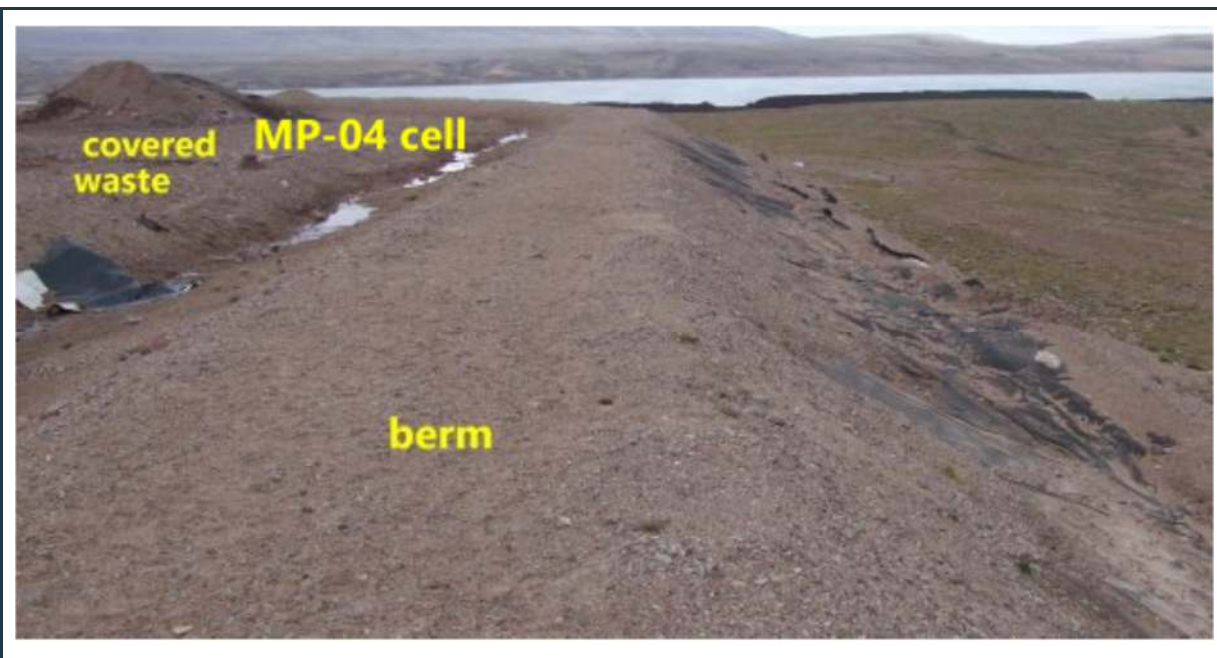
Figure 64: Stable berm at the MP-04 landfarm with exposed liner on the downstream face of the berm.

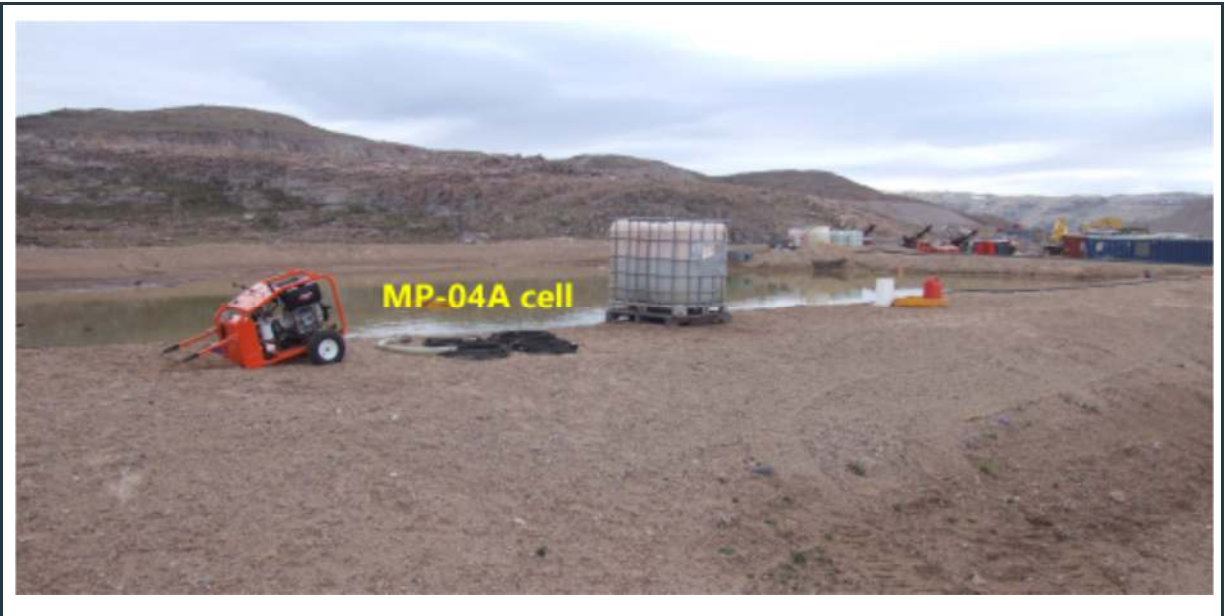
Figure 65: View of the MP-04A contaminated snow dump cell with stable berms.

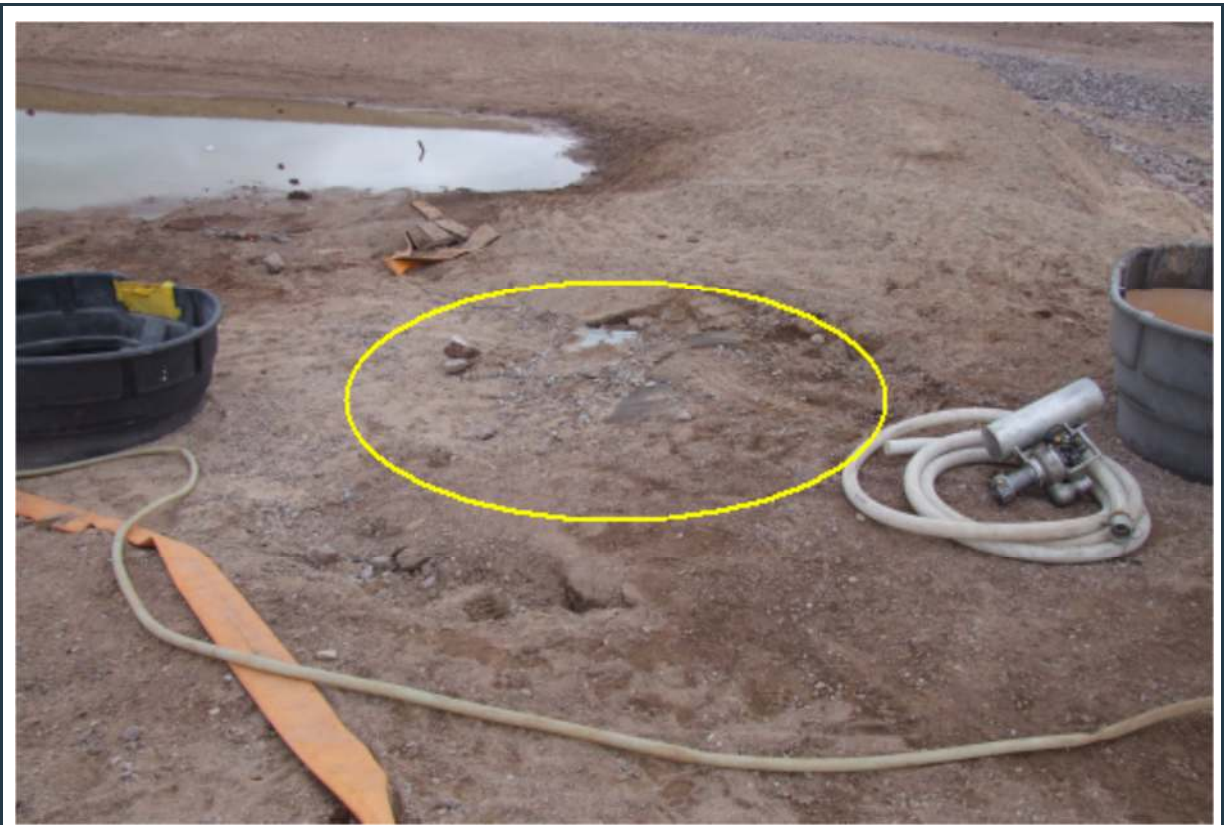
Figure 66: Condition of the ramp to the MP-04A snow dump, with exposed liner (yellow circle).

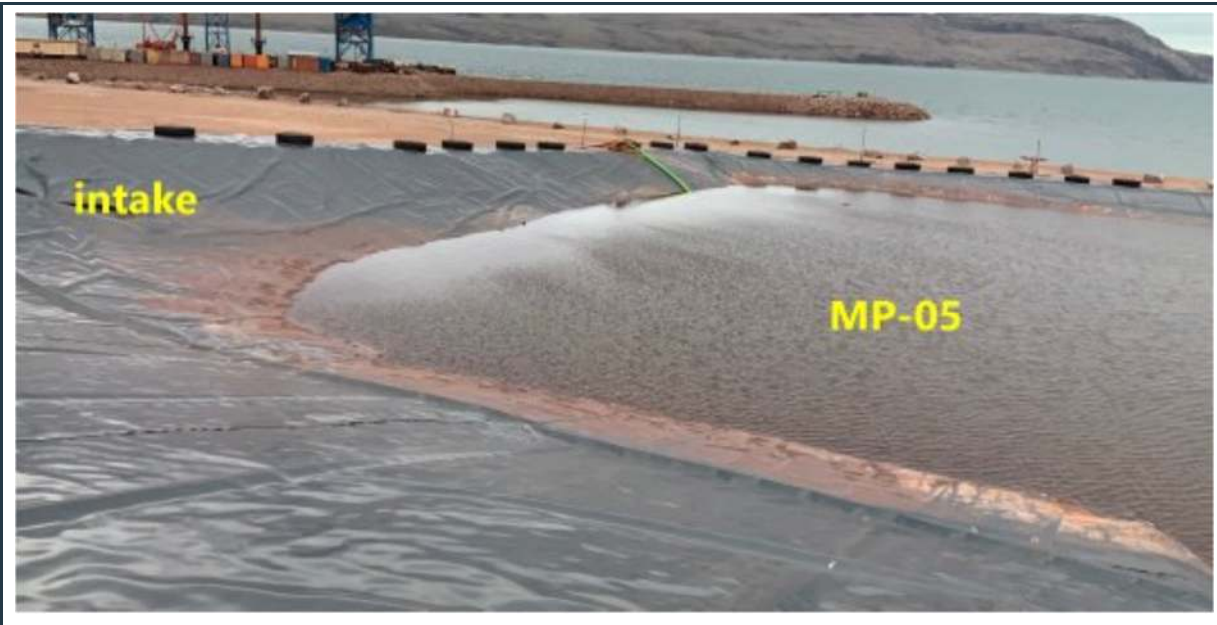
Figure 67: View of stable berms at the MP-05 settling pond (north-east corner of the ore stockpile).

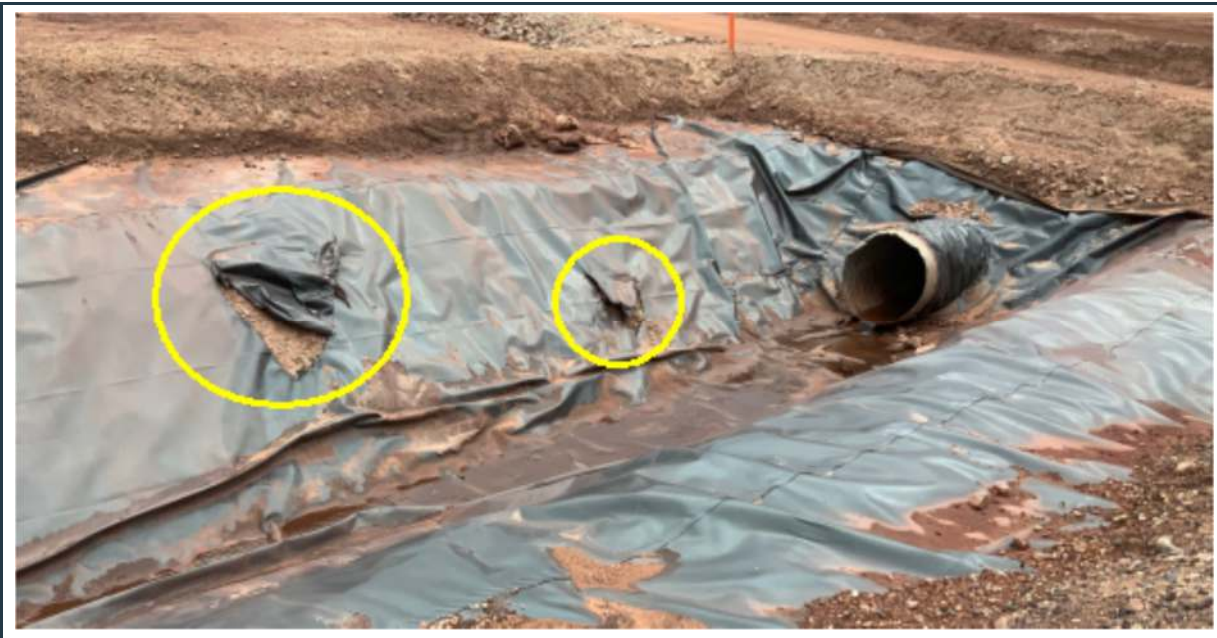
Figure 68: Some liner damage on the slope of the southern intake channel to the MP-05 settling pond.

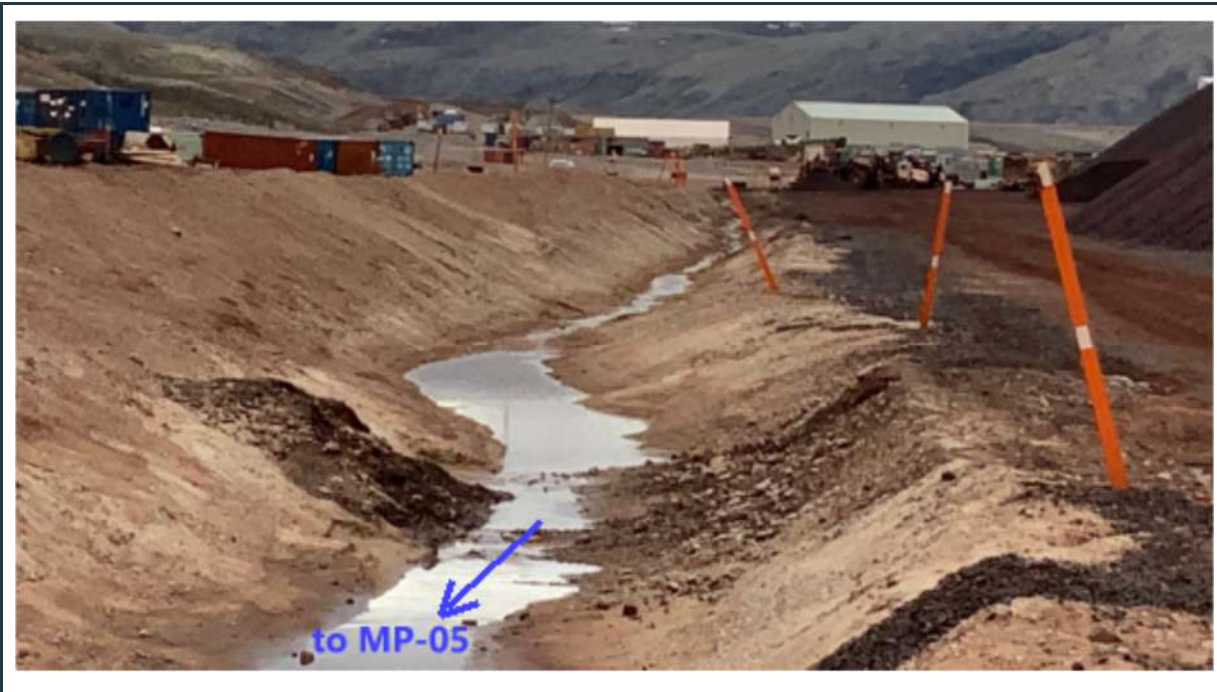
Figure 69: Surface water collection ditch adjacent to the crushed ore storage, draining to MP-05 pond.

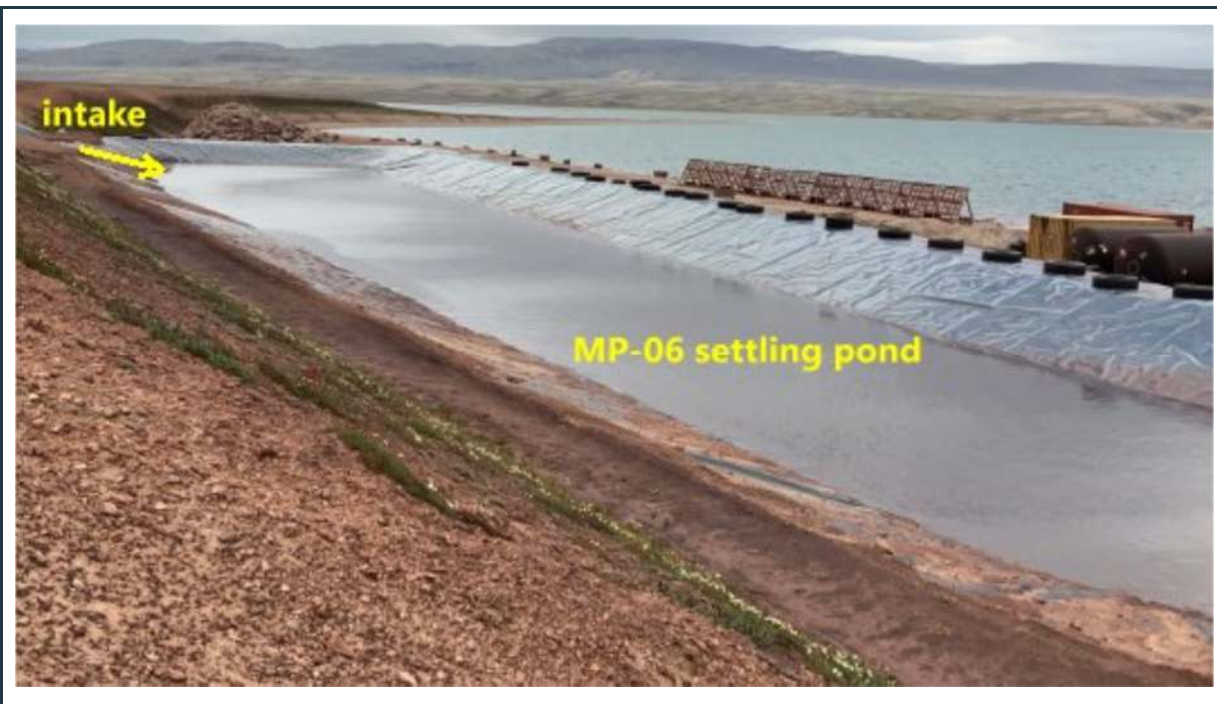
Figure 70: View of the lined MP-06 pond with stable berms (north-west corner of the ore stockpile).

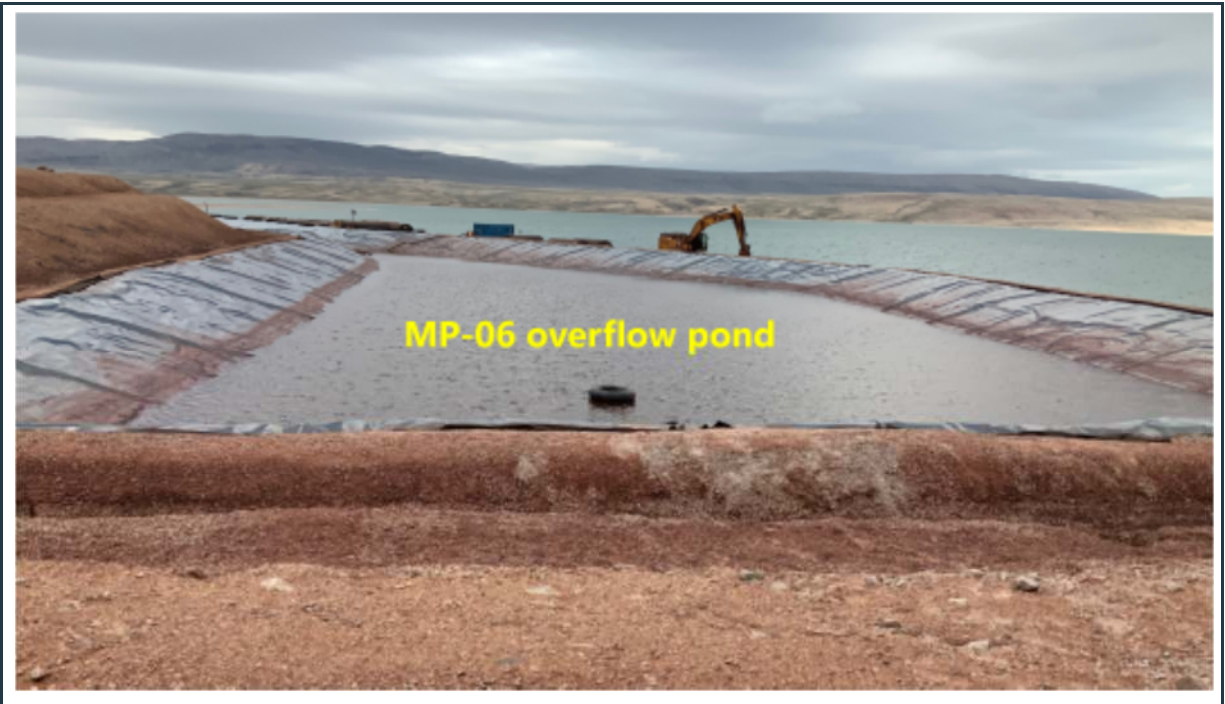
Figure 71: View of the lined MP-06 overflow pond, with stable berms.

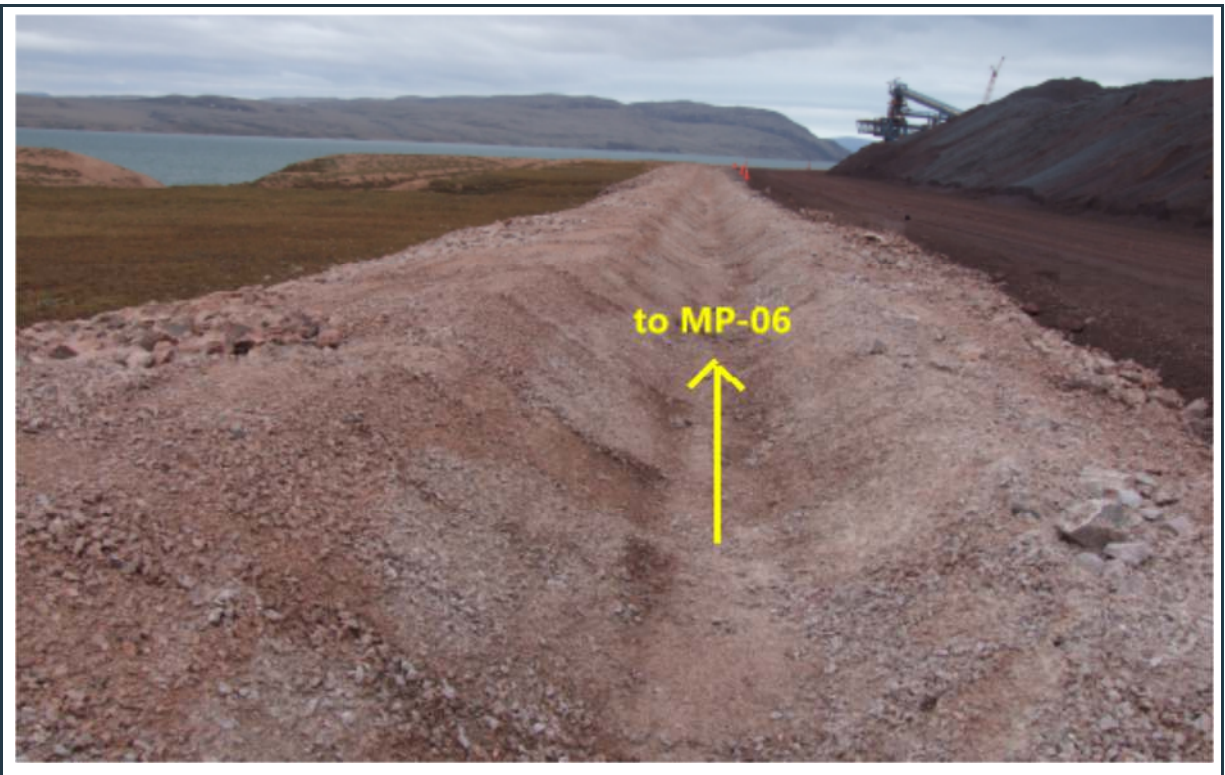
Figure 72: Surface water collection ditch adjacent to the crushed ore storage, draining to MP-06 pond.

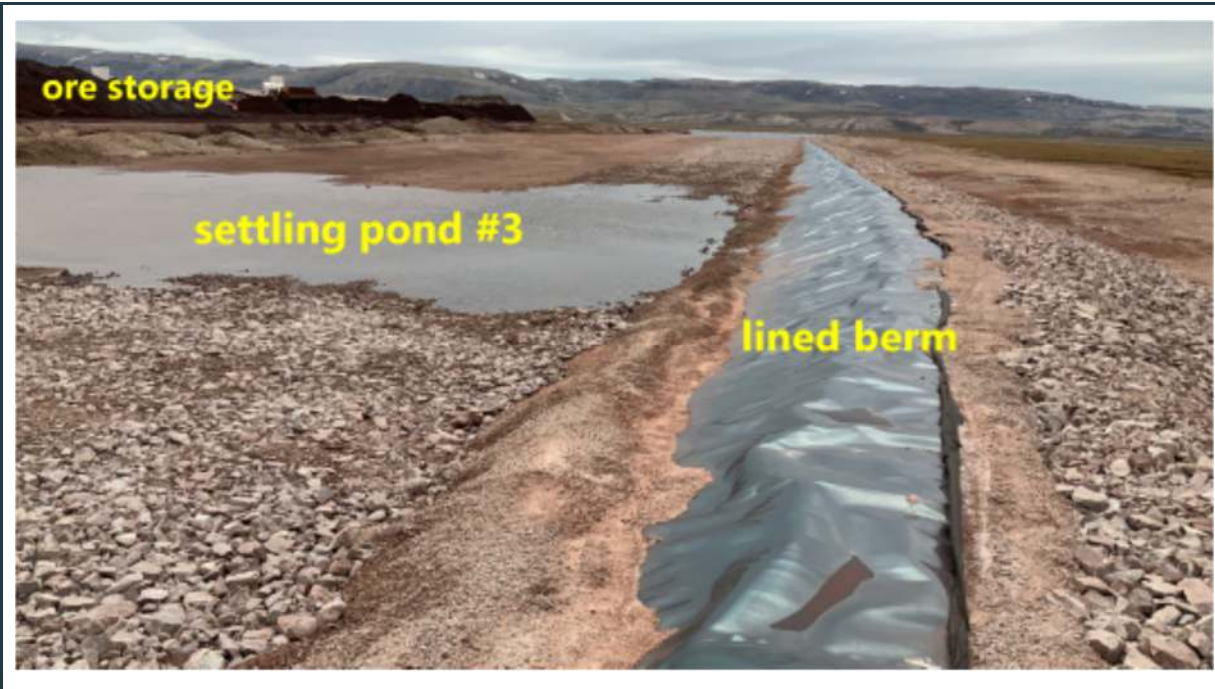
Figure 73: View of the lined, stable berm along the west side of settling pond #3.

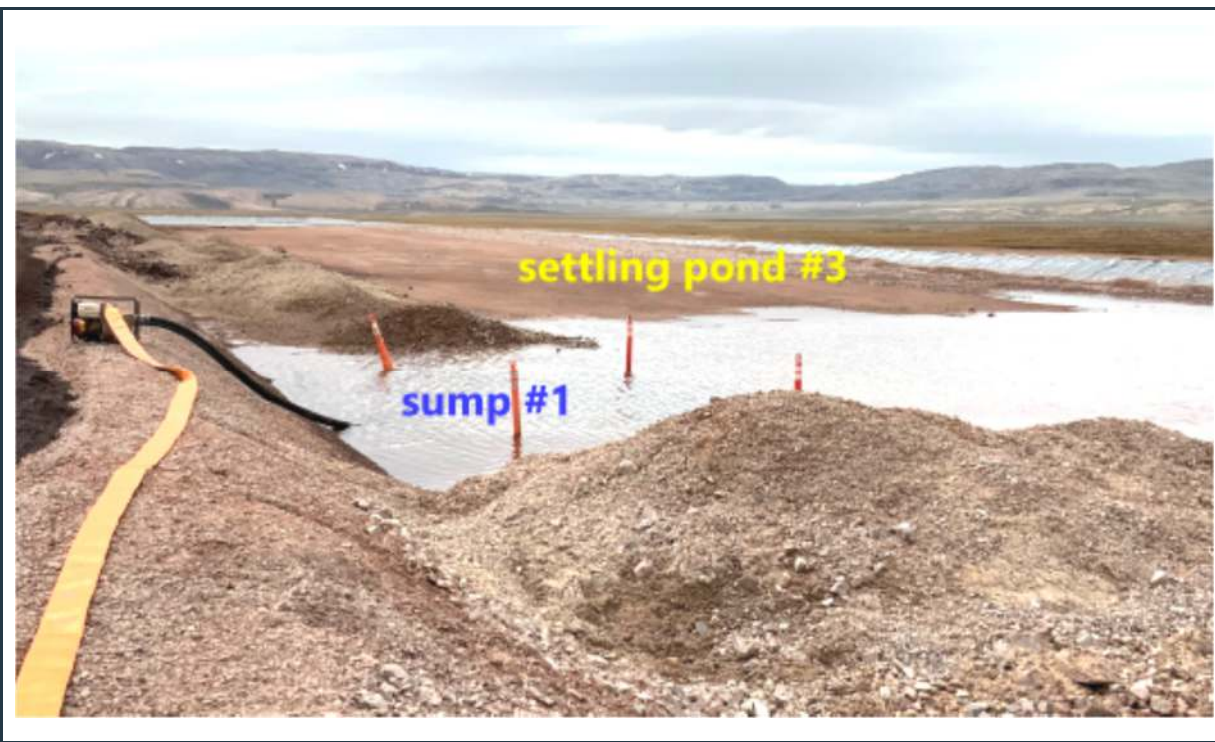
Figure 74: View of sump #1 in settling pond #3 along the west side of the ore stockpile.

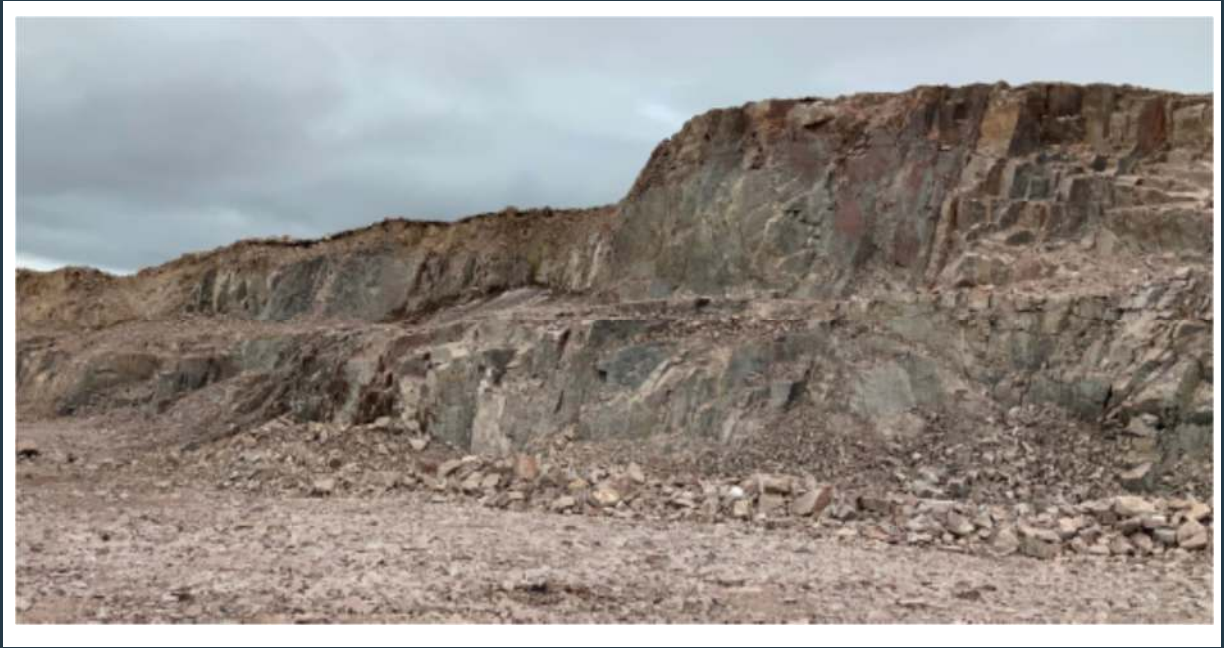
Figure 75: View of stable highwalls in the Q01 quarry.

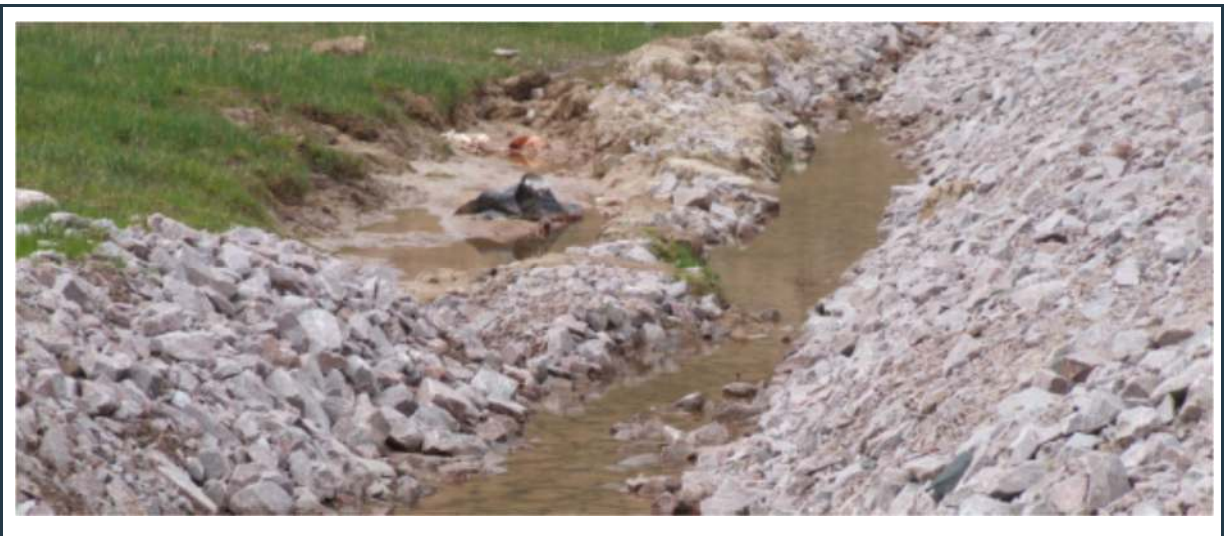
Figure 76: View of the “P-SWD-3 surface water collection ditch with failing side slope. The sloughing is caused by the uncontrolled water flow into the ditch along its alignment (see the next image).

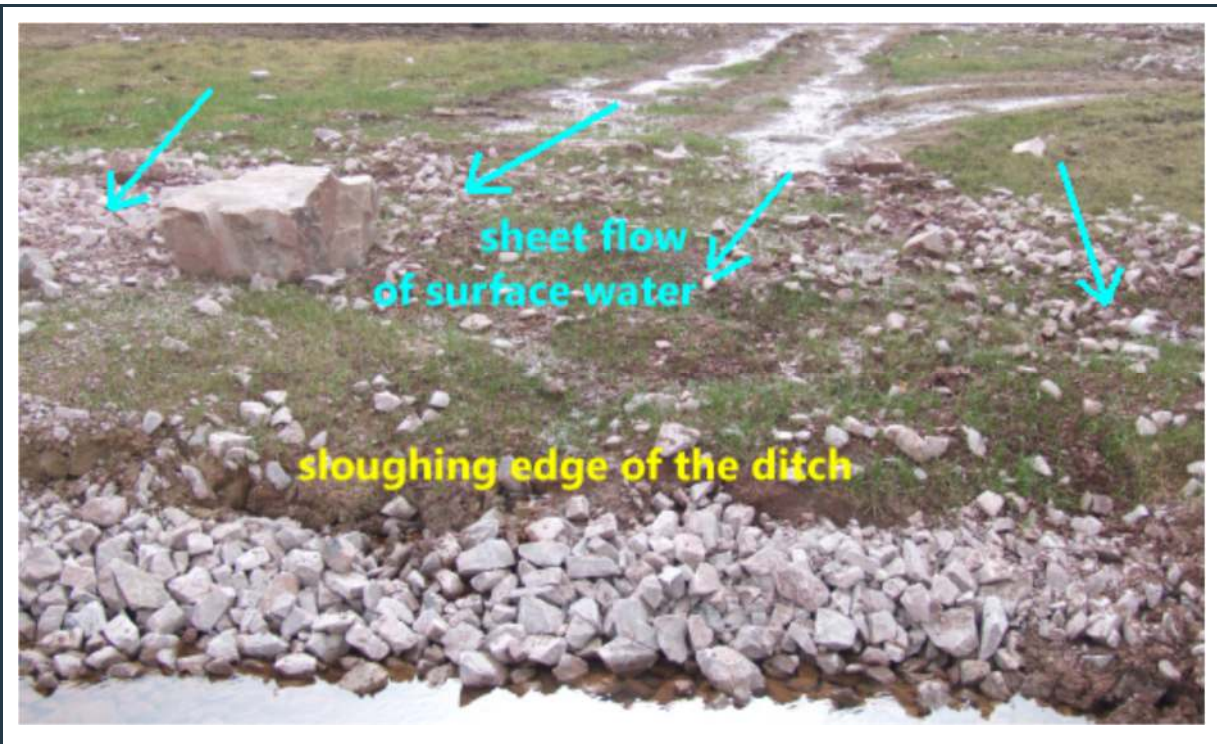
Figure 77: Sheet flow of surface water resulting in sloughing of one side of the P-SWD-3 ditch.

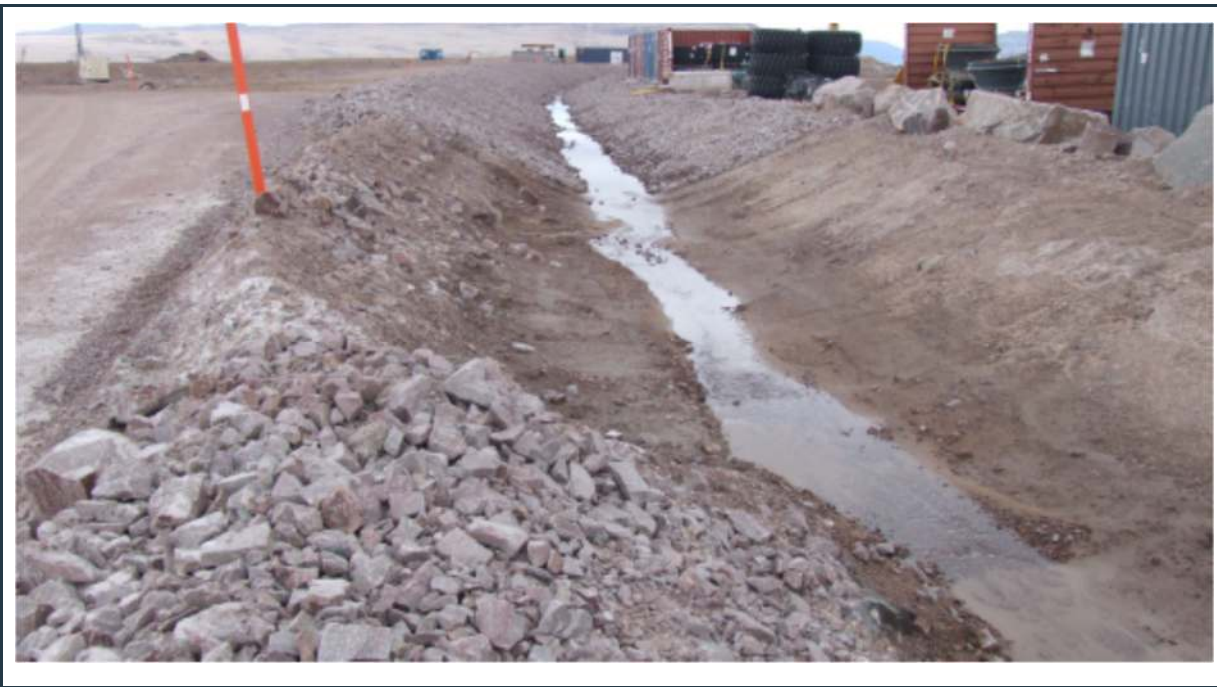
Figure 78: P-SWD-5 – "Q01-North" surface water collection ditch. Riprap is missing at one section.
