## **Baffinland Iron Mines Corporation**

**Project #: TC190307**

### **Annual Geotechnical Inspections – 2020 Report 1.**

### **APPENDIX “B” – Milne Inlet Port Site - Photographs**

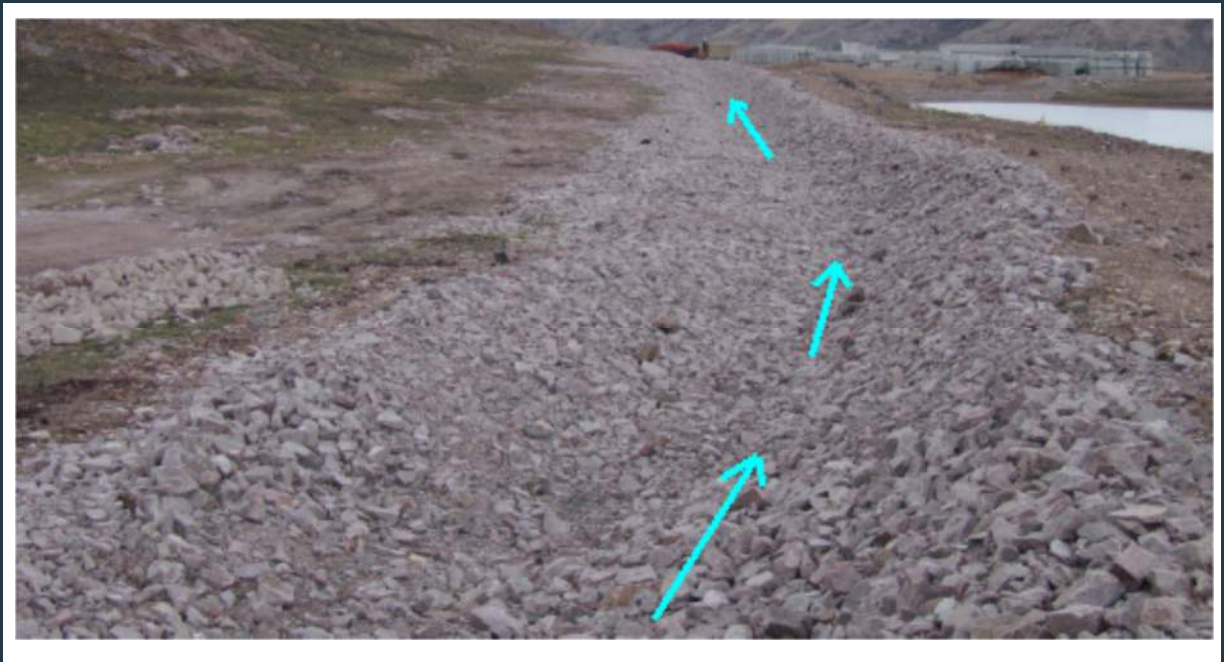
Figure 79: View of the well maintained P-SWD-6 - "Q01 South" surface water collection ditch.

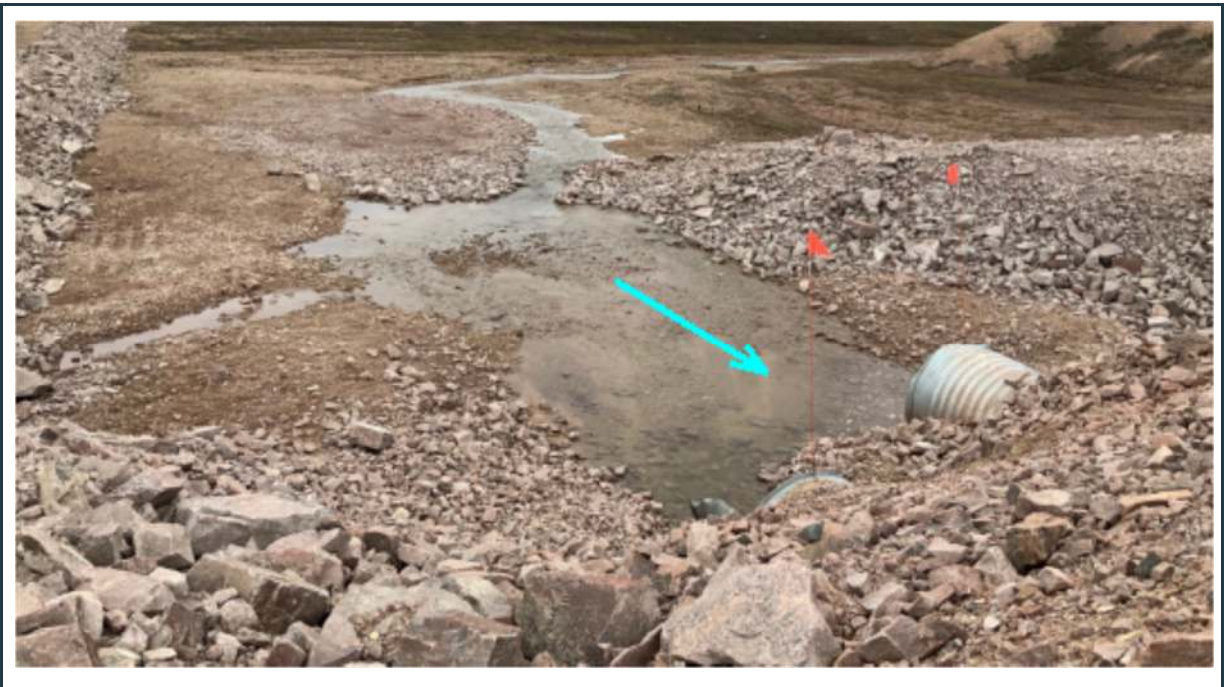
Figure 80: View of the P-SWD-7 surface water collection ditch and culverts (inlet).

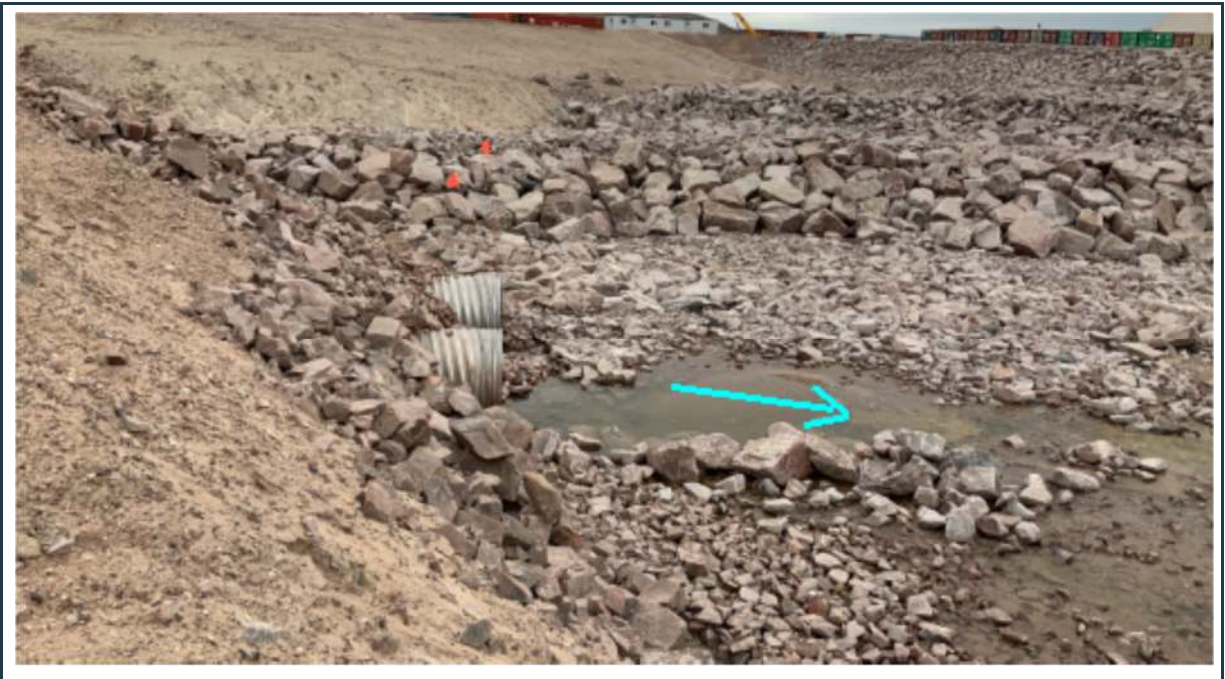
Figure 81: View of the P-SWD-7 surface water collection ditch and culverts (outlet).

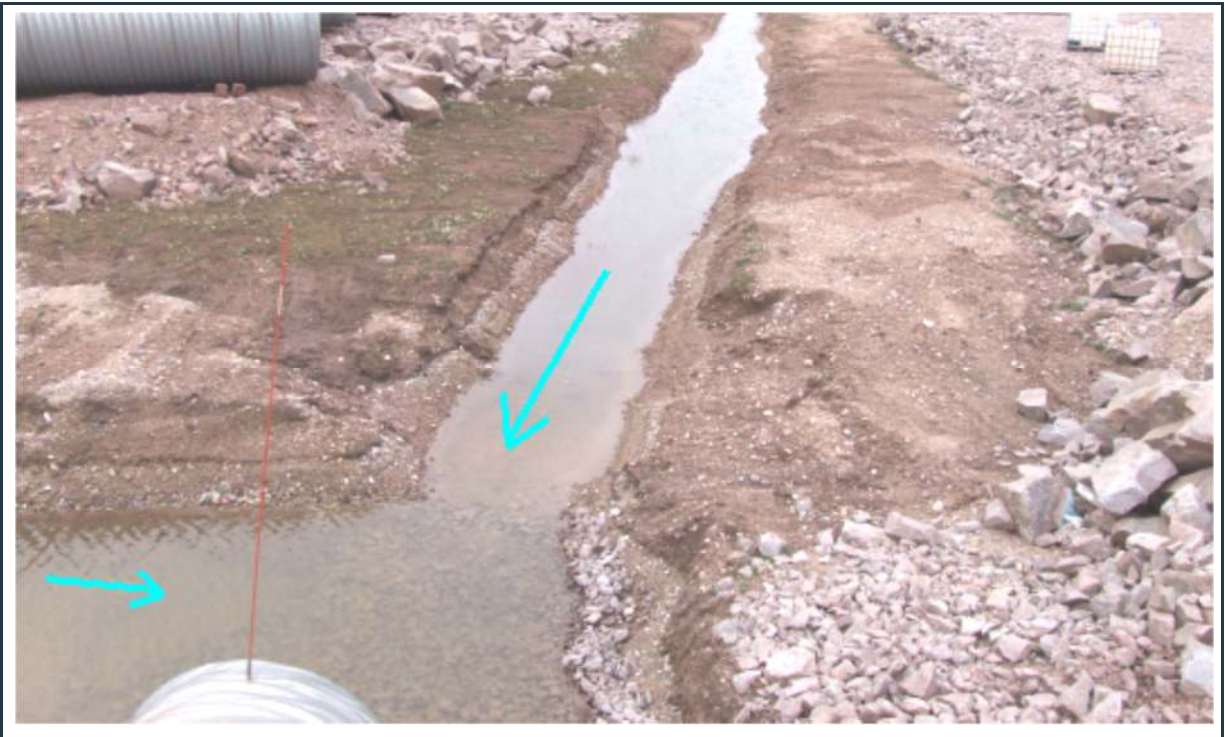
Figure 82: View of the W3/W14 surface water collection ditch and culvert inlet.

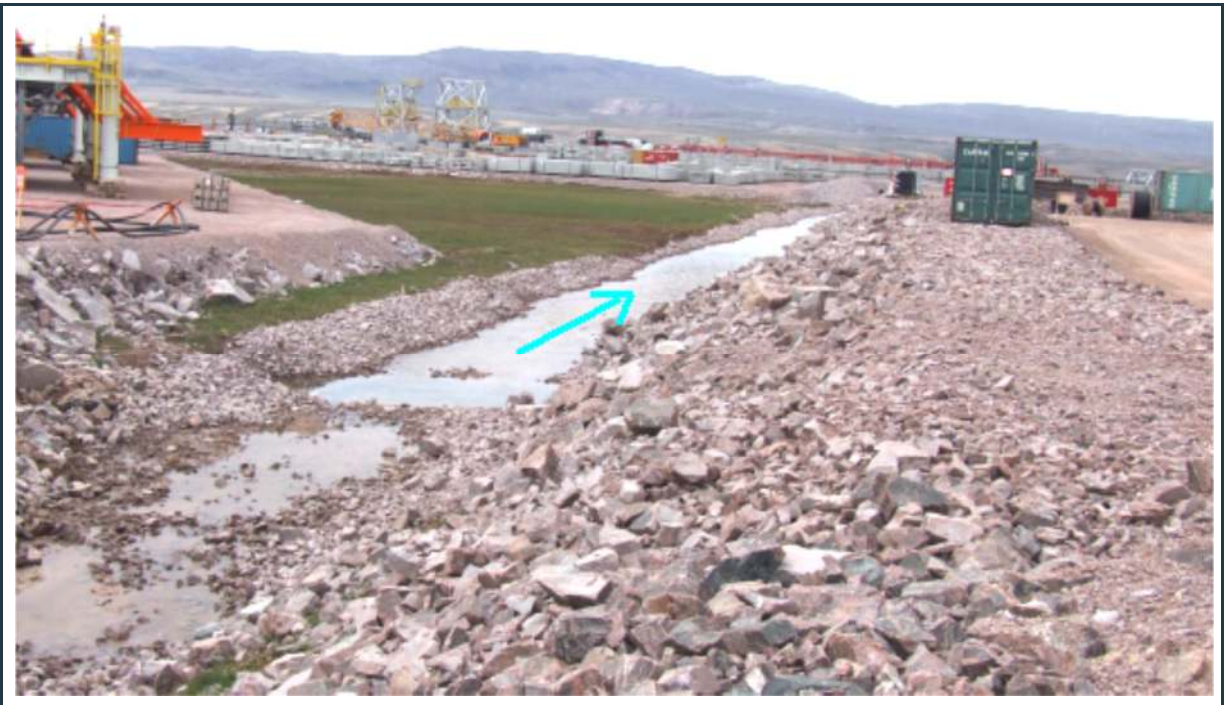
Figure 83: View of the south section of the 380 M surface water collection ditch, with minor riprap sloughing/rolling in the foreground.

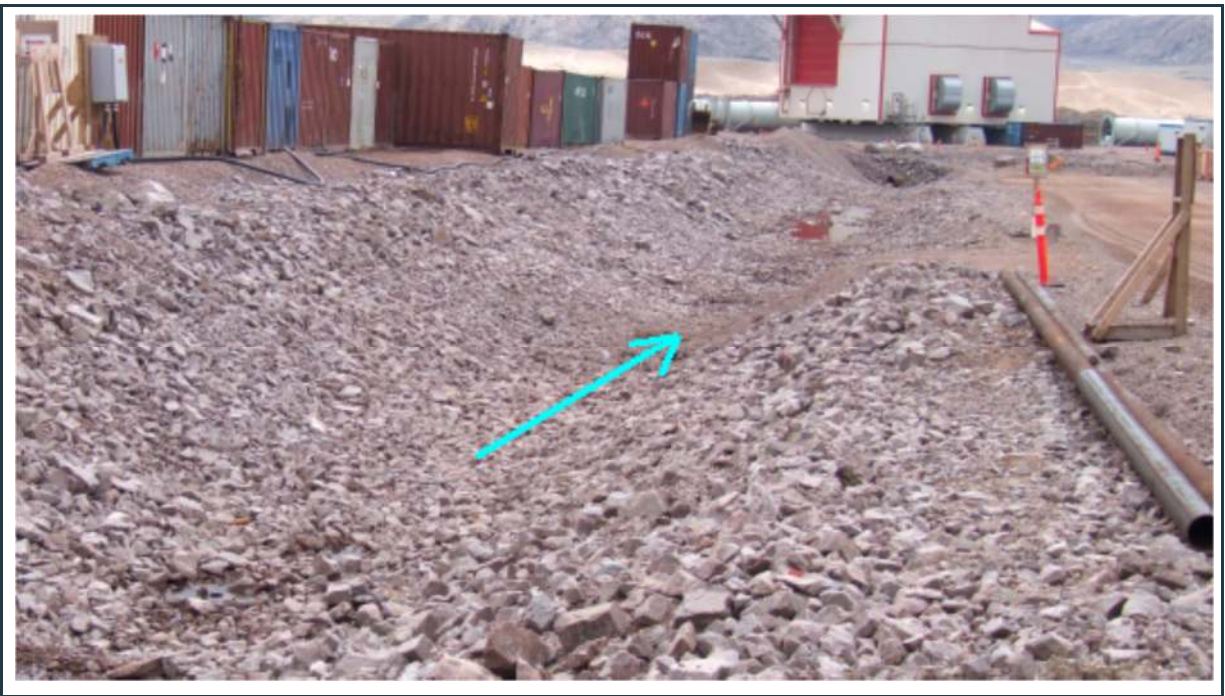
Figure 84: View of the east section of the 380 M surface water collection ditch, in good condition.

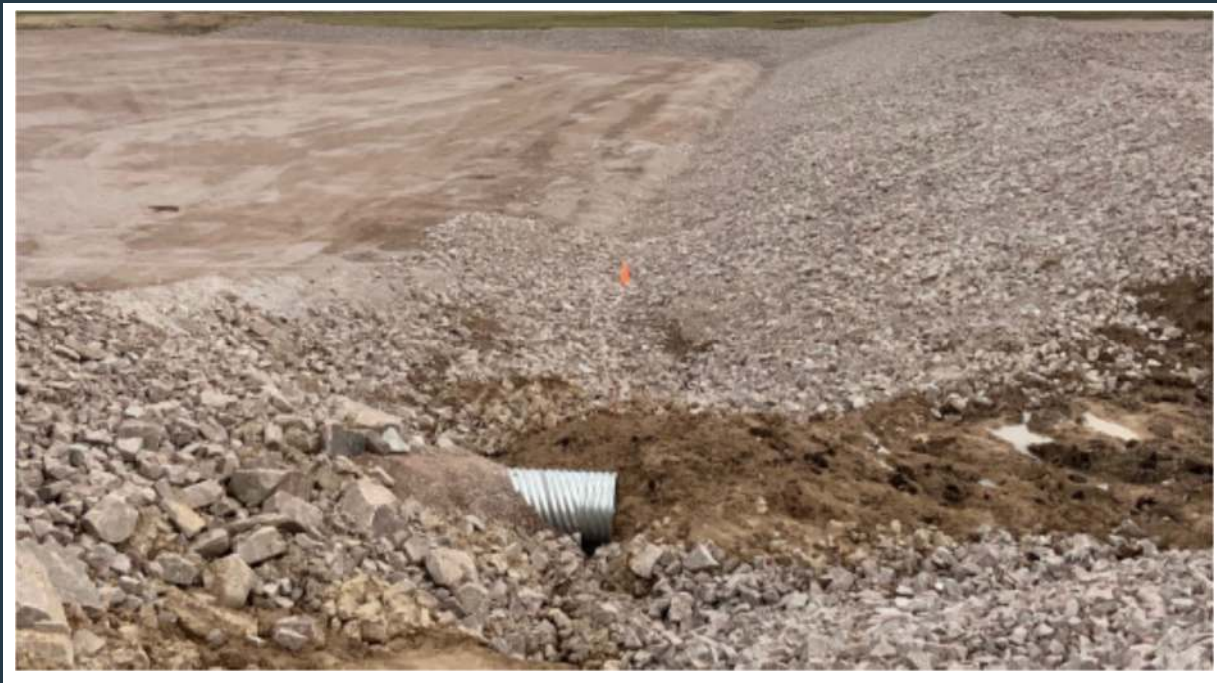
Figure 85: View of the P-SC surface water collection ditch and culvert (still under construction).

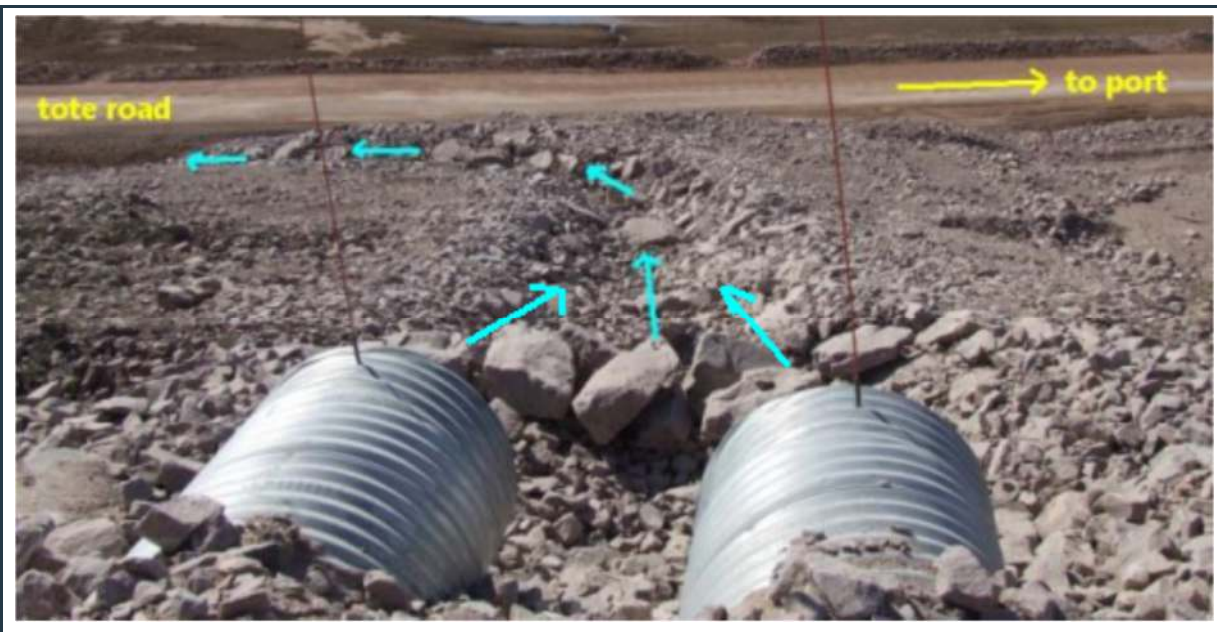
Figure 86: Culverts and drainage ditch, conveying surface water from the P-SWD-6 "Q01 South" ditch toward the tote road.

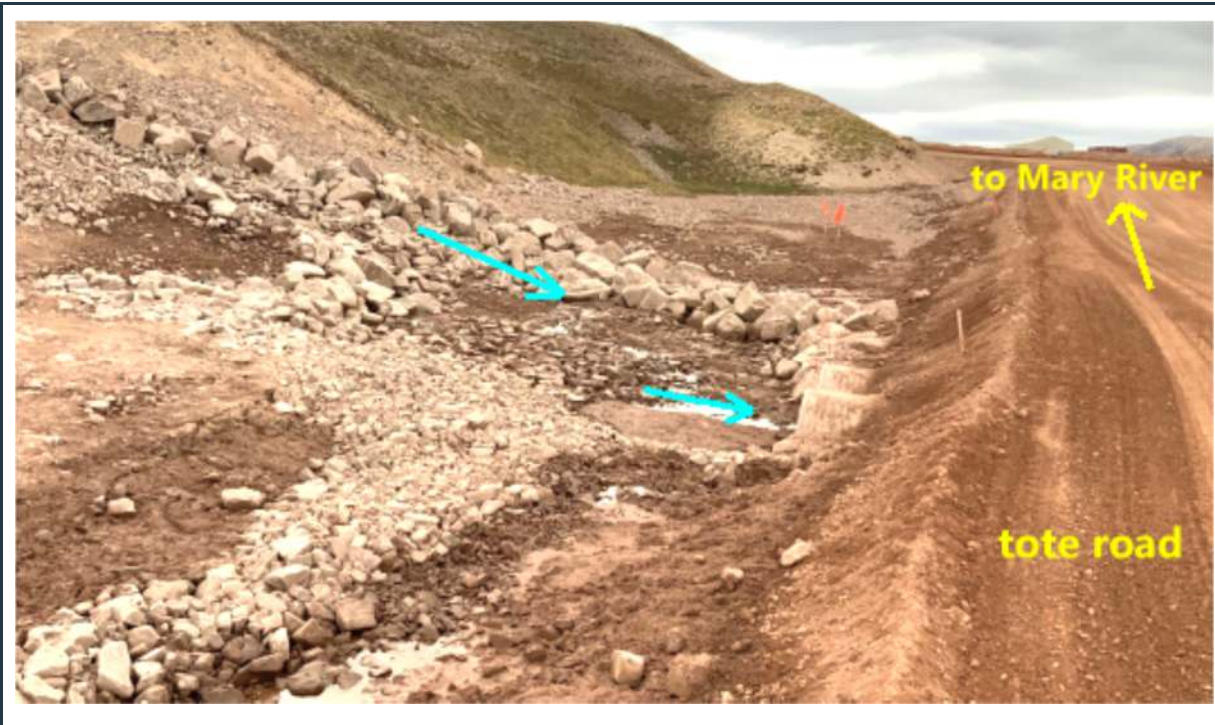
Figure 87: View of twin culverts, draining surface water under the tote road (inlet).

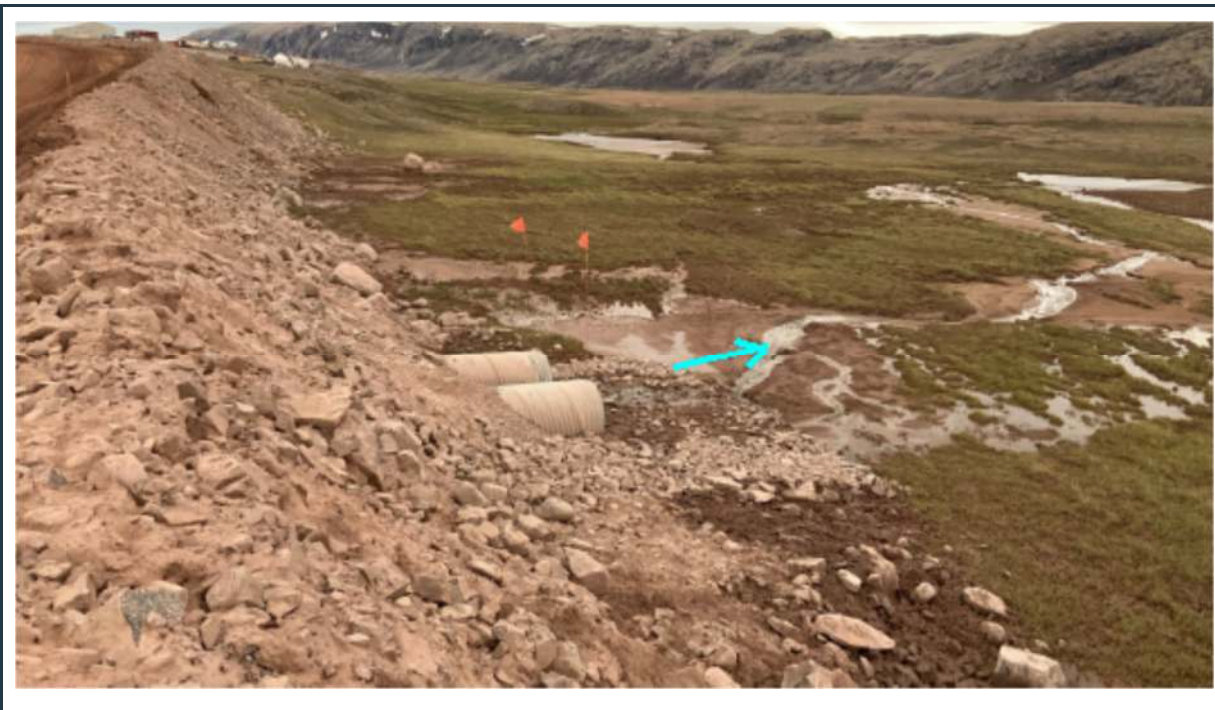
Figure 88: View of twin culverts, draining surface water under the tote road (outlet).
