Baffinland Iron Mines Corporation

Project #: TC190307

Annual Geotechnical Inspections – 2020 Report 1.

APPENDIX "C" – Tote/Haul Road - Photographs

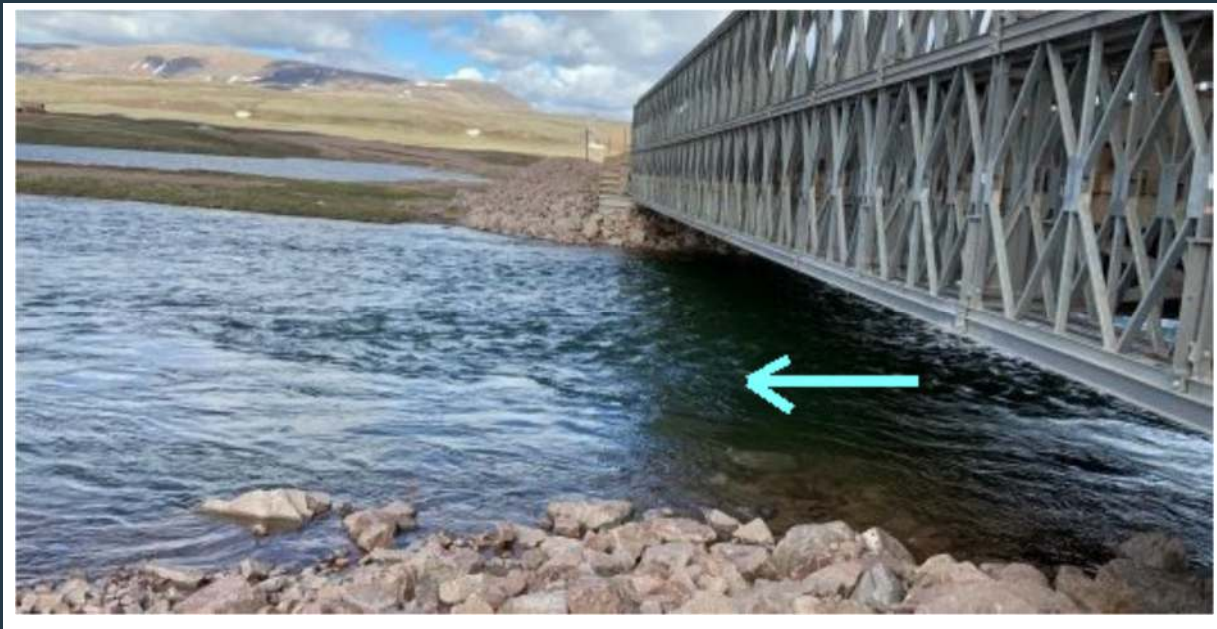
a) Bridge 17 (located approximately 17 km from Milne Inlet port)

Figure 89: View of “bridge 17”, looking north-east. Note the rip-rap scour protection.

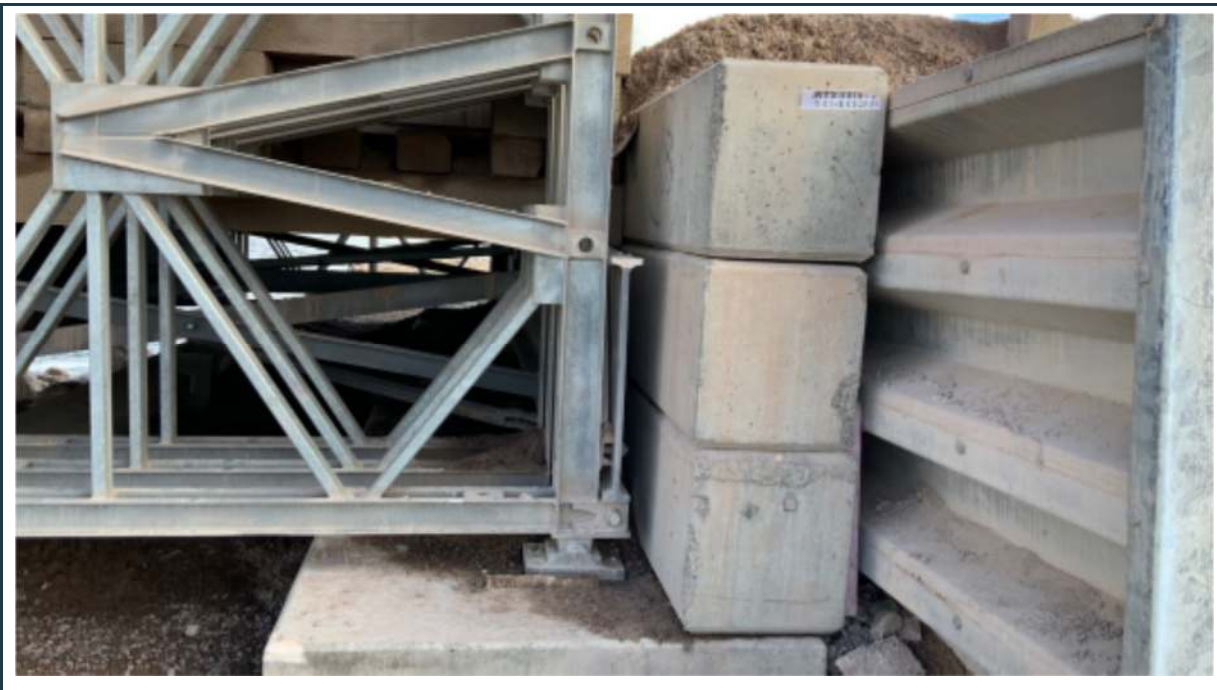
Figure 90: Foundation and abutment conditions at the south-west abutment of bridge 17.

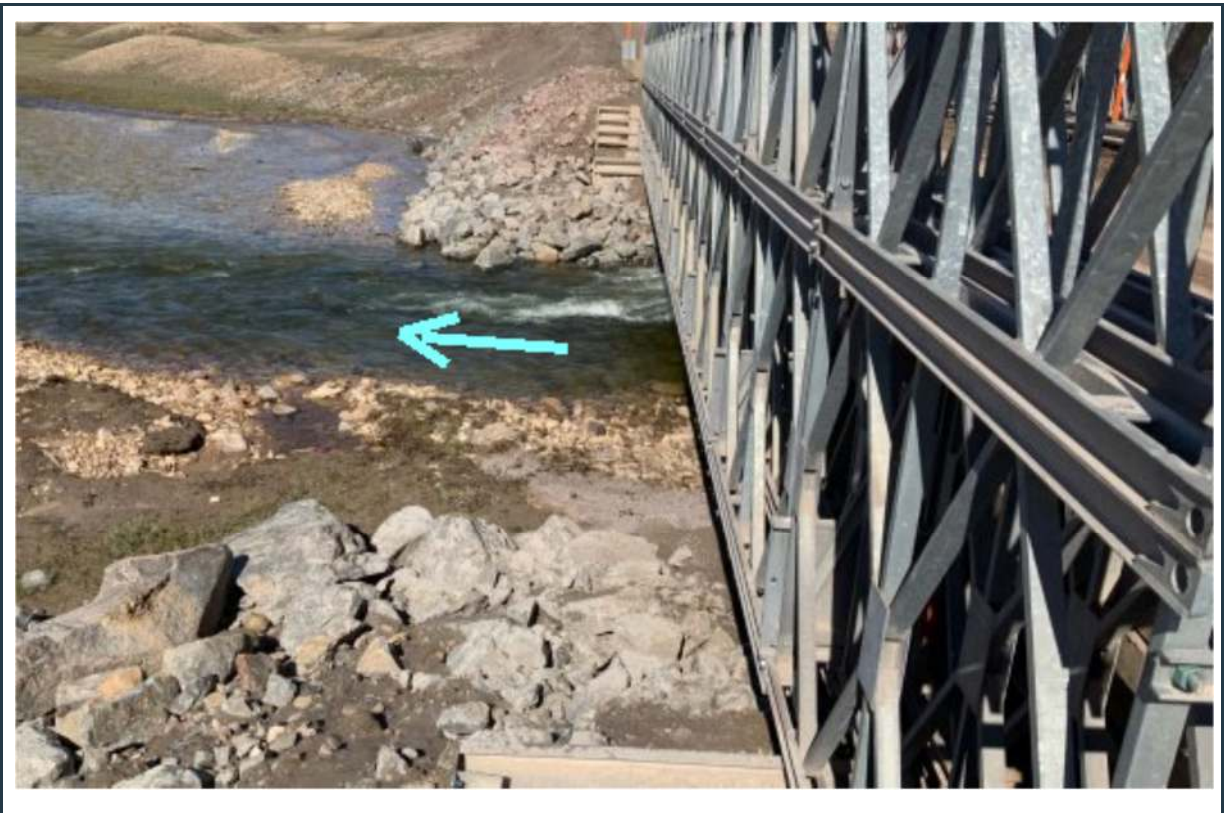
b) Bridge 63 (located approximately 63 km from Milne Inlet port)

Figure 91: View of bridge 63, looking north.

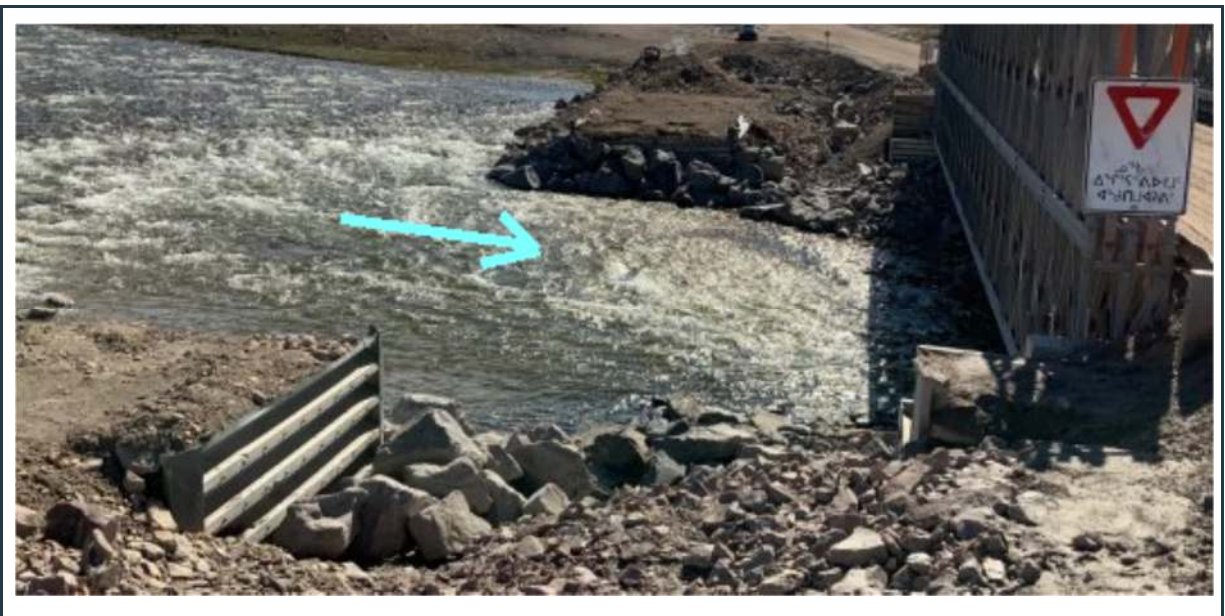
Figure 92: View of the "old" abutments at bridge 63.

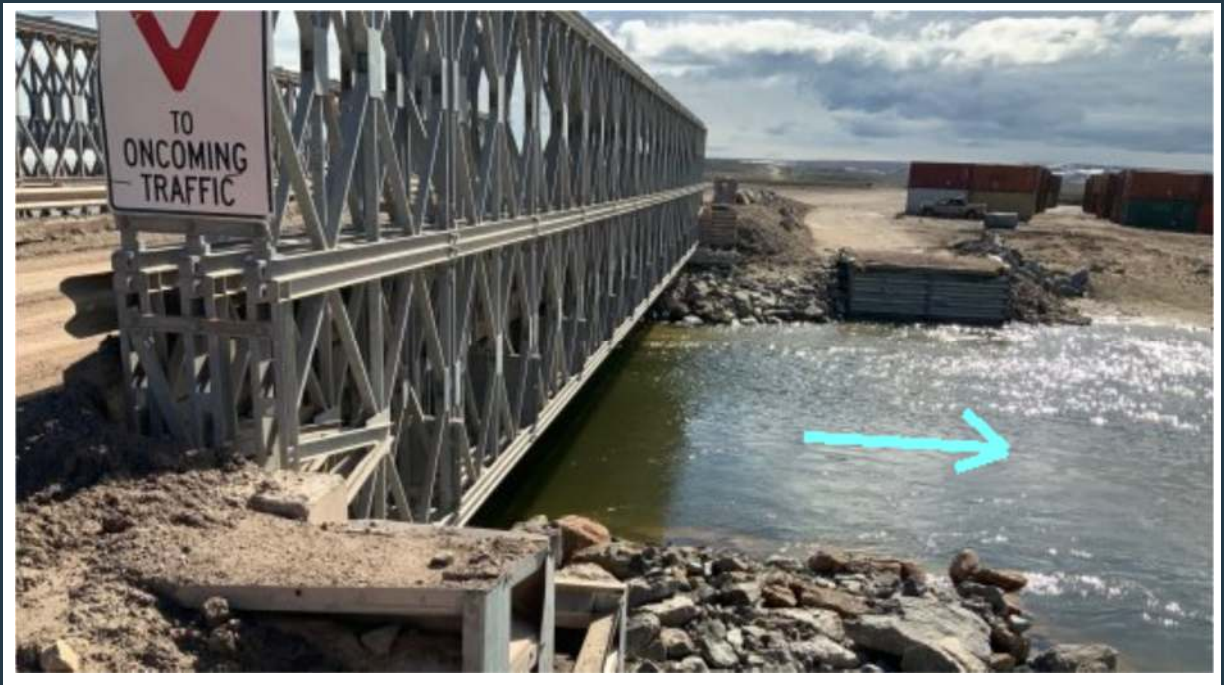
c) Bridge 80 (located approximately 80 km from Milne Inlet port)

Figure 93: View of bridge 80 with one of the old abutments, looking south.

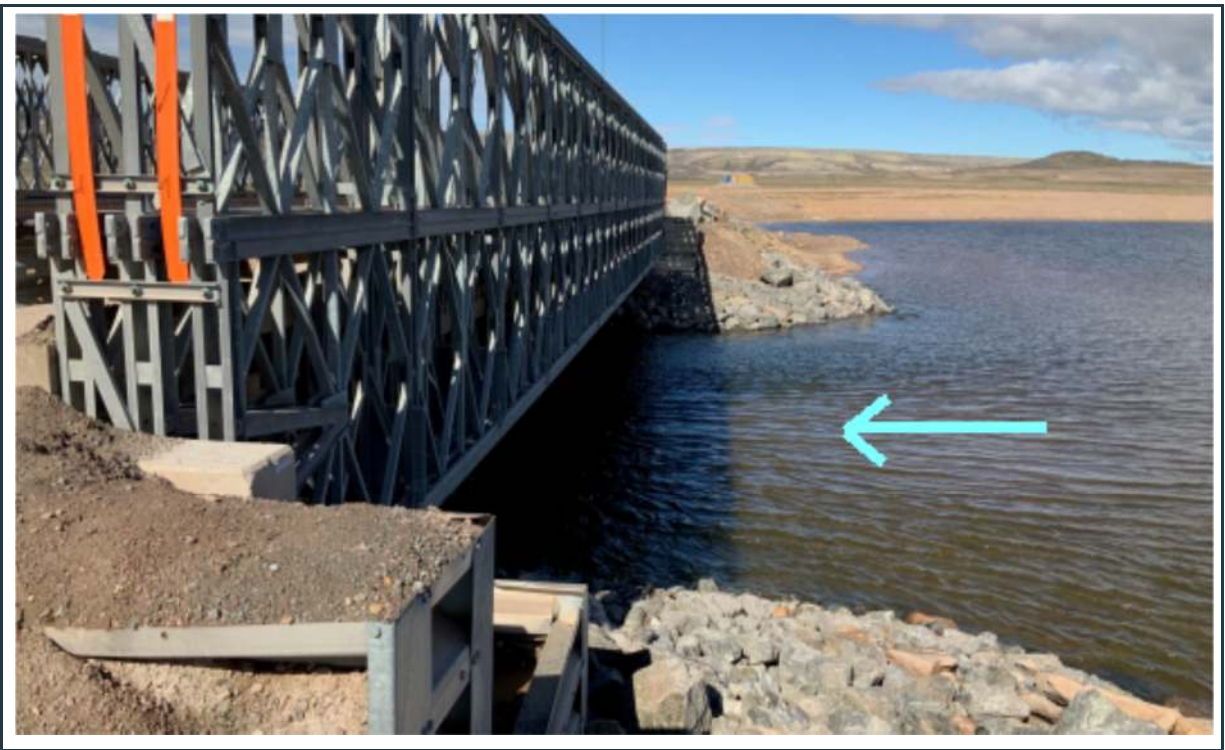
Figure 94: View of bridge 80, looking north.

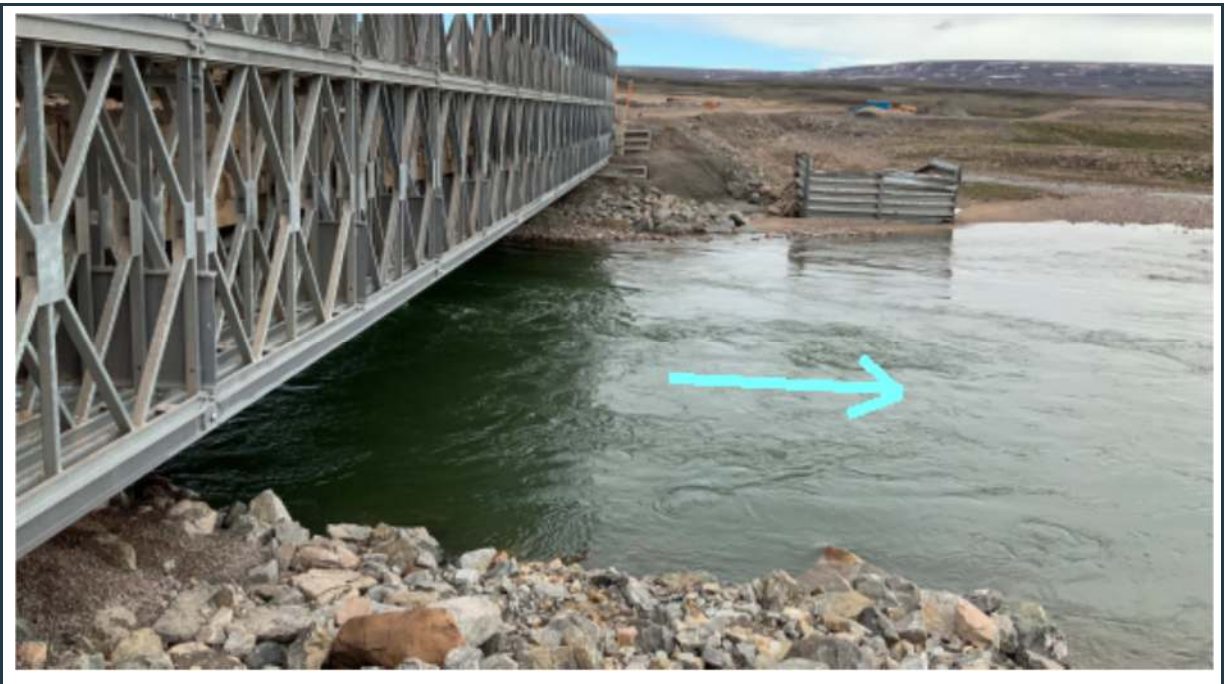
d) Bridge 97 (located approximately 97 km from Milne Inlet port)

Figure 95: View of bridge 97, looking south (one of the old abutments in the background).

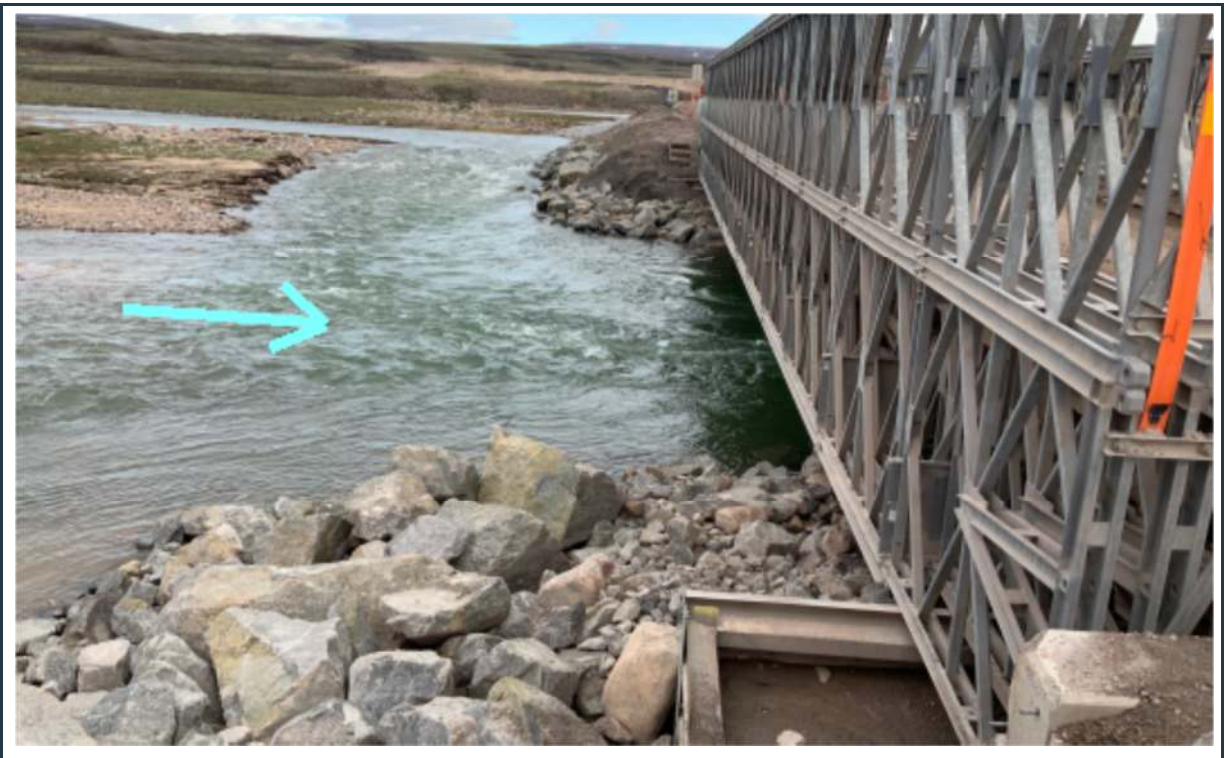
Figure 96: View of two abutments at the east side of bridge 97.

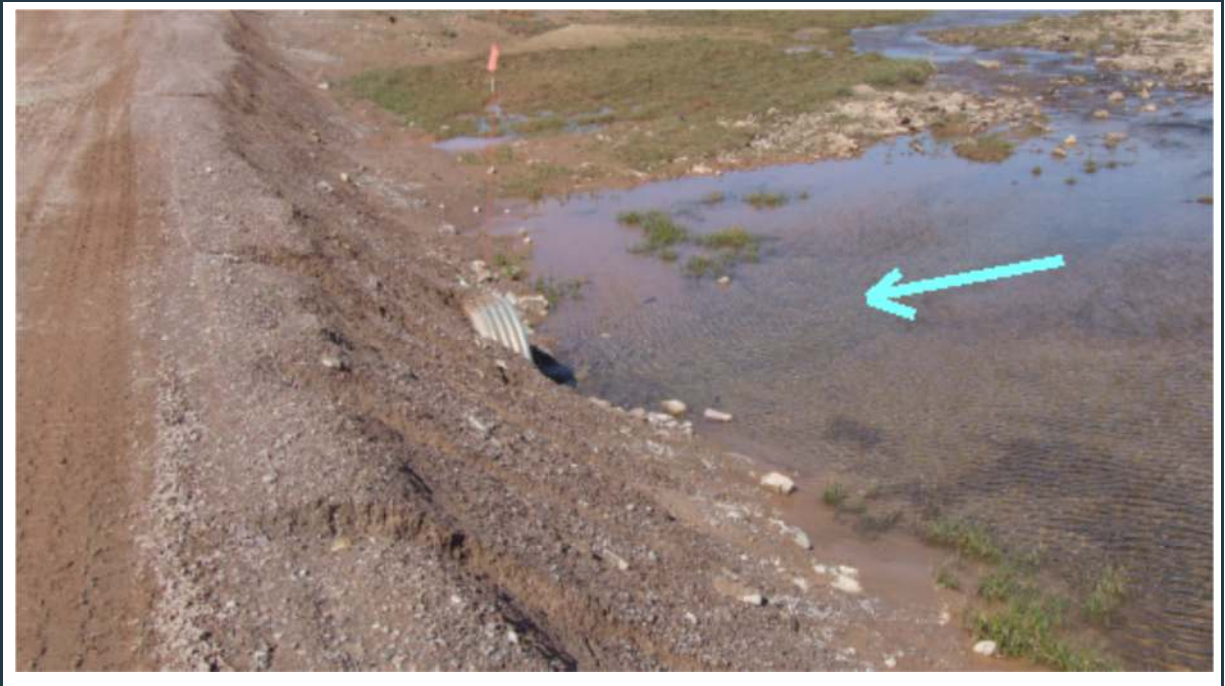
a) CV-076

Figure 97: View of culvert 076 (inlet).

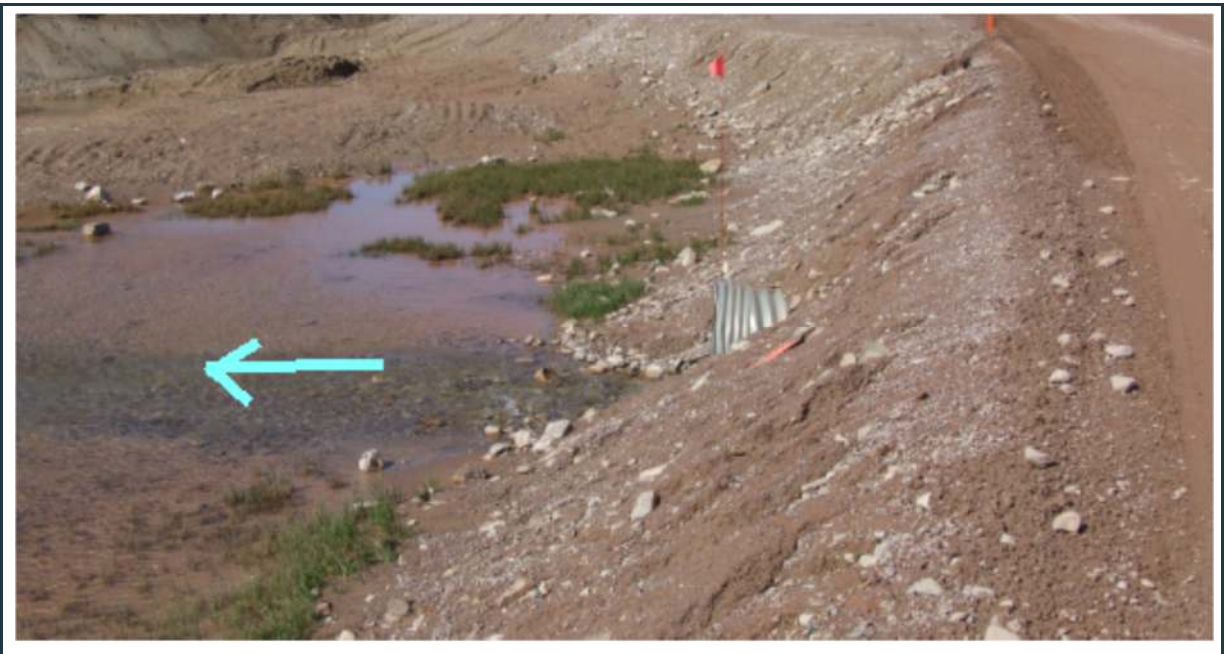
Figure 98: View of culvert 076 (outlet).

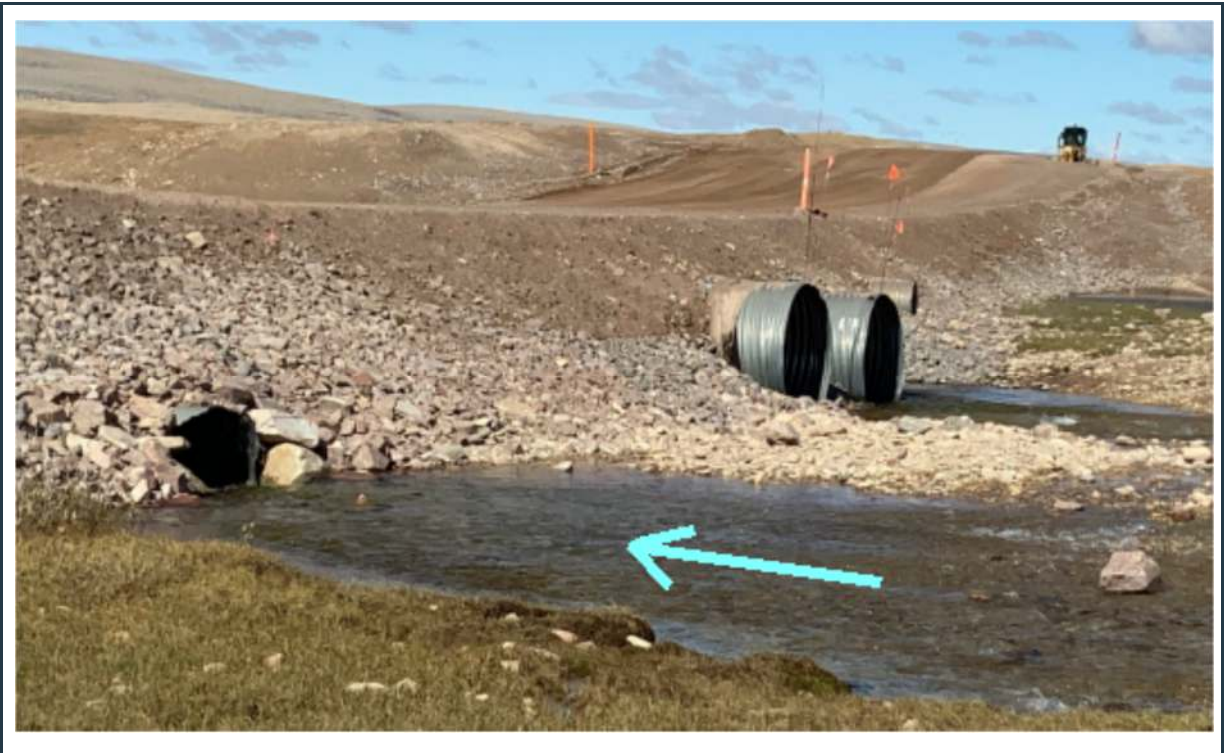
b) CV-078

Figure 99: View of culvert(s) 078 (inlet).

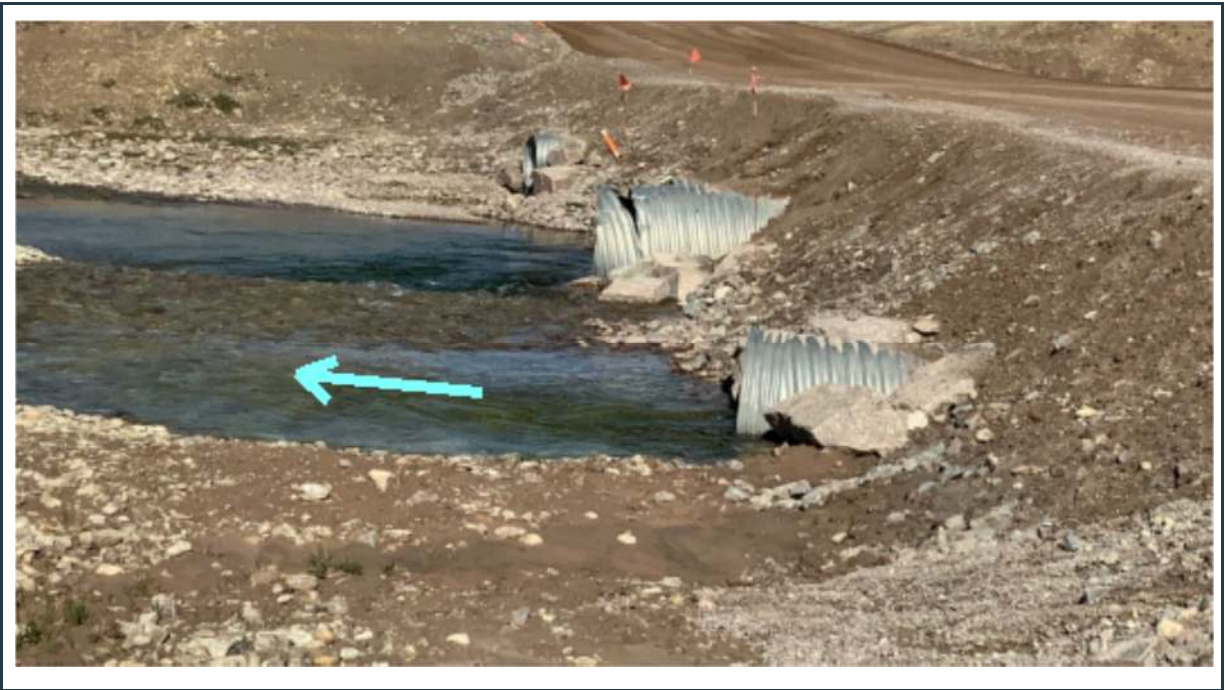
Figure 100: View of culvert(s) 078 (outlet). Minor damage visible on one pipe.

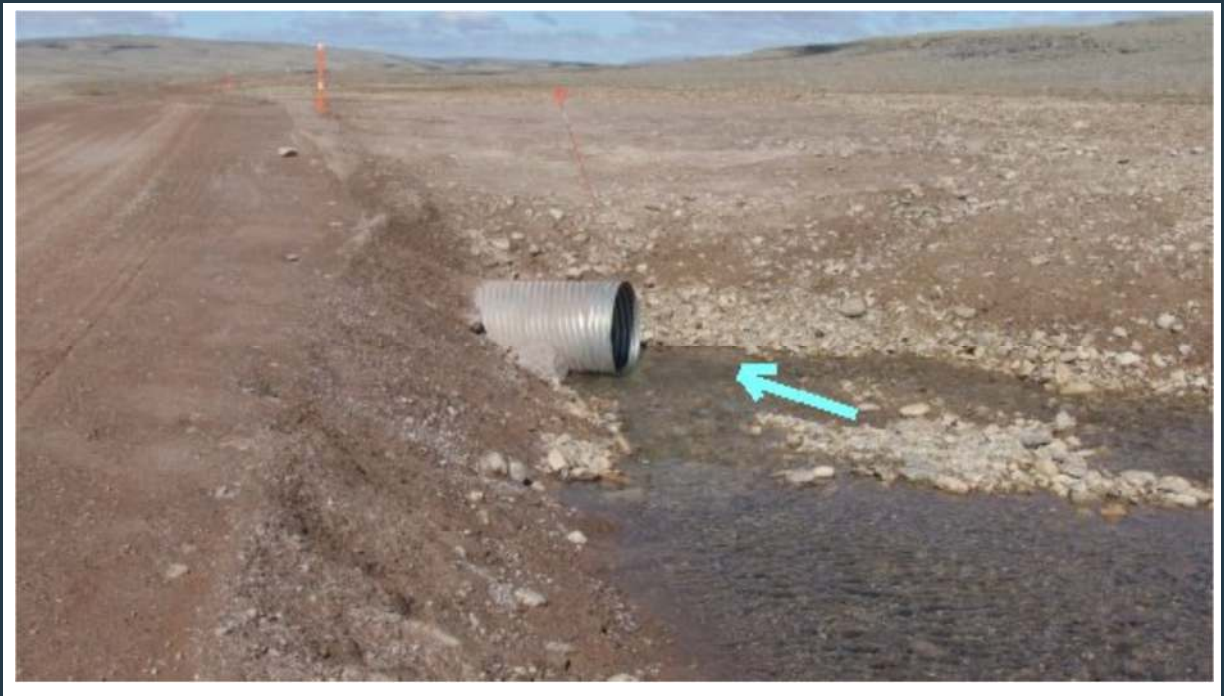
c) CV-083

Figure 101: View of culvert 083 (inlet)

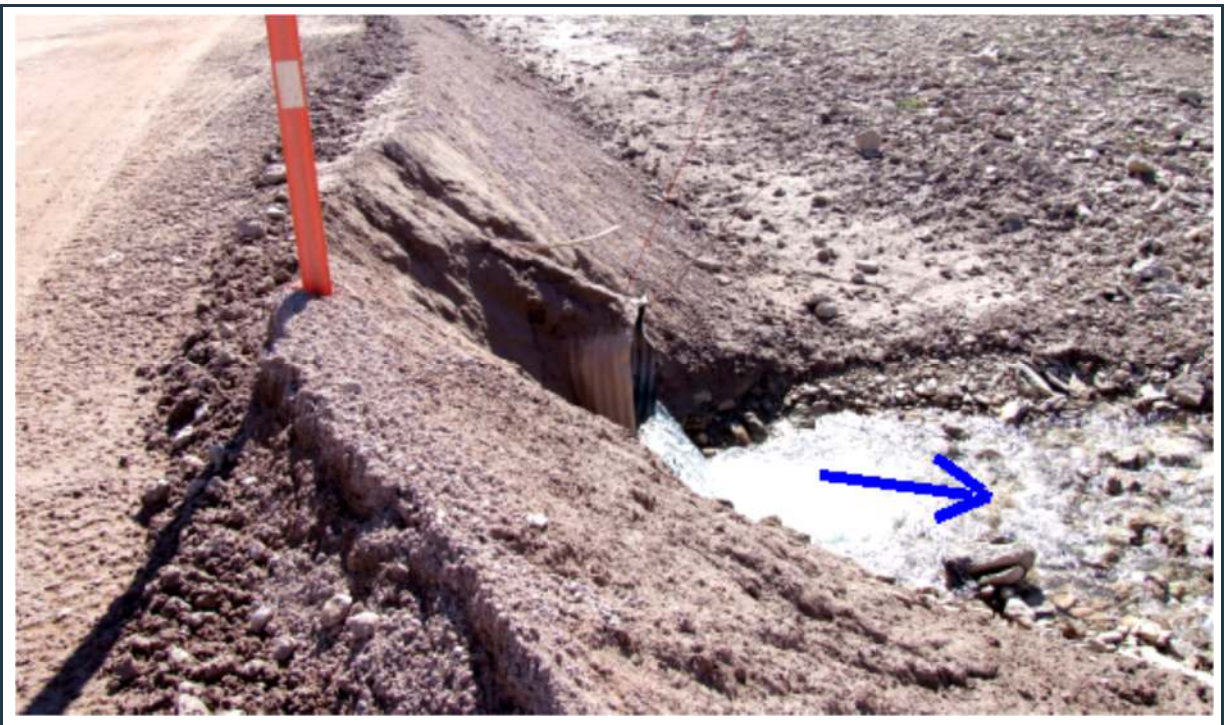
Figure 102: View of culvert 083 (outlet), with some slope erosion around the culvert.

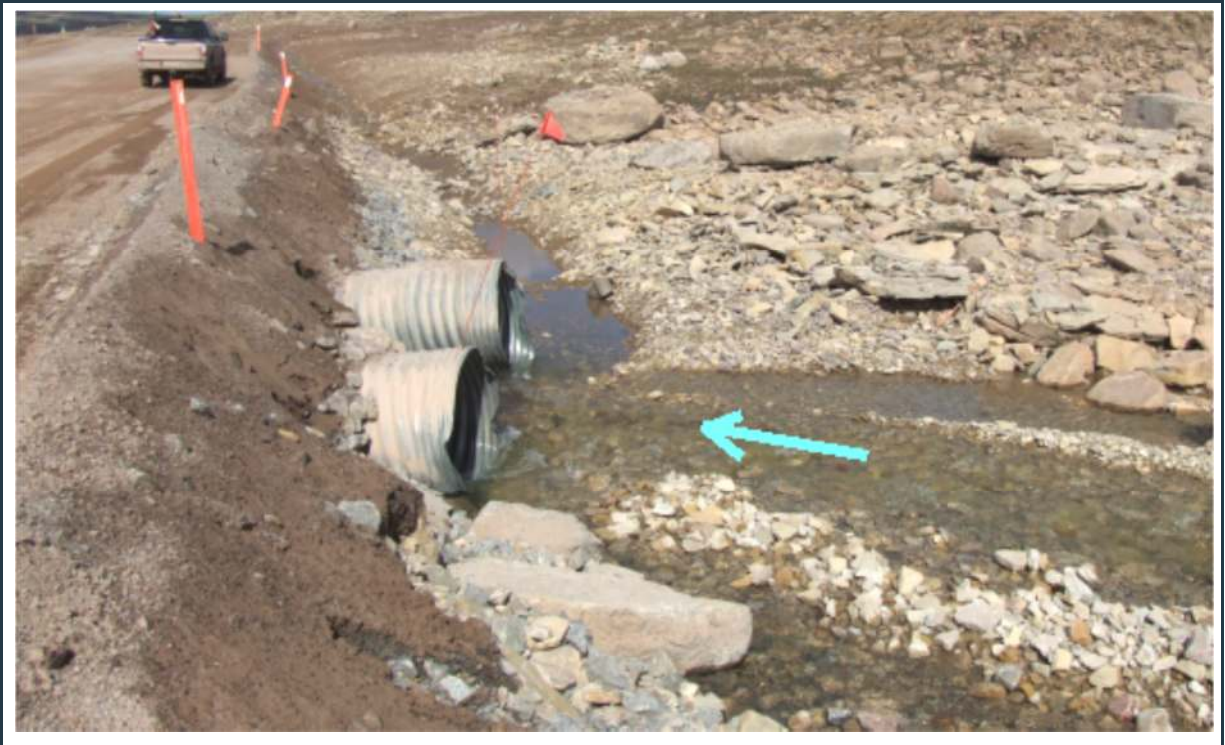
d) CV-094

Figure 103: View of culvert(s) 094 (inlet) in good condition.

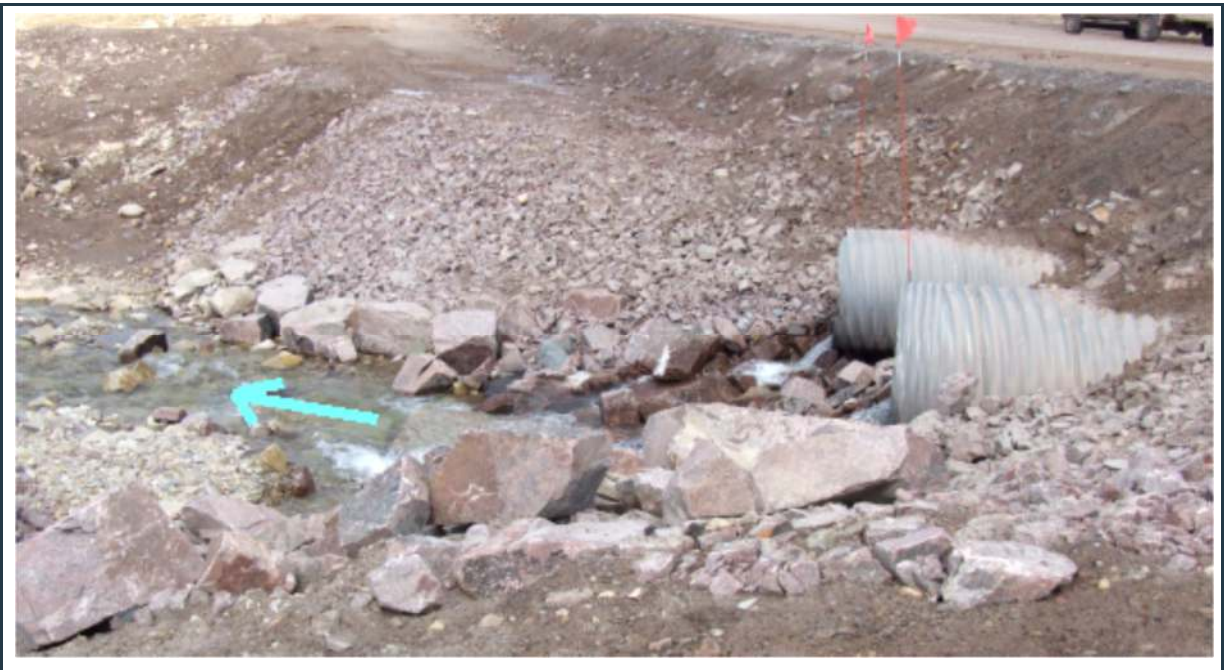
Figure 104: View of culvert(s) 094 (outlet) in good condition.

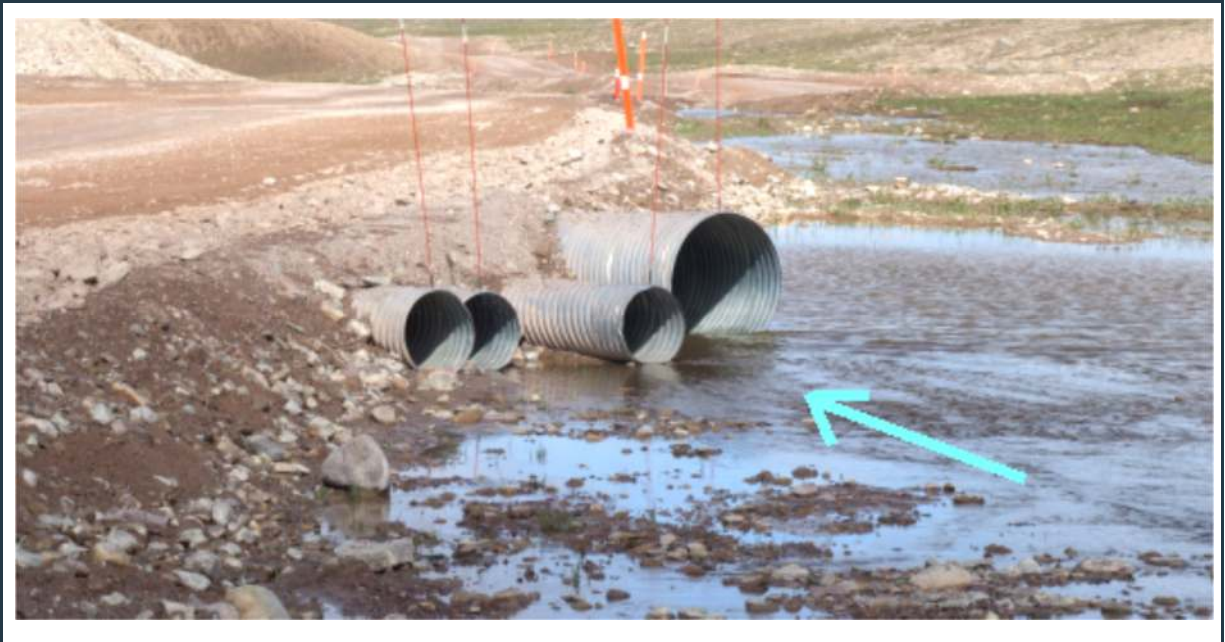
e) CV-102

Figure 105: View of culvert(s) 102 (inlet) in good conditions.

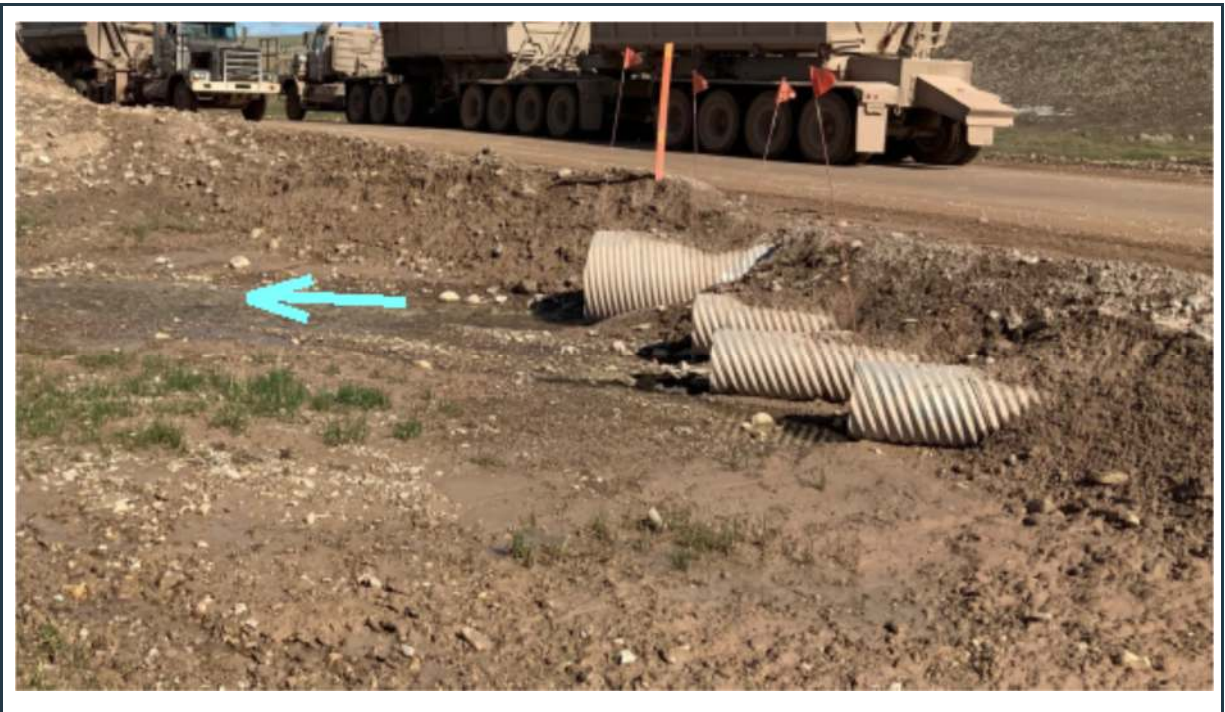
Figure 106: View of culvert(s) 102 (outlet) in good conditions.

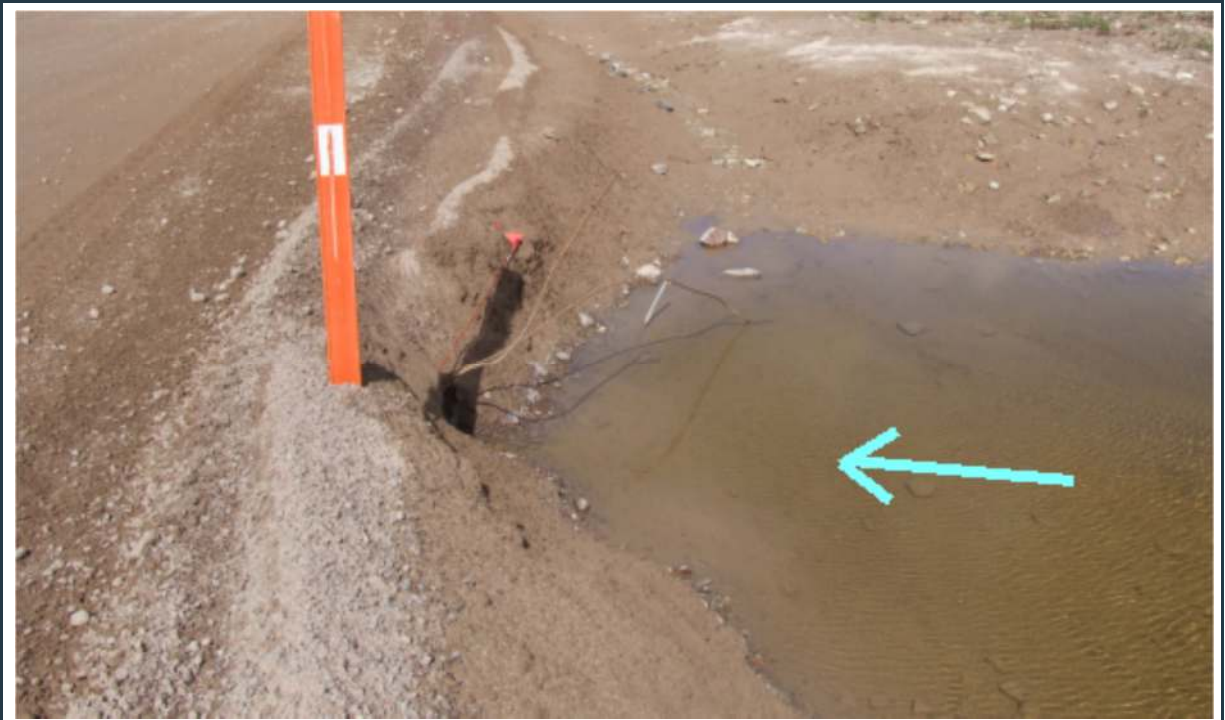
f) CV-107

Figure 107: View of culvert 107 (inlet). Extension of the culvert and placement of riprap are required.

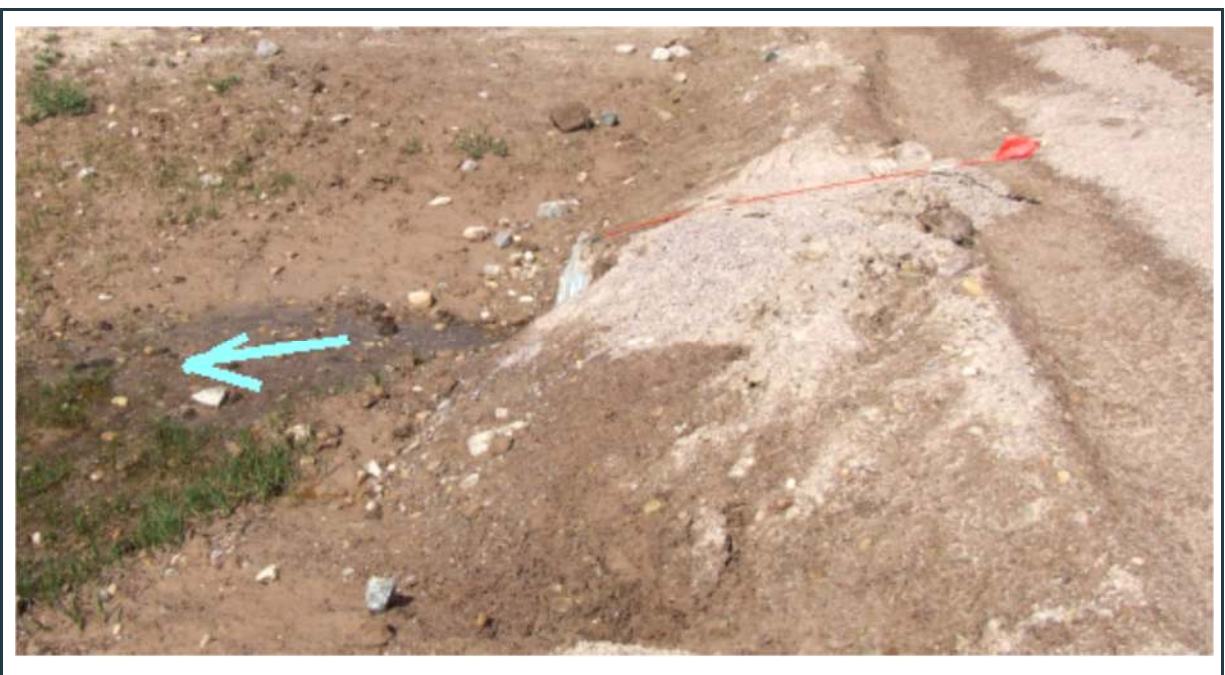
Figure 108: View of culvert 107 (outlet).

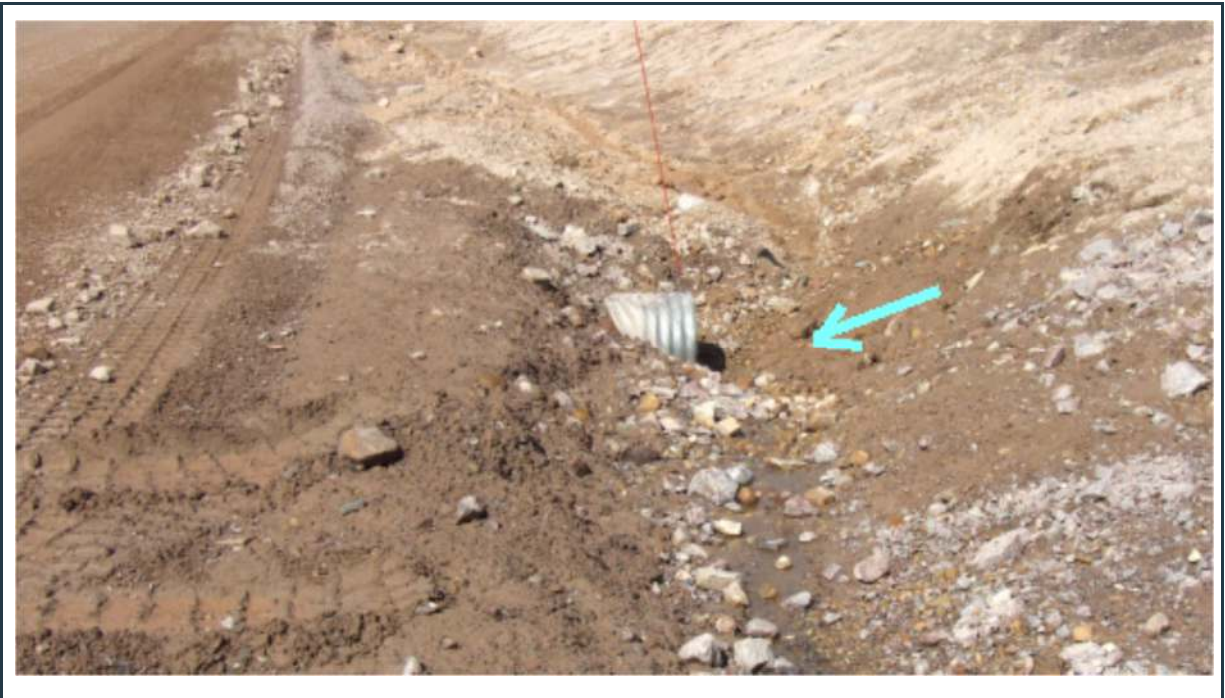
g) CV-110A

Figure 109: View of culvert 110A (inlet).

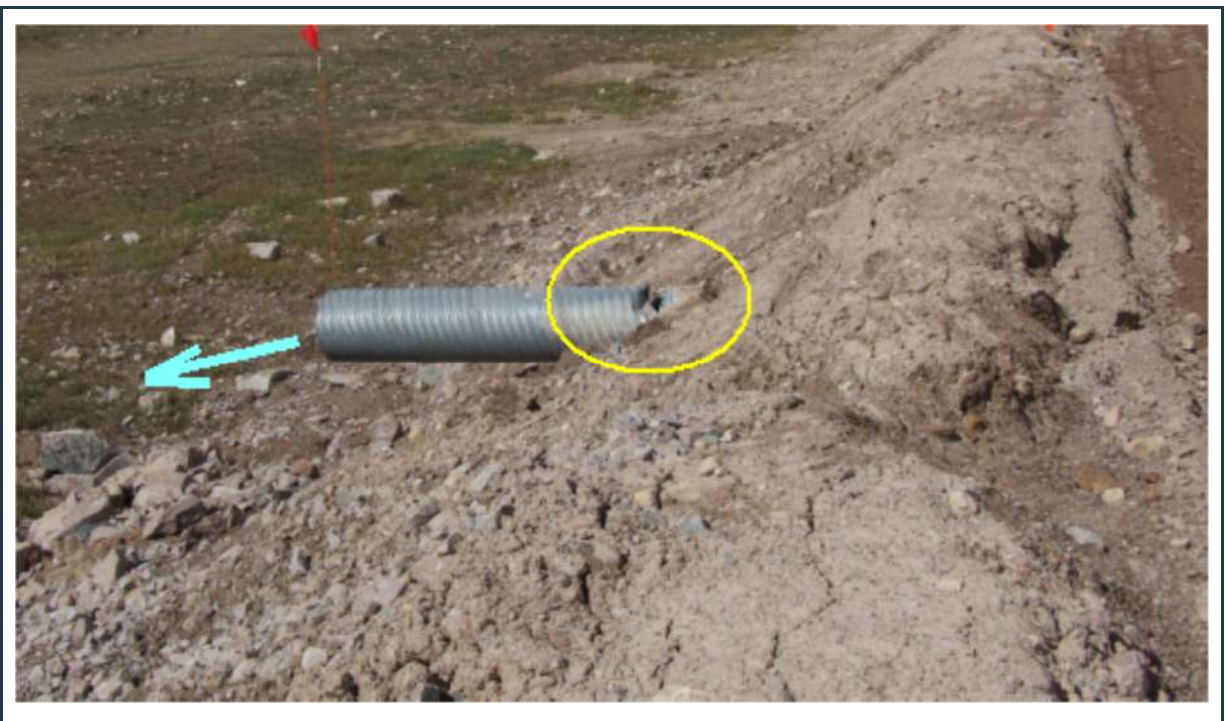
Figure 110: View of culvert 110A (outlet) with minor damage on the top of the pipe (yellow circle).

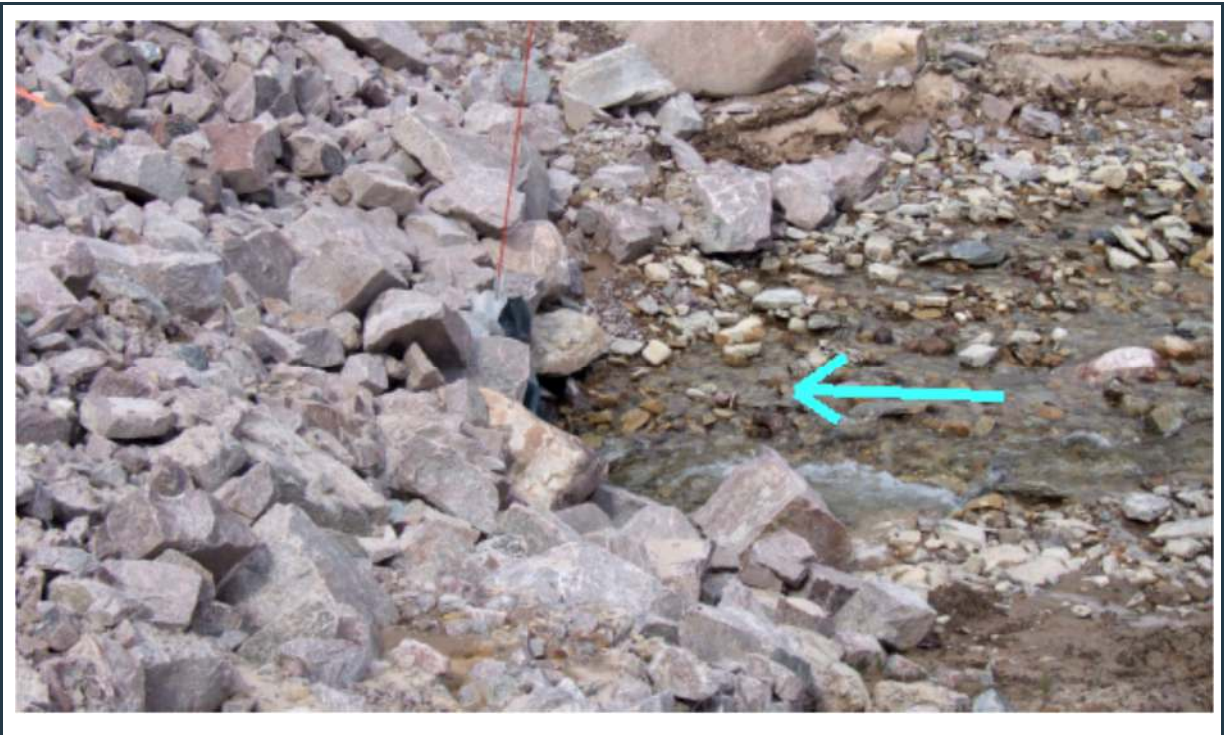
h) CV-111

Figure 111: View of culvert 111 (inlet).

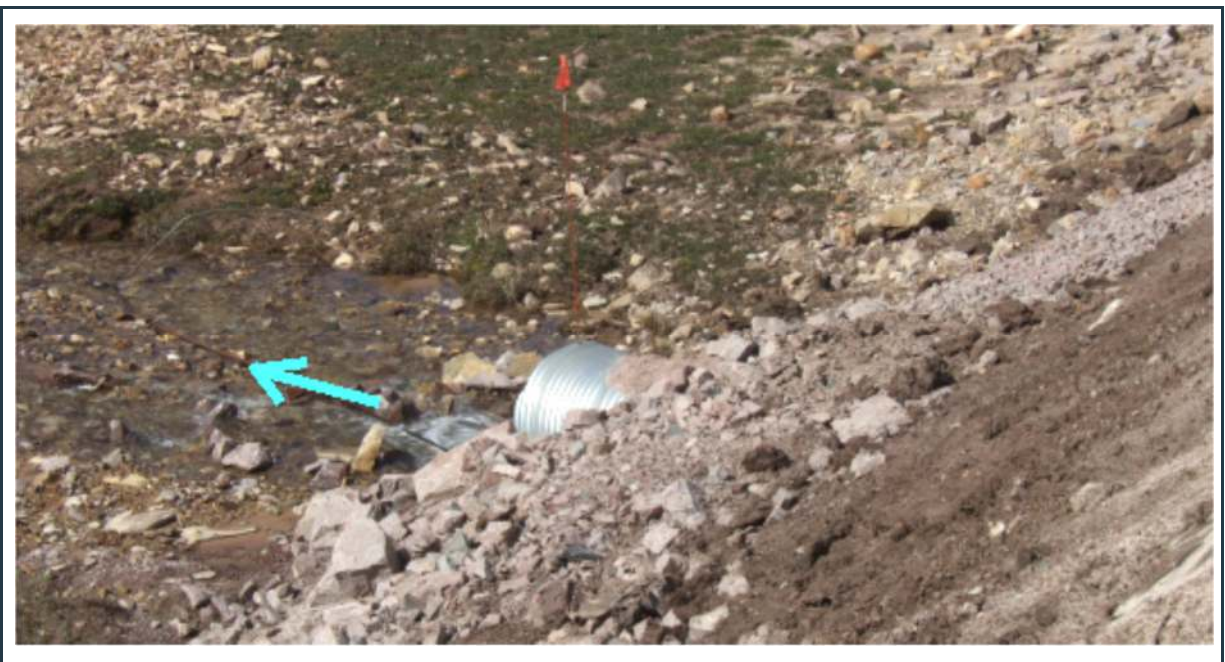
Figure 112: View of culvert 111 (outlet).

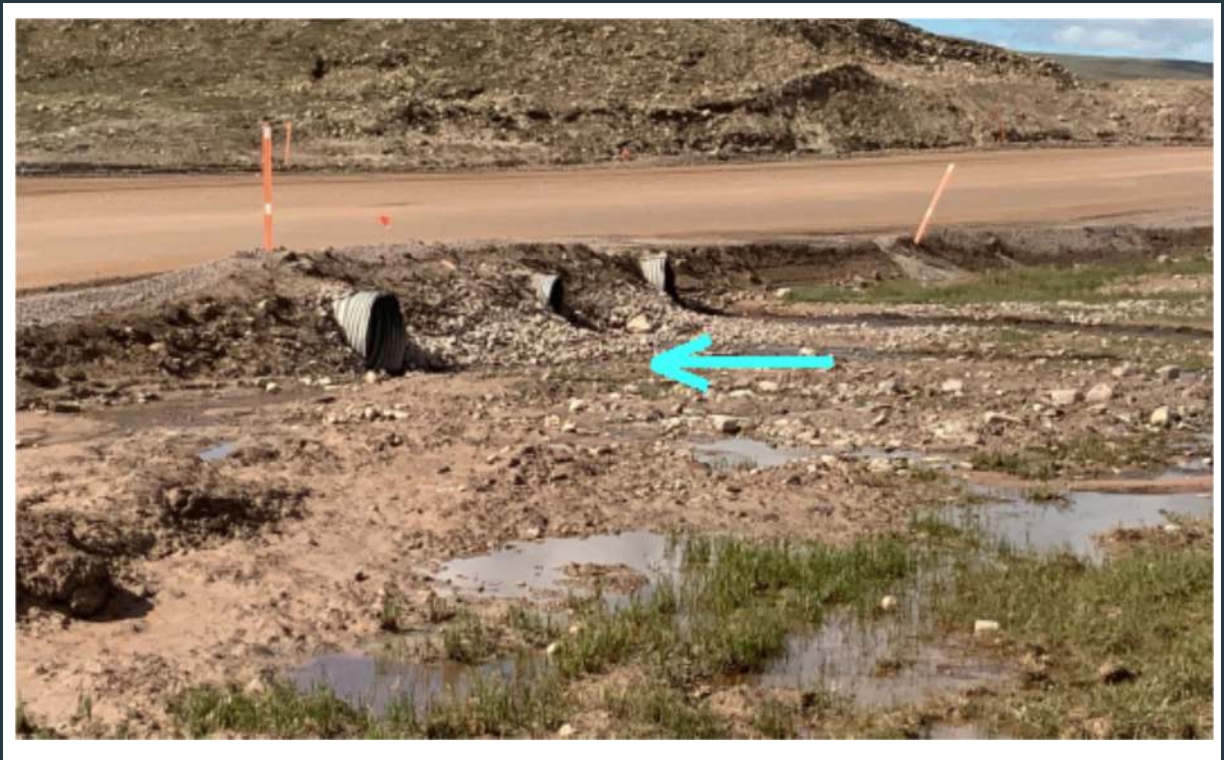
i) CV-112D

Figure 113: View of culvert(s) 112D (inlet).

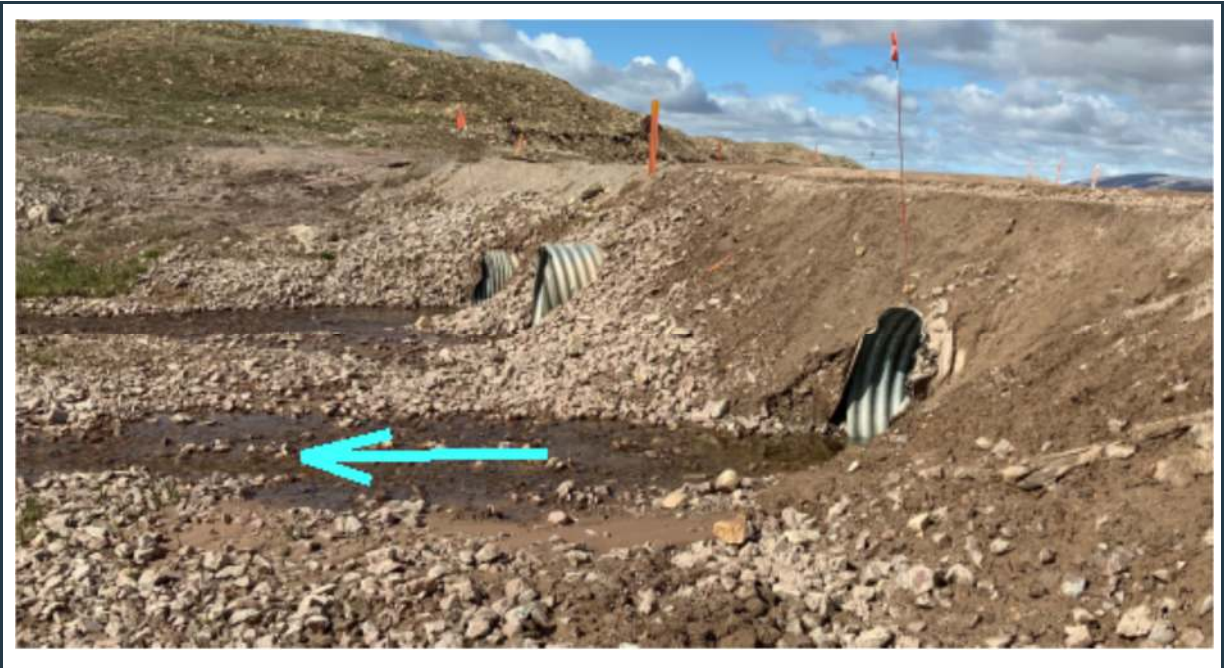
Figure 114: View of culvert(s) 112D (outlet).
