Baffinland Iron Mines Corporation

Project #: TC190307

Annual Geotechnical Inspections – 2020 Report 1.

APPENDIX "C" – Tote/Haul Road - Photographs

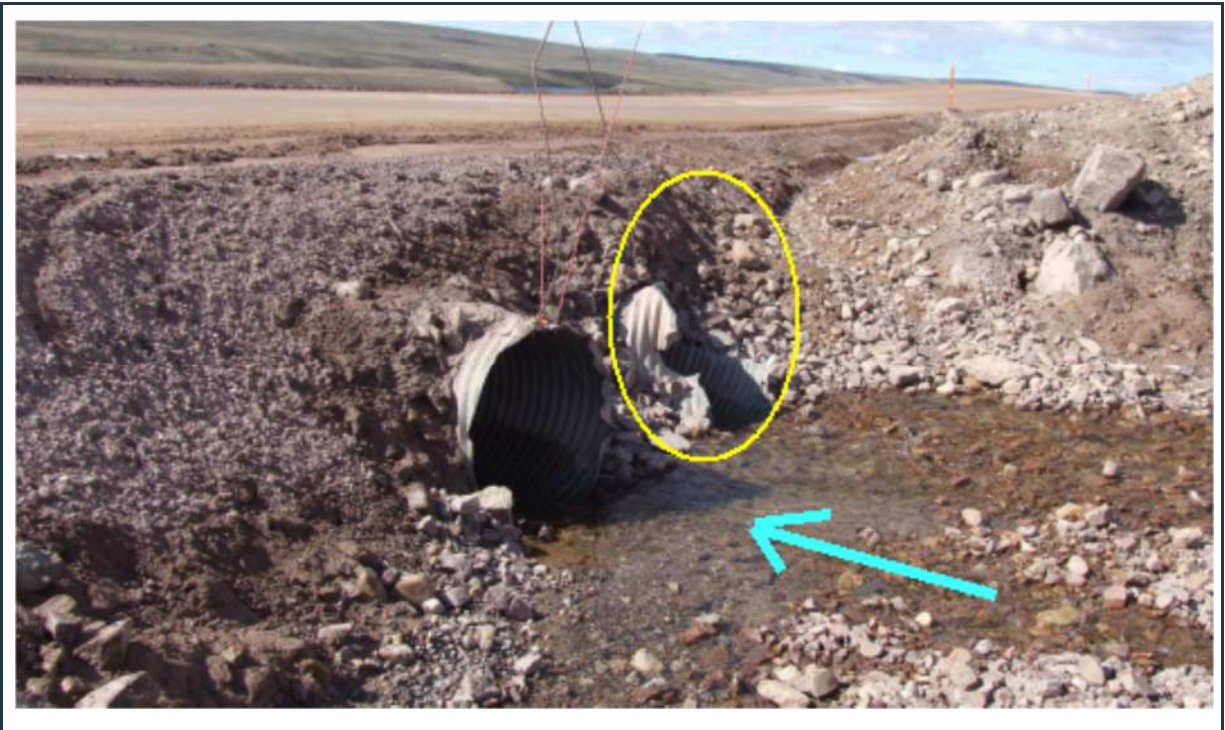
j) CV-114D

Figure 115: View of culvert(s) 114D inlet. Repair of the northern pipe is required (yellow circle).

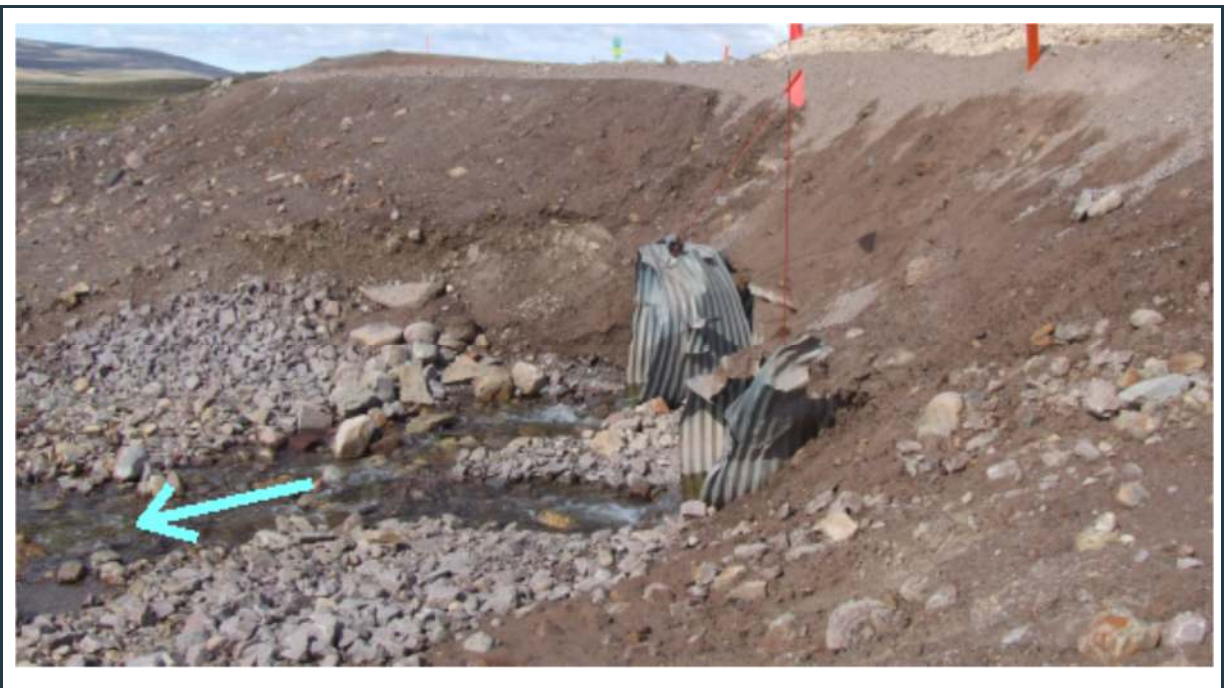
Figure 116: View of culvert(s) 114D (somewhat damaged outlet). Repair of both pipe ends required.

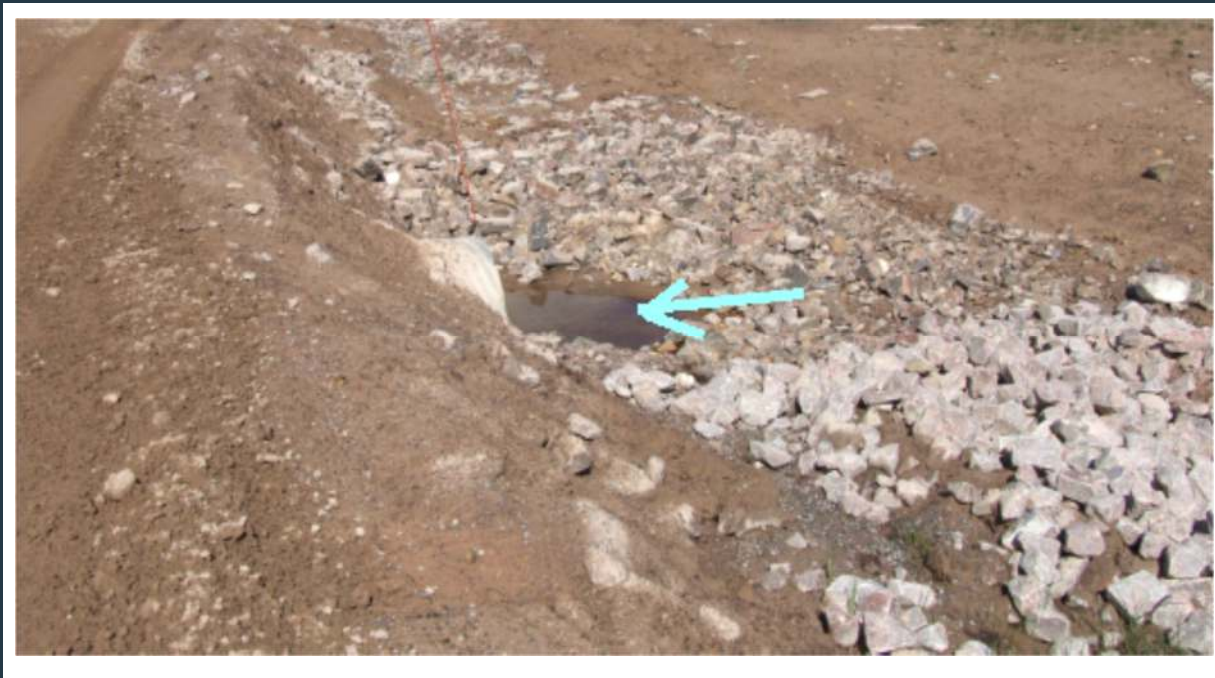
k) CV-202

Figure 117: View of culvert 202 (inlet).

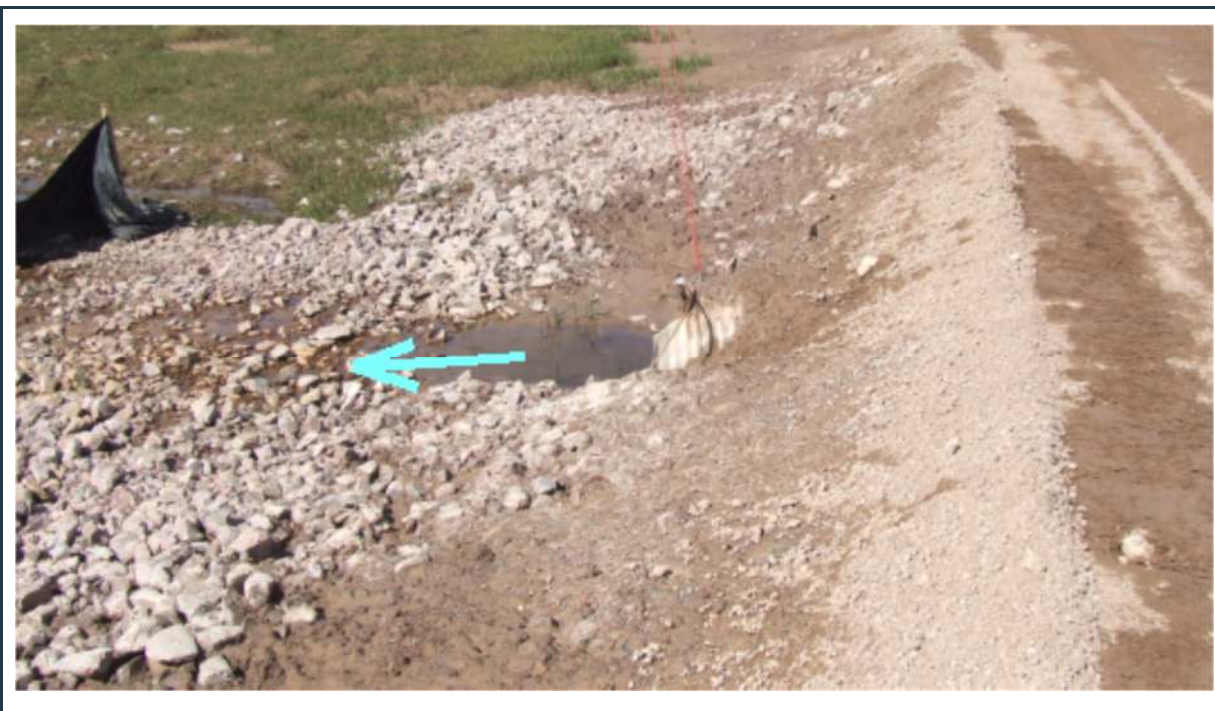
Figure 118: View of culvert 202 (outlet).

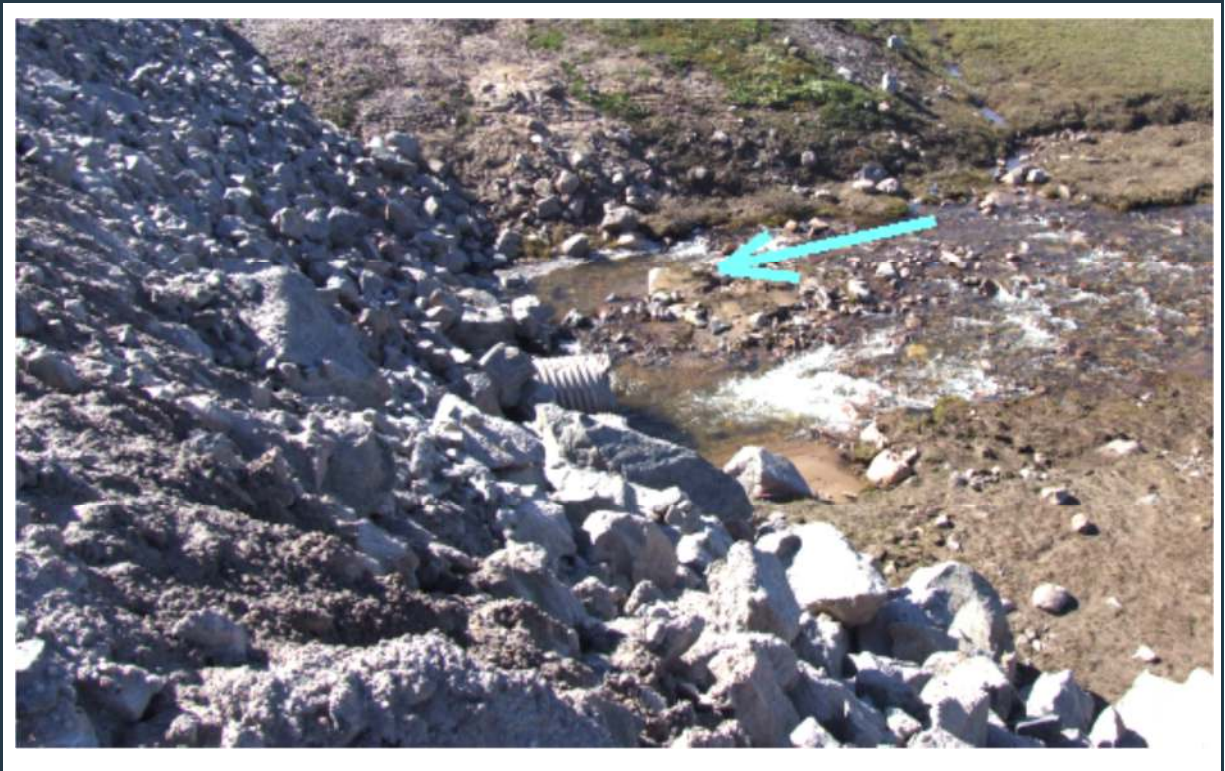
I) CV-225

Figure 119: View of culvert 225 (inlet).

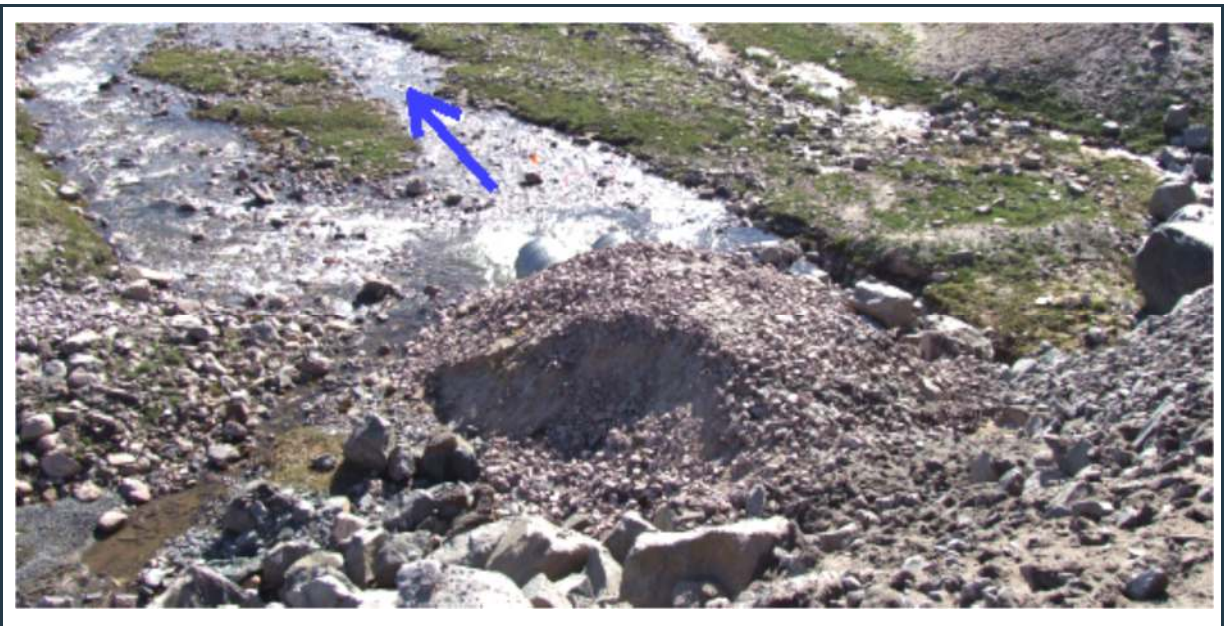
Figure 120: View of culvert 225 (outlet).
