Baffinland Iron Mines Corporation

Annual Geotechnical Inspections – 2020 Report 1. Mary River Iron Mine Complex – Nunavut

Re: Annual Site Inspections and Reporting - Mary River Iron Mine Complex, Nunavut

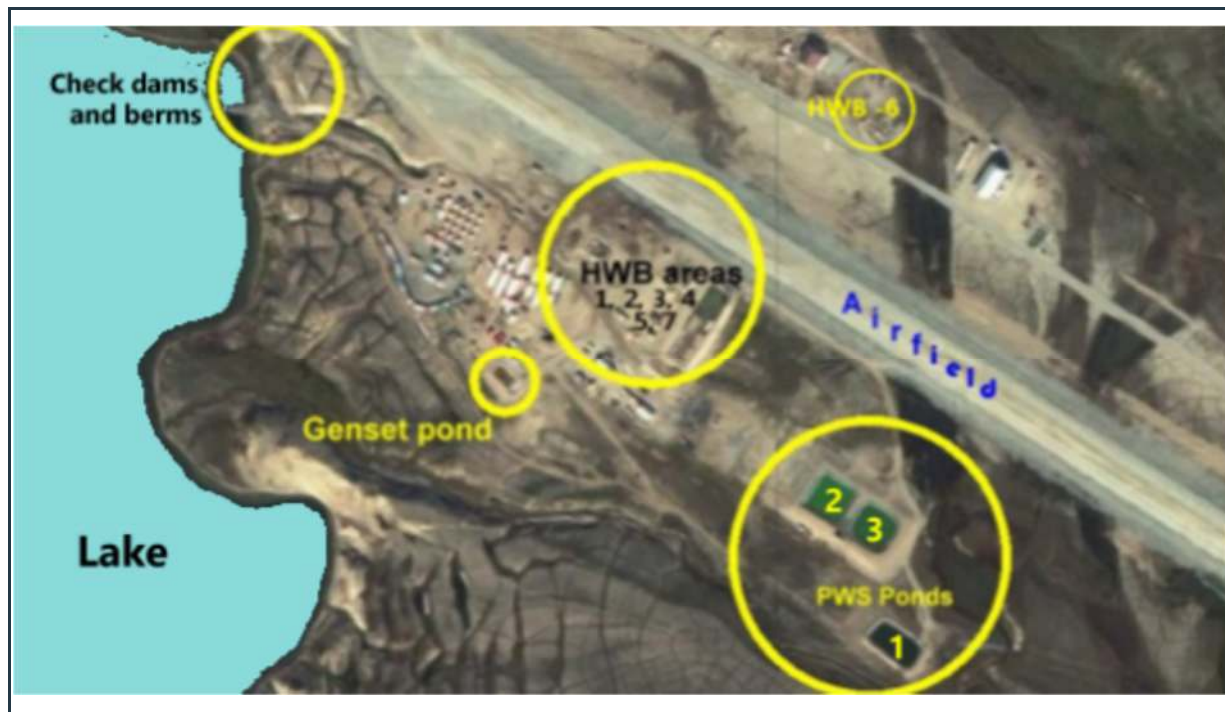
Figure 1: Site layout – Mary River Mine Site - Northern Zone, adjacent to the runway

There are seven hazardous waste berms at the Mary River mine site (HWB-1 to HWB-7). HWB-6 is located at the north side of the runway near the incinerator, as shown in Figure 1. The other six areas are located opposite of HWB-6, at the south side of the runway.

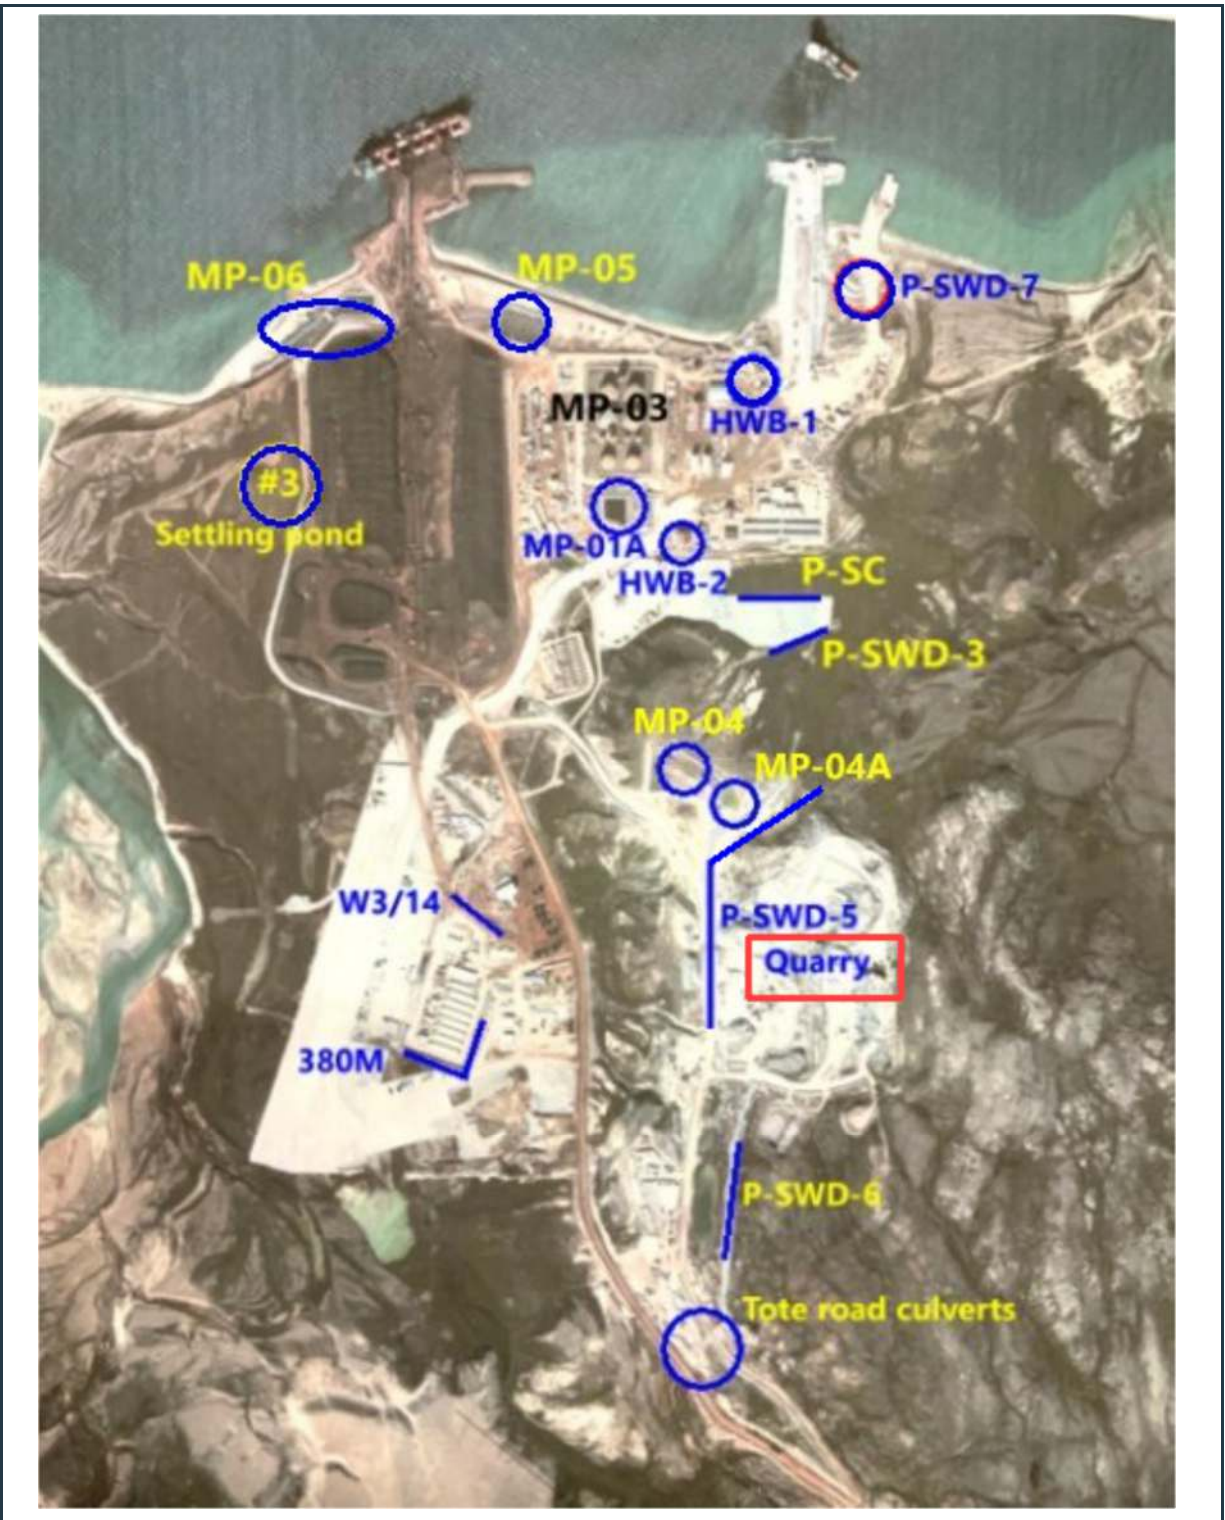
Figure 5: Site layout – Milne Inlet Port Site

Settling Pond #3 was recently constructed west of the ore storage area, as shown in Figure 5. The pond is surrounded along three sides with a stable, lined berm and contains two sumps, as shown in Figures 73 and 74. The geomembrane and protective geotextile on the internal slope of the berm extend 2.5 m below the surface and anchored into the permafrost zone to prevent any seepage from the pond into the ground below. Excess water from pond #3 is pumped into the nearby, large capacity MP-06 settling pond.
