## **RE: Submission of 2021 Geotechnical Inspection Report No. 1 (June 2021)**

August 23, 2021,  
Project #: TC190307.2021

### Annual Geotechnical Inspections – 2021 Report 1. Mary River Project – Nunavut

### Annual Geotechnical Inspections – 2021 Report 1. APPENDIX "A" - Mary River Mine Complex - Photographs

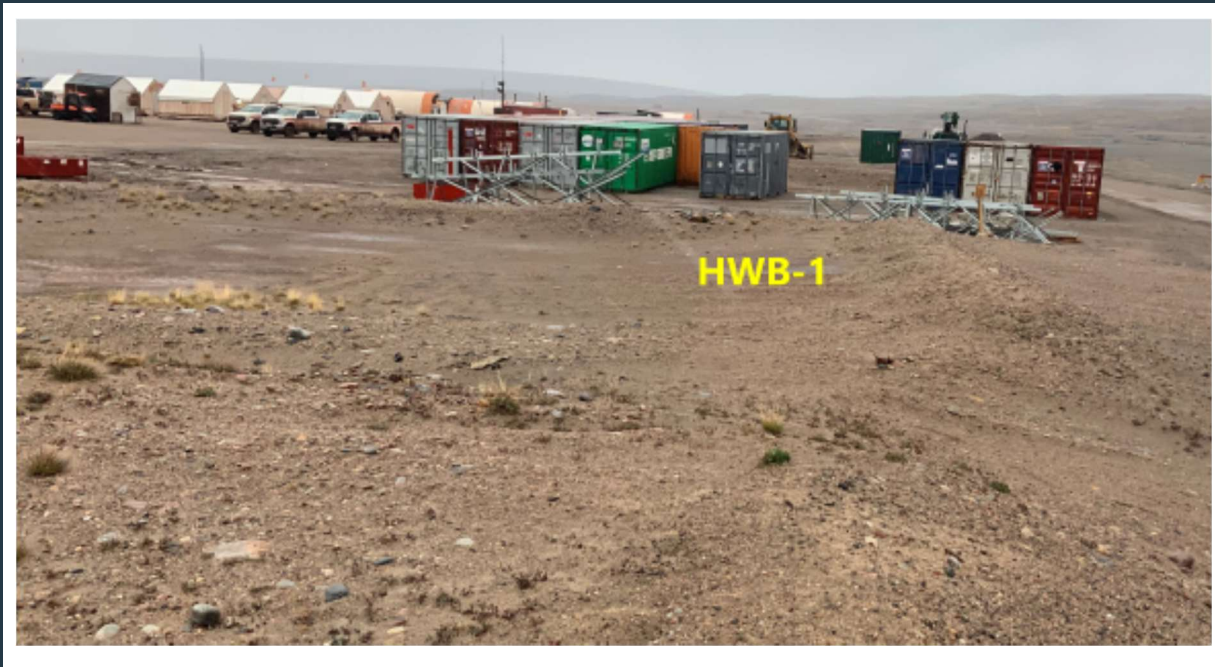
Figure 13: View of HWB-1 – Currently this cell is empty.

It may be advisable to remove the old liner from this cell and replace it with a new one and take advantage of the renewed storage capacity in the future.

Baffinland Action: Baffinland will remove the old liner from this cell and replace it with a new one should use of this HWB be required in the future, prior to storing material in the cell.

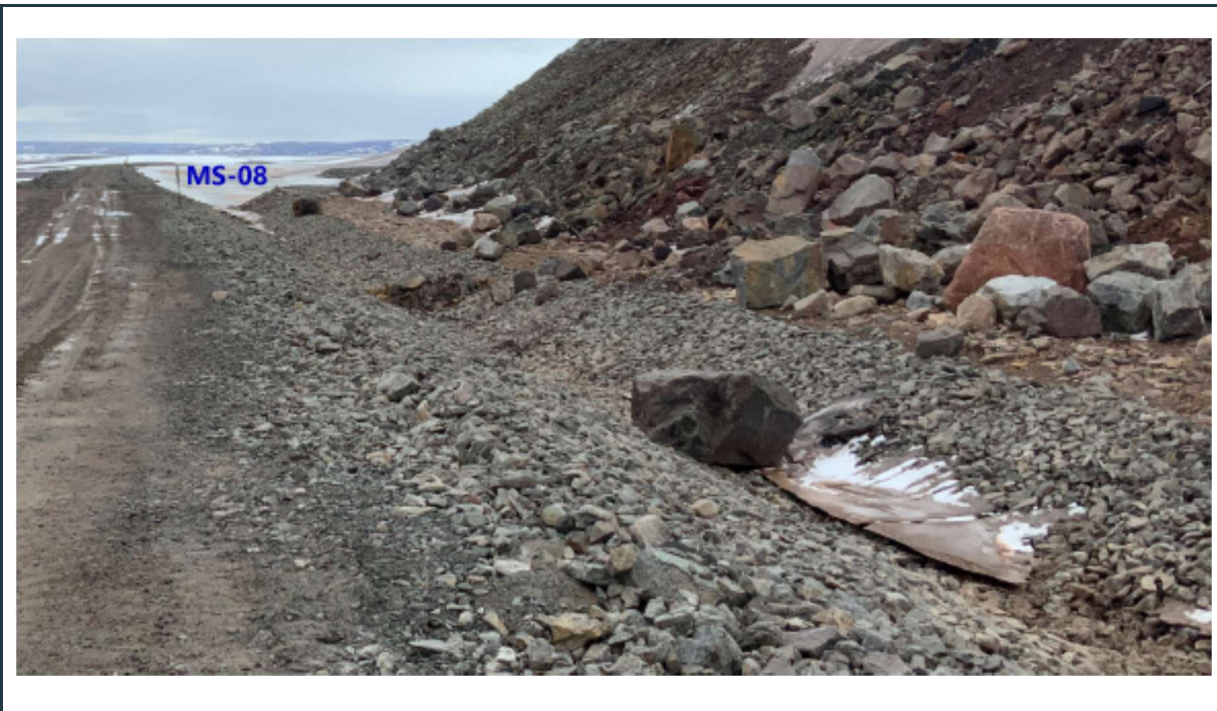
Figure 25: Drainage ditch around the west side of the waste rock facility. Boulders should be removed.

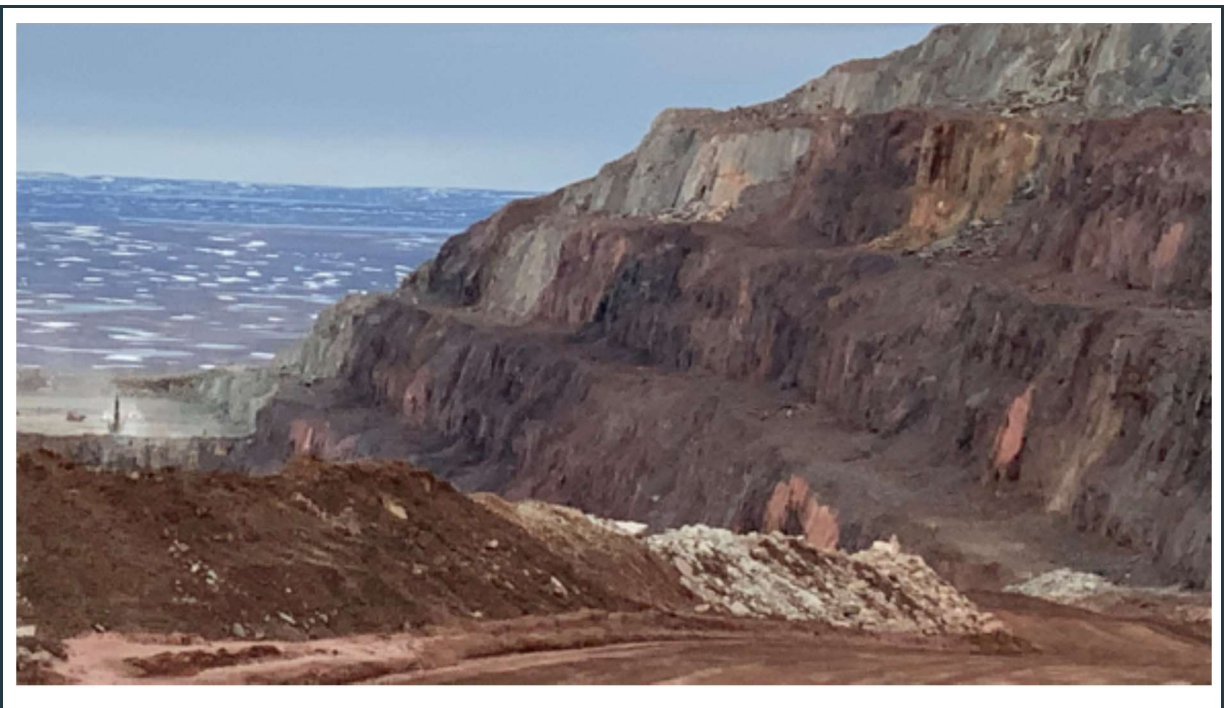
Figure 36: Stable pit-walls with minor rock weathering and pit-wall erosion.

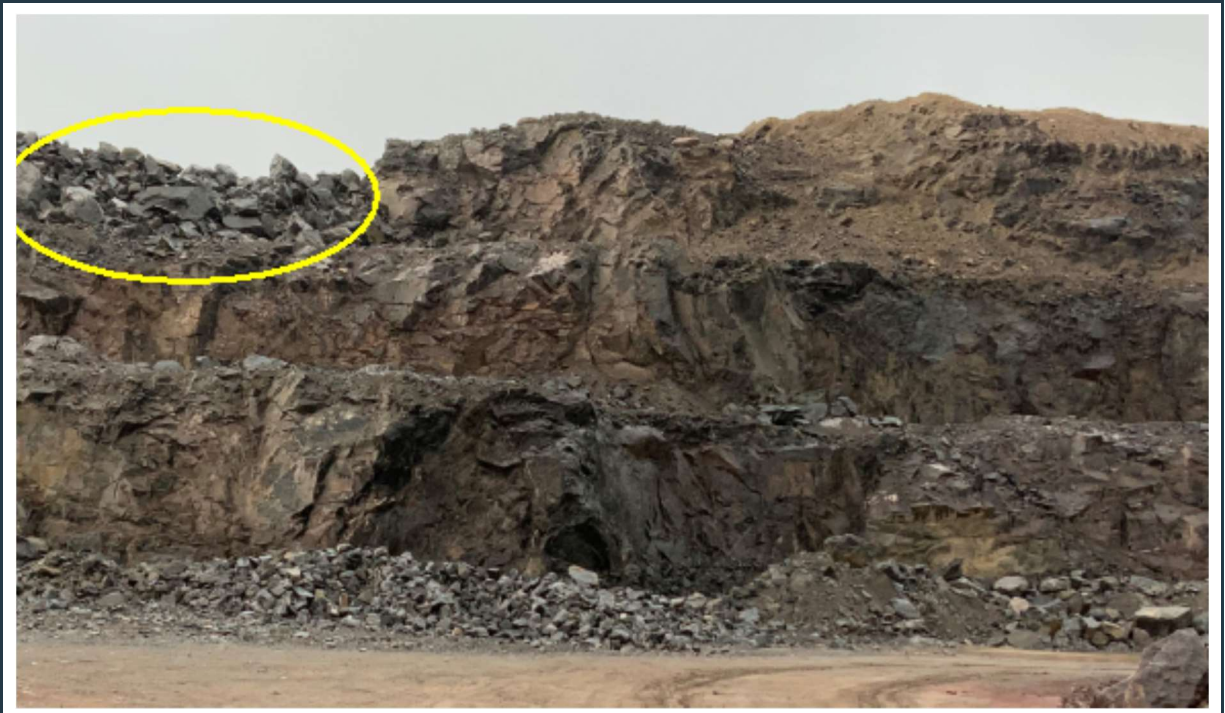
Figure 37: Stable rock face at the upper quarry level, with some potential rolling rock hazard (loose boulders, marked with the yellow circle).

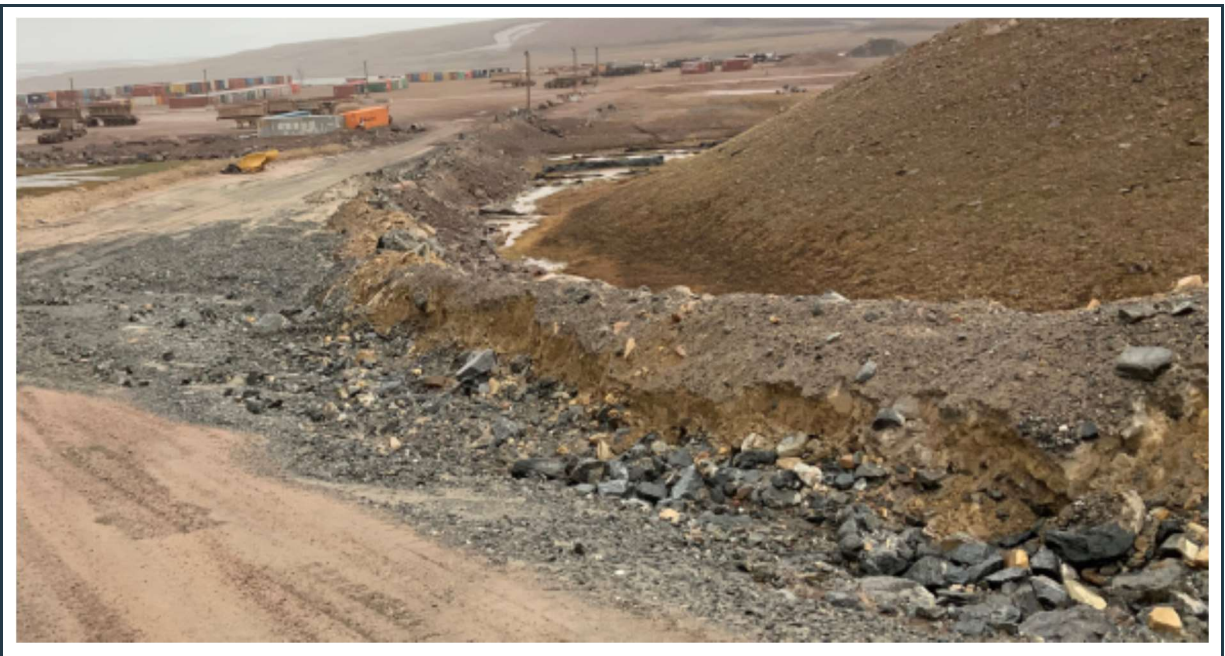
Figure 38: Erosion and stability problem along the access road to the quarry.

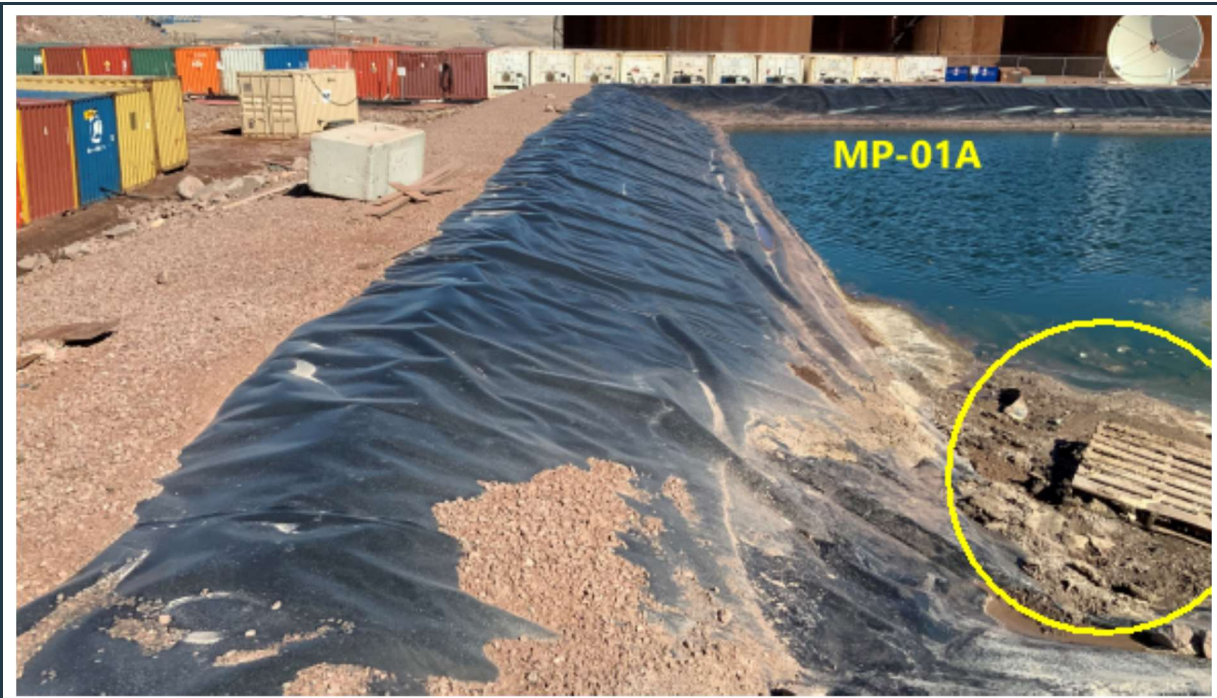
Some settled soil sediment and a wooden pallet were visible in one (1) corner of the pond, which should be removed from the cell. The removal of these materials should be carried out carefully, so as not to damage the geosynthetic liner.

Figure 46: Berms and liner in good condition with stable slopes around the MP-01A pond. The waste (soil and wood), shown in one corner of the pond, should be removed (yellow circle).

Baffinland Action: Baffinland will remove the wooden pallet from the pond using a method that does not damage the geosynthetic liner (Completion Q3 2021).

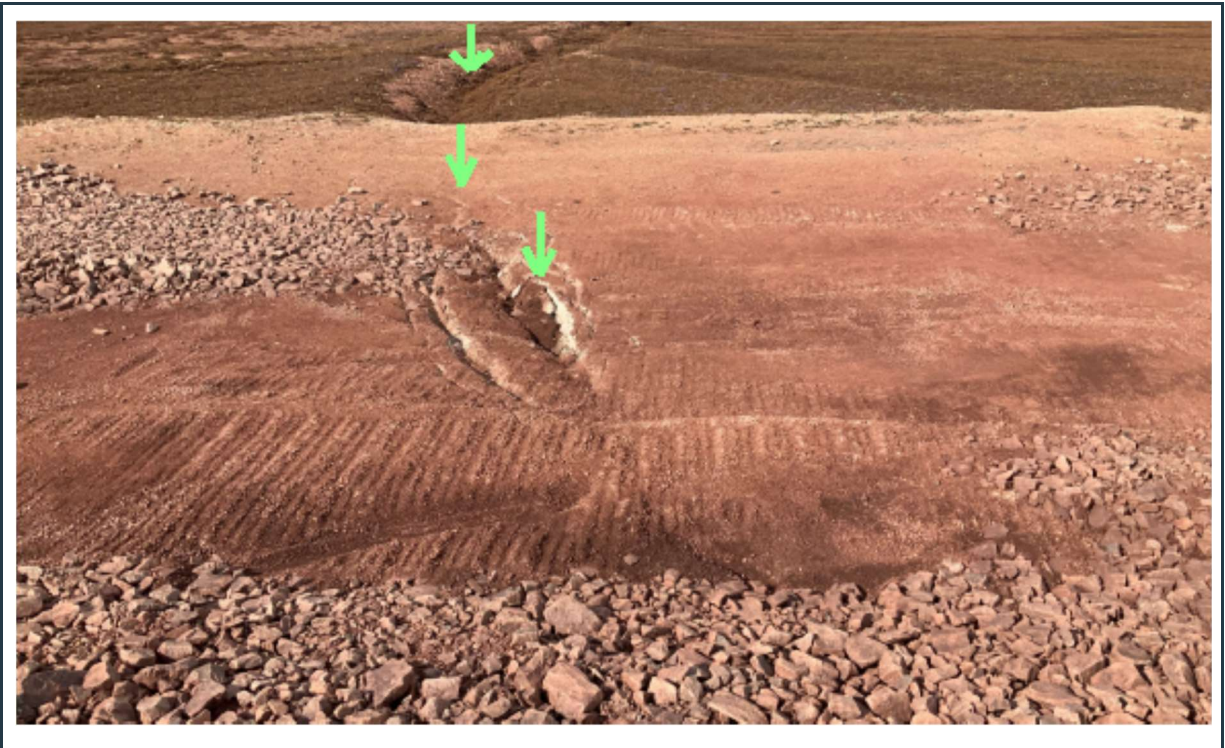
Cracks near the berm that form from repeated freezing and thawing should be filled with the same material that was used for the construction of the berms, to minimize ice-wedge development near the toe of the berms. The fill should be placed over the cracked areas within approximately 3 m of the downstream toe of the berms.

Figure 51: Cracking on the surface along a few historic depressions adjacent to the berm of pond #3.

Baffinland Action: To minimize potential ice-wedge development near the toe of the berm, Baffinland will fill the cracks that have formed within approximately 3 m of the downstream toe of the berm with construction grade material prior to freshet 2022 (Completion Q2 2022).

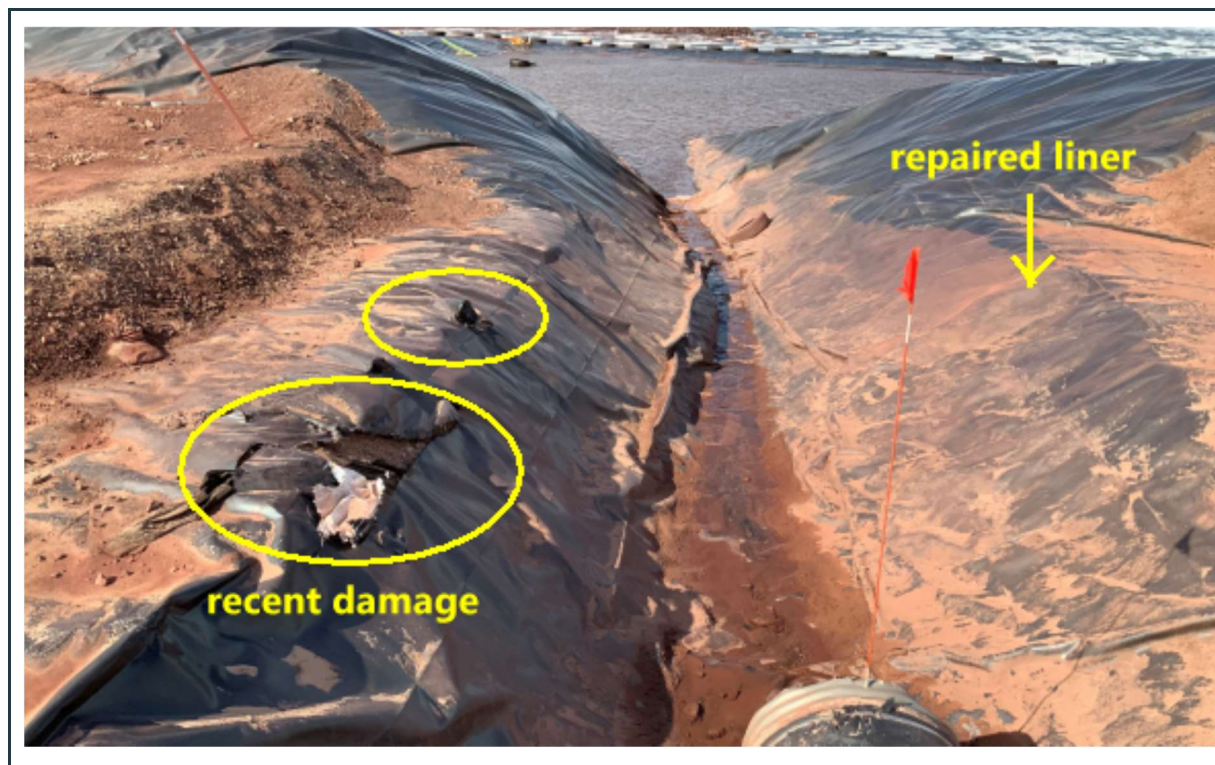
Recent minor liner damage was noted on the west slope of the intake channel. It appears that these damages are returning problems on the slopes of the intake channel, most likely caused by snow clearing

equipment during winters. Consideration should be given to place protective berms adjacent to the slope's crest near the channel to prevent such damages.

Figure 53: Some recent liner damage on the west slope of the southern intake channel.

Baffinland Action: Baffinland will place protective berms adjacent to the slope's crest near the channel to prevent recurring minor liner damage suspected to be caused by snow clearing operations (Completion Q3 2021).

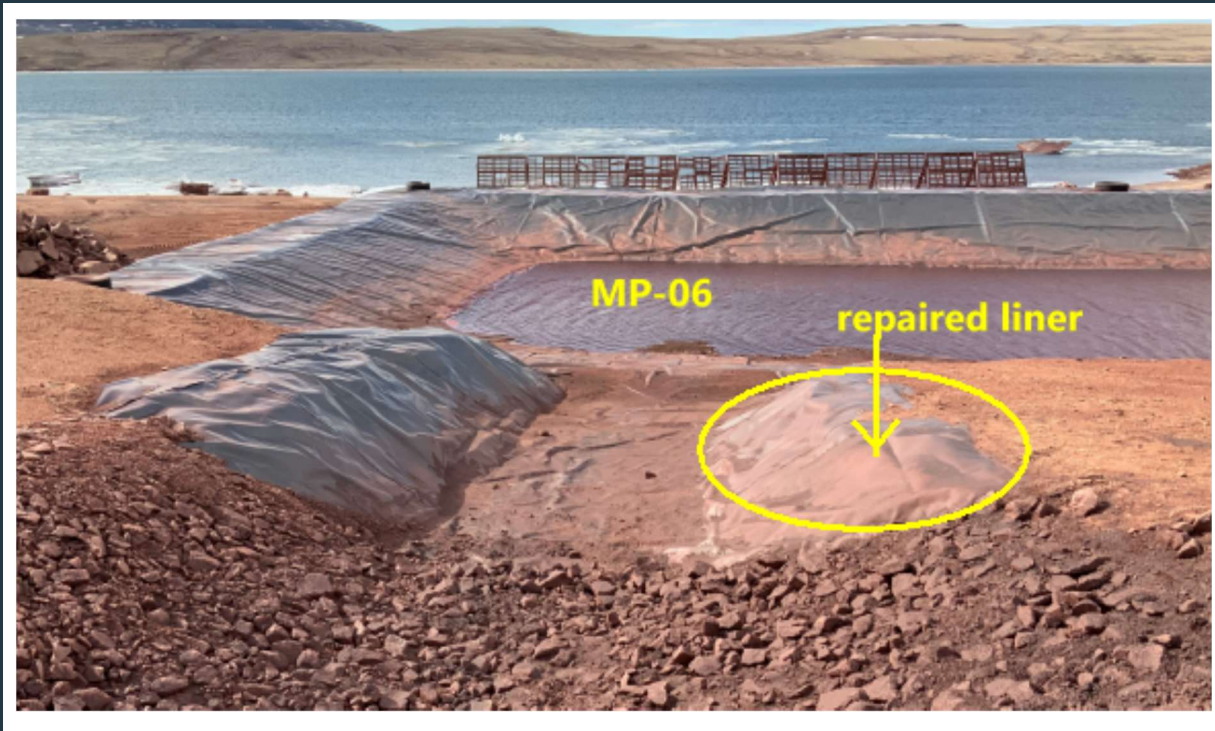
Figure 55: View of the lined MP-06 pond with robust, stable berms (north-west corner of the ore stockpile). Note the repaired liner on the slope of the intake to the pond (yellow circle).

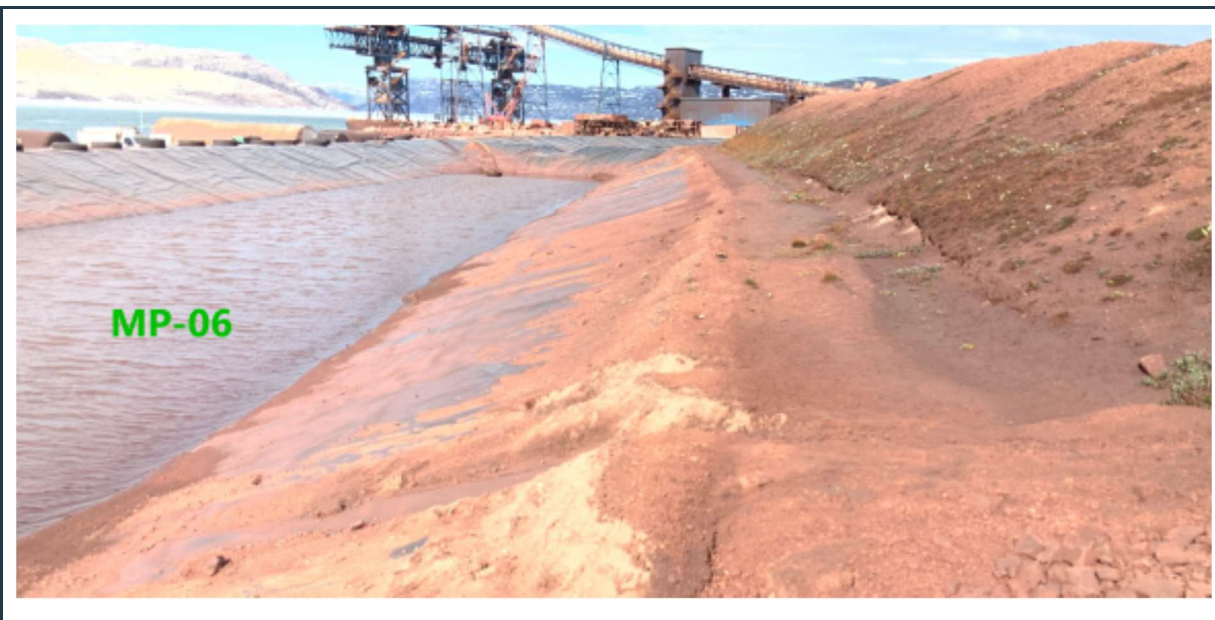
Figure 56: View of the east slope of the lined MP-06, with increased soil erosion from the adjacent berm.

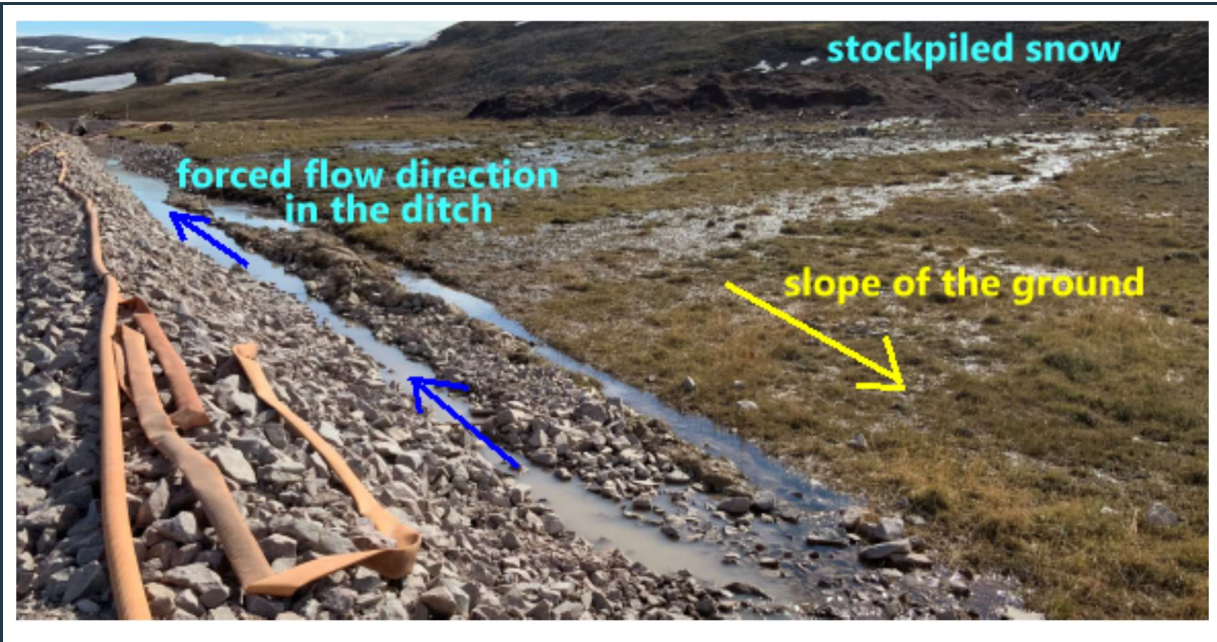
Sloughing of the sides of the P-SWD-3 ditch, adjacent to the LP2 laydown area, has occurred at several locations along the ditch. It is suggested that the existing condition of the P-SWD-3 drainage ditch and adjacent topography be re-evaluated in detail, and that the ditch be redesigned and reconstructed to drain the large amount surface water to the correct direction.

Figure 59: View of the "P-SWD-3 surface water collection ditch with failing side slope. The sloughing is caused by the uncontrolled water flow into the ditch along its alignment.

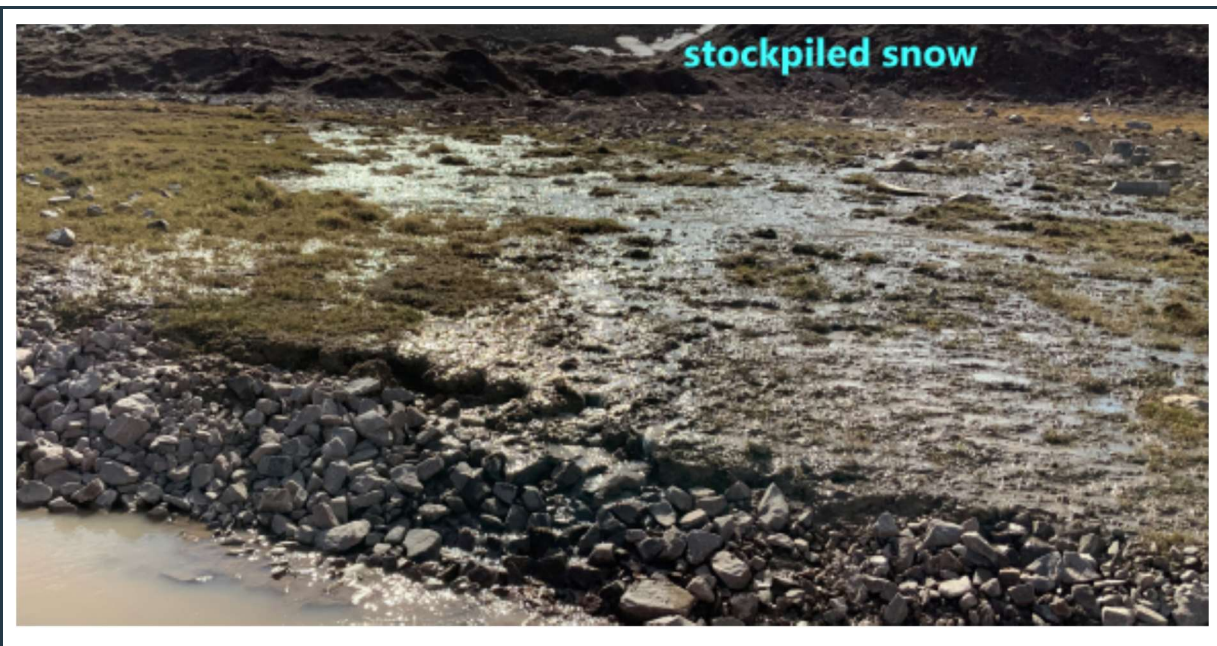
Figure 60: Continuous sheet flow of surface water from the snow stockpile area.

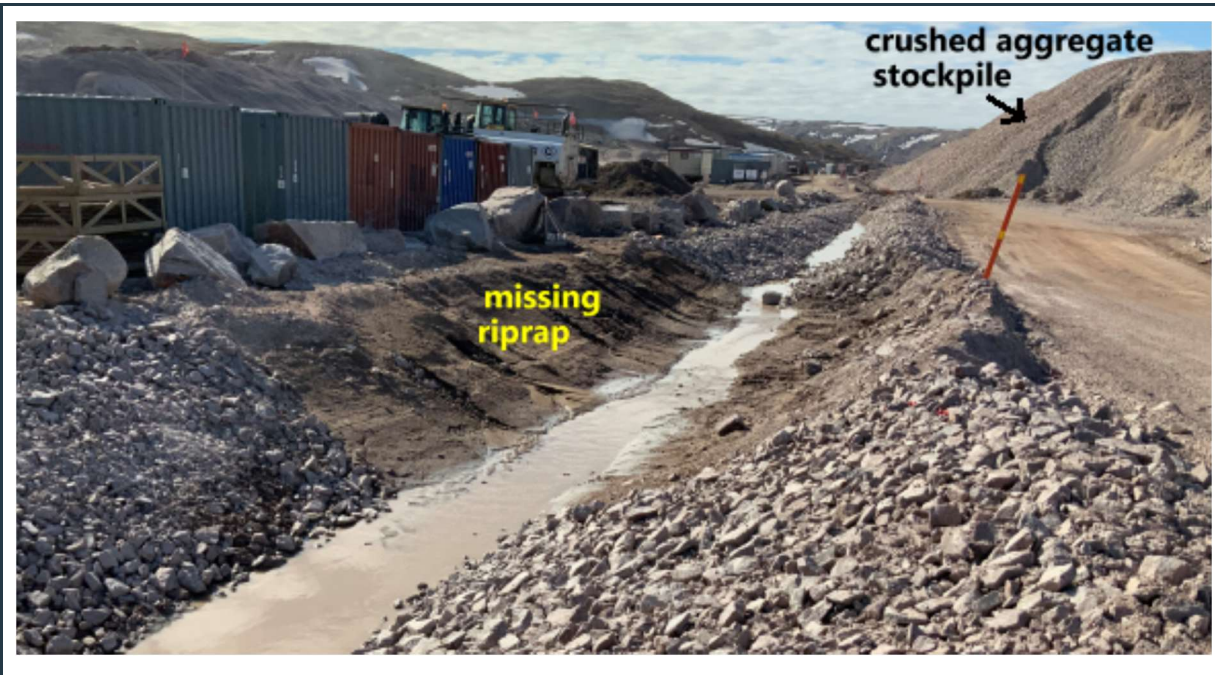
Sections of the P-SWD-5 ditch were noted with missing riprap. These sections should be repaired, and the slopes of the ditch regraded to facilitate uninterrupted flow in the ditch.

Figure 61: P-SWD-5 – “Q01-North” surface water collection ditch with missing riprap at a short section.

Baffinland Action: Baffinland commits to repairing and re-grading the slopes at the identified sections of the P-SWD-5 ditch prior to freshet 2022 (Completion Q2 2022).

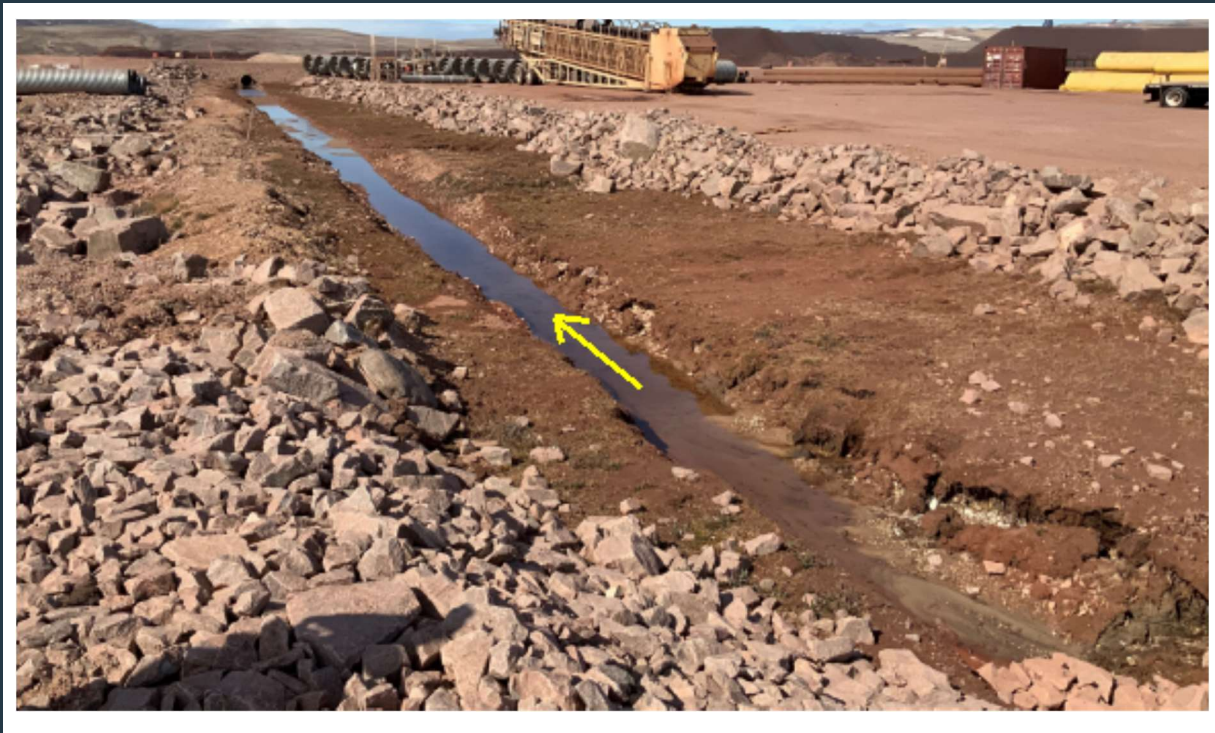
Figure 65: View of the W3/W14 uncompleted surface water collection ditch with some erosion.

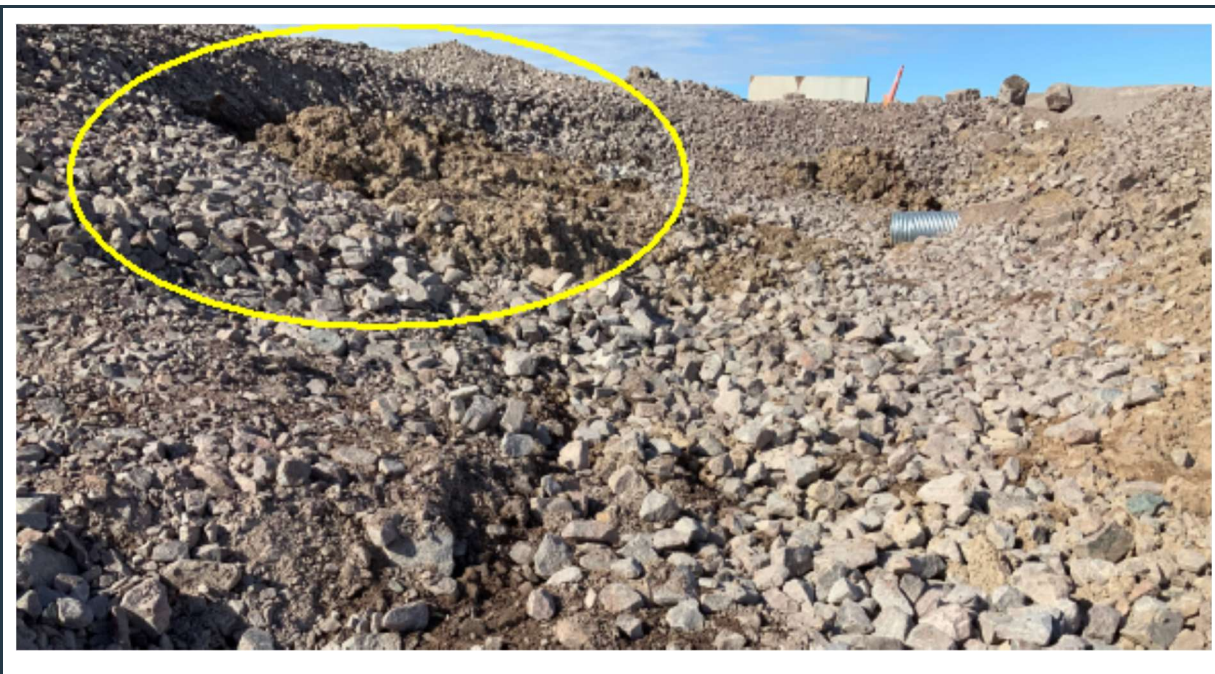
The PSC drainage ditch is still under construction, however, a localized slope failure at the west end of the ditch should be repaired, regraded and the riprap rock fill cover reinstated.

Figure 68: View of the PSC surface water collection ditch and culvert (still under construction). Note the localized slope failure on the left side of the image (yellow circle), which section will require slope rehabilitation with riprap placement.

Baffinland Action: Baffinland will repair and regrade the identified area in the ditch and reinstate the riprap rock cover prior to completion of the construction of the PSC drainage ditch.

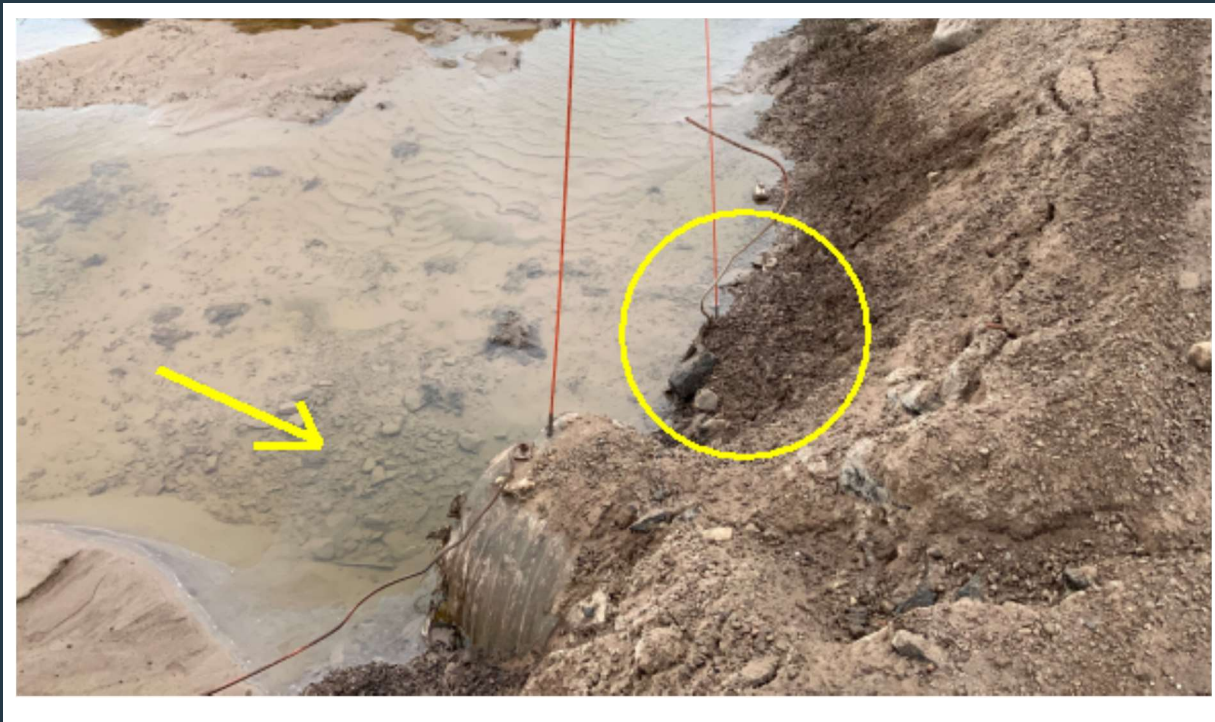
One (1) of the culverts is blocked with silt. It is suggested that the blocked pipe be replaced, and both ends of the pipes be protected from siltation by placing riprap around them.

Figure 81: View of the inlet to culverts 030A and B. Note that one of the pipes is clogged (yellow circle).

Baffinland Action: Baffinland commits to assessing the blocked culvert to determine if replacement is required (Q2 2022). Baffinland commits to placing riprap at both ends of the culvert prior to freshet 2022 to prevent further siltation for occurring (Completion Q2 2022).

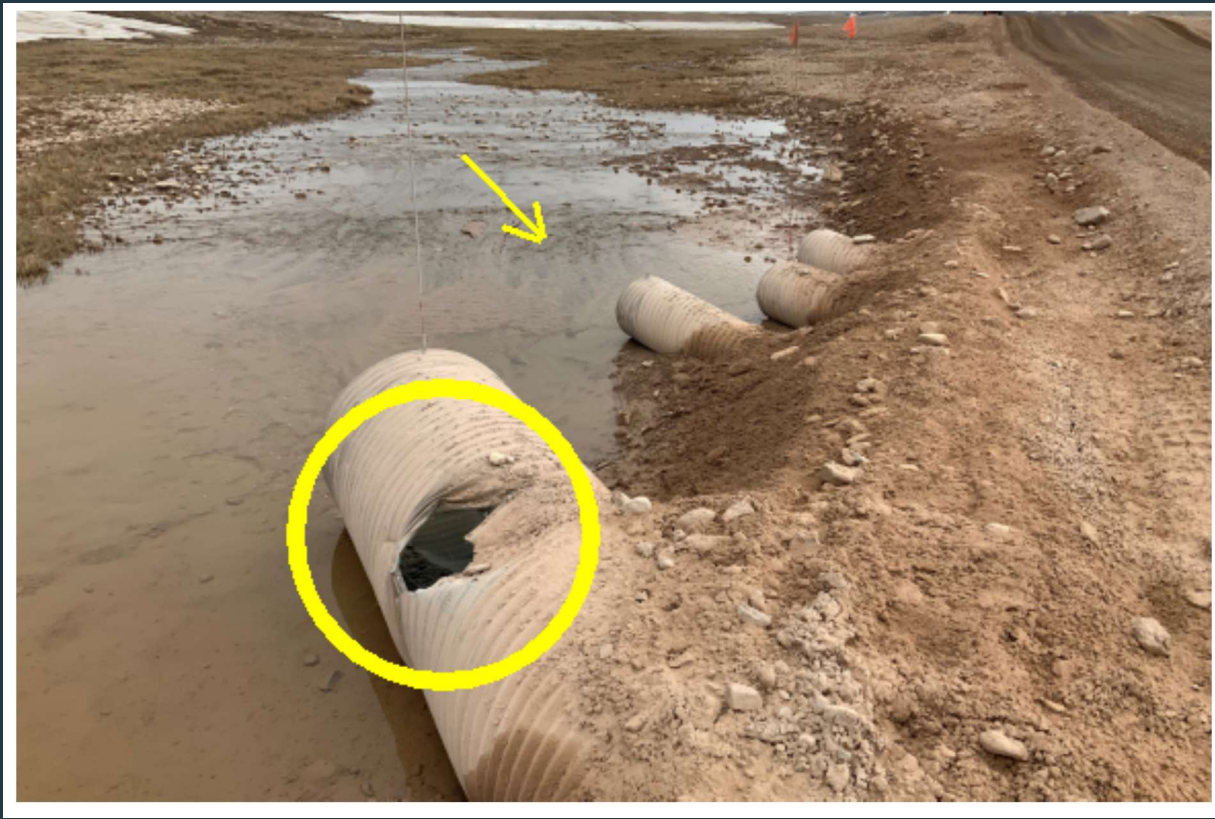
Figure 93: View of culvert(s) 102 inlets. Note the minor damage on one of the pipes (yellow circle).

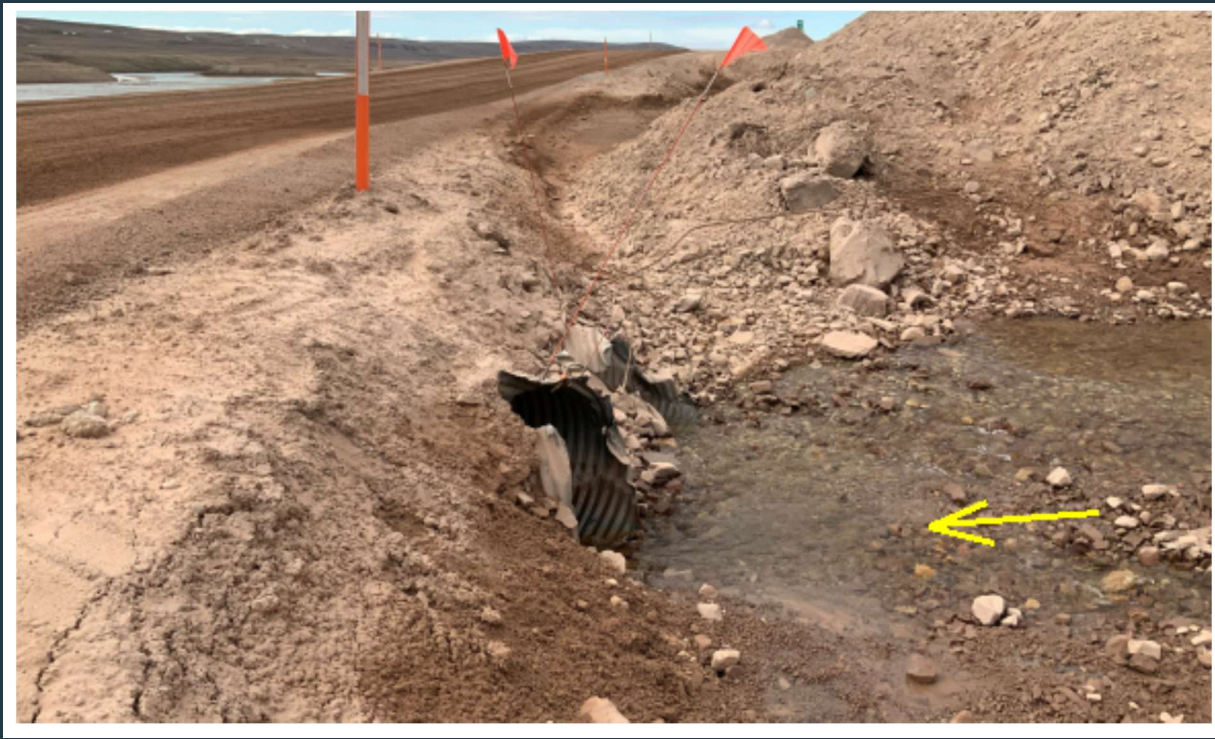
Both ends of the two (2) culverts are damaged and too short for the embankment slopes, particularly at the outlet ends (Figures 103 and 104).

Figure 103: View of culvert(s) 114D inlets. Repair of both pipes is required.

Baffinland Action: Baffinland commits to further inspecting this culvert to determine if replacement with longer, larger diameters pipes is required (Q2 2022). If the pipes are replaced, the road embankment will also be widened at the outlet end and riprap placed around the culverts to stabilize the embankment slopes and improve erosion protection. This work will be completed in alignment with the current approved Civil Design Criteria for the Project.

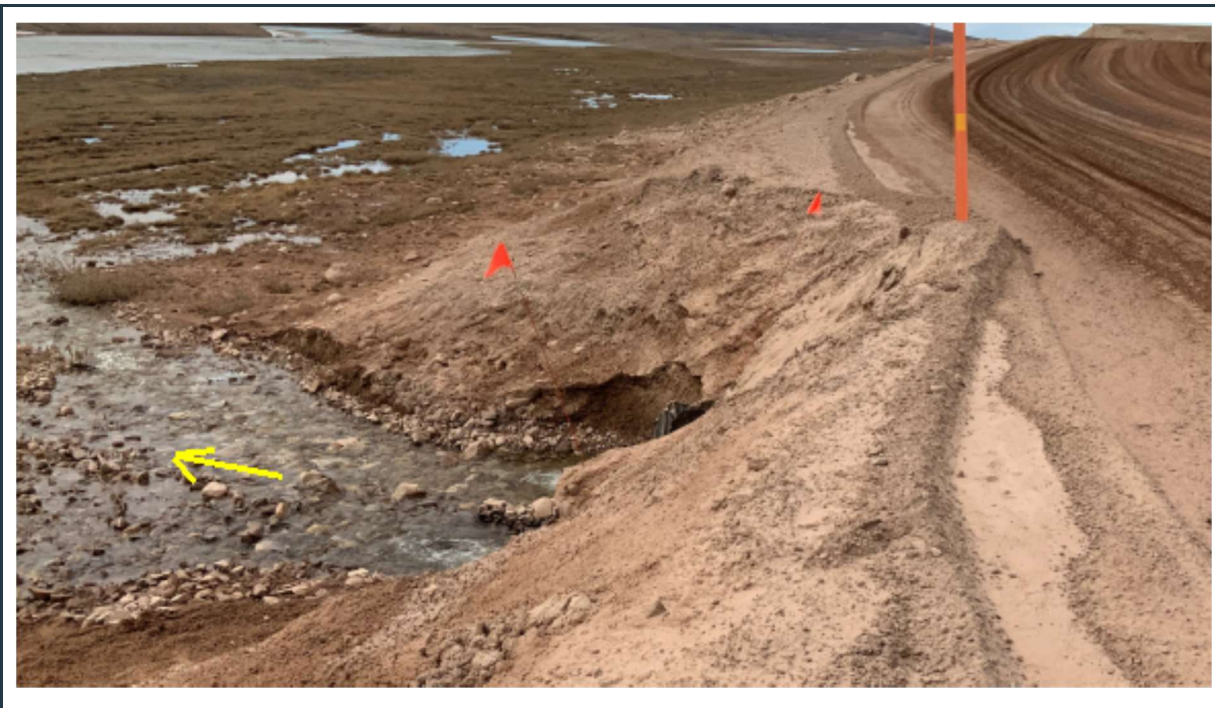
Figure 104: View of culvert(s) 114D damaged outlets. Repair (extension) of both pipes is required.
