RE: Submission of 2021 Geotechnical Inspection Report No. 2 (September 2021)

Mary River Project – Nunavut

November 16, 2021
TC190307.2021

Wood Environment & Infrastructure Solutions (Wood), has completed the second geotechnical field inspection of 2021 at the Mary River Project, which is a condition of the Type “A” Water Licence No: 2AM-MRY1325 – Amendment No.1 (“Water Licence”).

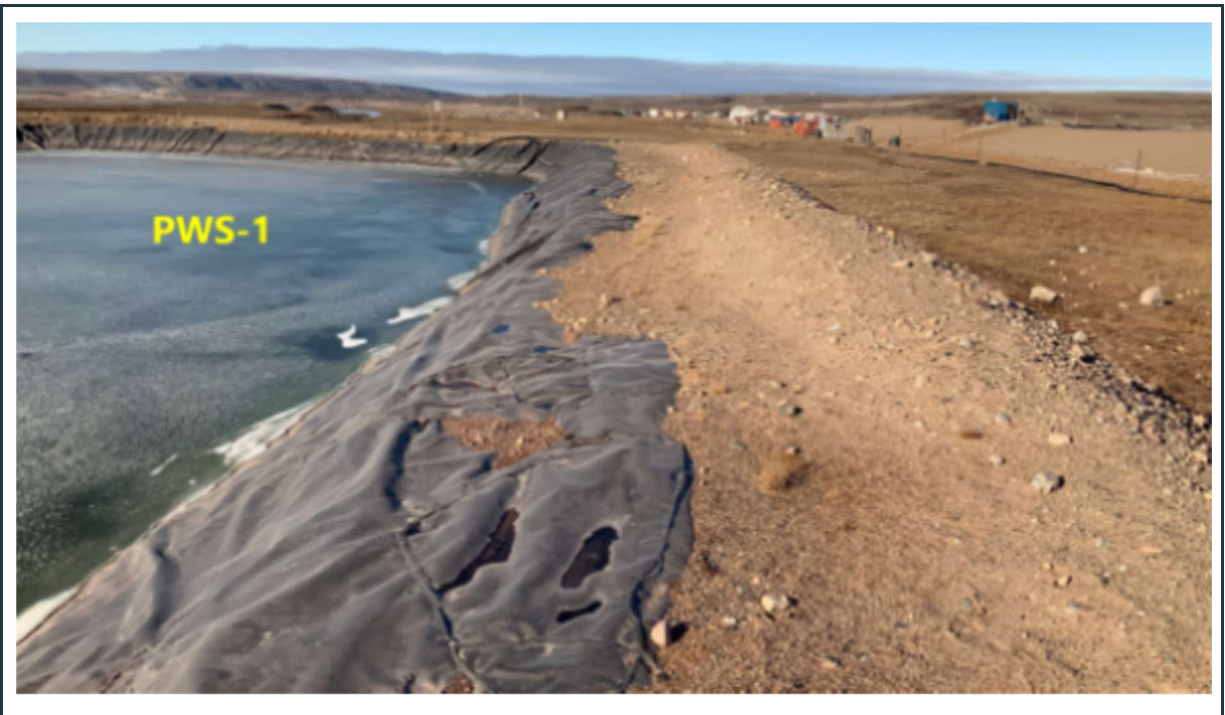
Figure 10: PWS pond #1. Well-maintained, stable perimeter berm and liner.

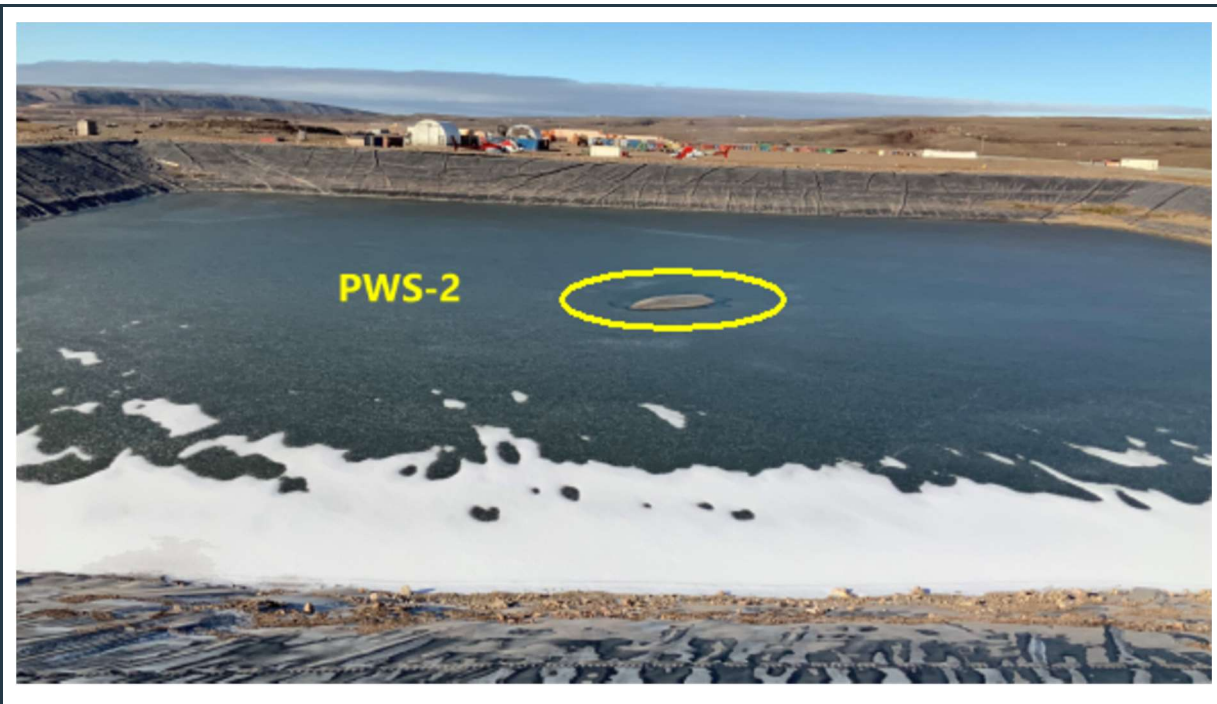
Figure 11: PWS pond #2 – Stable, well-maintained berm and liner. – A small section of the liner is visible in the center of the pond (yellow circle). Note the ice formation in the pond in September.

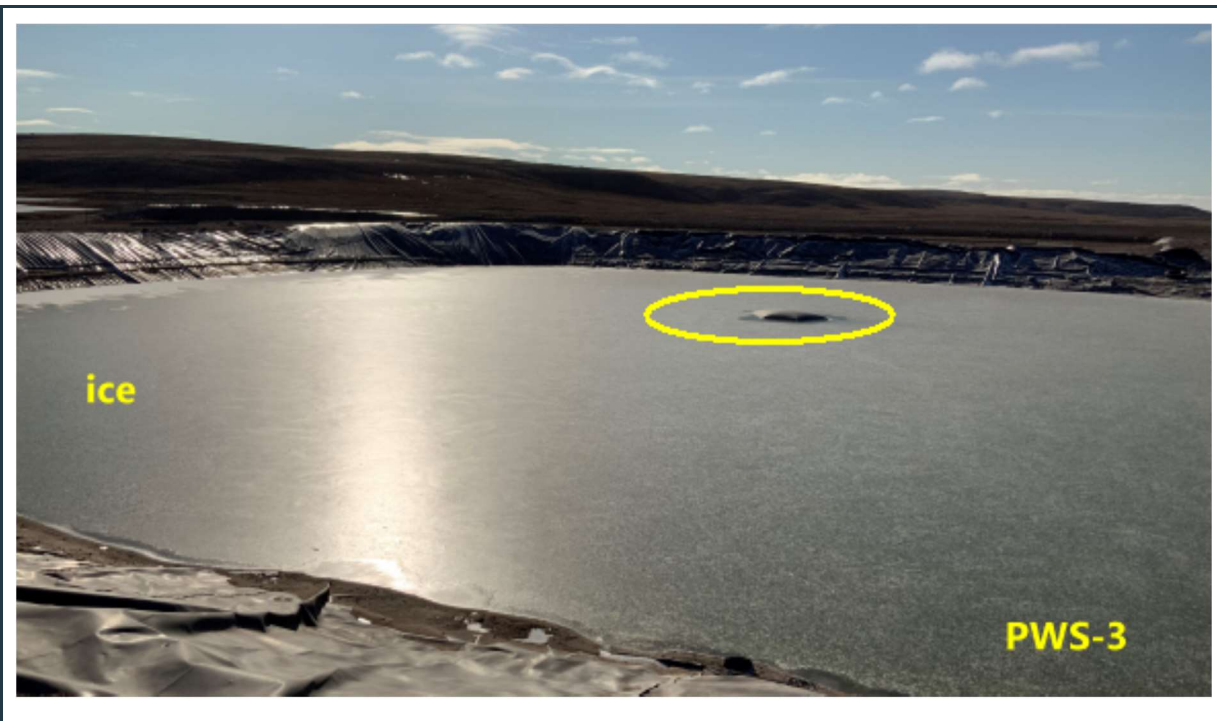
Figure 12: Stable perimeter berms around PWS pond #3 – A small section of the liner is visible in the shallow water of the pond (yellow circle).

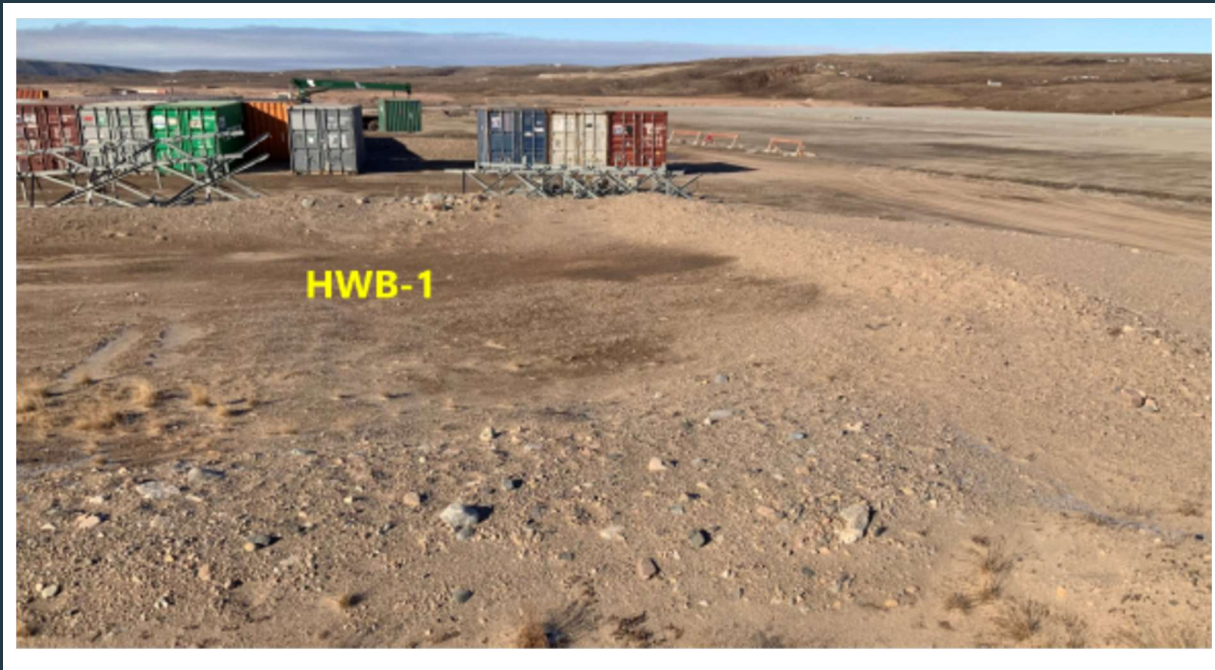
a) HWB-1

This cell is currently empty, as shown in Figure 13. As reported previously, concerns had been raised in the past to suspected potential liner damage within this cell, and consequently no material has been stored in this cell since this concern was identified.

Figure 13: View of HWB-1 – As earlier this year, the cell is still empty.

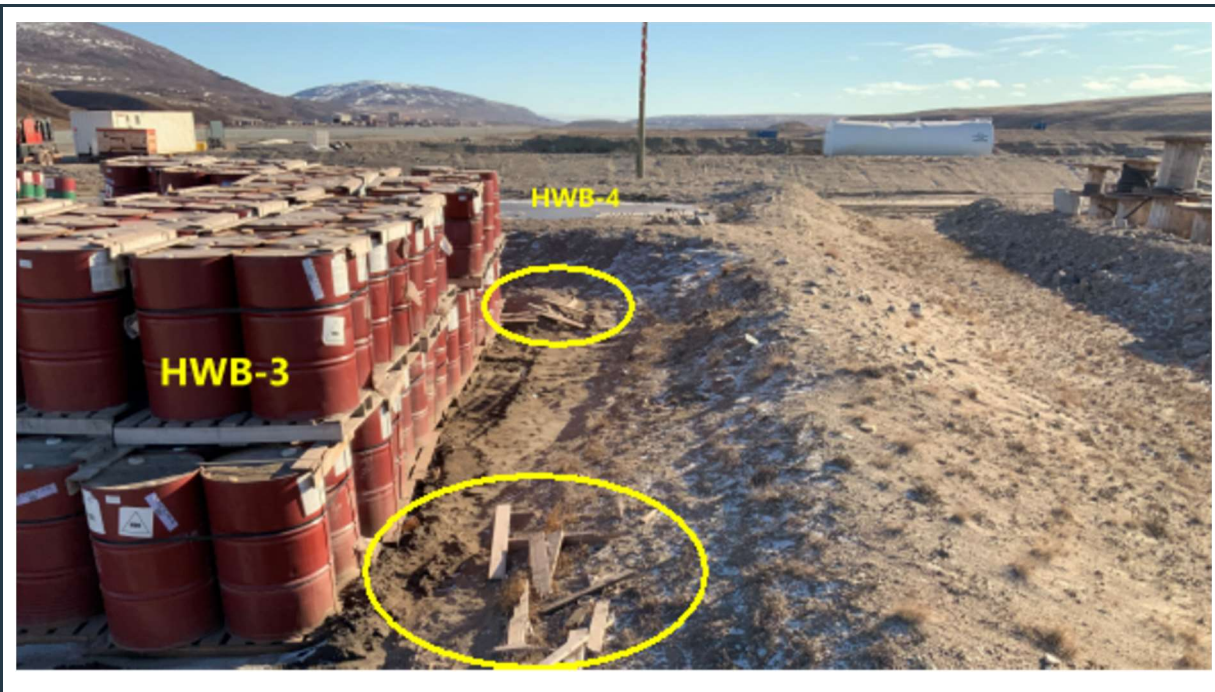
These cells were constructed as "twin-cells" and were called "Fuel Containment" cells in historic inspection reports. As shown in Figures 15 and 16, cell 3 is generally full of fuel barrels stored on wooden pallets (jet-fuel and diesel), while a few similar barrels are also stored in cell 4. The berms and liner around and within the cells appear to be in good condition and no seepage from either of the cells was noted. There is some wooden debris left in cell 3 (see the yellow circles in Figure 15), which should be removed during regular maintenance.

Figure 15: View of stable berms and stored fuel barrels in HWB-3. Wooden debris should be removed.

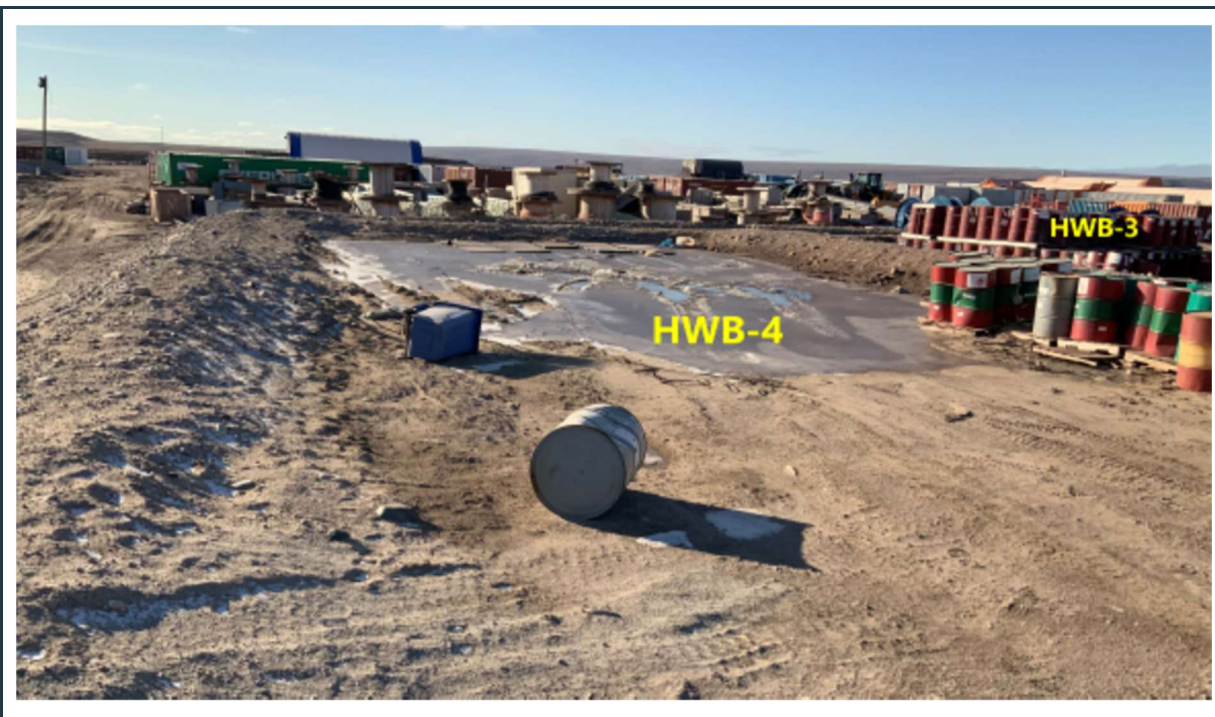
Figure 16: View of stable berms at HWB-4, with a few jet-fuel barrels stored on wooden pallets. Most of the barrels that were visible in June in this cell have been removed.

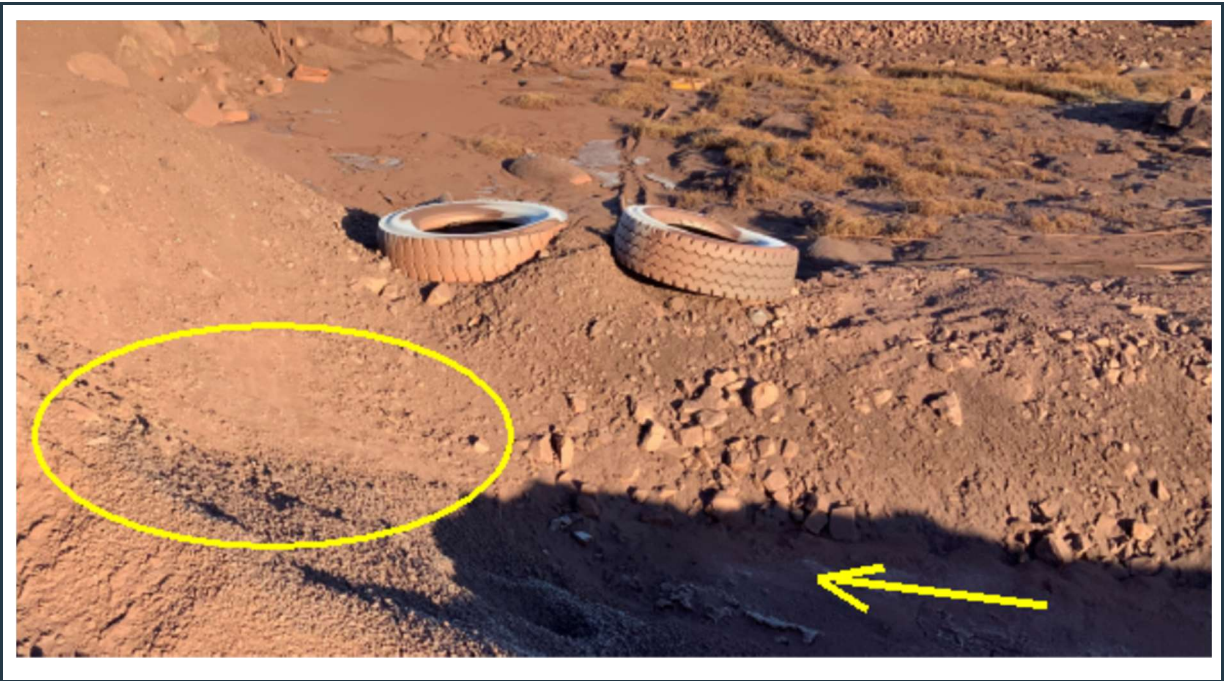
Figure 21: Drainage ditch next to the crusher plant leading to the MS-06 pond. The yellow circle indicates that the entry to the culvert that should drain the collected surface water from the ditch to the MS-06 pond is clogged, and it should be cleaned.

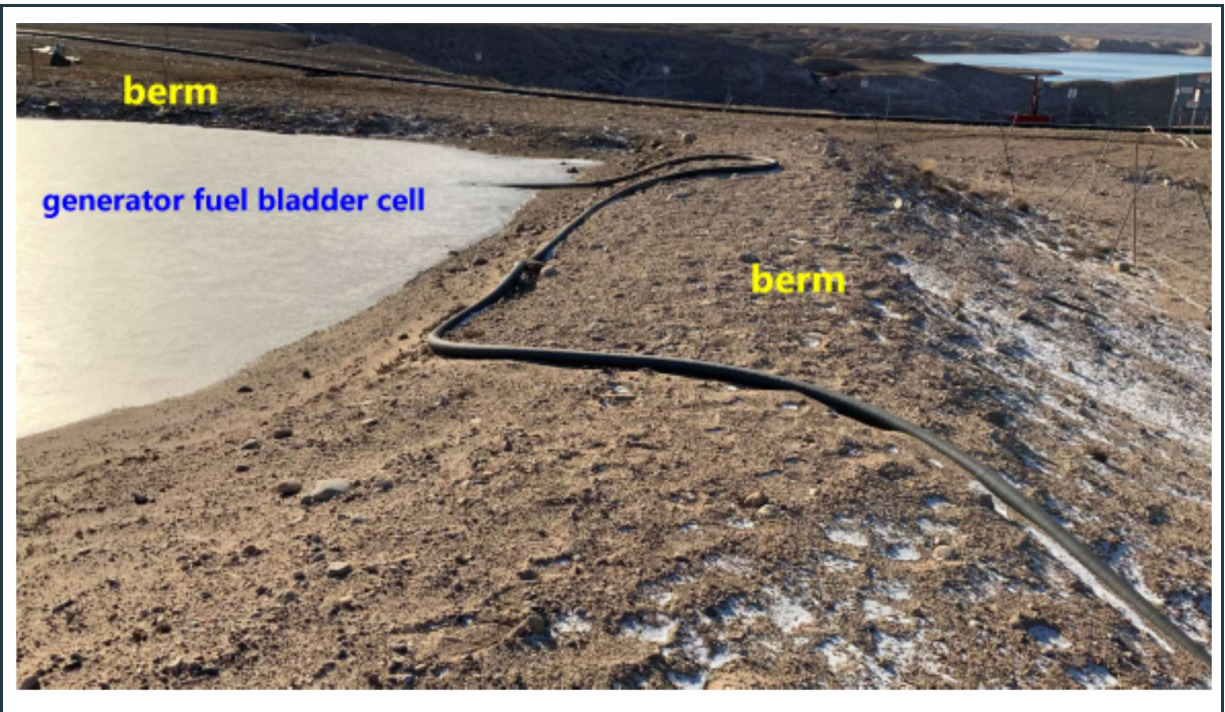
Figure 28: View of the robust, stable berm around the “generator fuel bladder” cell. The cell is currently empty. The ponding water within the cell indicates good liner performance.

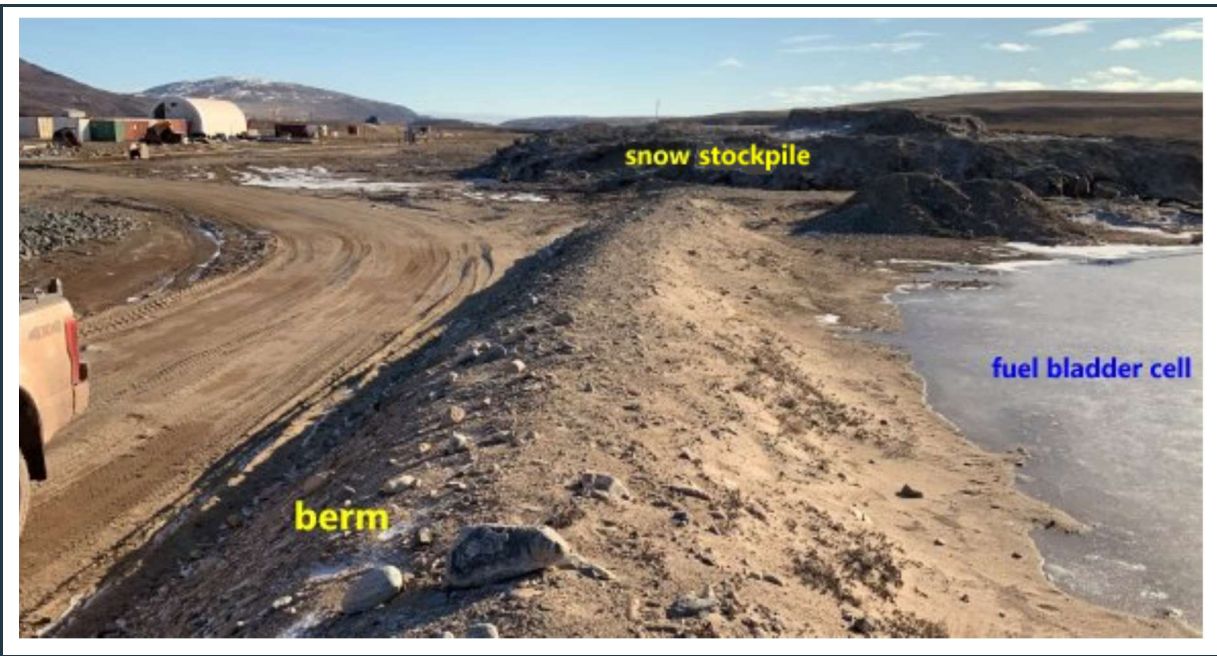
Figure 29: View of the snow stockpile adjacent to the “fuel bladder” cell. The melting snow has flooded the adjacent road next to the berm during the summer. It is recommended to excavate perimeter drainage ditches around the stockpile and prevent flooding of the road and berm.

As previously recommended in the June 2021 report, to prevent further deterioration of the pond's berm, the drainage of melting snow in the area must be rectified permanently. The surface water should be redirected away from the berms by excavating properly designed and constructed drainage ditches in the area, preferably around the adjacent snow stockpile.

Baffinland Action: Drainage ditches will be constructed in the area to prevent further deterioration of the pond's berm (Completion prior to Freshet 2022).

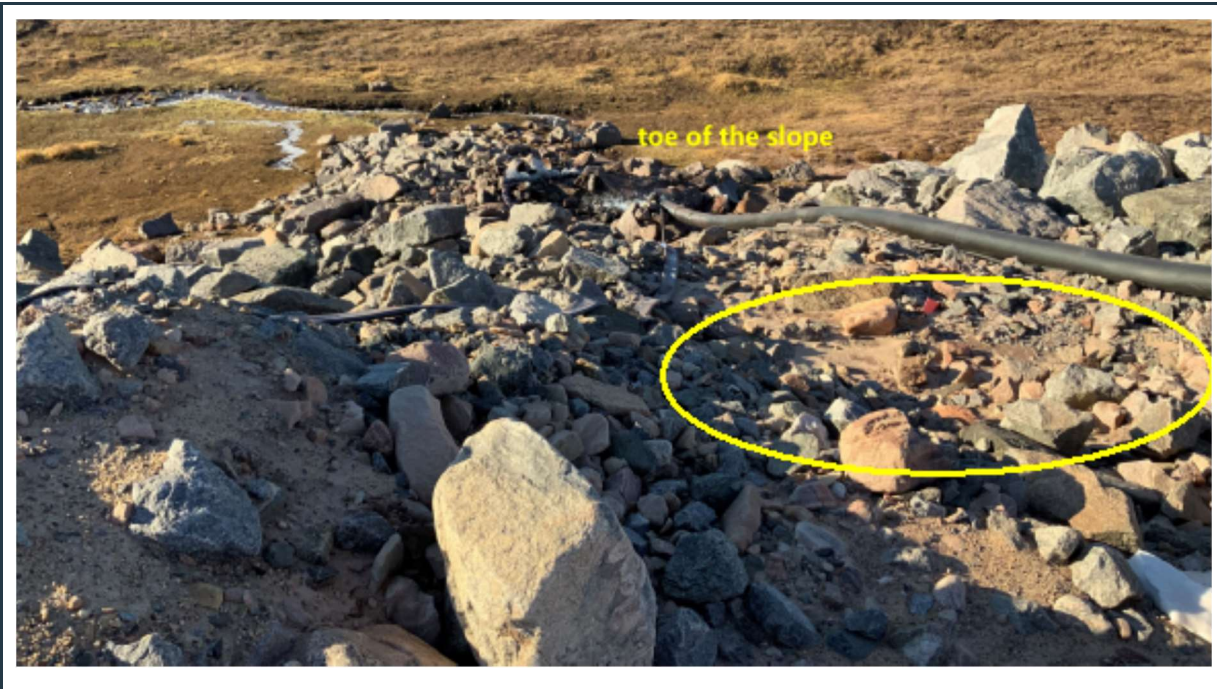
1.8 Rock Fill Slope at the Water Discharge Area

Some of the rock fill has been "washed down" from the crest to the toe of the slope in a small area. It is recommended that area be filled with additional rock fill to prevent the erosion of the underlying finer material down the slope.

Figure 35: Rock fill riprap slope protection at the water discharge area. Note that some of the rock fill had “moved” to the toe of the slope. It is recommended to place new rock fill in the area marked with the yellow circle.

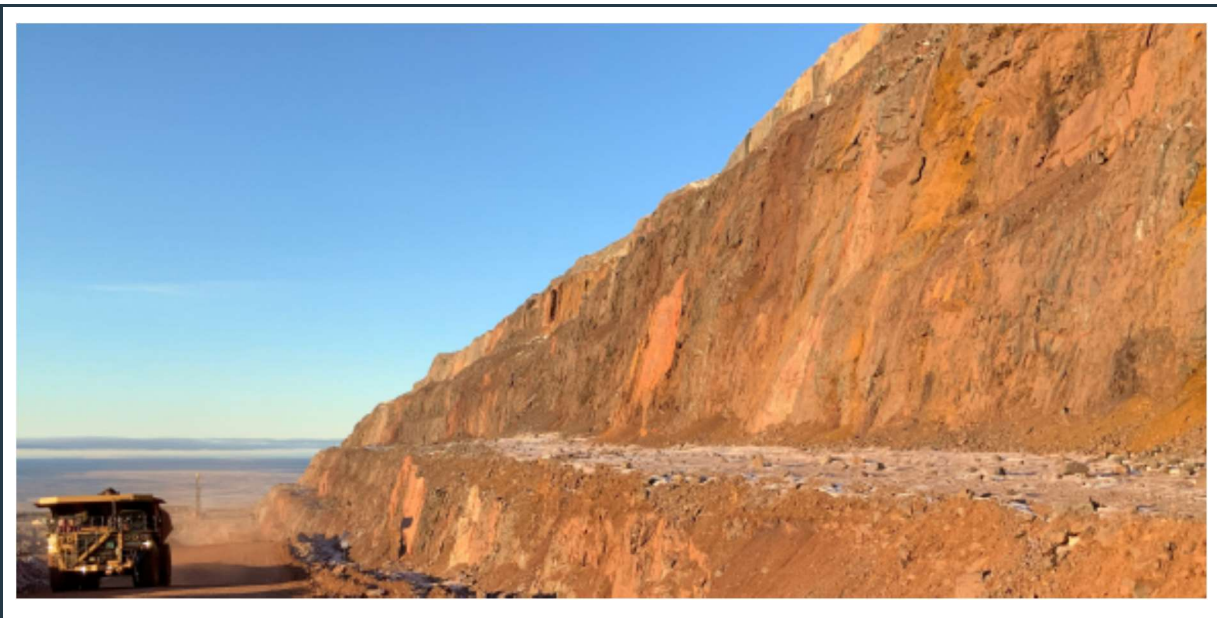
Figure 36: Stable pit-walls with minor rock weathering and pit-wall erosion.

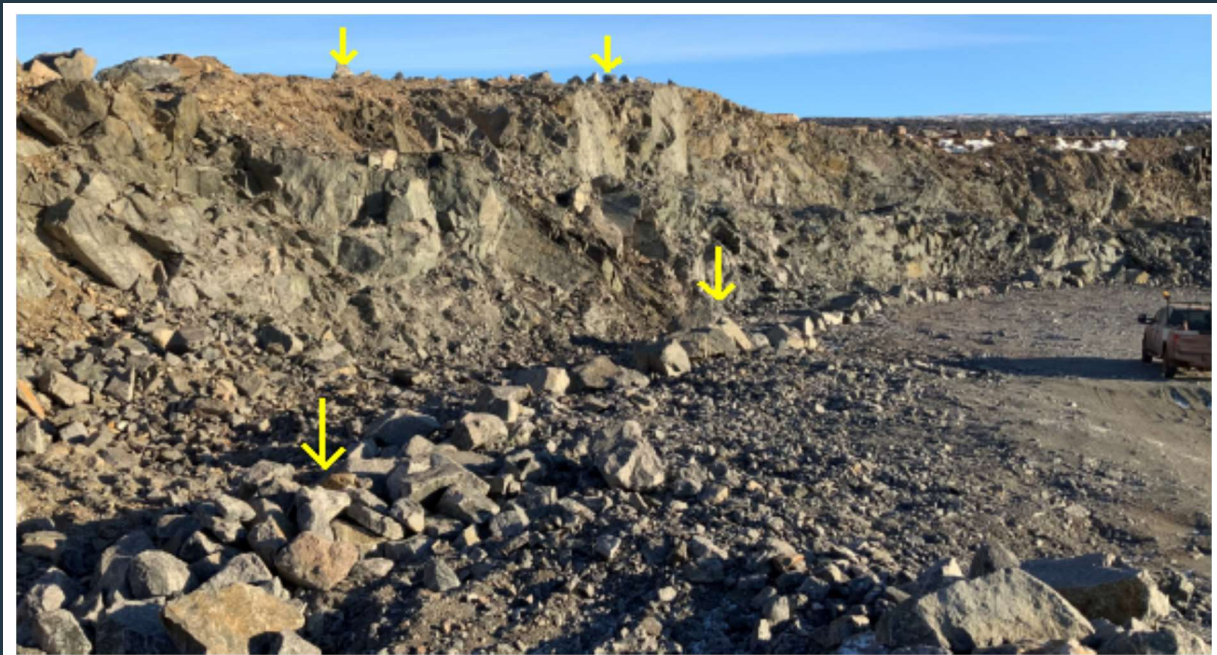
Figure 37: View of the rock face at the upper quarry level with some potential rolling rock hazard. Note the row of boulders placed on the crest and toe of the rock face to prevent unauthorized access to the wall. No activity is currently carried out in this quarry.

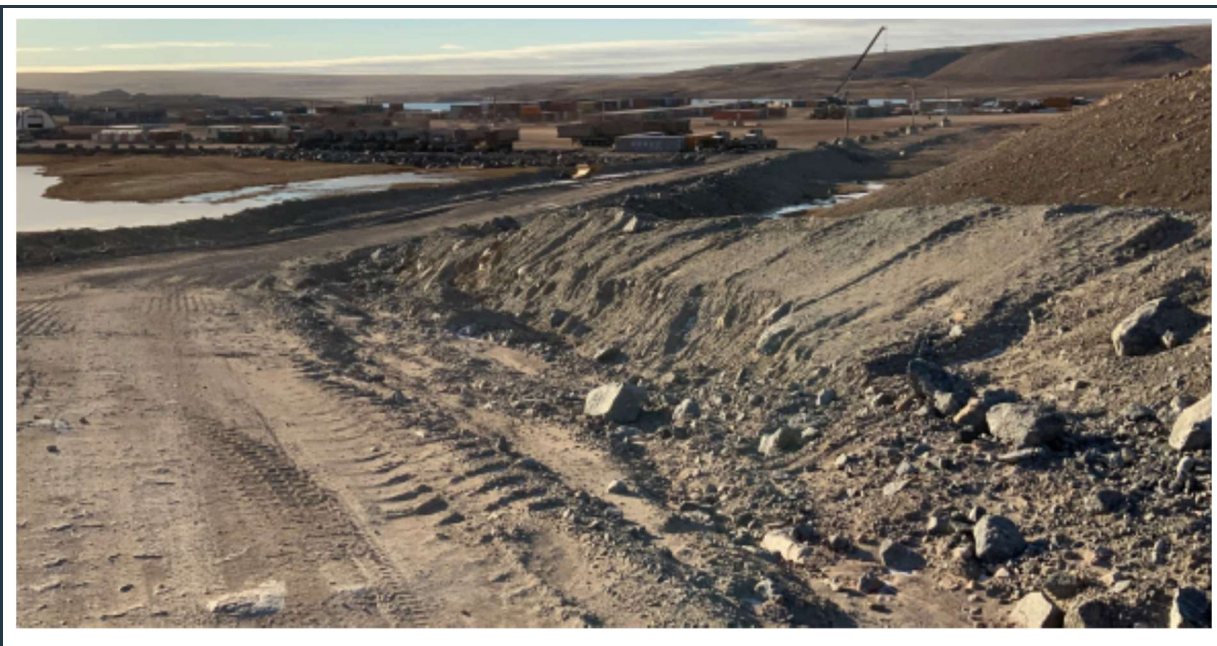
Figure 38: Erosion and stability problem along the access road to the quarry.

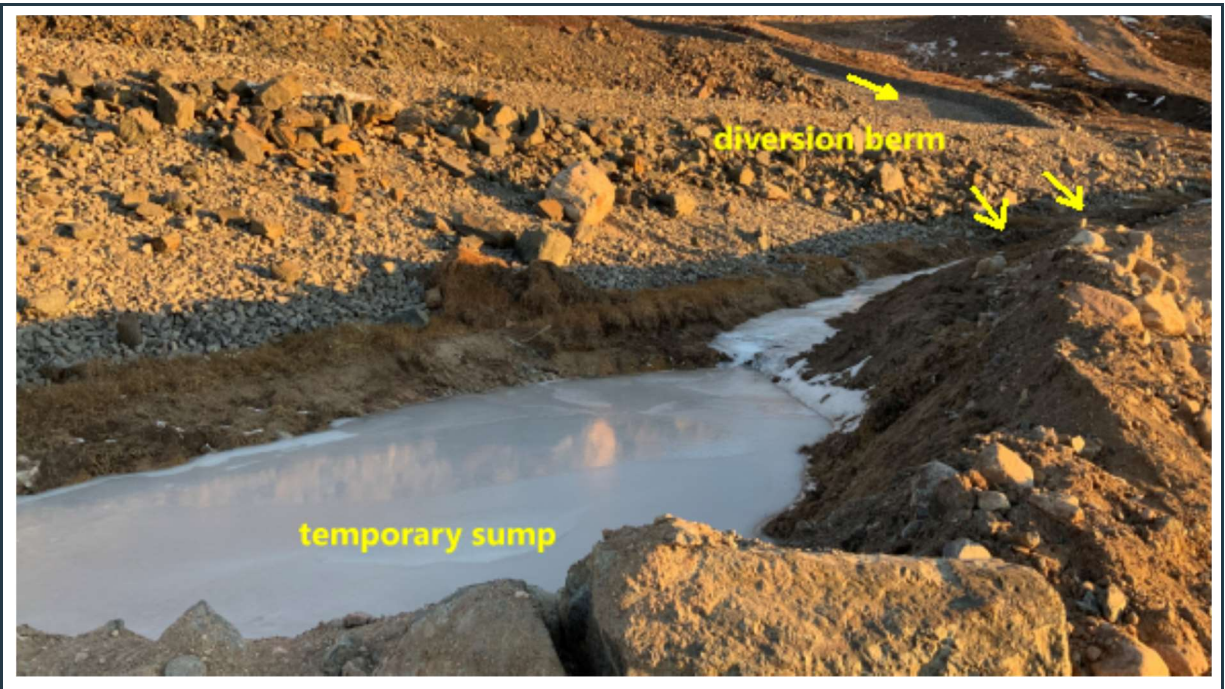
The "diversion" berm is constructed from granular fill that may not function well in diverting all surface runoff to the adjacent MS-07 pond. Consideration shall be given to add a fine-grained core into the granular berms at the critical locations where seepage through the berms was noted. To eliminate the need for pumping the collected water into the nearby MS-07 pond, consideration shall be given to provide a seal on the upstream side of the berm along the critical sections, by placing either a clay core or a synthetic liner to prevent seepage through the berm.

Figure 40: View of the surface water diversion berm at the new KM-106 ore stockpile area. Note the water seepage through the berm into a temporary sump, downstream from the diversion berm. The water from the sump is periodically pumped into the new nearby MS-07 pond.

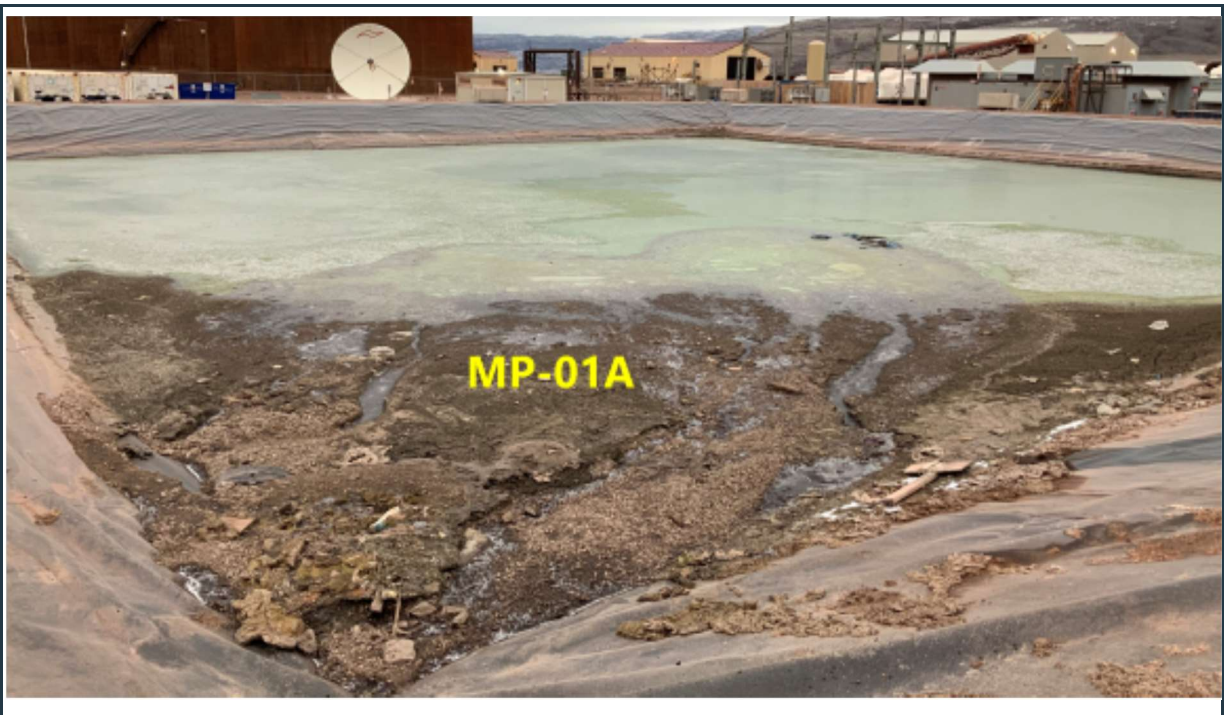
Some sewage sludge accumulation was visible in one (1) corner of the pond, which should be removed from the cell. This should be completed carefully, so as not to damage the liner.

Figure 46: Stable berms and intact liner in the MP-01A pond. The waste (soil and wood), shown in part of the pond, should be removed without damaging the liner.

Baffinland Action: Baffinland will assess the solids build up within PWSP MP-01A and if necessary will develop an implementation plan to remove the solids from the corner of the pond using a method that does not damage the liner (Completion Q3 2022).

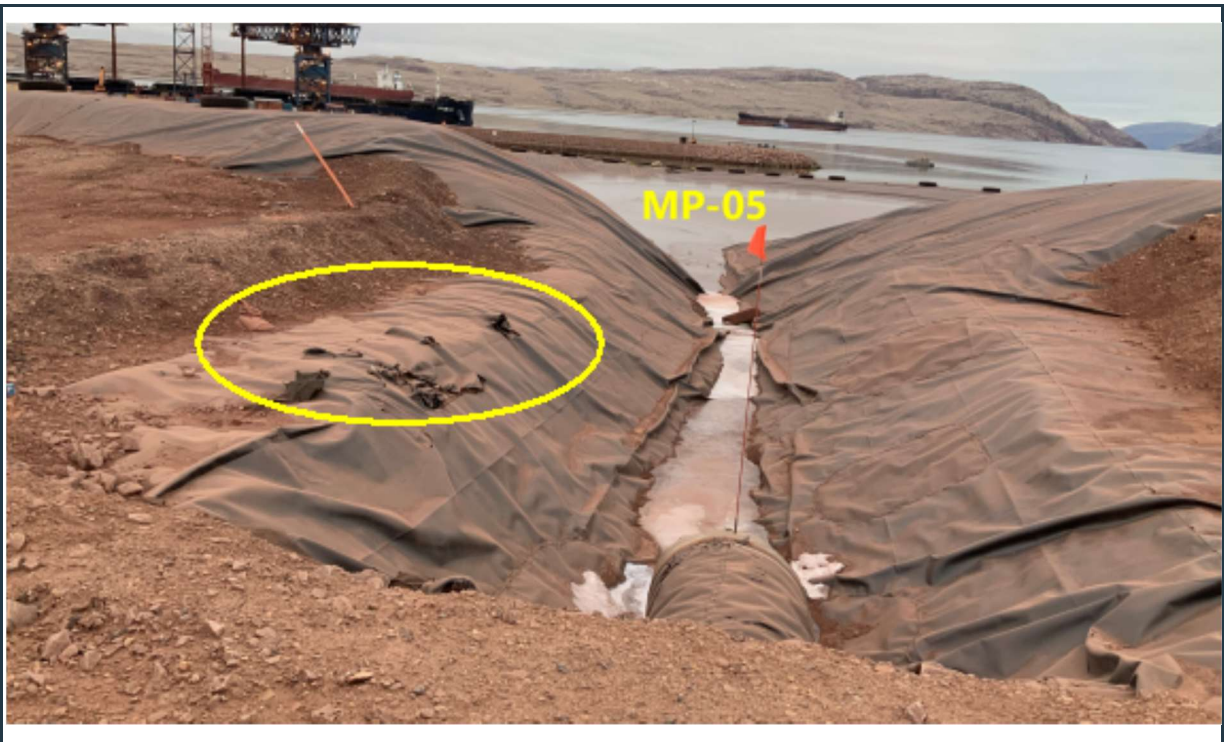
Minor liner damage was noted near the crest of the southern inlet channel to the pond. Consideration should be given to place protective berms adjacent to the slope's crest near the channel to prevent such damages.

Figure 52: Damages to the liner still visible on the west slope of the southern inlet channel to MP-05.

Baffinland Action: Baffinland is reviewing snow clearing practices for protection of this area and other suitable controls to prevent recurring minor liner damage (Completion prior to Freshet 2022). Baffinland will repair the liner damage that is above the water line (Completion Q3 2022).

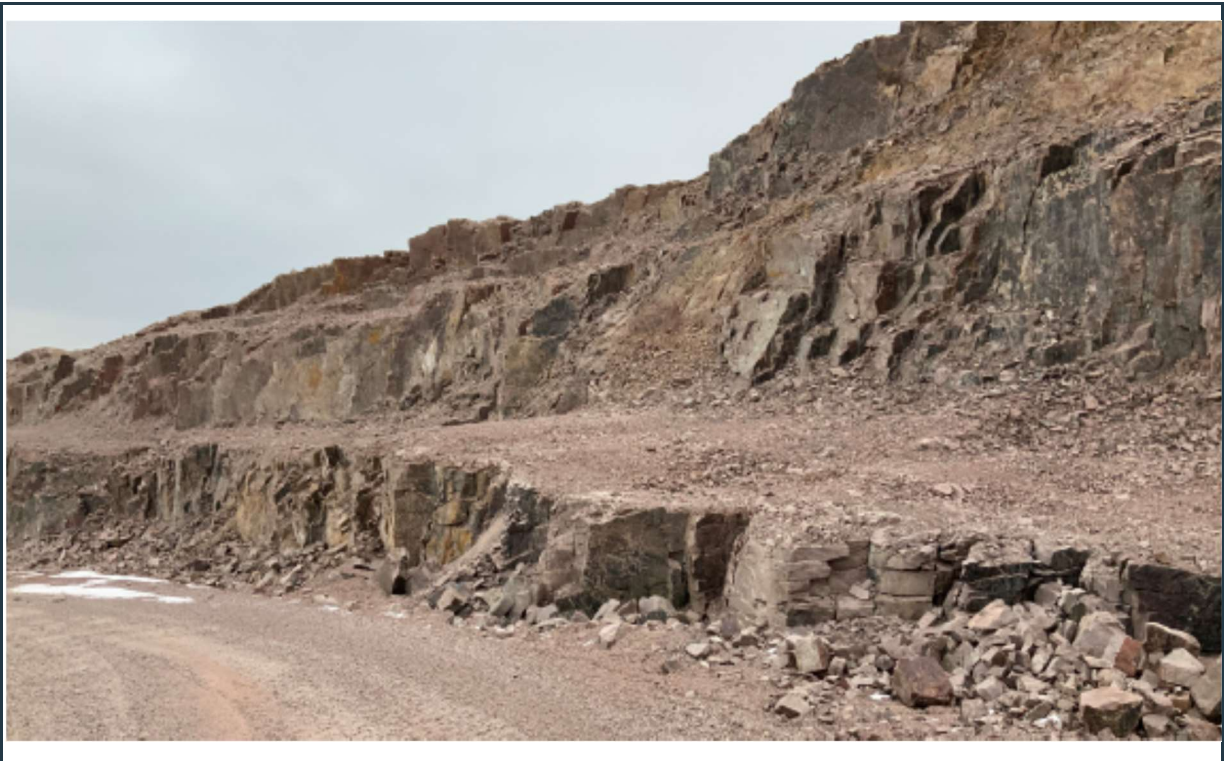
Figure 56: View of stable highwalls with minor weathering and bench erosion in the Q01 rock quarry.

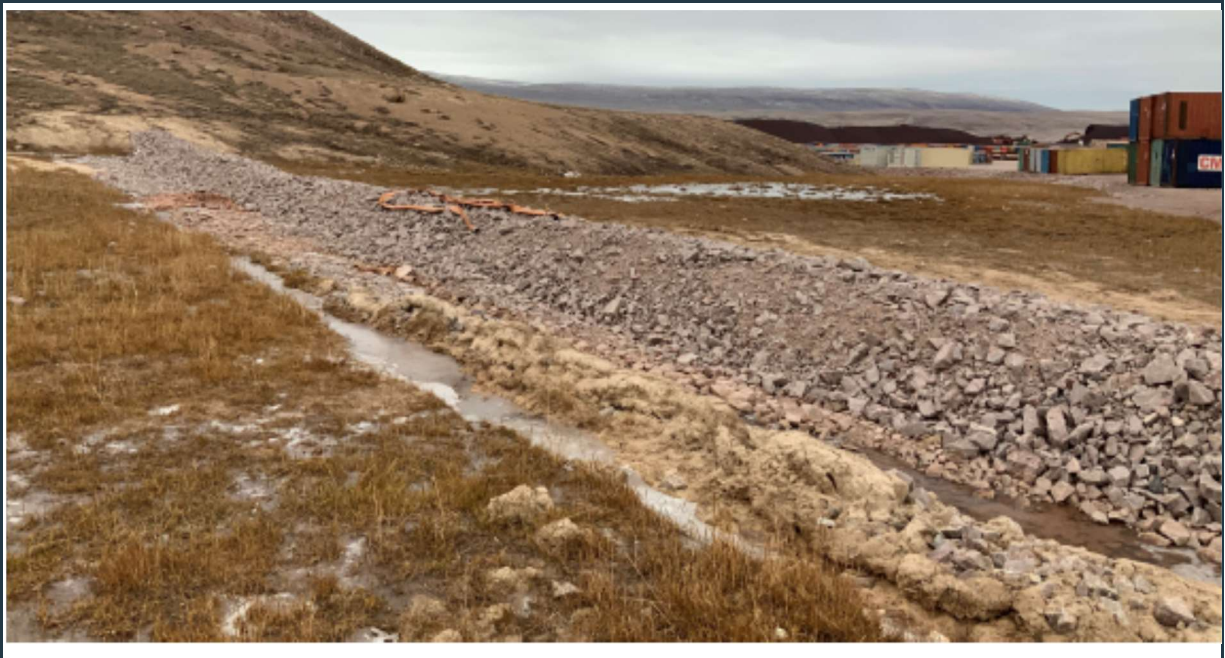
Sloughing of the sides of the P-SWD-3 ditch, adjacent to the LP2 laydown area, has occurred at several locations along the ditch. It is suggested that the existing condition of the P-SWD-3 drainage ditch and adjacent topography be re-evaluated in detail, and that the ditch be redesigned and reconstructed to drain the large amount of surface water to the correct direction. Some debris in the northern part of the ditch should also be removed.

Figure 57: View of a section of the P-SWD-3 surface water collection ditch with failed side slope. The failure of the ditch was caused by the uncontrolled water flow from the adjacent snow pile.

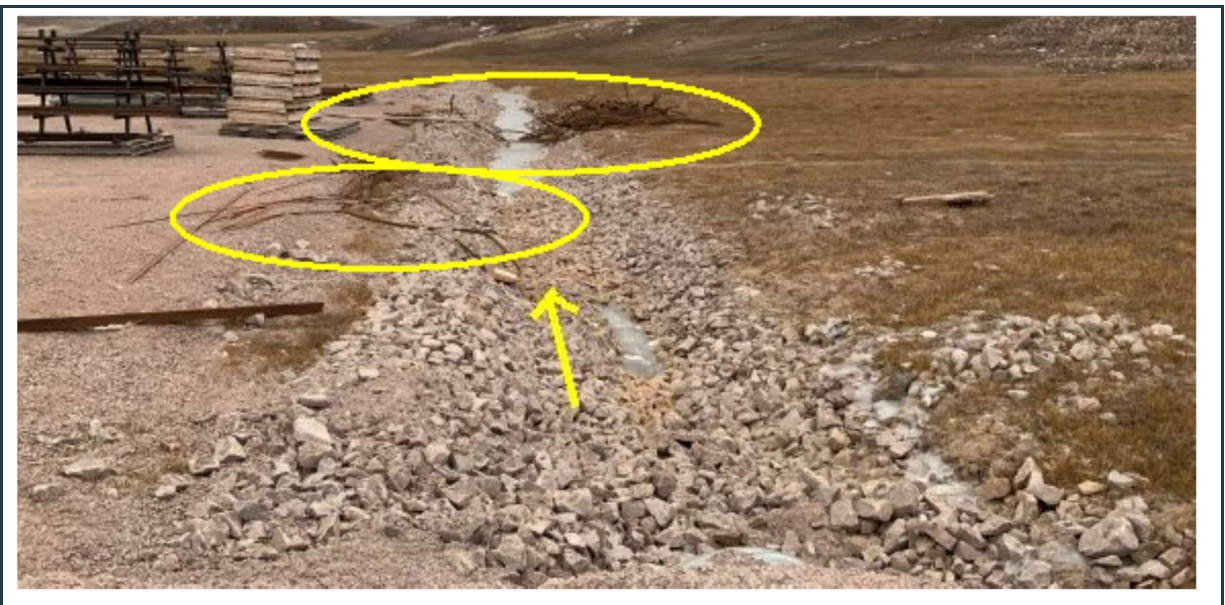
Figure 58: View of the north end of the P-SWD-3 surface water collection ditch. All debris should be removed from the ditch (yellow circles).

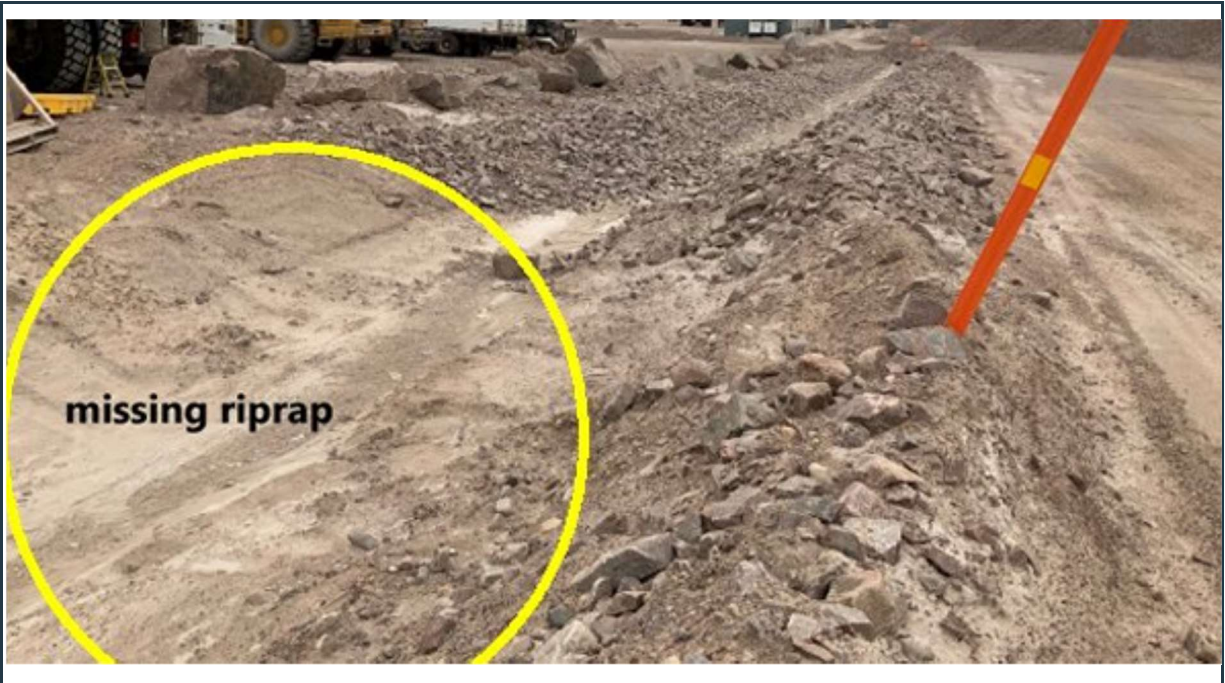
A short section of the P-SWD-5 ditch was noted with missing riprap. Rock fill riprap should be placed at this section to prevent unwanted erosion of the soil present at the base and slopes of the ditch.

Figure 59: P-SWD-5 – “Q01-North” surface water collection ditch with missing riprap at a short section.

Baffinland Action: Baffinland will repair the slopes at the identified section of the P-SWD-5 ditch (Completion prior to Freshet 2022).

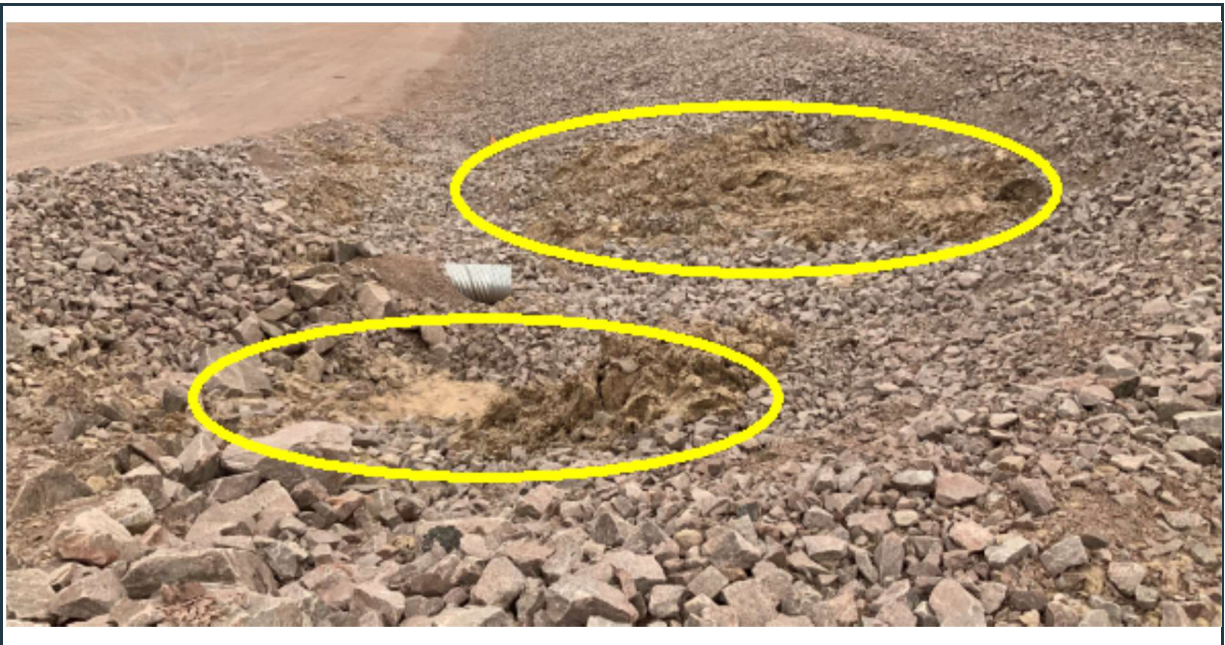
The PSC drainage ditch is still under construction, however, minor localized slope movements at the west end of the ditch should be repaired, regraded and the riprap rock fill cover reinstated.

Figure 66: View of the PSC surface water collection ditch and culvert (still under construction). Note the localized slope failures (yellow circles), which sections will require slope rehabilitation with riprap placement.

Baffinland Action: Baffinland will repair and regrade the identified area in the ditch and reinstate the riprap rock cover prior to completion of the construction of the PSC drainage ditch.

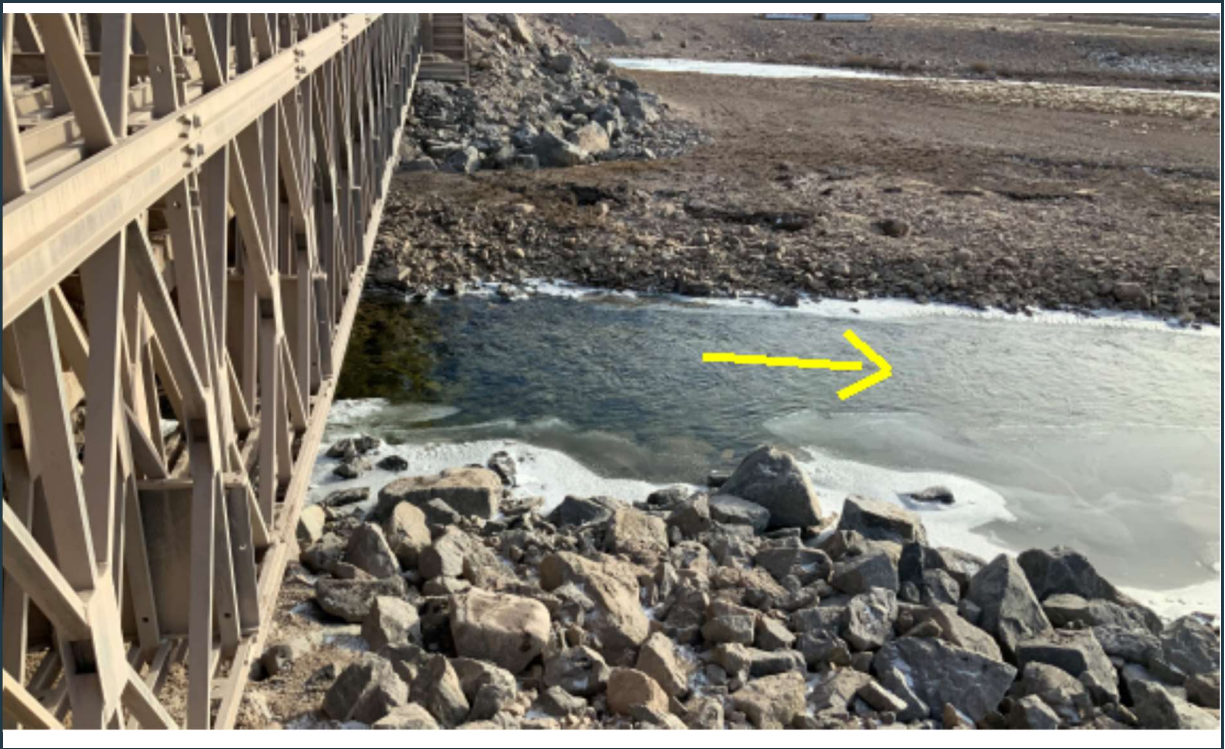
Figure 71: View of the west side of bridge 63, with stable abutments.

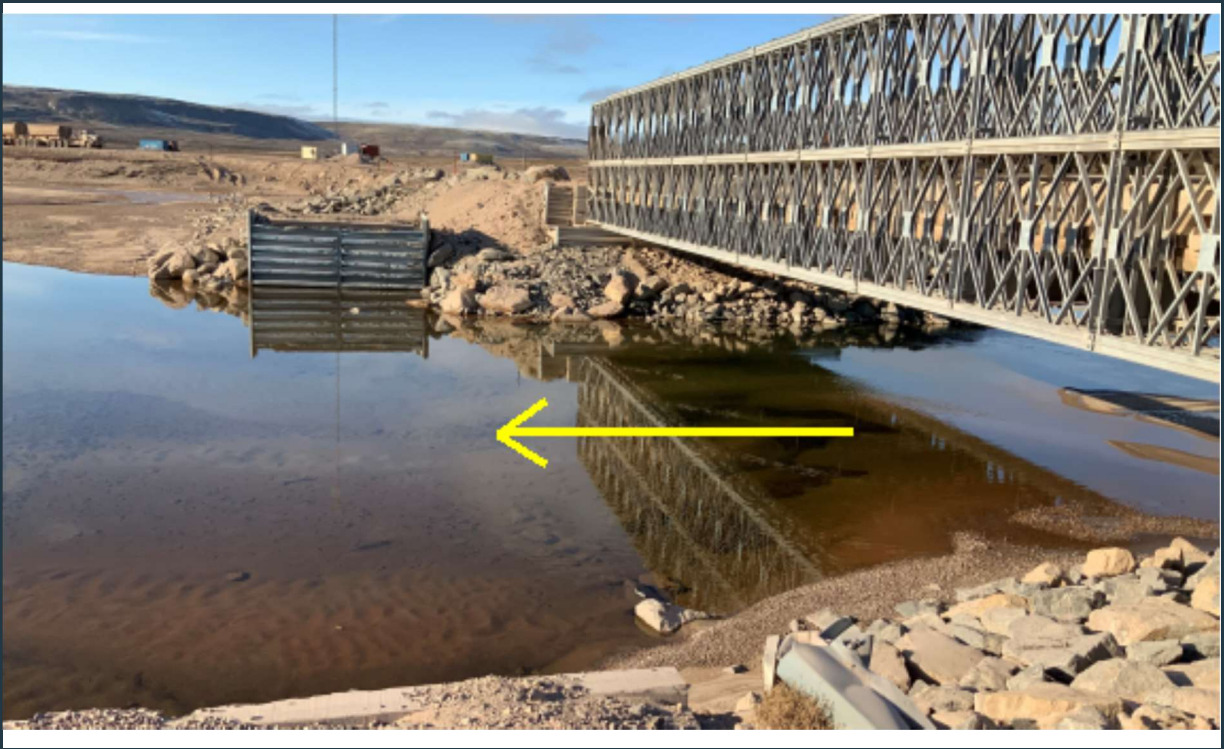
Figure 73: View of the west side of bridge 80, with the "old" abutment providing additional support.

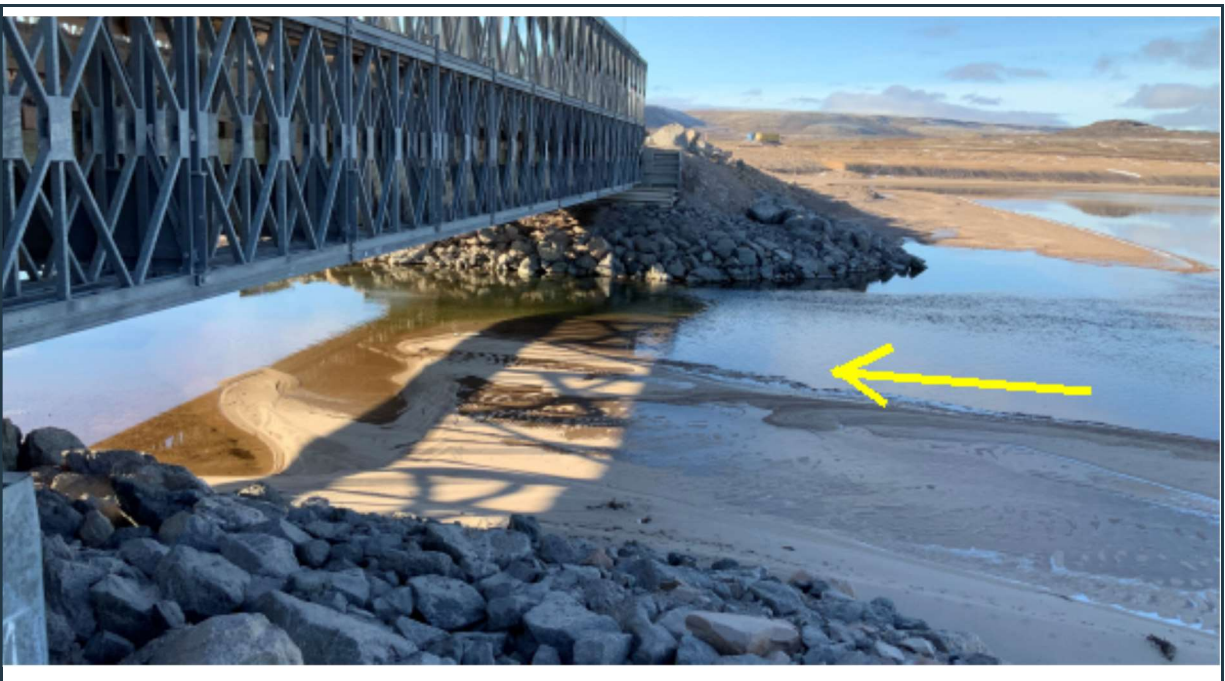
Figure 74: View of stable abutments at bridge 80. Note the low flow in September.
