RE: Submission of 2021 Geotechnical Inspection Report No. 2 (September 2021)

Mary River Project – Nunavut

November 16, 2021
TC190307.2021

Wood Environment & Infrastructure Solutions (Wood), has completed the second geotechnical field inspection of 2021 at the Mary River Project, which is a condition of the Type “A” Water Licence No: 2AM-MRY1325 – Amendment No.1 (“Water Licence”).

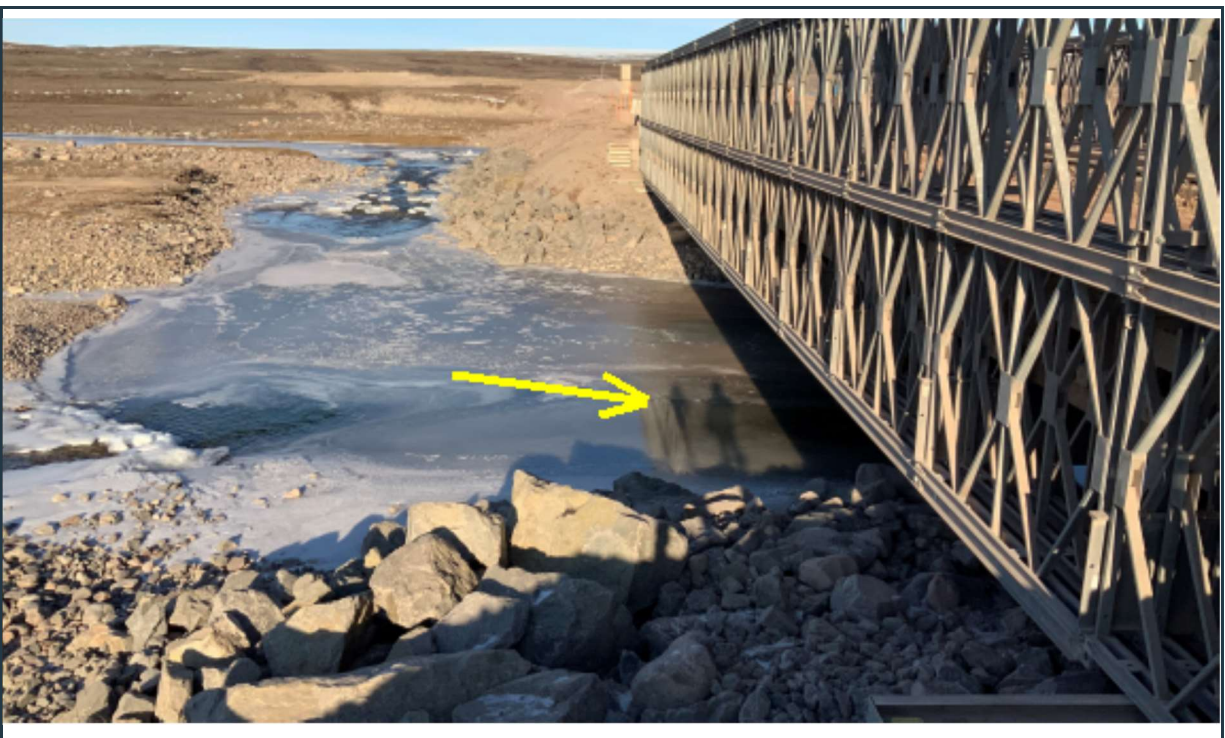
Figure 76: View of the two stable abutments and the east side of bridge 97, with ice in the river.

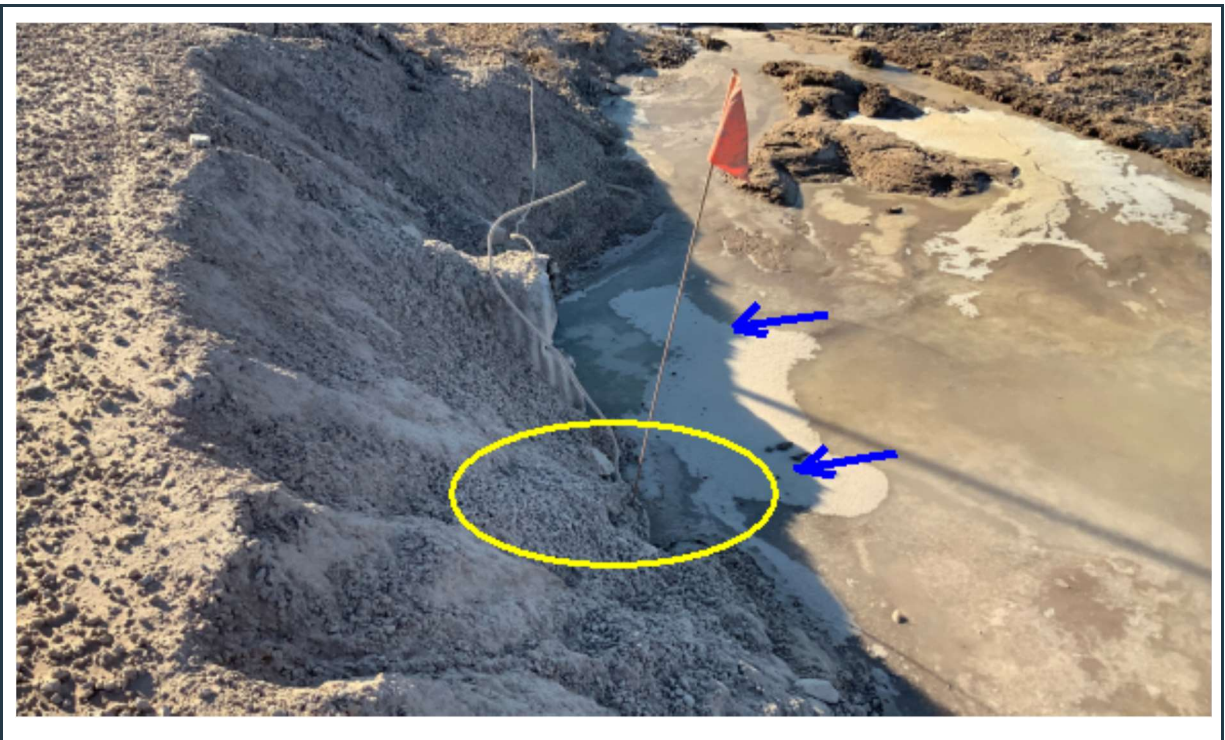
e) Culverts at the approximate station of KM 77+500 – (CV-030 A and B)

One (1) of the culverts is blocked with silt. It is suggested that the blocked pipe be replaced, and both ends of the pipes be protected from siltation by placing riprap around them.

Figure 86: View of the inlet to culverts 030A and B. Note that one of the pipes is clogged (yellow circle).

Baffinland Action: Baffinland commits to assessing the blocked culvert to determine if replacement is required and placing riprap at both ends of the culvert to prevent further siltation for occurring (Completion prior to Freshet 2022).

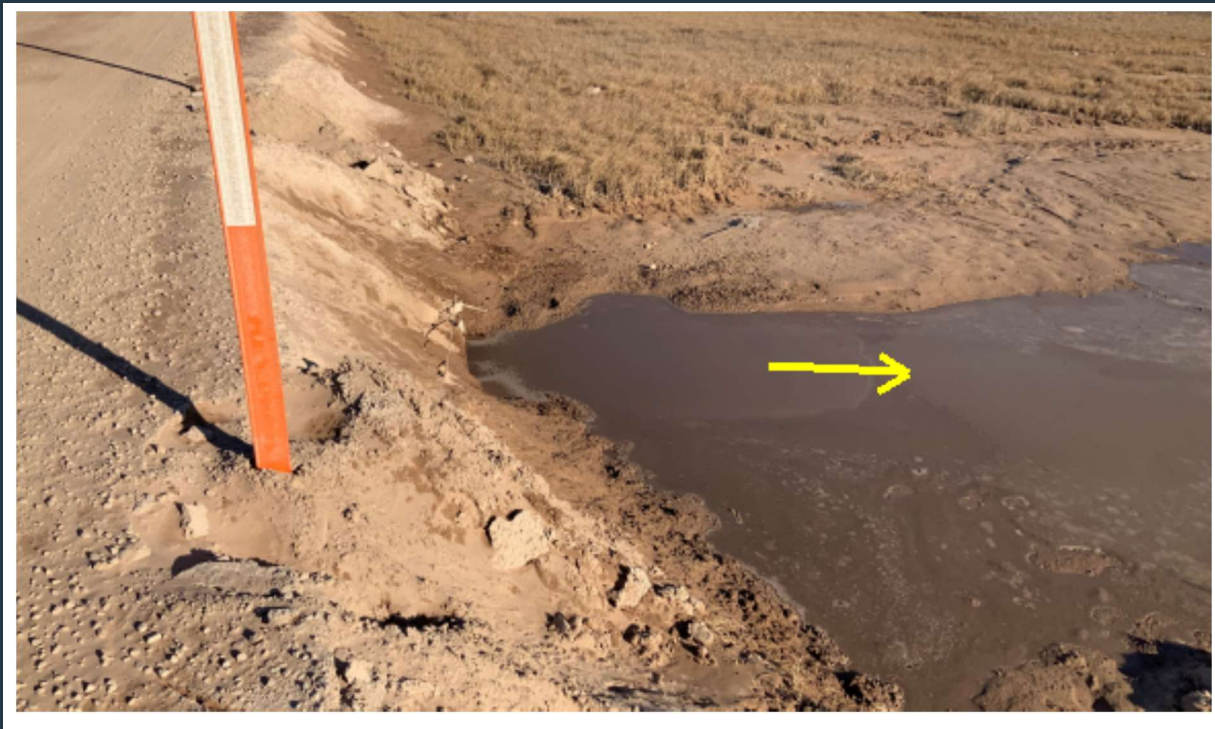
Figure 87: View of the outlet end of culverts 030A and B. Note that one of the pipes is clogged with soil.
