RE: Submission of 2022 Geotechnical Inspection Report No. 1 (June 2022)

Annual Geotechnical Inspections – 2022 Report 1.

Mary River Project – Nunavut

August 21, 2022,
OMGM2212

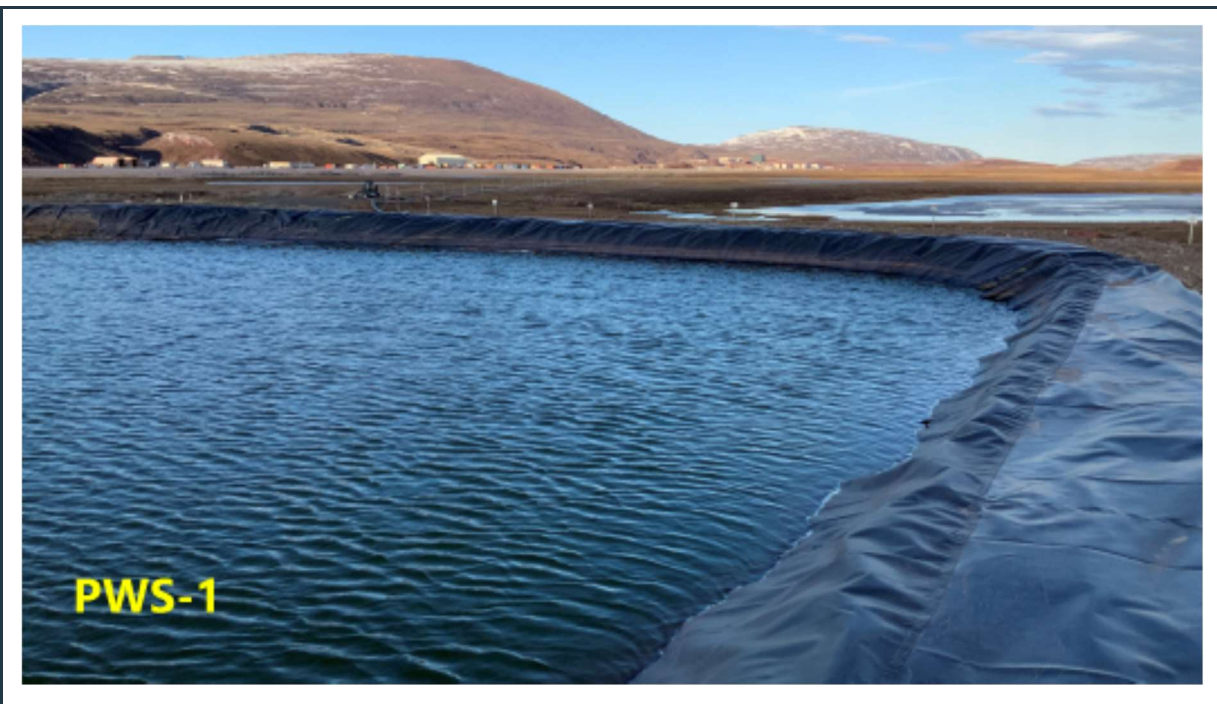
Figure 9: PWS pond #1. Well maintained stable perimeter berm and liner.

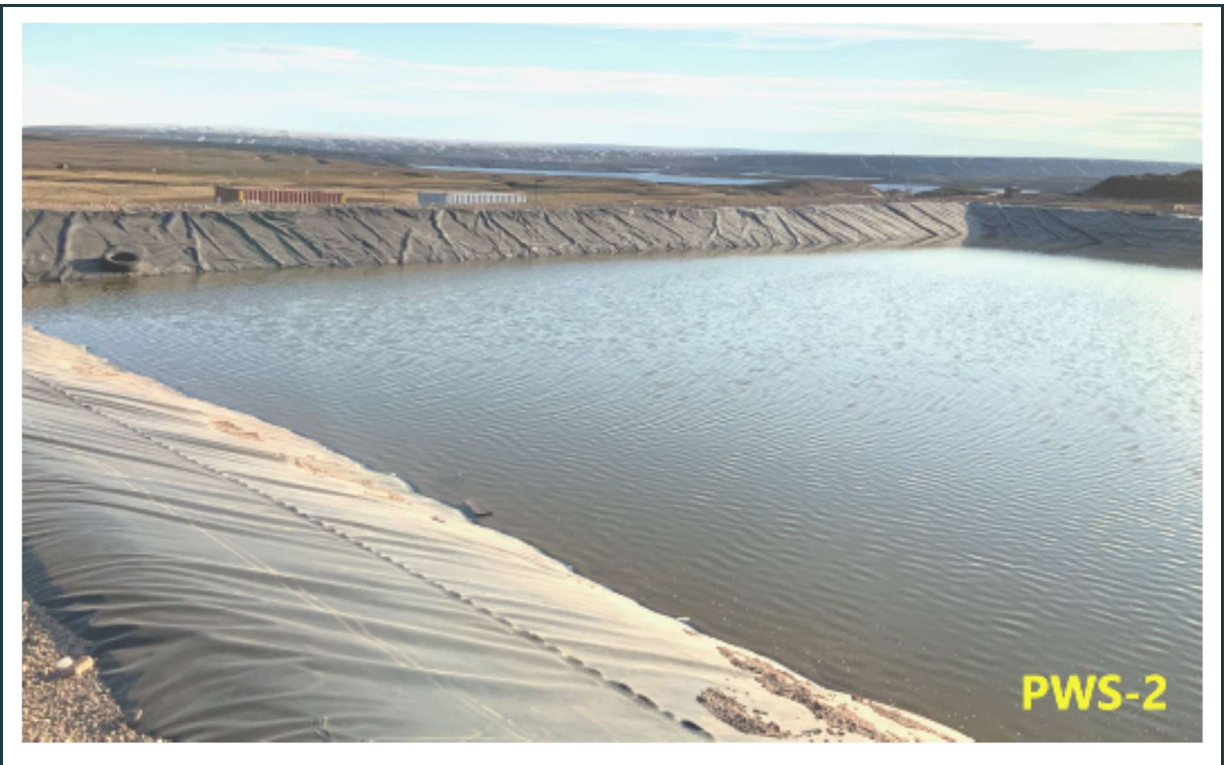
Figure 10: PWS pond #2 – Robust, stable, well-maintained berm and liner in and around the pond.

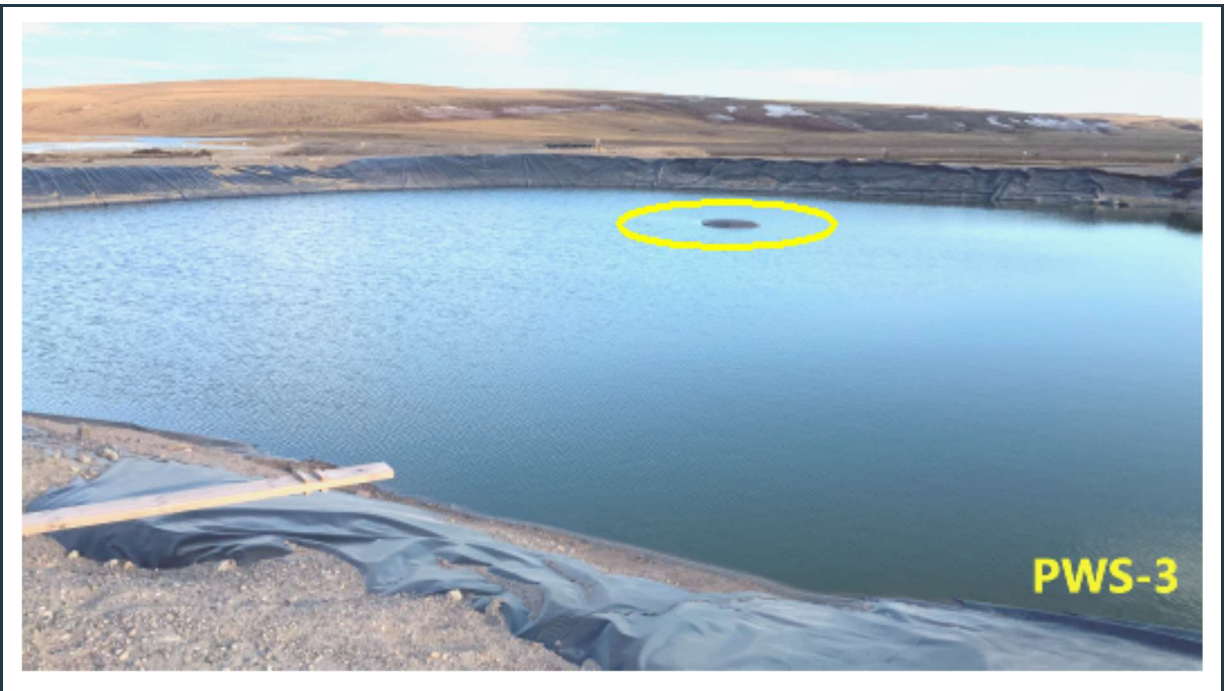
Figure 11: Stable perimeter berms and liner in PWS pond #3 – A small “floating” section of the liner is visible in the pond (yellow circle), which is quite common in shallow ponds.

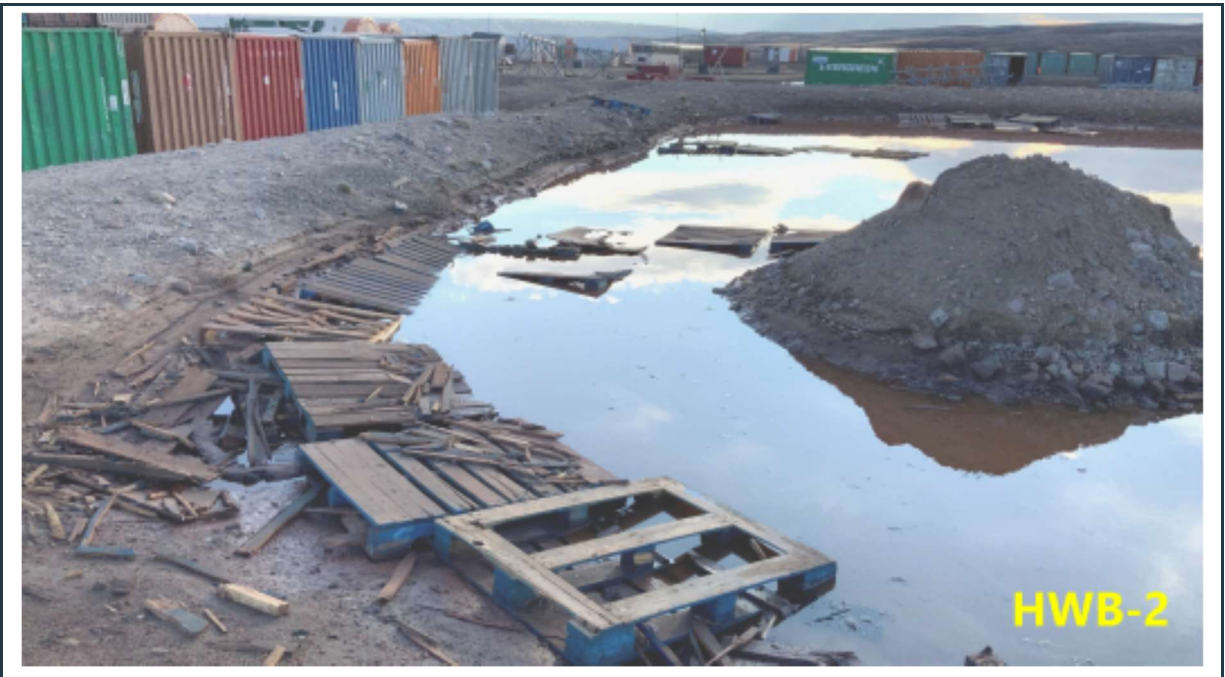
b) HWB-2

Wooden pallets observed in the cell should be removed to prevent potential damage to the liner.

Figure 13: View of stable berms around HWB-2. The wooden pallets should be removed.

Baffinland Action: Baffinland will remove the wooden pallets and wooden pallet debris from HWB-2, to prevent potential damage to the liner, during routine maintenance activities.

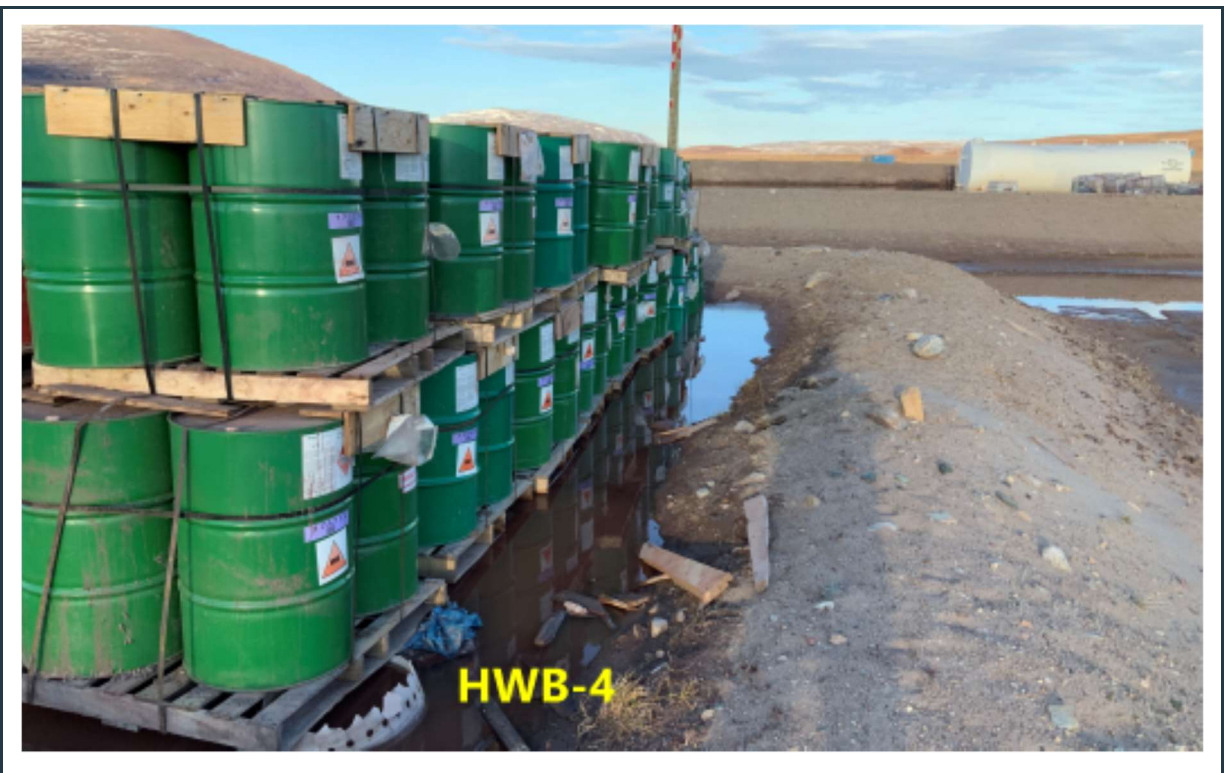
Figure 15: View of stable berms at HWB-4, with jet-fuel barrels stored on wooden pallets.

Baffinland Action: Baffinland will remove the wooden debris from HWB-4, to prevent potential damage to the liner, during routine maintenance activities.

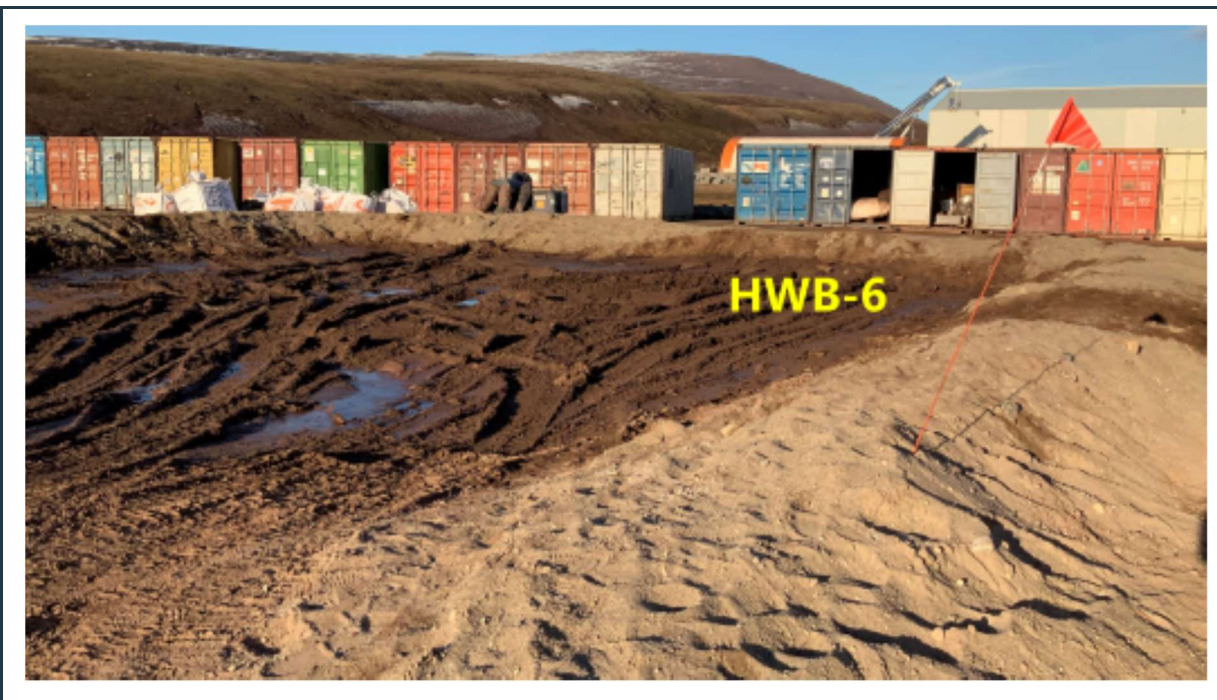
e) HWB-6

Some disturbance from foot-traffic was noted on sections of the berm. The cell was recently emptied and the internal subgrade was disturbed by truck-traffic. After the area dries, the disturbed granular subgrade must be leveled/regraded. The regrading operation should not damage the liner.

Figure 17: View of the somewhat disturbed but stable berm around the HWB-6 cell. The cell was recently emptied, and the internal subgrade disturbed, which needs to be leveled.

Baffinland Action: Baffinland will relevel/regrade the disturbed subgrade within the cell after the area dries in a manner that does not damage the liner (Completion Q3 2022). Berm sections disturbed by foot traffic will be maintained during routine maintenance activities. Baffinland continues to educate personnel on access to berms.

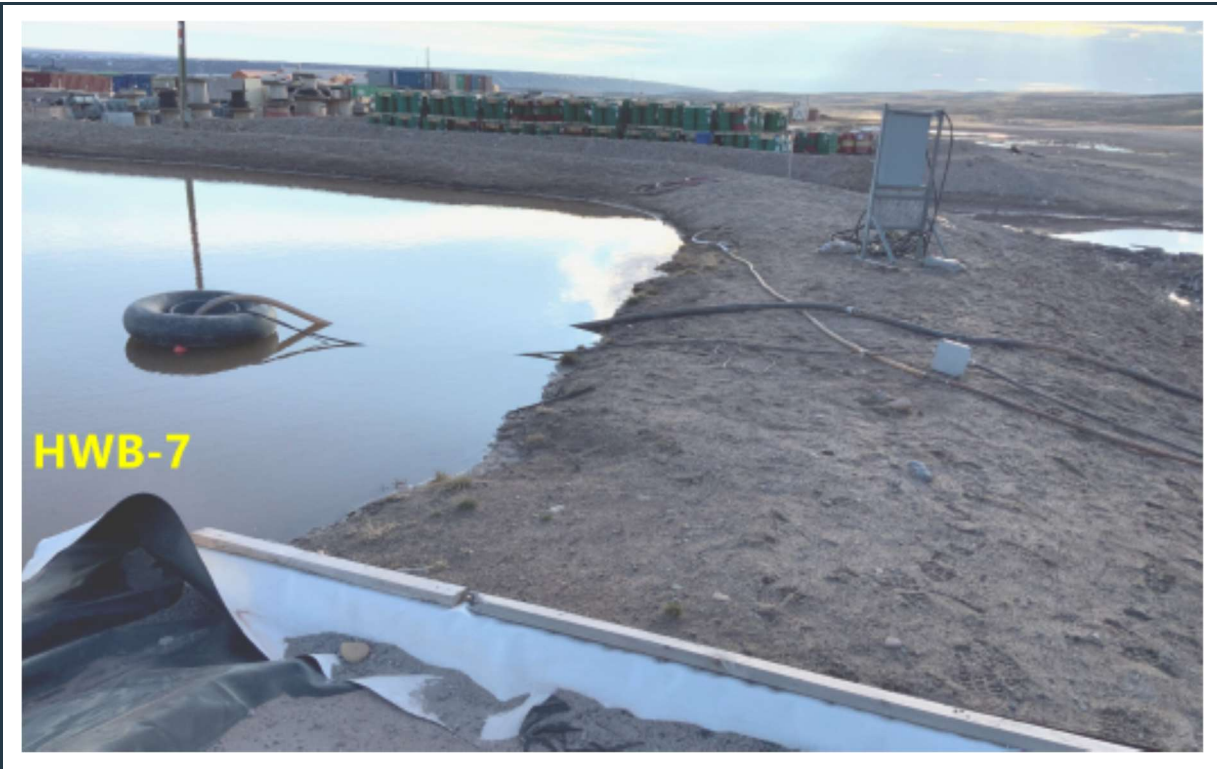
Figure 19: View of the somewhat lower crest of the east berm at the flooded HWB-7 cell.

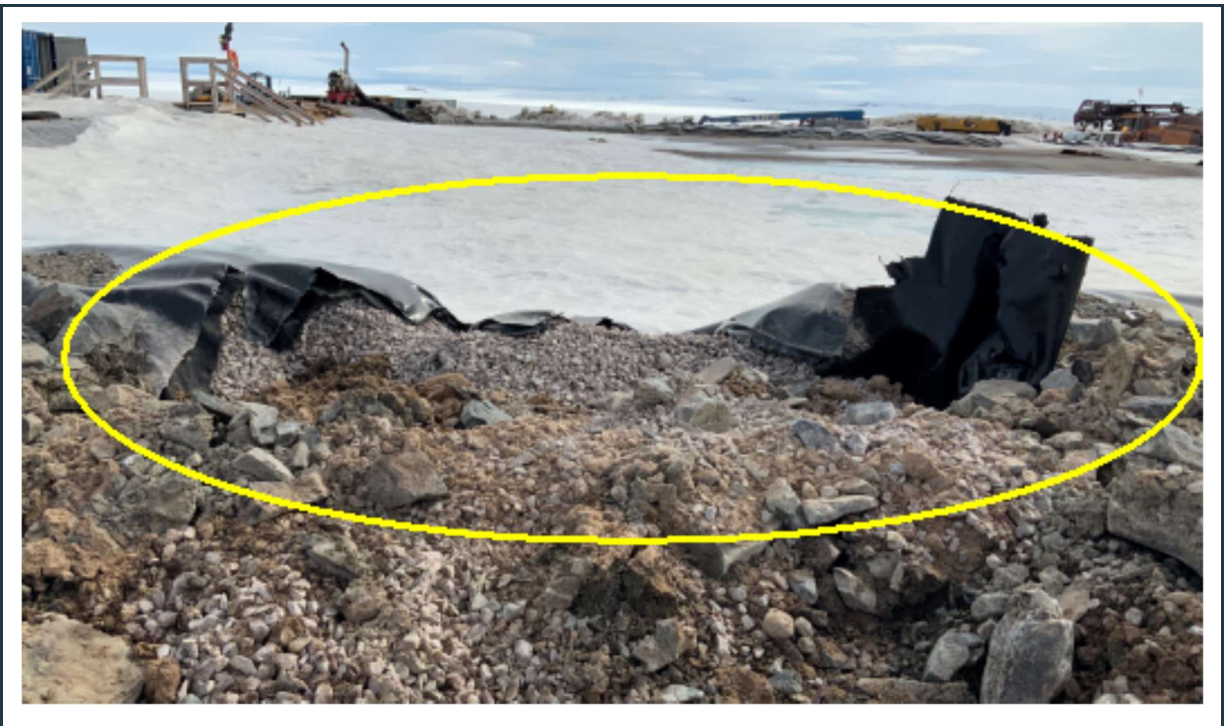
A section of the rock fill berm and liner at the south west berm of the pond have been damaged recently. The damaged berm section and liner should be repaired as soon as practically possible.

Figure 25: Damaged rock fill berm and liner at the south-west section of the berm at the water treatment pond, located adjacent to the waste rock disposal facility.

Baffinland Action: Baffinland will repair the damaged berm section and liner (Completion Q3 2022).

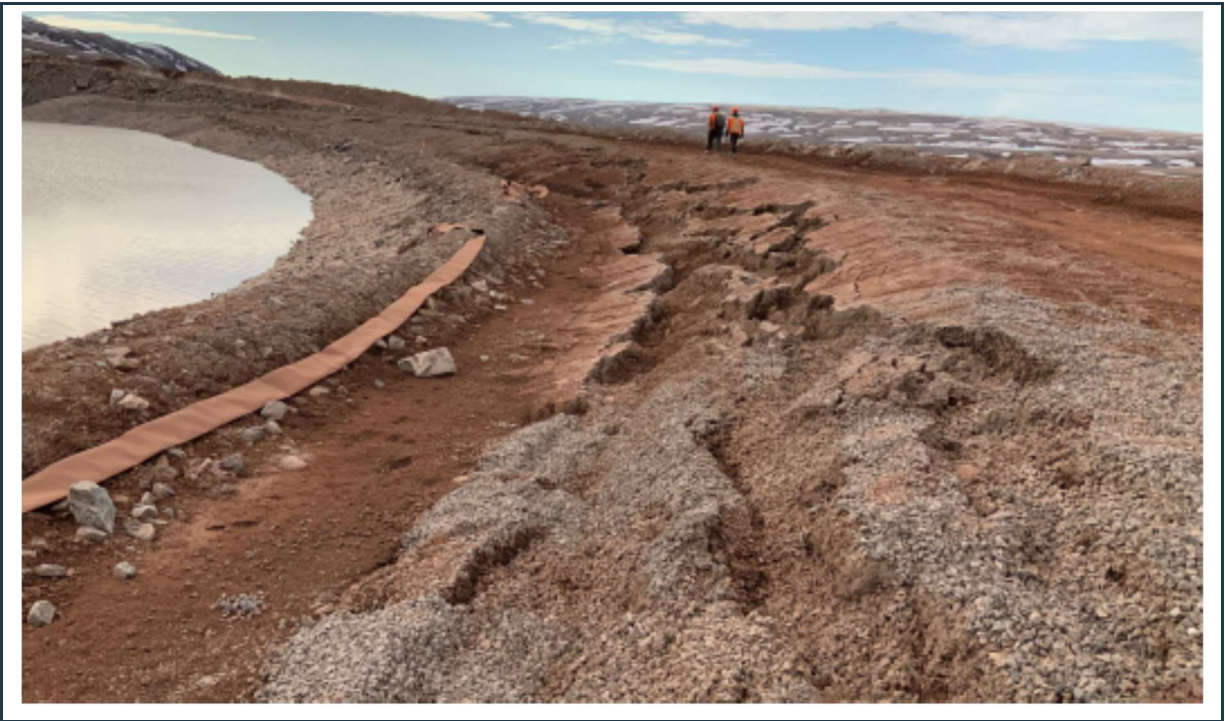
Some frost related damages were observed along the road next to the southern zone of the MS-11 pond's slope. It appears that large ice pockets were likely present in the ground during construction of the pond during the fall and winter which likely thawed during the start of summer resulting in cracks within the ground near the surface. The area of frost/thaw impacted zones must be regraded/filled as soon as practically possible to prevent water collection in those cracks in the future.

Figure 28: View of some frost related damages along the road next to the MS-11 pond (south pond) that must be repaired.

Baffinland Action: Baffinland evaluated the presence of cracks along the road next to the southern zone of the MS-11 pond's slope. The cracks resulted from material moving down the slope on the pond's liner. Observations noted by Baffinland engineers; the liner is intact and there is no risk to the integrity of construction as it appears the slope has stabilized.

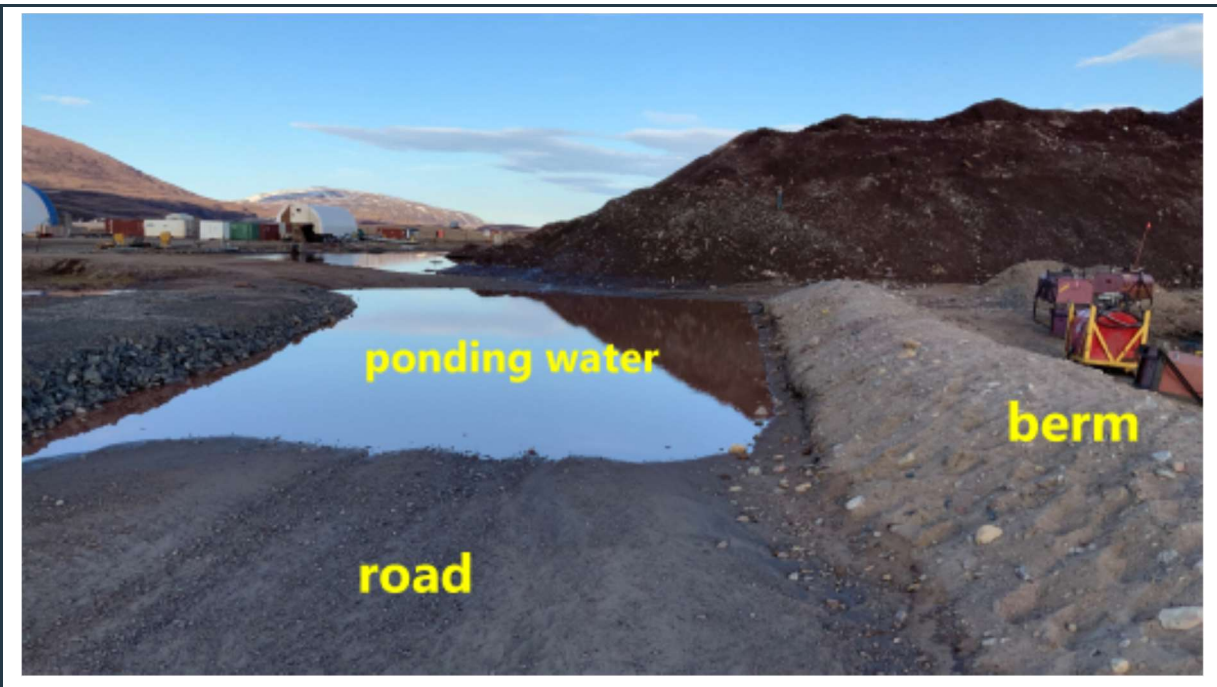
Figure 30: View of ponding water adjacent to the north-east berm of the “fuel bladder” cell. The low area of the road should be filled with sand and gravel, and the water diverted away from the cell.

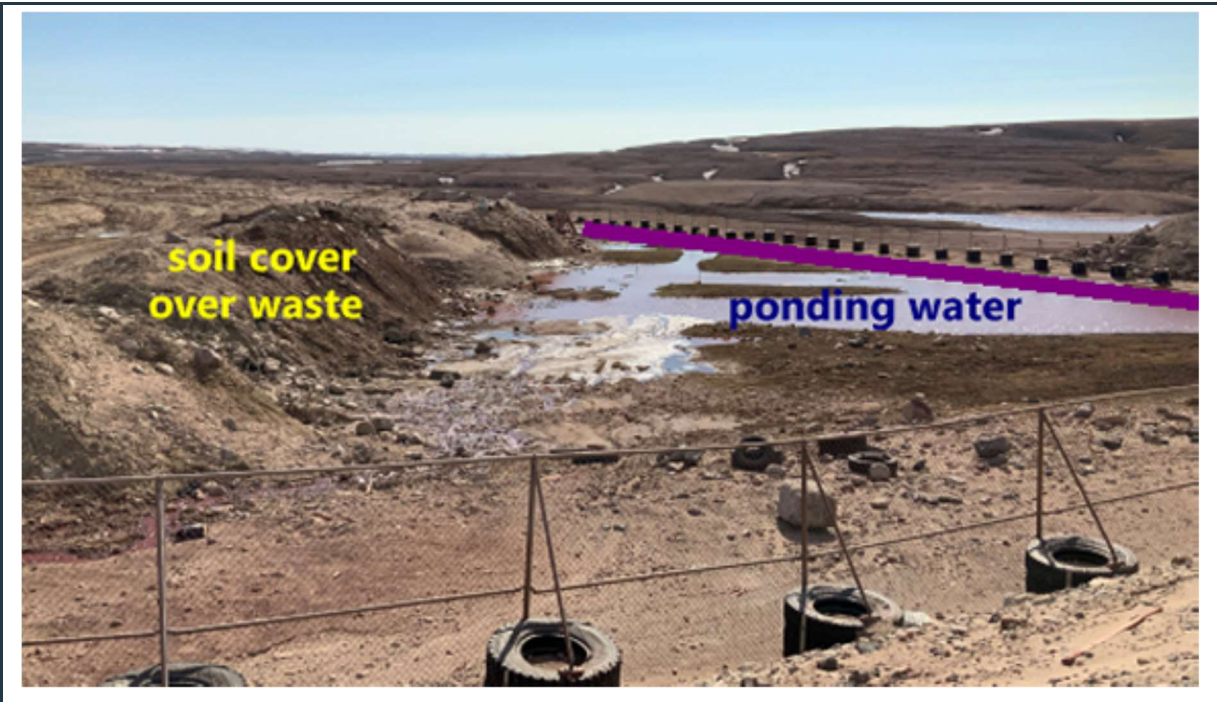
Surface water was ponding along a section of fence during the June inspection, and some of that water may flow out of the facility uninterrupted. To prevent the migration of suspended solids into the surrounding environment, it is recommended that an erosion and sediment control berm be constructed inside the fence. Similar observations were made during the first geotechnical inspection in 2021.

Figure 34: Solid waste landfill facility with ponding water along a section of the perimeter fence.

Baffinland Action: Water quality results at surface water drainage monitoring stations located down-gradient of the non-hazardous waste landfill do not indicate any impact to the downstream receiving environment from surface water runoff at the solid waste facility. Baffinland will continue to monitor the ponding water and receiving environment water quality and will implement mitigation measures if monitoring indicates a potential water quality issue.

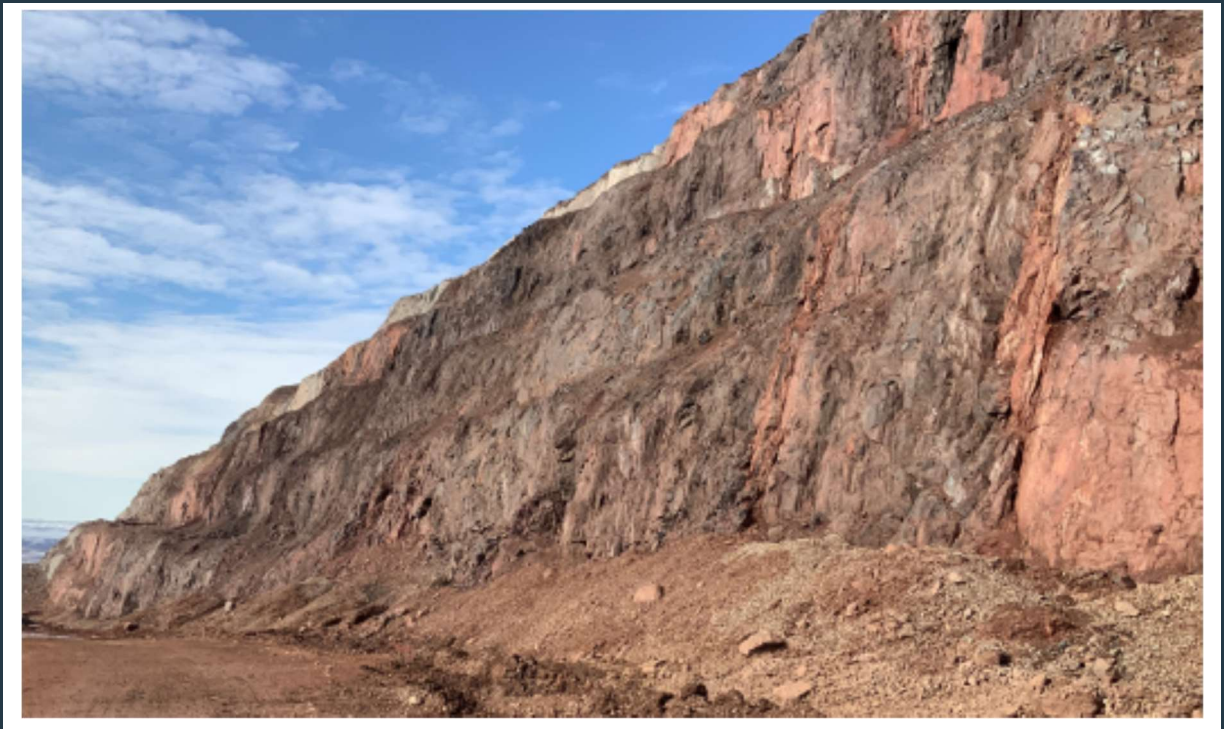
Figure 38: Stable pit-walls with minor rock weathering and pit-wall erosion.

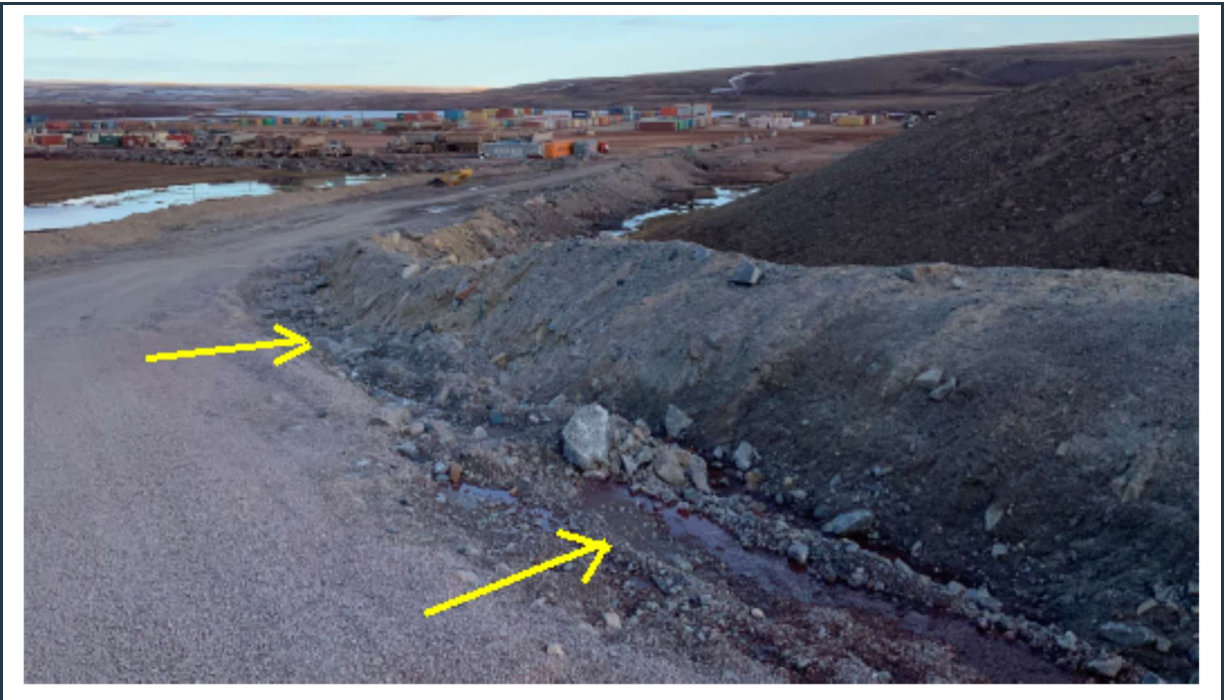
Figure 40: View of the access road to the quarry that requires additional maintenance work.

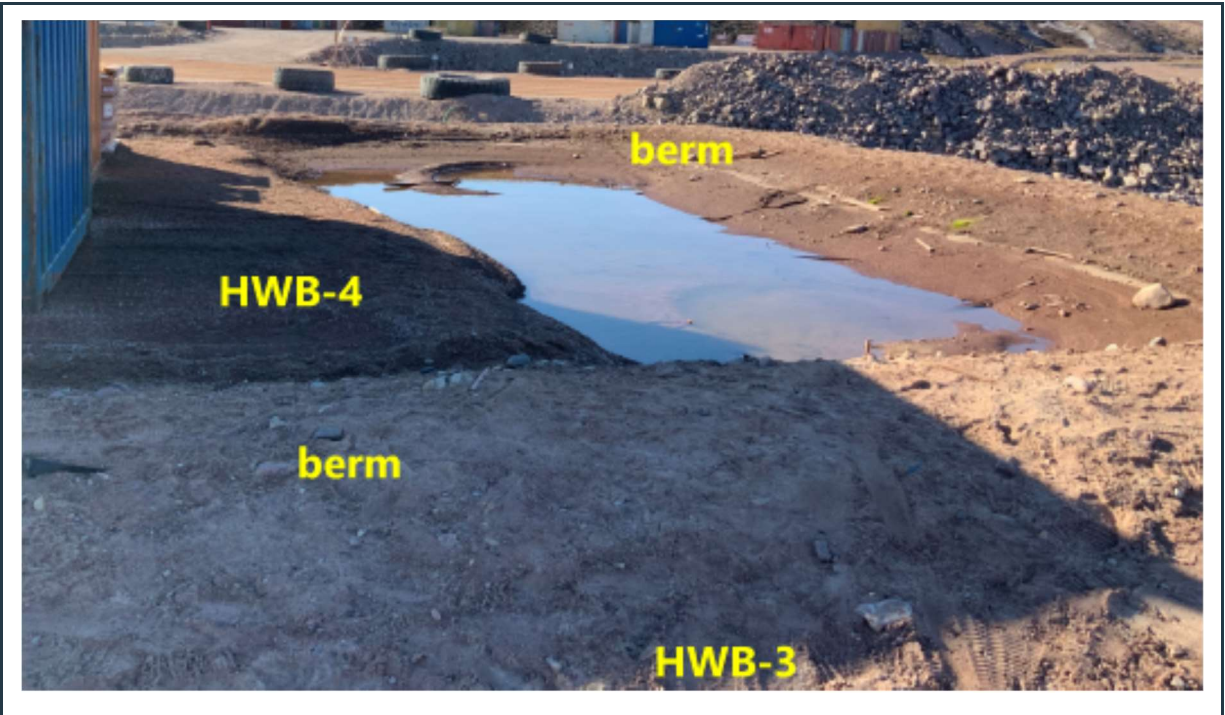
Figure 46: Stable berms around and ponding water within the HWB-3 and HWB-4 cells.

Baffinland Action: Baffinland recently completed regrading work at the entrance of HWB-3/HWB-4. An assessment of that work will be completed and, if necessary, additional regrading will be completed within the cells as recommended to ensure potential spills and contact water remain contained within the facility (Completion August 31, 2022).

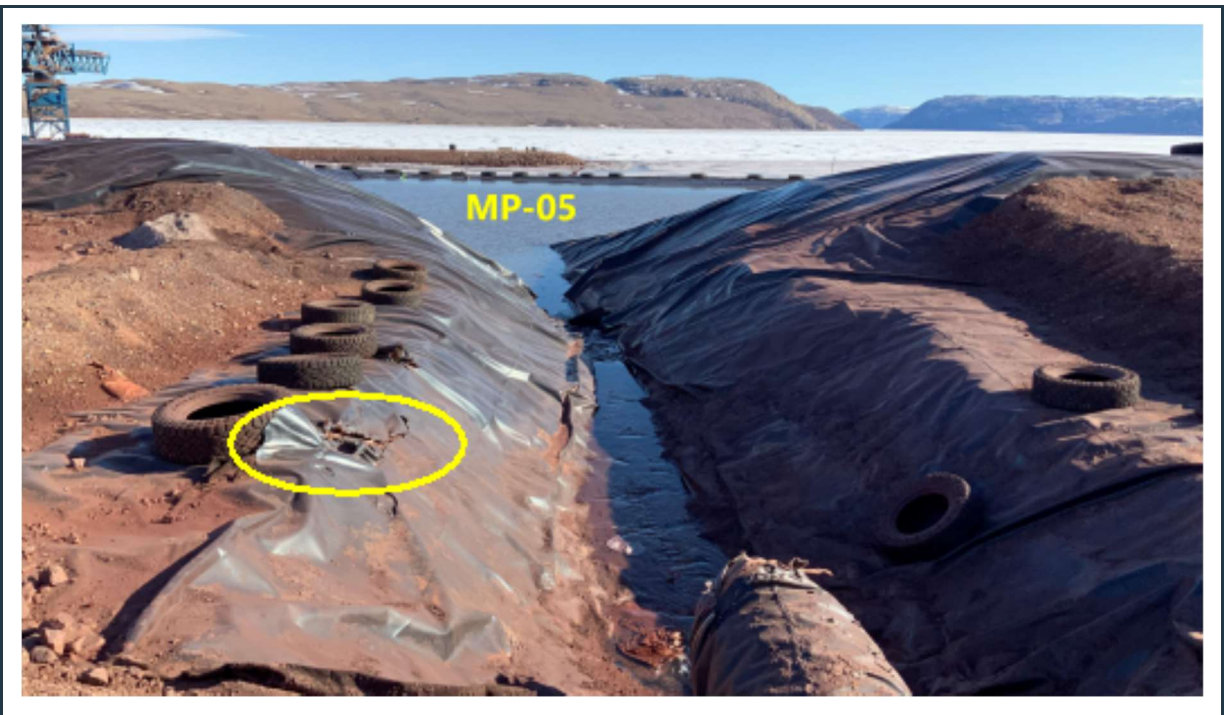
Minor liner damage was noted on the west slope of the southern inlet channel to the pond. Consideration should be given to place protective berms adjacent to the slope's crest near the channel to prevent such damages.

Figure 53: Minor liner damage on the west slope of the southern intake channel that should be repaired.
Note the still frozen bay in the background.

Baffinland Action: Baffinland is continuing to review snow clearing practices for protection of this area and to determine if there are suitable controls to prevent recurring minor liner damage). Baffinland will repair the liner damage on the west slope of the southern inlet channel (Completion Q3 2022).

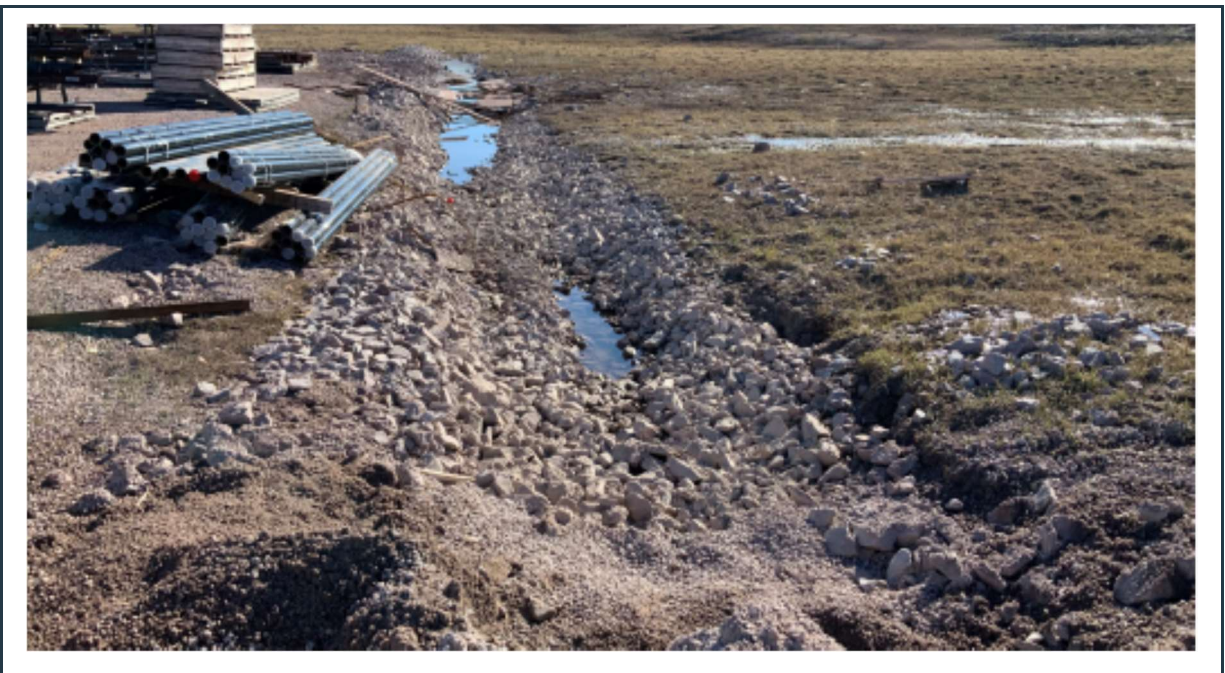
Sloughing of the sides of the P-SWD-3 ditch, adjacent to the LP2 laydown area, has occurred at several locations along the ditch. It is suggested that the existing condition of the P-SWD-3 drainage ditch and adjacent topography be re-evaluated, and that the ditch be redesigned and reconstructed to drain the large amount of surface water to the correct direction. It is also suggested that the snow stockpile adjacent to the drainage ditch be relocated to reduce flow to the ditch and allow for more efficient surface flow conditions during freshet.

Figure 59: View of the northern part of the "P-SWD-3 surface water collection ditch with failed slopes and ponding water. The ditch should be redesigned and reconstructed.

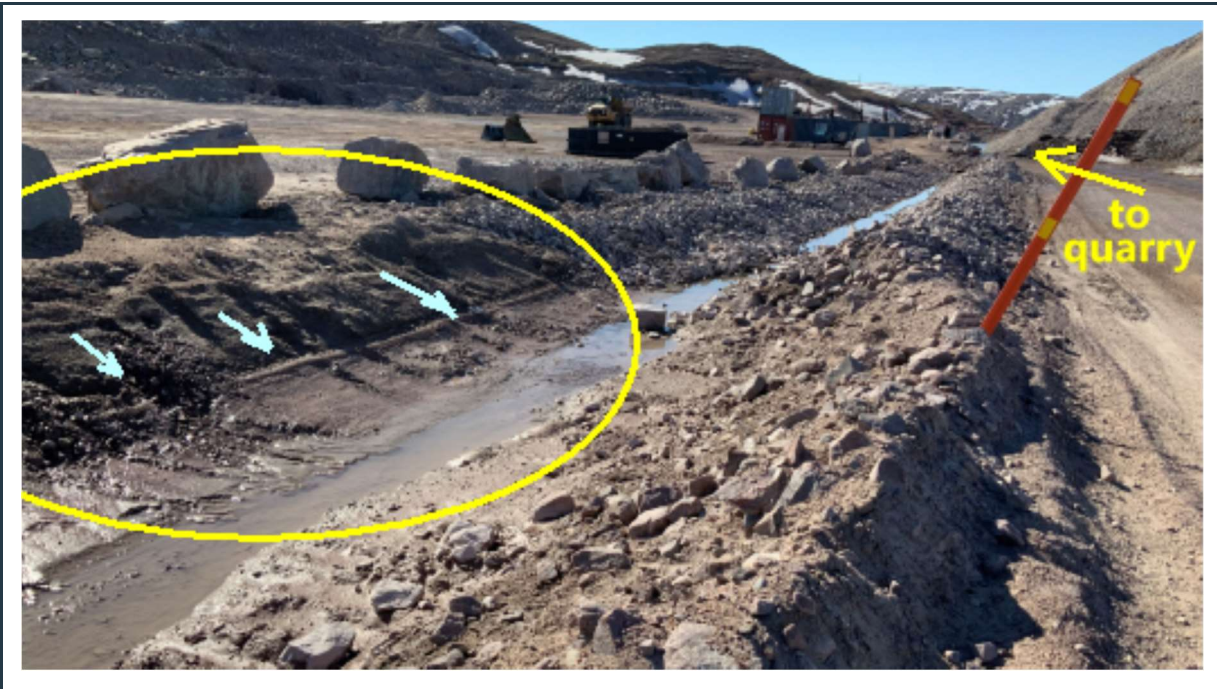
A short section of the P-SWD-5 ditch was noted with missing riprap and continuous water seepage from the side-slope was observed during the recent inspection. The side-slope should be covered with geotextile and rock fill riprap should be placed at this section to prevent unwanted seepage, and erosion of the soil present at the base and slopes of the ditch. Due to the increased localized seepage from the quarry at this location, placement of a more robust riprap slope protection is recommended. There is also

Figure 60: P-SWD-5 – “Q01-North” surface water collection ditch with missing riprap at a short section.

Baffinland Action: Baffinland has initiated remedial actions to repair the slopes at the identified section of the P-SWD-5 ditch (Completion Q3 2022). Baffinland will assess the clogged culvert to determine appropriate corrective actions to reestablish proper drainage flow (Completion Q3 2022).

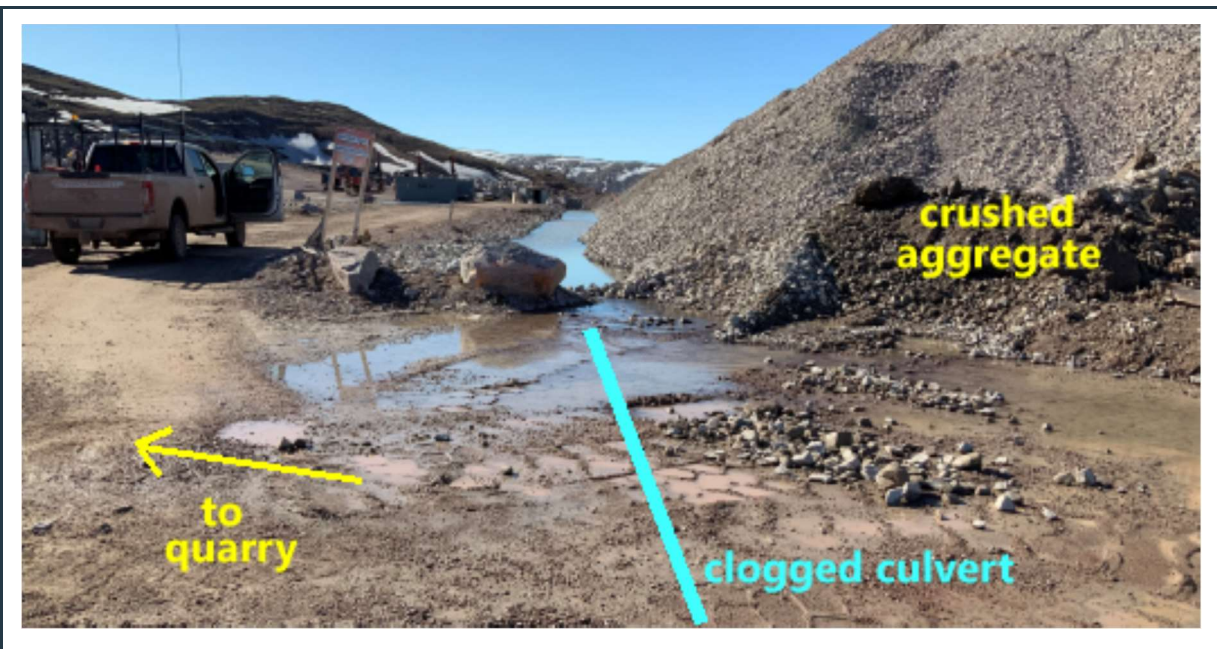
a clogged culvert along this ditch, located beneath the road at the entrance to the quarry. The clogged culvert should be cleaned or replaced if necessary; preferably with a larger diameter culvert.

Figure 61: Clogged culvert at the entrance to the quarry in P-SWD-5 – “Q01-North” surface water collection ditch. The south section of the ditch is flooded and the collected water flows onto the road to the quarry.

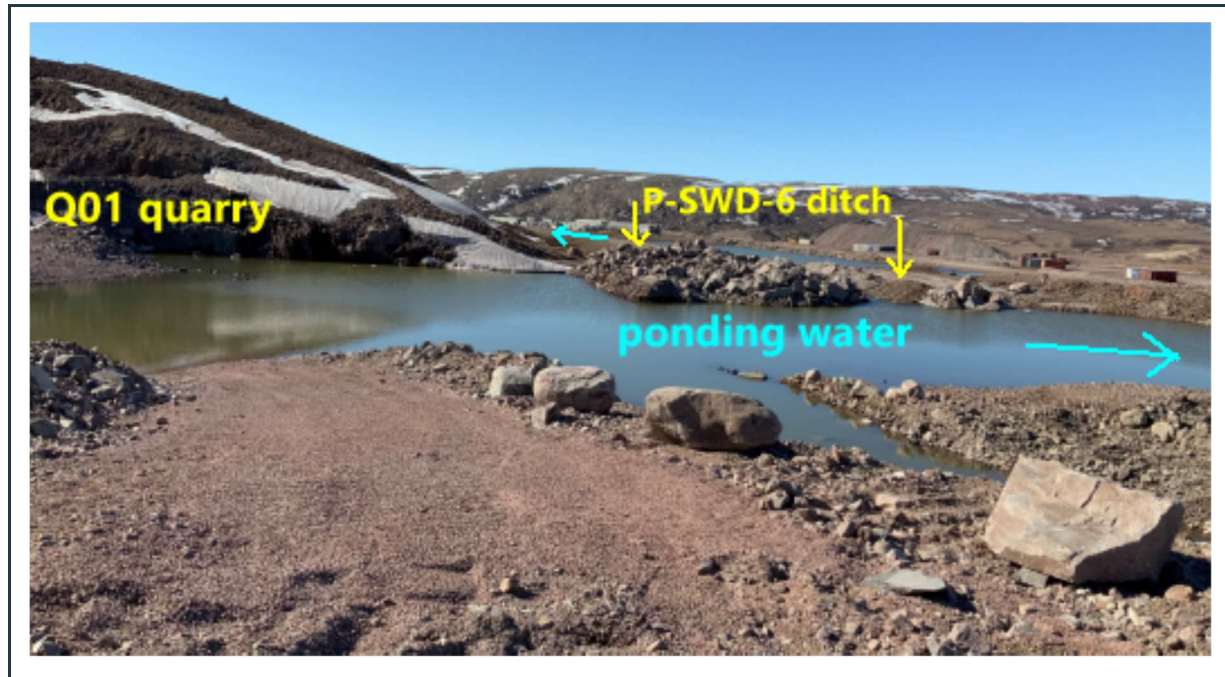
Figure 62: Ponding water next to the P-SWD-6 - "Q01 South" surface water collection ditch.

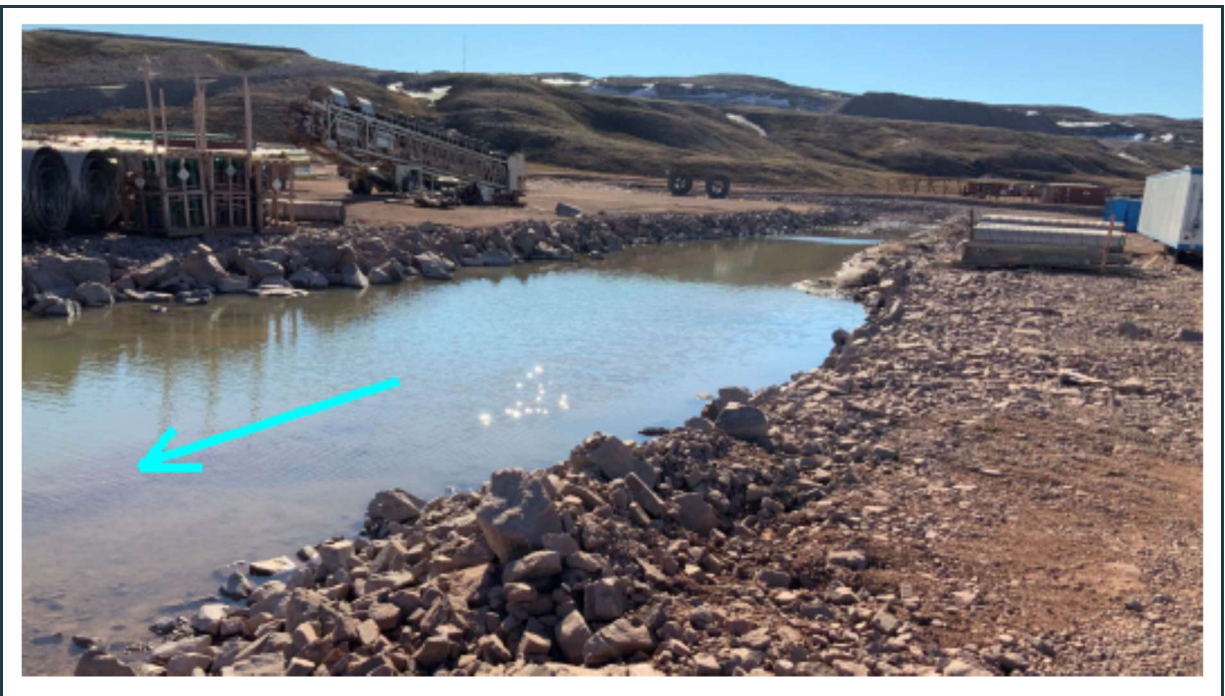
During the inspection, short-term high flow was observed in the W3/S14 drainage ditch. To drain the increased flow more efficiently, it was suggested that the ditch be extended toward the west.

Figure 65: View of the W3/W14 surface water collection ditch, experiencing temporary high flow.

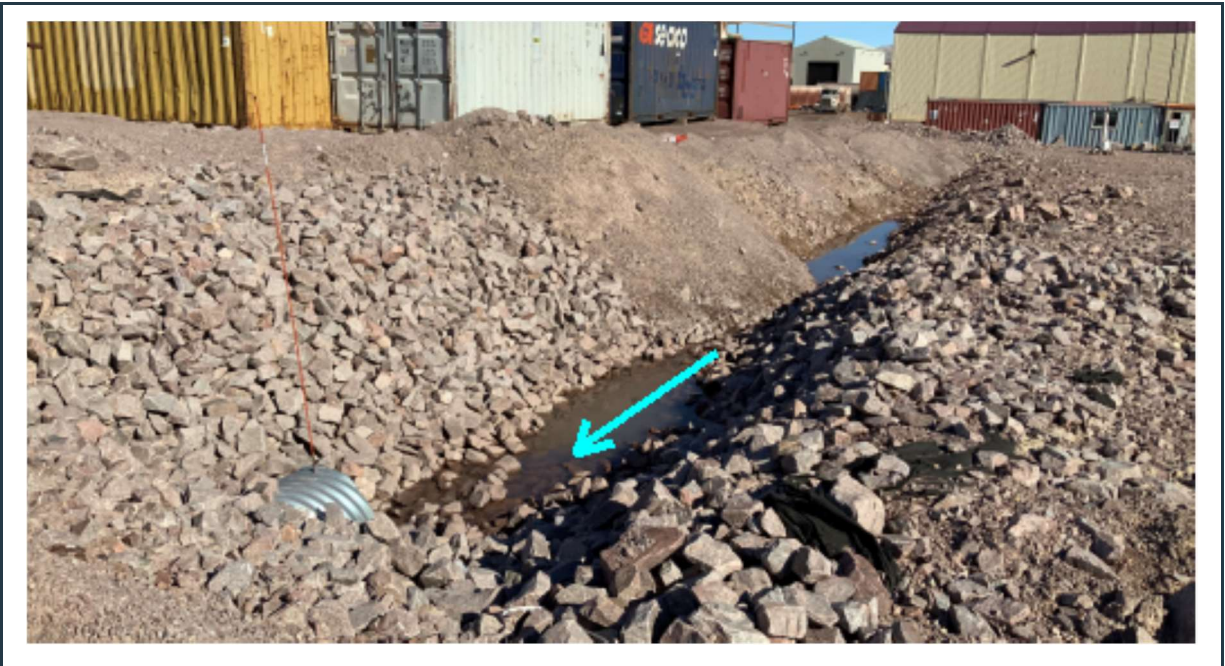
The PSC drainage ditch is still under construction, however, minor localized slope movements/failure at the west end of the ditch should be repaired, regraded and the riprap rock fill cover reinstated. Consideration should be given to reshape the west section of the ditch and reinstall the culvert to a lower invert level to prevent ponding in this section of the ditch.

Figure 68: View of the west section of the PSC surface water collection ditch. Note the culvert with too high invert elevation, resulting in ponding water in this section of the ditch.

Baffinland Action: Baffinland completed the repair and regrade of the identified area in the ditch where localized slope movements/failure have occurred and reinstated the riprap rock cover. Baffinland will inspect and if required, repair the invert level of the west ditch section culvert, prior to completion of the construction of the PSC drainage ditch.

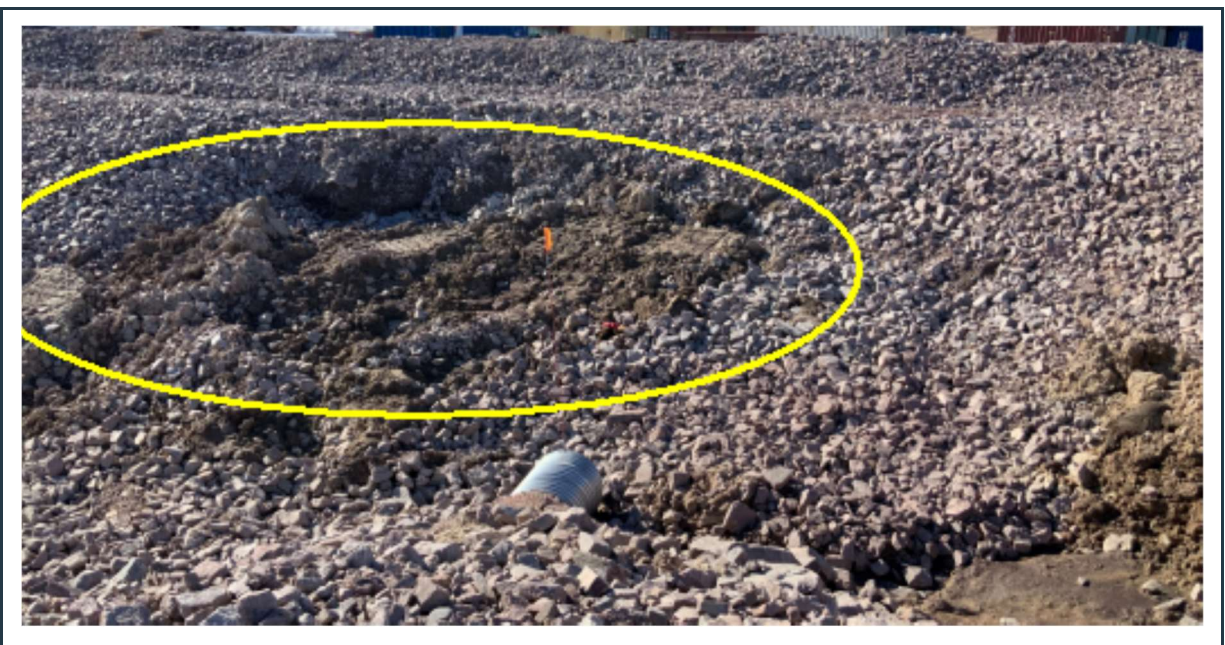
Figure 69: View of the south end of the same (Figure 67) culvert with too high invert elevation. Note the localized slope failure adjacent to the culvert, which should be repaired as soon as practically possible.
