# Baffinland Iron Mines Corporation

Project #: OMGM2212-2023

## **Annual Geotechnical Inspections – 2023 Report 1.**

### **APPENDIX "A" - Mary River Mine Complex - Photographs**

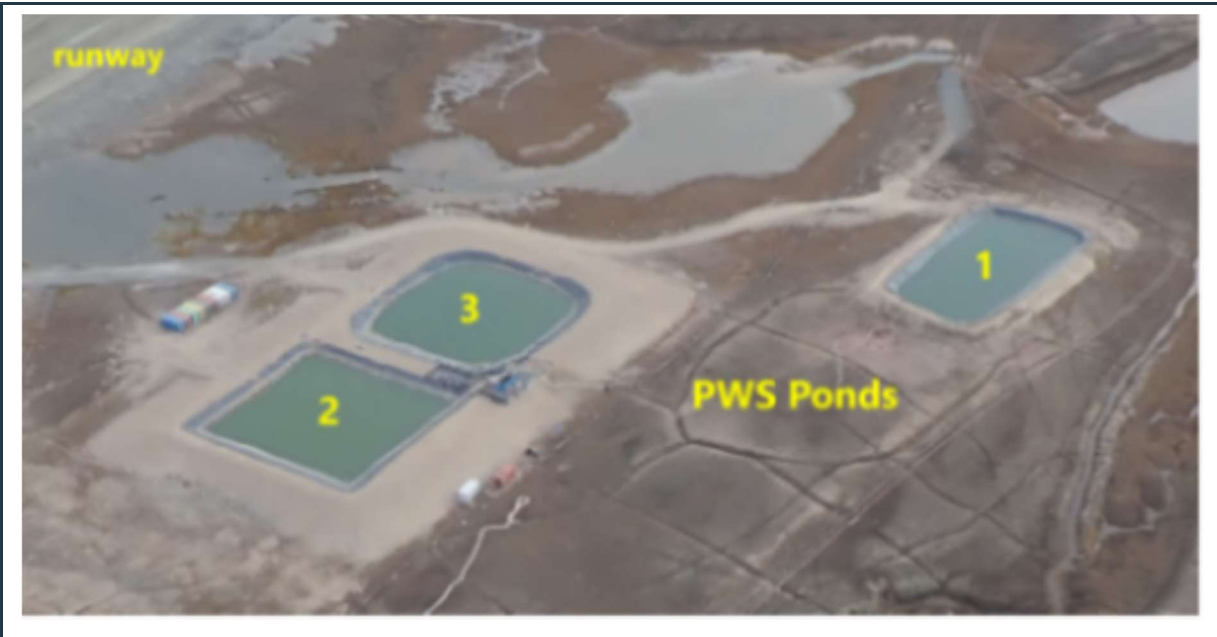
Figure 12: Historic aerial image of the layout of the three PSW ponds with robust, stable berms.

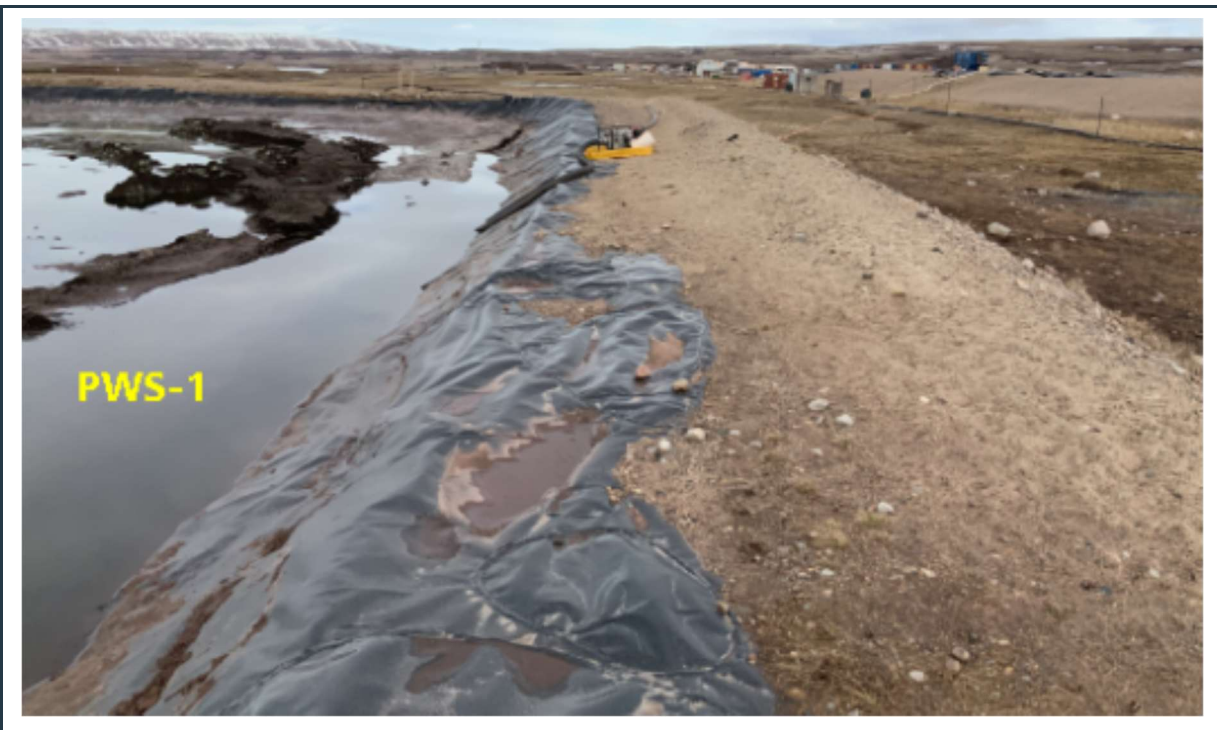
Figure 13: PWS pond #1. Well-maintained, stable perimeter berm and intact liner at the pond. Note the ice in the pond on June 22, 2023.

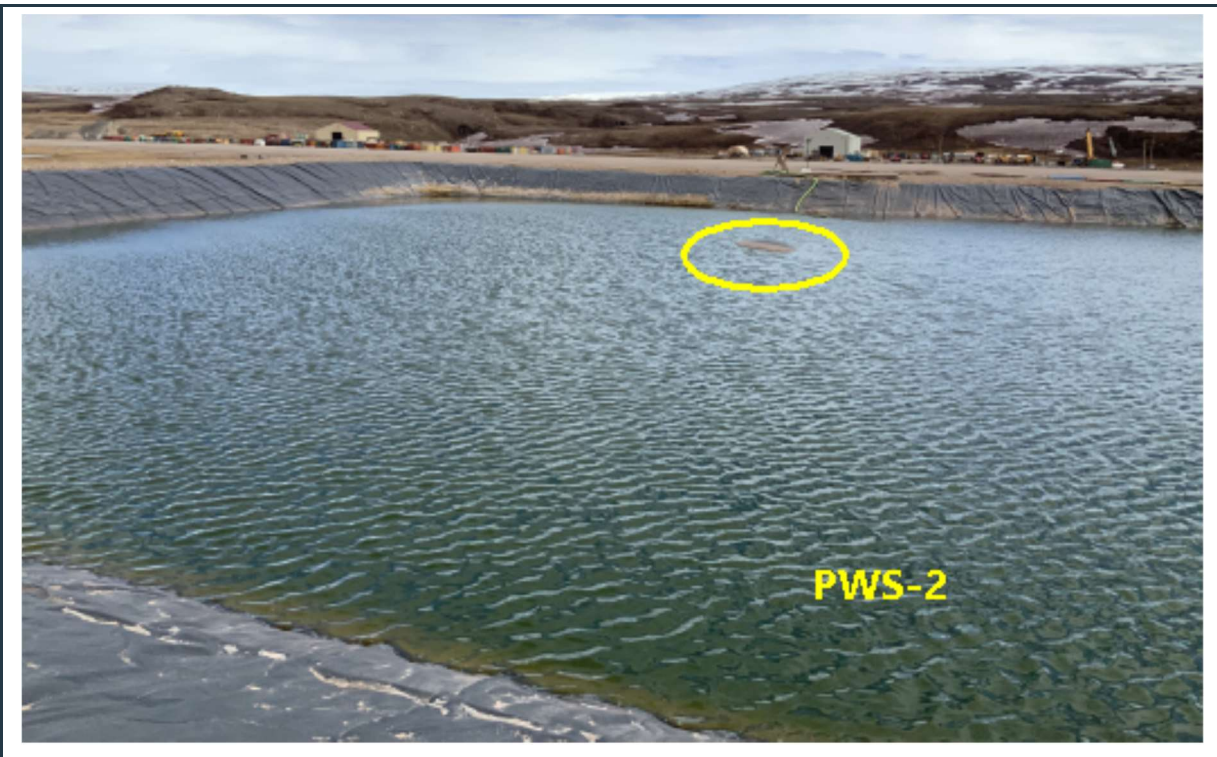
Figure 14: PWS pond #2 with stable, well-maintained berm and liner. – A small, uplifted section of the liner is visible in the pond (yellow circle), which does not pose a risk to the integrity of the liner.

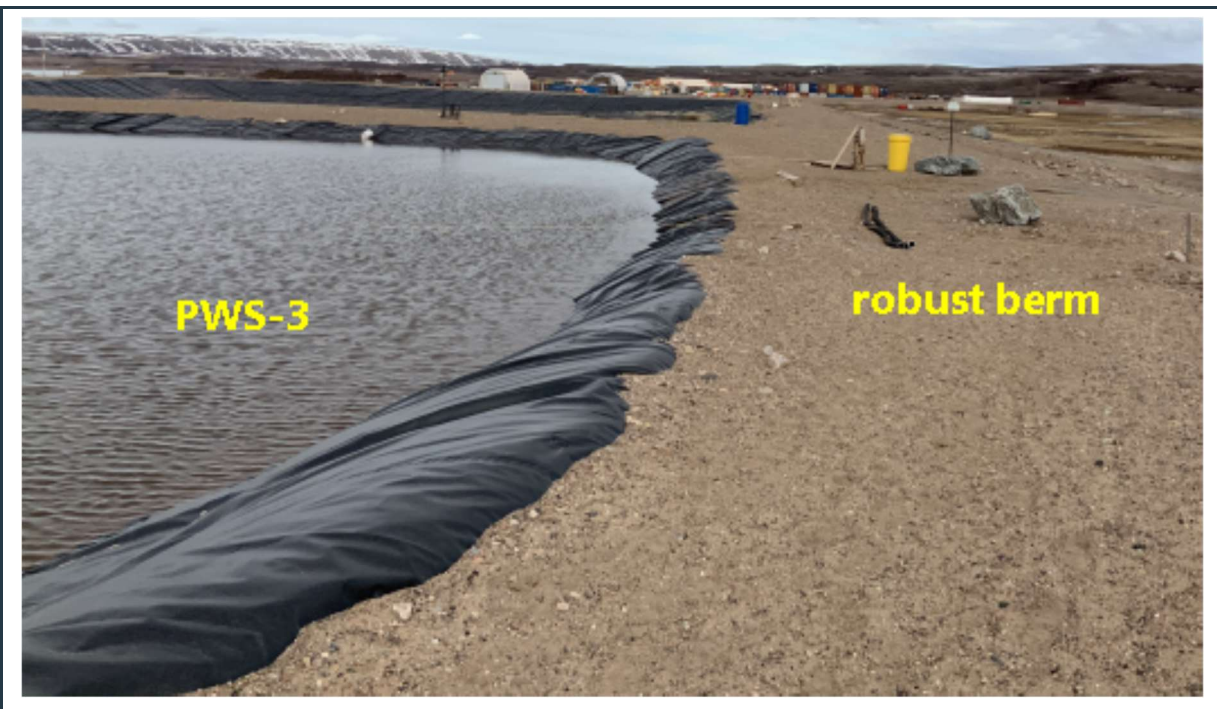
Figure 15: Robust, stable perimeter berms around PWS pond #3 – Wrinkles are common on exposed liners, but they do not pose a risk to the integrity of the high-strength HDPE liners.

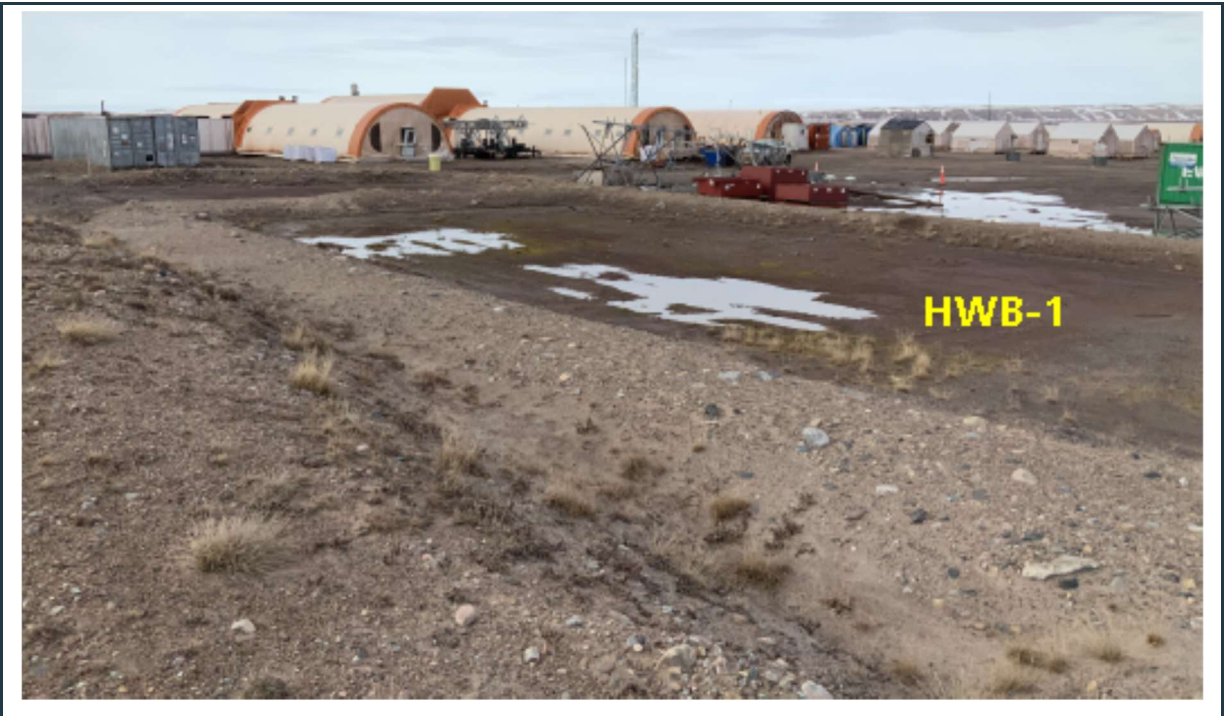
Figure 16: View of HWB-1 – Currently this cell is not in use.

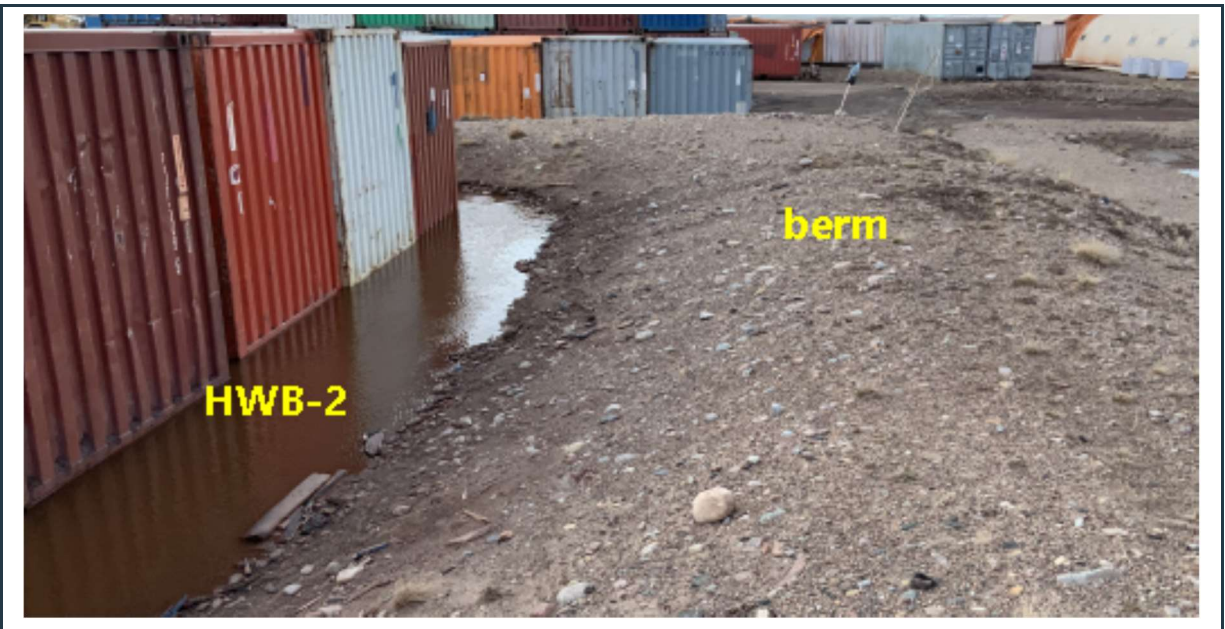
Figure 17: View of the robust, stable berms around HWB-2. The presence of water in the cell indicates good liner performance.

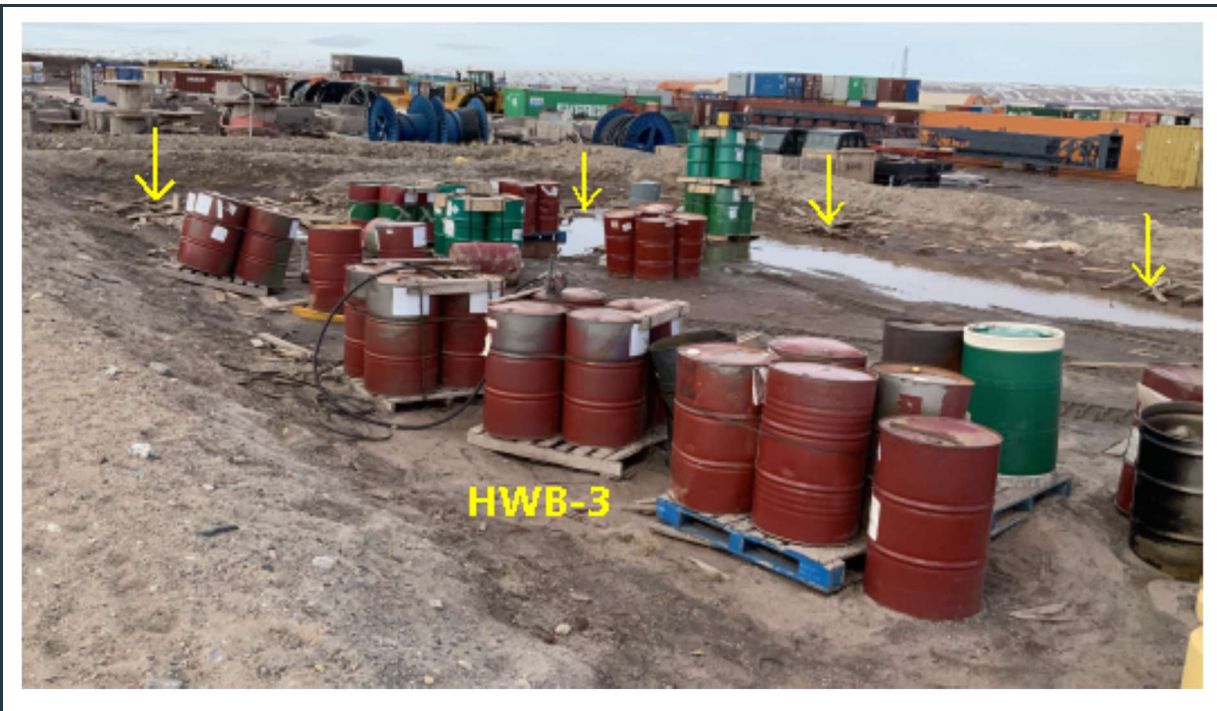
Figure 18: View of stable berms and stored fuel barrels in HWB-3.

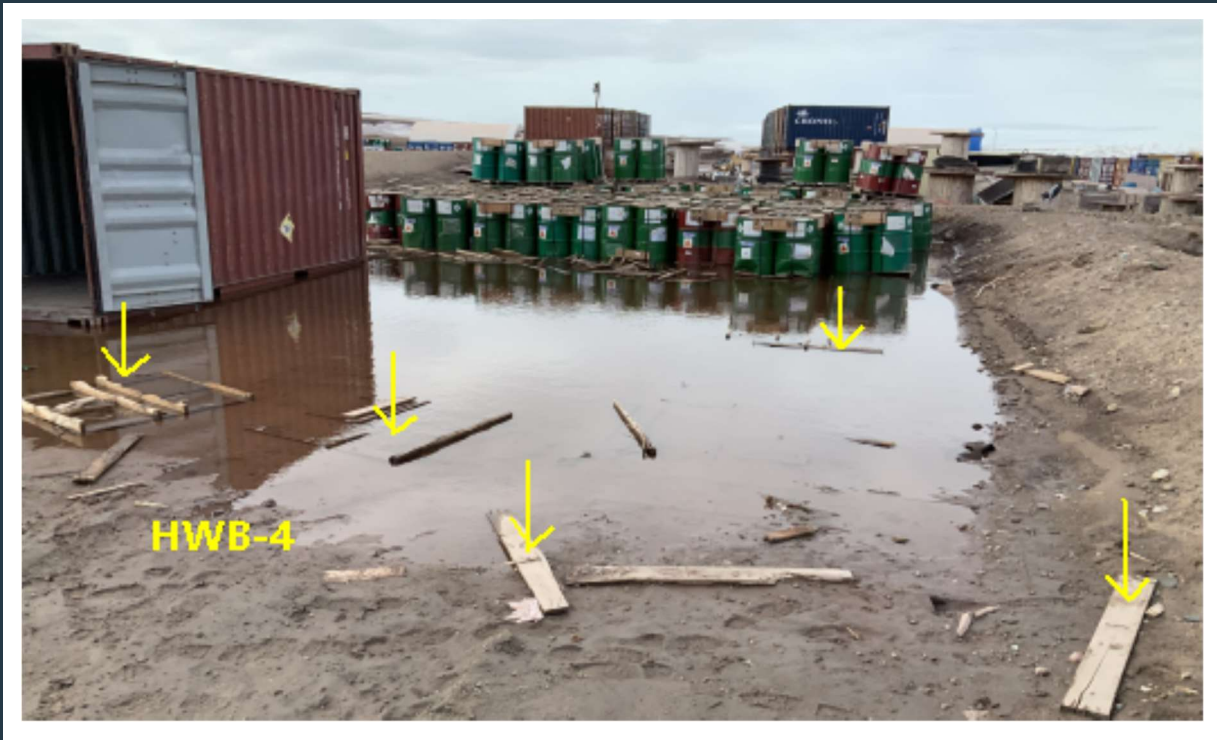
Figure 19: View of stable berms around the HWB-4 cell, with a shipping container and fuel barrels on wooden pallets stored in the cell. The broken pallets (yellow arrow) should be removed.

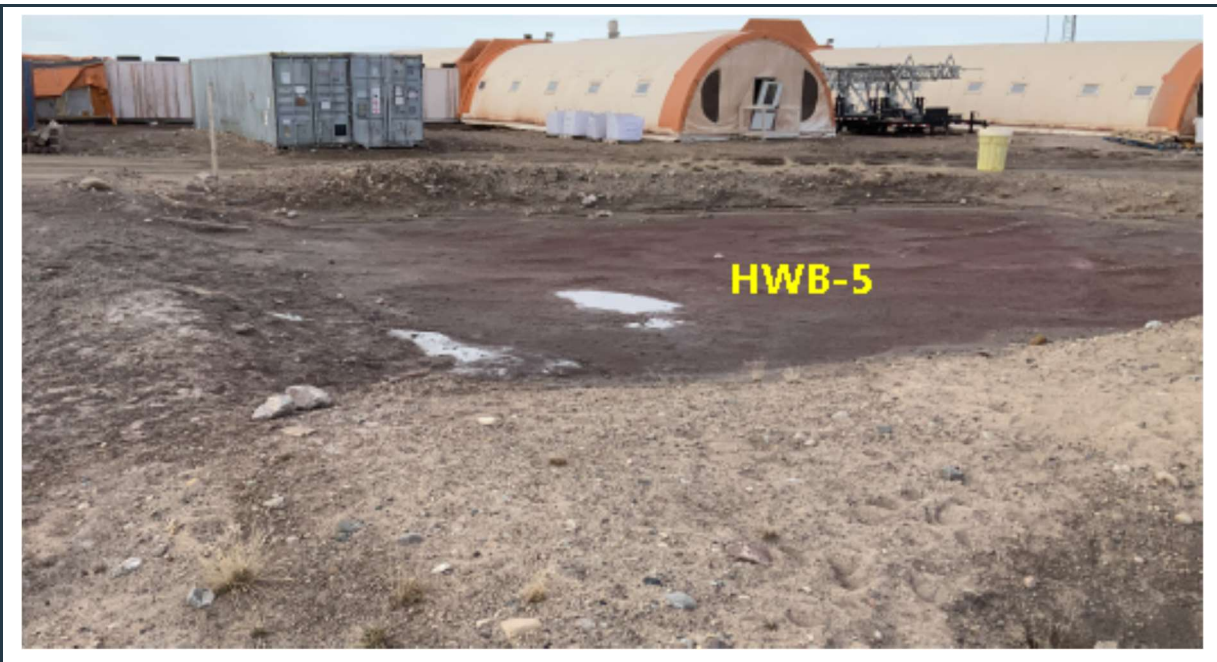
Figure 20: View of HWB-5 – Currently this cell is not in use.

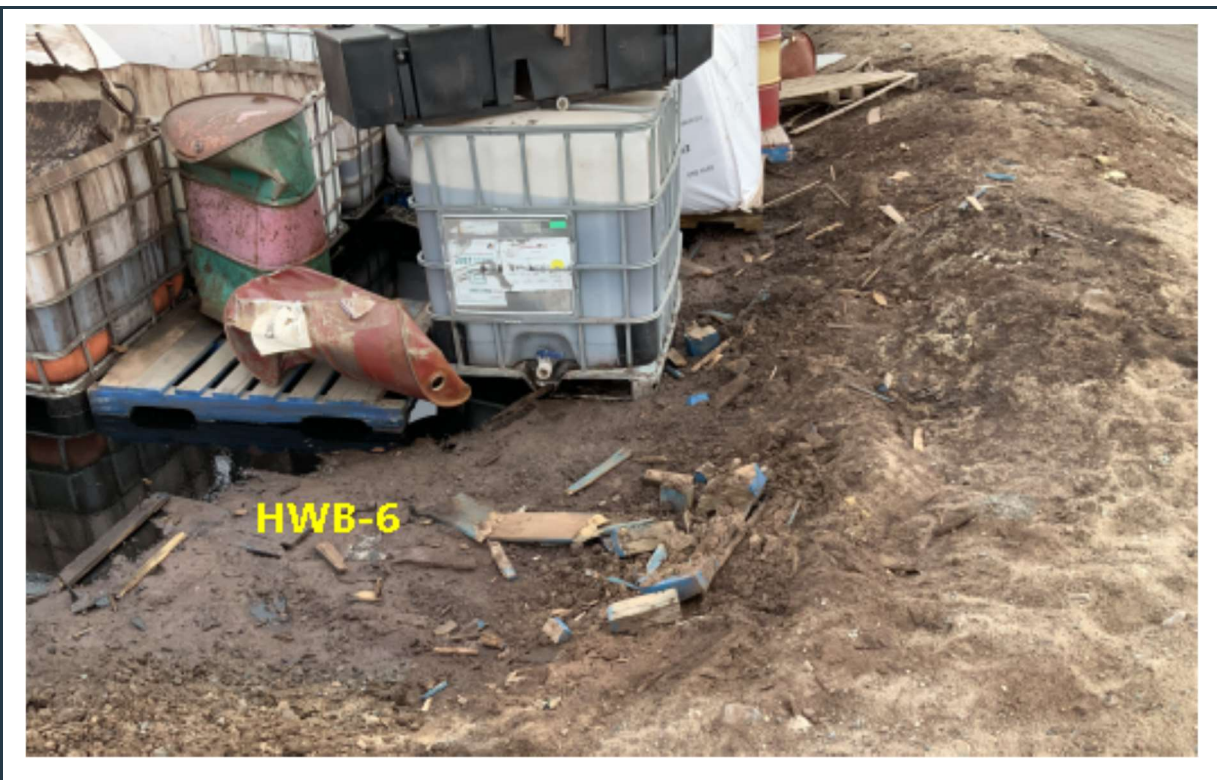
Figure 21: View of the completely full HWB-6 cell. The berm around the cell requires maintenance.

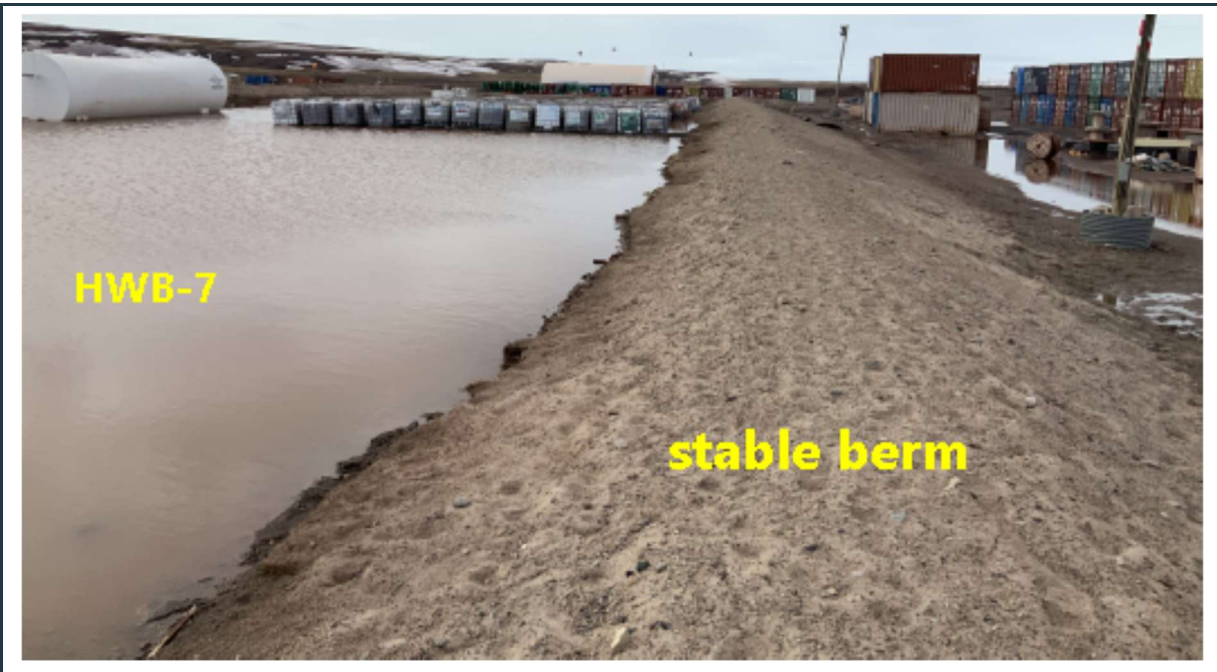
Figure 22: View of the stable berm around the HWB-7 cell, with an old fuel tank and oil filled plastic containers stored in the cell. The ponding water indicates good liner performance.

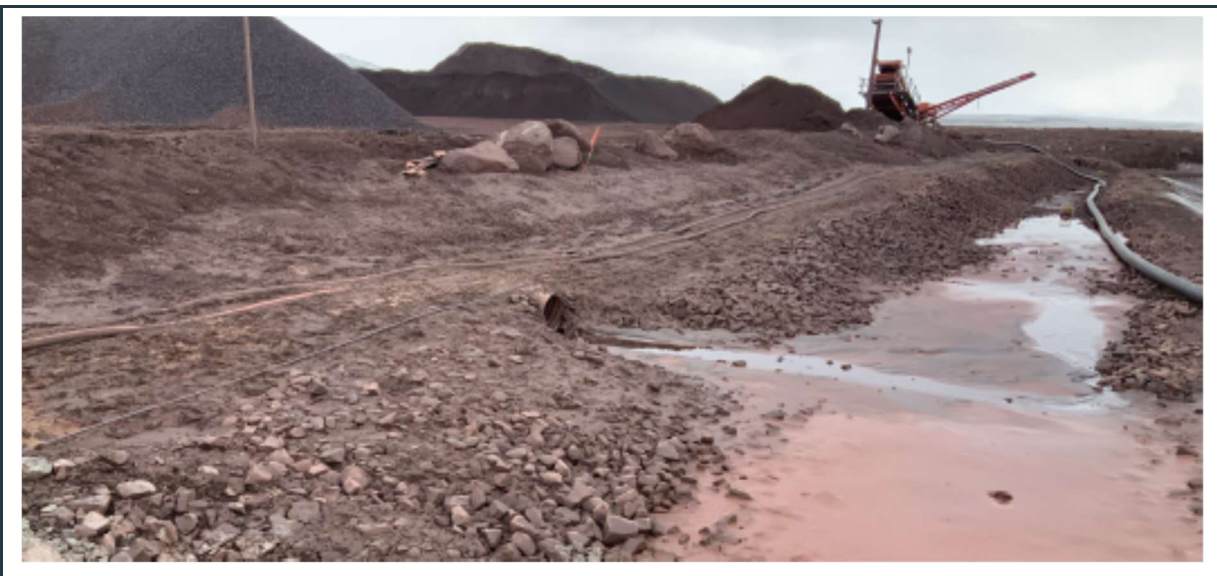
Figure 23: View of the discharge end of the recently cleaned culvert, draining the collected surface water from the crusher area to the MS-06 pond.

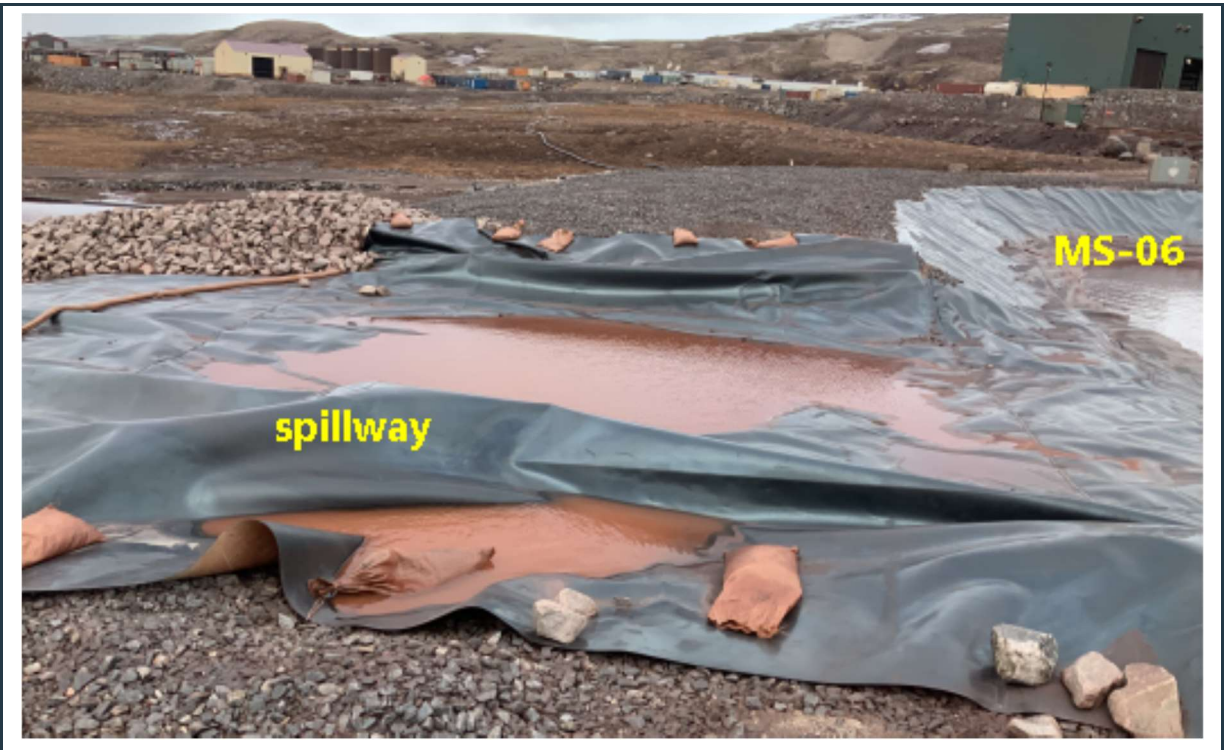
Figure 24: View of the robust, stable berm around the MS-06 pond, with temporary problem with the liner (lift-up by wind) at its spillway. Placement of more, heavier sandbags is recommended.

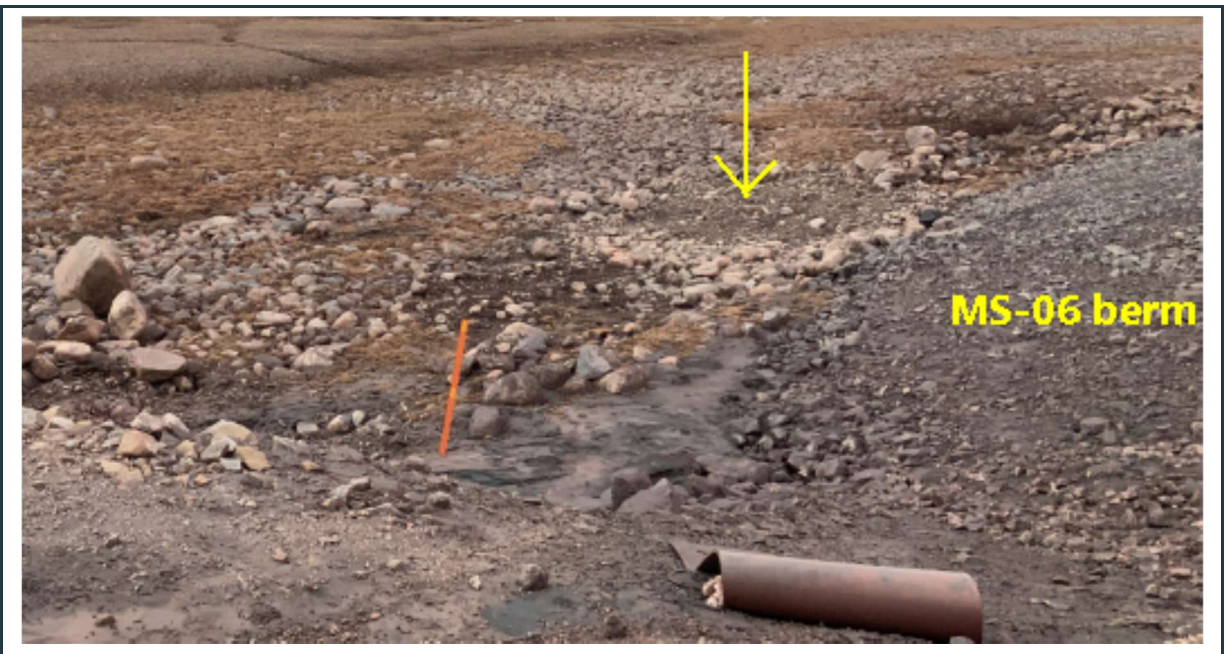
Figure 25: View of the MS-06 pond's berm. The previously excavated temporary sump at the toe of the berm had been backfilled (yellow arrow), as recommended during the previous inspection.

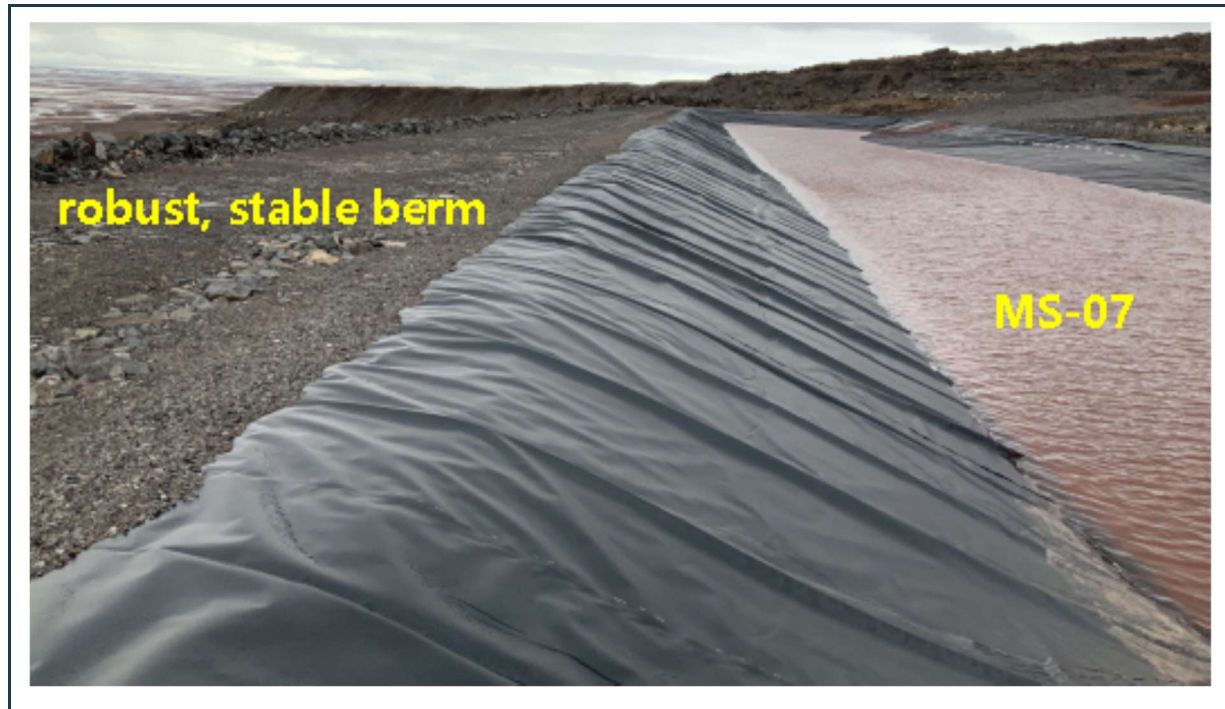
Figure 26: View of the robust, stable berms and intact liner at the MS-07 surface-water management pond.

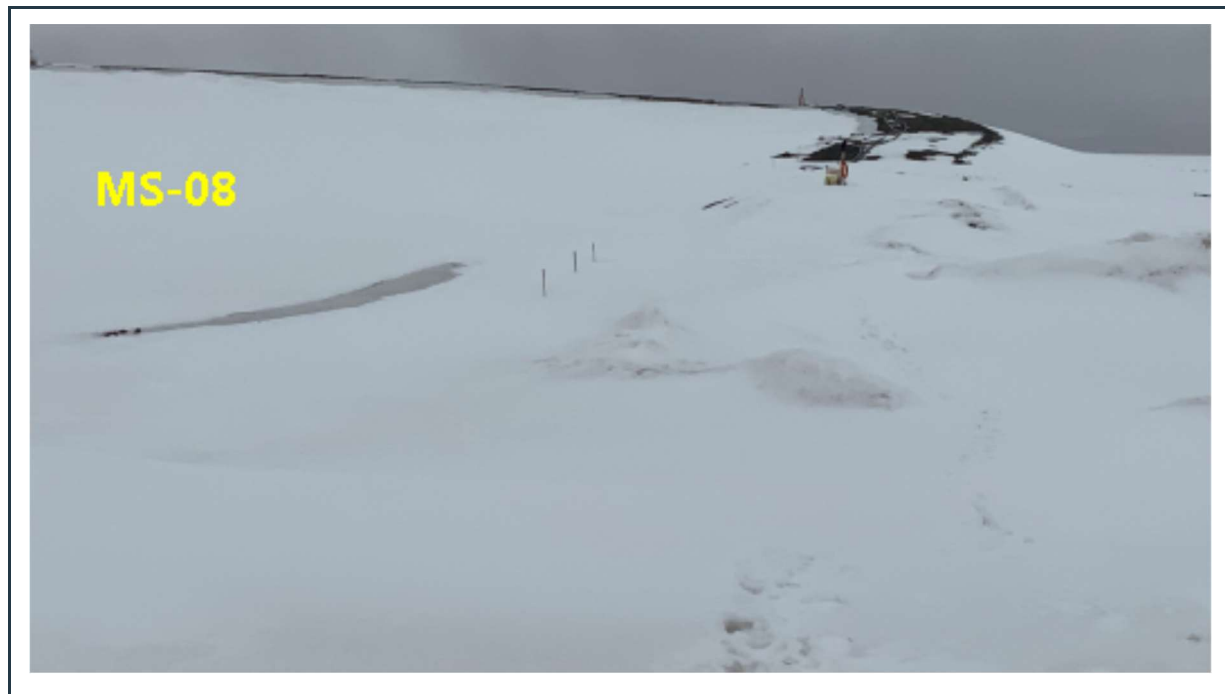
Figure 27: View of the snow- and ice-covered MS-08 pond.

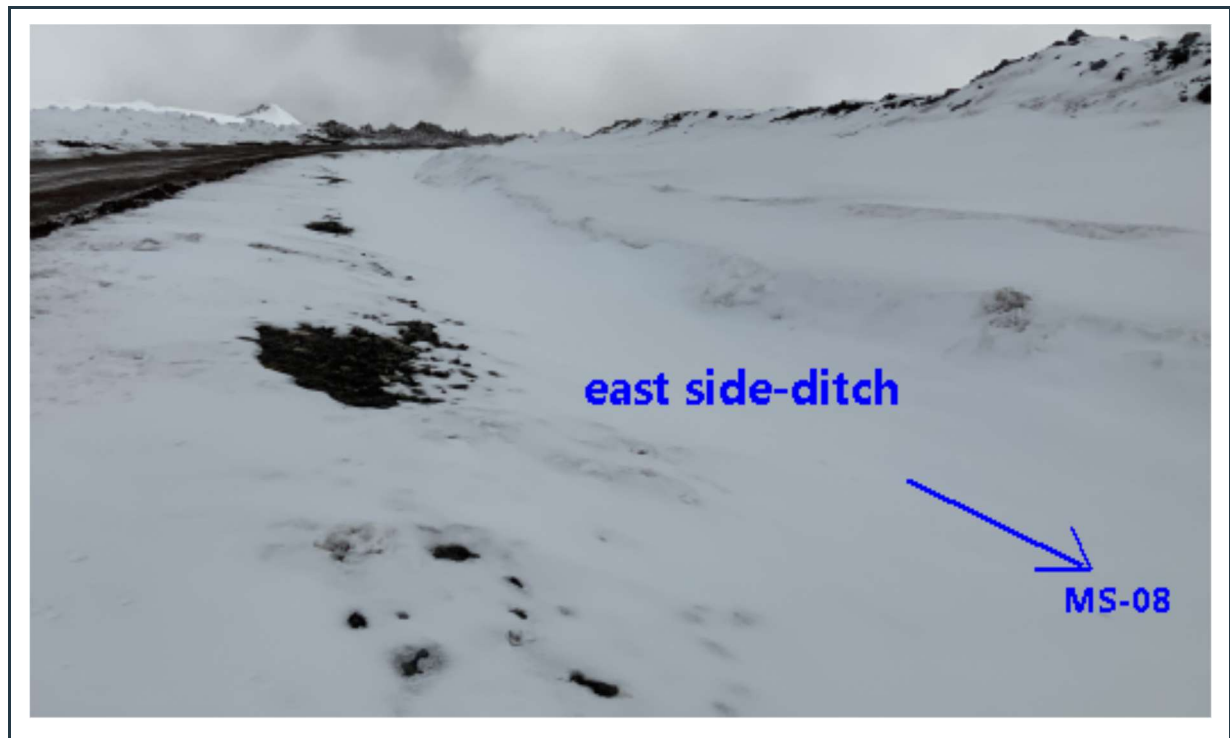
Figure 28: View of the snow- and ice-covered drainage ditch around the east side of the waste rock facility, leading to the MS-08 pond.

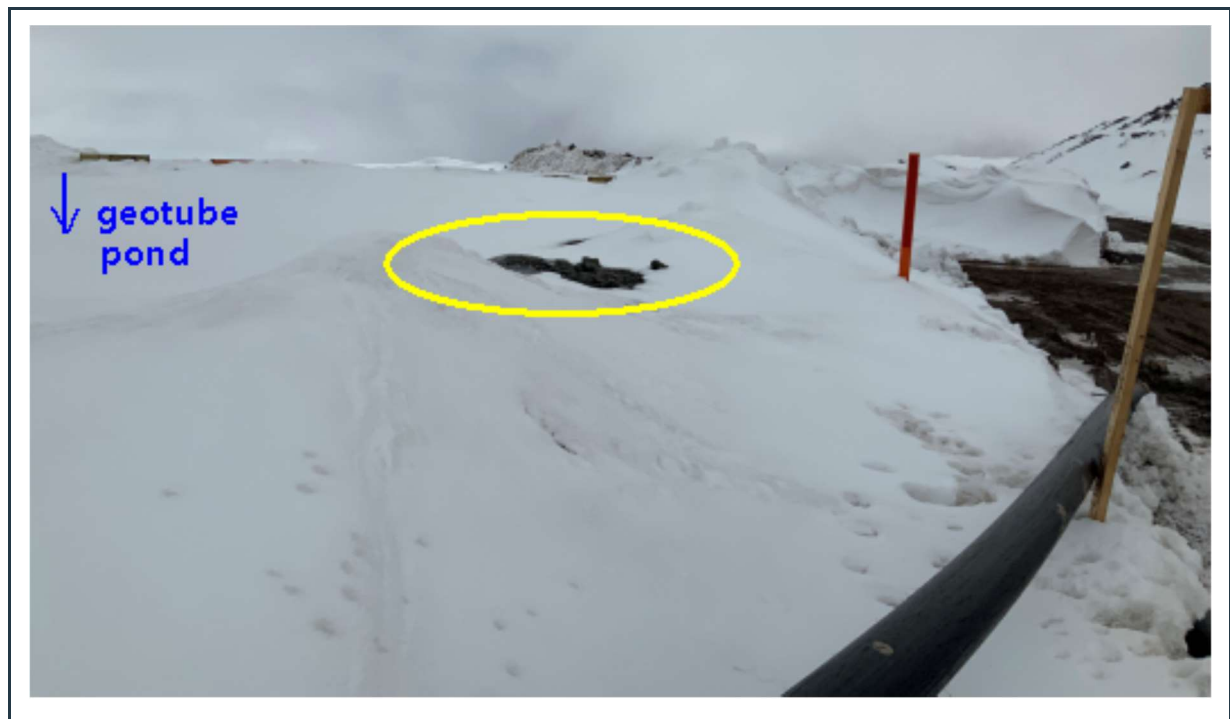
Figure 29: View of the snow- and ice-covered geotube pond. A small section of the liner at the south-west section of the berm (yellow circle) is still damaged and will require repair.

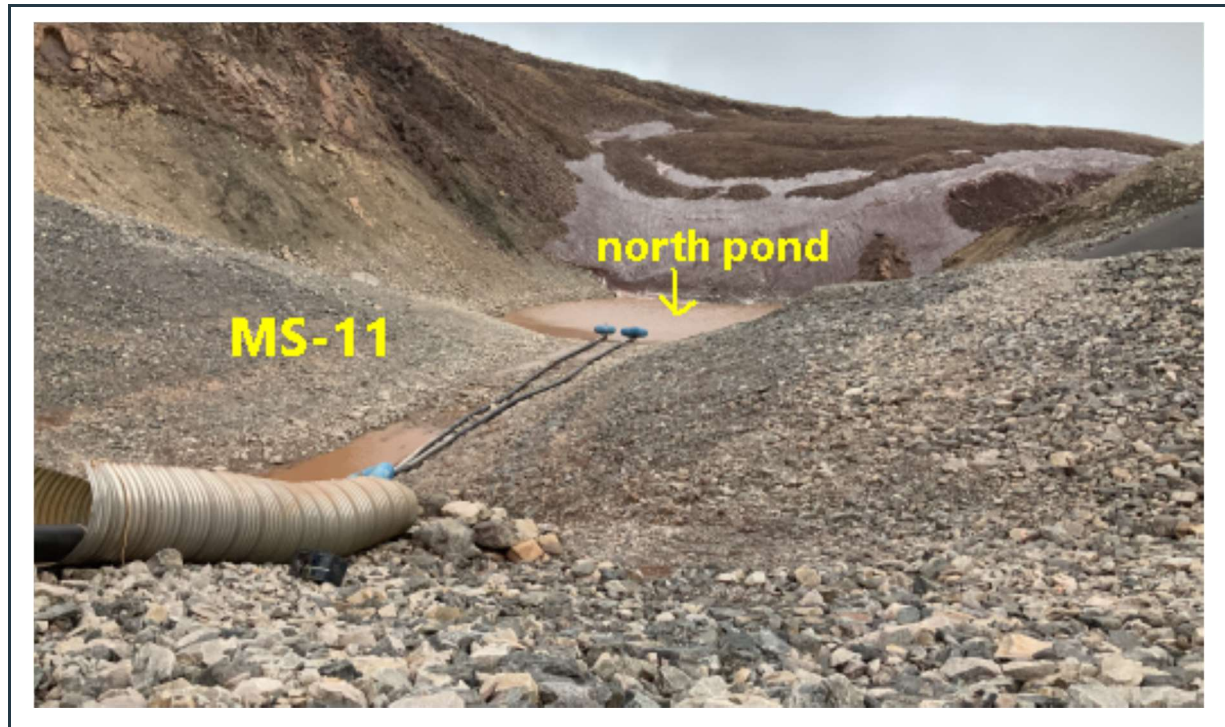
Figure 30: View of the north part of the MS-11 pond at KM105.

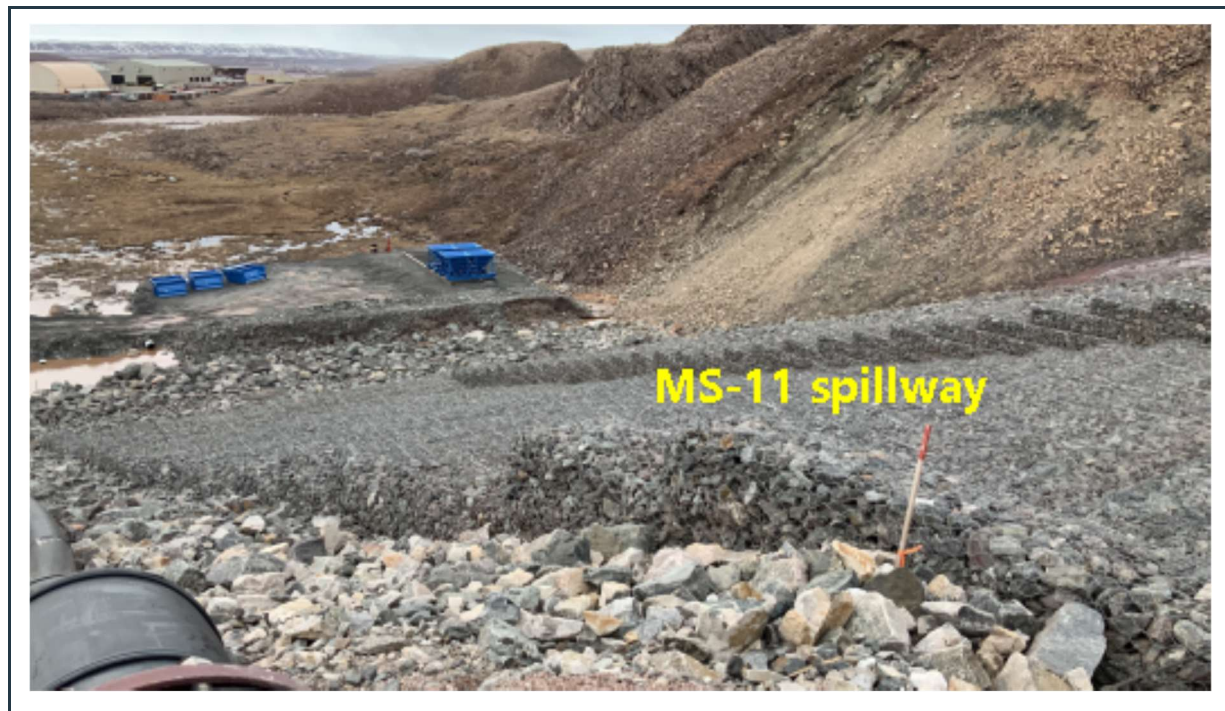
Figure 31: View of the robust and stable emergency spillway (gabion baskets and blankets filled with crushed rock) at KM105. Note the water seepage at the toe of the spillway.

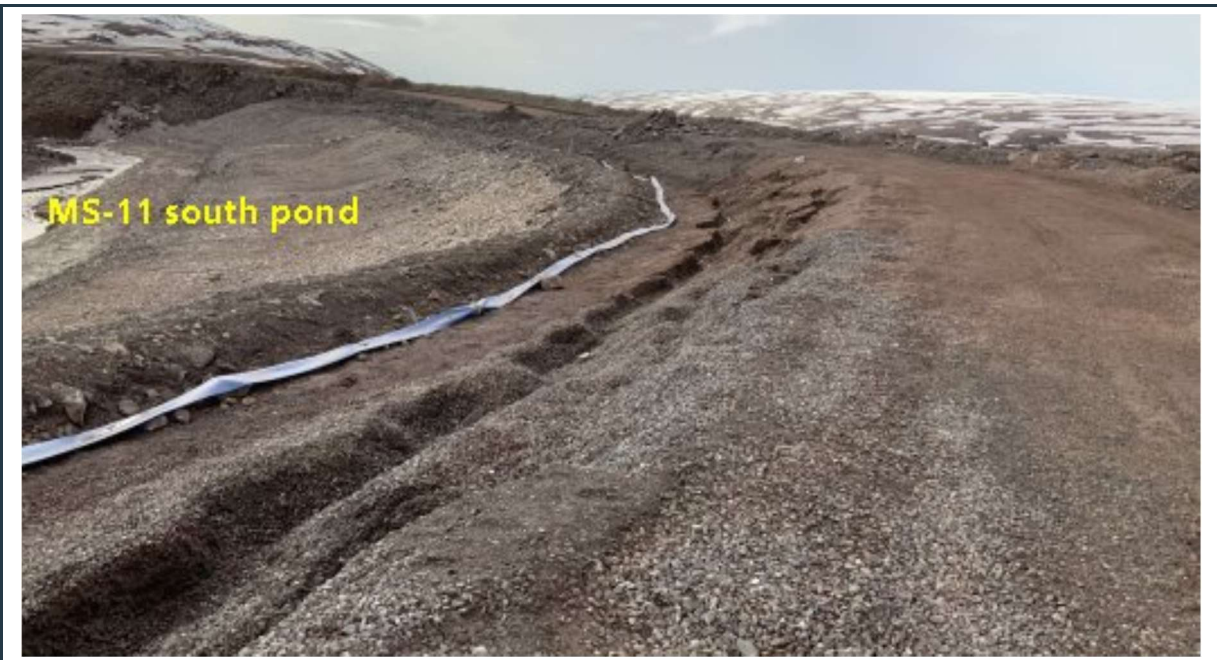
Figure 32: View of the loosely filled and cracked liner anchor trench along the road next to the south MS-11 pond's slope. The cracks should be backfilled with fine-grained soils, regraded, and compacted to minimize water infiltration into the ground next to the slope.

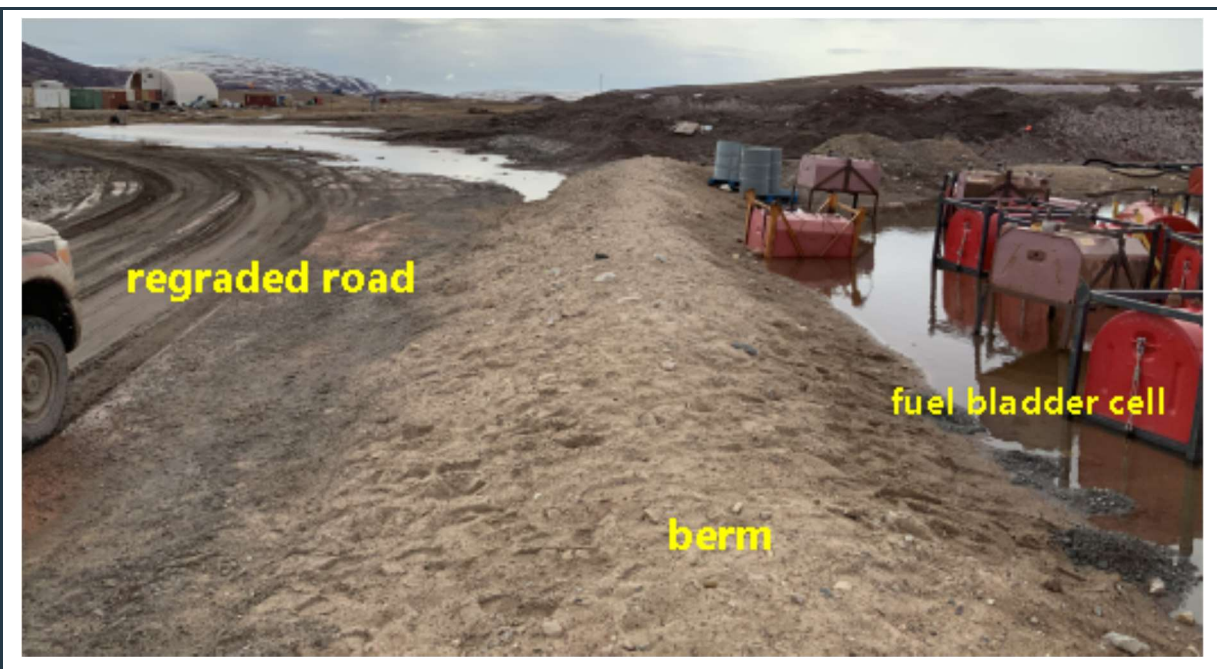
Figure 33: View of the stable berm around the "fuel bladder" cell. The adjacent road next to the east berm was recently regraded.

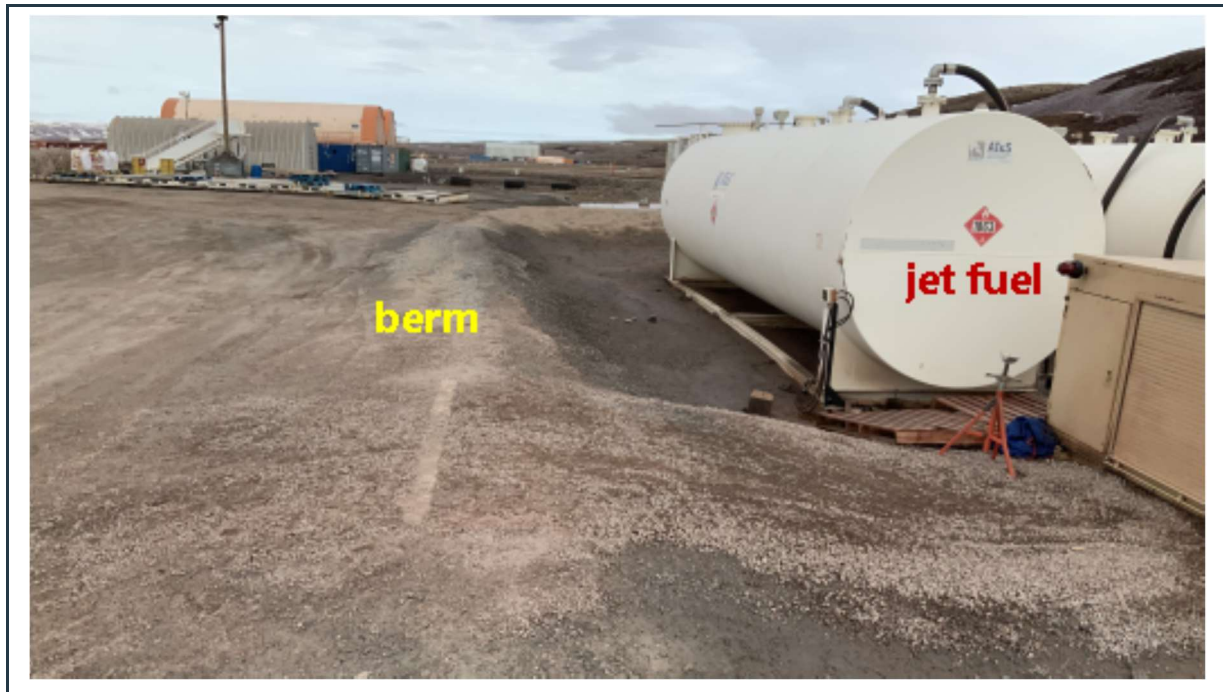
Figure 34: View of the well-maintained sand and gravel berm and access ramp at the lined jet-fuel storage facility.

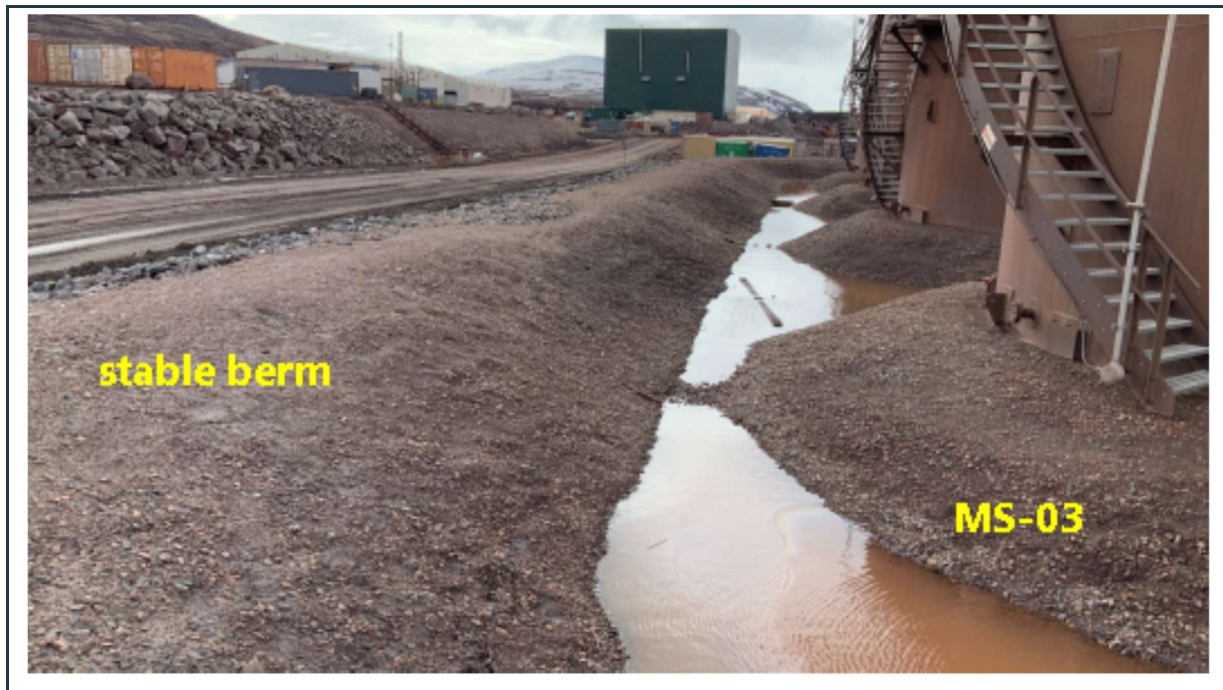
Figure 35: Well-maintained, stable berm around the MS-03 diesel fuel farm, with some ponding water.

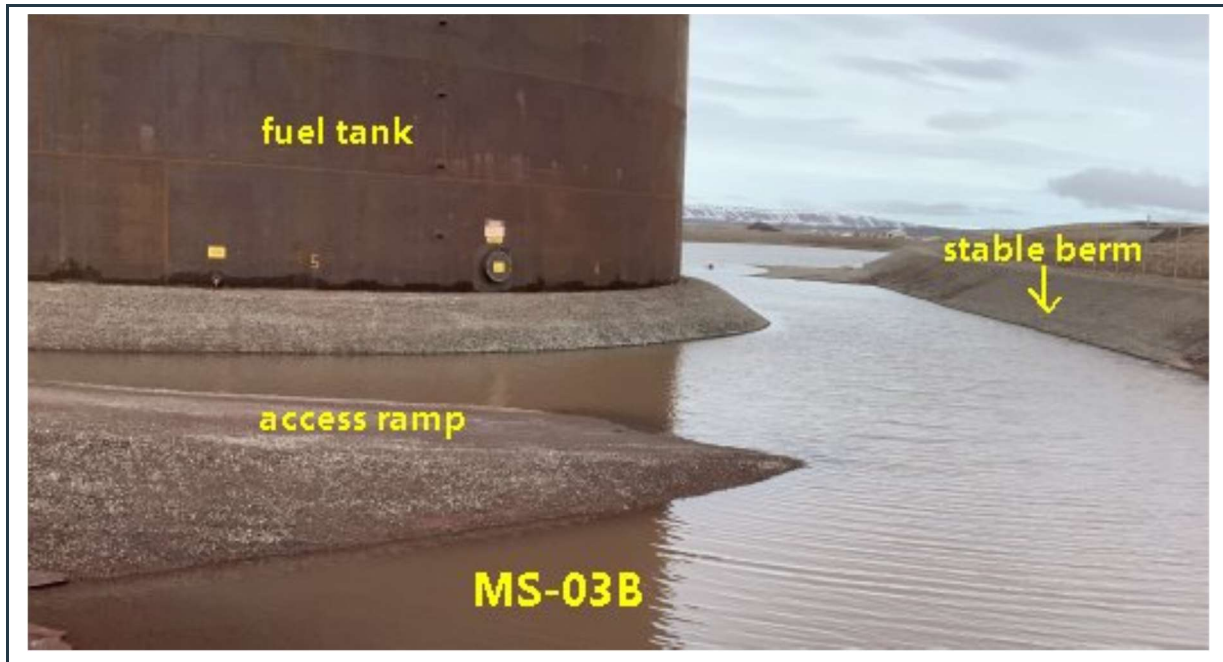
Figure 36: View of the well-maintained stable berm and access ramp to the interior of the new fuel tank farm. Note the ponding water, indicating good liner performance.

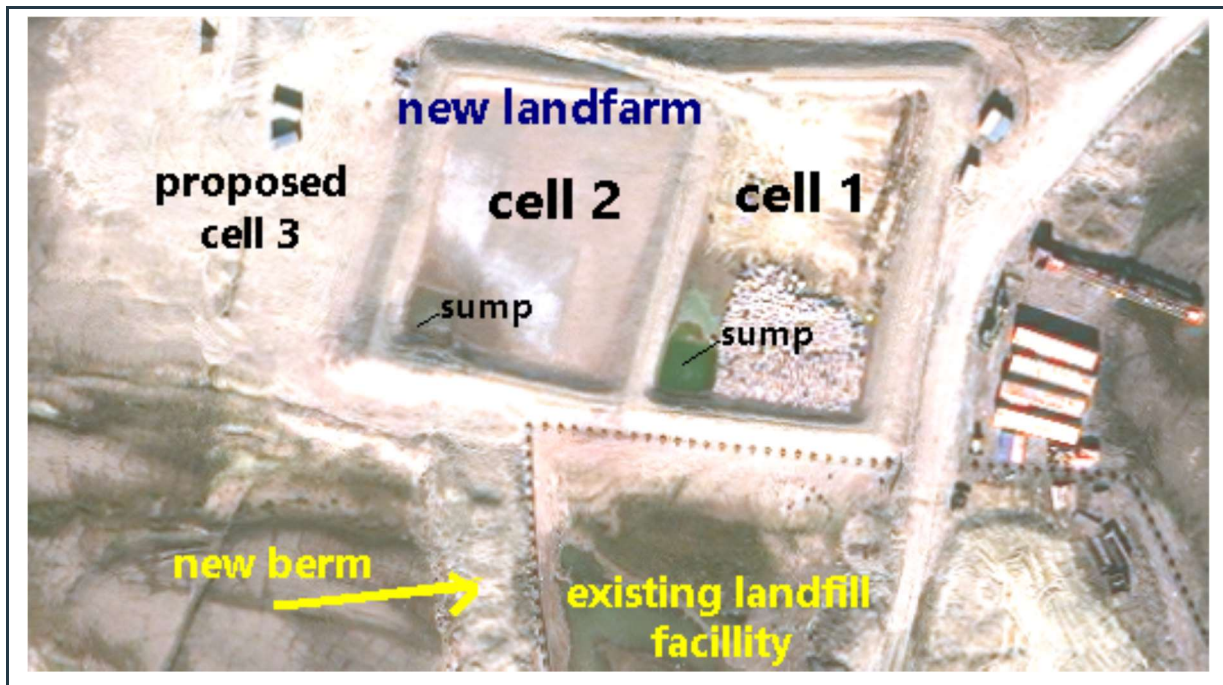
Figure 37: Satellite view of the existing solid waste landfill facility and the adjacent two, recently constructed landfarm cells. Cell 3 is proposed for construction in the future.
