# Baffinland Iron Mines Corporation

Project #: OMGM2212-2023

## **Annual Geotechnical Inspections – 2023 Report 1.**

### **APPENDIX "A" - Mary River Mine Complex - Photographs**

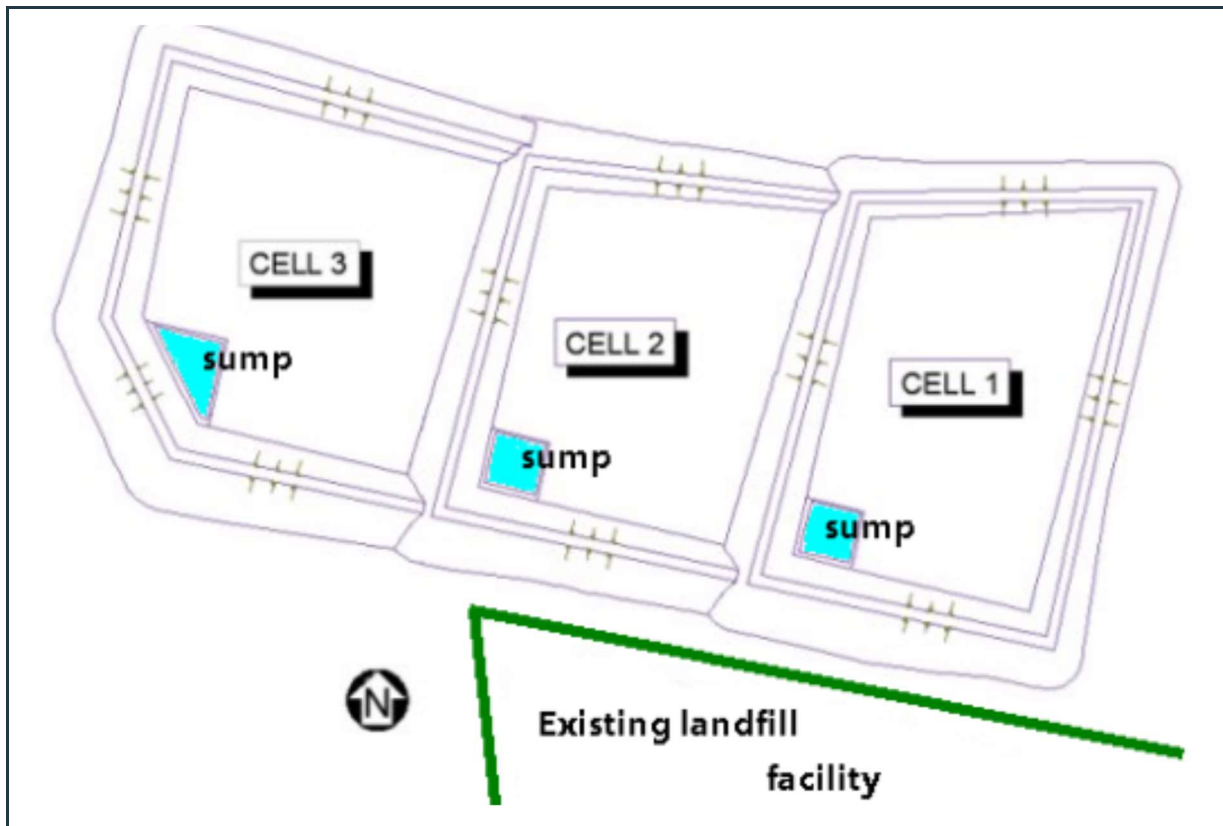
Figure 38: Layout map of the three new land-farm cells, adjacent to the existing landfill facility.

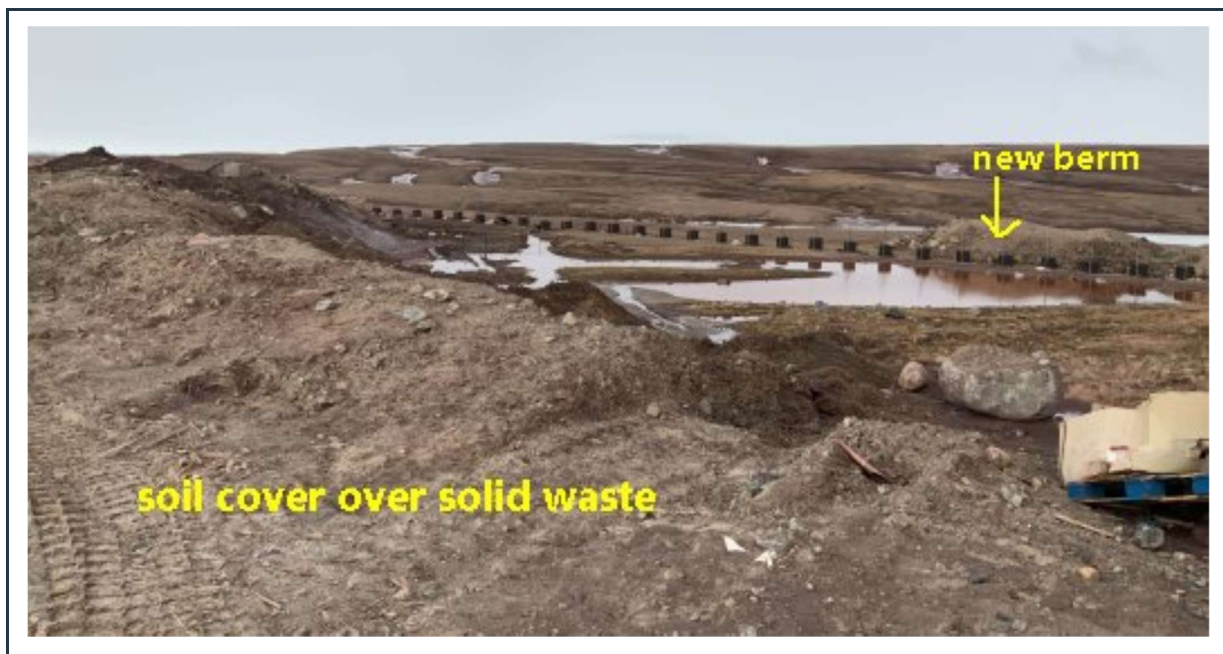
Figure 39: View of soil cover over non-hazardous solid waste in the landfill facility. Note the new berm under construction outside of the fence to prevent surface water leaving the landfill site.

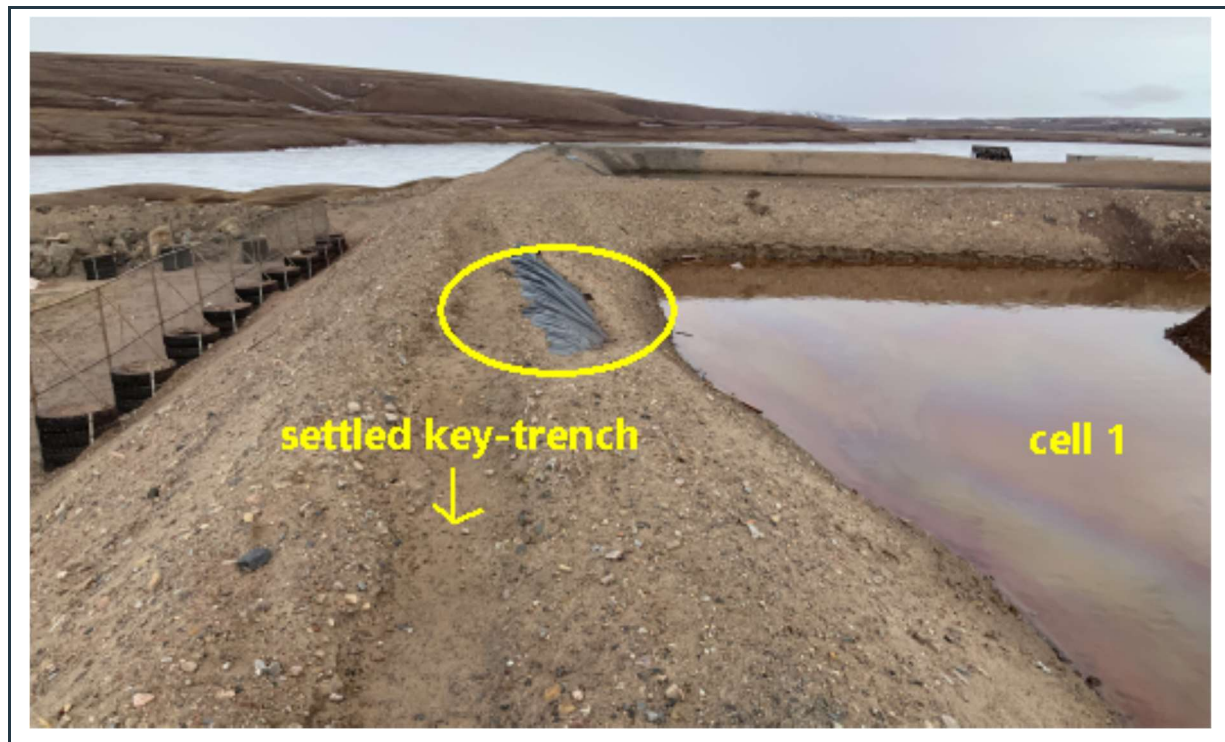
Figure 40: View of a section of the recently constructed berm at the landfarm's Cell 1. Note the exposed liner in one area of the berm and the settled anchor trench along the crest of the berm.

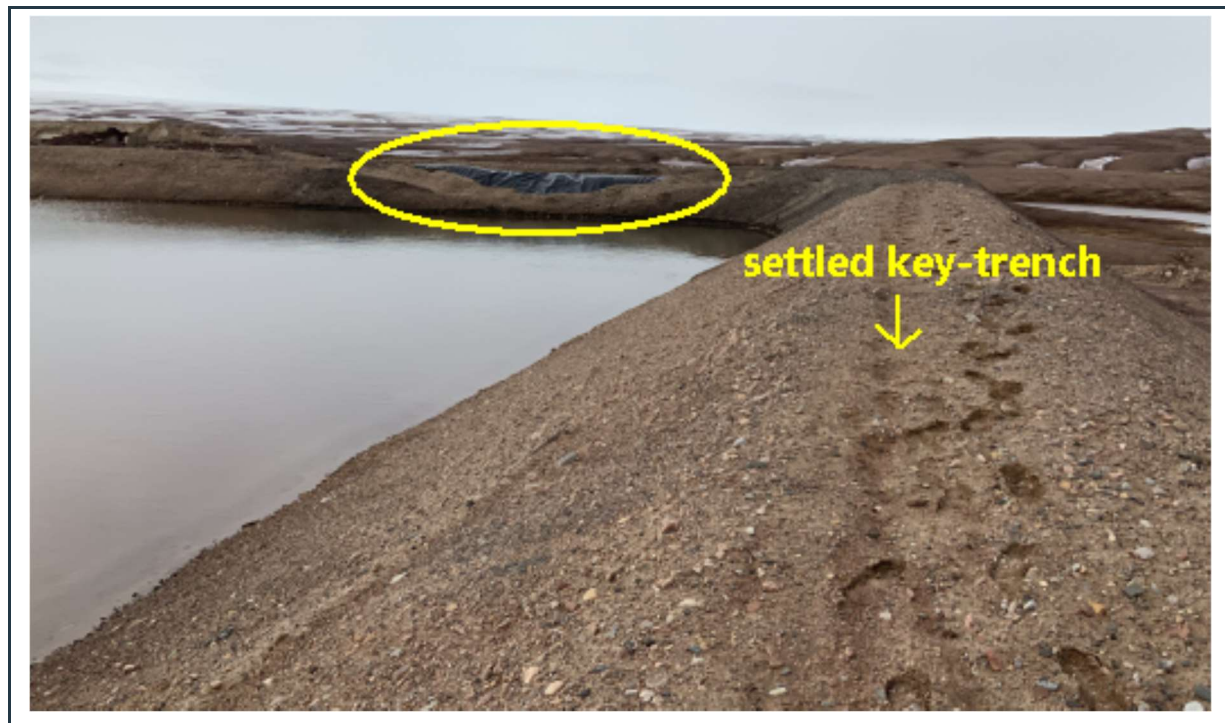
Figure 41: View of the currently empty Cell 2 at the landfarm. Note the exposed liner at one section of the berm, above the internal sump within the facility (see Figure 38).

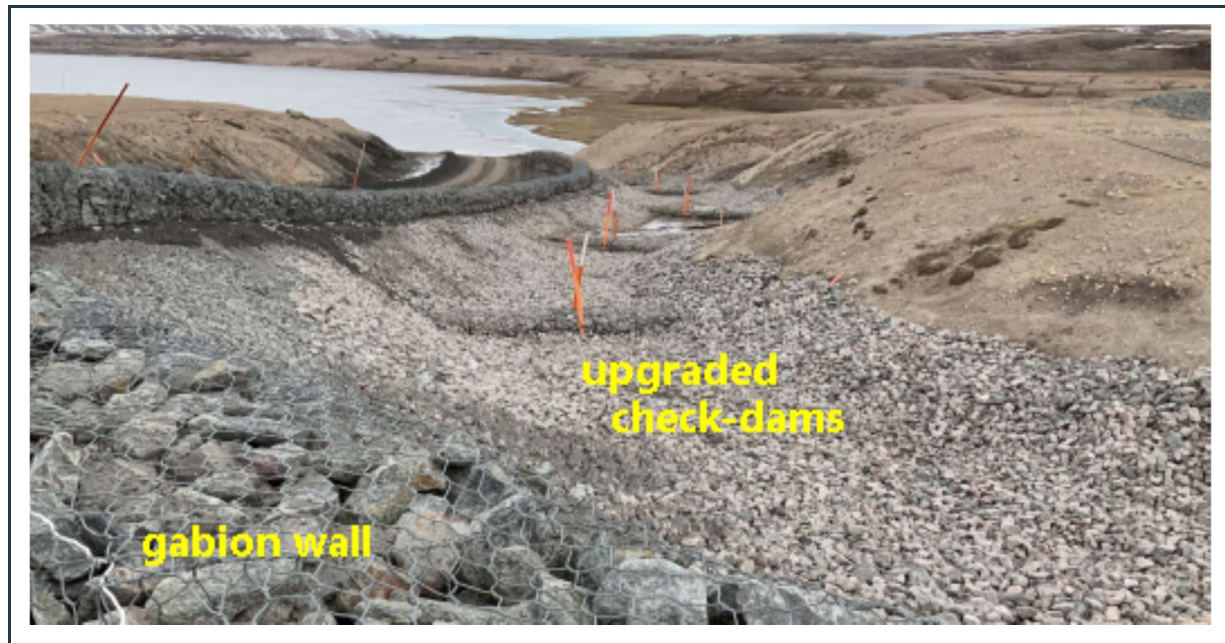
Figure 42: View of the upgraded Camp Lake check dams and new gabion wall along the road to the lake.

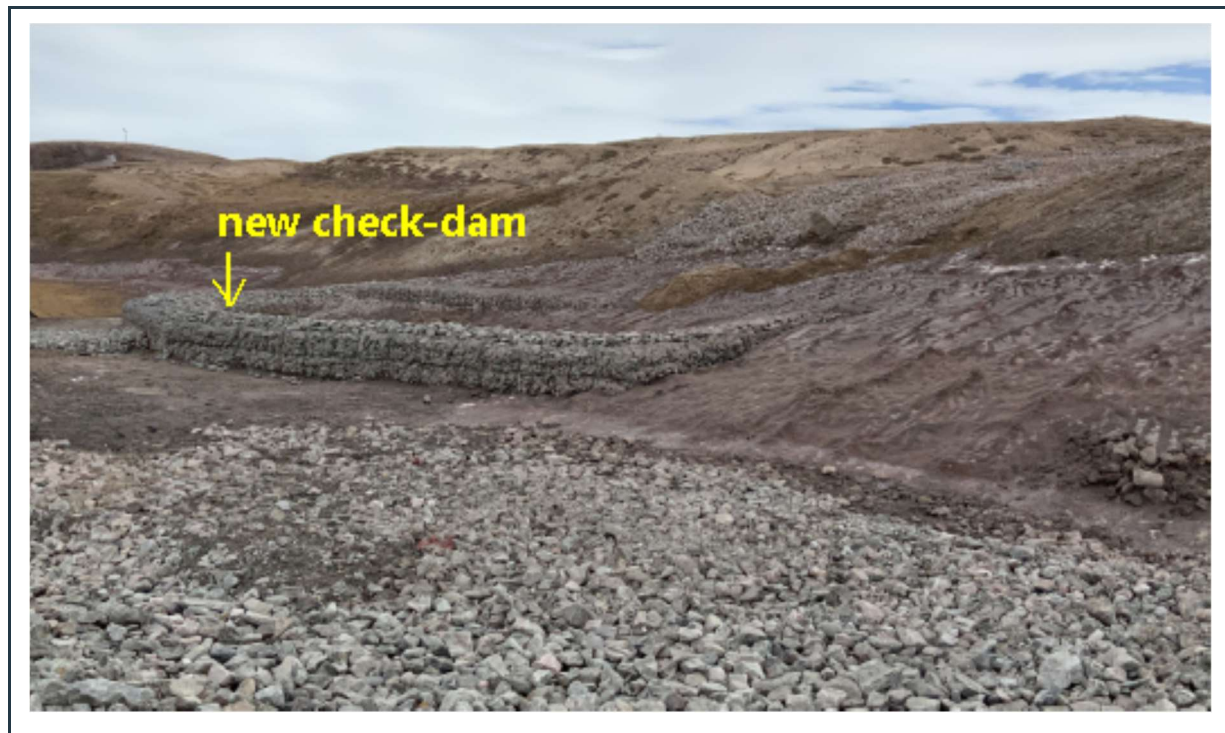
Figure 43: View of the new check-dam, adjacent to Camp Lake, to capture suspended solids potentially eroding from the airfield area and to prevent siltation in the lake.

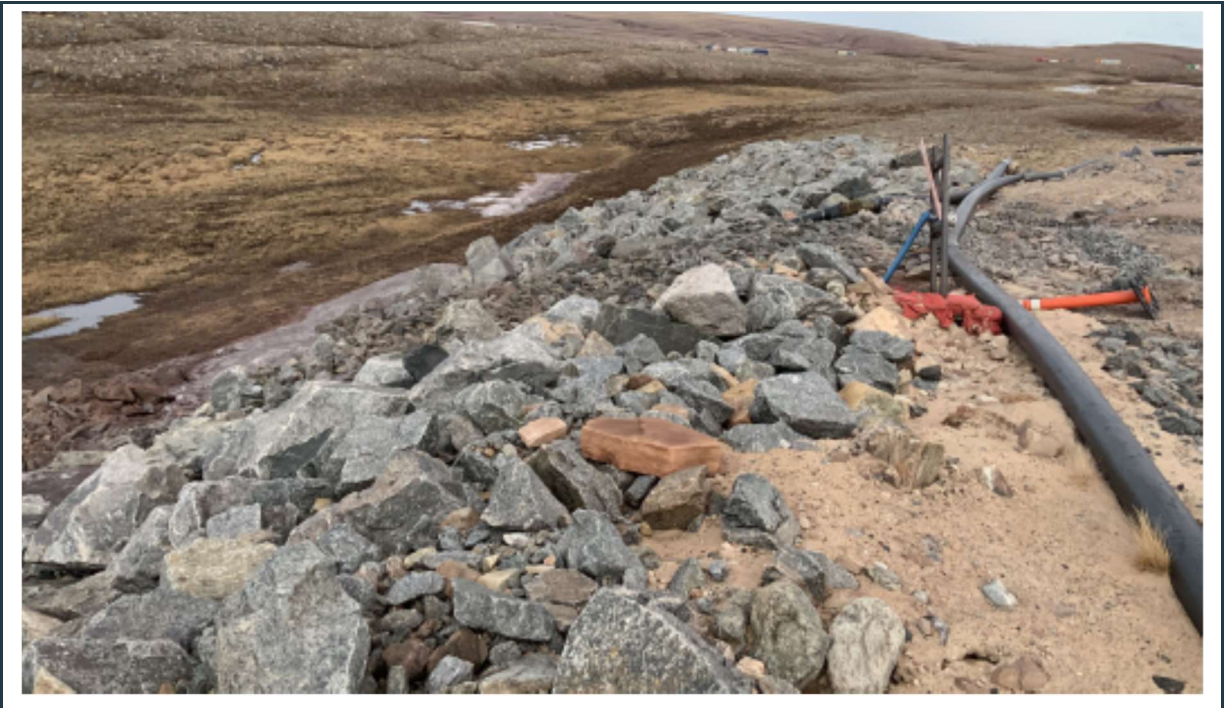
Figure 44: View of the stable rockfill riprap slope at the water discharge area.

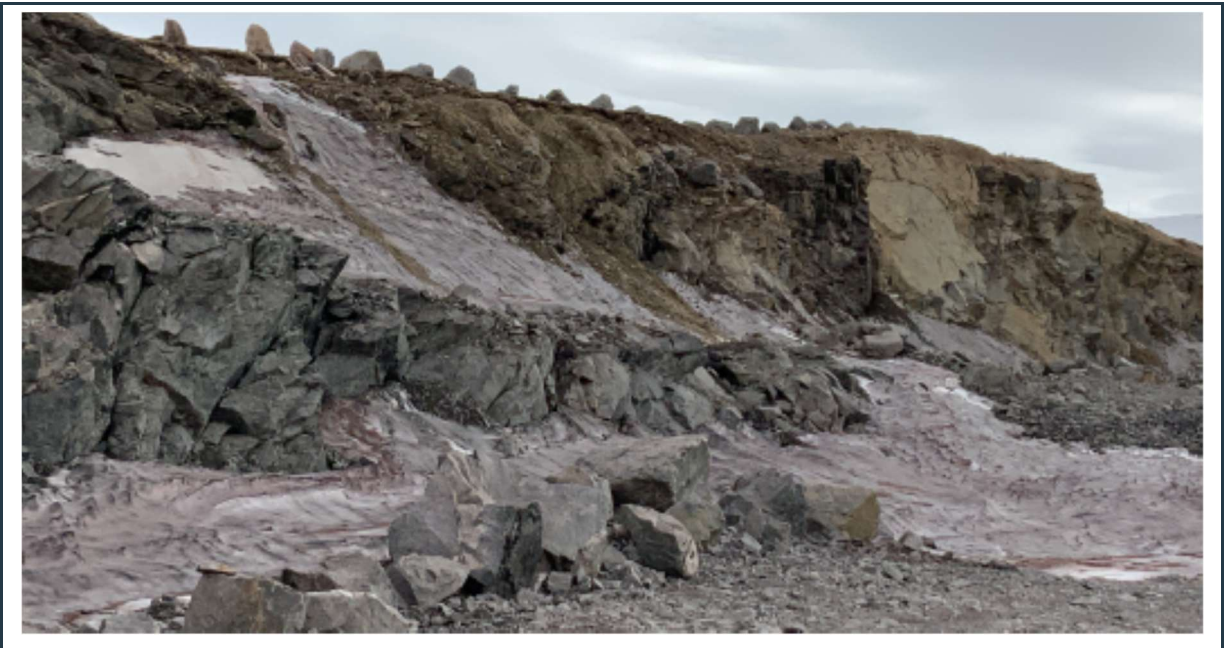
Figure 45: View of the snow-covered rock face at the upper quarry level with minor potential erosion and rolling rock hazard. No activity is currently carried out in this quarry.

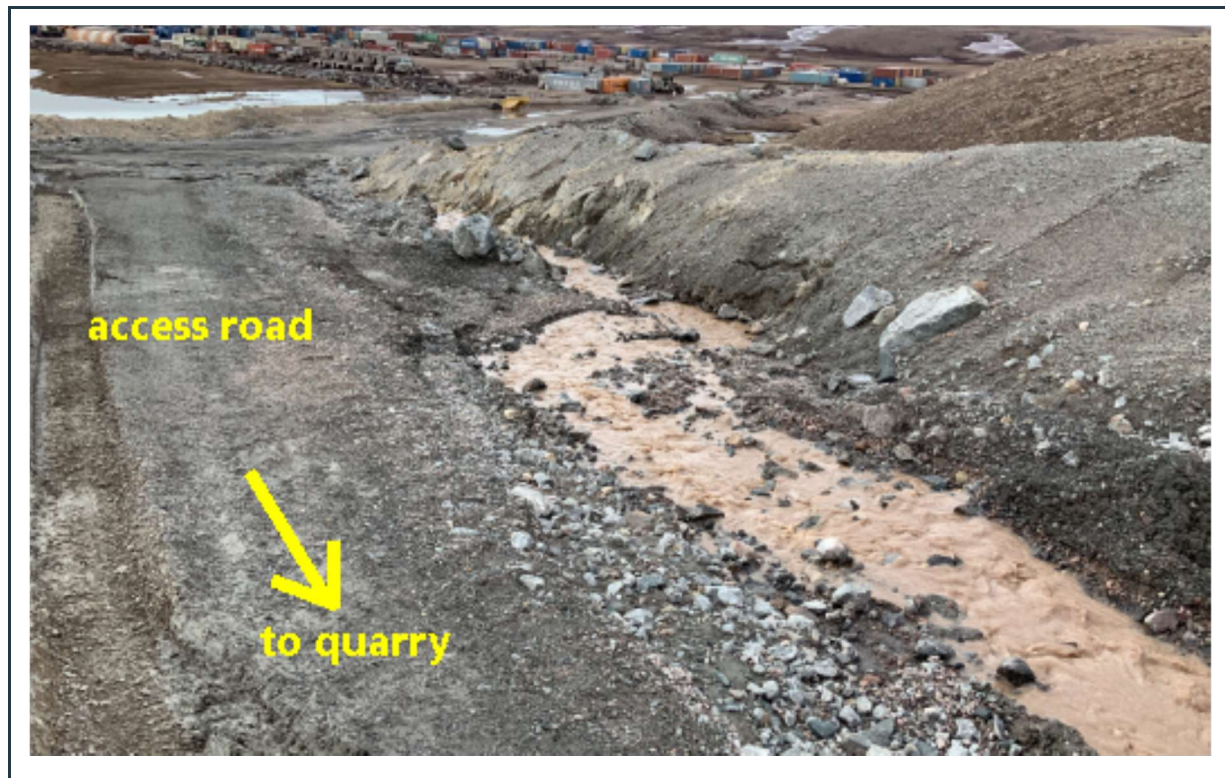
Figure 46: Erosion problem still exists along the edge of the access road to the quarry.

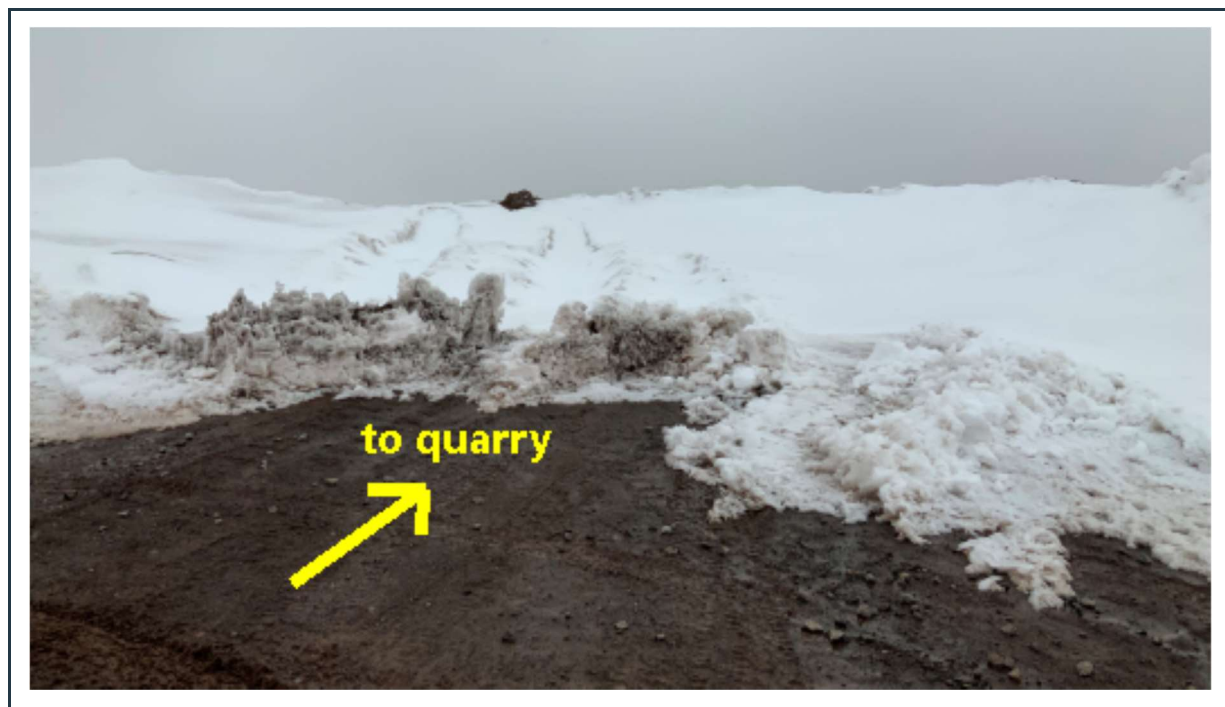
Figure 47: No activity is currently carried out in this quarry and the access road was blocked by snow.

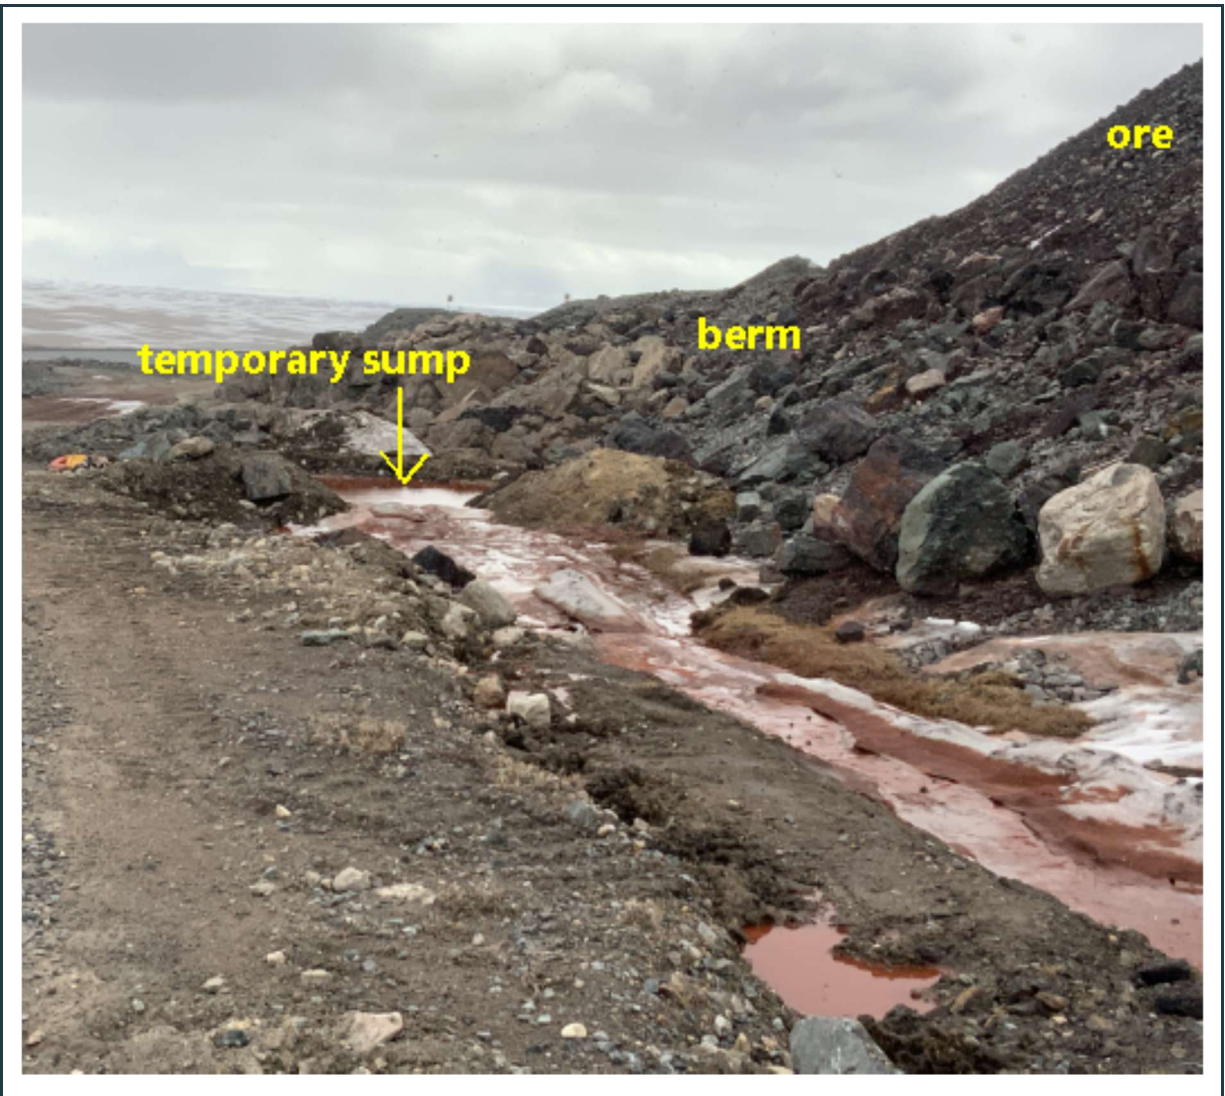
Figure 48: View of the edge of the stockpiled ore, and rockfill berm at the new KM-106 ore stockpile area and a temporary sump, downstream from the berm. The drainage ditch to the sump should be cleaned/graded and the water from the sump should be pumped into the nearby MS-07 pond (see Figure 26).
