Baffinland Iron Mines Corporation

Project #: OMGM2212-23

Annual Geotechnical Inspections – 2023 Report 1.

APPENDIX "B" – Milne Inlet Port Site - Photographs

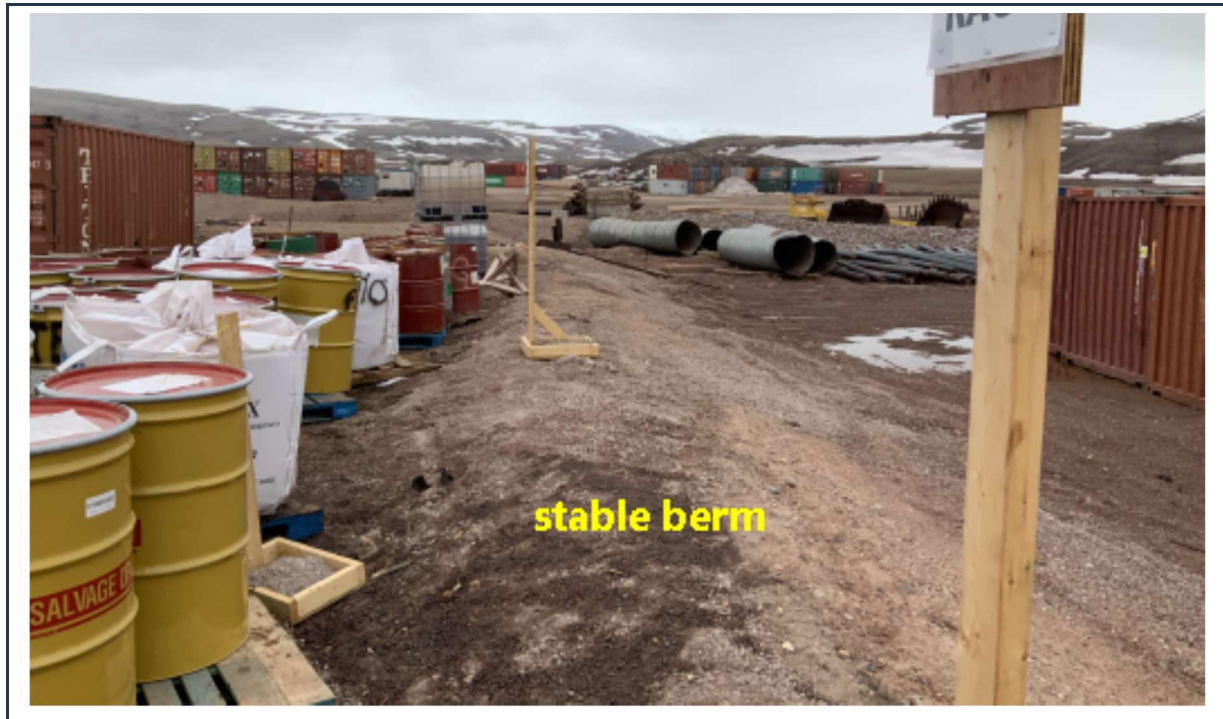
Figure 49: View of the stable berm around the HWB-1 cell.

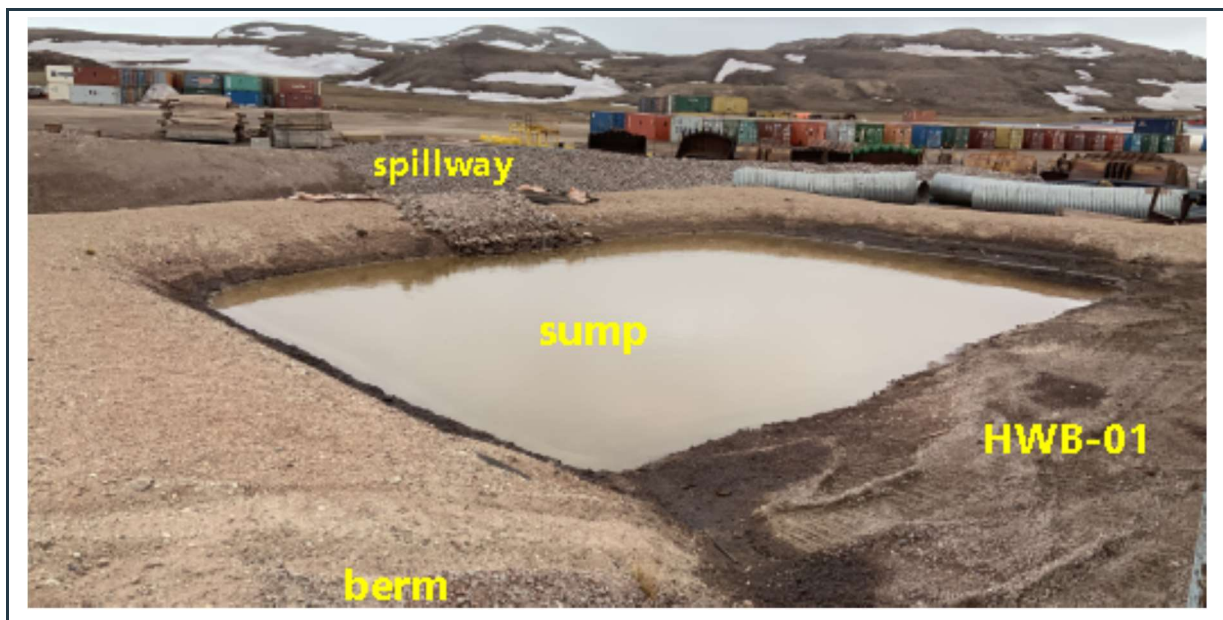
Figure 50: View of the sump and spillway at the back of the HWB-01 cell with stable berms.

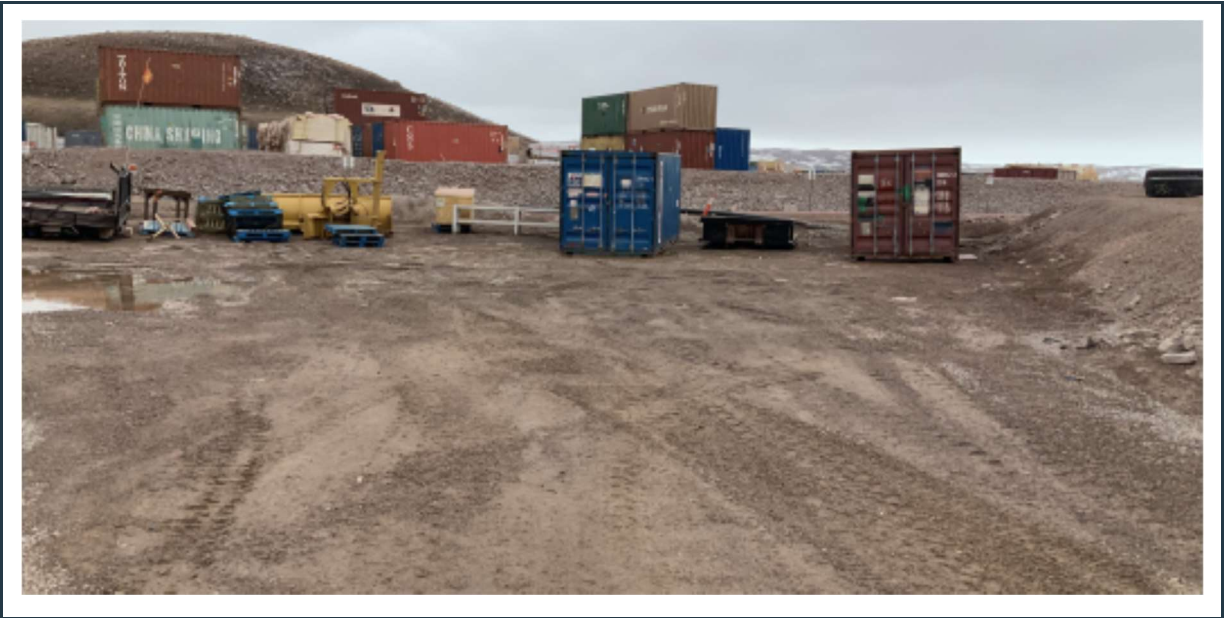
Figure 51: View of the former, now decommissioned, HWB-2 cell, with only a couple of empty containers stored on the top of clean sand and gravel fill pad. No hazardous waste is stored in this cell.

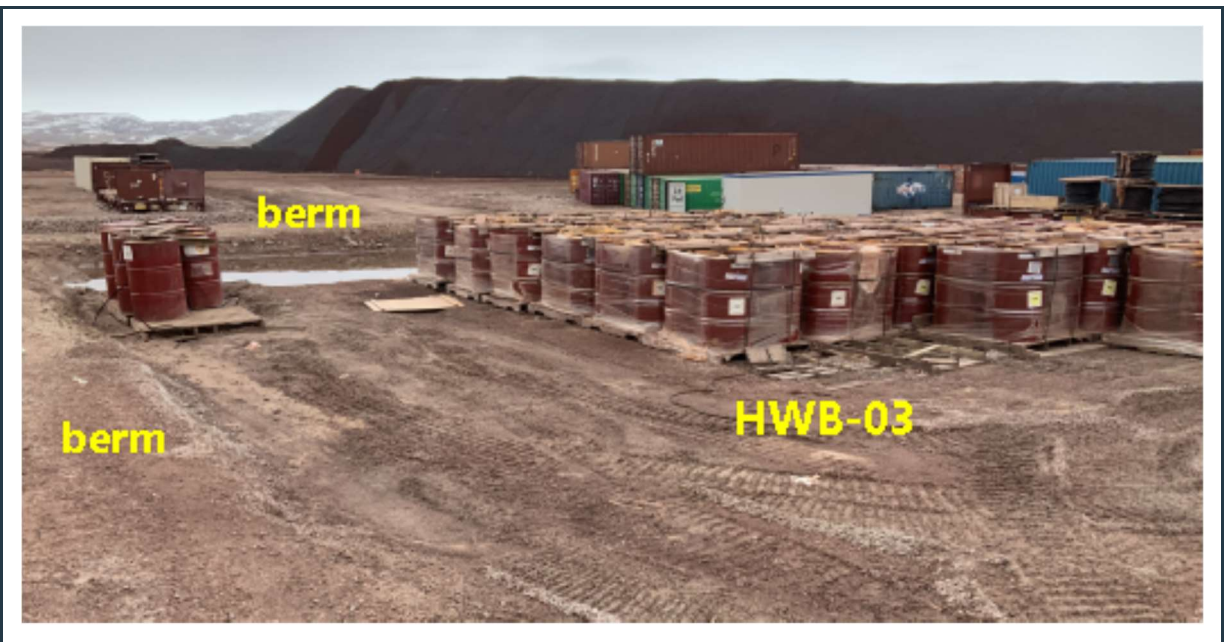
Figure 52: View of the HWB-03 cell with stable berms, containing fuel barrels. The interior subgrade has been regraded/lowered using clean sand and gravel fill, as specified in previous inspection report.

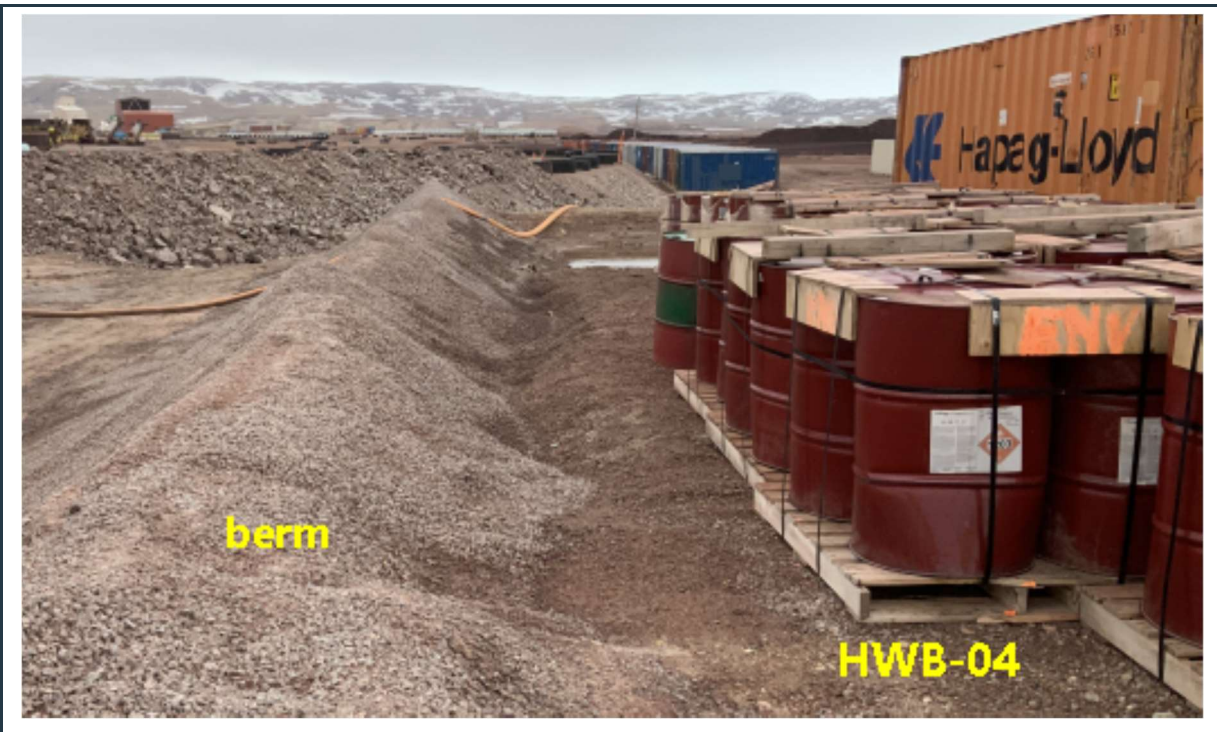
Figure 53: Recently improved (raised) berm at the HWB-04 cell, storing jet fuel and shipping containers.

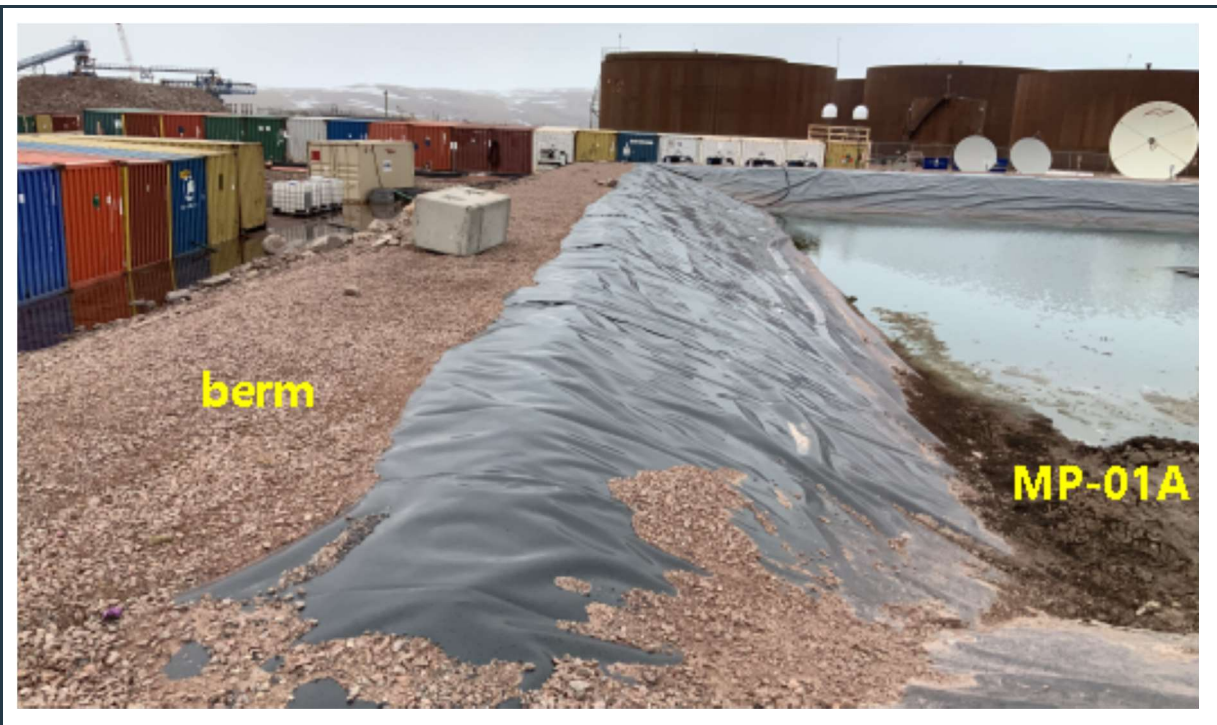
Figure 54: View of the robust, stable berms and intact liner in the MP-01A pond.

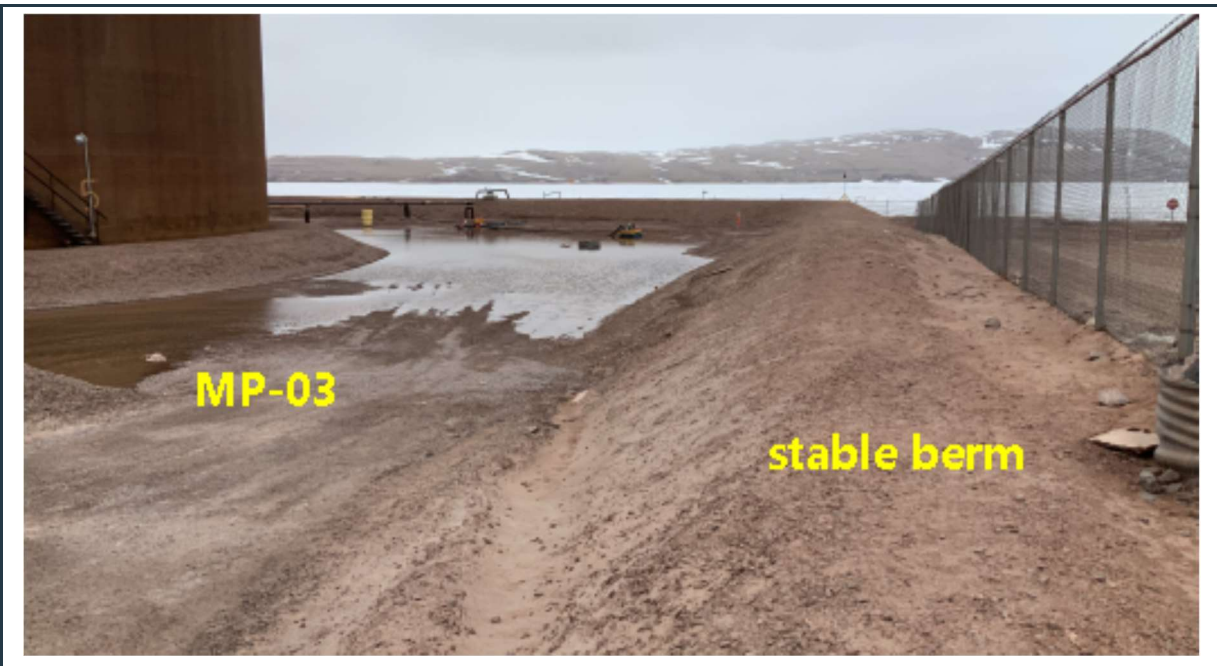
Figure 55: View of the well-maintained stable berms around the MP-03 fuel tank farm. The ponding water indicates good liner performance.

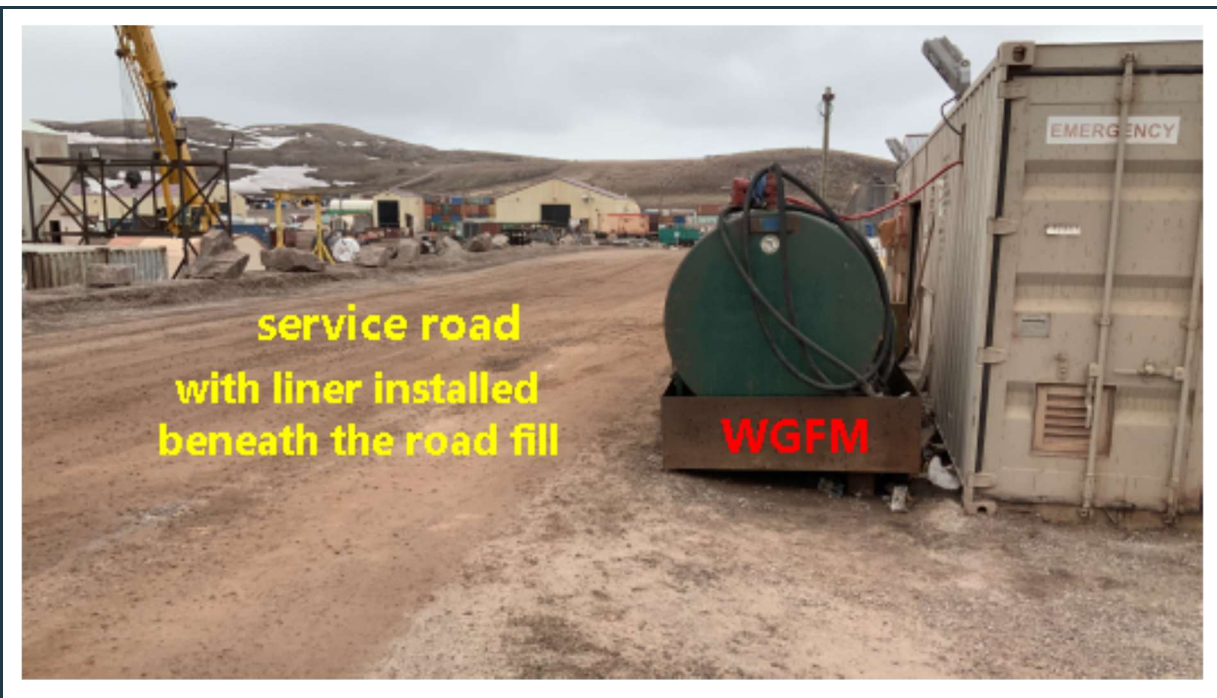
Figure 56: View of the Western Globe Fuel Module (WGFM) adjacent to MP-03 fuel tank farm. Based on site information, liner is present beneath the road fill and beneath the WGFM.

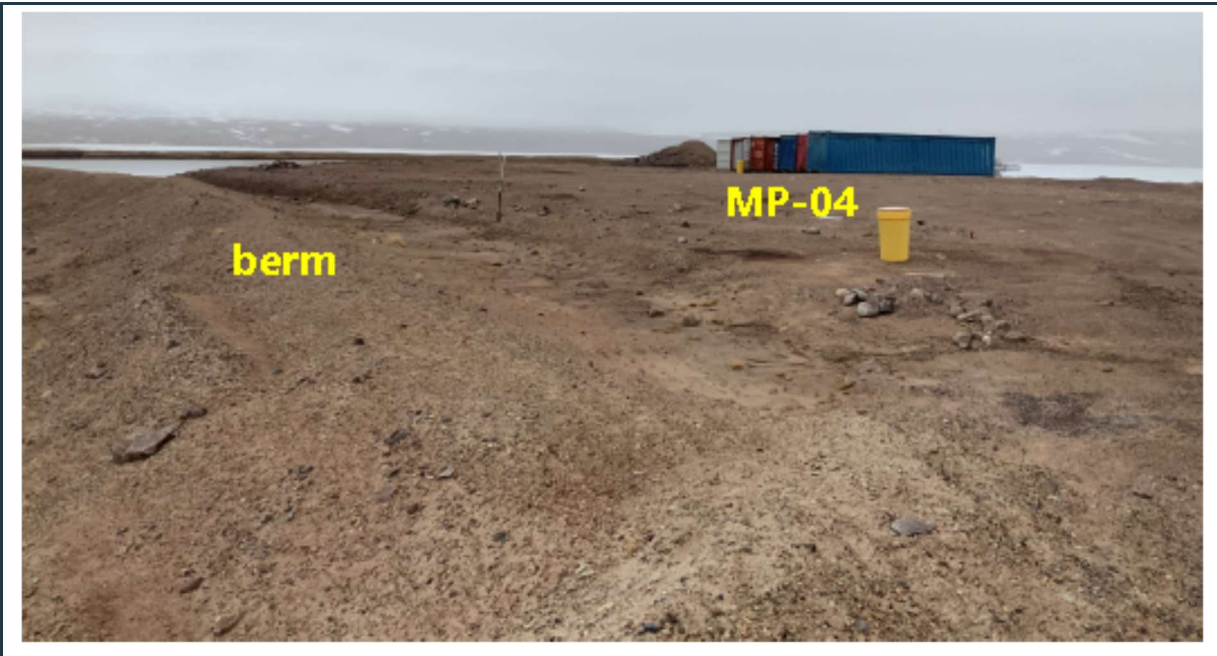
Figure 57: View of stable berm around the MP-04 land-farm, with ponding water in one corner of the cell.

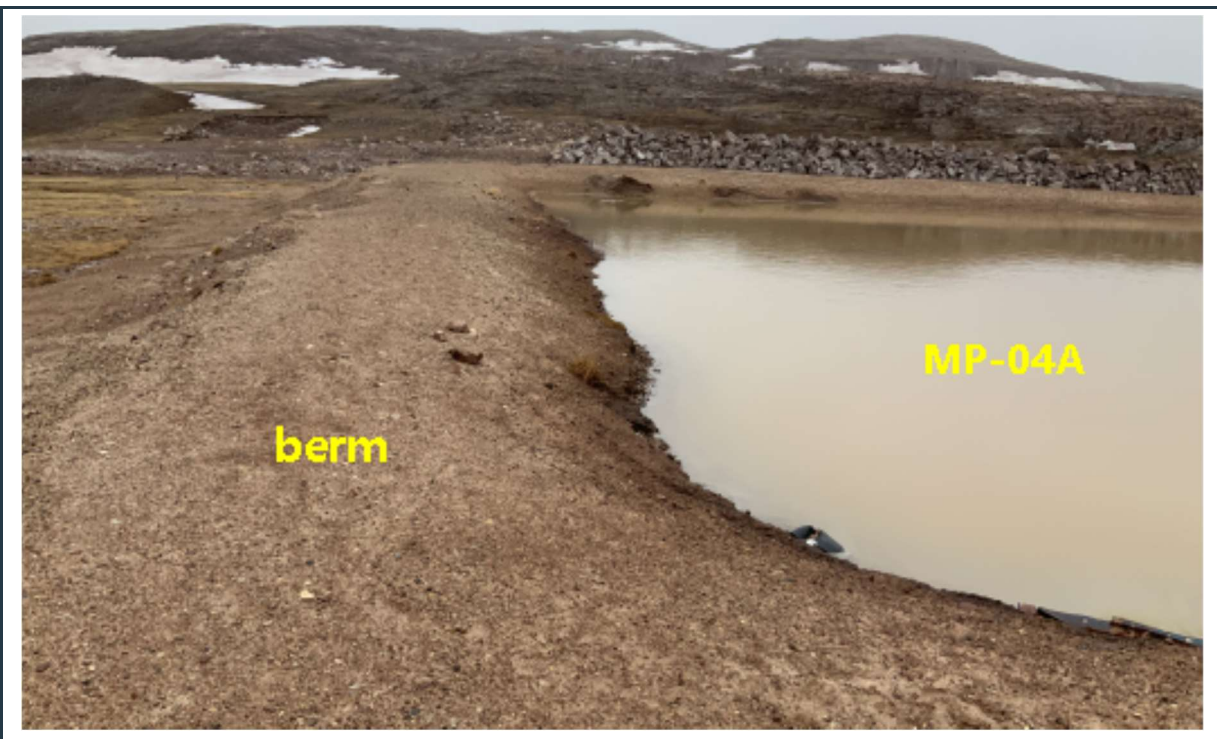
Figure 58: View of the MP-04A cell with stable berms. The ponding water indicates good liner performance.

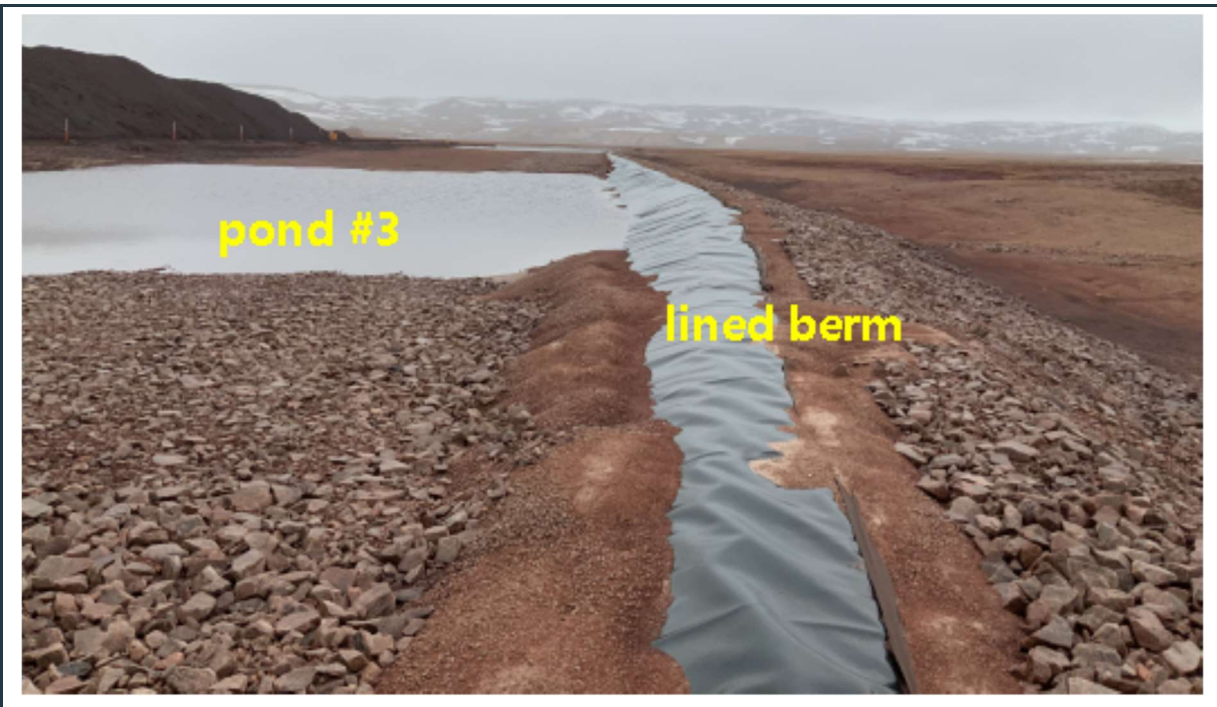
Figure 59: View of surface water management pond #3, with lined, stable berms.

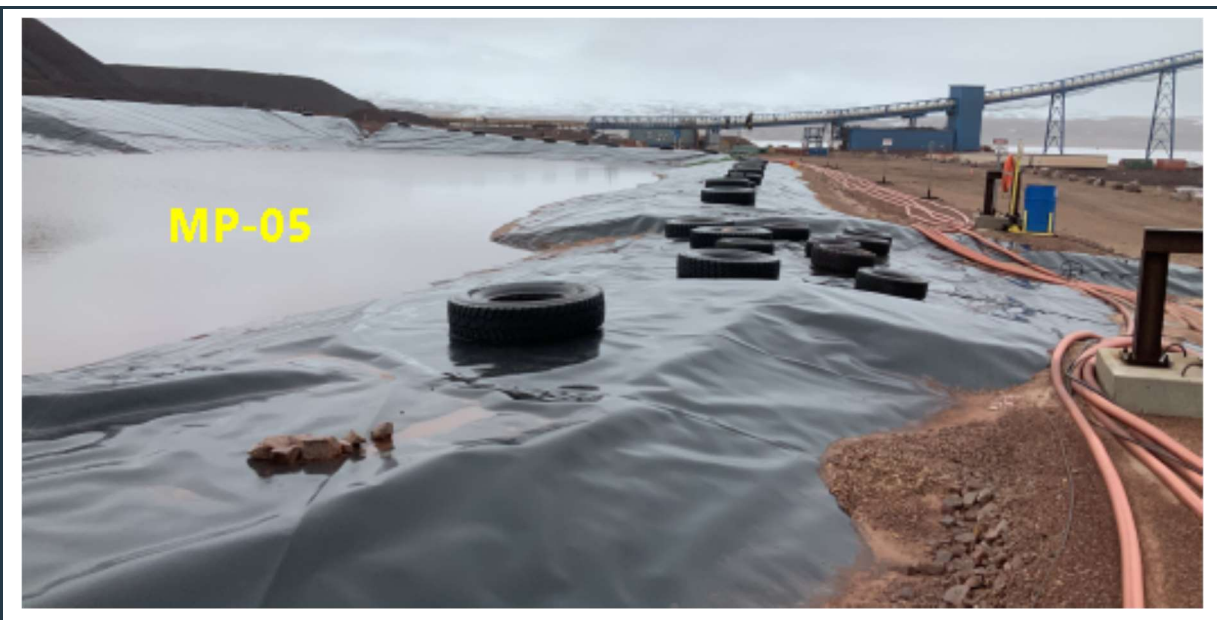
Figure 60: View of the robust, stable berms and intact liner at the MP-05 pond.

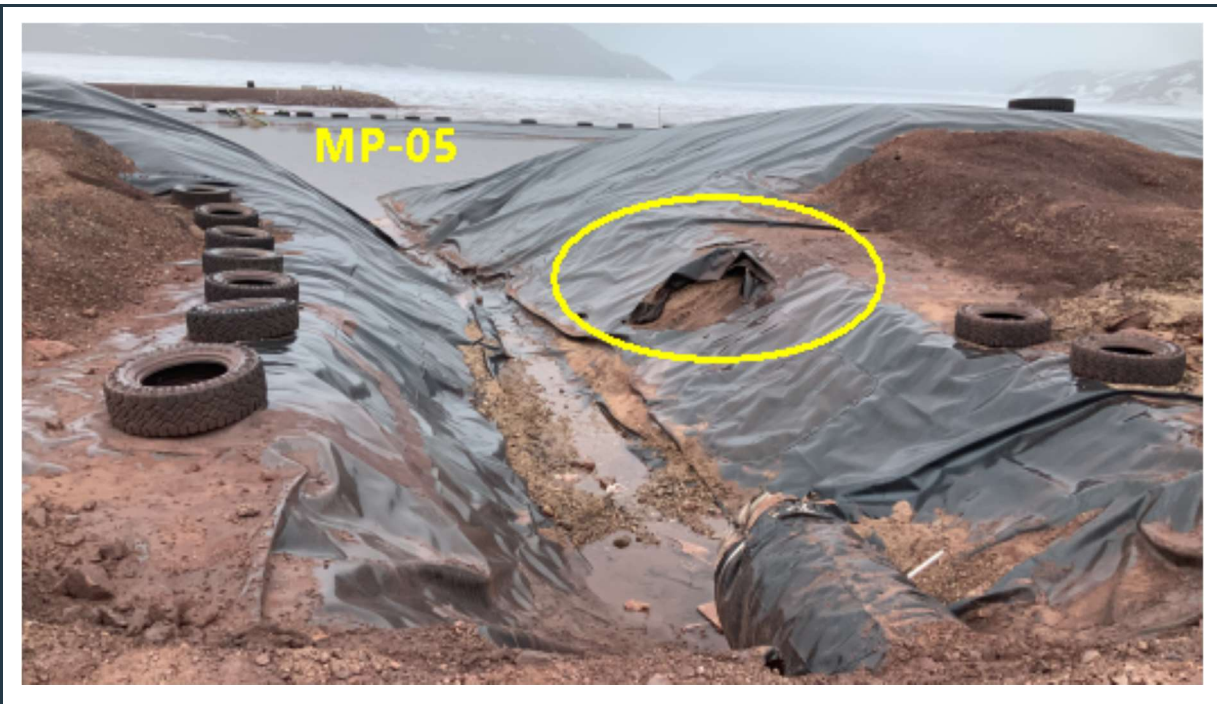
Figure 61: View of the inlet channel to the MP-05 pond, with the liner damaged at one location (yellow circle). The liner should be repaired as soon as practically possible.

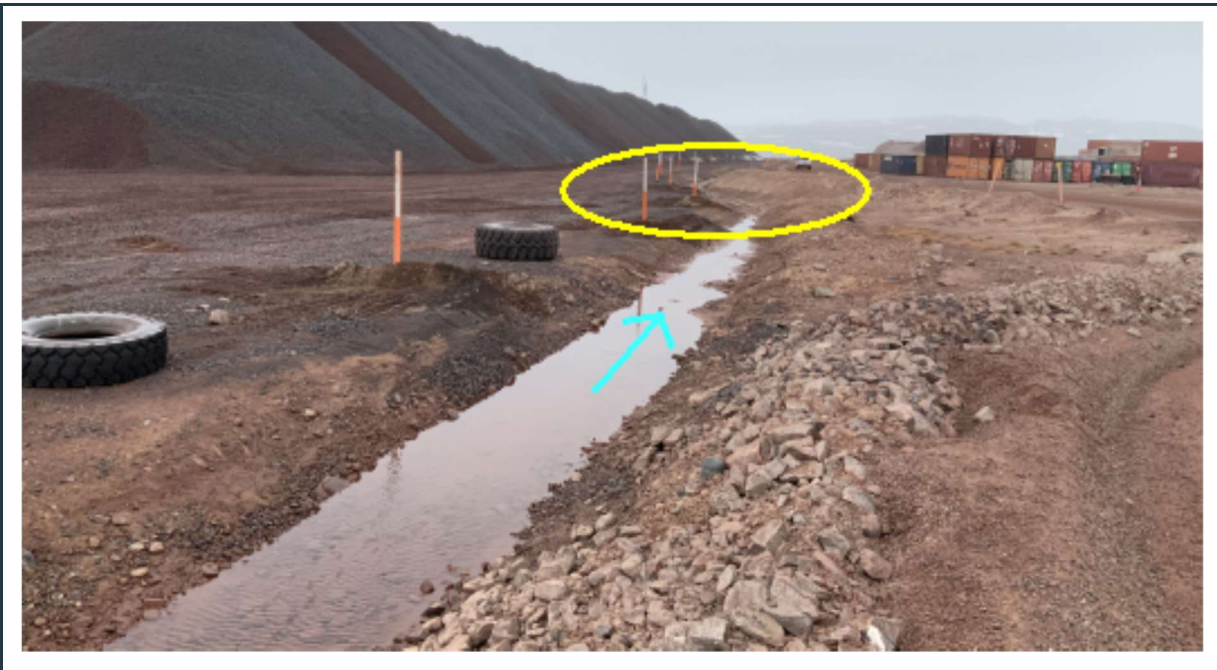
Figure 62: View of the "east" surface water collection ditch adjacent to the ore storage, draining to the MP-05 pond. Note the ponding water at the south end of the ditch. The ditch should be deepened/excavated in the area of the yellow circle to facilitate water flow to the MP-05 pond.

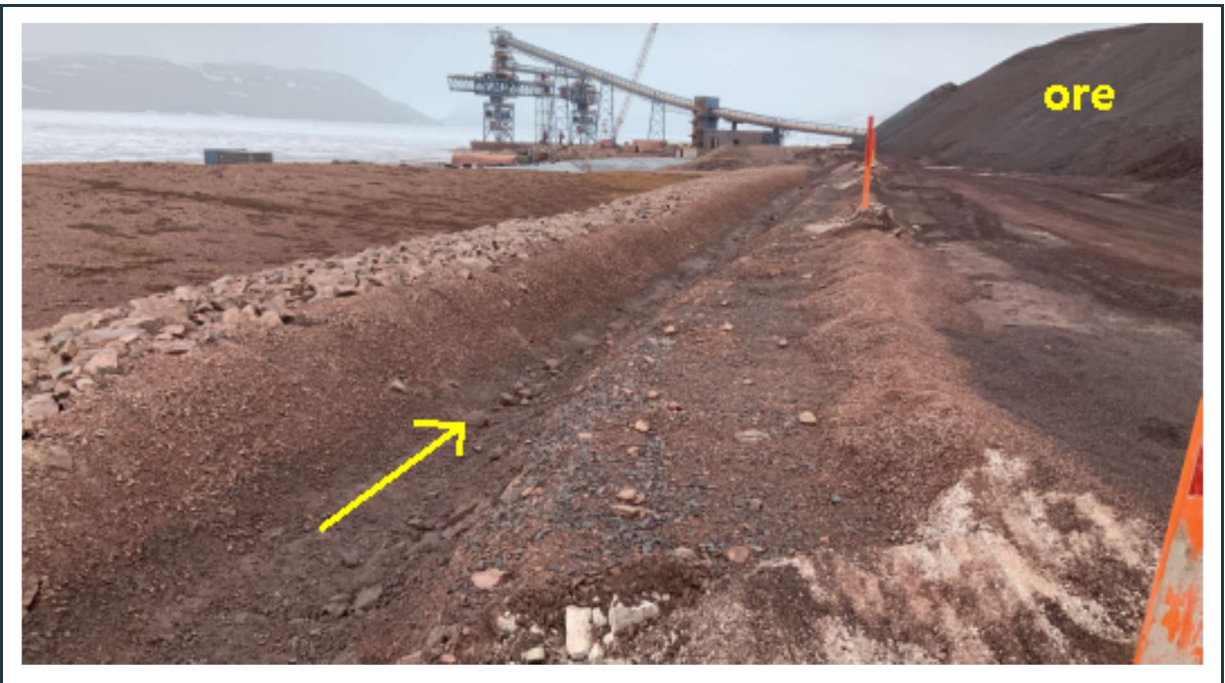
Figure 63: View of the well-maintained "west" surface water collection ditch adjacent to the ore storage, draining to the MP-06 pond.

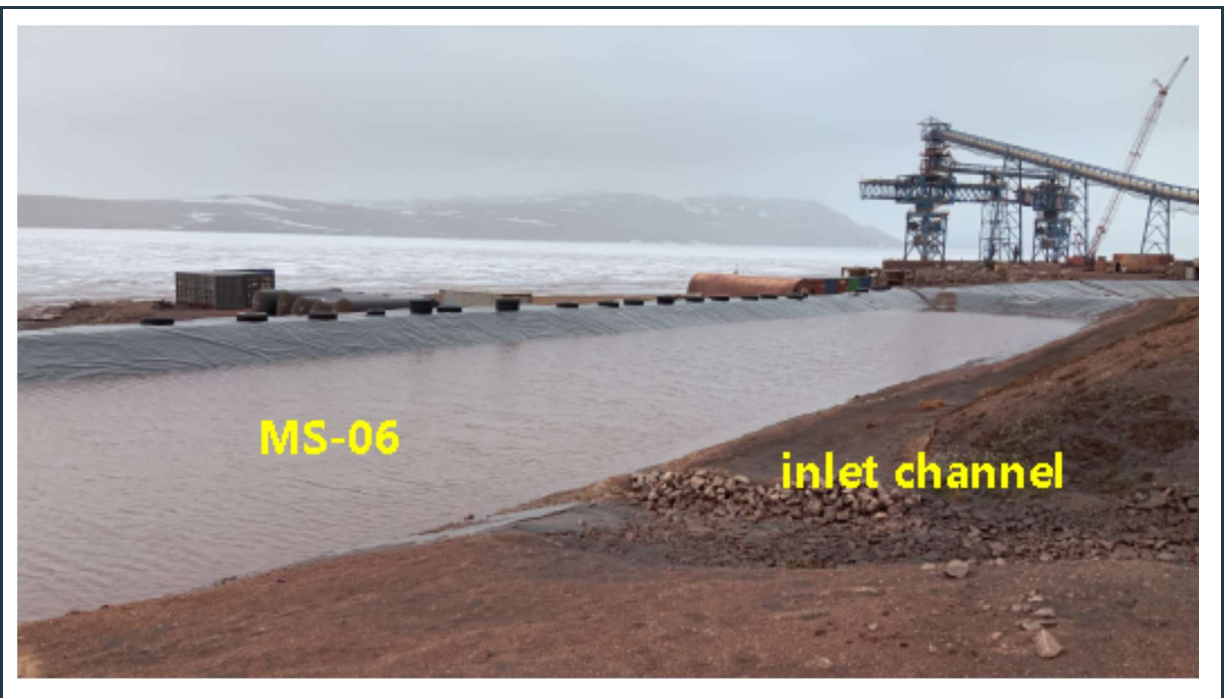
Figure 64: View of the lined MP-06 pond with robust, stable berms.

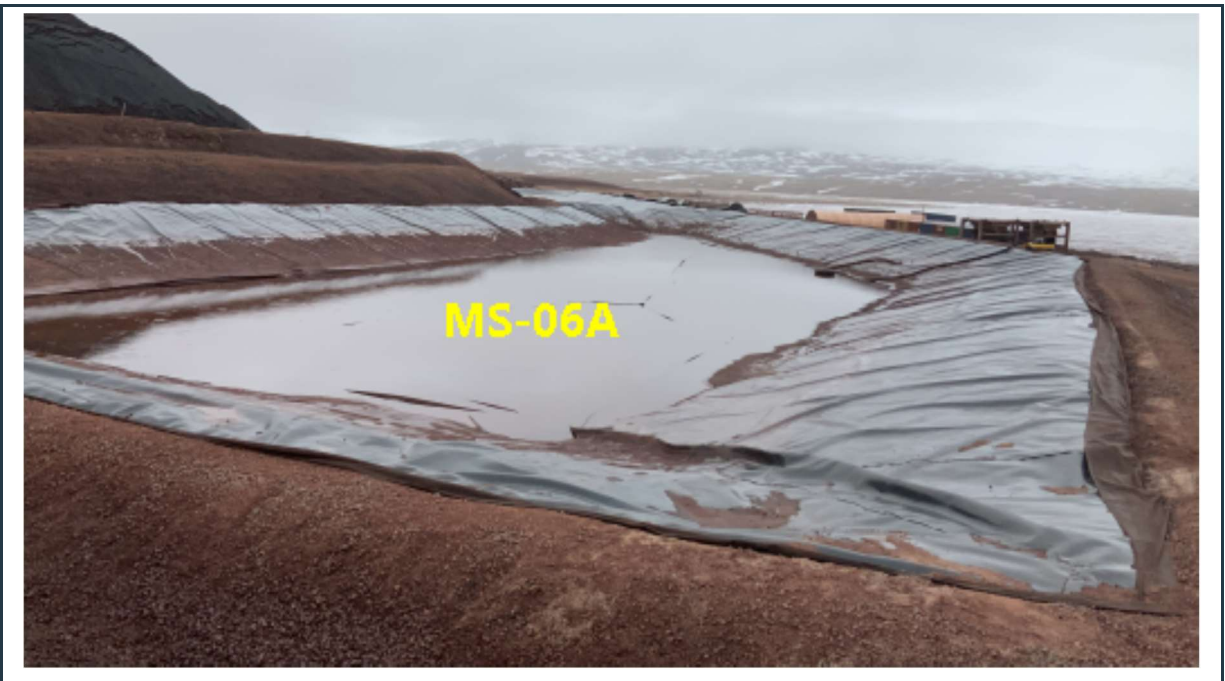
Figure 65: View of the lined MP-06A overflow pond with robust stable berms.

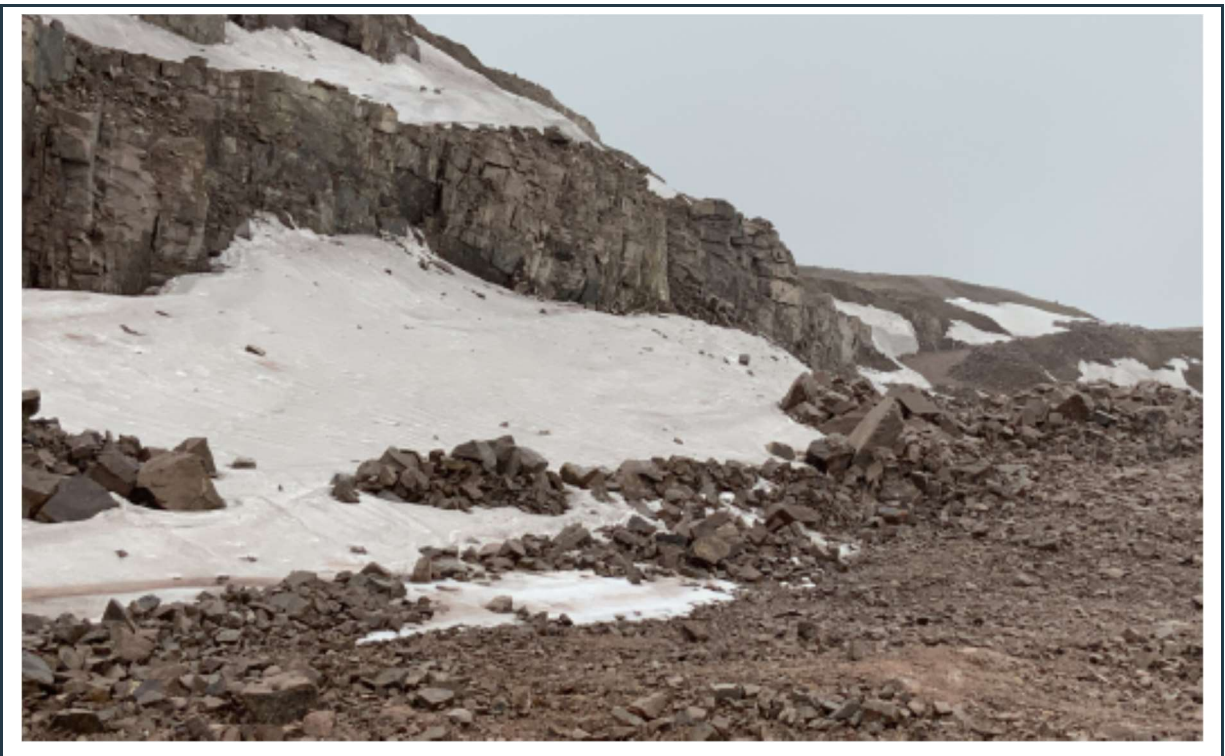
Figure 66: View of the snow-covered stable rock face with some weathering and bench erosion in the Q01 rock quarry. Currently there is no activity in this quarry.

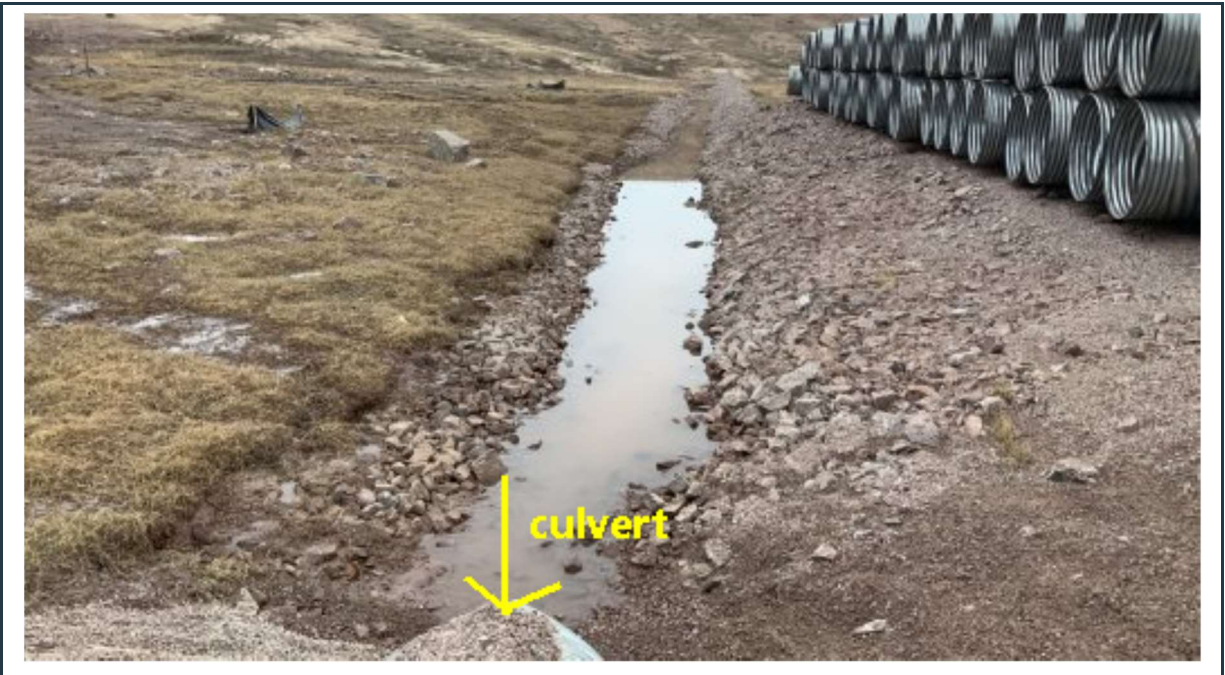
Figure 67: View of the southern part of the P-SWD-3 surface water collection ditch with failed slope sections, and ponding water due to inadequate longitudinal channel slope.

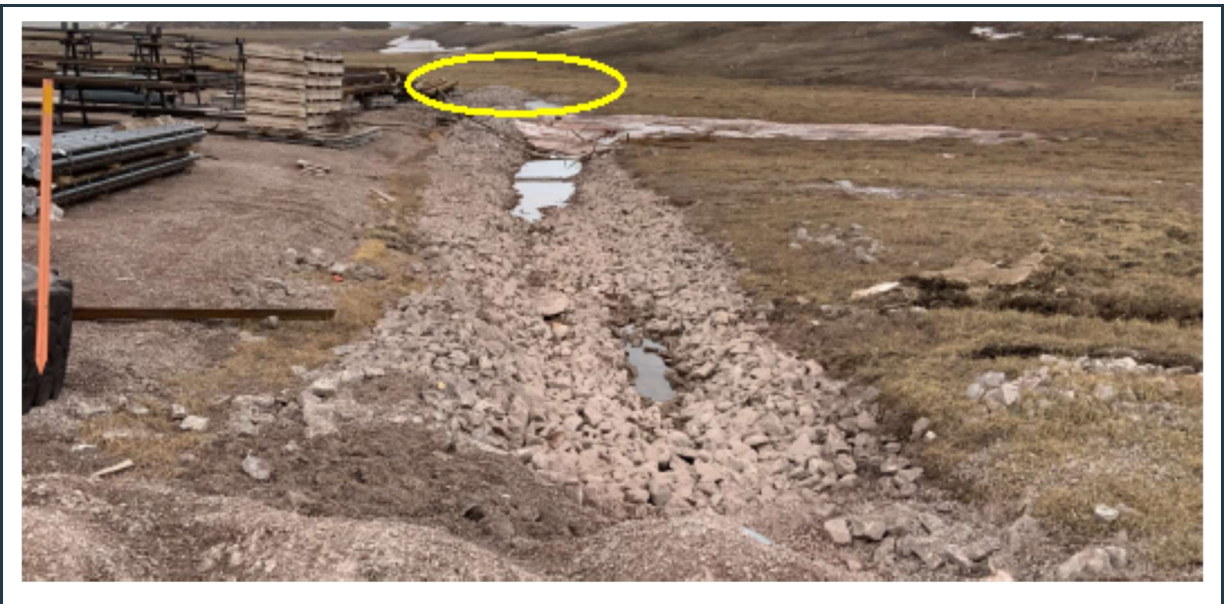
Figure 68: View of the northern part of the P-SWD-3 surface water collection ditch with failed slopes and some debris left in the channel, which should be removed. The ditch should be reconstructed.

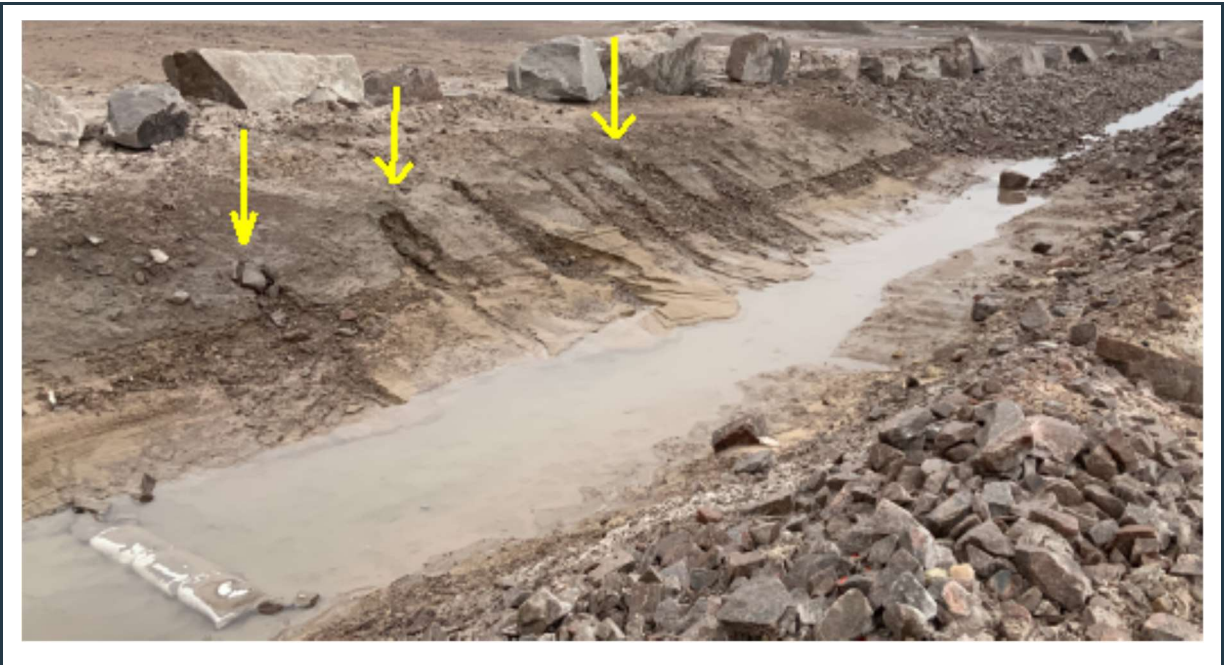
Figure 69: P-SWD-5 – “Q01-North” surface water collection ditch with missing riprap at one section of the ditch, where continuous seepage is noted from the side-slope.

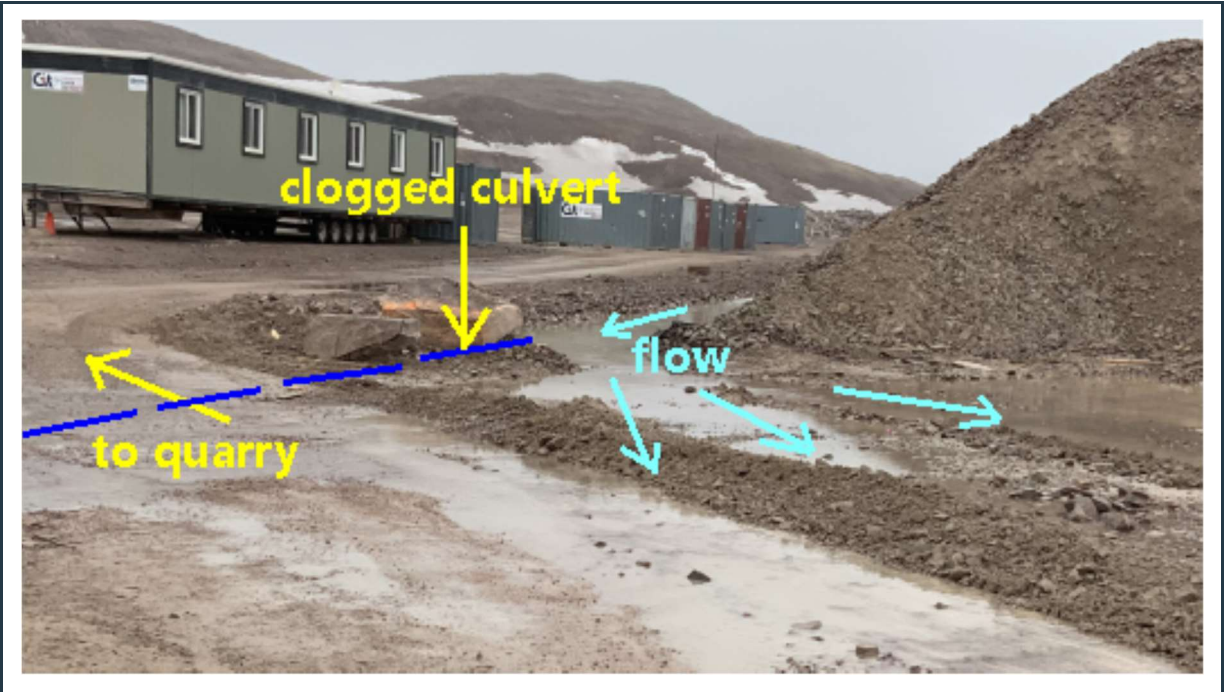
Figure 70: Clogged culvert at the entrance to the quarry in P-SWD-5/Q01-North surface water collection ditch. As a result, water from the ditch flows on the surface of the access road to the quarry.

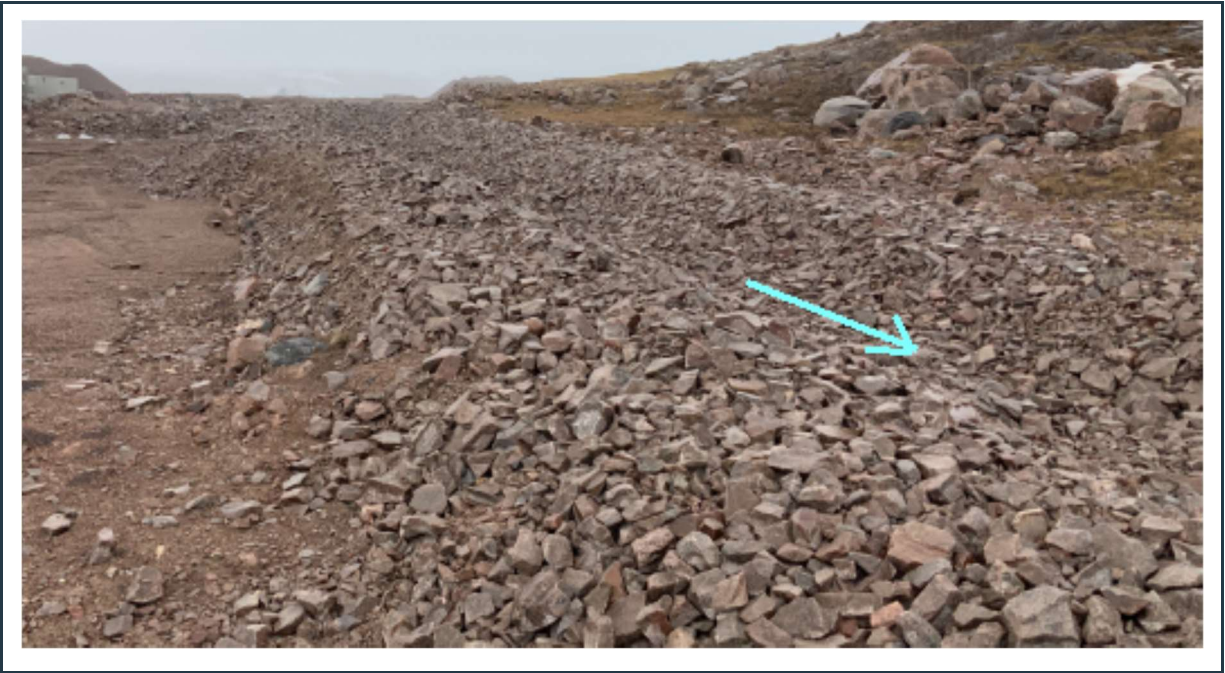
Figure 71: View of the now inefficient P-SWD-6 surface water collection ditch, due to over-blasting in the rock quarry.

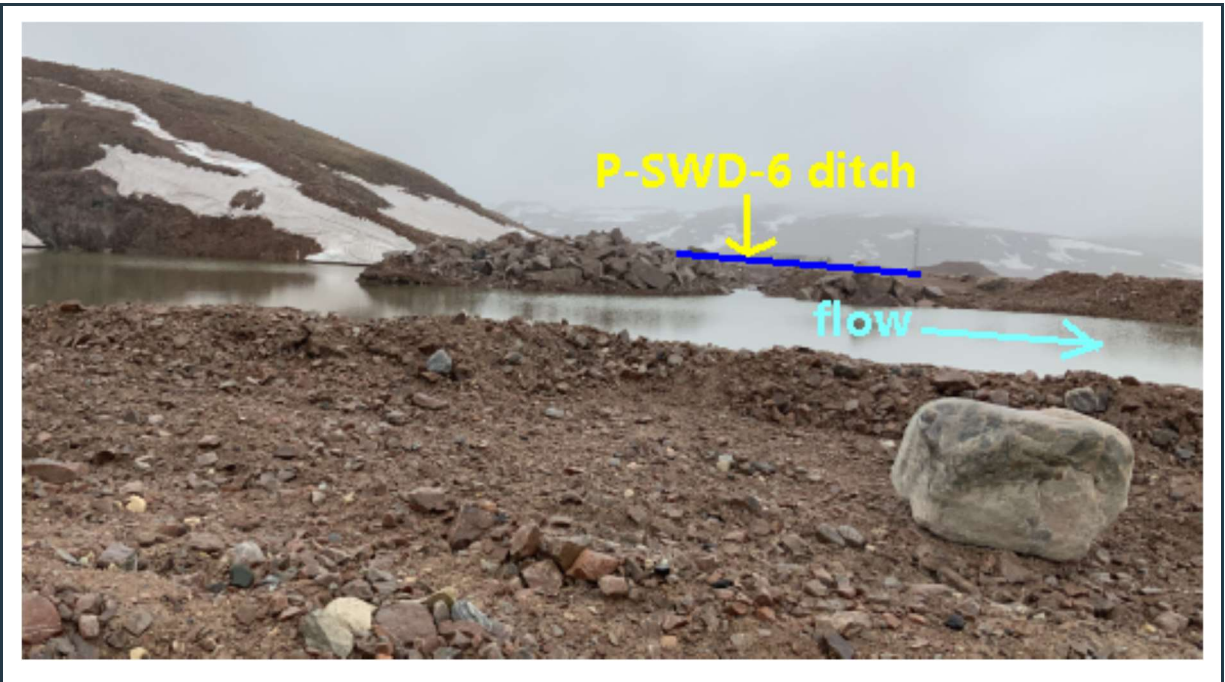
Figure 72: View of the now inefficient P-SWD-6 surface water collection ditch with elevated invert level above the ponding water in part of the quarry. Water flows uncontrolled away from the ditch.

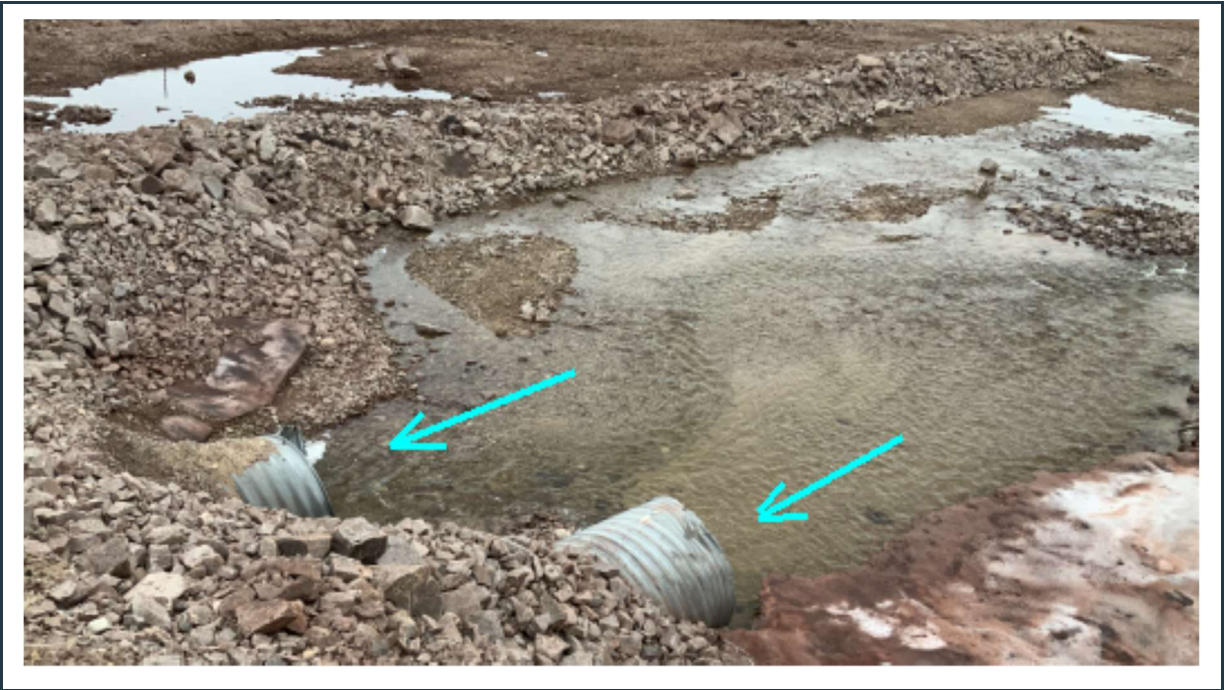
Figure 73: View of the P-SWD-7 surface water collection ditch and culverts (inlet).

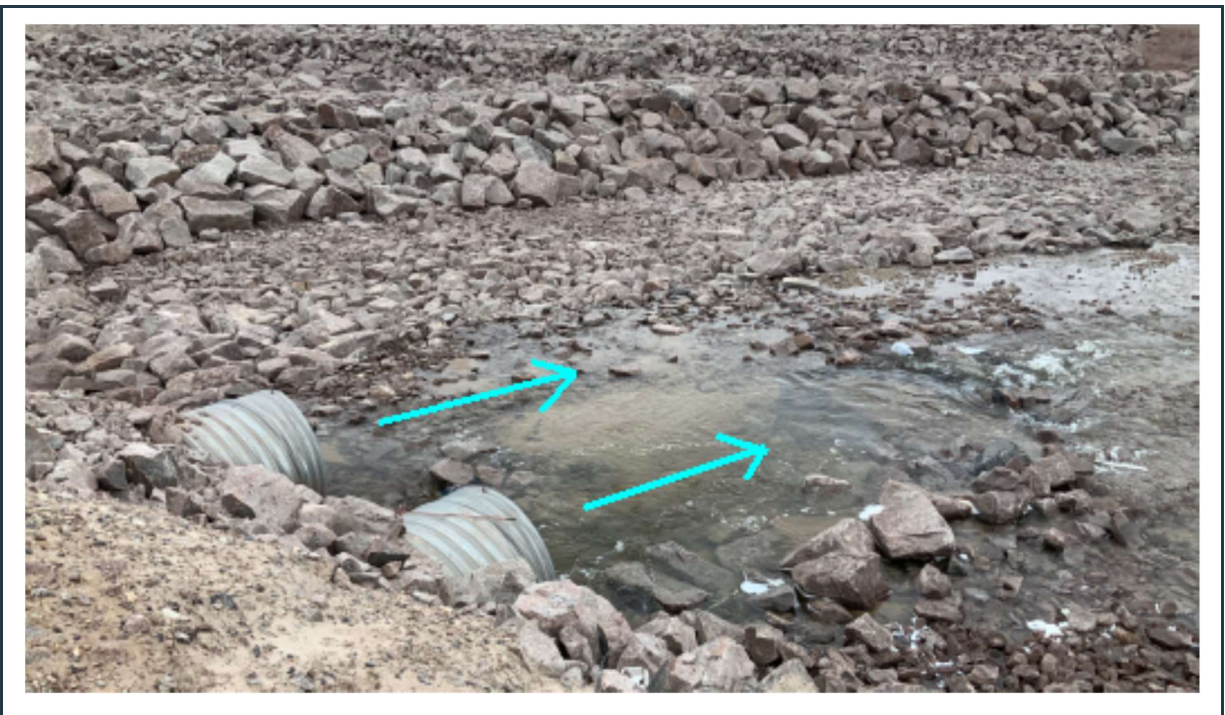
Figure 74: View of the well-maintained P-SWD-7 surface water collection ditch and culverts (outlet).
