Baffinland Iron Mines Corporation

Project #: OMGM2212-23

Annual Geotechnical Inspections – 2023 Report 1.

APPENDIX "B" – Milne Inlet Port Site - Photographs

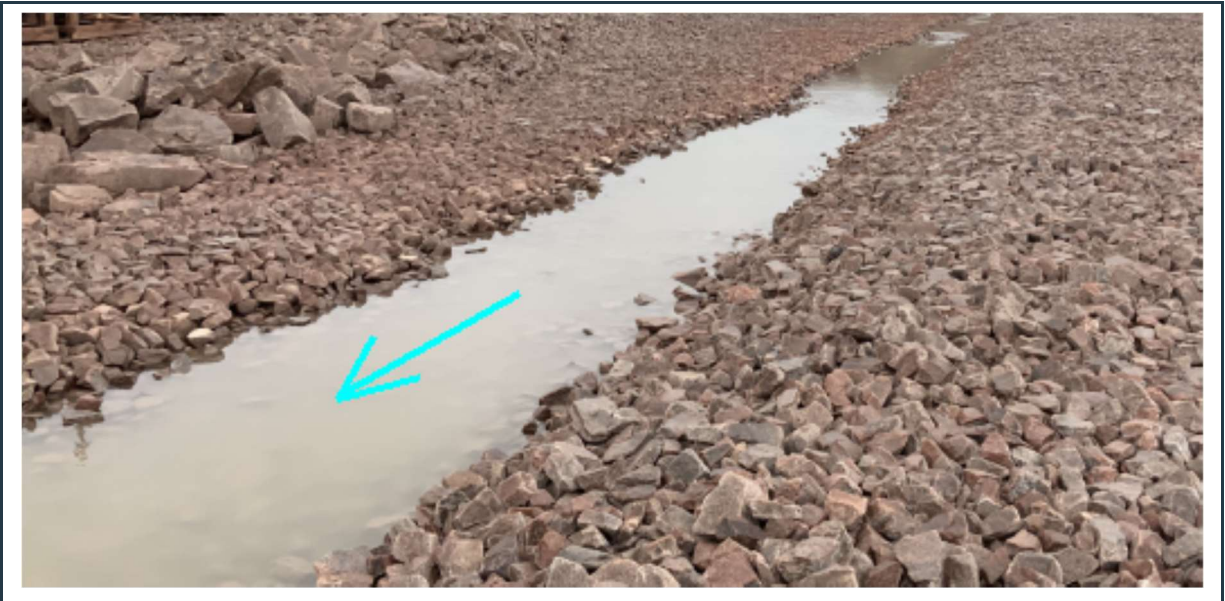
Figure 75: View of the recently completed W3/W14 surface water collection ditch with crushed rock riprap slope protection.

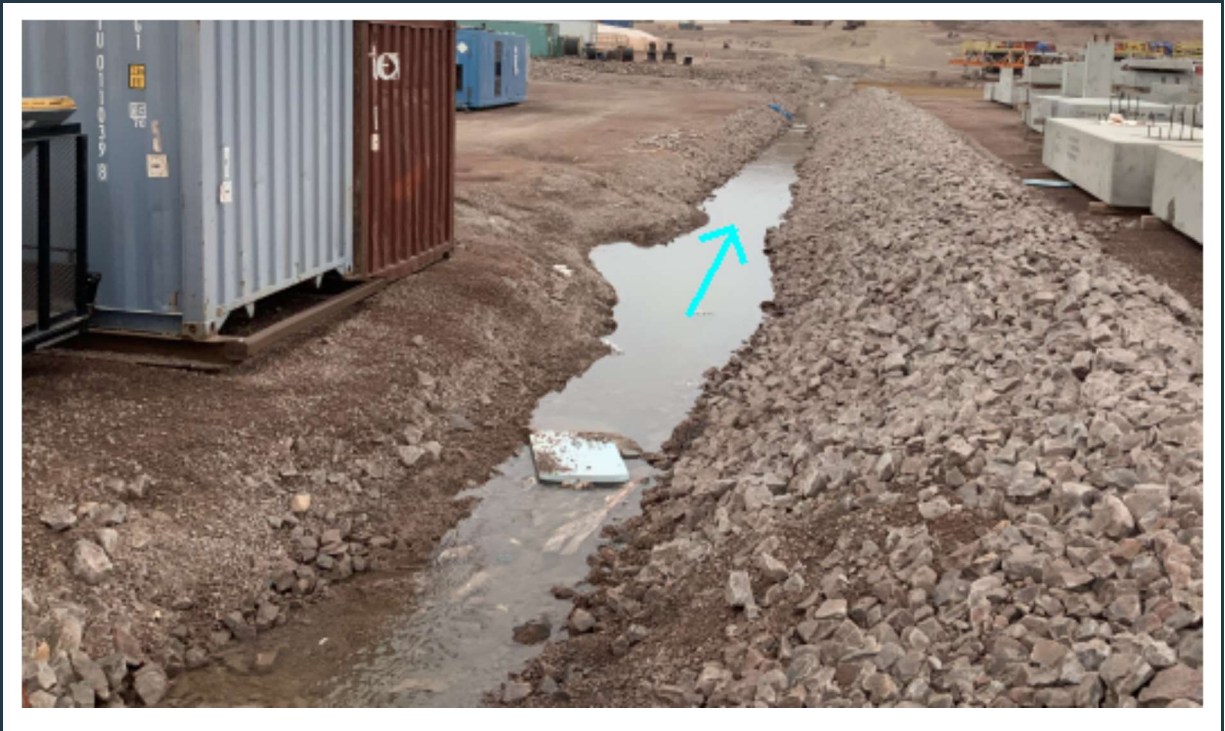
Figure 76: View of the south section of the 380-Person Camp surface water collection ditch. All debris (Styrofoam etc.) should be removed from the ditch.

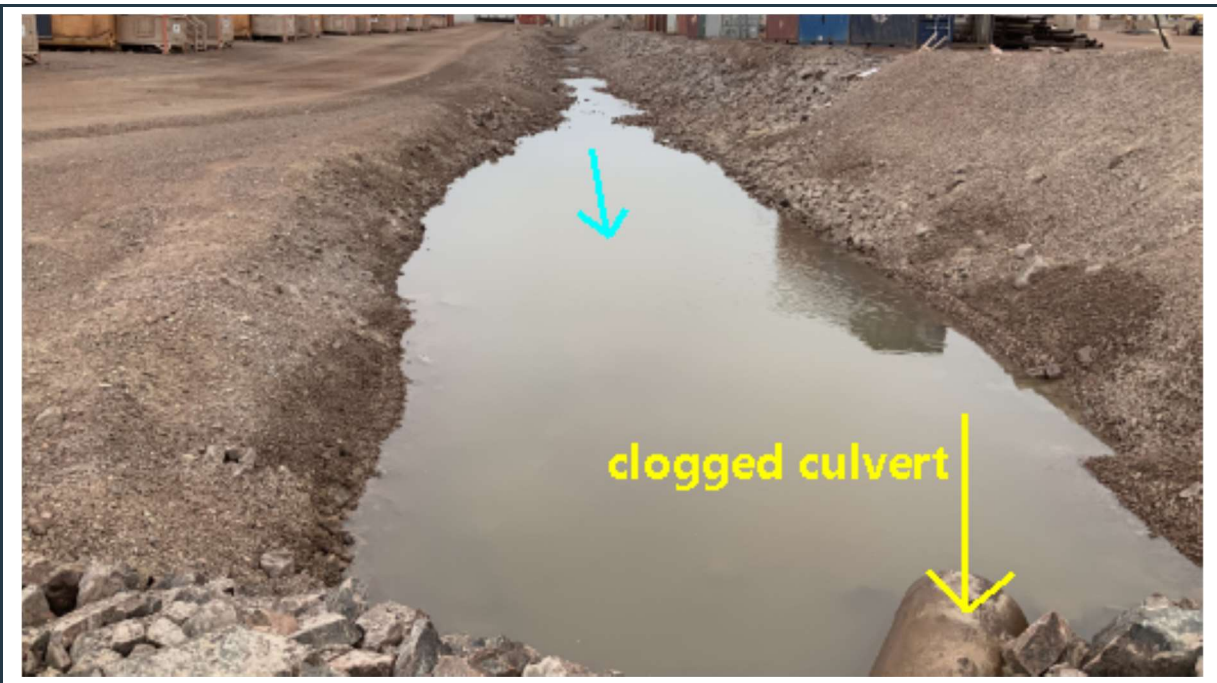
Figure 77: View of the east section of the 380-Person Camp surface water collection ditch with ponding water, due to the completely clogged culvert, which should be cleaned.

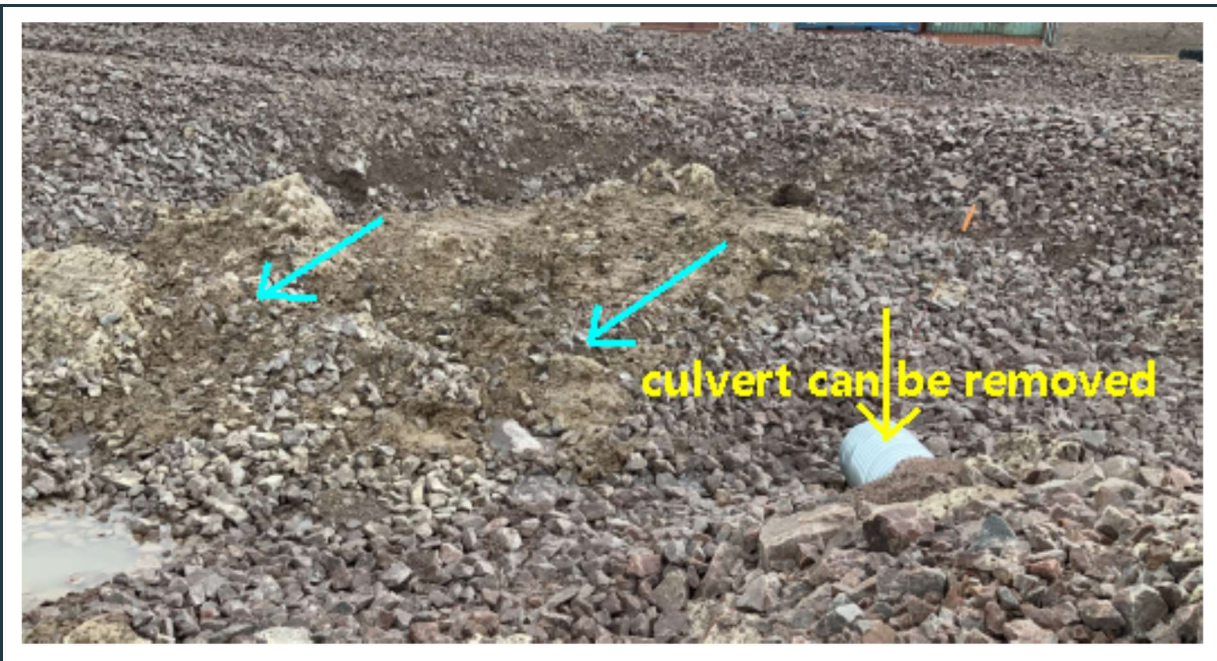
Figure 78: View of the "west end" of the PSC surface water collection ditch (red circle in Figure 7). Note the localized slope degradation due to frequent water seepage from the granular fill of the LP-2 laydown pad (blue arrows). The culvert in the area can be removed.

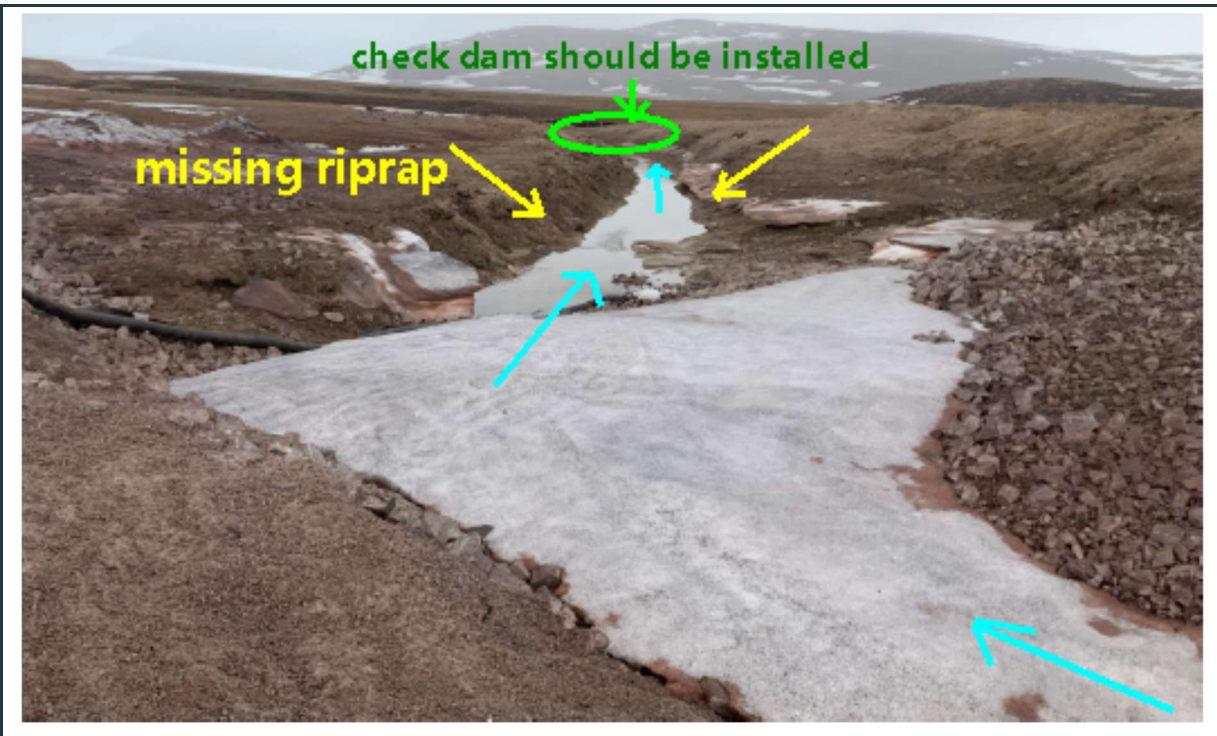
Figure 79: View of the unfinished “east end” of the PSC surface water collection ditch (green circle in Figure 7). Riprap and a check dam should be installed at this section if the ditch.

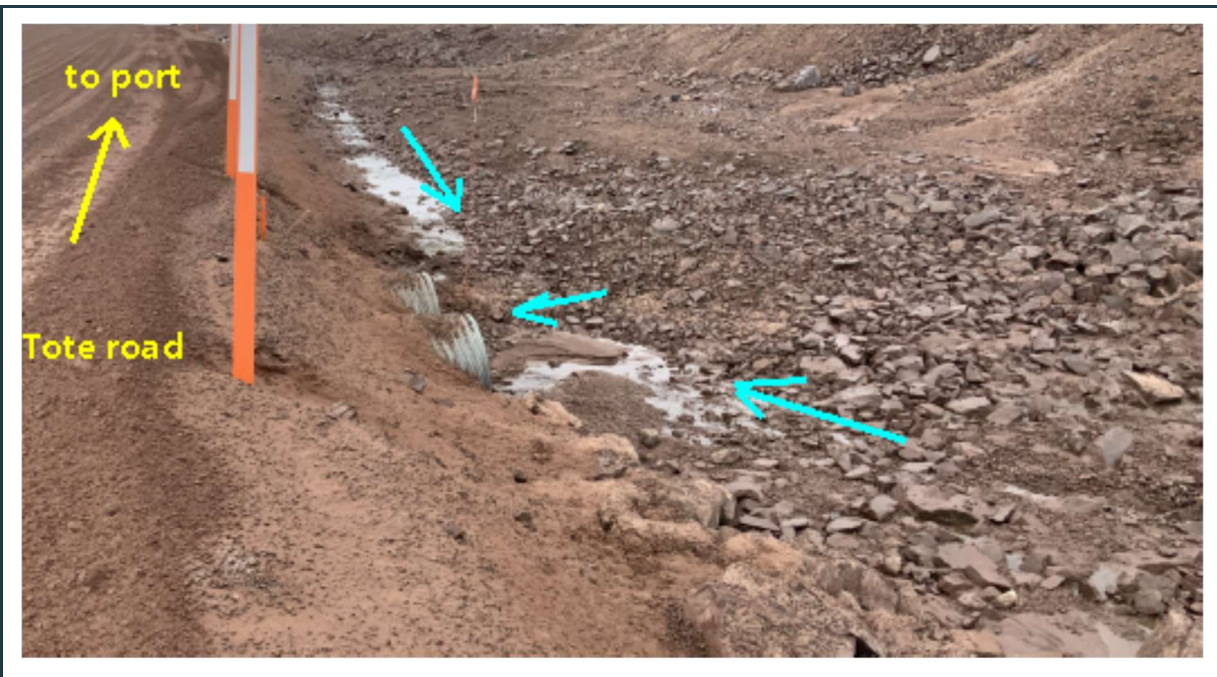
Figure 80: View of twin culverts, draining surface water from the quarry area under the tote road (inlet).

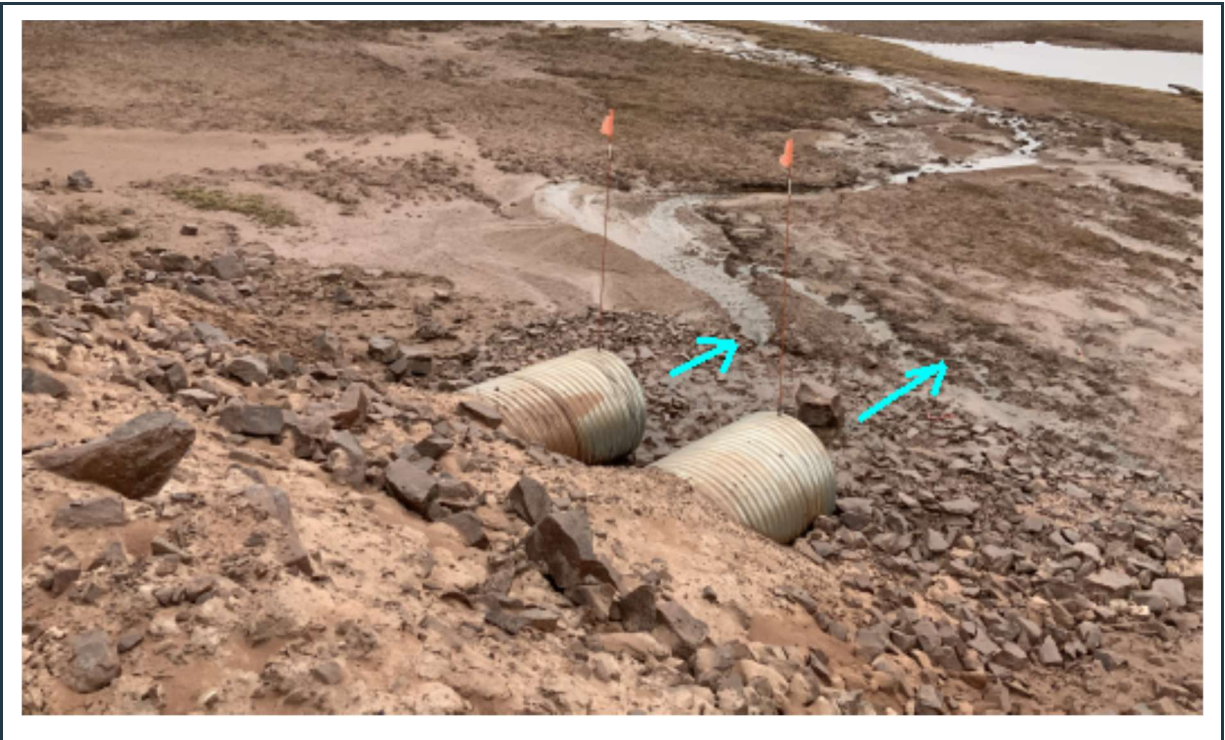
Figure 81: View of twin culverts, draining surface water from the quarry area (outlet).

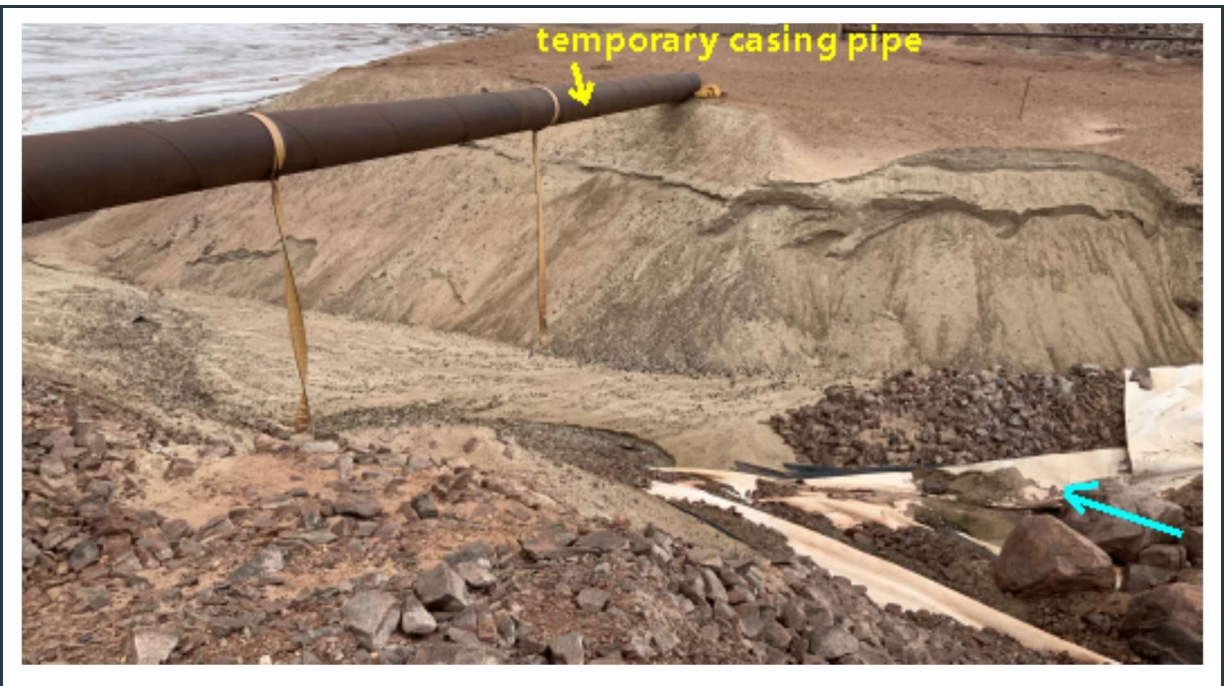
Figure 82: View of the end of the water discharge pipe (blue arrow) and deteriorating (eroding) slopes. This section of the valley should be filled with rock fill, placed over geotextile.

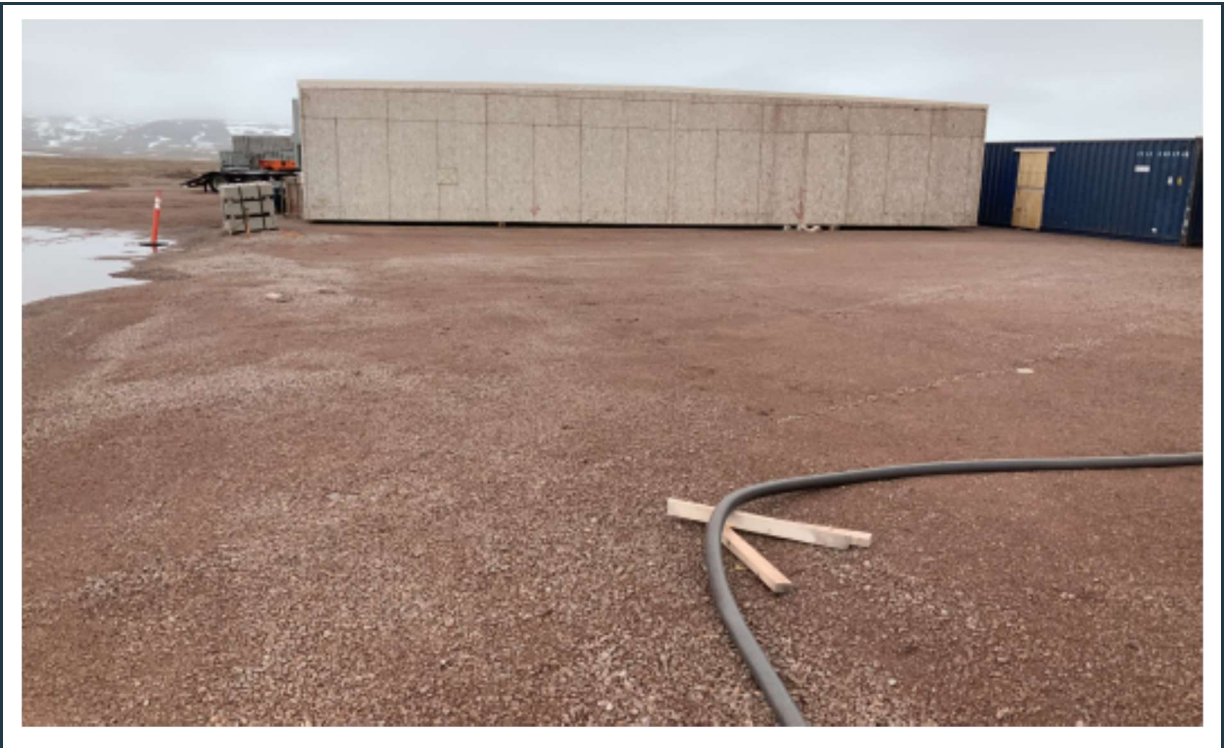
Figure 83: View of the recently regraded LP-5 storage area.

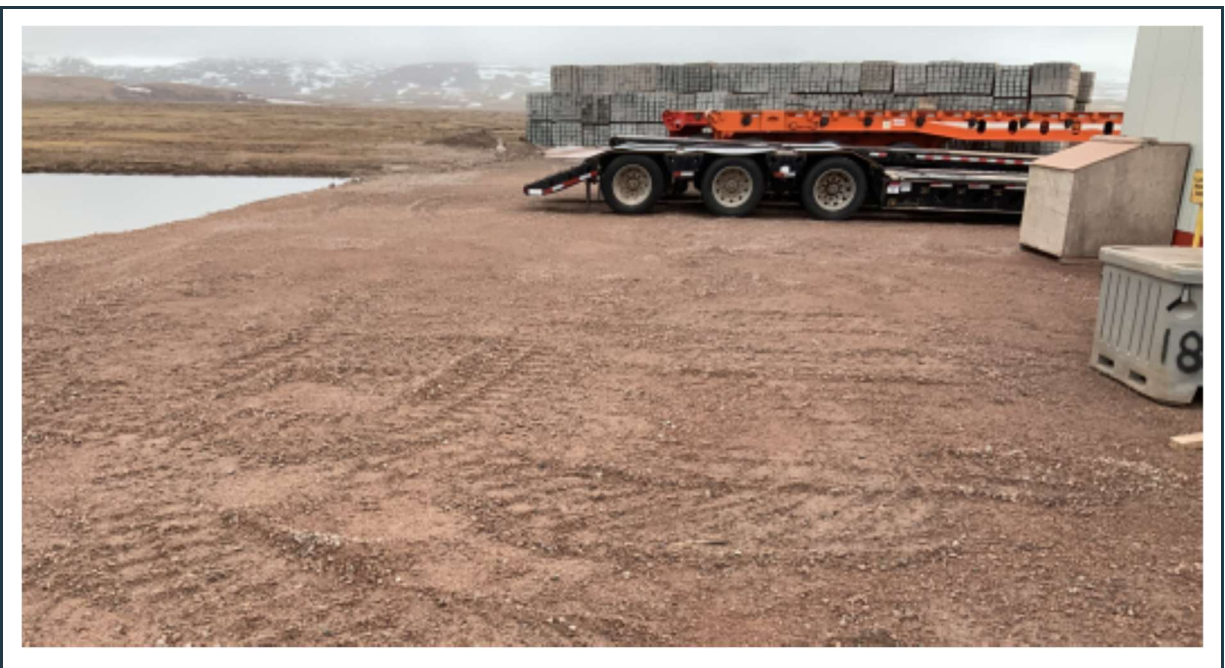
Figure 84: View of the recently regraded LP-5 storage area.
