# Baffinland Iron Mines Corporation

Project #: OMGM2212-23

## **Annual Geotechnical Inspections – 2023 Report 1.**

### **APPENDIX "C" – Tote/Haul Road - Photographs**

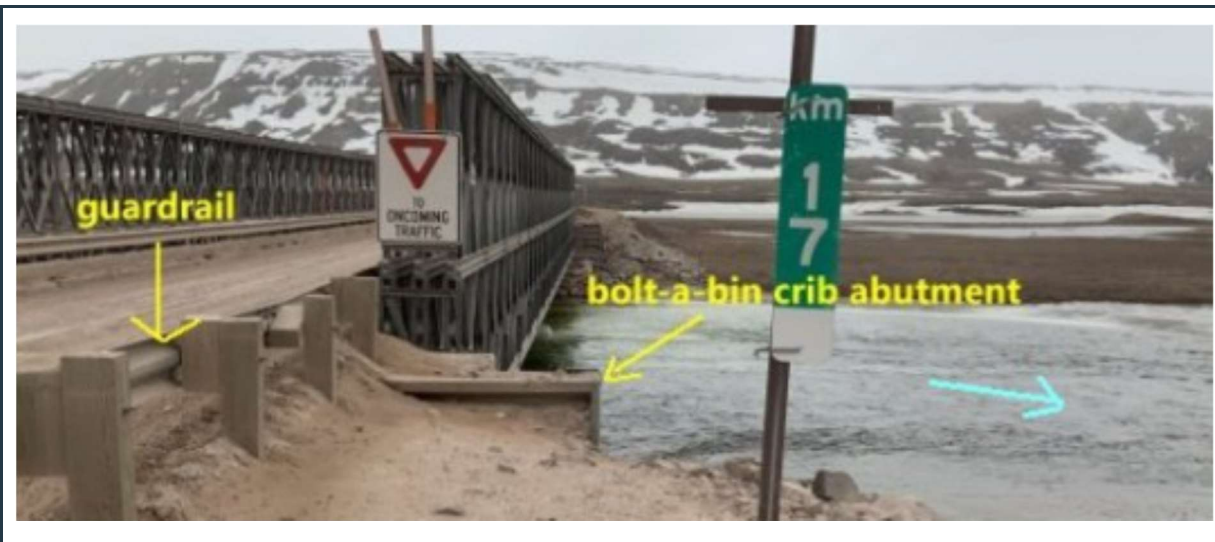
Figure 85: View of the north side of "bridge 17", with the bolt-a-bin crib abutment and guardrail.

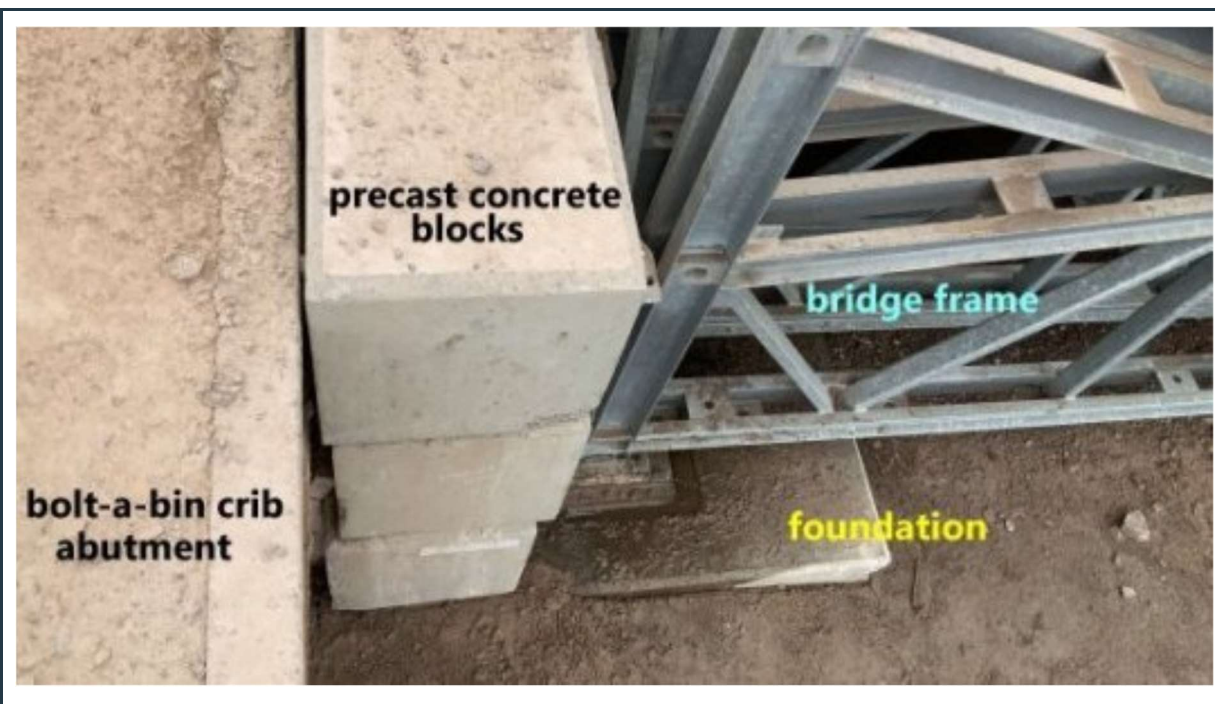
Figure 86: View of the components of the bridge and bridge abutment at KM-17.

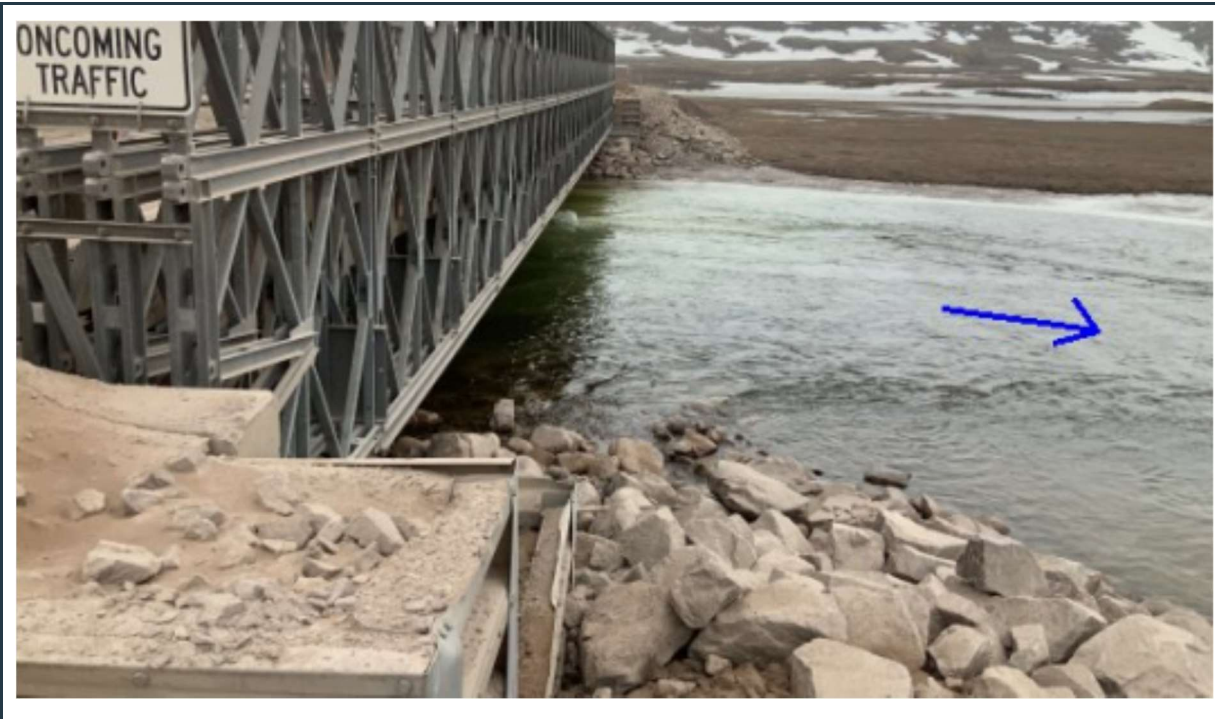
Figure 87: View of the stable abutments with riprap erosion protection at the north side of bridge KM17.

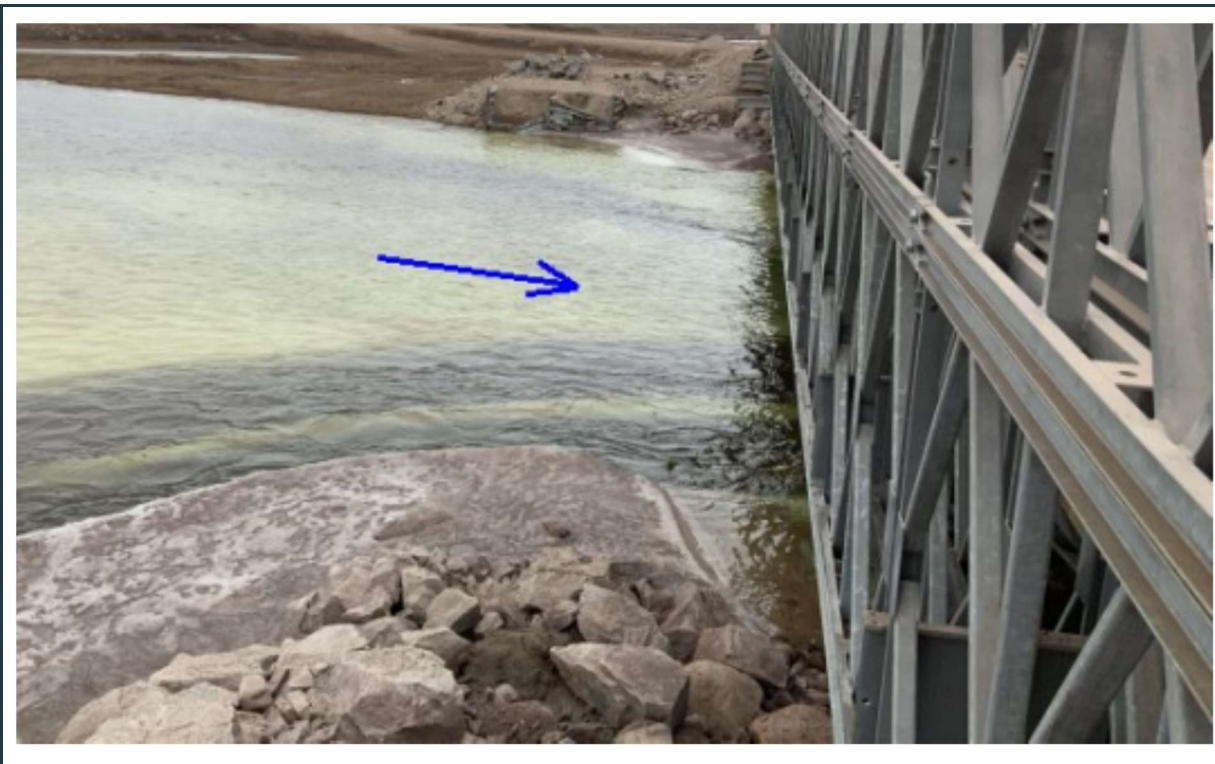
Figure 88: View of the stable abutments with riprap scour protection at the south side of bridge KM-17.

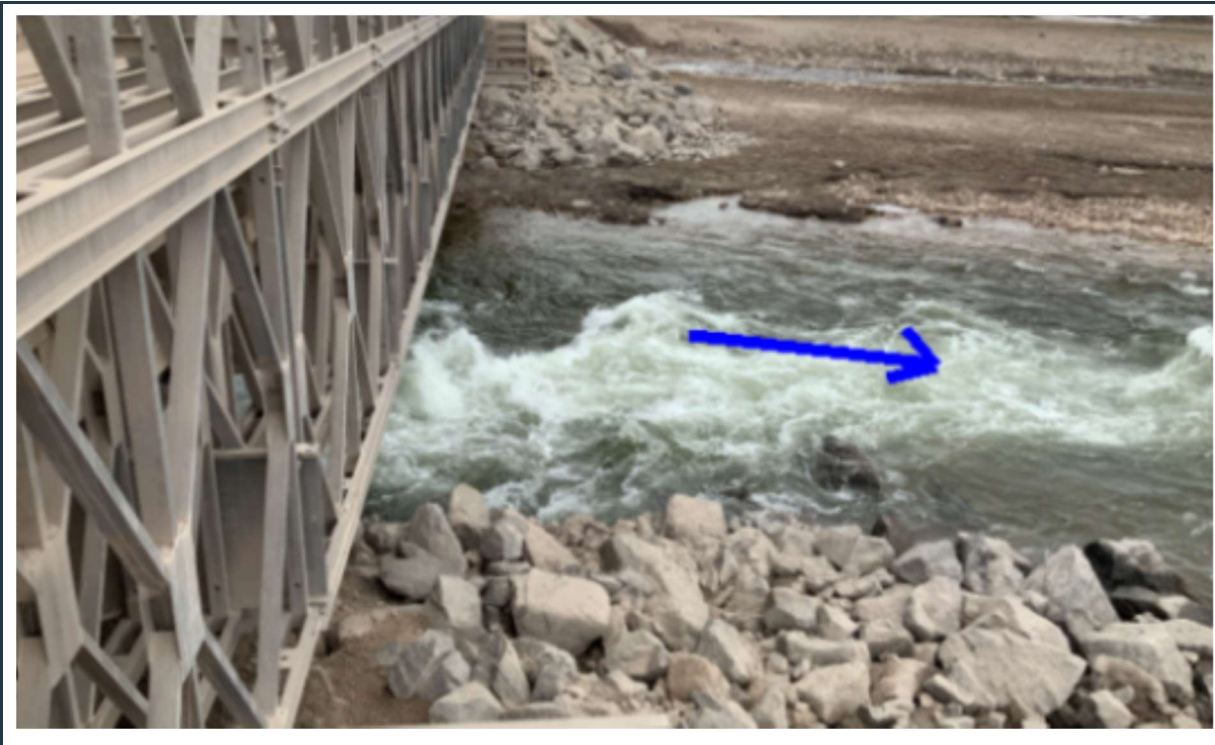
Figure 89: View of the west side of bridge 63, with stable abutments protected against scour.

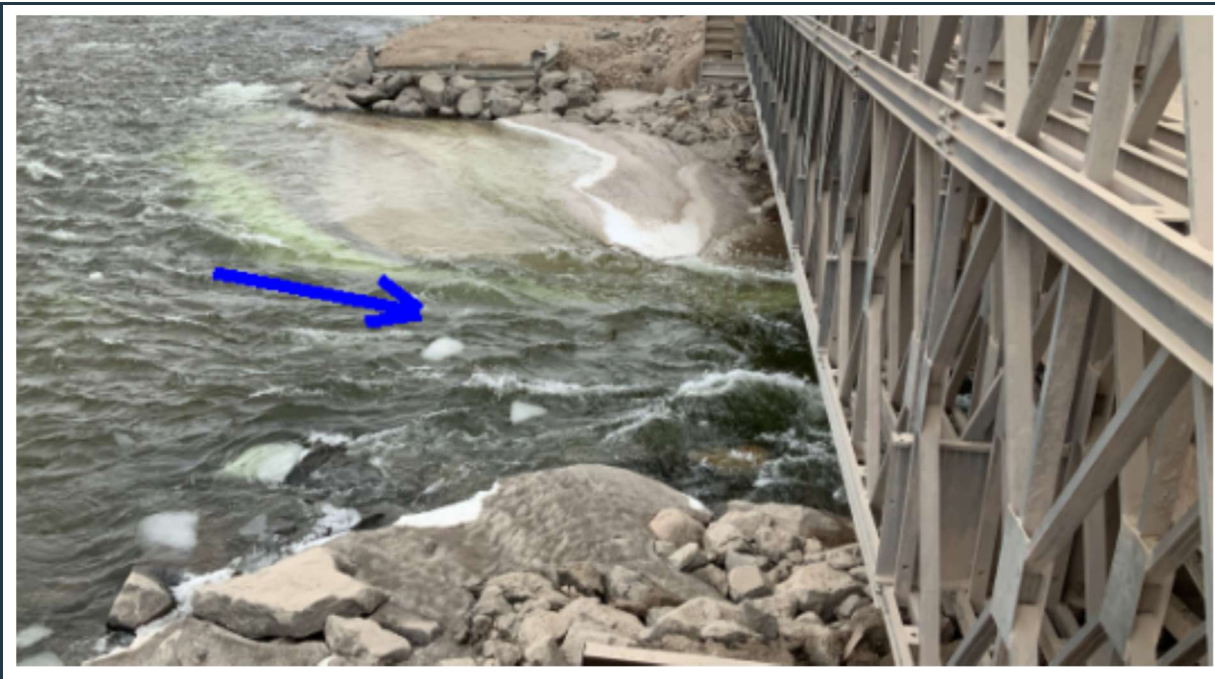
Figure 90: View of the stable abutments at the east side of bridge 63. Also note one of the two “old” abutments with riprap protection. Snow and ice still present around the abutments.

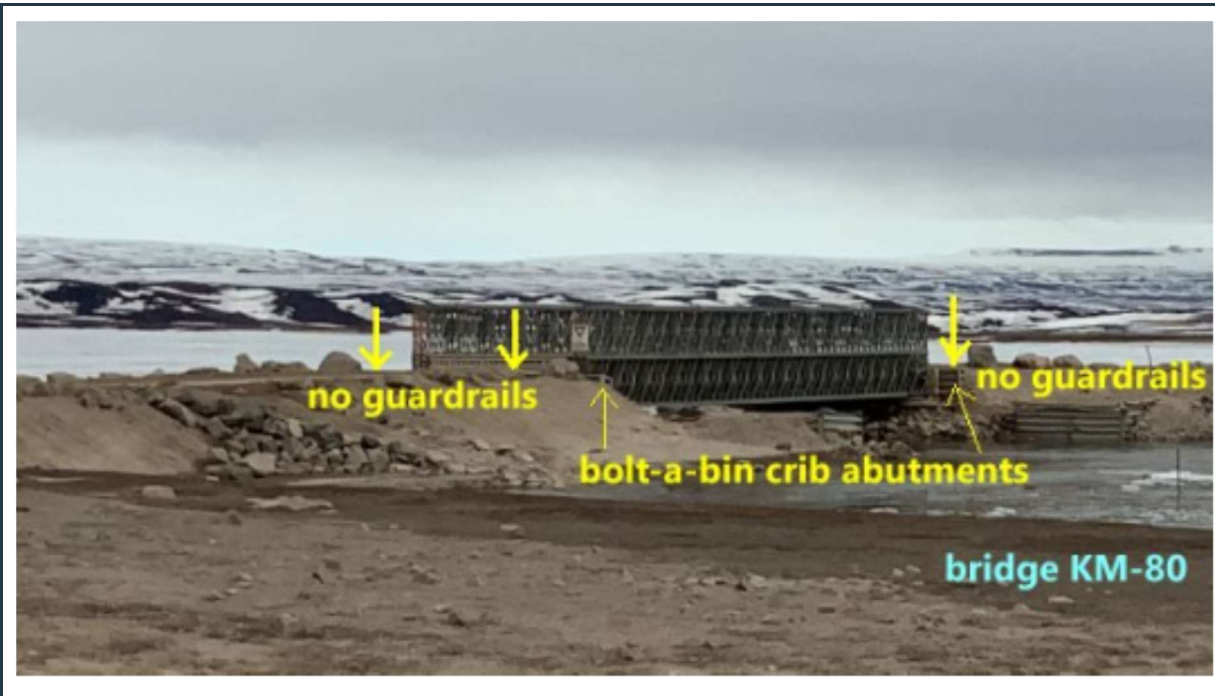
Figure 91: View of the approach embankments with bolt-a-bin cribs at bridge 80. No guardrails adjacent to the cribs at this bridge.

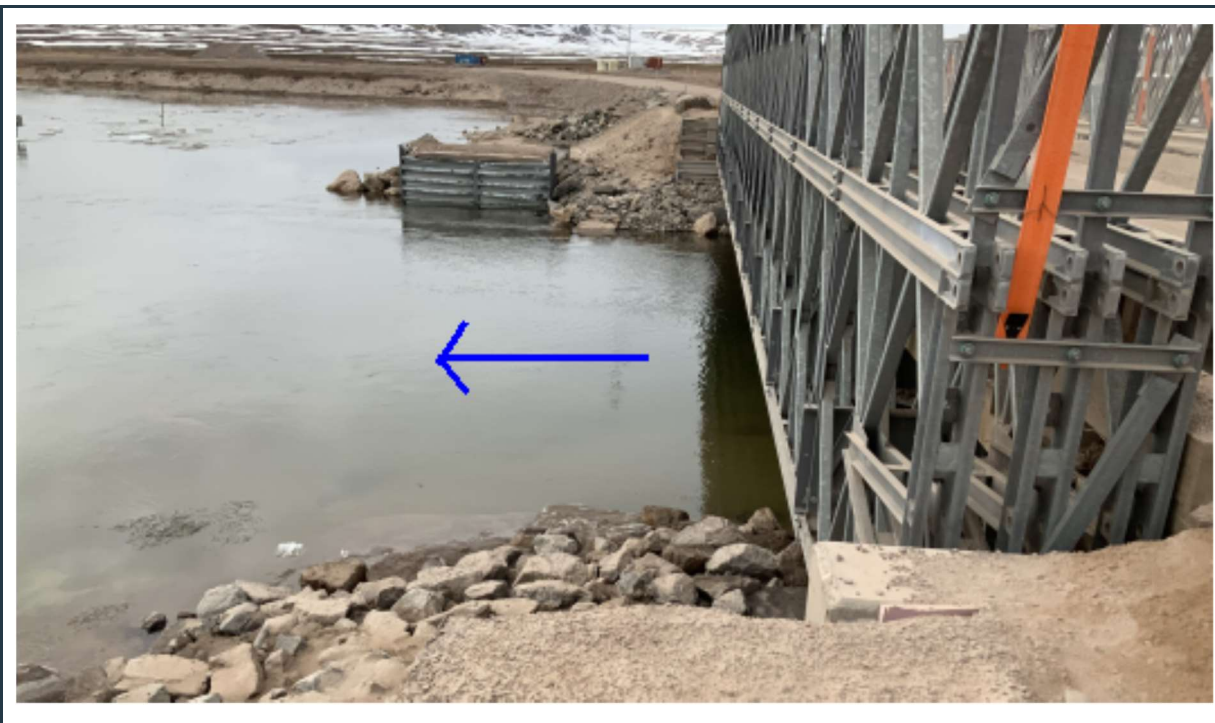
Figure 92: View of the west side of bridge 80, with riprap scour protection around the abutments.

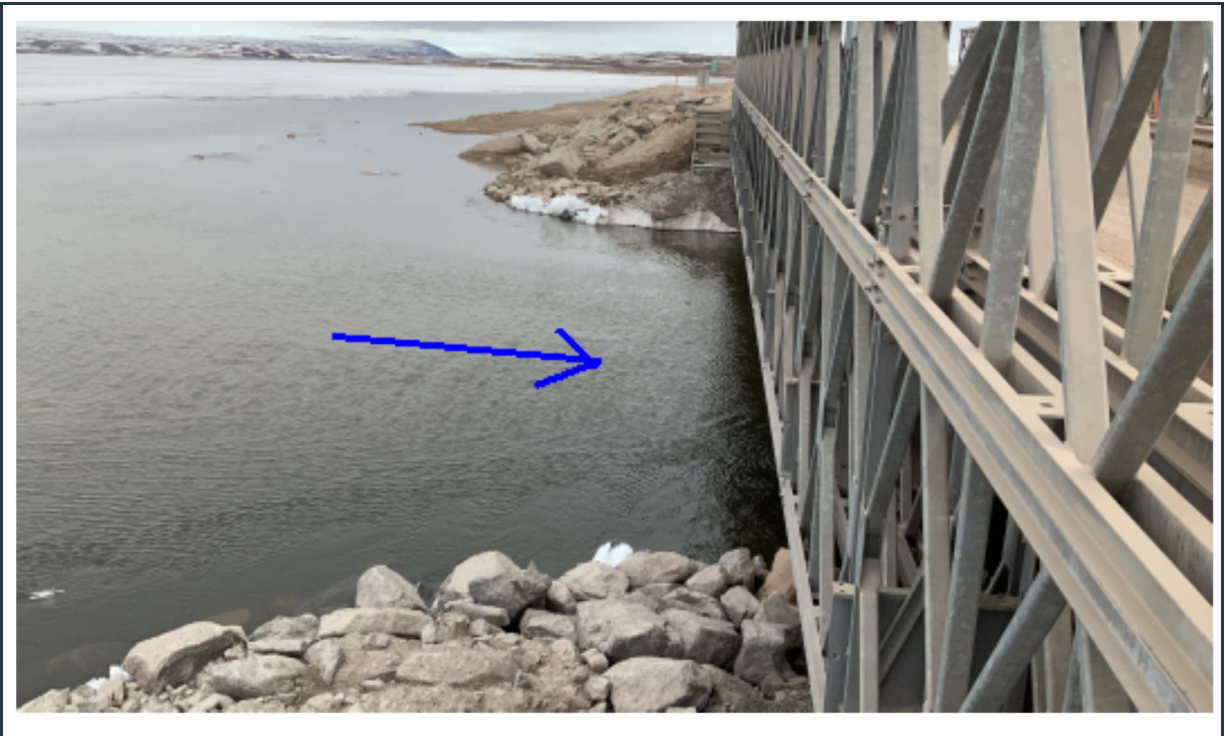
Figure 93: View of abutments with riprap scour protection at the east side of bridge 80.

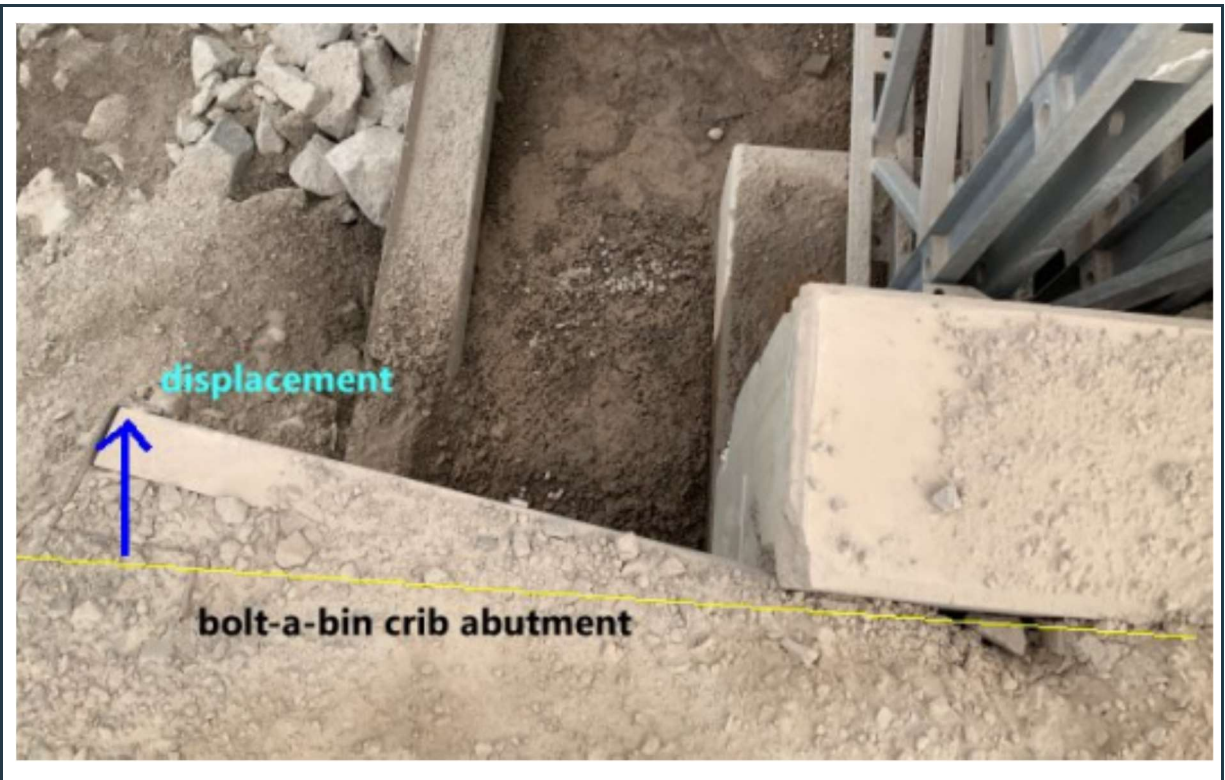
Figure 94: View of some displacement of the bolt-a-bin crib at one of the abutments at bridge 80.

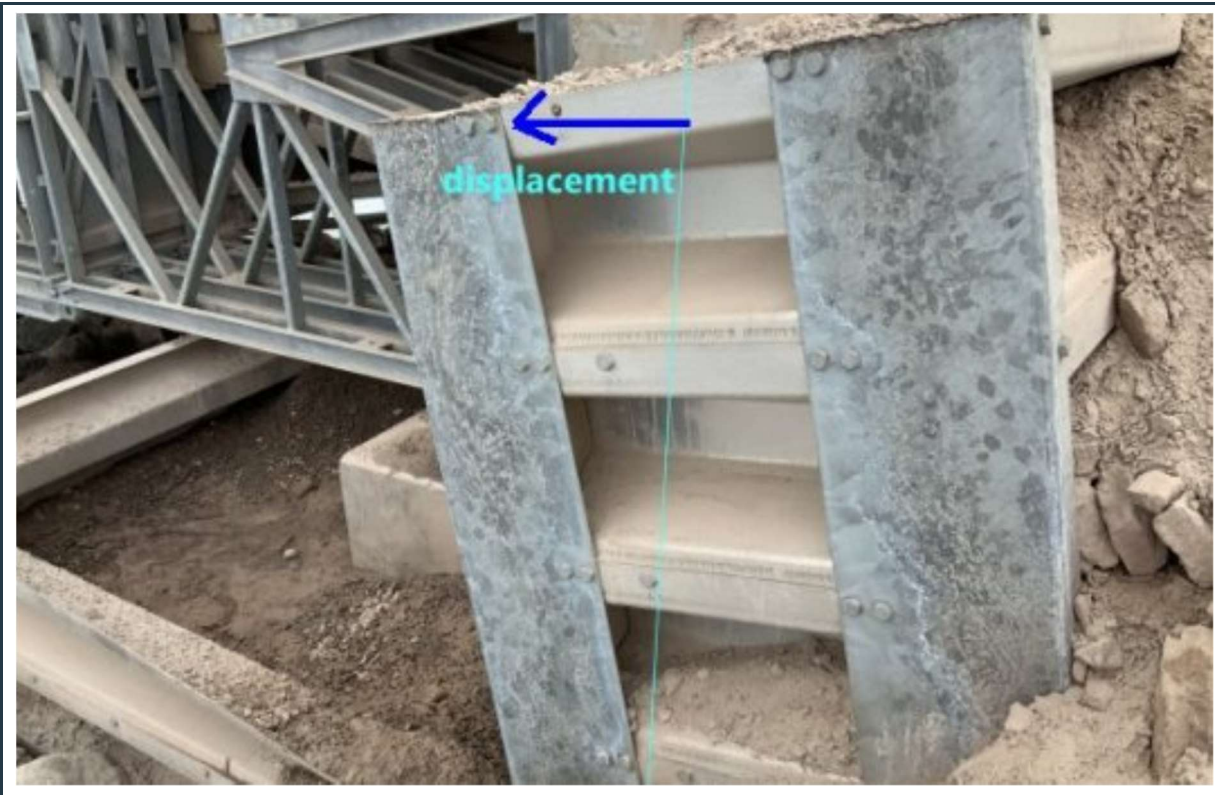
Figure 95: View of displacement/tilt of the bolt-a-bin crib at one of the abutments at bridge 80.

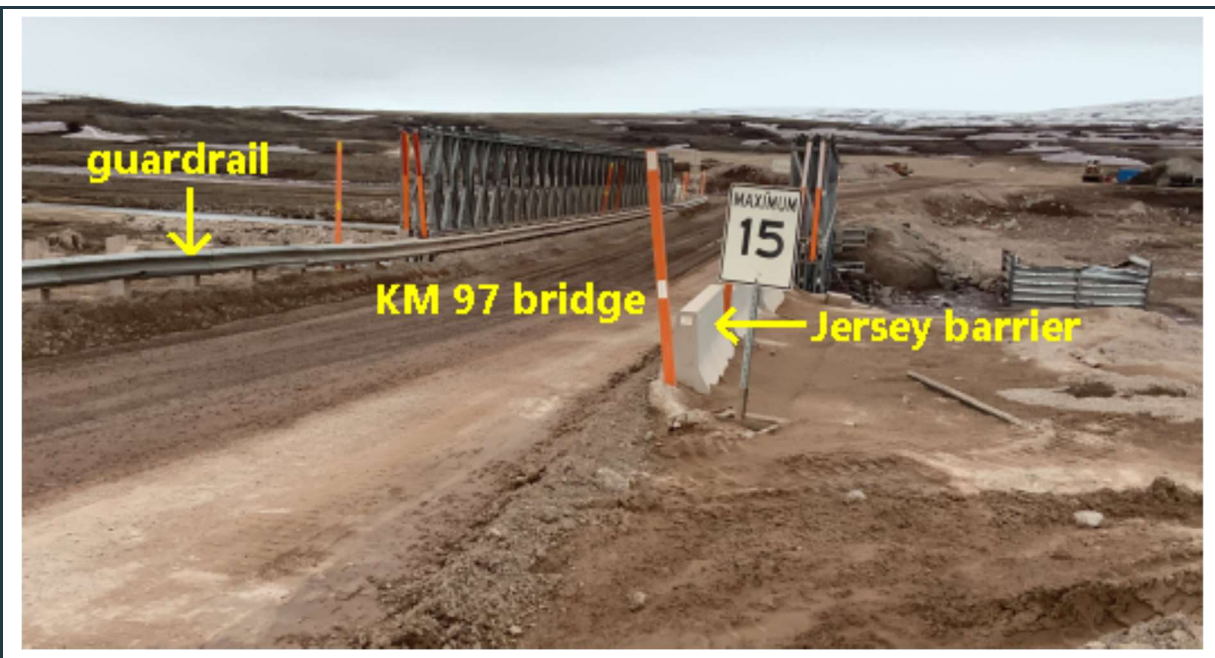
Figure 96: View of the approach embankment and abutment at bridge KM 97.

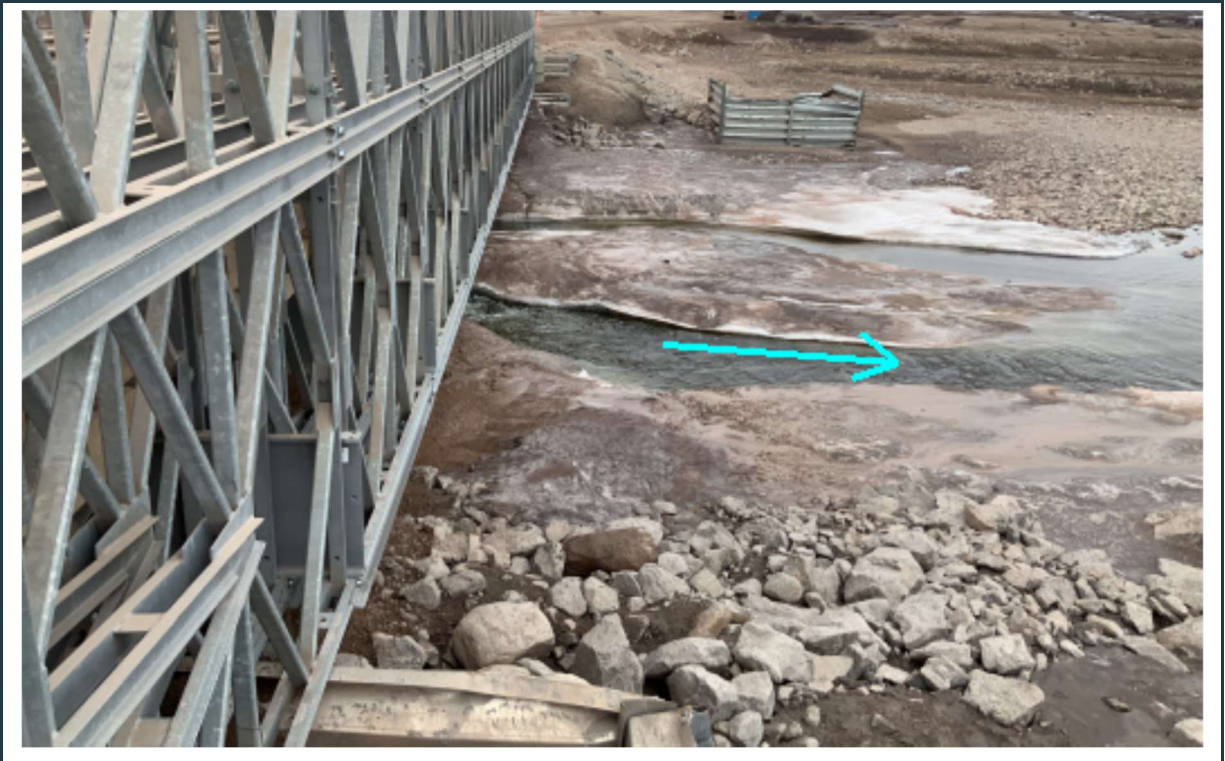
Figure 97: View of the stable abutments with riprap scour protection at the west side of bridge KM 97.

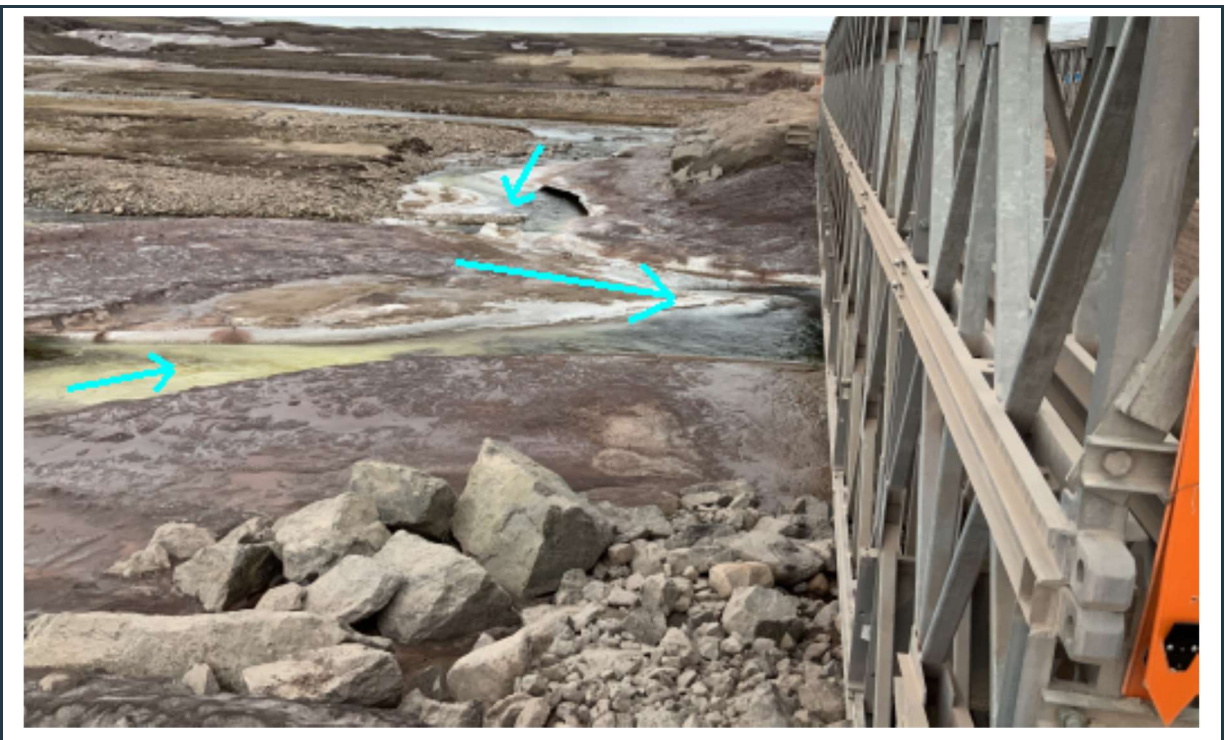
Figure 98: View of the two stable abutments with riprap scour protection at the east side of bridge KM97.

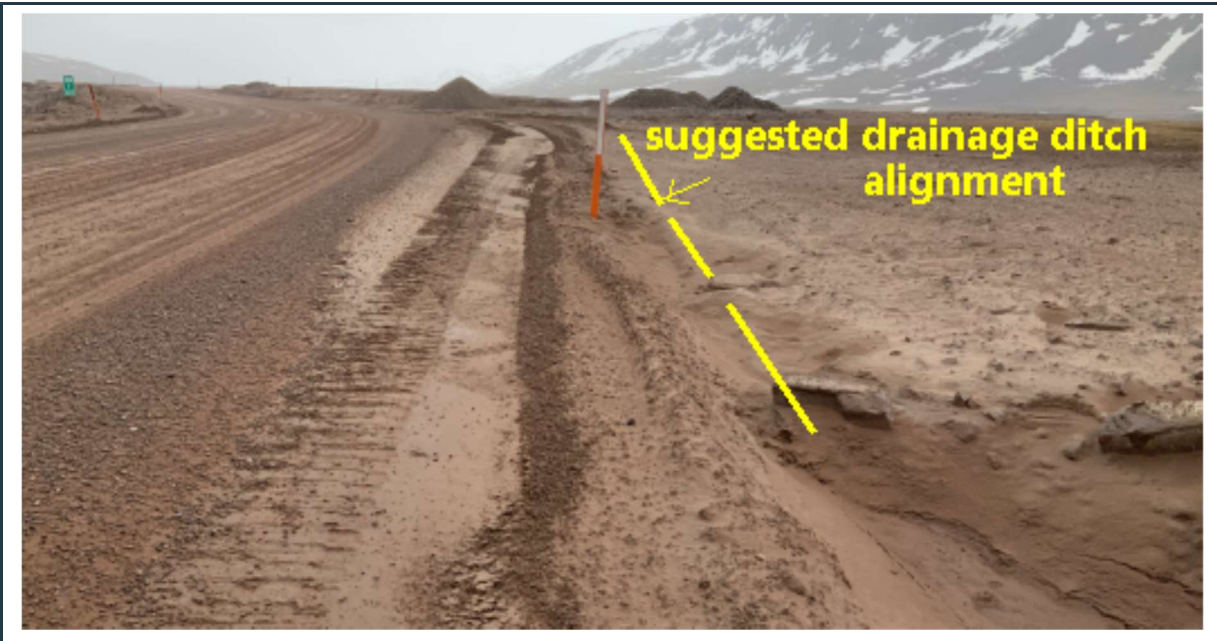
### a) KM 06+900

Figure 99: View of a section of the tote road around KM 06+900. Excavation of a drainage ditch is suggested to improve drainage of surface water from the road's surface.

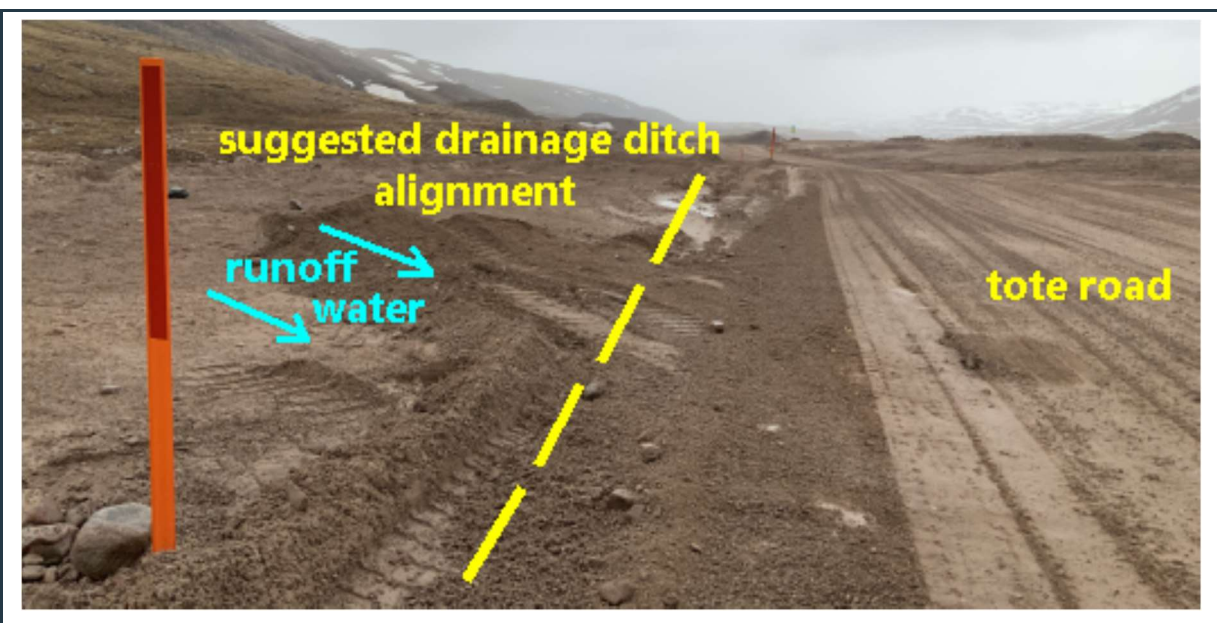
### b) KM 07+700

Figure 100: View of a section of the tote road around KM 07+700. No drainage ditch is provided although the ground adjacent to the road is higher than the road level and sloping toward the road.

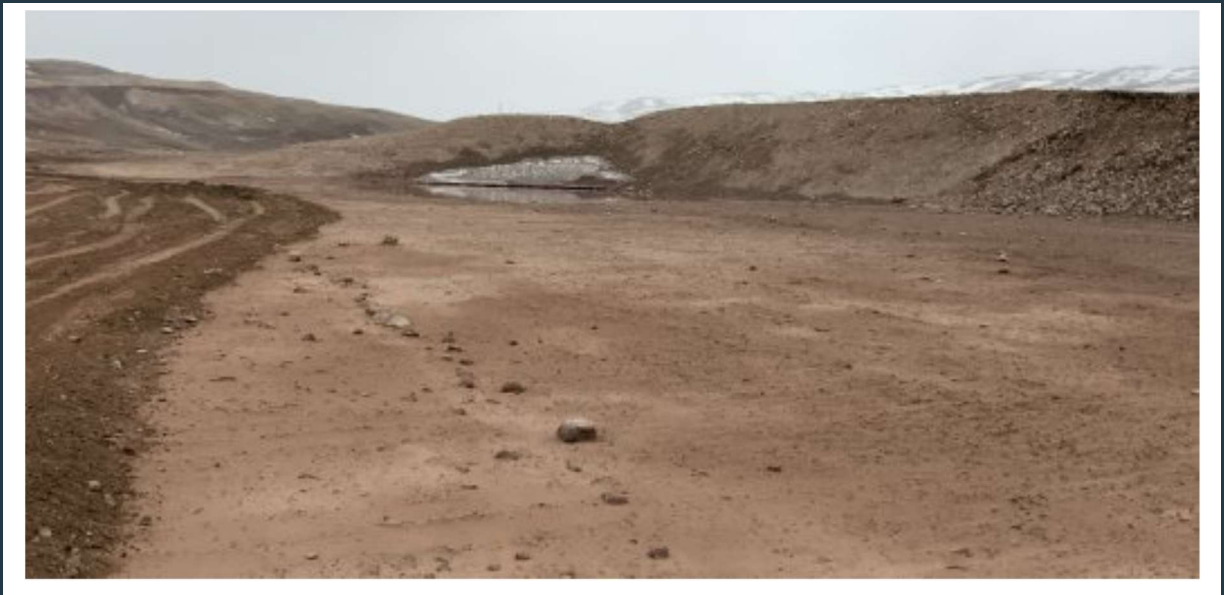
**c) KM 09+700**

Figure 101: View of the face of the slope in a former borrow area at KM 09+700. Note the large distance of the slope from the tote road.

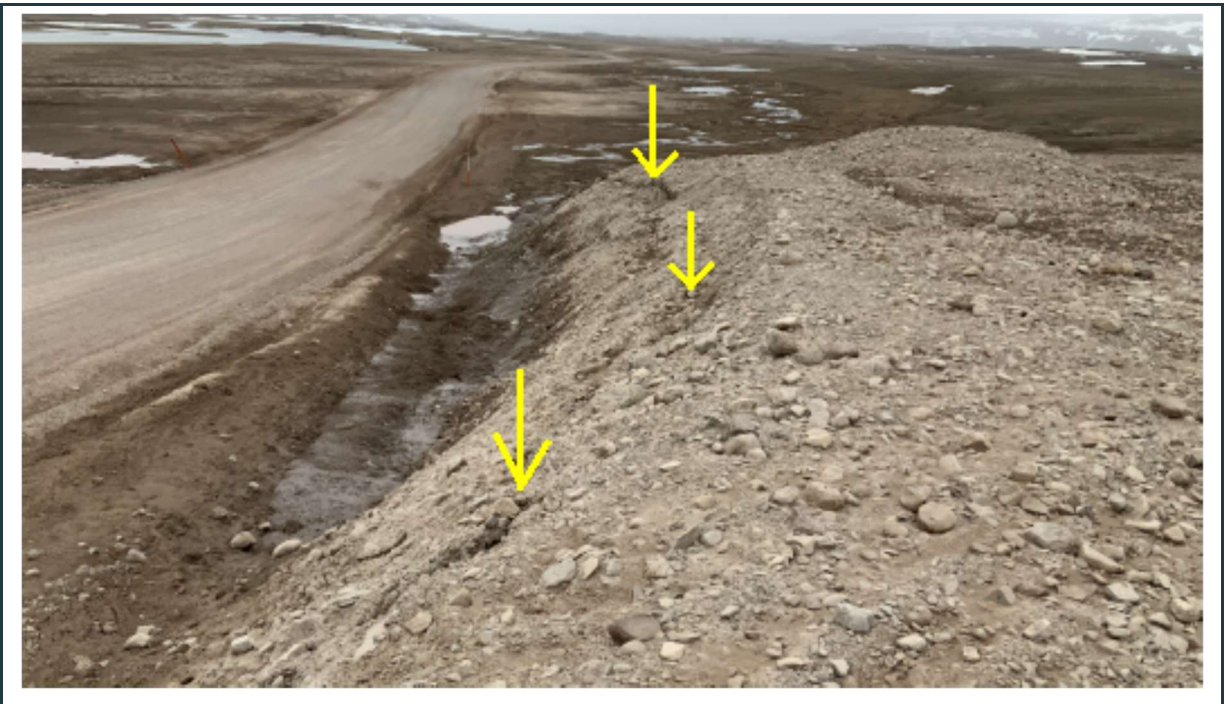
**d) KM 28+900**

Figure 102: View of the slope at a cut section of the road at KM 28+900. Note the tension cracks on the crest of the slope (yellow arrows) due to freezing and thawing action. The slope should be monitored and reshaped to shallower inclination if necessary.

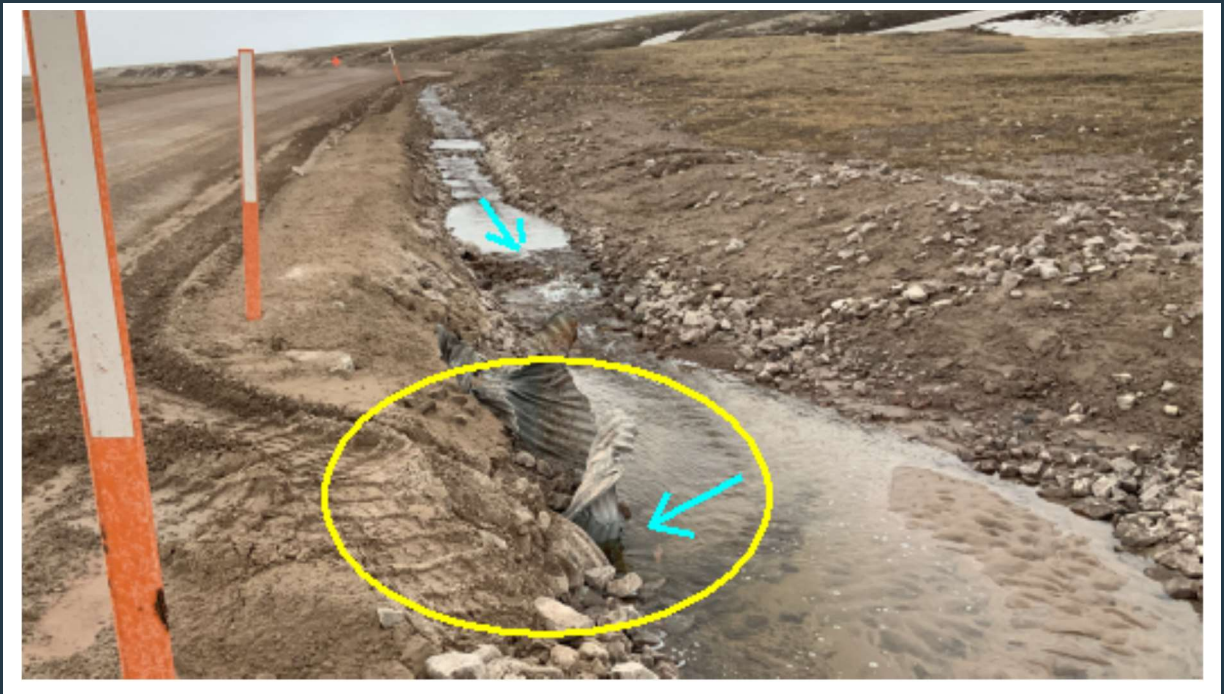
Figure 103: View of the damaged culvert at its inlet at KM 33+000. The culvert should be replaced as soon as practically possible. More rockfill should also be placed around the culvert's inlet.

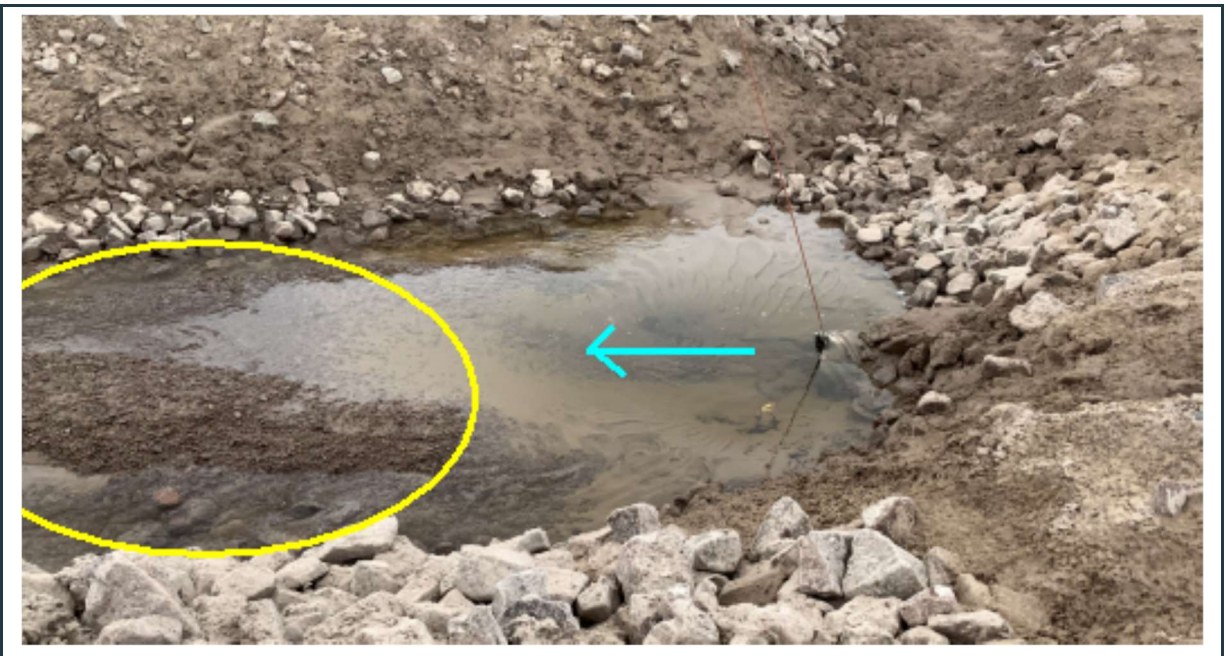
Figure 104: View of the outlet of the culvert at KM 33+000. The ditch at the front of the culvert should be cleaned during culvert replacement.

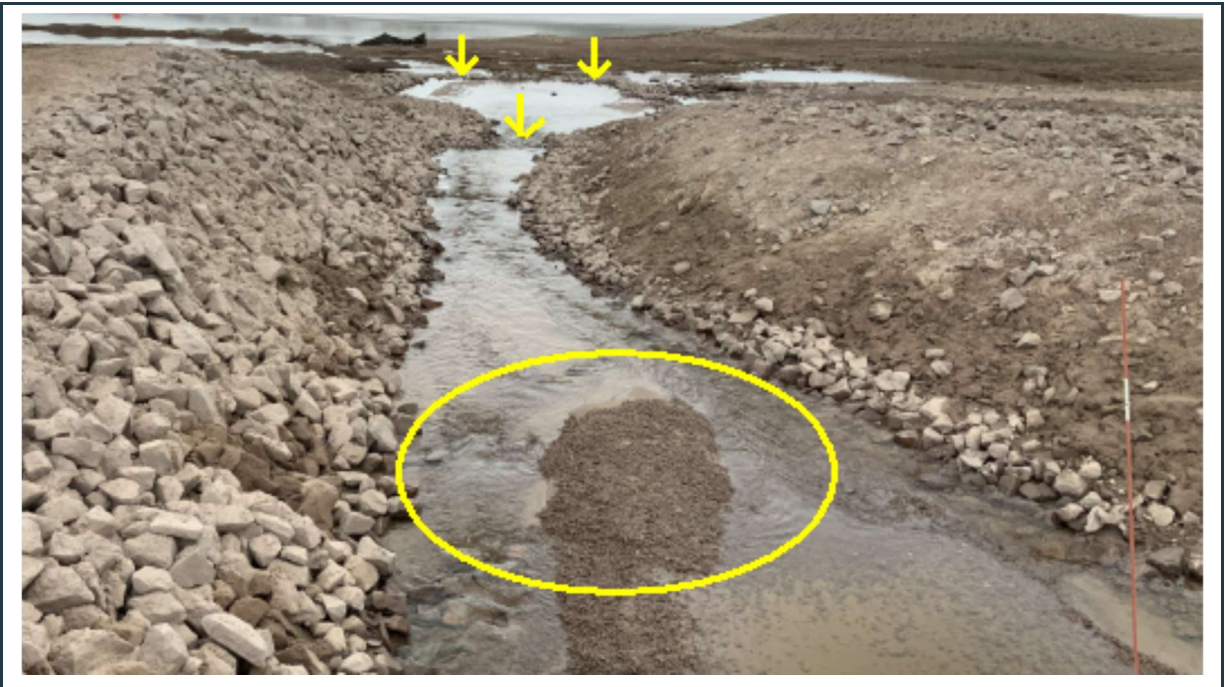
Figure 105: View of the ditch and check dams at KM 33+000. The ditch should be cleaned (yellow circle) and the crest of the check dams repaired/raised (yellow arrows) during culvert replacement.

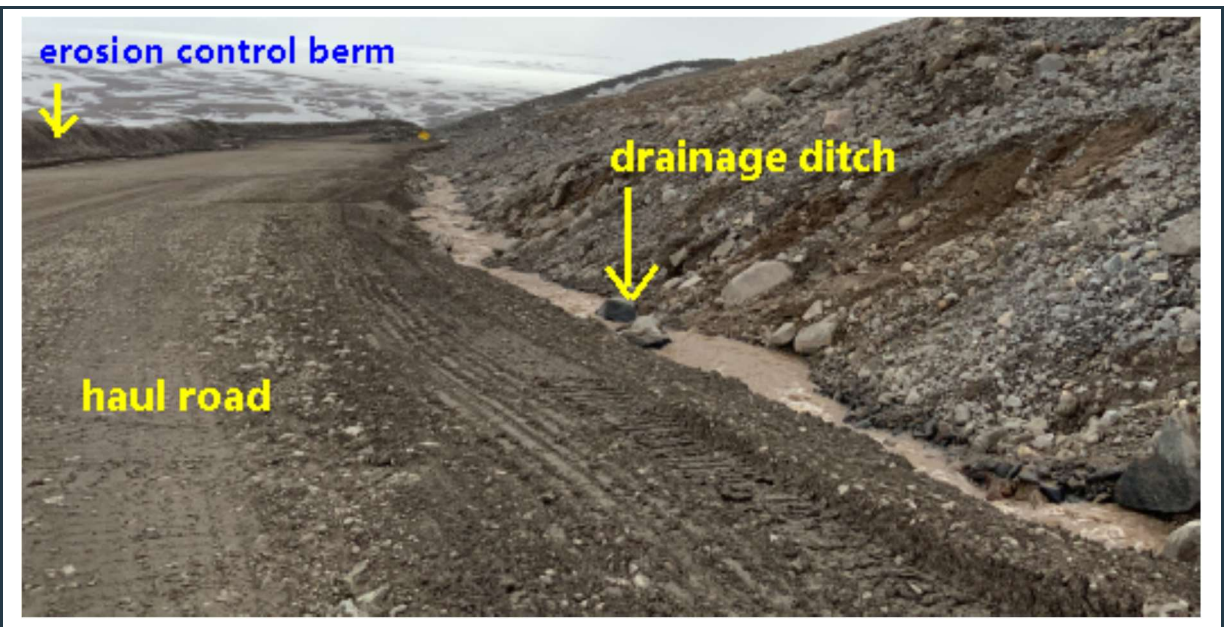
Figure 106: View of the well-maintained haul road between the crusher pad and the open pit around KM-107. Note the standard road components in the image, the safety berm along the fill (left) side of the road and the upgraded drainage ditch along the cut side (right) of the road.

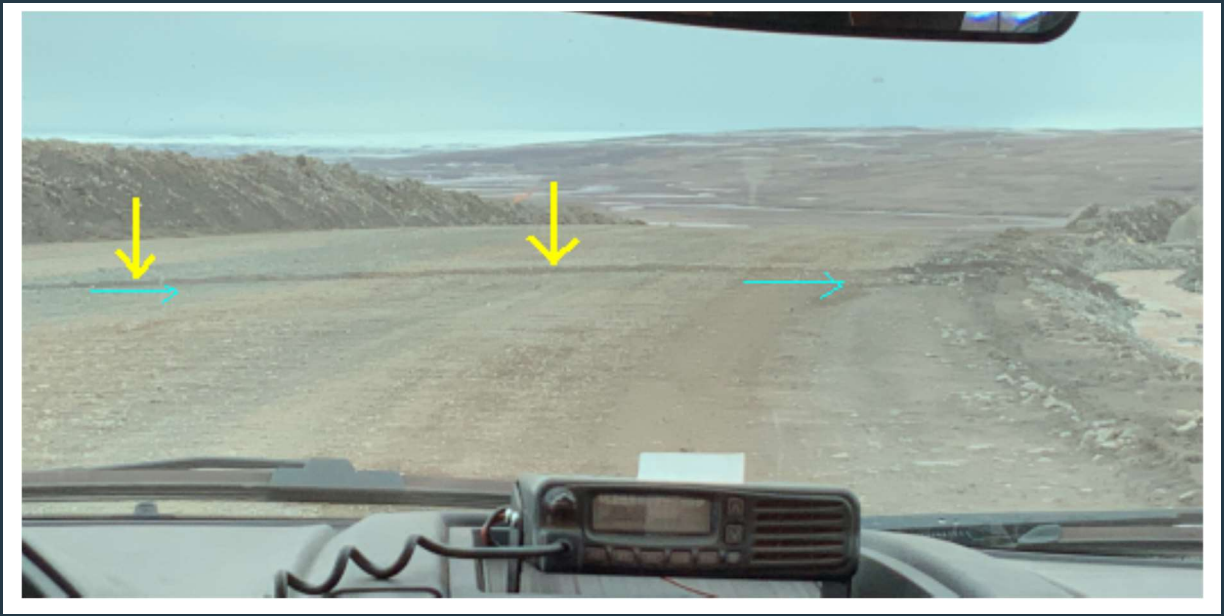
Figure 107: View of a cross drain (combination of a whoa-boy and shallow ditch) intercepting run-off flowing down the haul road and direct the collected water to the side-ditch. Many of such drains have been formed recently to improve erosion control along the haul road.

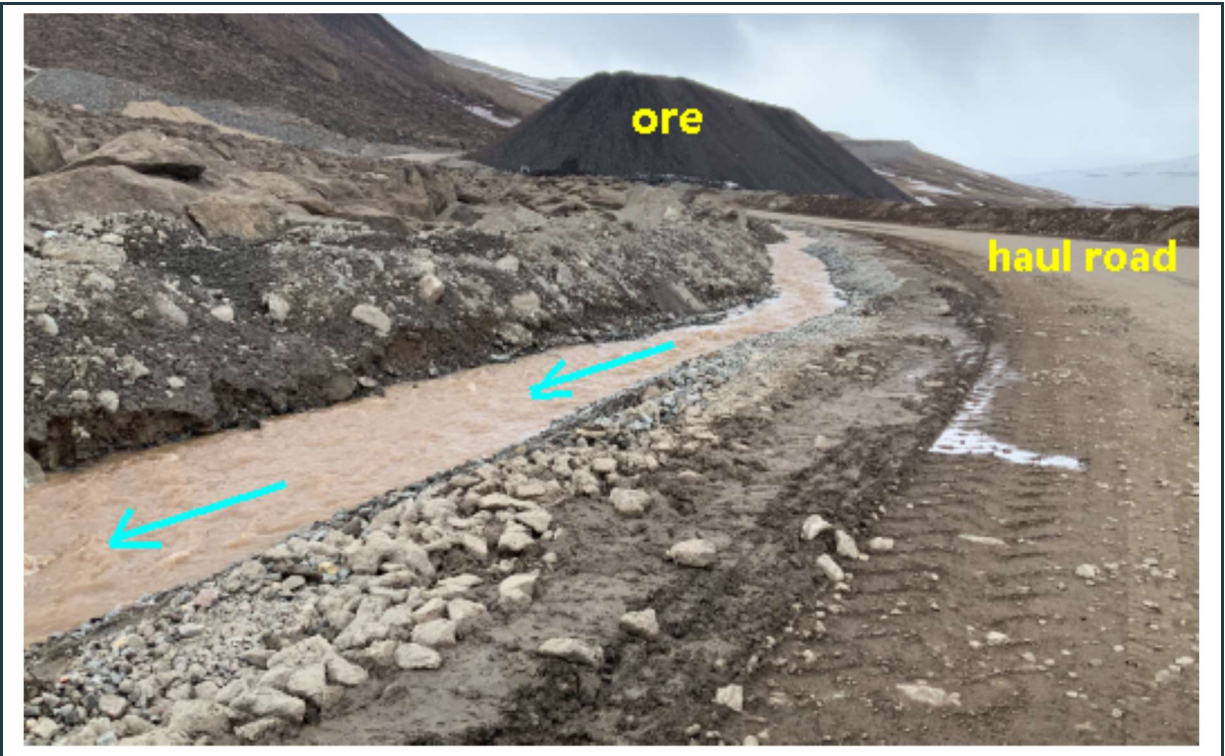
Figure 108: View of a section of the haul road near the ore stockpile (KM106) with improved side drainage ditch.
