Baffinland Iron Mines Corporation

October 31, 2023
Project #: OMGM2212-2023

Annual Geotechnical Inspections – 2023 Report 2.
APPENDIX "A" - Mary River Mine Complex - Photographs
Figure 12 to Figure 51

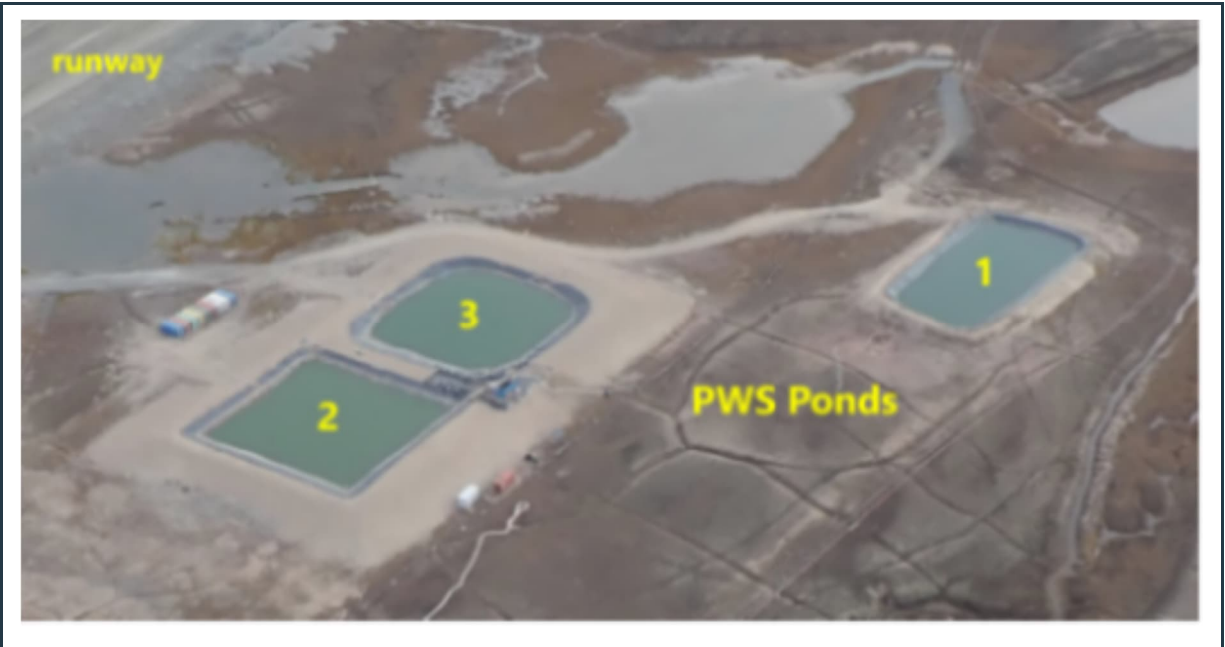
Figure 12: Historic aerial image of the layout of the three PSW ponds with robust, stable berms.

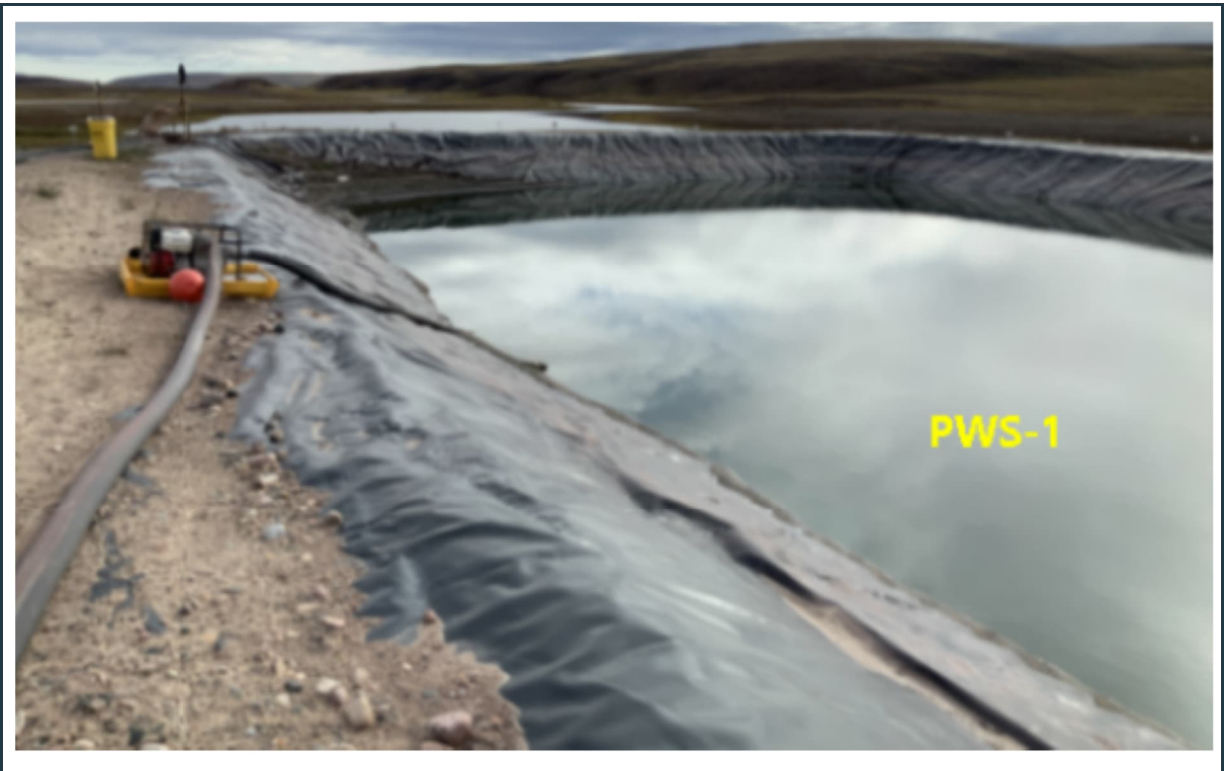
Figure 13: PWS pond #1. Well-maintained, stable perimeter berm and intact liner at the pond.

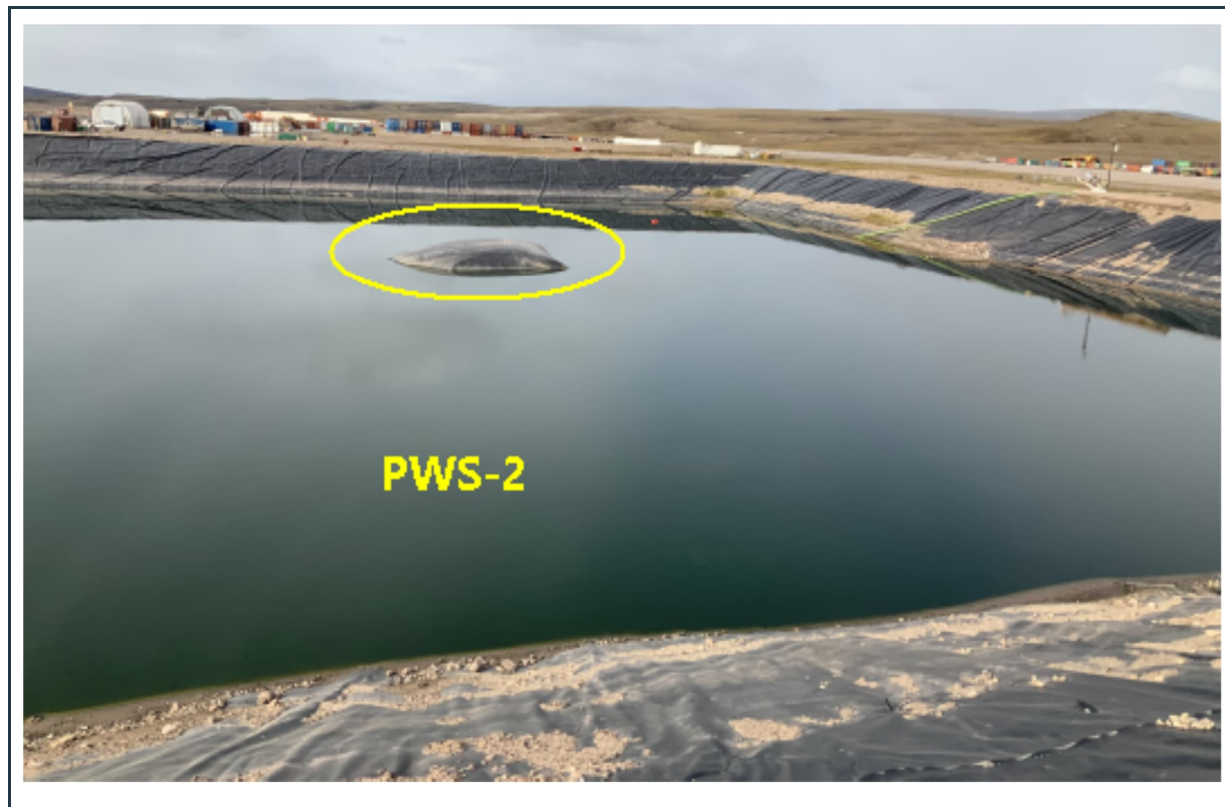
Figure 14: PWS pond #2 with stable, well-maintained berms and liner. – A section of the liner is visible in the pond above the water (yellow circle), which does not pose a risk to the integrity of the liner.

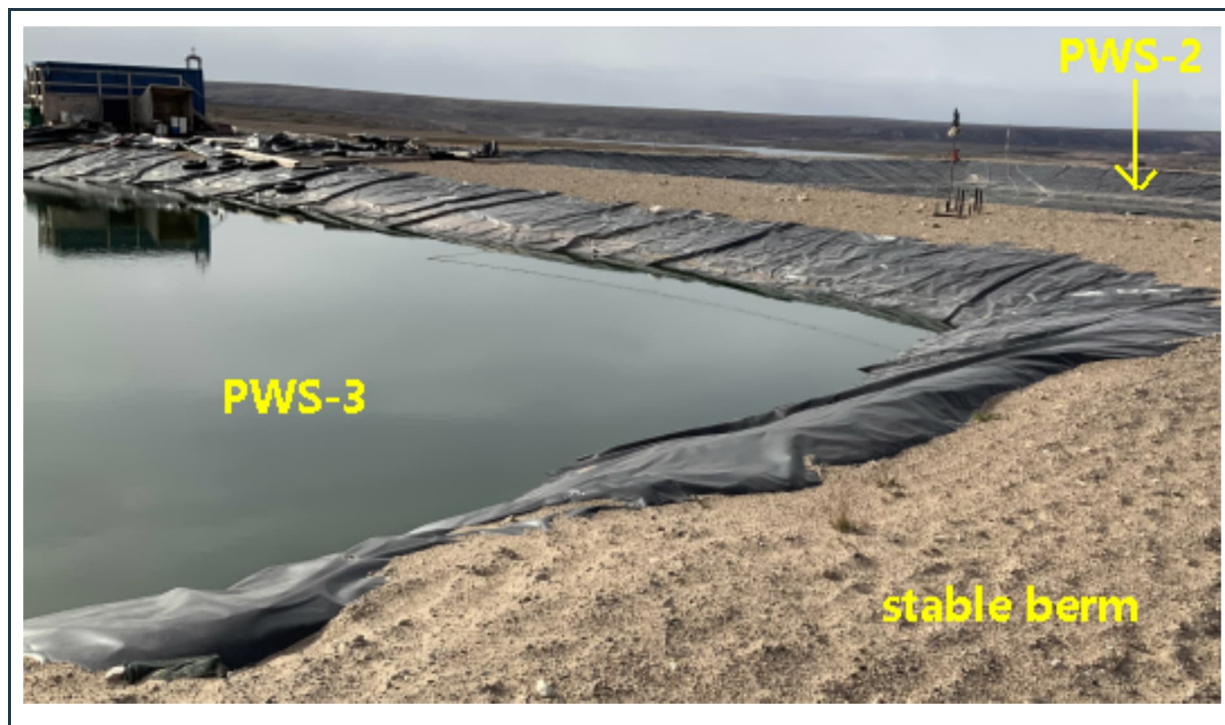
Figure 15: Robust, stable perimeter berms around PWS pond #3

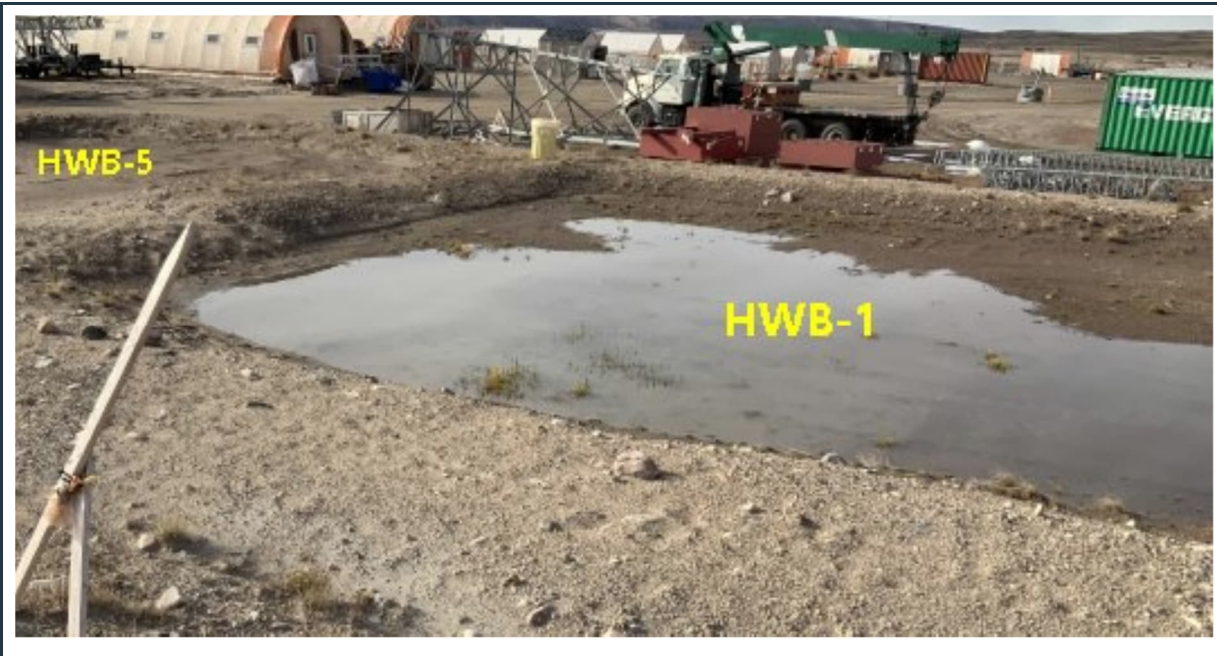
Figure 16: View of HWB-1 – Currently this cell is not in use. It appears that the liner is intact in this cell.

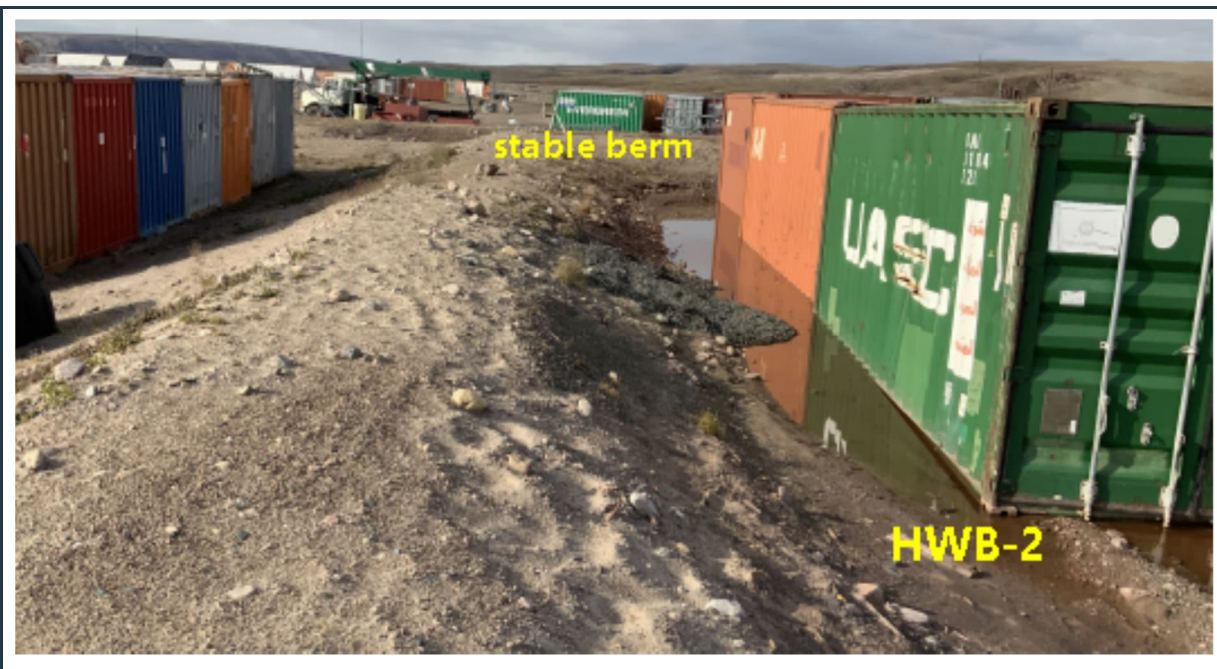
Figure 17: View of the robust, stable berms around HWB-2. The presence of water in the cell indicates good liner performance.

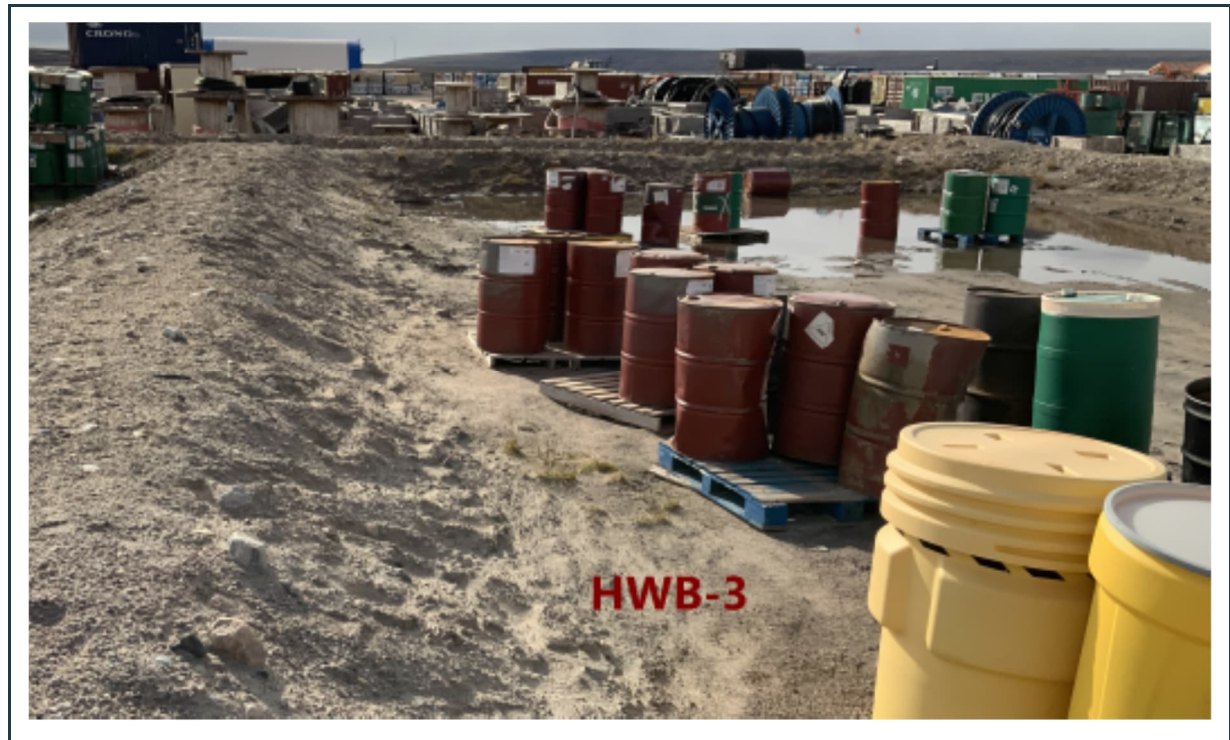
Figure 18: View of stable berms and a few stored fuel barrels in HWB-3.

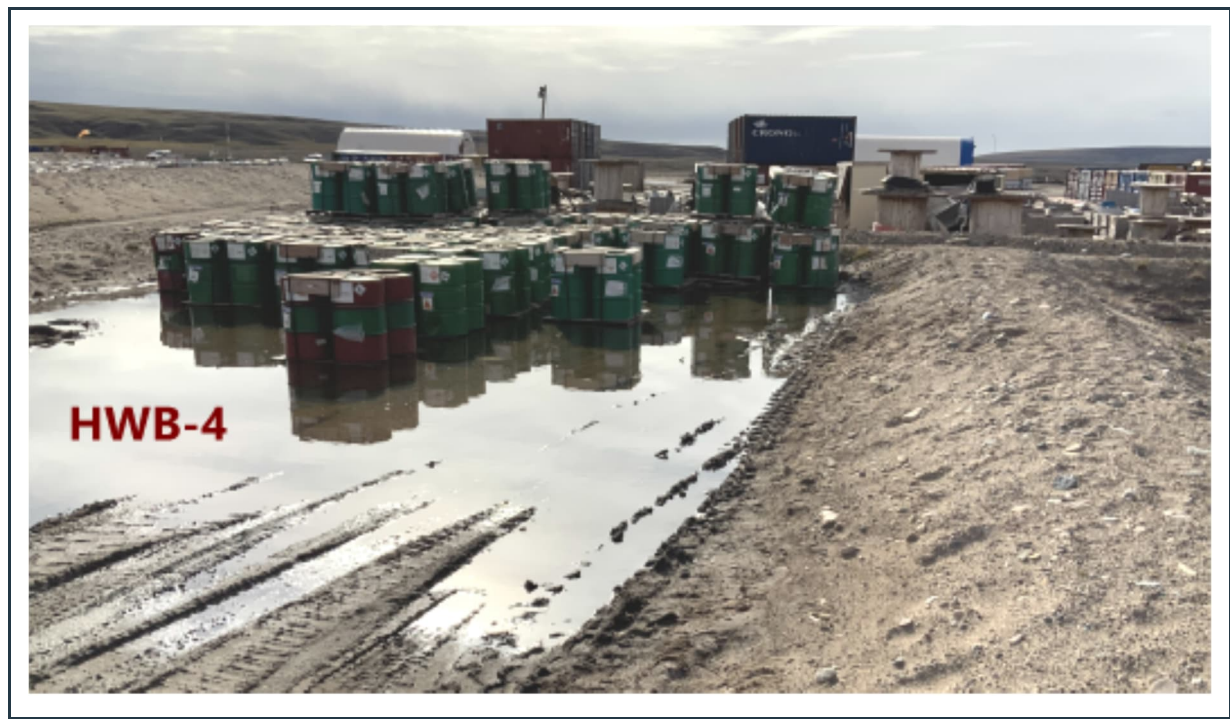
Figure 19: View of stable berms around the HWB-4 cell, with fuel barrels on wooden pallets stored in the cell. The shipping container and debris that were visible in June in this cell, have been removed.

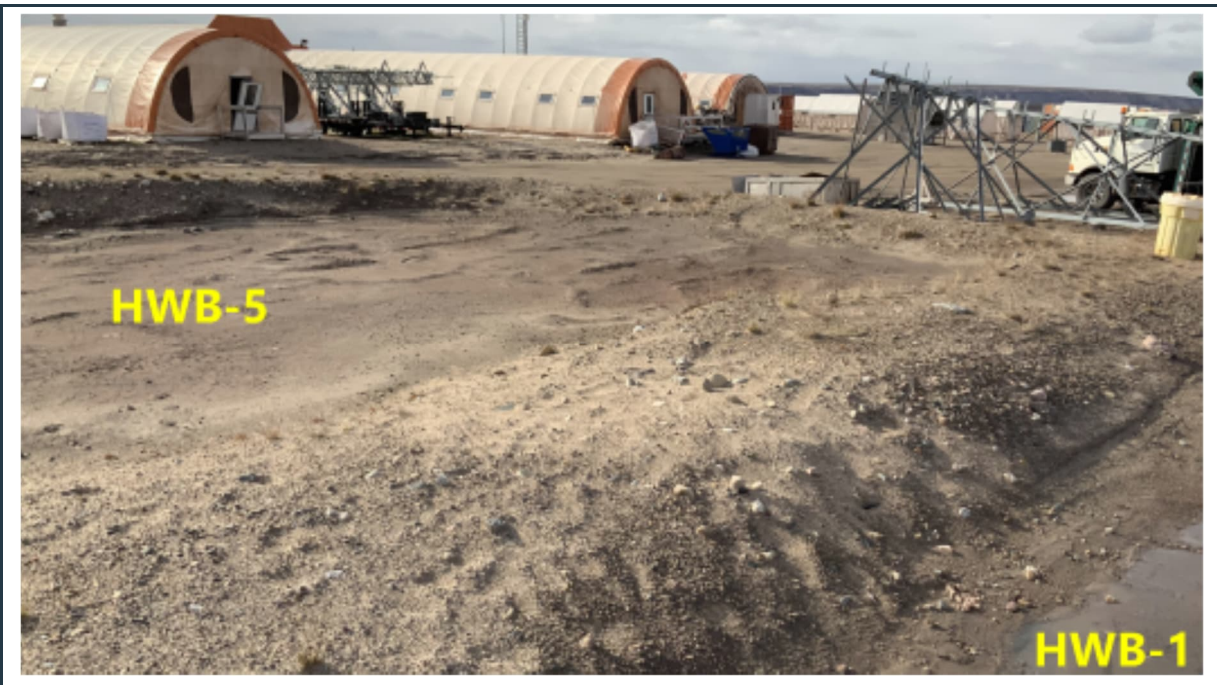
Figure 20: View of HWB-5 – Currently this cell is not in use.

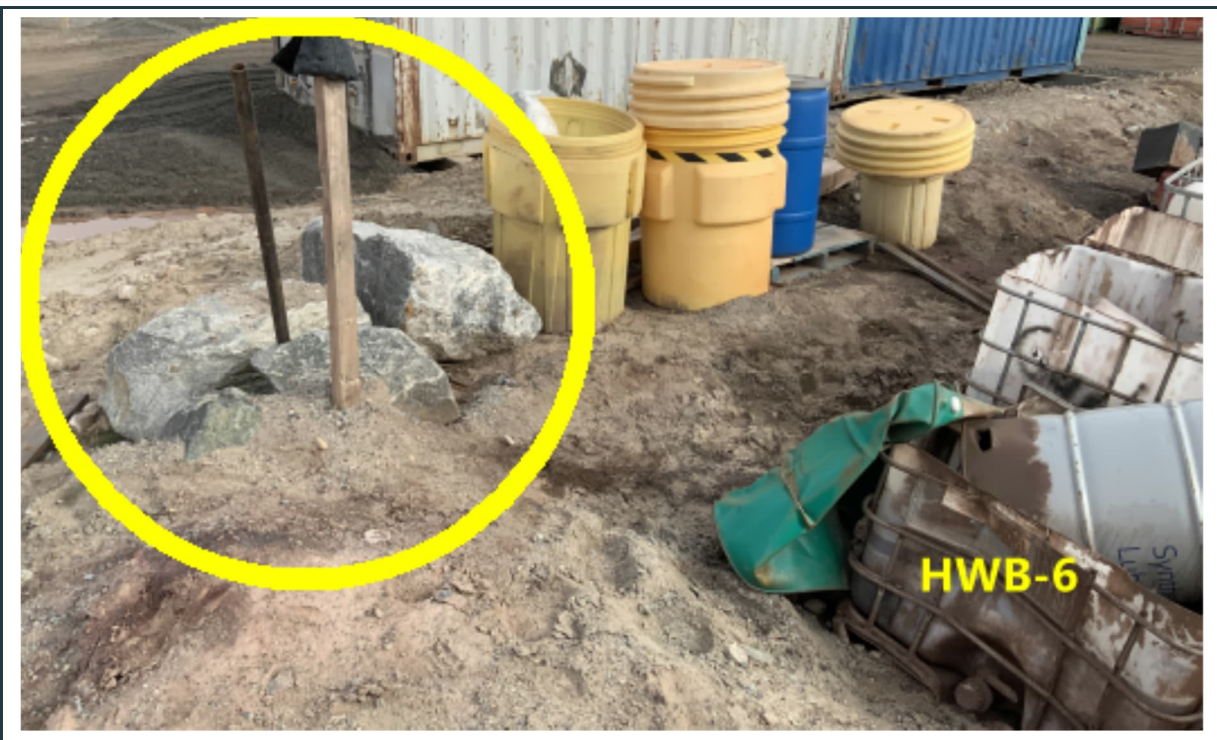
Figure 21: View of the north-east corner of the cell, where the berm required maintenance.

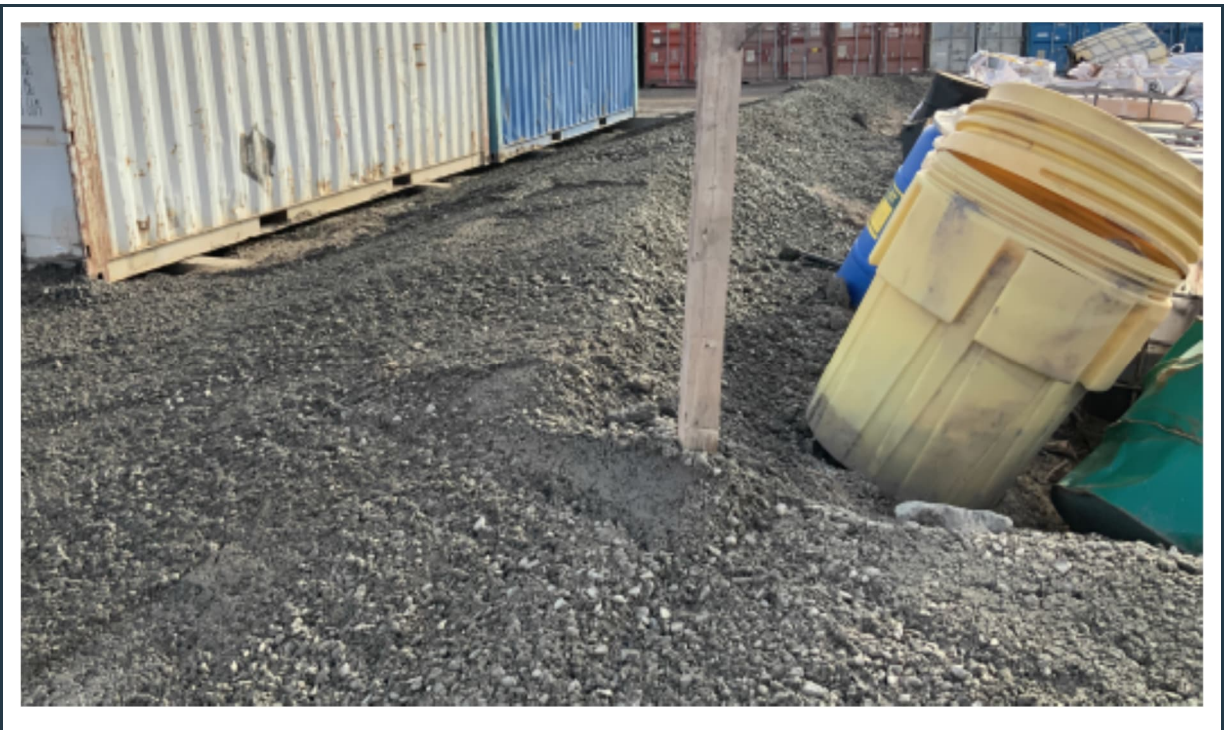
Figure 22: View of the north-east corner cell HWB-6 one day after the initial inspection. Note that the problem with the berm had been rectified by site services (all boulders have been removed).

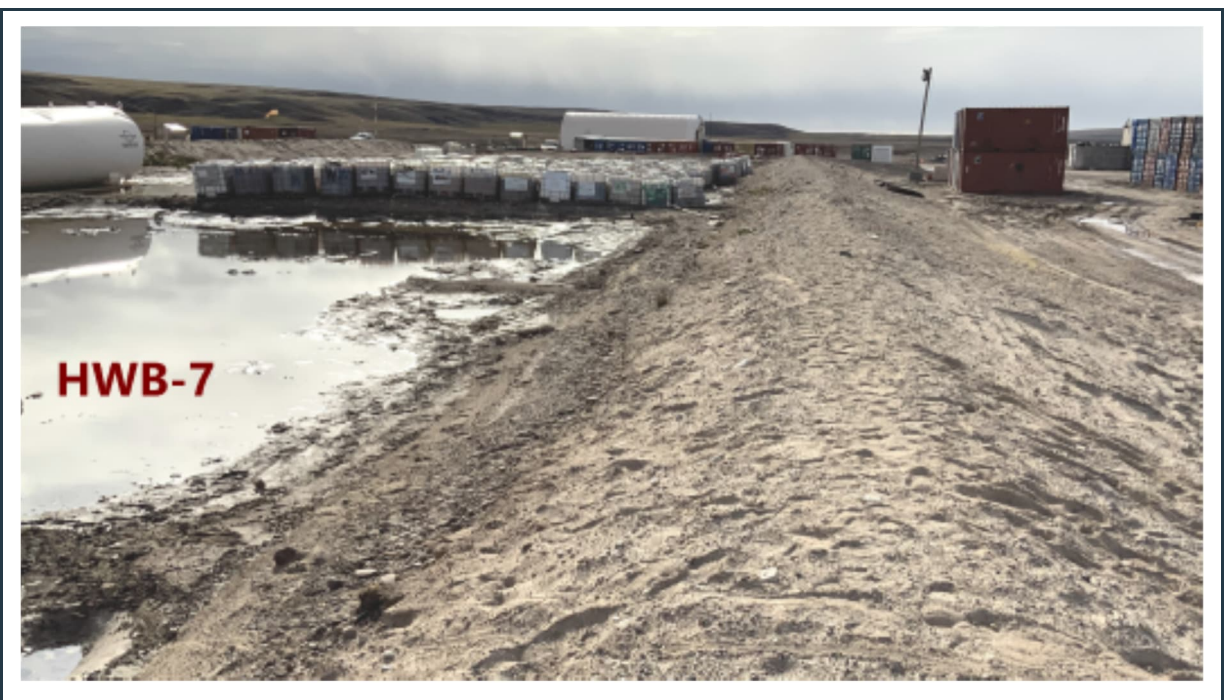
Figure 23: View of the stable berm around the HWB-7 cell, with an old fuel tank and oil filled plastic containers stored in the cell. The ponding water indicates good liner performance.

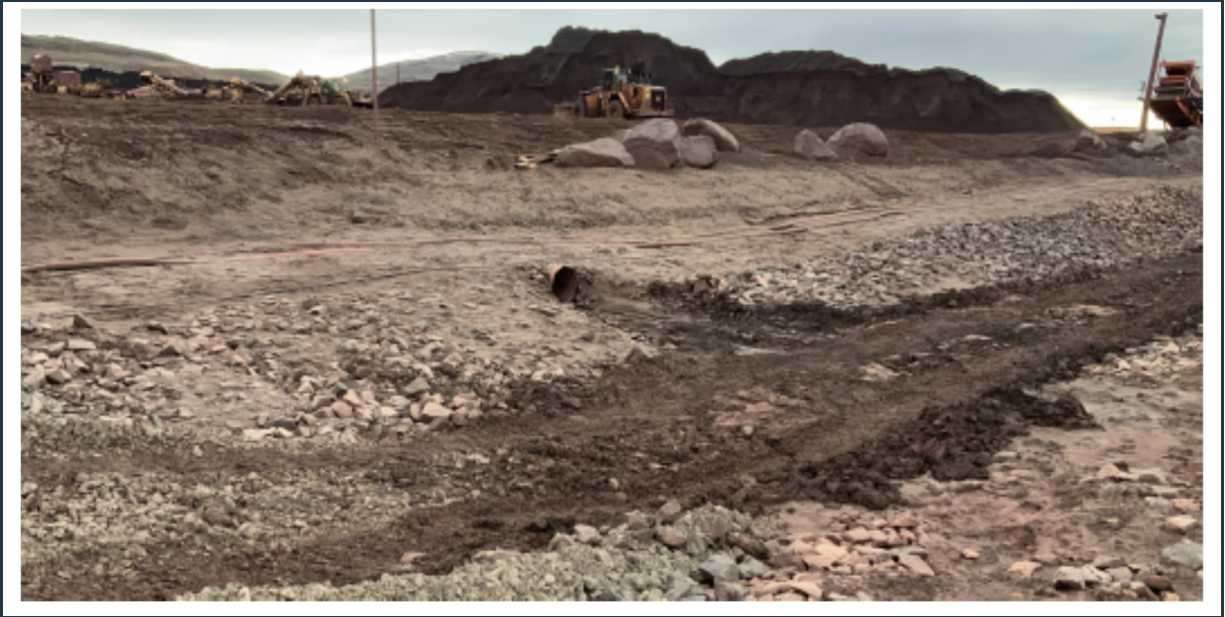
Figure 24: View of the discharge end of the recently cleaned culvert, draining the collected surface water from the crusher area to the MS-06 pond.

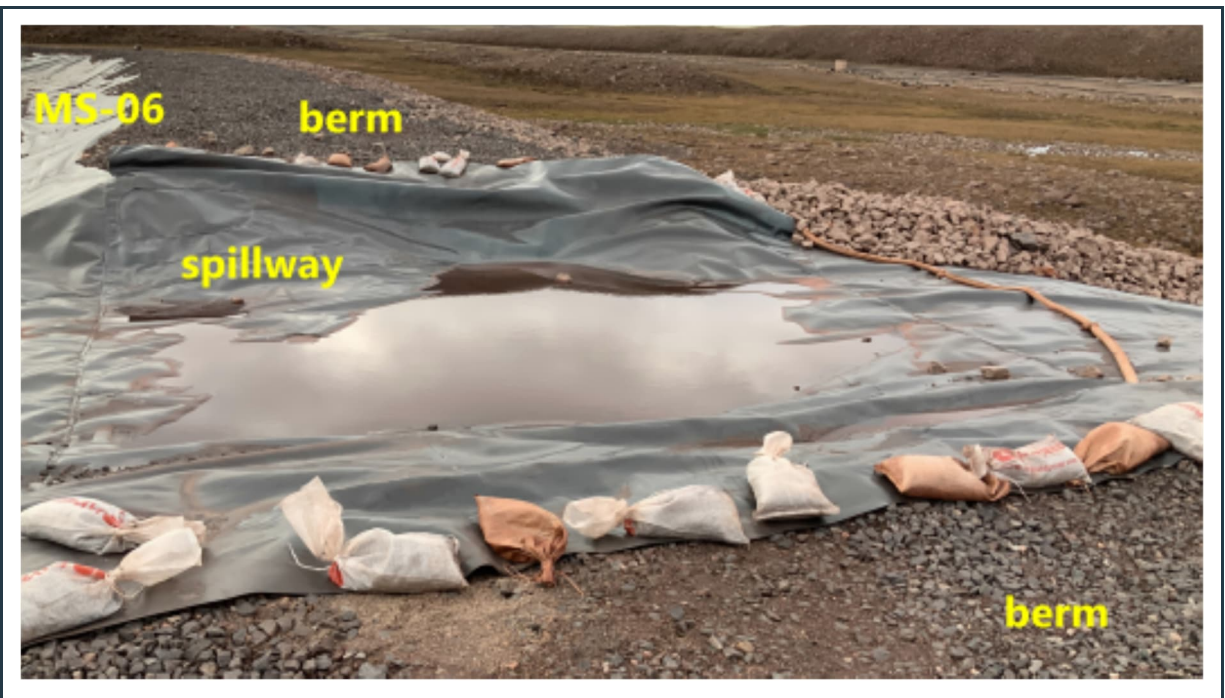
Figure 25: View of the robust, stable berm around the MS-06 pond, with the liner at the spillway recently fixed by the placement of more sandbags against potential uplift.

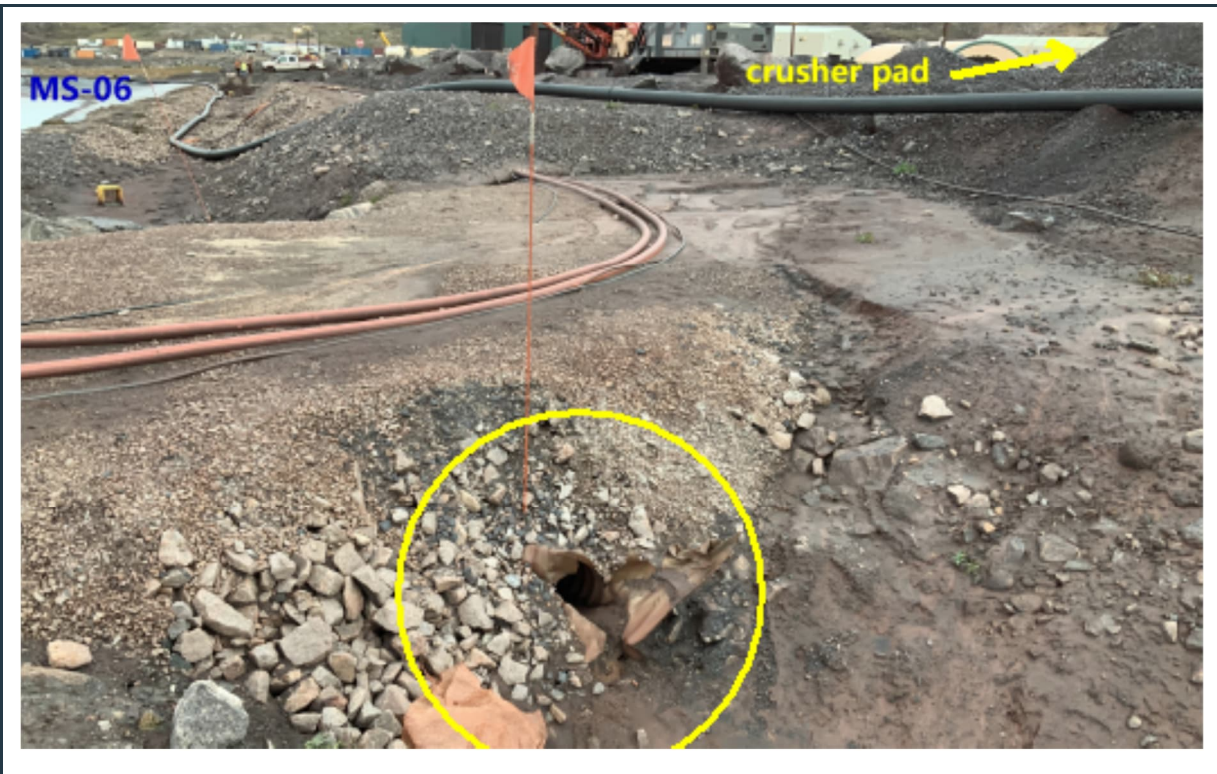
Figure 26: View of the side-ditch and culvert leading to the MS-06 pond. Based on field observation, the culvert requires cleaning (removal of trapped silt and sand from the pipe).

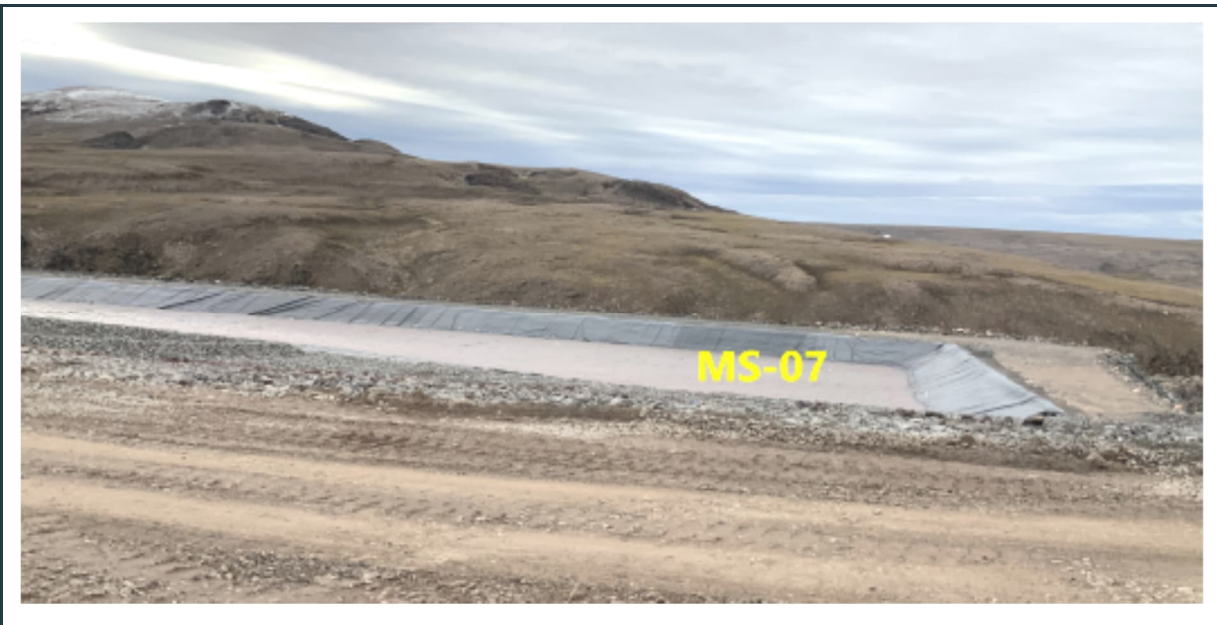
Figure 27: View of the robust, stable berms and intact liner at the MS-07 surface-water management pond.

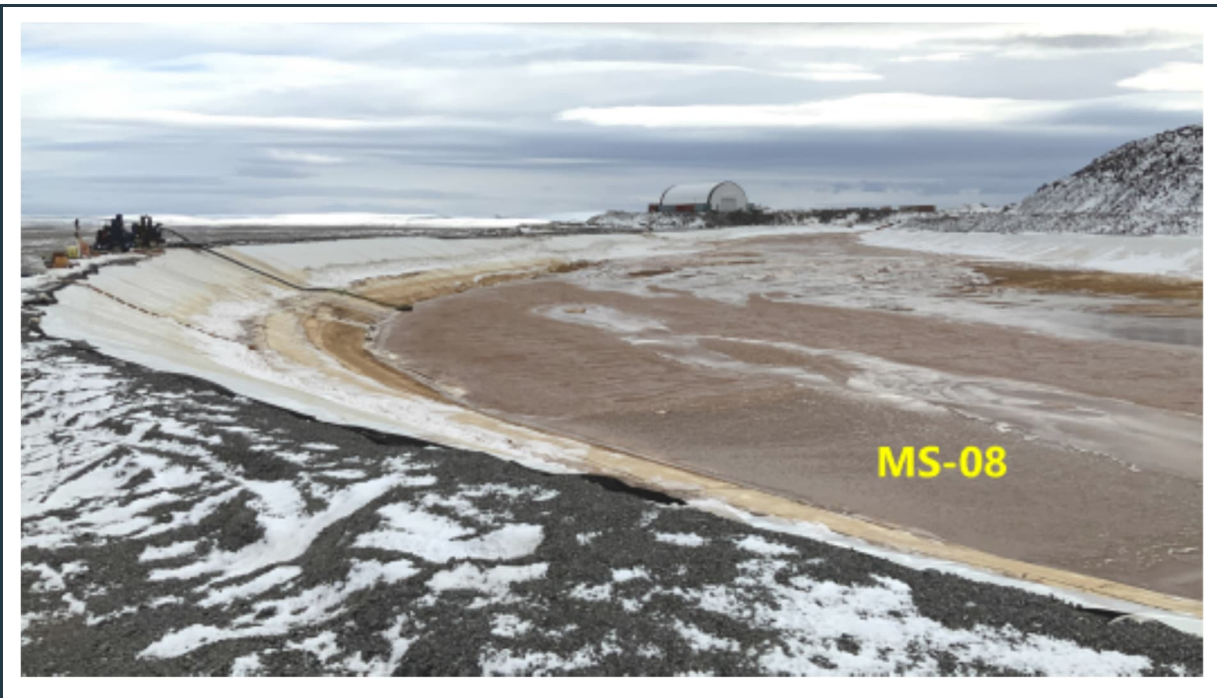
Figure 28: View of the stable, robust berm and intact liner at the MS-08 pond.

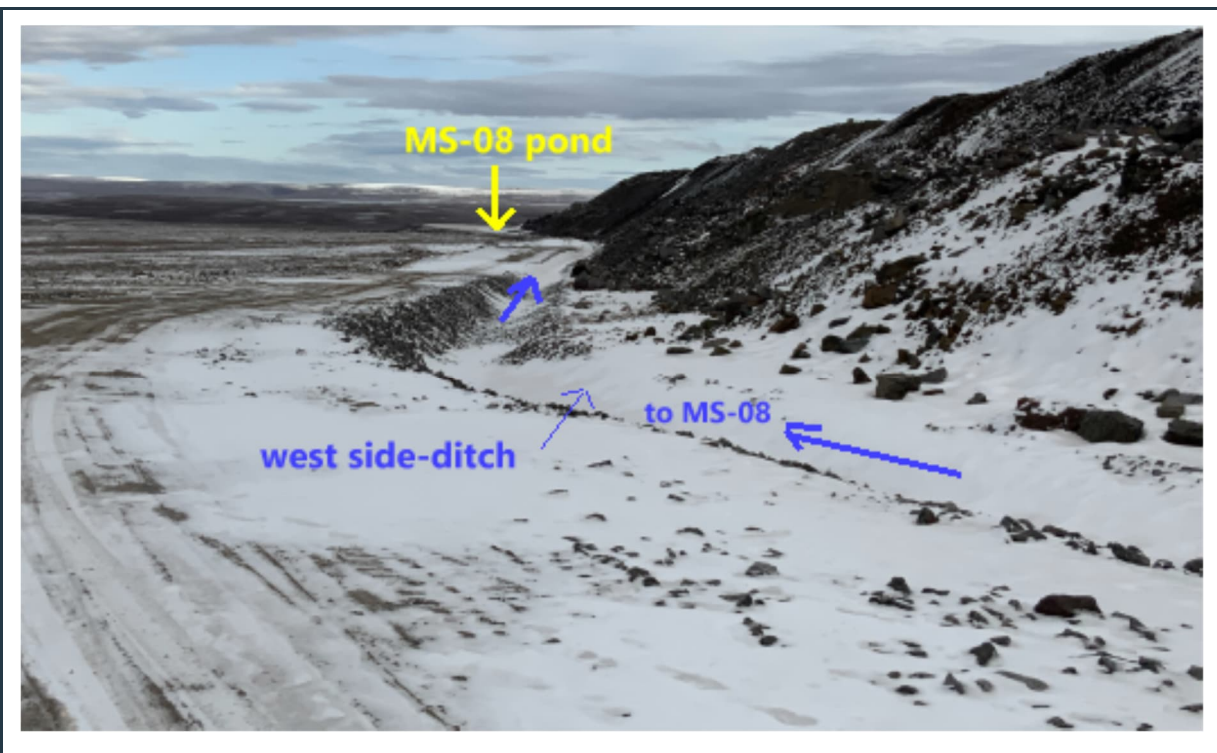
Figure 29: View of the well-maintained drainage ditch around the west side of the waste rock facility, leading to the MS-08 pond. There was already some snow in the ditch in September.

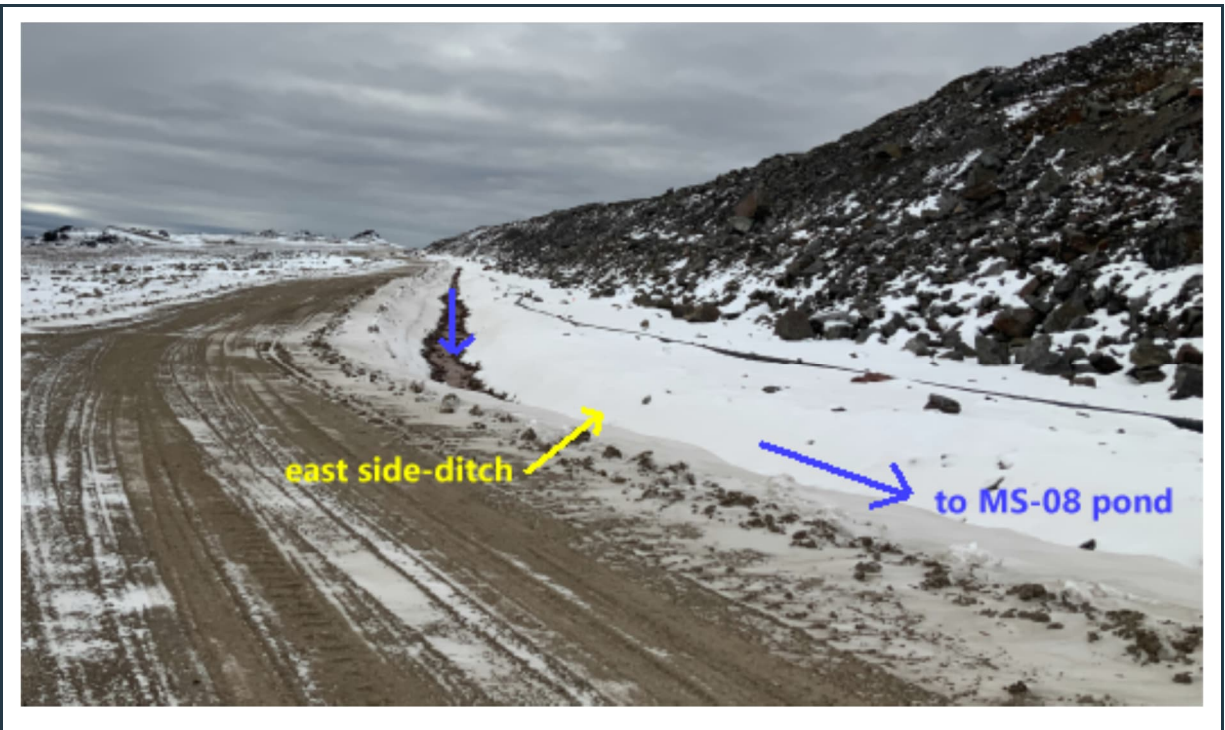
Figure 30: View of the well-maintained drainage ditch around the east side of the waste rock facility, leading to the MS-08 pond. There was already some snow in the ditch in September.

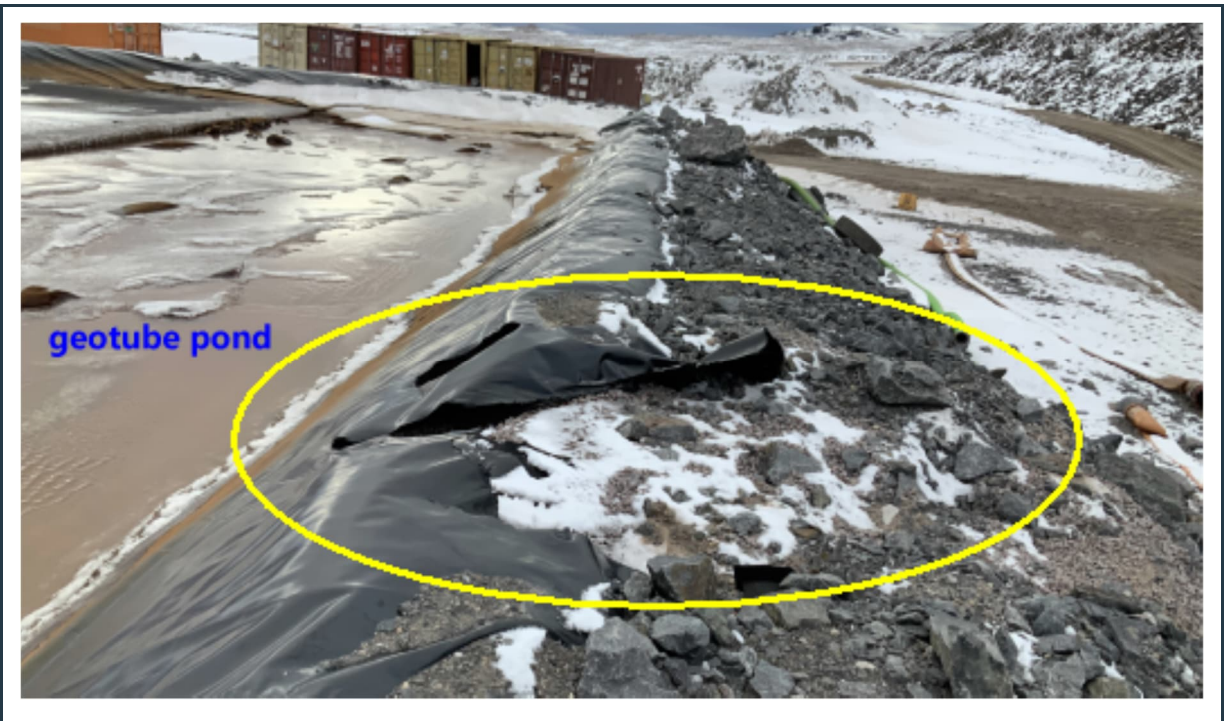
Figure 31: View of the perimeter berm around the geotube pond. A small section of the liner at the south-west section of the berm (yellow circle) is still damaged and will require repair.

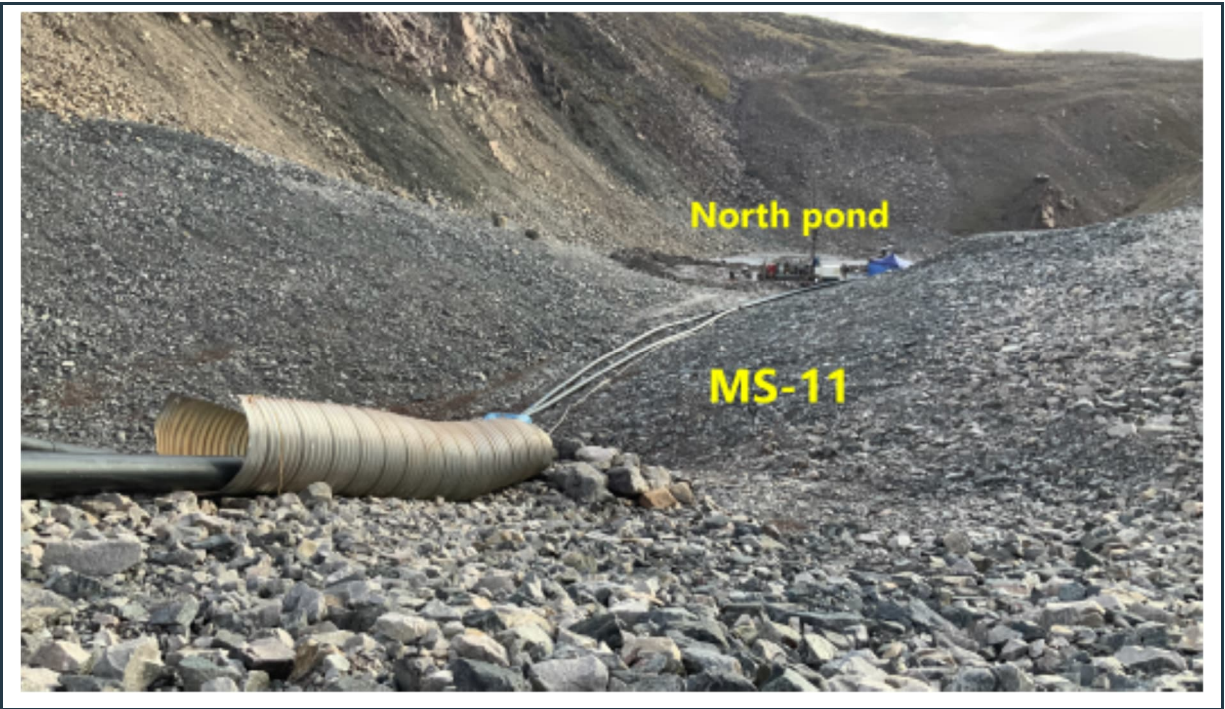
Figure 32: View of the north part of the MS-11 pond at KM105. Note the ongoing geotechnical investigation at the base of the pond.

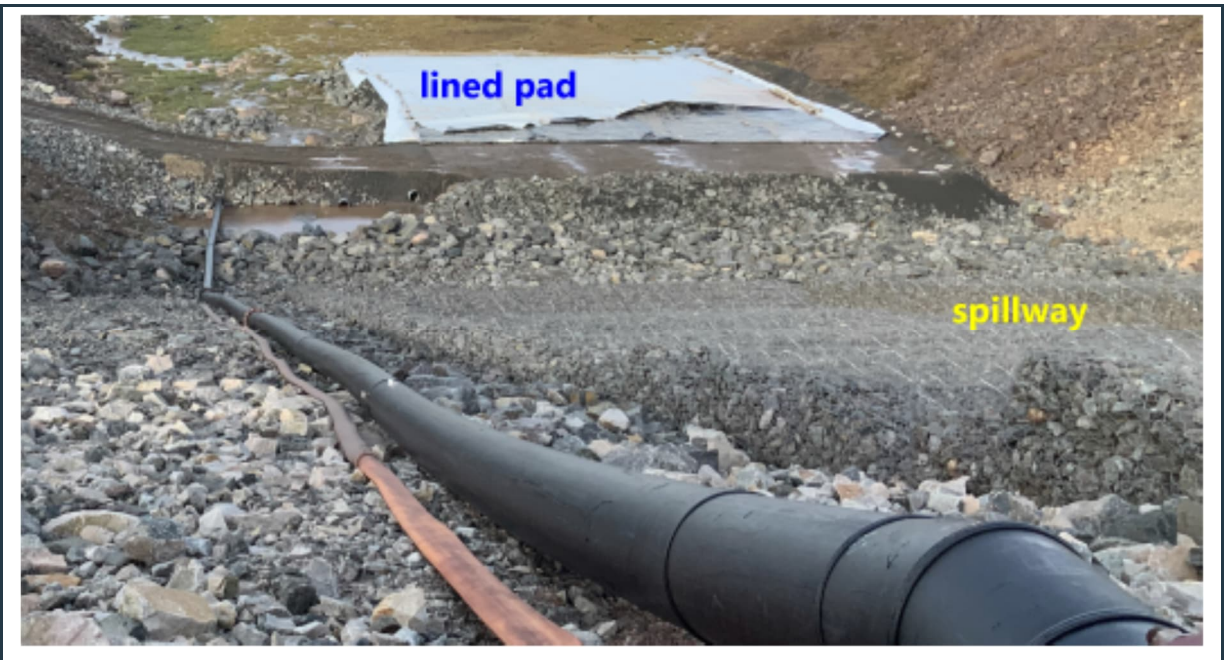
Figure 33: View of the robust and stable emergency spillway (gabion baskets and blankets filled with crushed rock) at KM105. Note the lined, compacted pad that will support geotubes at that location.

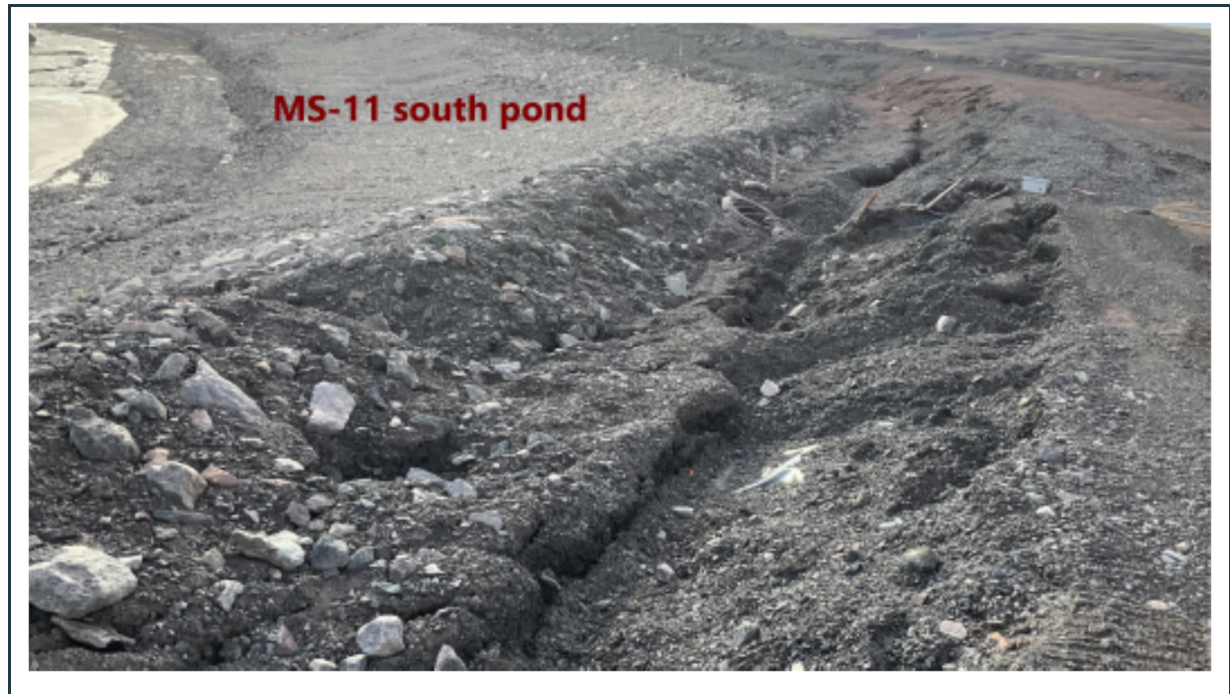
Figure 34: View of the loosely filled liner anchor trench along the road next to the south MS-11 pond's slope. The open gaps do not appear to be related to slope movements, but they should be backfilled and regraded to minimize water infiltration into the ground next to the slope.

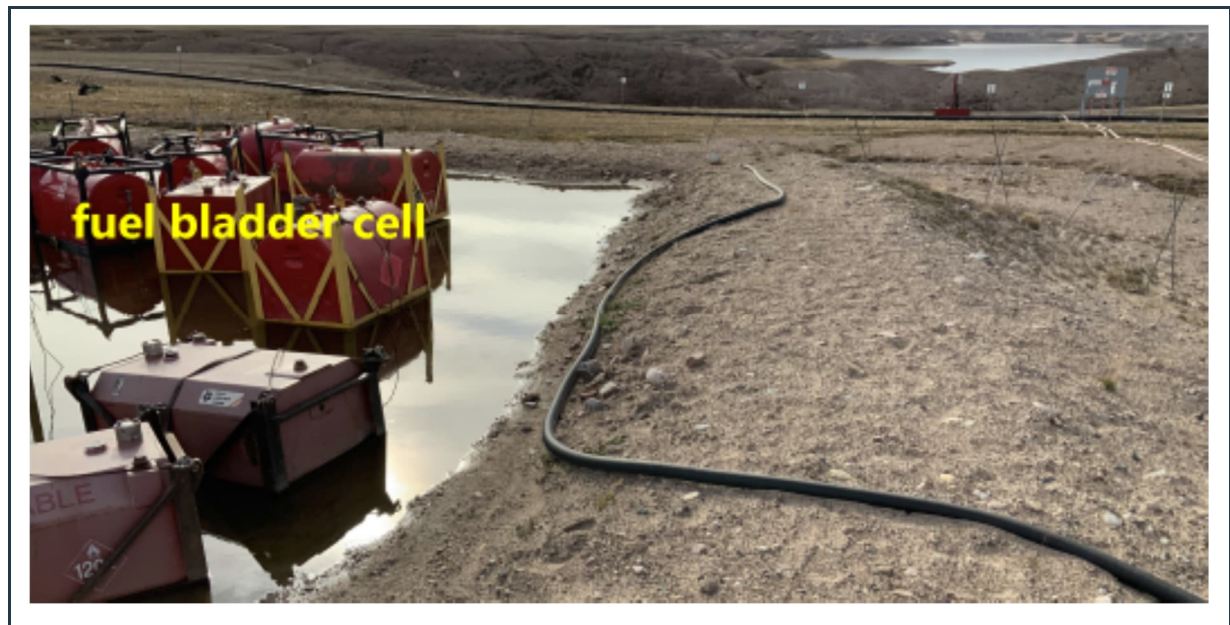
Figure 35: View of the stable berm around the "fuel bladder" cell. The ponding water in the cell indicates good liner performance.

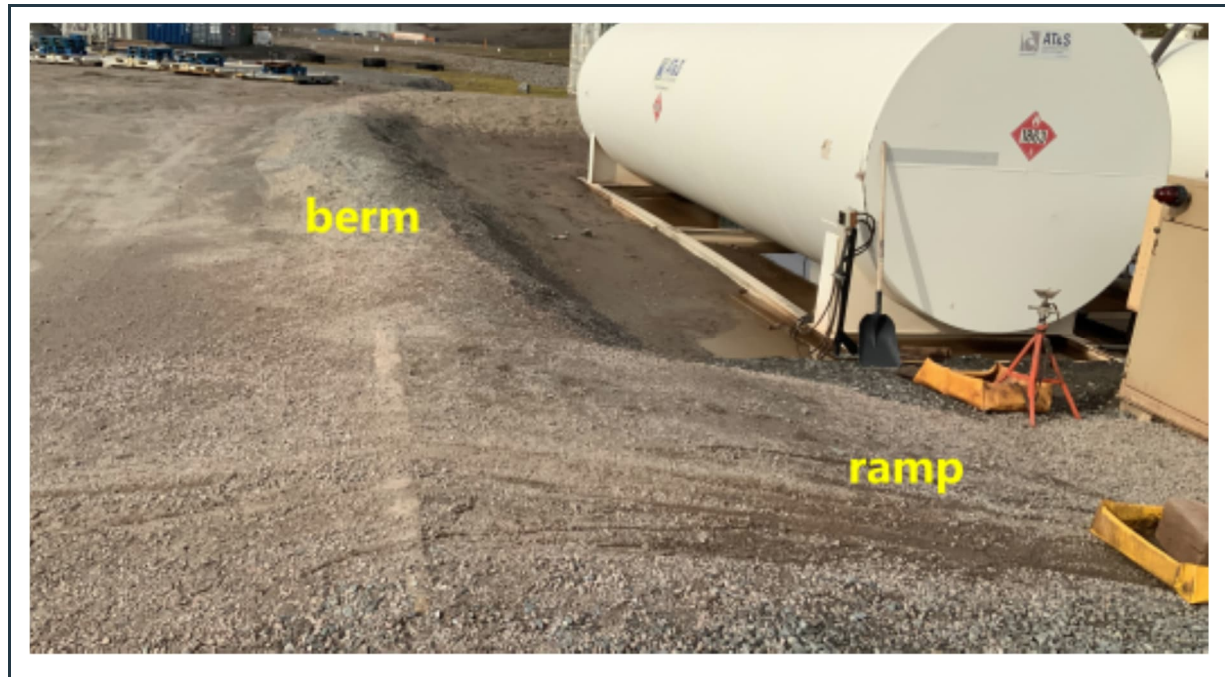
Figure 36: View of the well-maintained sand and gravel berm and access ramp at the lined jet-fuel storage facility. Ponding water in the cell indicates good liner performance.
