Baffinland Iron Mines Corporation

October 31, 2023
Project #: OMGM2212-2023

Annual Geotechnical Inspections – 2023 Report 2.
APPENDIX "A" - Mary River Mine Complex - Photographs
Figure 12 to Figure 51

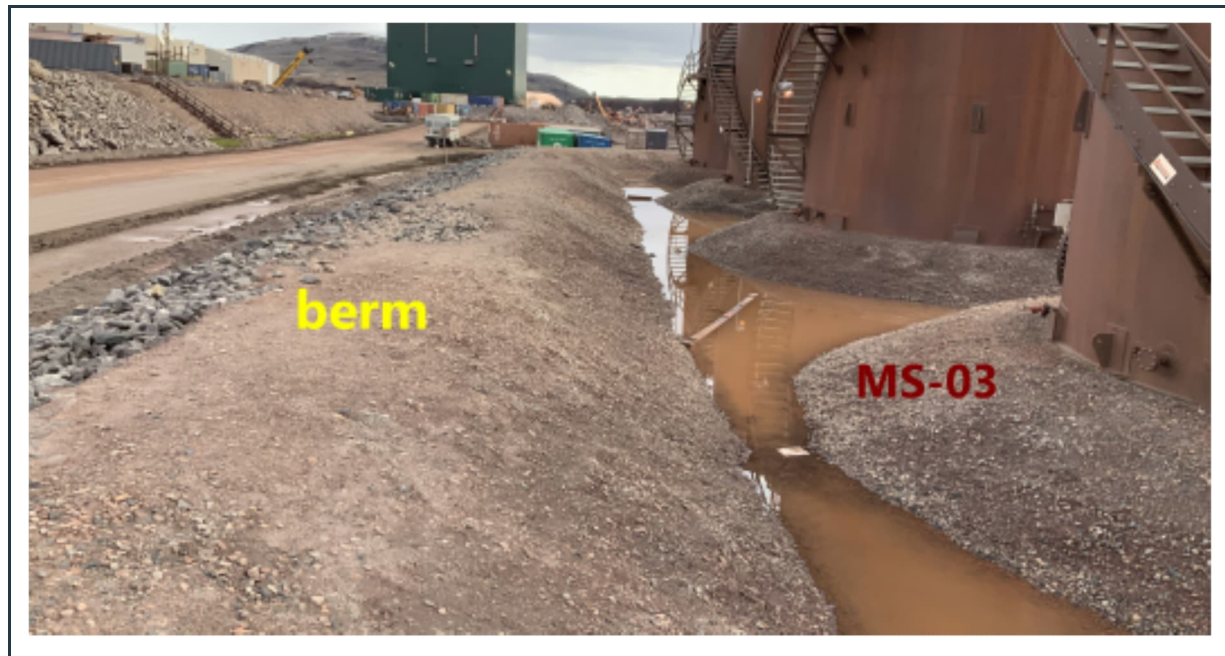
Figure 37: Well-maintained, stable berm around the MS-03 diesel fuel farm, with some ponding water, which is indication of good liner performance. Note the rock fill on the downstream slope.

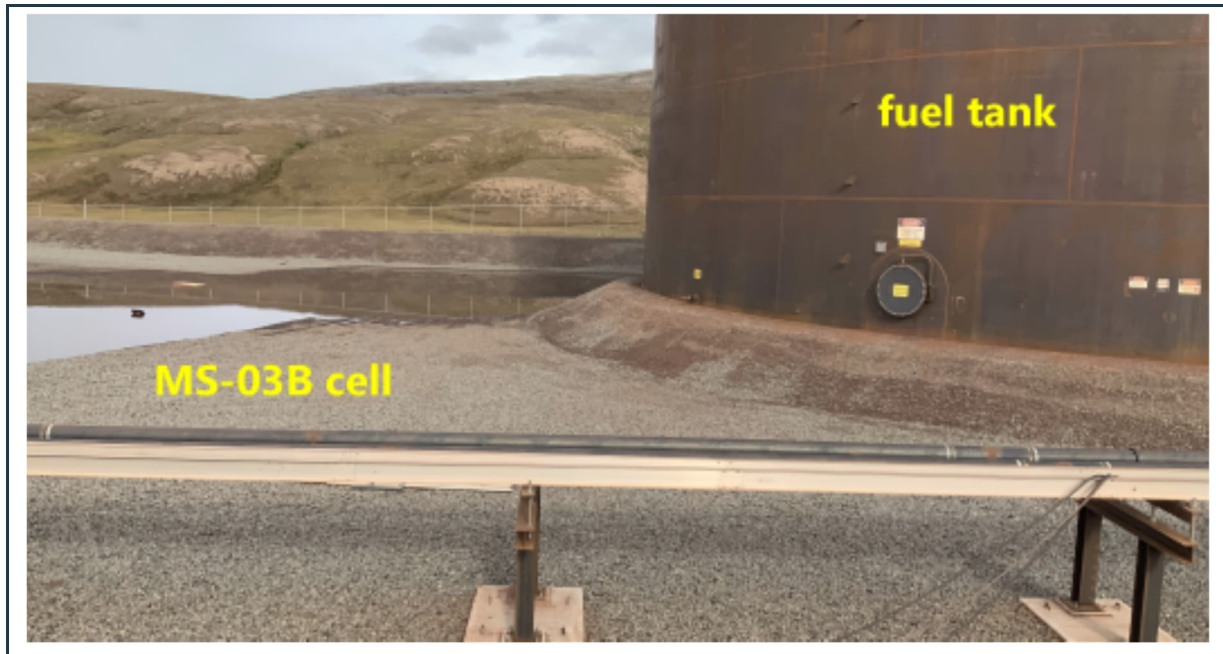
Figure 38: View of the well-maintained stable berm and interior granular fill over the liner at the new fuel tank farm. Note the ponding water in the cell, indicating good liner performance.

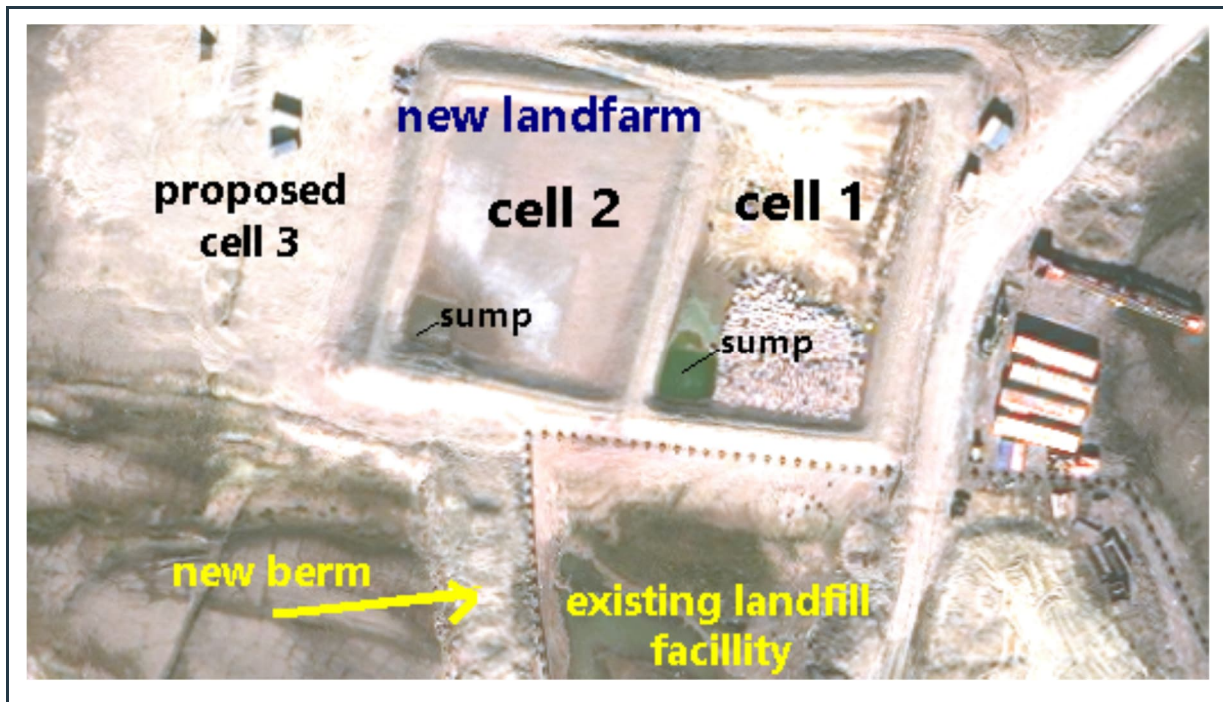
Figure 39: Satellite view of the solid waste landfill facility and the adjacent two, recently constructed landfarm cells (1 and 2). Cell 3 is proposed for construction in the future.

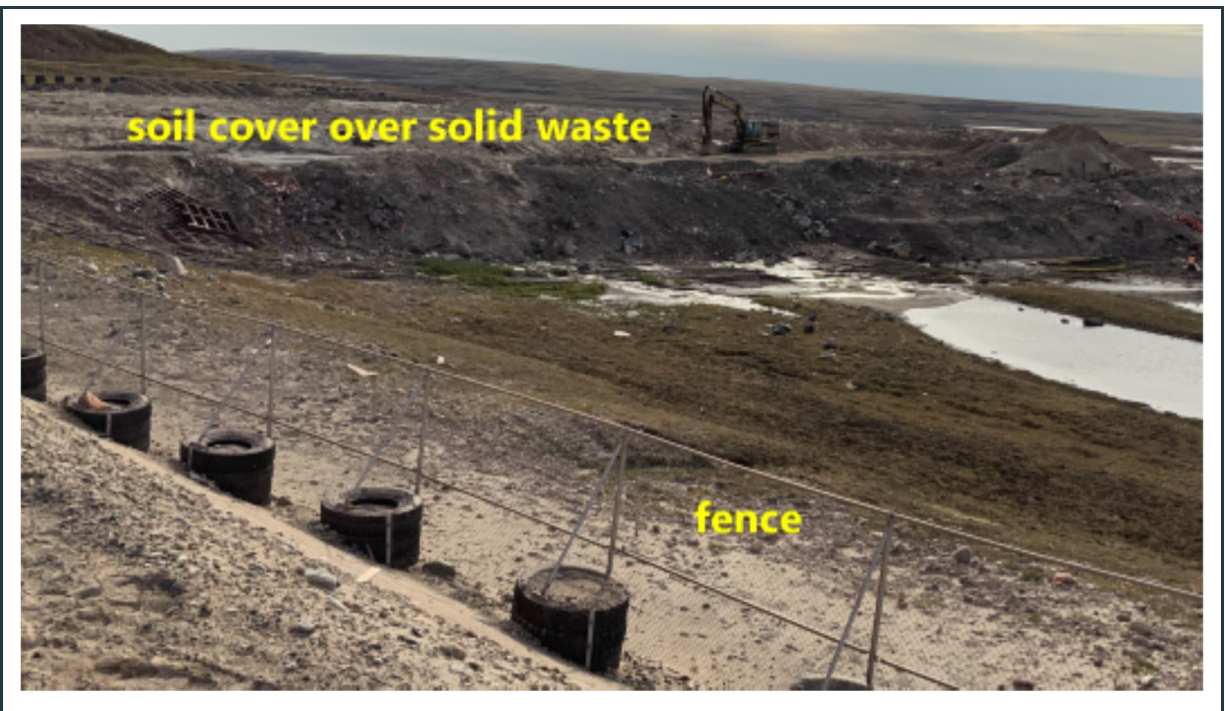
Figure 40: View of soil cover over non-hazardous solid waste in the fenced-in, gated landfill facility.

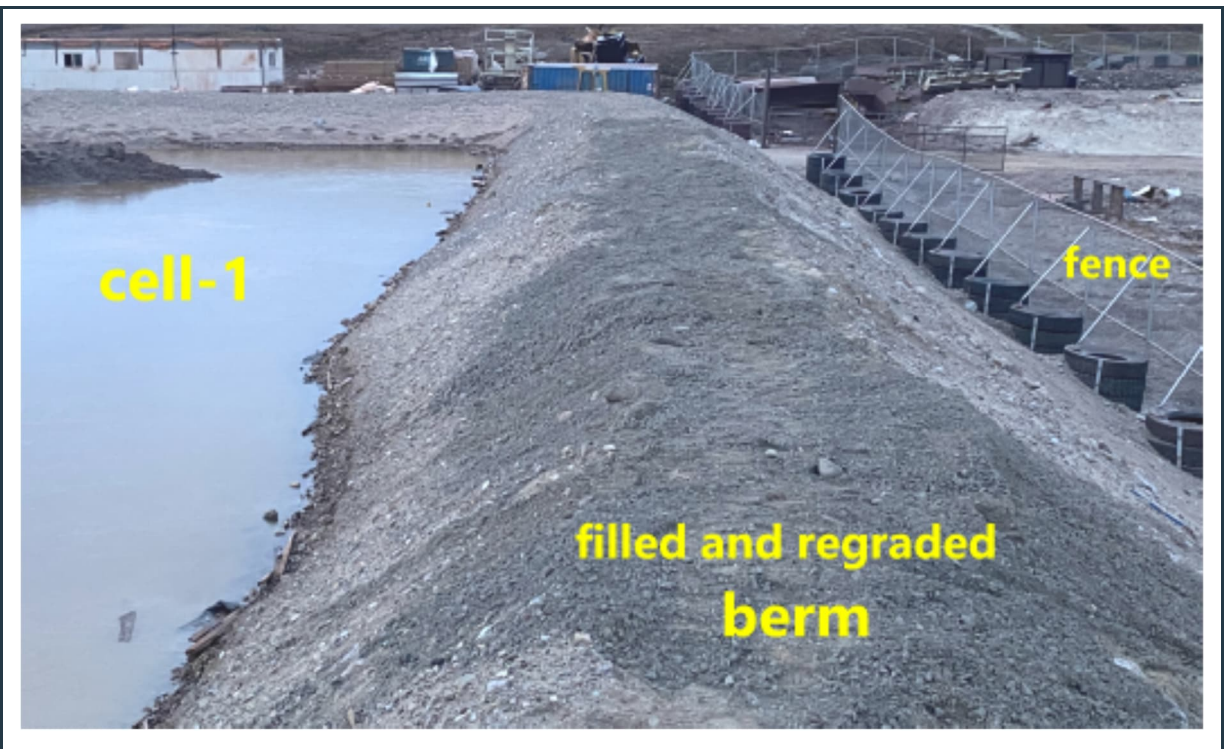
Figure 41: View of a section of the stable berm at the landfarm's Cell 1. Note that the settled anchor trench on the crest of the berm has been regraded and the exposed liner covered by Site Services, as specified in our earlier report (June 2023).

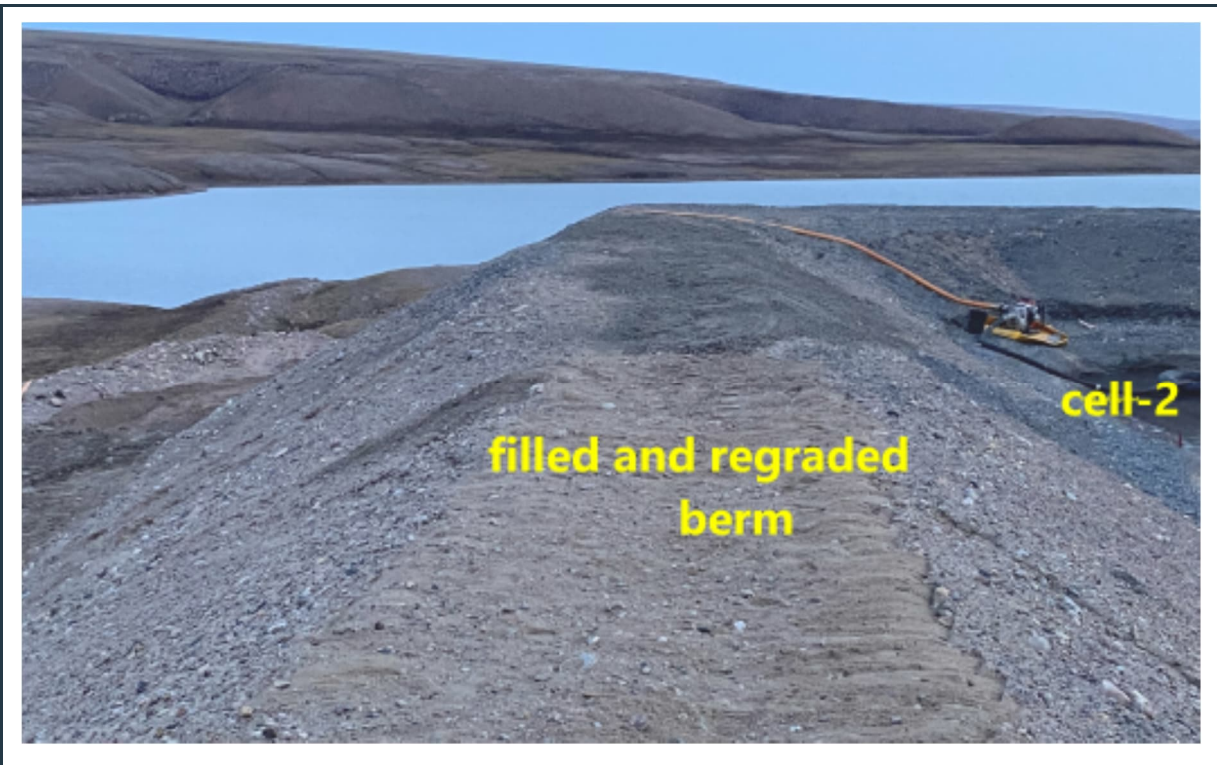
Figure 42: View of the currently empty cell-2 at the new landfarm. Note that the previously exposed liner has been covered and the anchor trench filled as specified in our earlier report.

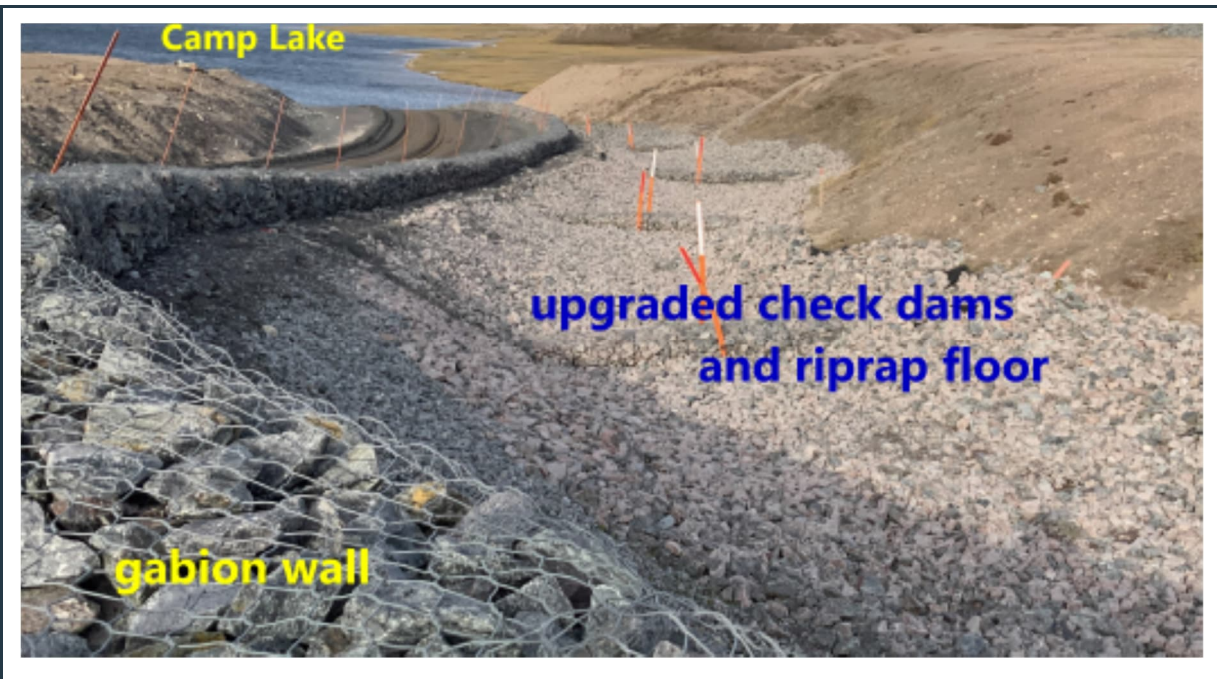
Figure 43: View of the upgraded Camp Lake check dams and new gabion wall along the road to the lake.

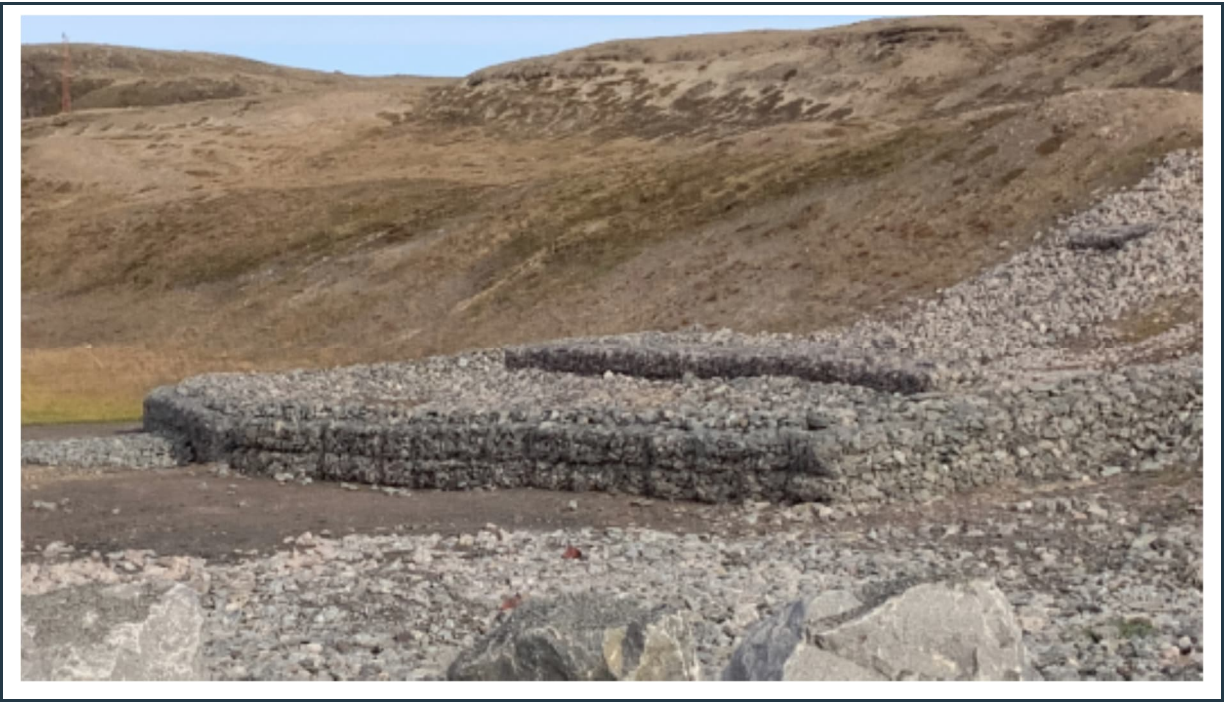
Figure 44: View of the new check-dam and riprap cover adjacent to Camp Lake to capture suspended solids potentially eroding from the airfield area and to prevent siltation in the lake.

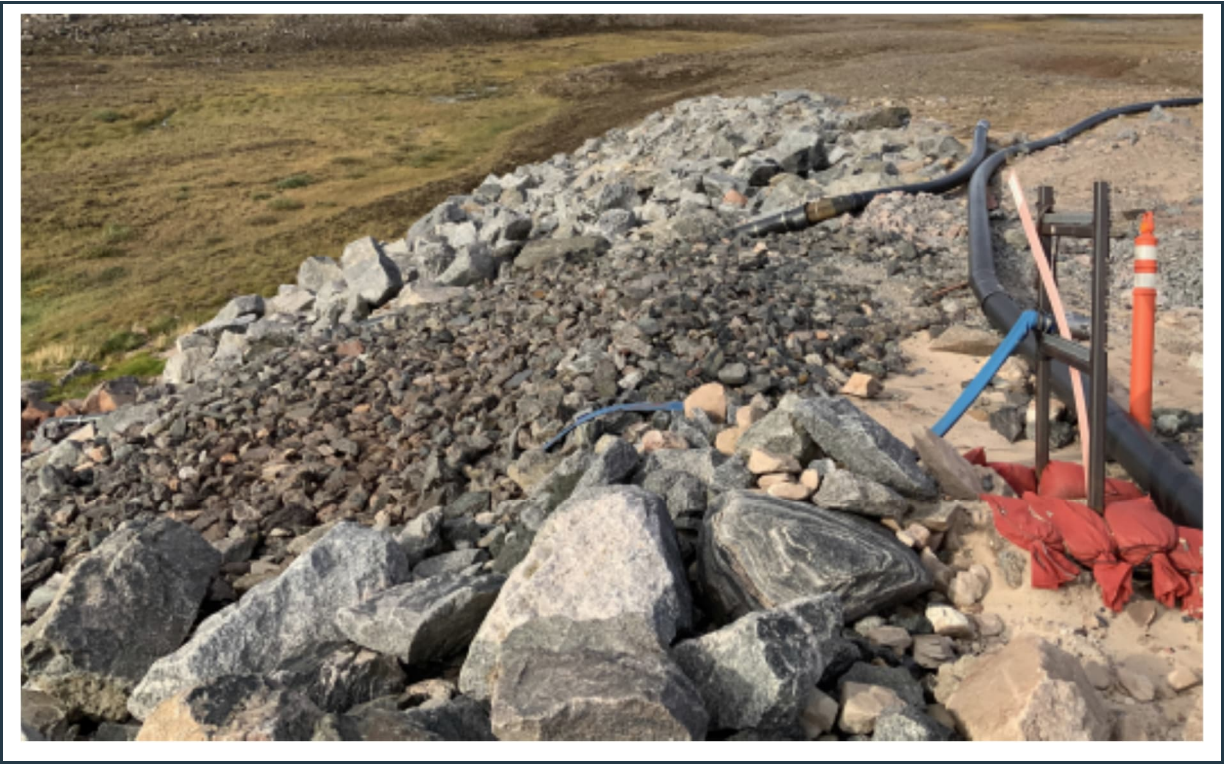
Figure 45: View of the stable rockfill riprap slope at the water discharge area.

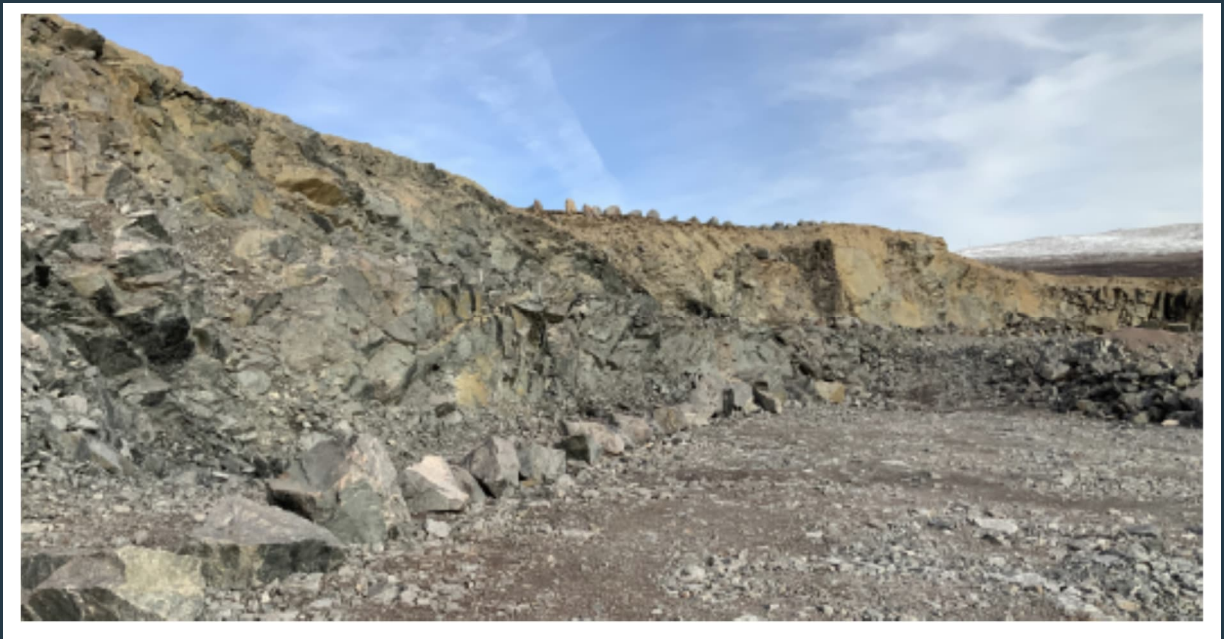
Figure 46: View of the stable rock face at the upper quarry level with protective boulders placed along the toe and crest of the rock cut. No activity is currently carried out in this quarry.

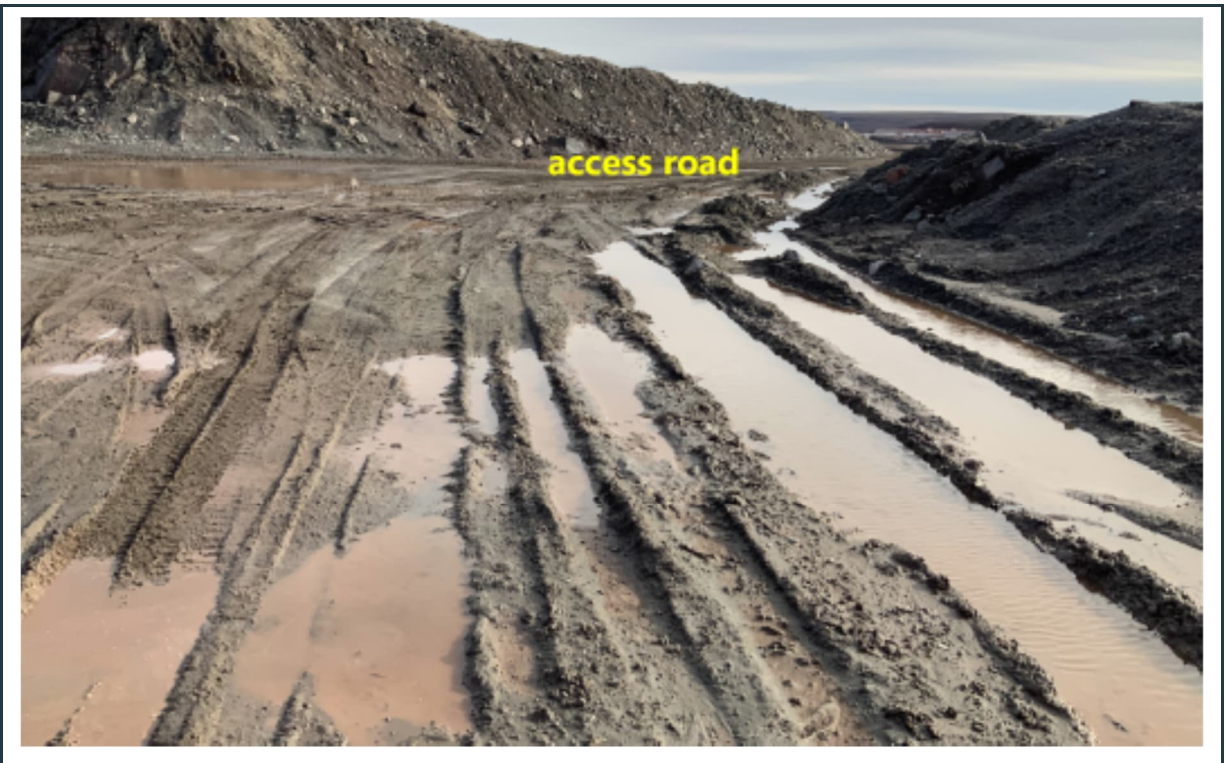
Figure 47: Drainage problems still exist at the first quarry level. Surface drainage shall be rectified.

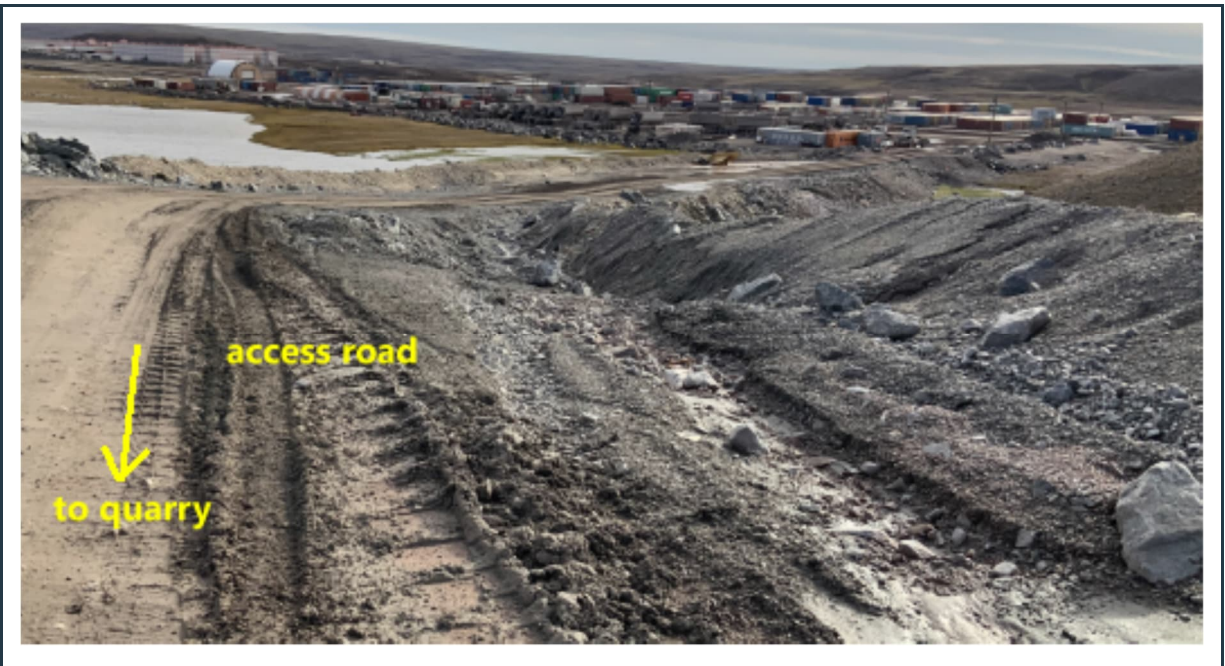
Figure 48: Erosion problem still exists along the edge of the access road to the quarry.

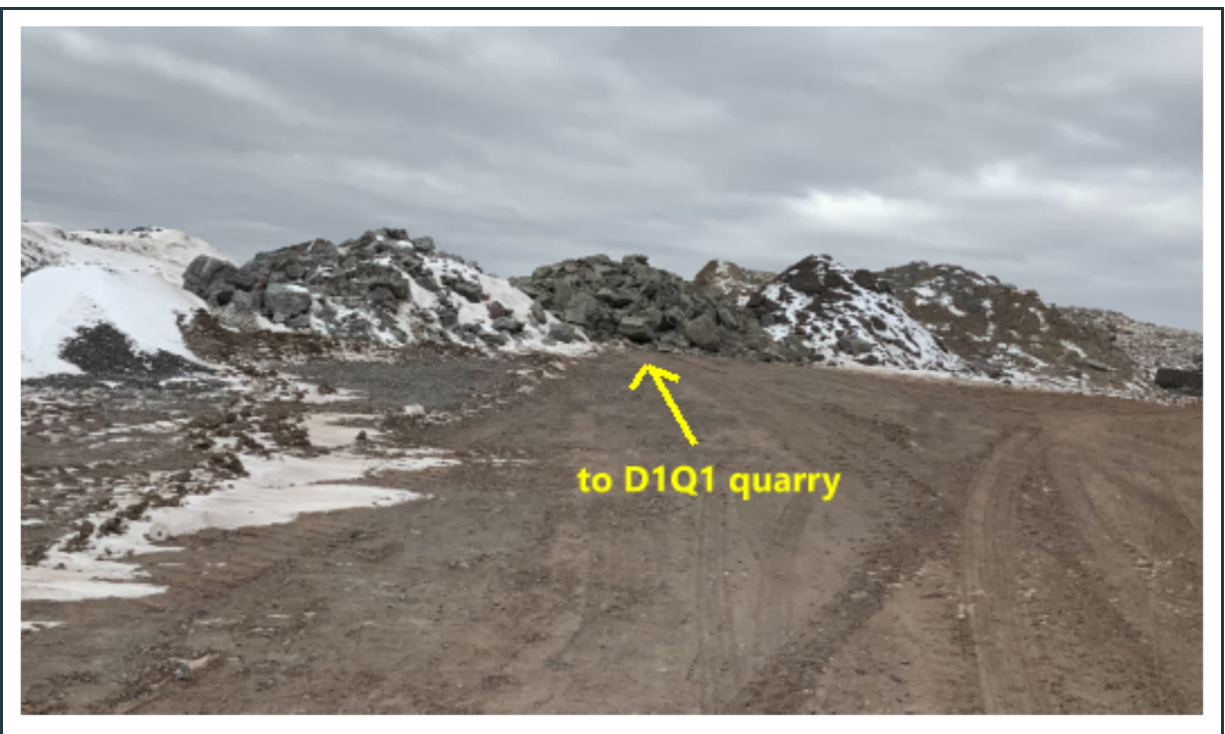
Figure 49: No activity is currently carried out in this quarry and the access road is blocked by rockfill.

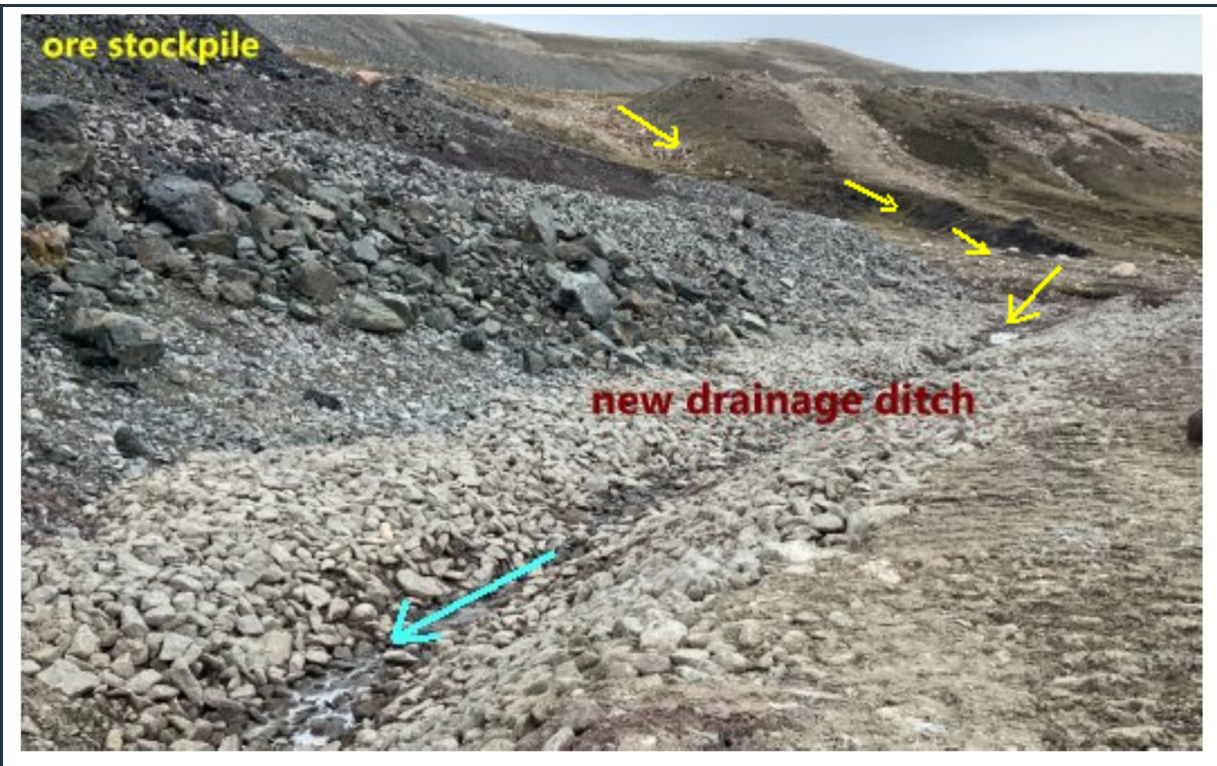
Figure 50: View of the new drainage ditch south of the KM-106 ore stockpile area, collecting local run-off (yellow arrows).

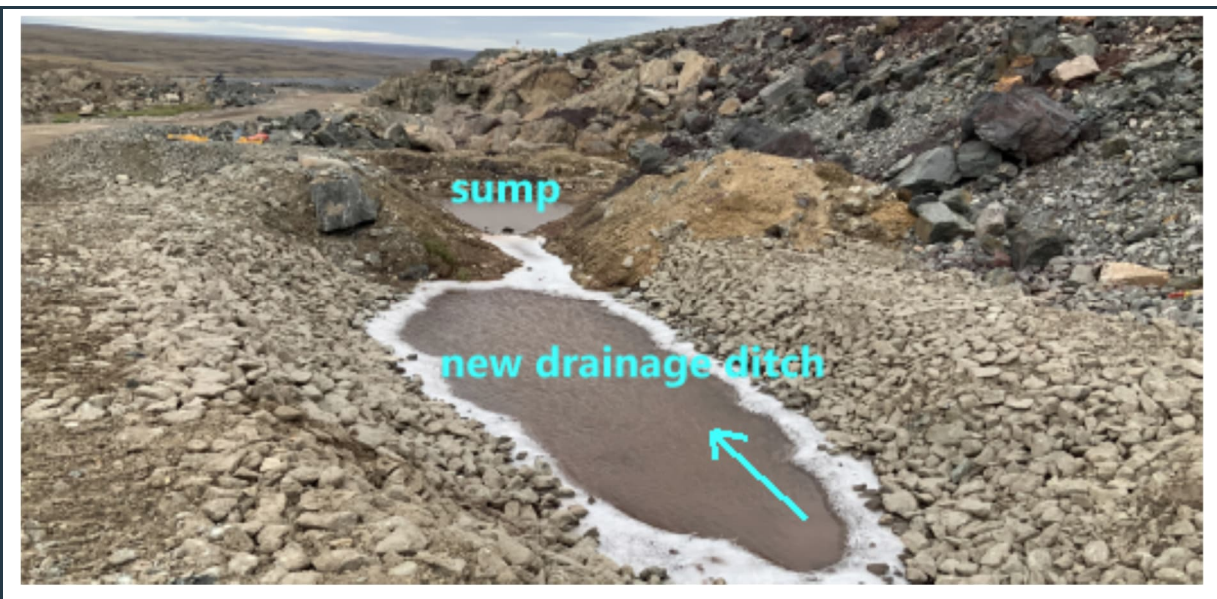
Figure 51: View of the new drainage ditch and sump (under construction) south of the ore stockpile area. Placement of riprap is required on the slopes of the sump as well.
