# Baffinland Iron Mines Corporation

October 31, 2023  
Project #: OMGM2212-23

## Annual Geotechnical Inspections – 2023 Report 2.

### APPENDIX "B" – Milne Inlet Port Site - Photographs

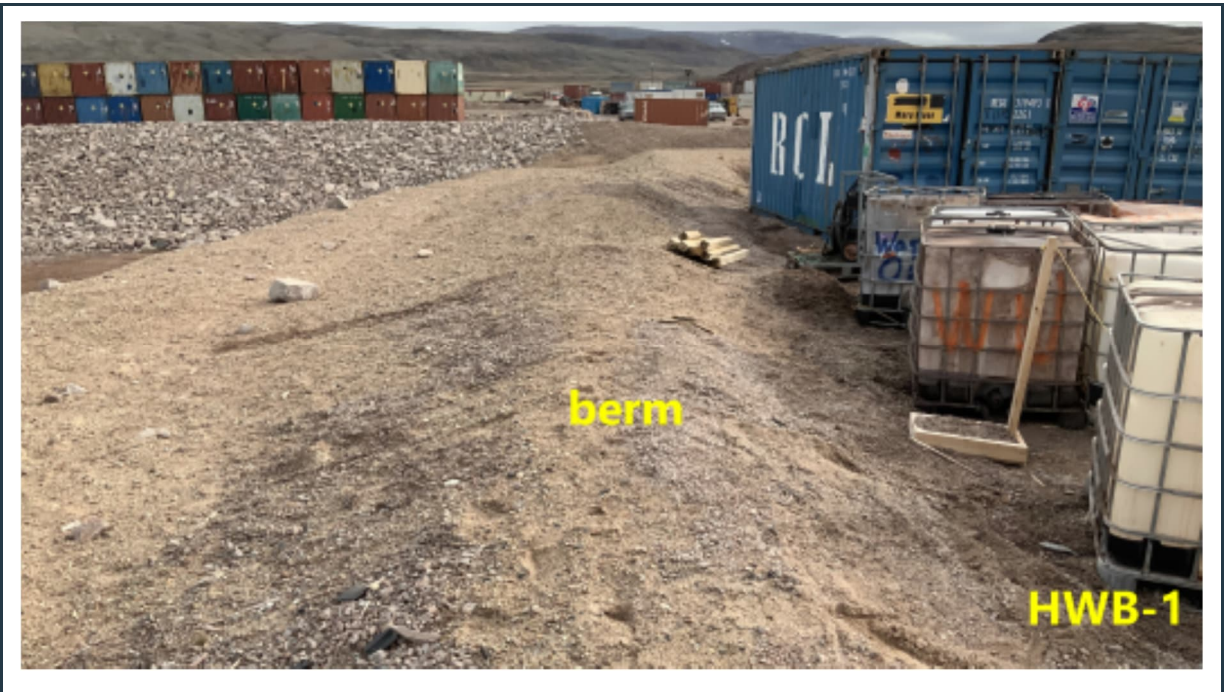
Figure 52: View of the stable berm around the lined HWB-1 cell.

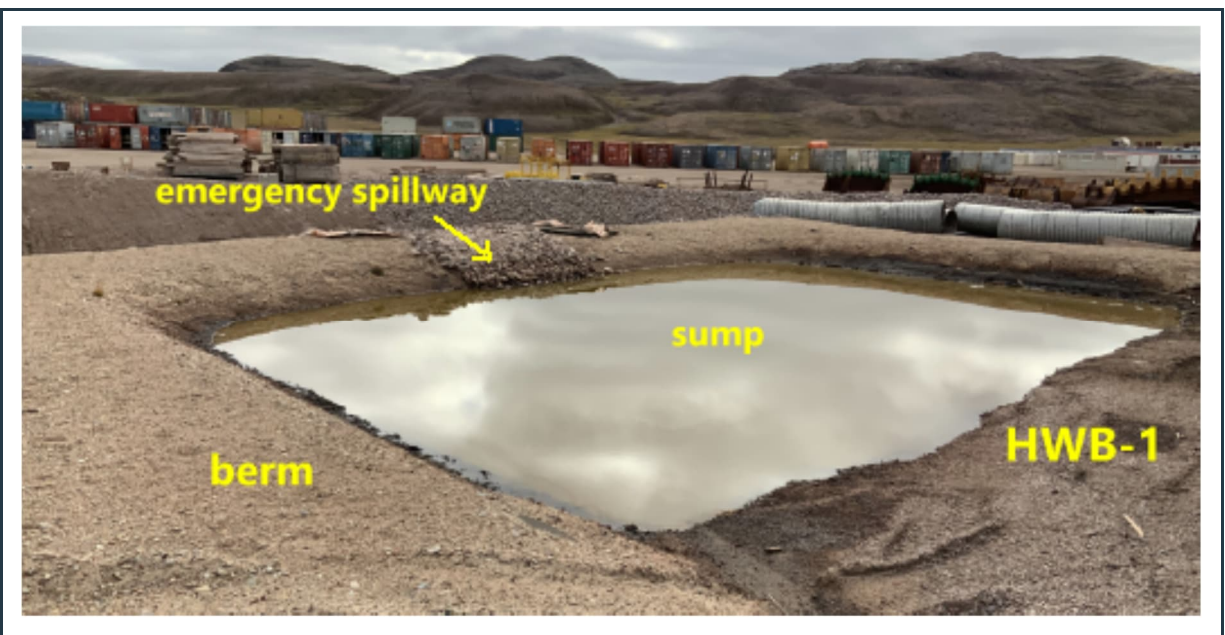
Figure 53: View of the sump and emergency spillway at the back of the HWB-1 cell with stable berms.

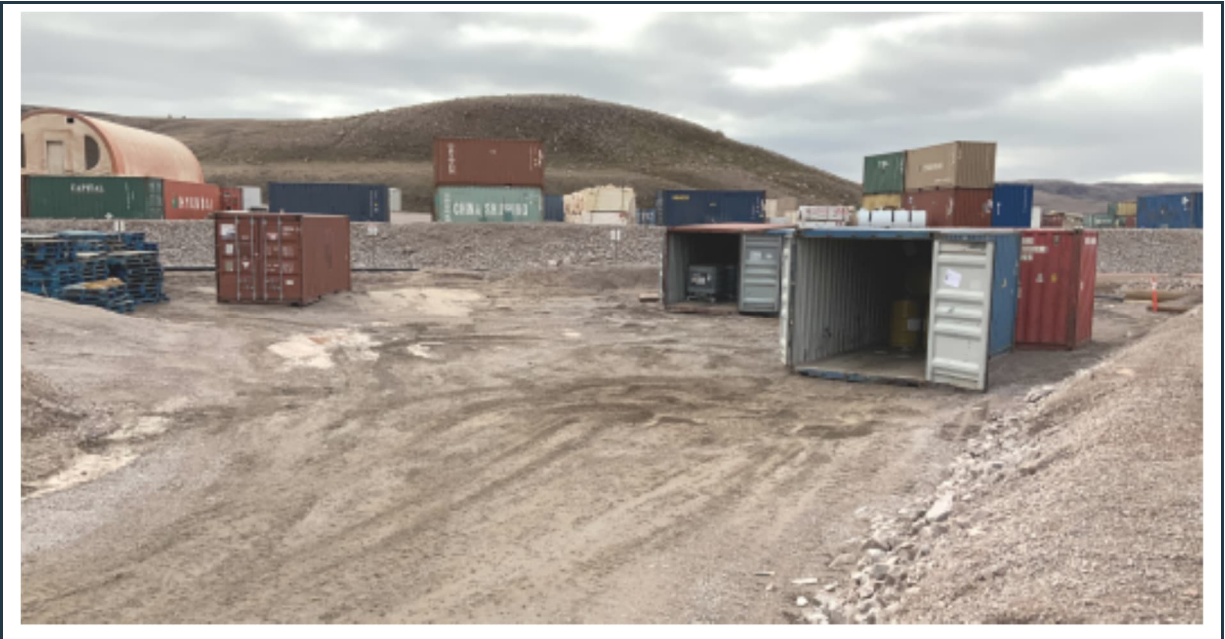
Figure 54: View of the former, now decommissioned, HWB-2 cell, with only a couple of empty containers stored on the top of clean sand and gravel fill pad. No hazardous waste is stored in this cell.

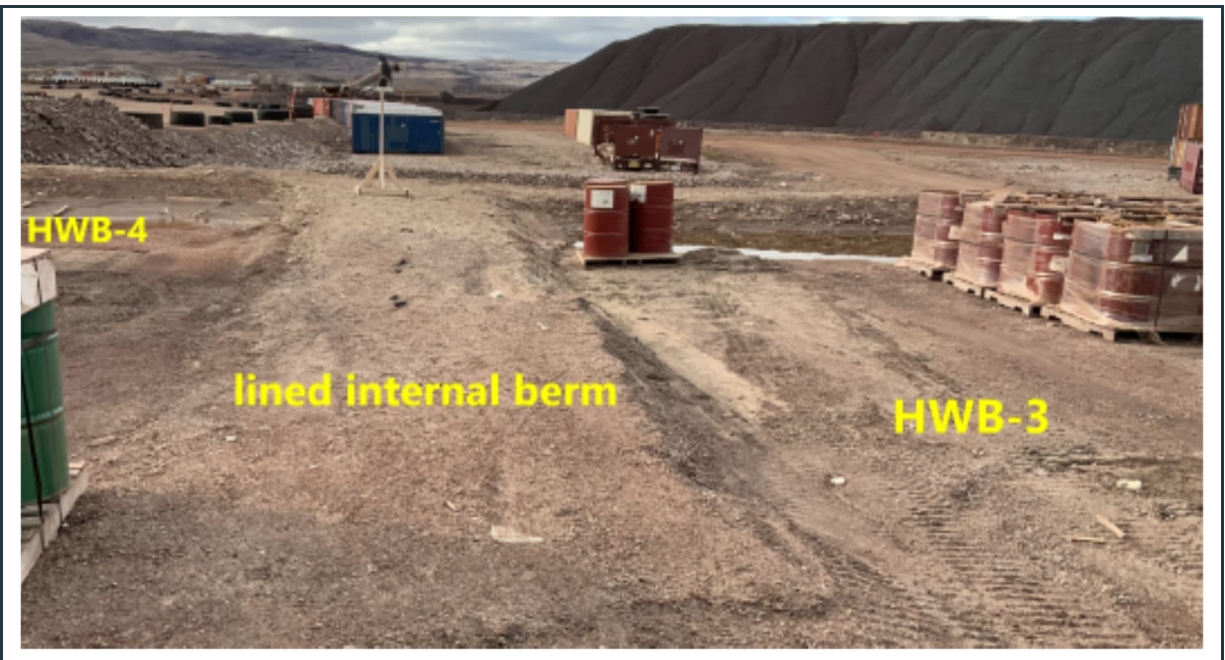
Figure 55: View of the well-maintained HWB-3 cell (right) with stable berms, containing fuel barrels. The interior subgrade of the cells has been regraded recently using clean sand and gravel fill.

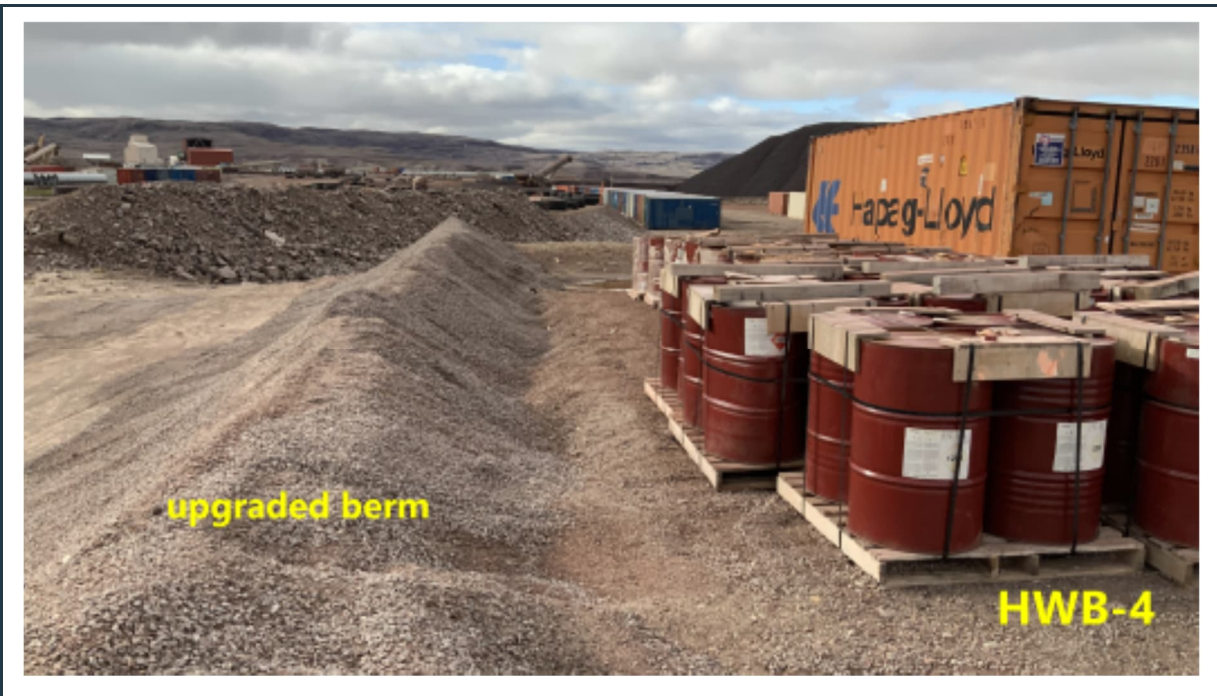
Figure 56: Recently improved (raised) berm at the HWB-4 cell, storing jet fuel and shipping containers. Note the improved granular base within the cell, protecting the liner.

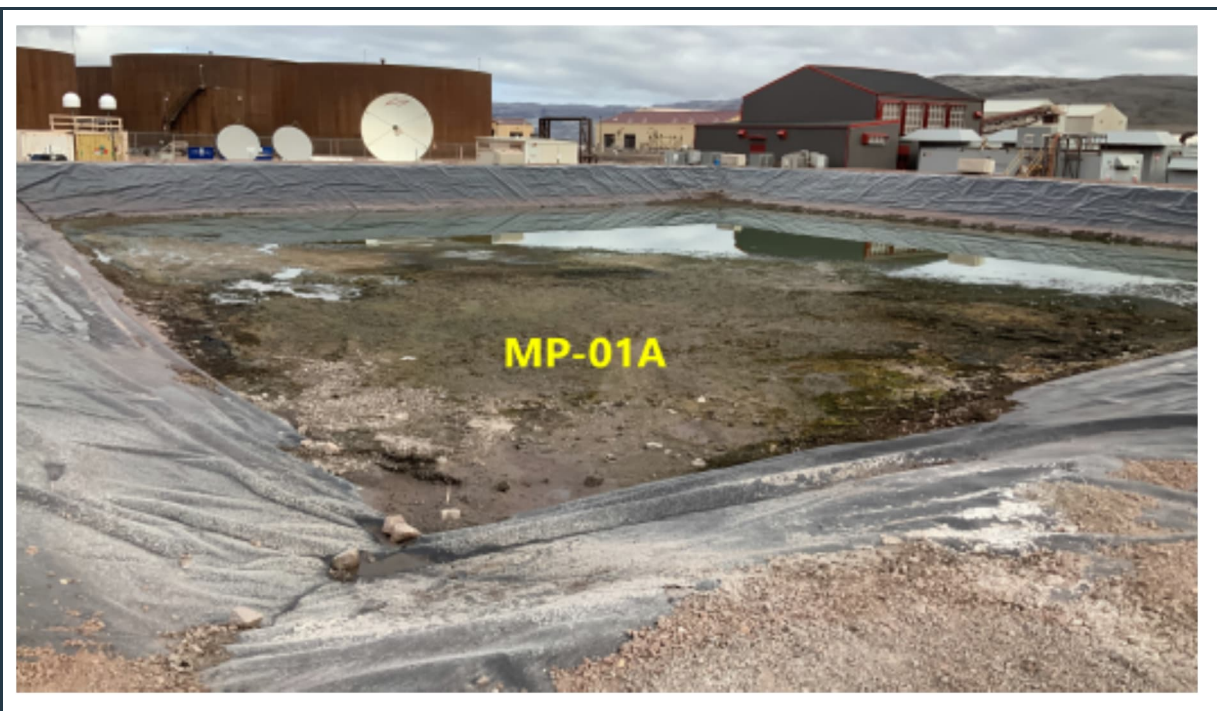
Figure 57: View of the robust, stable berms and intact liner at the practically empty MP-01A pond.

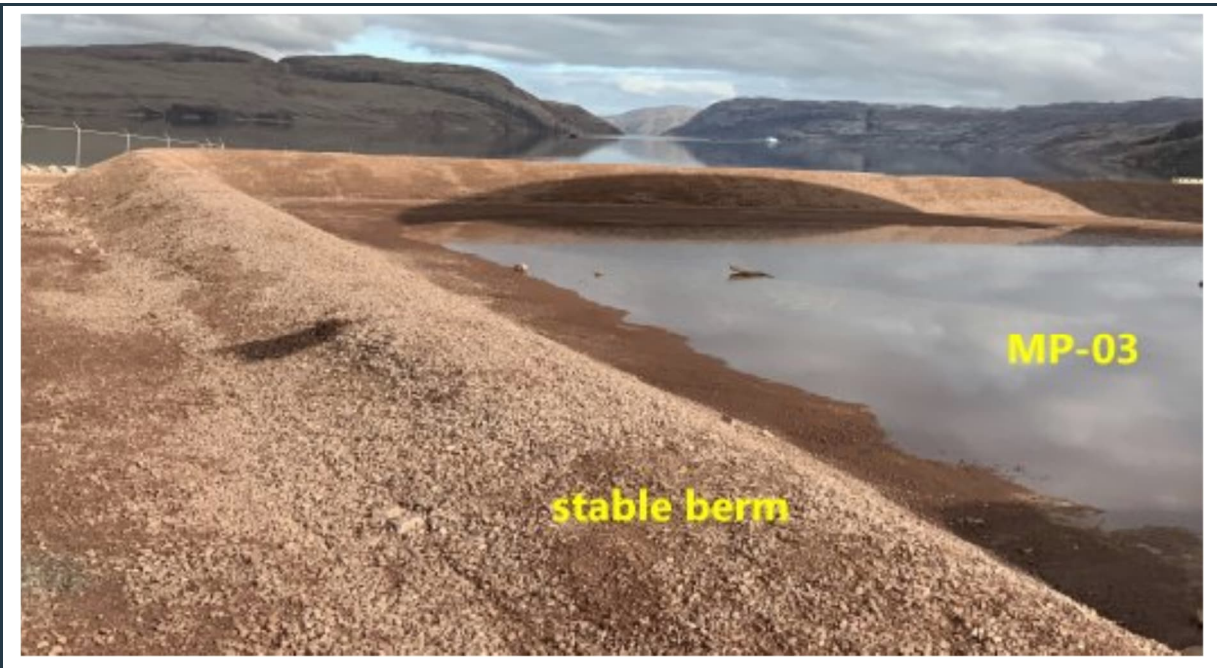
Figure 58: View of the well-maintained stable berms around the lined MP-03 fuel tank farm. The ponding water indicates good liner performance.

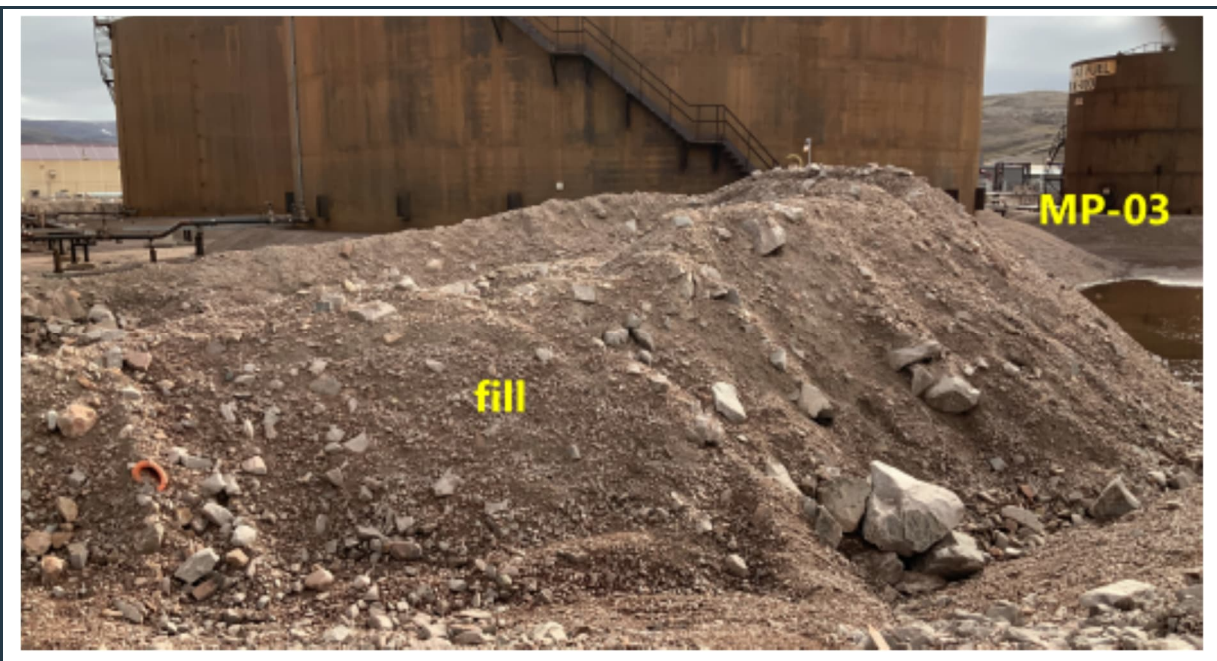
Figure 59: View of a pile of fill in the western part of the MP-03 fuel farm. Based on site information, this material was part of the granular base within the cell and potentially contaminated. Hence, it should be left in place at its current location within the lined facility.

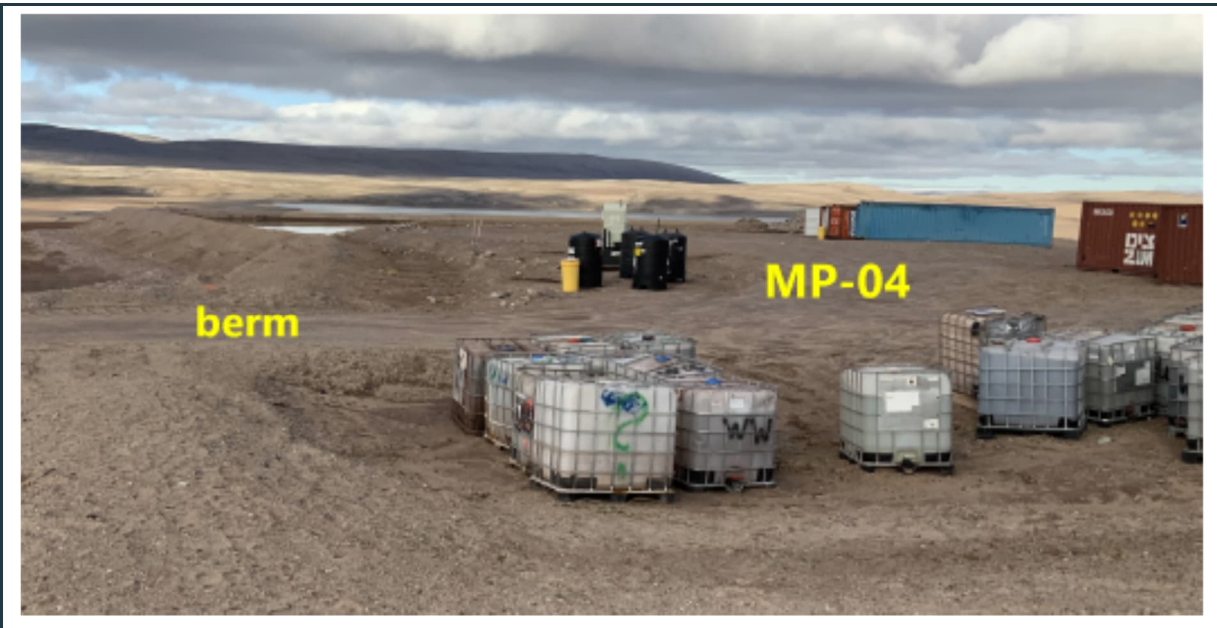
Figure 60: View of stable berm around the MP-04 land-farm, with ponding water in one corner of the cell. In addition to the buried waste, shipping and plastic containers are stored in the cell.

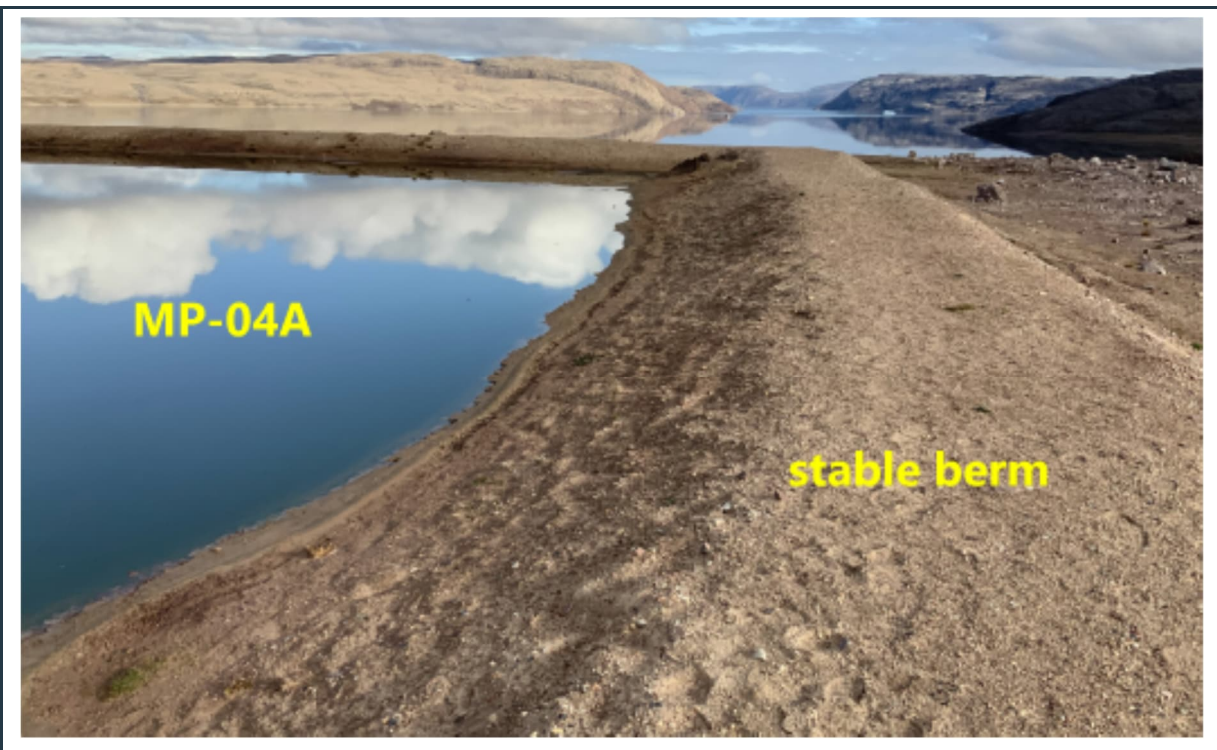
Figure 61: View of the lined MP-04A contaminated snow disposal cell with stable berms. The ponding water (melted snow) indicates good liner performance.

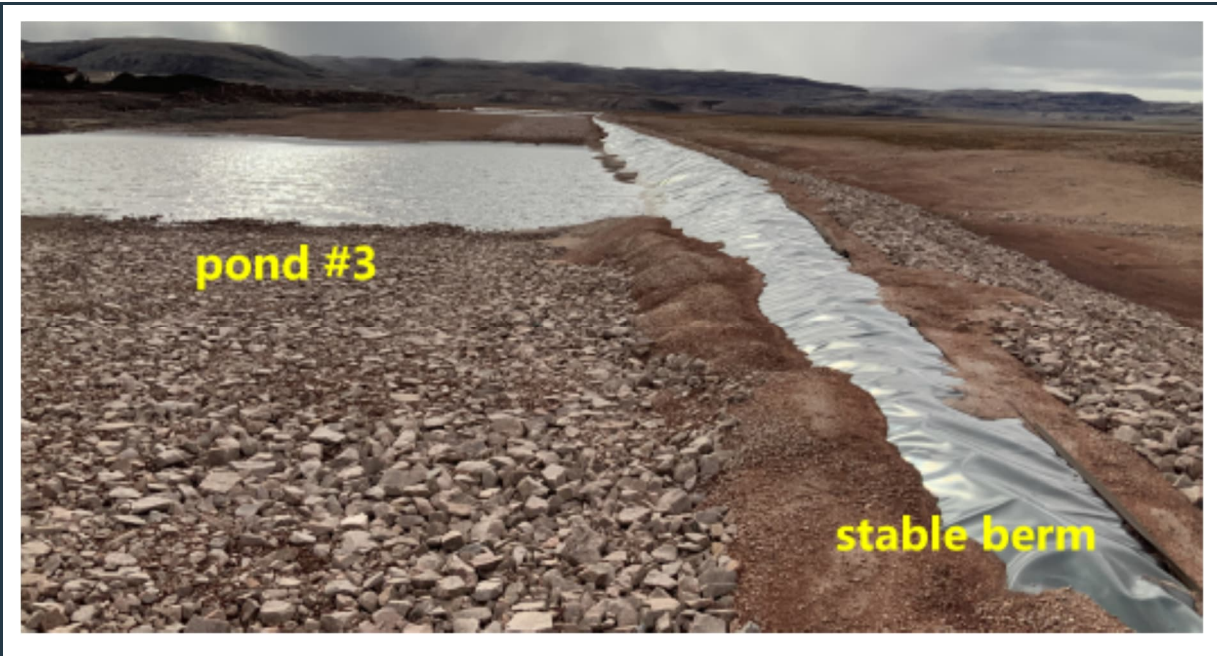
Figure 62: View of surface water management pond #3, with lined, stable berms.

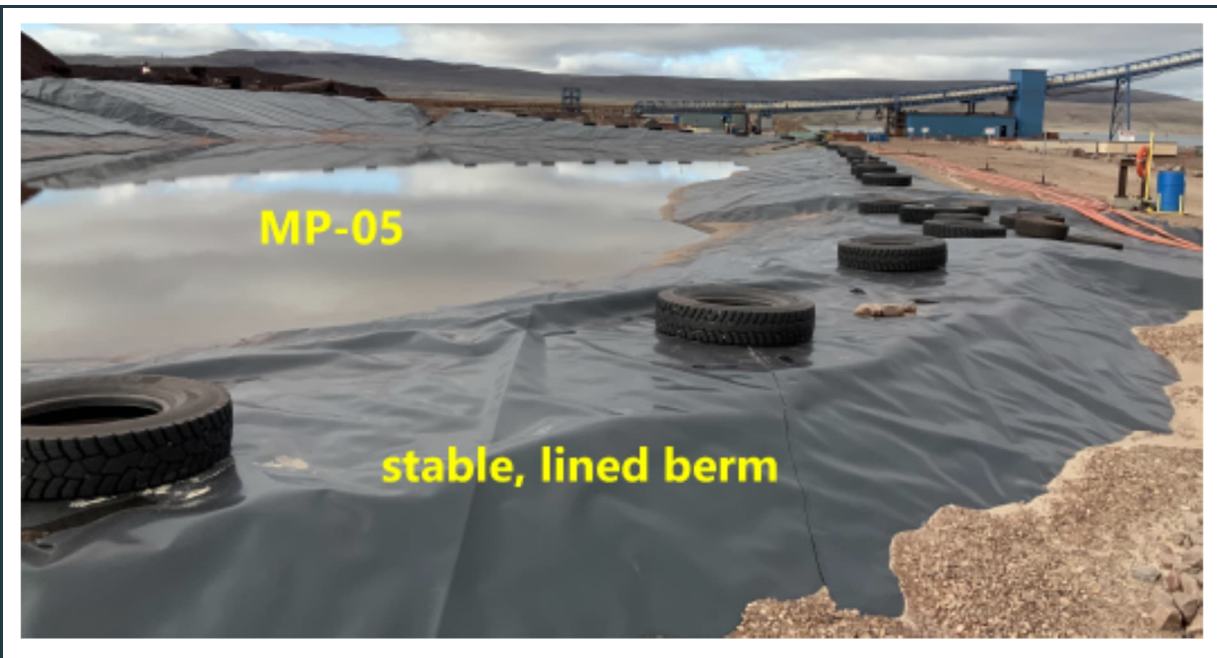
Figure 63: View of the robust, stable berms and intact liner at the MP-05 pond.

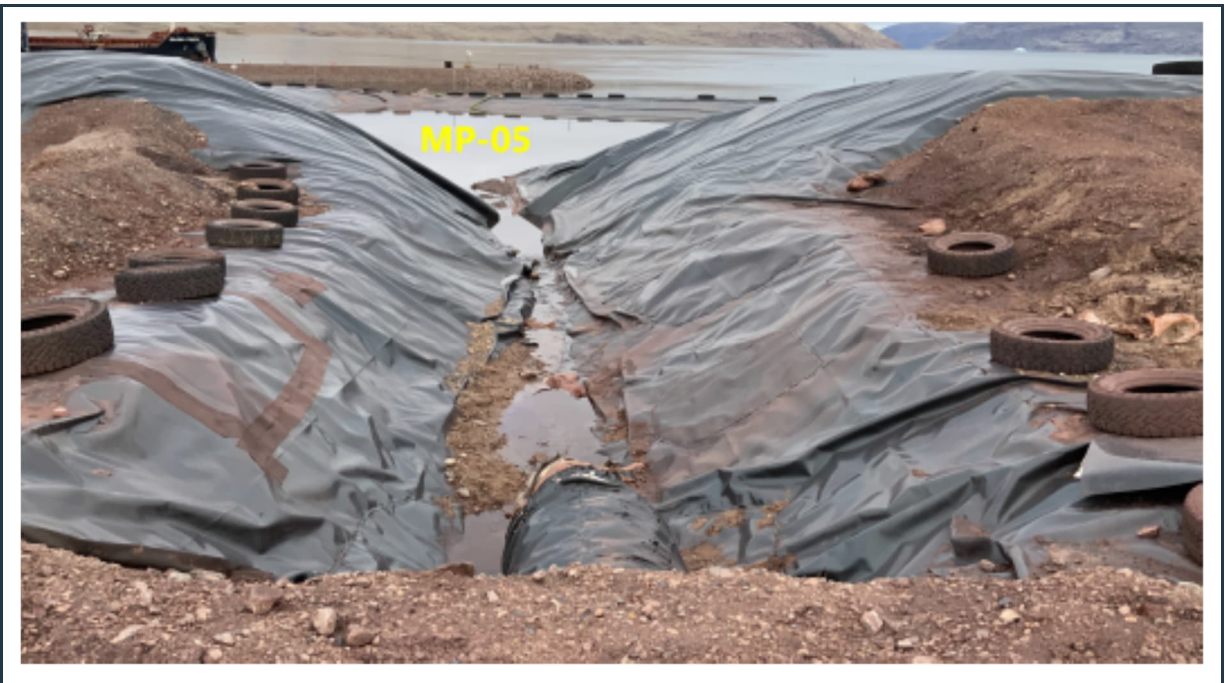
Figure 64: View of the inlet channel to the MP-05 pond. The previously damaged liner has been repaired.

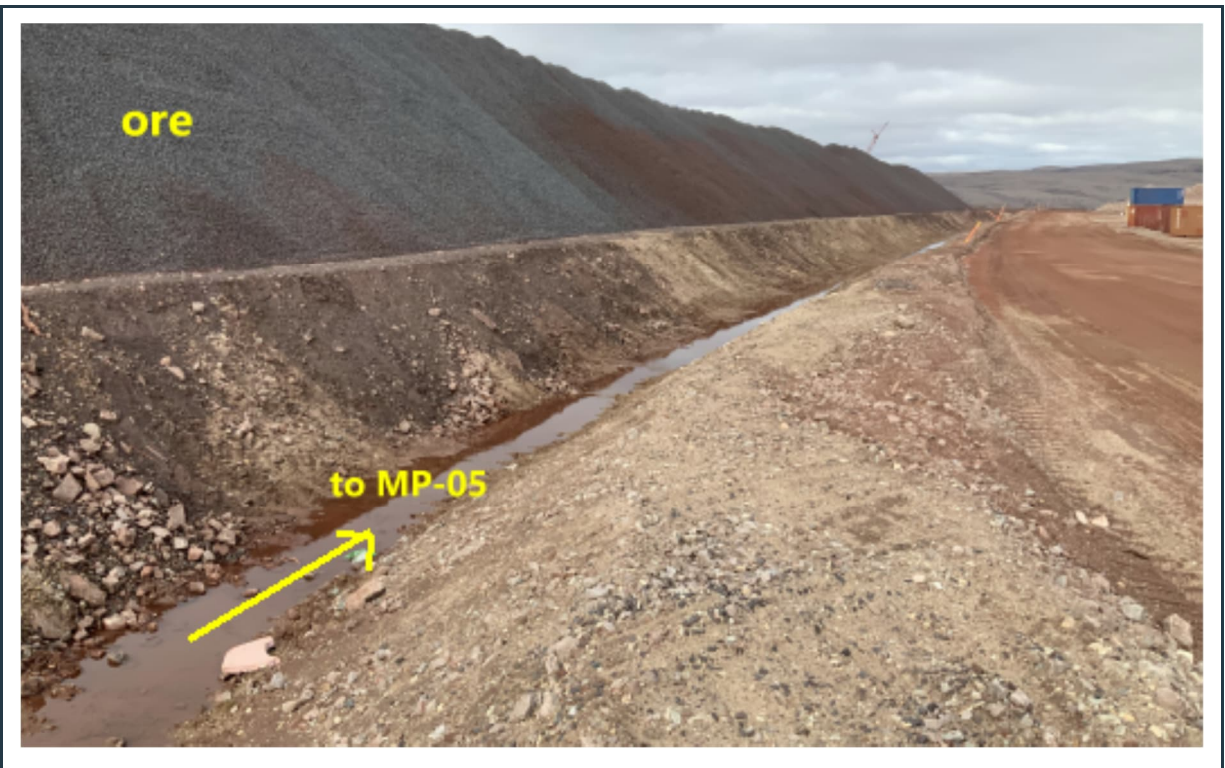
Figure 65: View of the "east" surface water collection ditch adjacent to the ore storage, draining to the MP-05 pond.

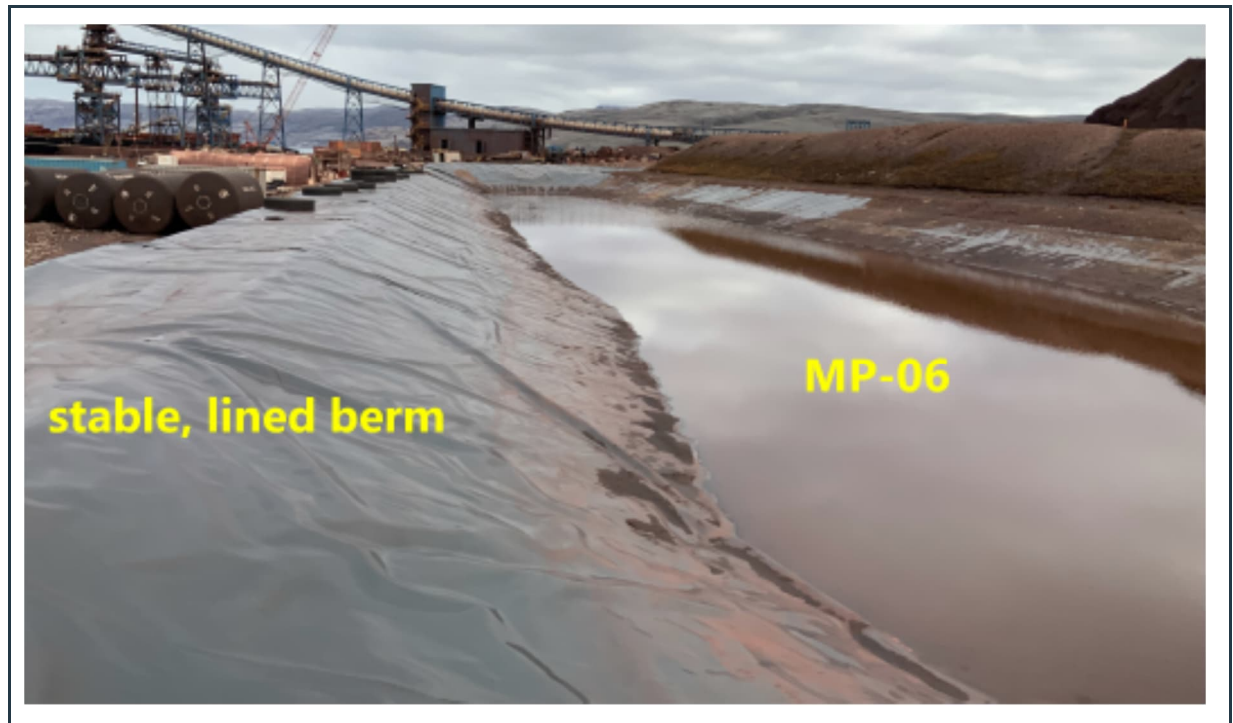
Figure 66: View of the lined MP-06 pond with robust, stable berms.

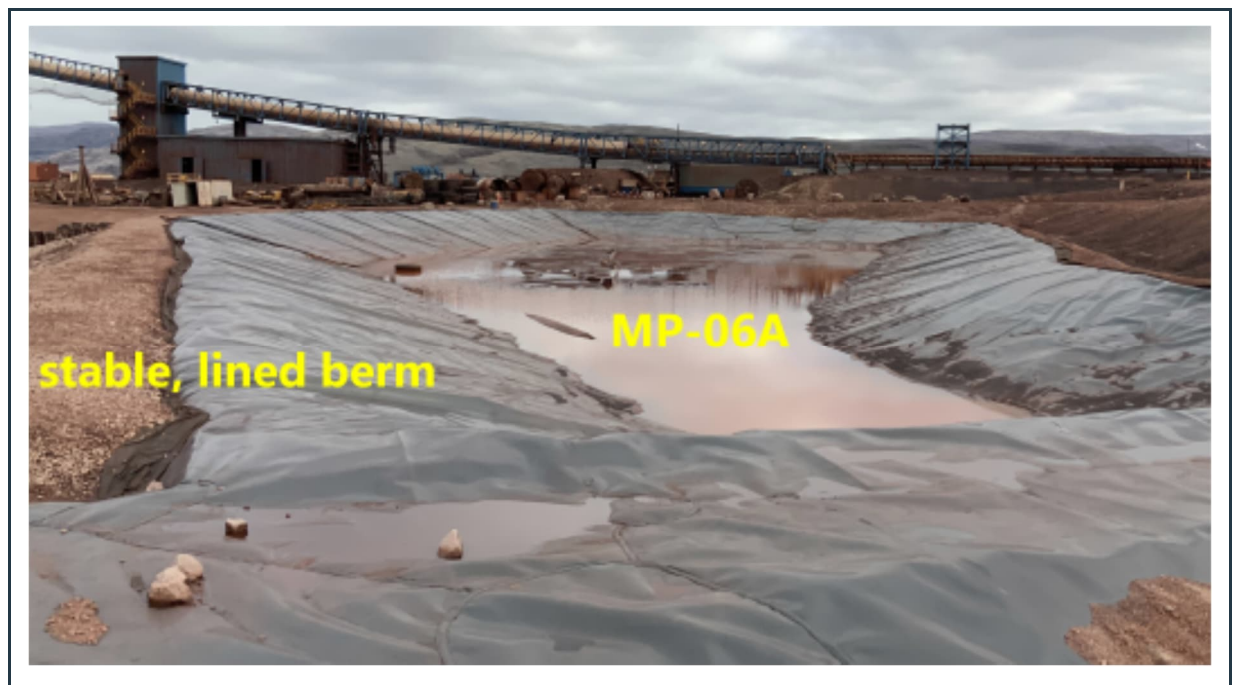
Figure 67: View of the lined MP-06A overflow pond with robust stable berms.

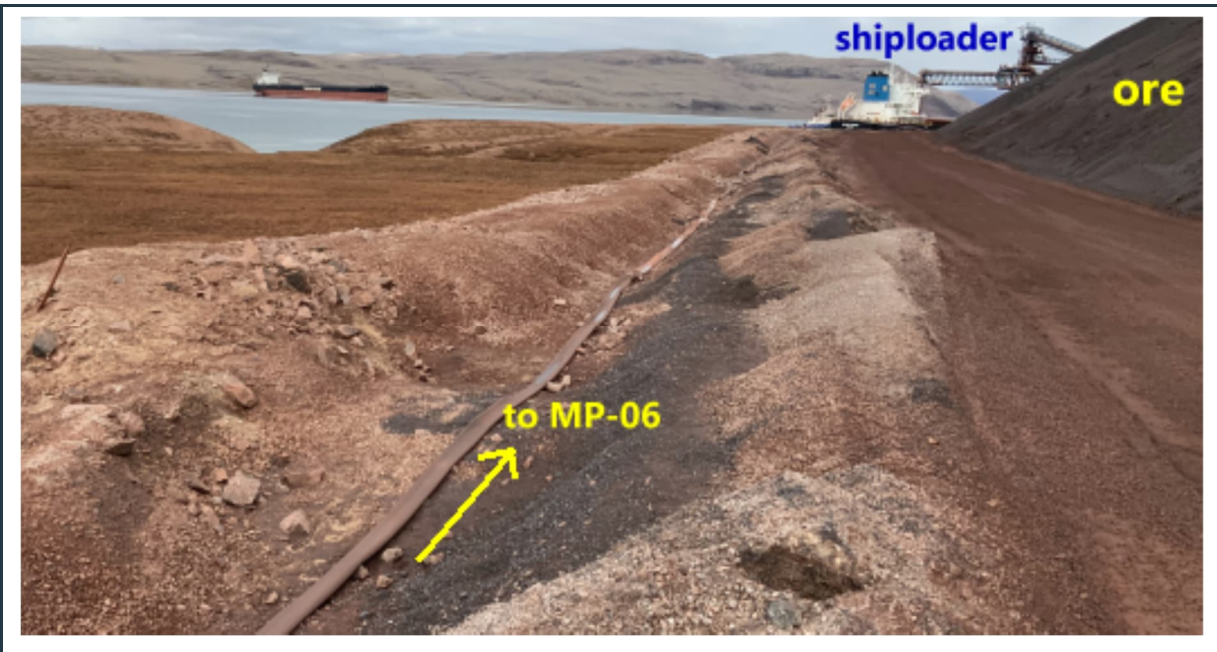
Figure 68: View of the “west” surface water collection ditch adjacent to the ore storage, draining from pond #3 to the MP-06 pond.

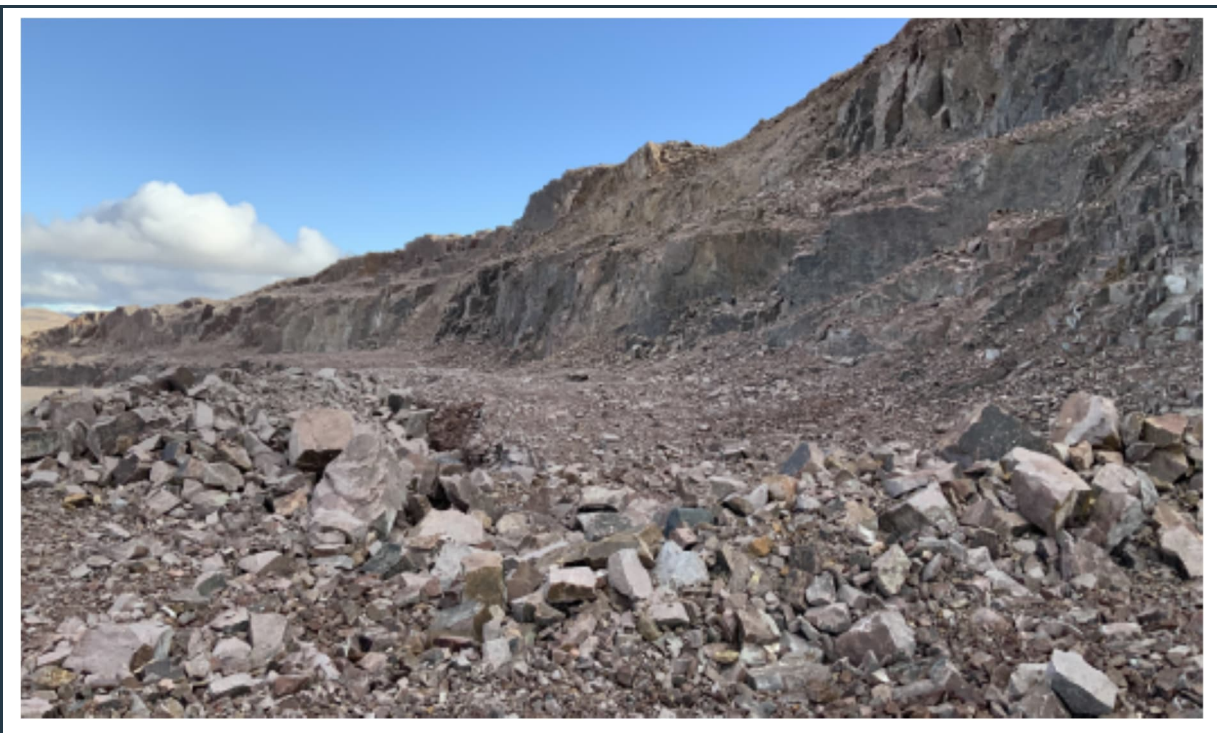
Figure 69: View of the stable rock face with some weathering and bench erosion in the Q01 rock quarry. Currently there is no activity in this quarry.

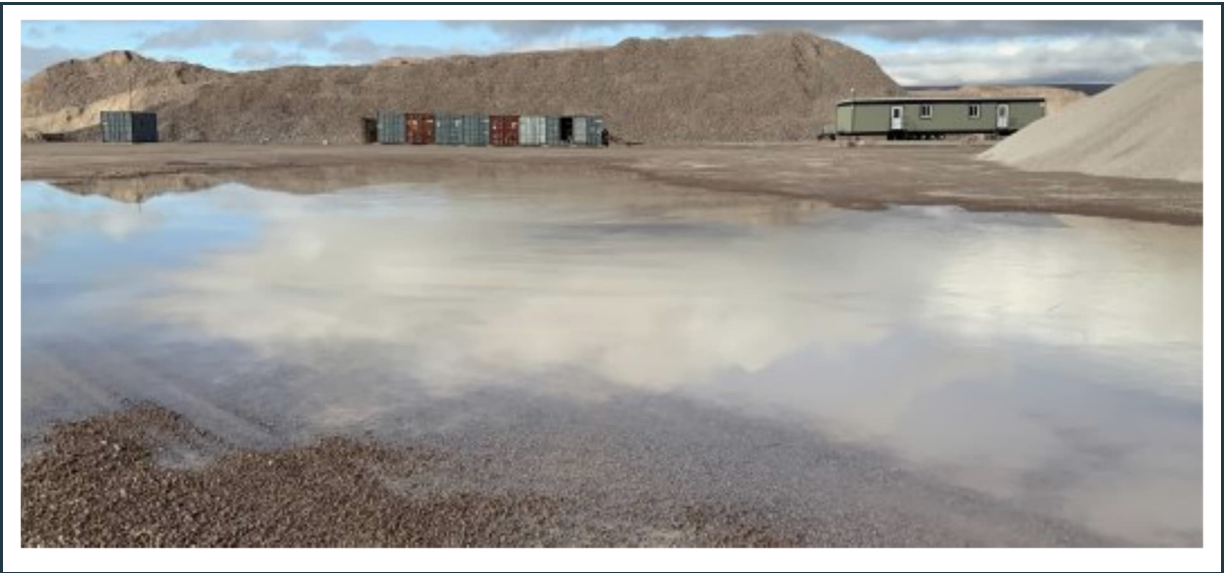
Figure 70: View of ponding water across the lower level of the Q01 rock quarry. The drainage problem should be rectified prior to restarting the operation in the quarry.

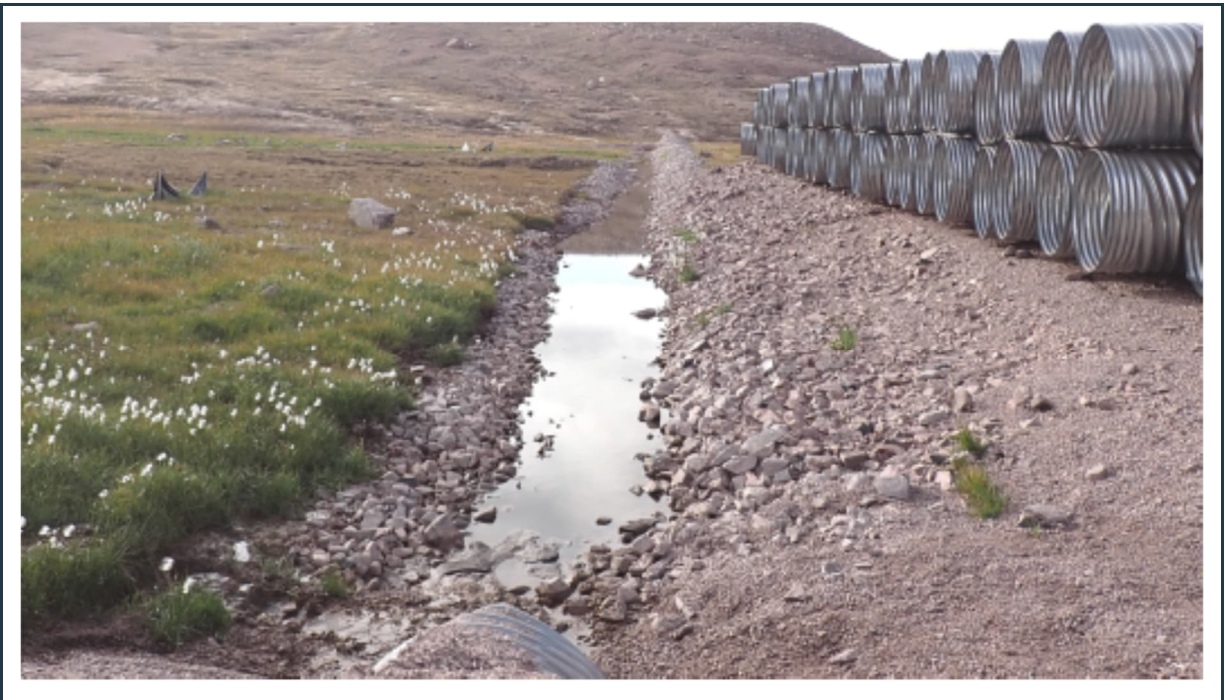
Figure 71: View of the southern section of the P-SWD-3 surface water collection ditch with failed slope sections, and ponding water due to inadequate longitudinal channel slope.

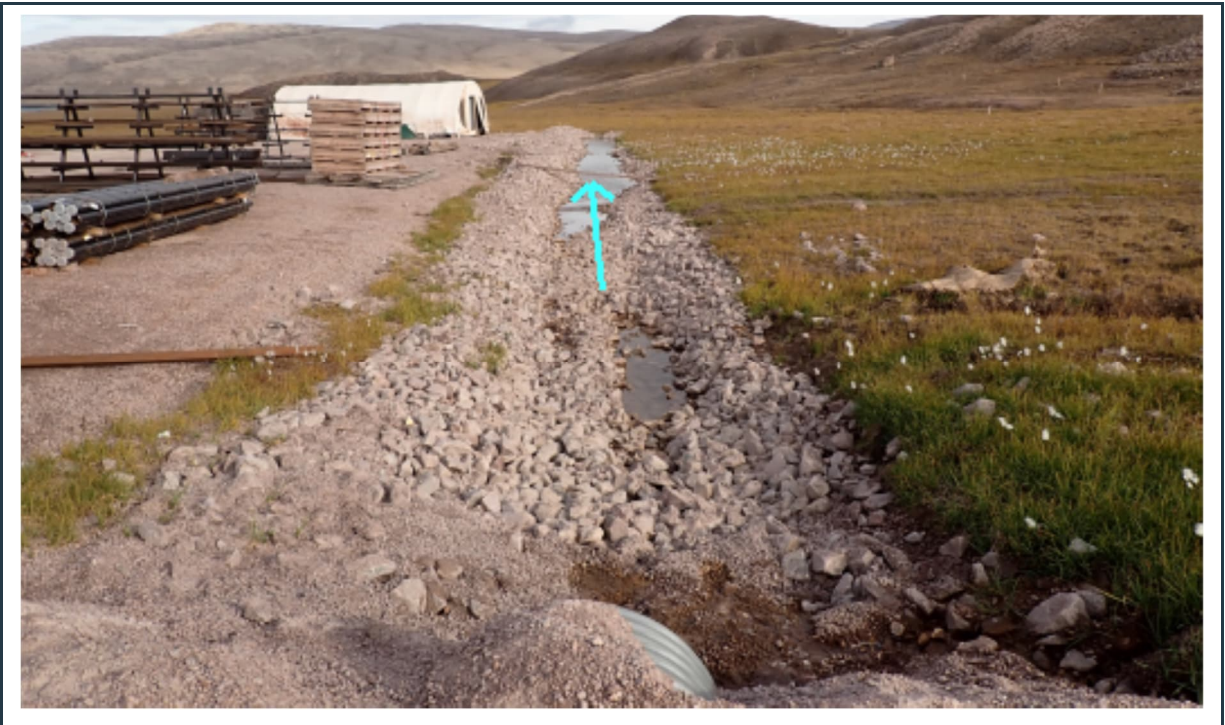
Figure 72: View of the northern section of the P-SWD-3 surface water collection ditch with failed slopes and ponding water. The ditch should be reconstructed with flow direction shown in the image.

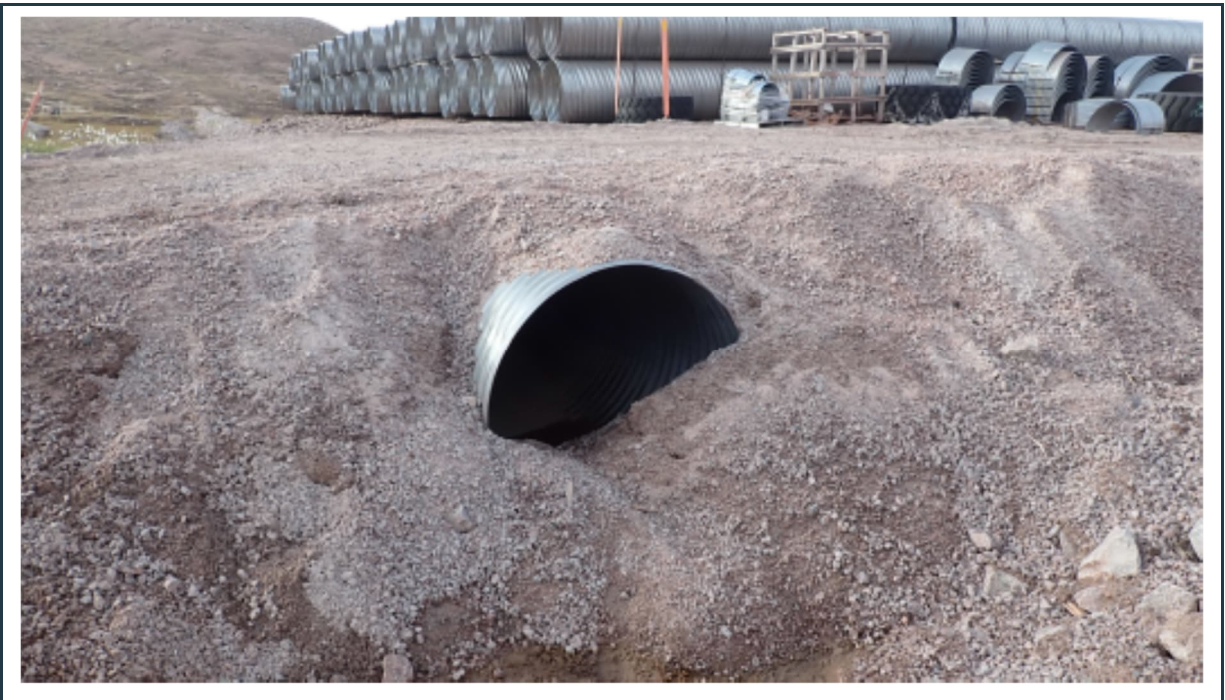
Figure 73: View of the culvert in the P-SWD-3 ditch with its invert above the invert level of the ditch. The culvert should be removed and then reinstalled during the rehabilitation of the ditch.

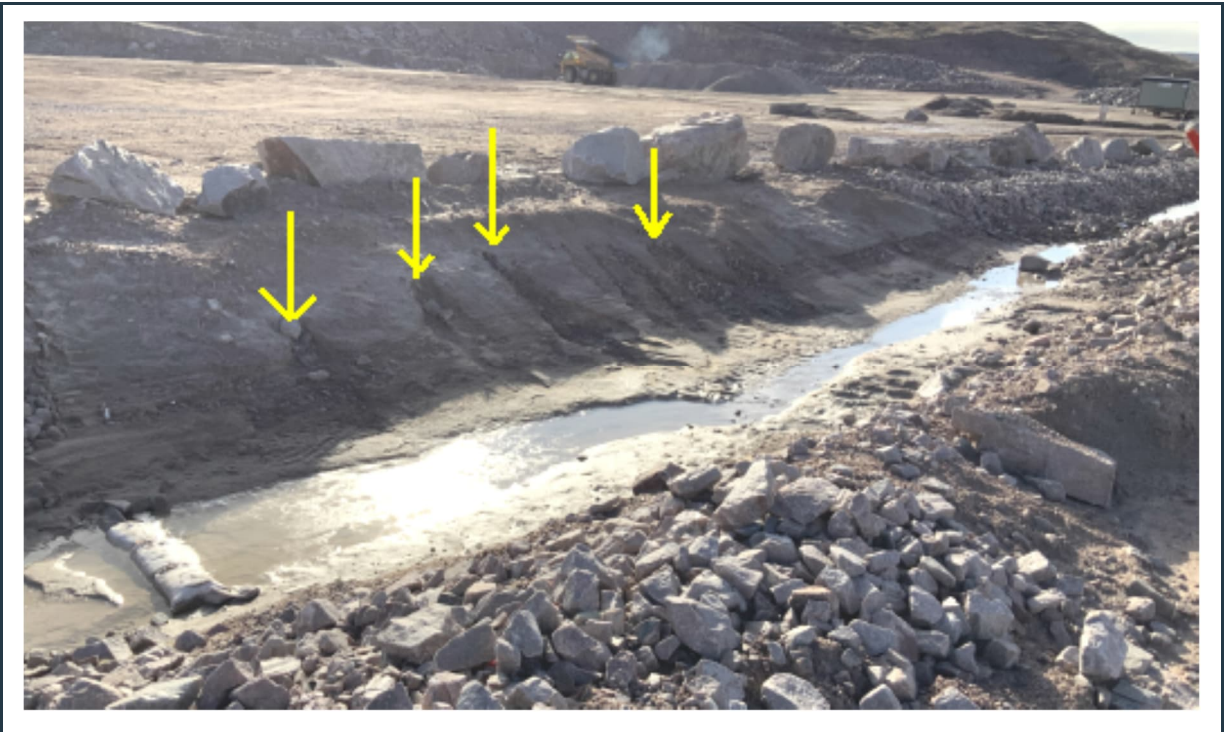
Figure 74: P-SWD-5 – “Q01-North” surface water collection ditch with missing riprap at one section of the ditch. Note the continuous seepage from the granular fill of the quarry’s lower level.

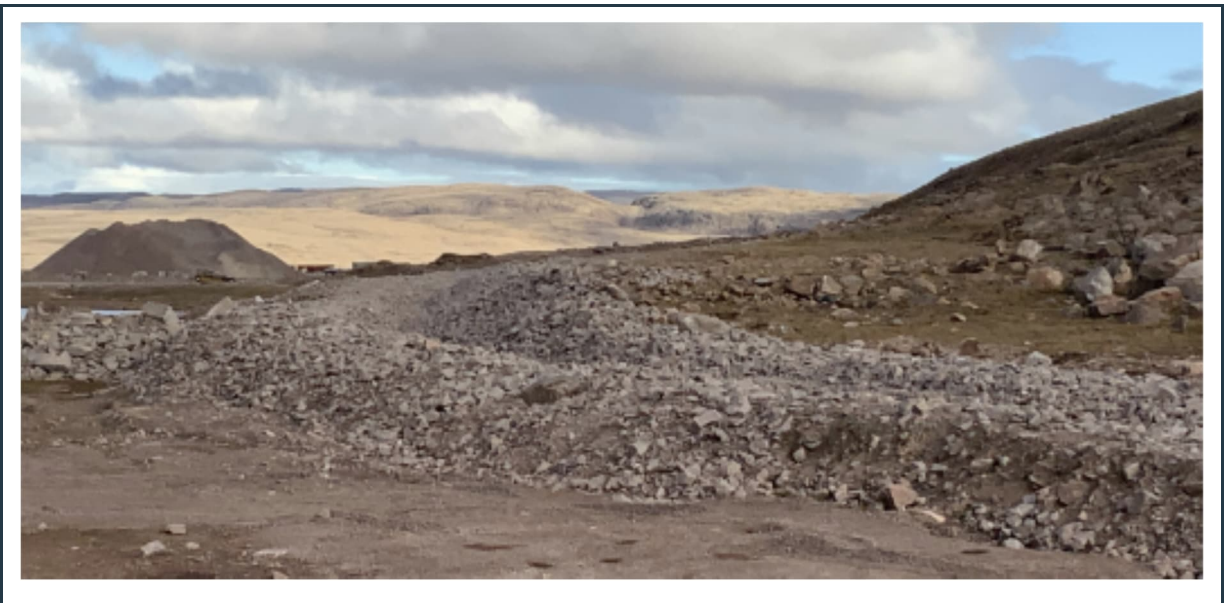
Figure 75: View of the P-SWD-6 surface water collection ditch. No water is drained from the quarry in this ditch with its invert level constructed above the lower level of the quarry.

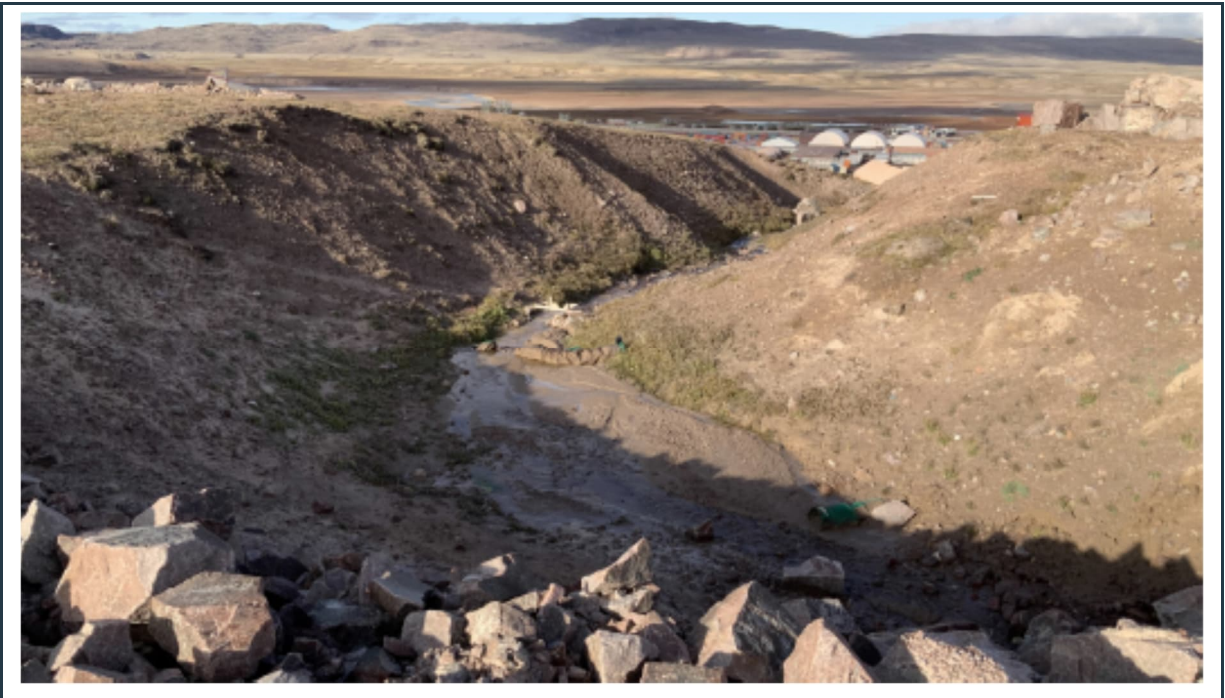
Figure 76: View of a side-valley near the south-west corner of the quarry (see also the red rectangle in Figure 10 of the report). This valley should be “upgraded” to drain the collected surface water from the quarry to the side ditch of the tote road and then to the W3/W14 ditch.

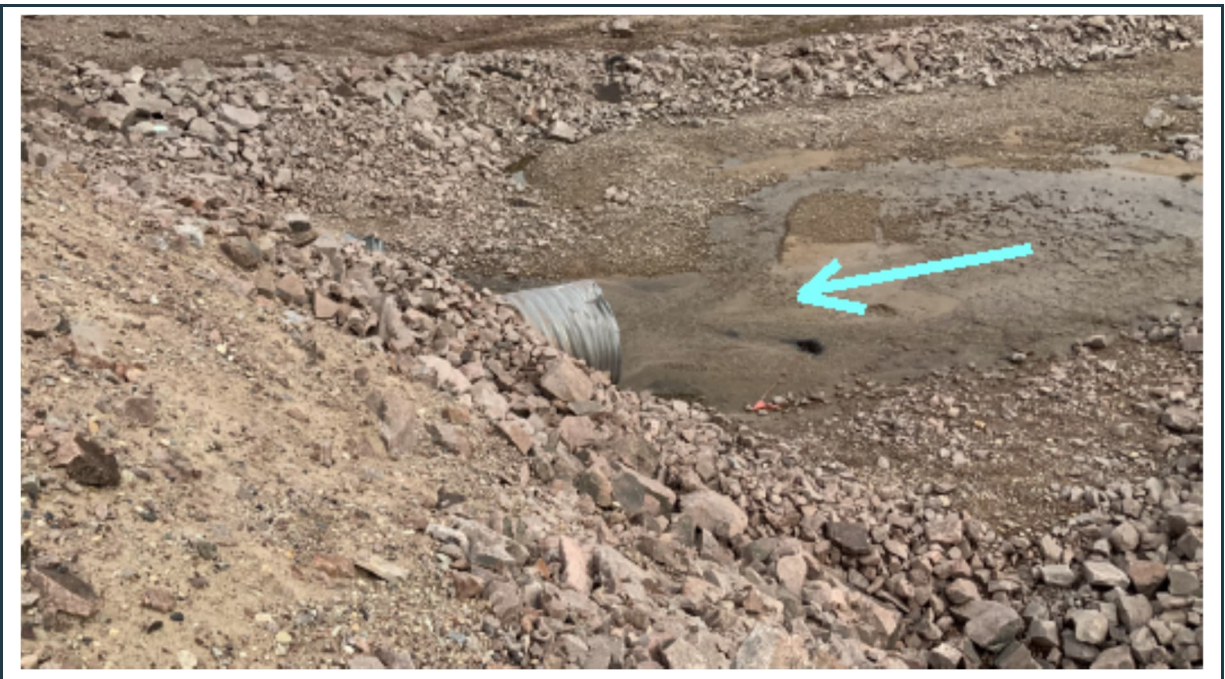
Figure 77: View of the P-SWD-7 surface water collection ditch and culverts (inlet).
