# Baffinland Iron Mines Corporation

October 31, 2023  
Project #: OMGM2212-23

## Annual Geotechnical Inspections – 2023 Report 2.

### APPENDIX "B" – Milne Inlet Port Site - Photographs

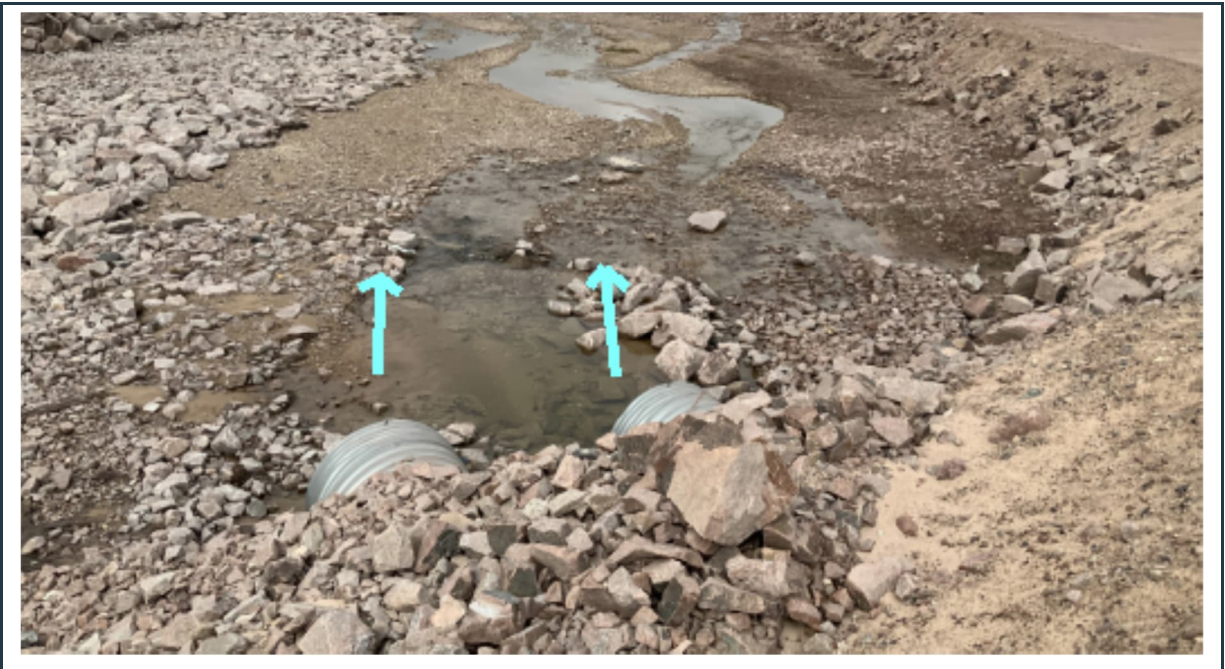
Figure 78: View of the well-maintained P-SWD-7 surface water collection ditch and culverts (outlet).

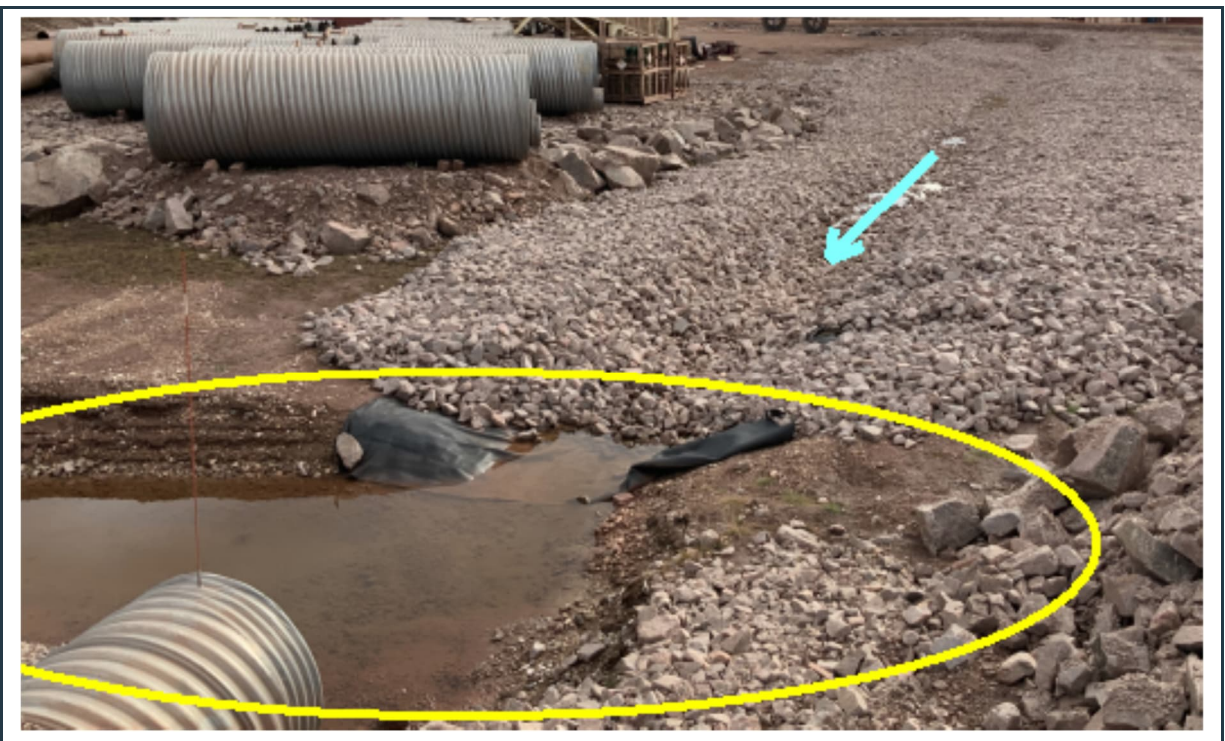
Figure 79: View of the W3/W14 surface water collection ditch with crushed rock riprap slope protection. The area around the culvert's inlet still requires the placement of geotextile and riprap.

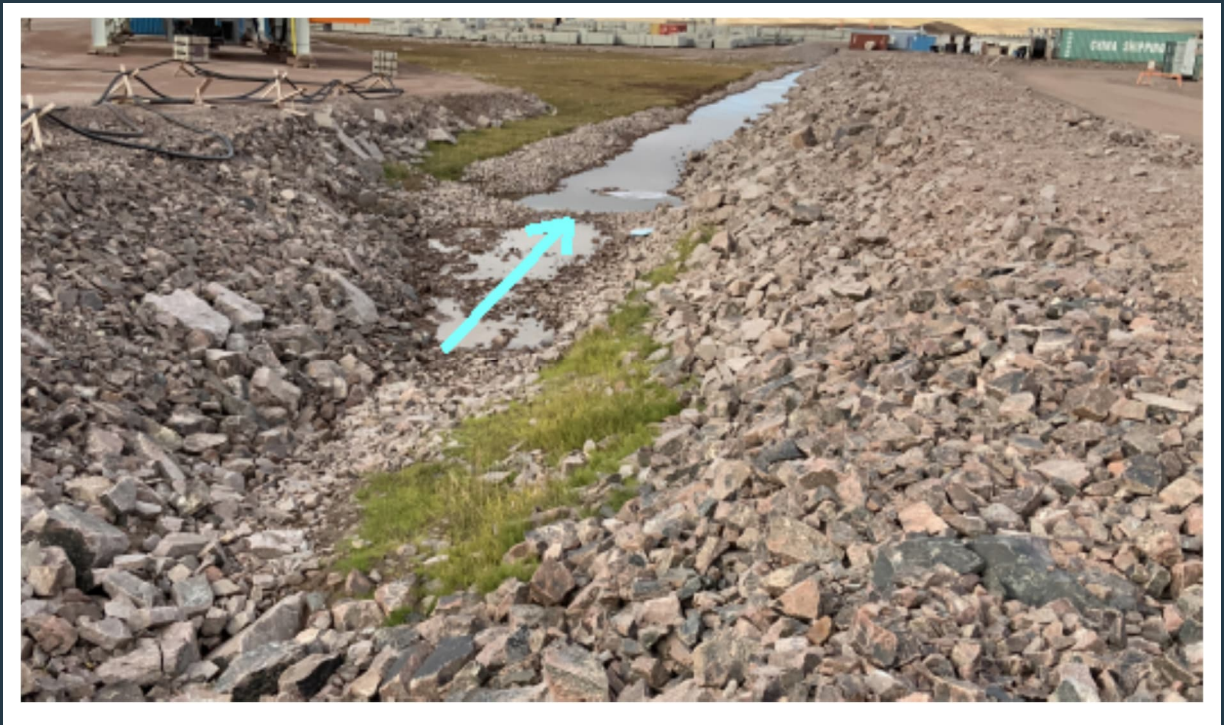
Figure 80: View of the south section of the 380-Person Camp surface water collection ditch.

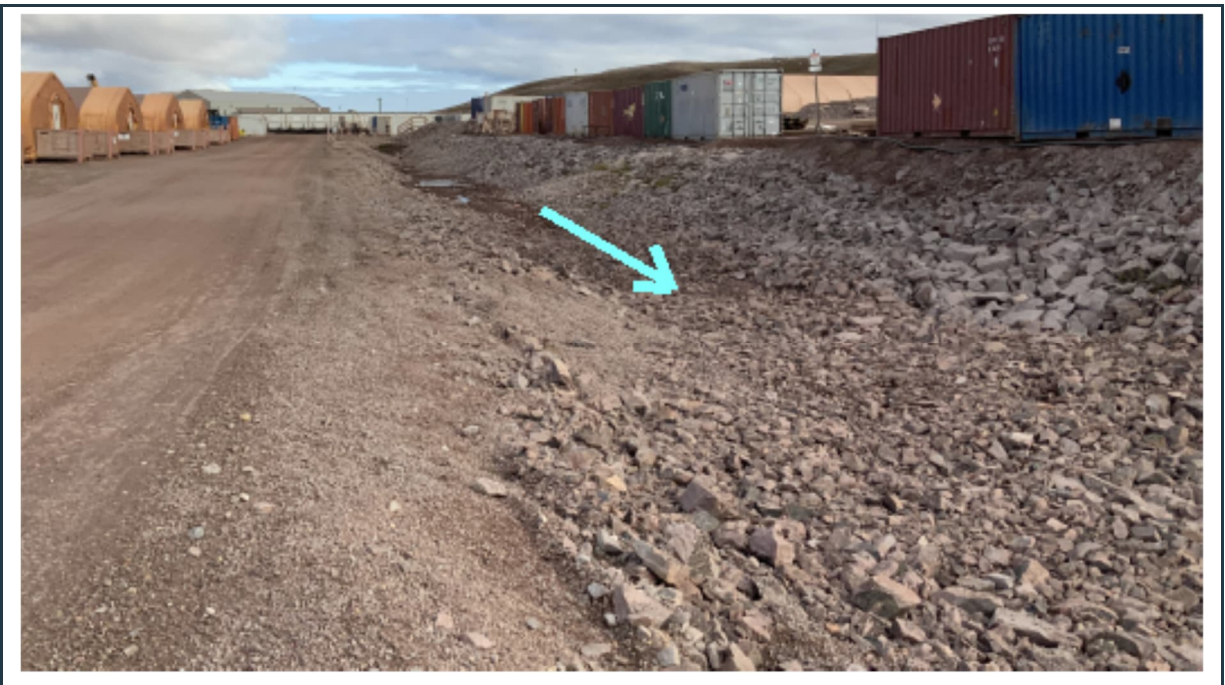
Figure 81: View of the east section of the 380-Person Camp surface water collection ditch. The clogged culvert in the ditch has been cleaned.

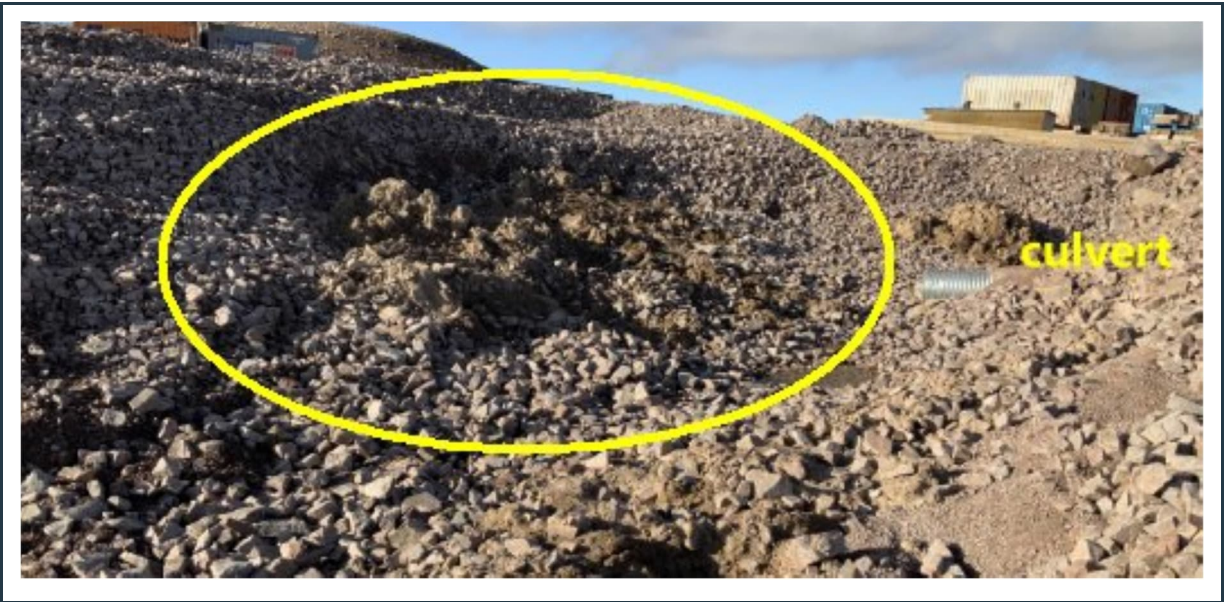
Figure 82: View of the “west end” of the PSC surface water collection ditch (red circle in Figure 7). Note the localized slope degradation due to frequent water seepage from the granular fill of the LP-2 laydown pad (yellow circle here). The culvert shown in the image can be removed.

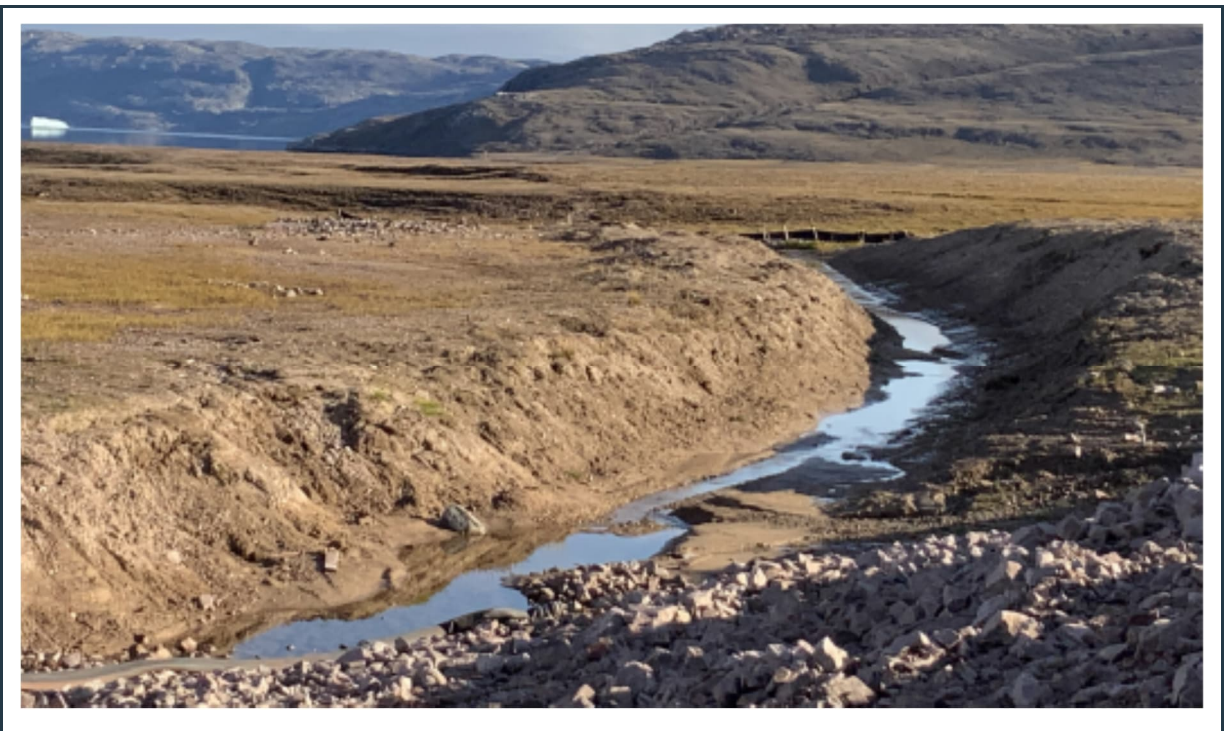
Figure 83: View of the unfinished “east end” of the PSC surface water collection ditch (also shown by the green circle in Figure 7). Riprap and a check dam should be installed at this section if the ditch.

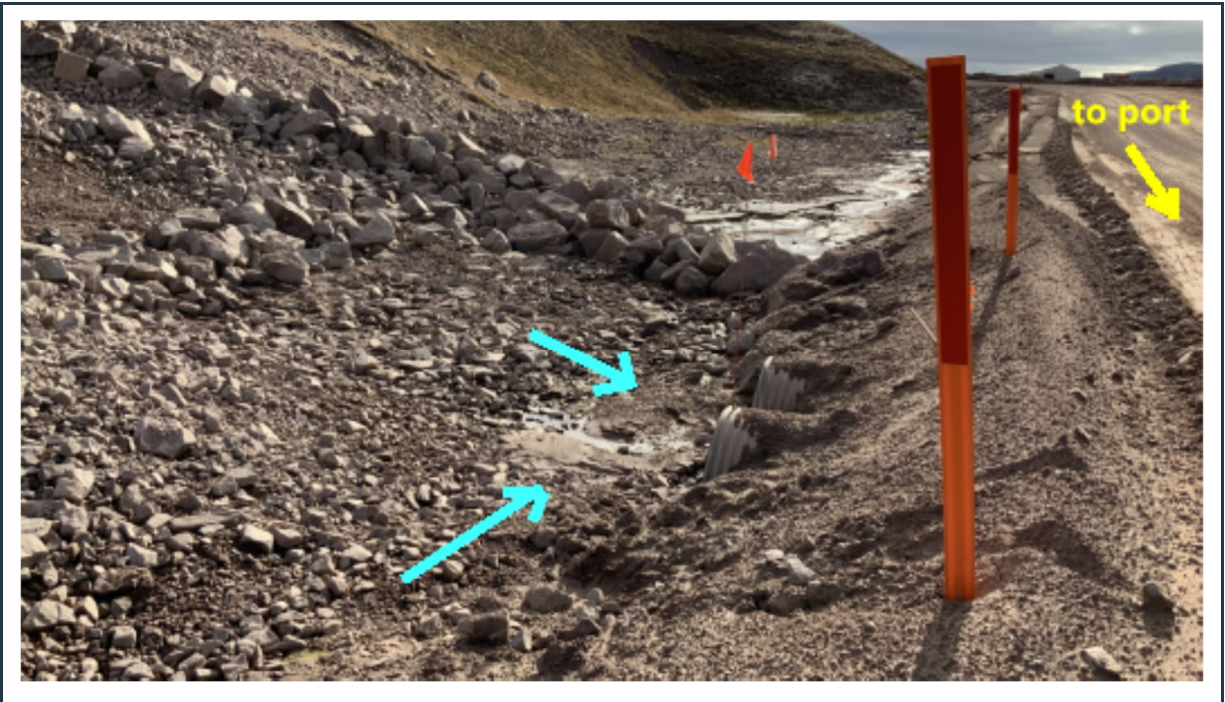
Figure 84: View the inlet of twin culverts draining surface water from the P-SWD-6 ditch under the road.

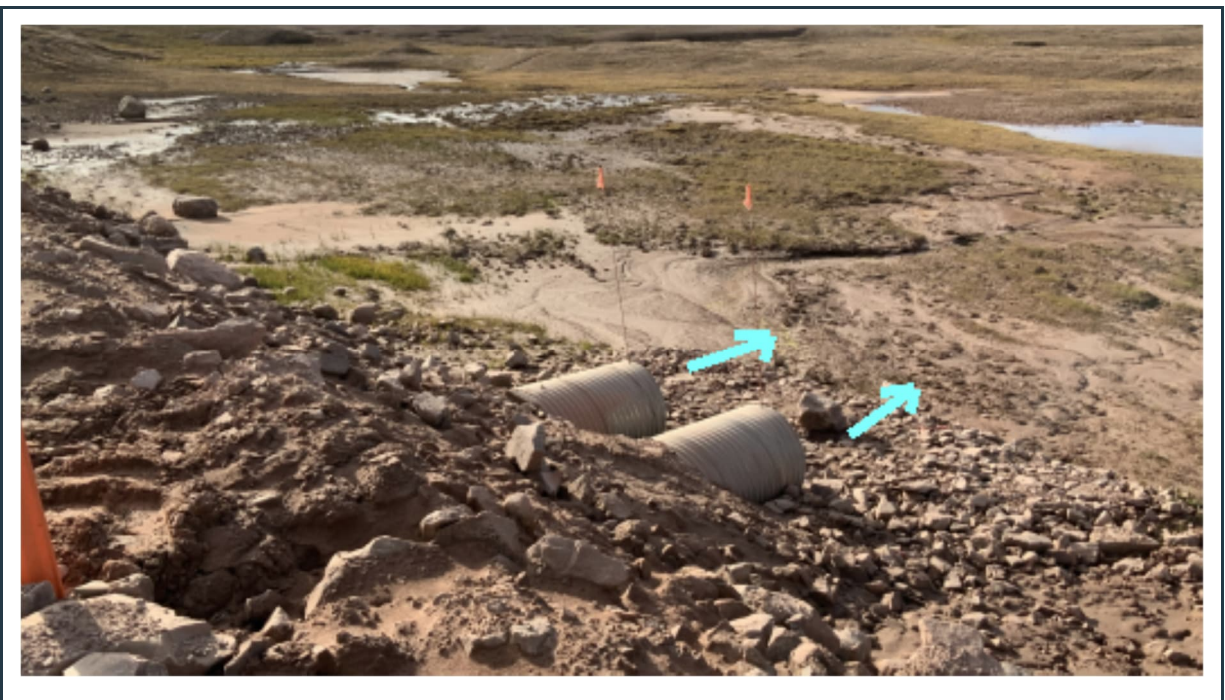
Figure 85: View of twin culverts, draining surface water from the P-SWD-6 ditch under the road (outlet).

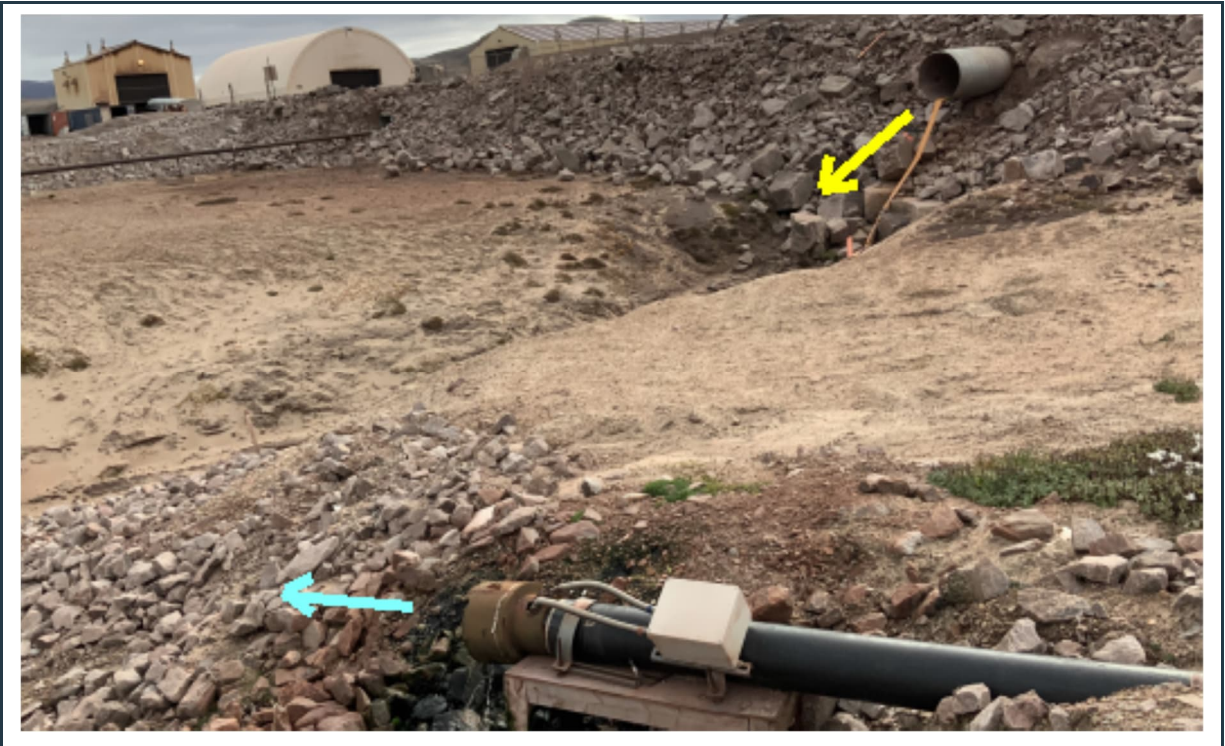
Figure 86: View of the end of the water discharge pipe (blue arrow) and a nearby culvert (yellow arrow) draining water to the same valley (see the next image below).

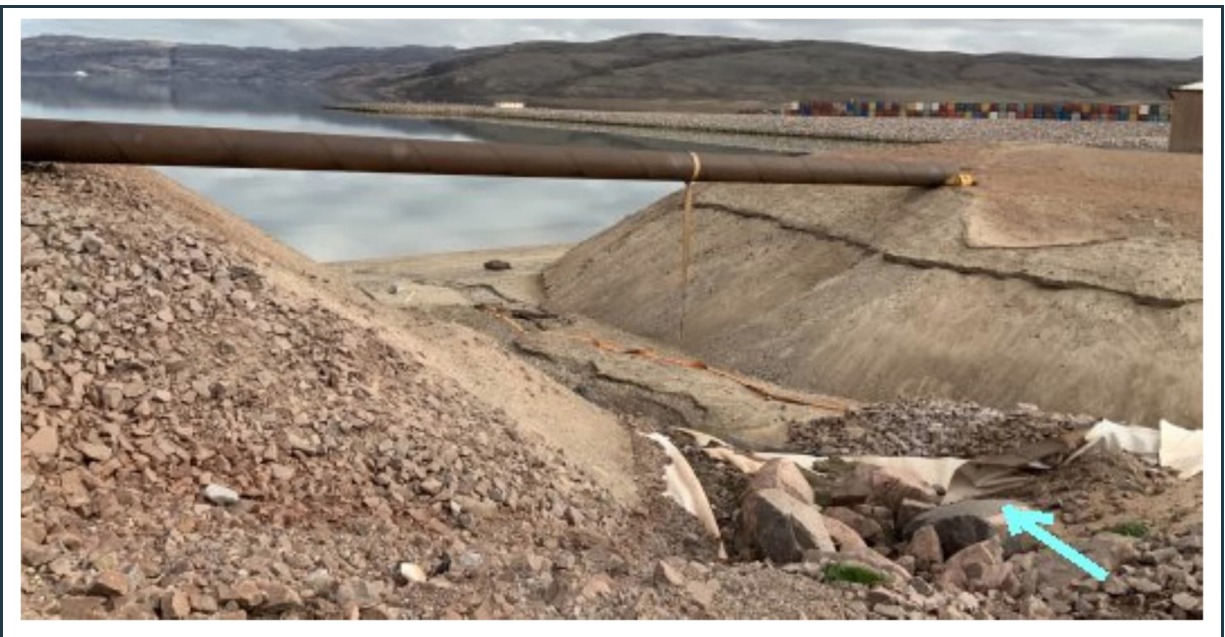
Figure 87: View of the "valley" at the front of the water discharge area (blue arrow) and deteriorating (eroding) slopes. This section of the valley should be filled with rock fill, placed over geotextile.

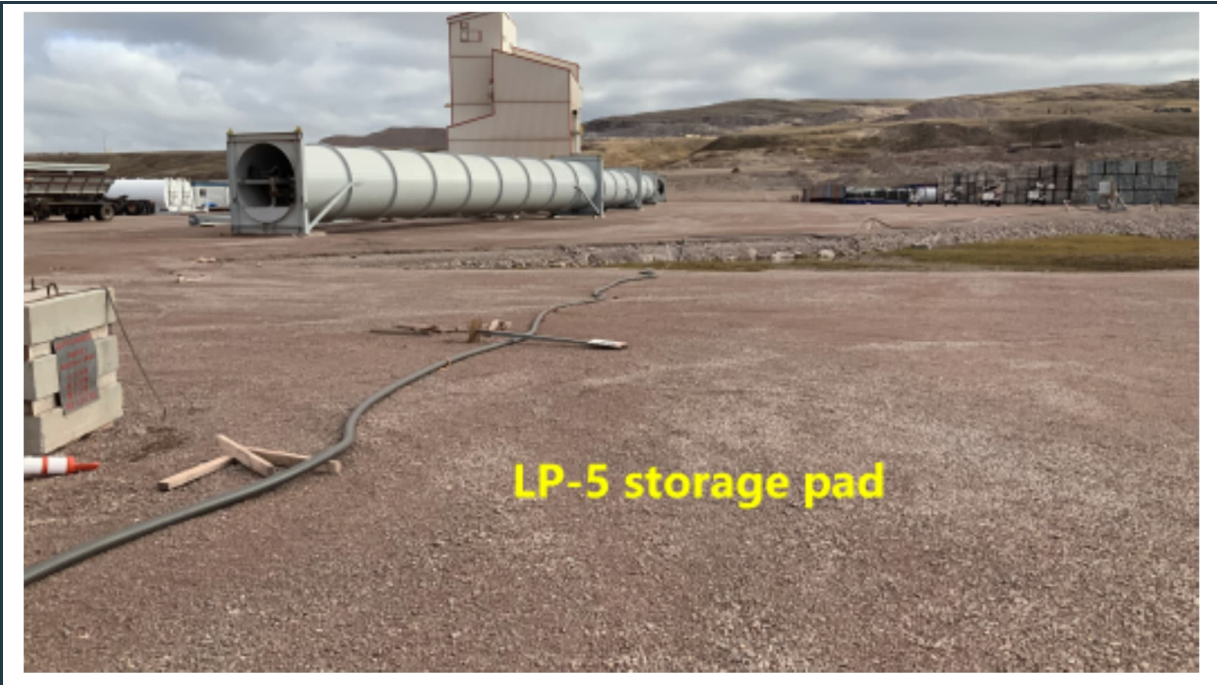
Figure 88: View of the recently regraded LP-5 storage area.

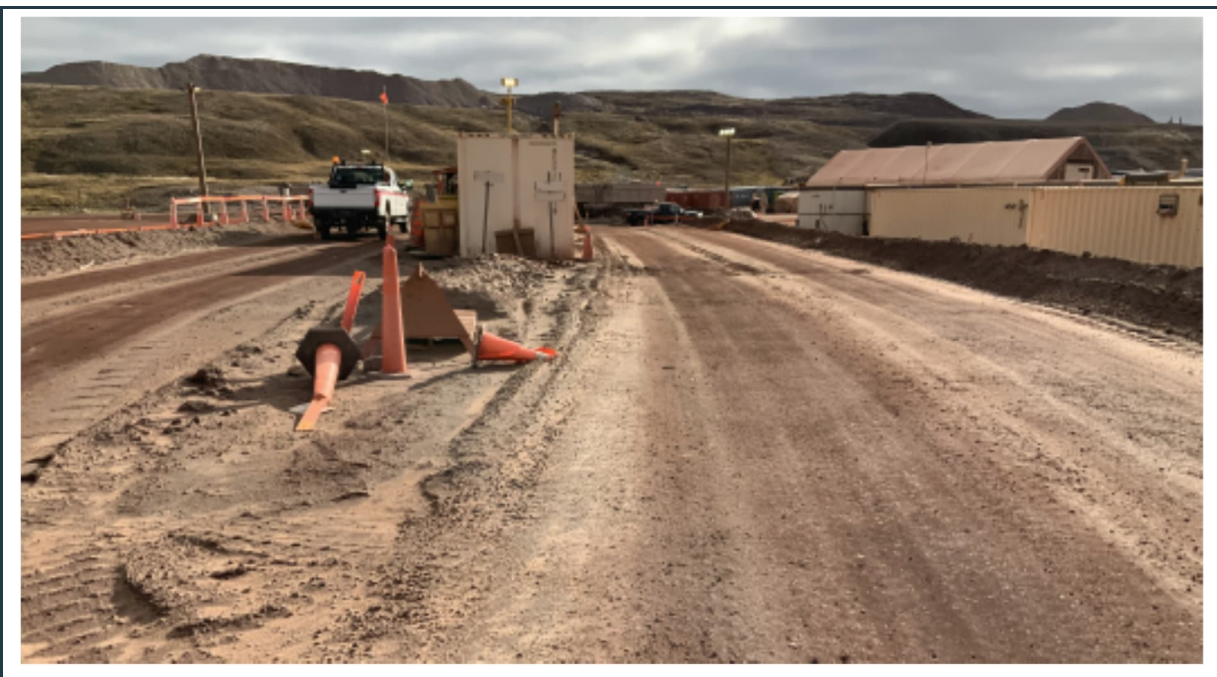
Figure 89: View of the Western Globe Fuel Module (WGFM) north of the 380 Camp. No humps are visible at the entrance and exit points of the refueling station.

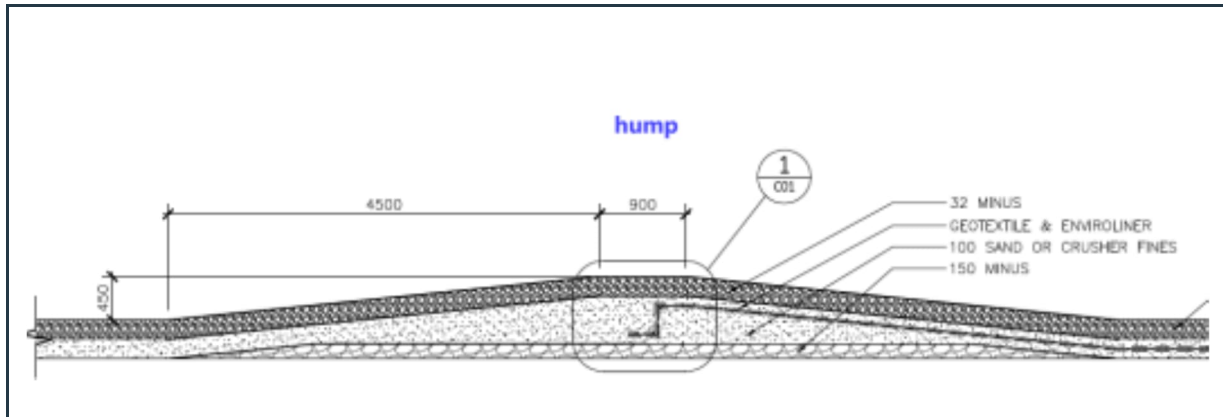
Figure 90: Section of 900 mm wide (at its crest) drainage control hump with 10H:1V slopes for the Western Globe Fuel Module (WGFM), specified by B.H. Martin Consulting Engineer and Architect, in June 2016. The humps should prevent oily surface water escaping the refueling area toward the entrance and exit zone of the WGFM.

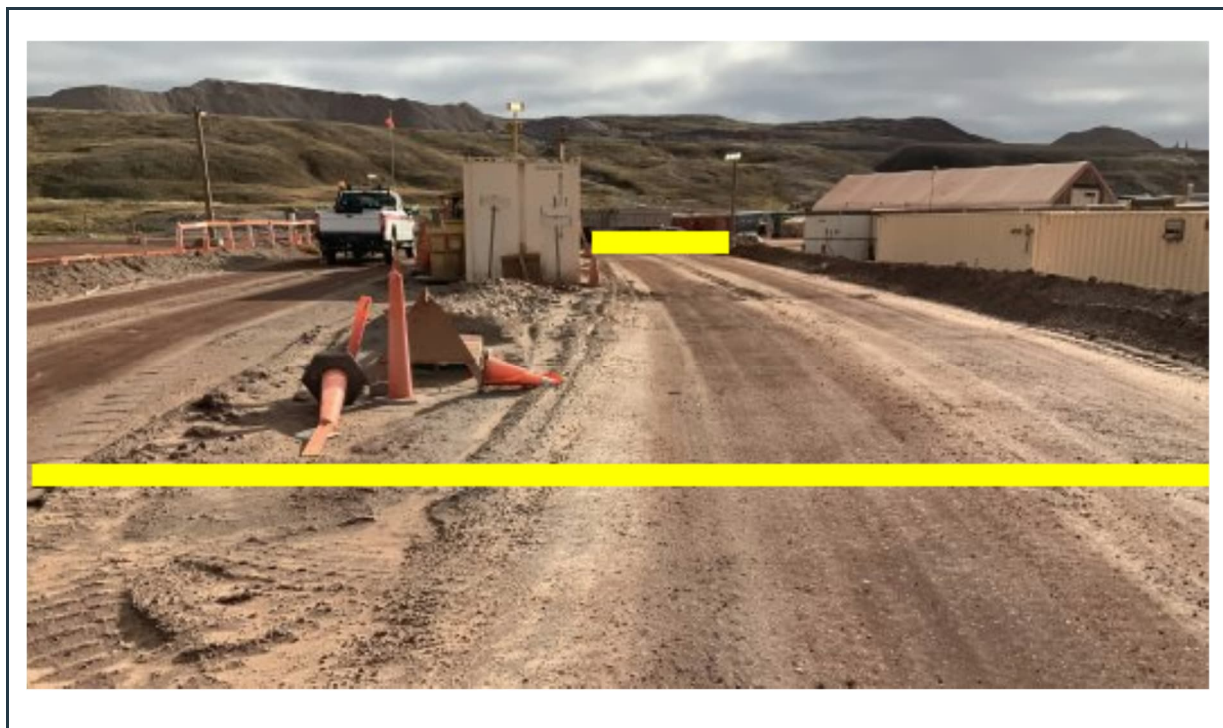
Figure 91: The yellow lines indicate where the drainage control humps should be provided.
