Baffinland Iron Mines Corporation

October 31, 2023
Project #: OMGM2212-23

Annual Geotechnical Inspections – 2023 Report 2.

APPENDIX "C" – Tote/Haul Road - Photographs

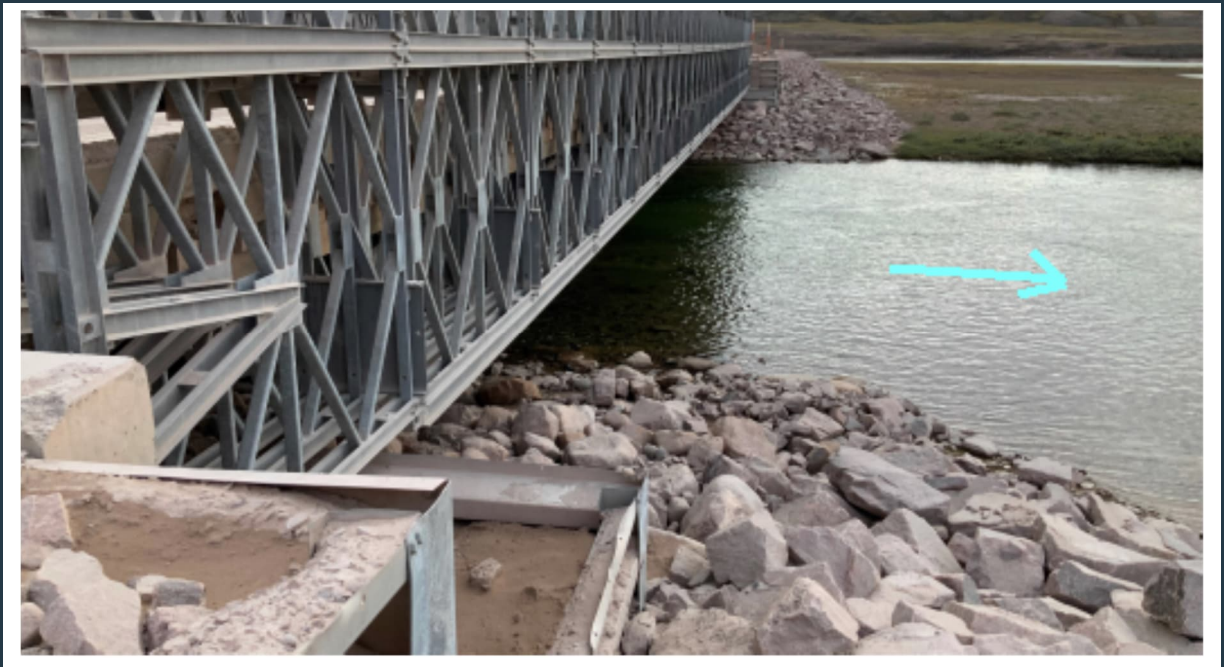
Figure 92: View of the stable abutments with riprap erosion protection at the north side of bridge KM17.

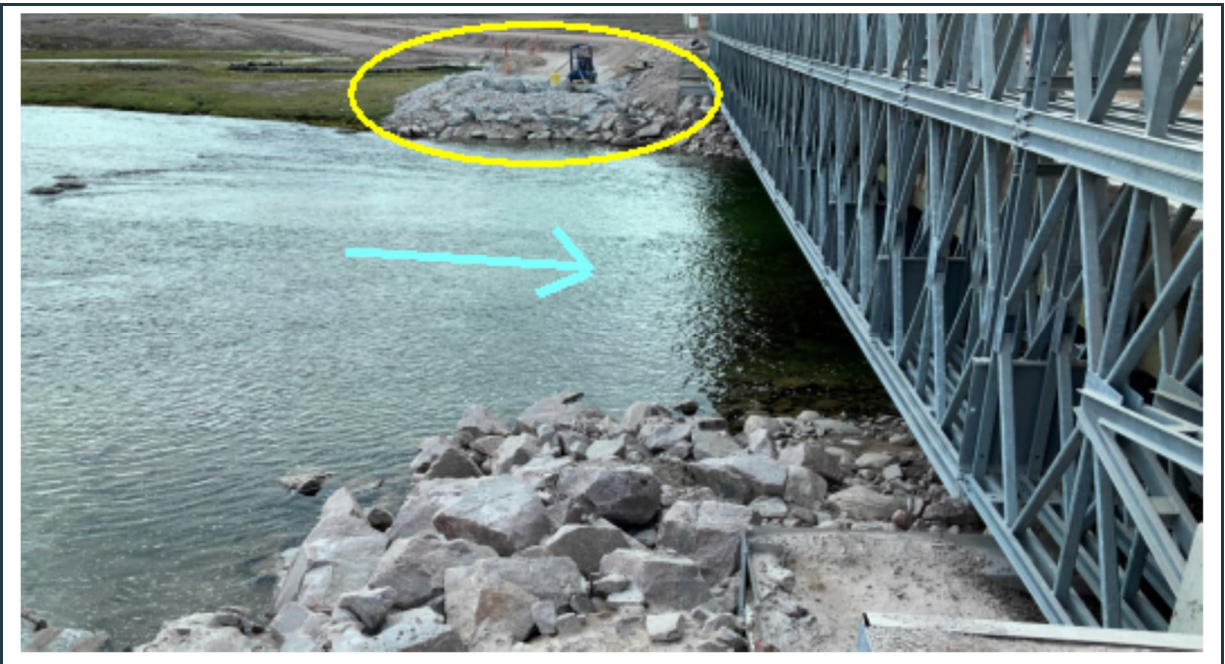
Figure 93: View of the stable abutments with riprap scour protection at the south side of bridge KM-17.

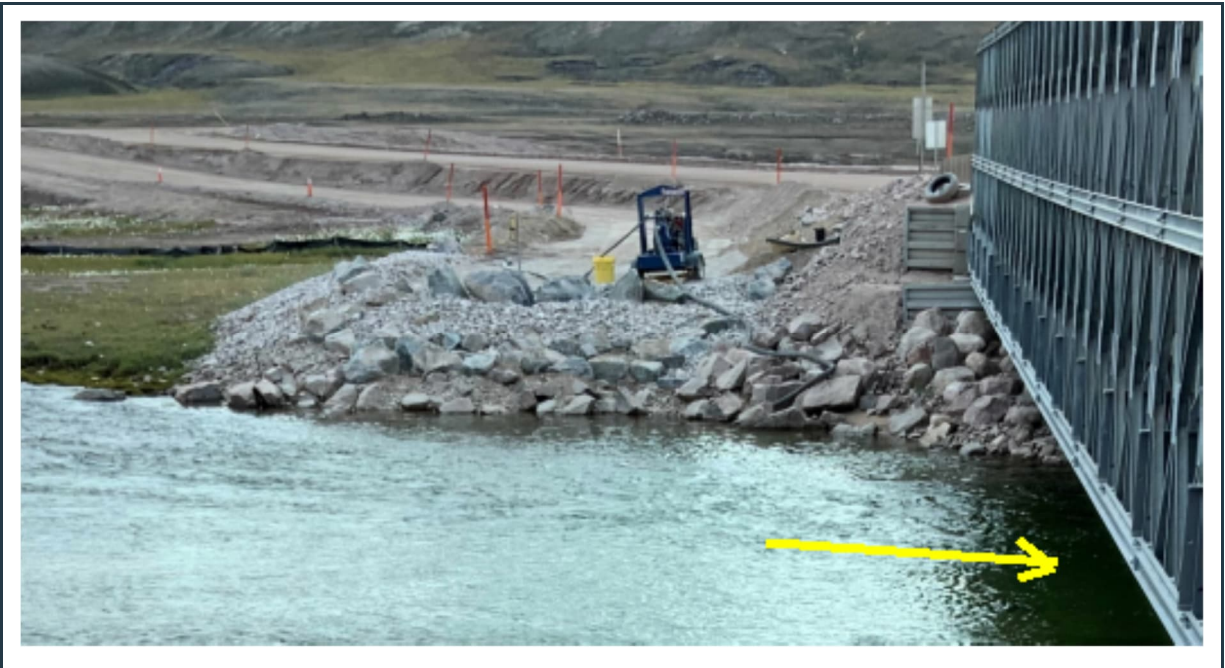
Figure 94: View of the west abutment, where the old metal crib has been removed and replaced with new riprap erosion protection at the south side of bridge KM17 (yellow circle in Figure 93).

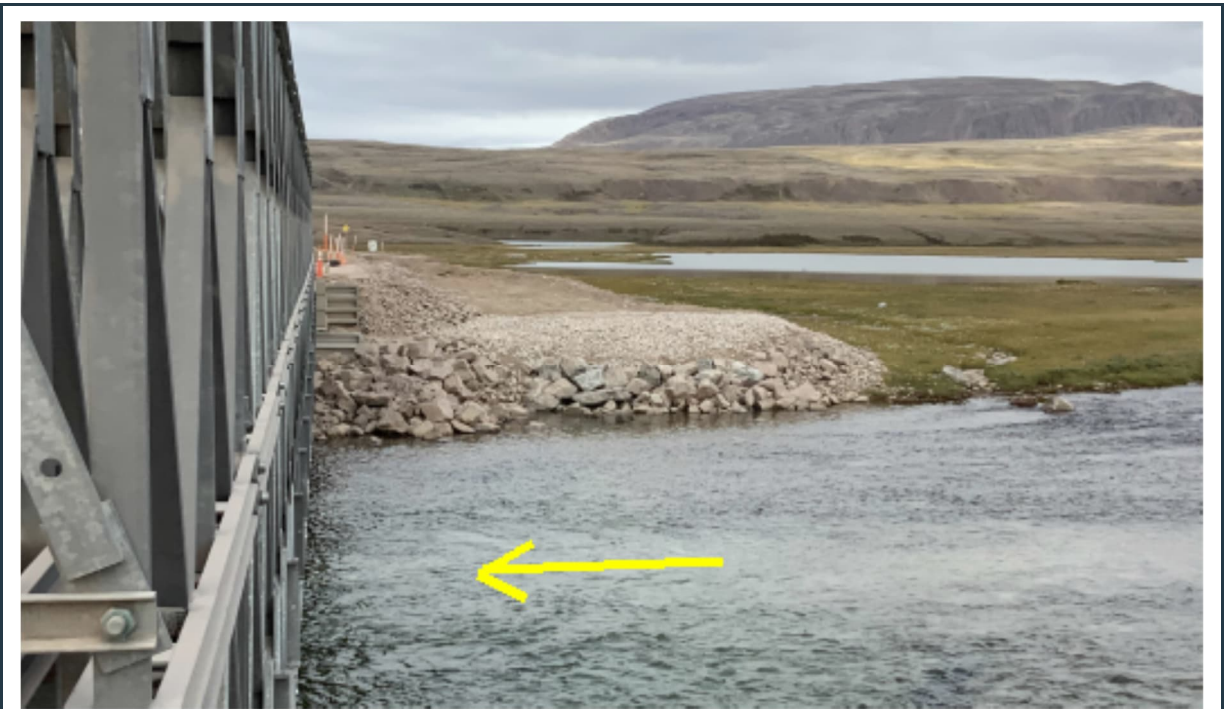
Figure 95: View of the east abutment, where the old metal crib has been removed and replaced with new riprap erosion protection at the south side of bridge KM17.

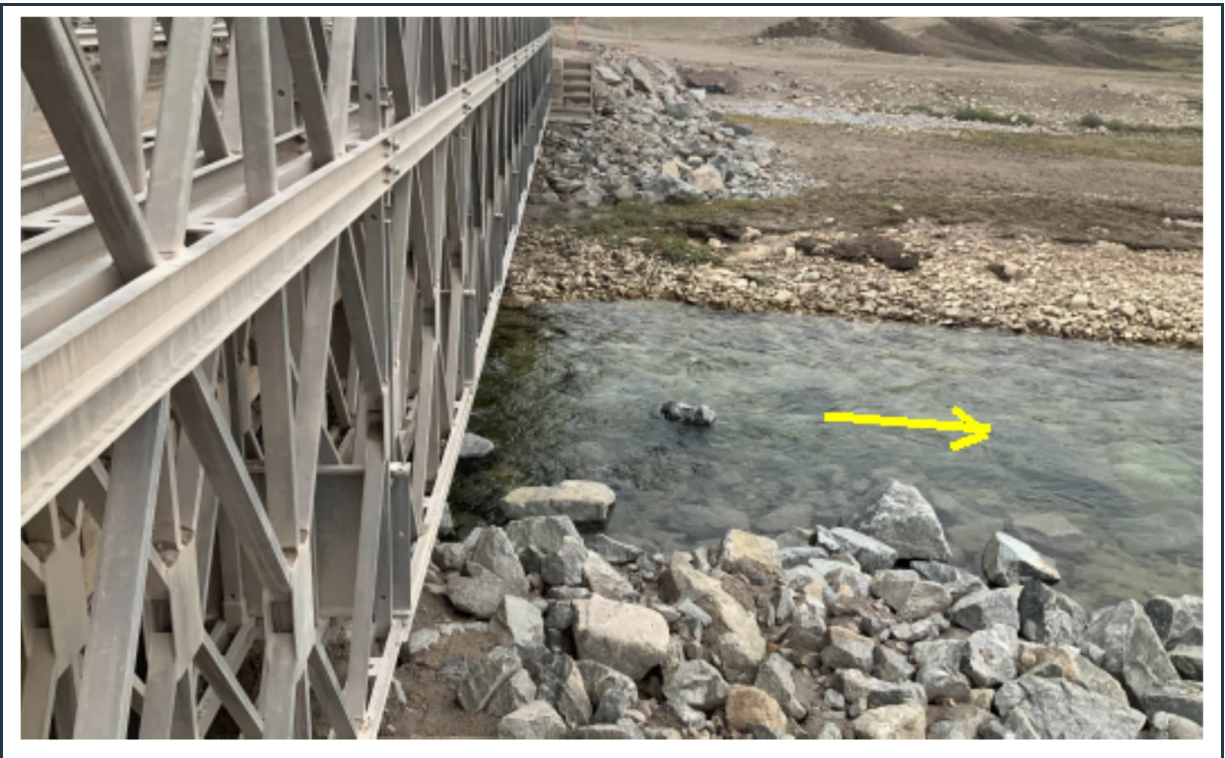
Figure 96: View of the west side of bridge 63, with stable abutments and riprap scour protection.

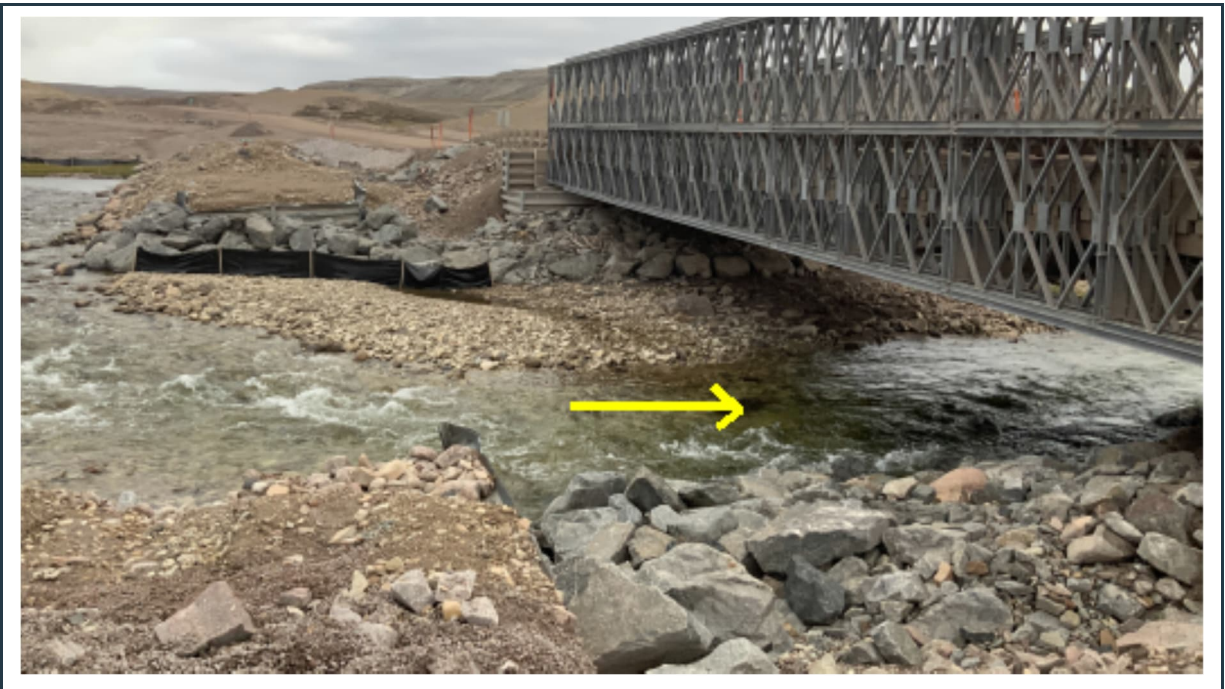
Figure 97: View of the stable abutments at the east side of bridge 63. Also note one (south) of the two “old” crib abutments with riprap protection and a silt-curtain.

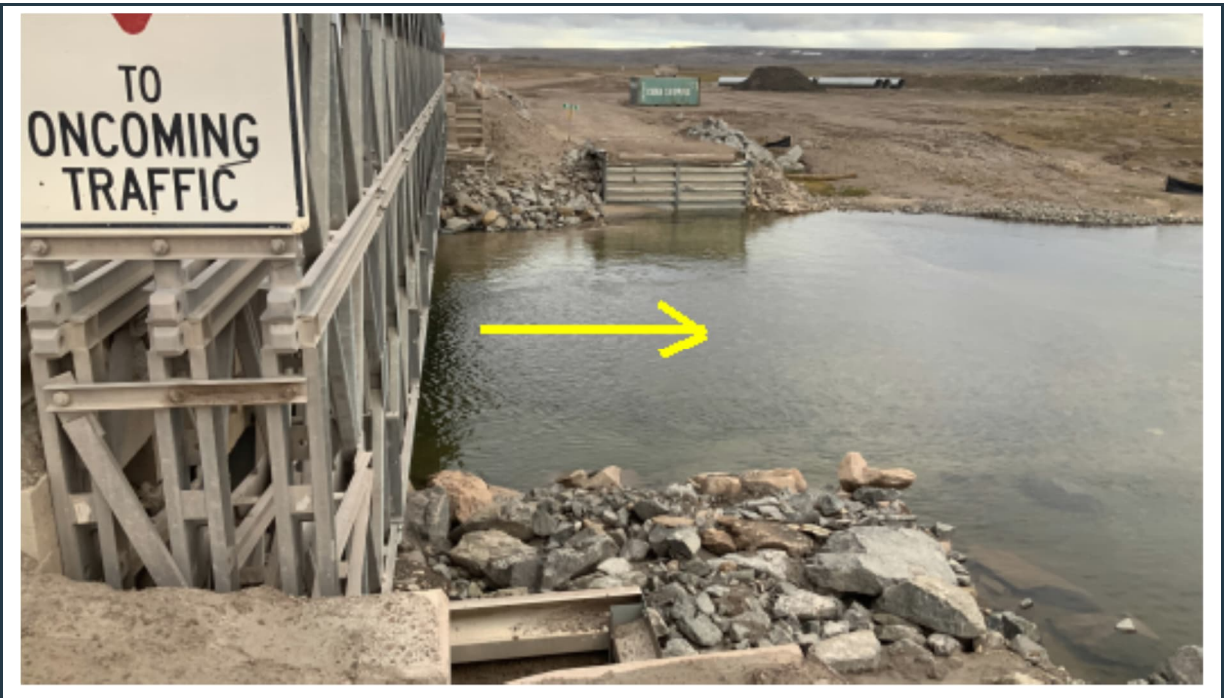
Figure 98: View of the west side of bridge 80, with riprap scour protection around the abutments.

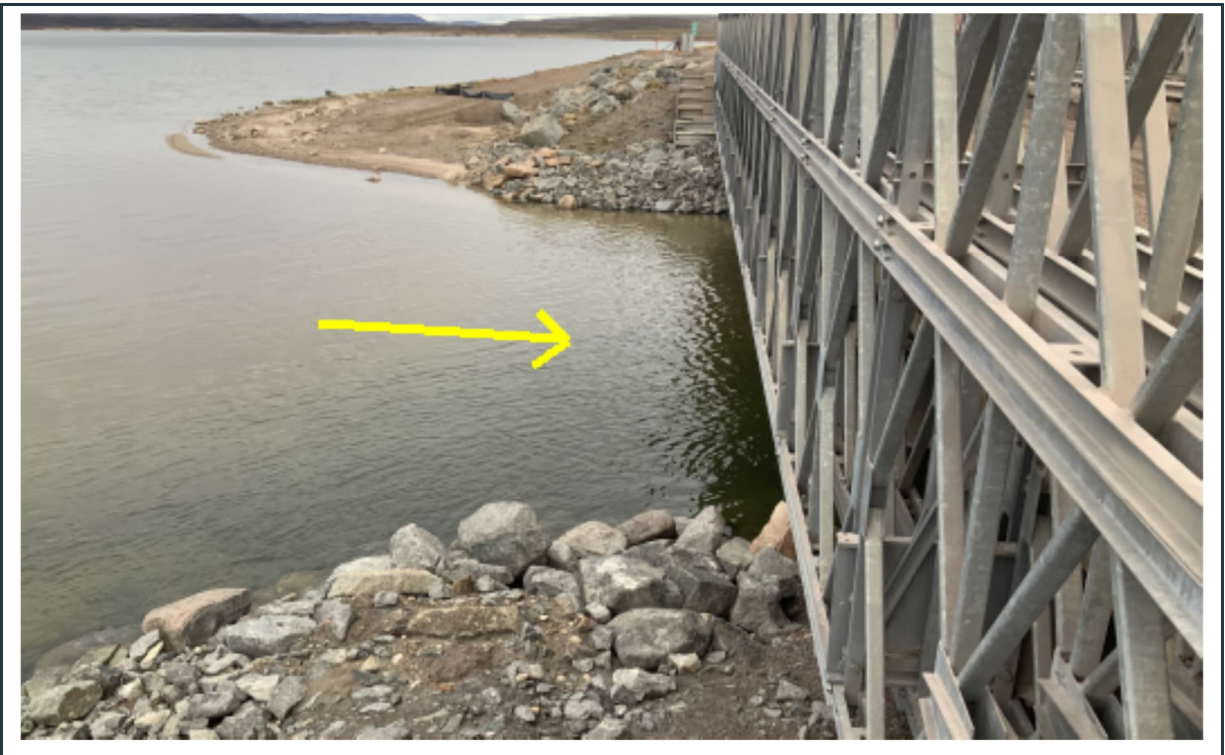
Figure 99: View of the abutments with riprap scour protection at the east side of bridge 80.

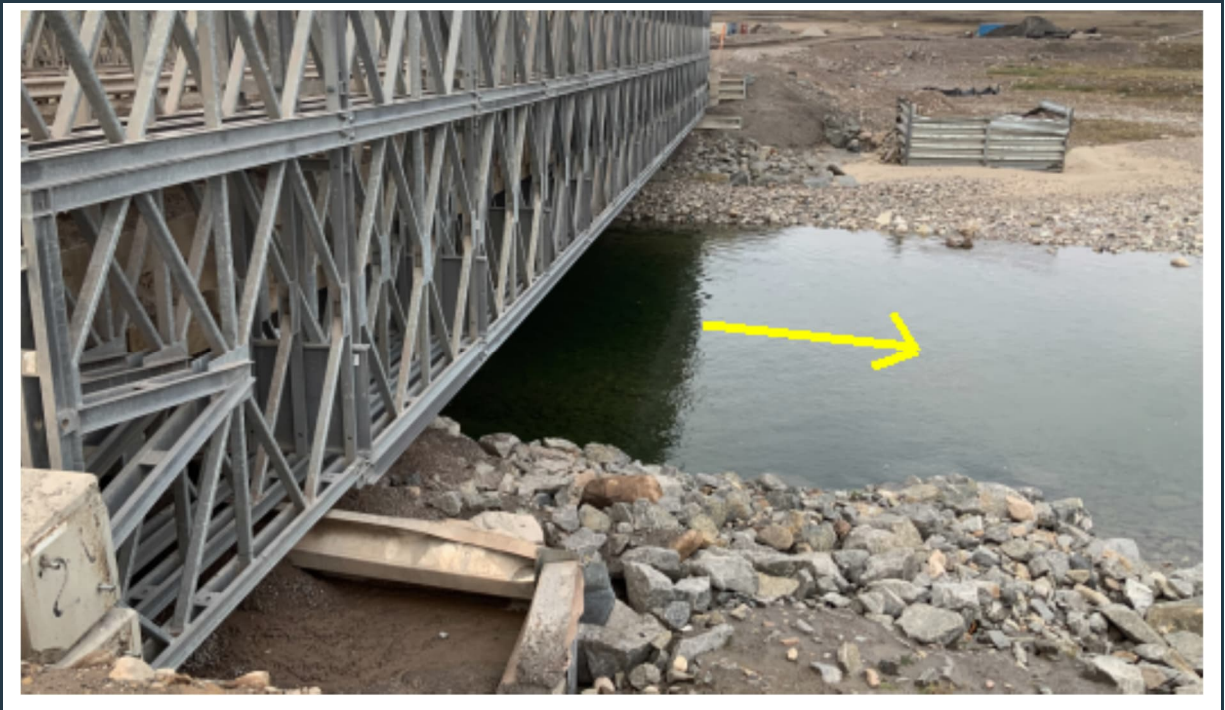
Figure 100: View of the stable abutments with riprap scour protection at the west side of bridge KM 97.

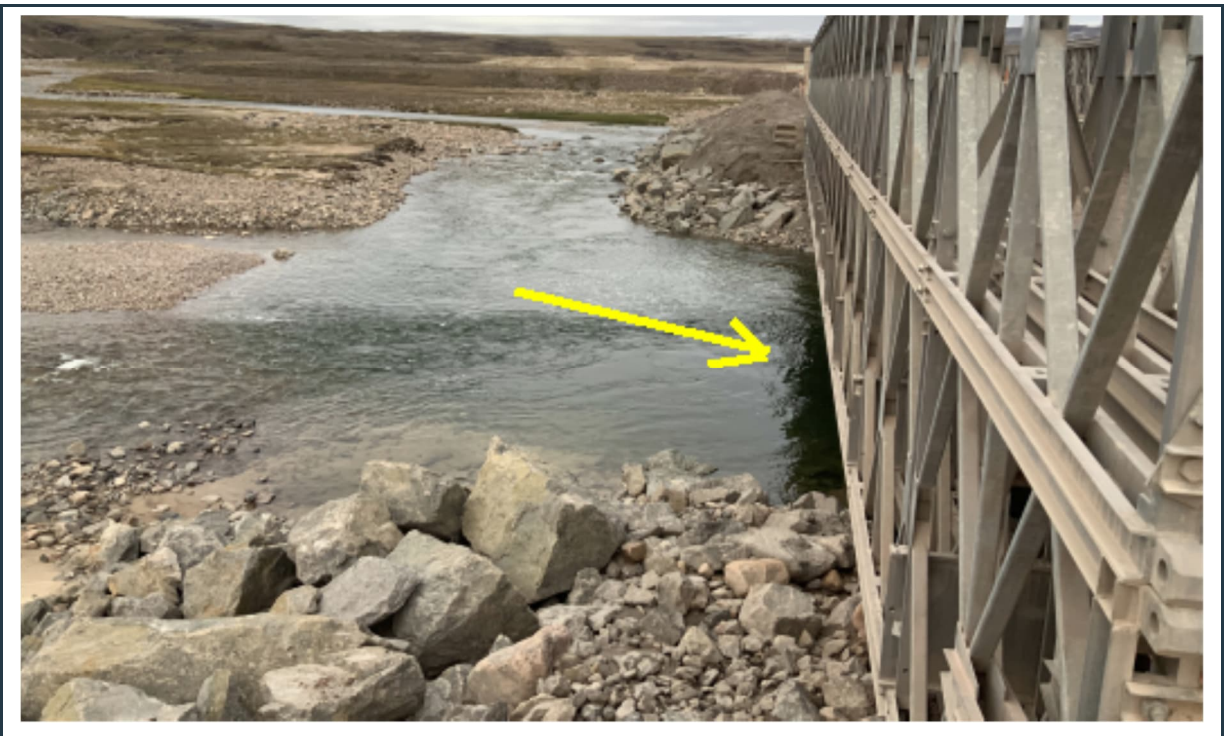
Figure 101: View of the two stable abutments with riprap scour protection at the east side of bridge KM97.

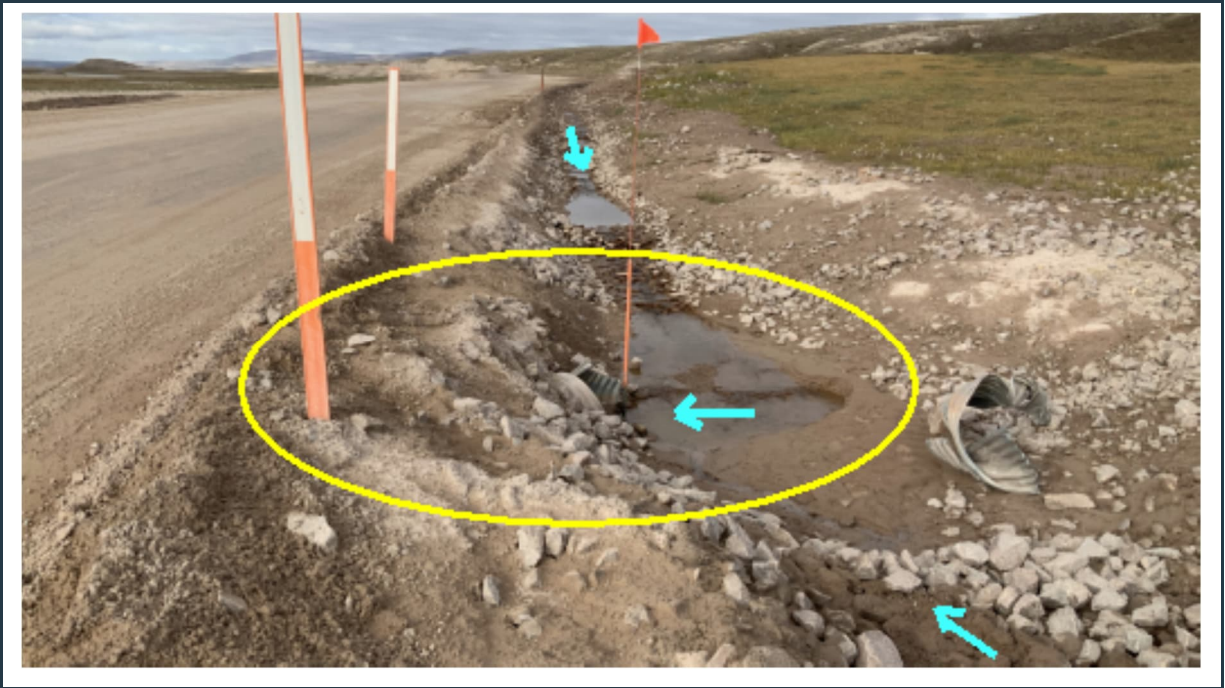
Figure 102: View of the damaged culvert at its inlet at KM 33+000. The culvert should be replaced as soon as practically possible. More rockfill should also be placed around the culvert's inlet.

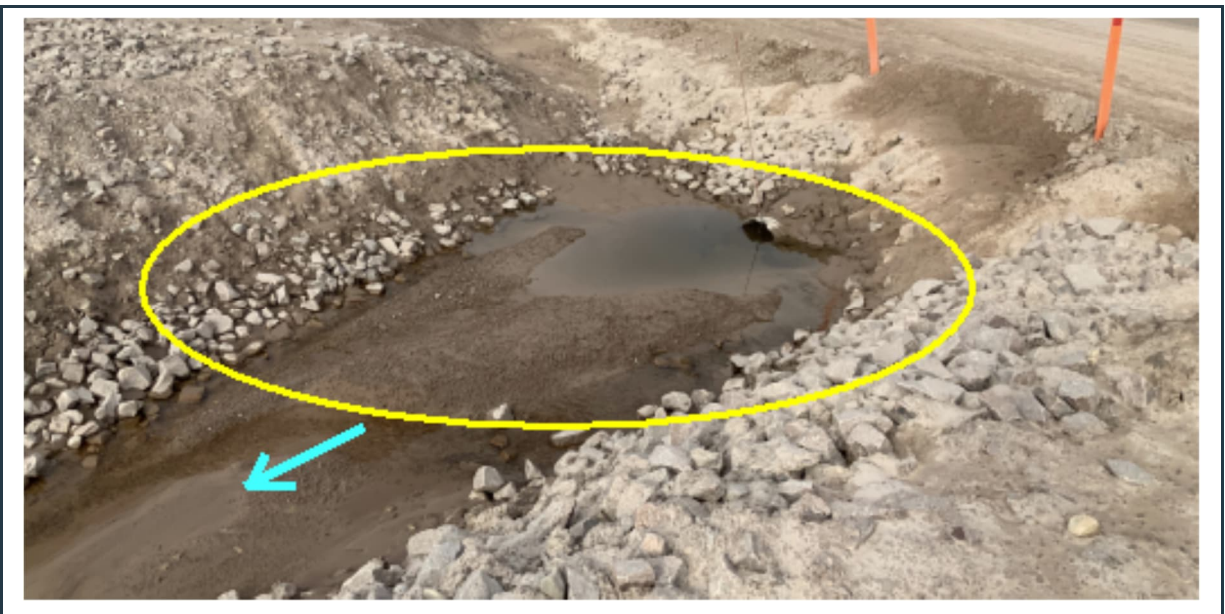
Figure 103: View of the outlet of the culvert at KM 33+000. The ditch at the front of the culvert should be cleaned during culvert replacement and more ripraps should be placed.

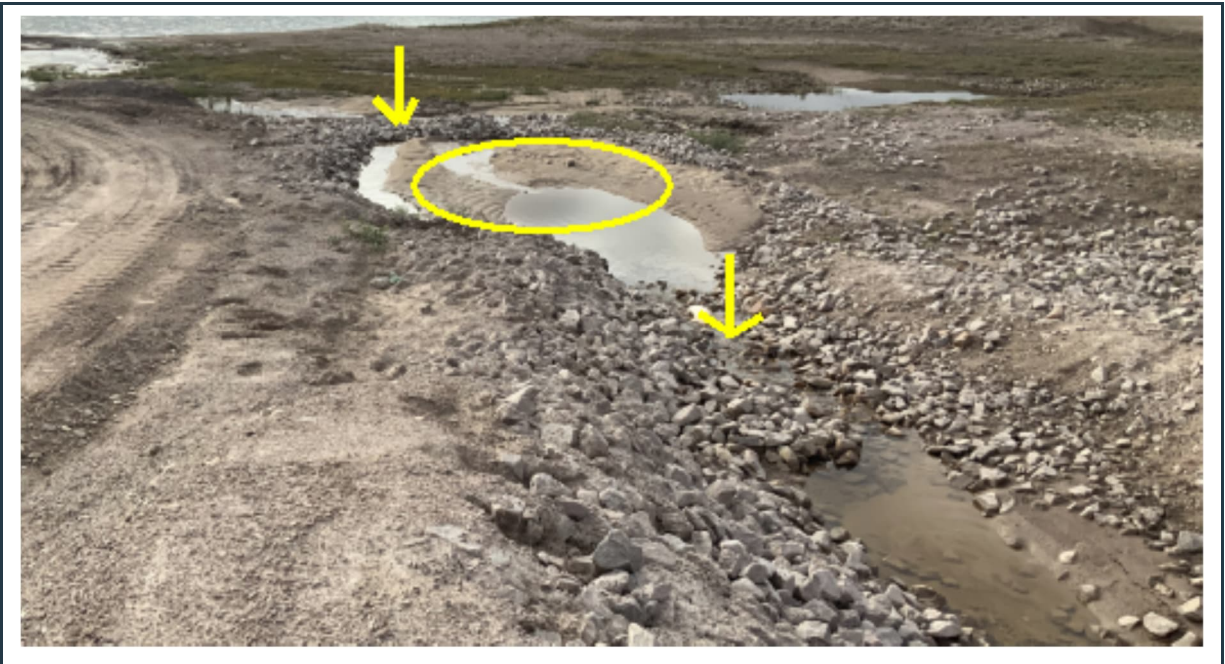
Figure 104: View of the ditch and check dams at KM 33+000. The ditch should be cleaned (yellow circle) and the crest of the check dams repaired/raised (yellow arrows) during culvert replacement.

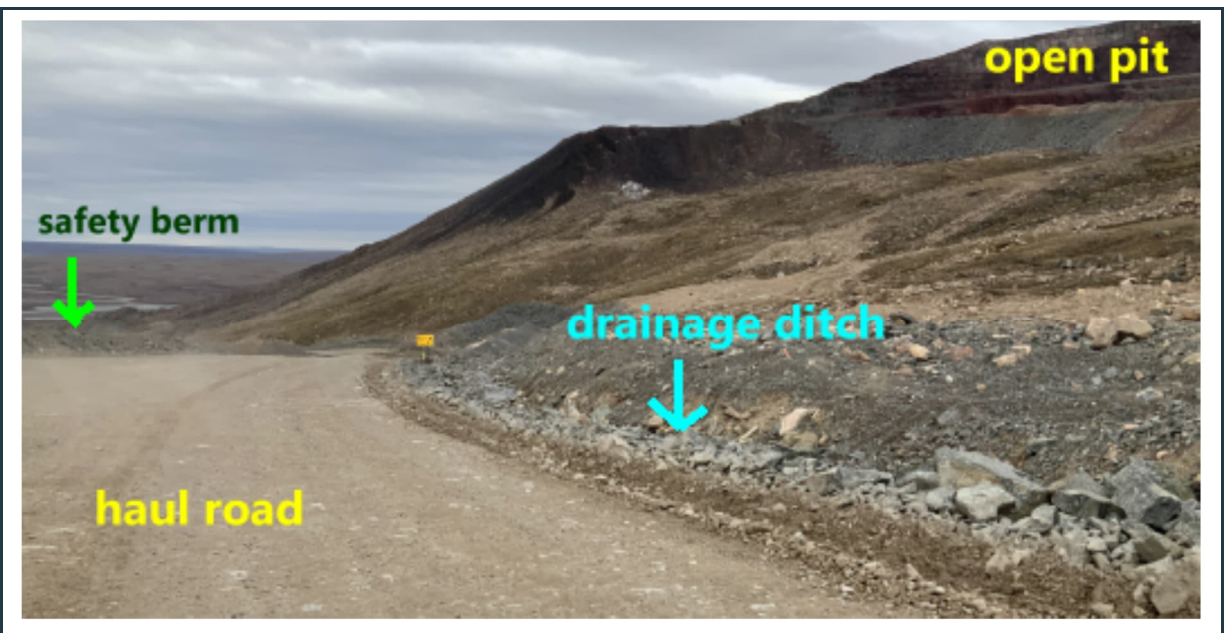
Figure 105: View of the well-maintained haul road between the crusher pad and the open pit around KM-107. Note the safety berm along the downslope side and the upgraded, erosion-controlled drainage ditch along the upslope side of the road with additional rock fill in critical areas.

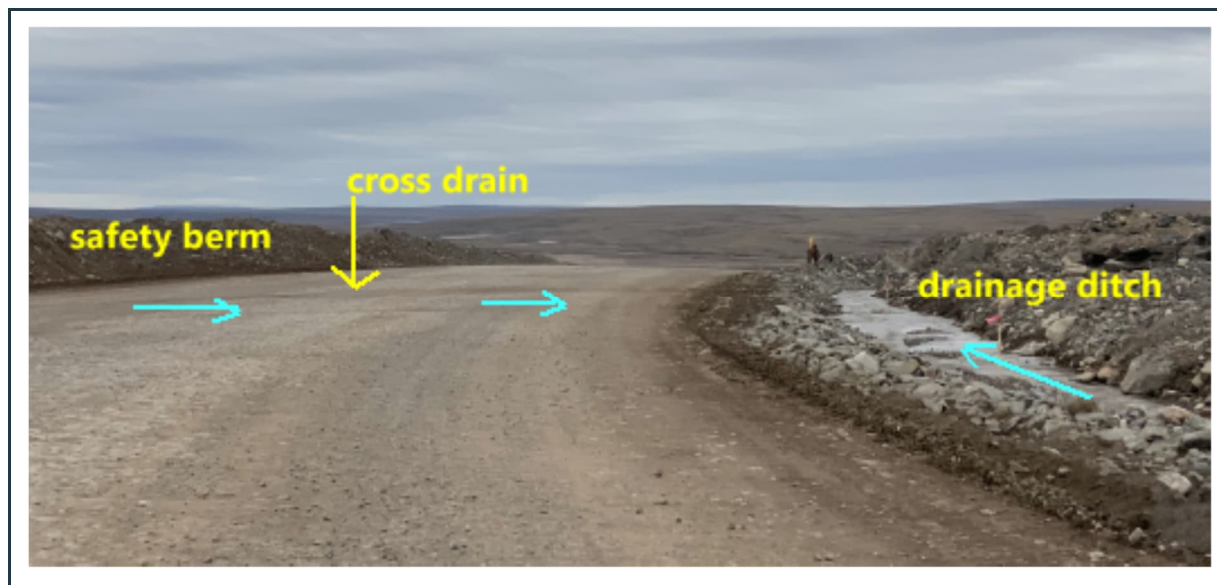
Figure 106: View of a cross drain (combination of a whoa-boy and shallow ditch) intercepting run-off flowing down the haul road and direct the collected water to the side-ditch. The excellent condition of the haul road is an indication of effectiveness of such drains.

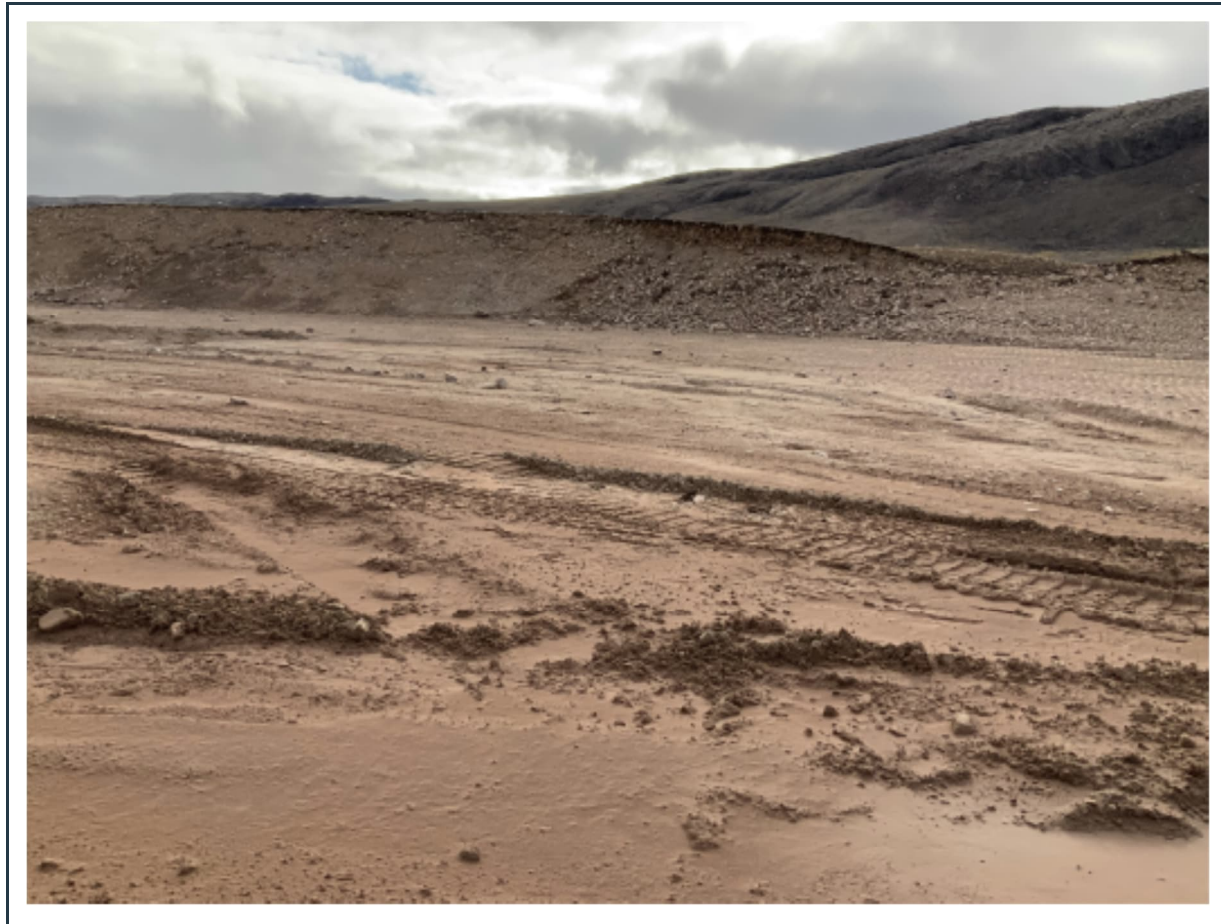
Figure 111: View of a former borrow area at KM 6.9. - September 3, 2023.

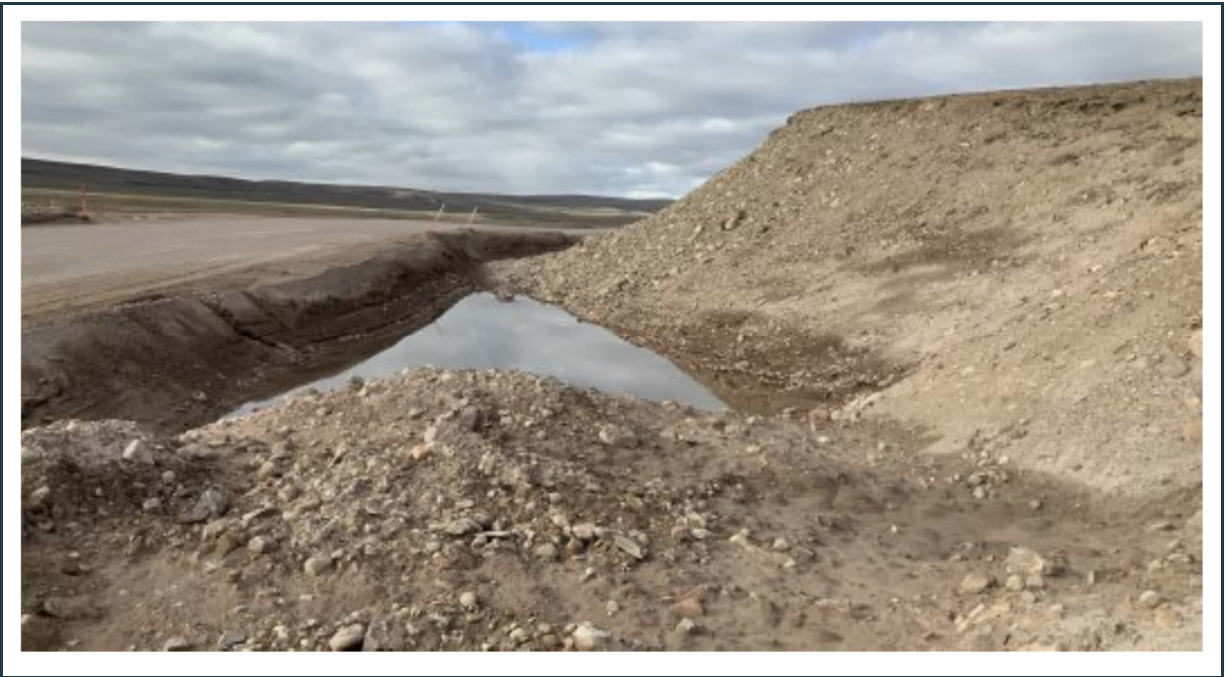
Figure 112: View of a generally stable slope in a cut area, and the adjacent road embankment with poor surface drainage at KM 28.9. - September 3, 2023.

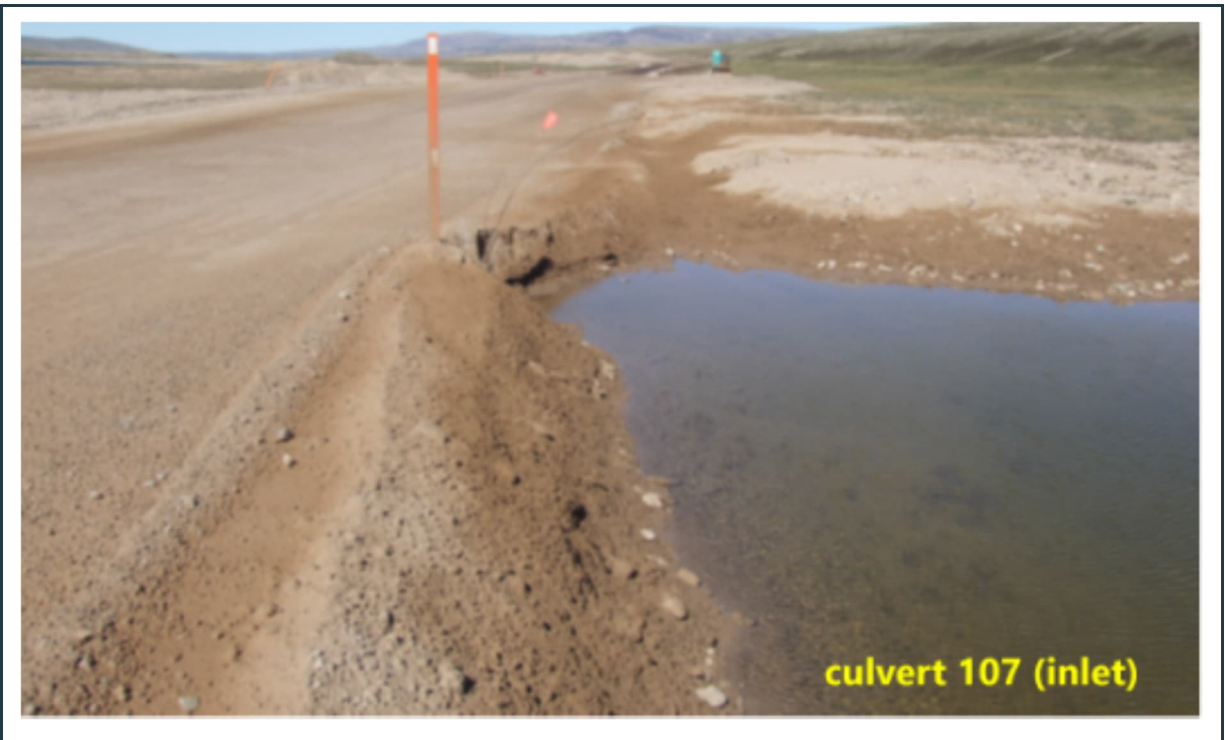
Figure 113: View of typical problems at one section of the Tote Road. (a) Ponding water adjacent to shallow road embankment and (b) unacceptably short culvert in a historic image from 2019.

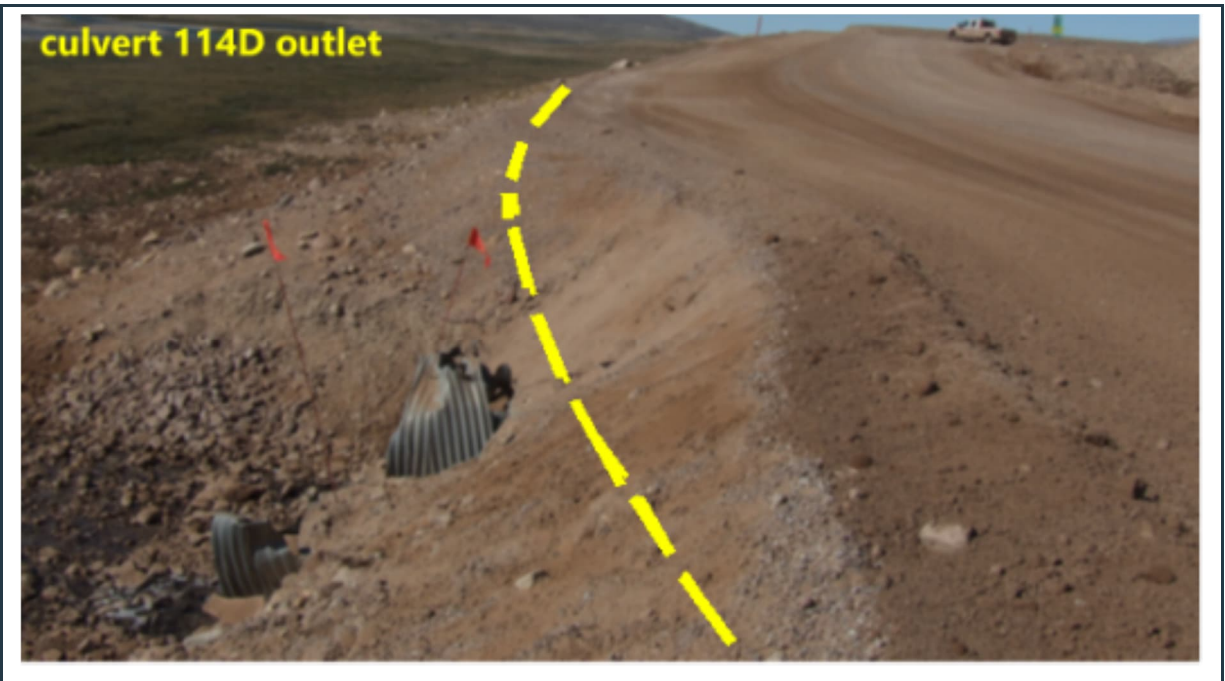
Figure 114: View of a short culvert at a curve of the road in a historic image from 2019. The broken yellow line marks the desired (safe) edge of the road.

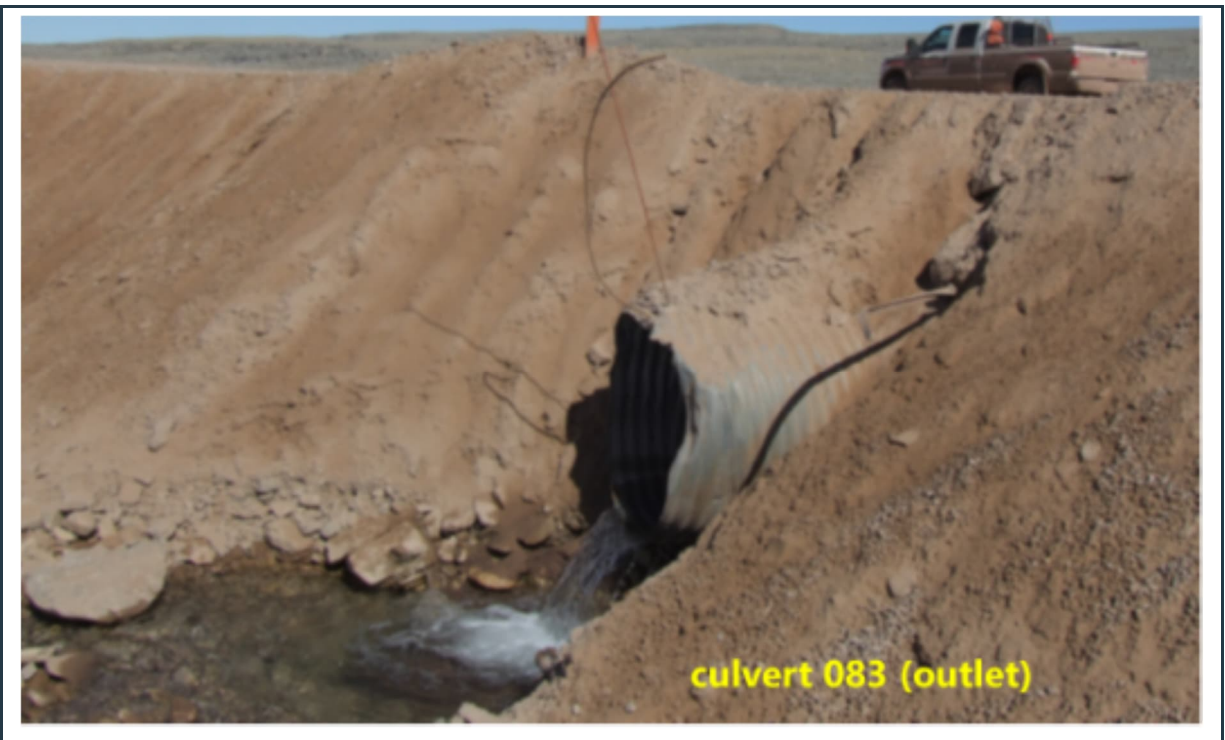
Figure 115: View of the most typical problems (short culvert and erosion at the toe of the embankment) along the Tote Road in a historic image from 2019.
