**Submission of Annual Geotechnical Inspection – 2024, Mary River Project – Nunavut, Project # CA0039374.4332**

#### Mary River Project – Nunavut

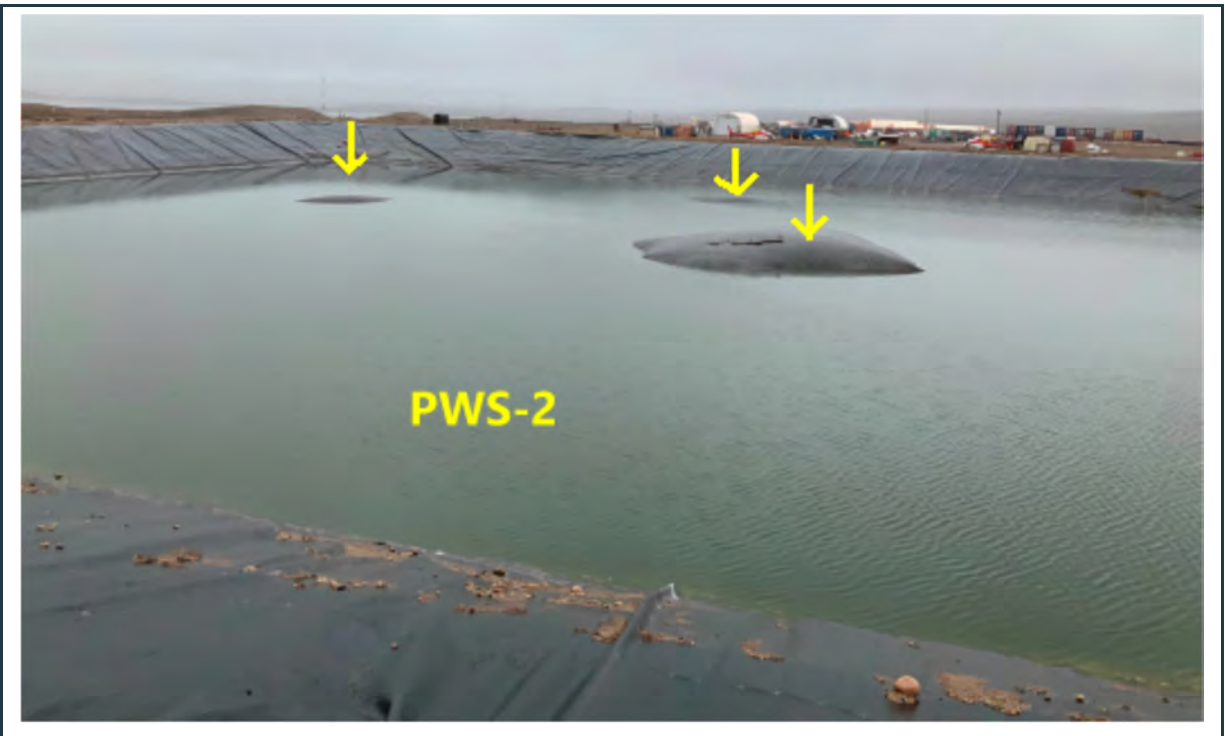
Figure 15: PWS pond #2 with stable, well-maintained berms and liner. – Sections of the liner (“whales”) are visible in the pond above the water (yellow arrows), which do not pose a risk to the integrity of the liner.

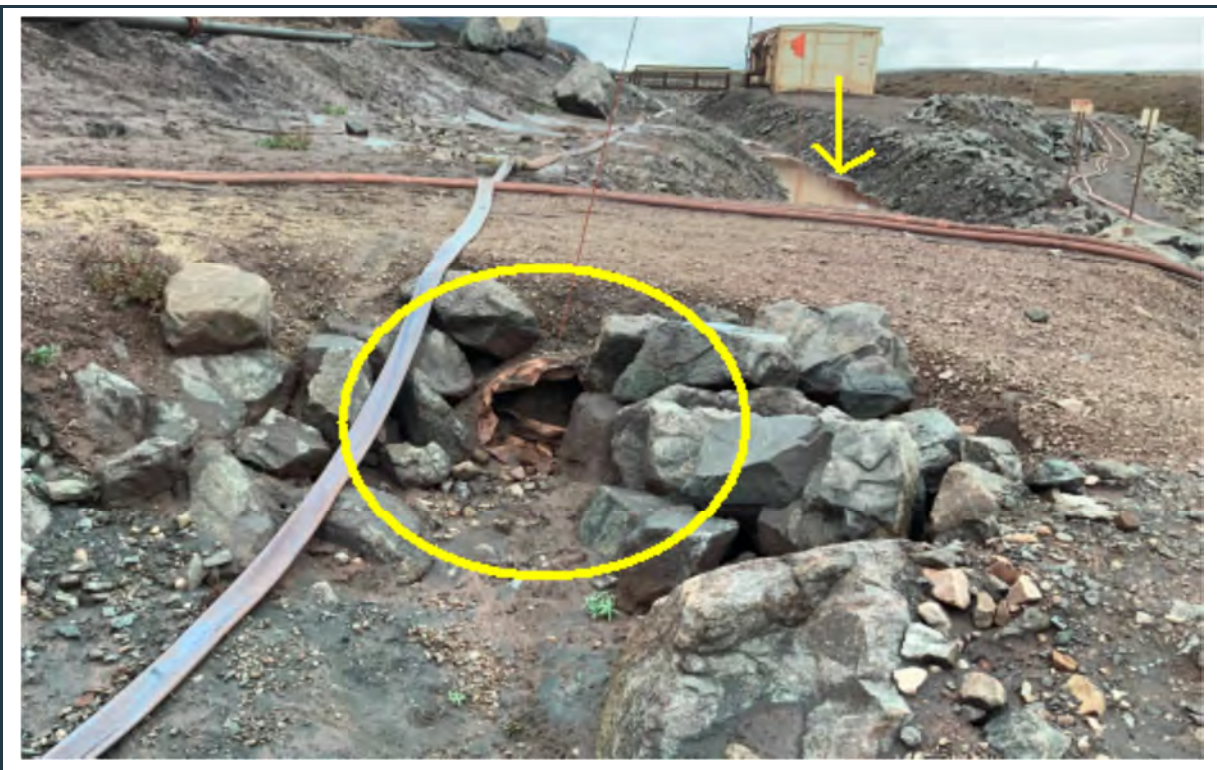
*Recommendation: A culvert is located near the south-east corner of the pond, within an adjacent drainage ditch. This culvert is damaged, preventing the collected water from the upstream section of the ditch reaching the MS-06 pond.*

Figure 26: View of one of the side-ditches and a culvert leading to the MS-06 pond. As shown by the yellow circle, the culvert is damaged and clogged, preventing the collected water from the upstream section of the ditch (yellow arrow) reaching the pond.

**Baffinland Action:** The culvert will be inspected and cleaned and/or replaced as required.

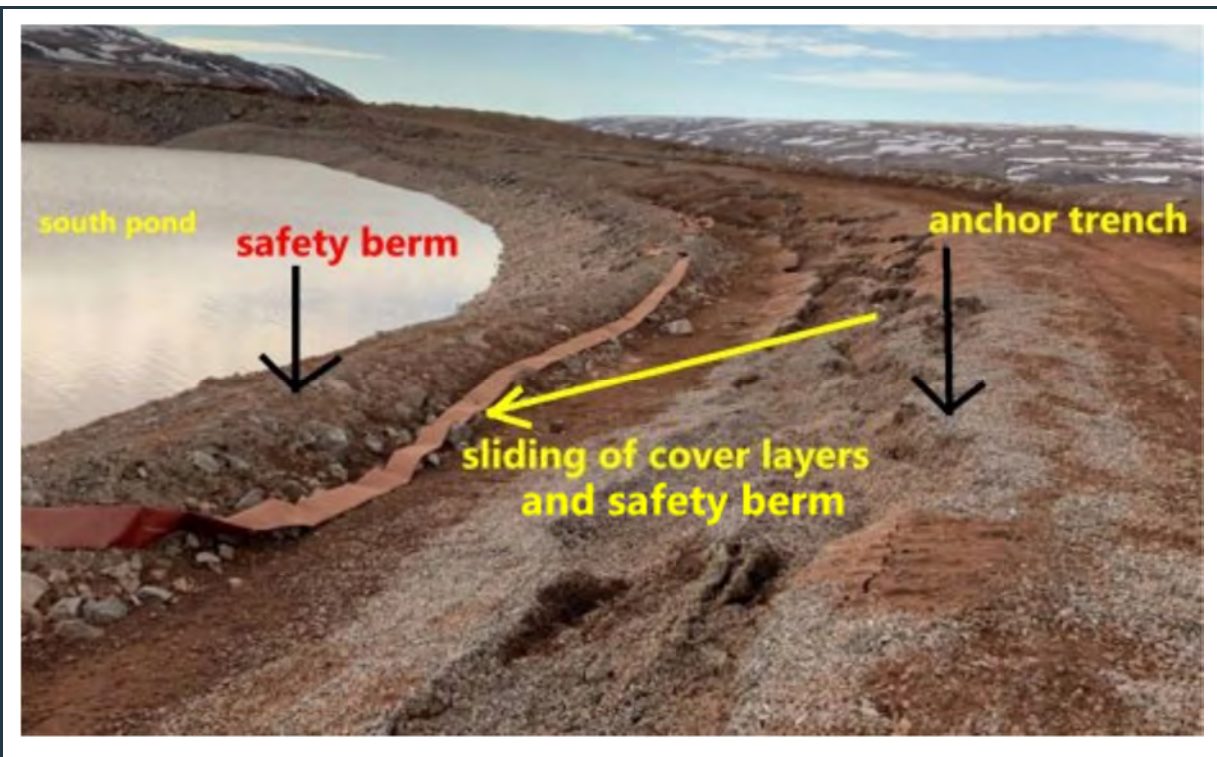
Figure 35: Sliding of the cover layers and safety berm above the liner in the south pond (image was taken on June 22, 2022).

*Recommendation: It is likely that the rehabilitation of the slope will include the placement of sand cover and riprap in the upper (displaced) part of the cover layers, and the reconstruction of the safety berm at its original location adjacent to the anchor trench. It is also likely that placement of additional riprap along the toe of the south slope will be necessary (like a wide and heavy toe-berm) to provide additional support at the toe to prevent similar sliding of the cover layers in the future.*

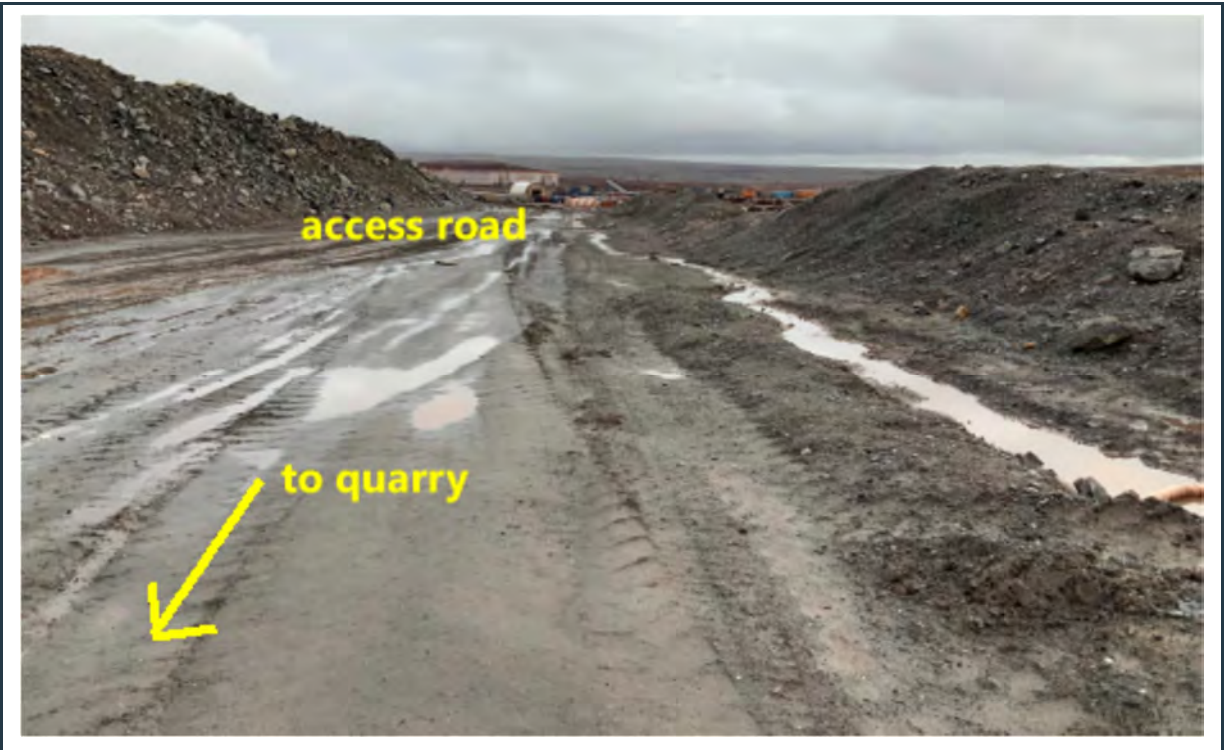
Figure 48: Drainage problems still exist at the first quarry level. Surface drainage shall be rectified.

*Recommendation: It is suggested that consideration be given to the installation of slope-drain pipes, chutes, or flume drains from the sumps, as erosion protection measures on the side-slope, instead of letting the water to flow uncontrolled along the edge of the access road and down on the side-slopes.*

**Baffinland Action:** Baffinland is assessing and has previously identified the above noted issue. Drainage improvements of the lower level of QMR2 quarry is being developed. A plan based on the above recommendation will be implemented in 2025.

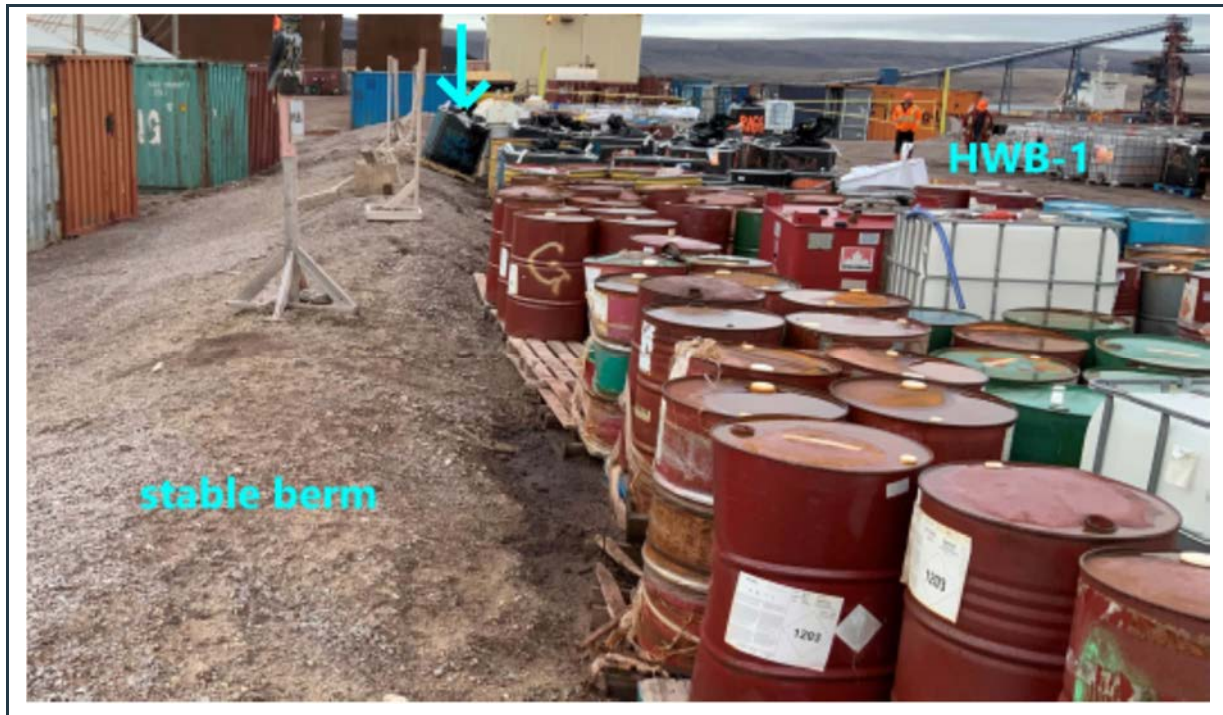
Figure 53: View of the stable perimeter berm around the lined HWB-1 cell with various materials and two shipping containers stored within the cell. Materials on pallets should be stored within the cell, not on the berms (note the container marked by the blue arrow).

*Recommendation: Materials on pallets should be stored within the cell, not on the berms.*

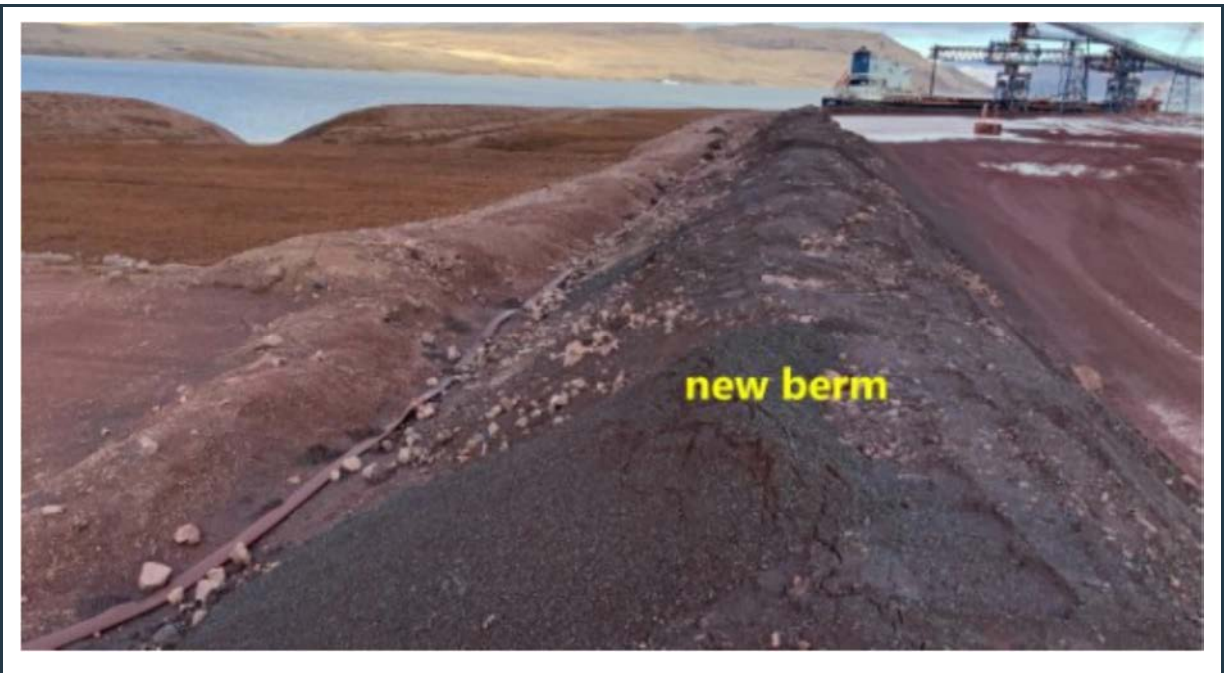
Figure 67: View of the 2024 condition of the “west” surface water collection ditch adjacent to the ore storage area. Note the new, widened berm along the ditch, partly constructed within the ditch.

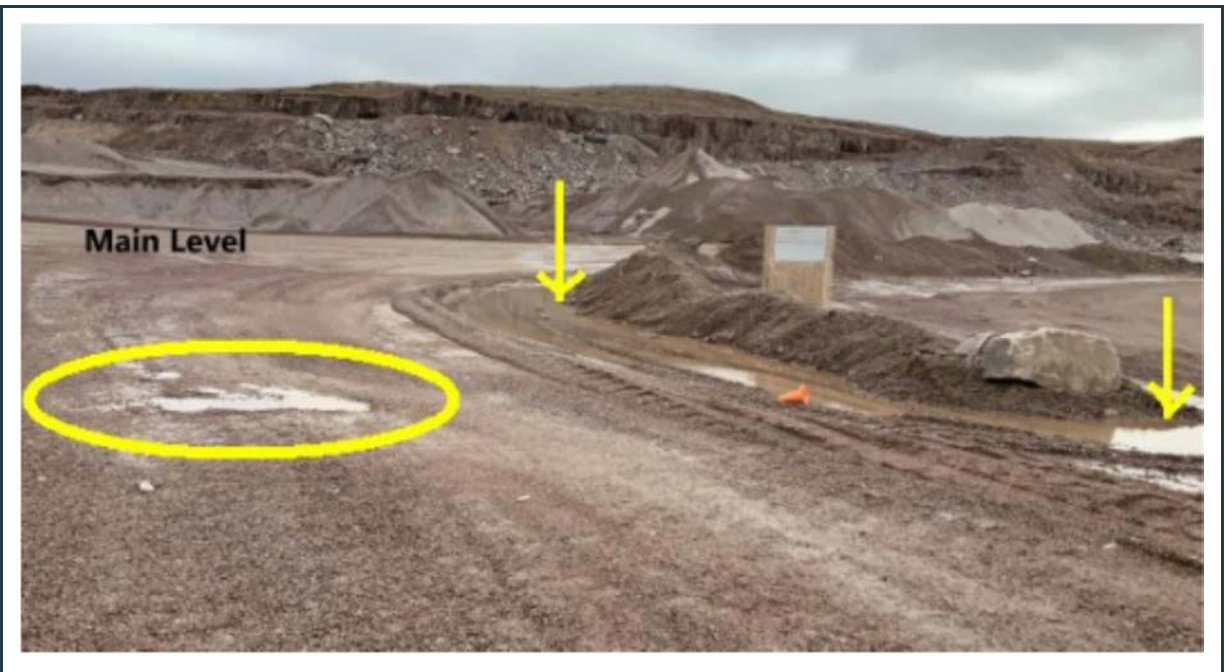
Figure 68: View of ponding and flowing water at many areas of the lower (main) level of the Q01 rock quarry. The drainage problem should be rectified prior to restarting the operation in the quarry.

**Recommendation:** *It is recommended that the somewhat finer soil, currently forming the side of the ditch, be removed to a depth/width of around 1 m and replaced with crushed rock fill. To minimize migration of fine soil particles from the quarry pad to the ditch, the crushed rock fill should be placed over a layer of geotextile fabric. The improvement of this section of the ditch shall be completed with the formation/excavation of additional drainage ditches, required to rectify the ponding water present in many parts of the lower (main) level of the quarry.*

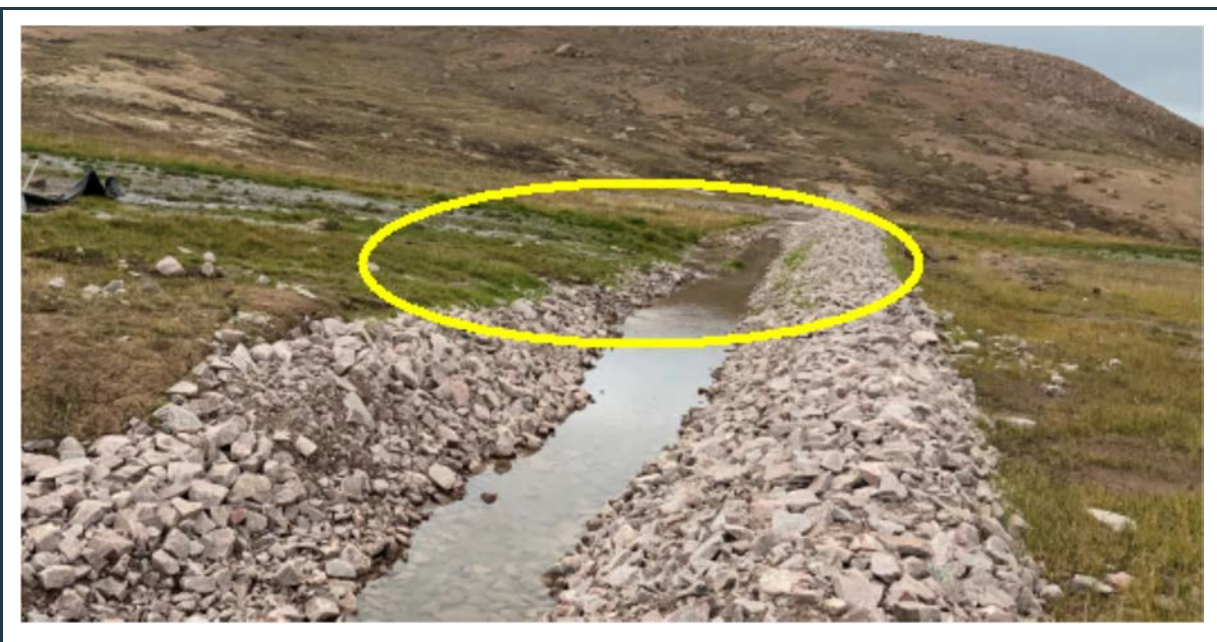
Figure 70: View of the southern section of the P-SWD-3 surface water collection ditch with failed slope sections and ponding water due to inadequate longitudinal channel slope.

**Recommendation:** *To improve the drainage capability of the P-SWD-3 ditch, it is recommended that it should be reconstructed to drain the large quantity of surface water from the snow-dump to the north-east. The culvert in the ditch beneath the access road to the snow-dump has also been damaged recently. This culvert should be replaced and installed to the correct invert level (to be specified during the redesign and reconstruction process). To prevent the migration of fine soil particles from the ditch to the environment, a rockfill check dam should be installed/constructed at the discharge point of the upgraded/reconstructed ditch. The culvert under the access road to the quarry in the P-SWD-3 ditch should be removed and replaced with a larger diameter pipe.*

**Baffinland Action:** Drainage improvement initiatives will be considered in 2025 with intent to improve the drainage capability of the P-SWD-3 ditch. Damaged or impacted culverts will be evaluated to consider if it still effectively passes water.

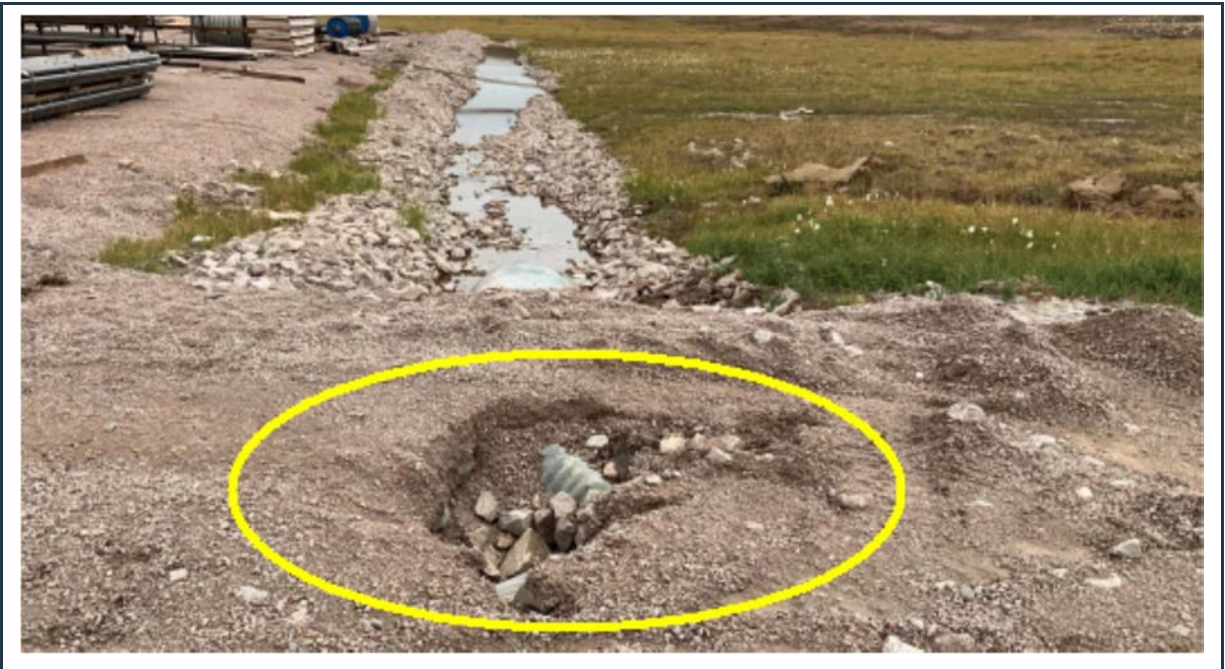
Figure 71: View of the damaged culvert (yellow circle) and the northern section of the P-SWD-3 surface water collection ditch with failed slopes and ponding water.

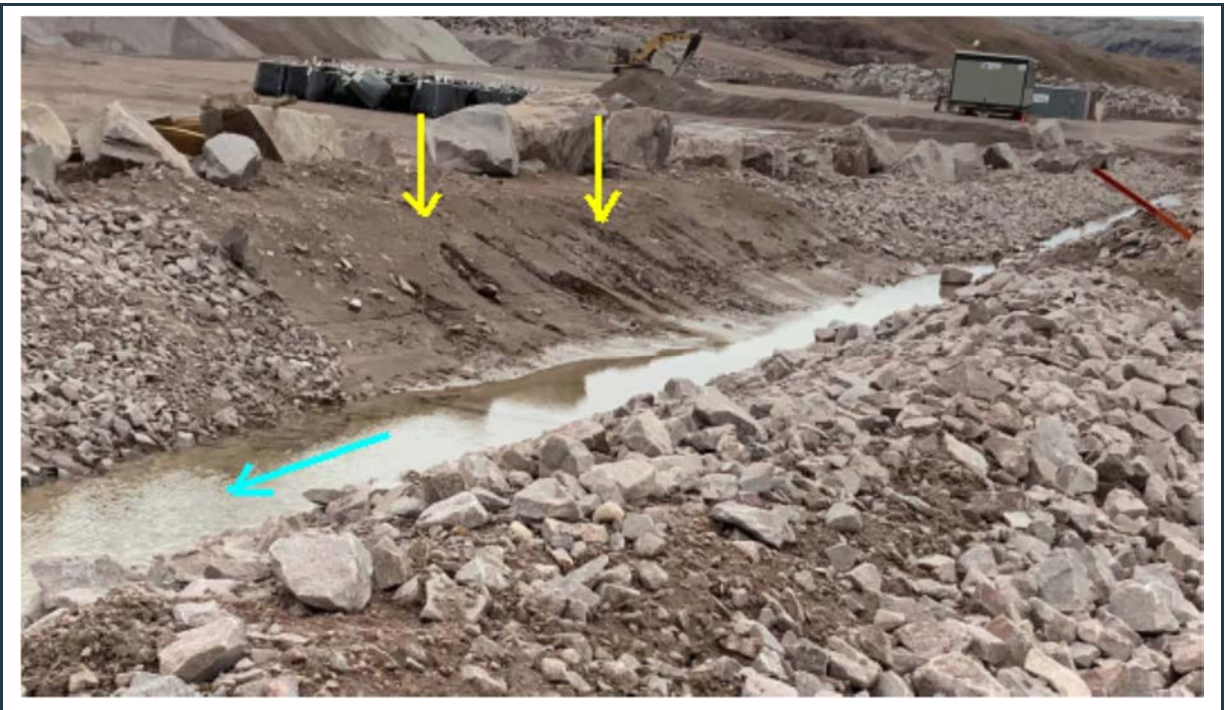
Figure 72: P-SWD-5 – “Q01-North” surface water collection ditch with missing riprap at one section of the ditch. Note the continuous seepage from the granular fill pad of the quarry’s lower level.

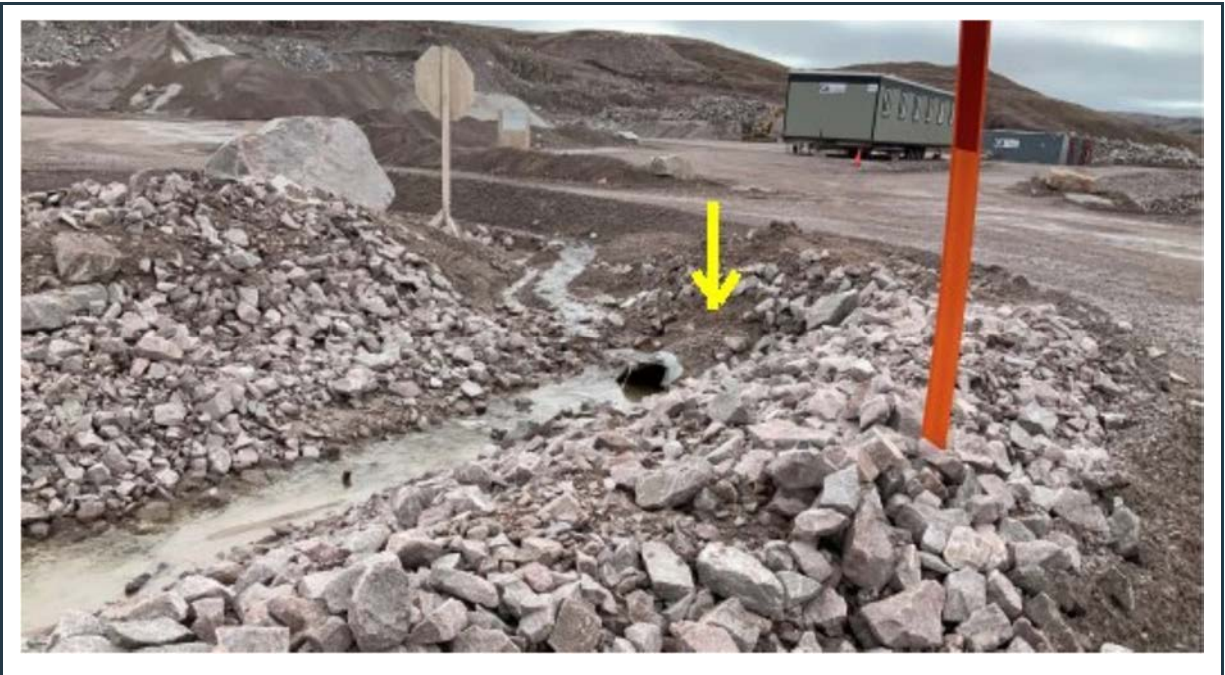
Figure 73: View of the clogged, undersized culvert beneath the access road to the Q01 rock quarry. This culvert should be removed and replaced with a larger diameter pipe.

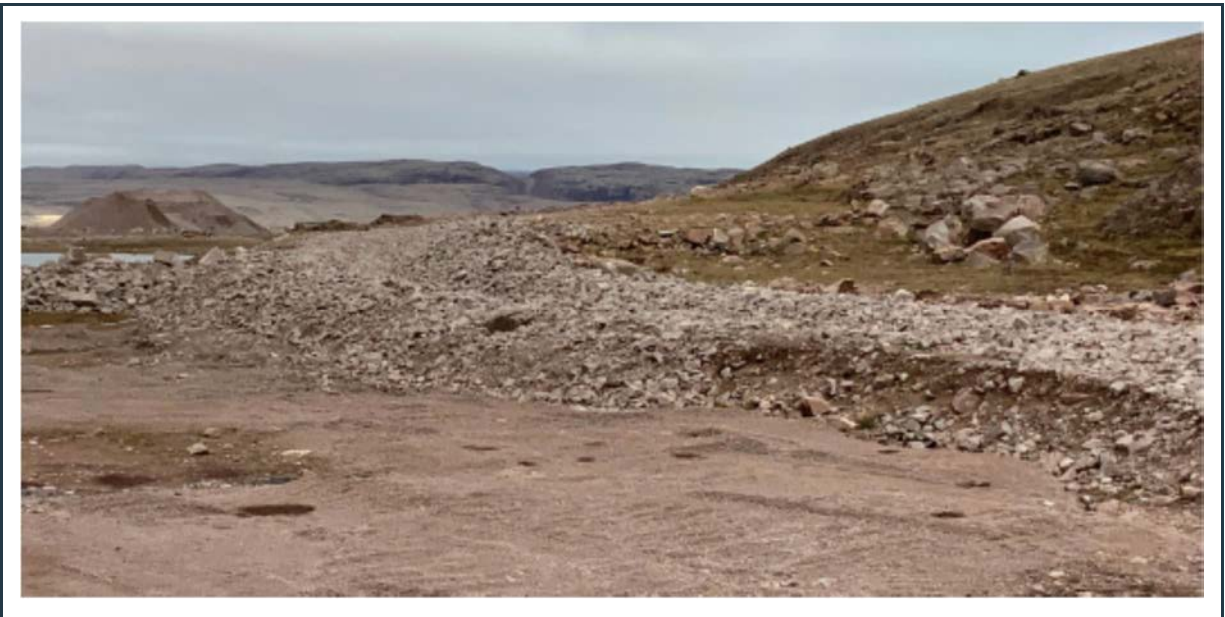
Figure 74: View of the P-SWD-6 surface water collection ditch. As opposed to the original design intent, no water is drained from the quarry in this ditch with its invert level constructed above the current (lower) level of the quarry (see Figure 75 as well).

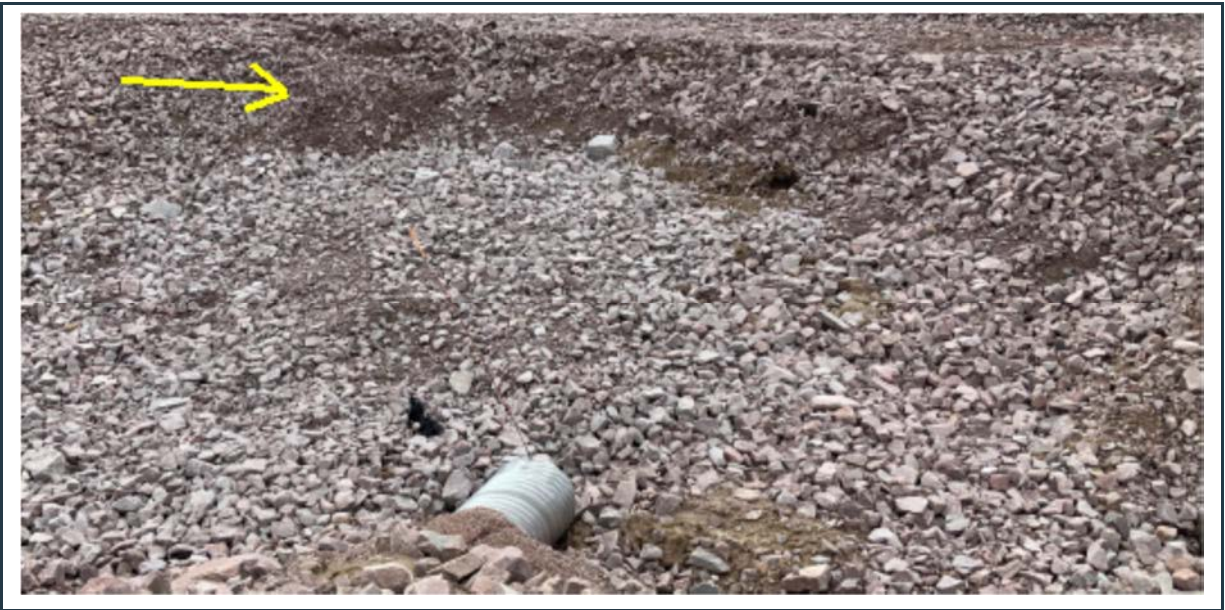
Figure 81: View of the “west end” of the PSC surface water collection ditch (red circle in Figure 8). Note the localized slope degradation due to frequent water seepage from the granular fill of the LP-2 laydown pad (yellow arrow). The culvert shown in the image can be removed.

*It is recommended that the drainage conditions at the P-SWD-3 and PSC ditches be reviewed and rectified as early as practically possible. Once the drainage conditions in the P-SWD-3 ditch would be improved/rectified, the slope condition at the PSC ditch can also be improved. The reparation should include the placement of some additional riprap in the affected area. Based on field observations, the outflow end of the PSC ditch should also be further upgraded by the installation of geotextile and riprap along the base and side-slopes of the ditch. To prevent the migration of fine soil particles from the ditch to the environment, a rockfill check dam should also be installed/constructed at the discharge point of the upgraded/reconstructed ditch*

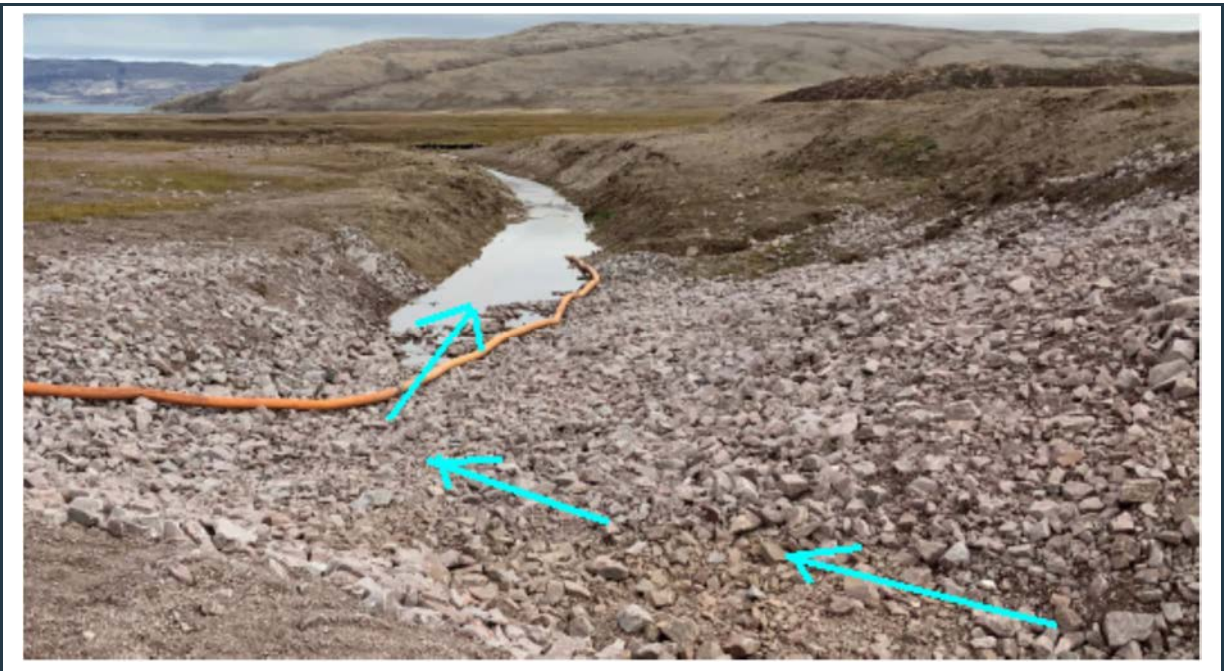
Figure 82: View of the “east end” of the PSC surface water collection ditch (also shown by green circle B in Figure 8). Additional riprap and a check dam should be installed along this section of the ditch.

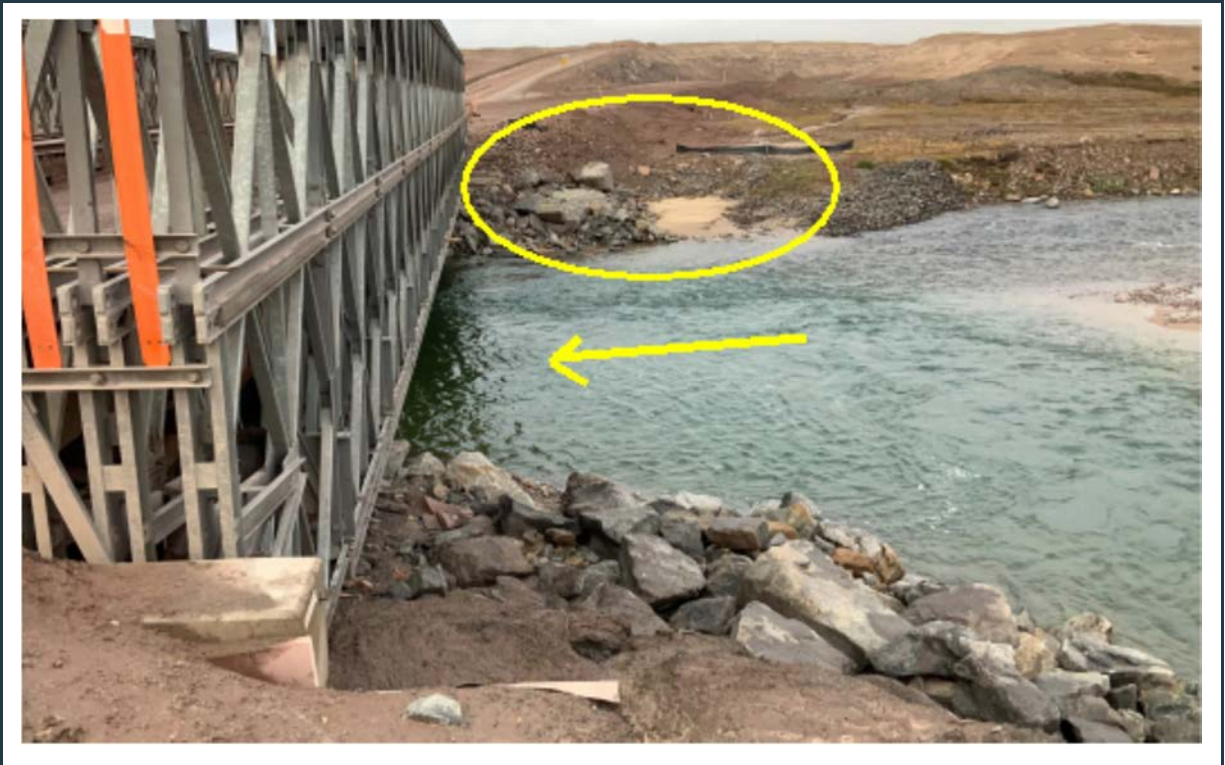
Figure 99: View of the stable abutments at the east side of bridge KM97. Note the area marked by the yellow circle where additional rock fill should be placed at the shore of the river and adjacent to the approach embankment to the bridge abutment, for erosion protection.

**Recommendation:** *There are areas at two locations where some additional rock fill should be placed over fine soils at the surface, to prevent erosion and migration of the finer material into the river.*

**Baffinland Action:** Erosion mitigation measures will be evaluated at the identified zones and implemented in snow free conditions.

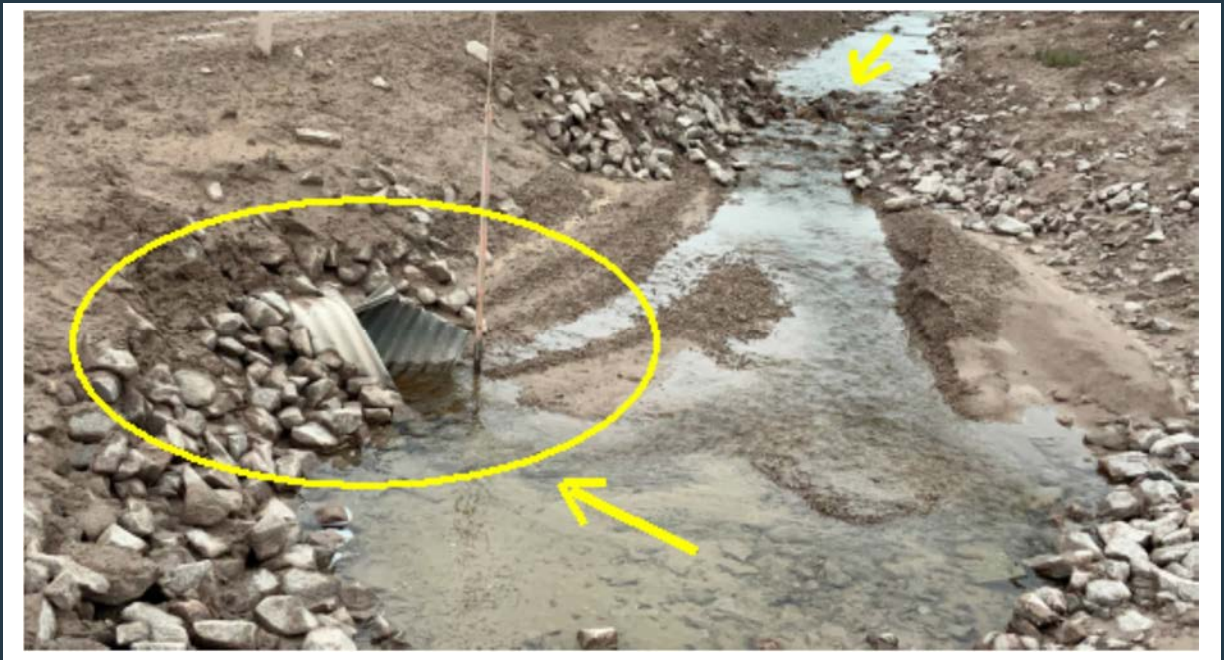
Figure 101: View of the damaged culvert at its inlet at KM 32+900. The culvert should be replaced as soon as practically possible. More rockfill should also be placed around the culvert's inlet.

**Recommendation:** *To provide uninterrupted flow, the culvert should be cleaned or replaced with a longer pipe as soon as practically possible. More rockfill should also be placed around the culvert's inlet, while the silt, deposited at the front of its outlet, should also be removed. The crest of the nearby check-dams, show some loss of rock fill. The dams should therefore be raised by placing additional rock fill on their crests, and the ditch behind the dams should be cleaned (fine soil removed).*

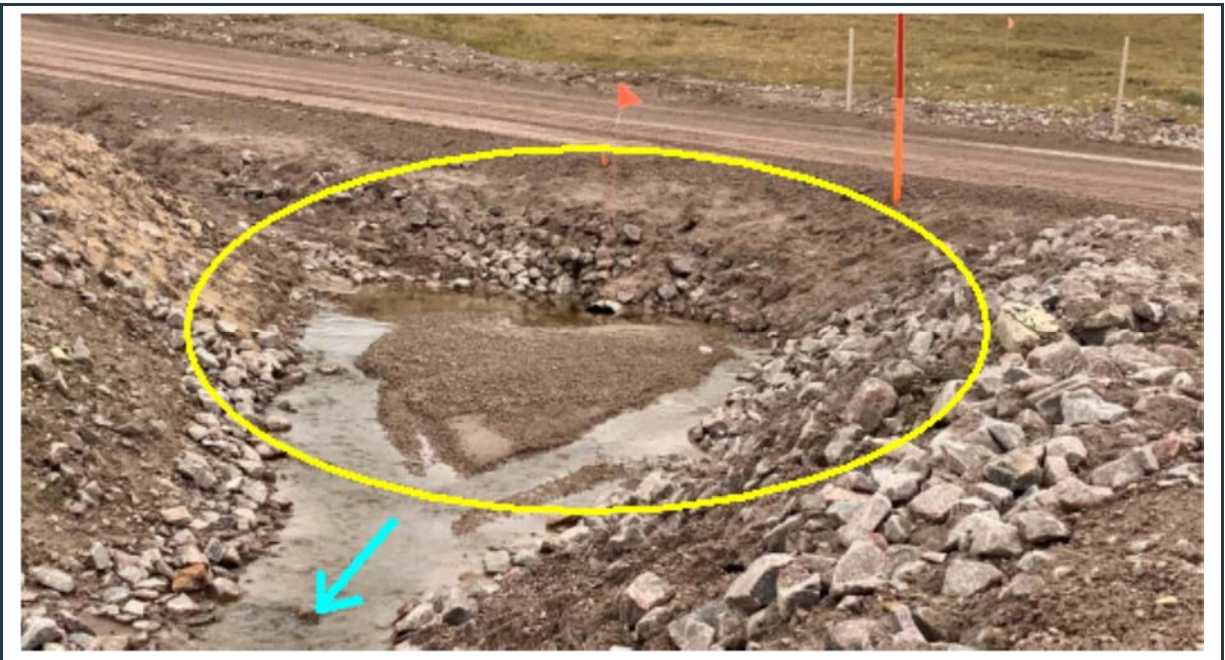
Figure 102: View of the outlet of the culvert at KM 32+900. The ditch at the front of the culvert should be cleaned from the sediment during culvert replacement, and more riprap should be placed.

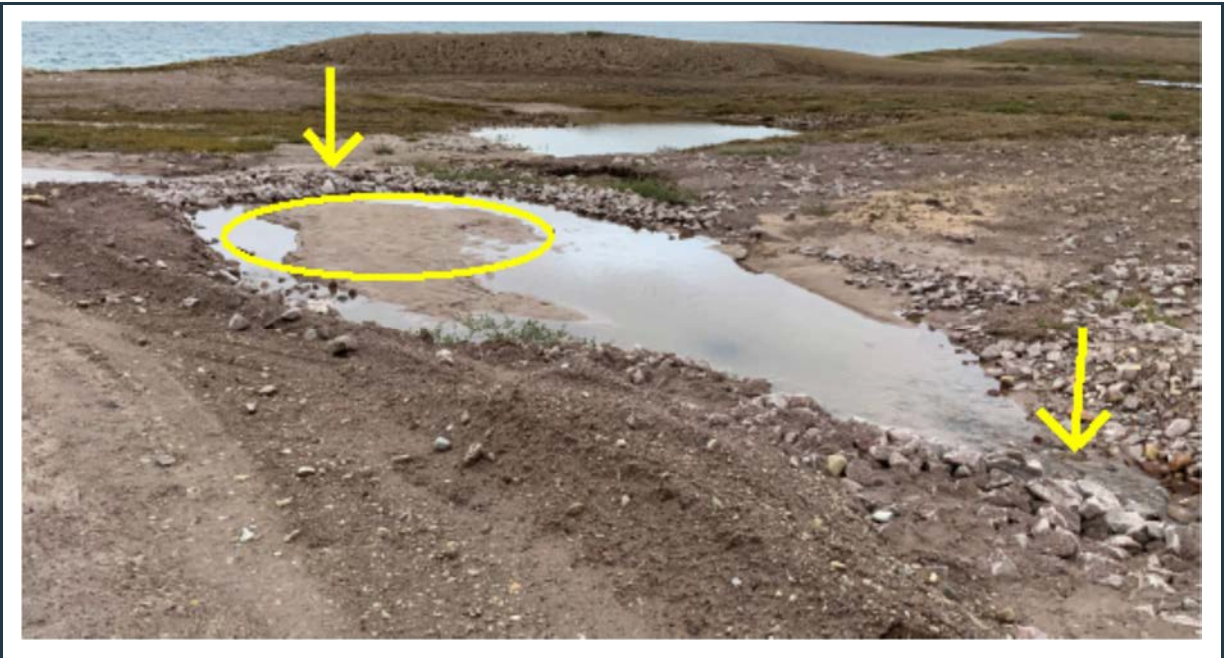
Figure 103: View of the ditch and check dams at KM 32+900. The ditch should be cleaned (yellow circle) and the crest of the check dams repaired/raised (yellow arrows) during maintenance work.

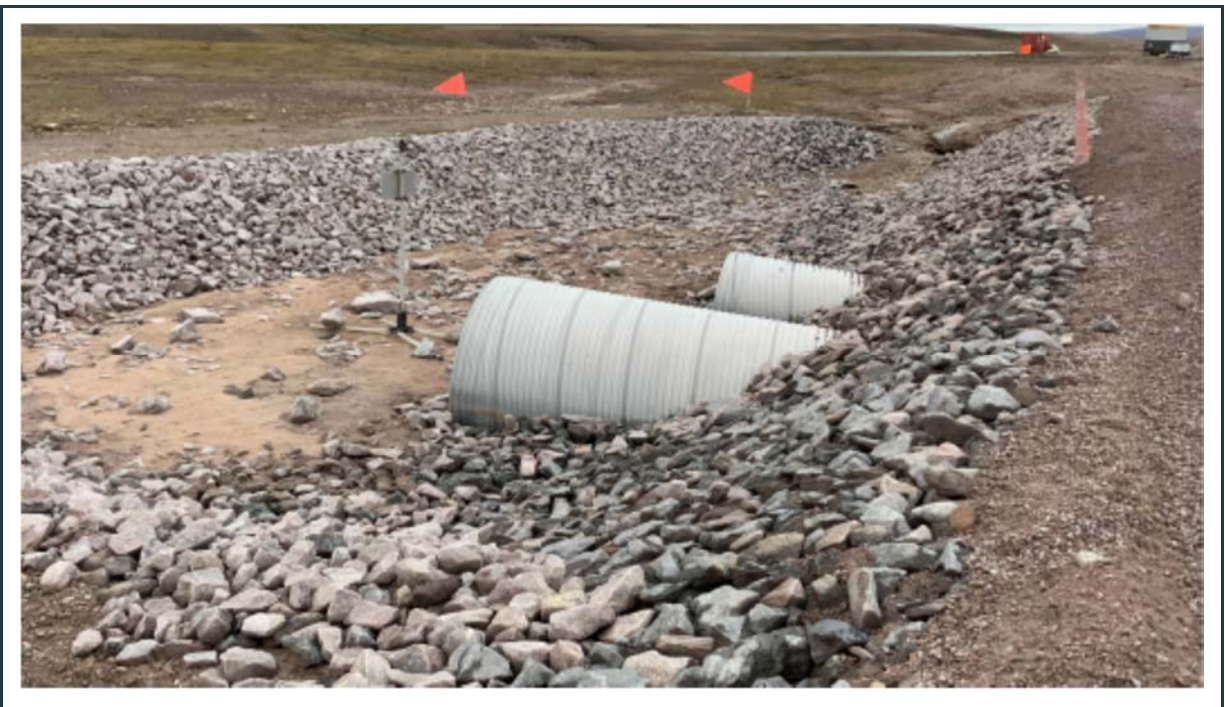
Figure 104: View of the inlet of the twin culverts at KM 33+100. No water was flowing through the culverts that show some sagging in their centre, under the weight of the road embankment.

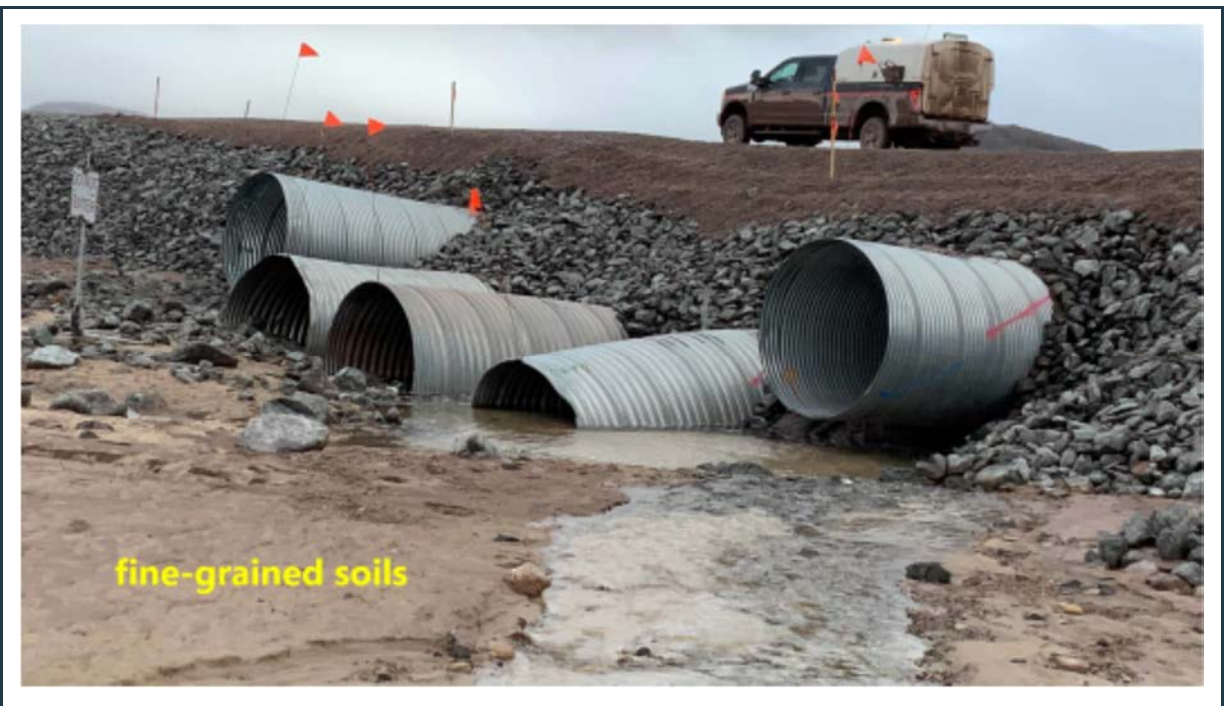
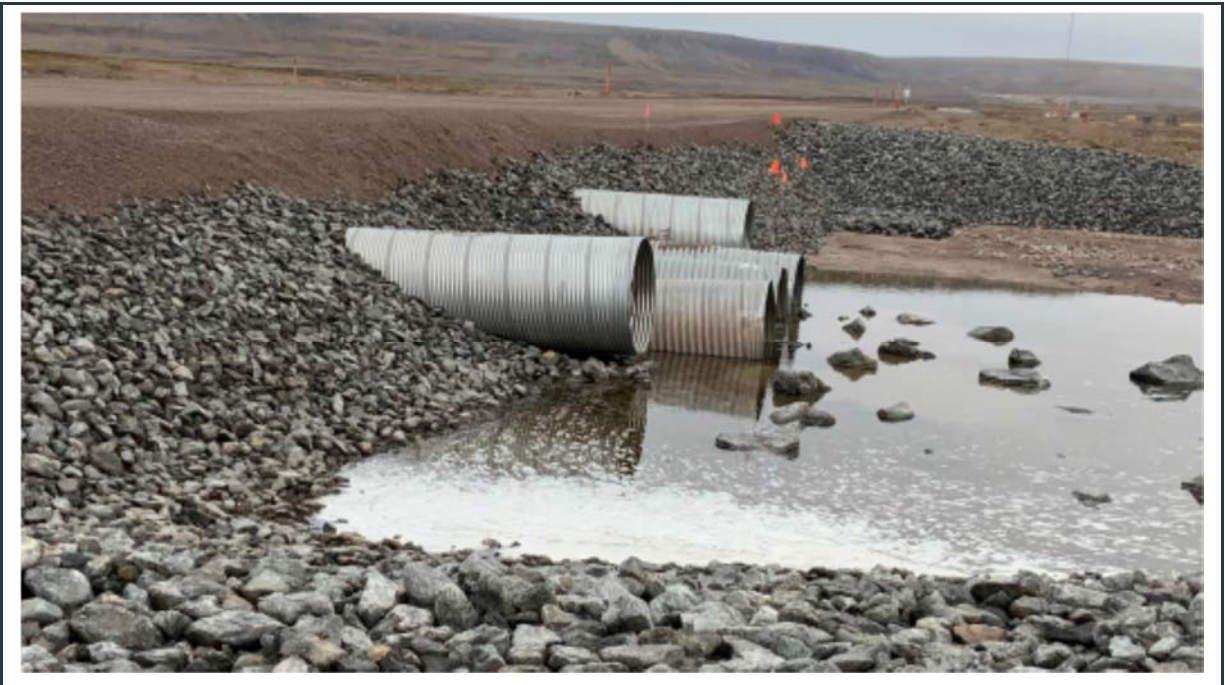
Figure 110: View of the inlet of five culverts at KM 80+500. All five culverts suffered serious differential settlements (sagging) and all of them will need to be replaced as soon as practically possible.

Figure 111: View of the outlet of five culverts at KM 80+500. All five culverts suffered serious differential settlements (sagging) and all of them will need to be replaced as soon as practically possible.

**Recommendation:** *The culverts were installed over poor soil subgrade which, after thawing, has lost its strength and bearing capacity, resulting in significant differential settlements of all pipes. To prevent similar settlement problems in the future, the thaw unstable, ice-rich soils will need to be removed from beneath the new culverts and replaced with thaw-stable, compacted granular materials to a depth of at least 1.5 m below the invert level of the pipes.*

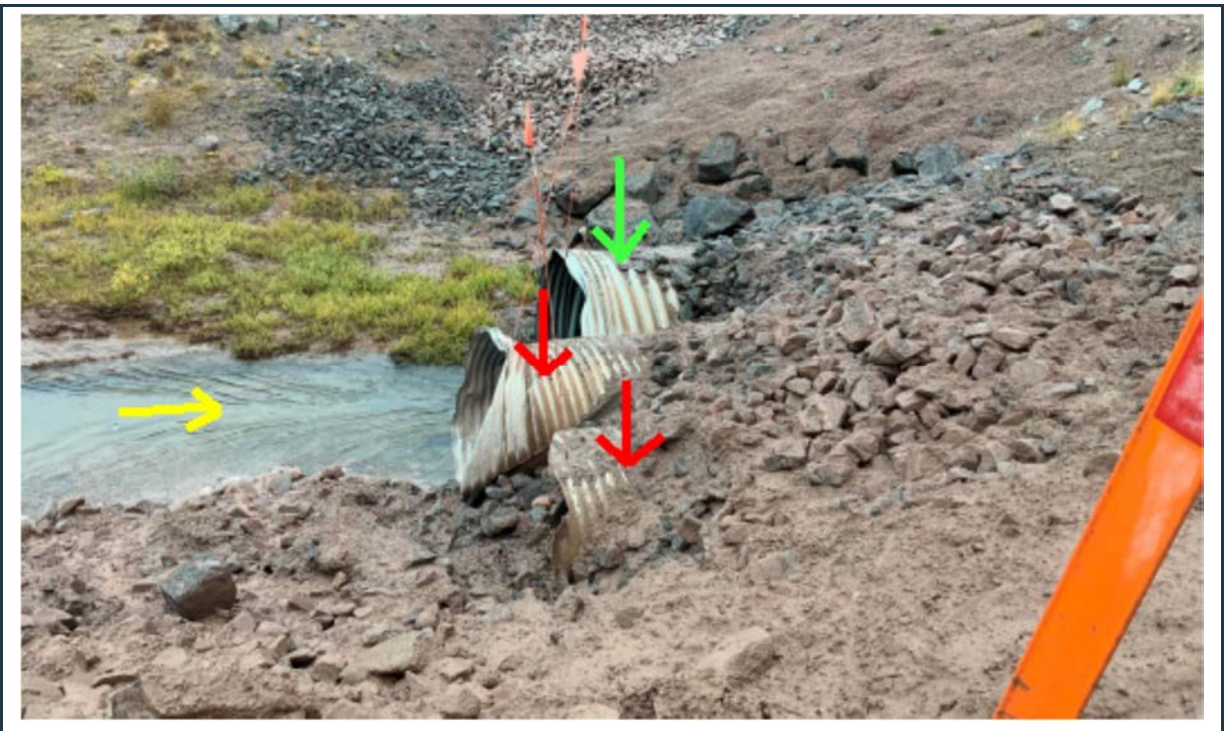
Figure 112: View of the inlet of three culverts at KM 90+100. Only one (green arrow) is operational.
