RE: Submission of Annual Geotechnical Inspection – 2025, Mary River Project – Nunavut, August 29, 2025; Project # CA0055338.6747

WSP Canada Inc., has completed the required geotechnical field inspection of 2025 at the Mary River Mining Project, which is a condition of the Nunavut Water Board's Renewed Type "A" Water Licence No: 2AM-MRY2540.

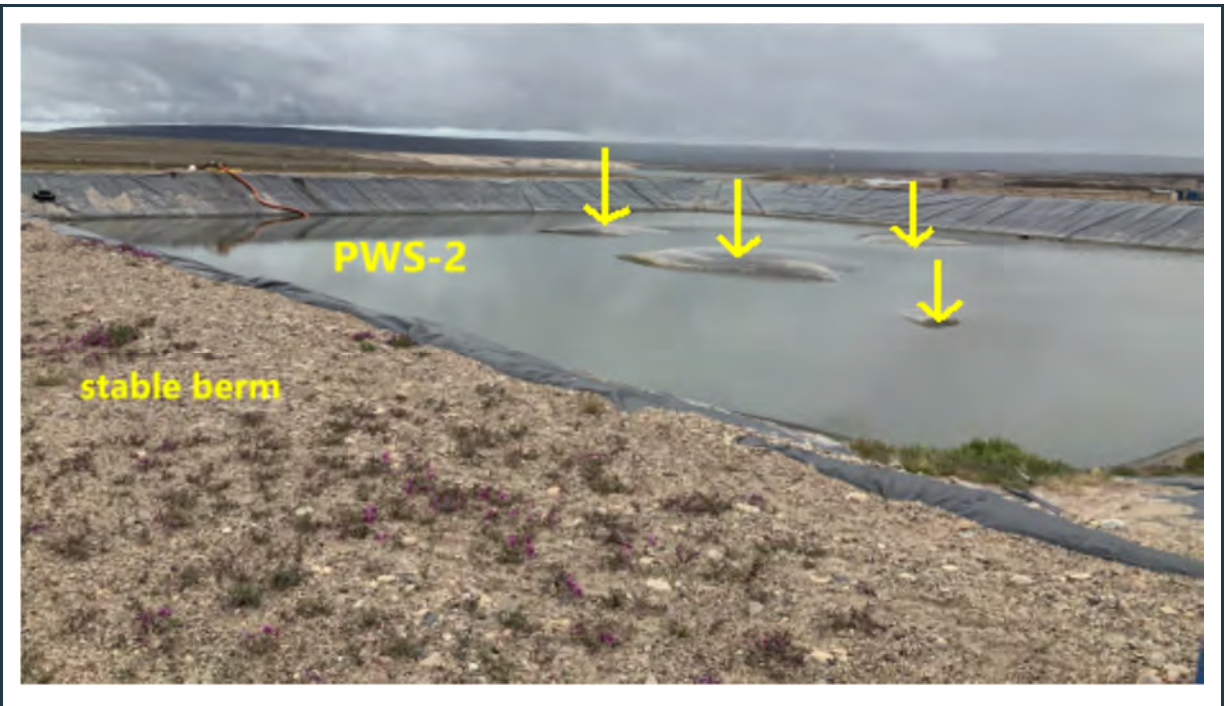
Figure 14: PWS pond #2 with stable, well-maintained berms and liner. – Sections of the liner ("whales") are visible in the pond above the water (yellow arrows), which do not pose a risk to the integrity of the liner.

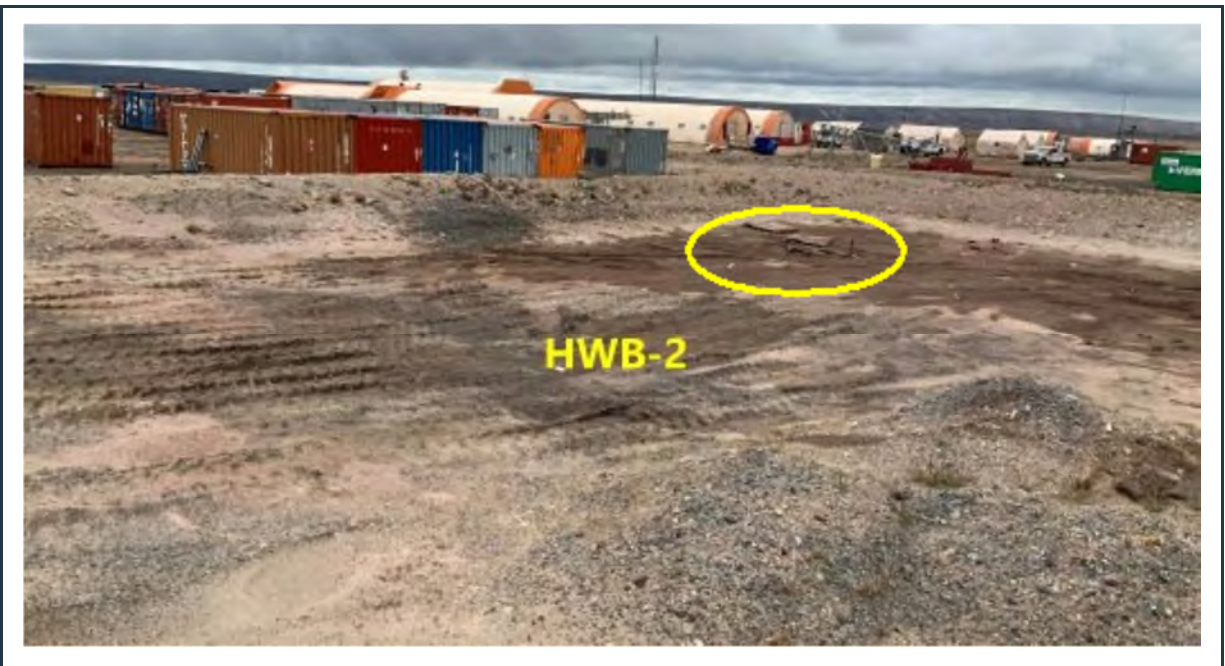
Figure 17: View of the stable berms around the currently empty HWB-2 cell. Debris from the cell (yellow circle) should be removed.

Recommendation: Debris in one corner should be removed. One shipping container was left on the access ramp to the cell, which should be removed or moved into the cell from the ramp.;

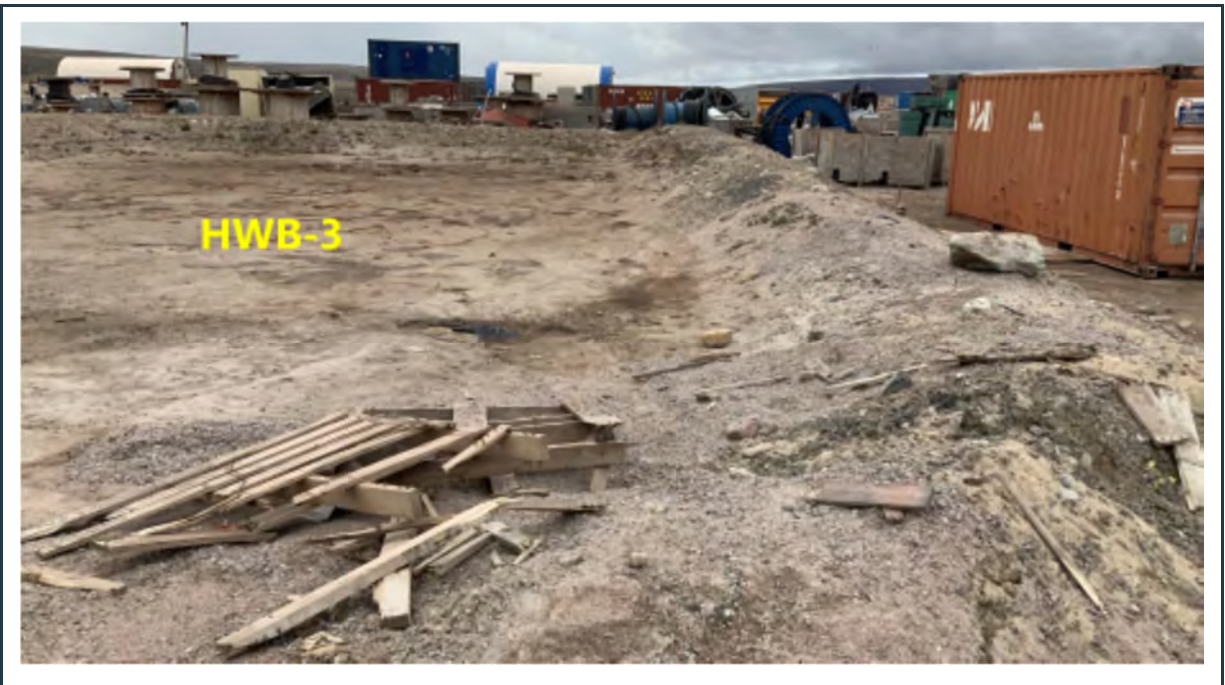
Figure 18: View of stable berms around HWB-3. The broken wooden pallets and other debris should be removed from the cell and from the berms.

Recommendation: Broken wood pallets and other debris should be removed from the cells and from the crest and slopes of the berms.

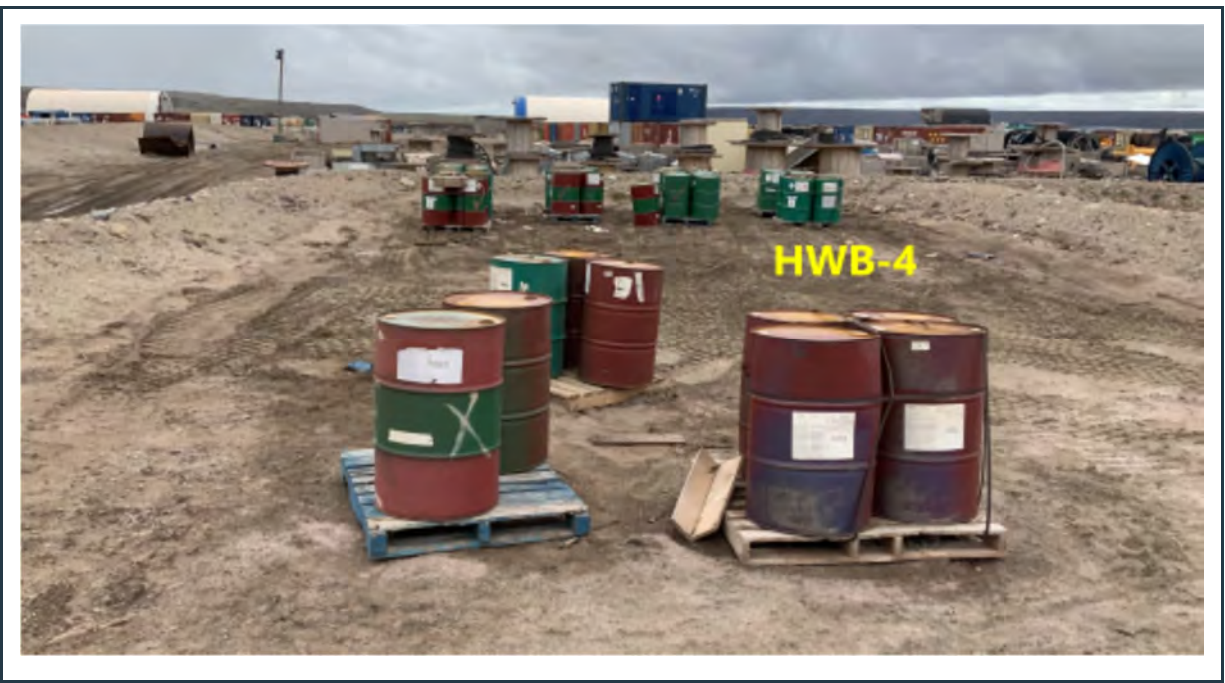
Figure 19: View of the stable berms around the HWB-4 cell, with a few fuel barrels stored on wooden pallets in the cell. The debris, visible in the cell should be removed.

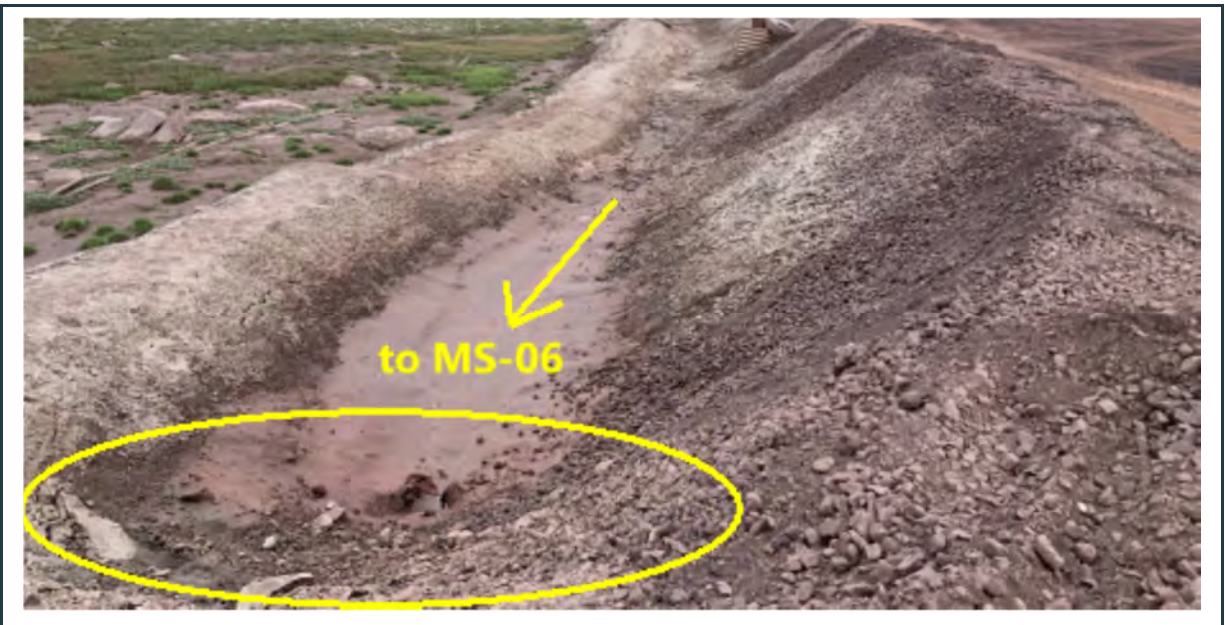
Figure 25: View of the partially clogged intake end of the culvert (yellow circle), shown in Figure 24. This end of the culvert should be cleaned as soon as practically possible.

Recommendation: One side of a culvert is partially blocked and should be cleaned to facilitate uninterrupted flow of water through the pipe. A second culvert is damaged and clogged. This culvert should be replaced or restored. Alternatively, this culvert could be removed permanently and the slopes of the ditch reinstated.

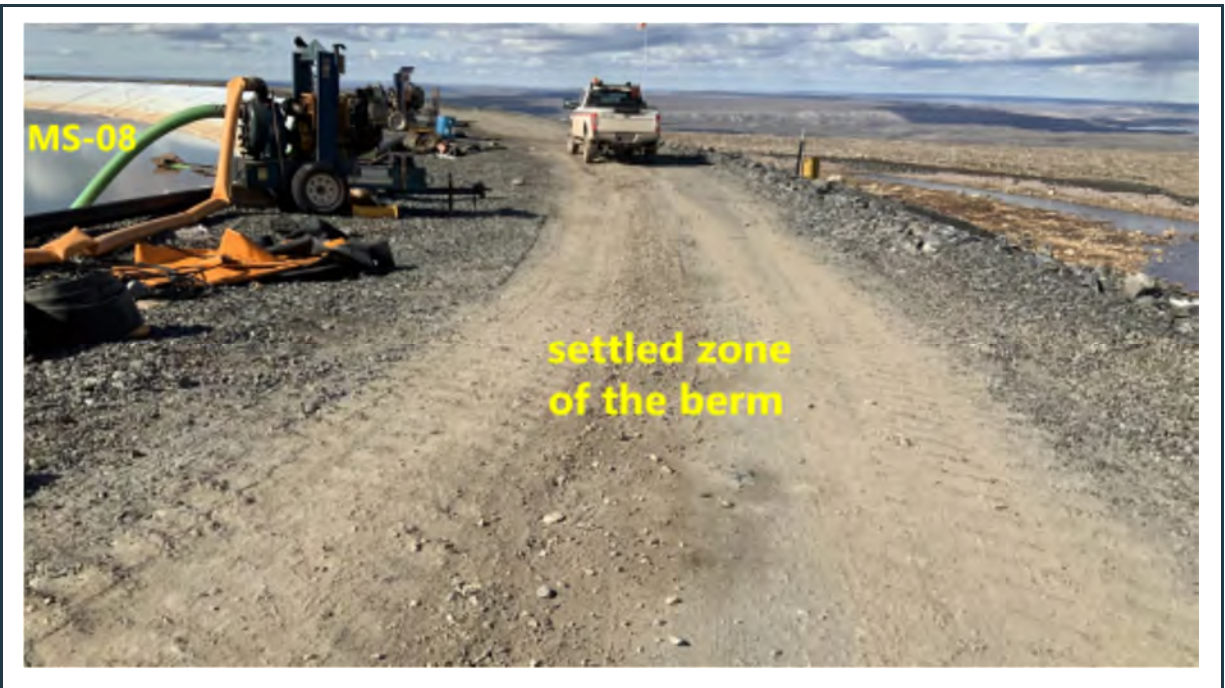
Figure 30: View of a settled zone of the berm, where two pumps are located. The anchor trench of the liner is still in its original position. The crest of the berm along this zone should be raised to its original crest elevation by crushed aggregate.

Recommendation: Along the settled zone, the crest of the berm should be raised back to its original elevation by placement of crushed aggregate/rock fill.

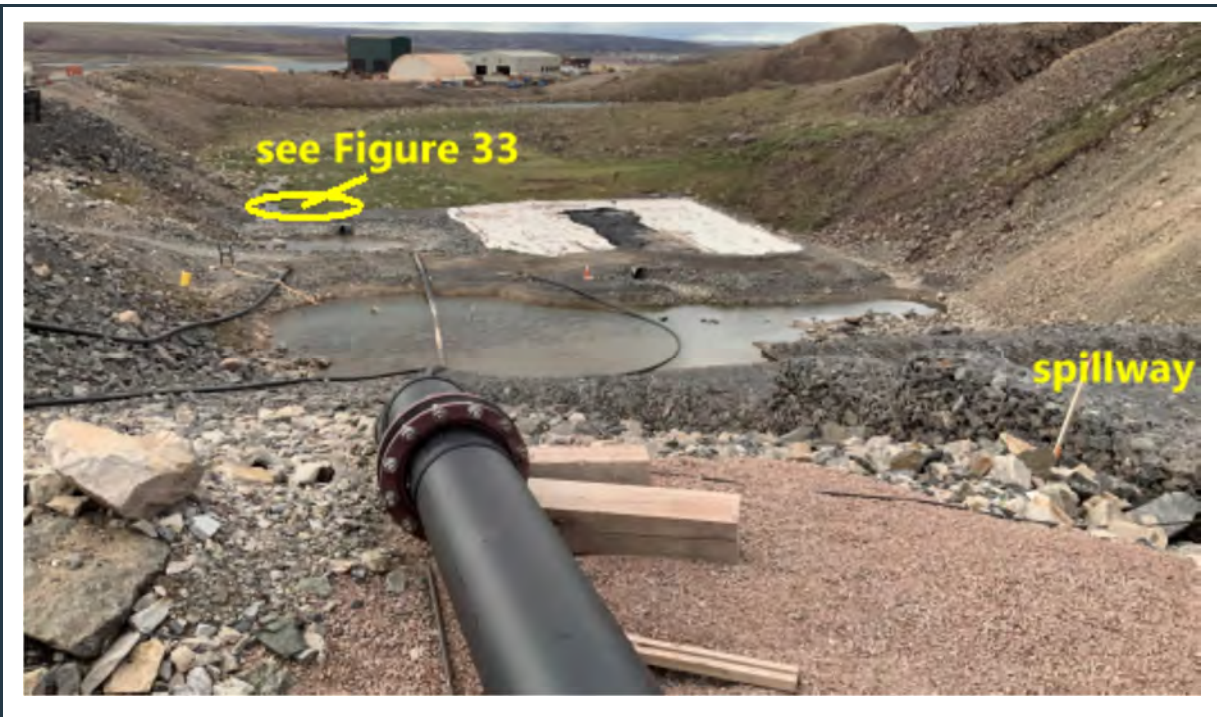
Figure 32: View of the downstream side of the spillway at the main dam of the KM105 sedimentation control pond. The presence of water at the toe is the result of "piping" beneath the dam. See the enlarged image of the location marked by the yellow circle in Figures 33 and 34.

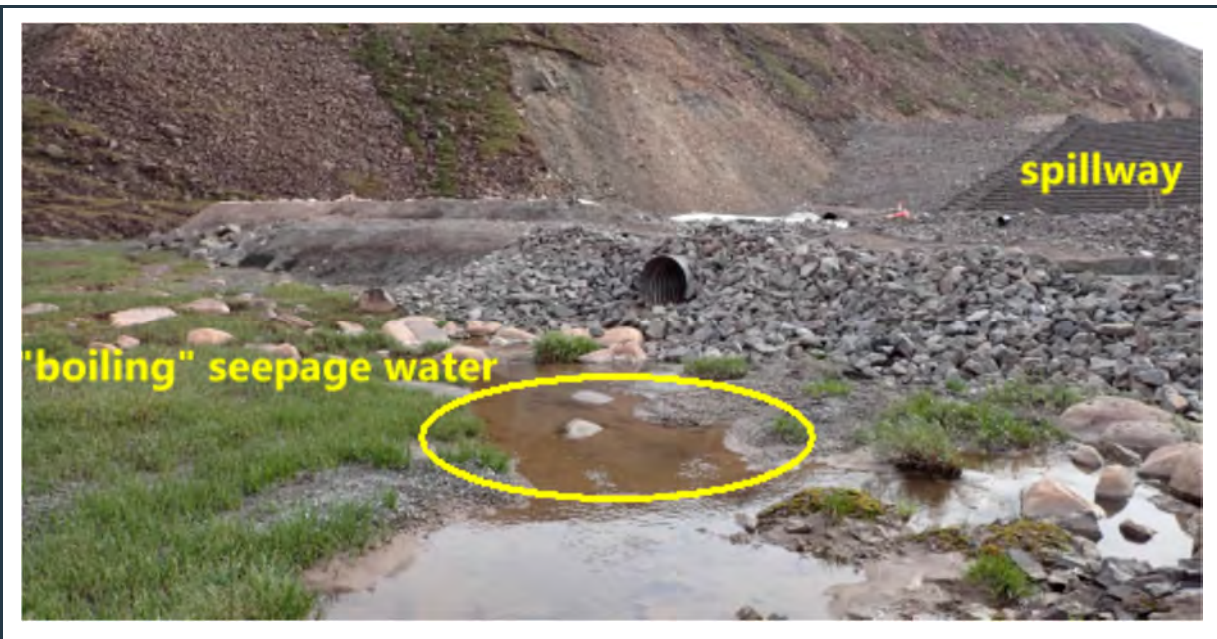
Figure 33: View of the location of "boiling" seepage water at the downstream toe of the spillway of the main dam at MS-11.

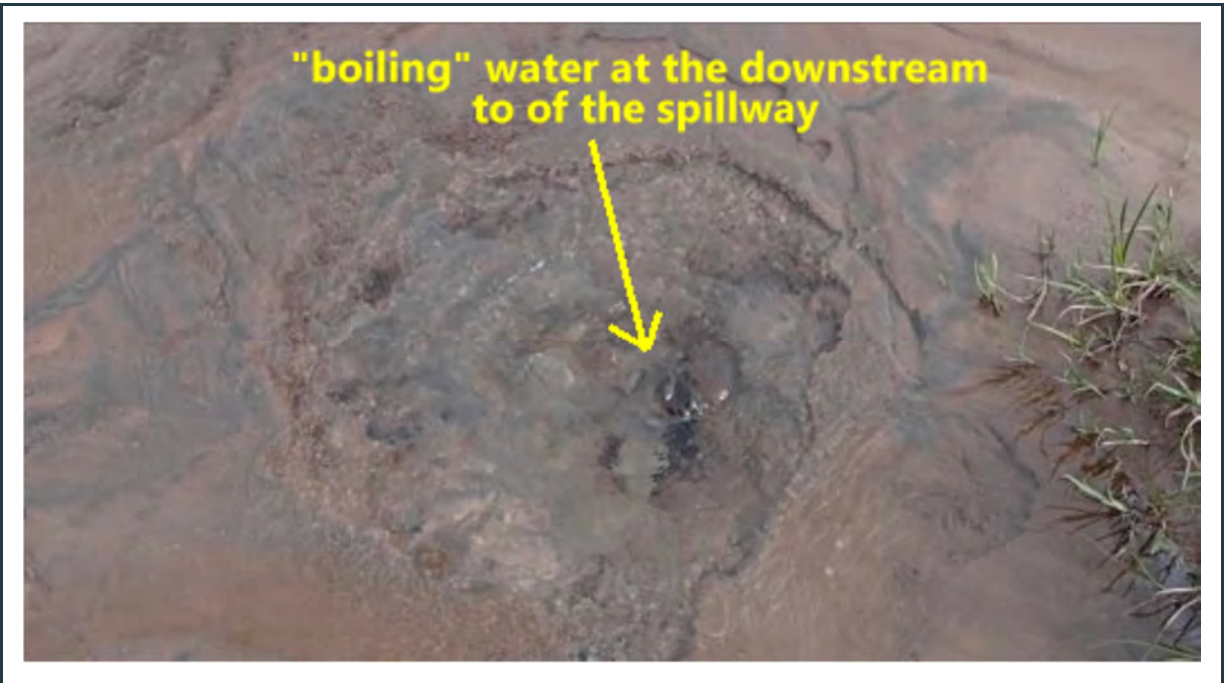
Figure 34: View of boiling water at the downstream toe of the spillway of the main dam at MS-11.

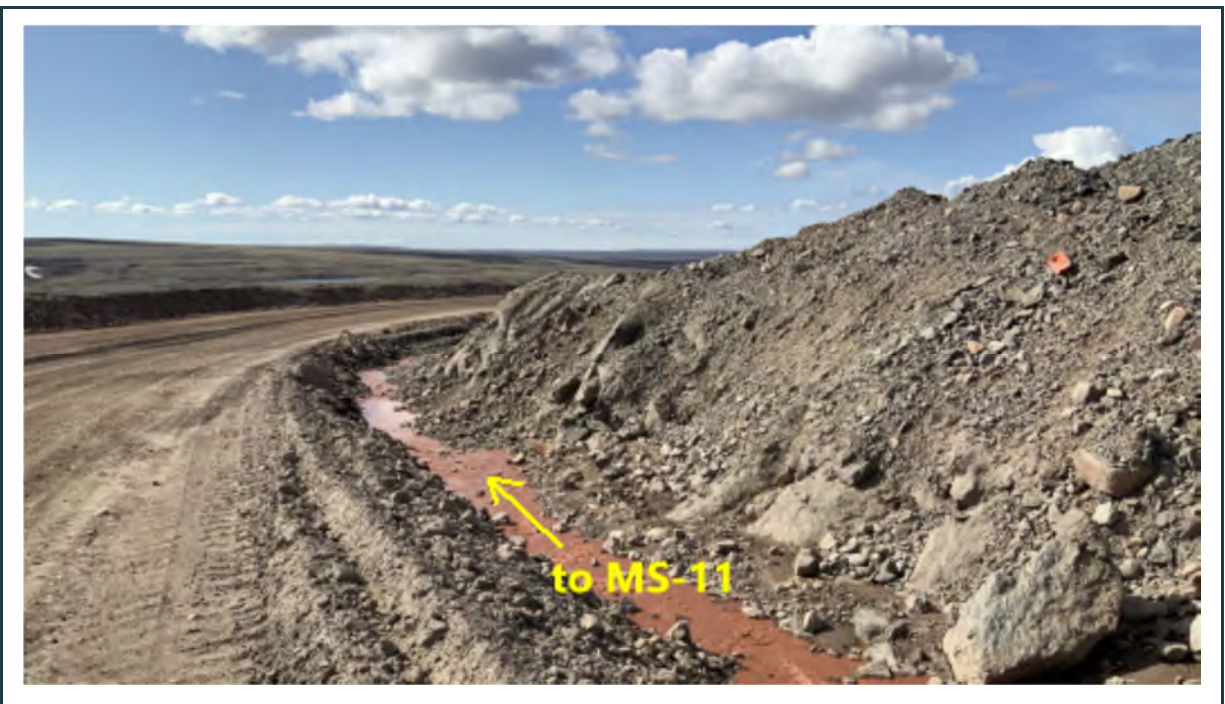
Figure 35: View of the side-ditch along the haul road draining surface water into the MS-11 sedimentation control pond. Note the muddy water in the ditch, entering the pond.

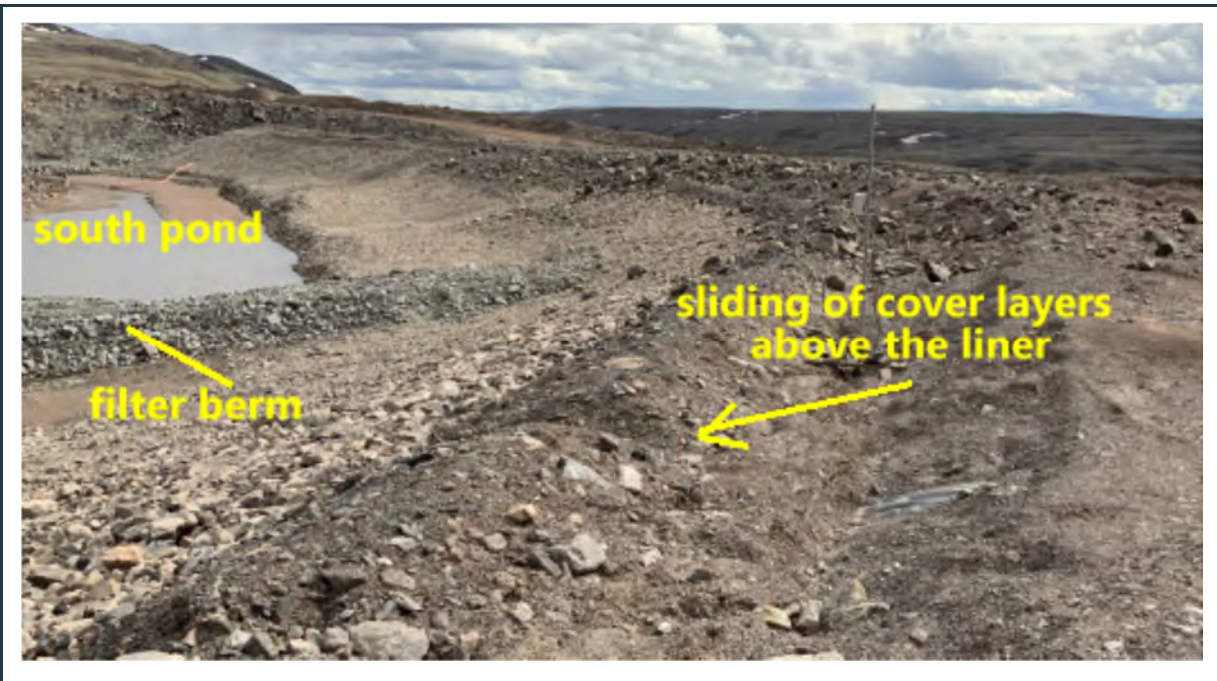
Figure 36: View of the new filter berm and sliding of the cover layers above the liner in the MS-11 south pond (image was taken in July 2025). See Figure 5 for the location of the new filter berm within the south pond.

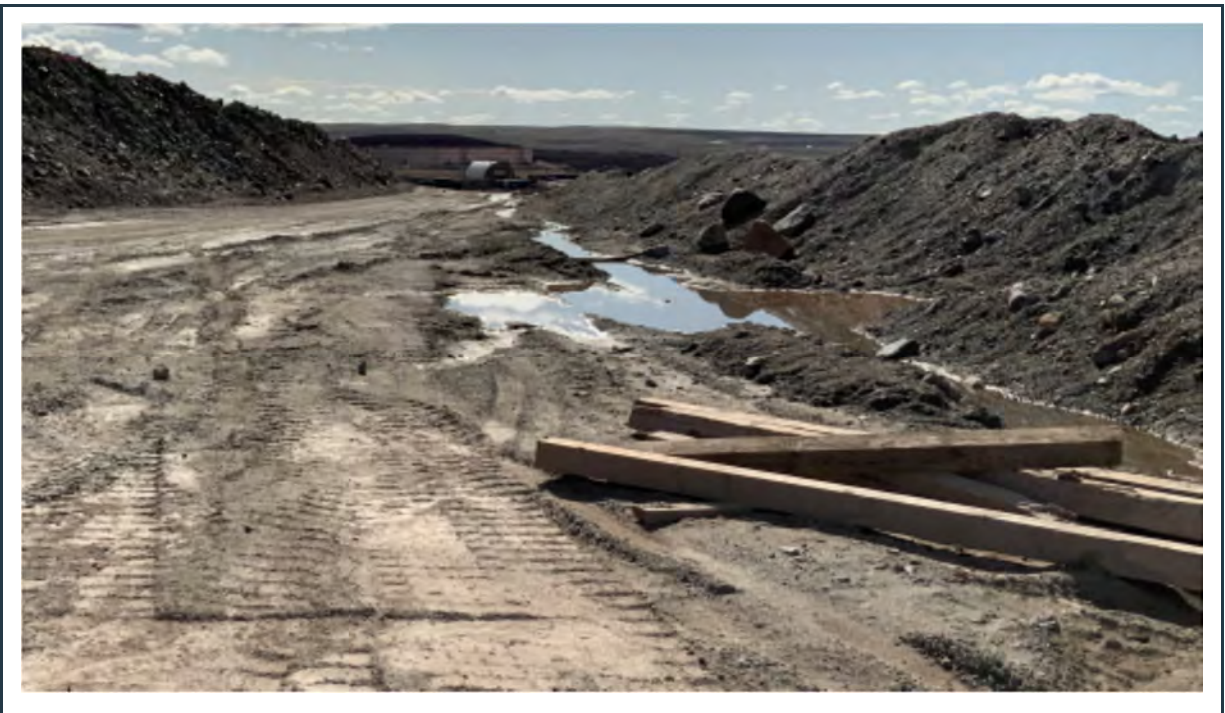
Figure 45: Drainage problems still exist at the first quarry level. Surface drainage shall be rectified.

Recommendation: The uncontrolled surface water presents not only potential slope stability issues in the area, but also traffic safety issues as well, particularly during freezing periods. If the operation in the quarry were to resume, the surface water at the quarry’s main level should be collected in drainage ditches and sumps excavated at strategic locations, and then properly drained from the sump(s) down on the side-slope of the plateau to maintain traffic safety and stable slopes.

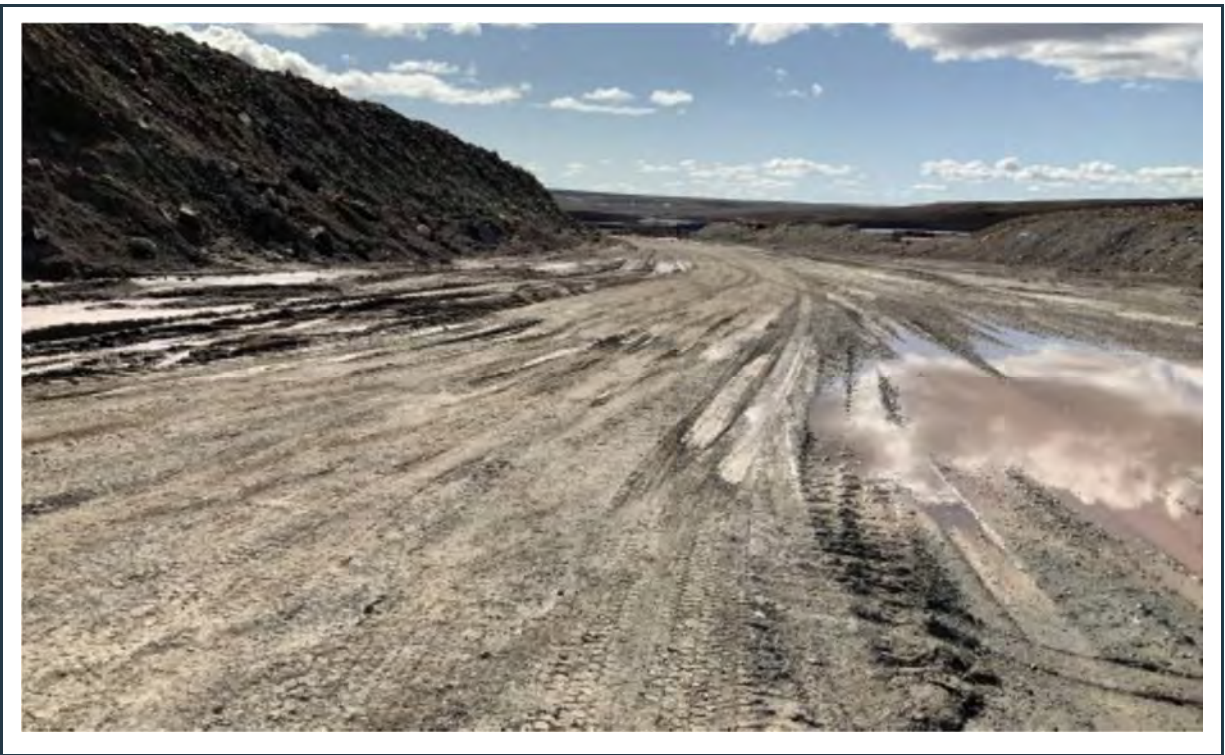
Figure 46: Drainage problems still exist at the first quarry level. Surface drainage shall be rectified.

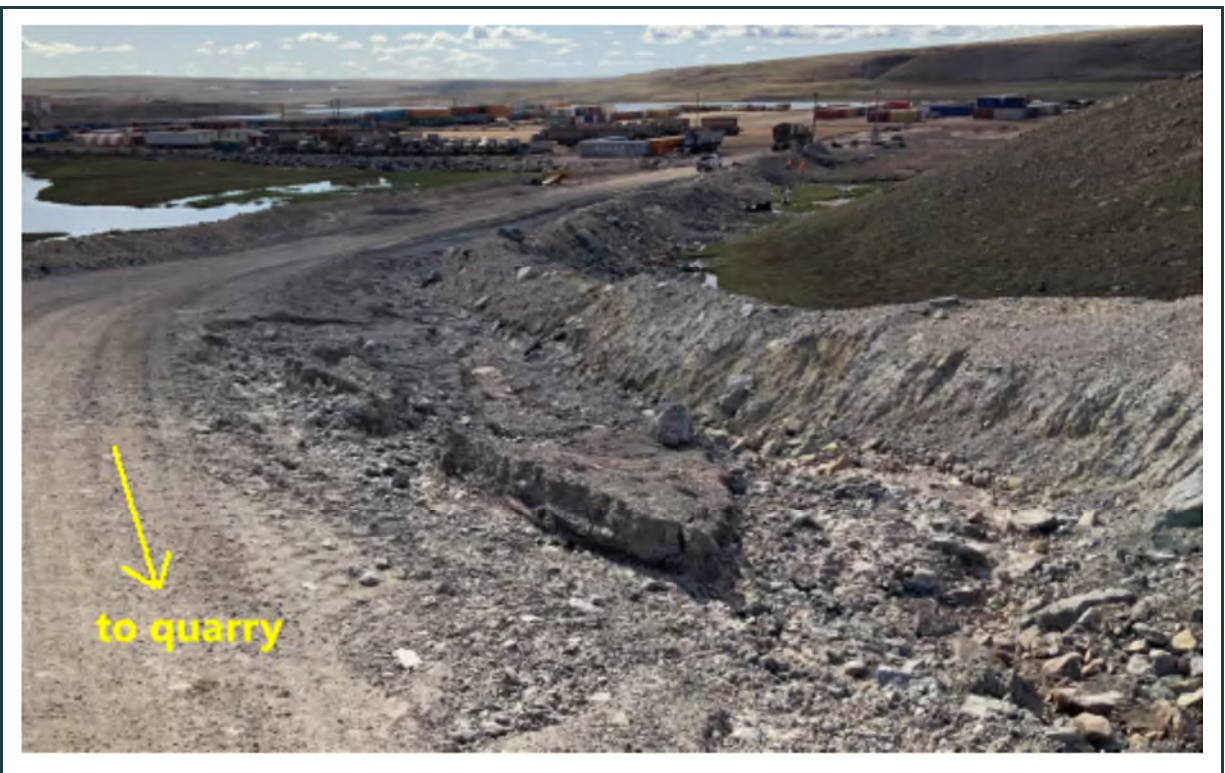
Figure 47: View of erosion related problems along the edge of the access road to the quarry.

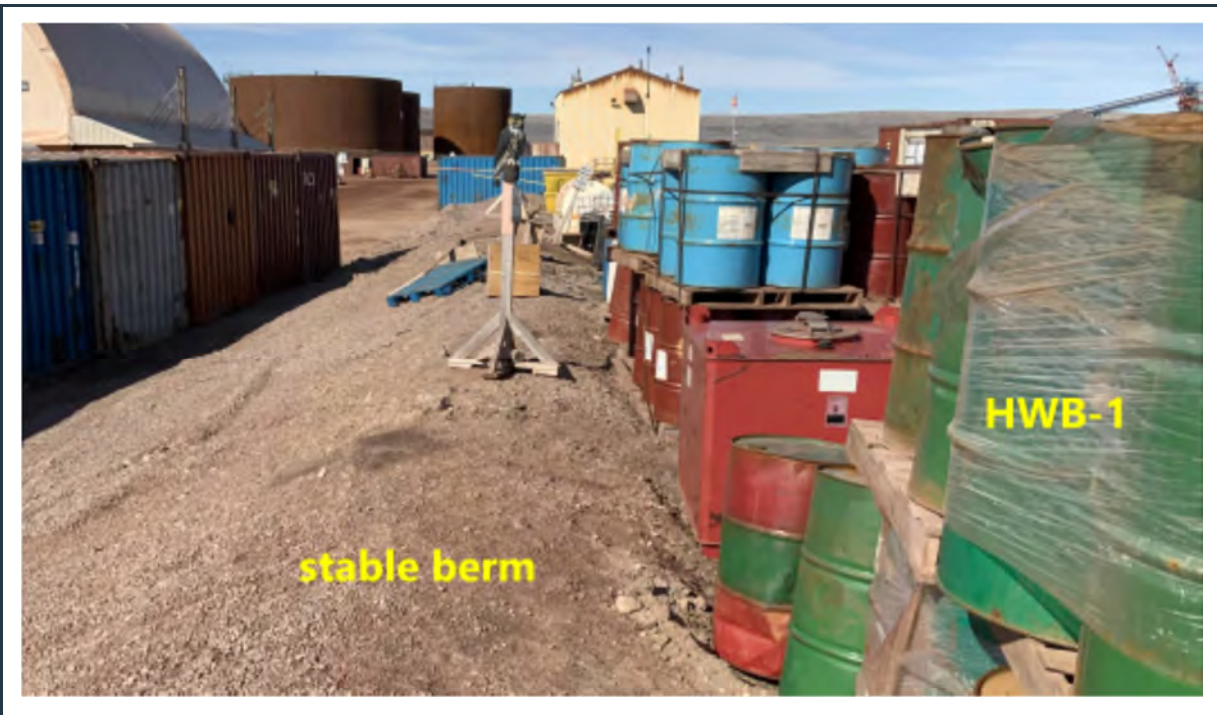
Figure 48: View of the stable perimeter berm around the lined HWB-1 cell with various materials and seven shipping containers stored within the cell. Materials on pallets should be stored within the cell, not on the berms.

Recommendation: Materials on pallets should be stored within the cell, not on the slopes and crest of the berms.

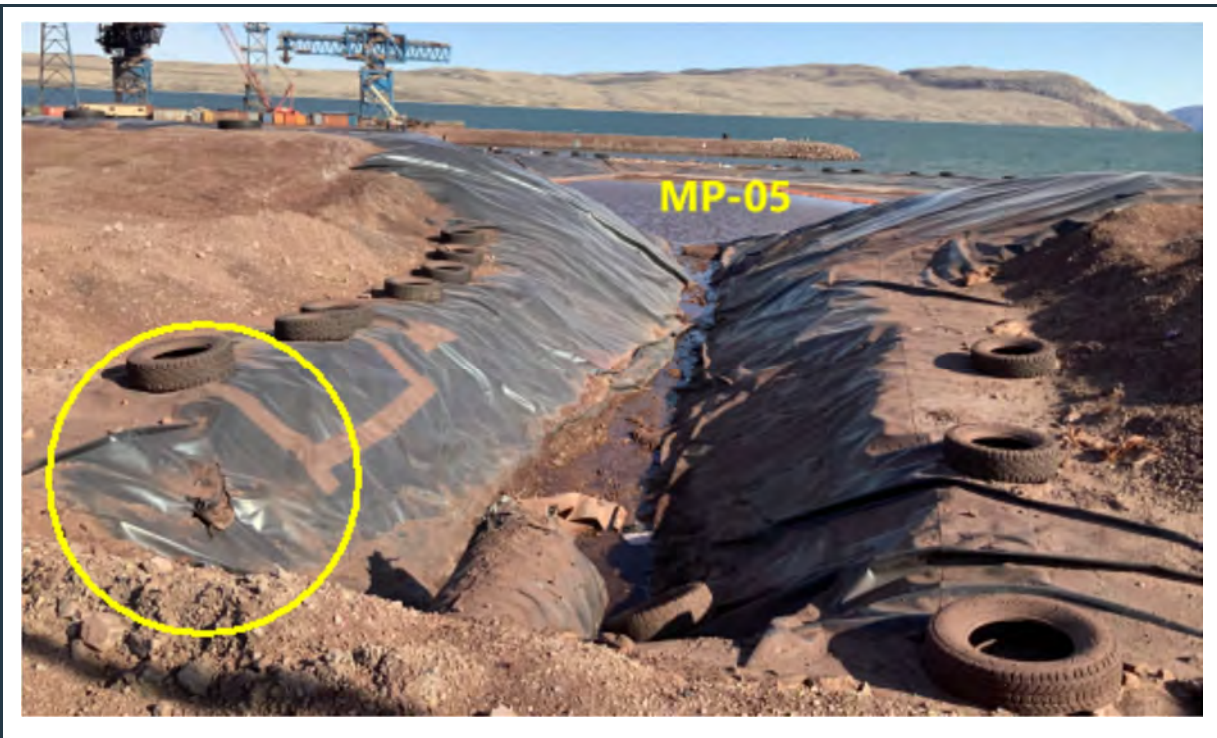
Recommendation: Minor damage was noted in the liner at the intake channel to the MP-05 pond, as shown in Figure 58. The damage should be repaired as soon as practically possible.

Figure 58: View of the slightly damaged liner (yellow circle) at the intake channel to the MP-05 pond.

Baffinland Action: Baffinland notes that that the damage in no way currently impairs the conveyance of water to the pond and the impacted liner is well above the high-water mark of flow from the ditches. Baffinland will continue to monitor the liner damage and make repairs should it functionally impact the water conveyance

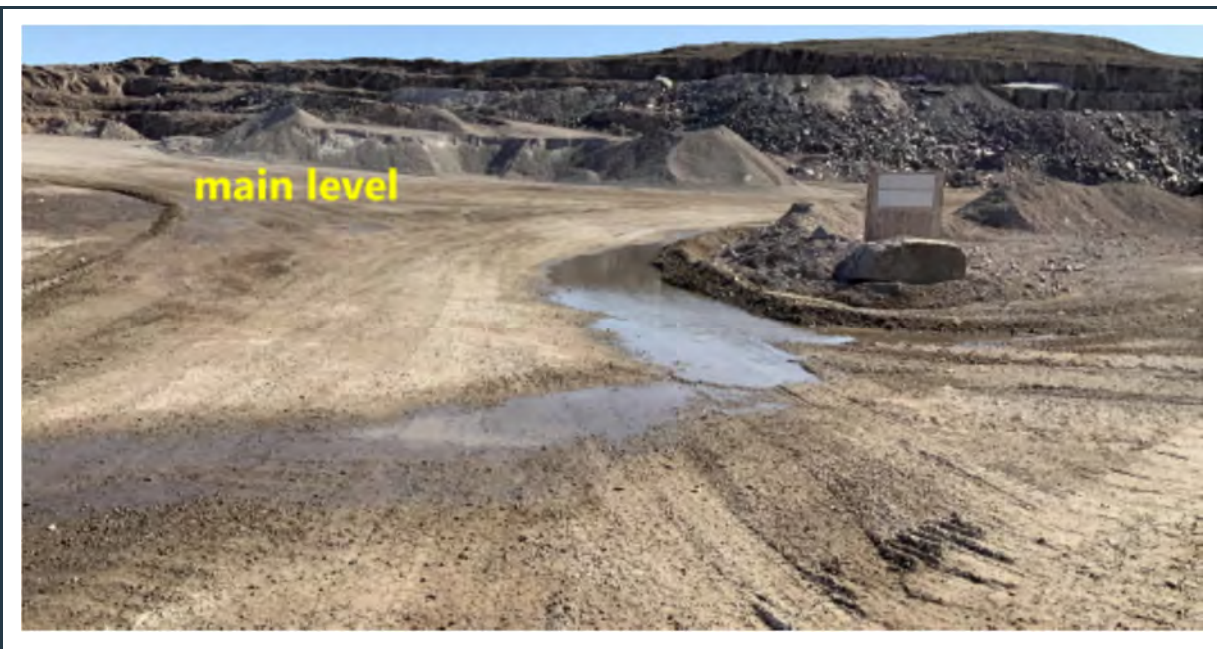
Figure 61: View of ponding and flowing water in many areas of the lower (main) level of the Q01 rock quarry. The drainage problem should be rectified prior to restarting the operation in the quarry.

Recommendation: It is suggested that additional drainage ditches be provided within the new fill pad (around its perimeter at strategic locations), to improve the control of surface water in the area. The

Baffinland Action: Baffinland acknowledges the recommendation for the Q01 Rock Quarry area. Surface water management will be supported through pumping activities as required to maintain proper drainage and address ponding water. Baffinland also confirms that remedial work to address the missing riprap and associated erosion along the P-SWD-5 (“Q01-North”) ditch is scheduled for the next construction season. Baffinland will continue to monitor water quality coming from the quarry in alignment with the applicable Management Plans and the Water Licence.

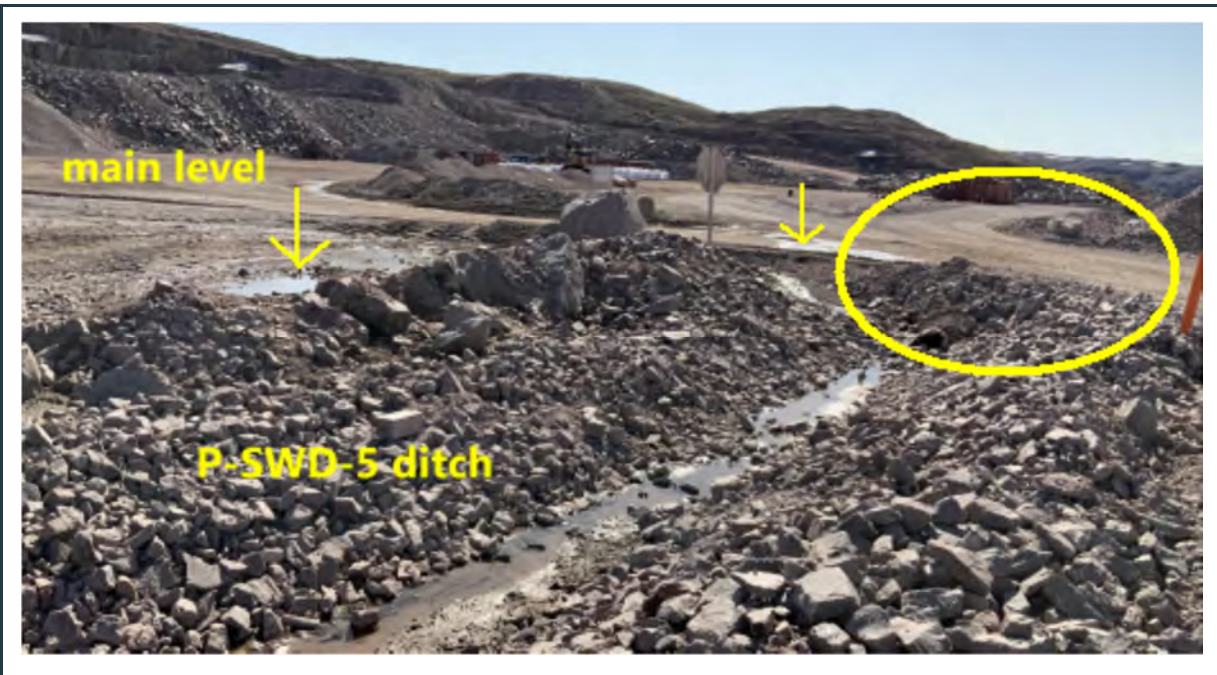
Figure 62: Poor surface water control in many areas of the lower (main) level of the Q01 rock quarry. The culvert at the entrance to the quarry (yellow circle) must be replaced.

The improvement of this section of the ditch shall be completed with the formation/excavation of additional drainage ditches, required to rectify the ponding water issue that is present in many parts of the lower (main) level of the quarry, as pointed out above. Figure 62 also shows a clogged, undersized culvert under the access road to the quarry in this P-SWD-3 ditch. The clogged, undersized culvert should be removed and replaced with a larger diameter pipe at this location.

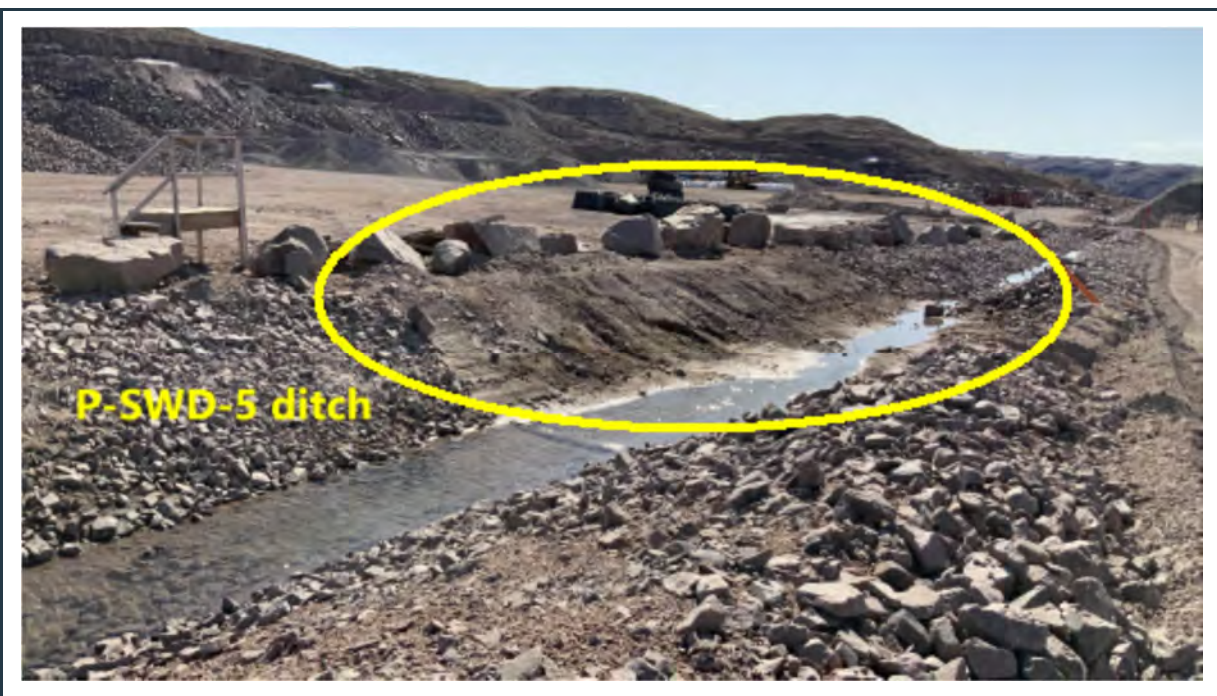
A section of the P-SWD-5 (“Q01-North”) ditch is missing riprap cover along a section of the quarry’s main level. As pointed out in earlier reports, it appears that there is continuous subsurface water seepage from within the adjacent granular pad of the quarry’s main level at that location, resulting in periodic sloughing/erosion of the quarry side of the ditch just along this short section shown in the image. It is recommended that the somewhat finer soil, currently forming the side of the ditch, be removed to a depth/width of around 1 m and replaced with crushed rock fill. To minimize migration of fine soil particles from the quarry’s granular pad to the ditch, the crushed rock fill should be placed over a layer of geotextile fabric.

Figure 63: P-SWD-5 – “Q01-North” surface water collection ditch with missing riprap at one section of the ditch. Note the continuous seepage from the granular fill pad of the quarry’s lower (main) level.
