**Baffinland Iron Mines Corporation  
Mary River Project**

**Construction Summary Report: Construction Summary Report: Milne  
Port Off-Spec Sewage Effluent Pond (PWSP)**

2013-12-19	0	Approved For Use	S. Potter	S. Hassan	S. Perry	O. Curran
DATE	REV.	STATUS	PREPARED BY	CHECKED BY	APPROVED BY	APPROVED BY

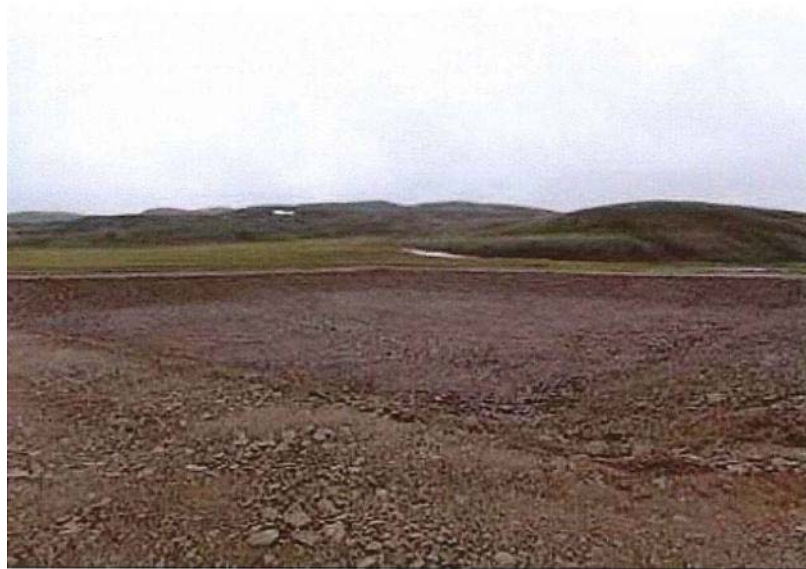
**Figure 1: Before – Sub-grade Prepared**

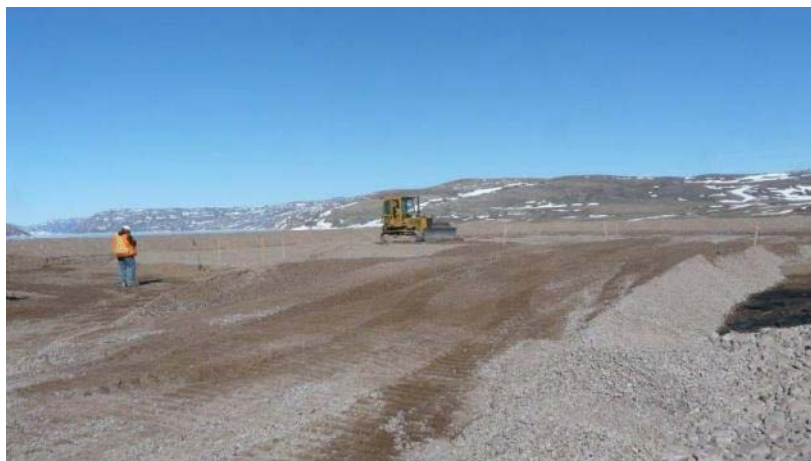
**Figure 2: Before – Levelling**

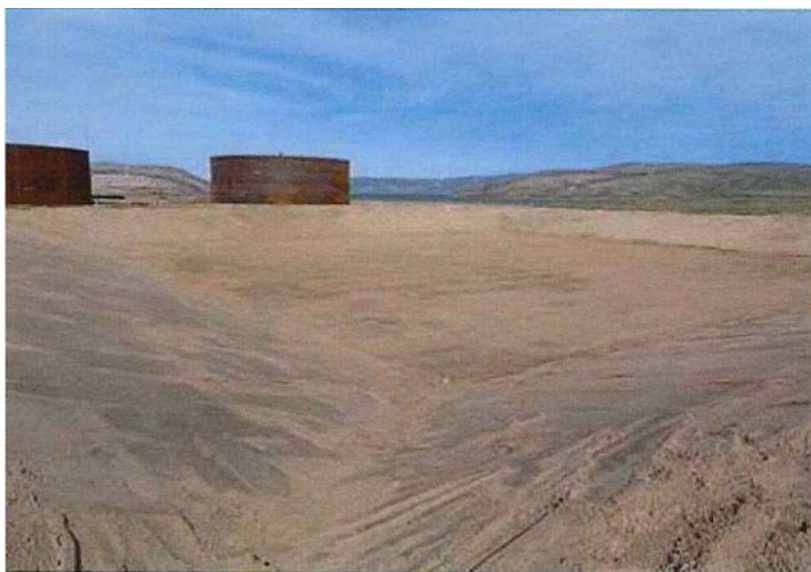
**Figure 3: During - Liner Installed**

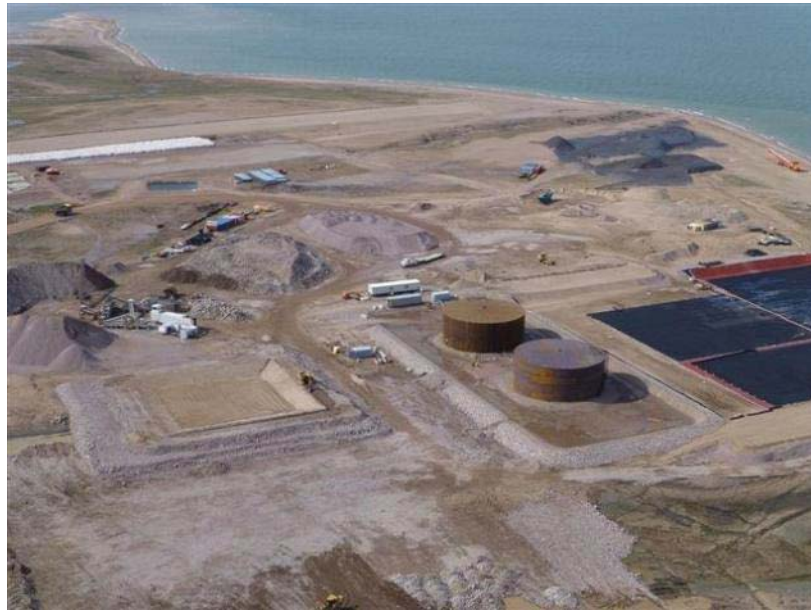
**Figure 4: During – Grading of Final Layer**

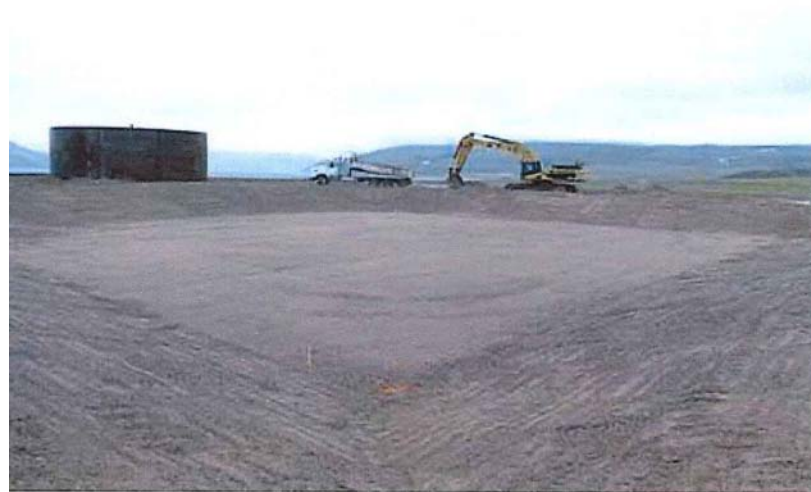
**Figure 5: Completed – Earthworks**

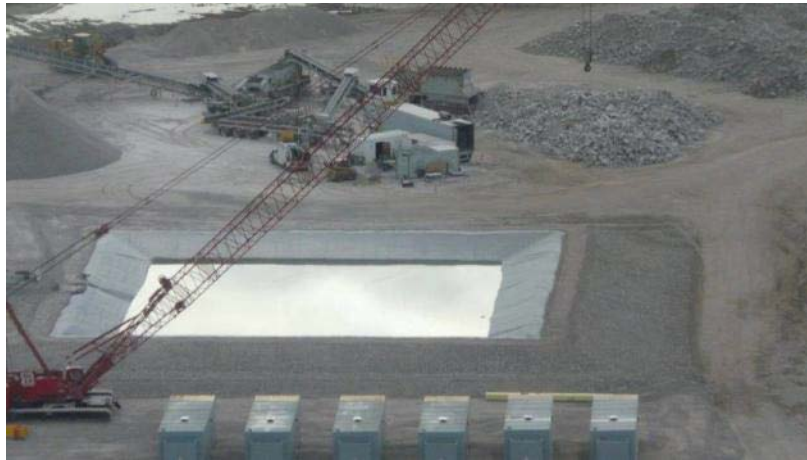
**Figure 6: Completed – Operational**
