## **4.0 MILNE INLET**

### **4.01 General**

### **Milne Inlet August Inspections**

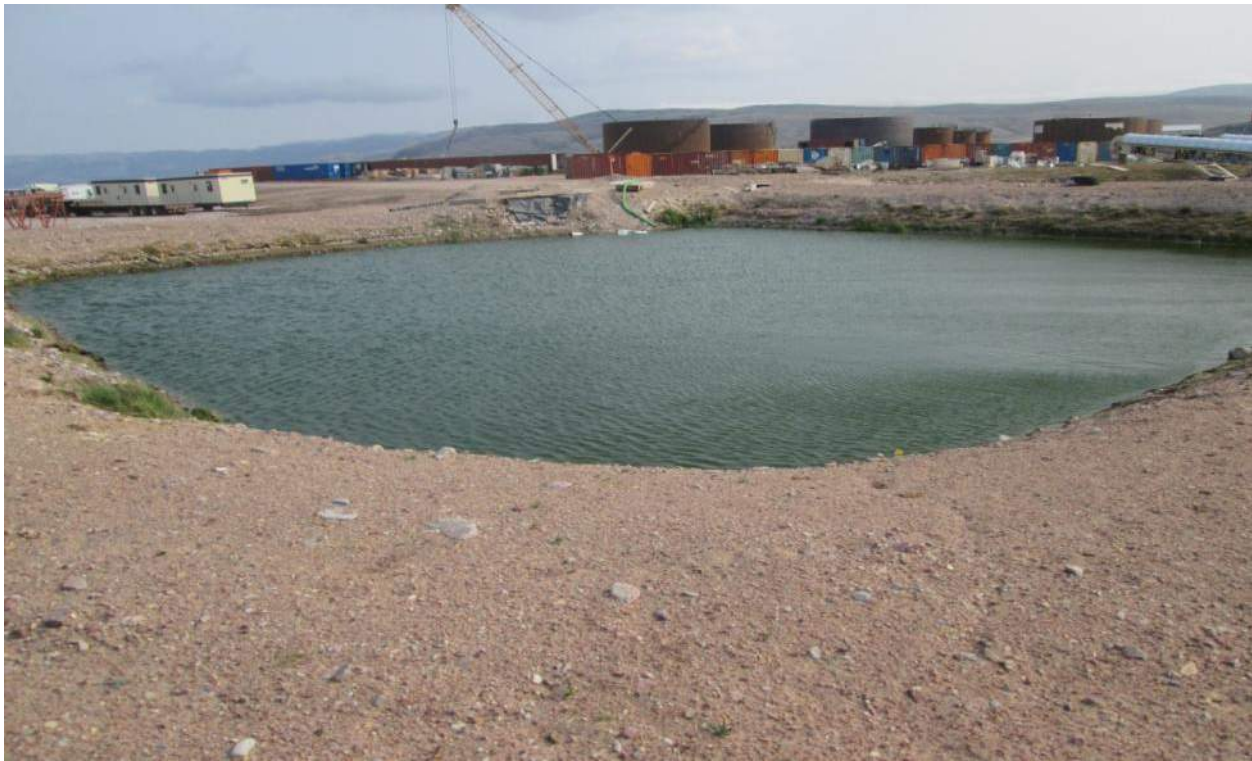
This particular PWSP is no longer part of the treatment process for sanitary sewage and in August was being pumped of effluent which was being transferred to the new effluent pond.

The structure is considered stable over the projected short life of the structure.

Photo taken from atop the soon to be decommissioned PWSP looking south.

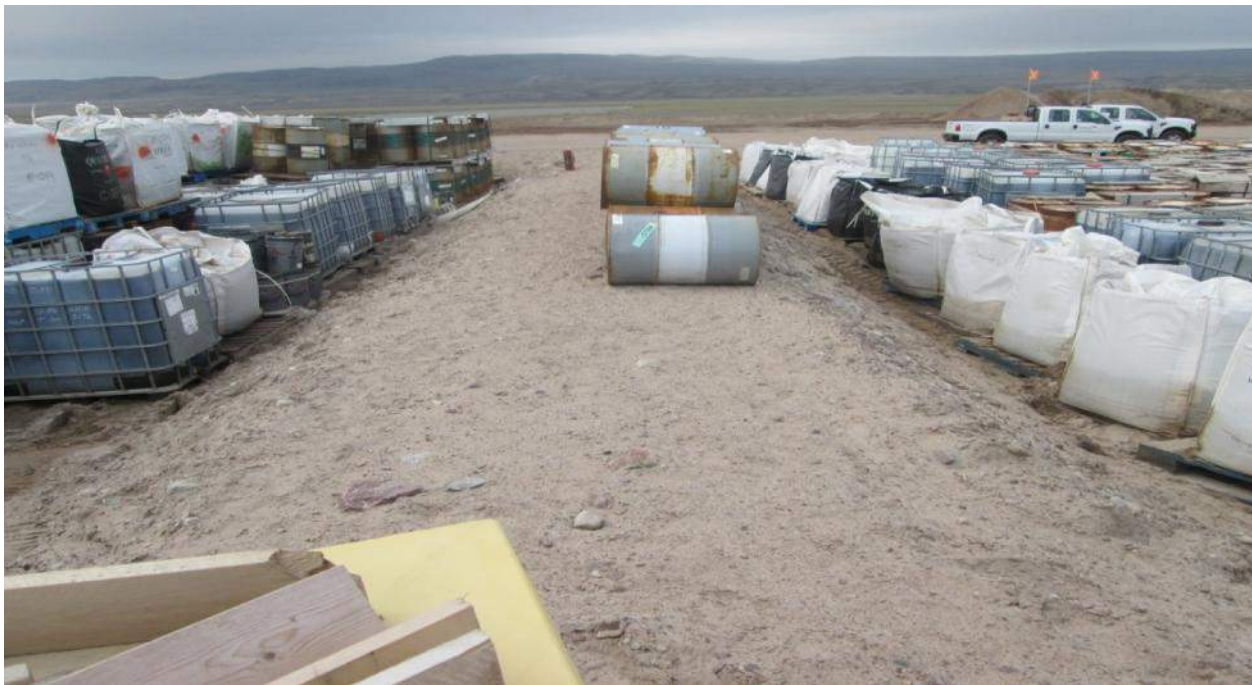
At the time of my August inspection, there was wet sand in the bottom of the two cells indicating the integrity of the liner.

Our review of the area around the cells, at the base of the exterior dyke slopes showed no sign of seepage, at that time.

Photo taken of central dyke in barrel fuel storage looking west.

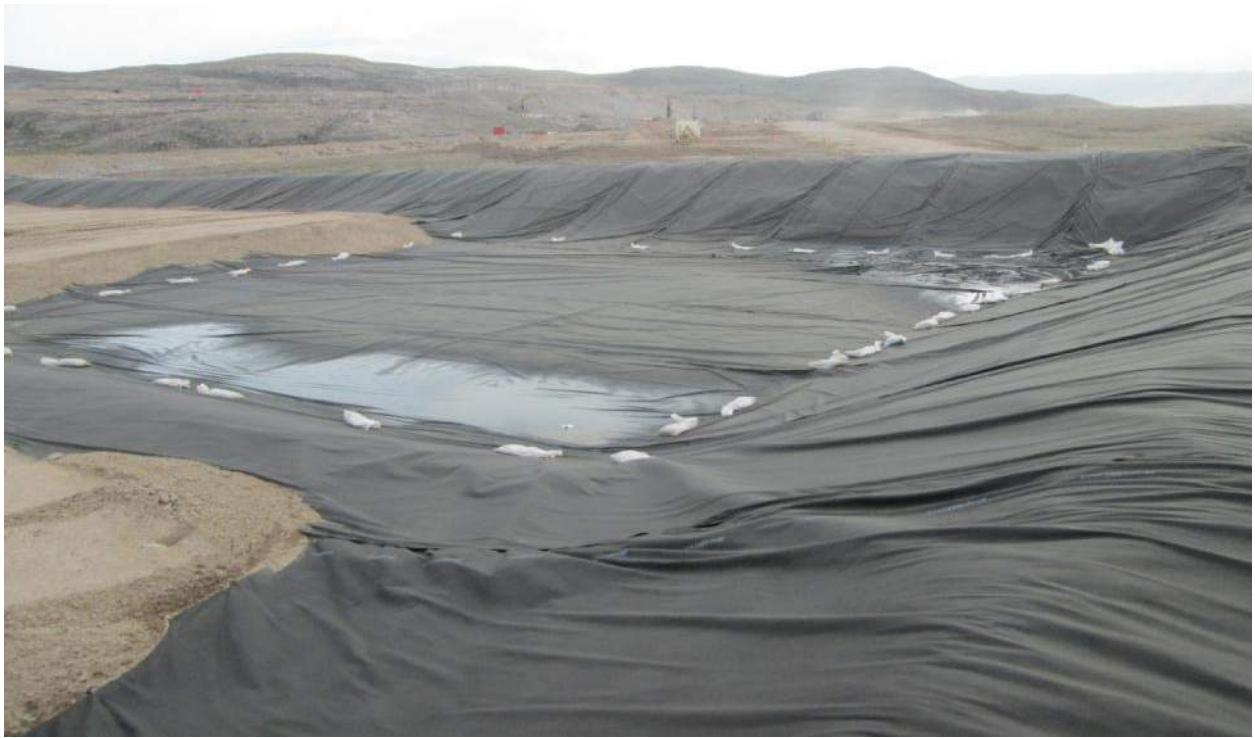
At the time of our August review, the base and dykes of the structure had been formed and the HDPE liner had been installed with a geotextile protection on each side. At the time of our September review the cover had yet to be installed on a small section of the dyke but other areas were covered.

Photo taken looking into the sump at the north east corner of the Landfarm.

We recommend that the remaining dyke structure without protective cover over it be covered as per the design drawings.

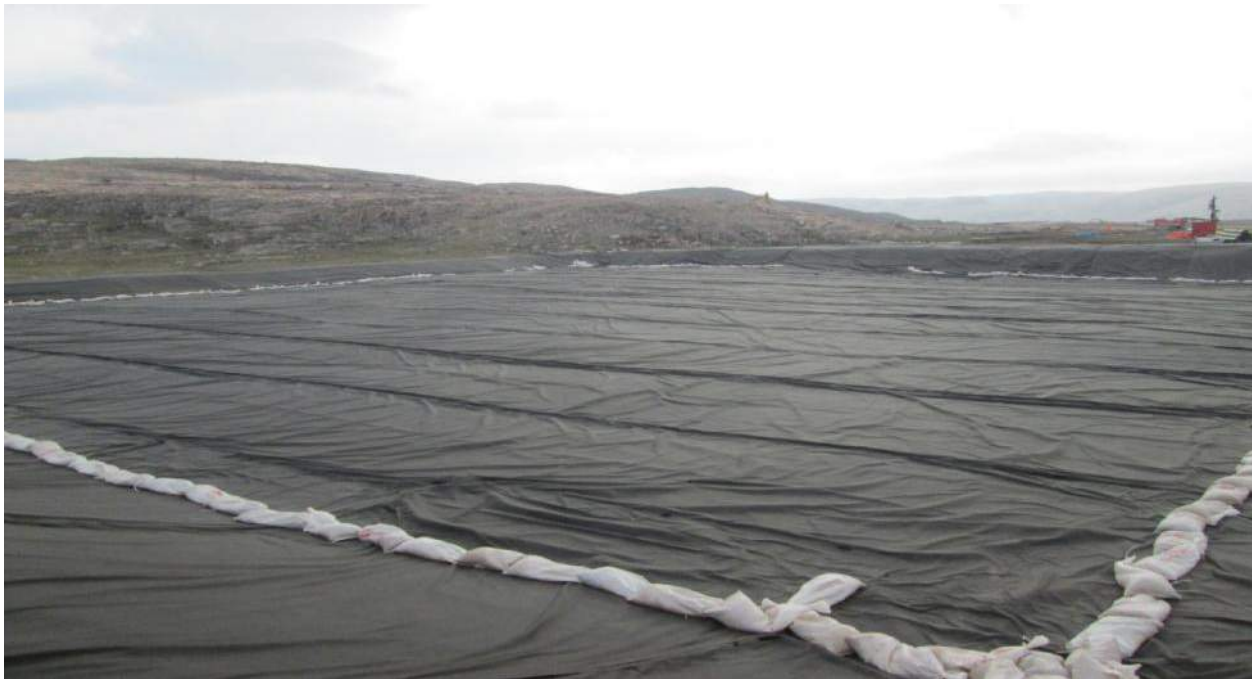
At the time of our August review, the base and dykes of the structure had been formed and the HDPE liner had been placed with a geotextile protection on each side. At the time of our September review construction had been completed in accordance with design drawings.

Photo taken from atop the dyke looking into the contaminated snow containment.

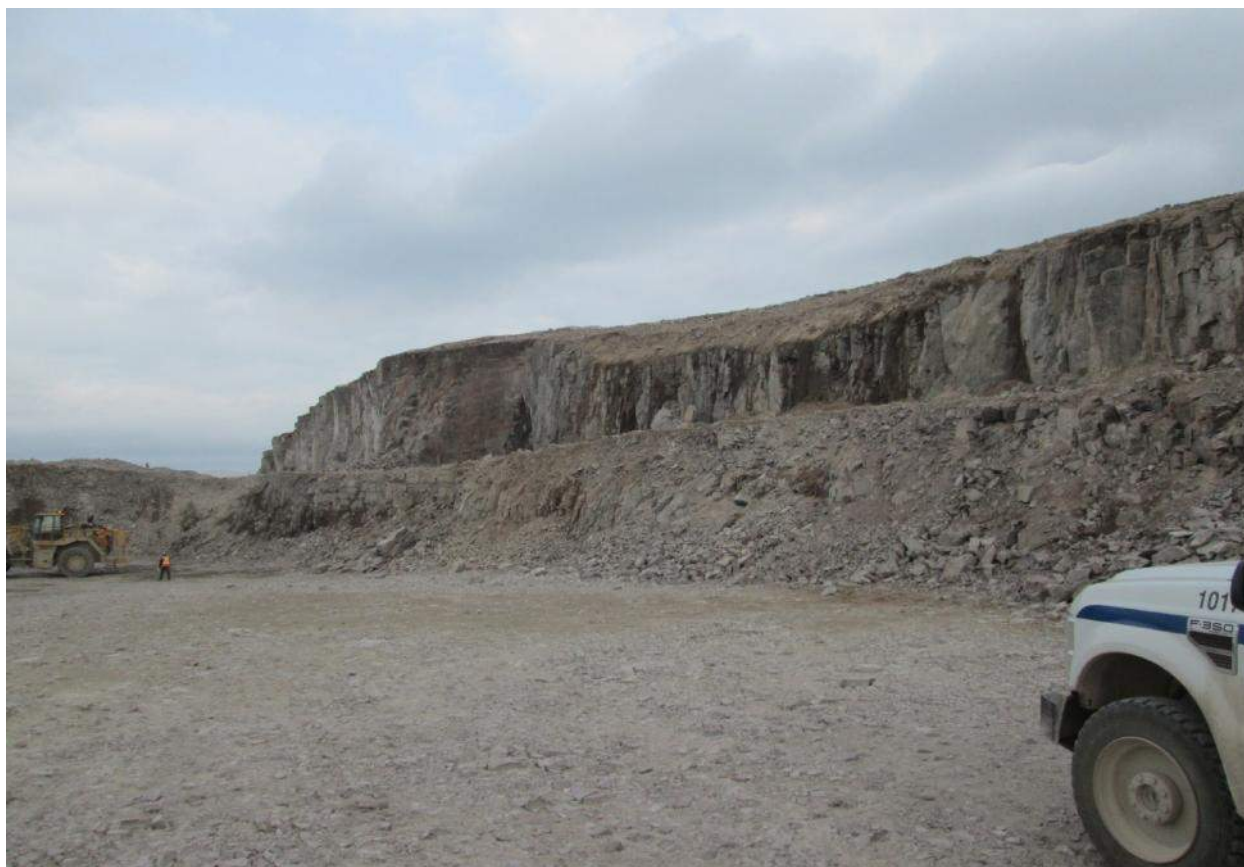
Rock faces appear stable.

Photo taken looking at the quarry face in the quarry showing the well developed benches and cover removed from atop solid rock.

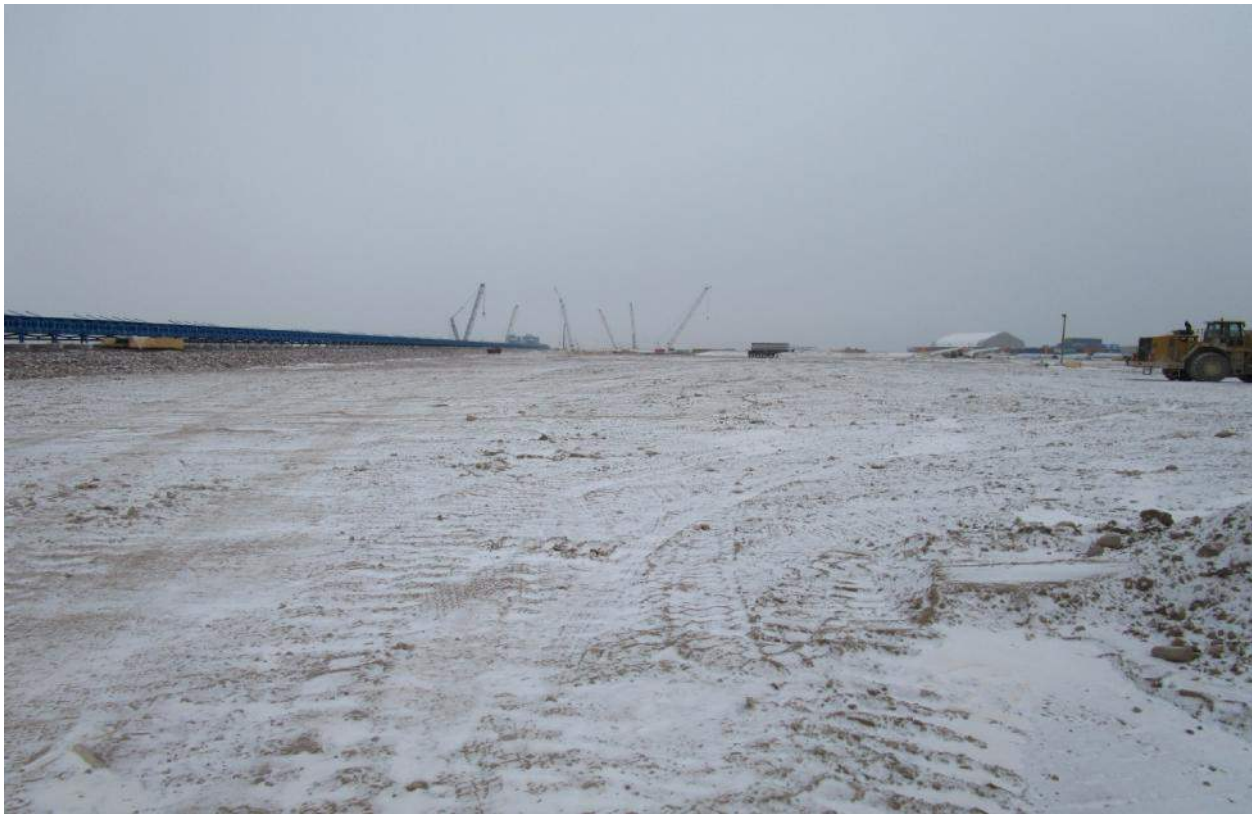
Our review of the area around the south end of the former Bulk Fuel Containment Facility showed no sign of oil or oil/water mixture and we conclude that the integrity of the liner has been maintained during the decommissioning process.

Site of recently decommissioned bulk fuel containment

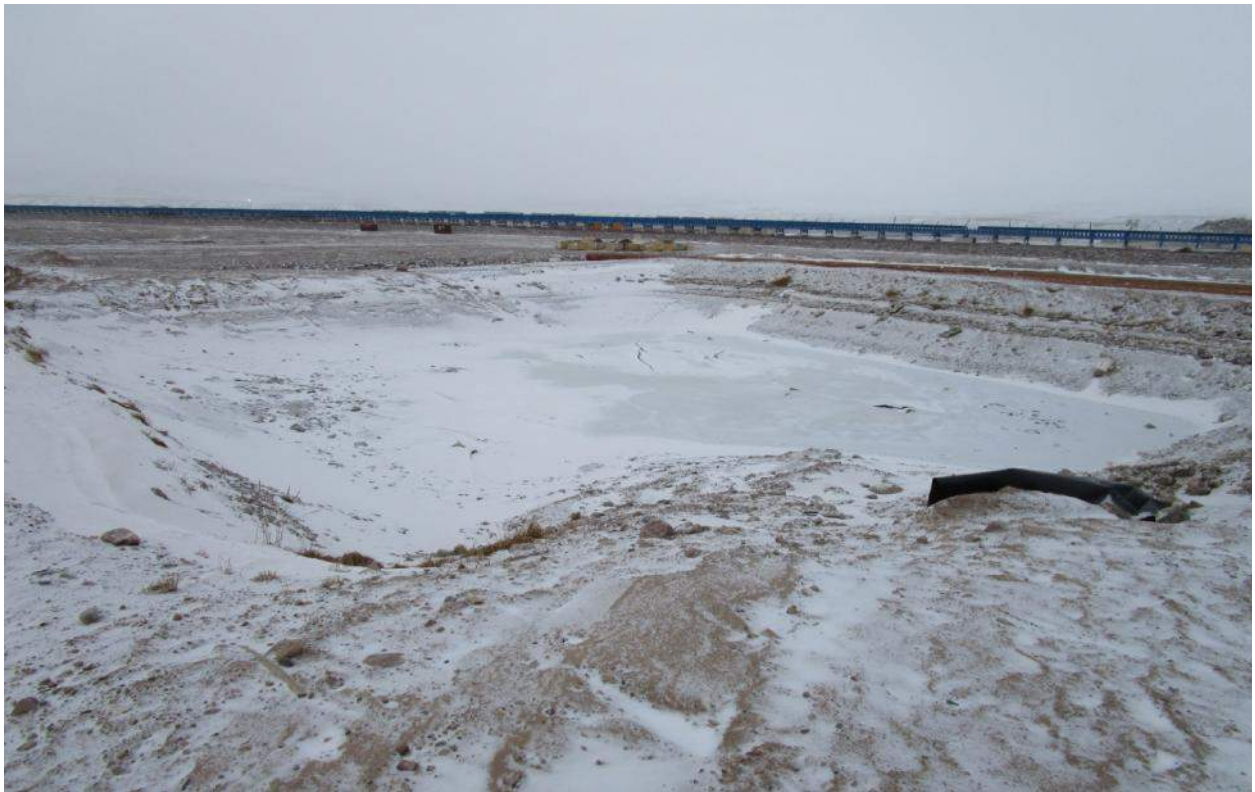
This transfer of effluent was part of the decommissioning of this PWSP. At the time of our second review in September, all effluent had been removed and the dykes were awaiting removal.

Existing PWSP now empty and being decommissioned

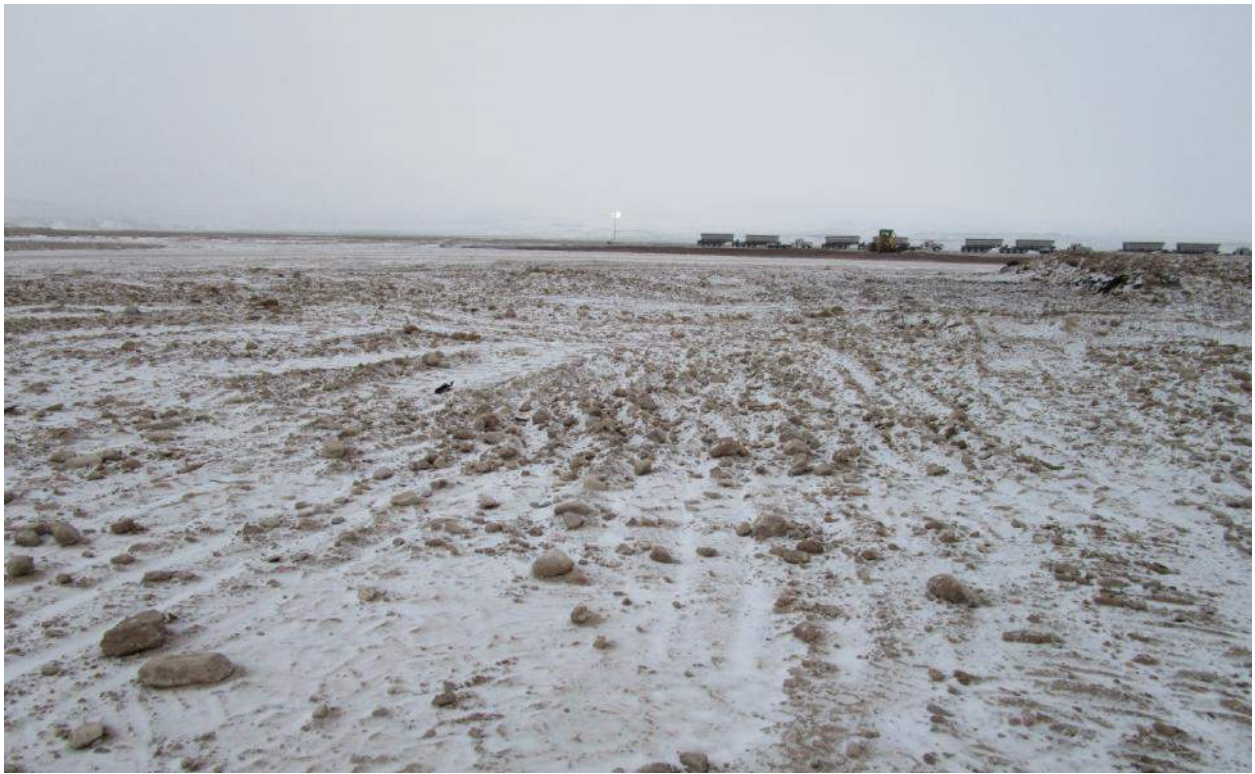
There was no sign of oil impacted granular in the area following decommissioning.

Site of recently decommissioned barrel fuel containment.

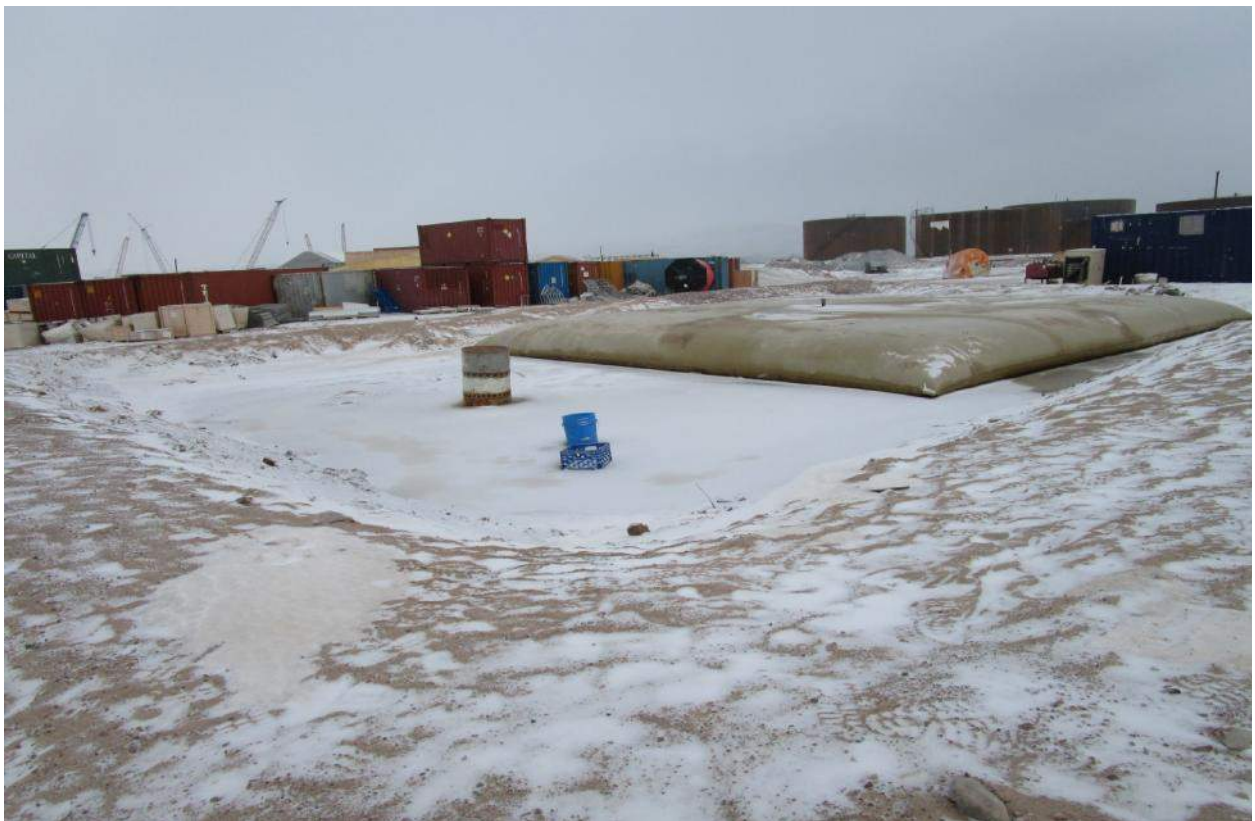
Hazardous waste storage containing bladder of contaminated material.

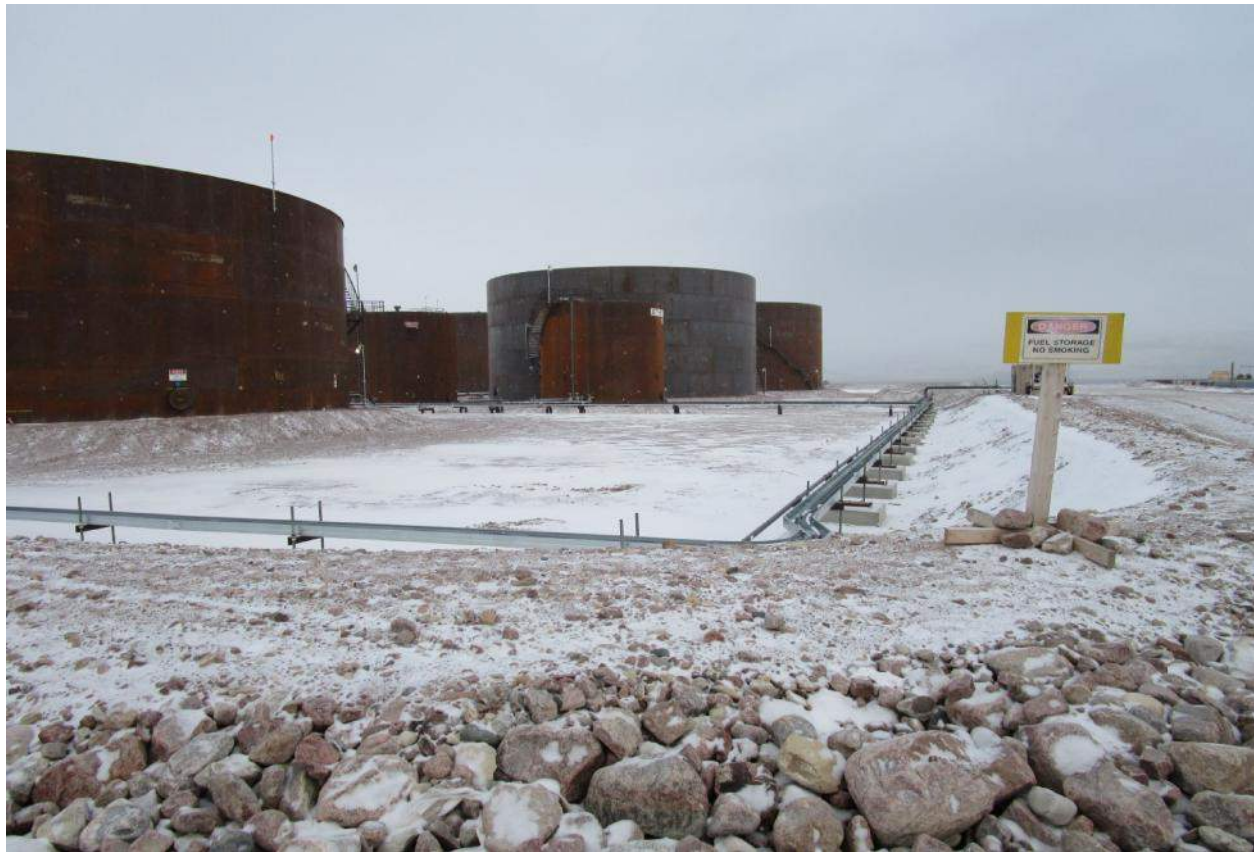
Fuel tank farm containment

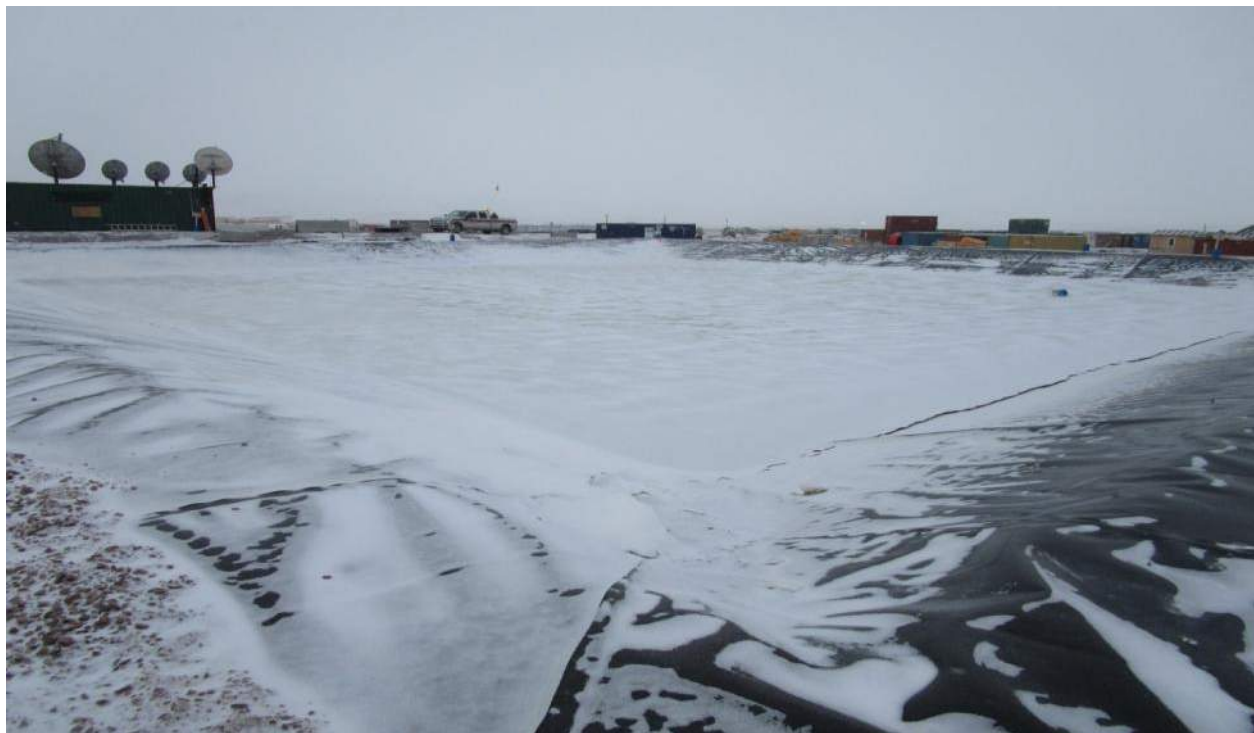
There was approximately 5' of freeboard at the time of our September review.

New effluent pond
