- D.1** BHM 14-084: Annual Geotechnical Inspection Baffinland Iron Mines Corporation Mary River Project – 2014 Inspections **[59 pages]**

ANNUAL GEOTECHNICAL INVESTIGATION

MARY RIVER PROJECT

2014 INSPECTIONS

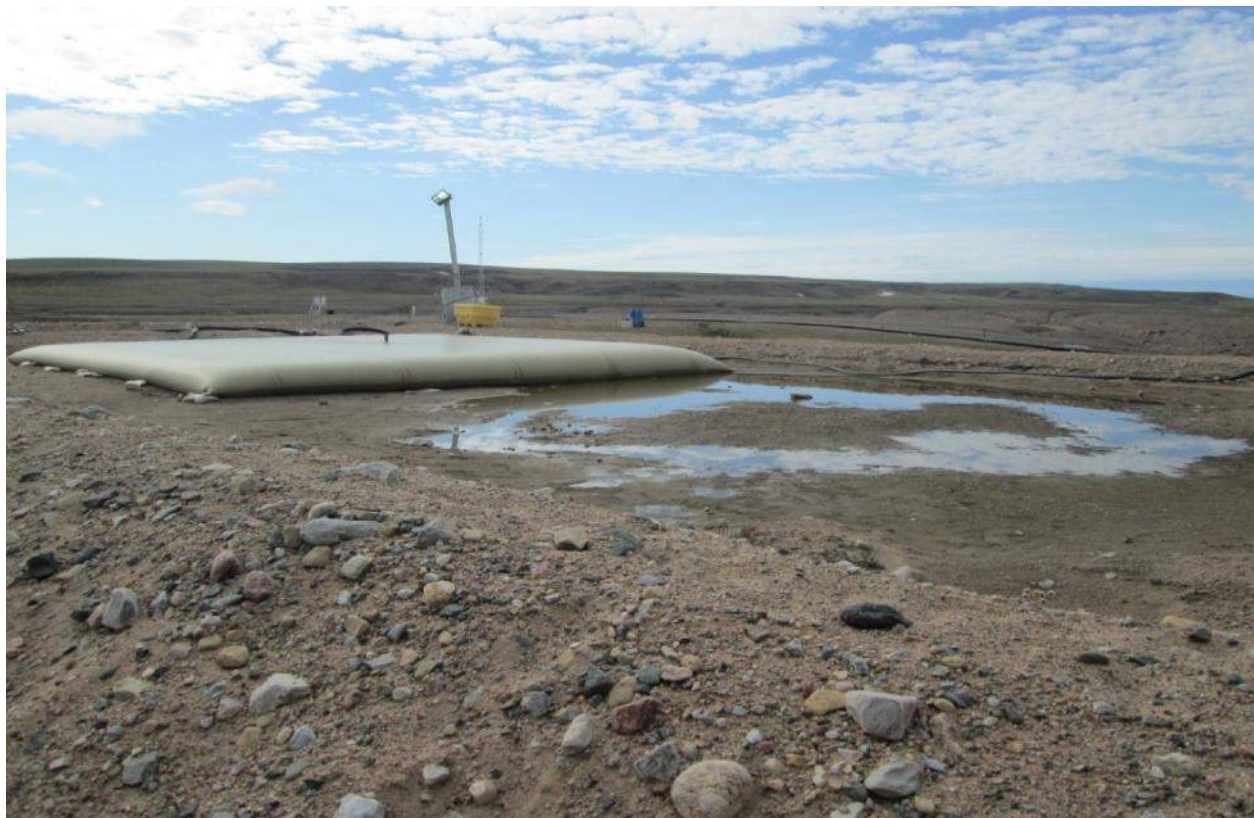
Generator Fuel Storage Facility Containment

At the time of our visit on August 1, 2013, the bladder height was measured at 21". There was water ponding in the bottom of the containment at the time of our review. At the time of our second review on Sept 26, 2014 the bladder height was measured at 20" and there was ice just above the gravel in the bottom of the containment.

The structure was visually inspected for any signs of subsidence or cracking and no such indications were noted. There was no sign of seepage at the base of the structure noted. The soil structure is considered to be stable in its present condition and is in conformance with our design principles.

We recommended that the water ponding above the bottom of the containment gravel cover be removed regularly by creating a sump in the gravel and pumping out the water to below the gravel surface.

We recommend that Baffinland Iron Mines continue to control the fuel in the bladder at a height of 30".

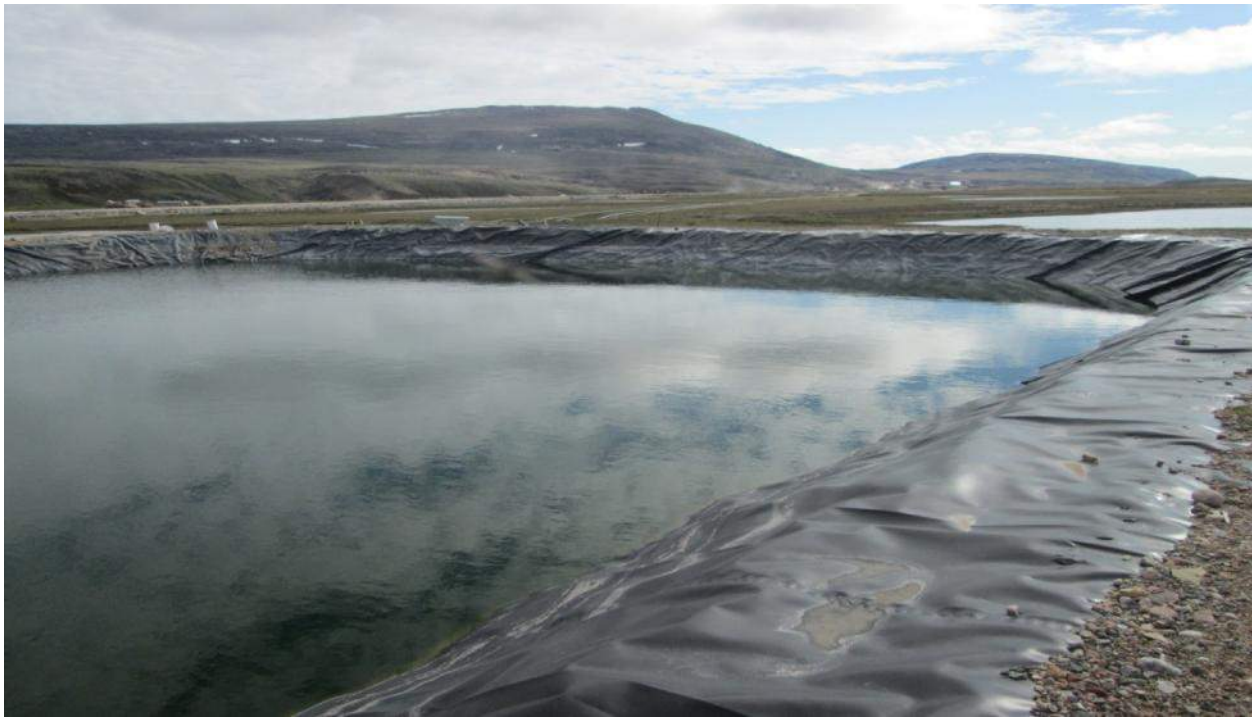
Polishing/Waste Stabilization Pond #1.

Our review of the area around the pond at the base of the slopes showed no sign of seepage and hence we conclude that the liner has been effective in containing sewage and there are no tears or ruptures in the membrane, excepting some minor tears from past activity at the top of the dyke well above the allowable effluent level in the structure in the horizontal portion of the membrane.

Many of the tears that had occurred in the liner on the top of the dyke have been patched during the period between reviews in 2008 and 2009 and are holding well. As well, there are no signs of weather related deterioration of the liner where it is exposed.

Monitoring points have been set up on the top of the dyke and have been monitored since 2009. Settlements have occurred since that time. These settlements have not led to any stress cracks in the structure. These settlements are an indication of consolidation in the berm structure and the active layer beneath the dyke and are not considered to be of any concern.

We see no reason to continue the monitoring of the top of the berm on an annual basis. With the excellent condition of the dyke construction, we see no reason to continue this function.

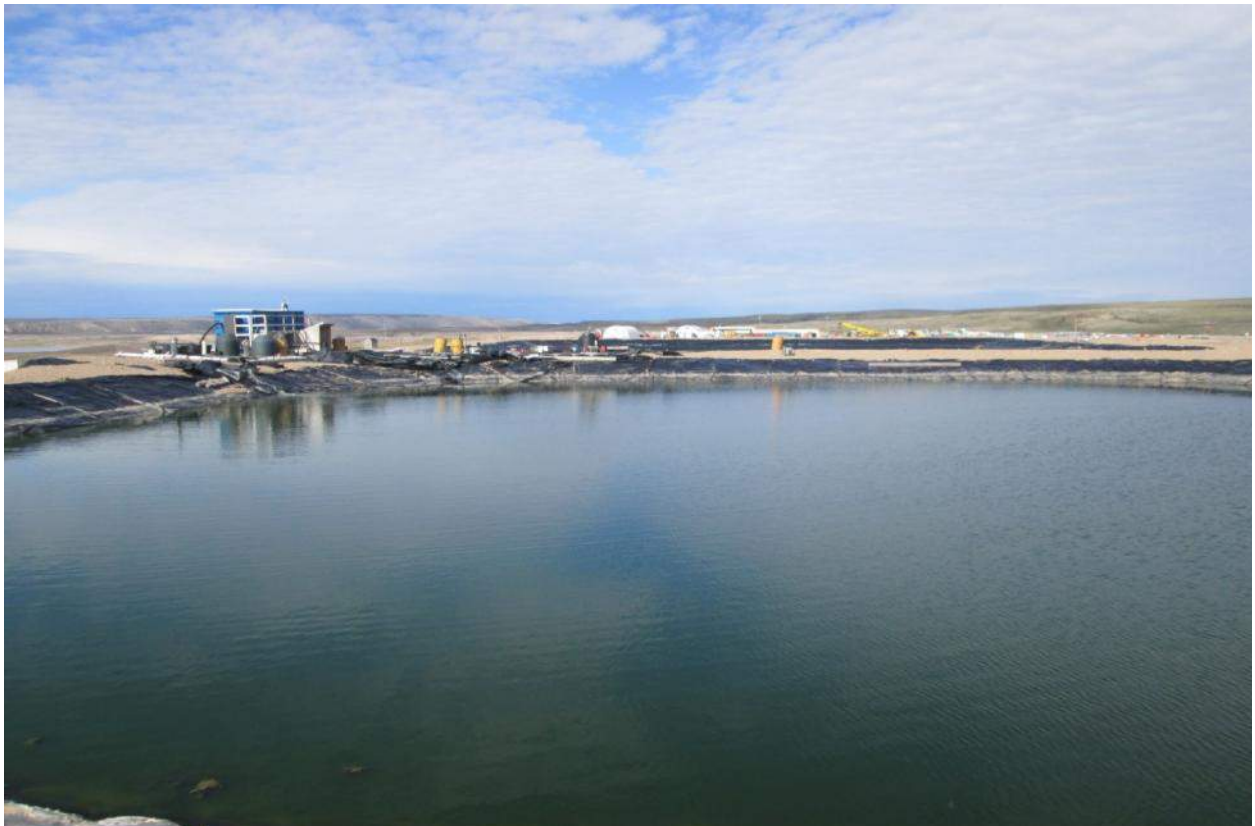
Polishing/Waste Stabilization Ponds #2 and #3.

Our review of the area around the pond at the base of the slopes showed no sign of seepage and hence we conclude that the liner has been effective in containing the sewage and there are no tears or ruptures in the membrane.

Longitudinal cracking which appeared in the dykes of PWSP#3 due to the melt of permafrost wedges in 2009 has not reoccurred and we consider this structure to be stable in its present condition.

Monitoring points have been set upon the top of the dyke and have been monitored since 2009. Settlements have occurred since that time. These settlements have not led to any stress cracks in the structure.

We see no reason to continue the monitoring of the top of the berm on an annual basis. With the excellent condition of the dyke construction, we see no reason to continue this function.

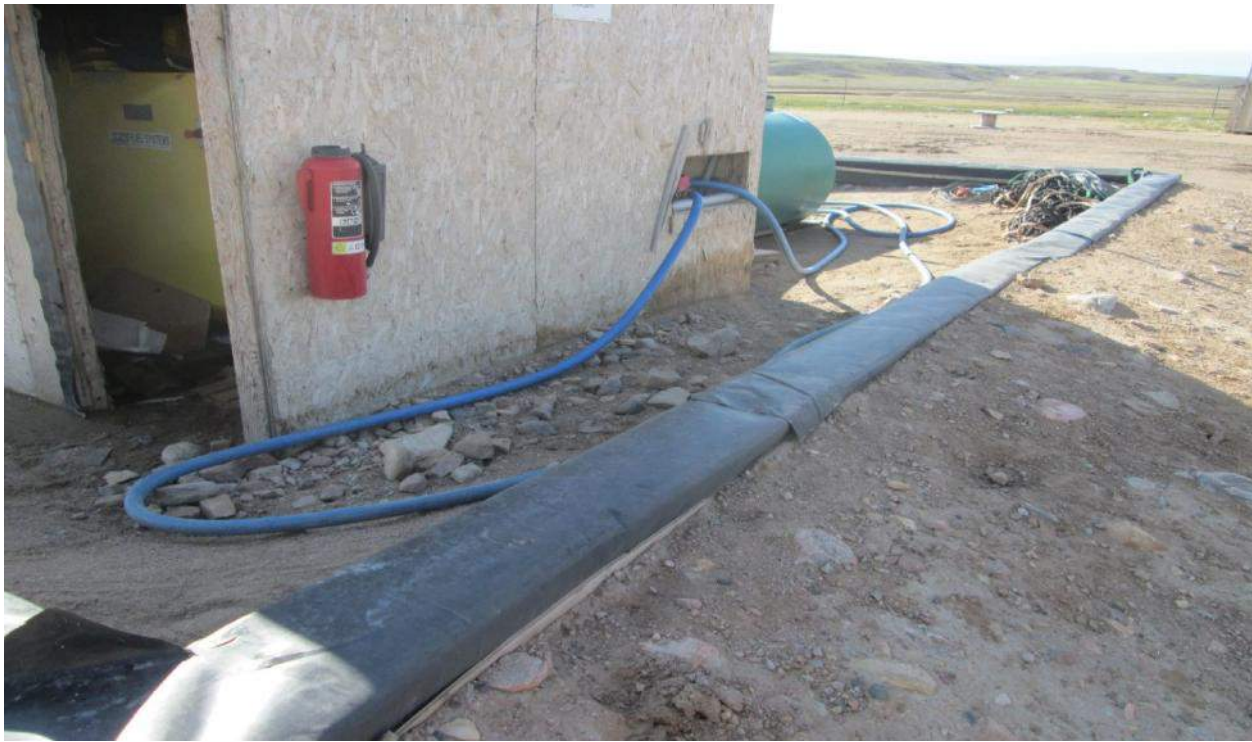
Helicopter Fuel Tank Containment.

A review of the exterior and the top of the berms showed no sign of cracking or settlement which would indicate stress within the structure.

The structure is considered to be stable in its present condition.

We have no recommendations with respect to this structure.

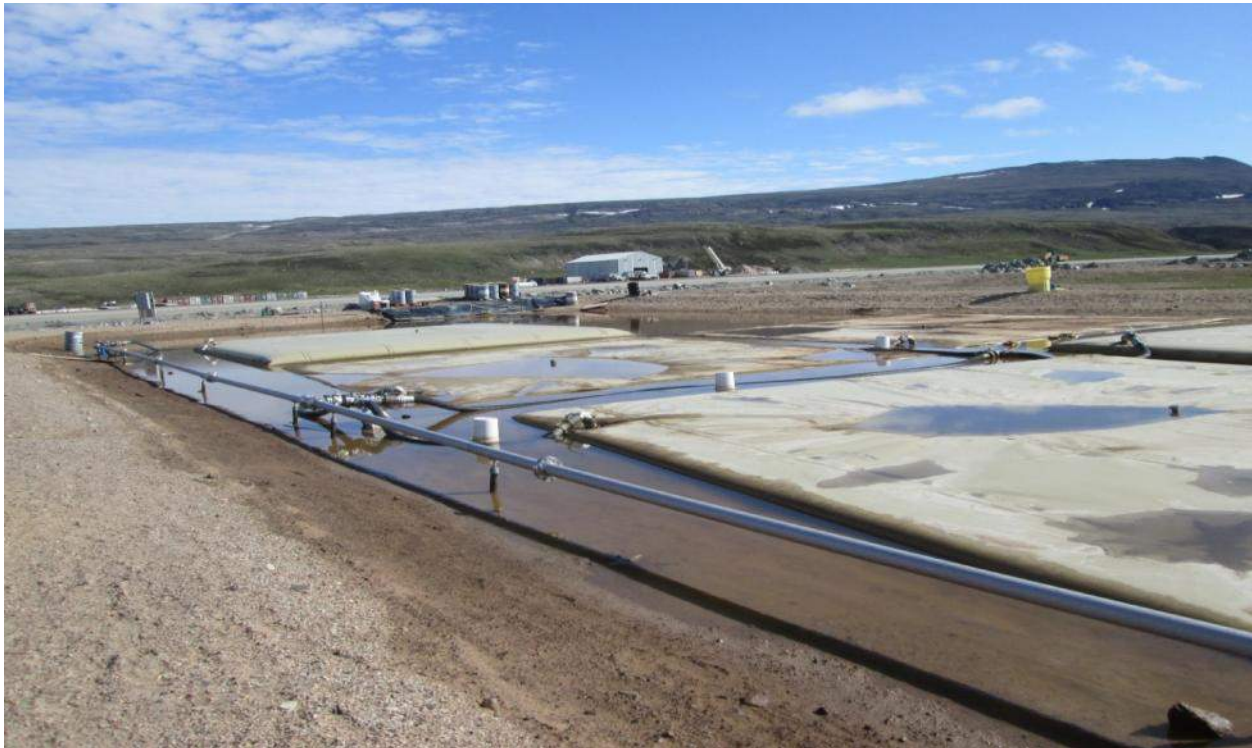
Bulk Fuel Storage Containment.

At the time of our first review, water had not been removed for a period from within the containment and water was ponding above the level of the gravel within the bottom of the containment. There was still considerable factor of safety against failure of oil holding bladders within the dykes with the water level as it exists. Such was the case during the second inspection, but the water had frozen.

The structure was visually inspected for any signs of cracking or subsidence. There was no indication of any settlement, seepage, or cracking in the soil structures that formed the dykes. As well, there was no indication of seepage at the base of the structure around the exterior.

The soil structure is considered stable in the present condition and is in conformance with the design basis for the facility.

We have one recommendation. There is limited storage for spills at the load out end of the facility. Water currently ponds above the gravel in this area confirming the integrity of the liner but minimizing the capacity of the structure for spill containment.

We recommend that this water be removed on a regular basis. If the water proves to be oil impacted, it may be pumped to within the storage containment for treatment at a future date.

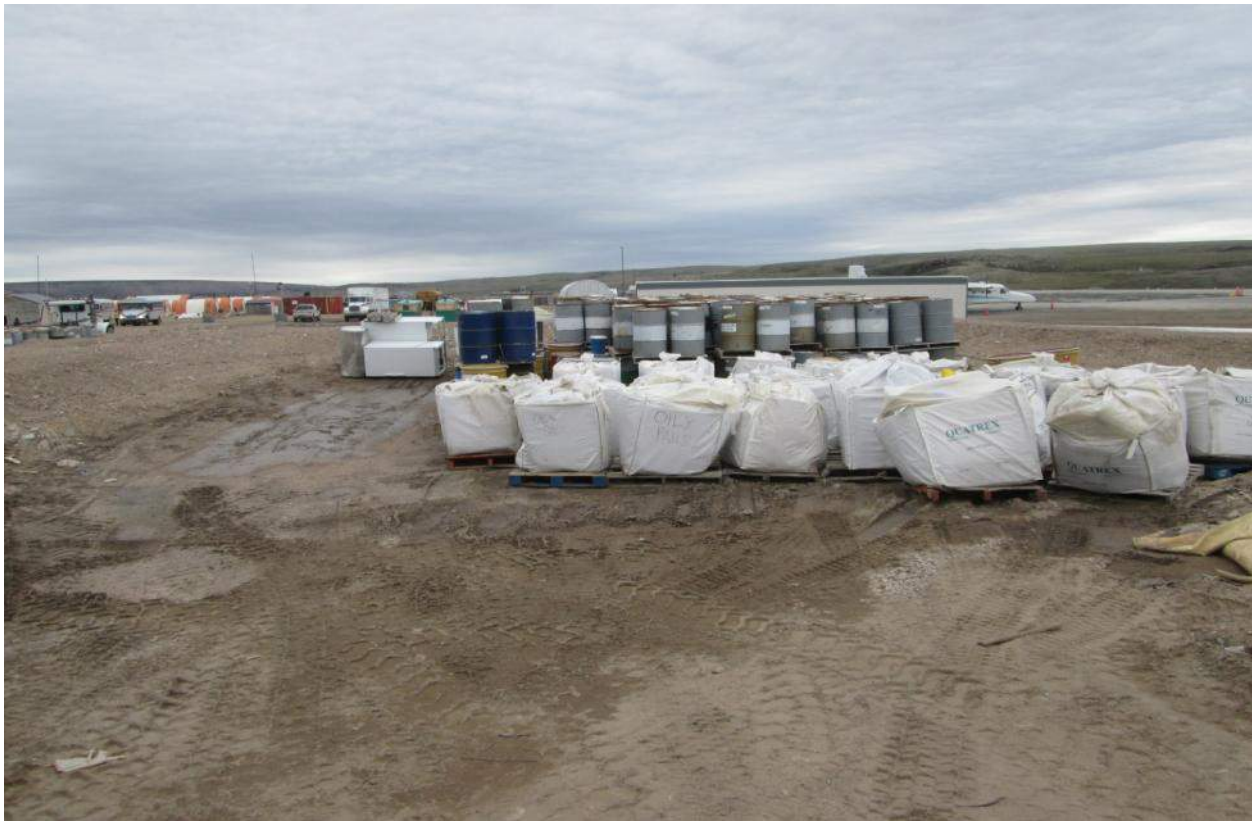
Hazardous Waste Storage.

This structure contains barrels and bags of hazardous waste.

The structure appears stable in its present condition.

There are no recommendations at this time.

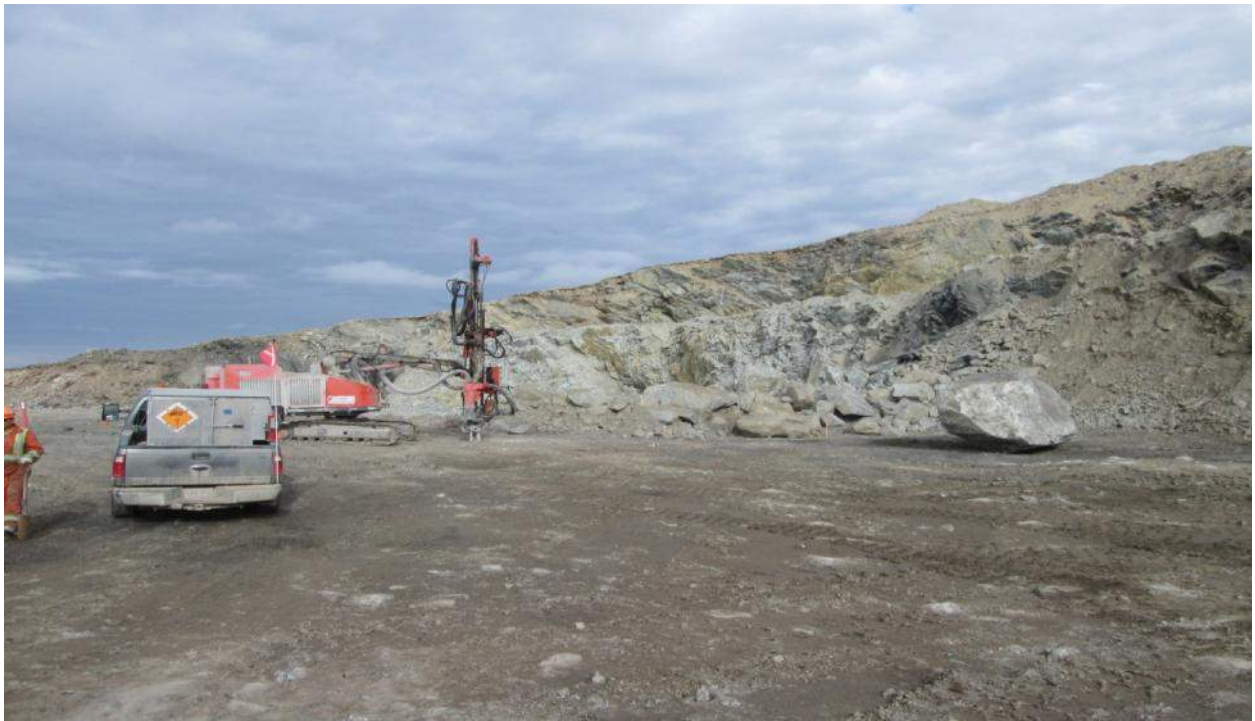
Quarry at Mary River.

The quarry has well defined benches. The quarry faces at the benches shall be scaled when quarry operations cease and the benches shall be cleaned and berms placed at the edges of the bench to control the movement of weather induced loose in the long term.

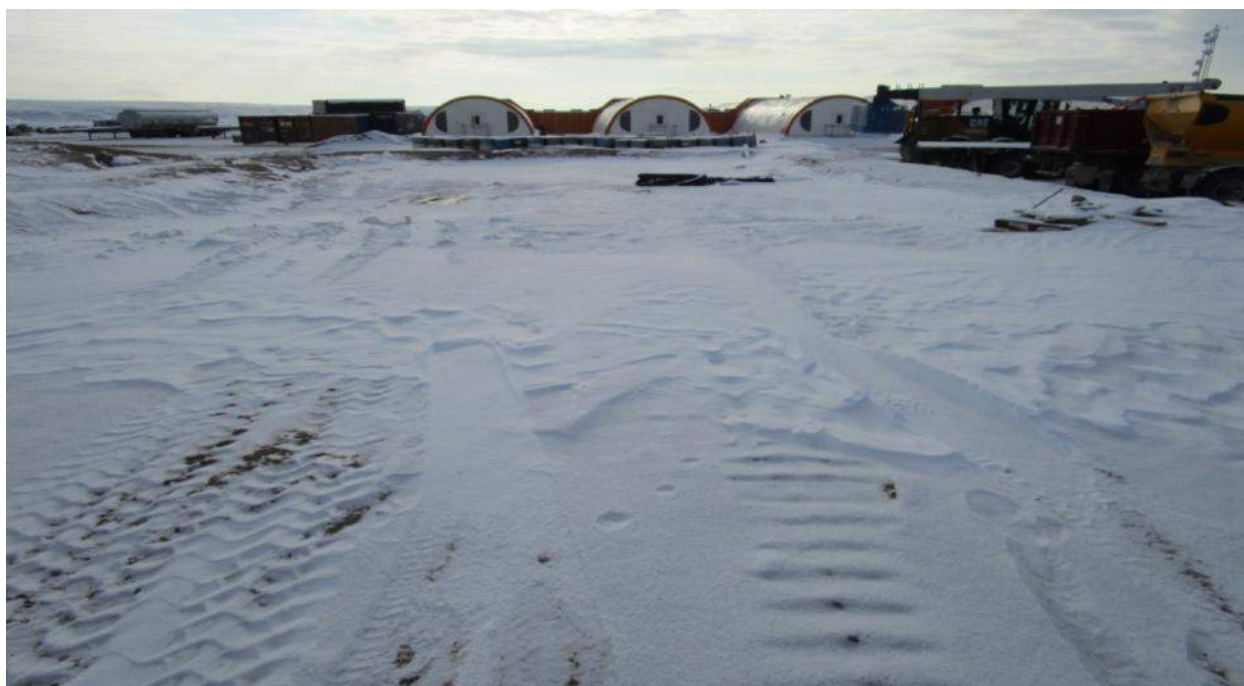
Enviro Tank Storage (Wash Bay)

This particular structure is constructed contiguous with the Hazardous Waste Storage constructed in 2010 and the Stove Oil Storage cell. It is now utilized as a wash down cell.

We recommend that the geotextile over the liner and the granular cover be made good prior to continuing use of this cell as a wash down cell.
