## **4.0 MILNE INLET**

### **4.01 General**

### **Milne Inlet August Inspections**

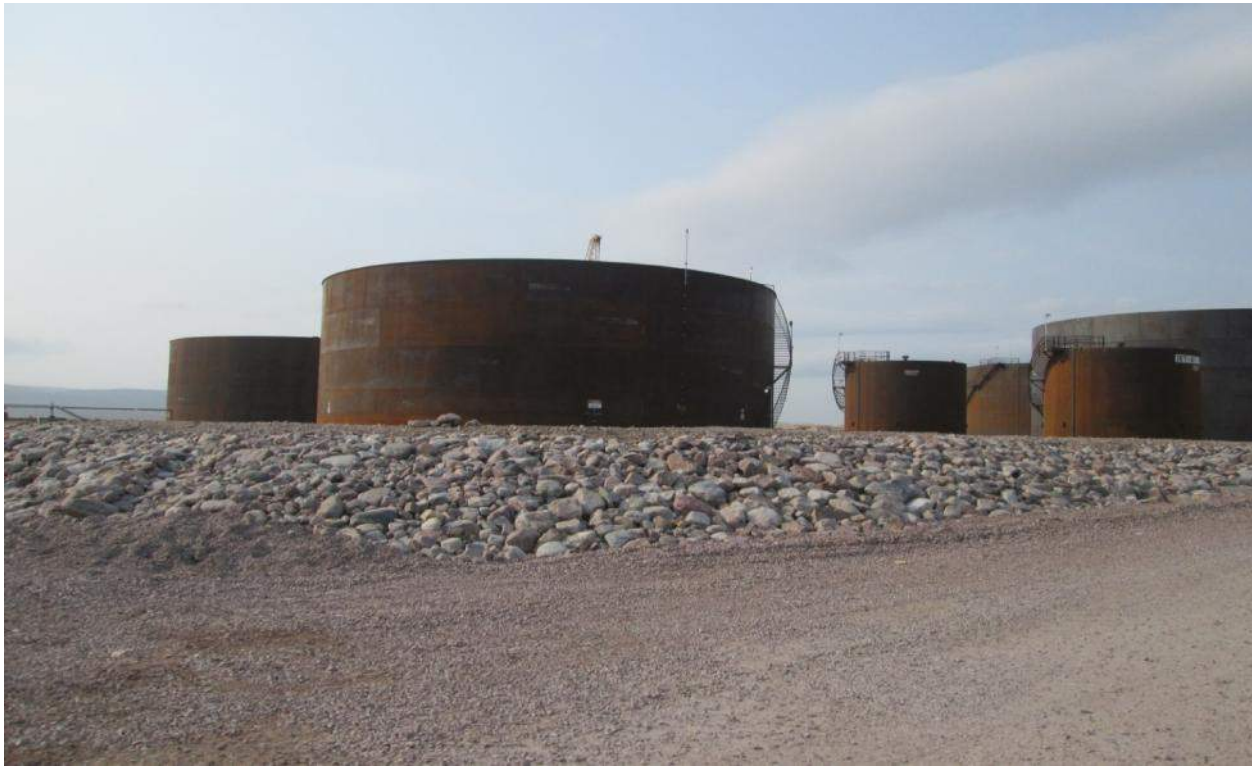
We noted no sign of weakness in any of the structure construction.

At both inspections we noted minor water ponding at the low end of the containment confirming the integrity of the liner.

Photo taken from the south east corner of the steel storage tank containment outside the containment looking north west.

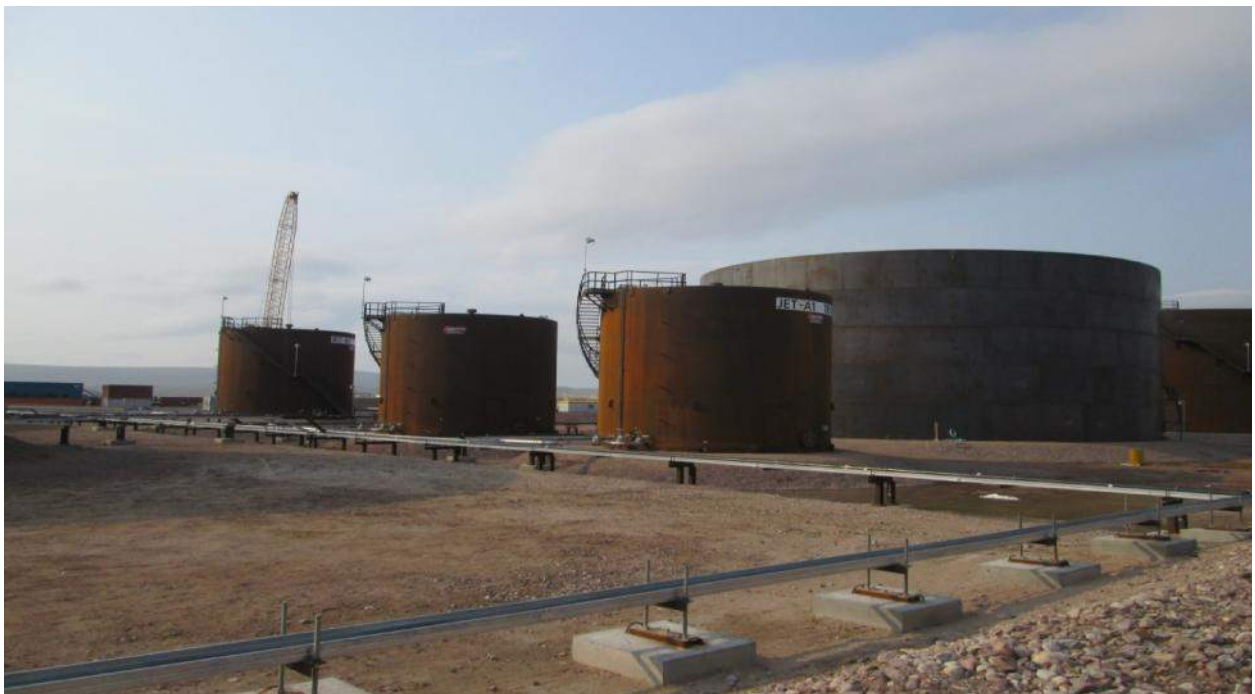
Photo taken from atop the containment dyke looking west into the containment.

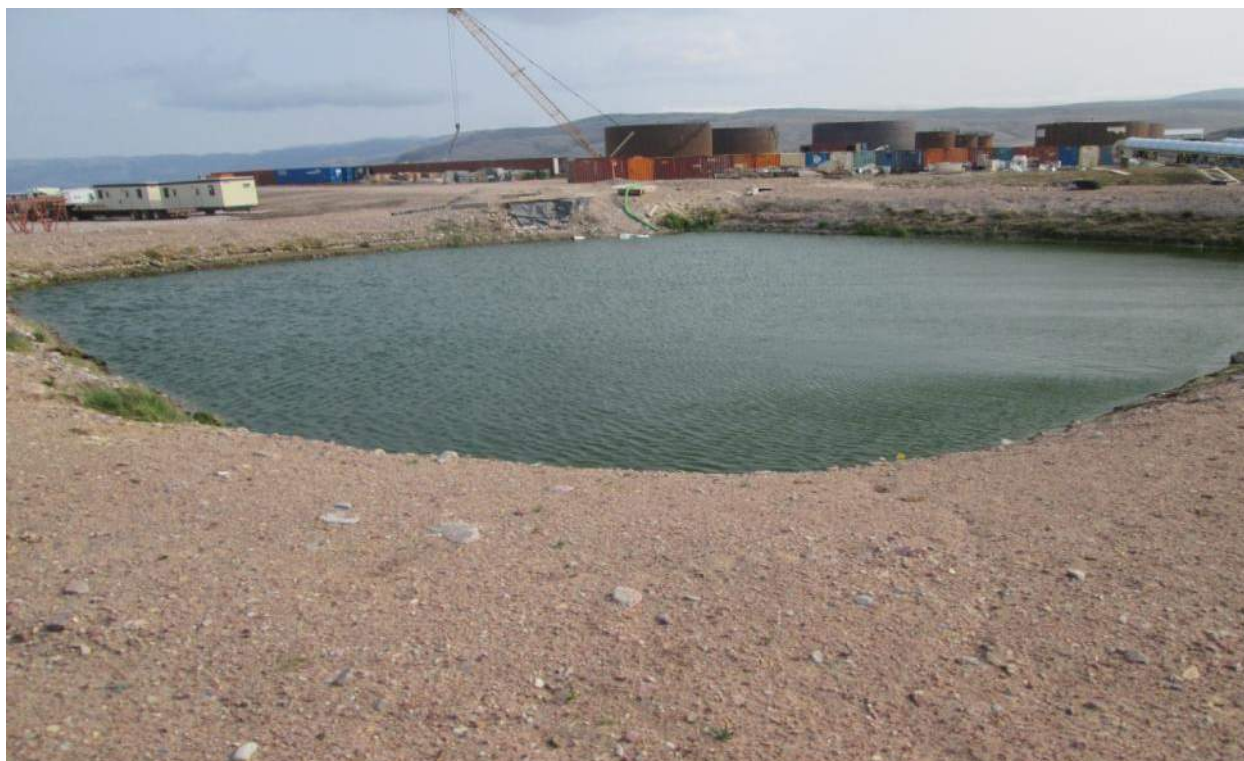
This transfer of effluent was part of the decommissioning of this PWSP. At the time of our second review in September, all effluent had been removed and the dykes were awaiting removal.

The structure is considered stable over the projected short life of the structure.

Photo taken from atop the soon to be decommissioned PWSP looking south.

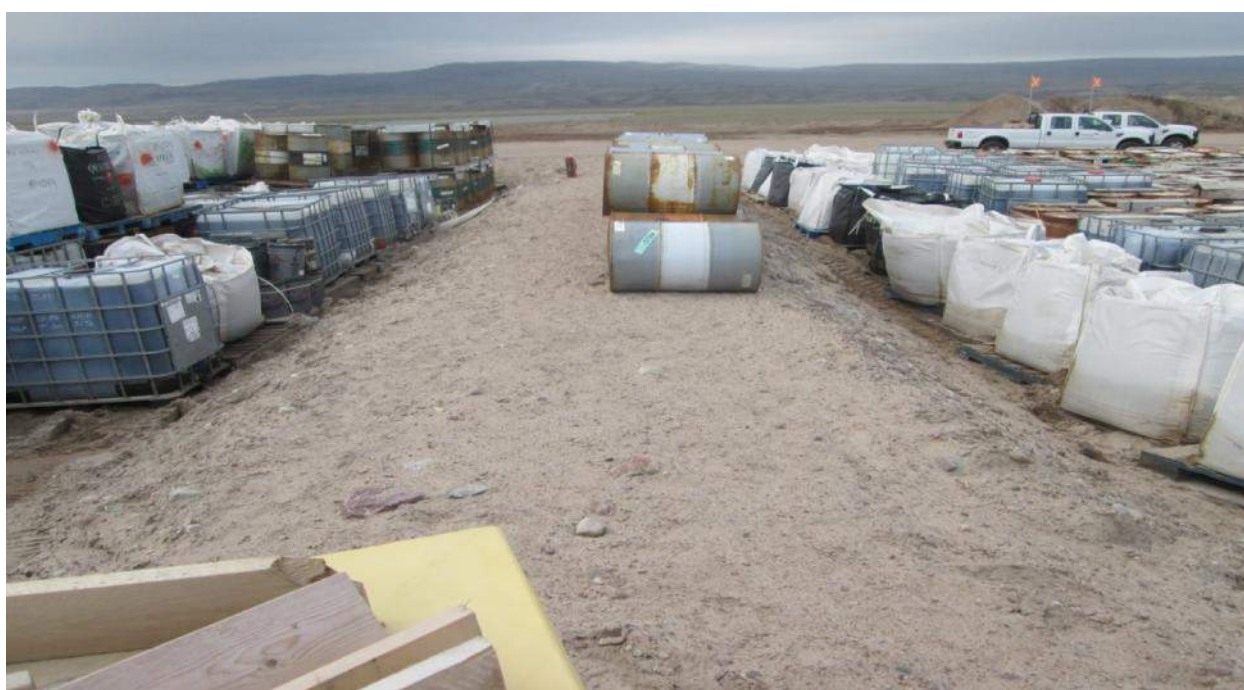
At the time of my August inspection, there was wet sand in the bottom of the two cells indicating the integrity of the liner.

Our review of the area around the cells, at the base of the exterior dyke slopes showed no sign of seepage, at that time.

Photo taken of central dyke in barrel fuel storage looking west.

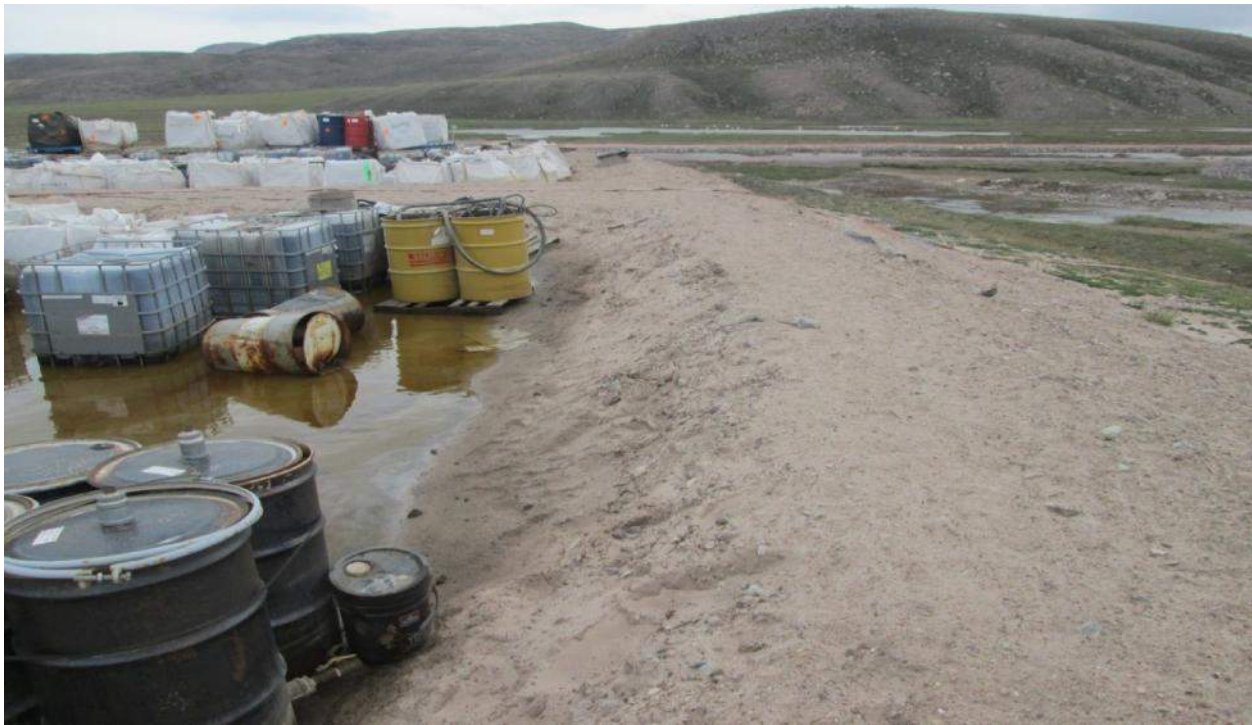
There is water ponding in both cells of the original structure confirming the integrity of the liner at this time.

Our review of the area around the dykes, at the base of the slopes, showed no sign of seepage. The structure is considered stable.

Photos taken along rear dyke at hazardous waste storage area. Note water contained within dyke.

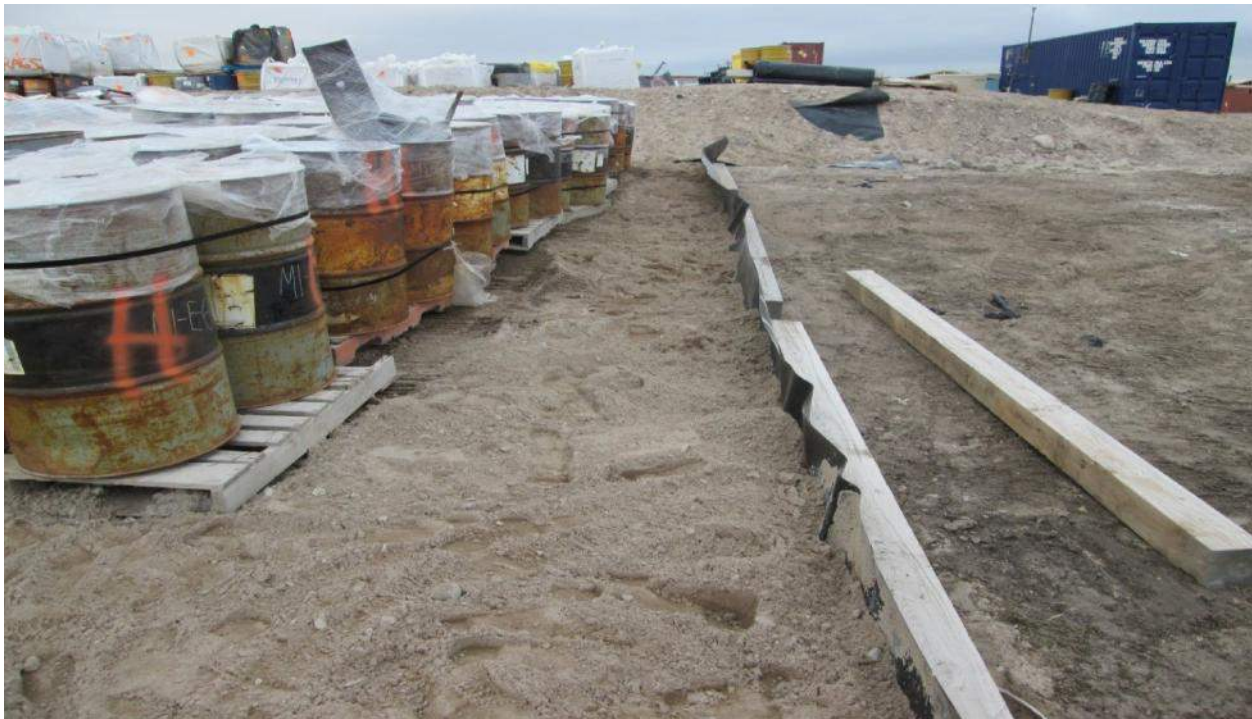
Due to an excess of hazardous waste in the two cells, a third temporary cell has been constructed for the very short term until the ship picks up the hazardous waste at the end of this summer season.

The third cell is constructed with a one piece liner and wood timber curb for this very short term and is contiguous with the south side of the structure.

Photo shows temporary curbed area for hazardous waste awaiting immediate shipment.

We recommend that the use of the temporary third cell, recently constructed, be discontinued when the currently stored hazardous waste is shipped out by the end of this shipping season.

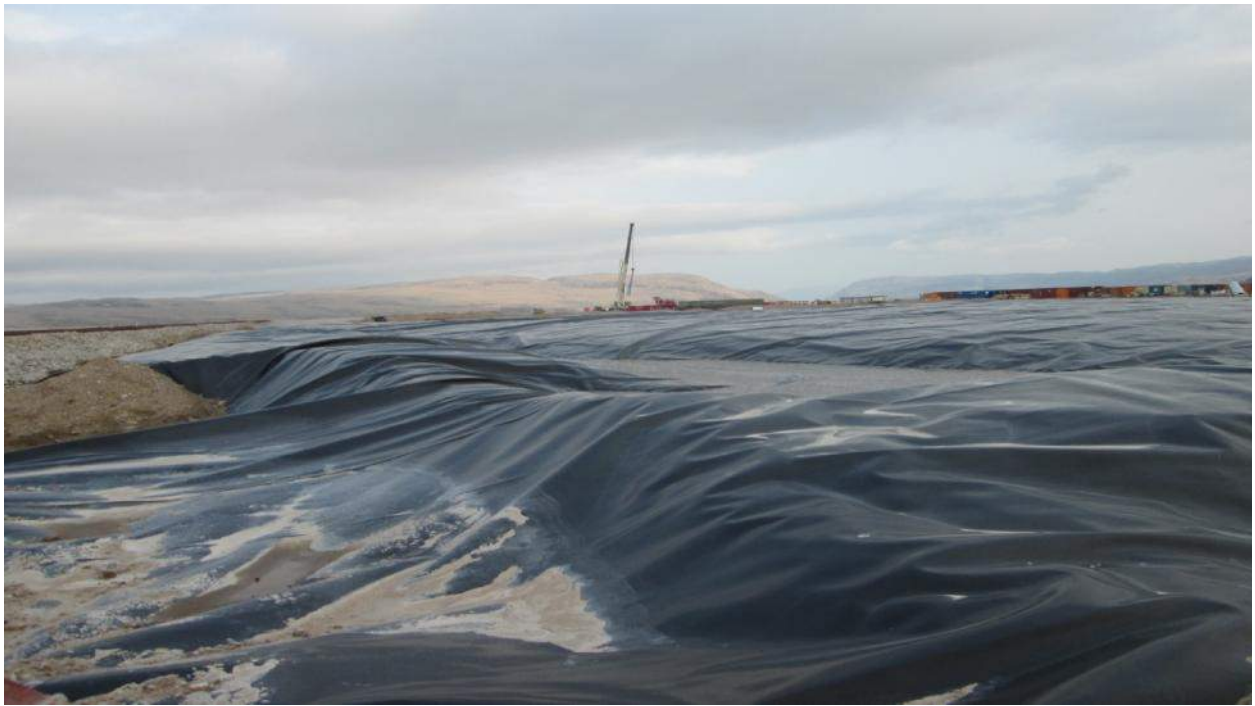
The oil impacted water had been removed and treated and the oil impacted sand/ gravel that was in the bottom of the structure and over the liner on the dykes had been removed from the south end of the structure and had been piled up in the north end where it had been covered to prevent an accumulation of further oil impacted water as noted during our first review in August. By September this facility had been decommissioned and the oil impacted material had been placed in the landfarm.

Photo taken looking north at the covered contaminated granular from the bulk fuel storage facility undergoing decommissioning.

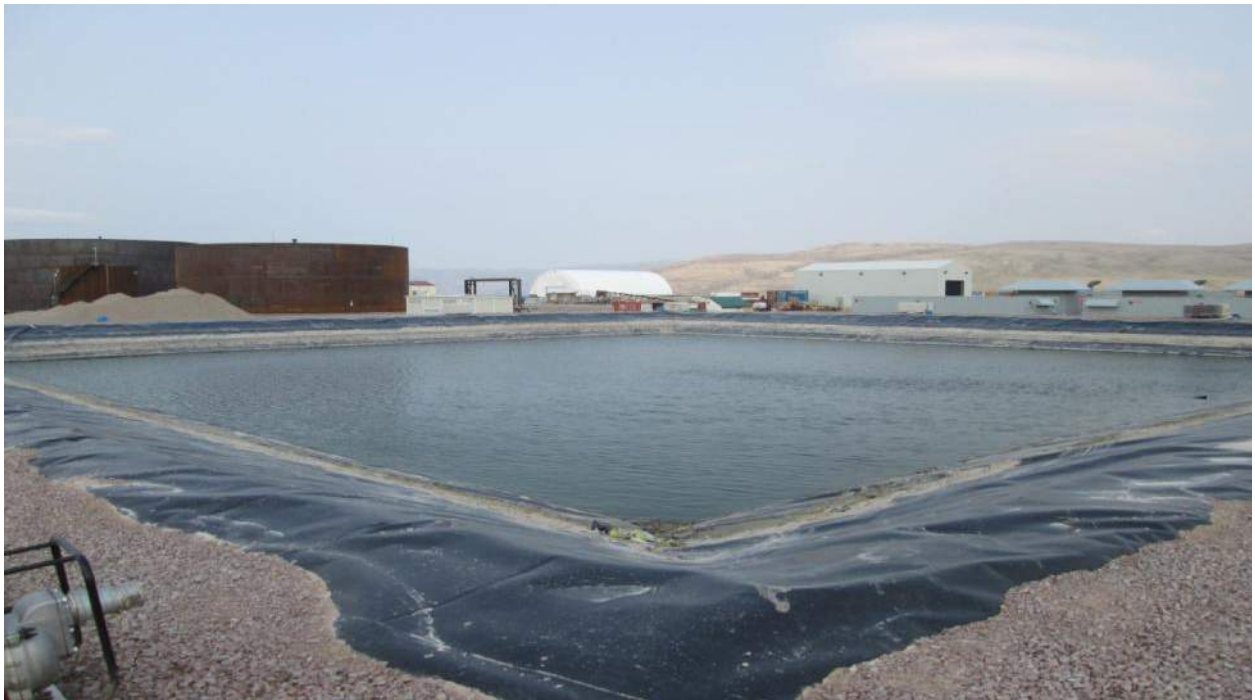
We noted no sign of weakness in any of the construction.

Photo taken from atop the south west corner of the New Sewage Effluent Pond looking north east.
