**Baffinland Iron Mines Corporation
Mary River Project**

**Construction Summary Report: Milne Port Waste Management
Package**

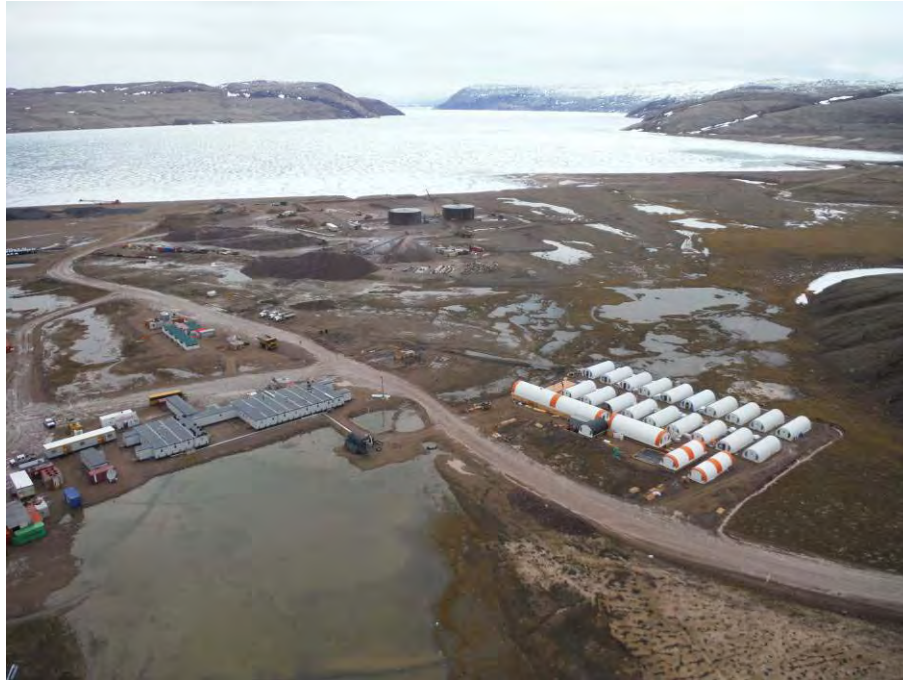
Figure 1: Pre-construction of the Milne Port waste management package [northeast view]

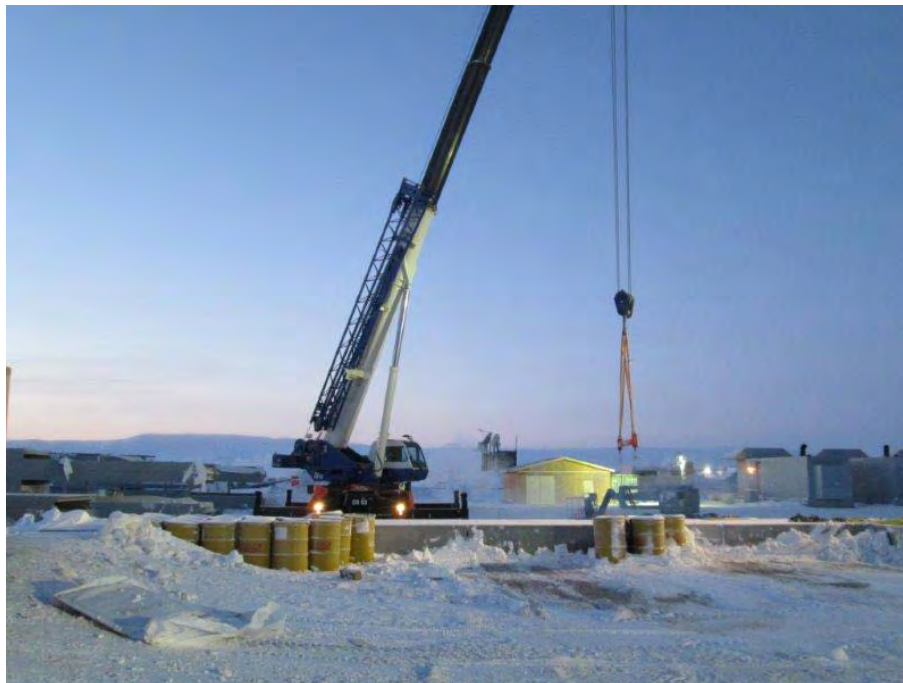
Figure 2: Waste Management Building: Preparing for fold away building erection

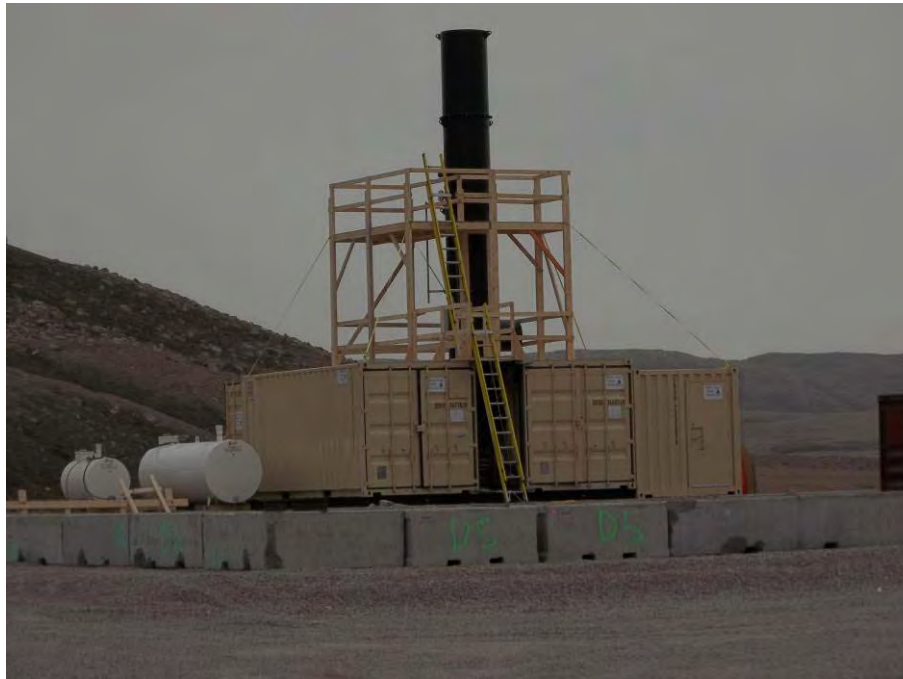
Figure 3: Waste Management Building: Incinerator equipment placed and commissioned

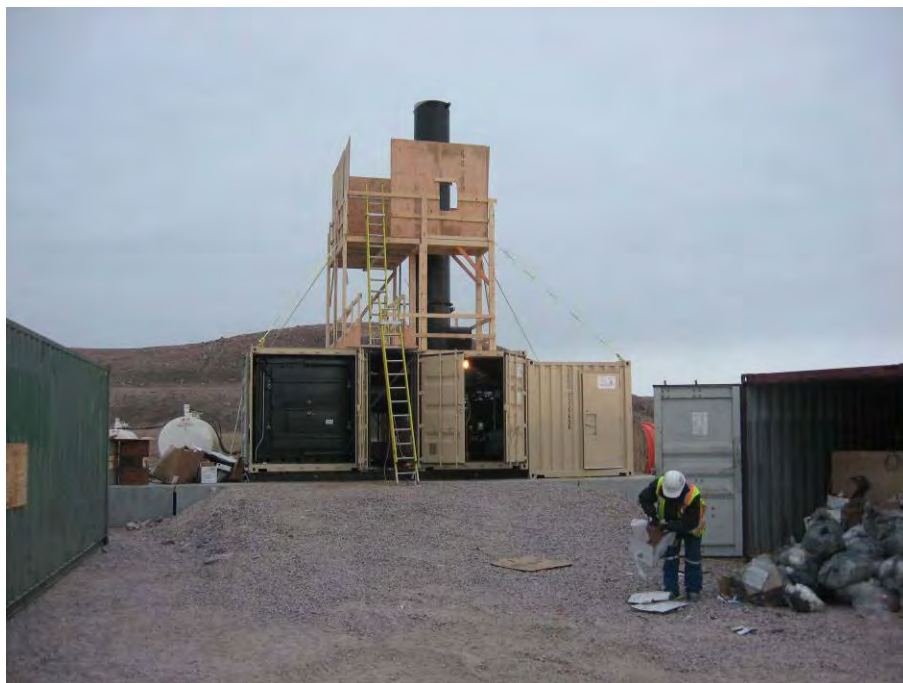
Figure 4: Waste Management Building: Installation of the incinerator equipment with temporary access platform for stack emissions testing

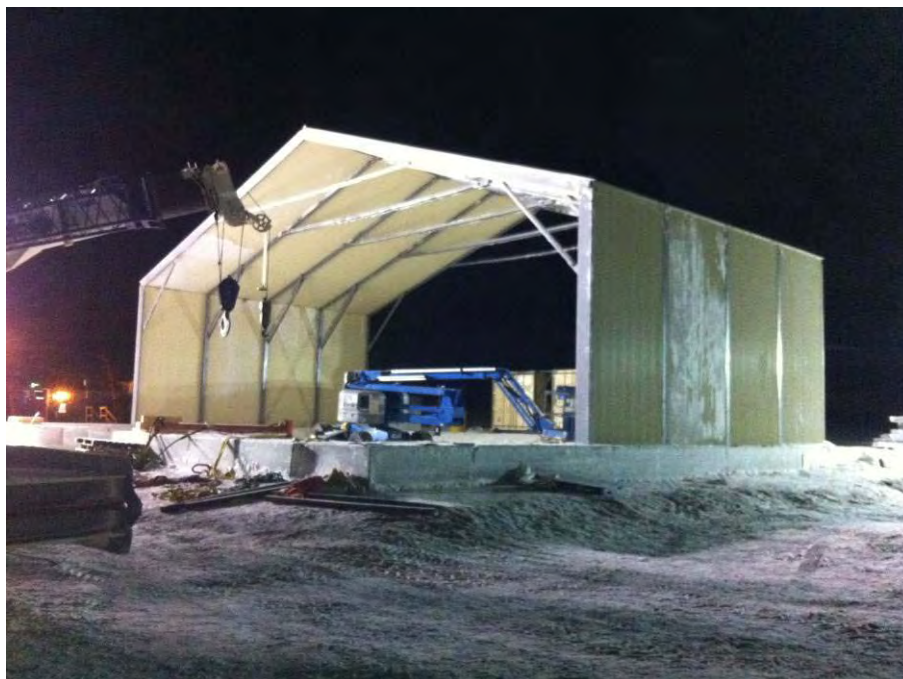
Figure 5: Waste Management Building: Erecting the fold away building

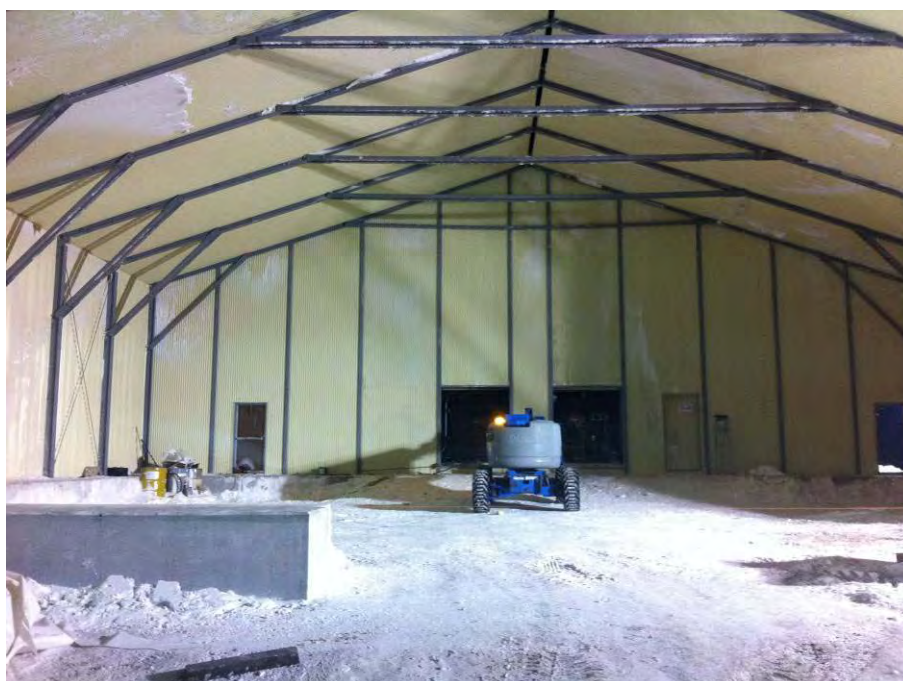
Figure 6: Waste Management Building: Installing the end walls (incinerator access ports on rear wall)

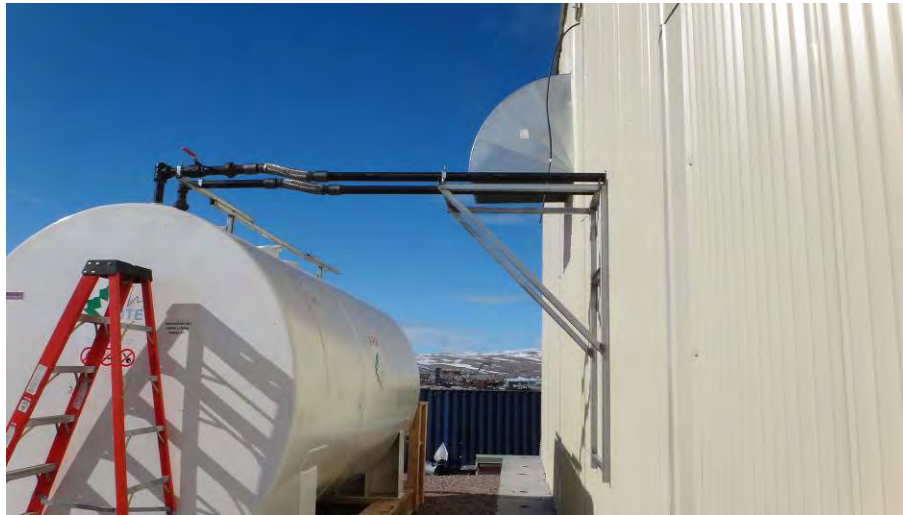
Figure 7: Waste Management Building: Incinerator fuel day tank installation

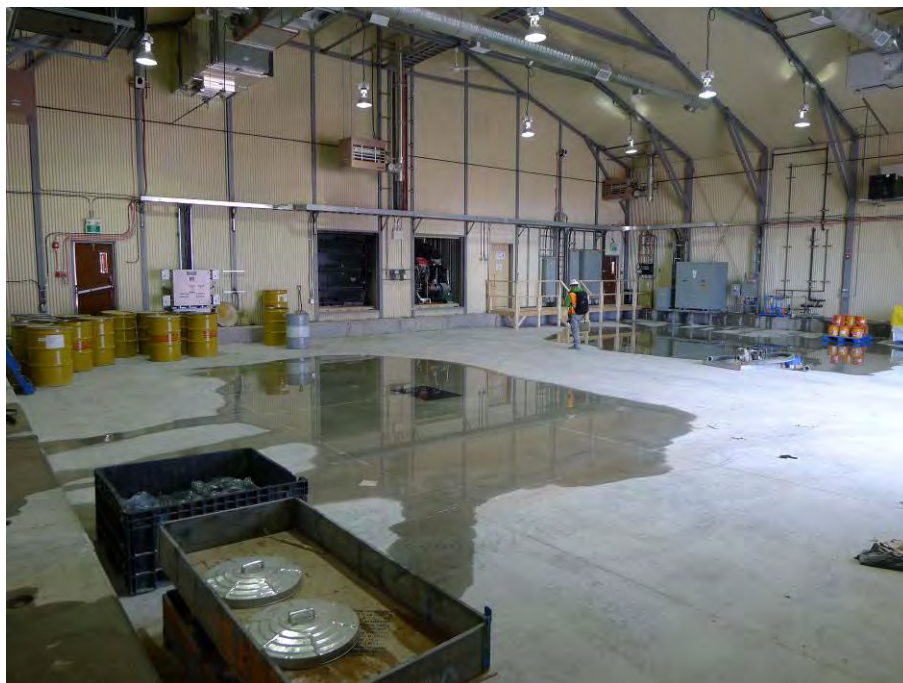
Figure 8: Waste Management Building: Completed installation viewed from the inside; access to incinerator visible in back wall

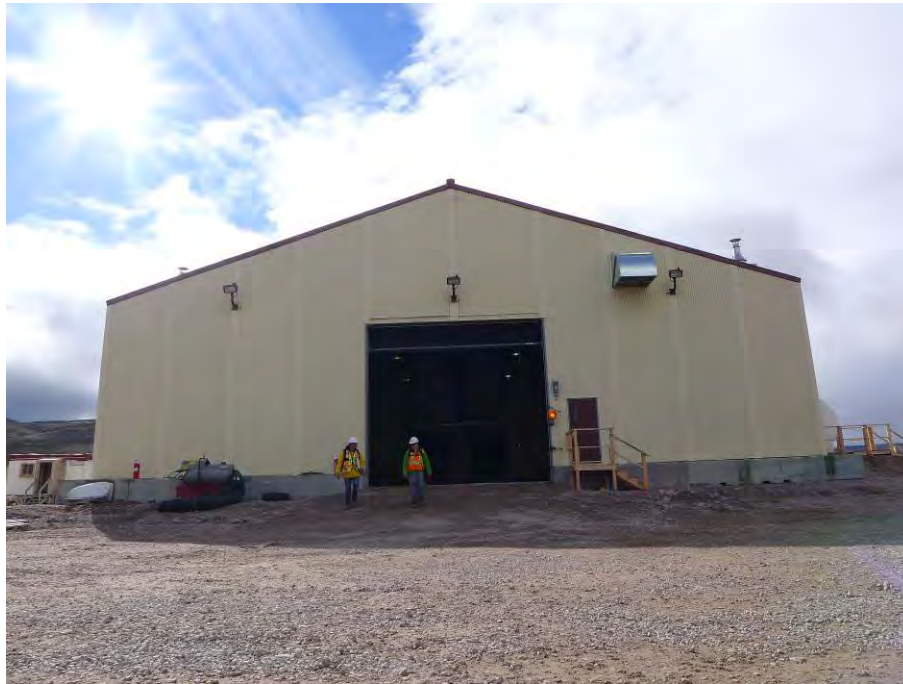
Figure 9: Waste Management Building: Completed installation from the outside

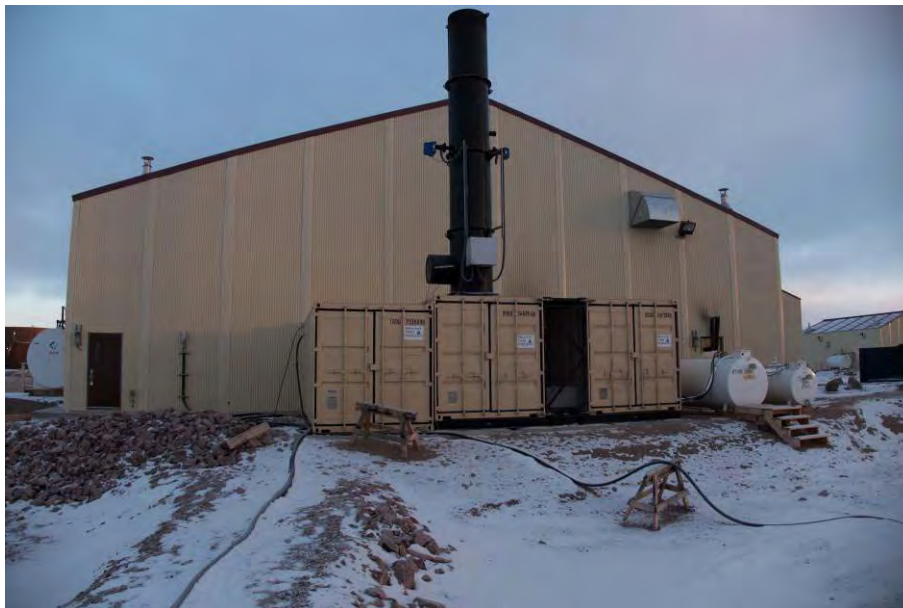
Figure 10: Waste Management Building: Completed installation, rear view

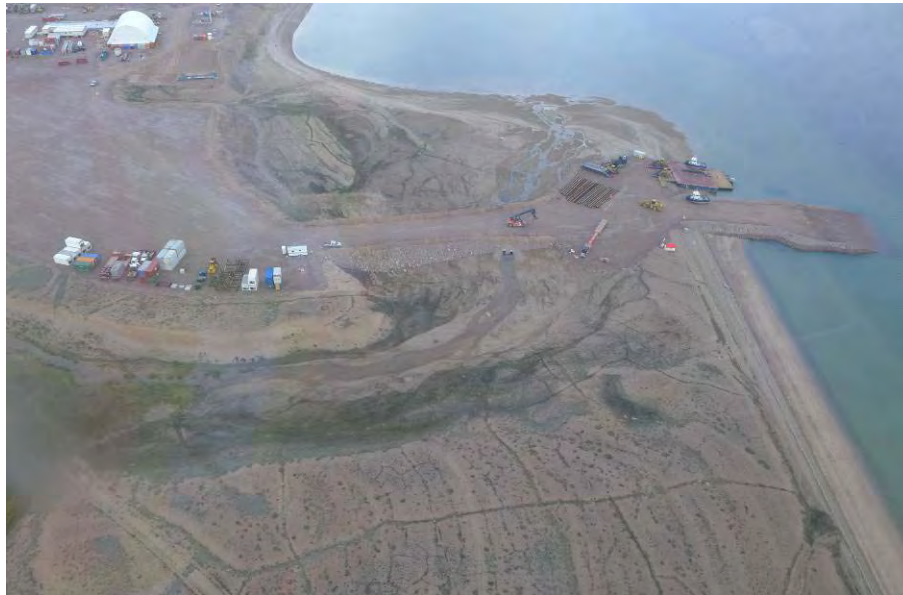
Figure 11: North hazardous waste containment area: pre-construction [west view]

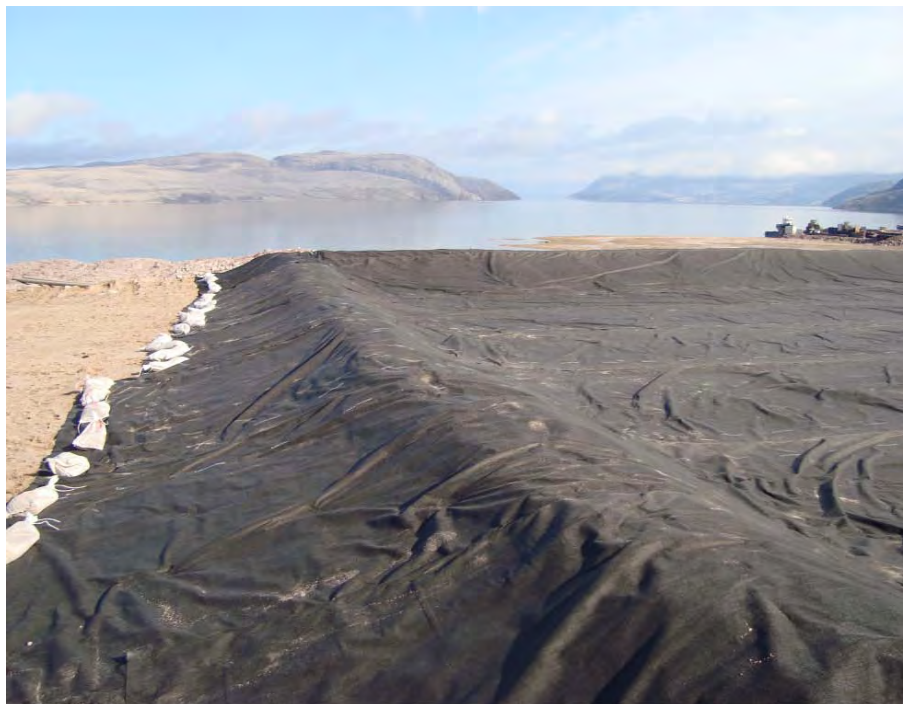
Figure 12: North hazardous waste containment area: placing liner [north view]

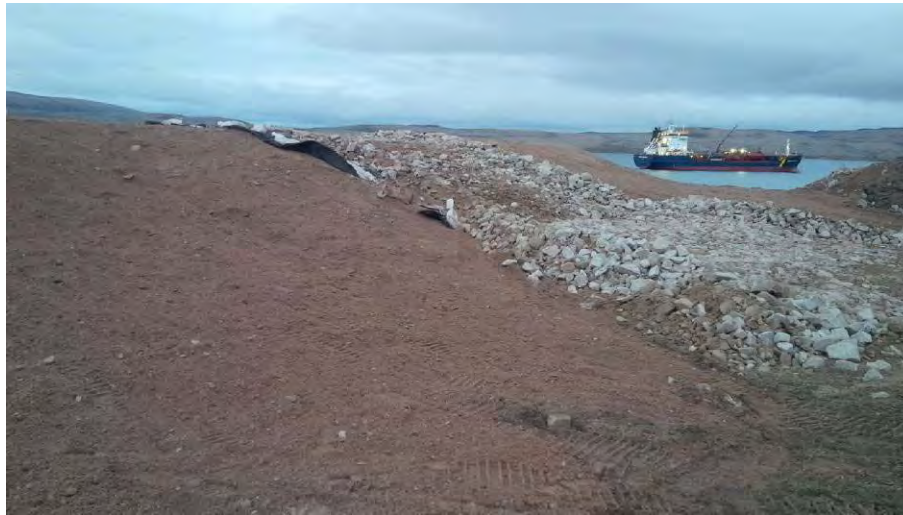
Figure 13: North hazardous waste containment area: North view of liner boundary [north view]

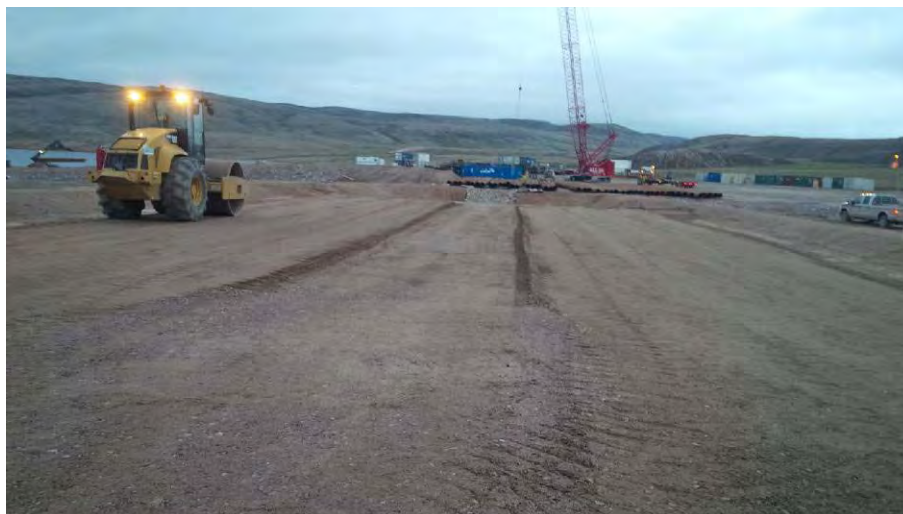
Figure 14: North hazardous waste containment area: Shaping the container pad earthworks (facing east) [west view]

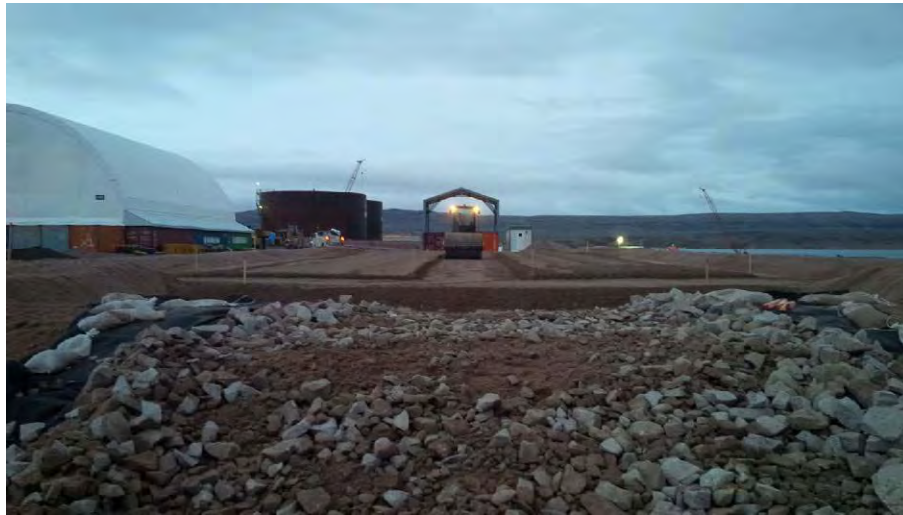
Figure 15: North hazardous waste containment area: Shaping the container pad earthworks [west view]

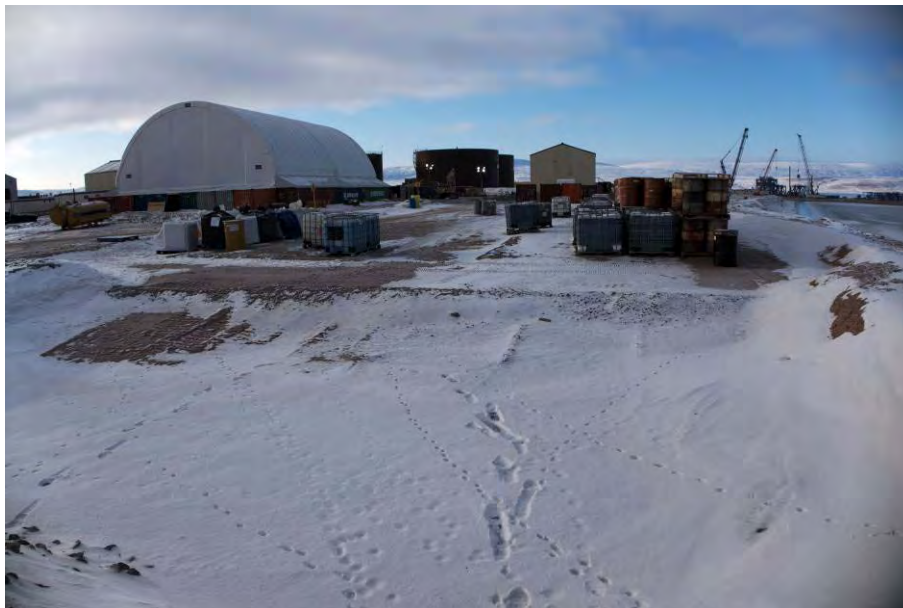
Figure 16: North hazardous containment area: Construction complete [west view]

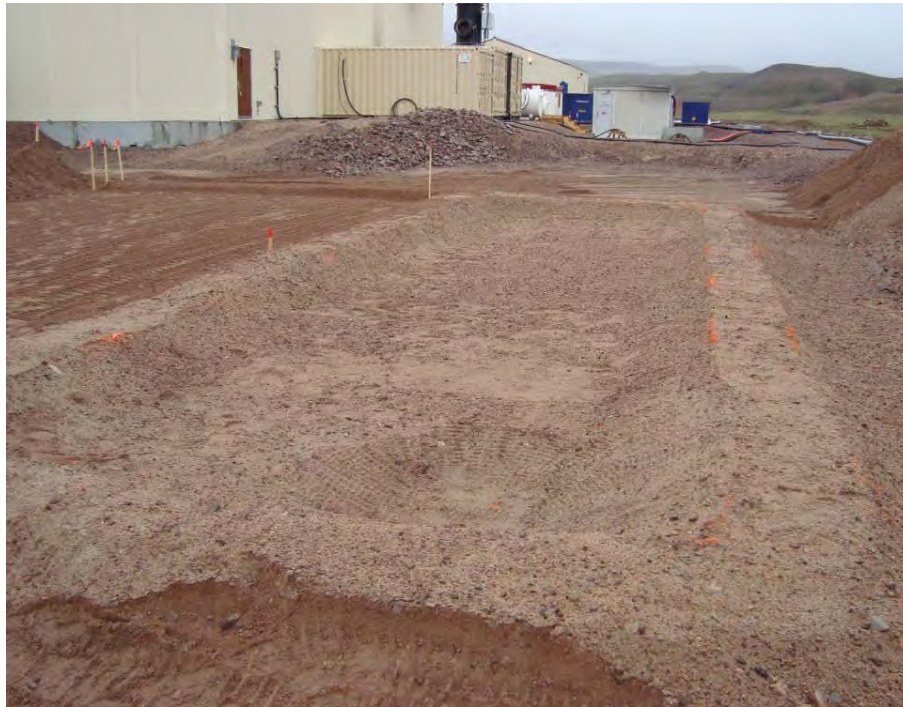
Figure 17: South hazardous containment area: Sub-base complete

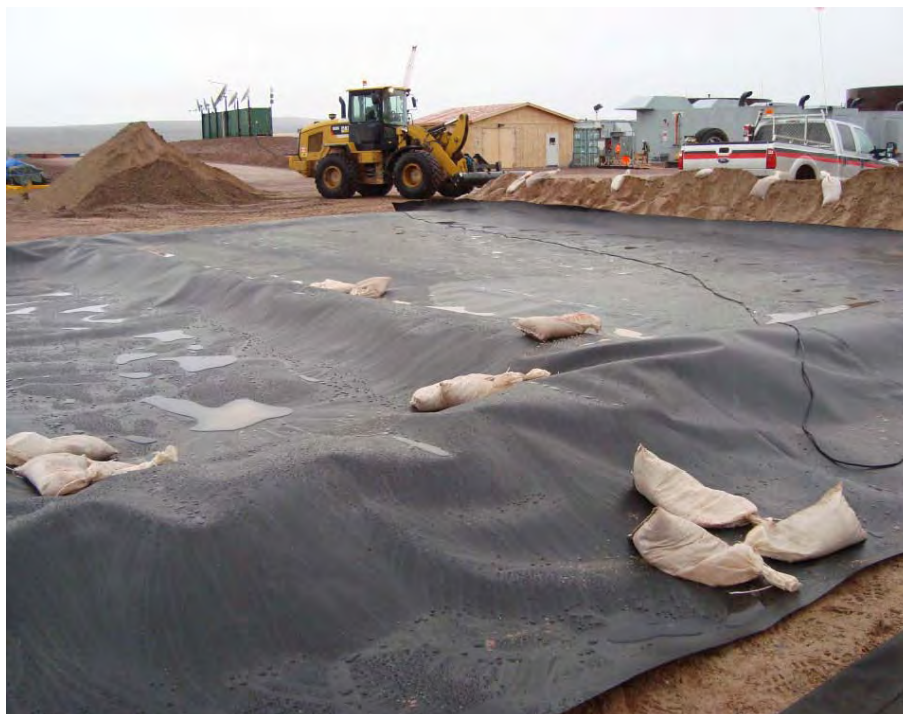
Figure 18: South hazardous containment area: Liner installation

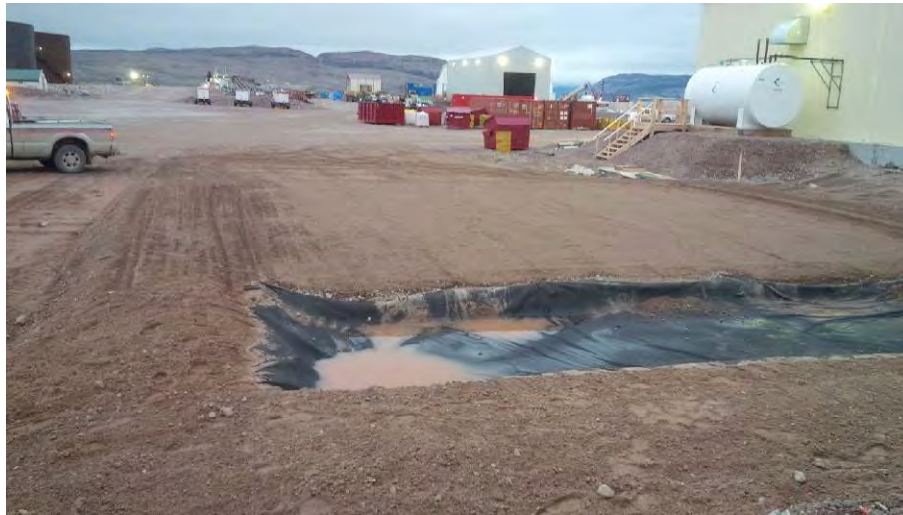
Figure 19: South hazardous containment area: Liner installed and berm shaped

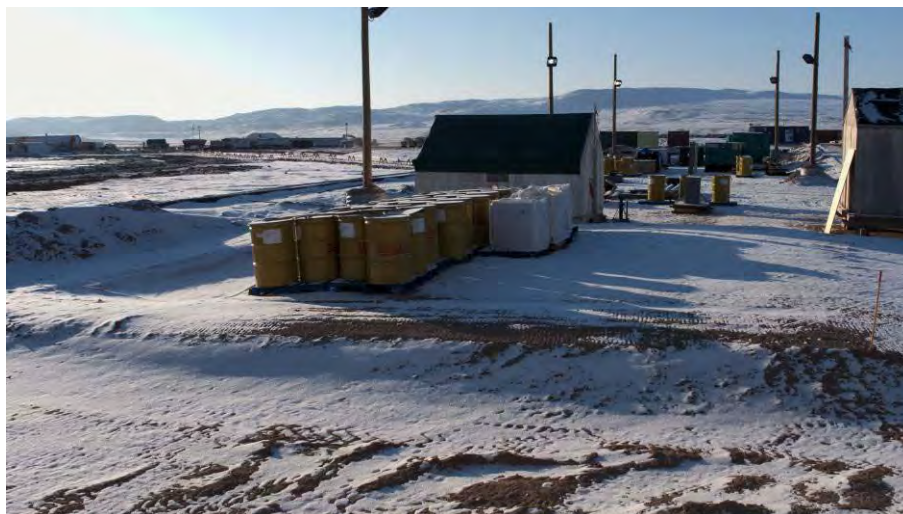
Figure 20: South hazardous containment area: Finished and in-use [west view]

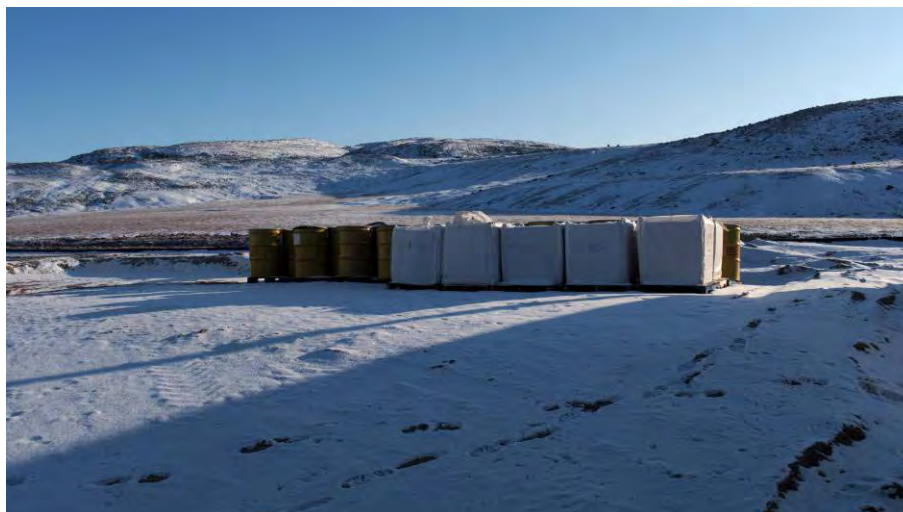
Figure 21: South hazardous containment area: Finished and in-use [south view]
