**Baffinland Iron Mines Corporation
Mary River Project**

**Construction Summary Report: Milne Port Tank Farm & Dispensing
Package**

ANNUAL GEOTECHNICAL INSPECTION
Baffinland Iron Mines Corporation
Mary River Project

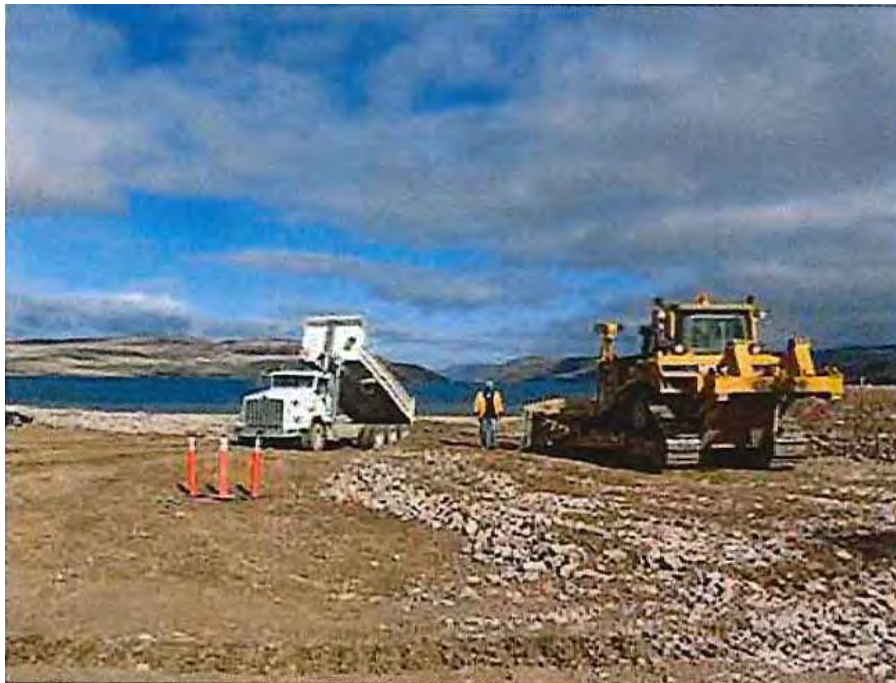
Figure 1: Commencement of earthworks [north view]

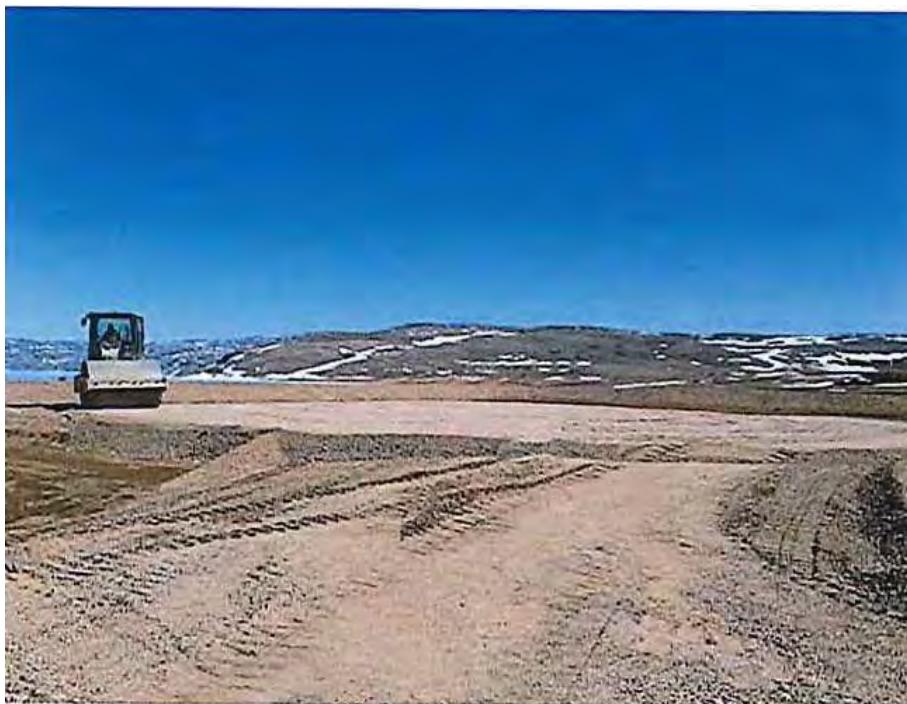
Figure 2: Preparation of sub-base

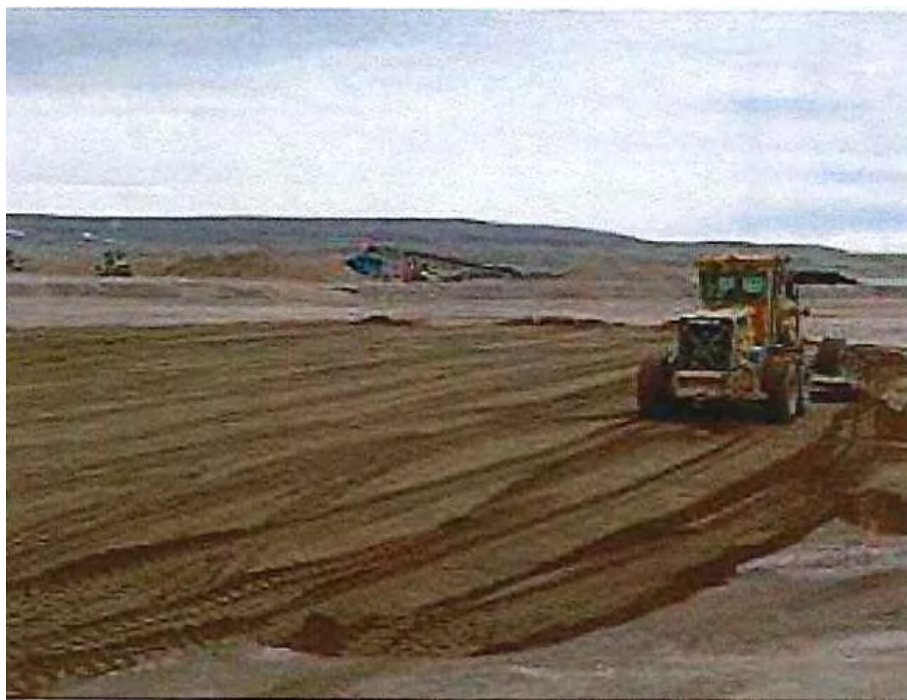
Figure 3: Placement of sand layer below liner

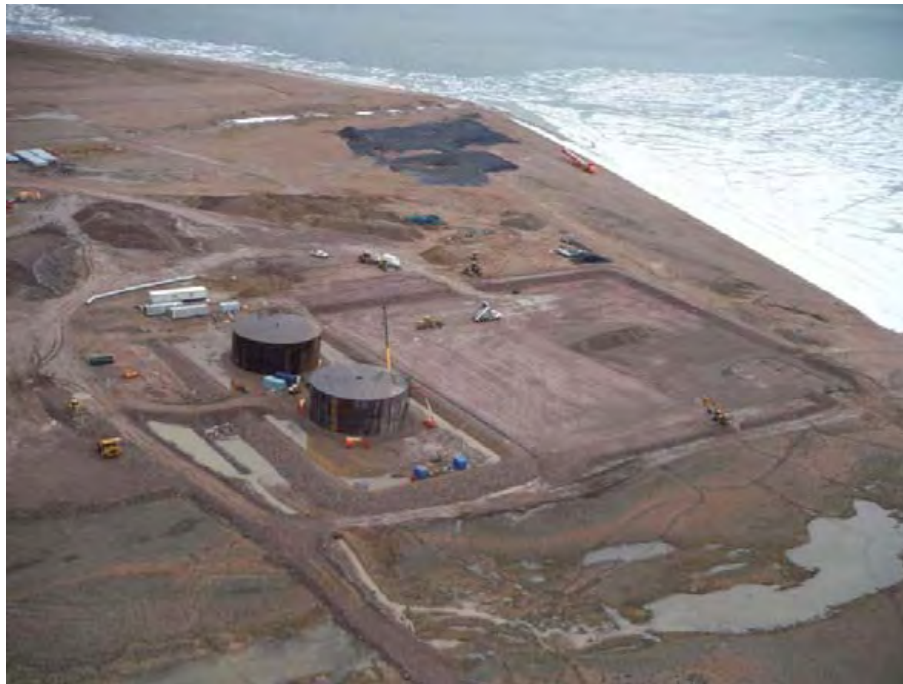
Figure 4: Preparation for liner installation [northwest view]

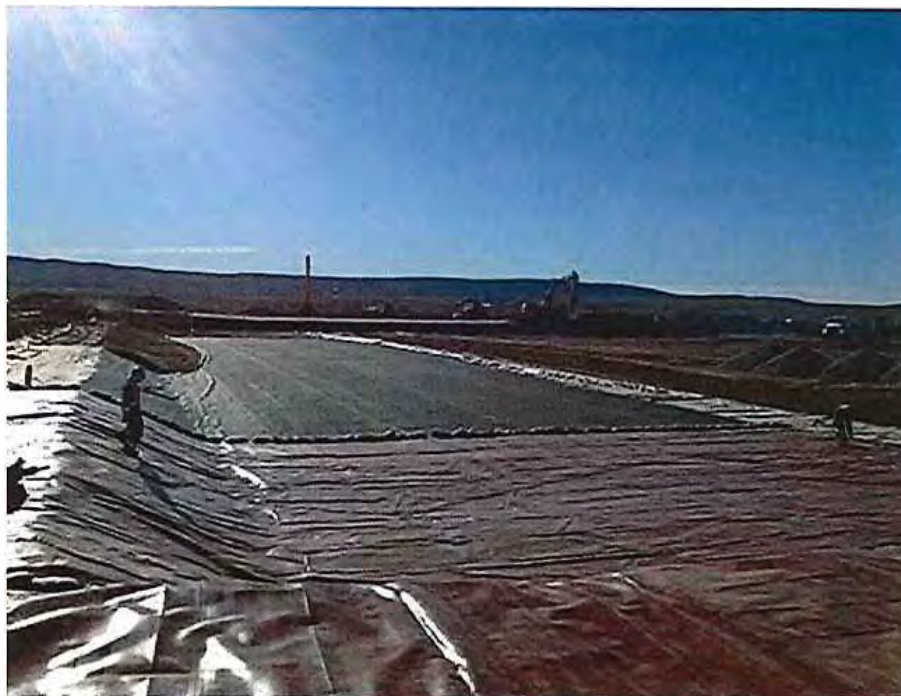
Figure 5: Installation of liner

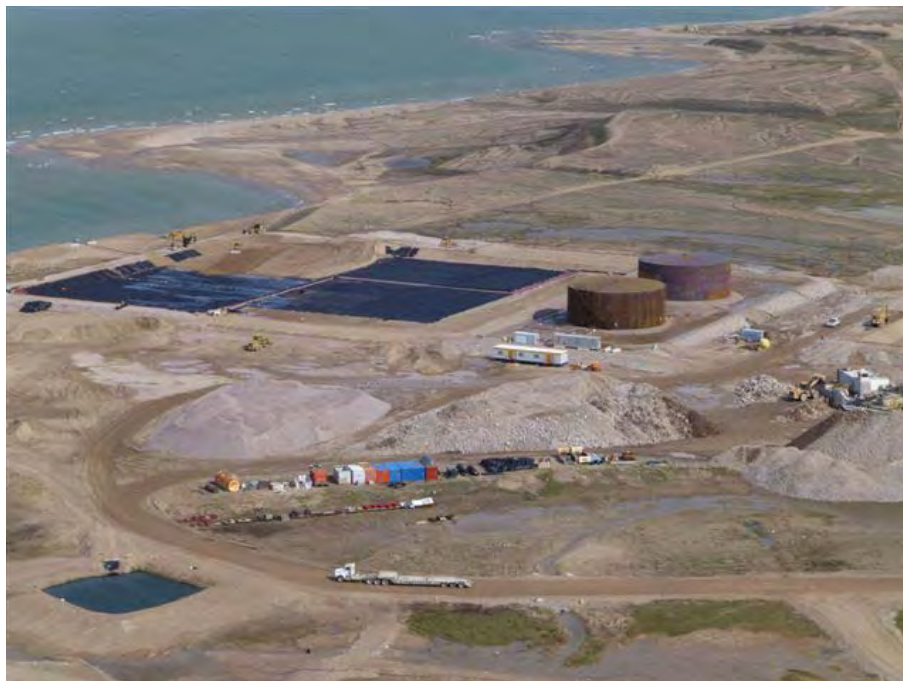
Figure 6: Liner installation in-progress [northeast view]

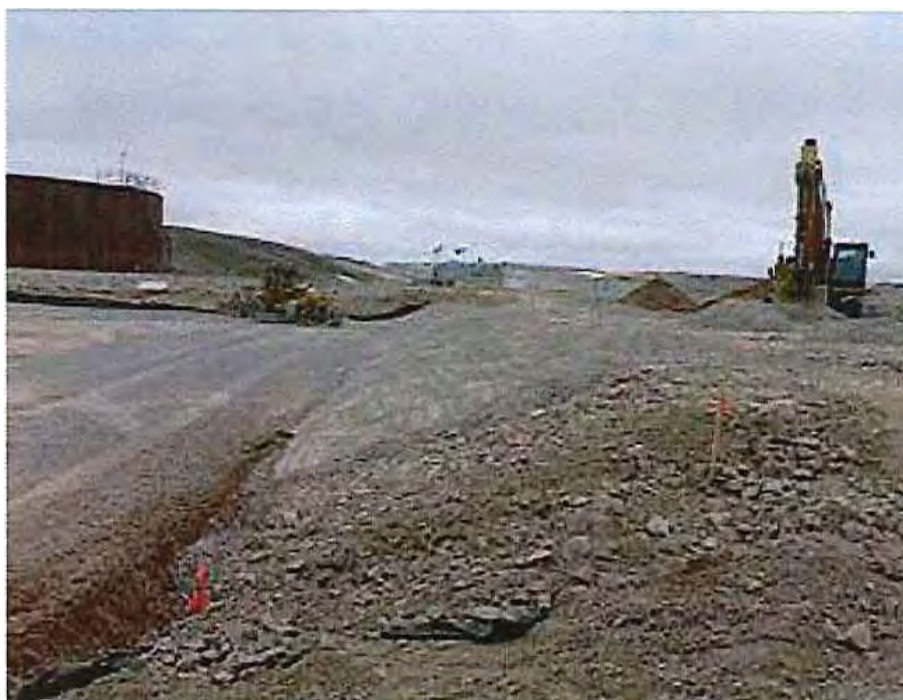
Figure 7: Berm construction

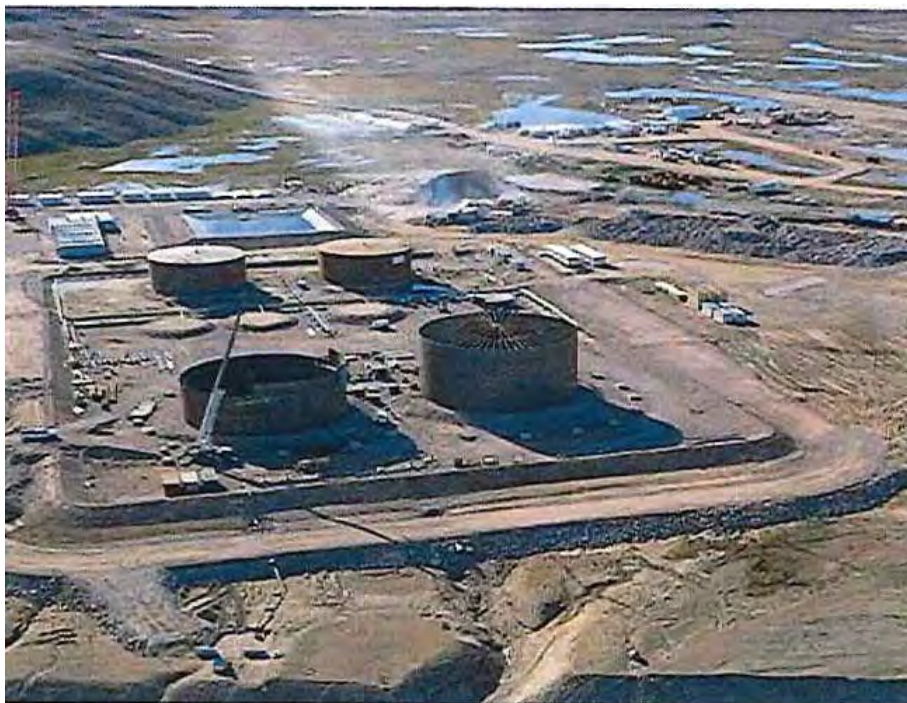
Figure 8: Containment earthworks completed [south view]

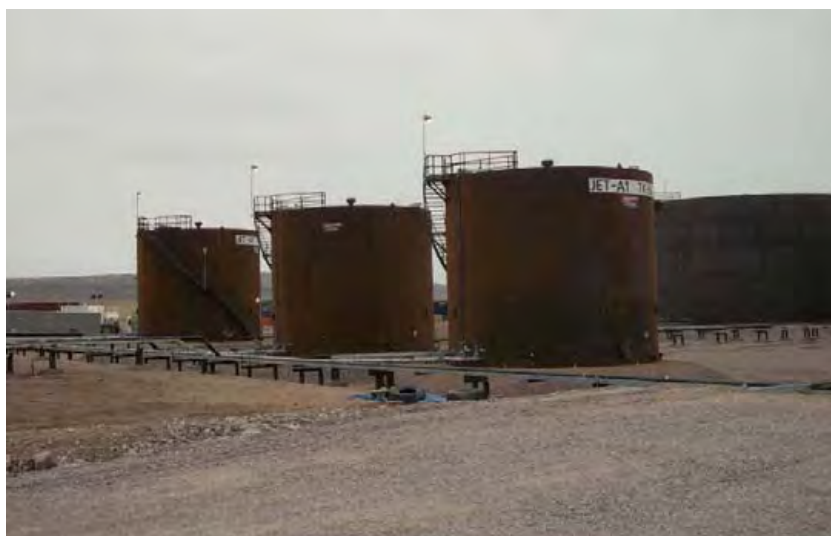
Figure 9: Valves and piping between the tanks and dispensing modules

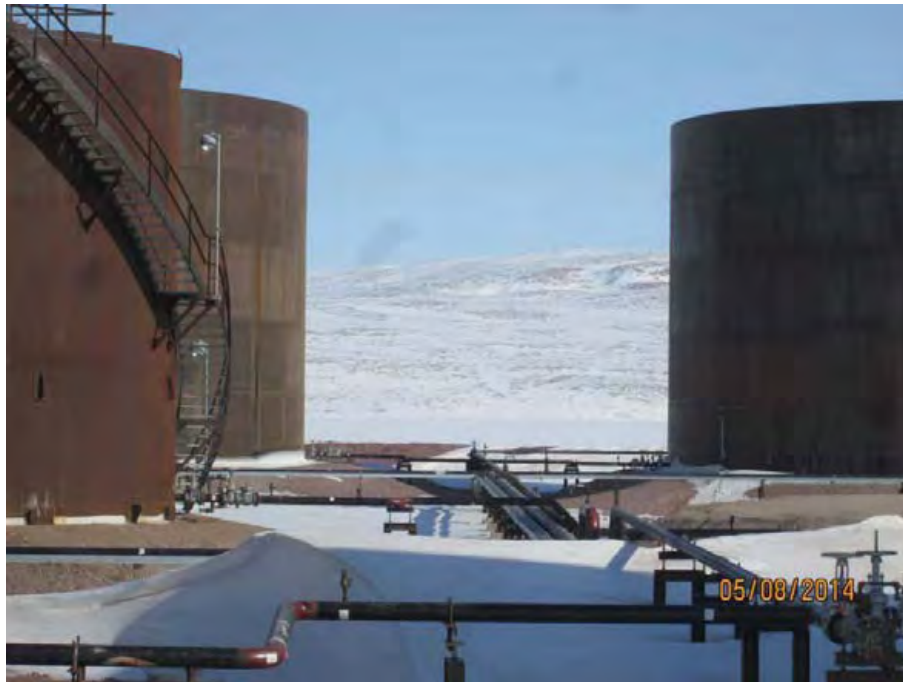
Figure 10: Valves and piping between the tanks and dispensing modules

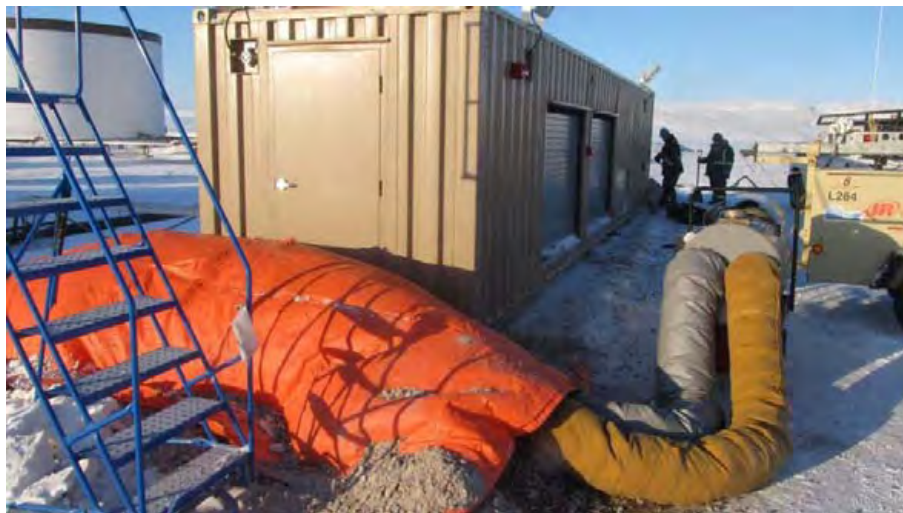
Figure 11: Placement of the dispensing module

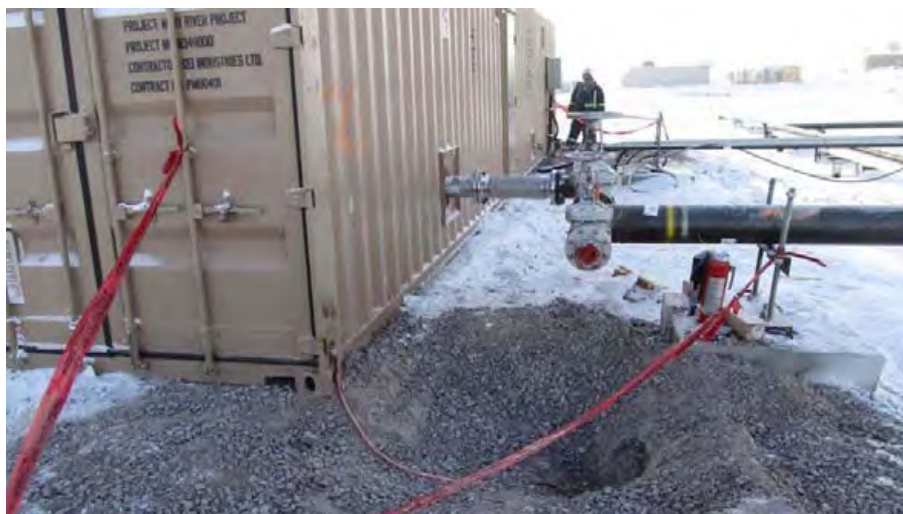
Figure 12: Dispensing module inlet piping from tanks

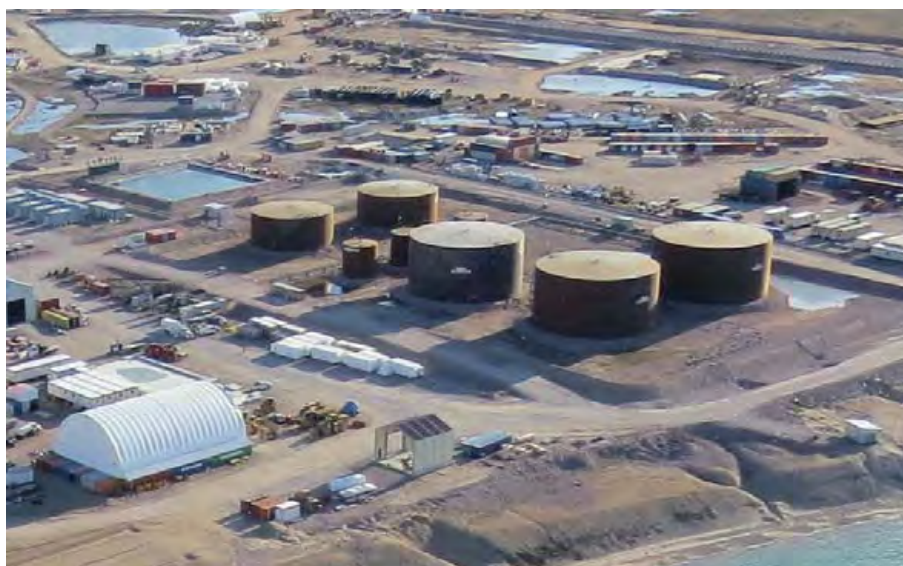
Figure 13: Completion of tank farm and dispensing package construction [southwest view]
