**Baffinland Iron Mines Corporation
Mary River Project**

**Construction Summary Report: Mine Site Tank Farm & Dispensing
Package**

MARY RIVER PROJECT

2014 INSPECTIONS

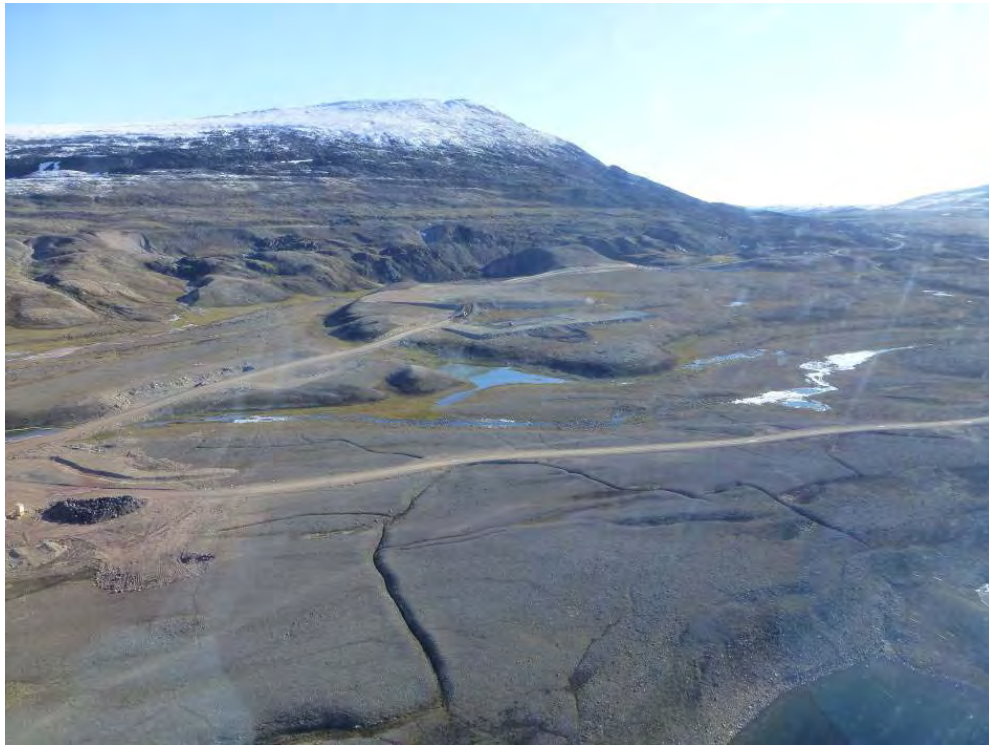
Figure 1: Earthworks pad in-progress [northeast view]

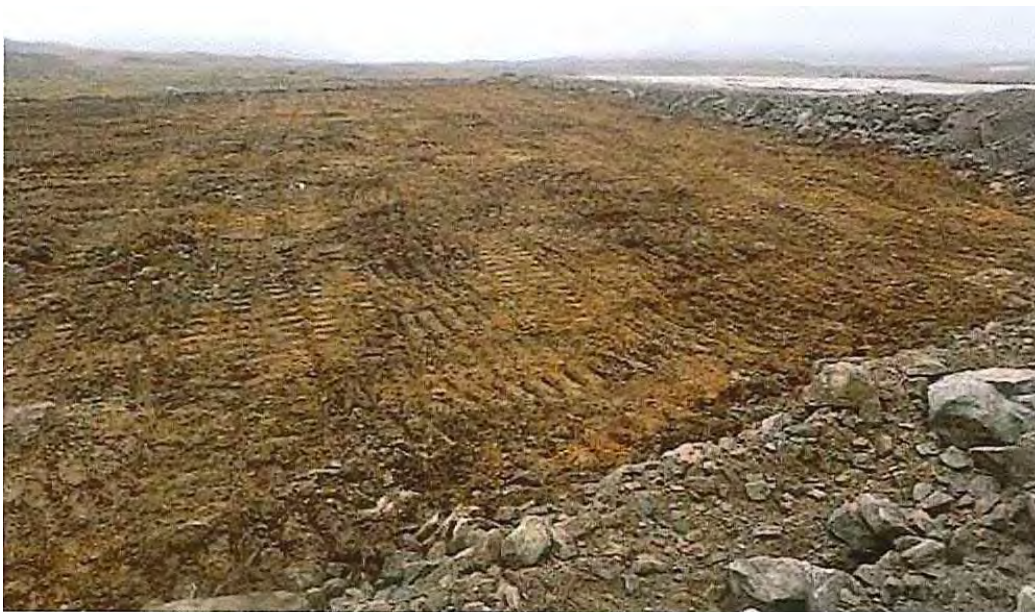
Figure 2: Graded sub-base

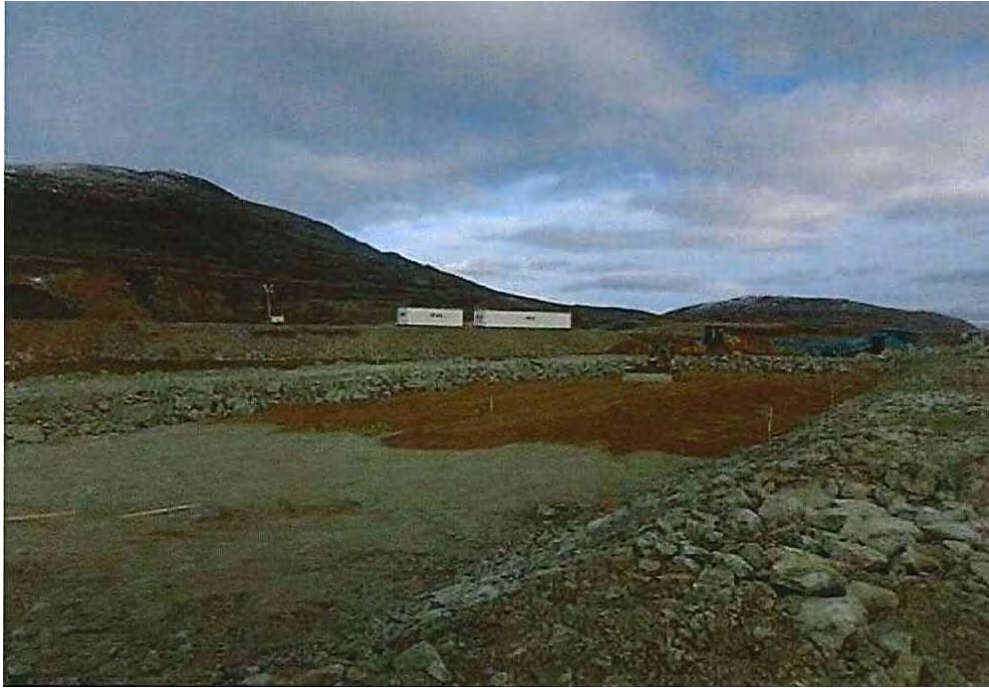
Figure 3: Installation of sand below liner

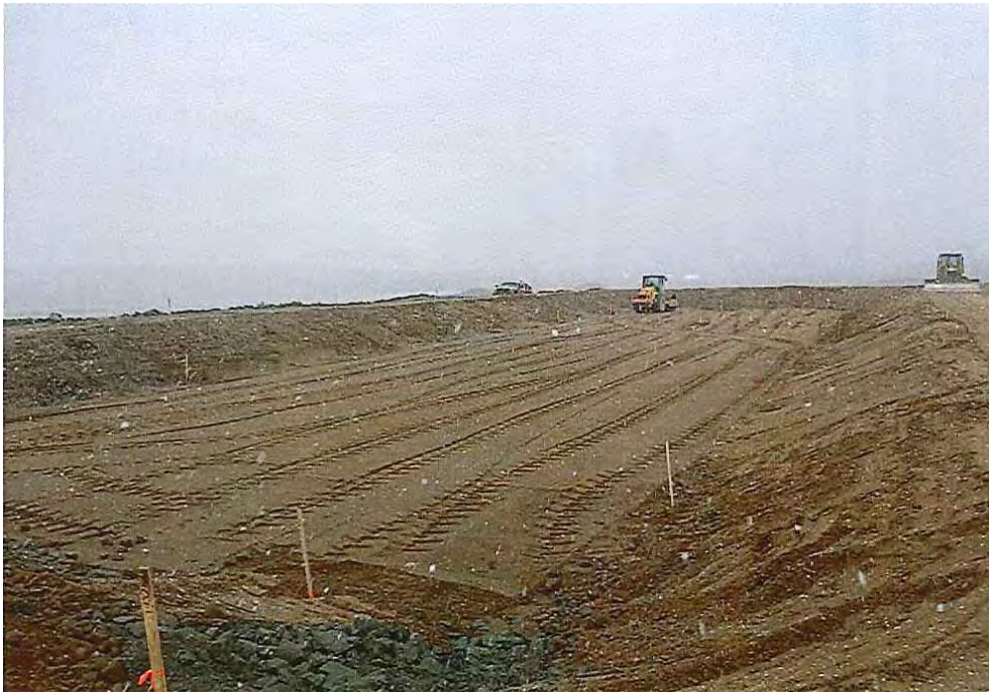
Figure 4: Compaction of sand layer

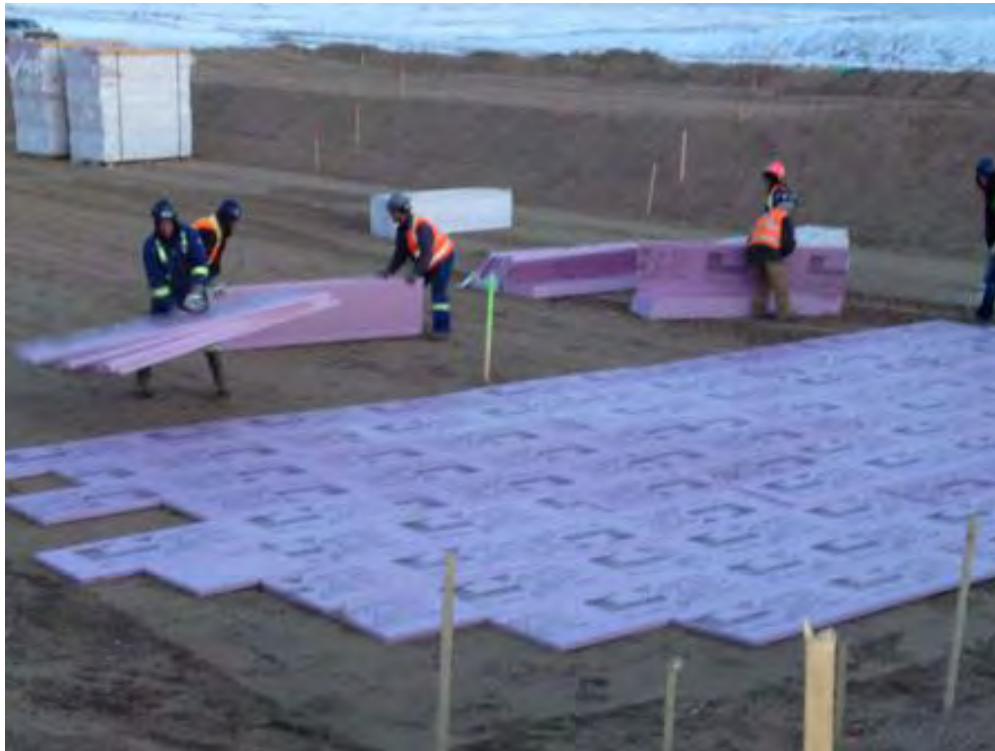
Figure 5: Installation of insulation layer

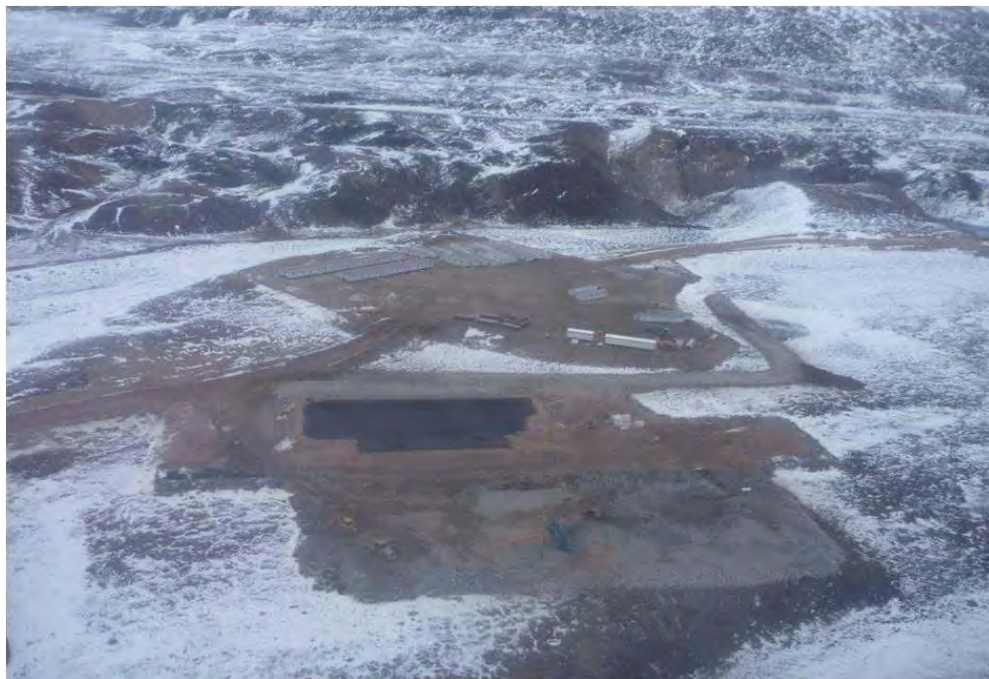
Figure 6: Liner installation in-progress [north view]

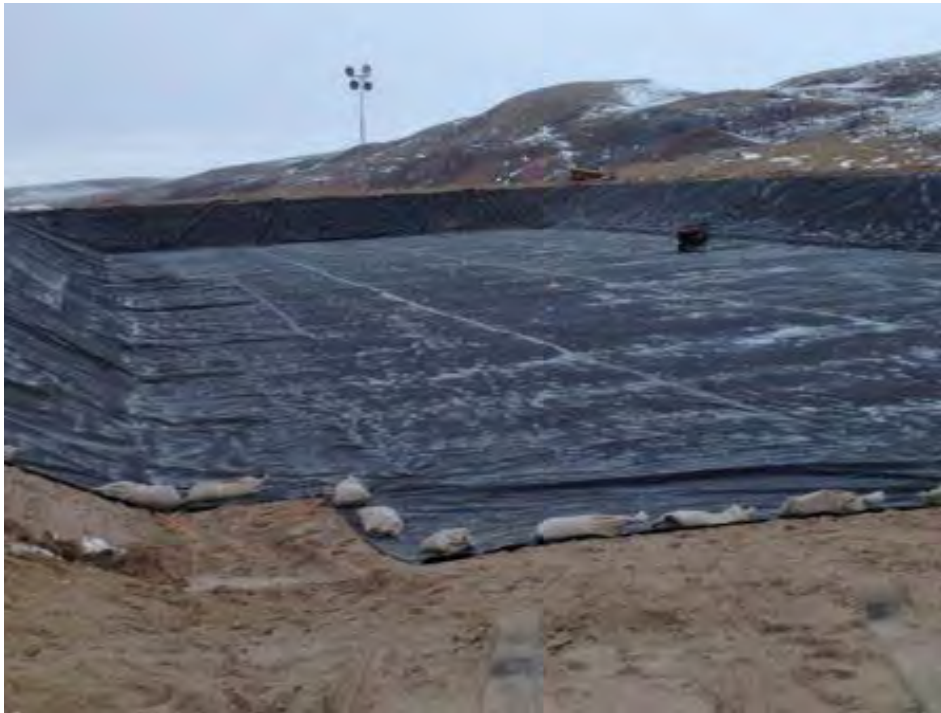
Figure 7: Liner installation in-progress

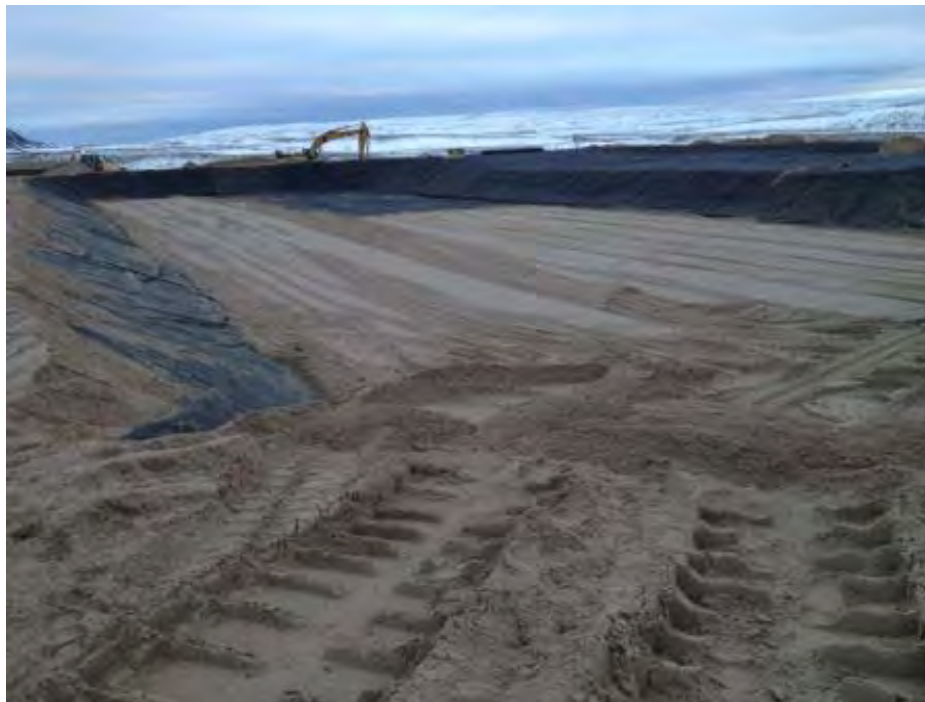
Figure 8: Installation of cover material over liner

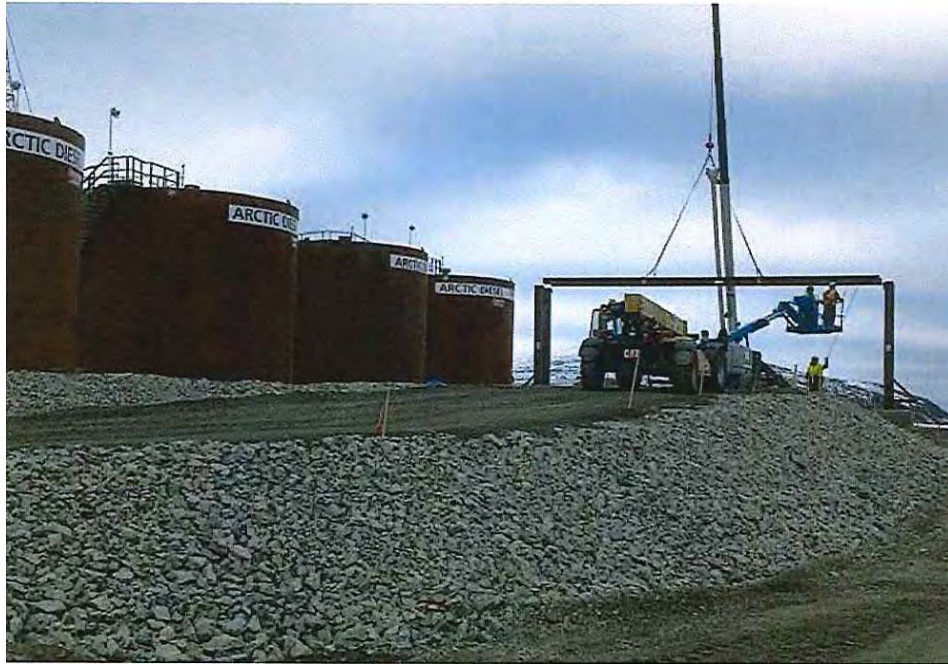
Figure 9: Finished side slopes [southeast view]

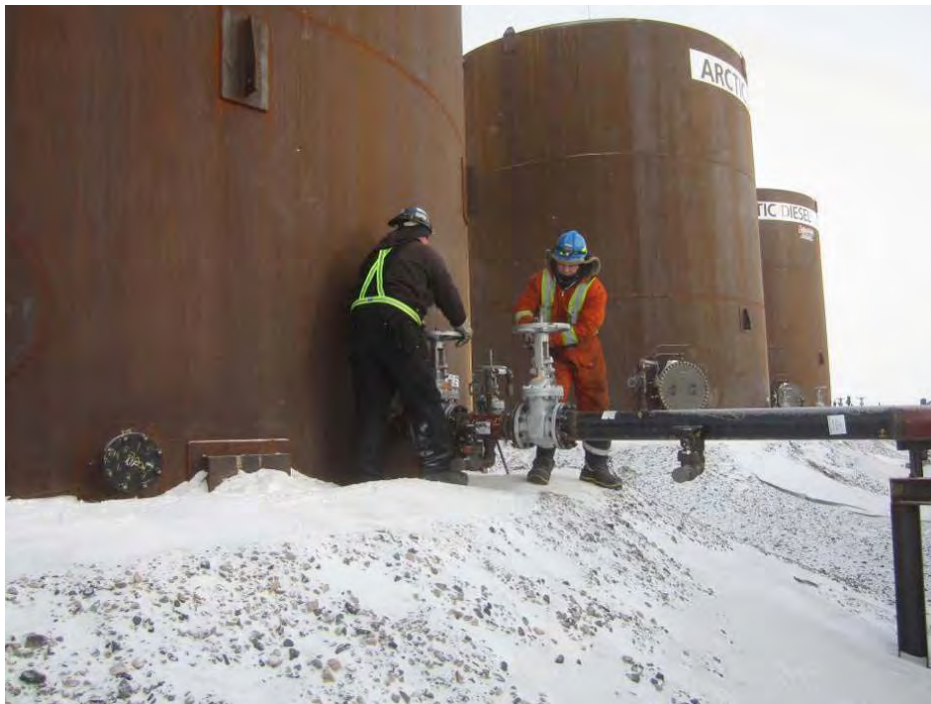
Figure 10: Valves and piping between tanks and dispensing module (at tanks)

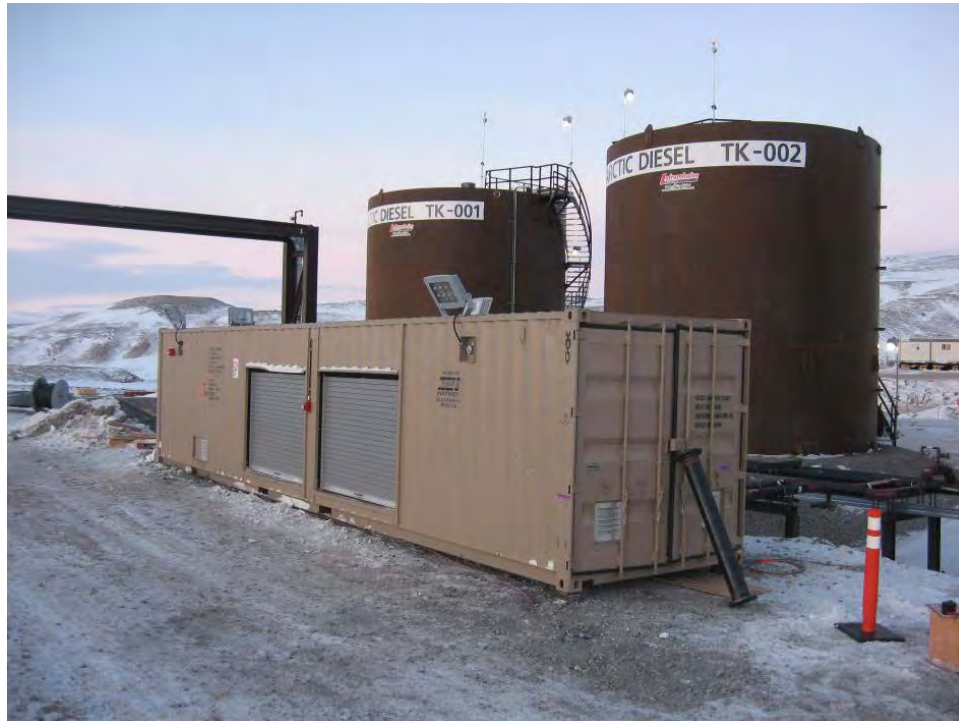
Figure 11: Fuel dispensing module and overhead piping tray

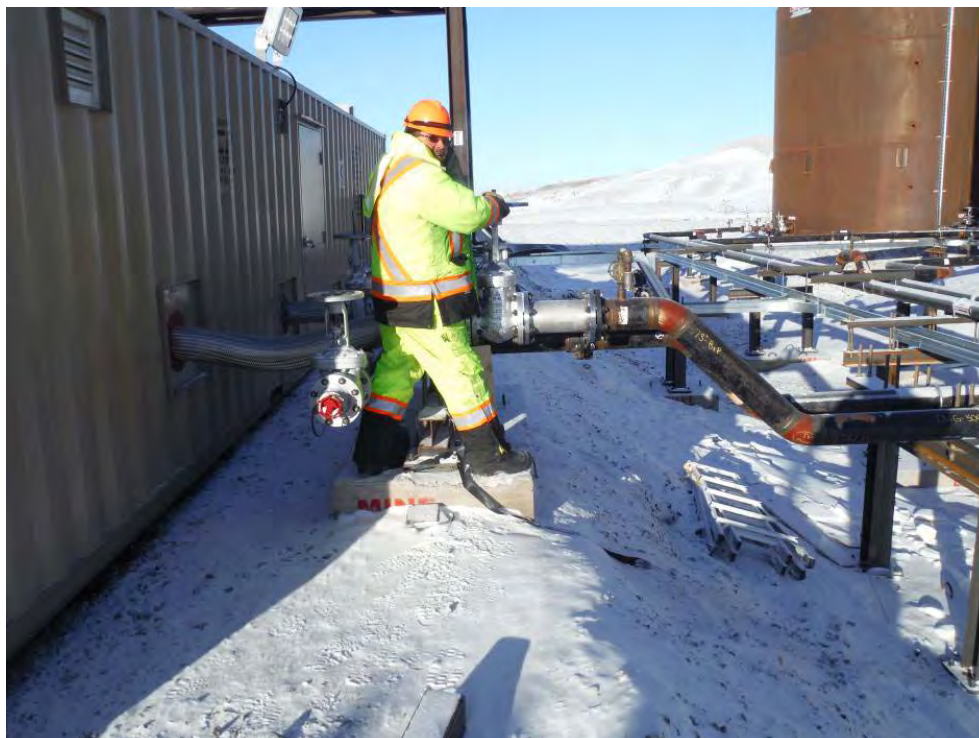
Figure 12: Valves and piping between tanks and dispensing module (at dispensing module)

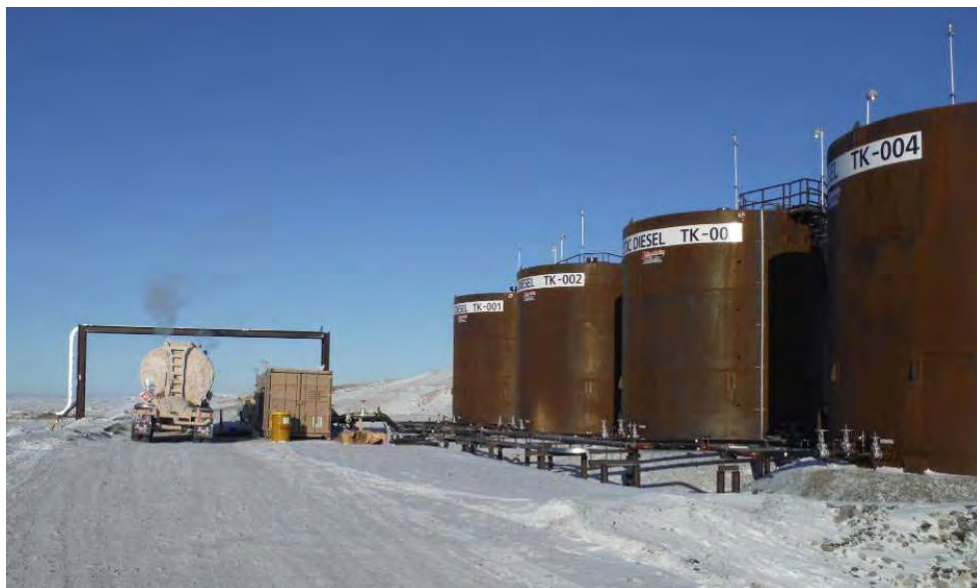
Figure 13: Tanks, piping, dispensing module, and overhead piping tray [northwest view]

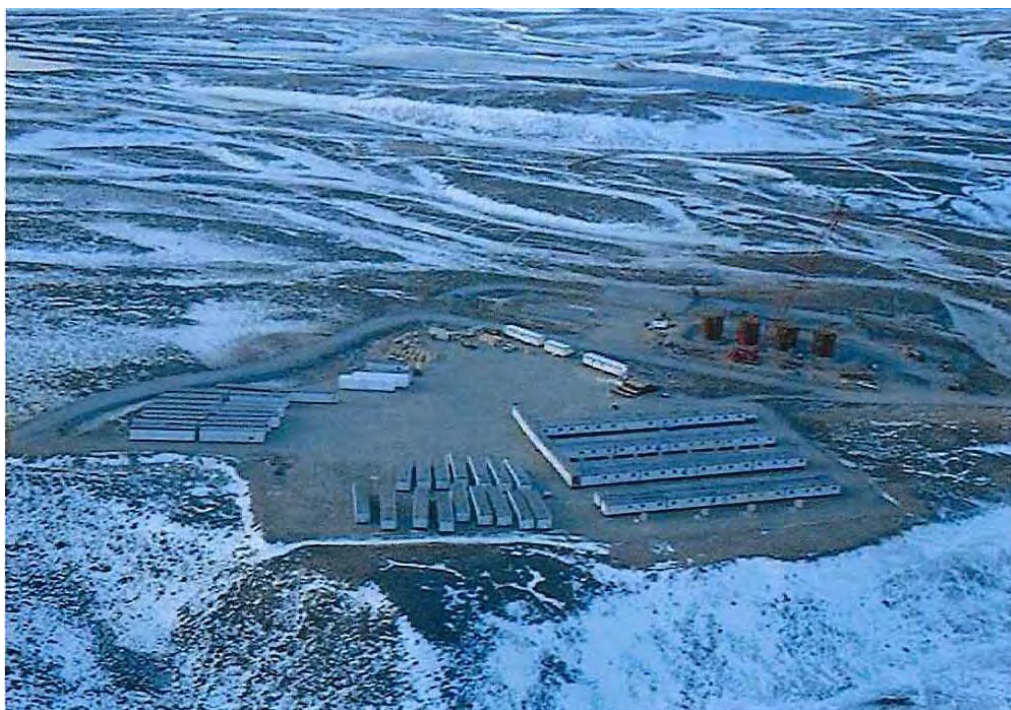
Figure 14: Completed Fuel Farm [south view]

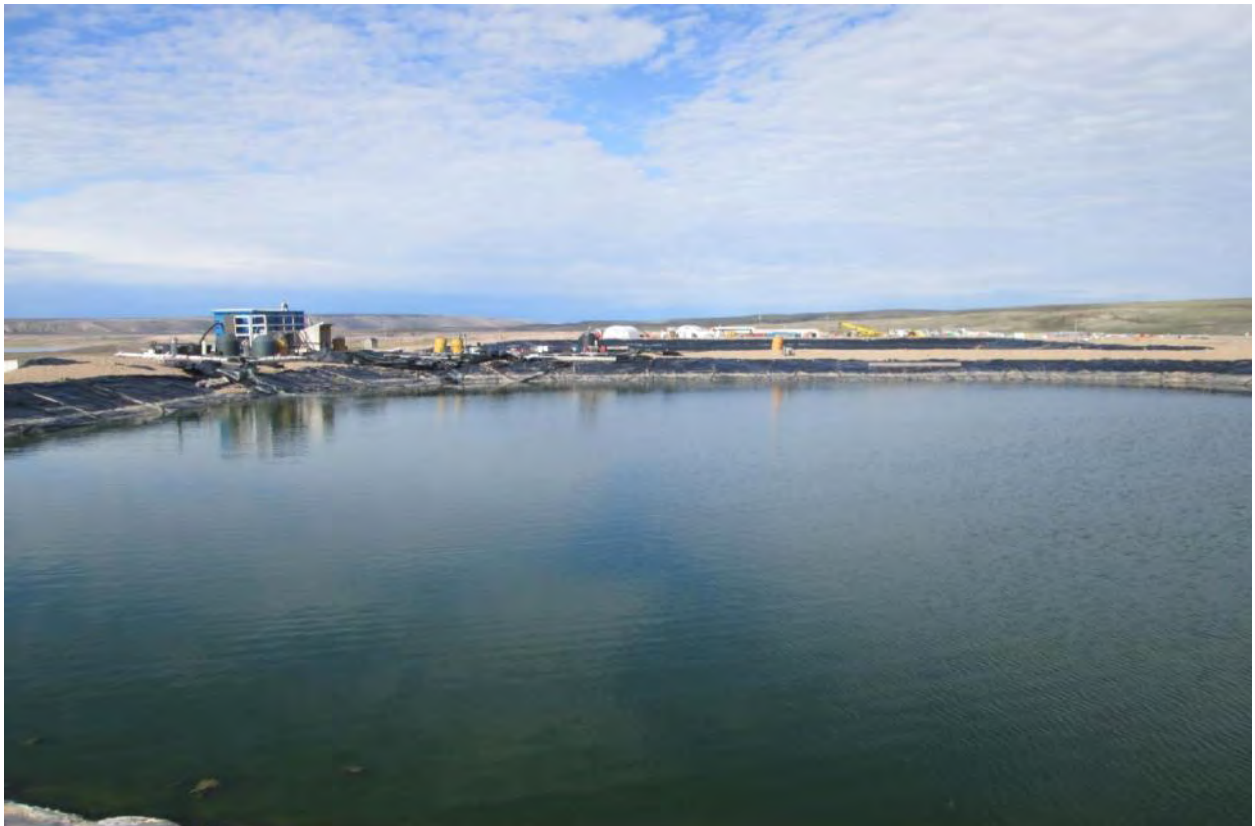
Polishing/Waste Stabilization Ponds #2 and #3.

Longitudinal cracking which appeared in the dykes of PWSP#3 due to the melt of permafrost wedges in 2009 has not reoccurred and we consider this structure to be stable in its present condition.

We see no reason to continue the monitoring of the top of the berm on an annual basis. With the excellent condition of the dyke construction, we see no reason to continue this function.

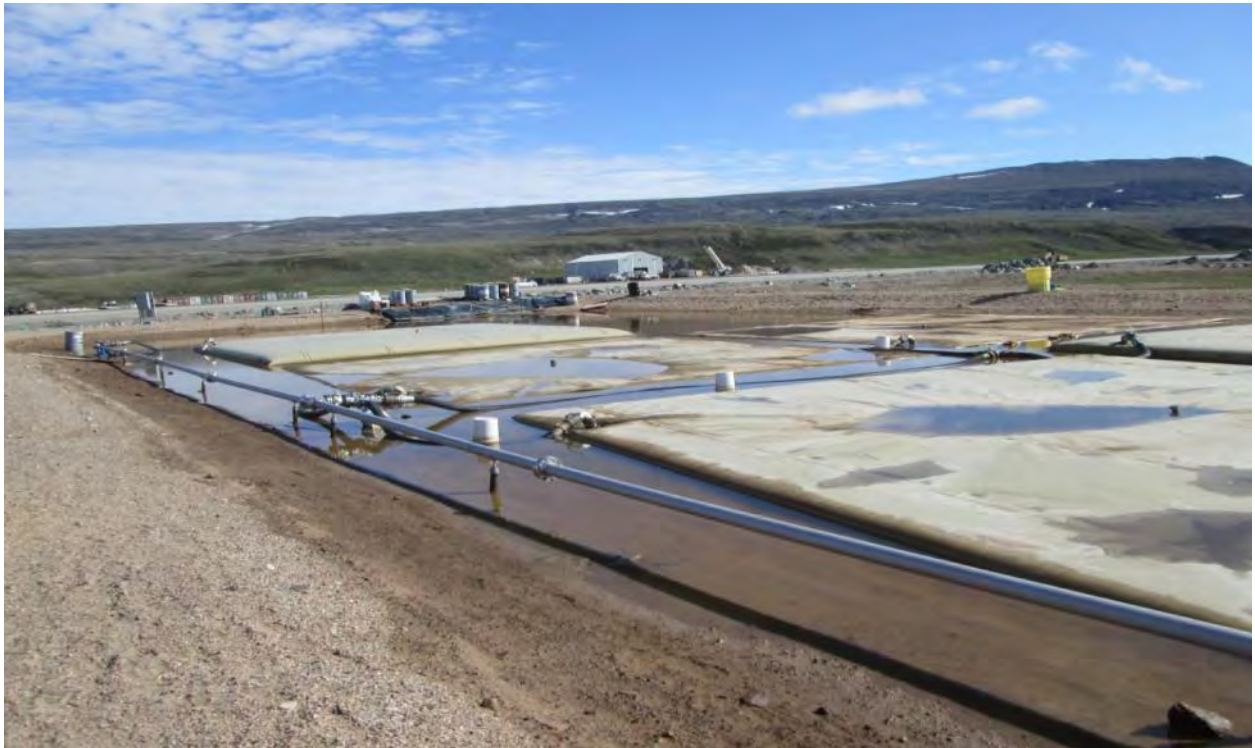
Bulk Fuel Storage Containment.

At the time of our first review, water had not been removed for a period from within the containment and water was ponding above the level of the gravel within the bottom of the containment. There was still considerable factor of safety against failure of oil holding bladders within the dykes with the water level as it exists. Such was the case during the second inspection, but the water had frozen.

The structure was visually inspected for any signs of cracking or subsidence. There was no indication of any settlement, seepage, or cracking in the soil structures that formed the dykes. As well, there was no indication of seepage at the base of the structure around the exterior.

The soil structure is considered stable in the present condition and is in conformance with the design basis for the facility.

We have one recommendation. There is limited storage for spills at the load out end of the facility. Water currently ponds above the gravel in this area confirming the integrity of the liner but minimizing the capacity of the structure for spill containment.

We recommend that this water be removed on a regular basis. If the water proves to be oil impacted, it may be pumped to within the storage containment for treatment at a future date.

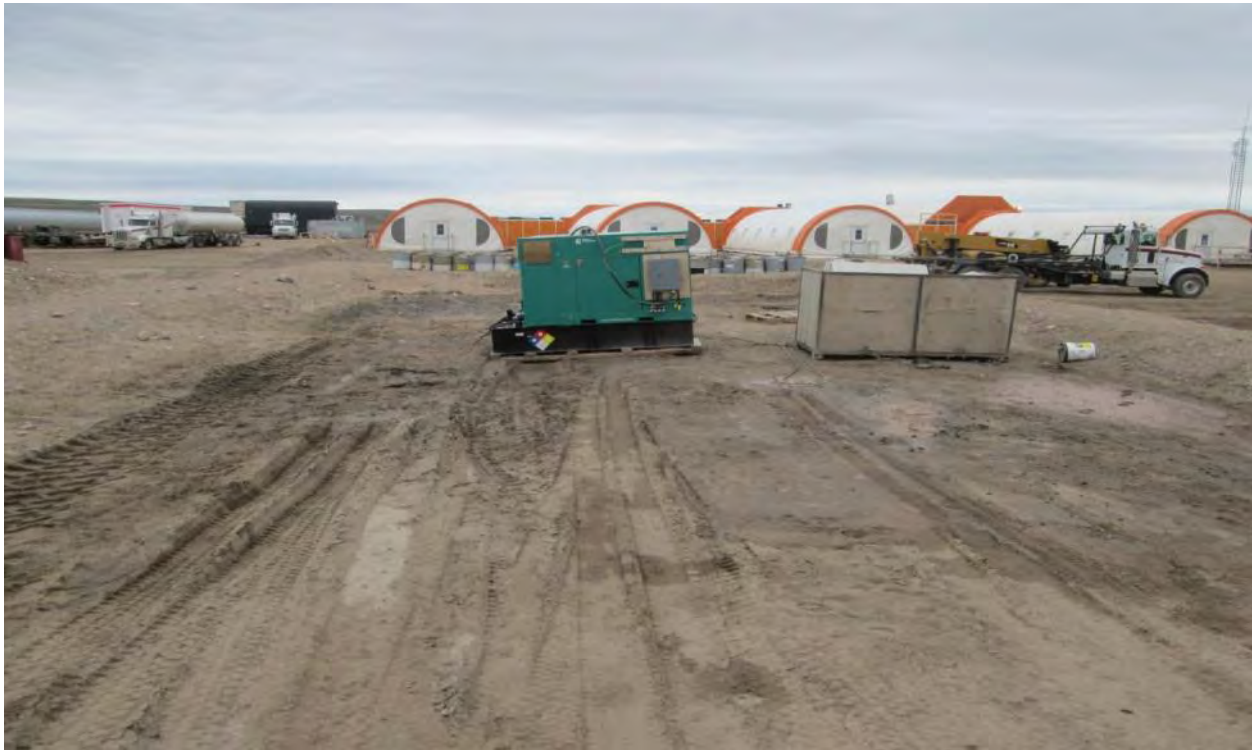
Enviro Tank Storage

This particular structure is constructed contiguous with the Hazardous Waste Storage constructed in 2010 and the Stove Oil Storage cell. It is now utilized as a wash down cell.

We recommend that the geotextile over the liner and the granular cover be made good prior to continuing use of this cell as a wash down cell.

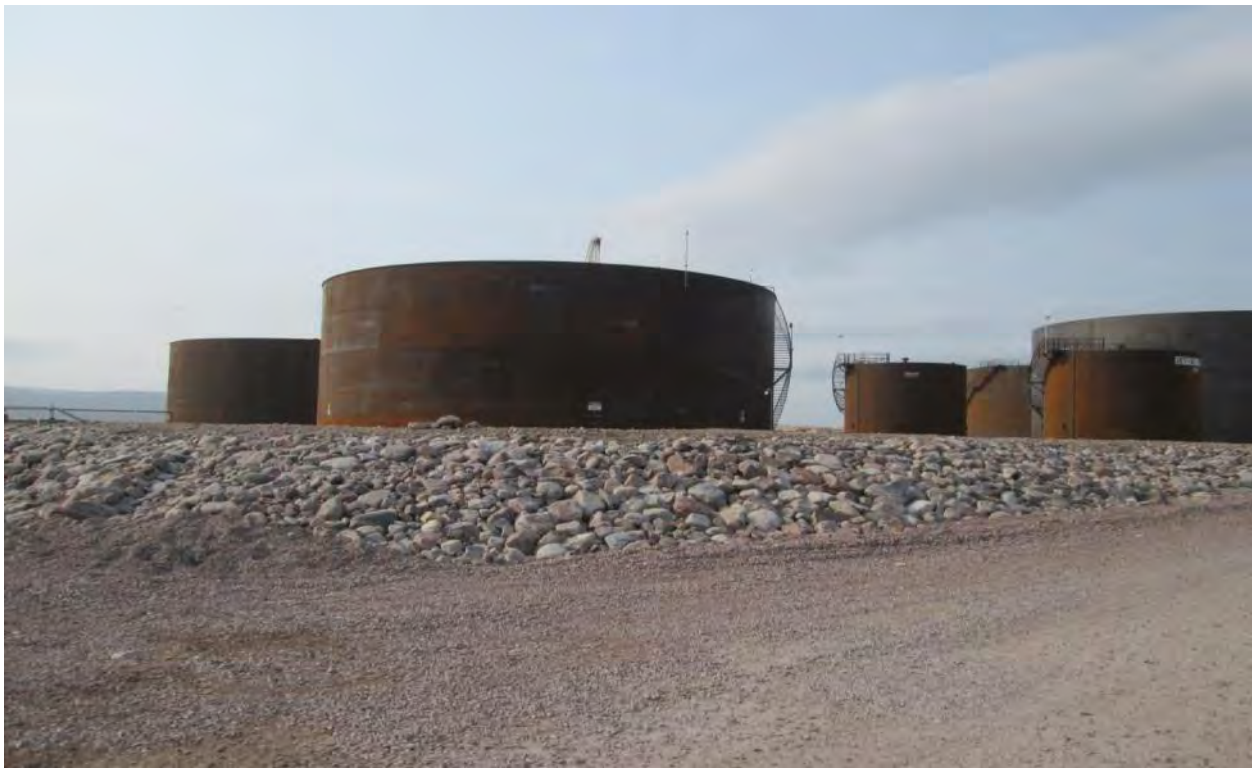
Photo taken from the south east corner of the steel storage tank containment outside the containment looking north west.

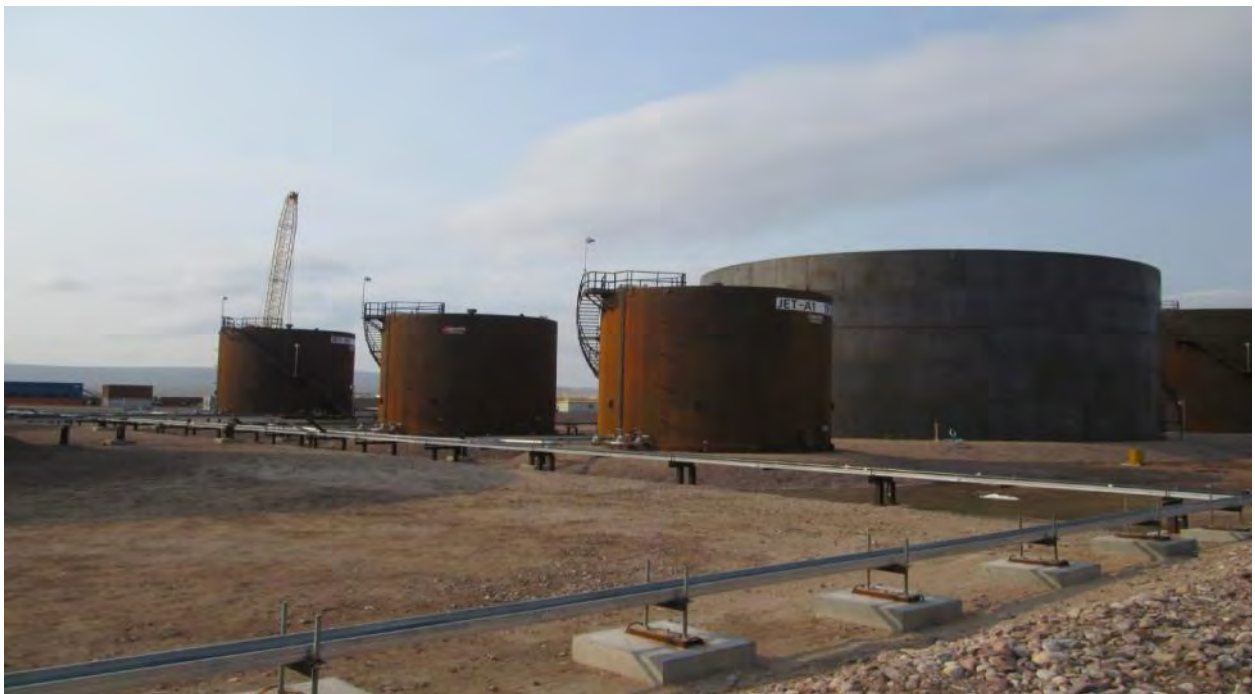
Photo taken from atop the containment dyke looking west into the containment.

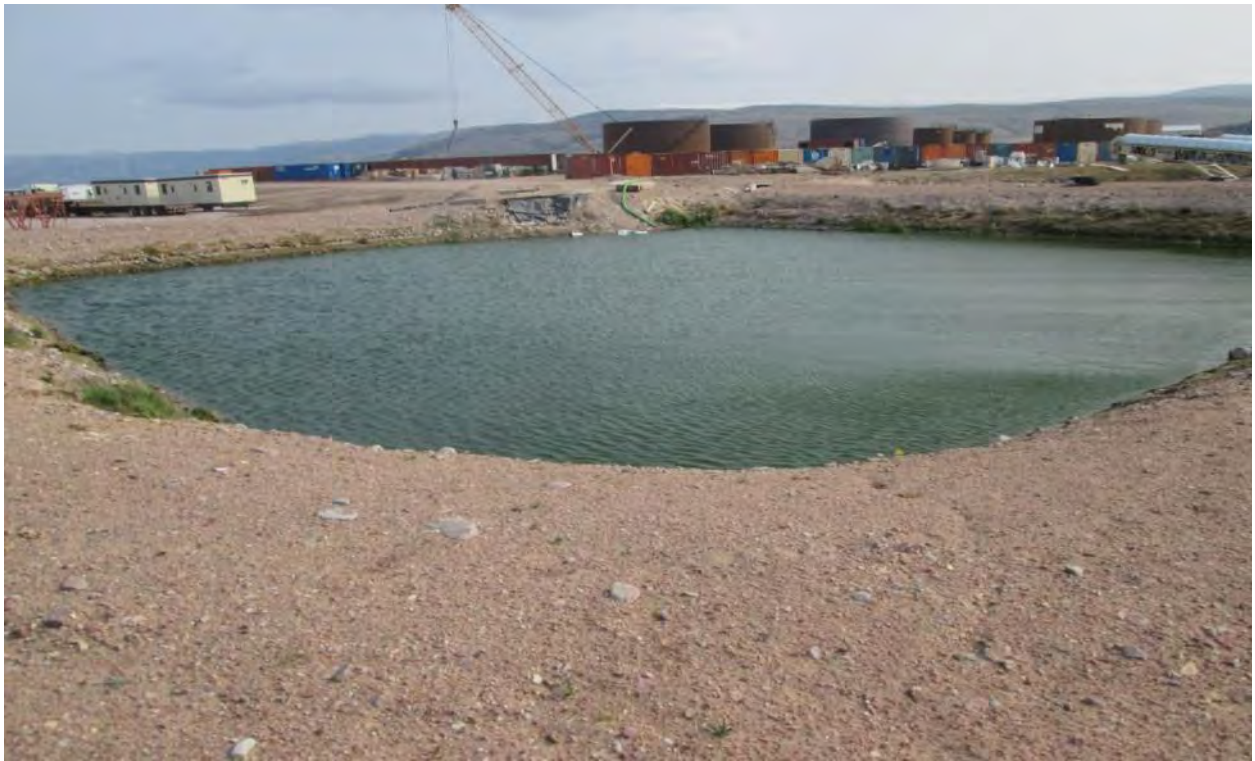
Photo taken from atop the soon to be decommissioned PWSP looking south.

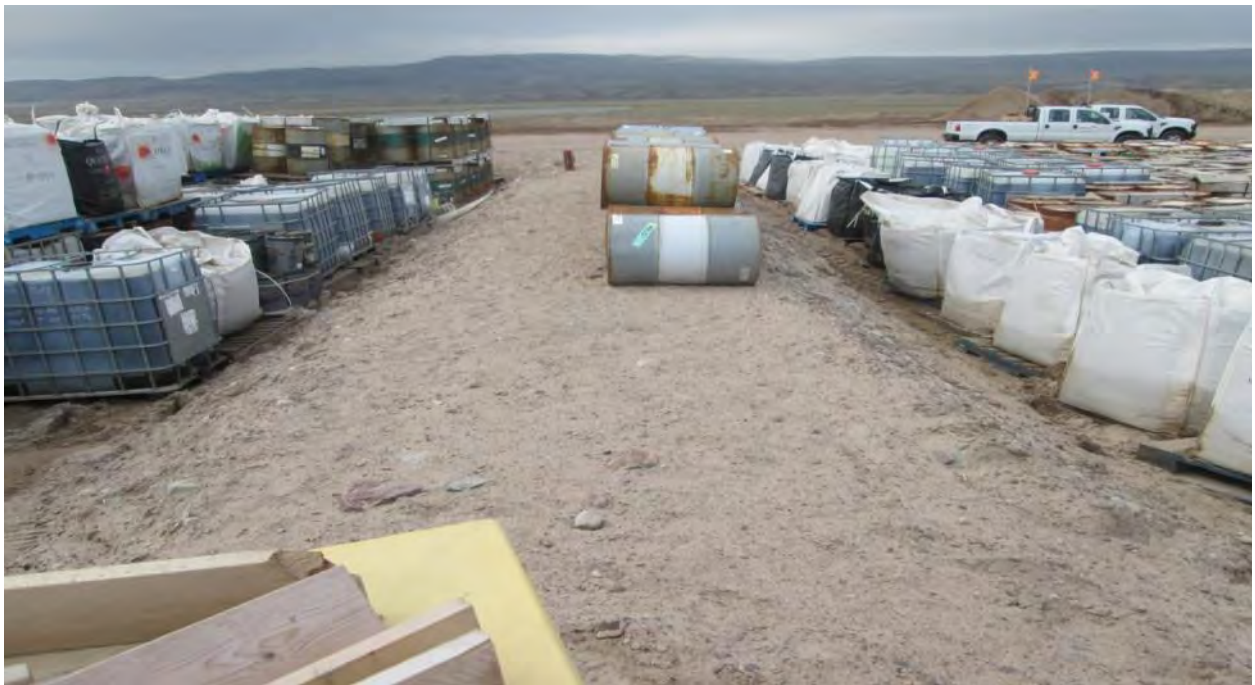
Photo taken of central dyke in barrel fuel storage looking west.

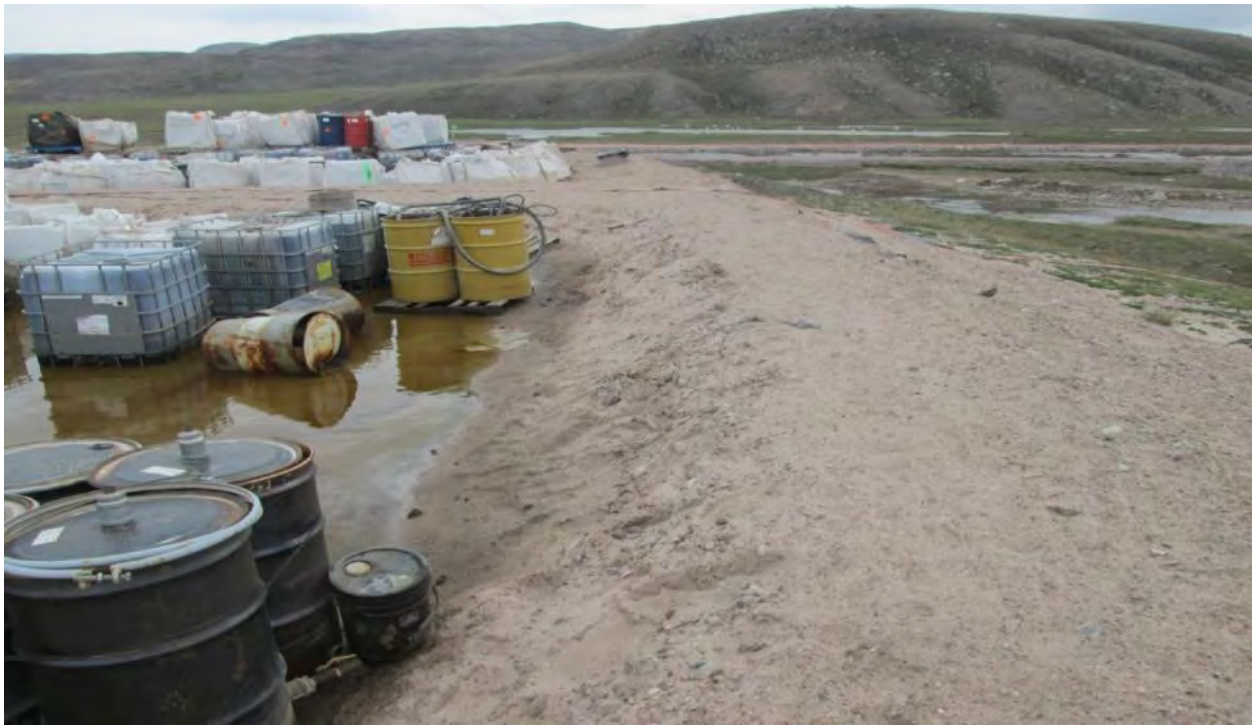
Photos taken along rear dyke at hazardous waste storage area. Note water contained within dyke.

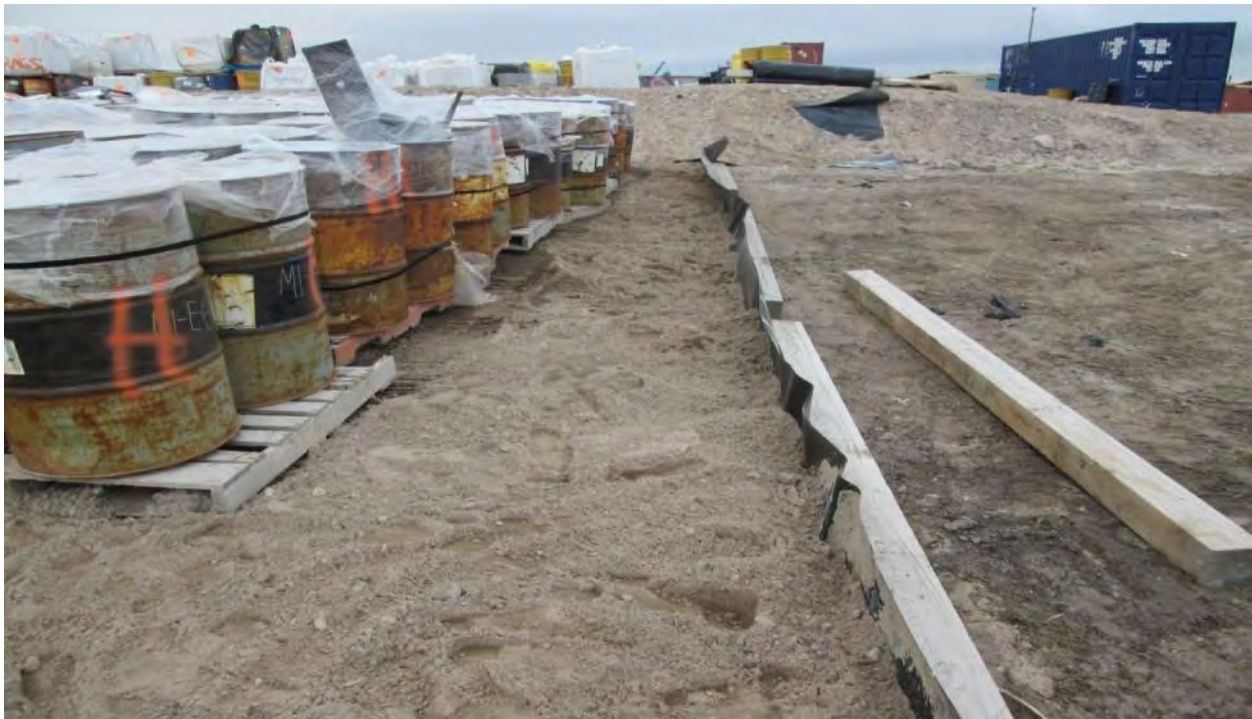
Due to an excess of hazardous waste in the two cells, a third temporary cell has been constructed for the very short term until the ship picks up the hazardous waste at the end of this summer season.

Photo shows temporary curbed area for hazardous waste awaiting immediate shipment.

We recommend that the use of the temporary third cell, recently constructed, be discontinued when the currently stored hazardous waste is shipped out by the end of this shipping season.

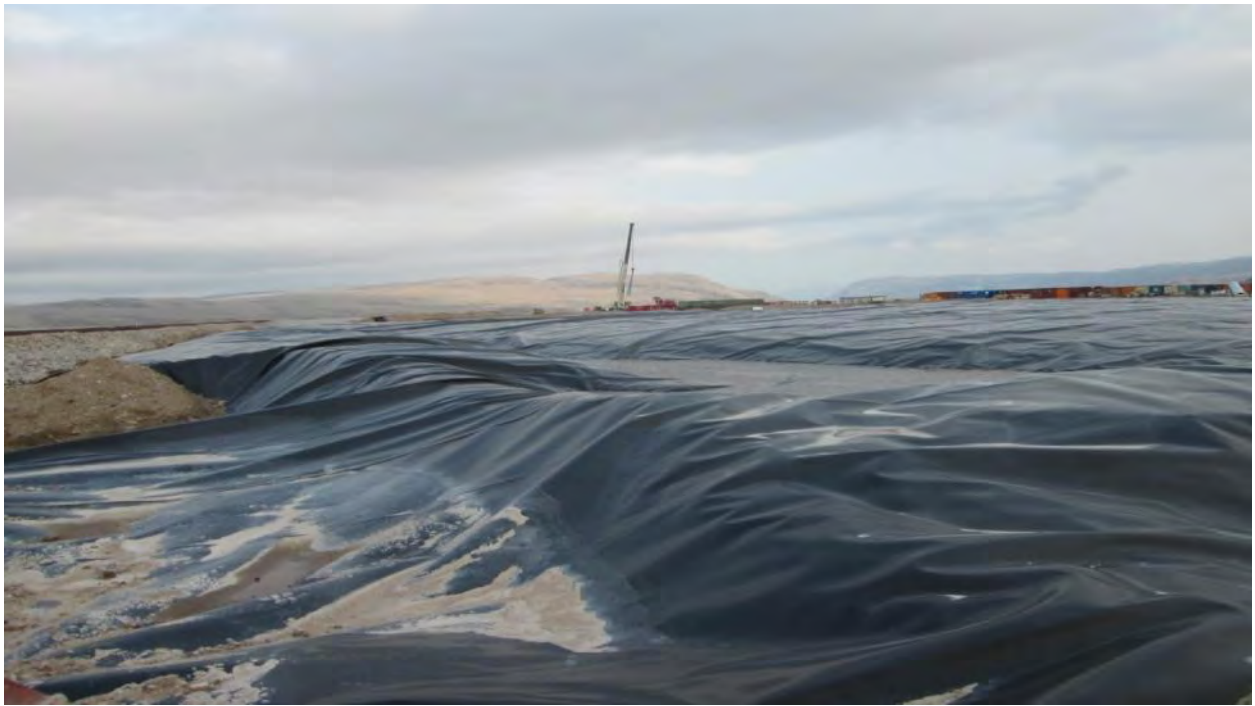
Photo taken looking north at the covered contaminated granular from the bulk fuel storage facility undergoing decommissioning.

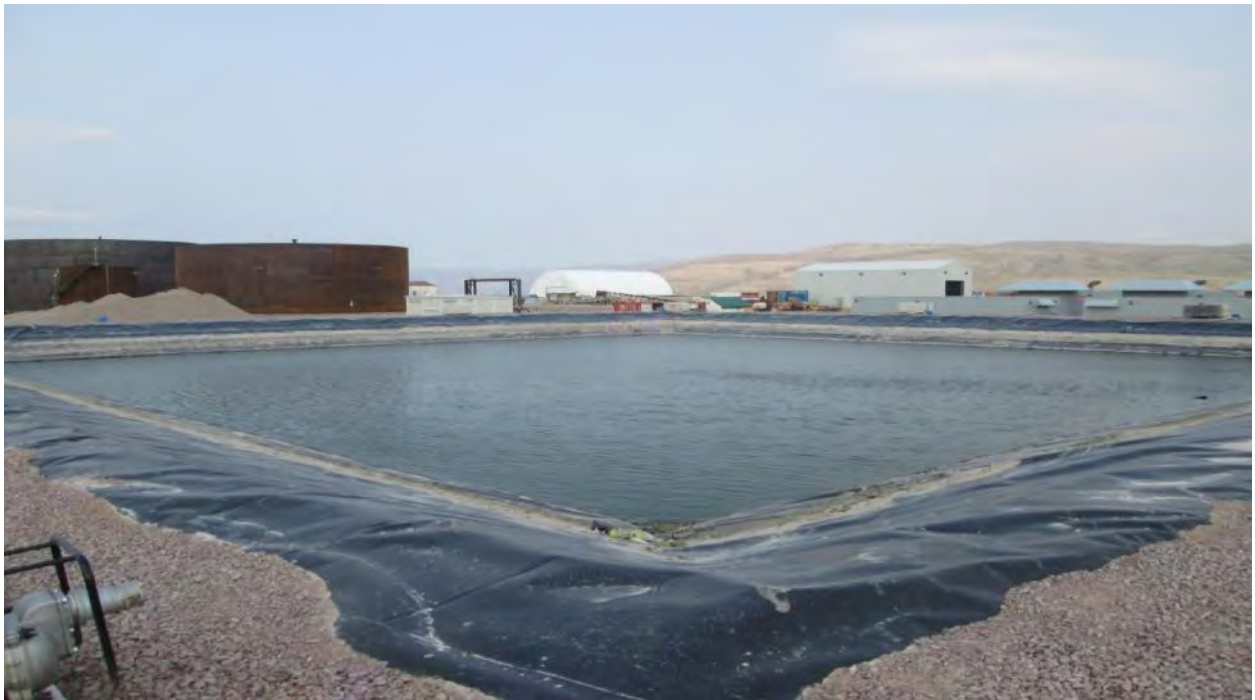
Photo taken from atop the south west corner of the New Sewage Effluent Pond looking north east.

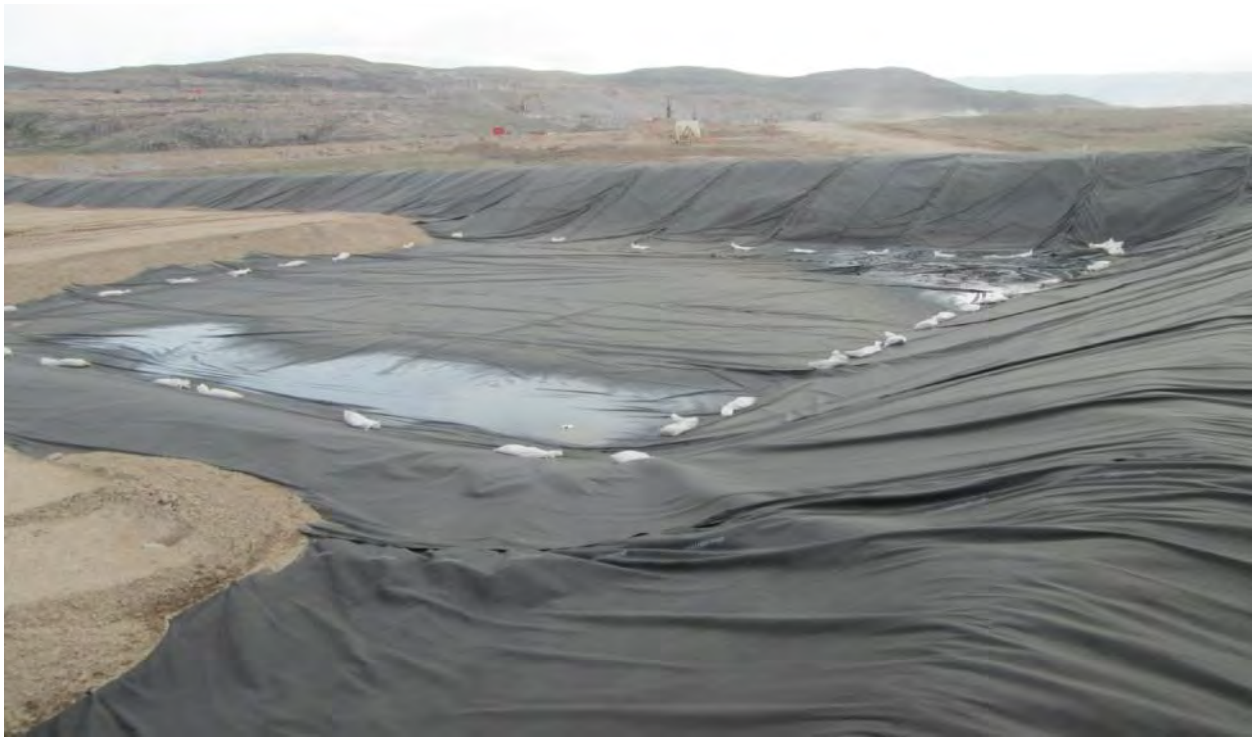
Photo taken looking into the sump at the north east corner of the Landfarm.

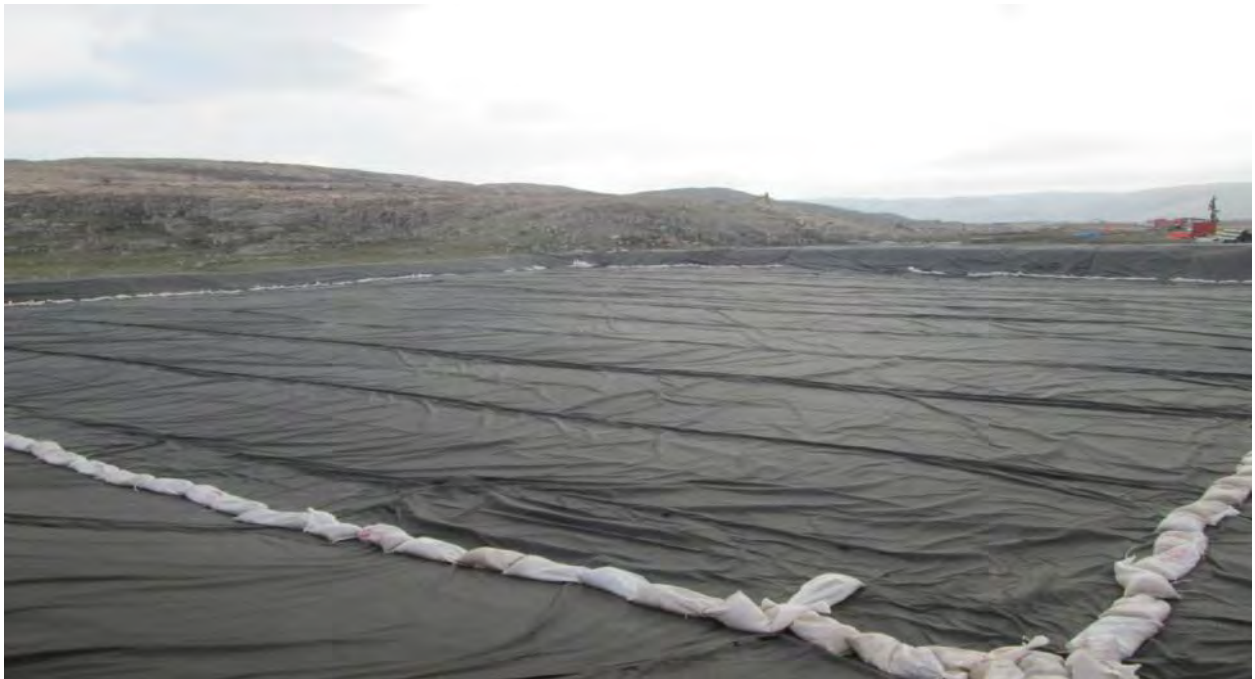
Photo taken from atop the dyke looking into the contaminated snow containment.
