**Baffinland Iron Mines Corporation
Mary River Project**

**Construction Summary Report: Mine Site Tank Farm & Dispensing
Package**

MARY RIVER PROJECT

2014 INSPECTIONS

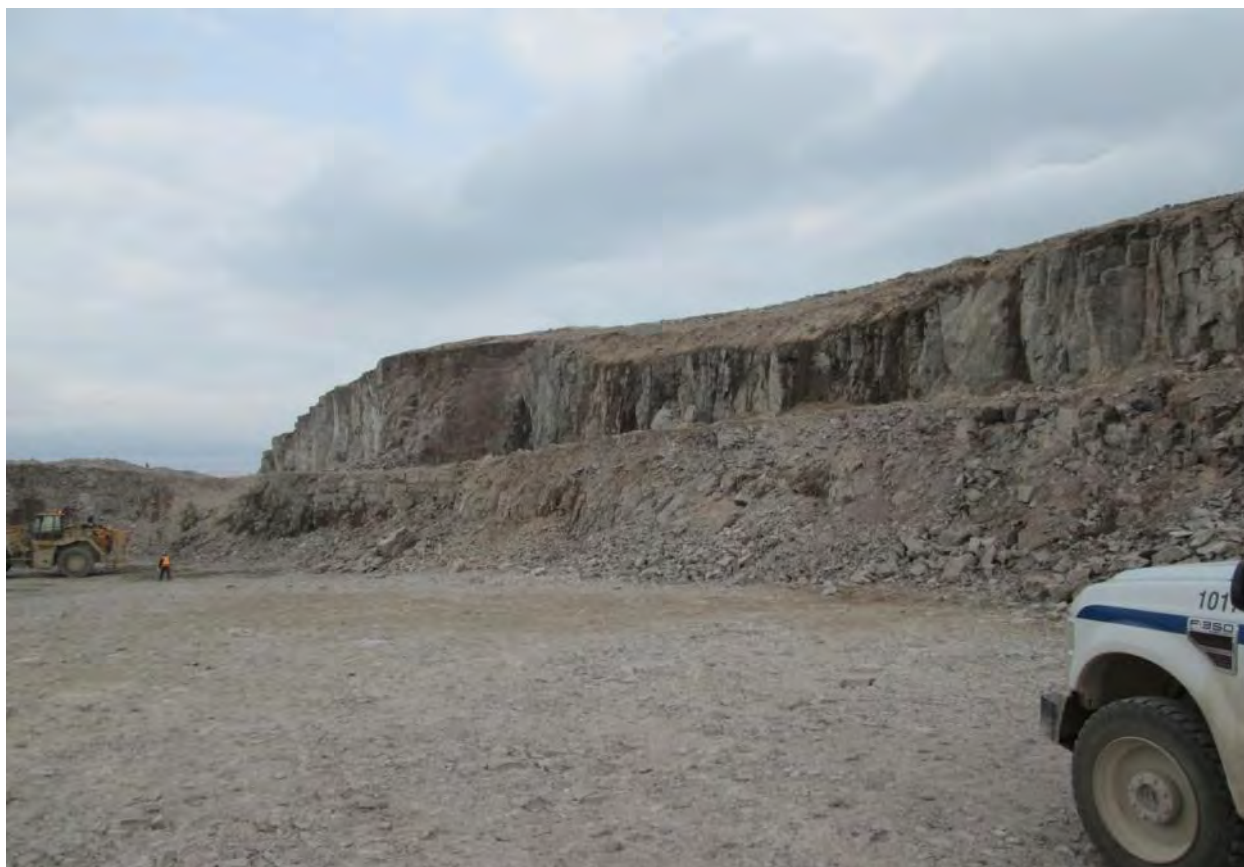
Photo taken looking at the quarry face in the quarry showing the well developed benches and cover removed from atop solid rock.

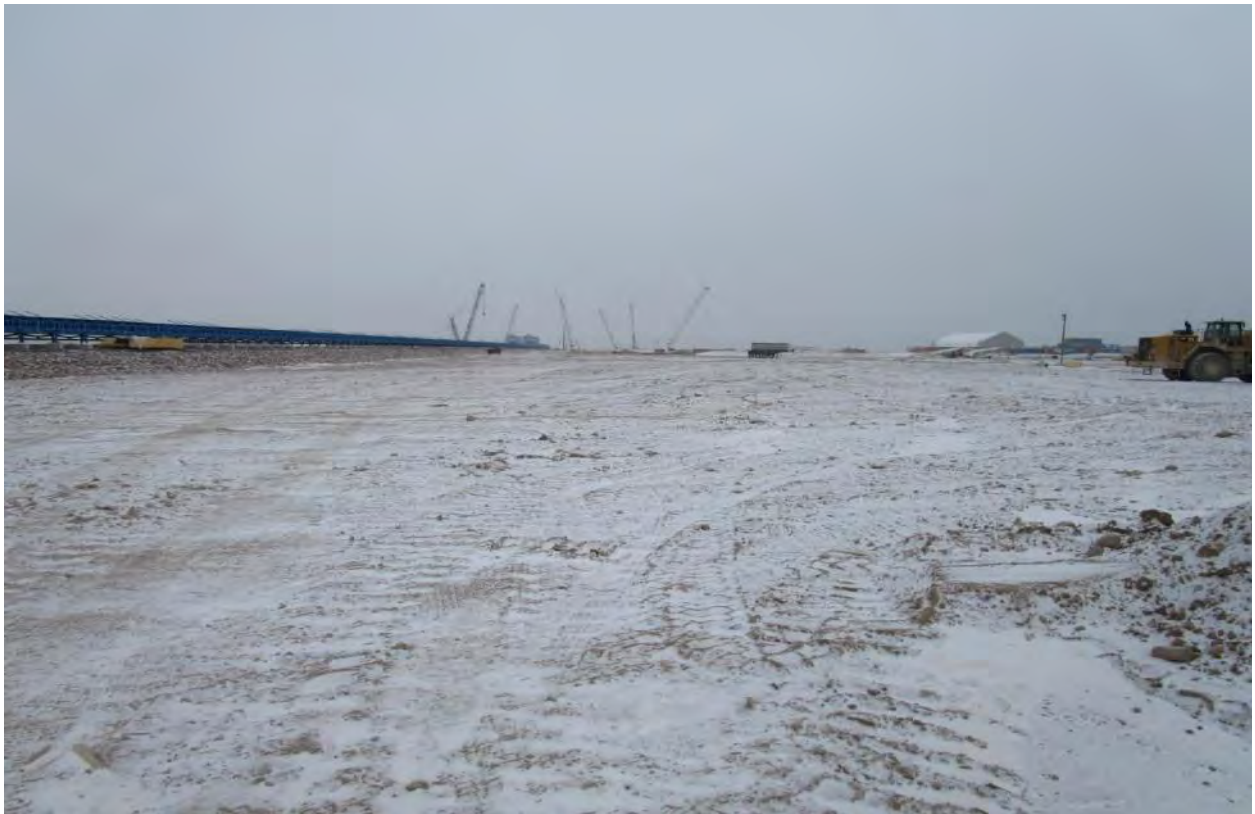
Site of recently decommissioned bulk fuel containment

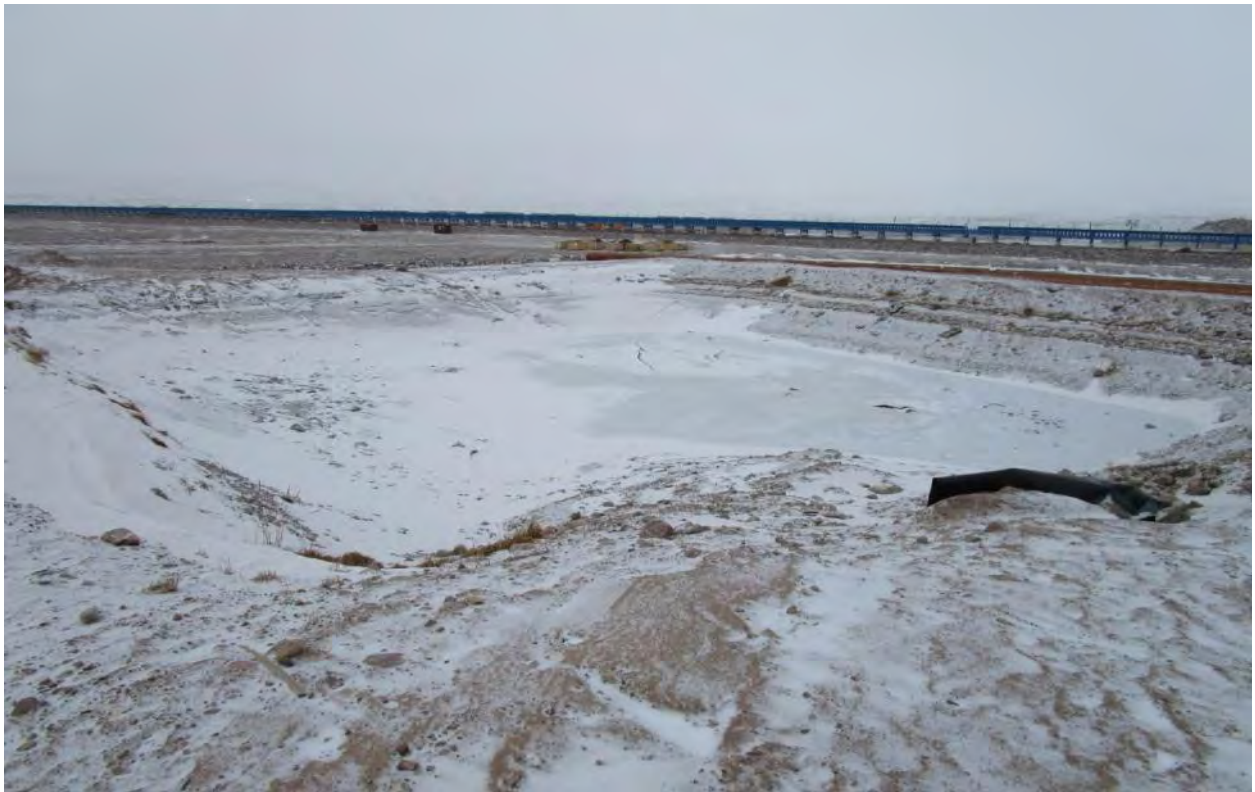
Existing PWSP now empty and being decommissioned

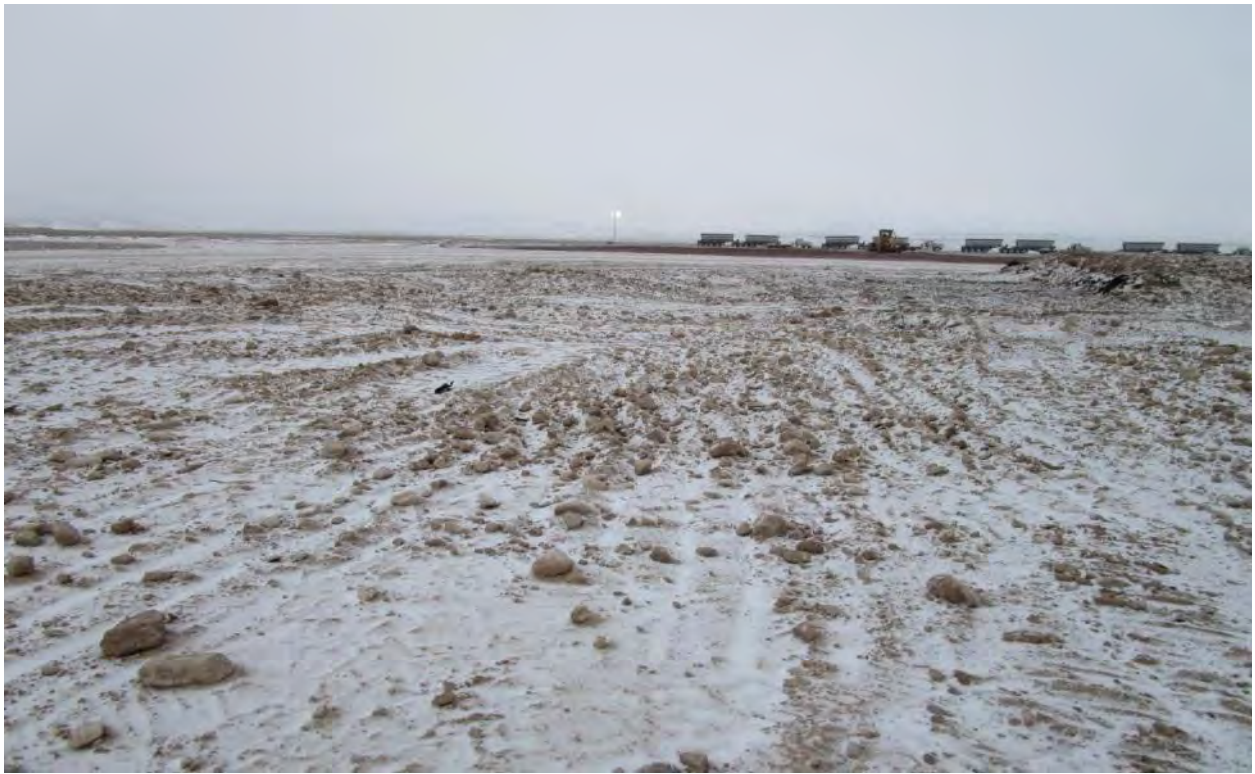
Site of recently decommissioned barrel fuel containment.

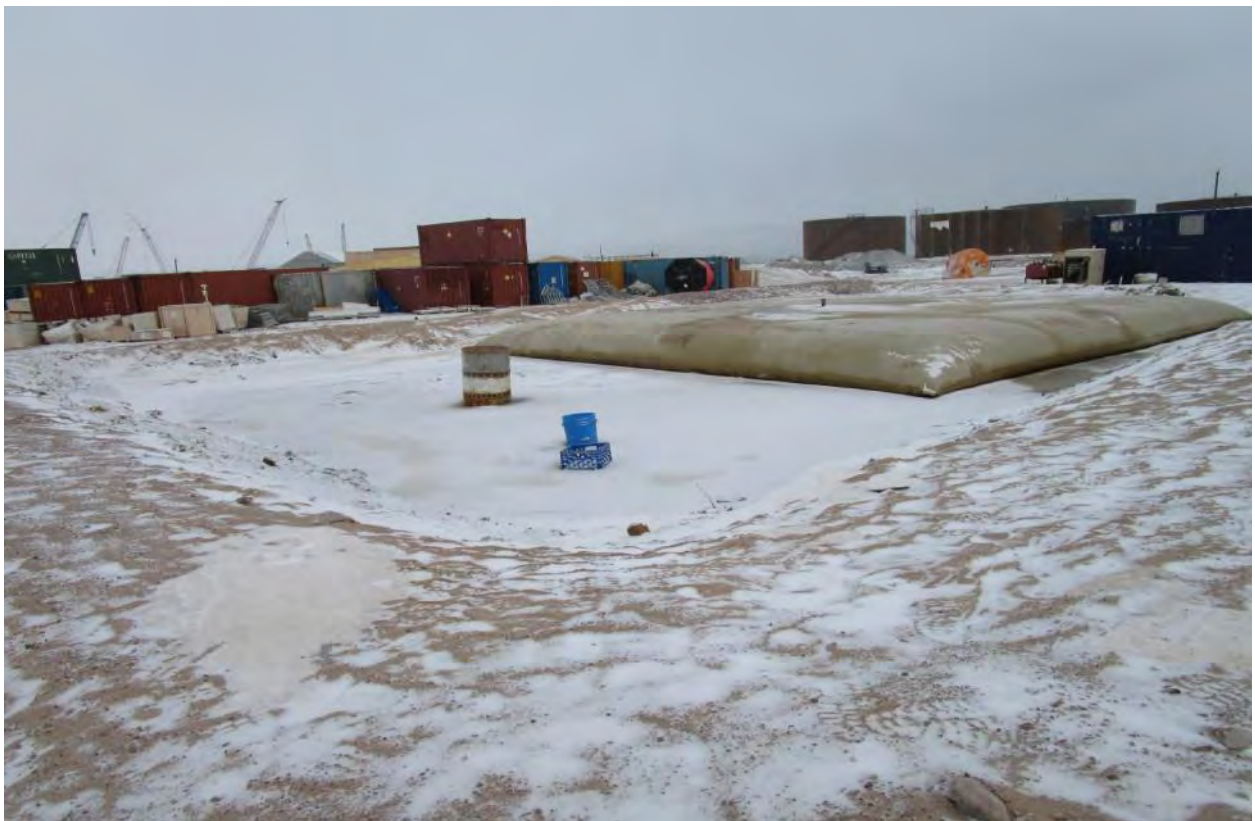
Hazardous waste storage containing bladder of contaminated material.

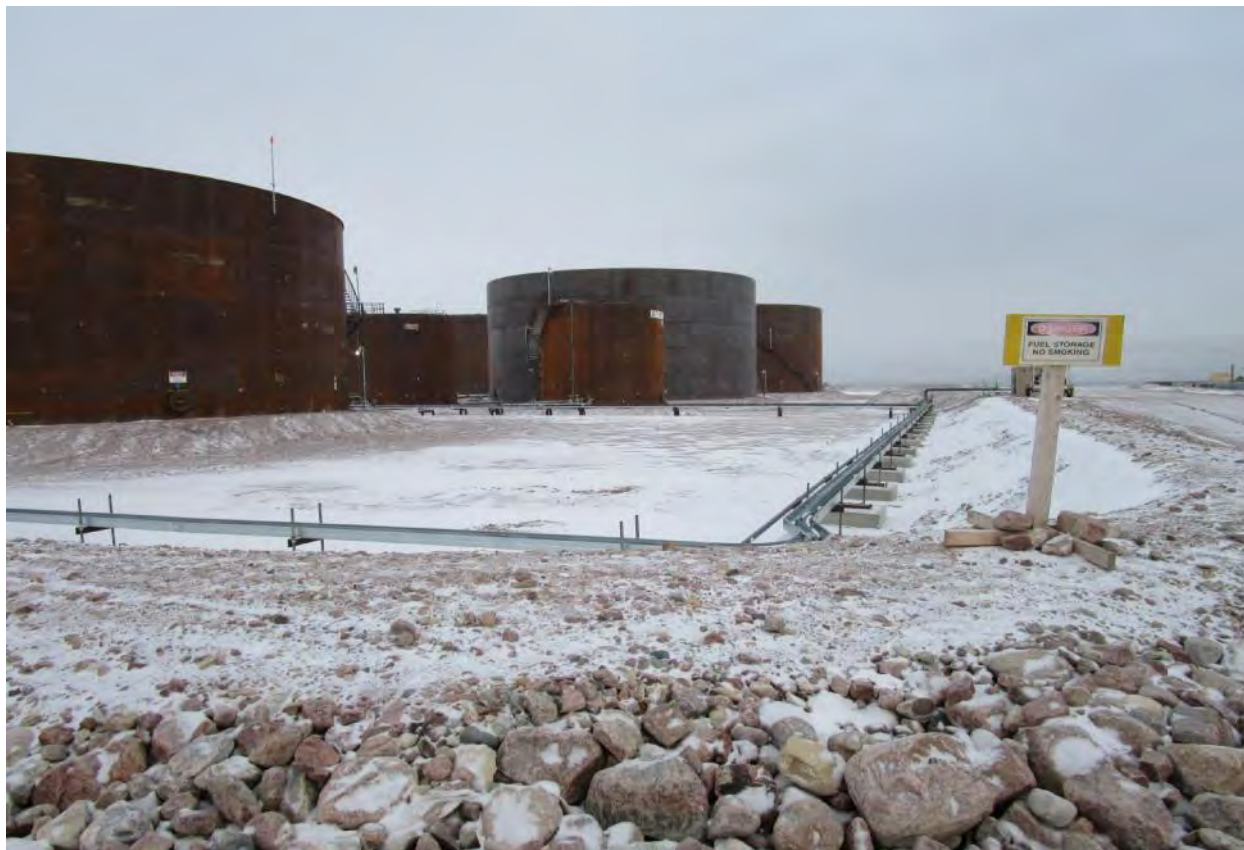
Fuel tank farm containment

At both inspections we noted minor water ponding at the low end of the containment confirming the integrity of the liner.

We have no recommendation for this structure.
